# **Pre-Dilapidation Report**

**19 GEORGE STREET**

**FRONT BUILDING (UNITS 1-19)**

Project Reference: 20250047.19G.2

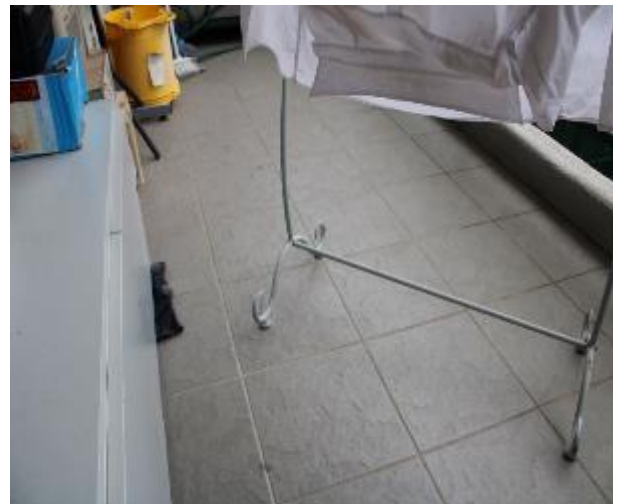
Figure 923 - General condition of balcony floor tiles

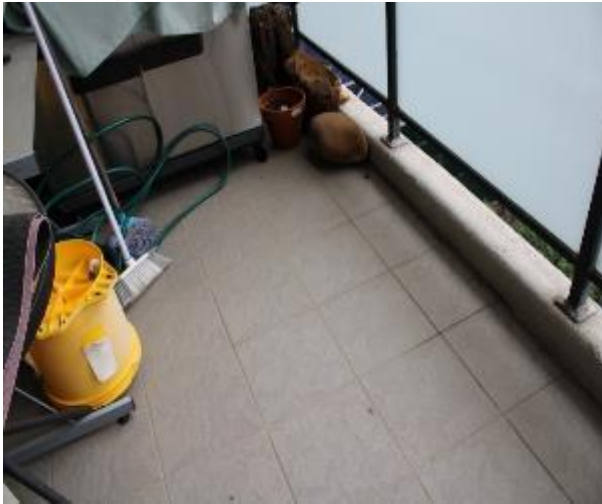
Figure 924 - General condition of balcony floor tiles

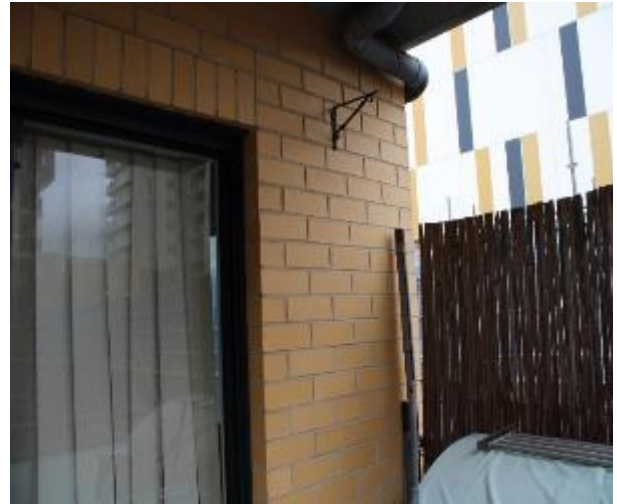
Figure 925 - General condition of external wall

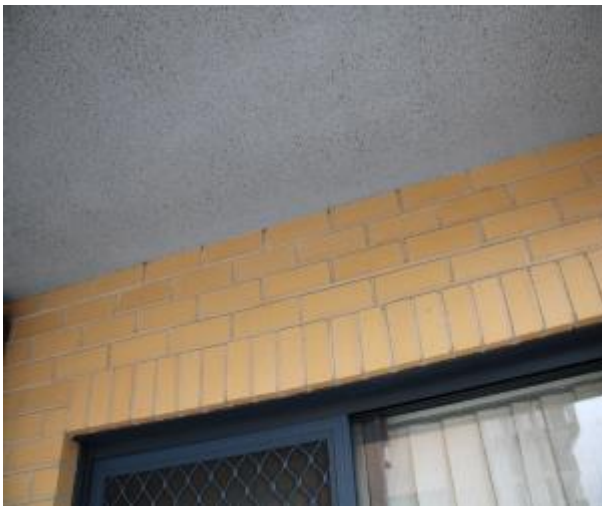
Figure 926 - General condition of external wall

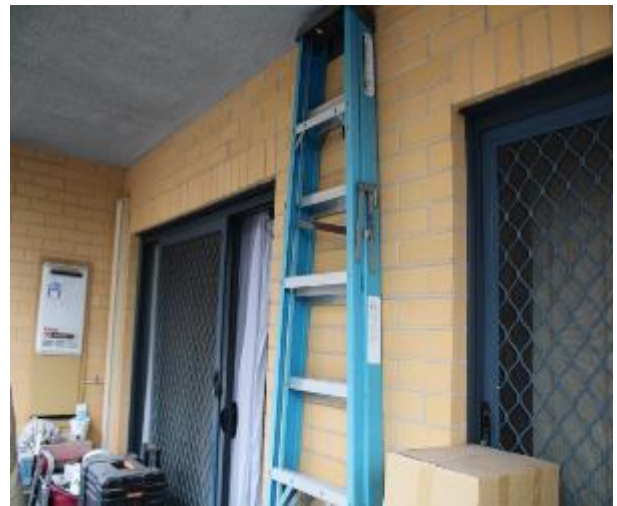
Figure 927 - General condition of external wall

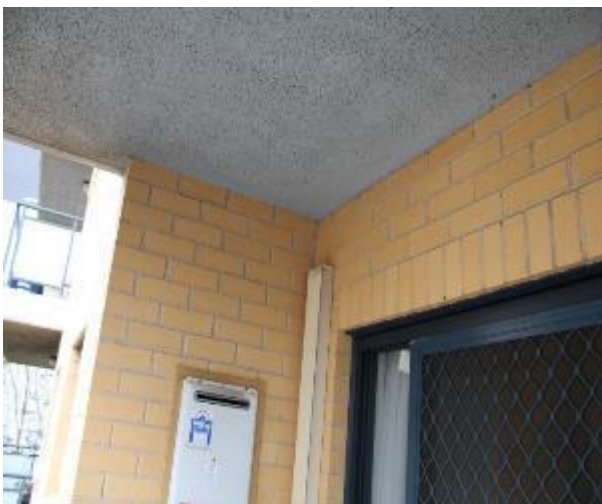
Figure 928 - General condition of external wall

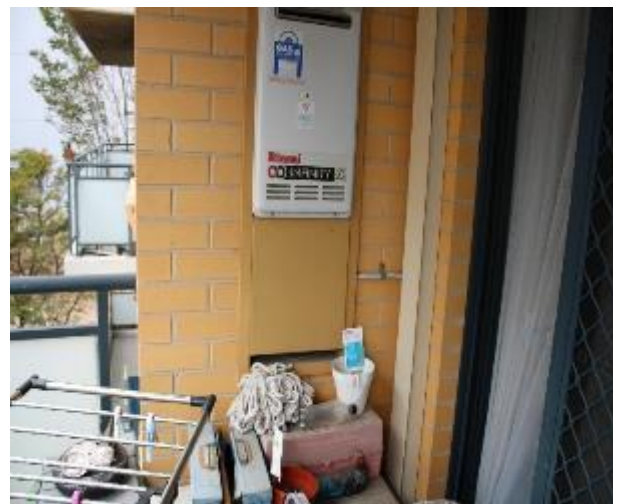
Figure 929 - General condition of external wall

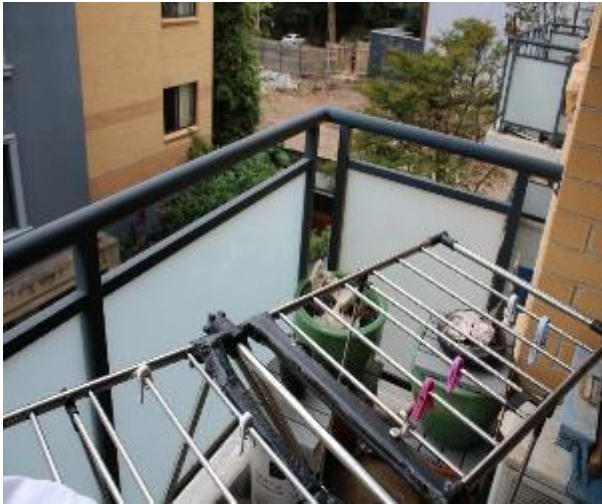
Figure 930 - General condition of balcony balustrade

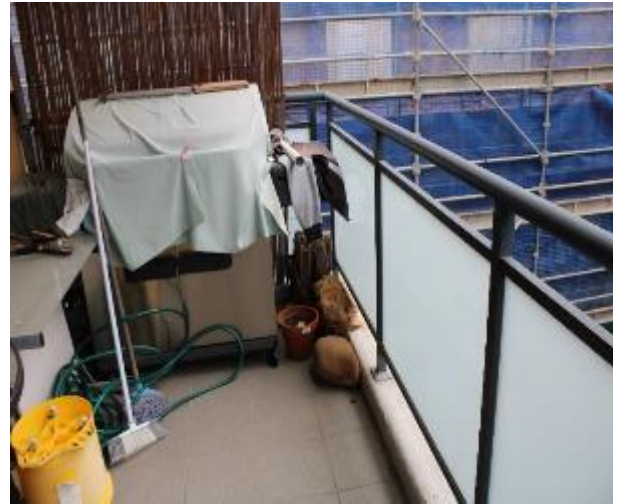
Figure 931 - General condition of balcony balustrade

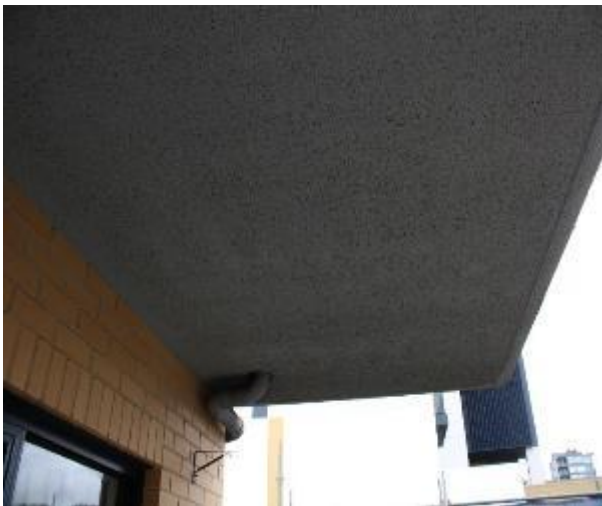
Figure 932 - General condition of balcony underside slab

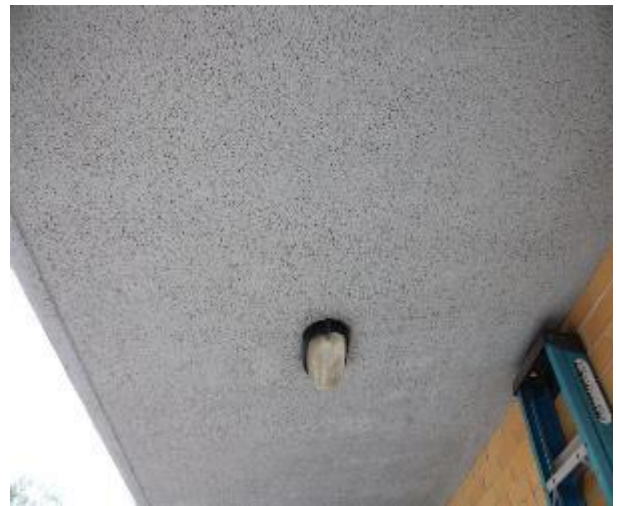
Figure 933 - General condition of balcony underside slab

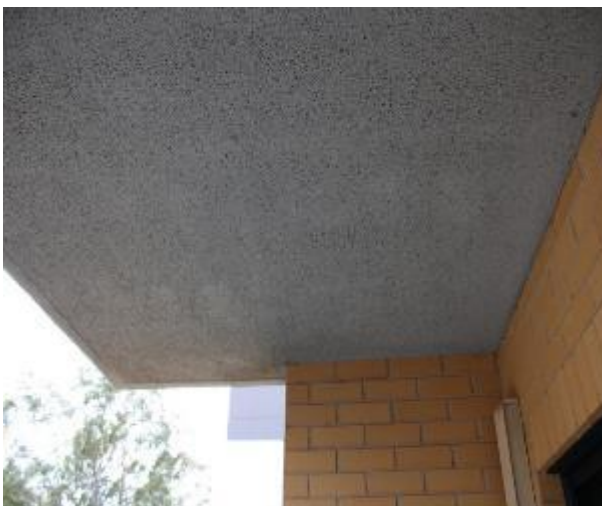
Figure 934 - General condition of balcony underside slab

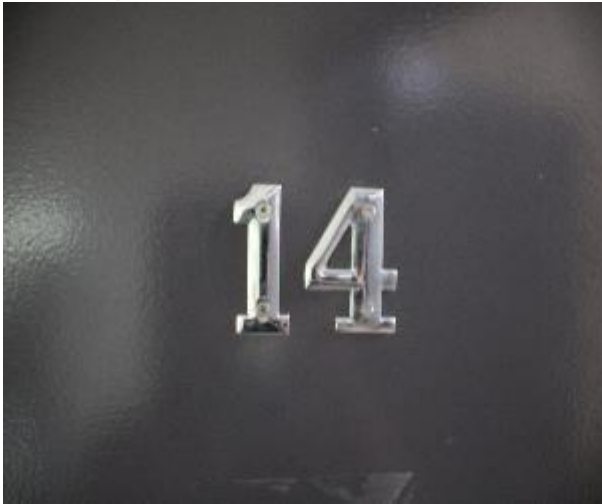
Figure 936 - The following images display the condition of Unit 14

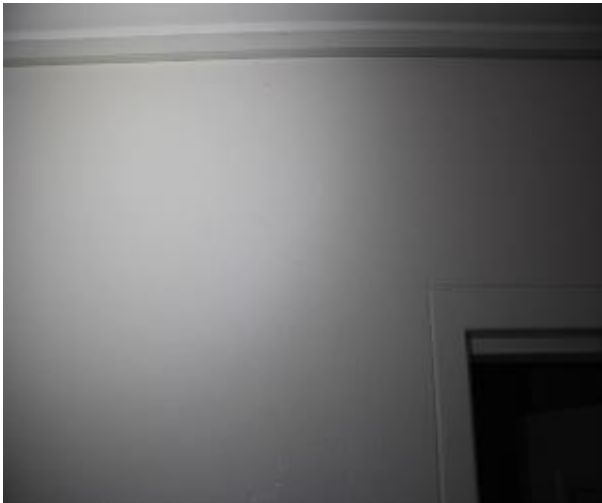
Figure 938 - Crack propagation through lounge room internal wall

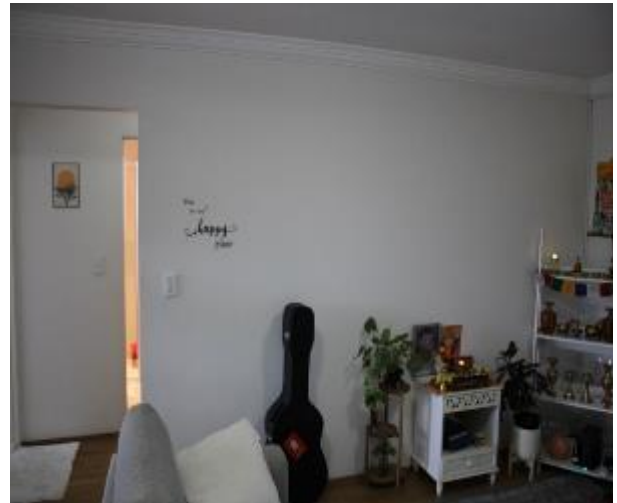
Figure 939 - General condition of lounge room internal wall

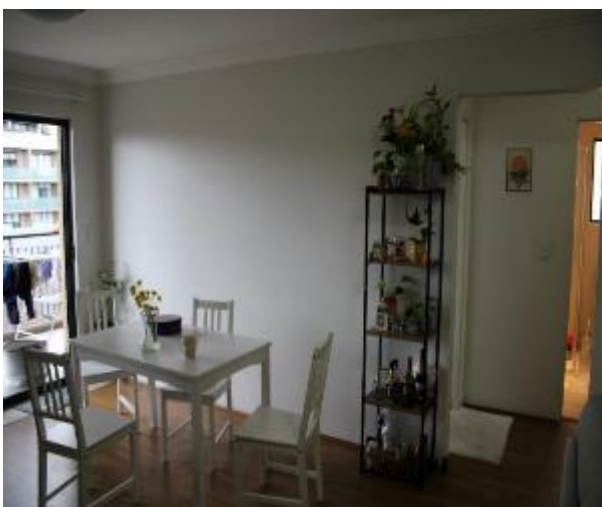
Figure 940 - General condition of lounge room internal wall

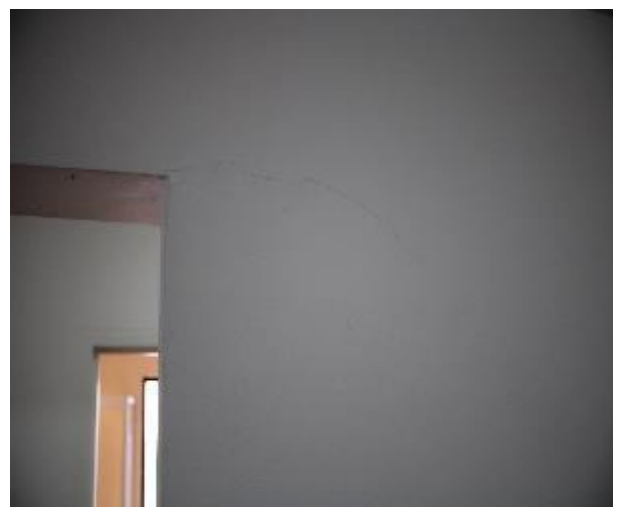
Figure 941 - Crack propagation through lounge room internal wall

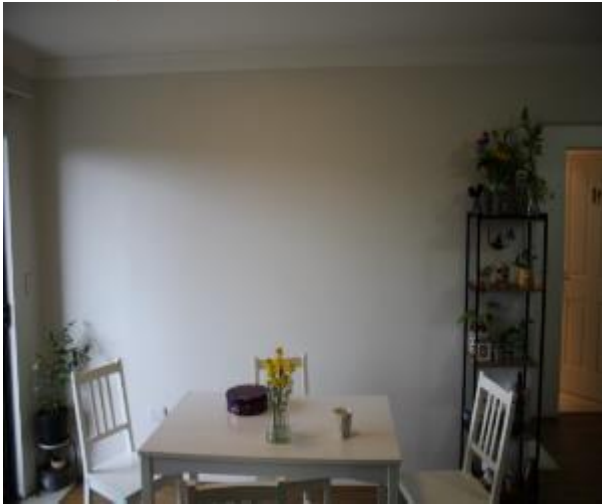
Figure 942 - General condition of lounge room internal wall

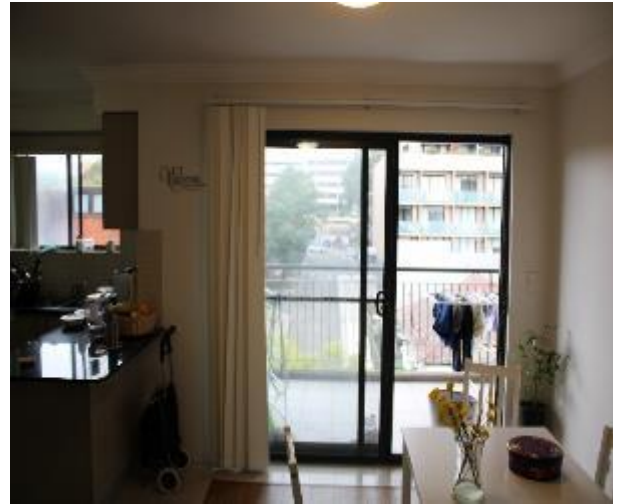
Figure 943 - General condition of lounge room internal wall

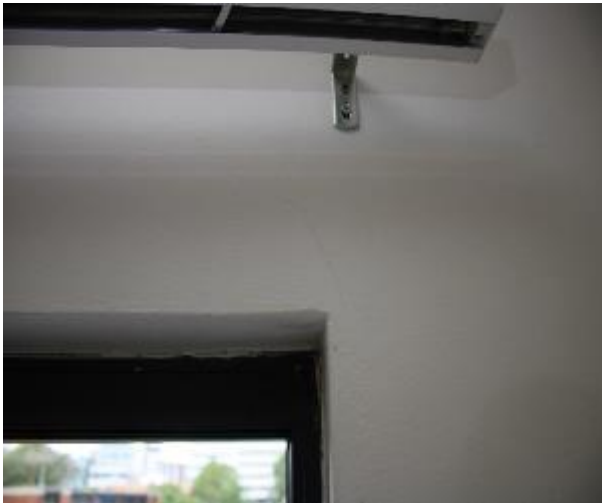
Figure 944 - Crack propagation through lounge room internal wall

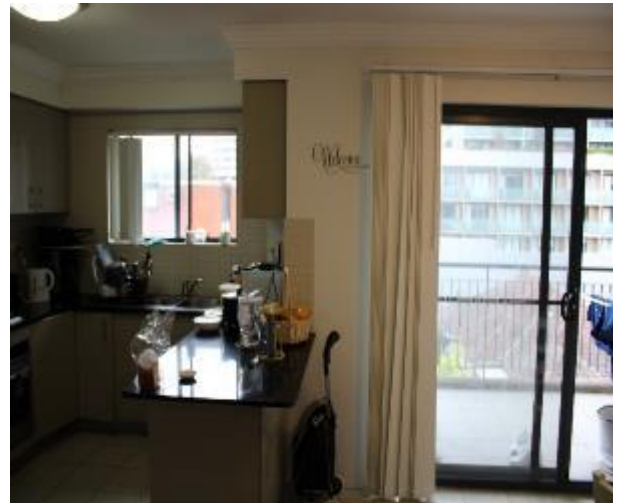
Figure 945 - General condition of lounge room internal wall

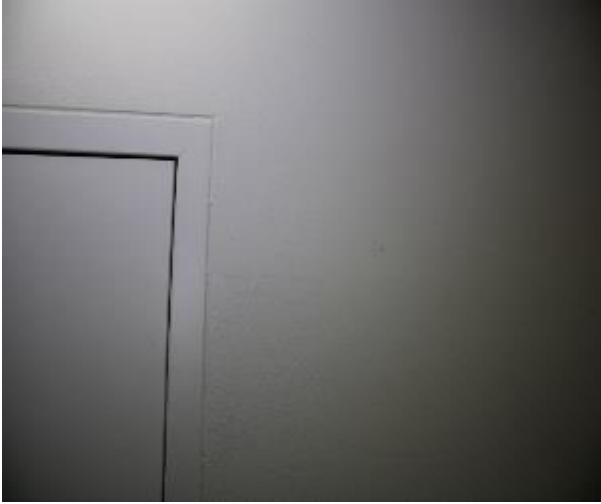
Figure 948 - Crack propagation through lounge room internal wall

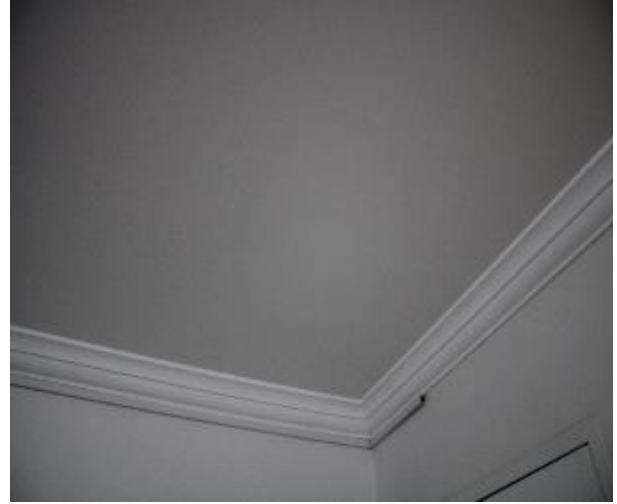
Figure 949 - General condition of lounge room ceiling

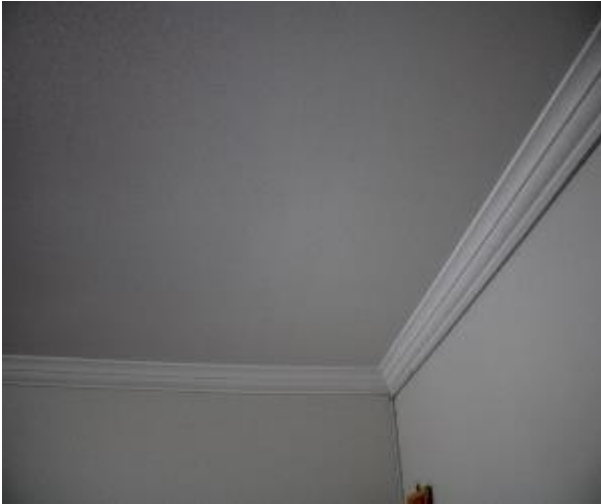
Figure 950 - General condition of lounge room ceiling

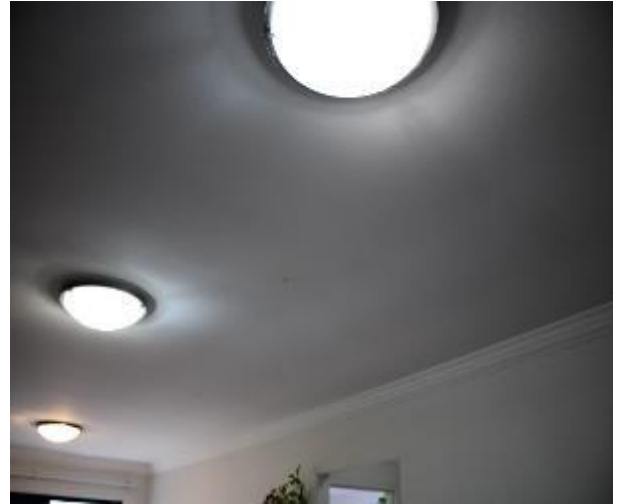
Figure 951 - General condition of lounge room ceiling

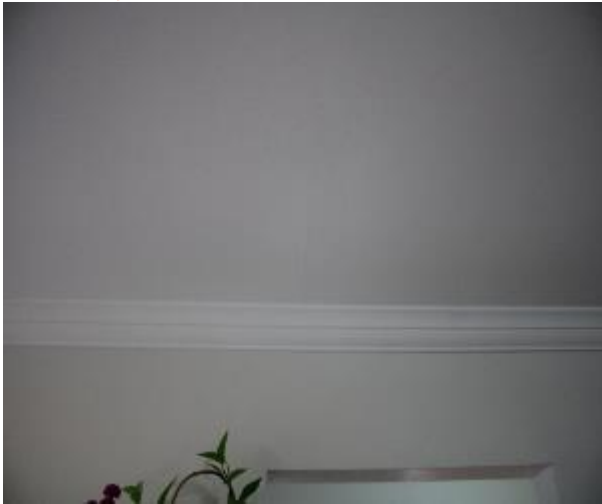
Figure 954 - Crack propagation through lounge room ceiling

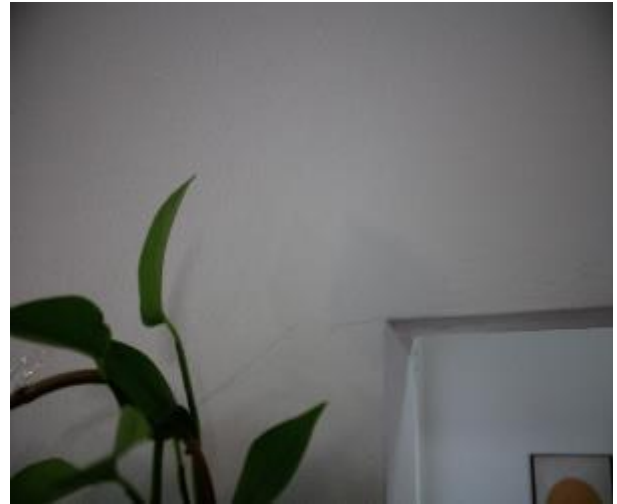
Figure 955 - Crack propagation through lounge room internal wall

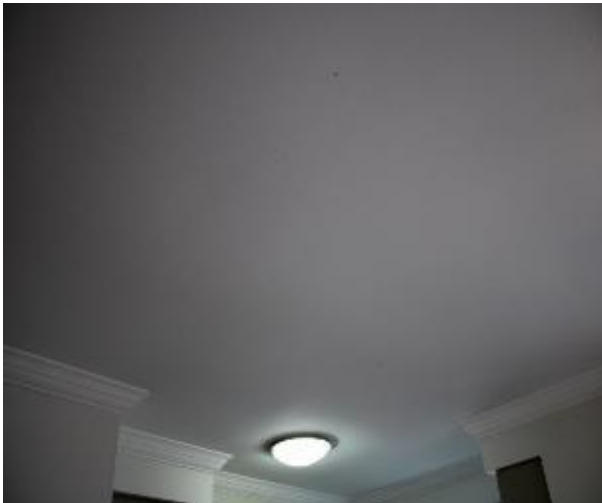
Figure 956 - General condition of lounge room ceiling

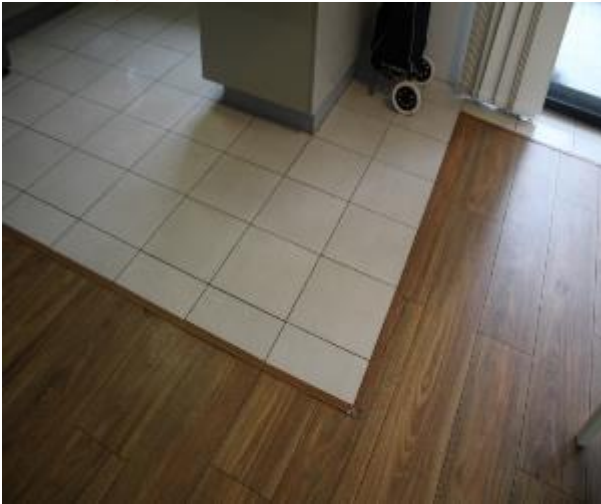
Figure 959 - General condition of kitchen floor tiles

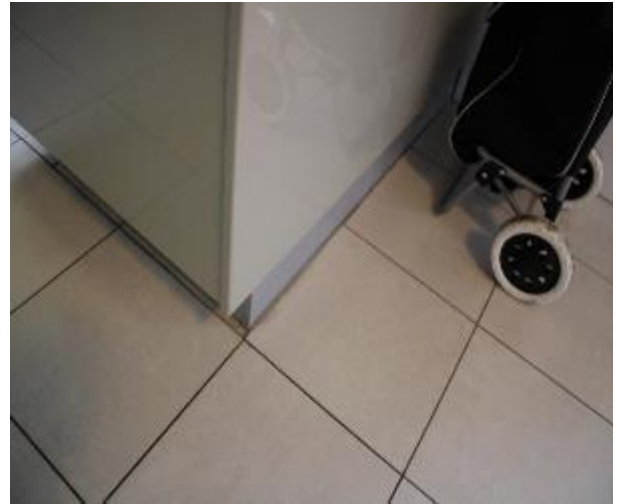
Figure 960 - General condition of kitchen floor tiles

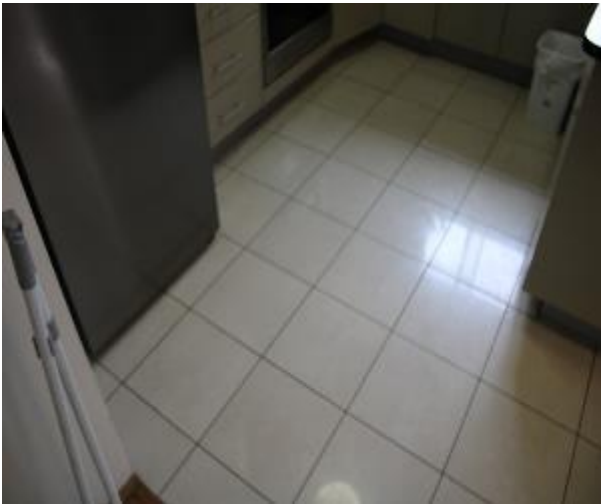
Figure 961 - General condition of kitchen floor tiles

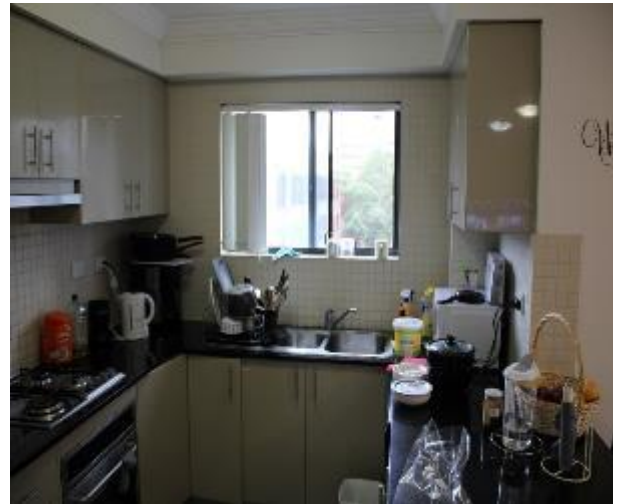
Figure 962 - General condition of kitchen floor tiles

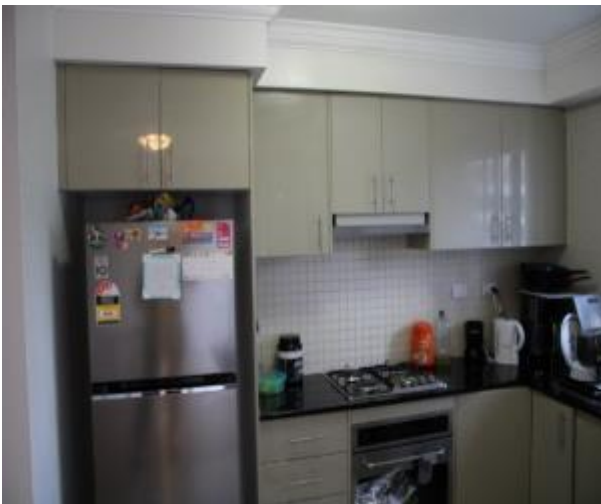
Figure 963 - General condition of kitchen internal wall

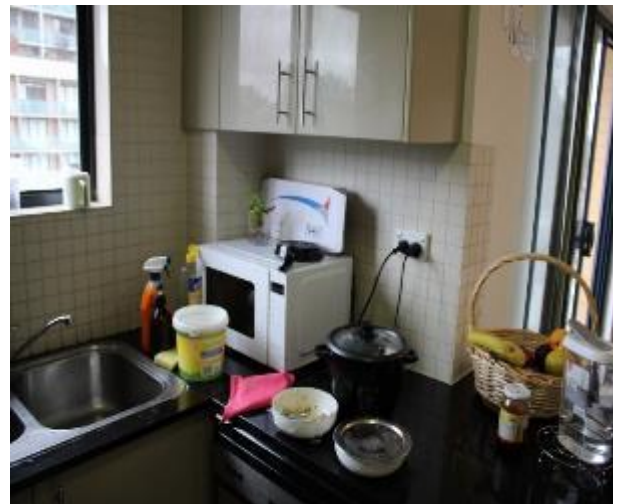
Figure 964 - General condition of kitchen internal wall

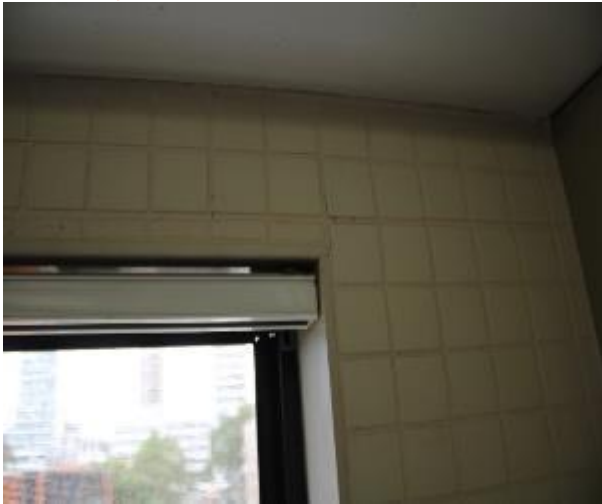
Figure 965 - General condition of kitchen internal wall

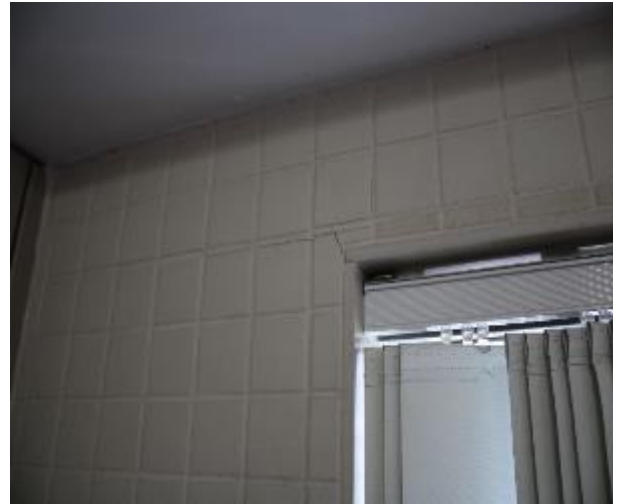
Figure 966 - Crack propagation through kitchen internal wall

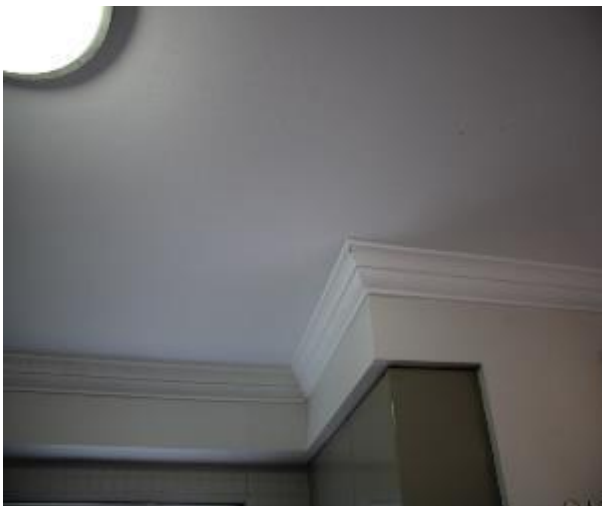
Figure 967 - Crack propagation through kitchen internal wall

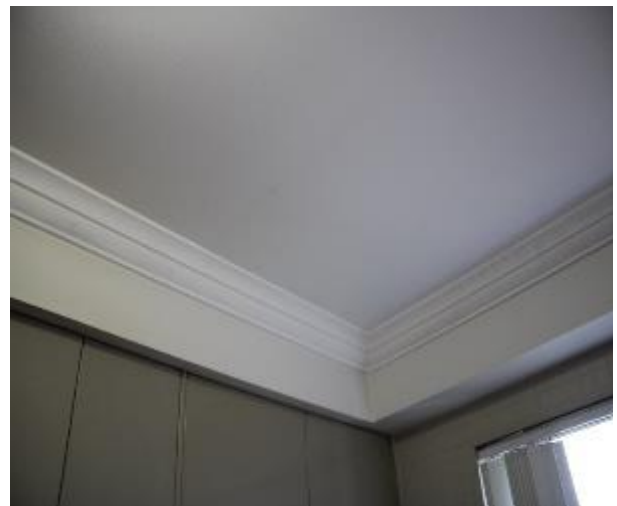
Figure 968 - General condition of kitchen ceiling

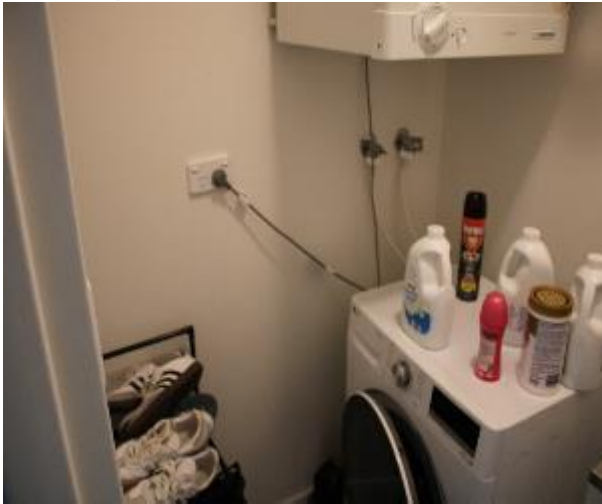
Figure 971 - General condition of laundry floor tiles

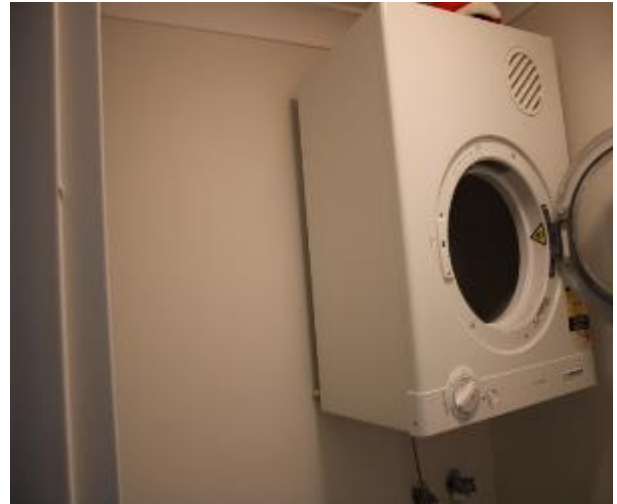
Figure 972 - General condition of laundry internal wall

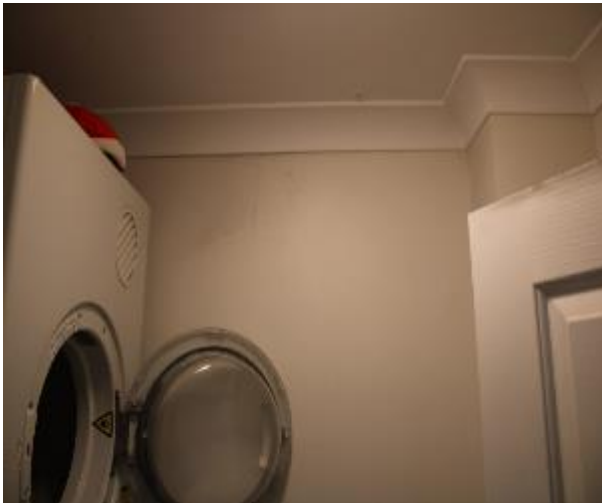
Figure 973 - General condition of laundry internal wall

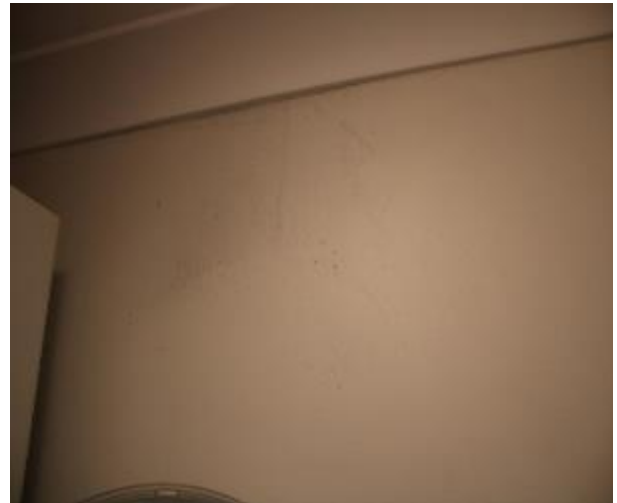
Figure 974 - General condition of laundry internal wall

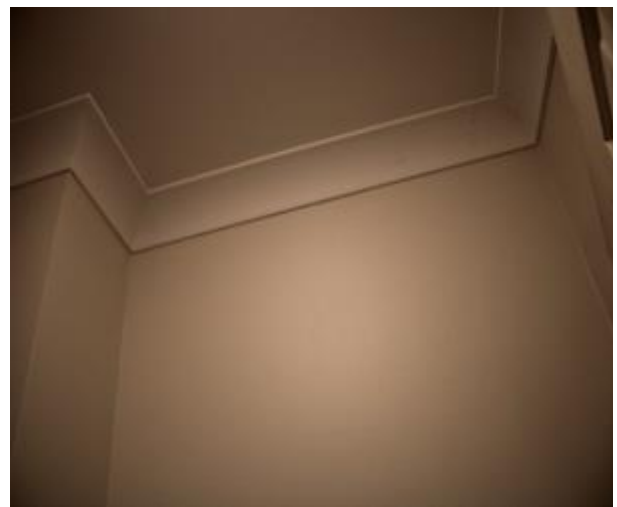
Figure 976 - General condition of laundry internal wall

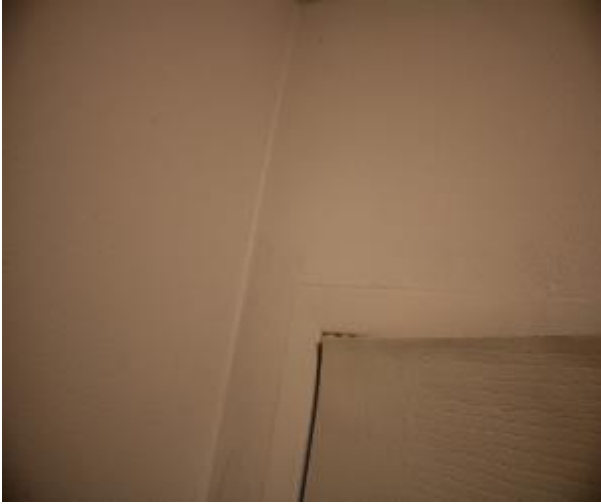
Figure 977 - General condition of laundry internal wall

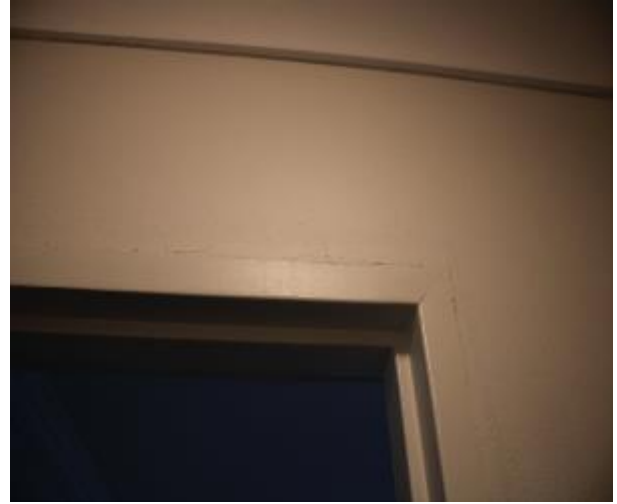
Figure 978 - Crack propagation through laundry internal wall

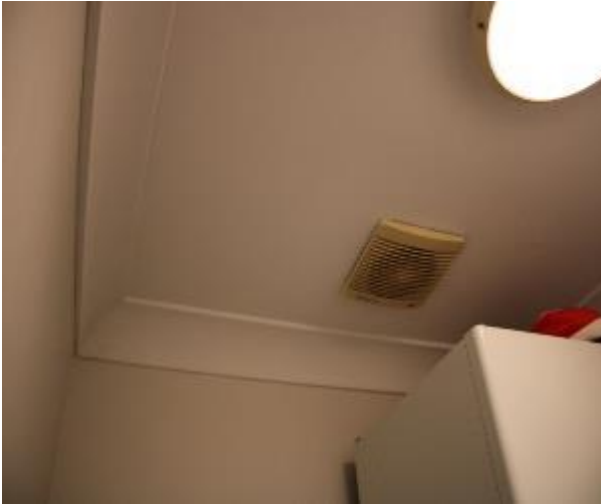
Figure 979 - Crack propagation through laundry internal wall

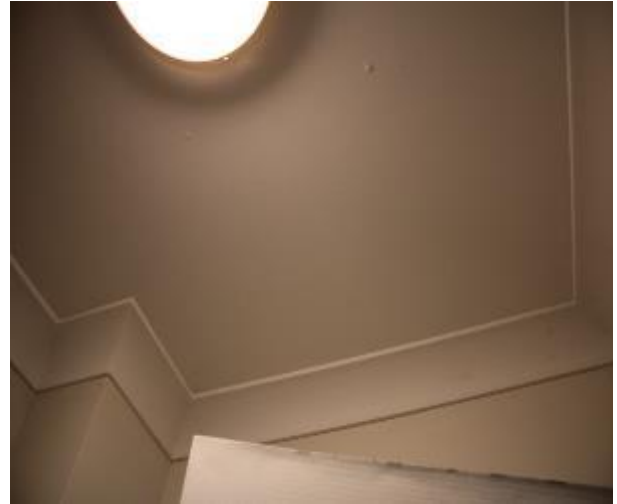
Figure 980 - General condition of laundry ceiling

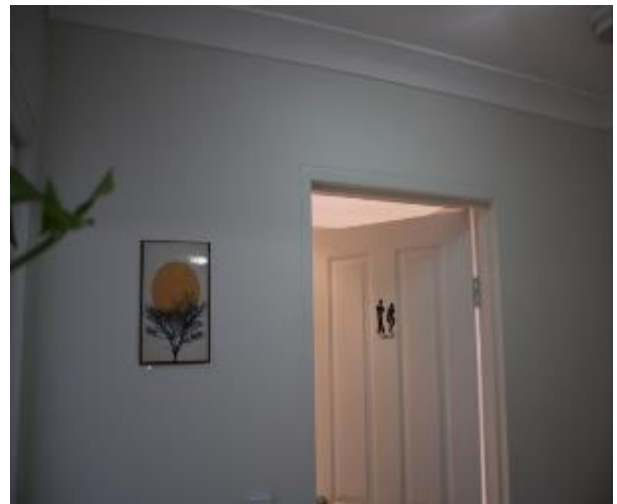
Figure 982 - General condition of corridor internal wall

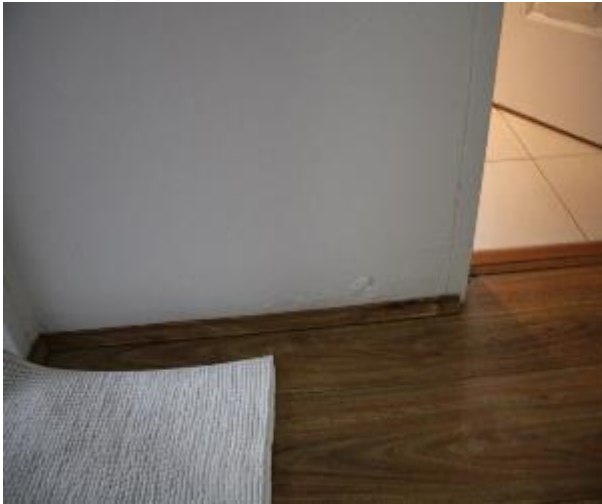
Figure 983 - General condition of corridor internal wall

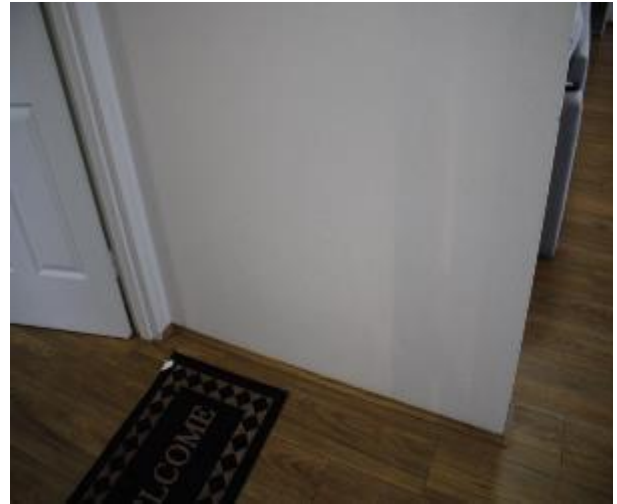
Figure 984 - Paint flaking through corridor internal wall

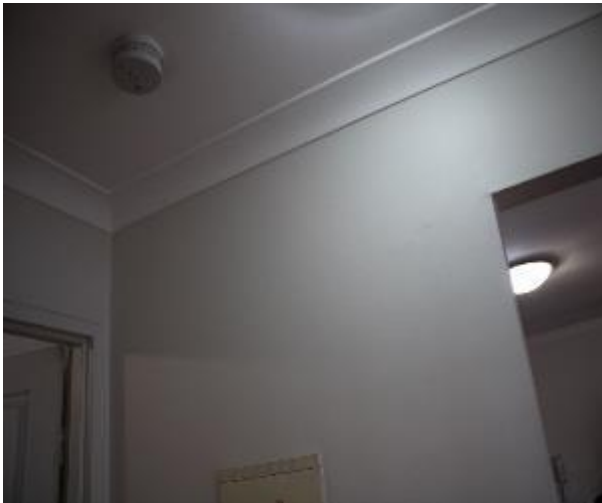
Figure 985 - General condition of corridor internal wall

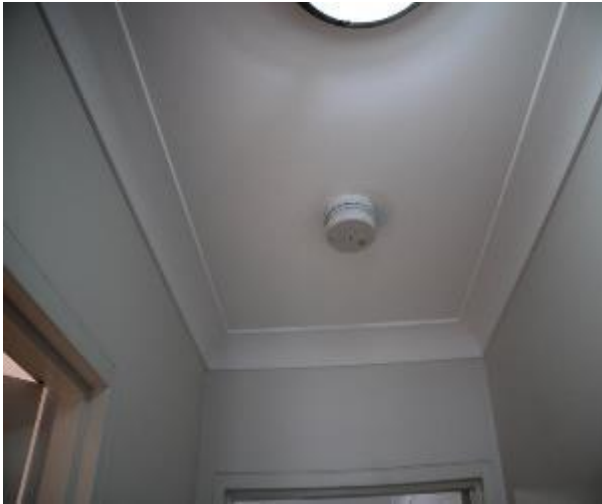
Figure 989 - General condition of corridor ceiling

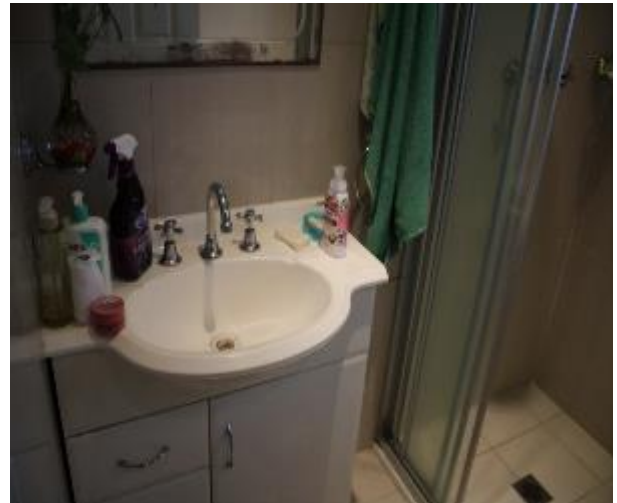
Figure 992 - General condition of bathroom 1 floor tiles

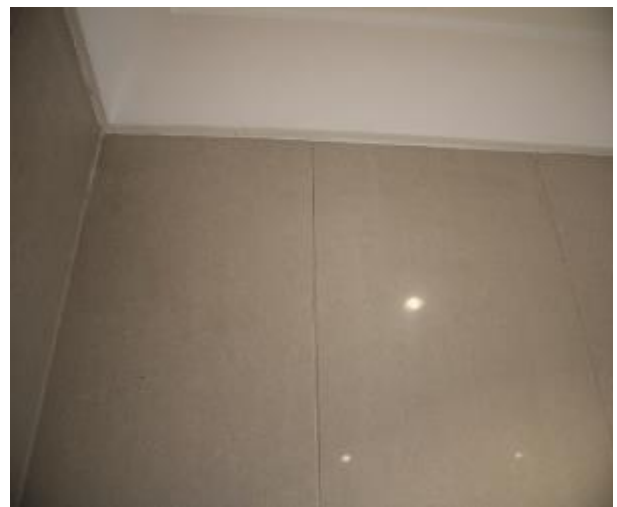
Figure 994 - General condition of bathroom 1 internal wall

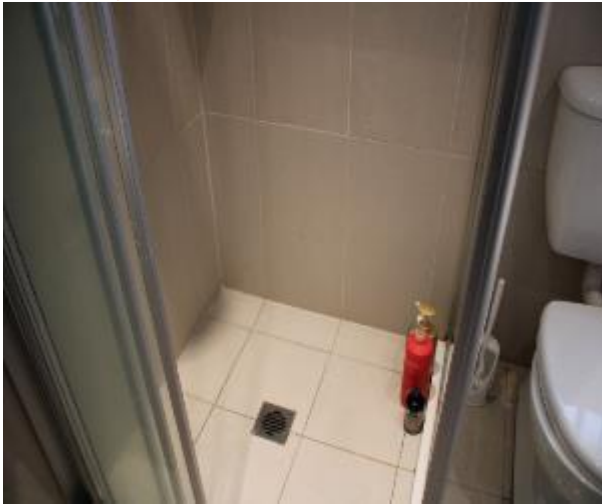
Figure 995 - Crack propagation through bathroom 1 internal wall

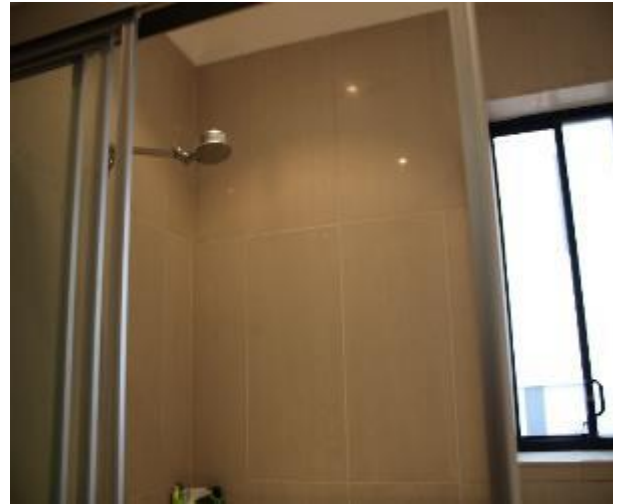
Figure 996 - General condition of bathroom 1 internal wall

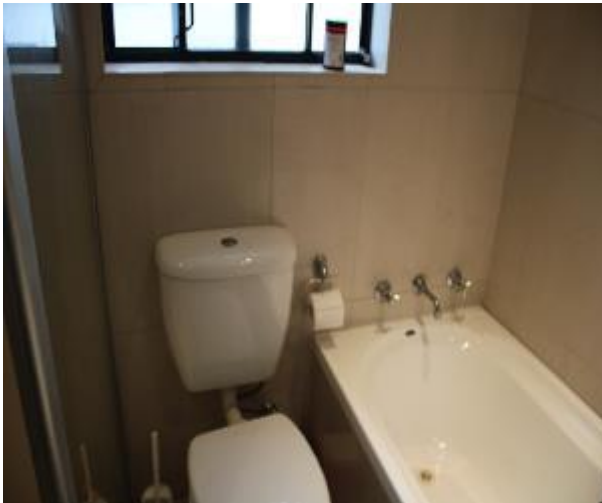
Figure 997 - General condition of bathroom 1 internal wall

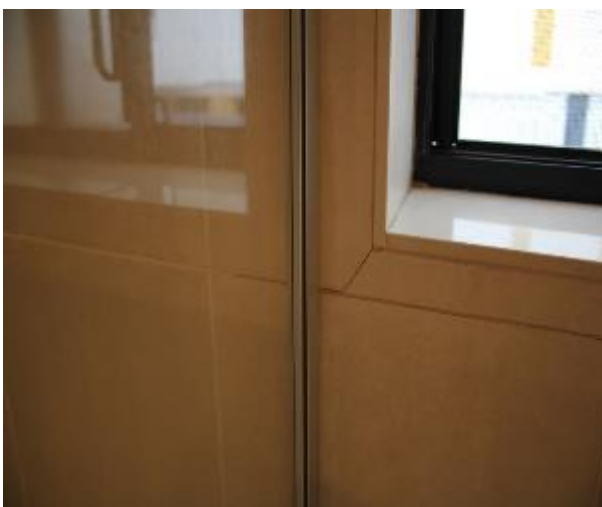
Figure 1000 - Crack propagation through bathroom 1 internal wall

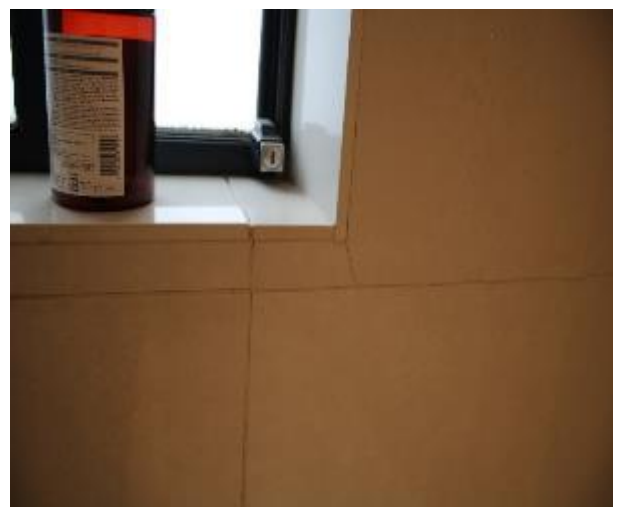
Figure 1001 - Crack propagation through bathroom 1 internal wall

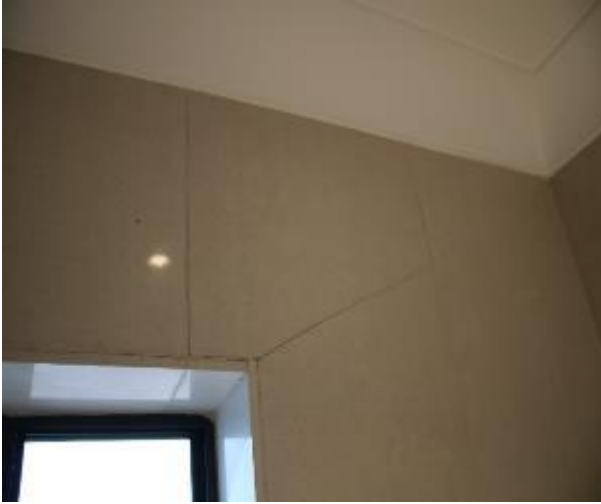
Figure 1002 - Crack propagation through bathroom 1 internal wall

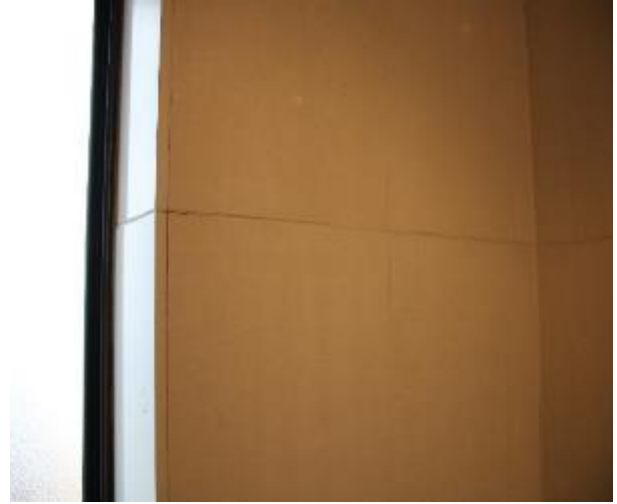
Figure 1003 - Crack propagation through bathroom 1 internal wall

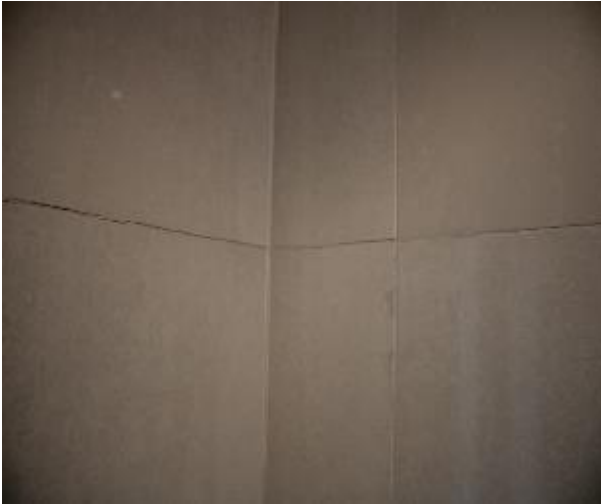
Figure 1004 - Crack propagation through bathroom 1 internal wall

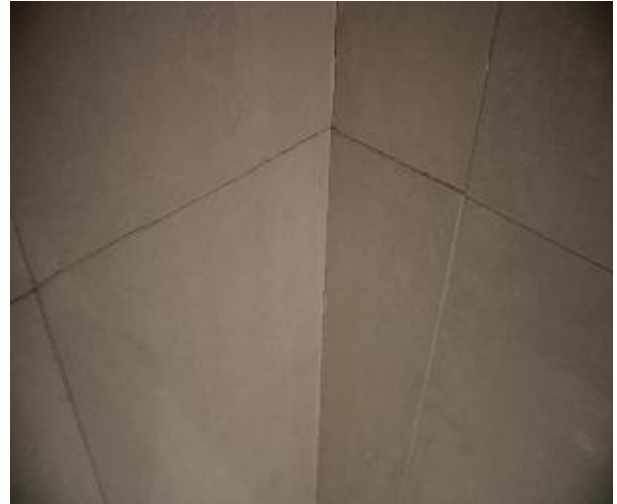
Figure 1005 - Crack propagation through bathroom 1 internal wall

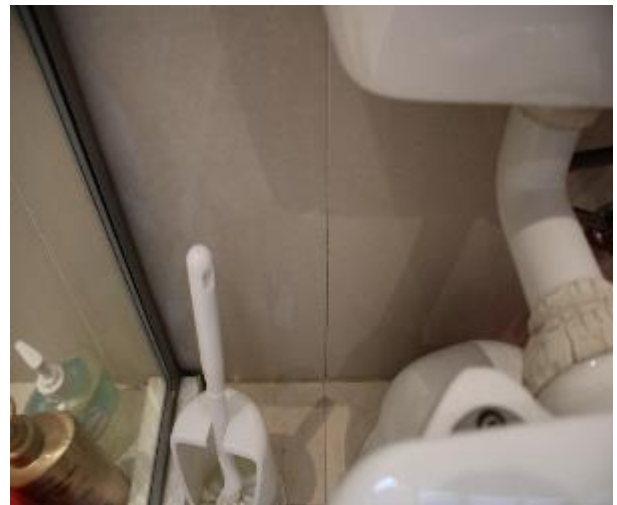
Figure 1007 - Crack propagation through bathroom 1 internal wall

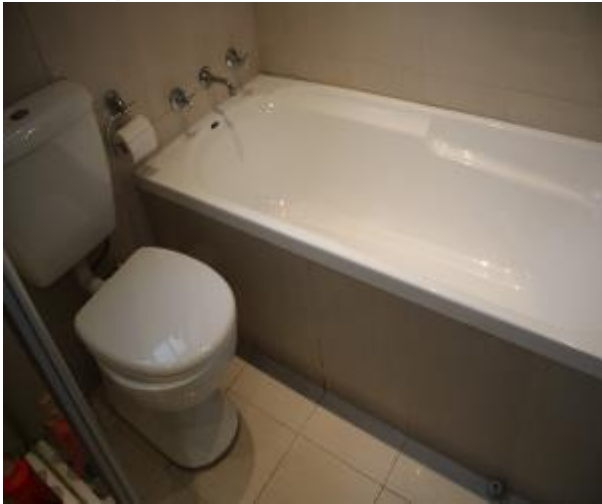
Figure 1008 - General condition of bathroom 1 internal wall

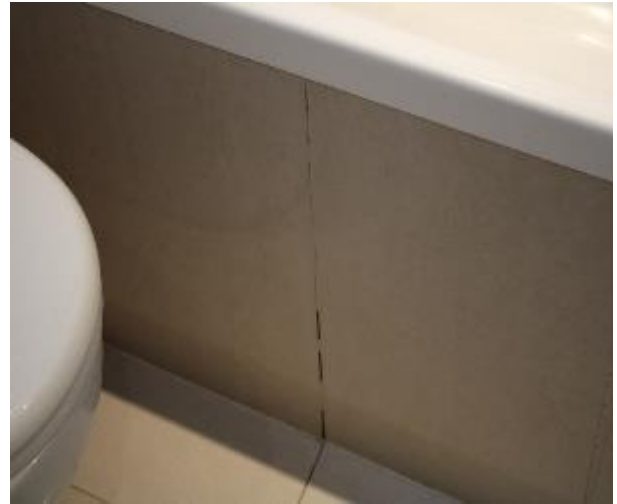
Figure 1009 - Crack propagation through bathroom 1 internal wall

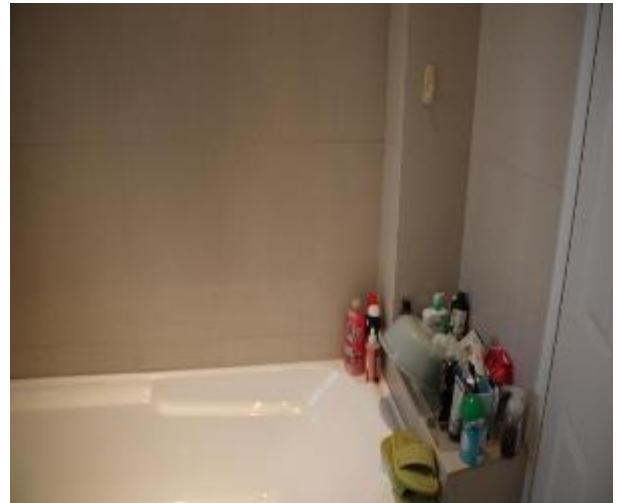
Figure 1011 - General condition of bathroom 1 internal wall

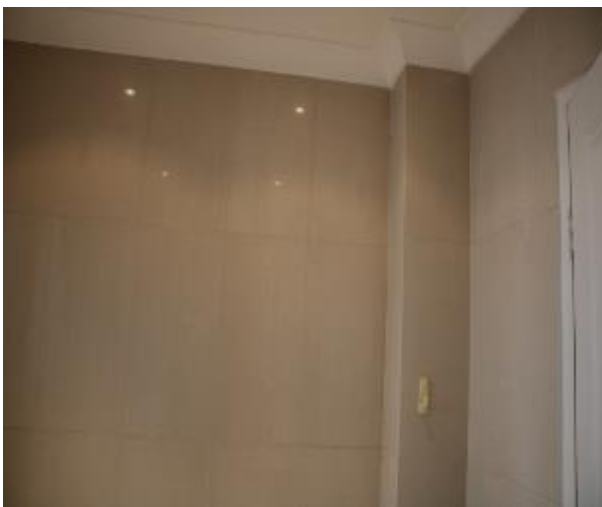
Figure 1012 - General condition of bathroom 1 internal wall

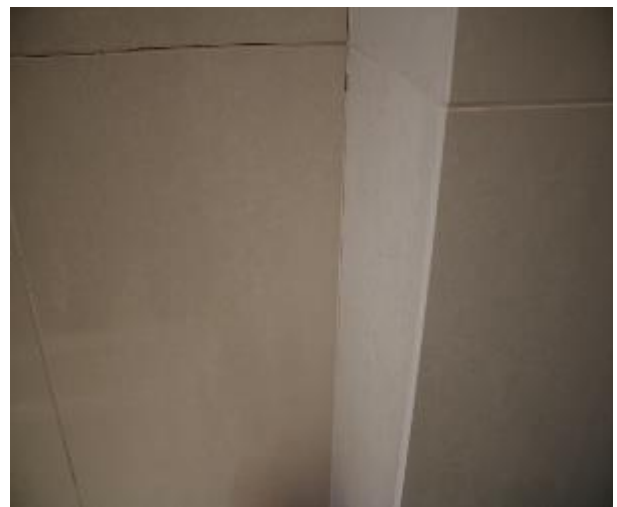
Figure 1013 - Crack propagation through bathroom 1 internal wall

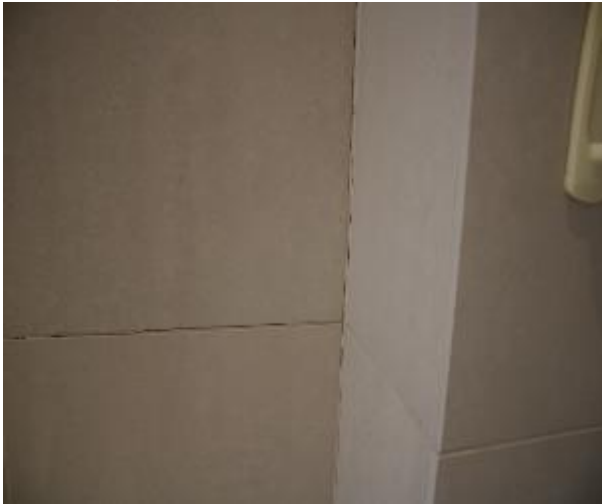
Figure 1014 - Crack propagation through bathroom 1 internal wall

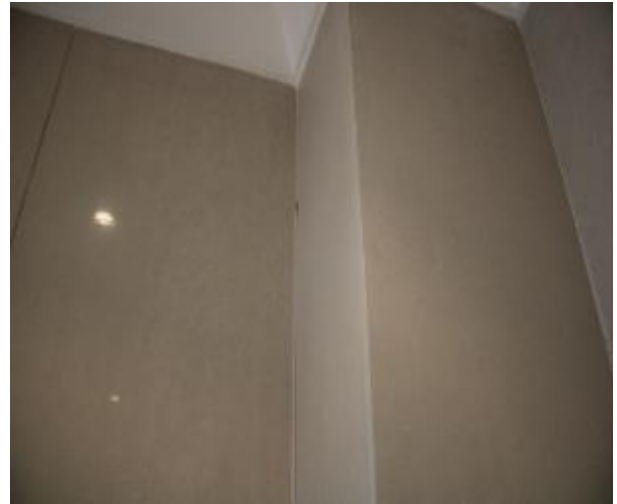
Figure 1015 - Crack propagation through bathroom 1 internal wall
