# **Pre-Dilapidation Report**

**19 GEORGE STREET**

**FRONT BUILDING (UNITS 1-19)**

Project Reference: 20250047.19G.2

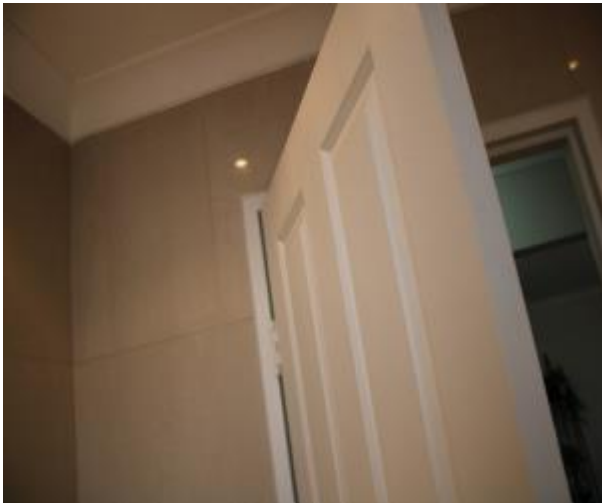
Figure 1016 - General condition of bathroom 1 internal wall

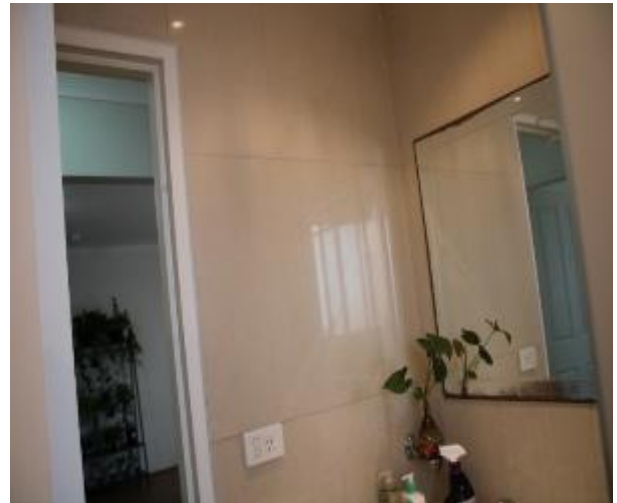
Figure 1017 - General condition of bathroom 1 internal wall

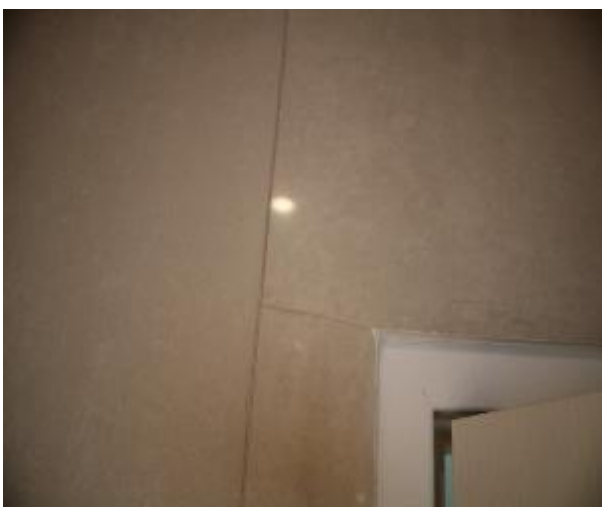
Figure 1018 - Crack propagation through bathroom 1 internal wall

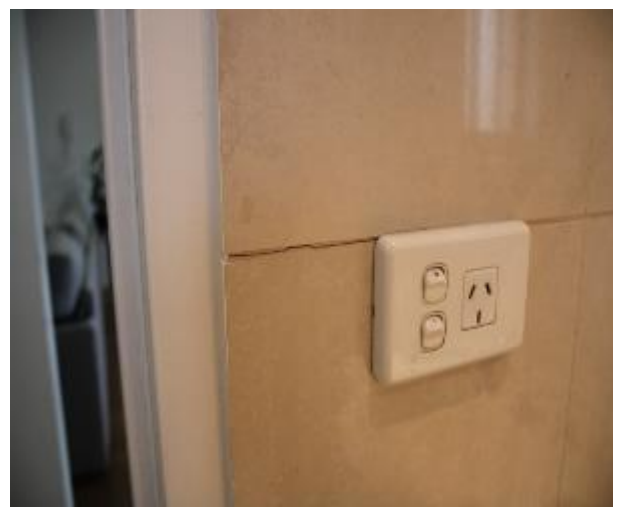
Figure 1019 - Crack propagation through bathroom 1 internal wall

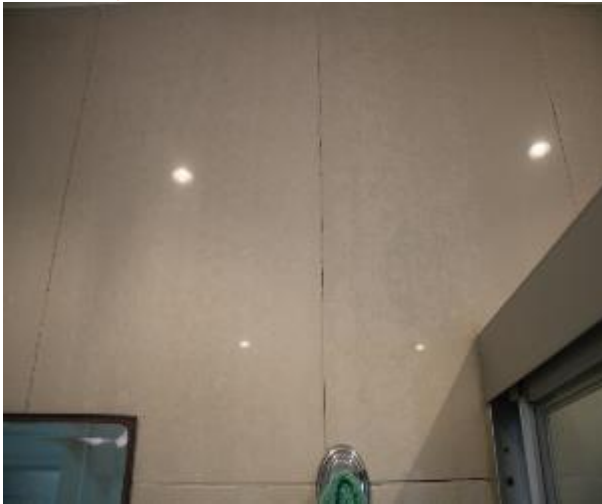
Figure 1020 - Crack propagation through bathroom 1 internal wall

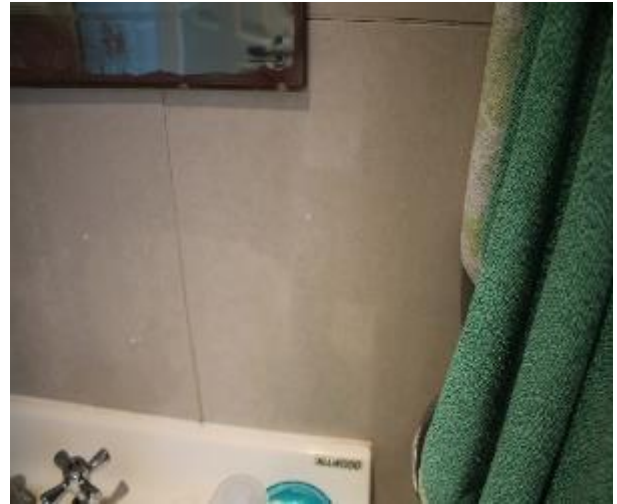
Figure 1021 - General condition of bathroom 1 internal wall

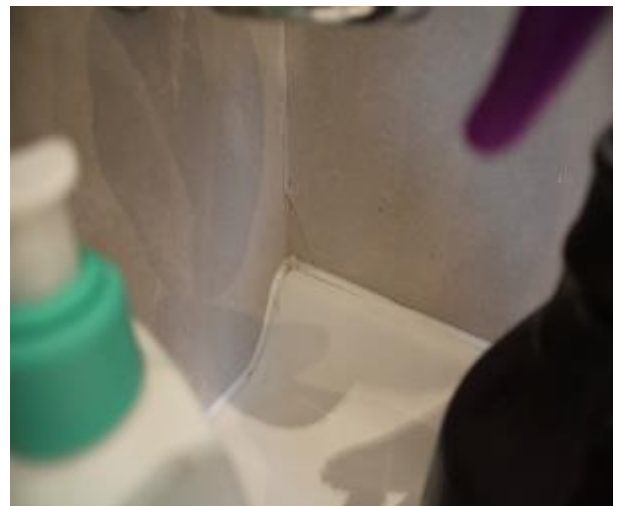
Figure 1023 - Crack propagation through bathroom 1 internal wall

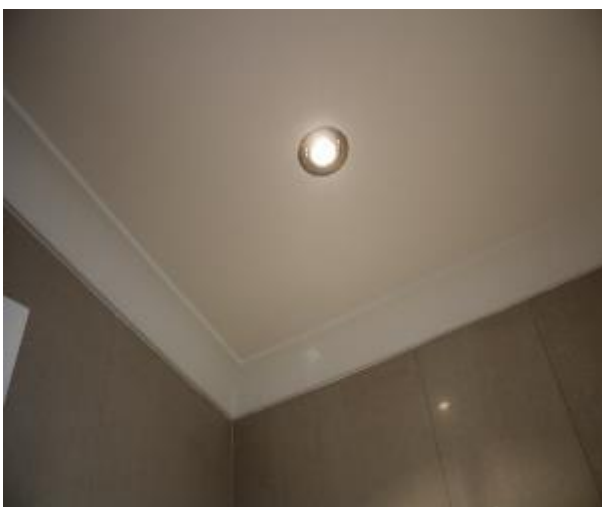
Figure 1024 - General condition of bathroom 1 ceiling

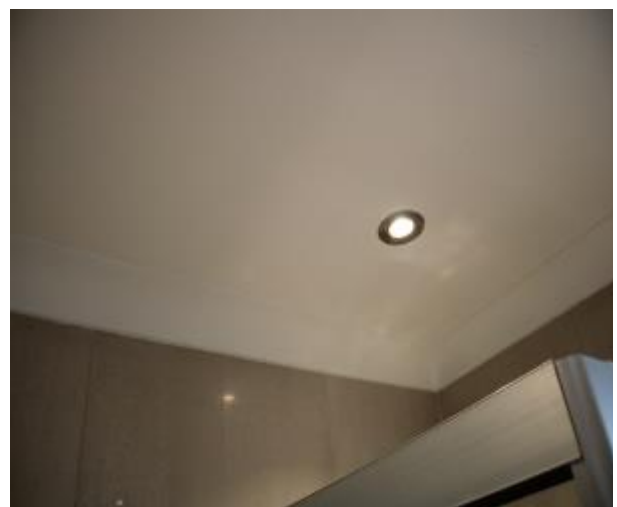
Figure 1025 - General condition of bathroom 1 ceiling

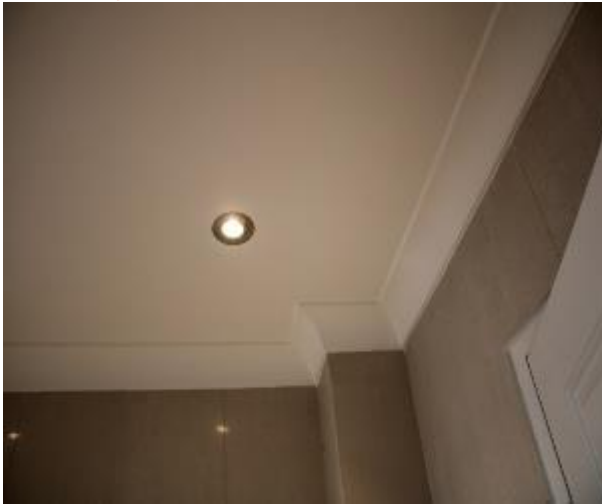
Figure 1026 - General condition of bathroom 1 ceiling

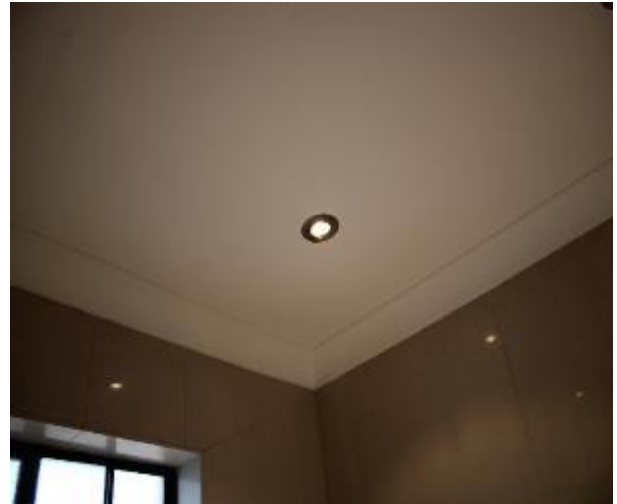
Figure 1027 - General condition of bathroom 1 ceiling

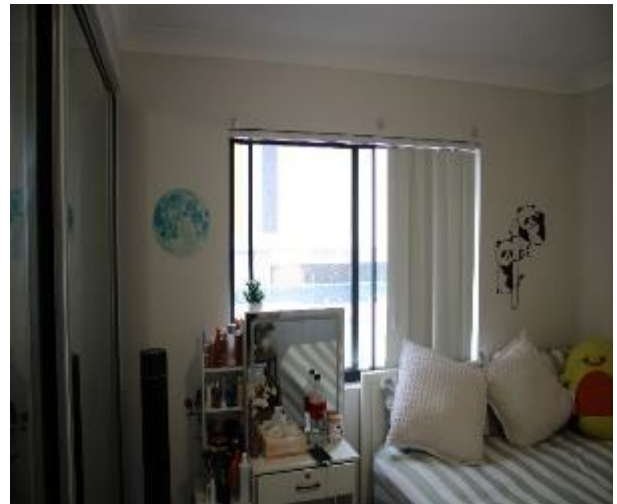
Figure 1029 - General condition of bedroom 1 internal wall

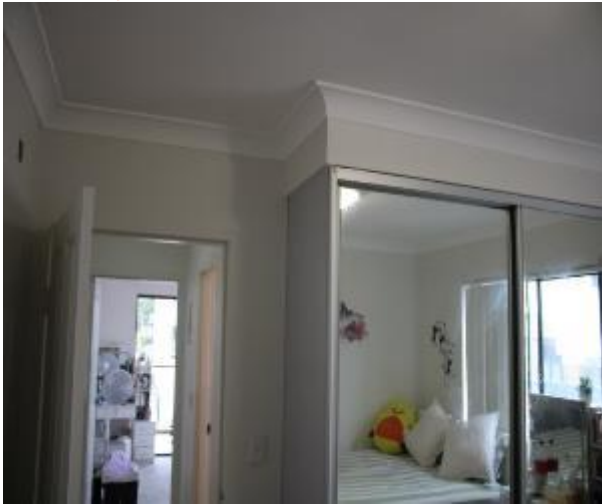
Figure 1032 - General condition of bedroom 1 internal wall

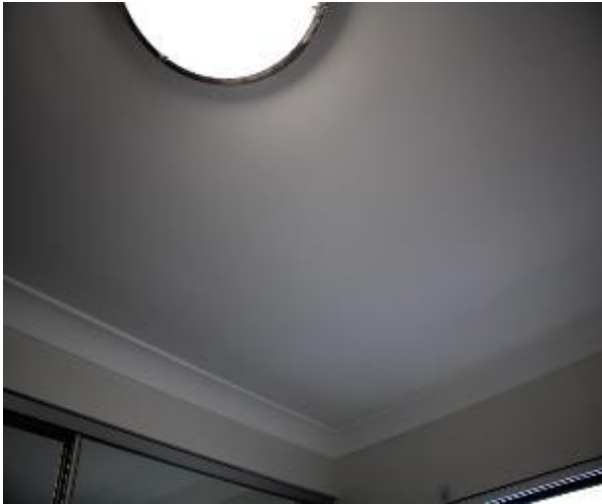
Figure 1038 - General condition of bedroom 1 ceiling

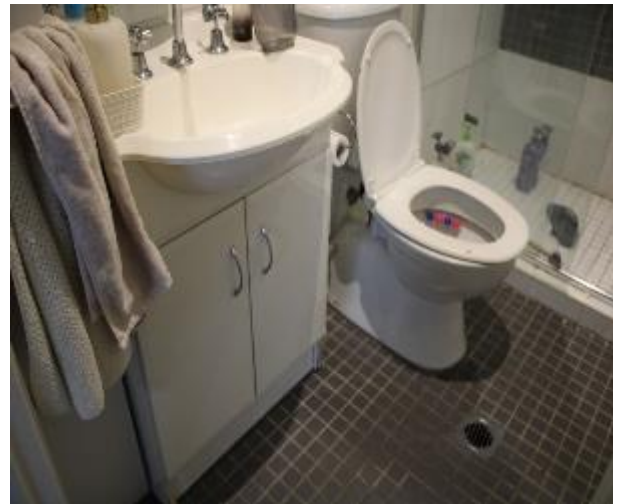
Figure 1041 - General condition of ensuite bathroom floor tiles

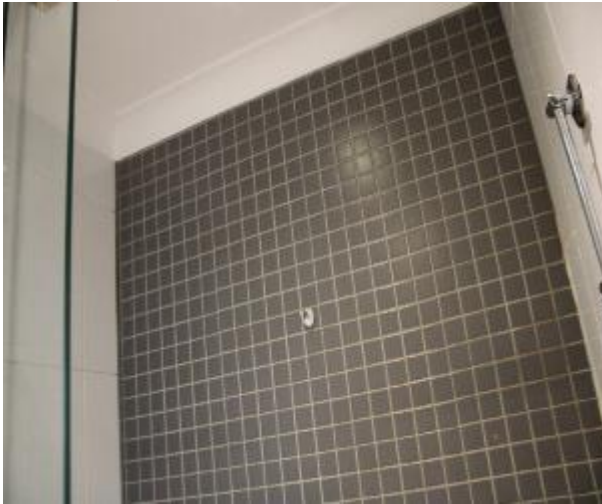
Figure 1044 - General condition of ensuite bathroom internal wall

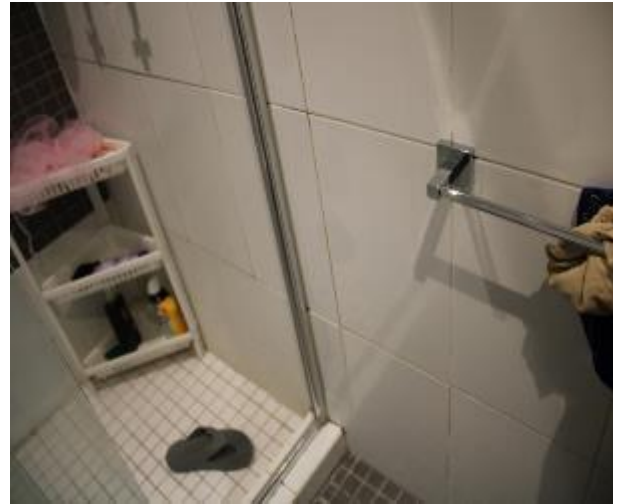
Figure 1045 - General condition of ensuite bathroom internal wall

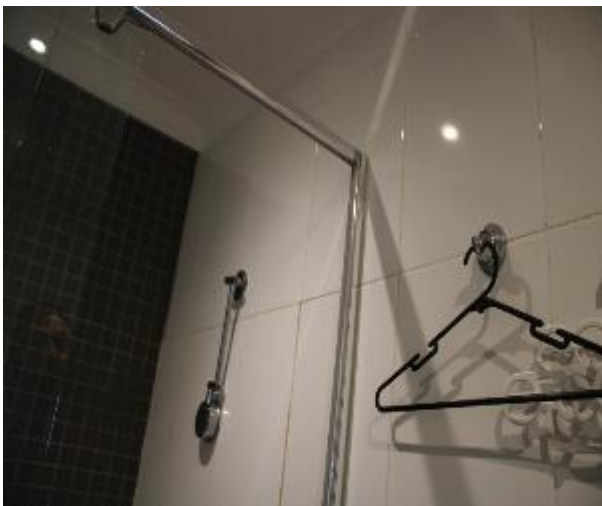
Figure 1046 - General condition of ensuite bathroom internal wall

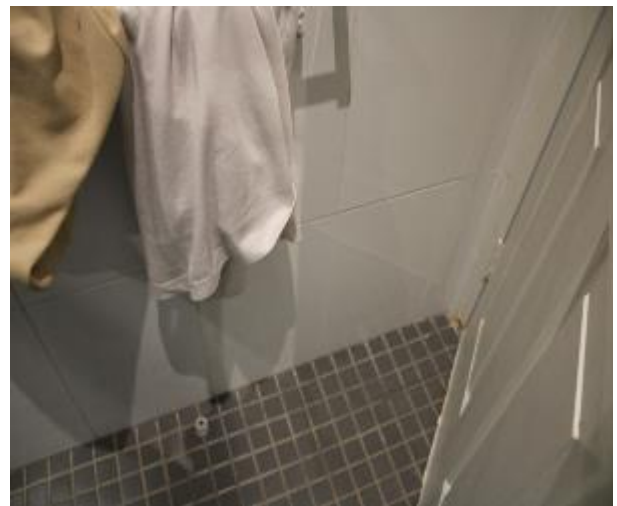
Figure 1047 - General condition of ensuite bathroom internal wall

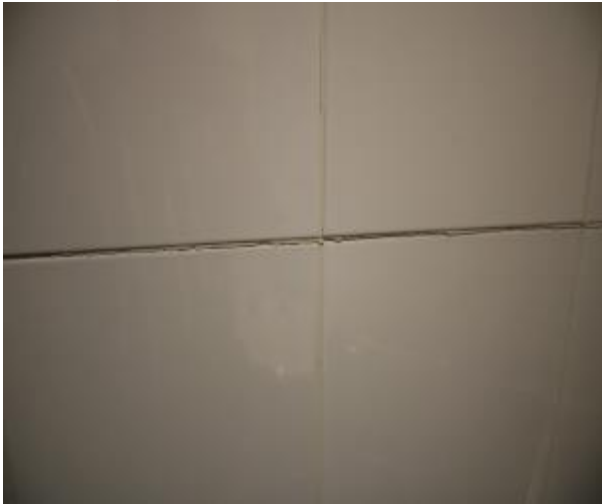
Figure 1050 - Crack propagation through ensuite bathroom internal wall

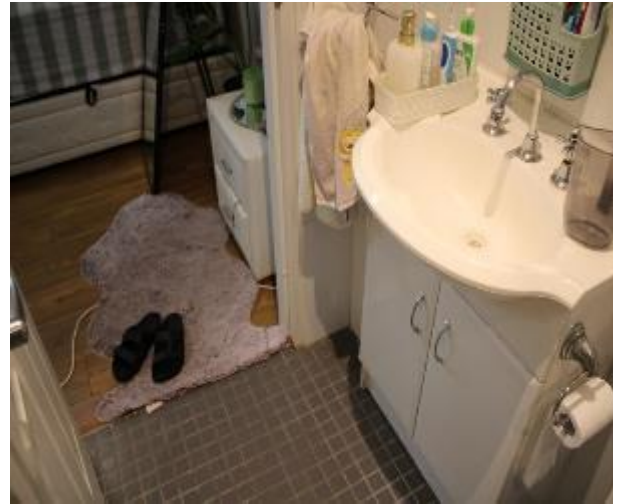
Figure 1051 - General condition of ensuite bathroom internal wall

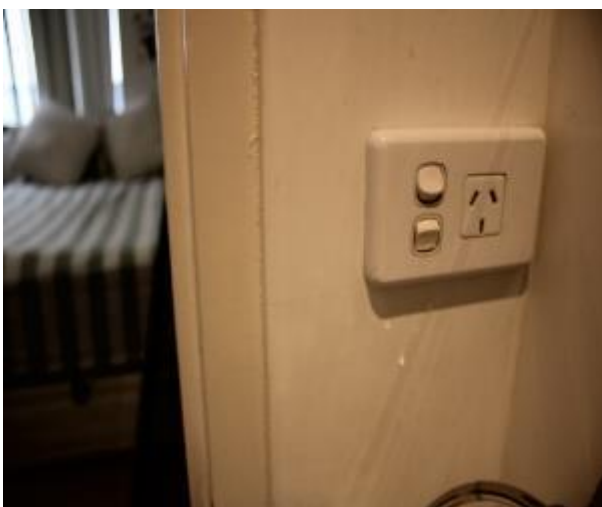
Figure 1054 - Crack propagation through ensuite bathroom internal wall

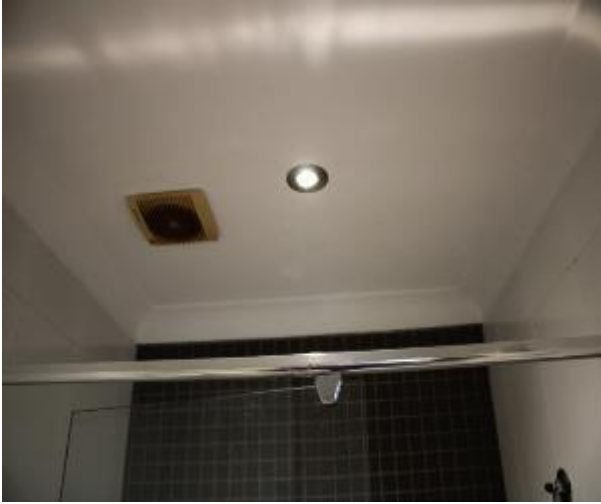
Figure 1056 - General condition of ensuite bathroom ceiling

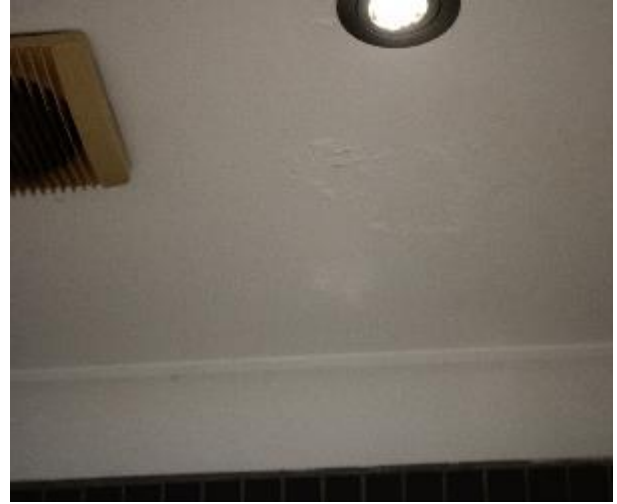
Figure 1057 - Paint flaking through ensuite bathroom ceiling

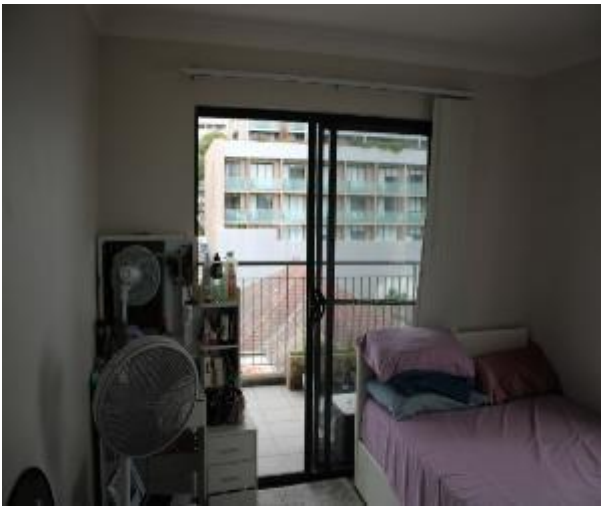
Figure 1058 - General condition of bedroom 2 internal wall

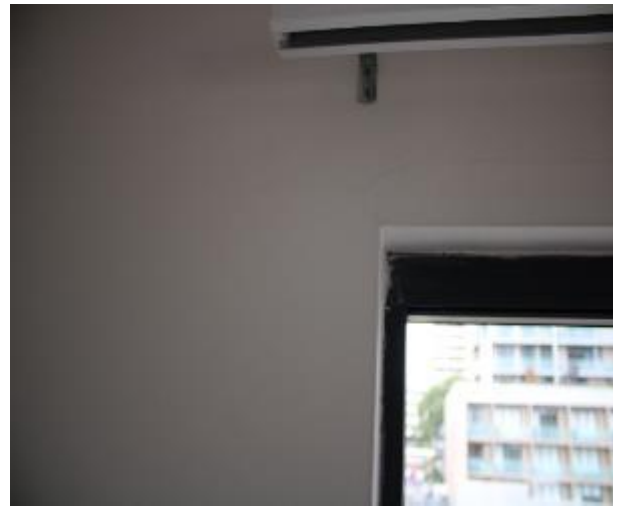
Figure 1059 - Crack propagation through bedroom 2 internal wall

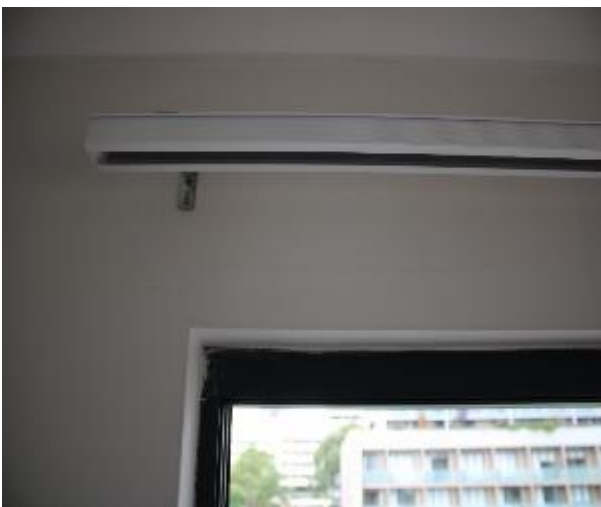
Figure 1060 - Crack propagation through bedroom 2 internal wall

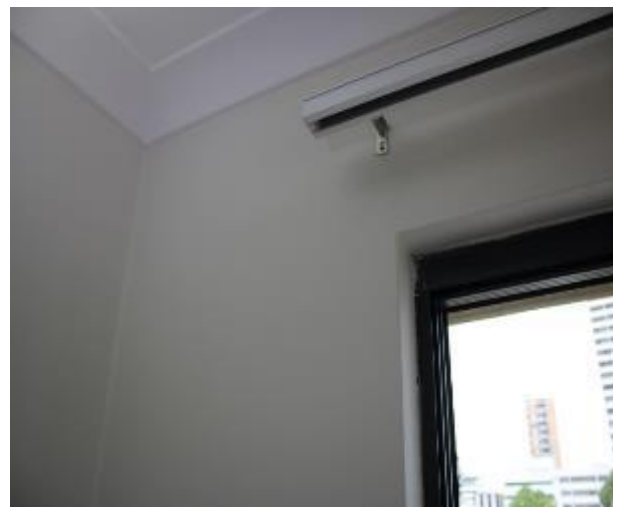
Figure 1061 - General condition of bedroom 2 internal wall

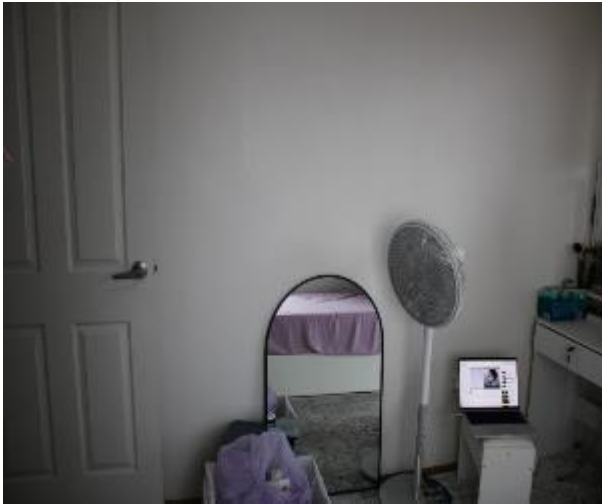
Figure 1062 - General condition of bedroom 2 internal wall

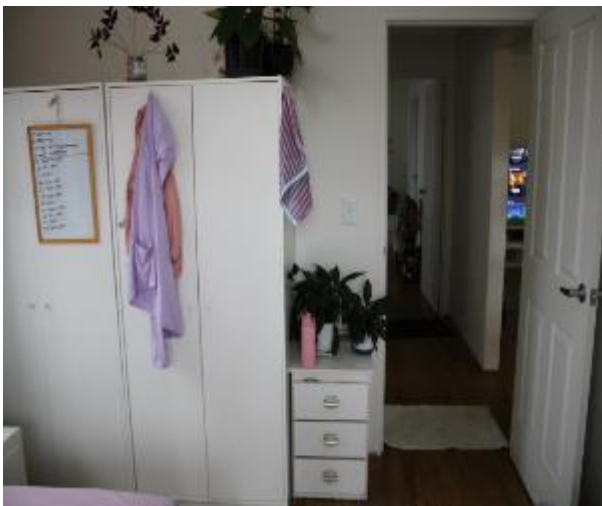
Figure 1064 - General condition of bedroom 2 internal wall

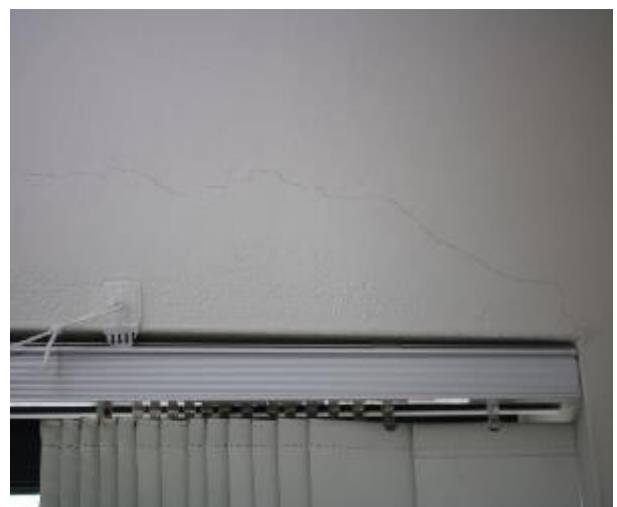
Figure 1067 - Crack propagation through bedroom 2 internal wall

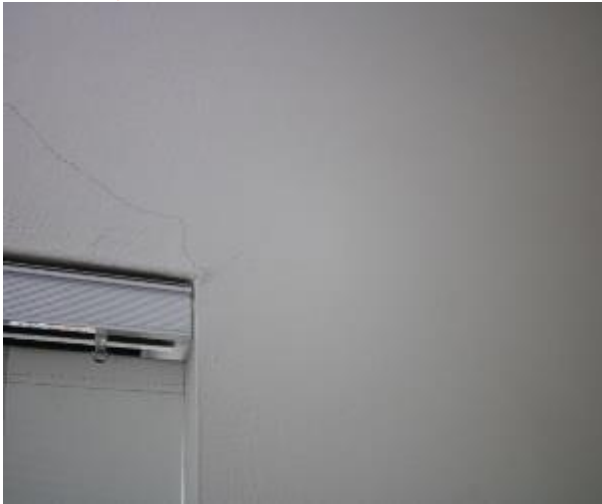
Figure 1068 - Crack propagation through bedroom 2 internal wall

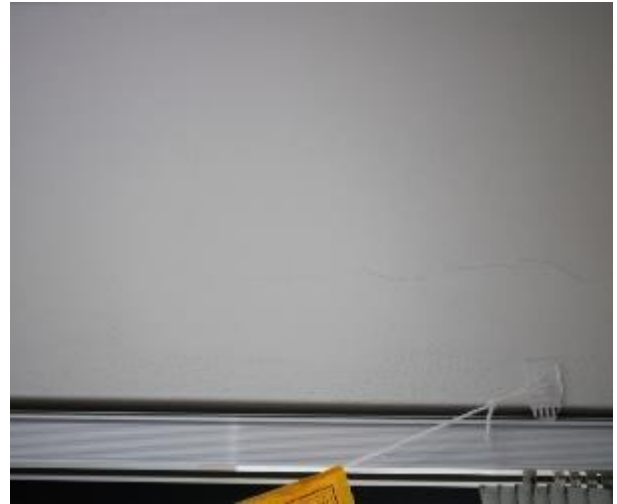
Figure 1069 - Crack propagation through bedroom 2 internal wall

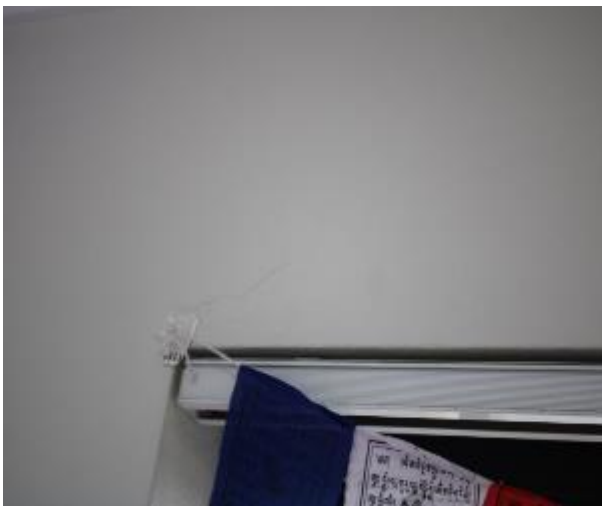
Figure 1070 - Crack propagation through bedroom 2 internal wall

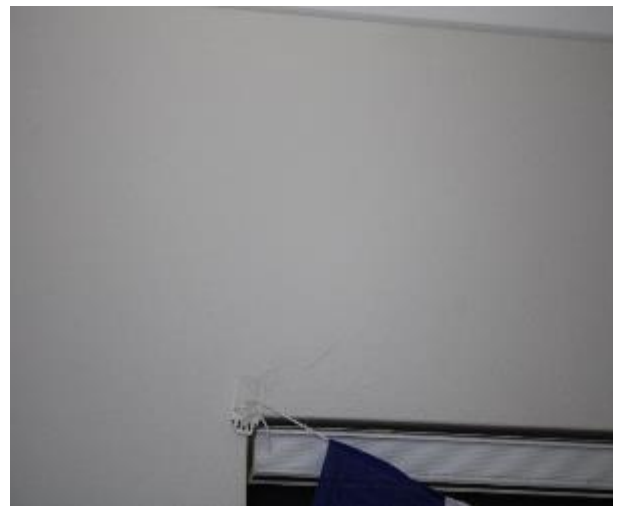
Figure 1071 - Crack propagation through bedroom 2 internal wall

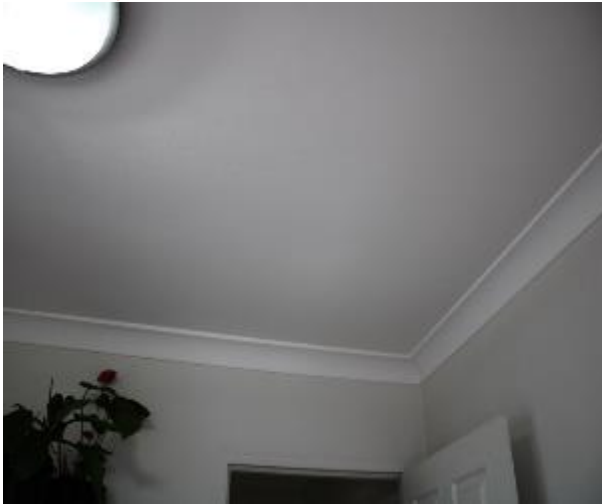
Figure 1074 - General condition of bedroom 2 ceiling

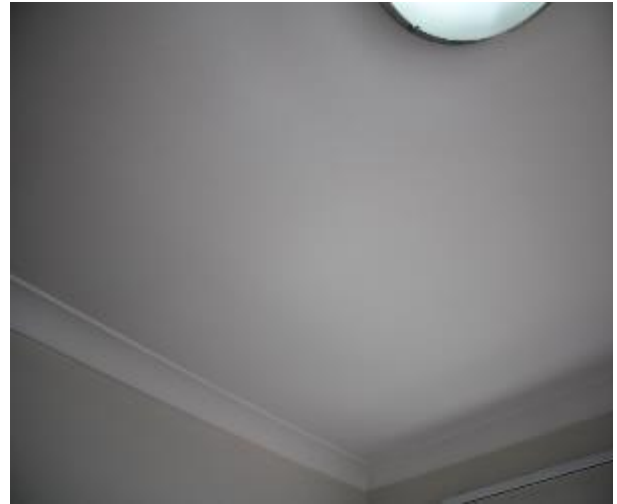
Figure 1075 - General condition of bedroom 2 ceiling

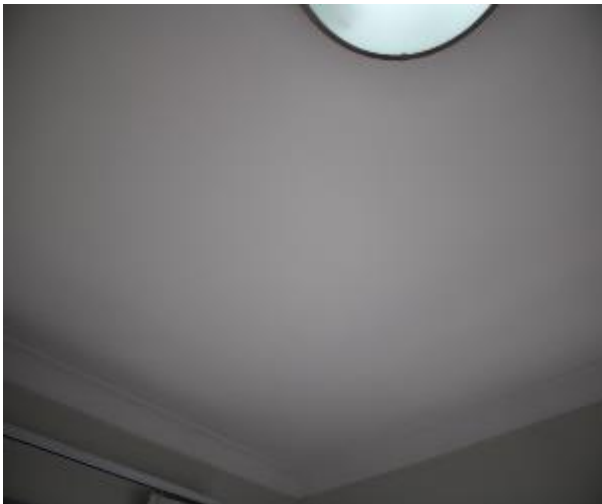
Figure 1076 - General condition of bedroom 2 ceiling

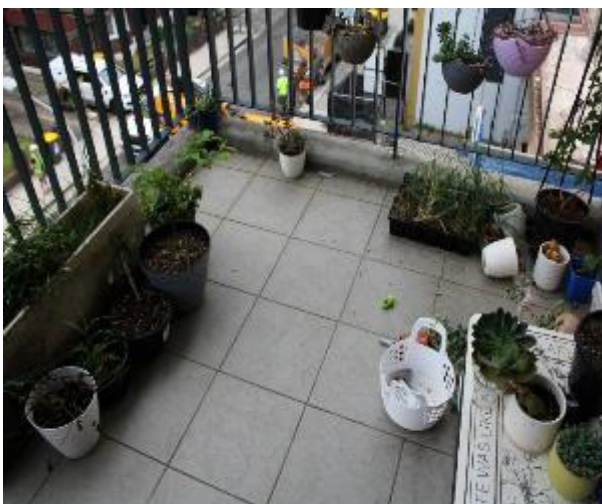
Figure 1078 - General condition of balcony floor tiles

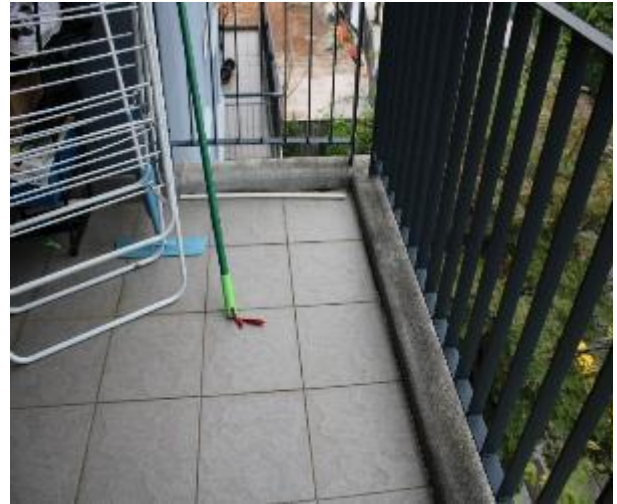
Figure 1081 - General condition of balcony floor tiles

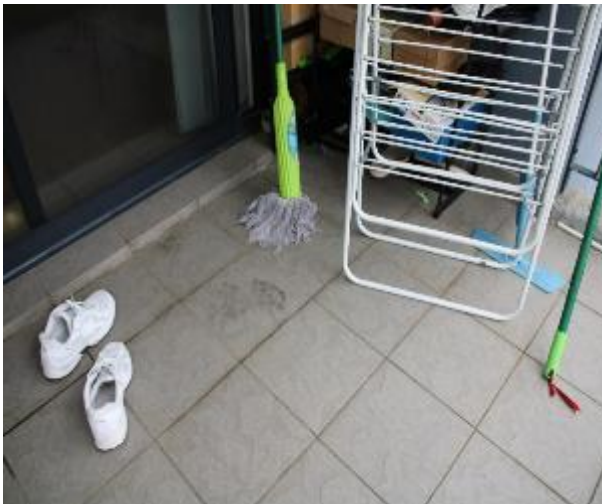
Figure 1082 - General condition of balcony floor tiles

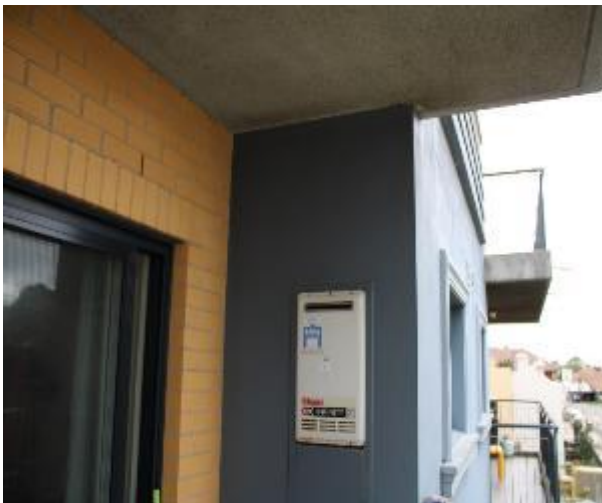
Figure 1084 - General condition of external wall

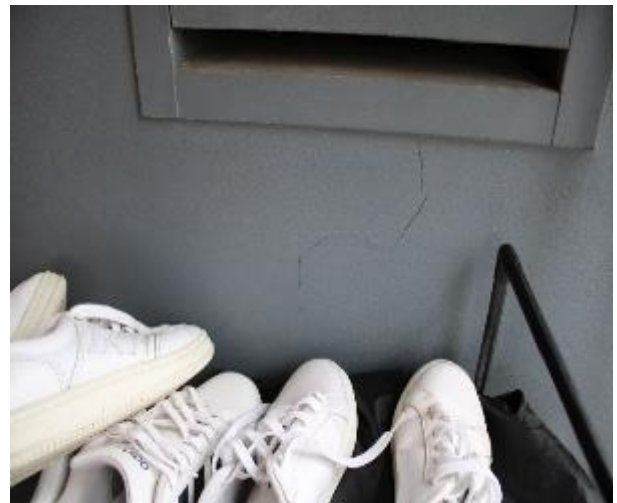
Figure 1085 - Crack propagation through external wall

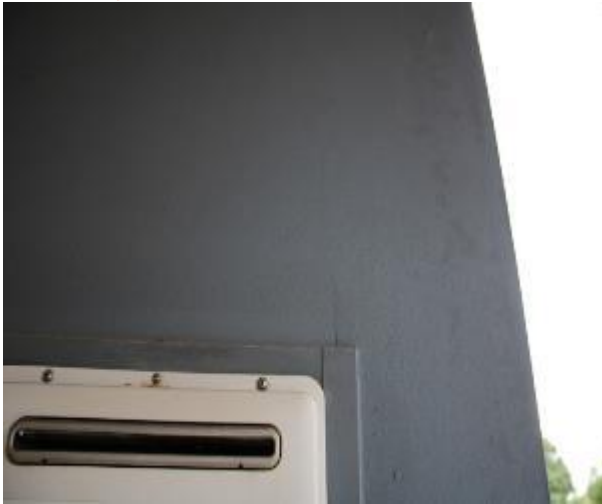
Figure 1086 - Crack propagation through external wall

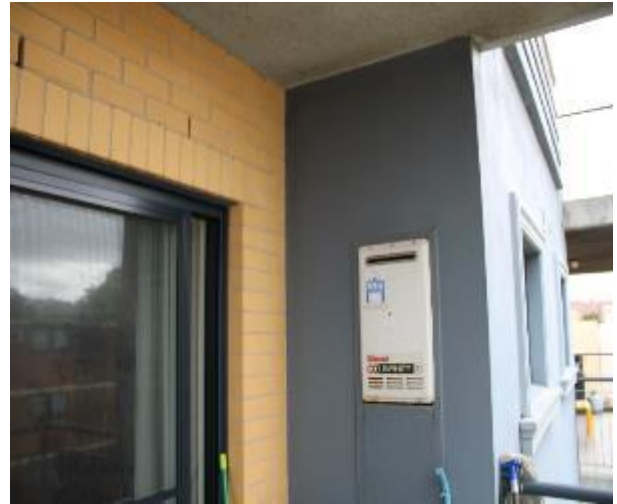
Figure 1087 - General condition of external wall

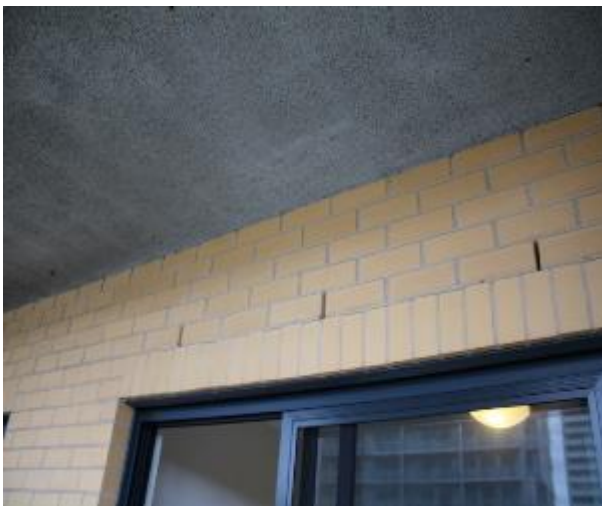
Figure 1088 - General condition of external wall

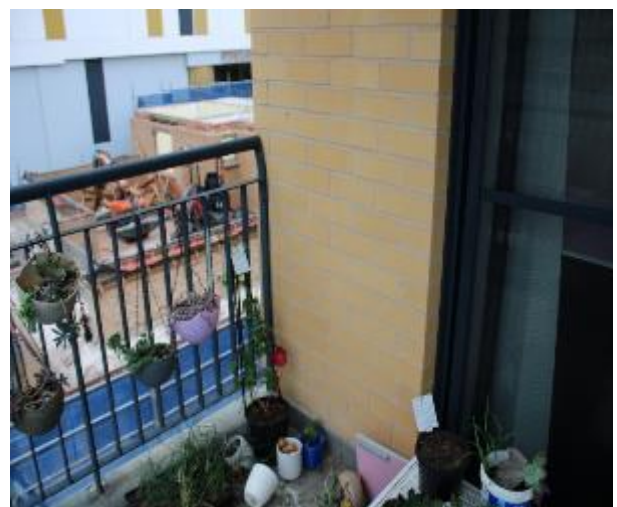
Figure 1091 - General condition of external wall

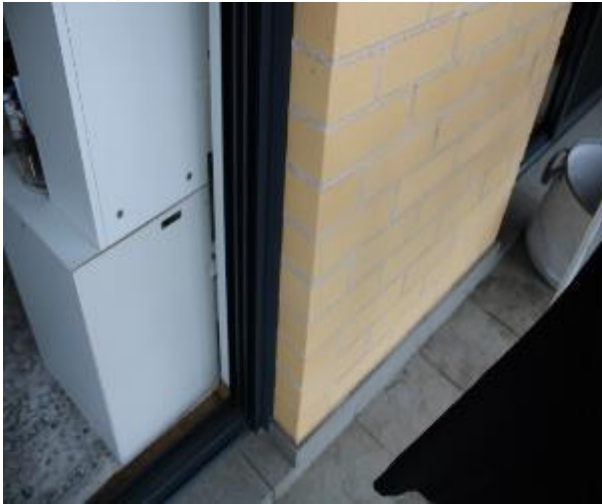
Figure 1092 - General condition of external wall

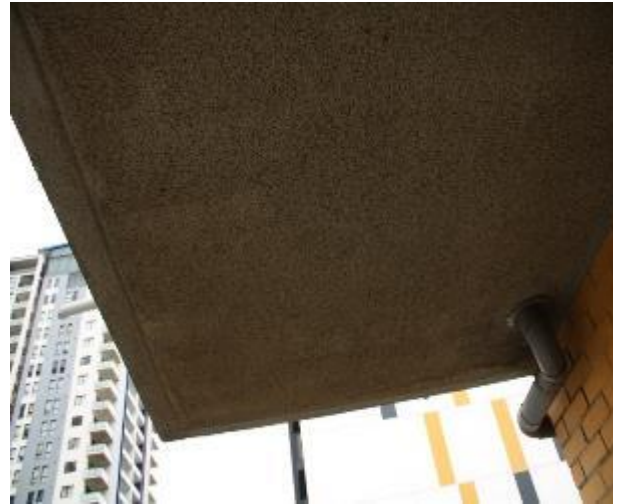
Figure 1093 - General condition of balcony underside slab

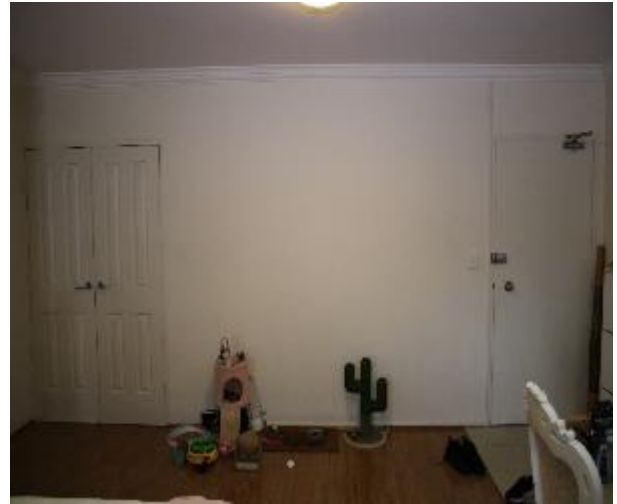
Figure 1098 - General condition of dining room internal wall

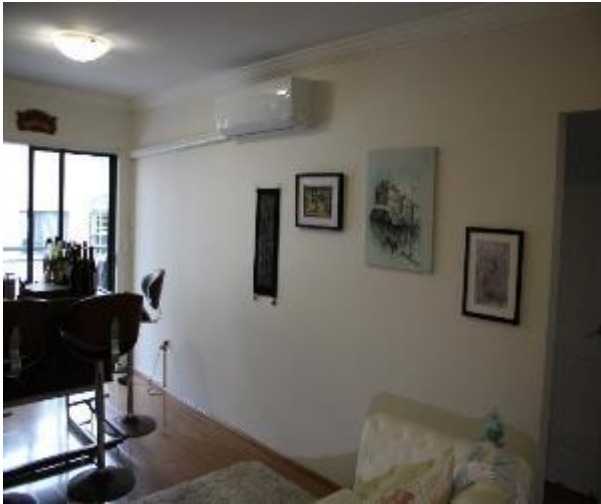
Figure 1103 - General condition of dining room internal wall

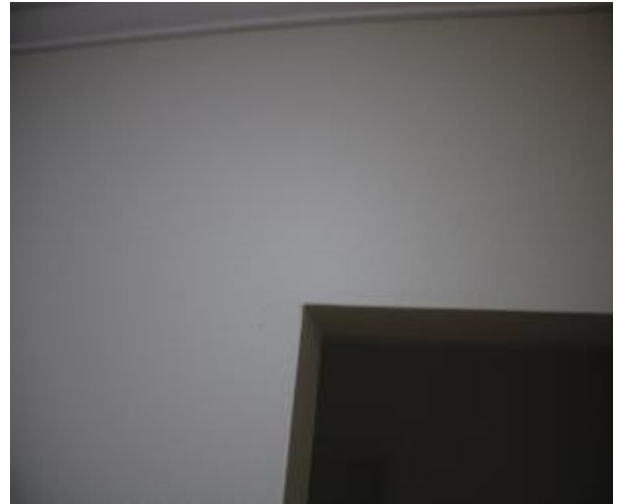
Figure 1104 - Crack propagation through dining room internal wall

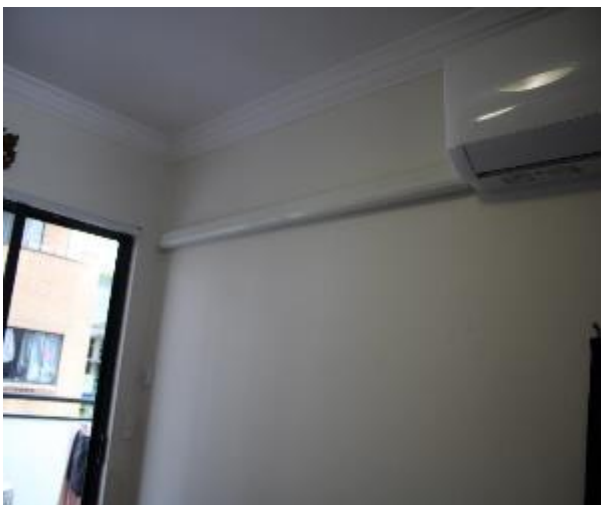
Figure 1107 - General condition of dining room internal wall

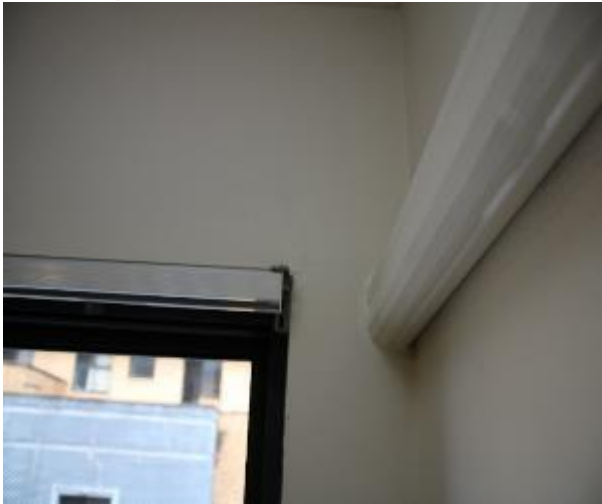
Figure 1109 - Crack propagation through dining room internal wall

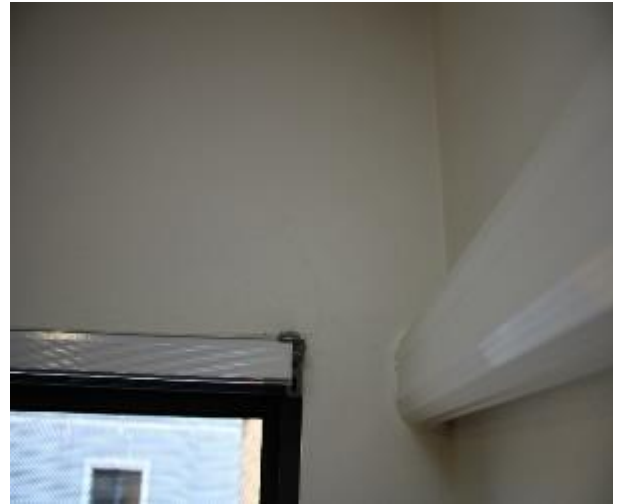
Figure 1110 - Crack propagation through dining room internal wall

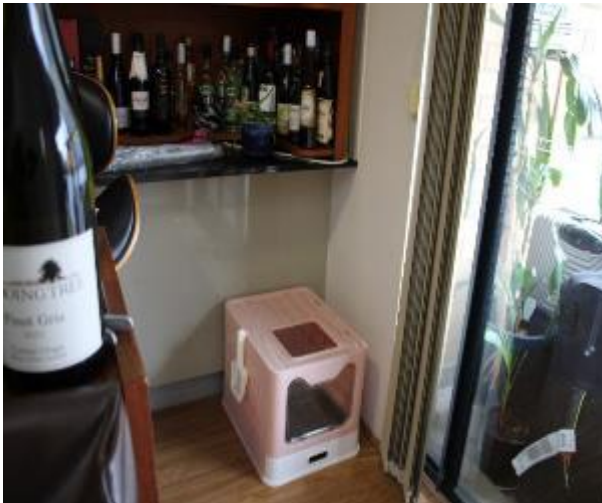
Figure 1111 - General condition of dining room internal wall

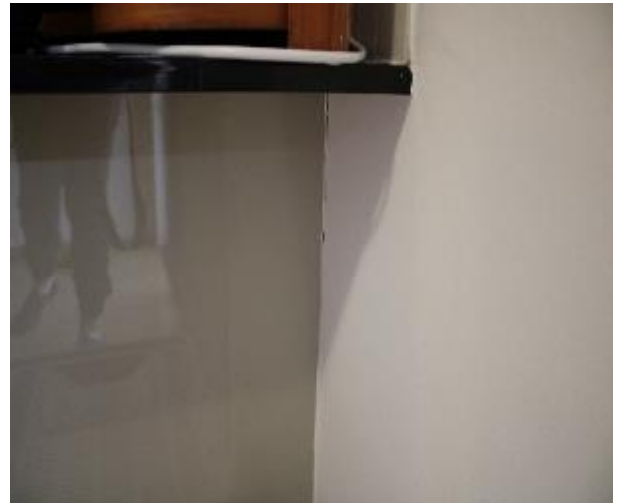
Figure 1112 - Crack propagation through dining room internal wall

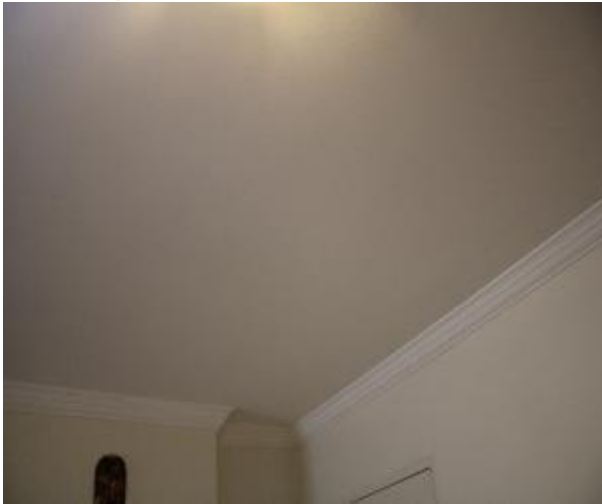
Figure 1115 - General condition of dining room ceiling

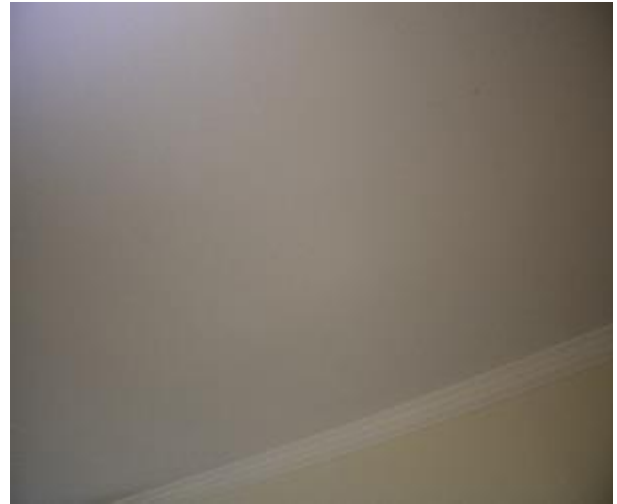
Figure 1116 - General condition of dining room ceiling

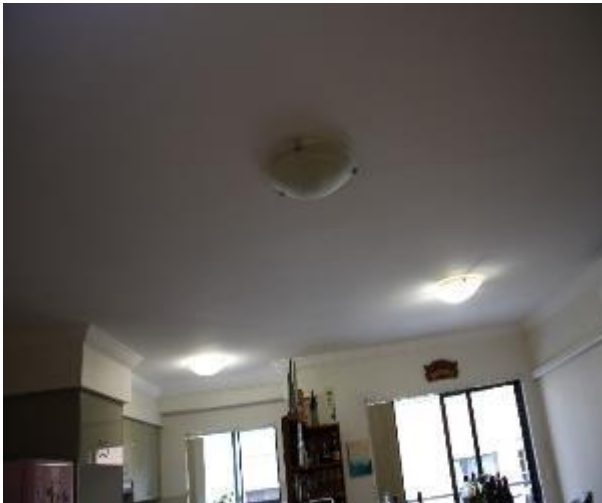
Figure 1117 - General condition of dining room ceiling

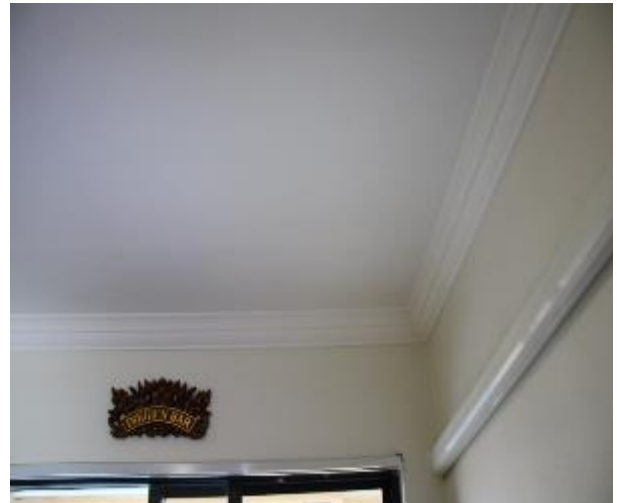
Figure 1118 - General condition of dining room ceiling

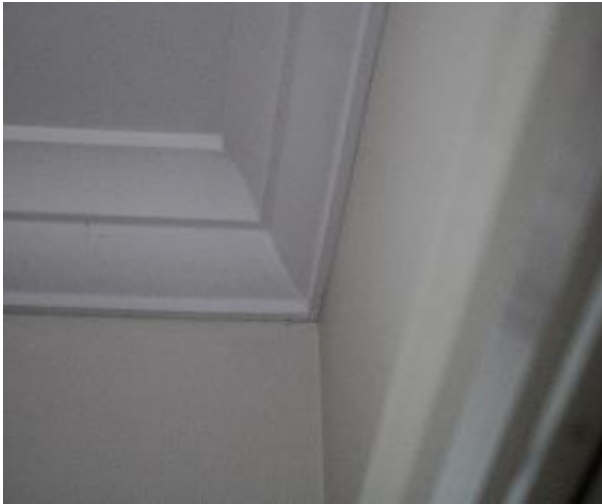
Figure 1121 - Crack propagation through dining room ceiling

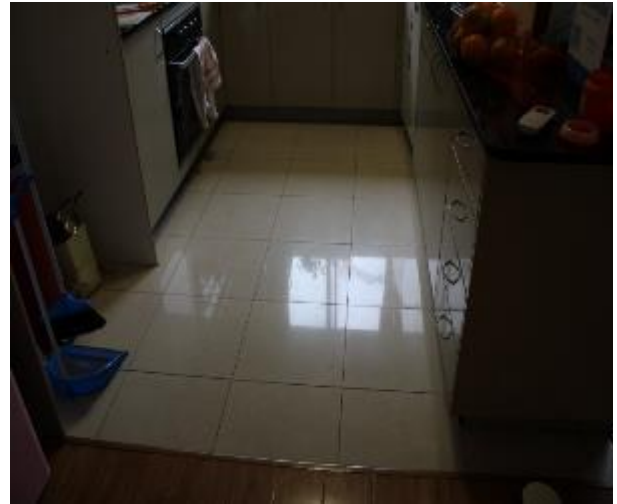
Figure 1122 - General condition of kitchen floor tiles

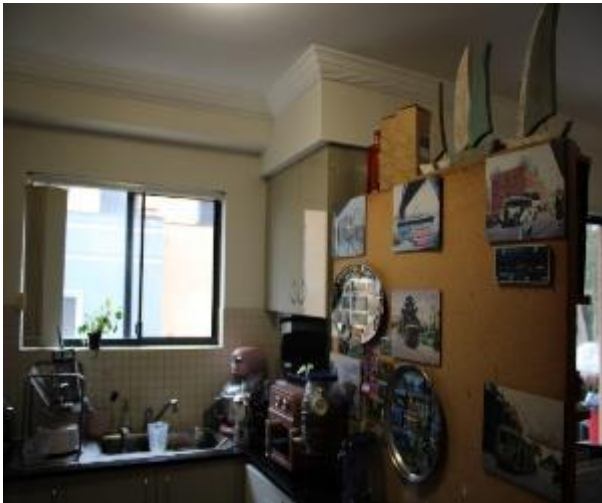
Figure 1123 - General condition of kitchen internal wall

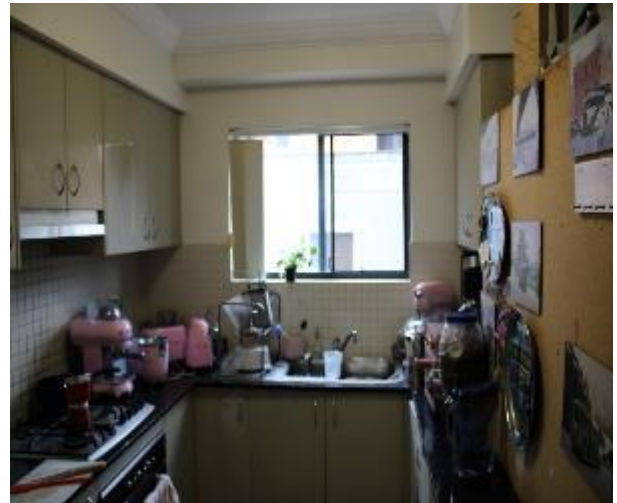
Figure 1124 - General condition of kitchen internal wall

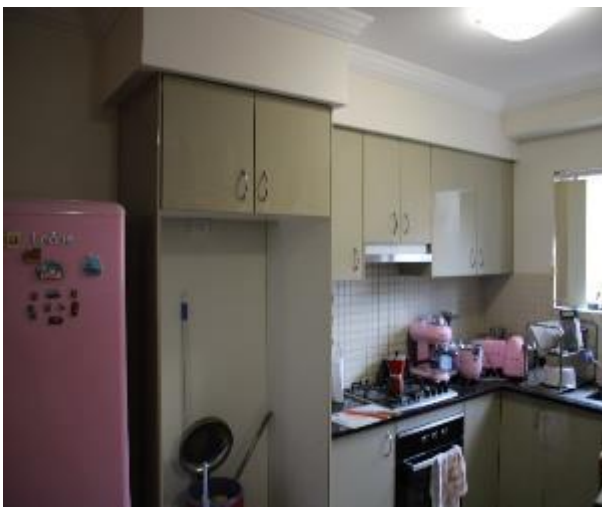
Figure 1125 - General condition of kitchen internal wall

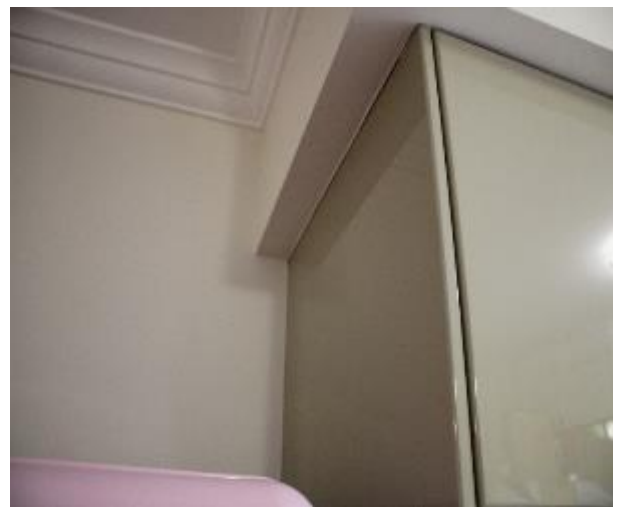
Figure 1126 - Crack propagation through kitchen internal wall

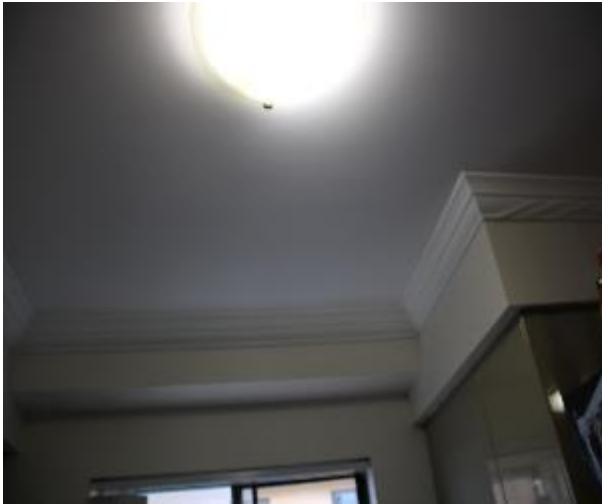
Figure 1127 - General condition of kitchen ceiling

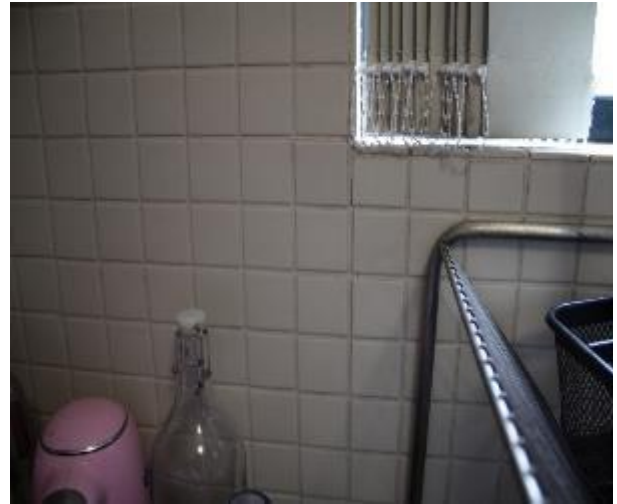
Figure 1128 - Crack propagation through kitchen internal wall

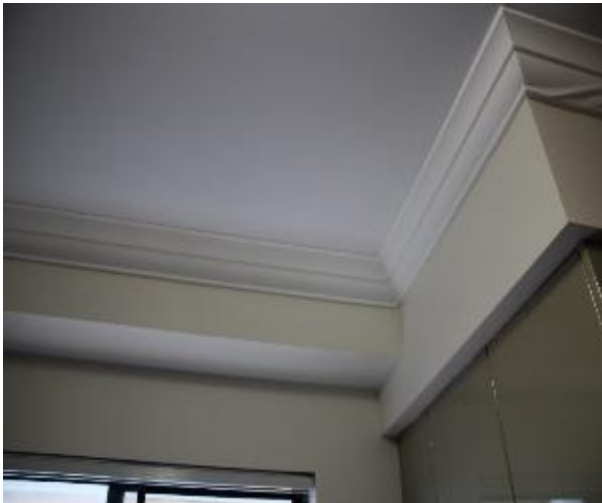
Figure 1129 - General condition of kitchen ceiling

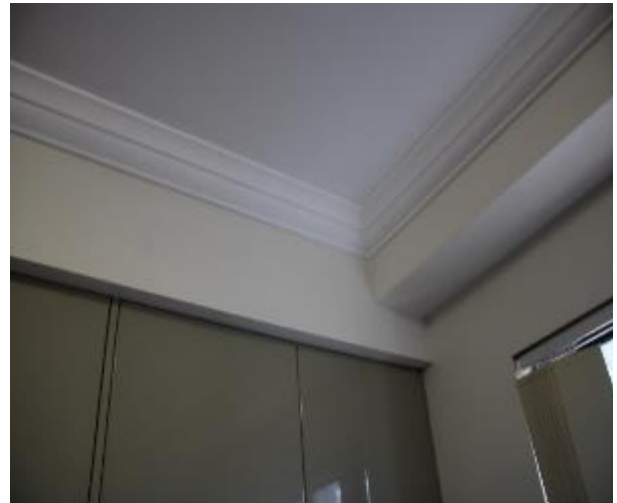
Figure 1130 - General condition of kitchen ceiling
