# **Pre-Dilapidation Report**

**19 GEORGE STREET**

**FRONT BUILDING (UNITS 1-19)**

Project Reference: 20250047.19G.2

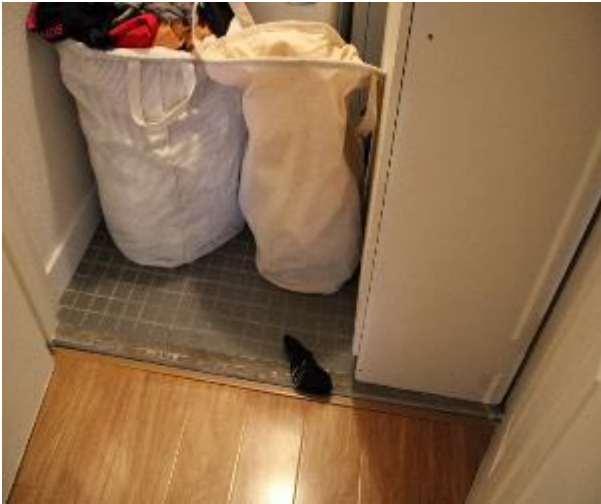
Figure 1133 - General condition of laundry floor tiles

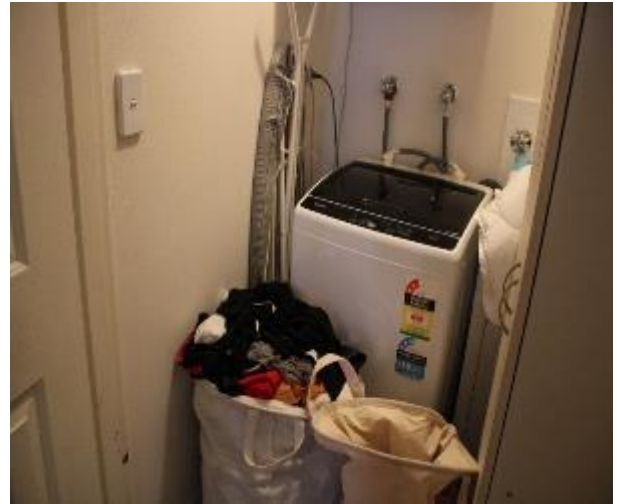
Figure 1134 - General condition of laundry internal wall

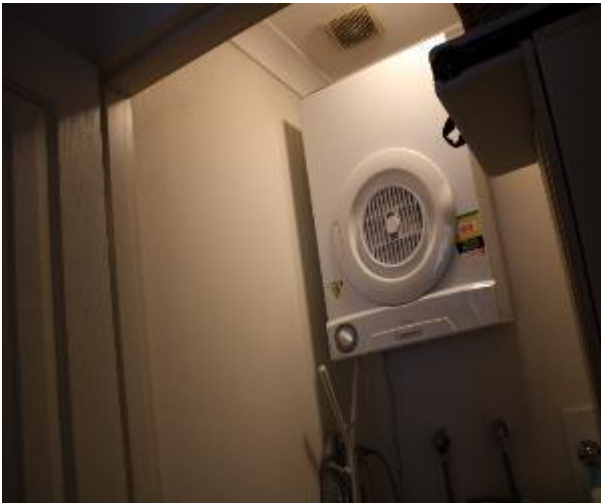
Figure 1135 - General condition of laundry internal wall

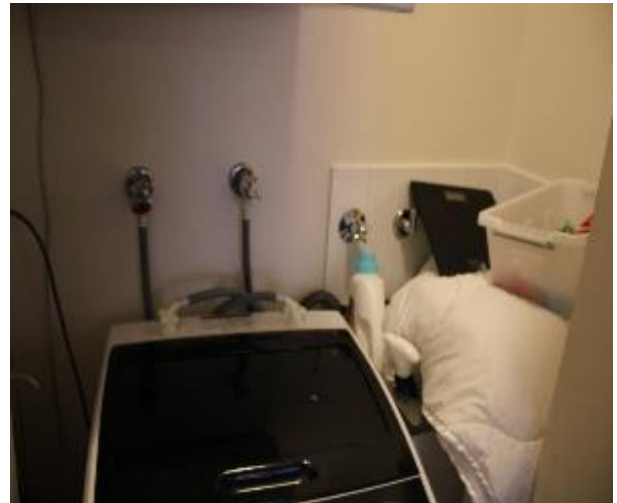
Figure 1136 - General condition of laundry internal wall

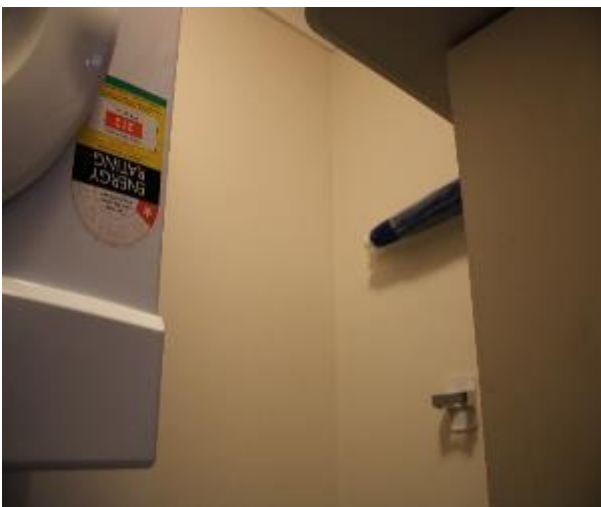
Figure 1137 - General condition of laundry internal wall

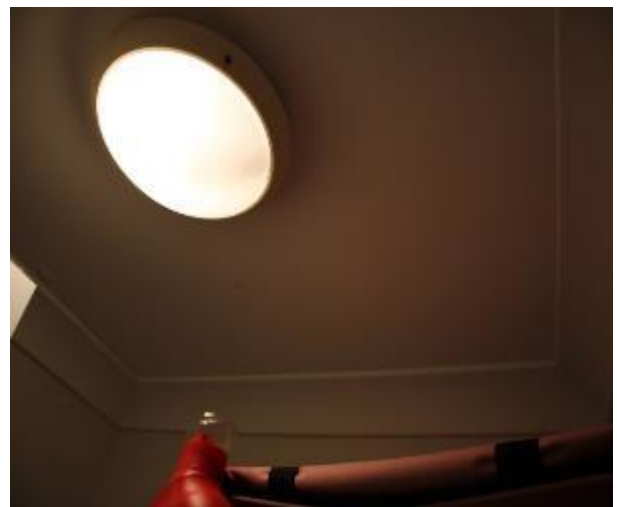
Figure 1138 - General condition of laundry ceiling

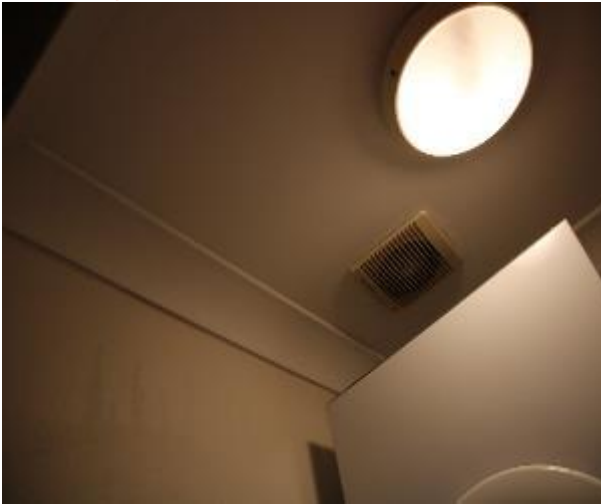
Figure 1139 - General condition of laundry ceiling

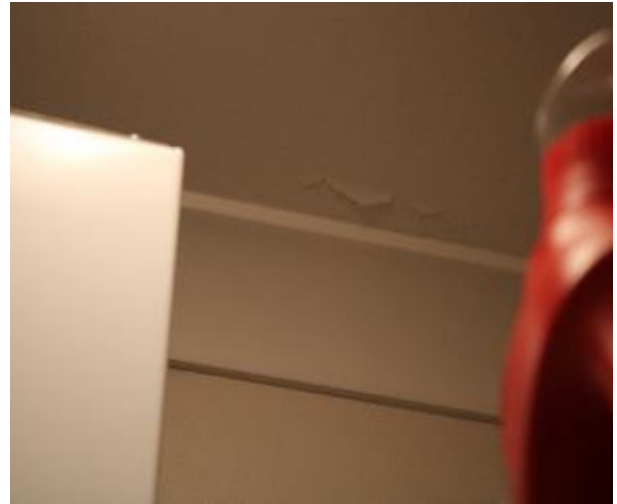
Figure 1140 - Crack propagation through laundry ceiling

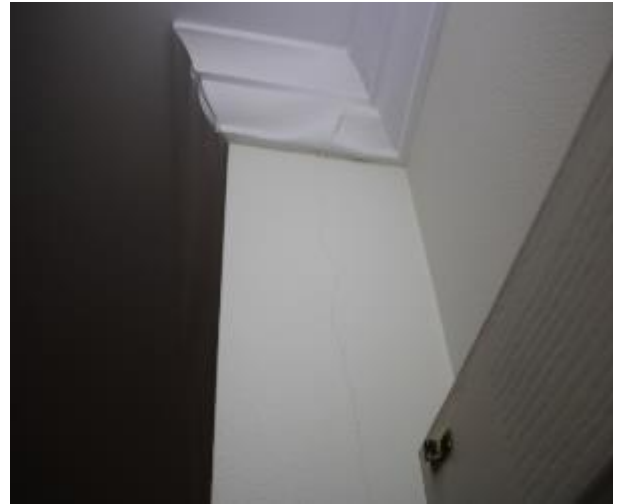
Figure 1146 - Crack propagation through dining room internal wall

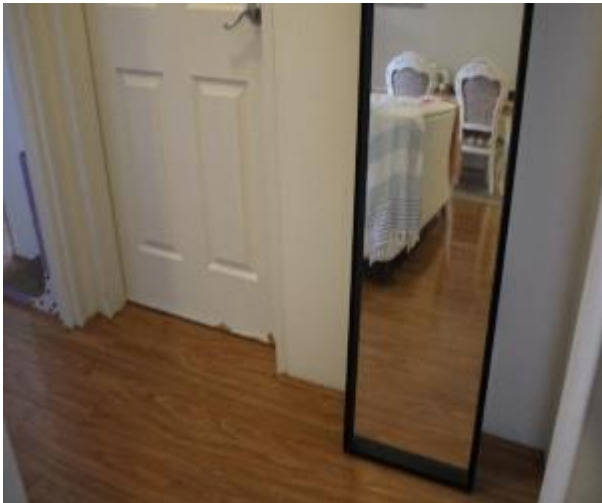
Figure 1147 - General condition of corridor internal wall

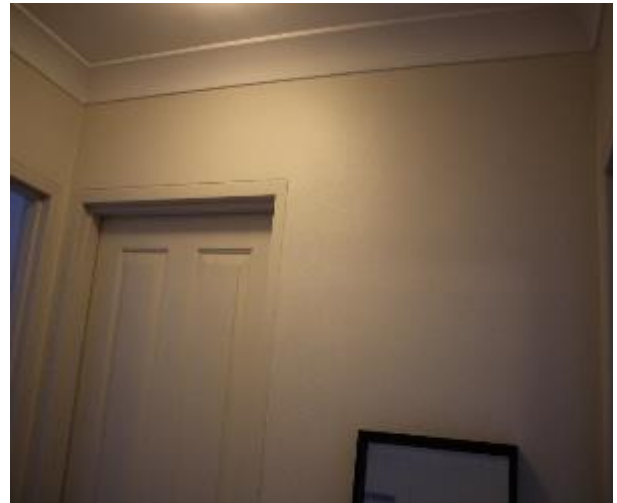
Figure 1148 - General condition of corridor internal wall

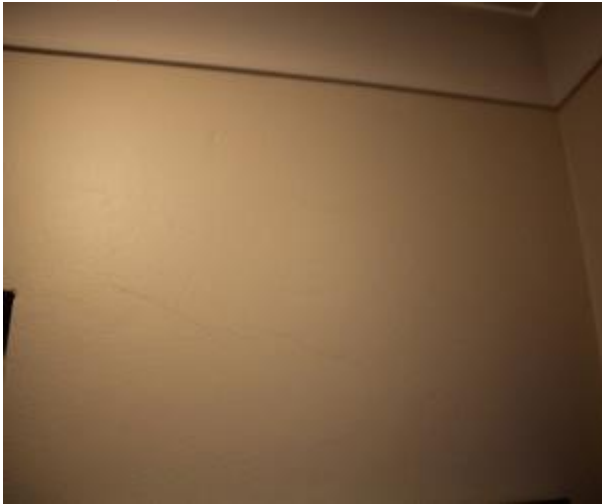
Figure 1151 - Crack propagation through corridor internal wall

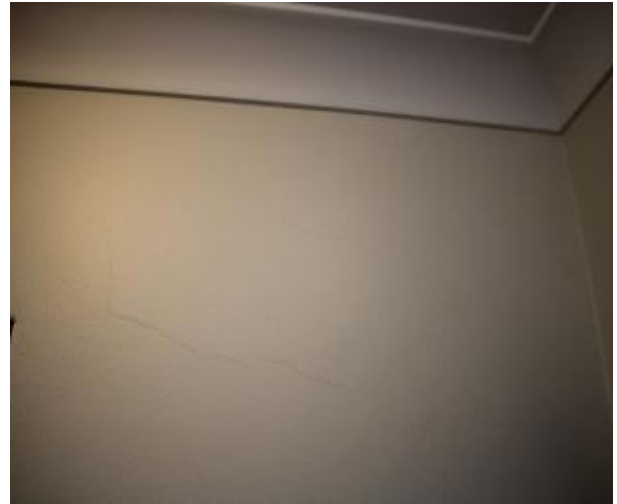
Figure 1152 - Crack propagation through corridor internal wall

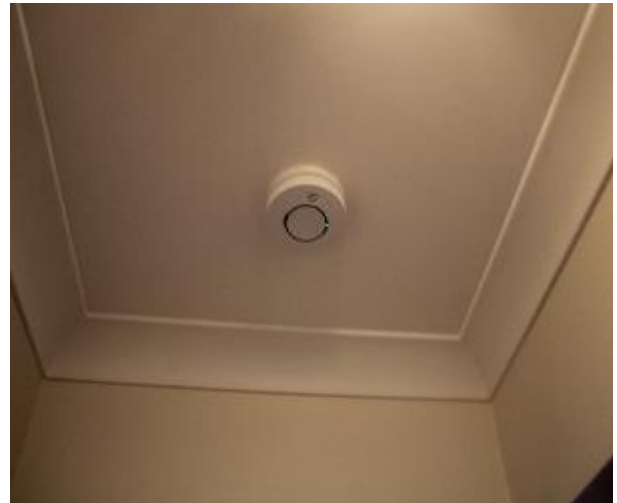
Figure 1154 - General condition of corridor ceiling

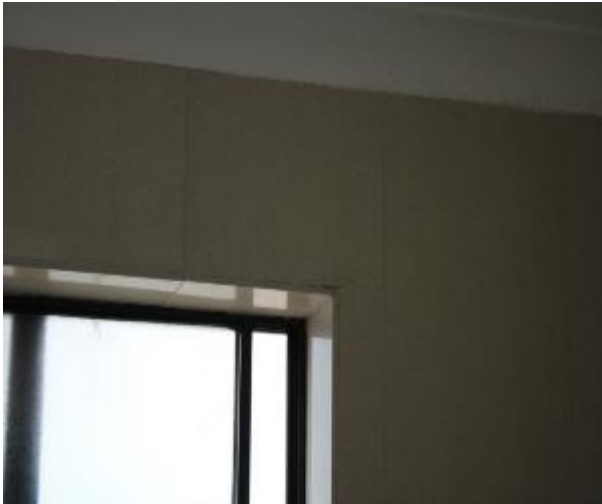
Figure 1162 - Crack propagation through bathroom 1 internal wall

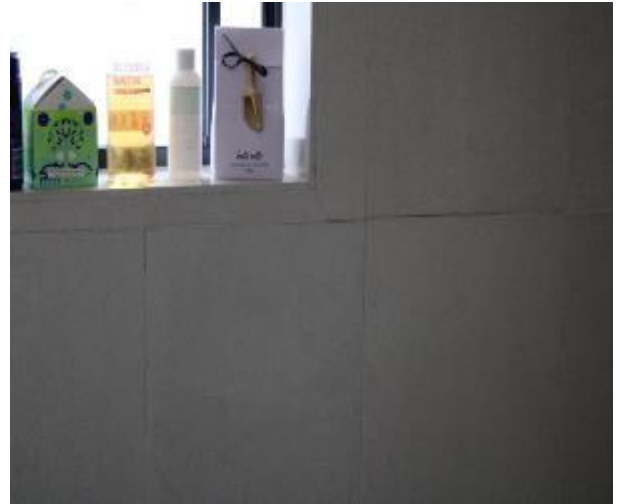
Figure 1163 - Crack propagation through bathroom 1 internal wall

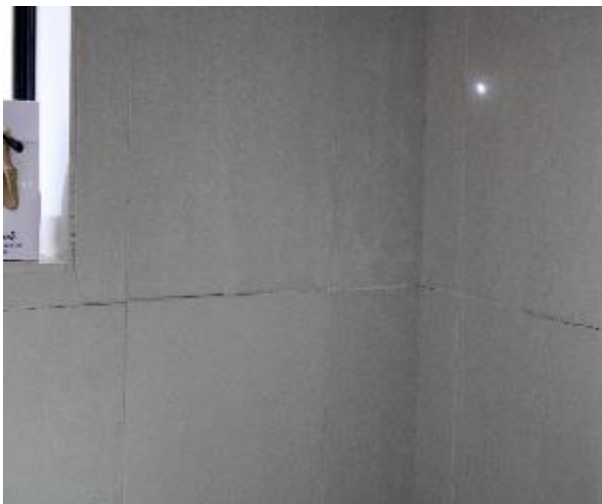
Figure 1164 - Crack propagation through bathroom 1 internal wall

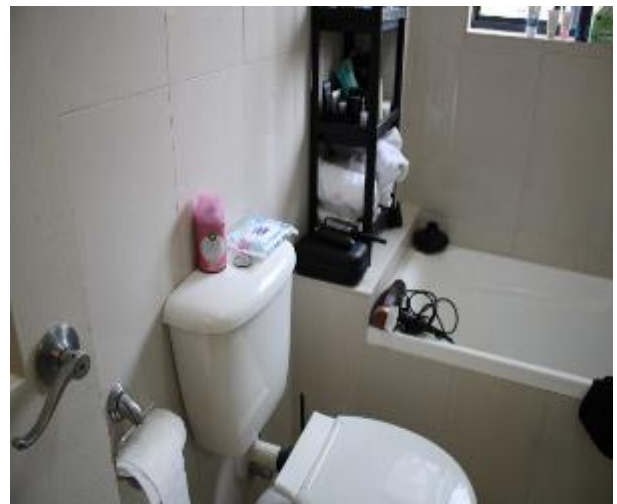
Figure 1165 - Crack propagation through bathroom 1 internal wall

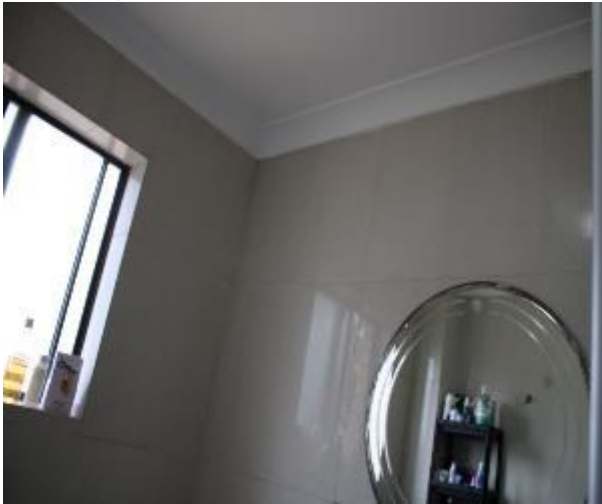
Figure 1168 - Crack propagation through bathroom 1 internal wall

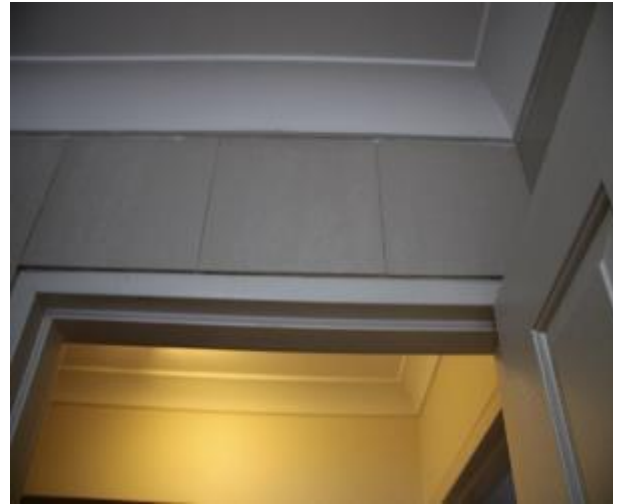
Figure 1169 - General condition of bathroom 1 internal wall

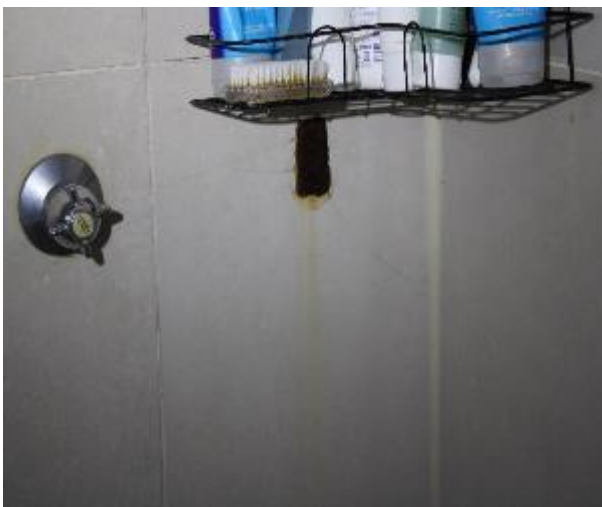
Figure 1172 - General condition of bathroom 1 internal wall

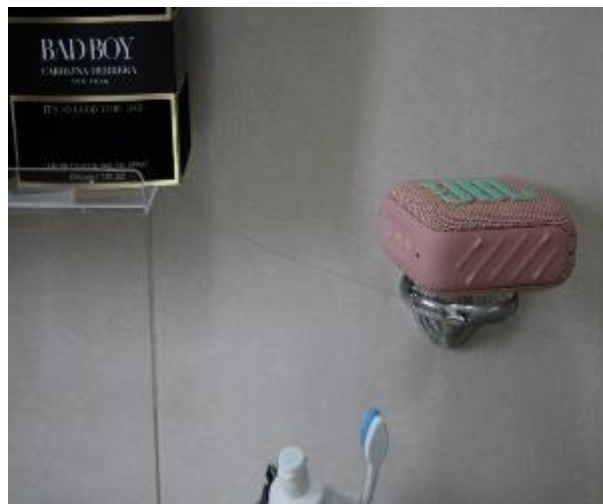
Figure 1175 - General condition of bathroom 1 internal wall

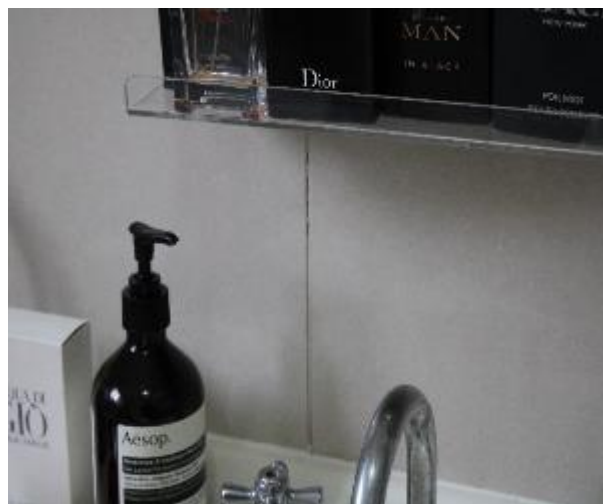
Figure 1177 - Crack propagation through bathroom 1 internal wall

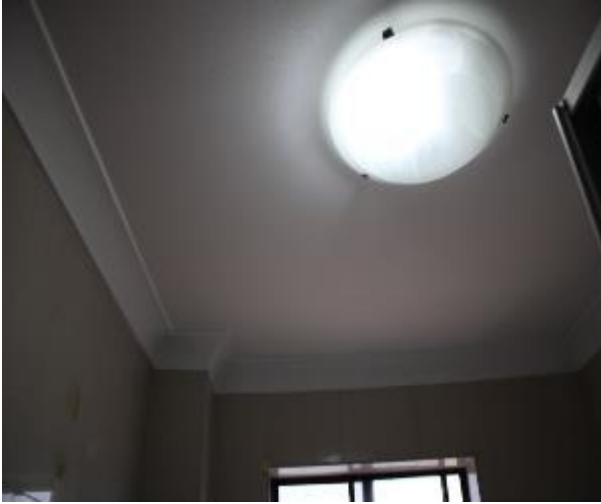
Figure 1180 - General condition of bathroom 1 ceiling

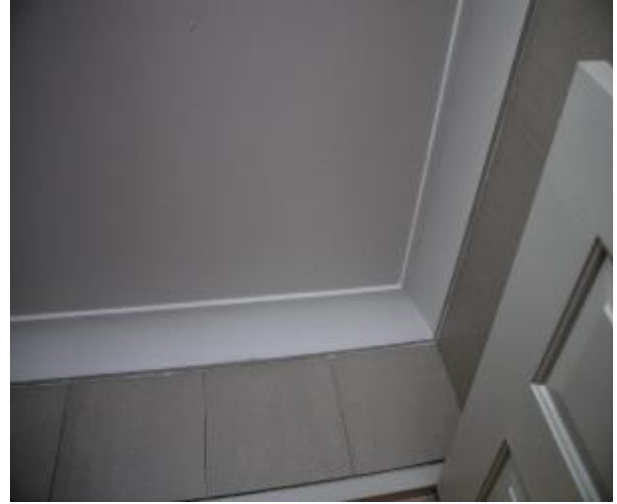
Figure 1181 - General condition of bathroom 1 ceiling

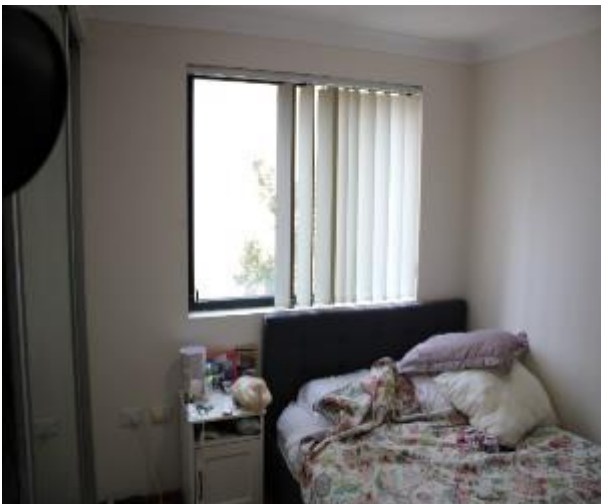
Figure 1184 - Crack propagation through bedroom 1 internal wall

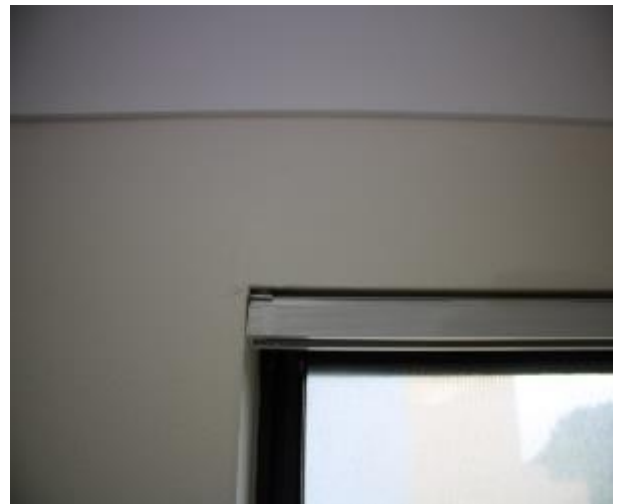
Figure 1185 - General condition of bedroom 1 internal wall

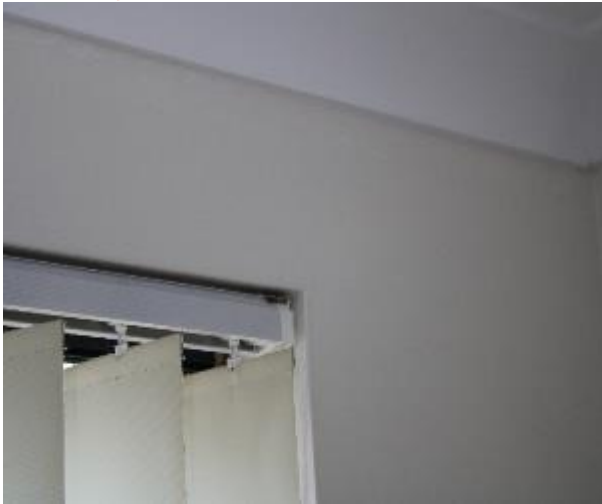
Figure 1186 - Crack propagation through bedroom 1 internal wall

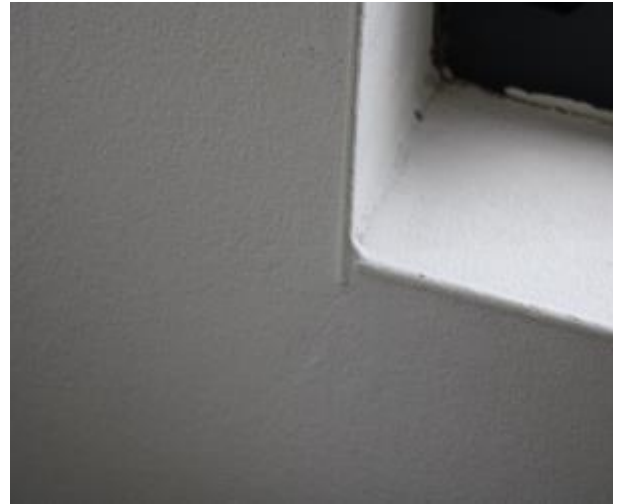
Figure 1187 - Crack propagation through bedroom 1 internal wall

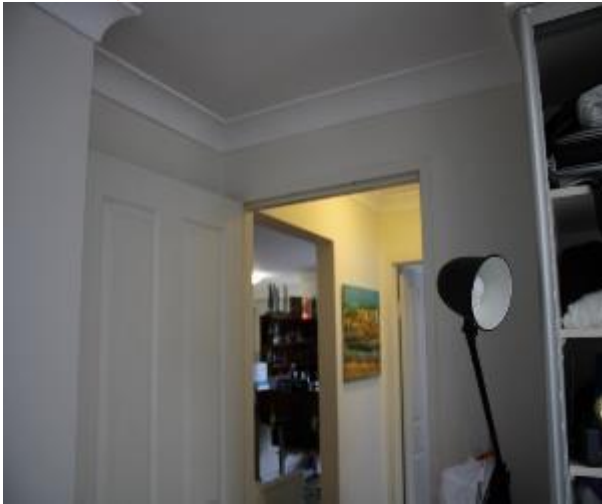
Figure 1192 - General condition of bedroom 1 internal wall

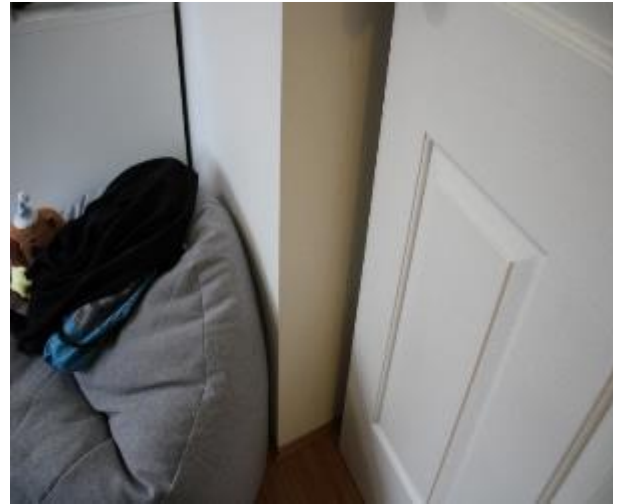
Figure 1193 - General condition of bedroom 1 internal wall

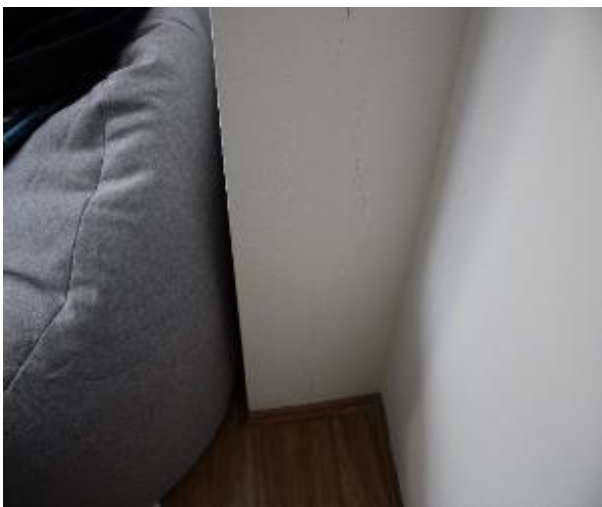
Figure 1196 - General condition of bedroom 1 internal wall

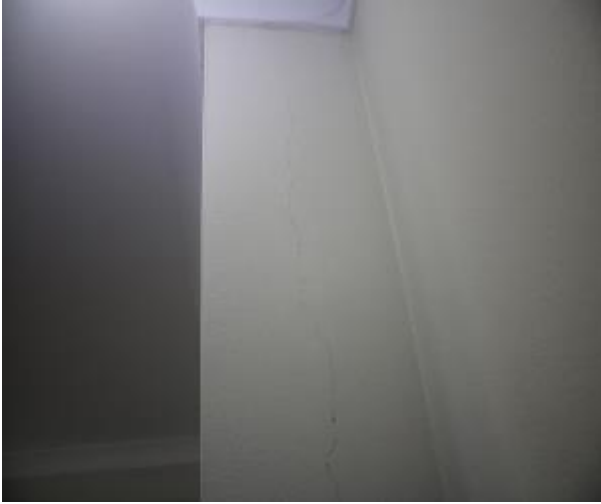
Figure 1199 - Crack propagation through bedroom 1 internal wall

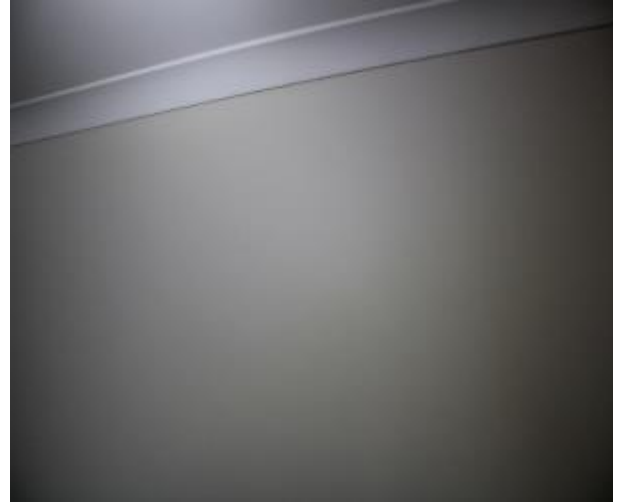
Figure 1200 - General condition of bedroom 1 internal wall

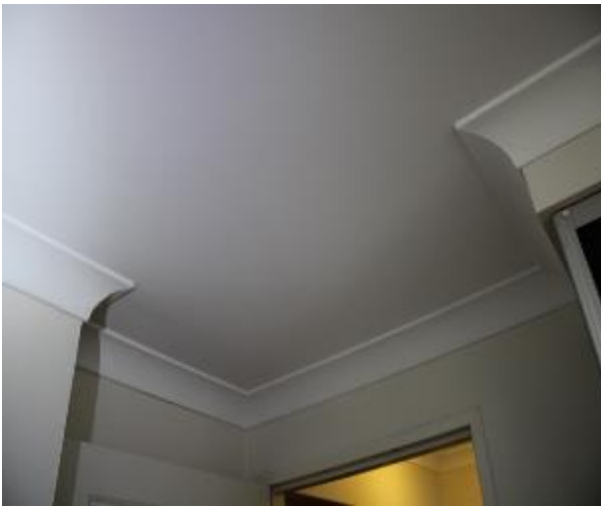
Figure 1201 - General condition of bedroom 1 ceiling

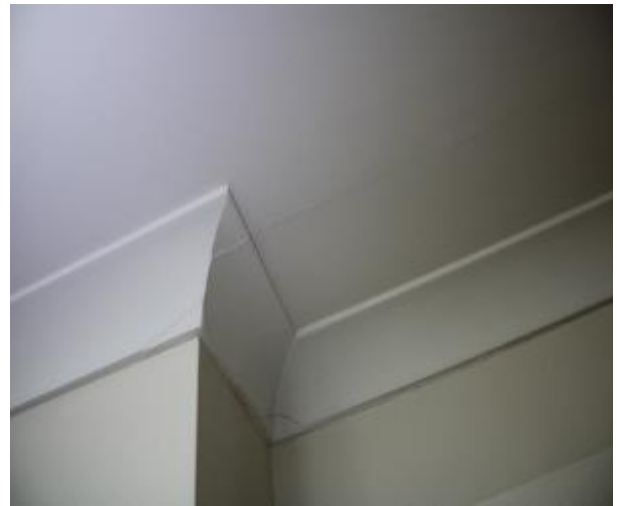
Figure 1202 - Crack propagation through bedroom 1 ceiling

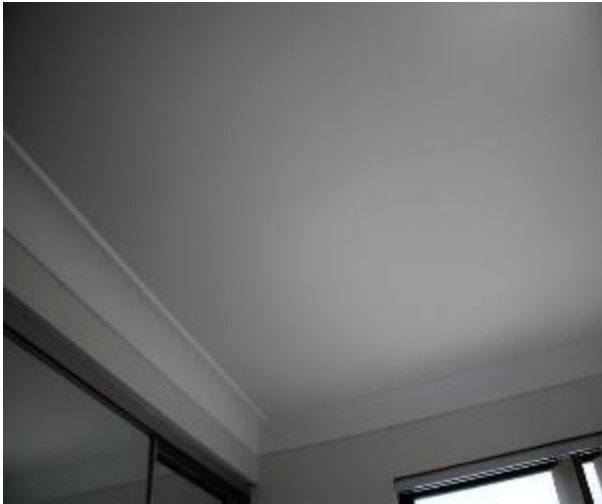
Figure 1205 - General condition of bedroom 1 ceiling

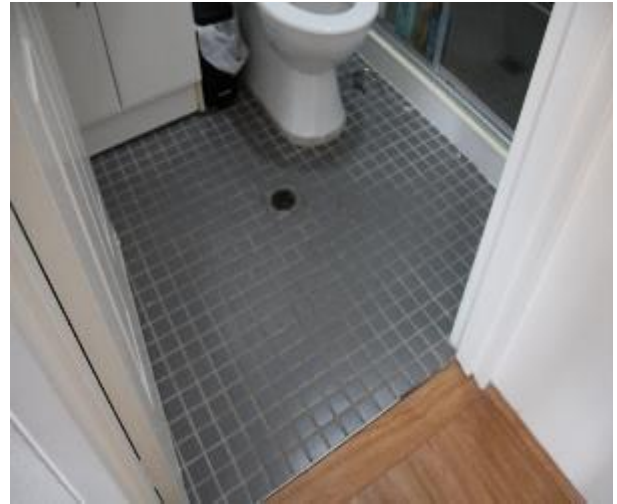
Figure 1206 - General condition of ensuite bathroom floor tiles

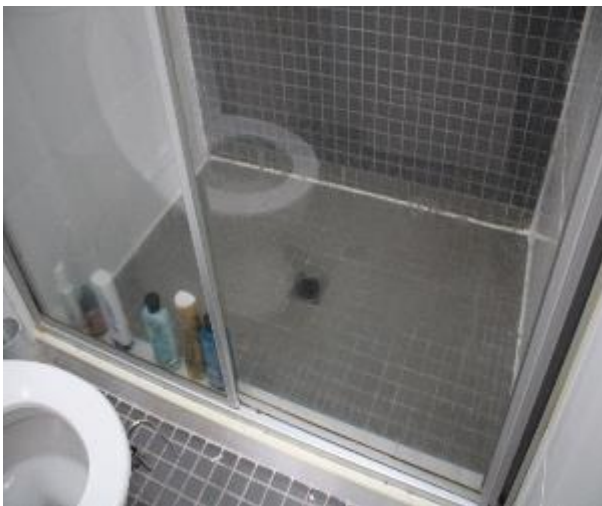
Figure 1207 - General condition of ensuite bathroom floor tiles

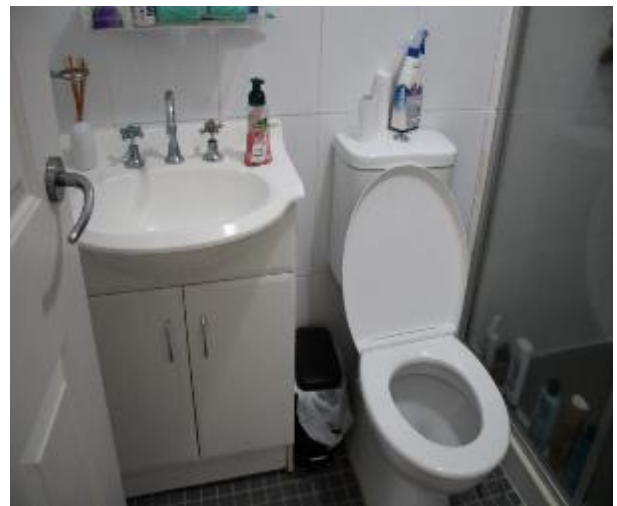
Figure 1208 - General condition of ensuite bathroom internal wall

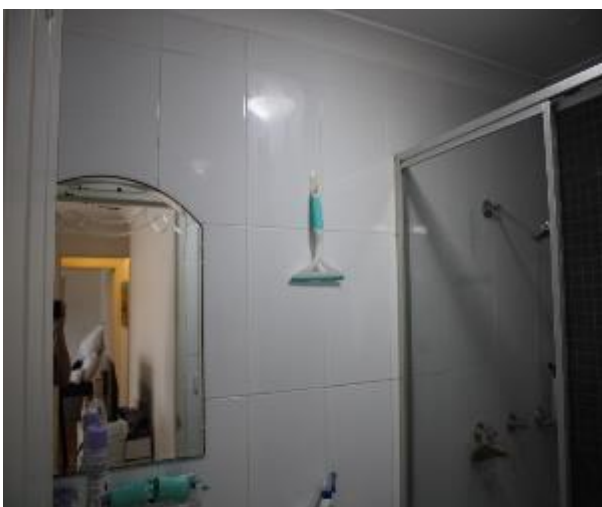
Figure 1209 - General condition of ensuite bathroom internal wall

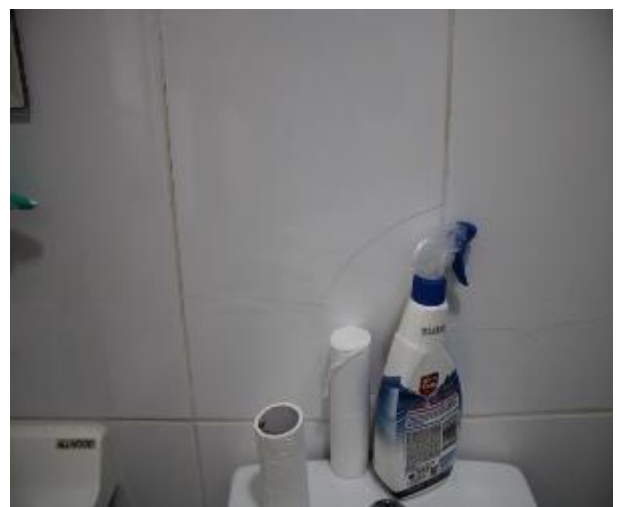
Figure 1210 - Crack propagation through ensuite bathroom internal wall

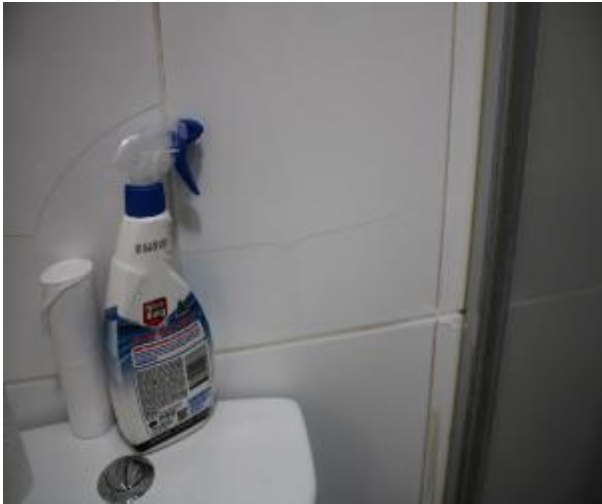
Figure 1211 - Crack propagation through ensuite bathroom internal wall

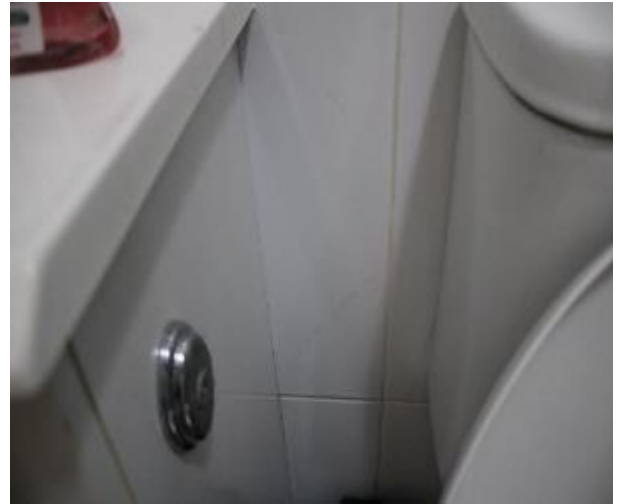
Figure 1212 - Crack propagation through ensuite bathroom internal wall

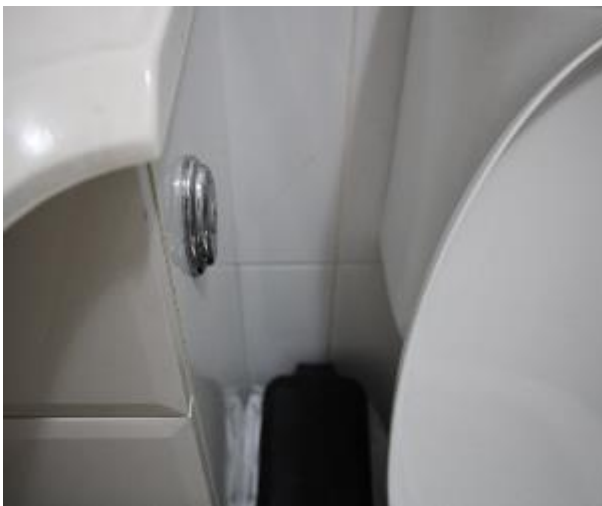
Figure 1213 - Crack propagation through ensuite bathroom internal wall

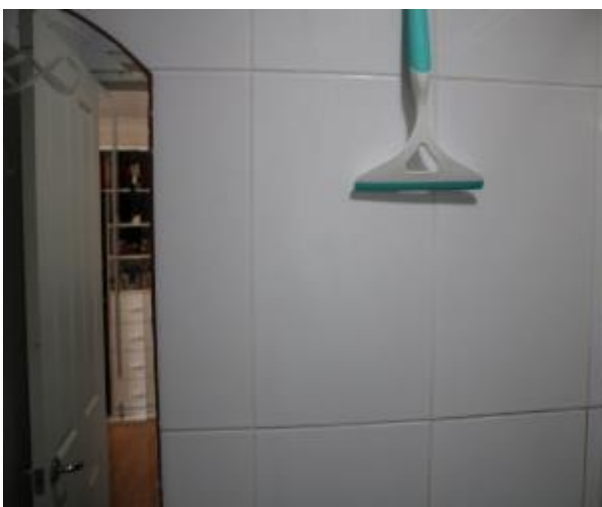
Figure 1215 - Crack propagation through ensuite bathroom internal wall

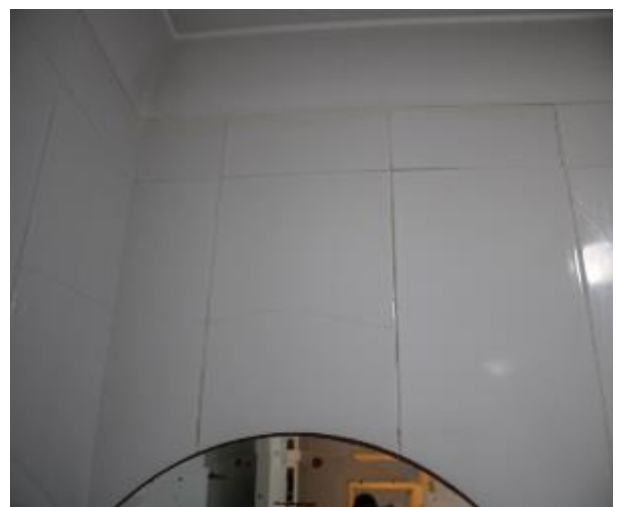
Figure 1216 - Crack propagation through ensuite bathroom internal wall

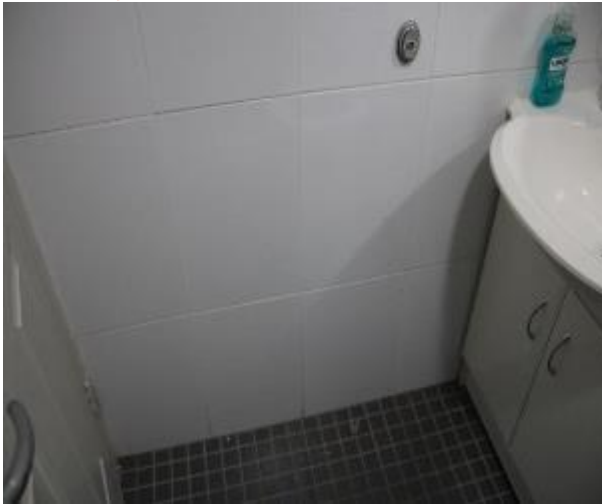
Figure 1217 - General condition of ensuite bathroom internal wall

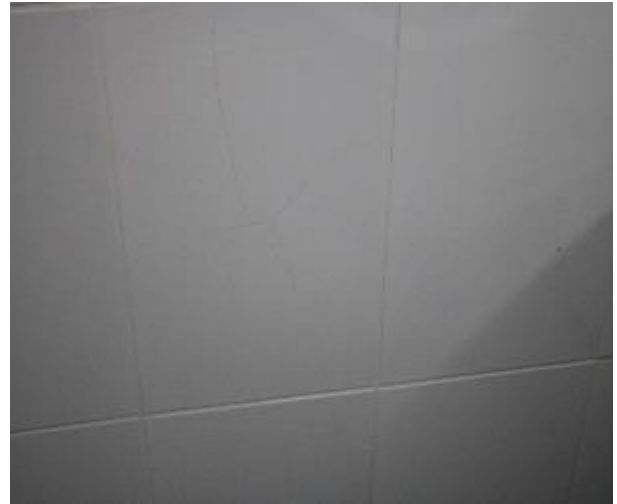
Figure 1218 - Crack propagation through ensuite bathroom internal wall

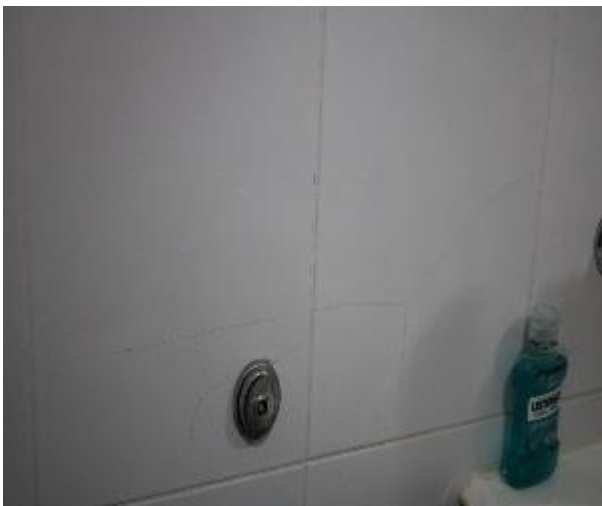
Figure 1219 - Crack propagation through ensuite bathroom internal wall

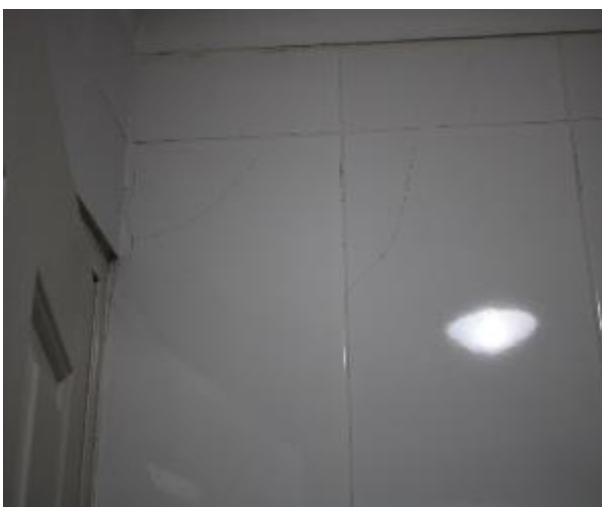
Figure 1221 - Crack propagation through ensuite bathroom internal wall

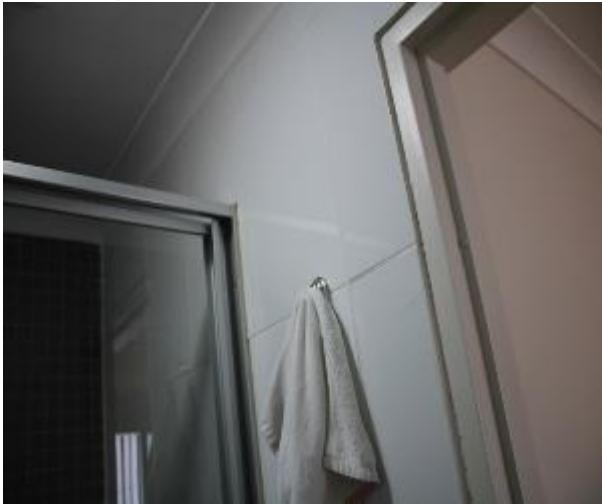
Figure 1223 - General condition of ensuite bathroom internal wall

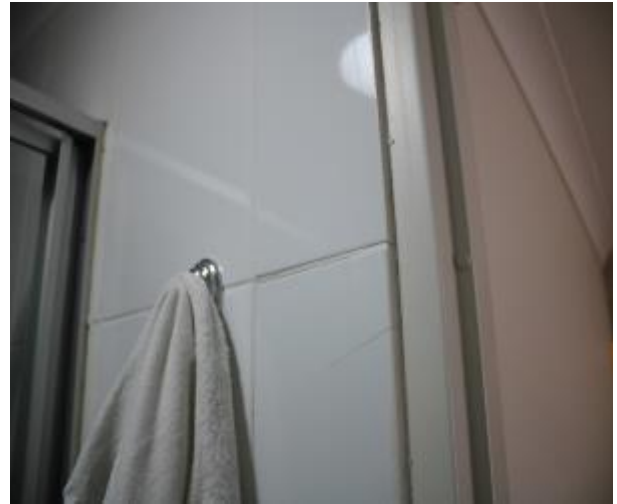
Figure 1224 - Crack propagation through ensuite bathroom internal wall

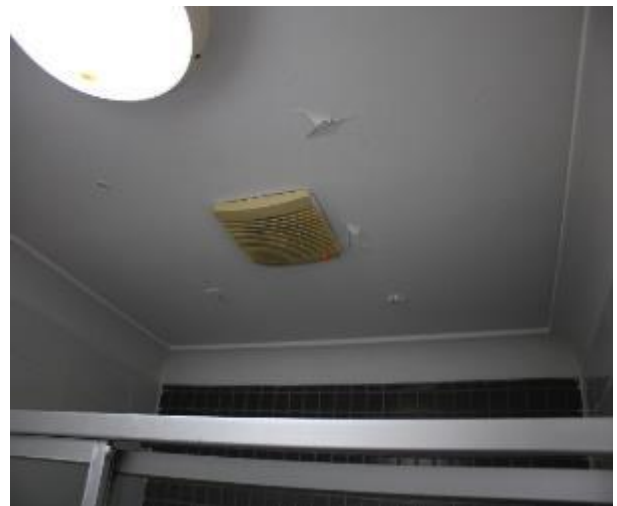
Figure 1226 - Paint flaking through ensuite bathroom ceiling

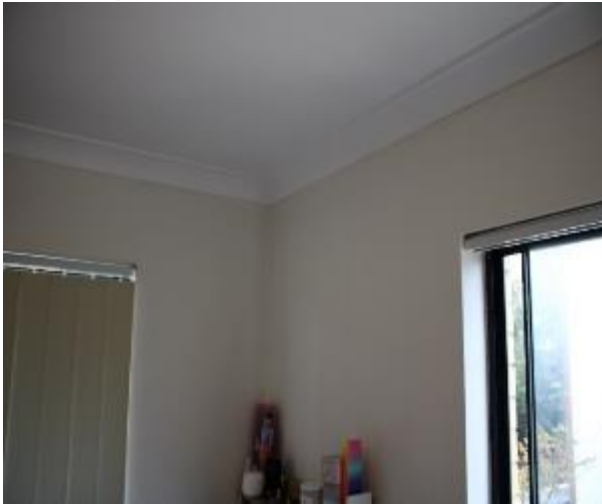
Figure 1229 - General condition of bedroom 2 internal wall

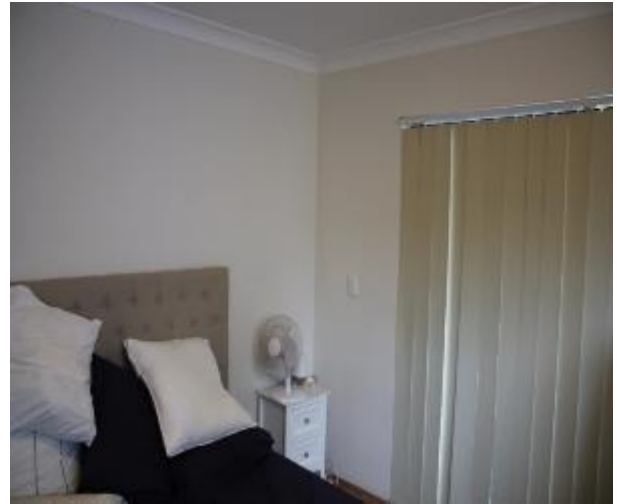
Figure 1230 - General condition of bedroom 2 internal wall

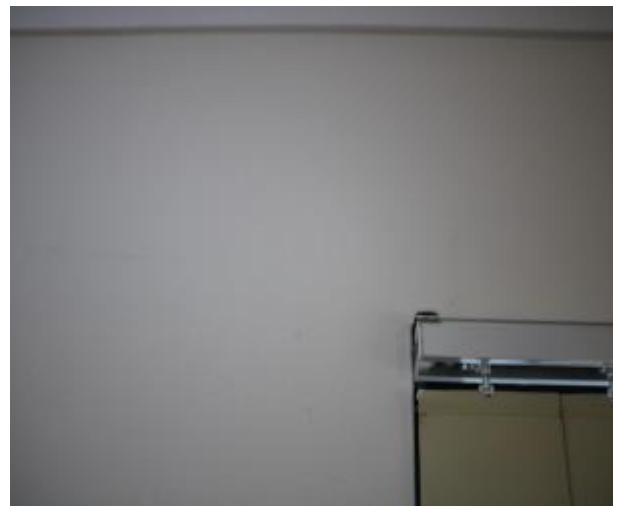
Figure 1232 - Crack propagation through bedroom 2 internal wall

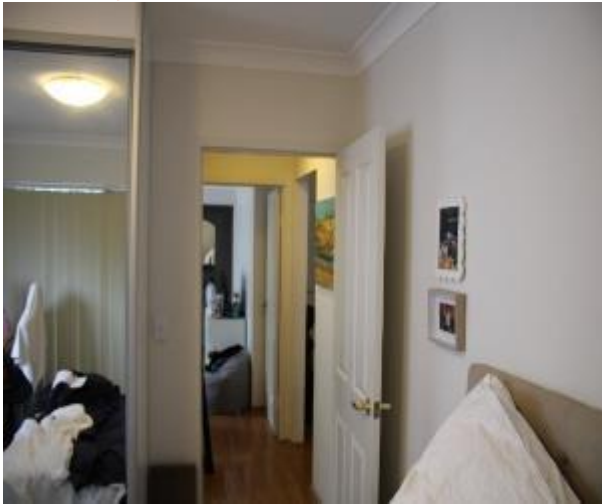
Figure 1235 - General condition of bedroom 2 internal wall

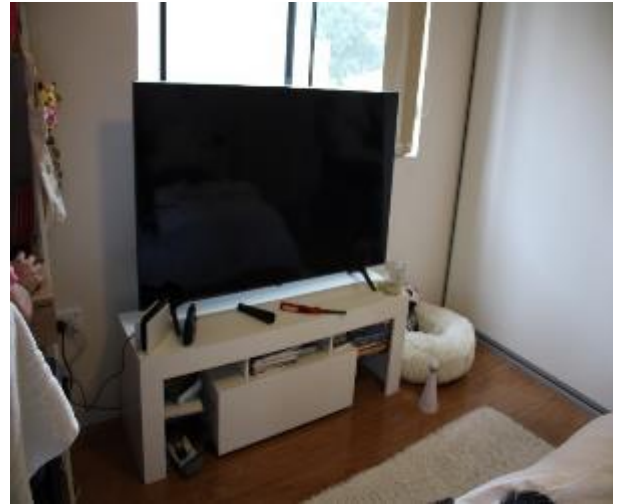
Figure 1236 - General condition of bedroom 2 internal wall

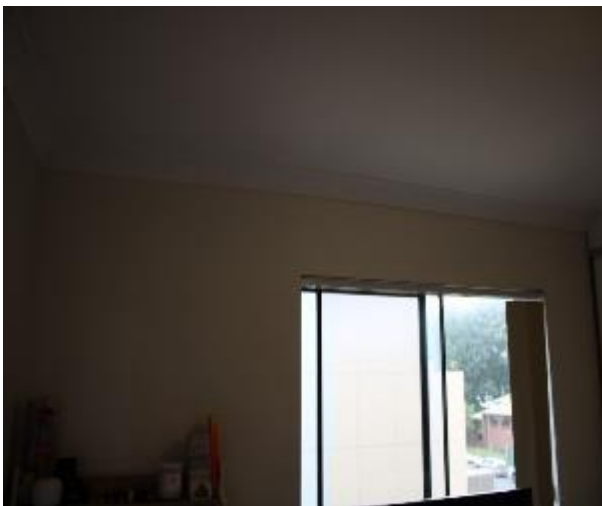
Figure 1237 - General condition of bedroom 2 internal wall

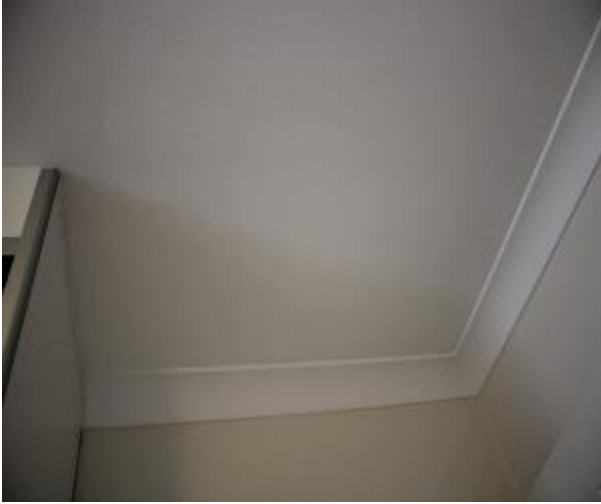
Figure 1241 - General condition of bedroom 2 ceiling

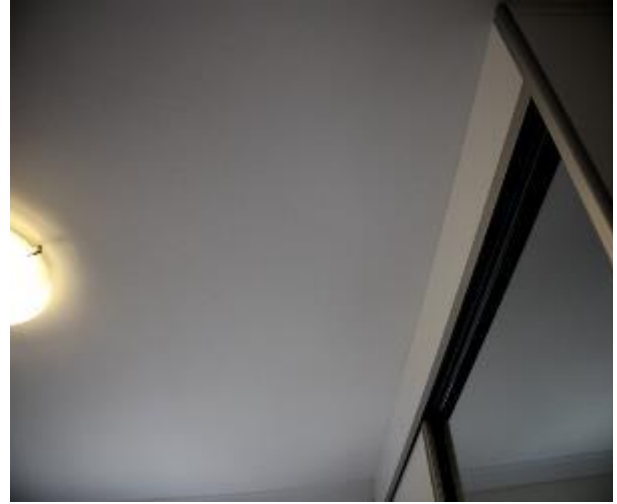
Figure 1242 - General condition of bedroom 2 ceiling

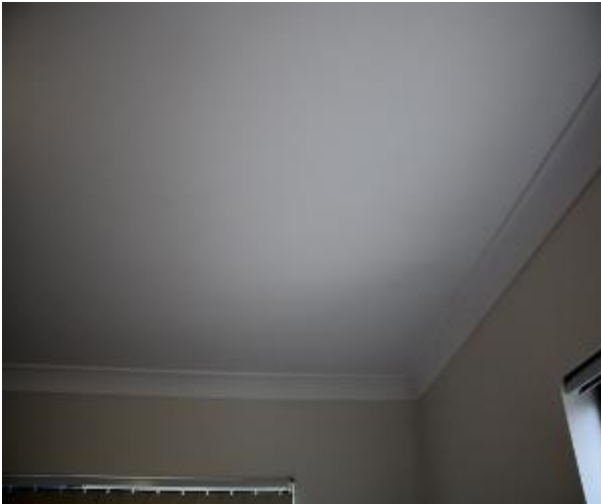
Figure 1243 - General condition of bedroom 2 ceiling

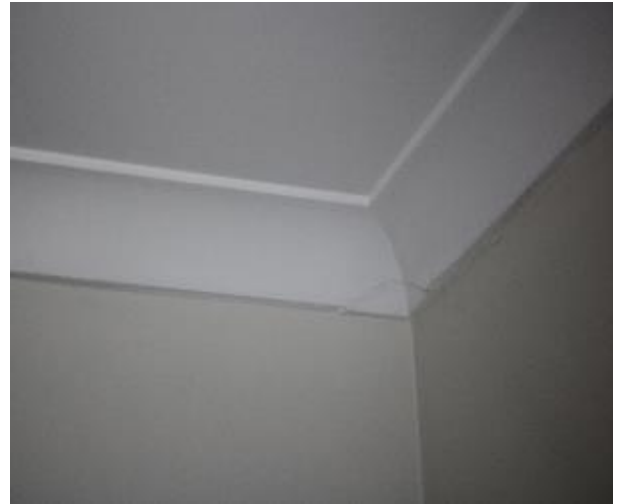
Figure 1244 - Crack propagation through bedroom 2 ceiling

Unit 15 was inspected and determined to be in reasonable condition with evidence of cracking through the internal and external walls, balcony underside slab, and balcony floor tiles. There were also cases of cracking and paint flaking through the ceiling.

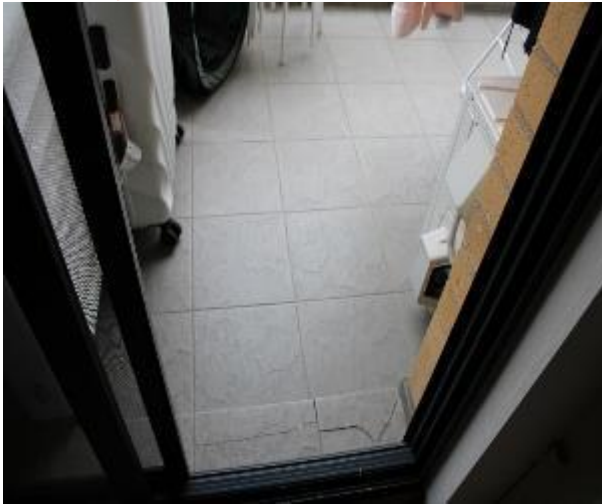
Figure 1247 - General condition of balcony floor tiles

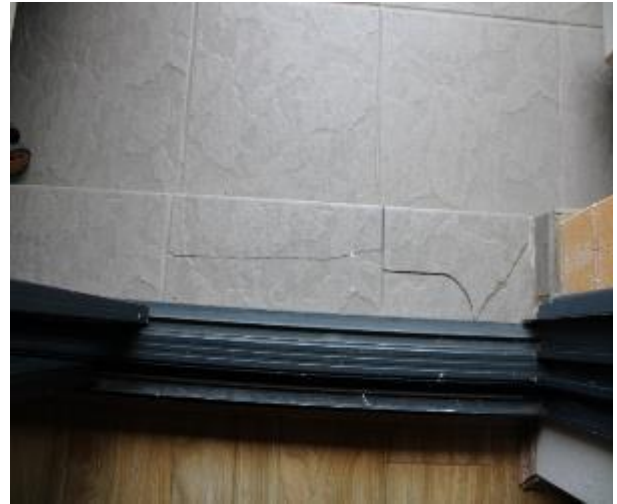
Figure 1248 - Crack propagation through balcony floor tiles

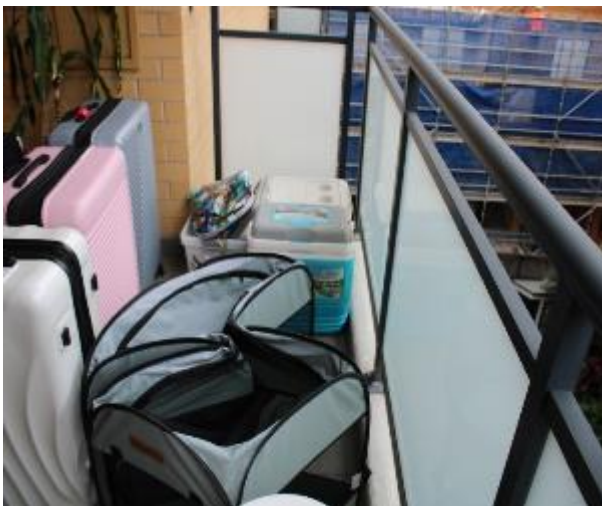
Figure 1249 - General condition of balcony floor tiles

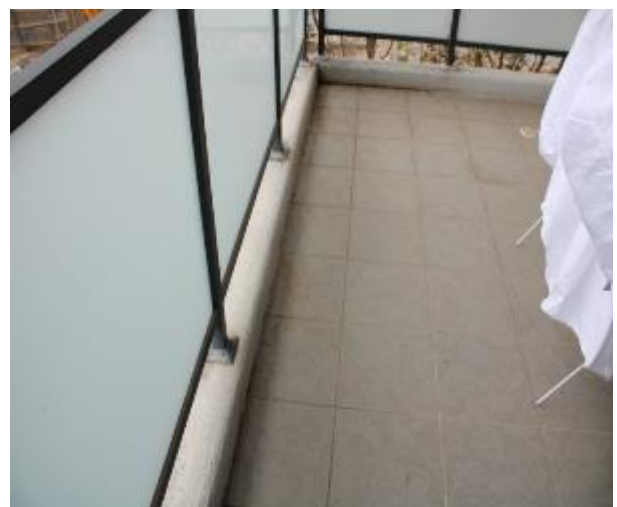
Figure 1252 - General condition of balcony floor tiles

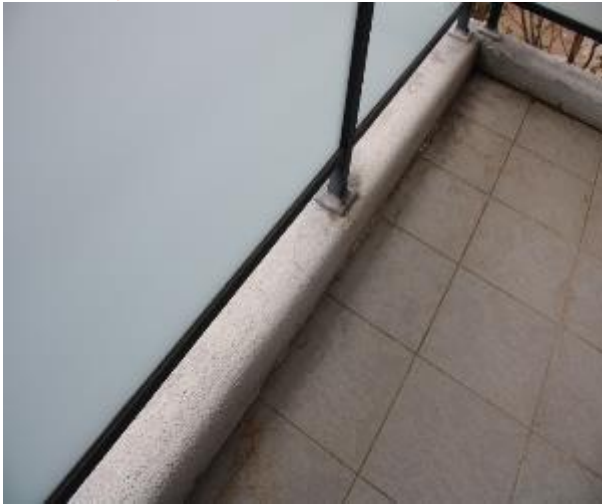
Figure 1253 - General condition of balcony floor tiles

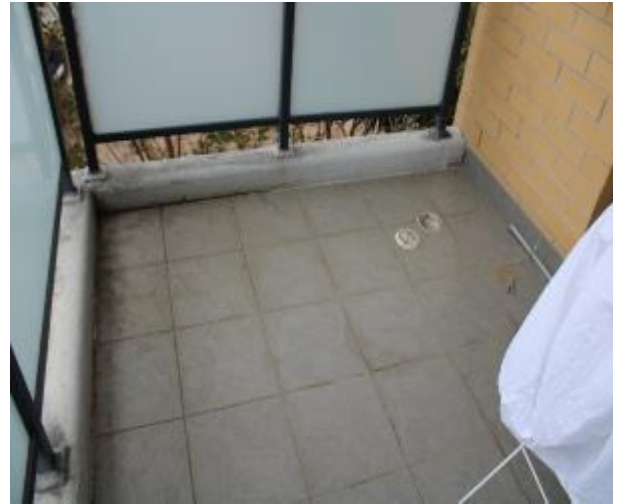
Figure 1254 - General condition of balcony floor tiles

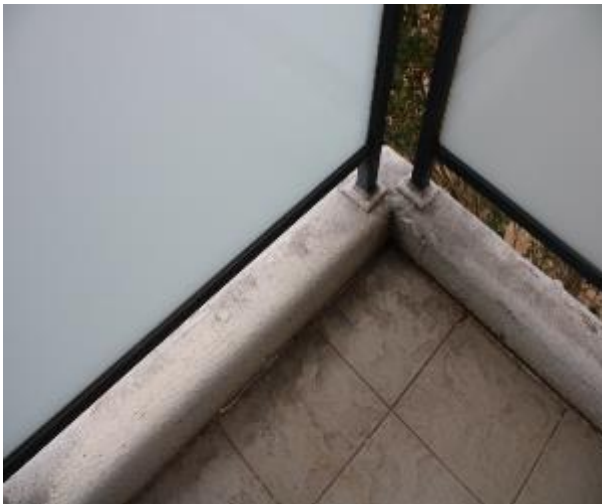
Figure 1255 - General condition of balcony floor tiles
