# **Pre-Dilapidation Report**

**19 GEORGE STREET**

**FRONT BUILDING (UNITS 1-19)**

Project Reference: 20250047.19G.2

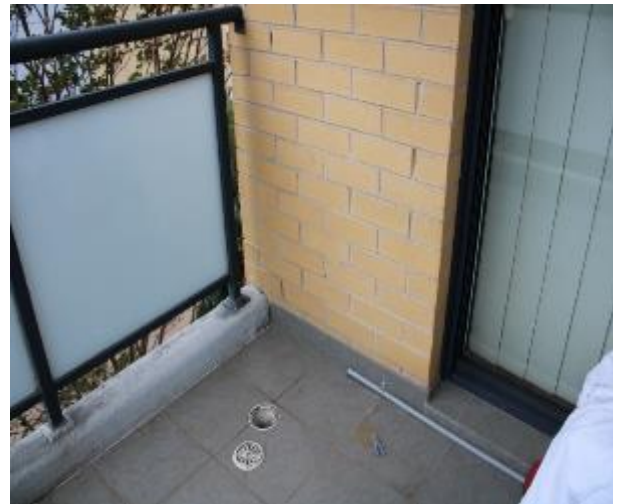
Figure 1256 - General condition of external wall

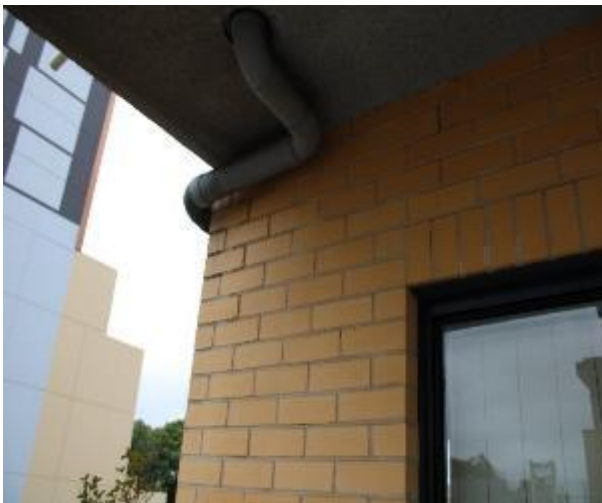
Figure 1257 - General condition of external wall

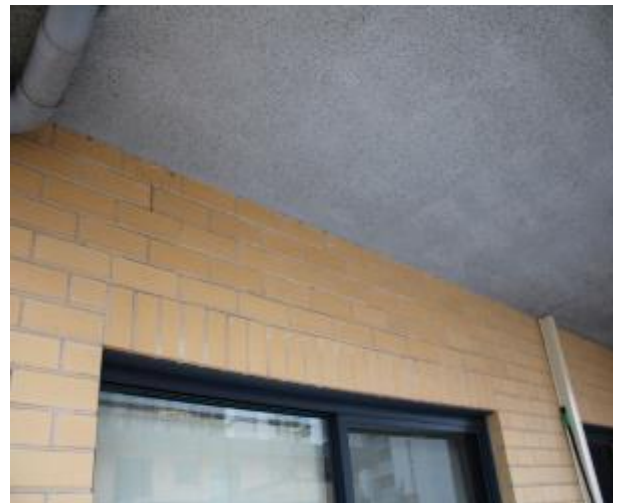
Figure 1258 - General condition of external wall

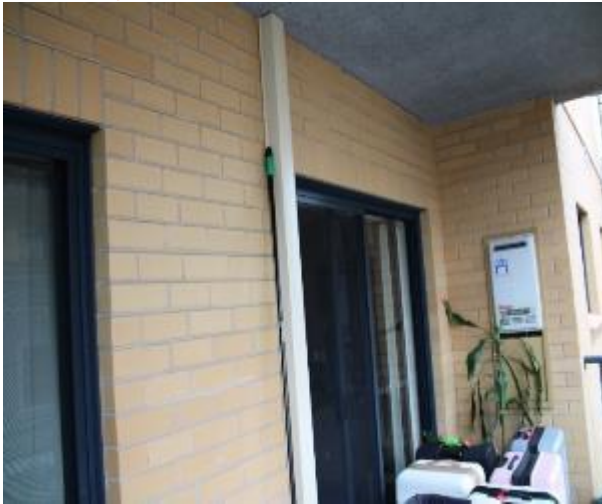
Figure 1259 - General condition of external wall

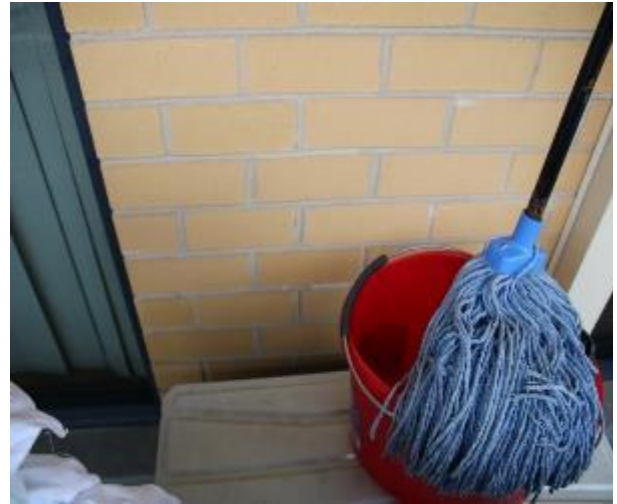
Figure 1260 - General condition of external wall

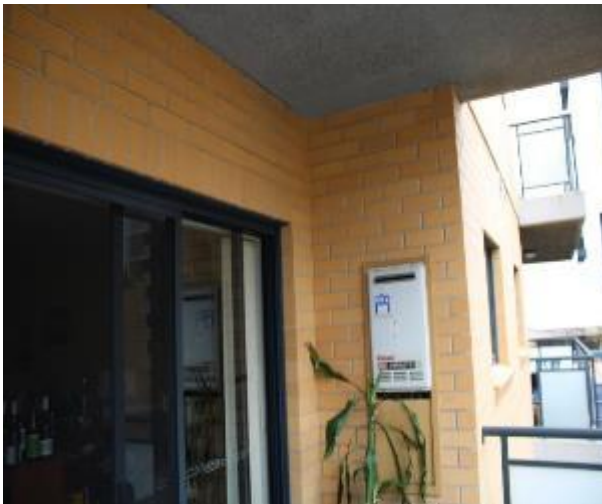
Figure 1261 - General condition of external wall

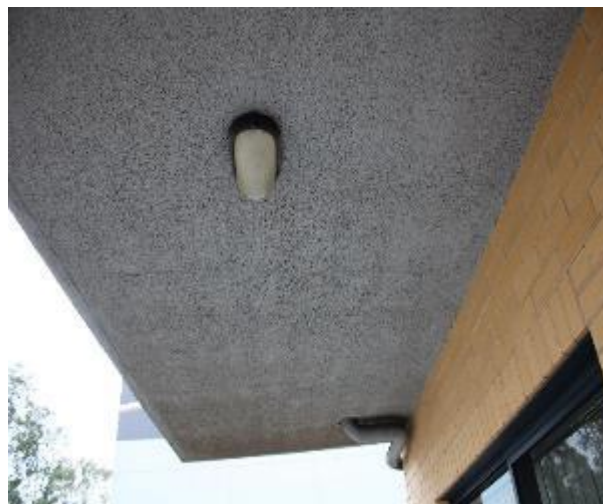
Figure 1266 - General condition of balcony underside slab

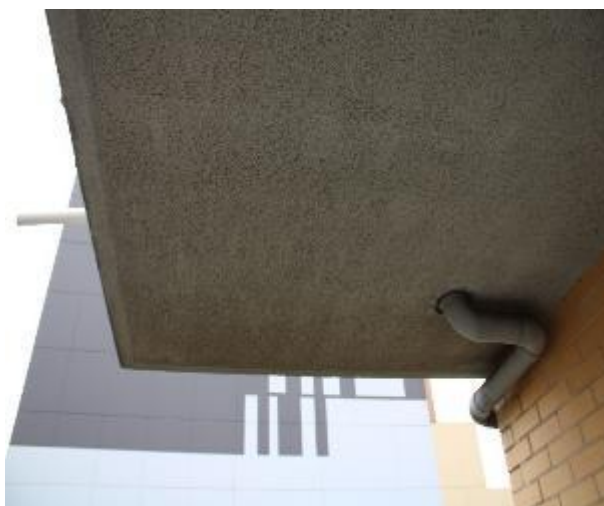
Figure 1267 - General condition of balcony underside slab

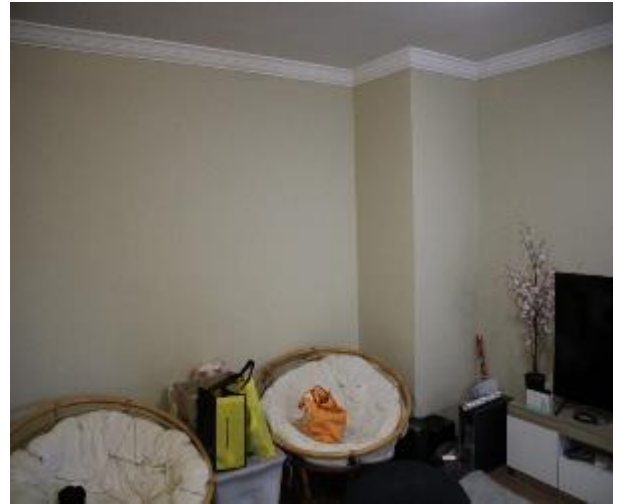
Figure 1269 - General condition of lounge room internal wall

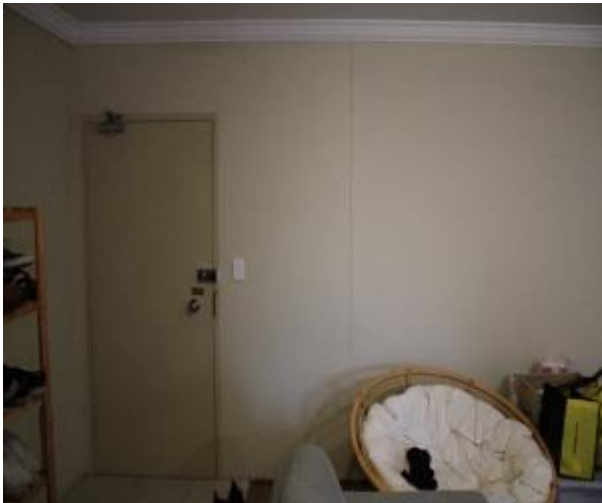
Figure 1270 - General condition of lounge room internal wall

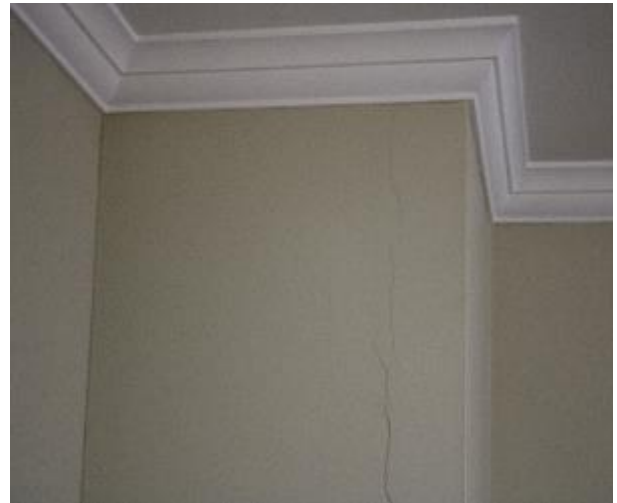
Figure 1271 - Crack propagation through lounge room internal wall

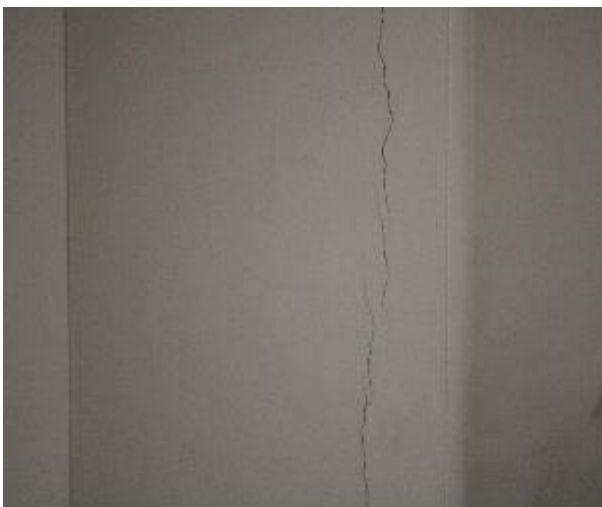
Figure 1272 - Crack propagation through lounge room internal wall

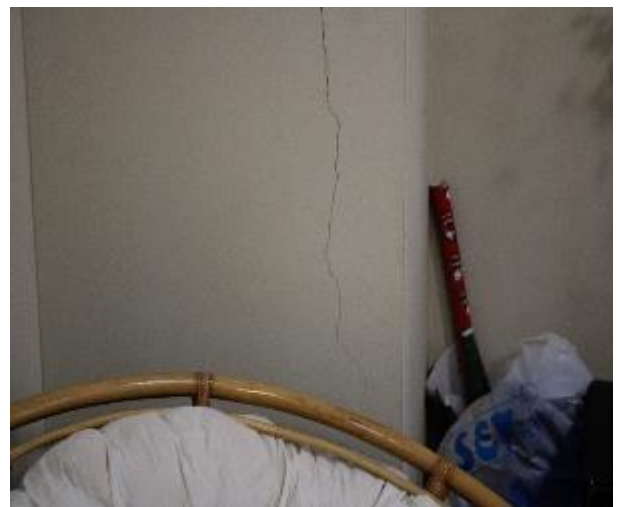
Figure 1273 - Crack propagation through lounge room internal wall

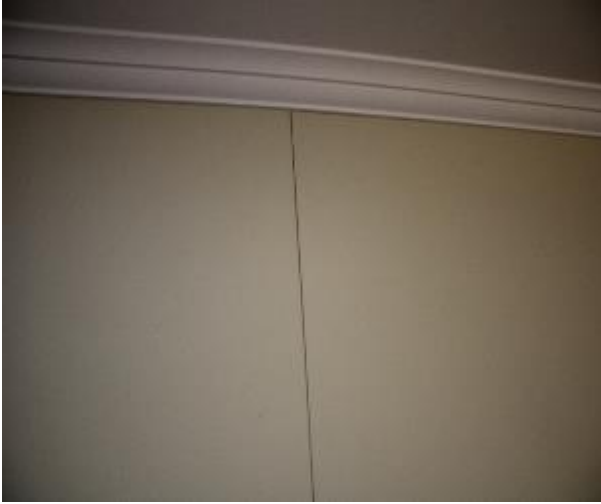
Figure 1274 - General condition of lounge room internal wall

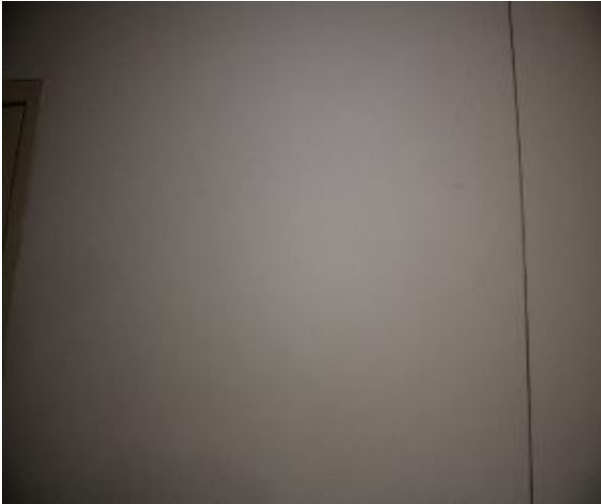
Figure 1276 - Crack propagation through lounge room internal wall

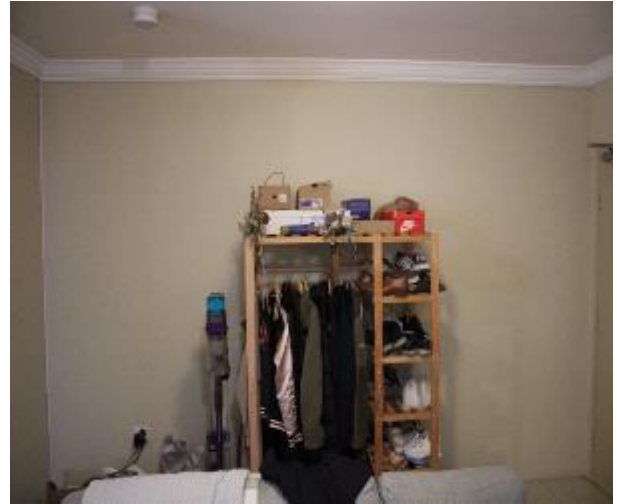
Figure 1277 - General condition of lounge room internal wall

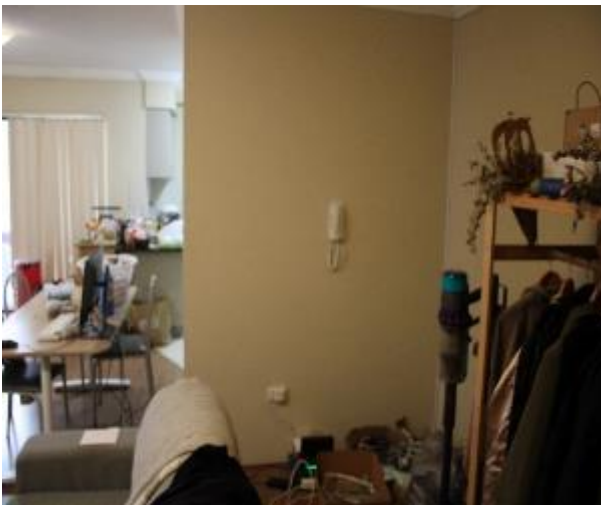
Figure 1278 - General condition of lounge room internal wall

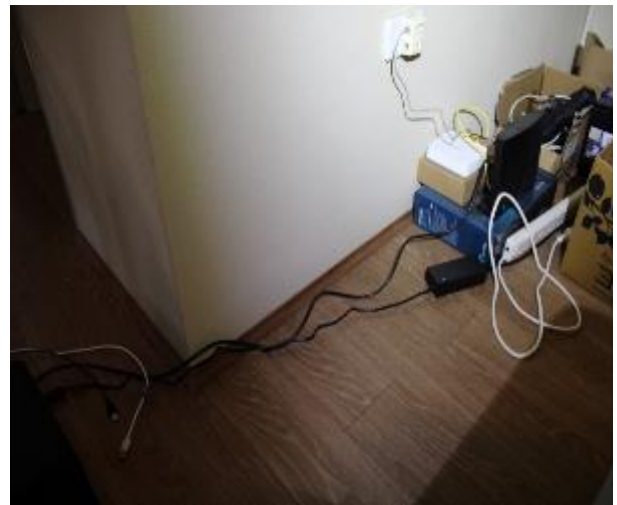
Figure 1279 - General condition of lounge room internal wall

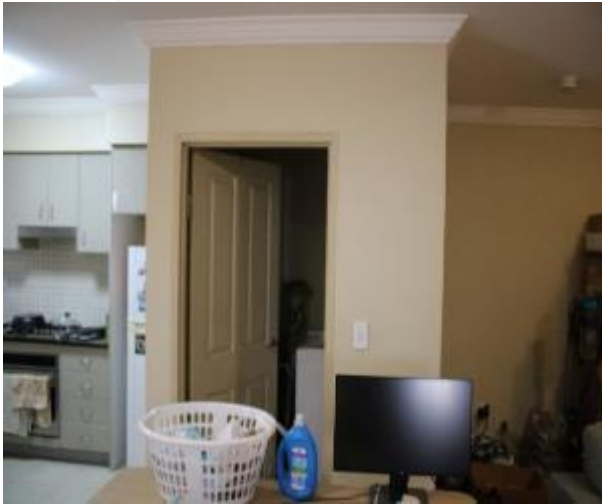
Figure 1280 - General condition of lounge room internal wall

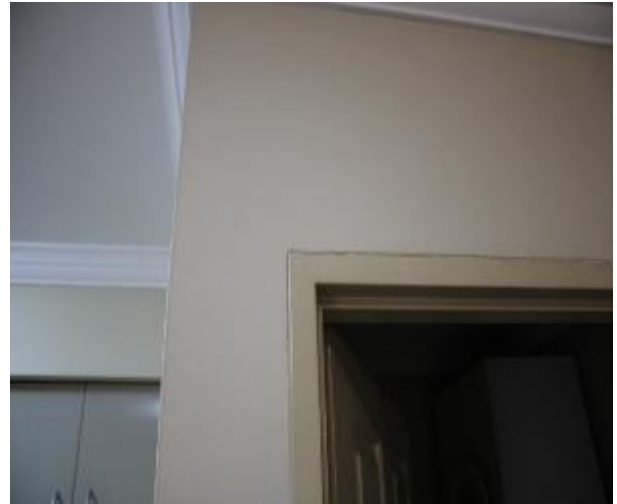
Figure 1281 - Crack propagation through lounge room internal wall

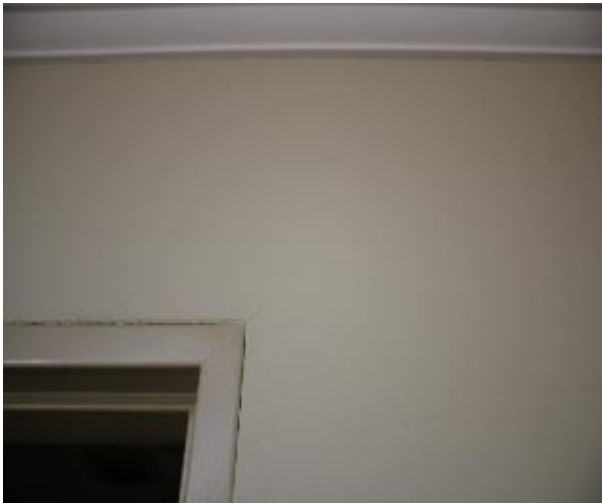
Figure 1282 - Crack propagation through lounge room internal wall

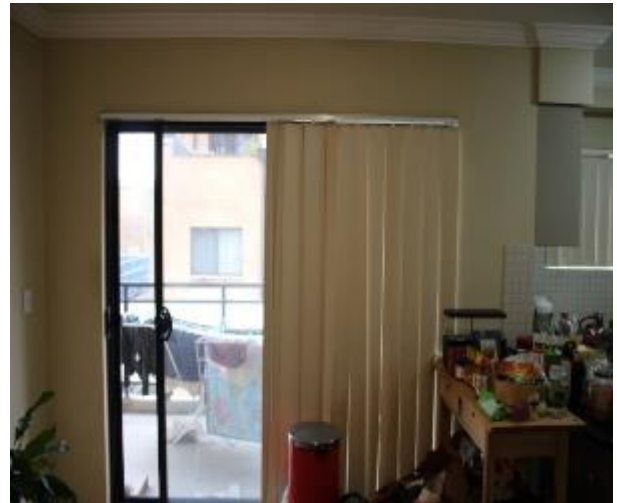
Figure 1283 - General condition of lounge room internal wall

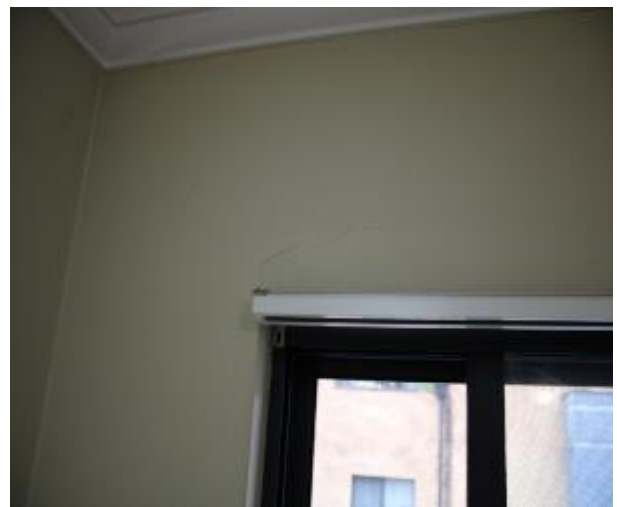
Figure 1285 - Crack propagation through lounge room internal wall

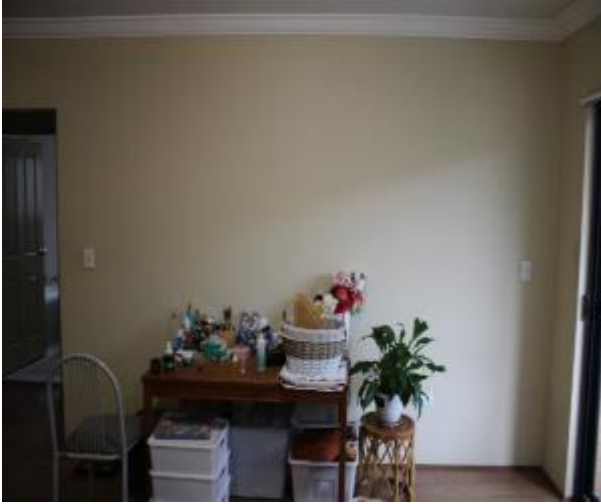
Figure 1286 - General condition of lounge room internal wall

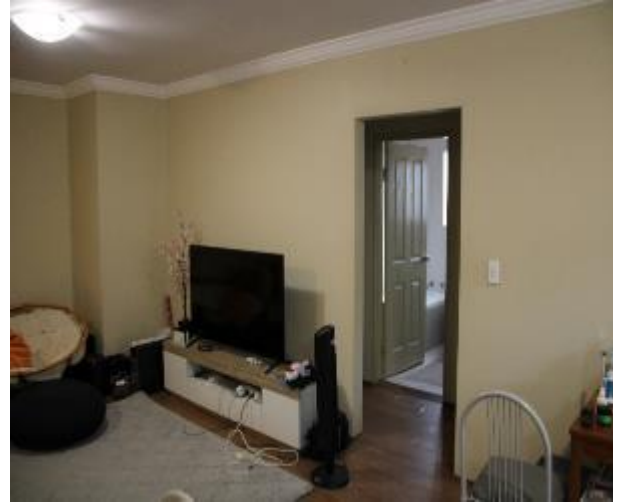
Figure 1287 - General condition of lounge room internal wall

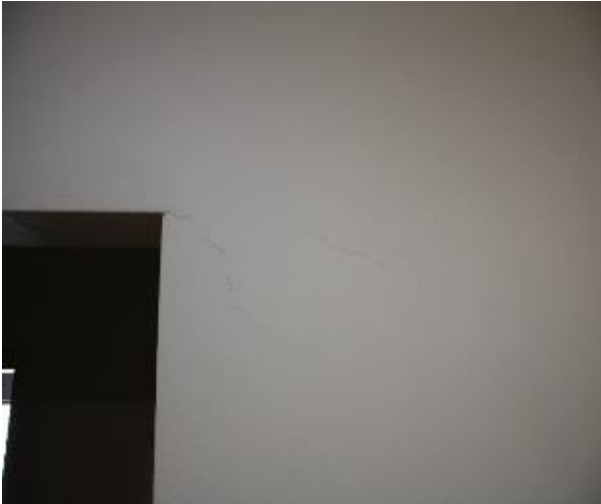
Figure 1288 - Crack propagation through lounge room internal wall

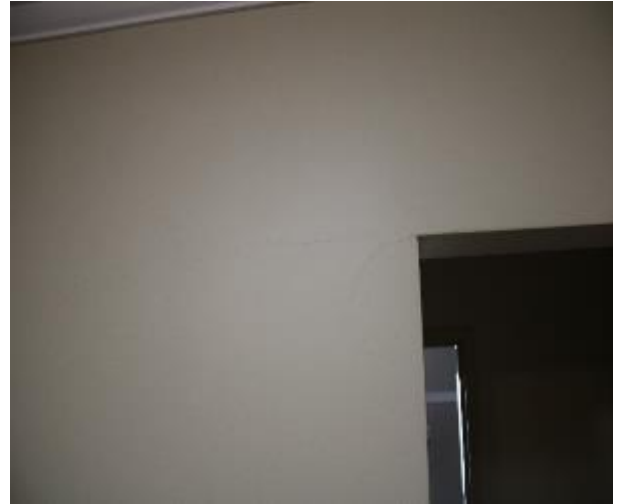
Figure 1289 - Crack propagation through lounge room internal wall

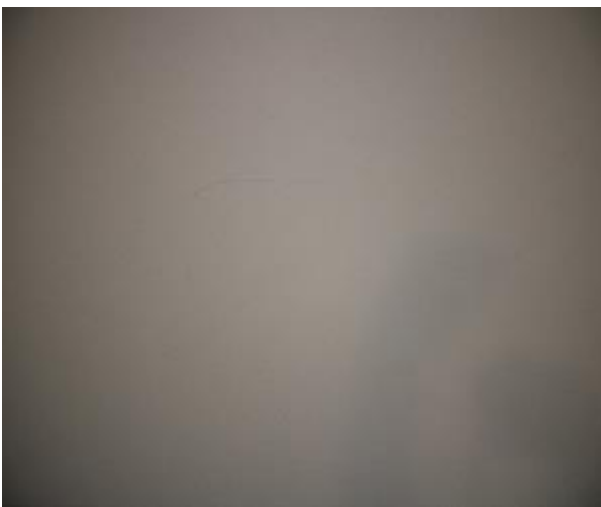
Figure 1290 - Crack propagation through lounge room internal wall

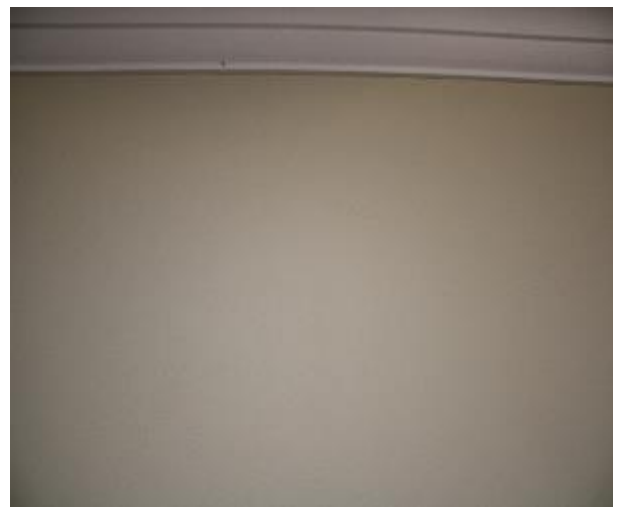
Figure 1291 - Crack propagation through lounge room internal wall

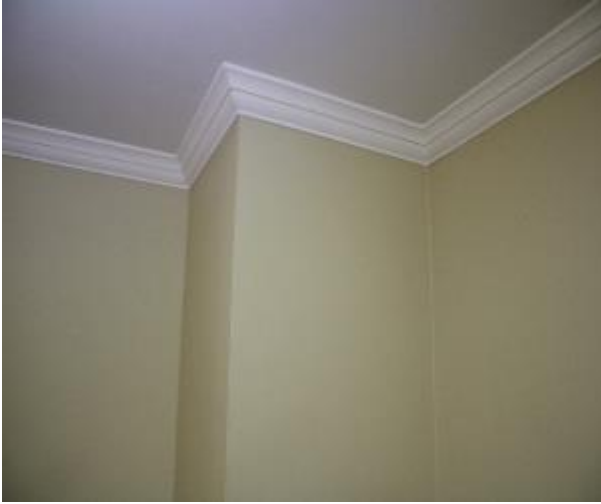
Figure 1292 - General condition of lounge room internal wall

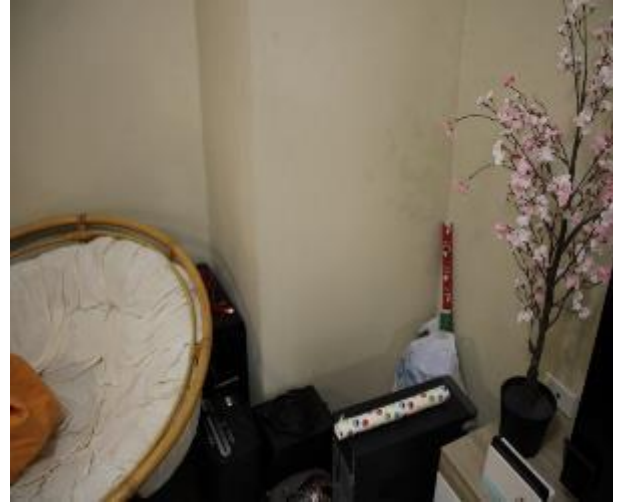
Figure 1293 - General condition of lounge room internal wall

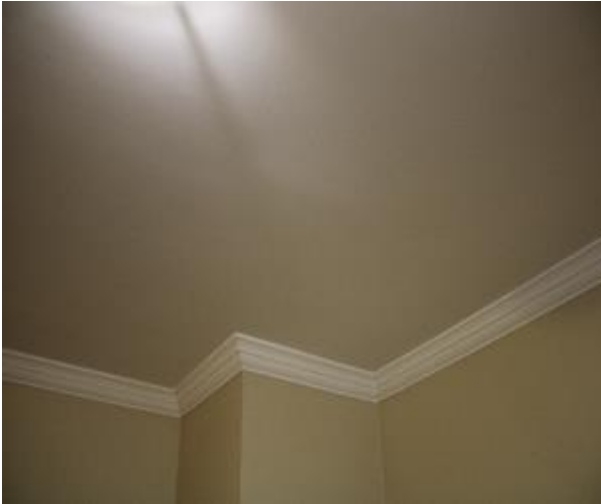
Figure 1294 - General condition of lounge room ceiling

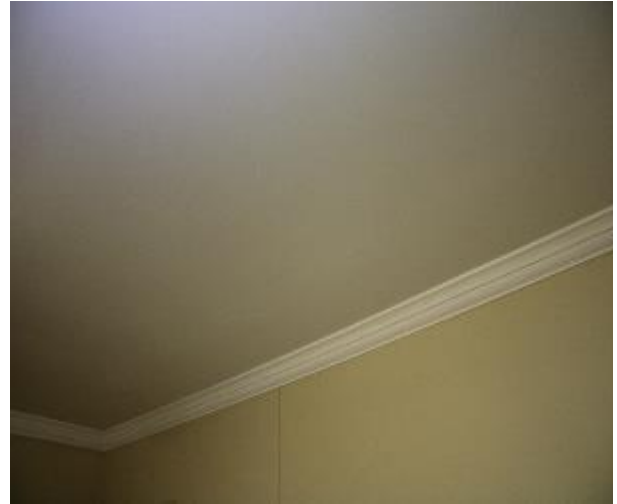
Figure 1295 - General condition of lounge room ceiling

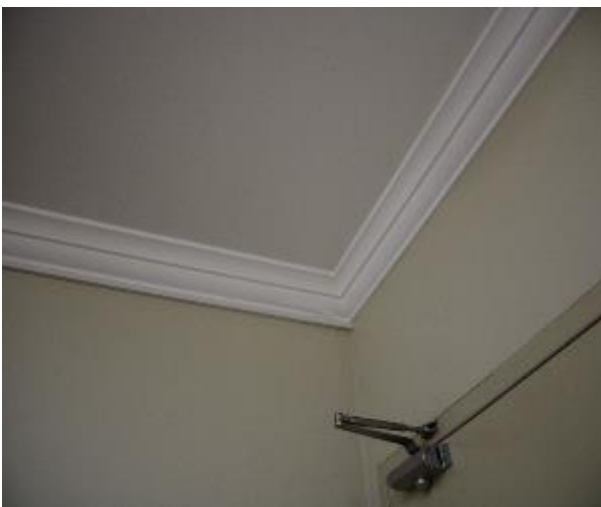
Figure 1296 - General condition of lounge room ceiling

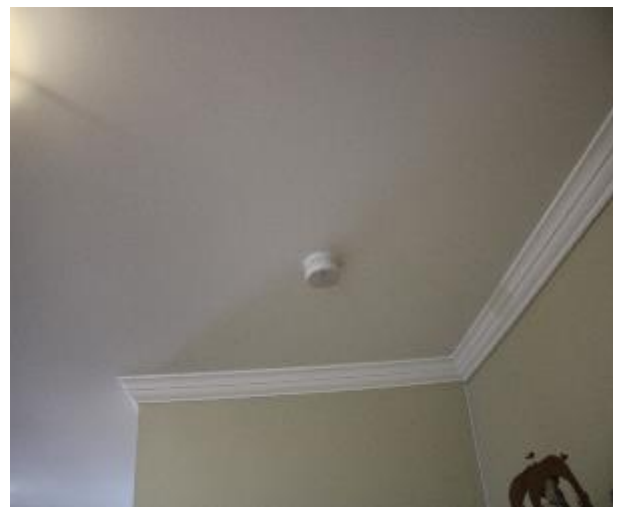
Figure 1297 - General condition of lounge room ceiling

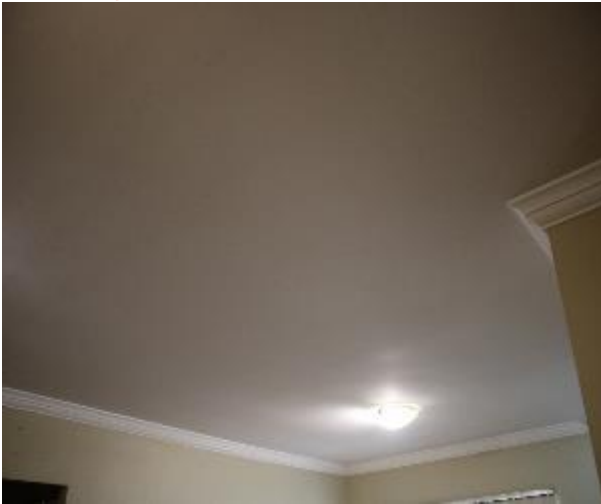
Figure 1298 - General condition of lounge room ceiling

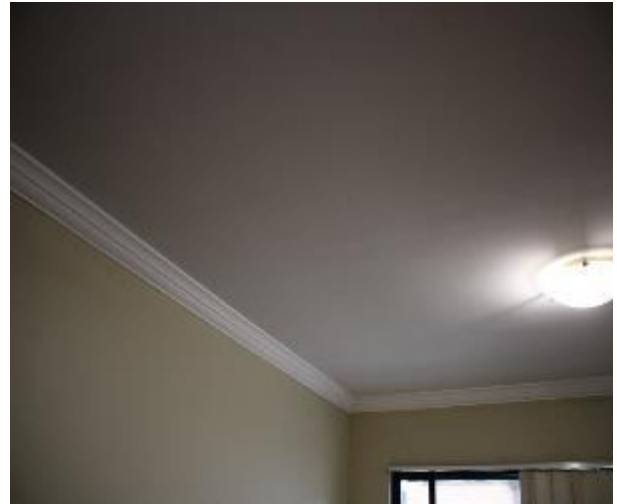
Figure 1299 - General condition of lounge room ceiling

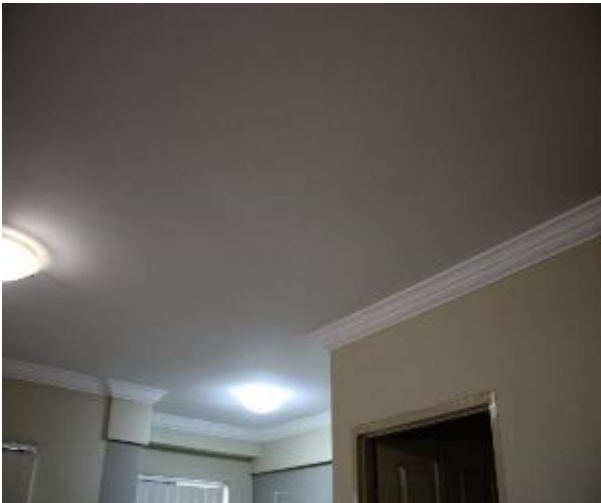
Figure 1300 - General condition of lounge room ceiling

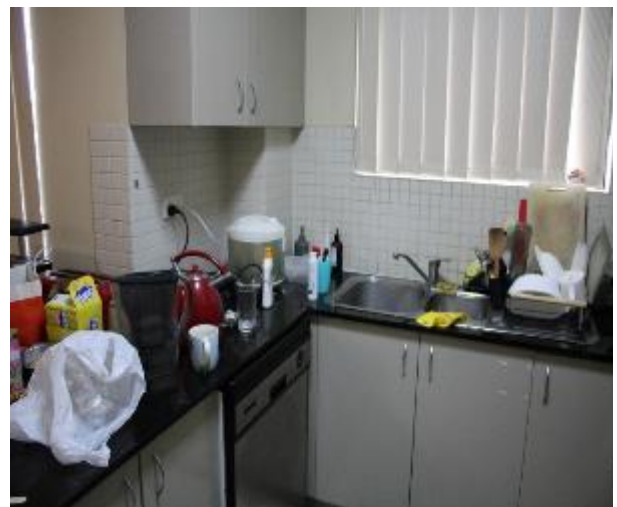
Figure 1303 - General condition of kitchen internal wall

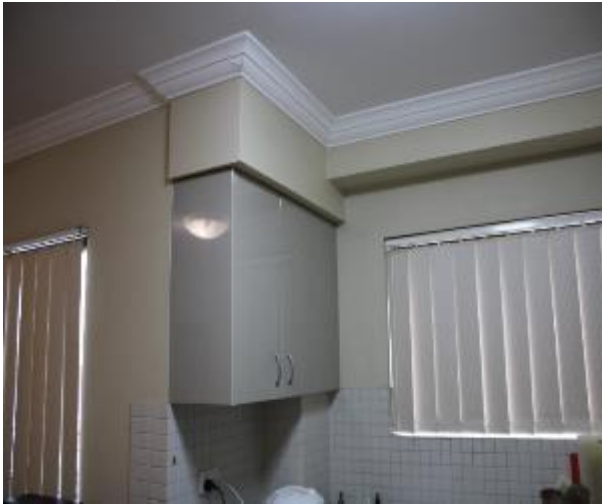
Figure 1304 - General condition of kitchen internal wall

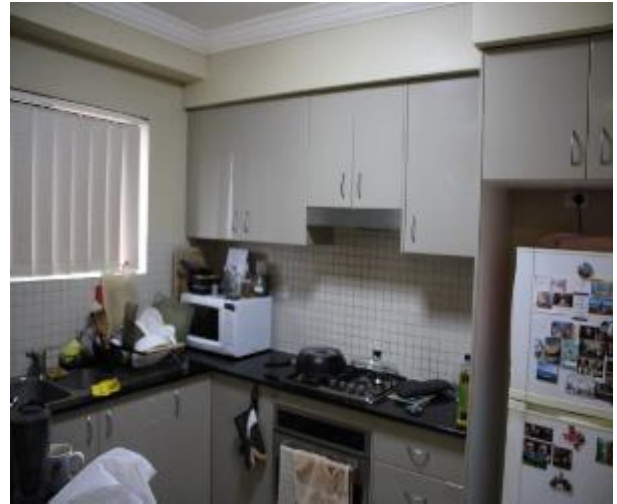
Figure 1305 - General condition of kitchen internal wall

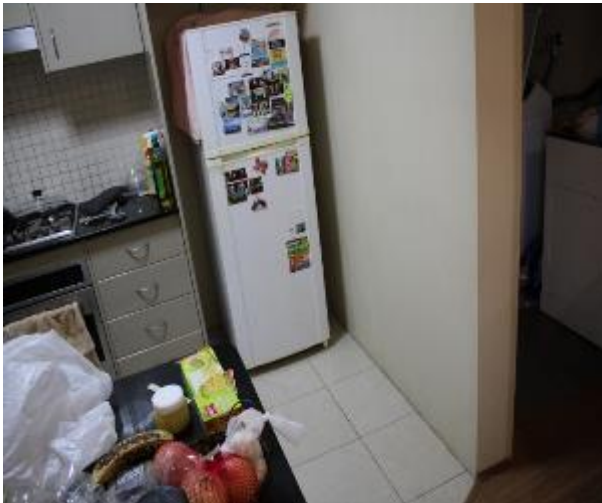
Figure 1306 - General condition of kitchen internal wall

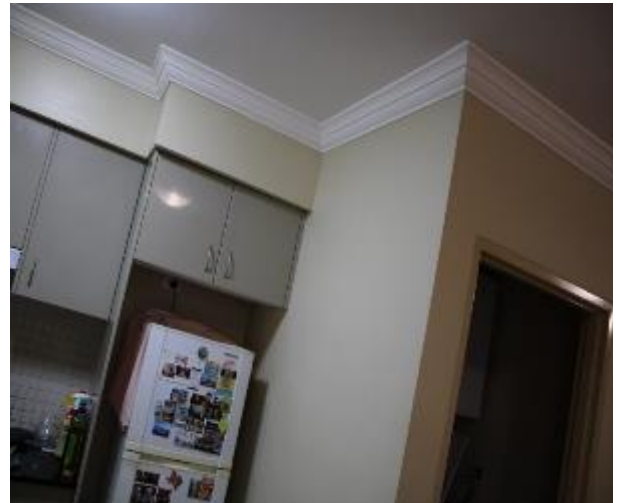
Figure 1307 - General condition of kitchen internal wall

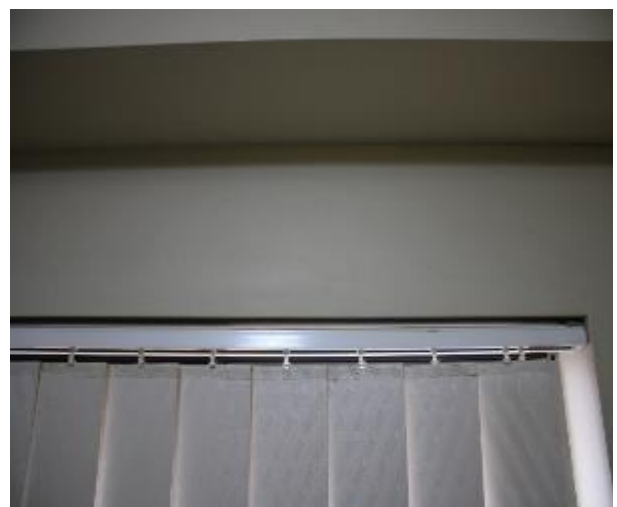
Figure 1309 - Crack propagation through kitchen internal wall

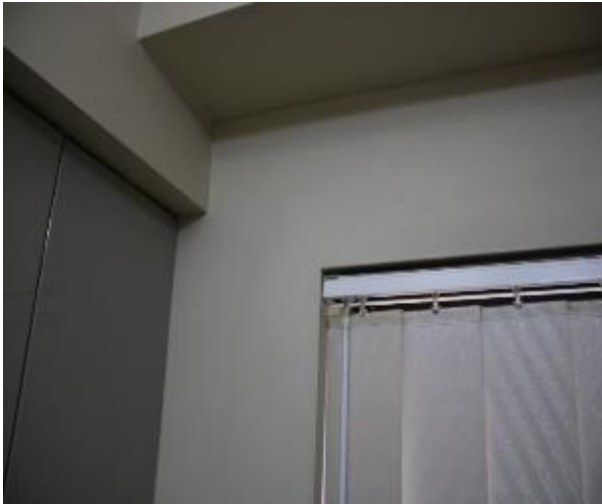
Figure 1310 - Crack propagation through kitchen internal wall

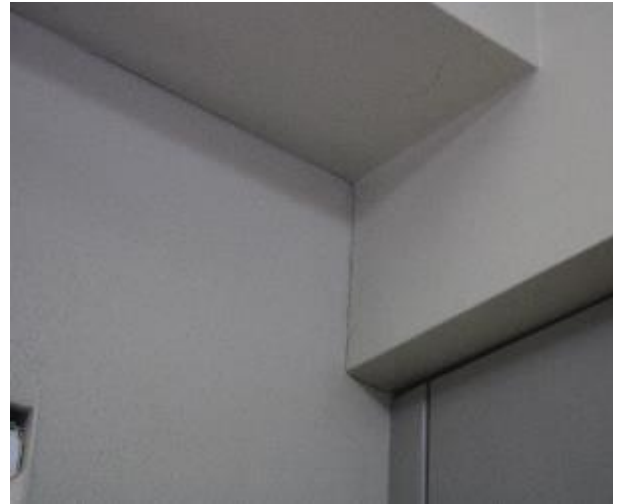
Figure 1311 - Crack propagation through kitchen internal wall

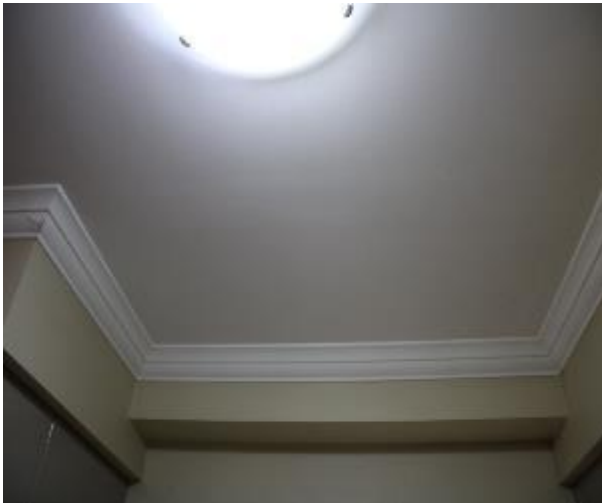
Figure 1312 - General condition of kitchen ceiling

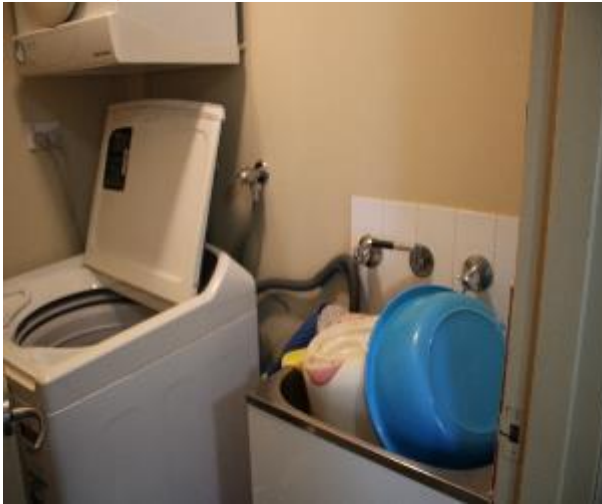
Figure 1316 - General condition of laundry internal wall

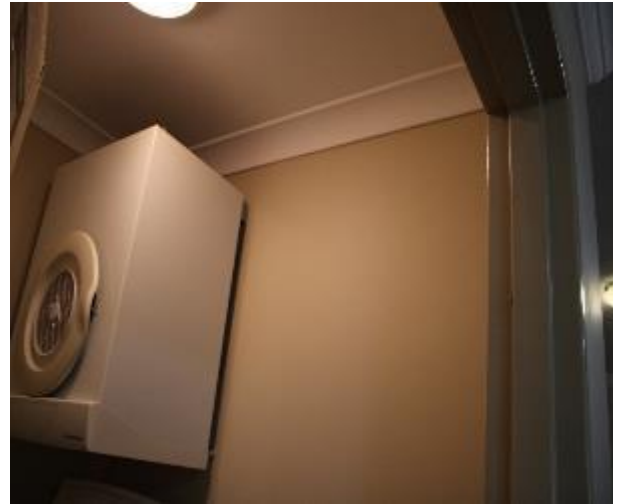
Figure 1317 - General condition of laundry internal wall

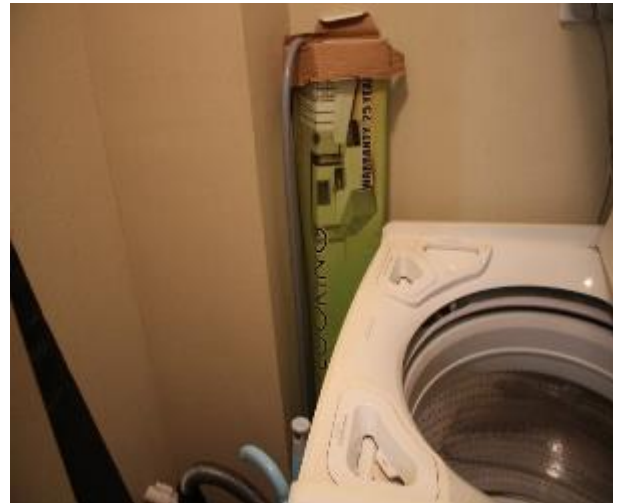
Figure 1318 - Crack propagation through laundry internal wall

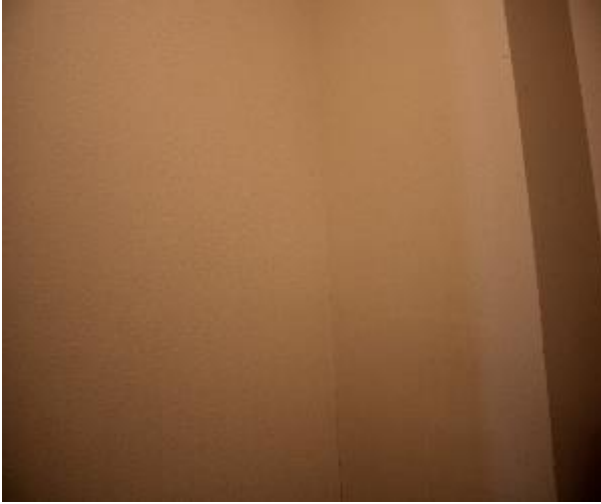
Figure 1321 - Crack propagation through laundry internal wall

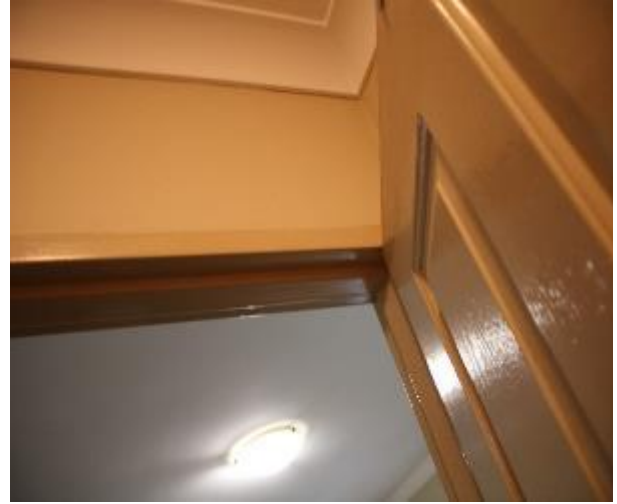
Figure 1322 - Crack propagation through laundry internal wall

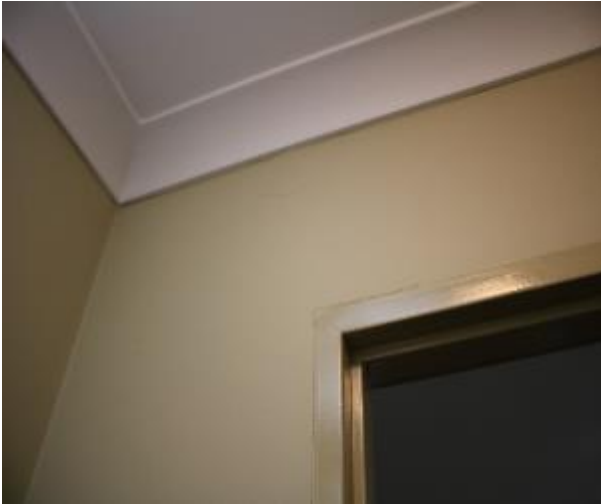
Figure 1323 - General condition of laundry internal wall

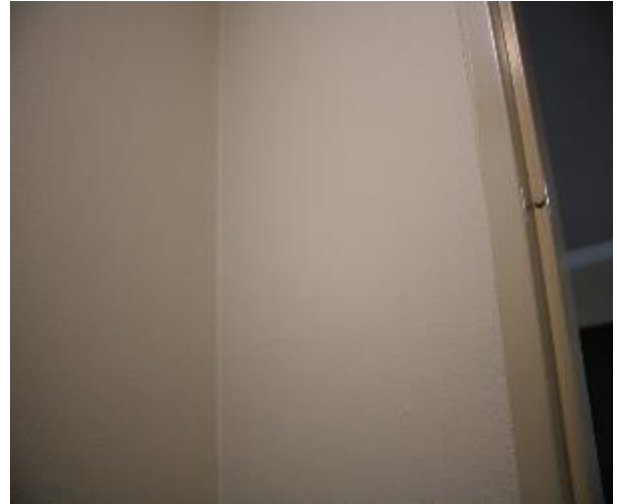
Figure 1324 - General condition of laundry internal wall

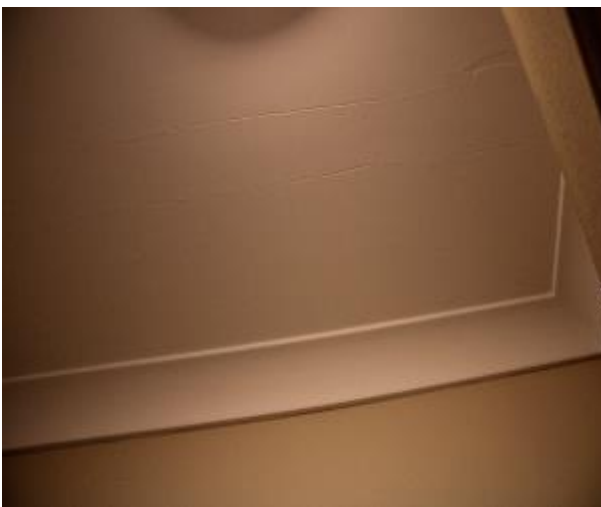
Figure 1325 - Crack propagation through laundry internal wall

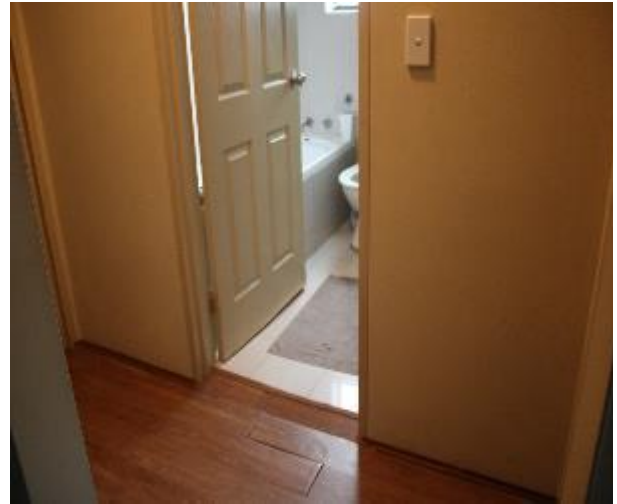
Figure 1328 - General condition of corridor flooring

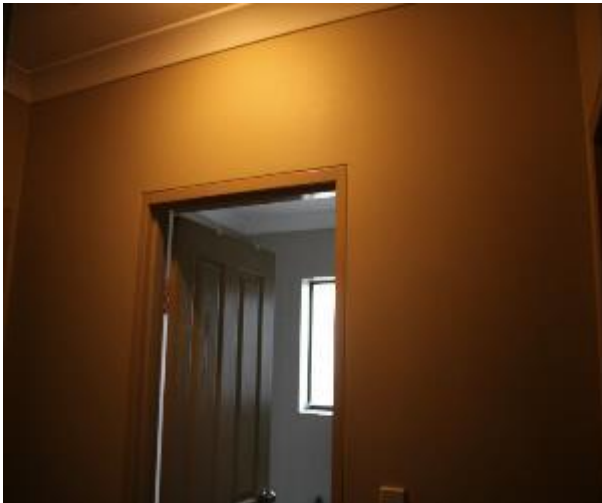
Figure 1329 - General condition of corridor internal wall

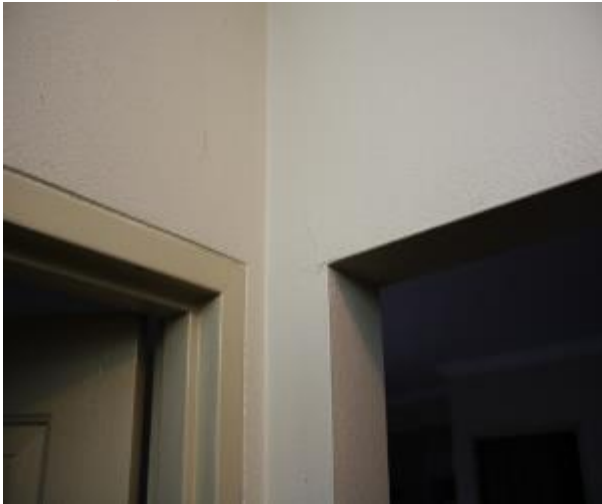
Figure 1333 - Crack propagation through corridor internal wall

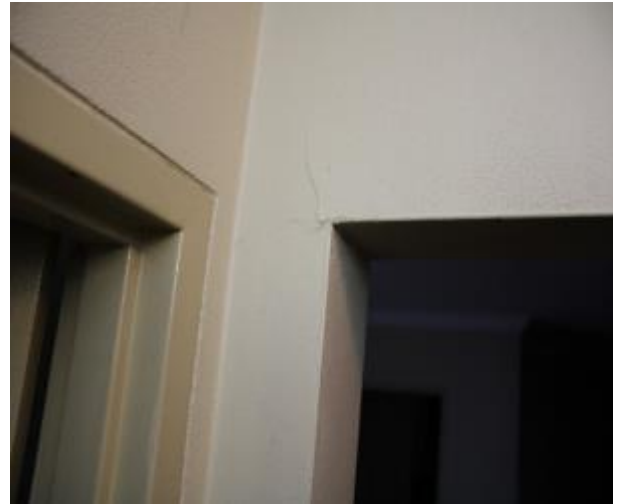
Figure 1334 - Crack propagation through corridor internal wall

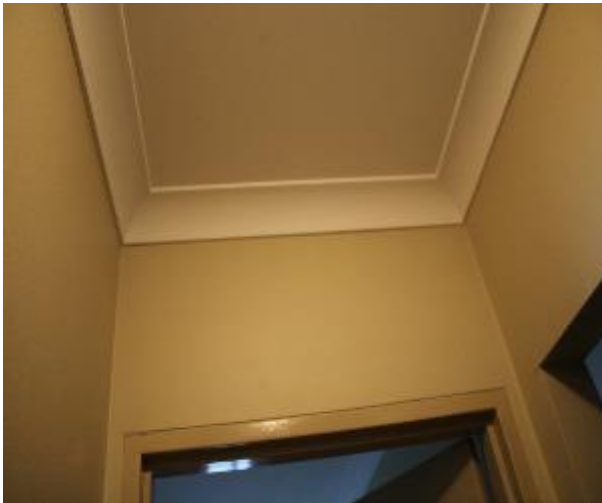
Figure 1335 - Crack propagation through corridor internal wall

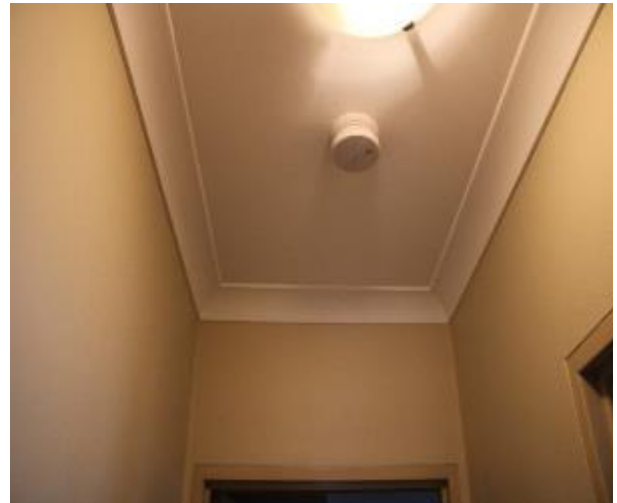
Figure 1336 - General condition of corridor internal wall

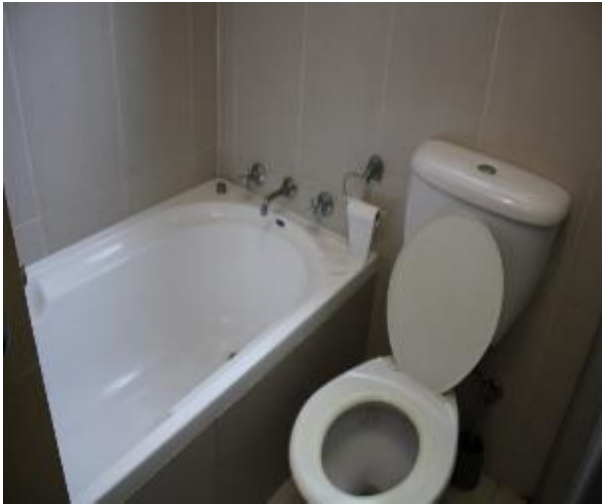
Figure 1345 - General condition of bathroom 1 internal wall

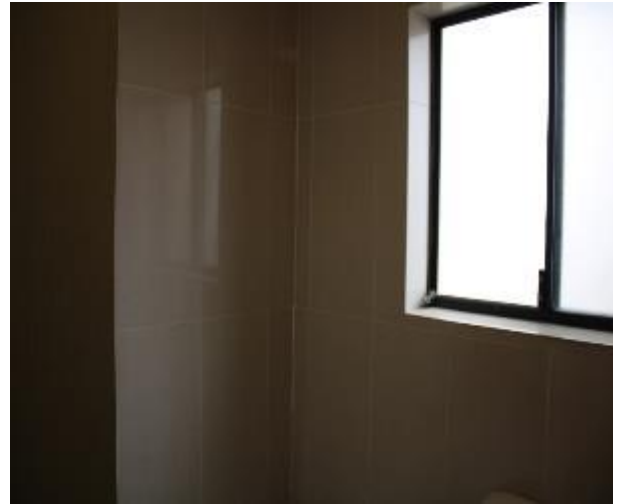
Figure 1346 - General condition of bathroom 1 internal wall

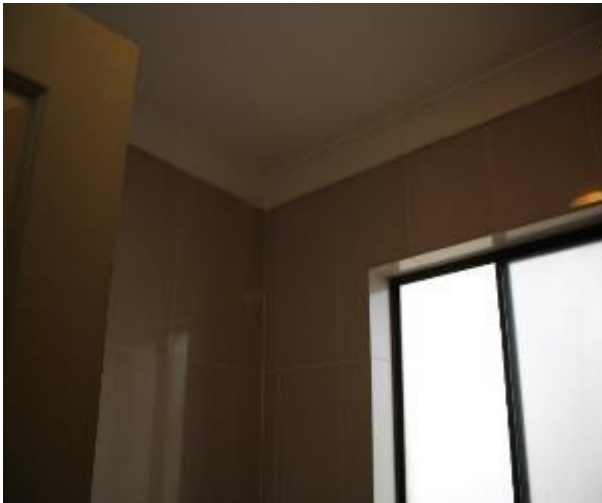
Figure 1347 - General condition of bathroom 1 internal wall

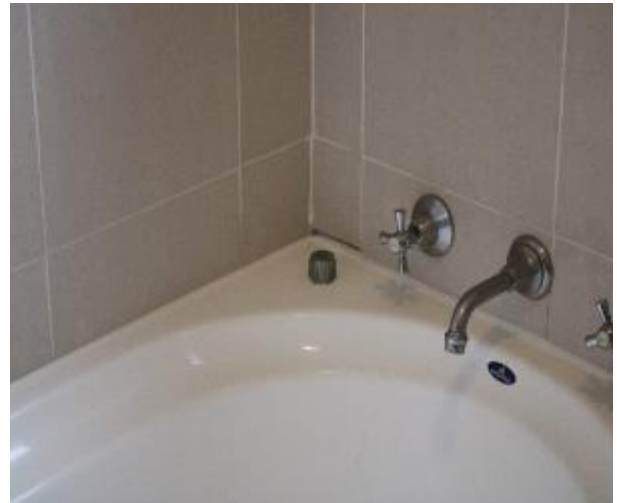
Figure 1348 - General condition of bathroom 1 internal wall

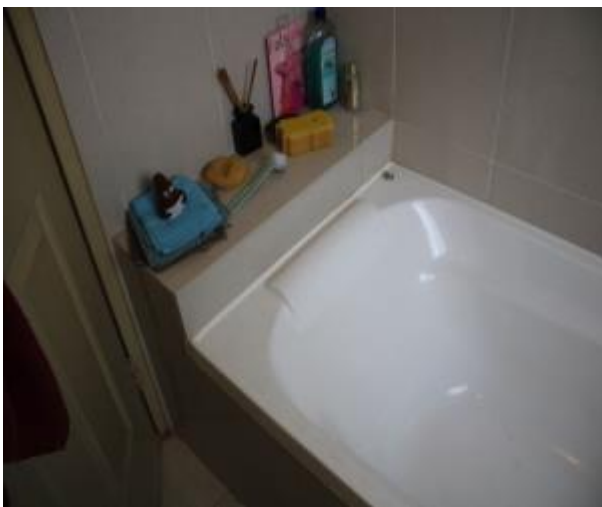
Figure 1349 - Crack propagation through bathroom 1 internal wall

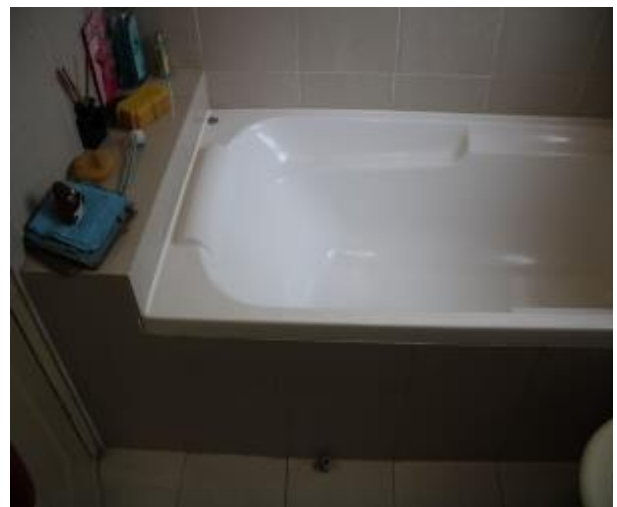
Figure 1350 - General condition of bathroom 1 internal wall

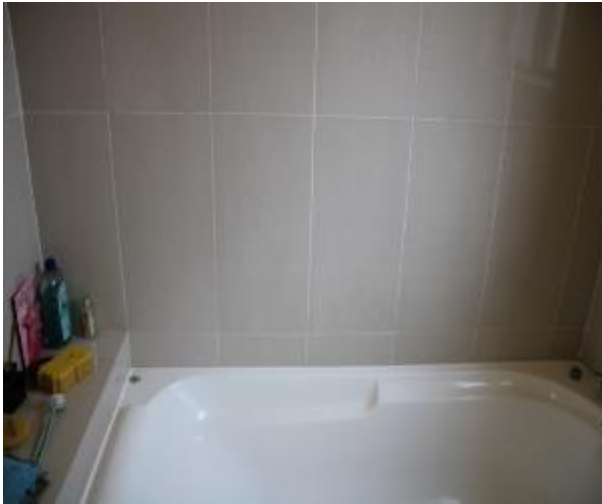
Figure 1351 - General condition of bathroom 1 internal wall

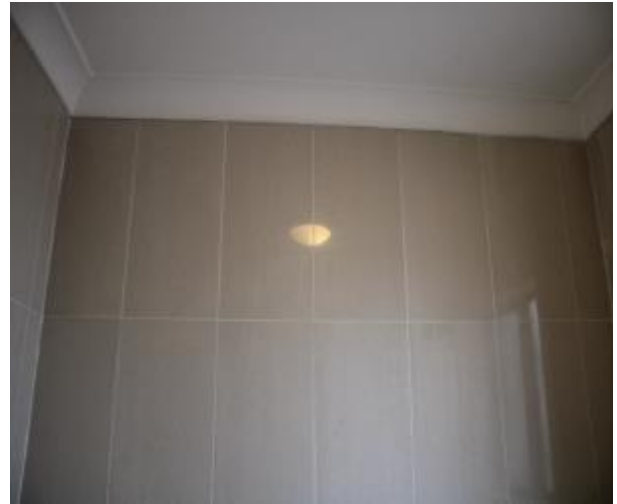
Figure 1352 - General condition of bathroom 1 internal wall

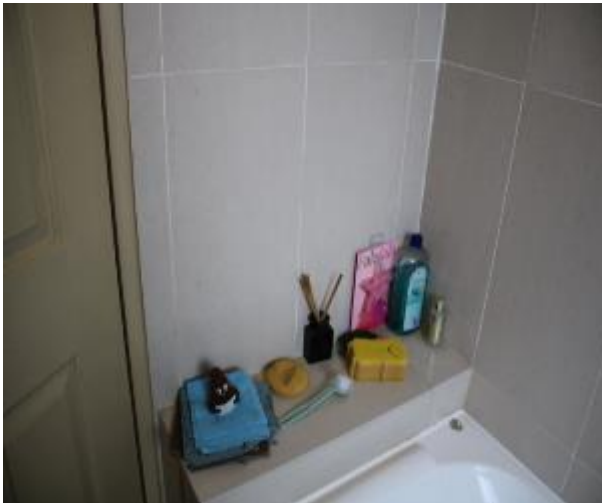
Figure 1353 - General condition of bathroom 1 internal wall

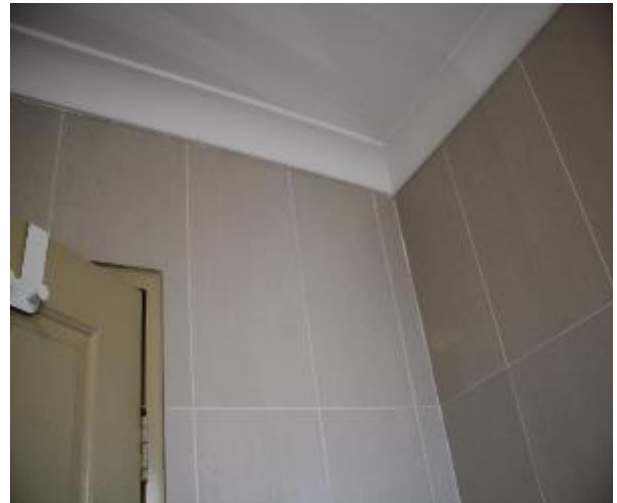
Figure 1354 - General condition of bathroom 1 internal wall
