# **Pre-Dilapidation Report**

**19 GEORGE STREET**

**FRONT BUILDING (UNITS 1-19)**

Project Reference: 20250047.19G.2

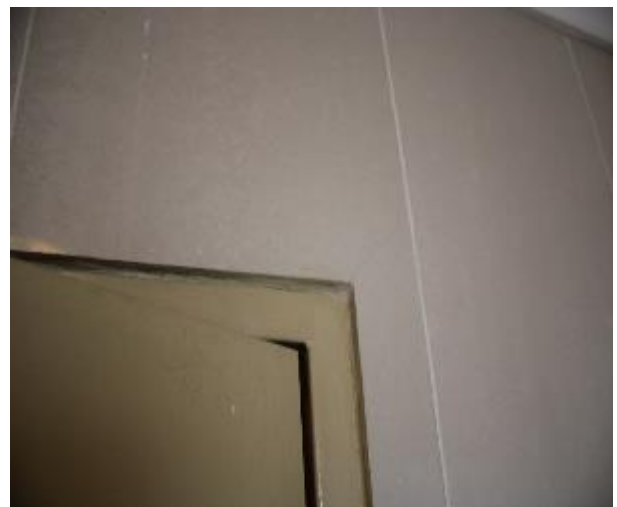
Figure 1356 - Crack propagation through bathroom 1 internal wall

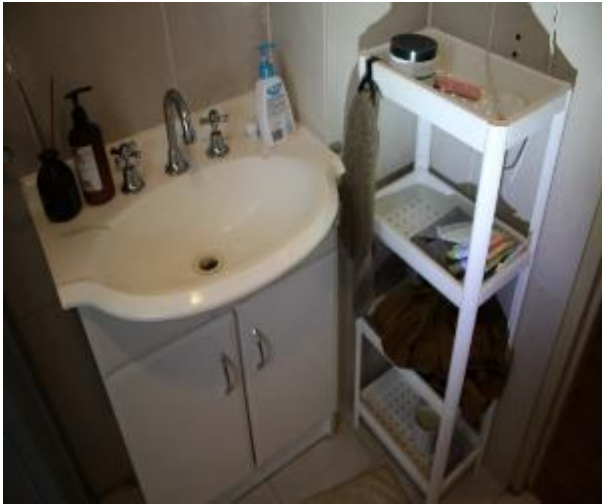
Figure 1358 - General condition of bathroom 1 internal wall

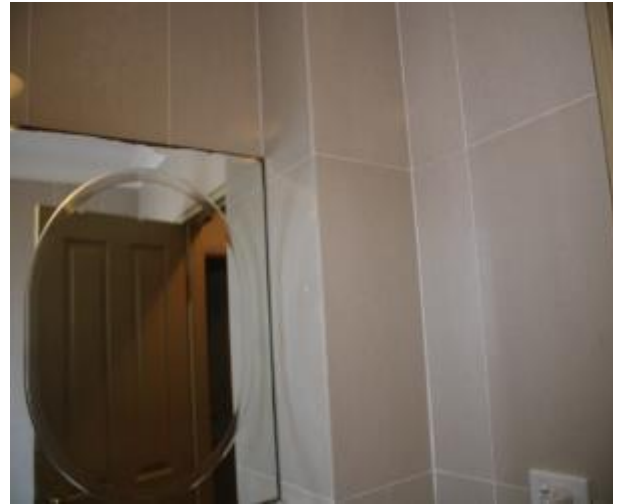
Figure 1359 - General condition of bathroom 1 internal wall

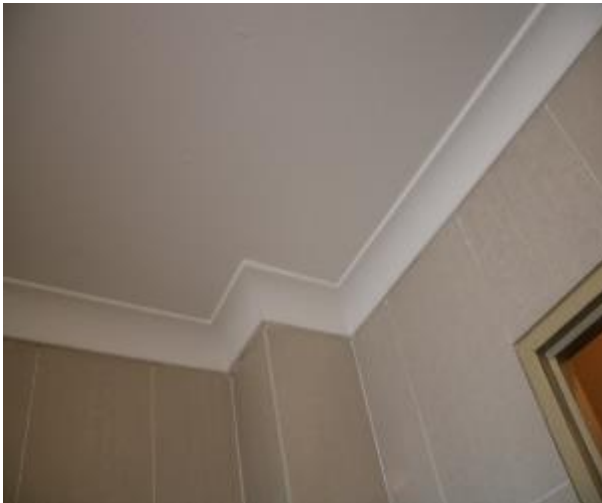
Figure 1360 - General condition of bathroom 1 ceiling

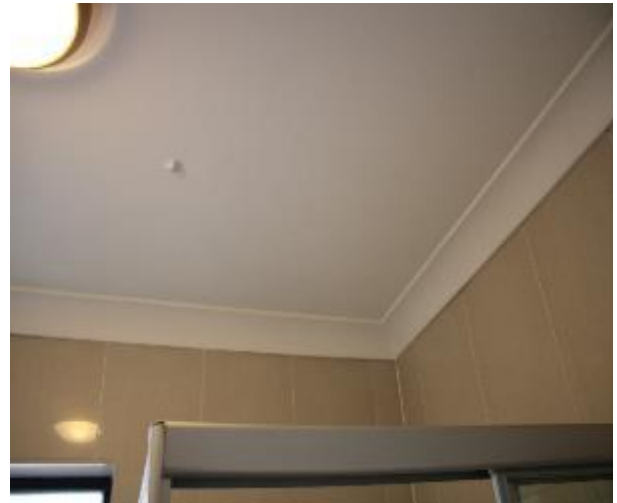
Figure 1361 - General condition of bathroom 1 ceiling

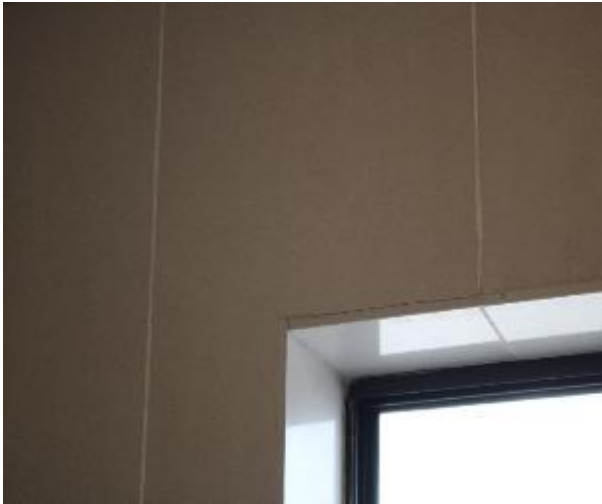
Figure 1364 - Crack propagation through bathroom 1 internal wall

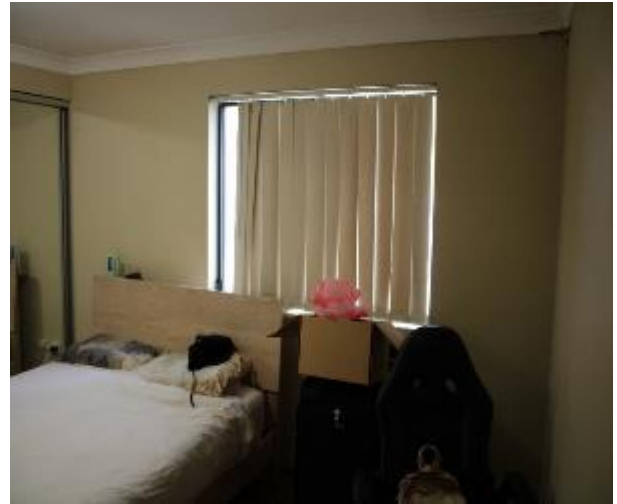
Figure 1365 - General condition of bedroom 1 internal wall

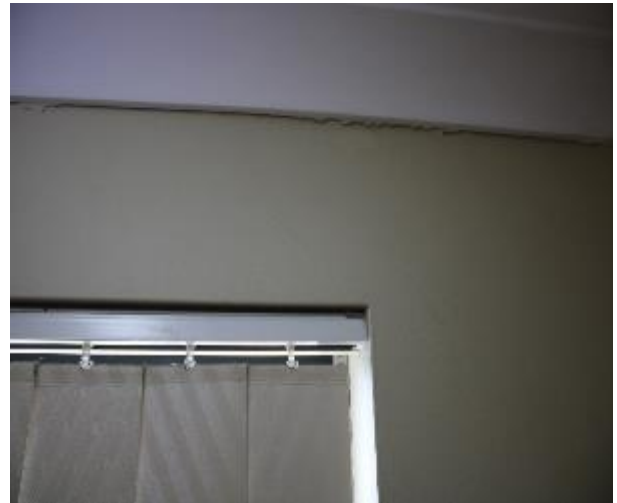
Figure 1367 - Crack propagation through bedroom 1 internal wall

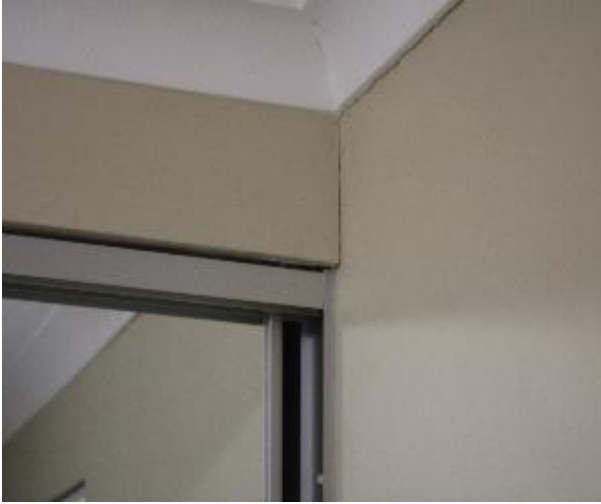
Figure 1370 - Crack propagation through bedroom 1 internal wall

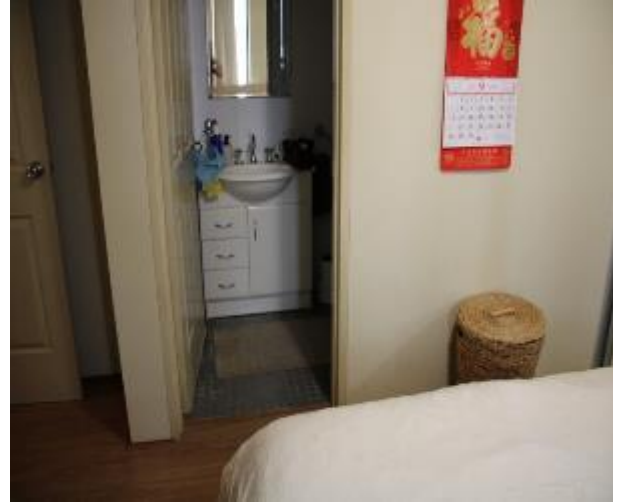
Figure 1371 - General condition of bedroom 1 internal wall

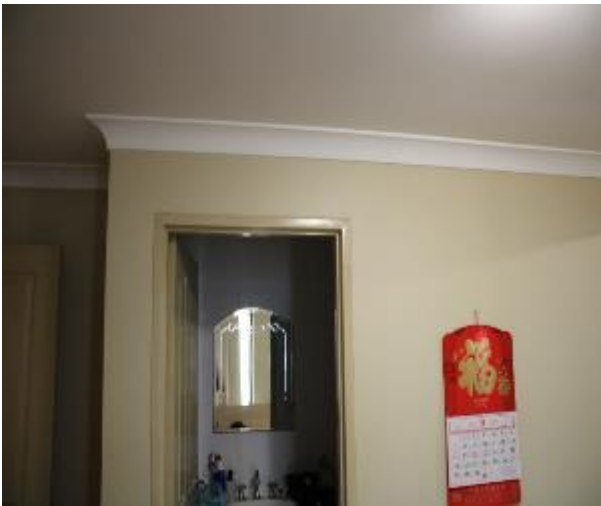
Figure 1372 - General condition of bedroom 1 internal wall

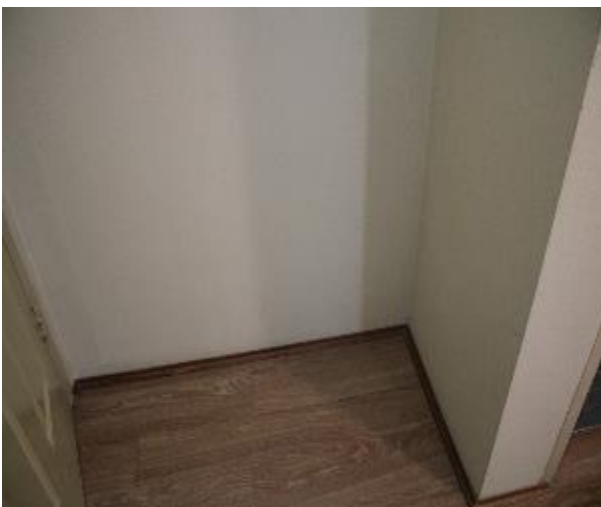
Figure 1374 - General condition of bedroom 1 internal wall

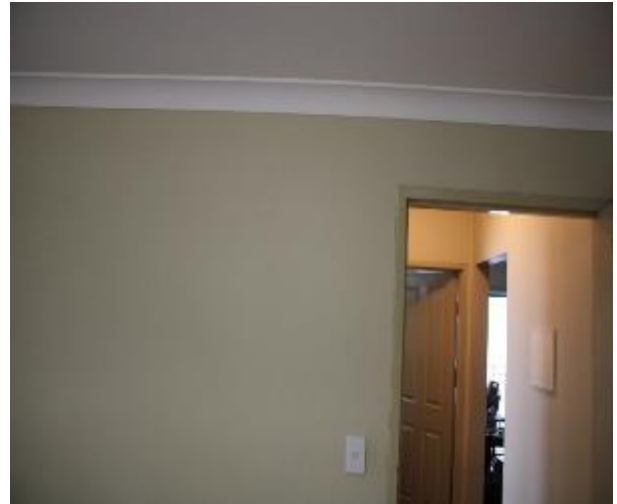
Figure 1377 - General condition of bedroom 1 internal wall

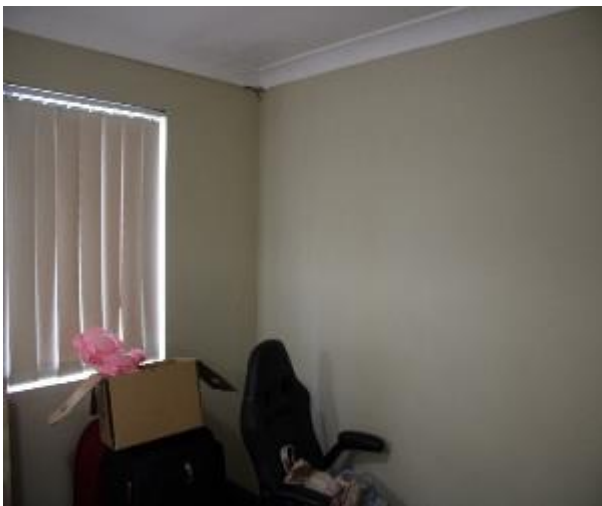
Figure 1378 - General condition of bedroom 1 internal wall

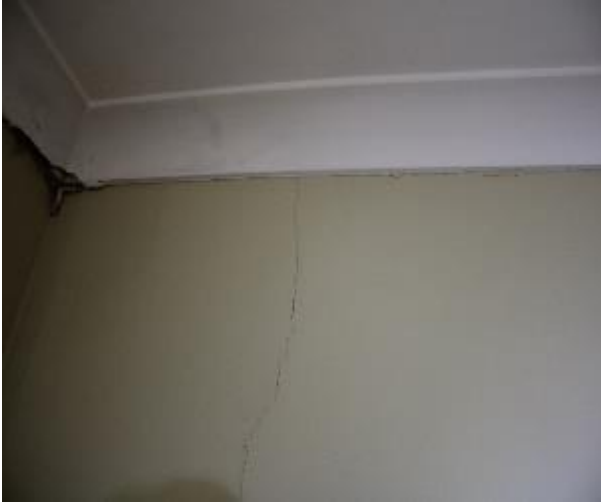
Figure 1382 - Crack propagation through bedroom 1 internal wall

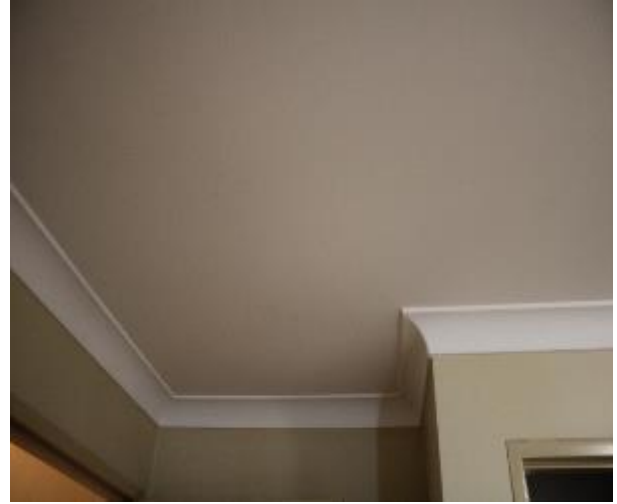
Figure 1383 - General condition of bedroom 1 ceiling

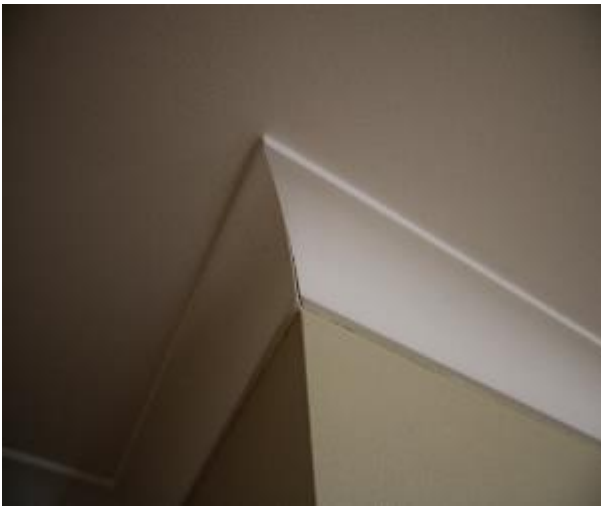
Figure 1384 - Crack propagation through bedroom 1 ceiling

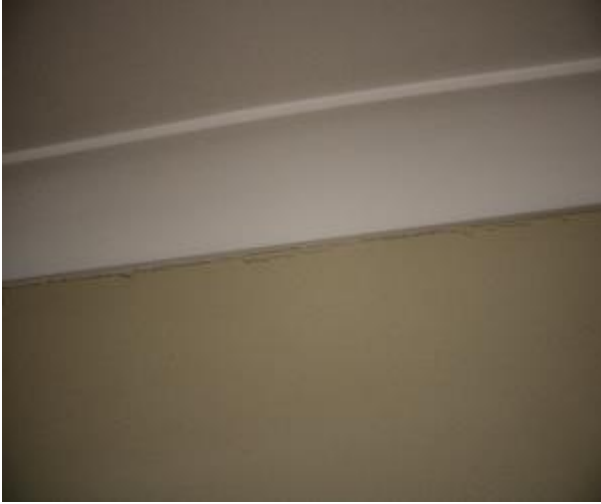
Figure 1388 - Crack propagation through bedroom 1 ceiling

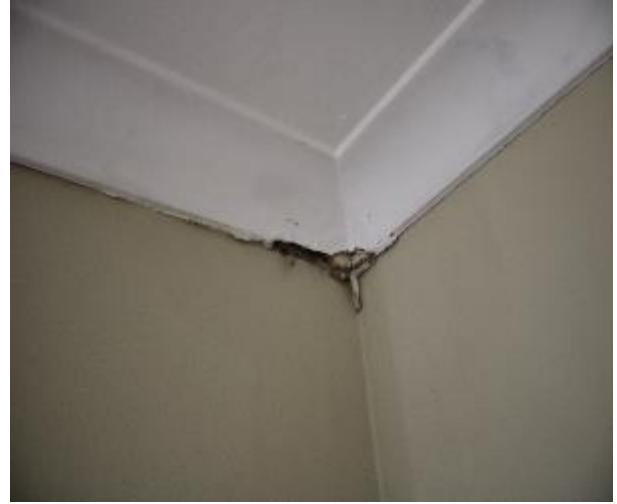
Figure 1389 - Water damage evident through bedroom 1 ceiling

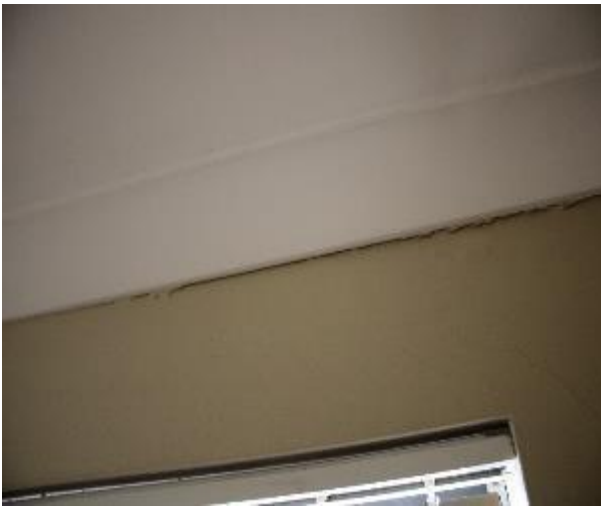
Figure 1390 - Crack propagation through bedroom 1 ceiling

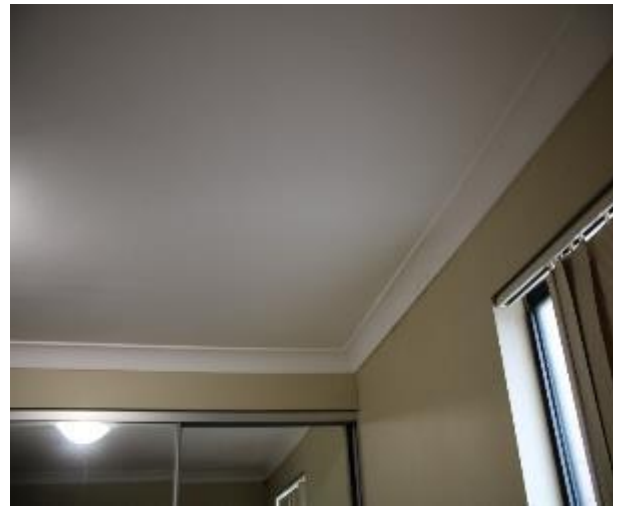
Figure 1391 - General condition of bedroom 1 ceiling

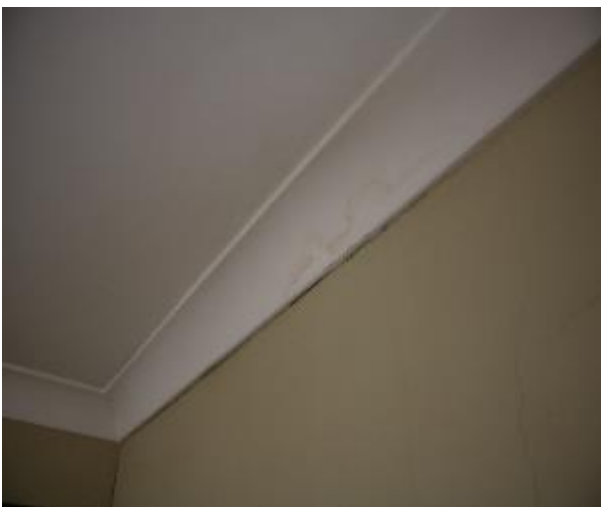
Figure 1392 - Crack propagation through bedroom 1 ceiling

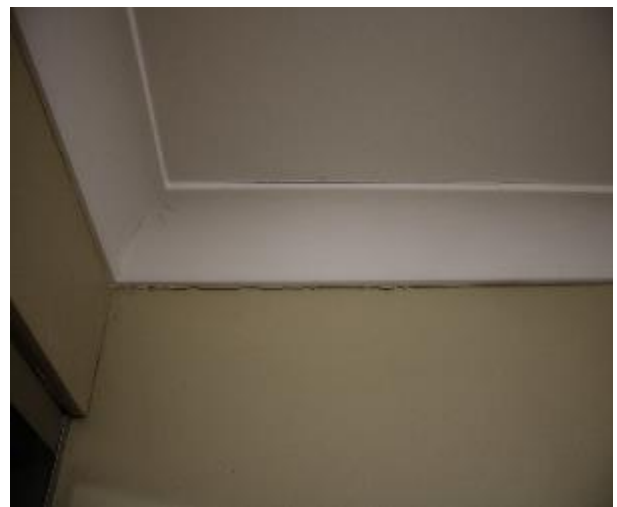
Figure 1393 - Crack propagation through bedroom 1 ceiling

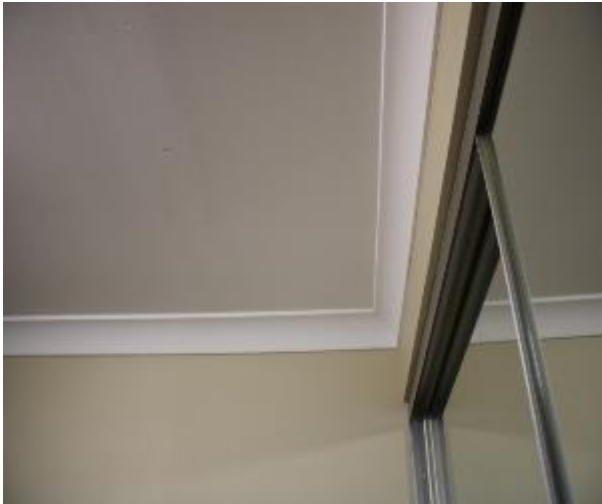
Figure 1394 - General condition of bedroom 1 ceiling

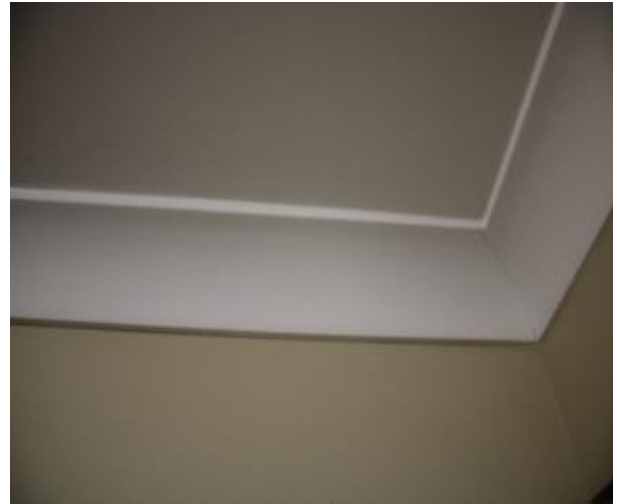
Figure 1395 - Crack propagation through bedroom 1 ceiling

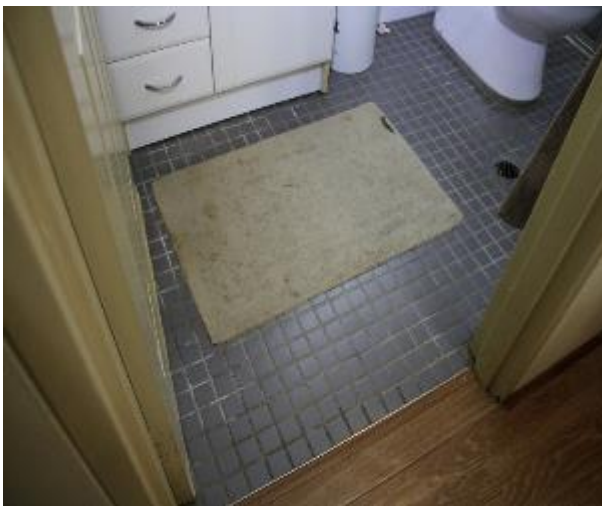
Figure 1396 - General condition of ensuite bathroom floor tiles

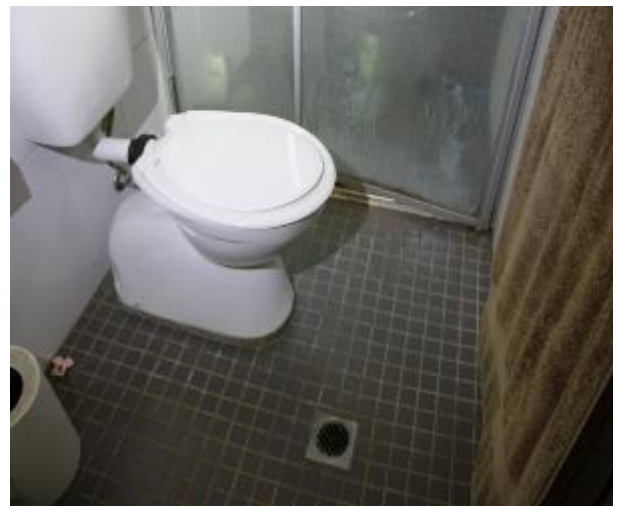
Figure 1397 - General condition of ensuite bathroom floor tiles

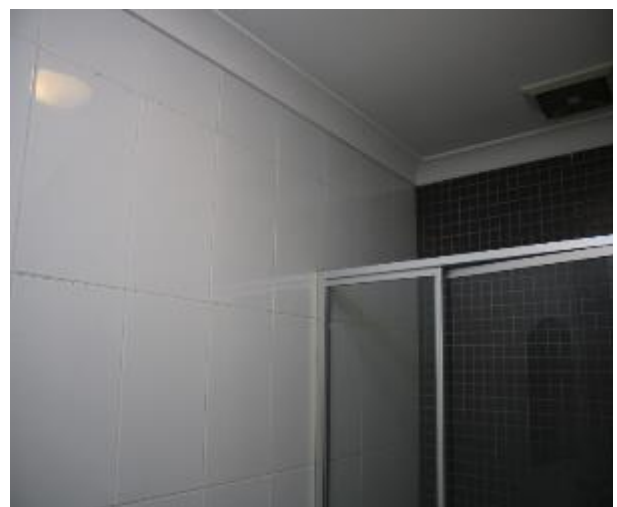
Figure 1398 - General condition of ensuite bathroom internal wall

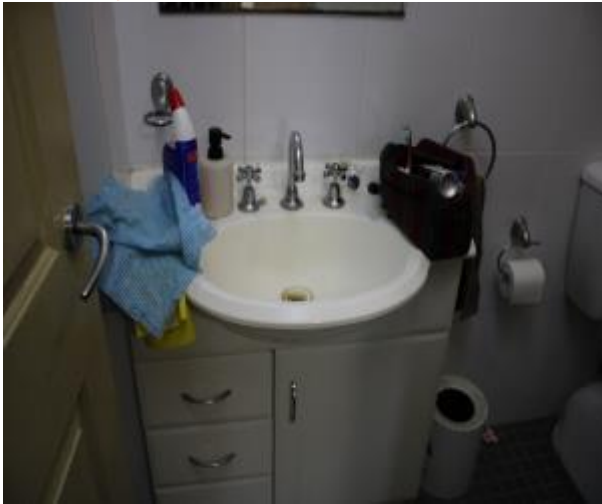
Figure 1399 - General condition of ensuite bathroom internal wall

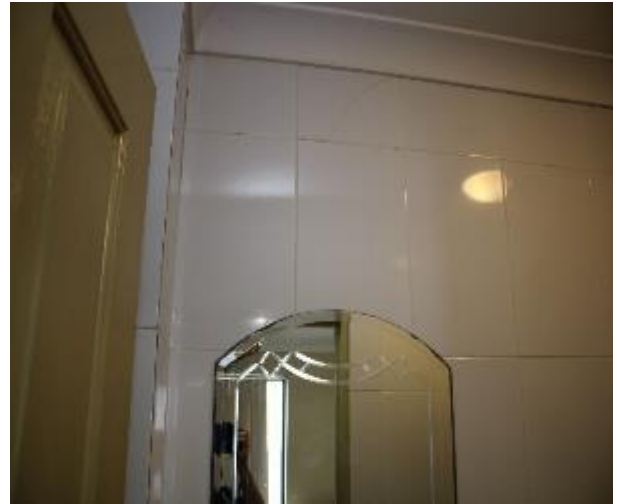
Figure 1400 - General condition of ensuite bathroom internal wall

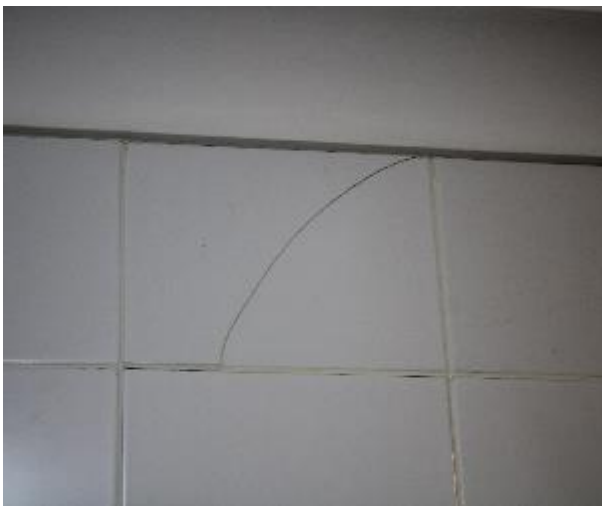
Figure 1401 - General condition of ensuite bathroom internal wall

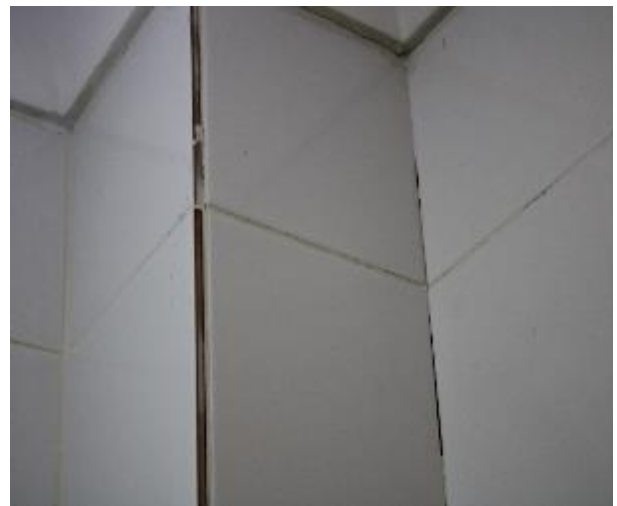
Figure 1402 - Crack propagation through ensuite bathroom internal wall

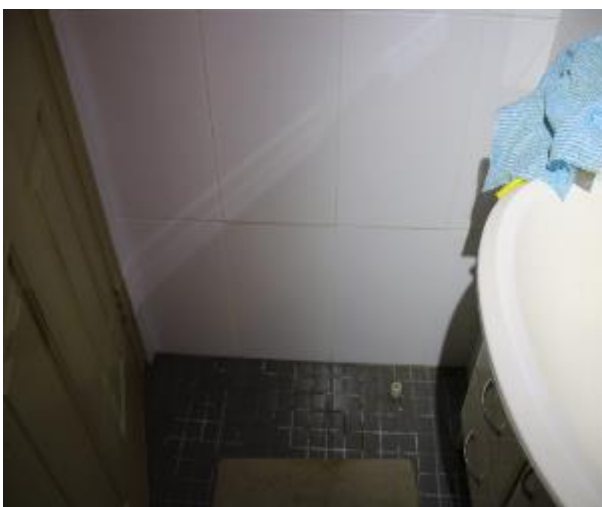
Figure 1403 - Crack propagation through ensuite bathroom internal wall

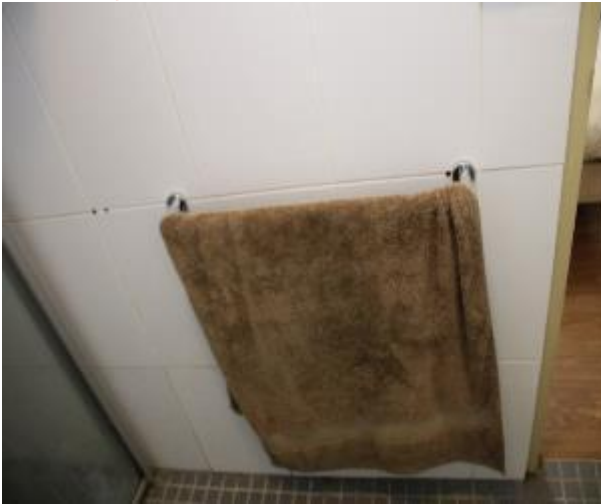
Figure 1405 - General condition of ensuite bathroom internal wall

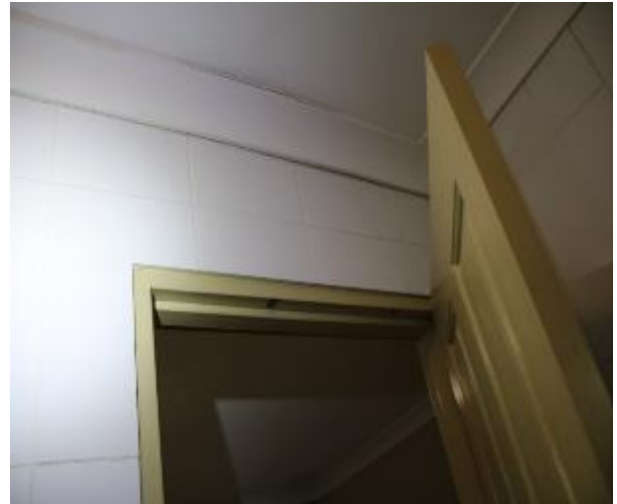
Figure 1406 - General condition of ensuite bathroom internal wall

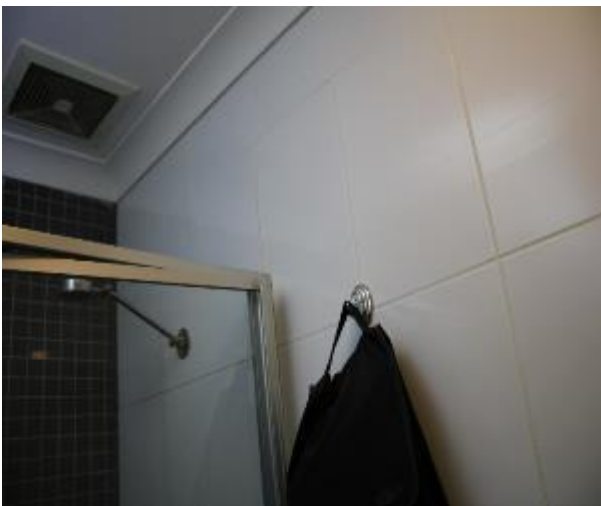
Figure 1407 - General condition of ensuite bathroom internal wall

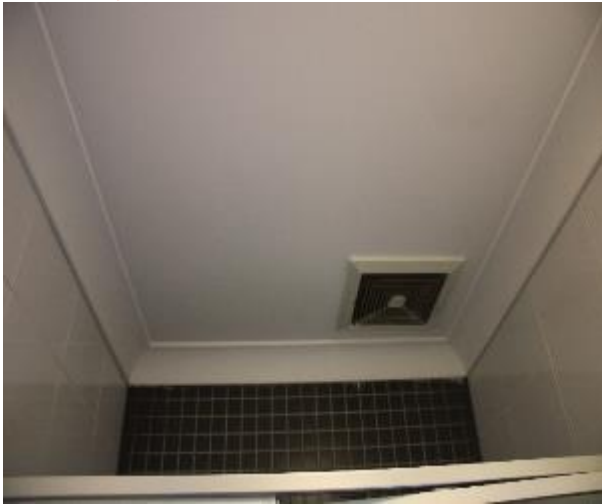
Figure 1411 - Crack propagation through ensuite bathroom ceiling

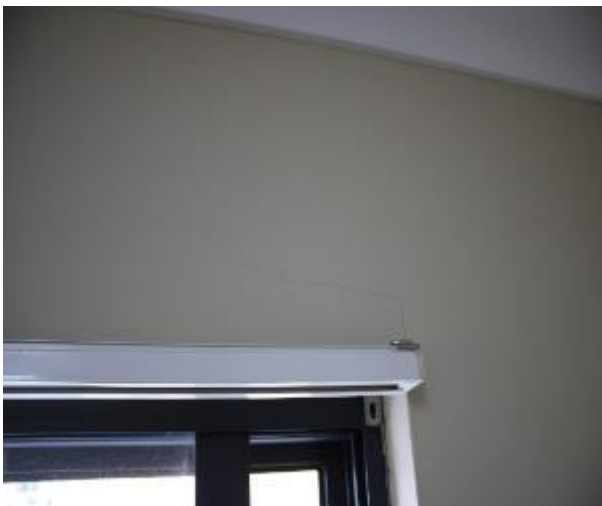
Figure 1413 - General condition of study internal wall

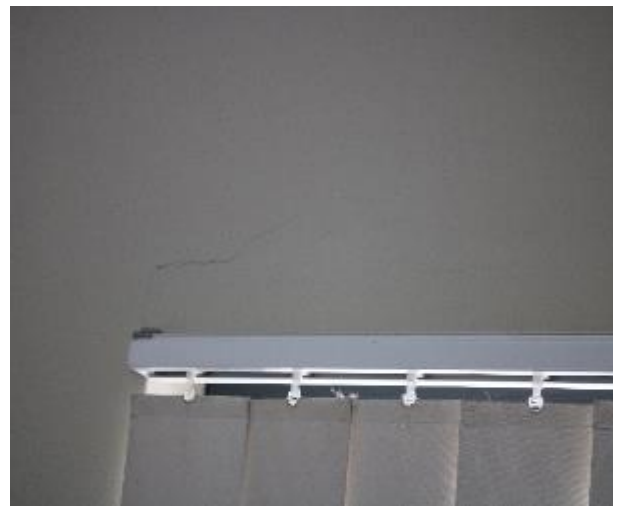
Figure 1414 - Crack propagation through study internal wall

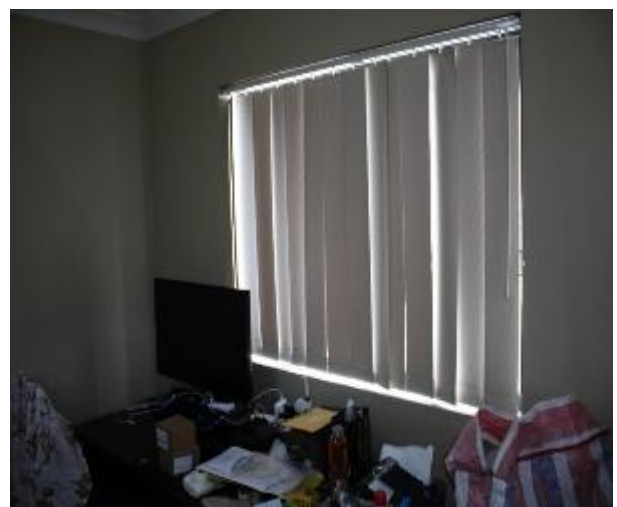
Figure 1416 - General condition of study internal wall

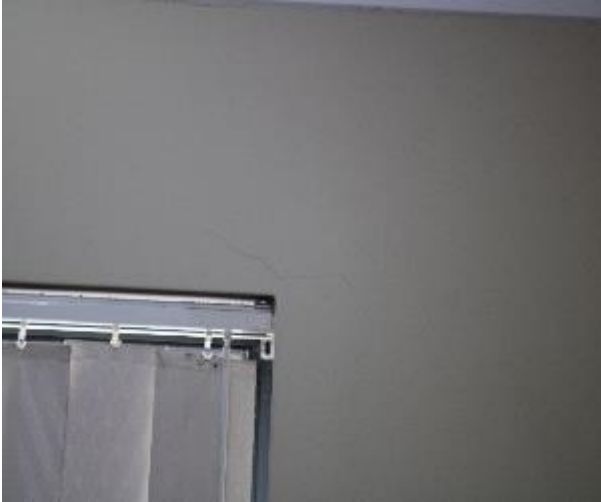
Figure 1417 - General condition of study internal wall

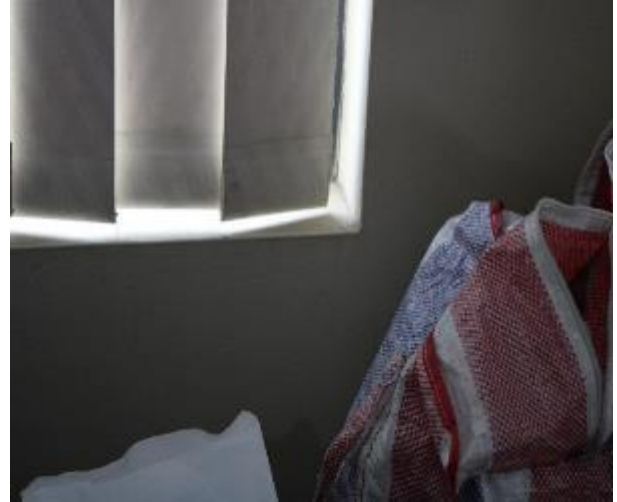
Figure 1418 - Crack propagation through study internal wall

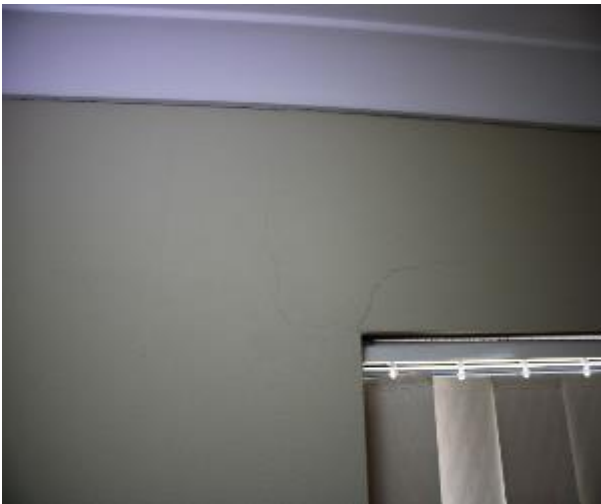
Figure 1419 - Crack propagation through study internal wall

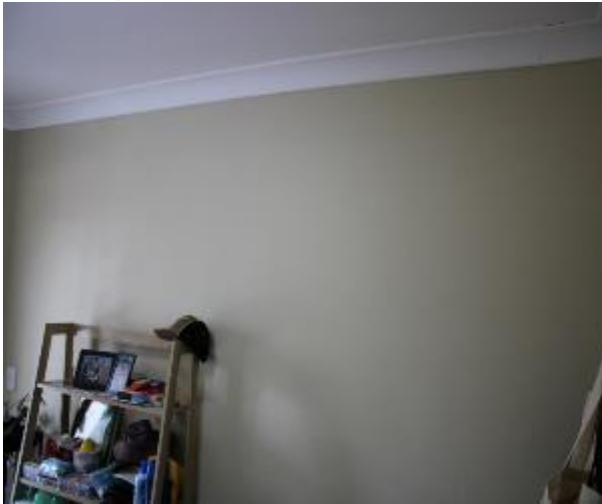
Figure 1423 - General condition of study internal wall

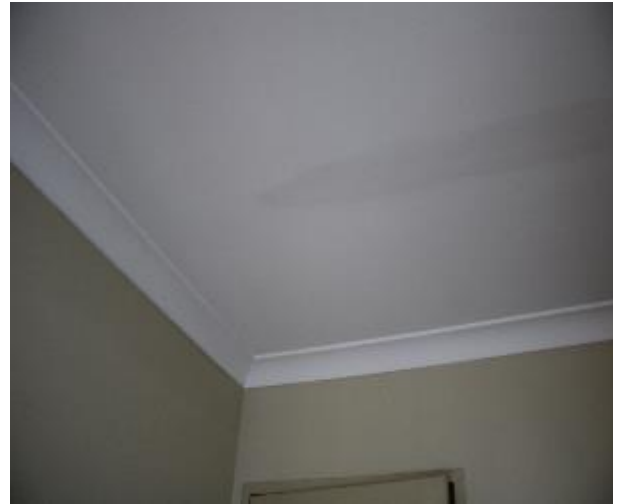
Figure 1424 - General condition of study internal wall

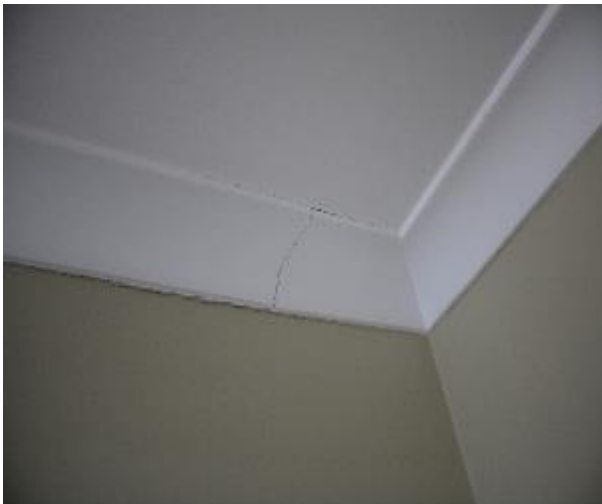
Figure 1425 - General condition of study ceiling

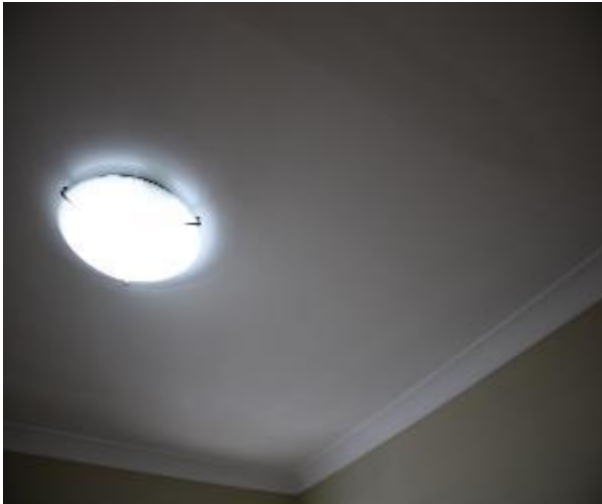
Figure 1429 - General condition of study ceiling

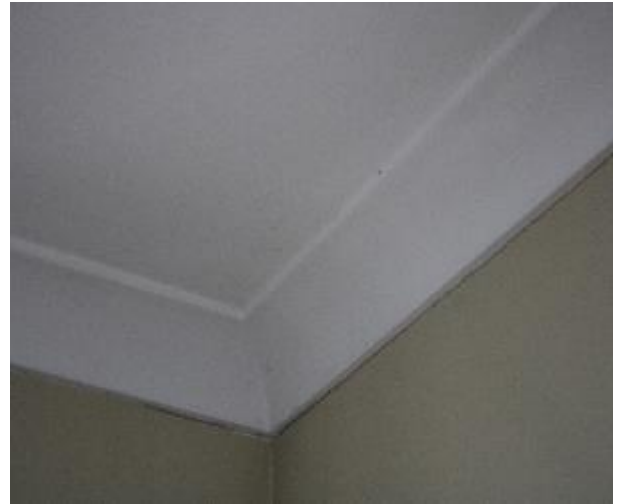
Figure 1430 - General condition of study ceiling

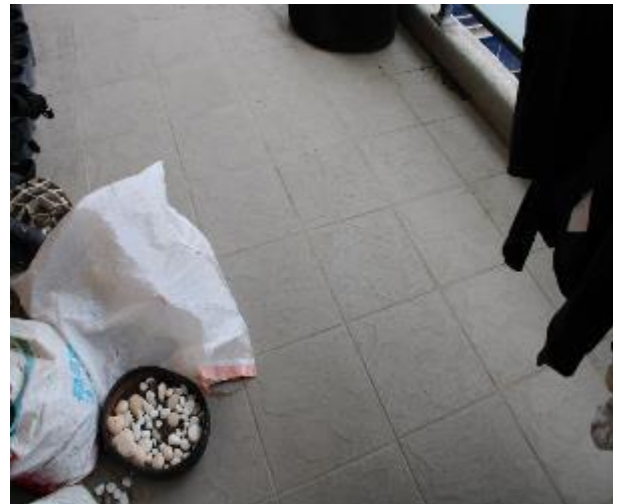
Figure 1432 - General condition of balcony floor tiles

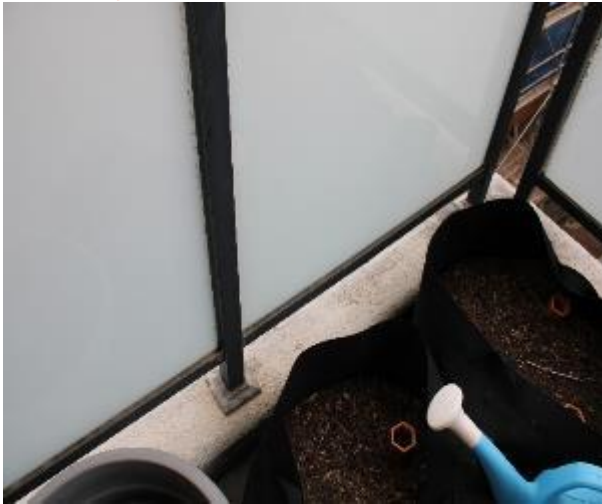
Figure 1435 - General condition of balcony floor tiles

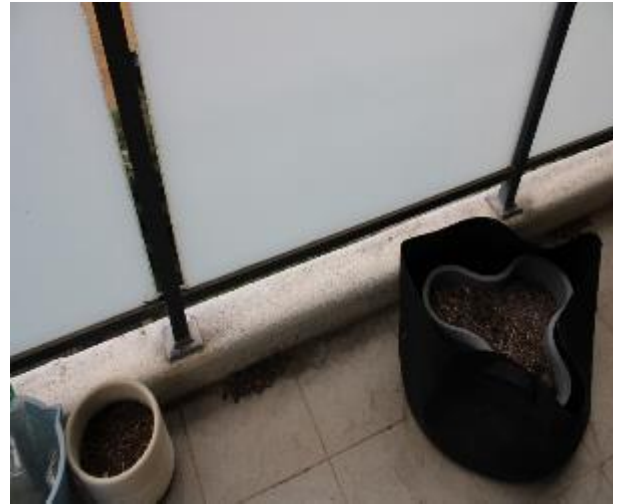
Figure 1436 - Crack propagation through external wall

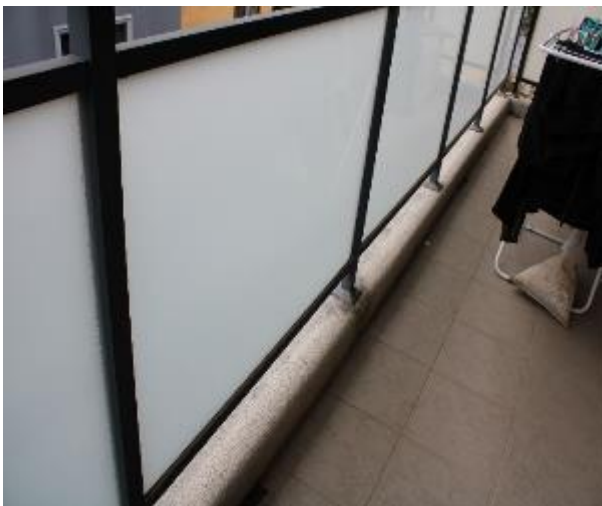
Figure 1437 - General condition of external wall

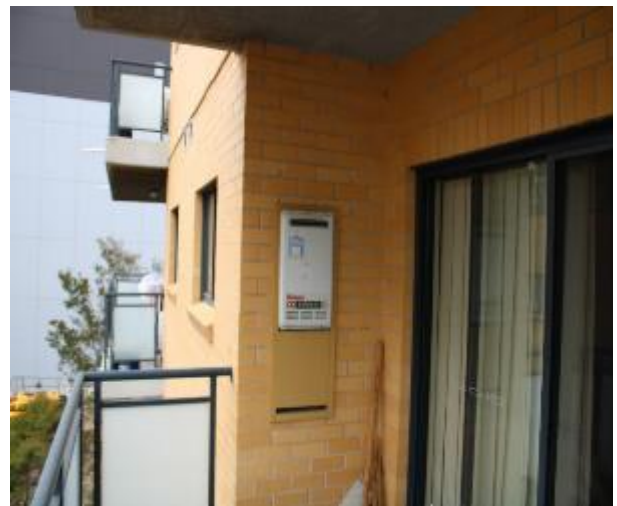
Figure 1438 - General condition of external wall

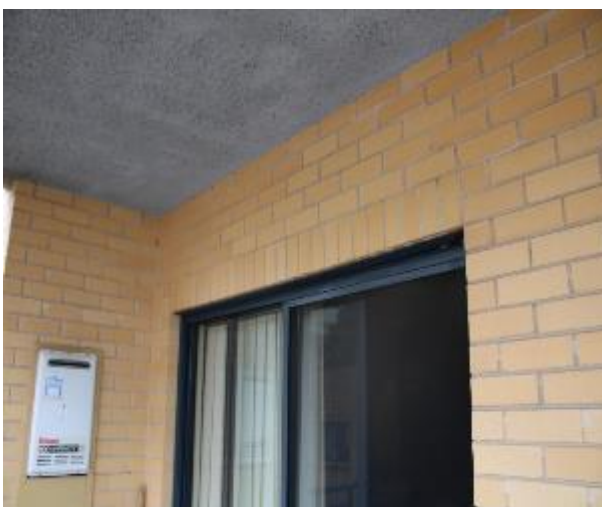
Figure 1439 - General condition of external wall

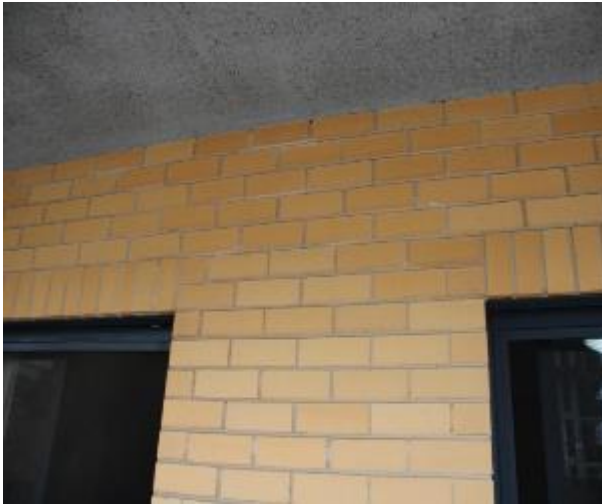
Figure 1441 - General condition of external wall

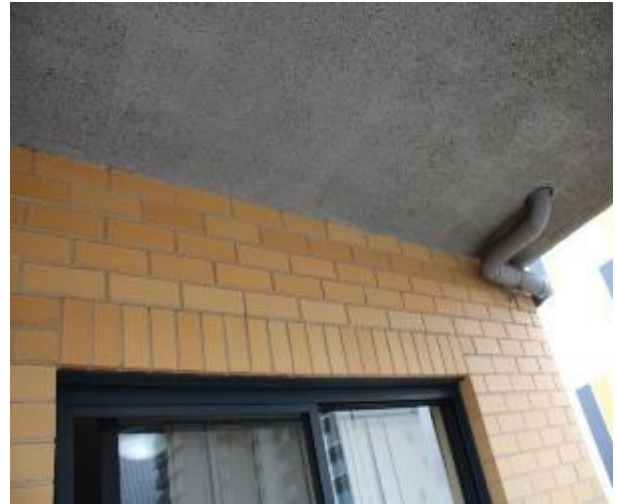
Figure 1442 - General condition of external wall

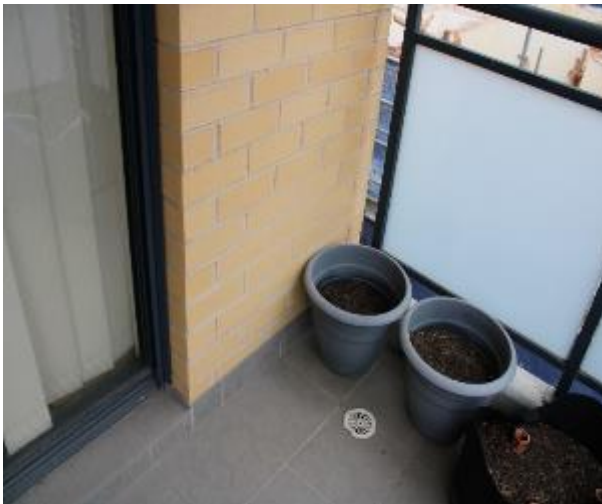
Figure 1443 - General condition of external wall

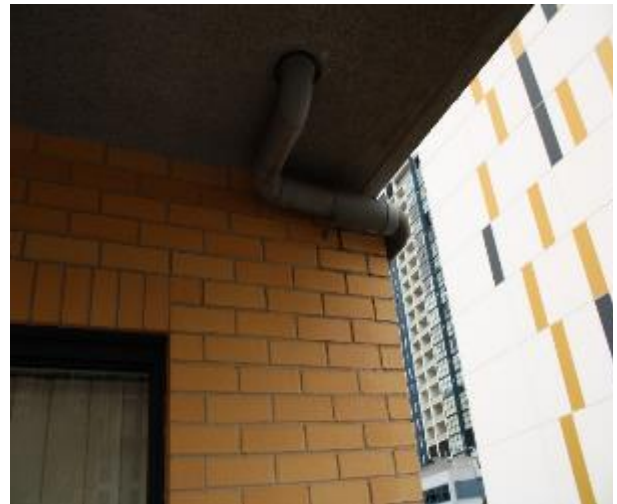
Figure 1444 - General condition of external wall

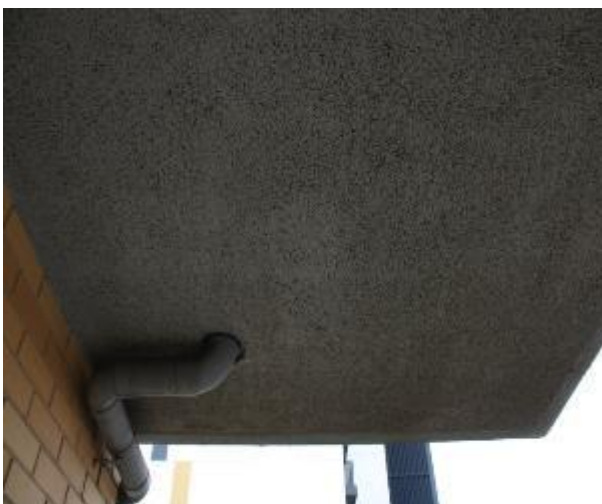
Figure 1445 - General condition of external wall

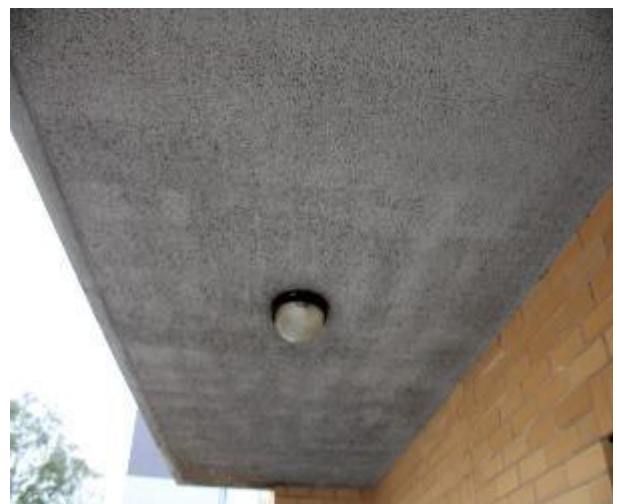
Figure 1446 - General condition of balcony underside slab

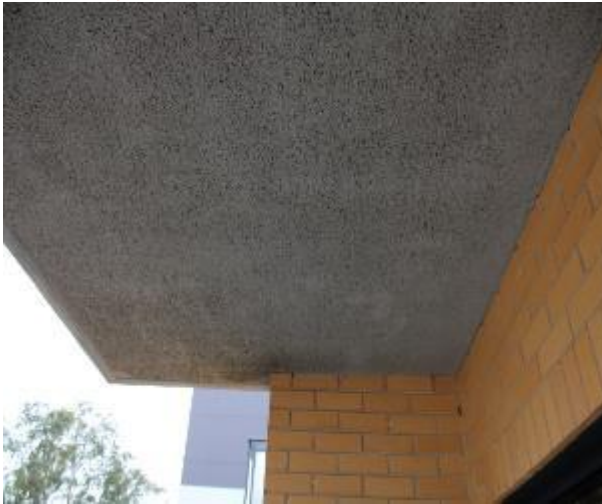
Figure 1447 - General condition of balcony underside slab

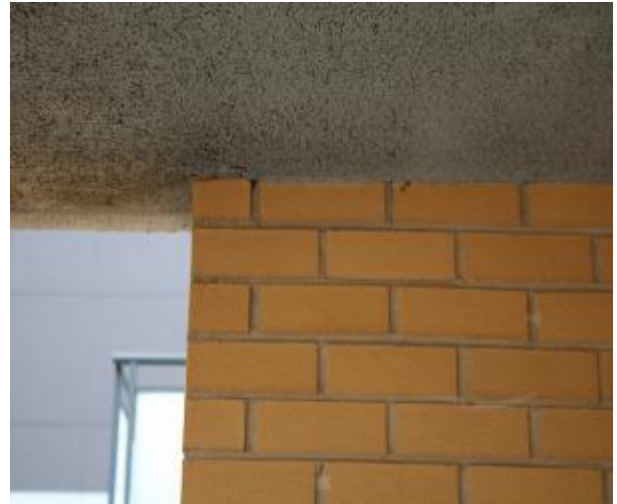
Figure 1448 - General condition of balcony underside slab

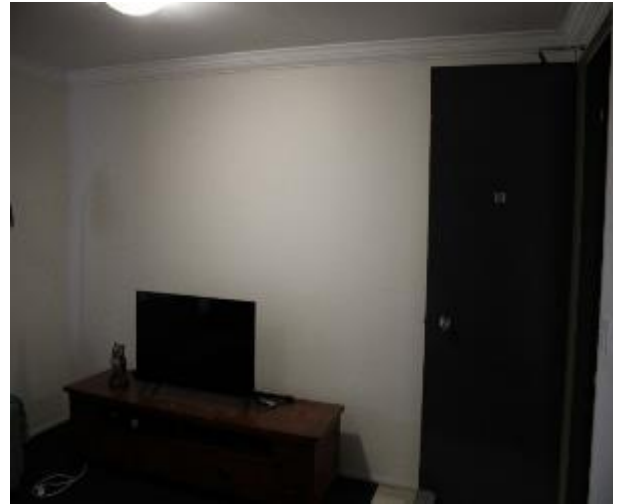
Figure 1452 - General condition of open kitchen/ lounge room internal wall

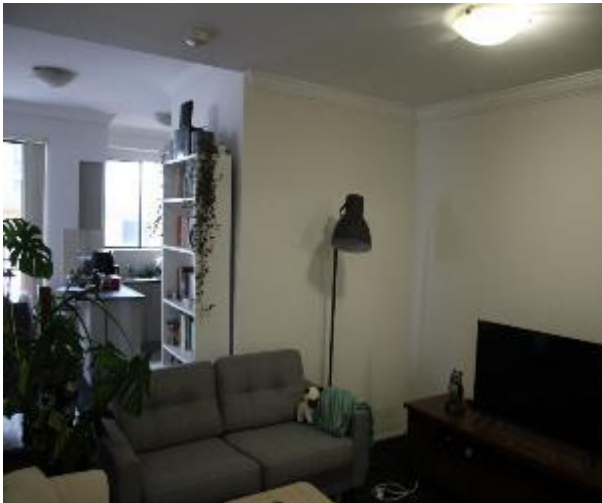
Figure 1453 - General condition of open kitchen/ lounge room internal wall

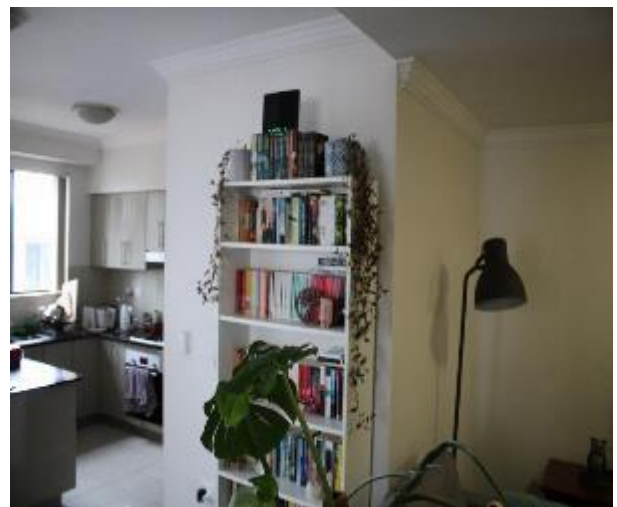
Figure 1456 - General condition of open kitchen/ lounge room internal wall

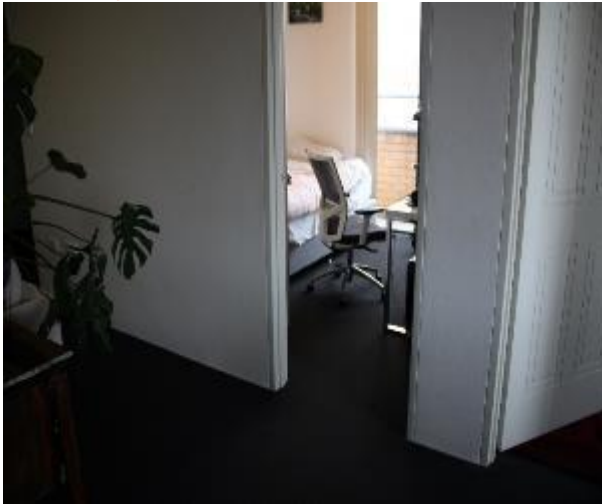
Figure 1457 - General condition of open kitchen/ lounge room internal wall

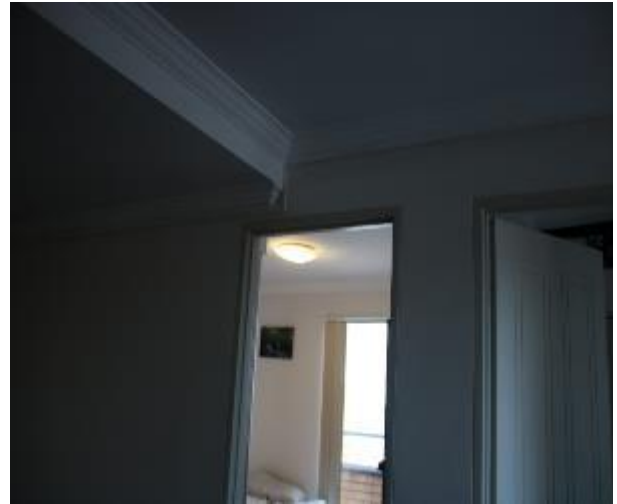
Figure 1458 - General condition of open kitchen/ lounge room internal wall

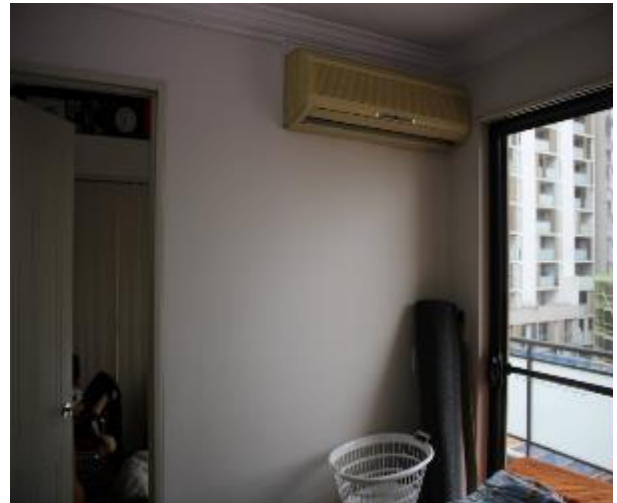
Figure 1460 - General condition of open kitchen/ lounge room internal wall

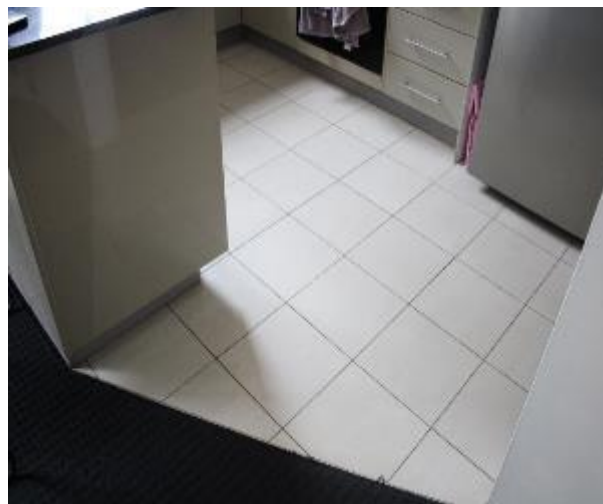
Figure 1464 - General condition of kitchen floor tiles

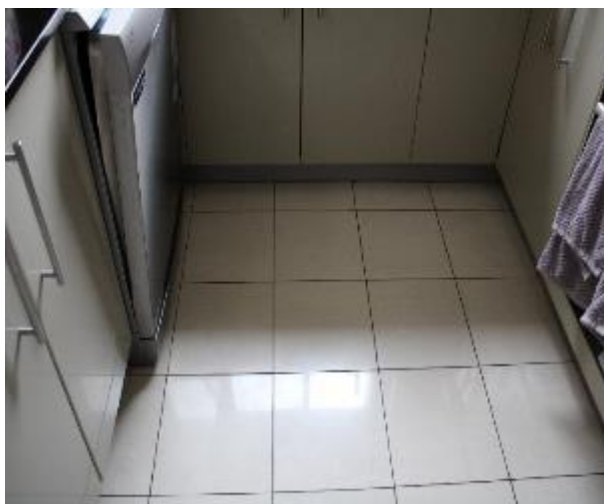
Figure 1465 - General condition of kitchen floor tiles

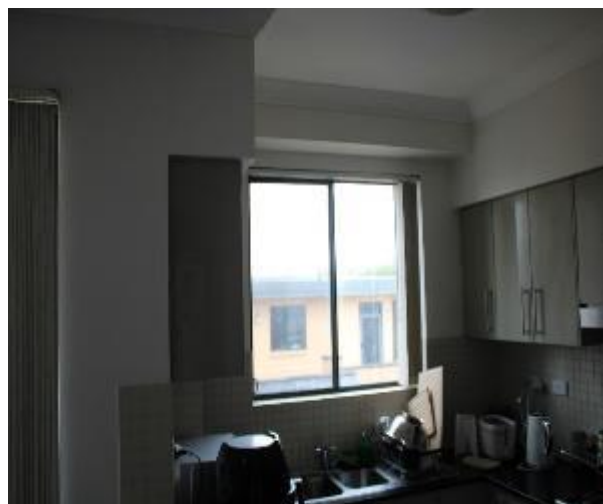
Figure 1466 - General condition of open kitchen/  
lounge room internal wall
