# **Pre-Dilapidation Report**

**19 GEORGE STREET**

**FRONT BUILDING (UNITS 1-19)**

Project Reference: 20250047.19G.2

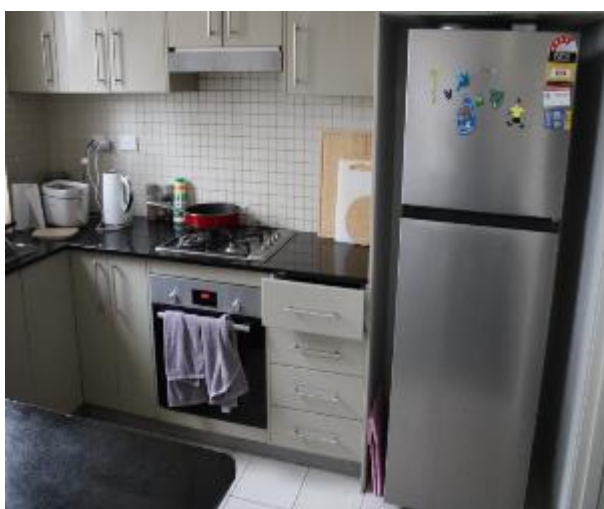
Figure 1467 - General condition of open kitchen/  
lounge room internal wall

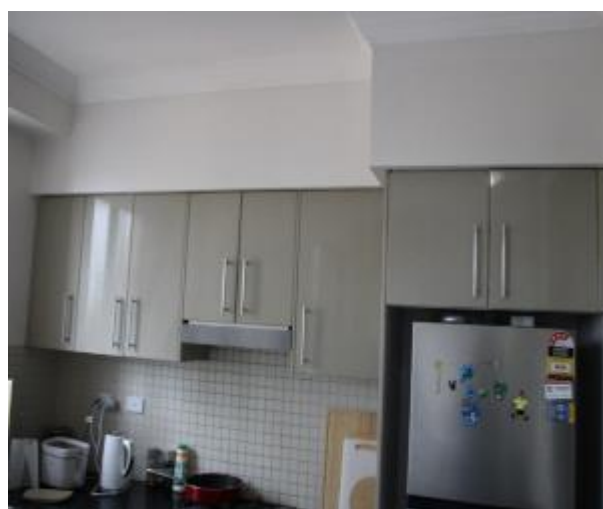
Figure 1468 - General condition of open kitchen/  
lounge room internal wall

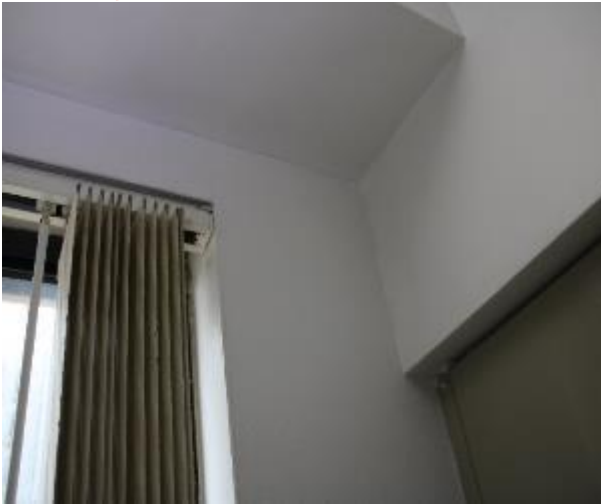
Figure 1469 - Crack propagation through open kitchen/ lounge room internal wall

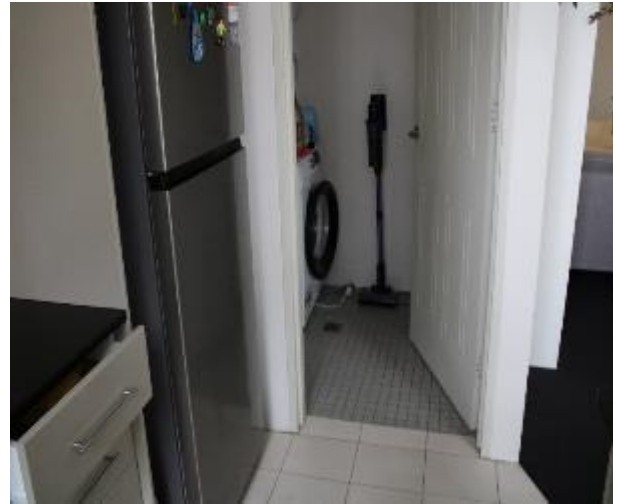
Figure 1470 - open kitchen/ lounge room internal wall

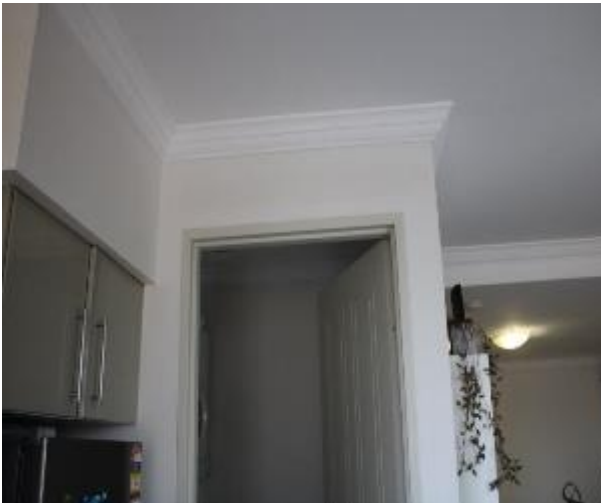
Figure 1471 - General condition of open kitchen/ lounge room internal wall

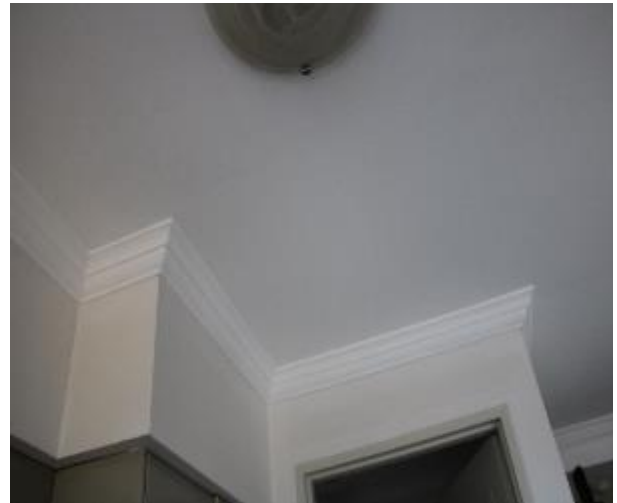
Figure 1472 - General condition of open kitchen/ lounge room ceiling

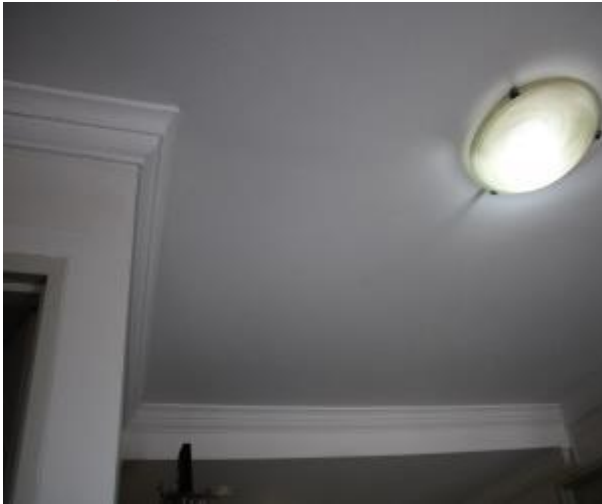
Figure 1474 - General condition of open kitchen/ lounge room ceiling

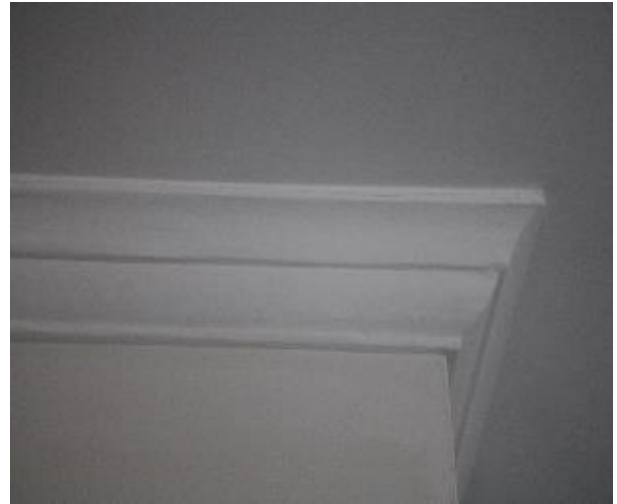
Figure 1475 - General condition of open kitchen/ lounge room ceiling

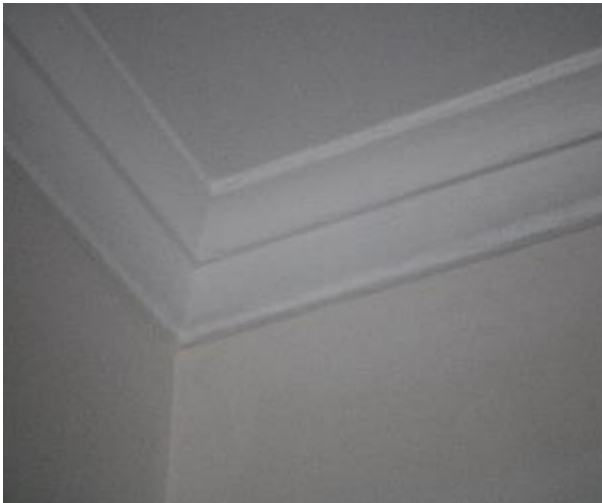
Figure 1476 - Crack propagation through open kitchen/ lounge room ceiling

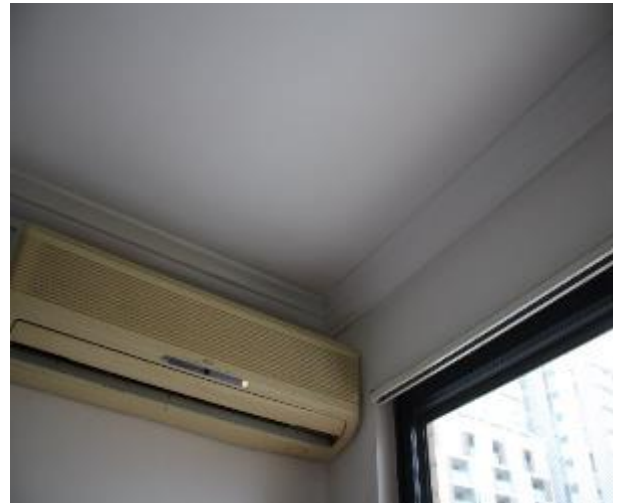
Figure 1477 - Crack propagation through open kitchen/ lounge room ceiling

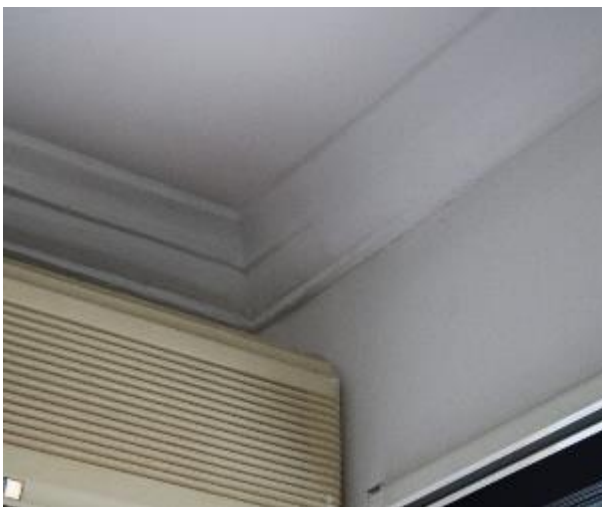
Figure 1478 - General condition of open kitchen/ lounge room ceiling

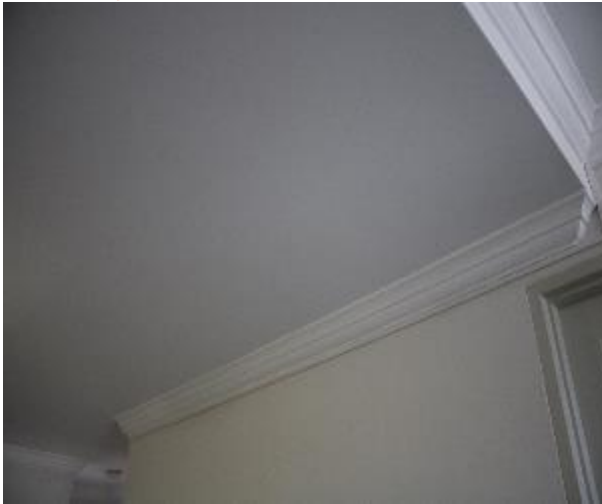
Figure 1480 - General condition of open kitchen/ lounge room ceiling

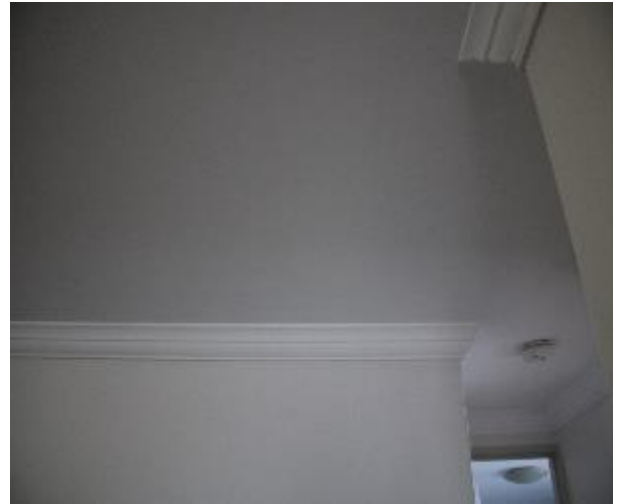
Figure 1481 - General condition of open kitchen/  
lounge room ceiling

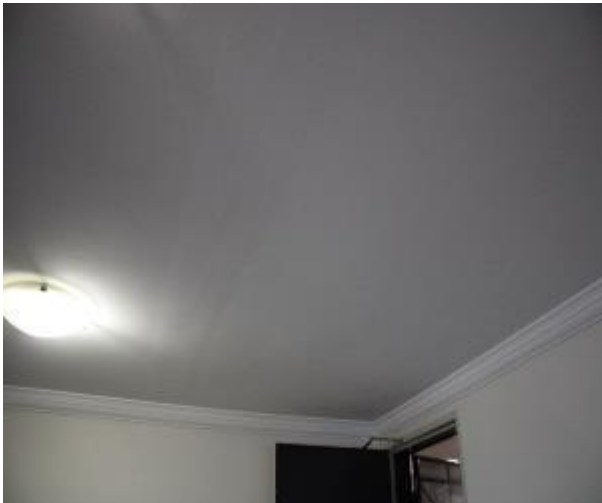
Figure 1482 - General condition of open kitchen/  
lounge room ceiling

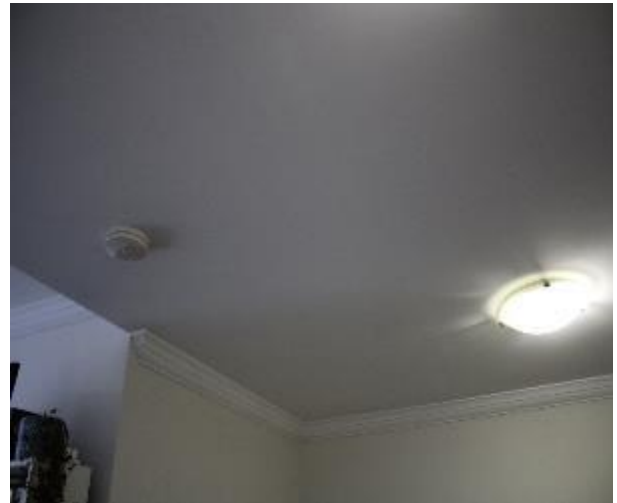
Figure 1483 - General condition of open kitchen/  
lounge room ceiling

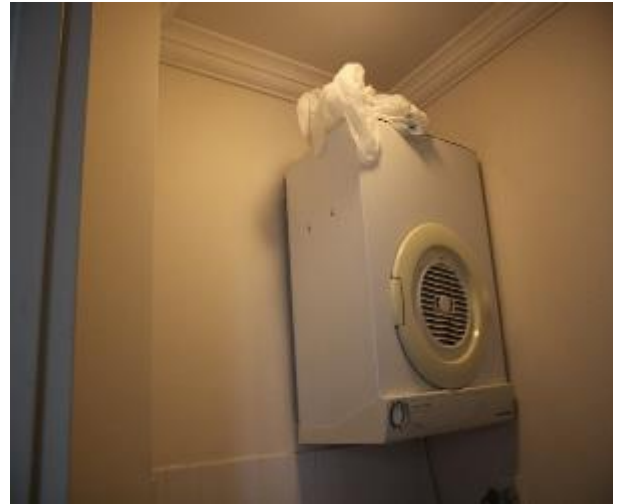
Figure 1487 - General condition of laundry internal wall

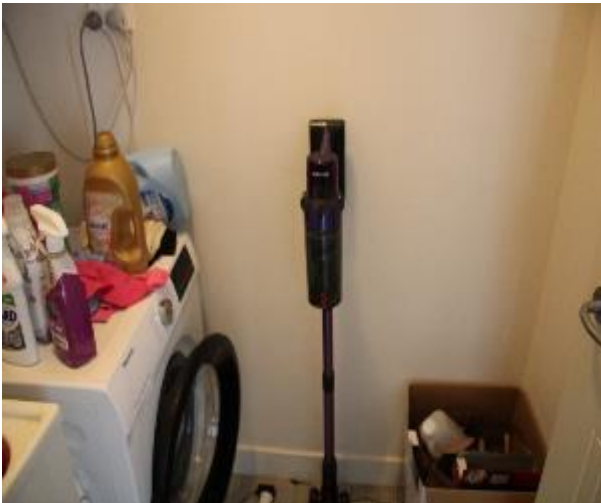
Figure 1488 - General condition of laundry internal wall

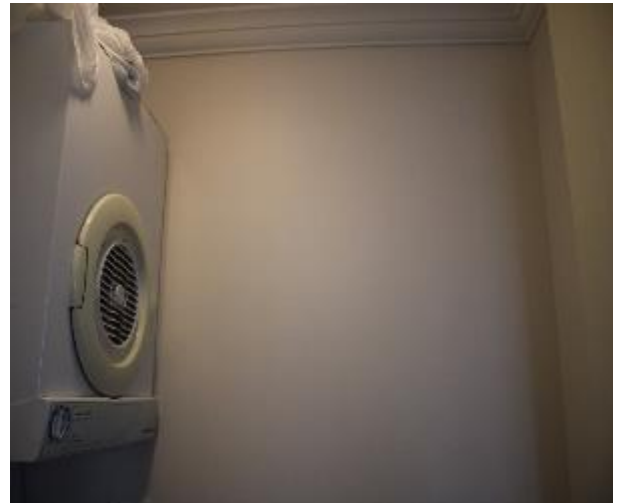
Figure 1489 - General condition of laundry internal wall

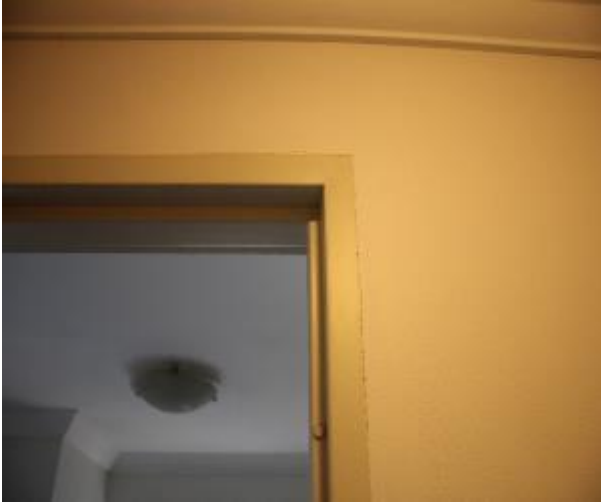
Figure 1492 - General condition of laundry internal wall

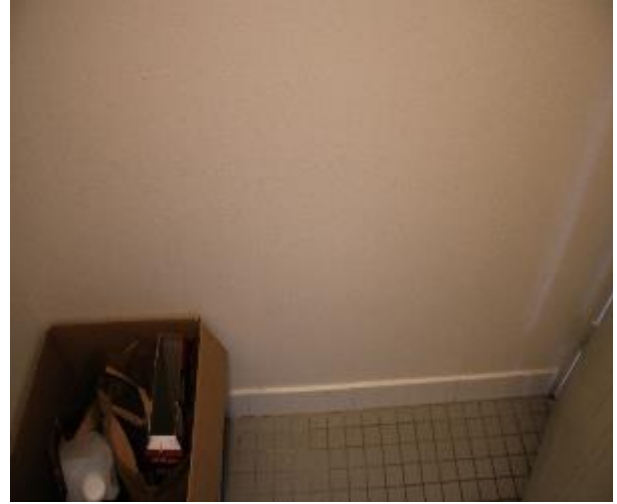
Figure 1493 - Crack propagation through laundry internal wall

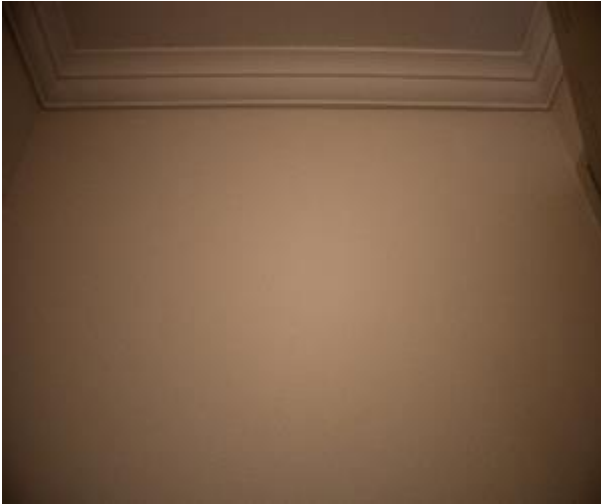
Figure 1494 - General condition of laundry internal wall

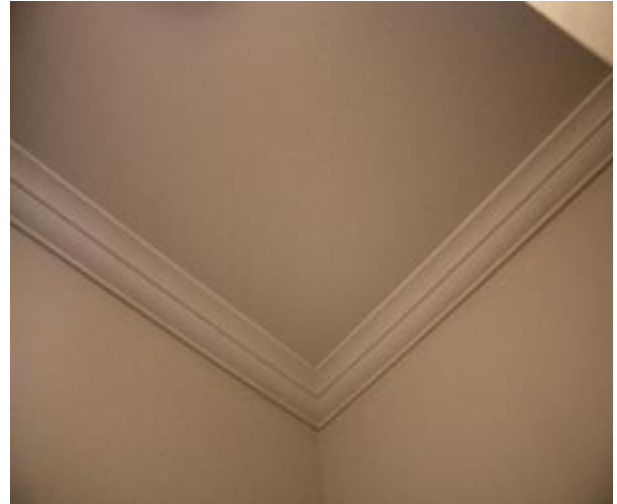
Figure 1495 - General condition of laundry internal wall

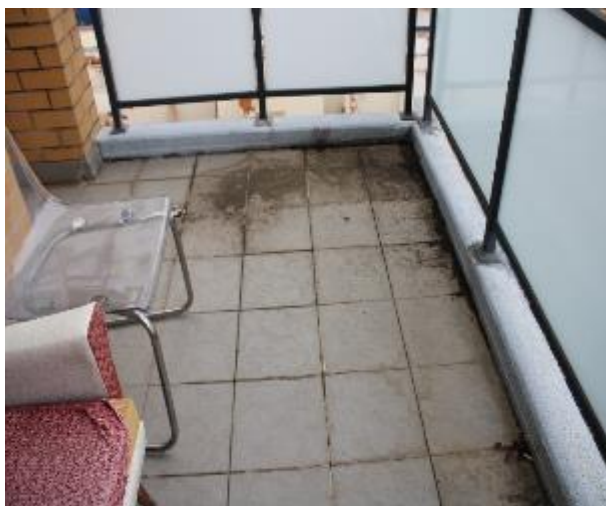
Figure 1500 - General condition of balcony floor tiles

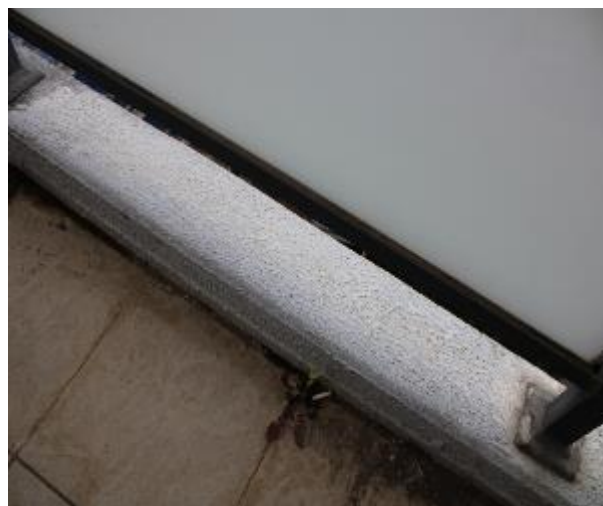
Figure 1501 - General condition of balcony floor tiles

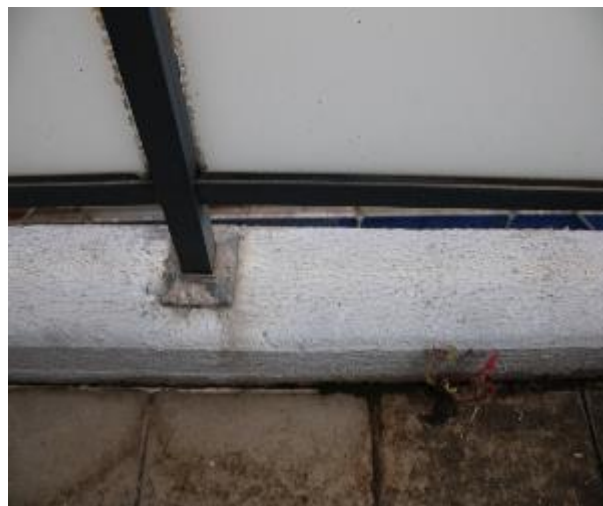
Figure 1503 - General condition of balcony floor tiles

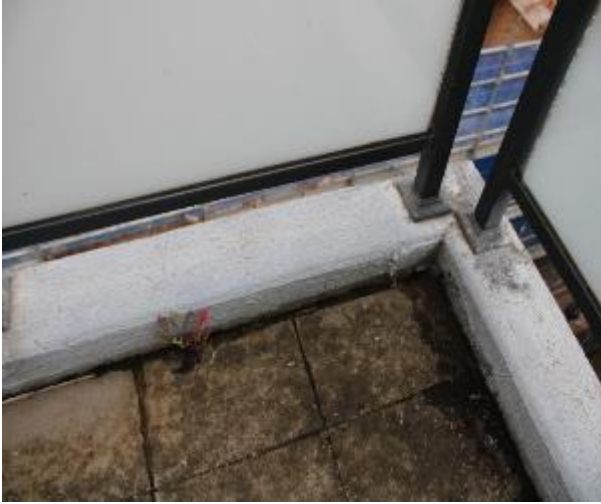
Figure 1504 - General condition of balcony floor tiles

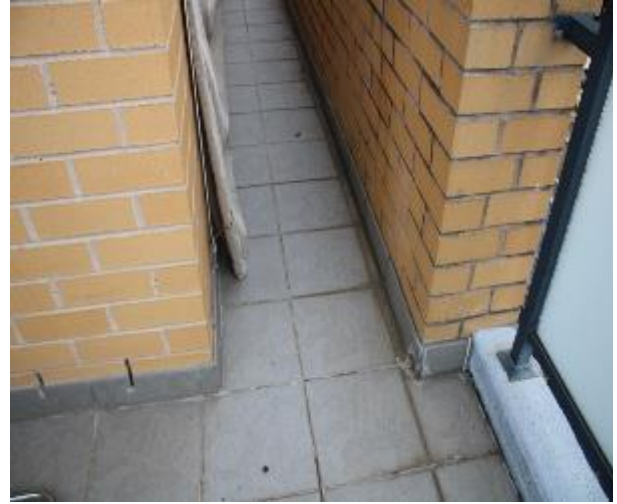
Figure 1505 - General condition of balcony floor tiles

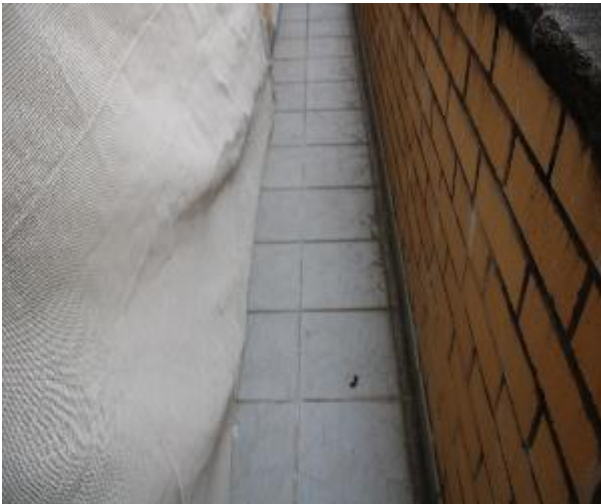
Figure 1506 - General condition of balcony floor tiles

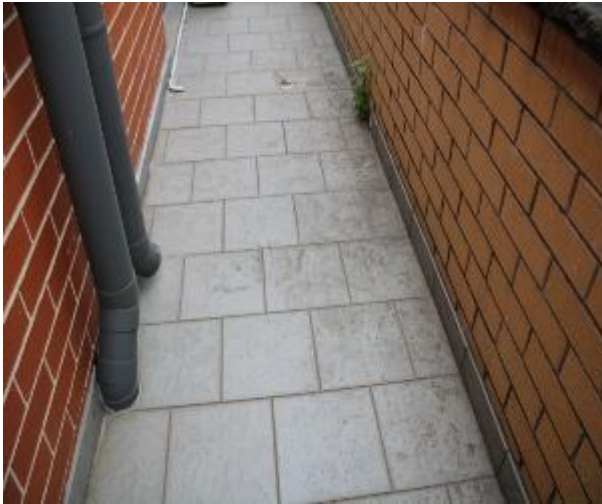
Figure 1510 - General condition of balcony floor tiles

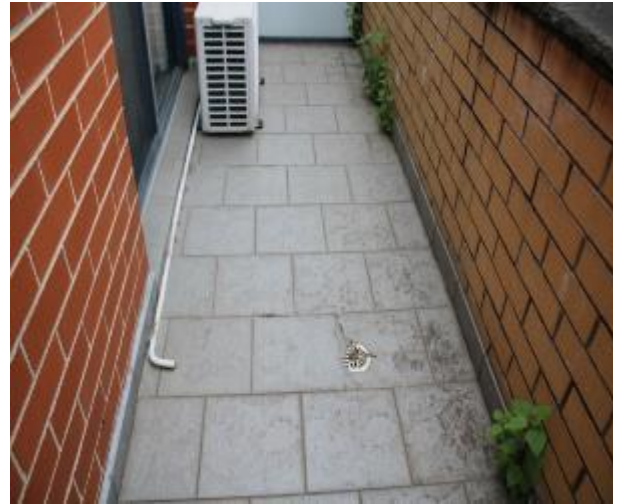
Figure 1511 - General condition of balcony floor tiles

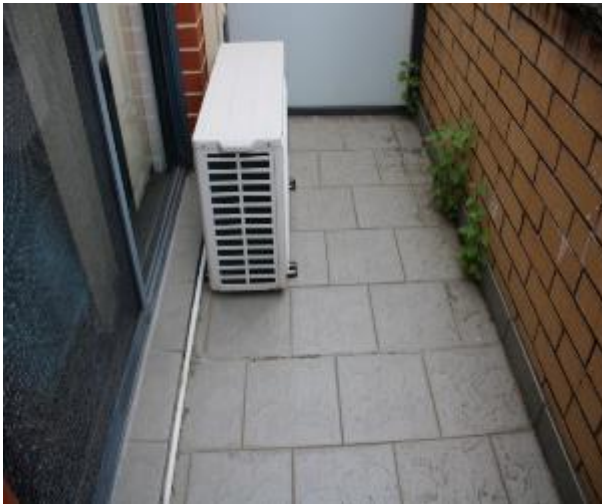
Figure 1512 - General condition of balcony floor tiles

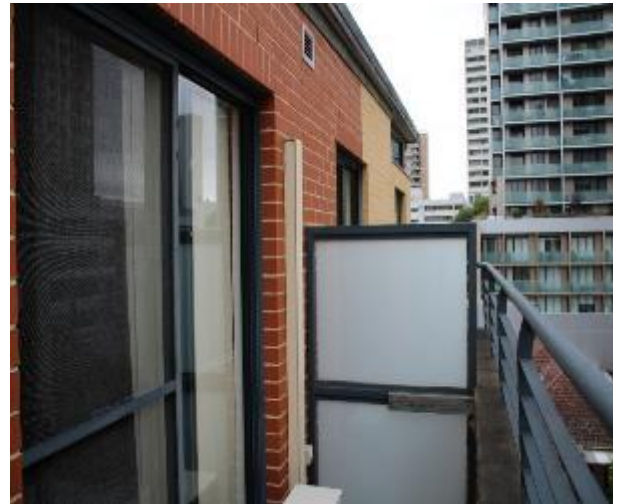
Figure 1513 - General condition of external wall

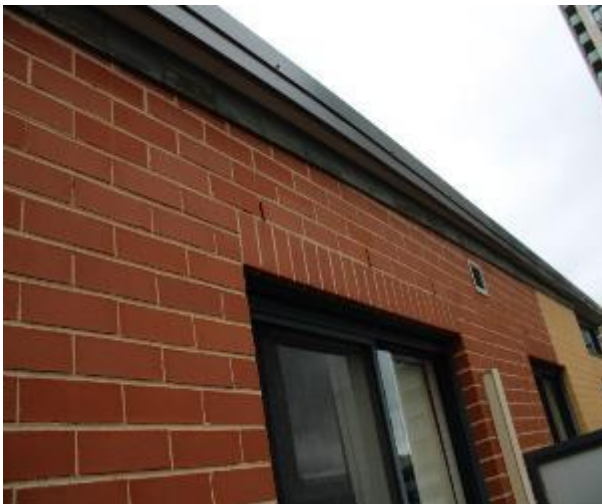
Figure 1515 - General condition of external wall

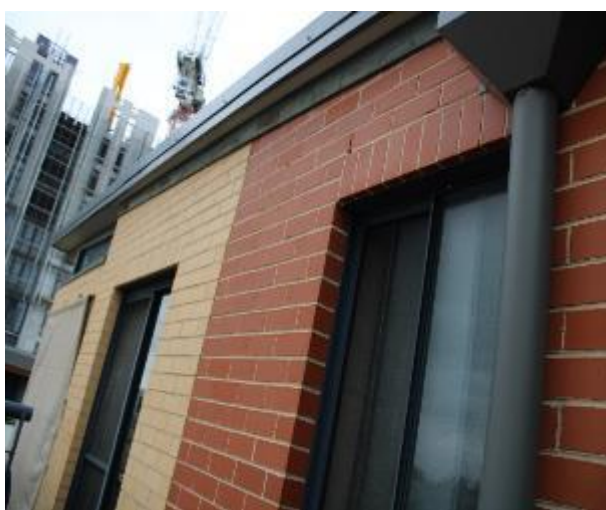
Figure 1519 - General condition of external wall

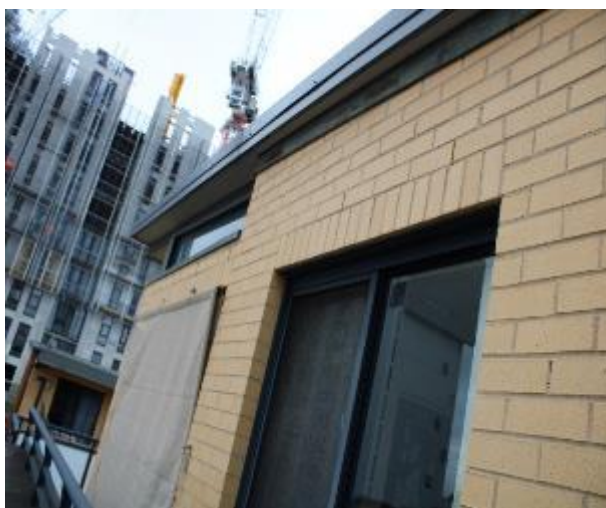
Figure 1521 - General condition of external wall

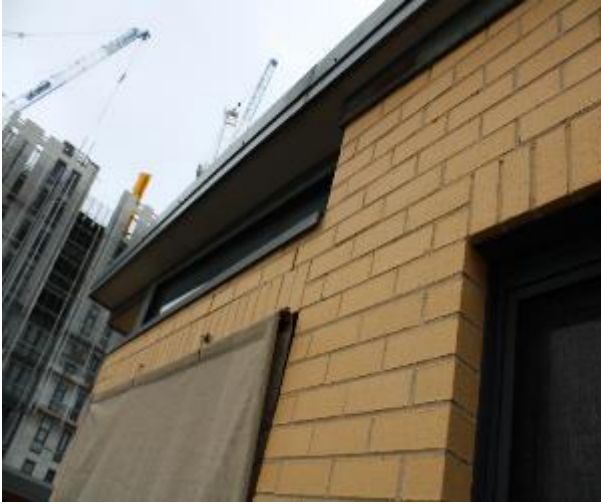
Figure 1523 - General condition of external wall

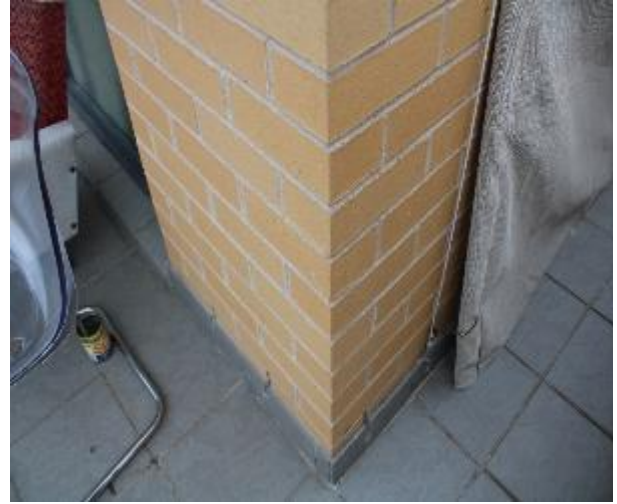
Figure 1524 - General condition of external wall

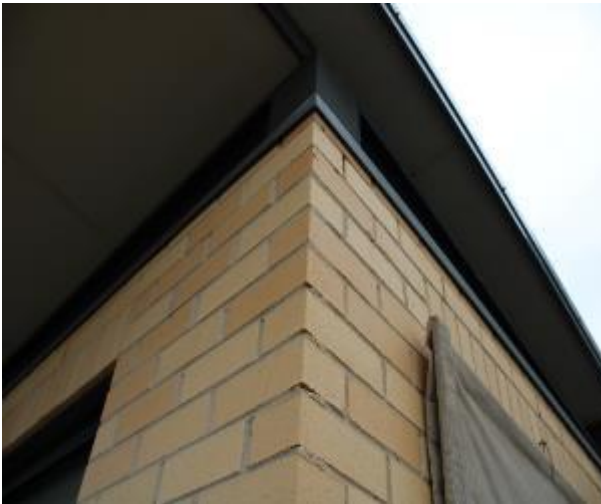
Figure 1525 - General condition of external wall

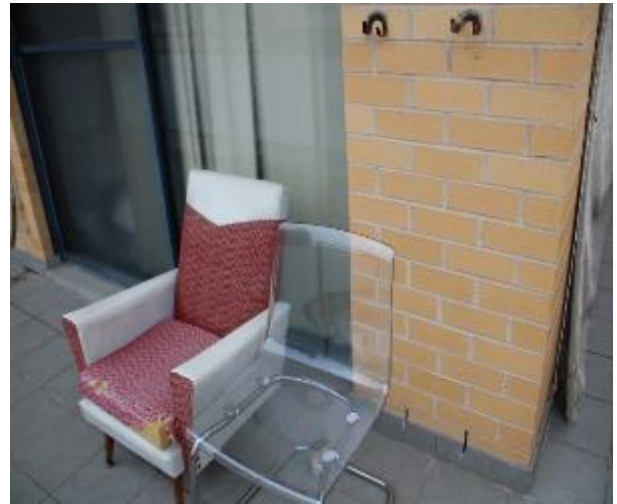
Figure 1526 - General condition of external wall

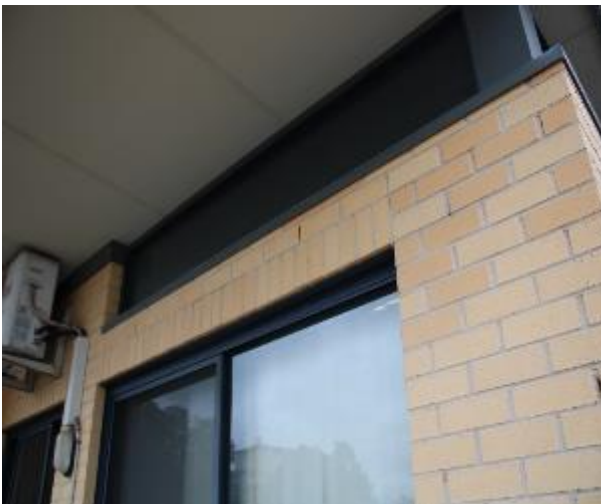
Figure 1527 - General condition of external wall

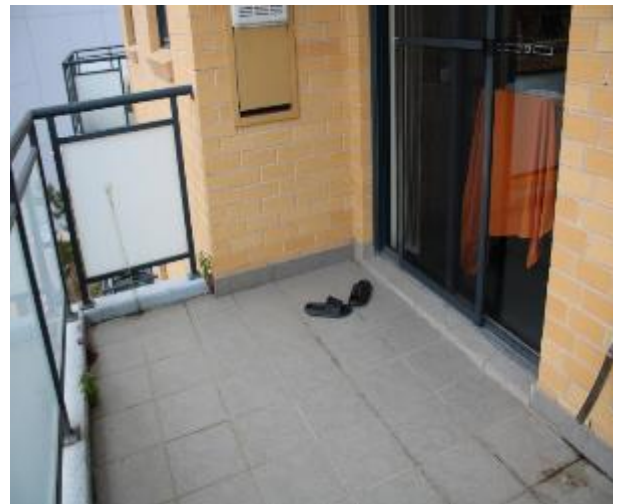
Figure 1528 - General condition of external wall

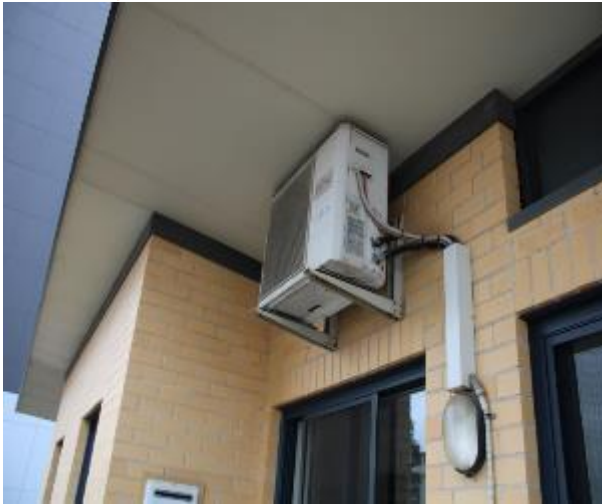
Figure 1529 - General condition of external wall

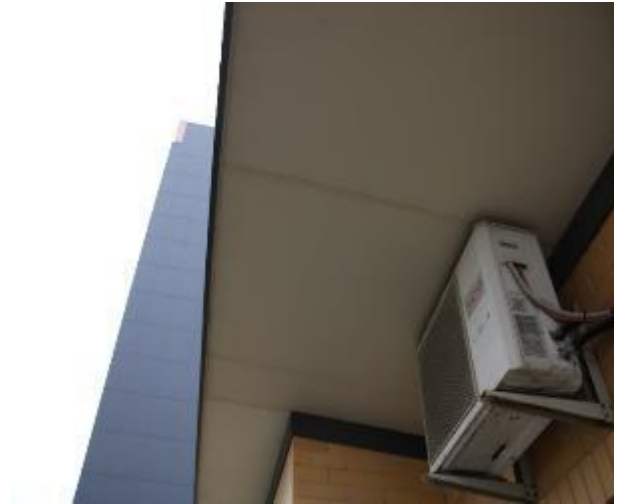
Figure 1530 - General condition of balcony underside slab

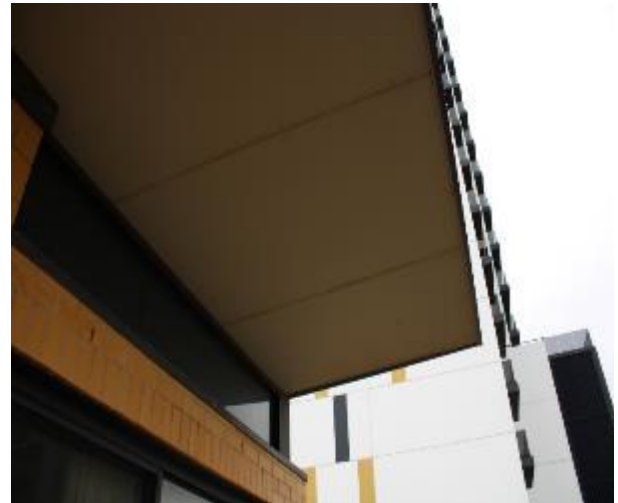
Figure 1532 - General condition of balcony underside slab

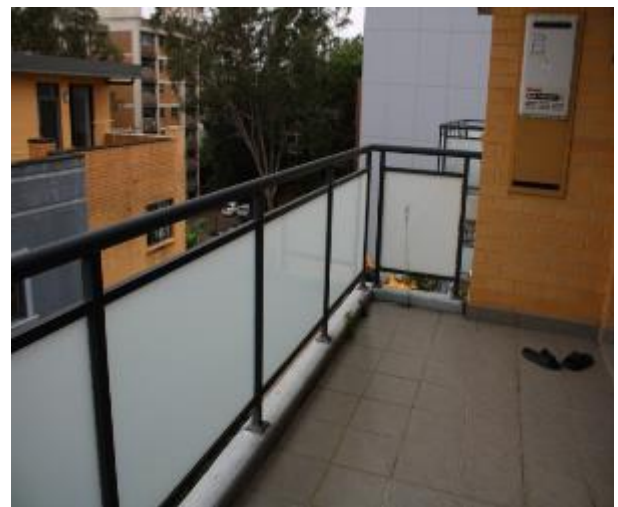
Figure 1534 - General condition of balcony balustrade

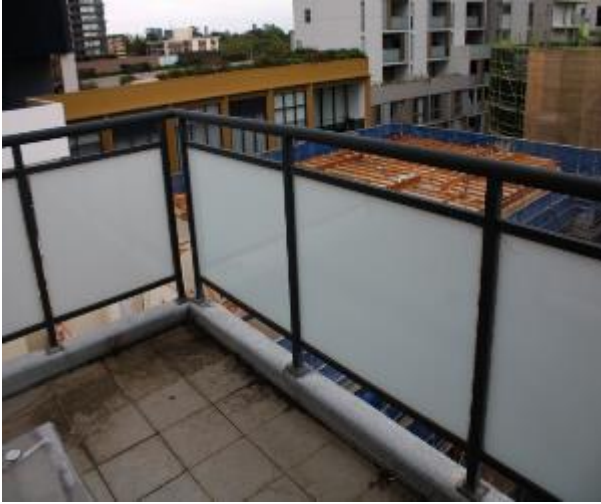
Figure 1535 - General condition of balcony balustrade

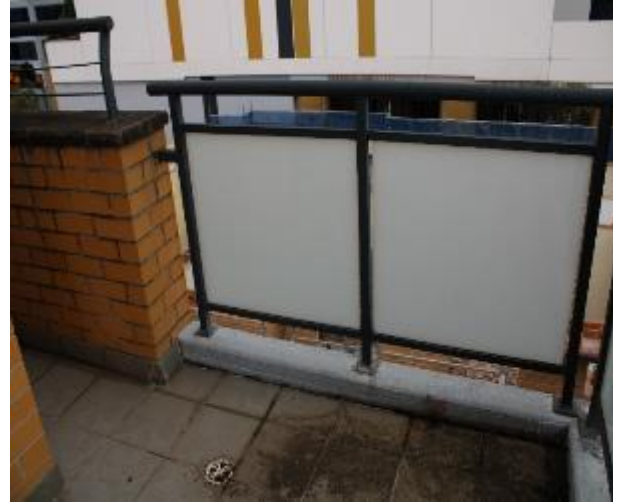
Figure 1536 - General condition of balcony balustrade

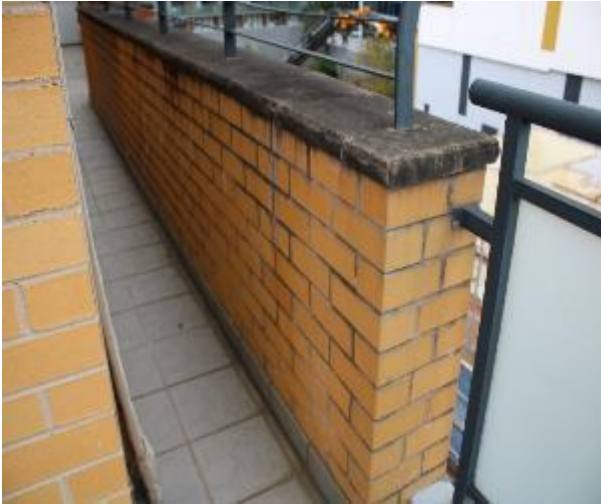
Figure 1537 - General condition of balcony balustrade

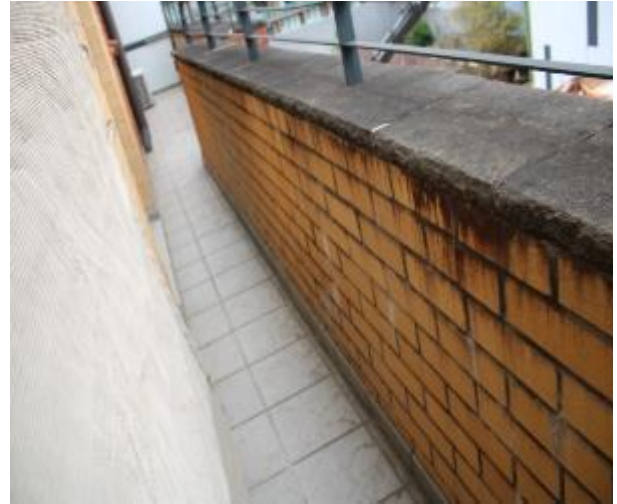
Figure 1538 - General condition of balcony balustrade

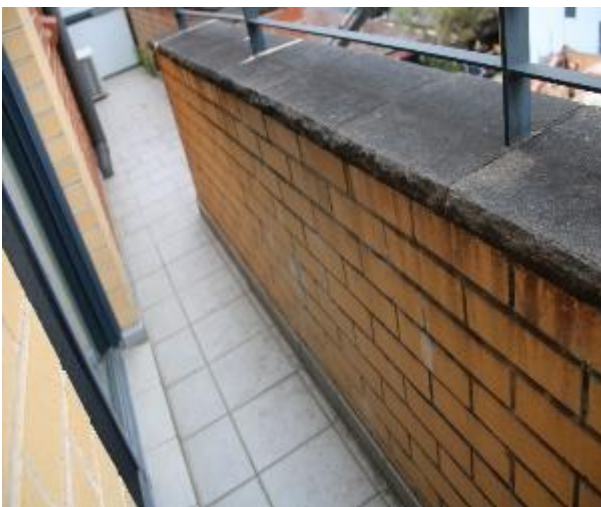
Figure 1539 - General condition of balcony balustrade

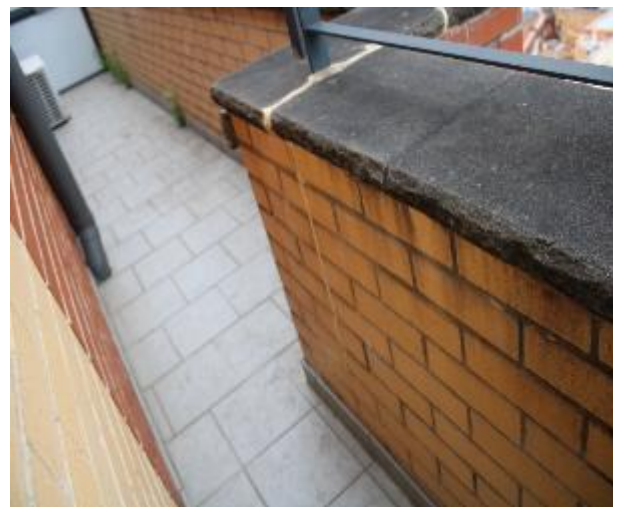
Figure 1540 - General condition of balcony balustrade

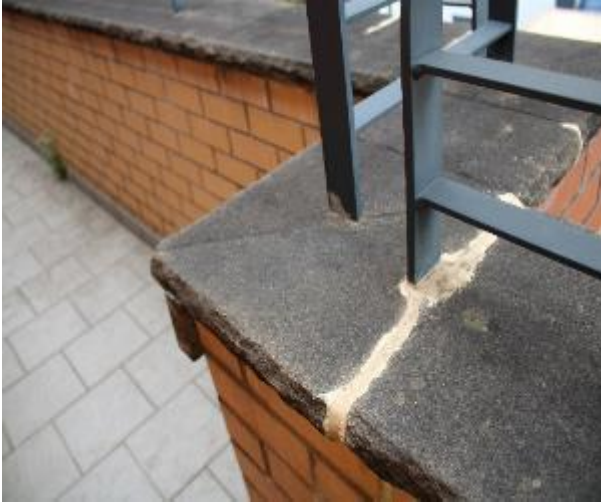
Figure 1541 - General condition of balcony balustrade

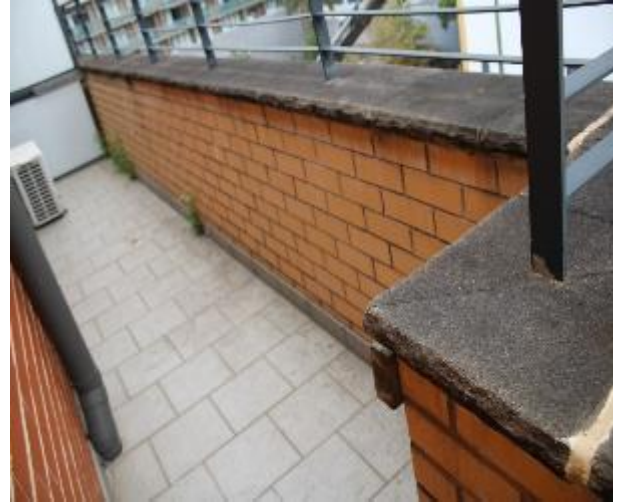
Figure 1542 - General condition of balcony balustrade

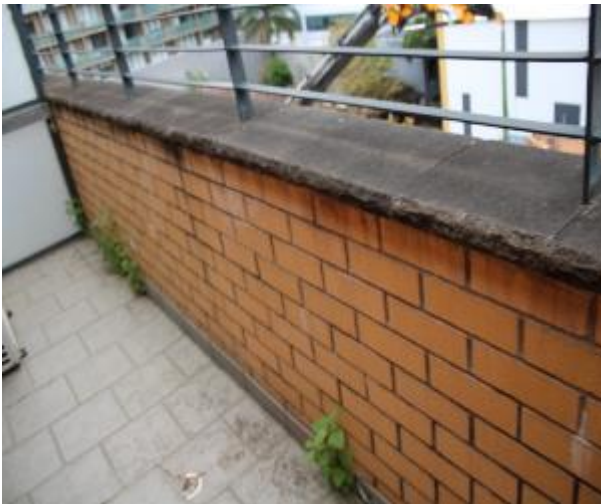
Figure 1543 - General condition of balcony balustrade

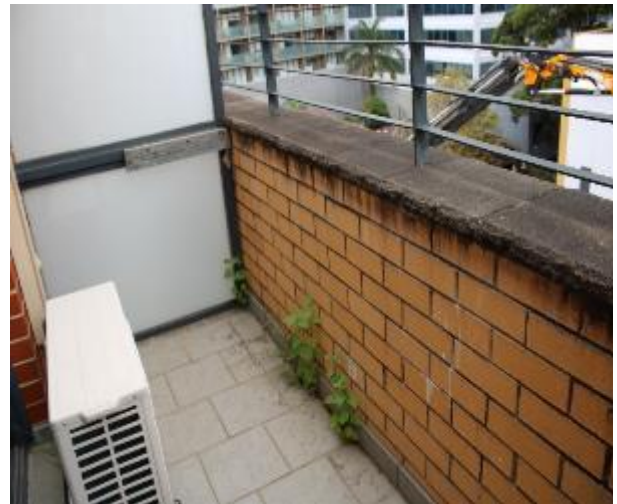
Figure 1544 - General condition of balcony balustrade

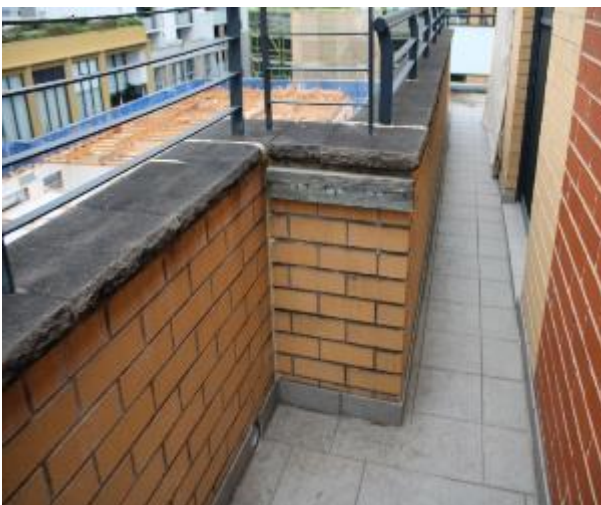
Figure 1545 - General condition of balcony balustrade

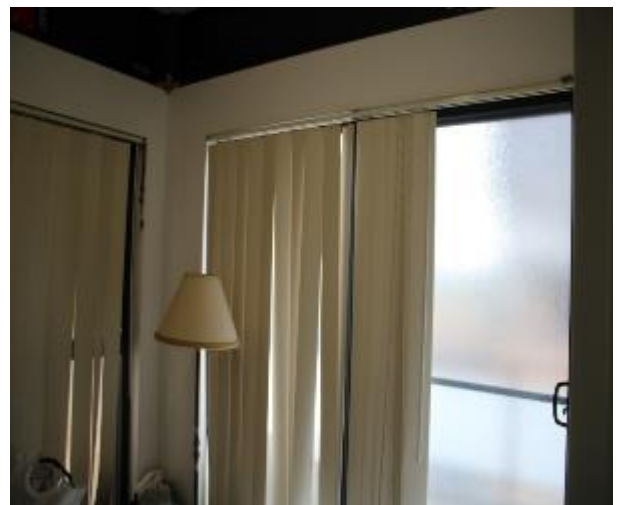
Figure 1546 - General condition of bedroom 1 internal wall

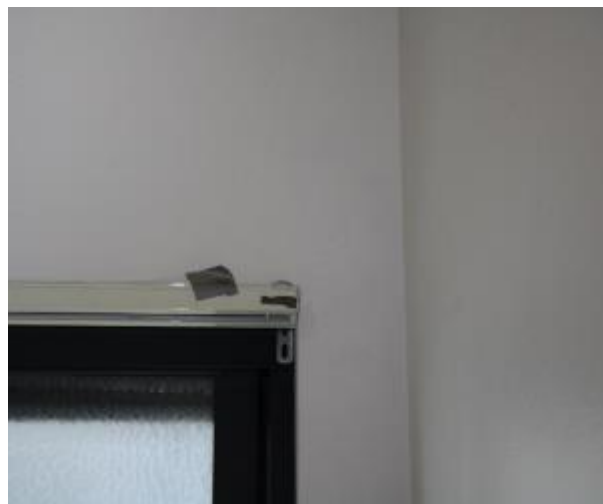
Figure 1548 - Crack propagation through bedroom 1 internal wall

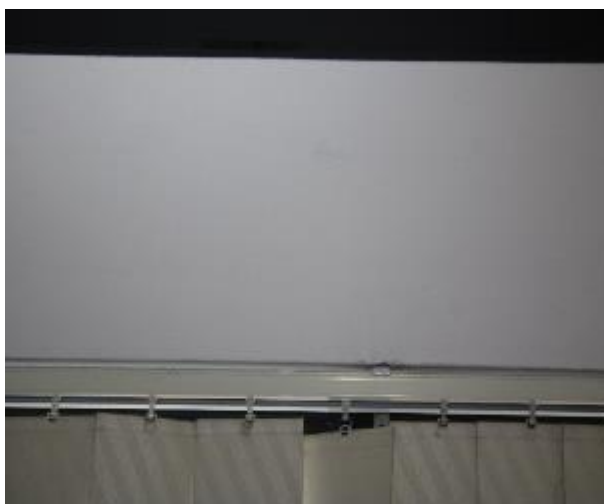
Figure 1549 - Crack propagation through bedroom 1 internal wall

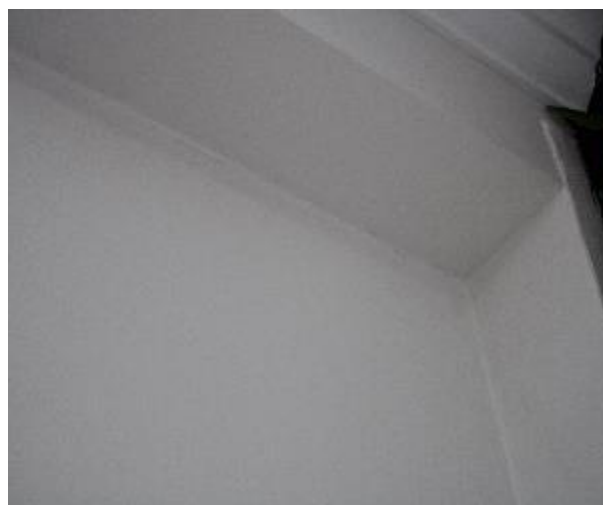
Figure 1552 - Crack propagation through bedroom 1 internal wall

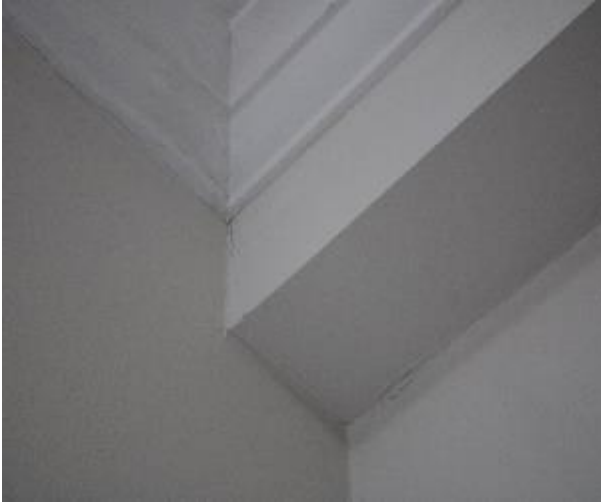
Figure 1553 - Crack propagation through bedroom 1 internal wall

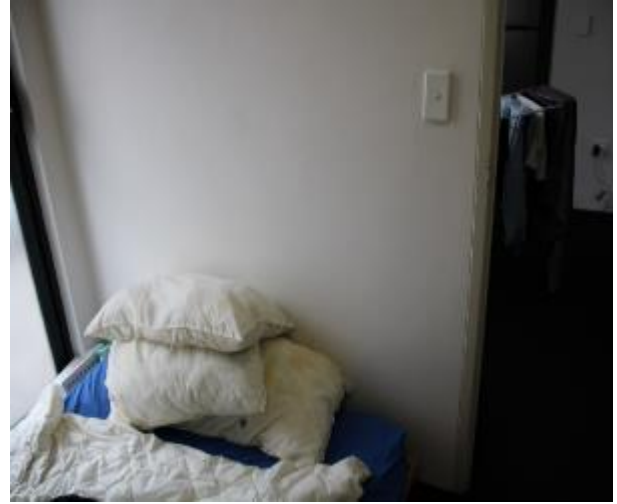
Figure 1554 - General condition of bedroom 1 internal wall

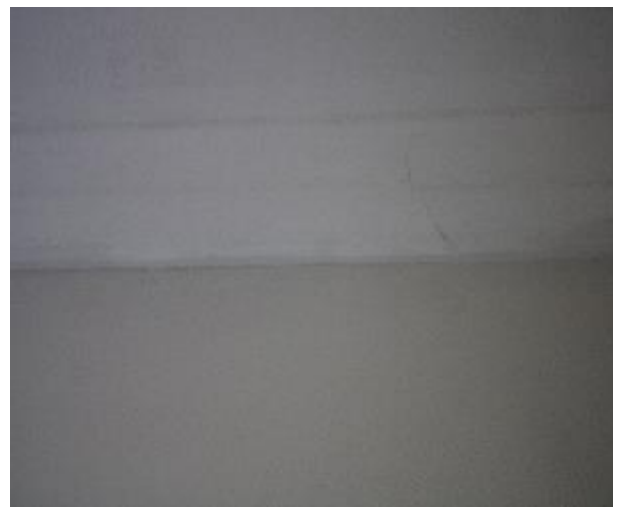
Figure 1558 - Crack propagation through bedroom 1 ceiling

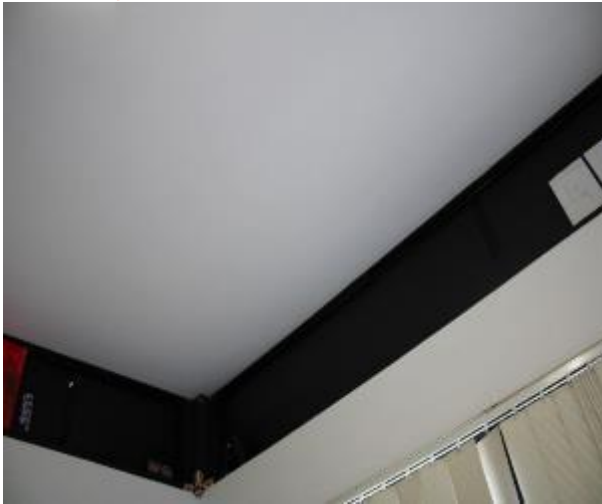
Figure 1559 - General condition of bedroom 1 ceiling

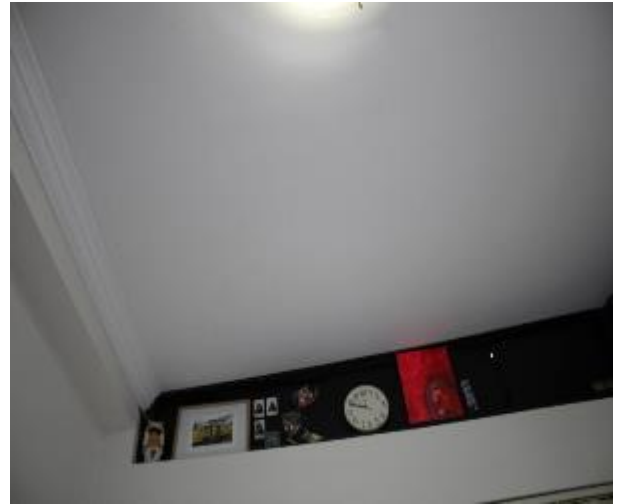
Figure 1560 - General condition of bedroom 1 ceiling

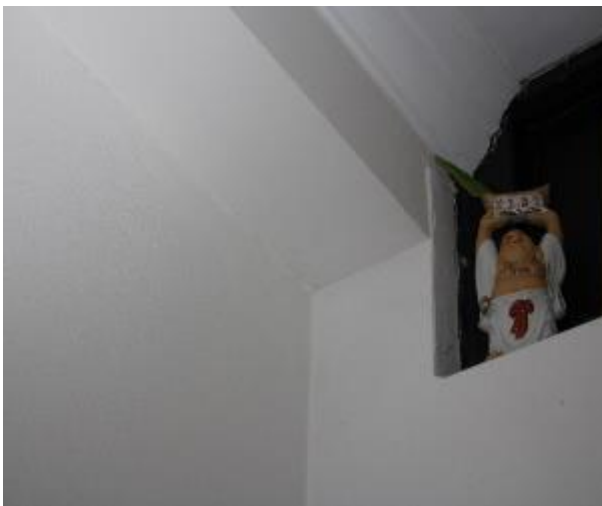
Figure 1561 - Crack propagation through bedroom 1 ceiling

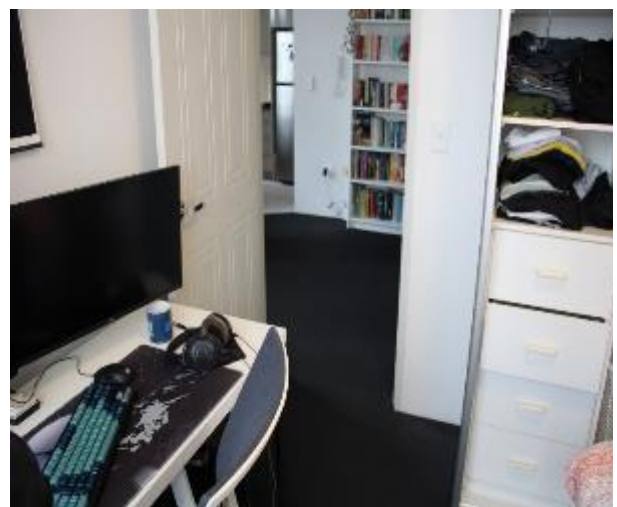
Figure 1564 - General condition of bedroom 2 internal wall

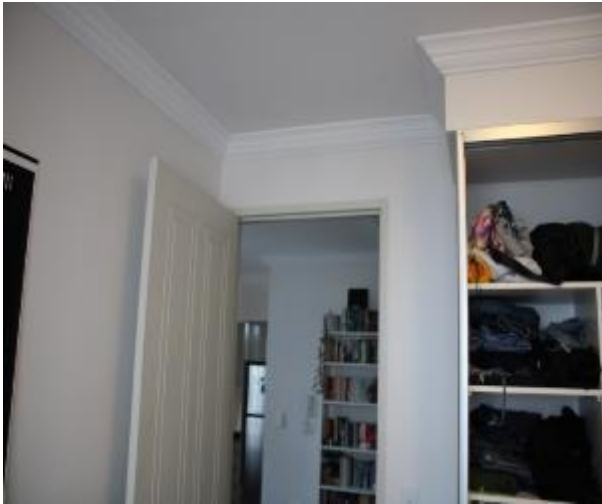
Figure 1565 - General condition of bedroom 2 internal wall

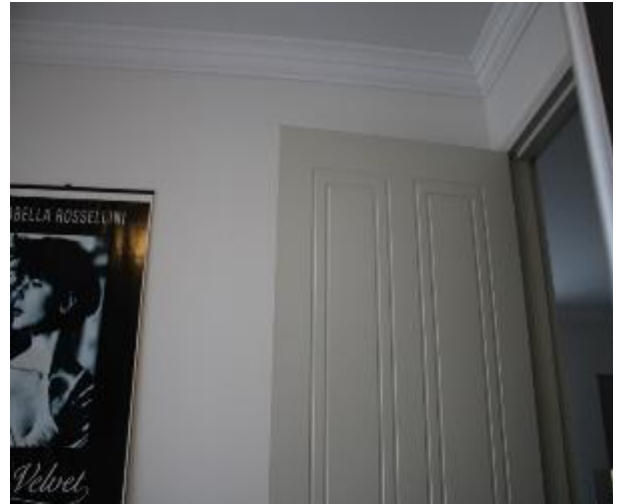
Figure 1566 - General condition of bedroom 2 internal wall

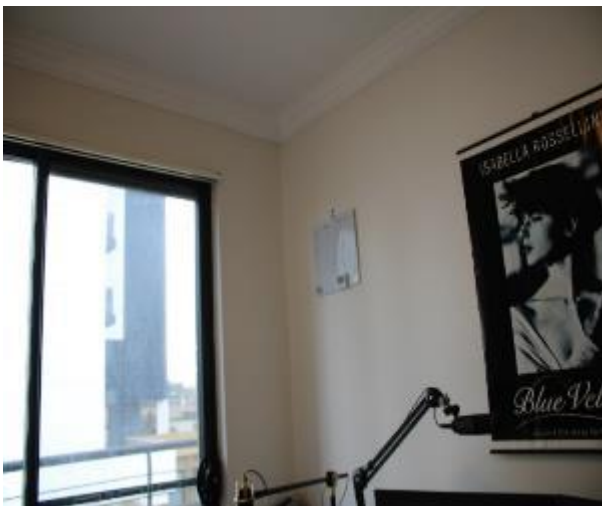
Figure 1567 - General condition of bedroom 2 internal wall

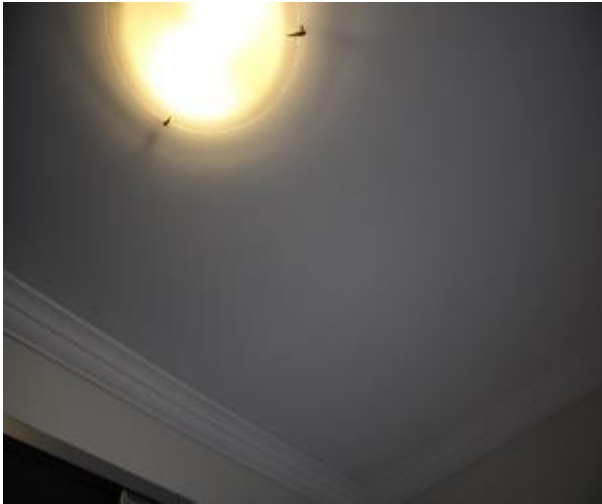
Figure 1571 - General condition of bedroom 2 ceiling

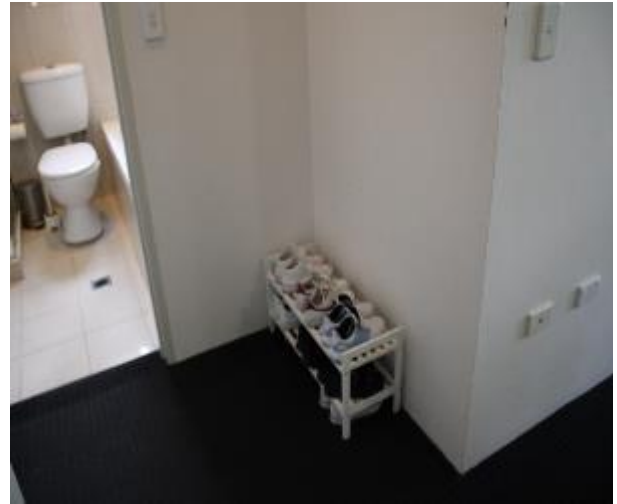
Figure 1572 - General condition of corridor internal wall
