# **Pre-Dilapidation Report**

**19 GEORGE STREET**

**FRONT BUILDING (UNITS 1-19)**

Project Reference: 20250047.19G.2

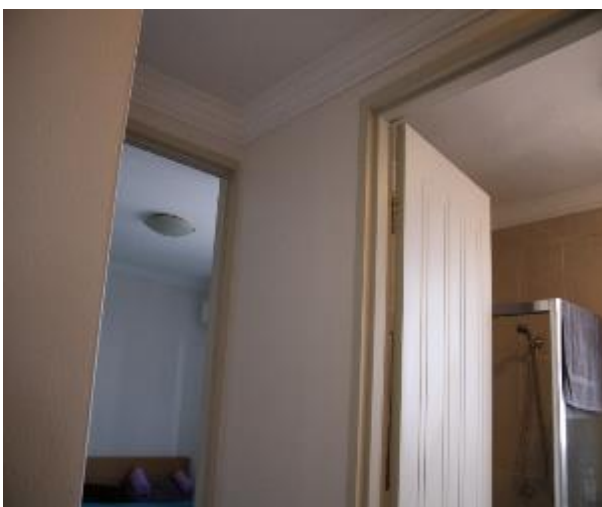
Figure 1575 - General condition of corridor internal wall

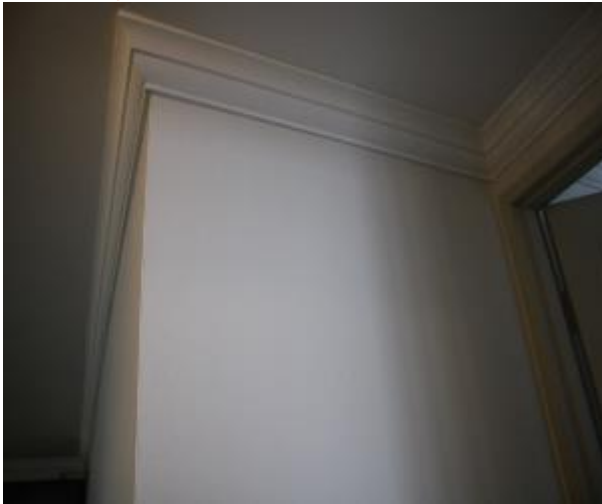
Figure 1577 - General condition of corridor internal wall

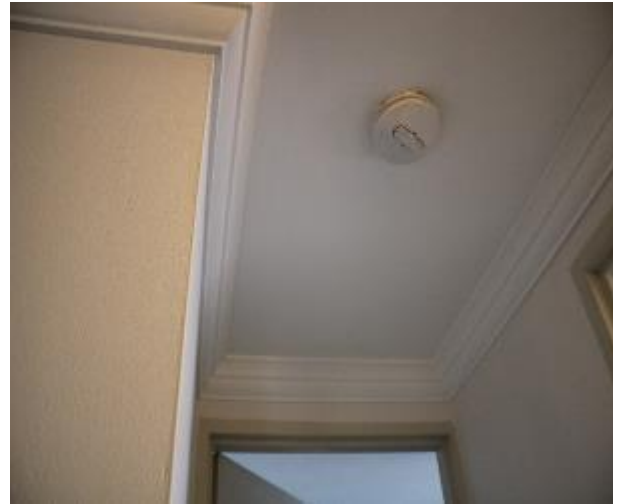
Figure 1578 - General condition of corridor ceiling

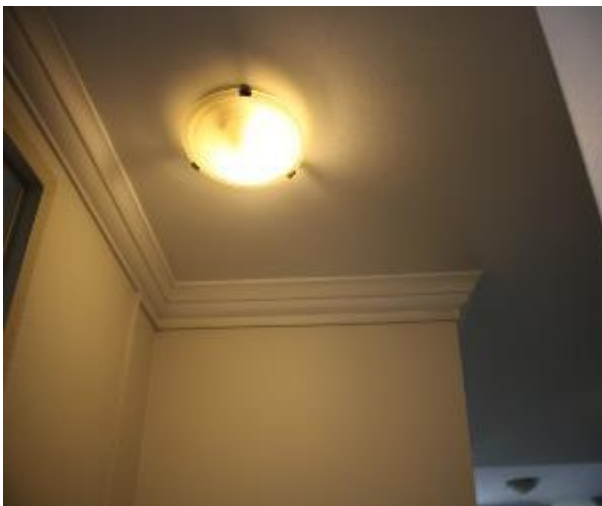
Figure 1579 - General condition of corridor ceiling

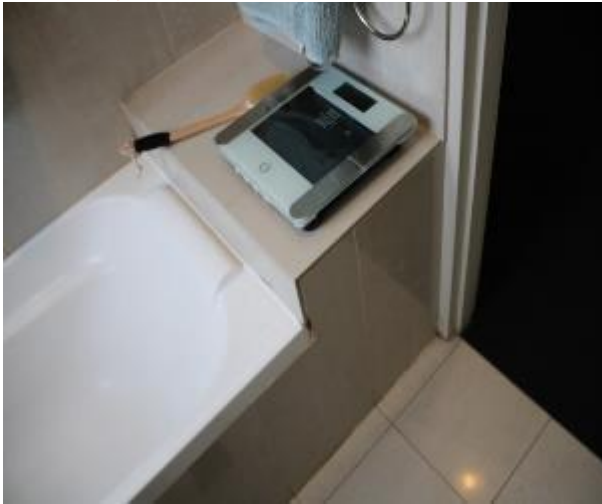
Figure 1583 - General condition of bathroom 1 internal wall

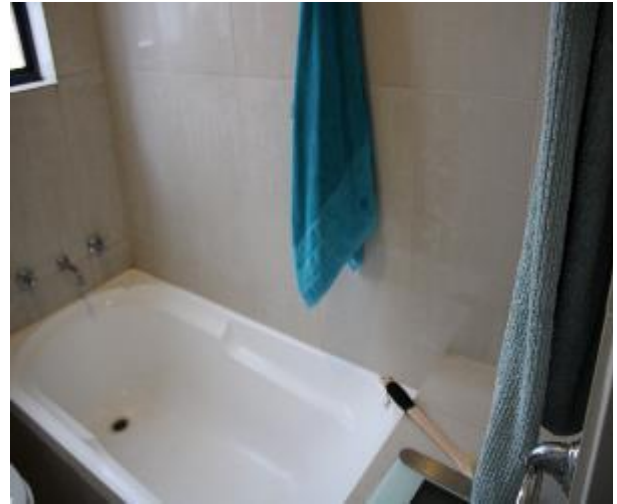
Figure 1584 - General condition of bathroom 1 internal wall

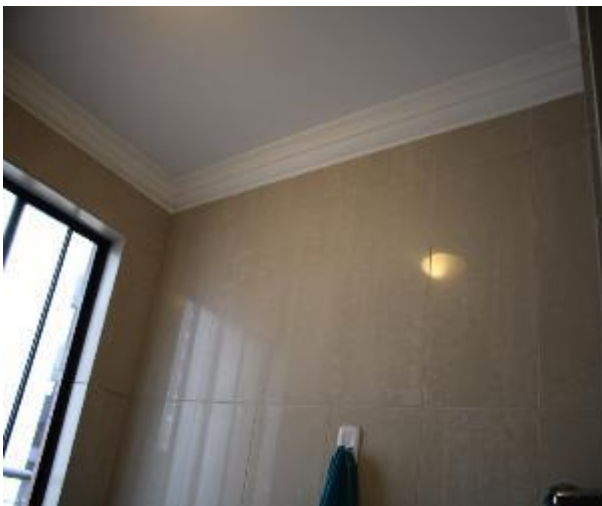
Figure 1585 - General condition of bathroom 1 internal wall

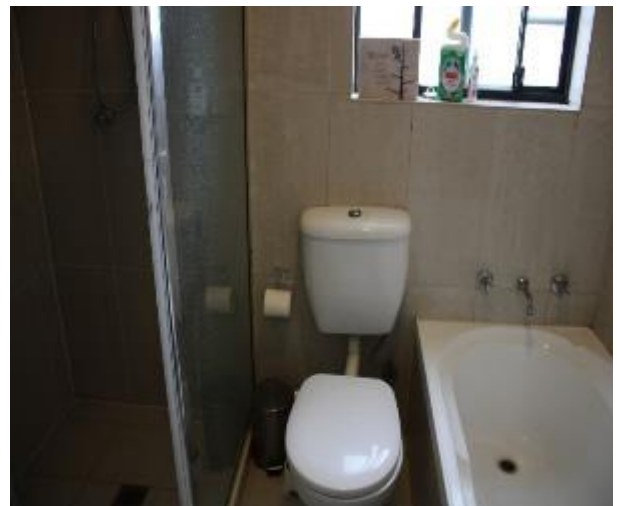
Figure 1586 - General condition of bathroom 1 internal wall

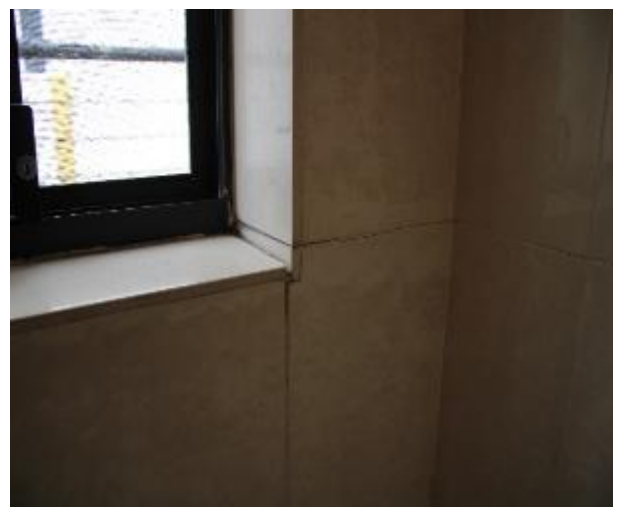
Figure 1588 - Crack propagation through bathroom 1 internal wall

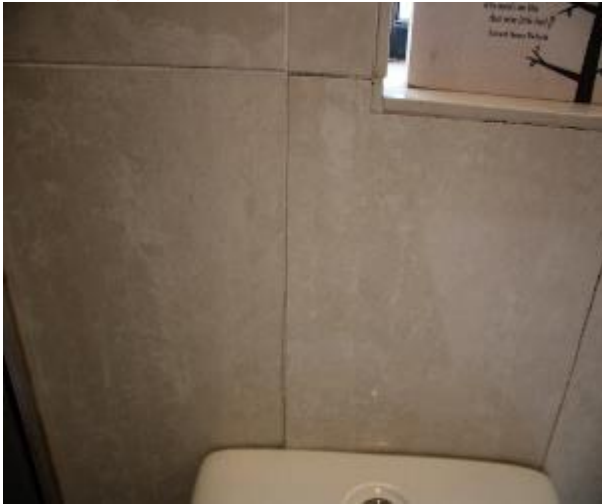
Figure 1589 - Crack propagation through bathroom 1 internal wall

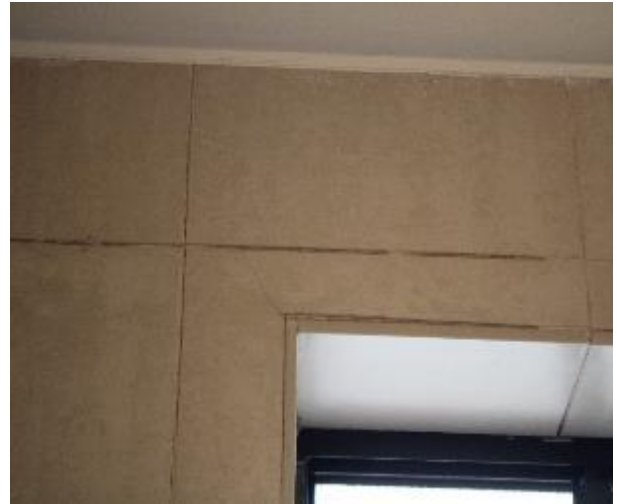
Figure 1590 - Crack propagation through bathroom 1 internal wall

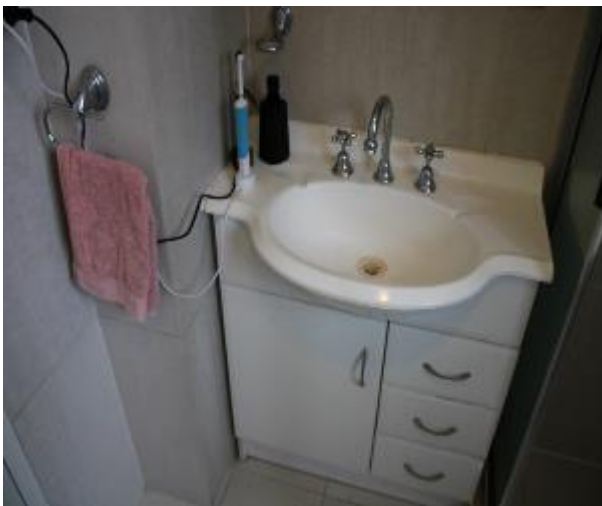
Figure 1591 - General condition of bathroom 1 internal wall

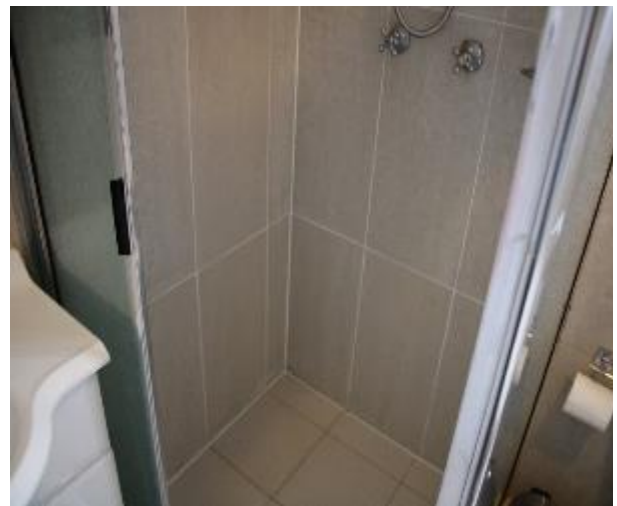
Figure 1592 - General condition of bathroom 1 internal wall

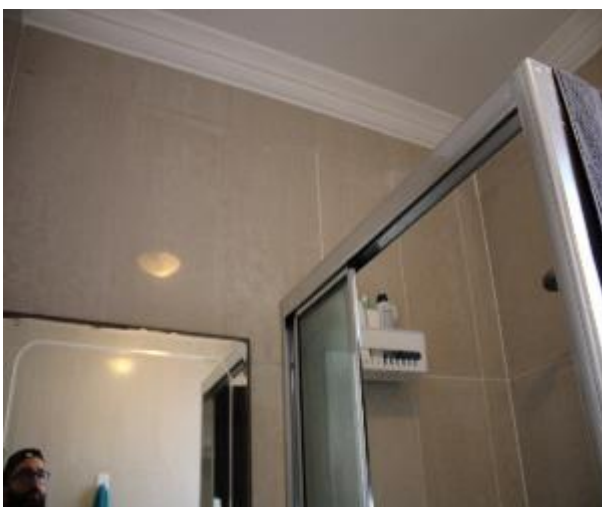
Figure 1593 - General condition of bathroom 1 internal wall

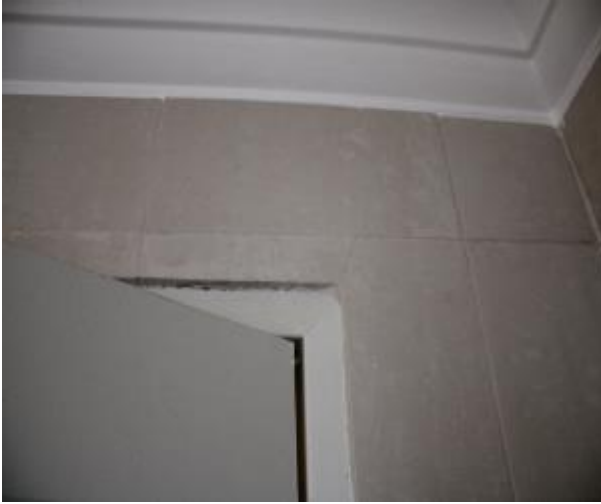
Figure 1595 - Crack propagation through bathroom 1 internal wall

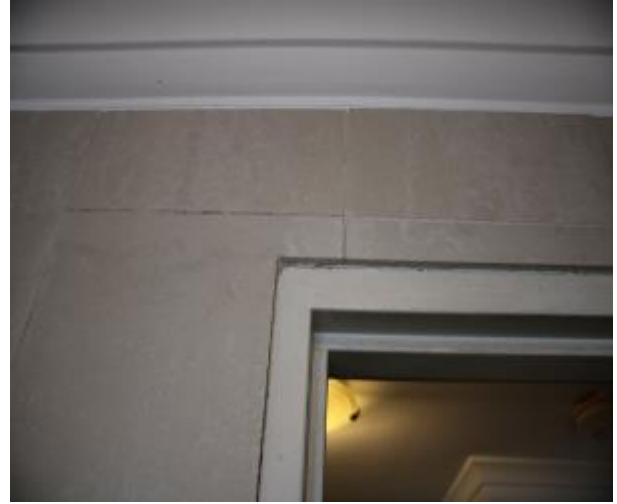
Figure 1596 - Crack propagation through bathroom 1 internal wall

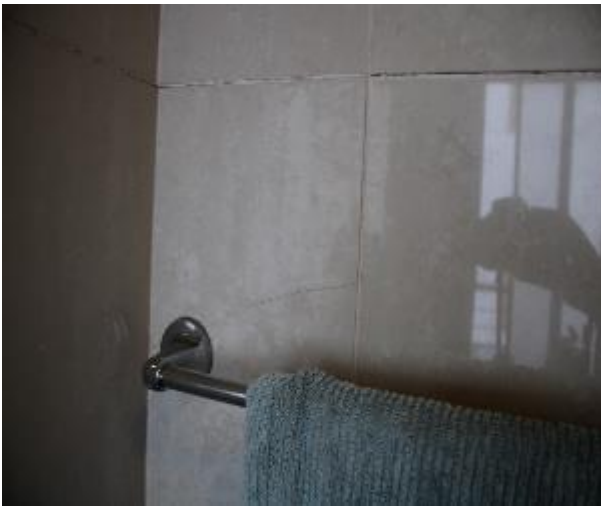
Figure 1597 - Crack propagation through bathroom 1 internal wall

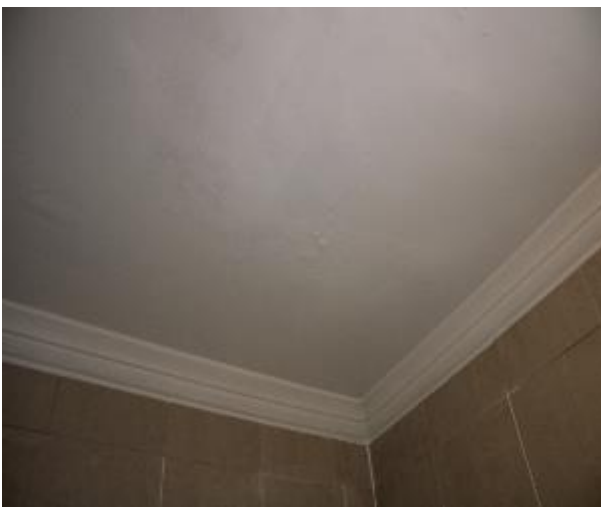
Figure 1599 - General condition of bathroom 1 ceiling

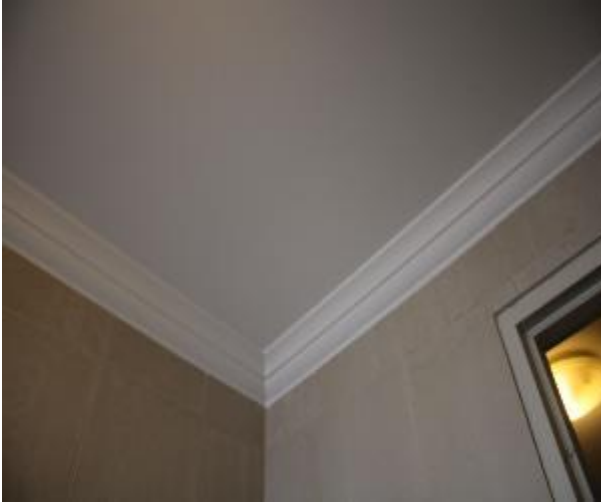
Figure 1601 - General condition of bathroom 1 ceiling

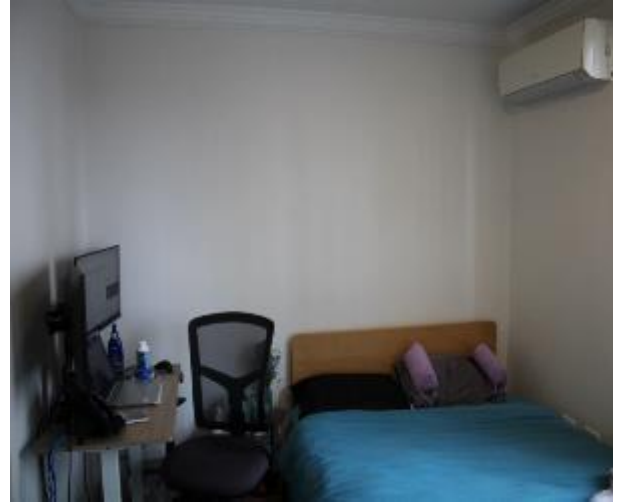
Figure 1602 - General condition of bedroom 3 internal wall

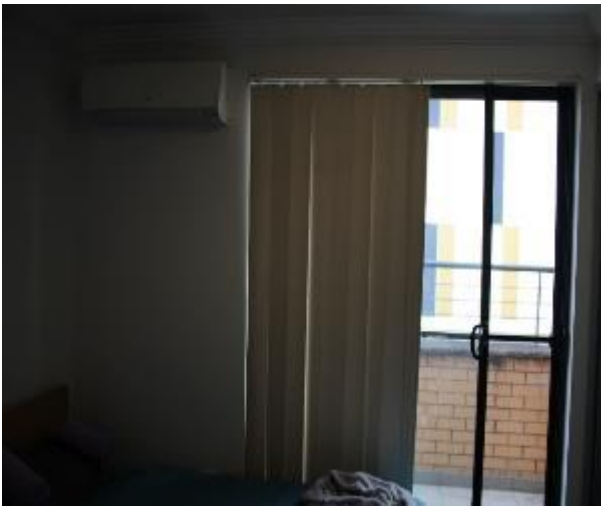
Figure 1603 - General condition of bedroom 3 internal wall

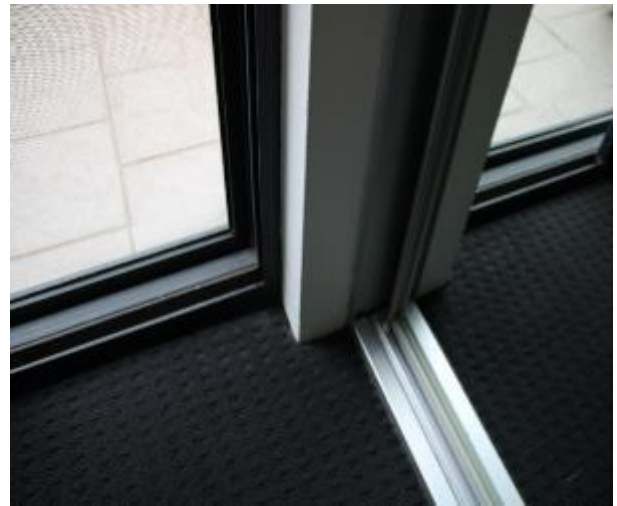
Figure 1604 - Crack propagation through bedroom 3 internal wall

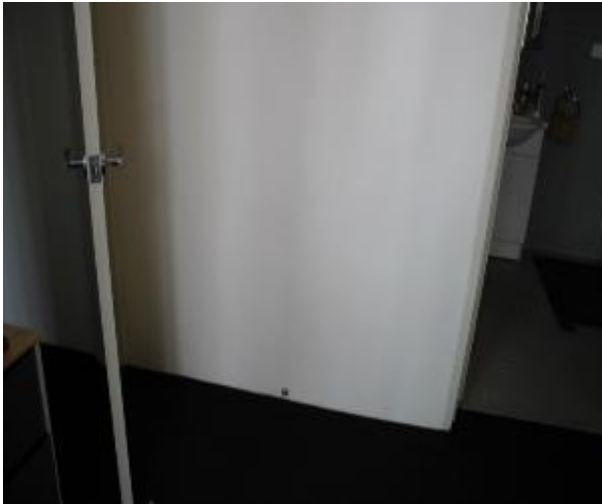
Figure 1607 - General condition of bedroom 3 internal wall

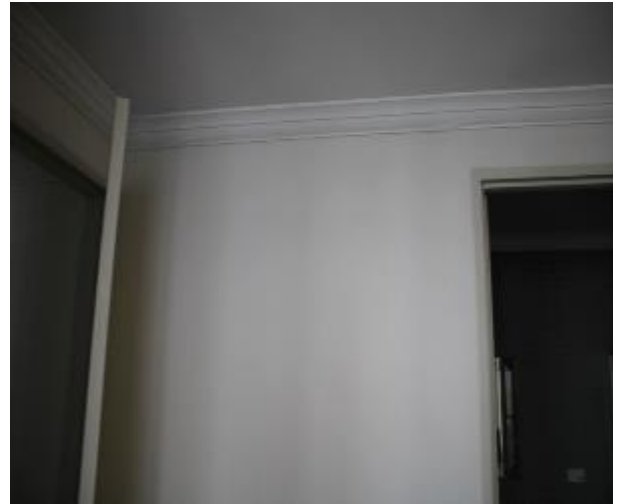
Figure 1608 - General condition of bedroom 3 internal wall

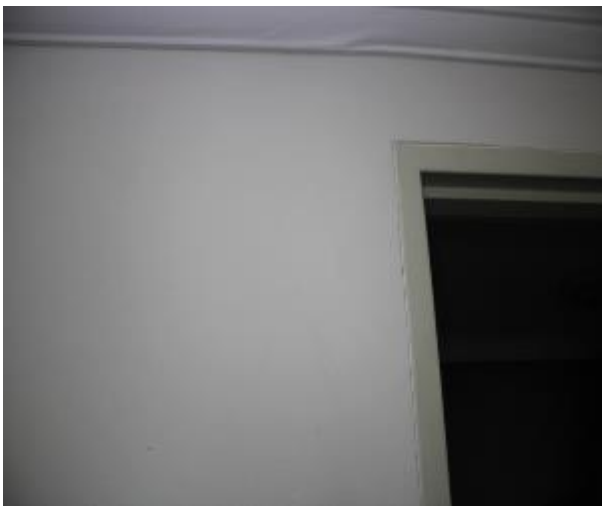
Figure 1609 - Crack propagation through bedroom 3 internal wall

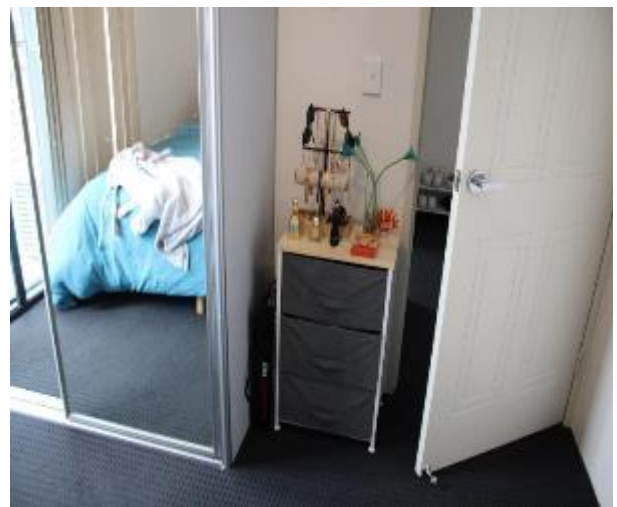
Figure 1612 - General condition of bedroom 3 internal wall

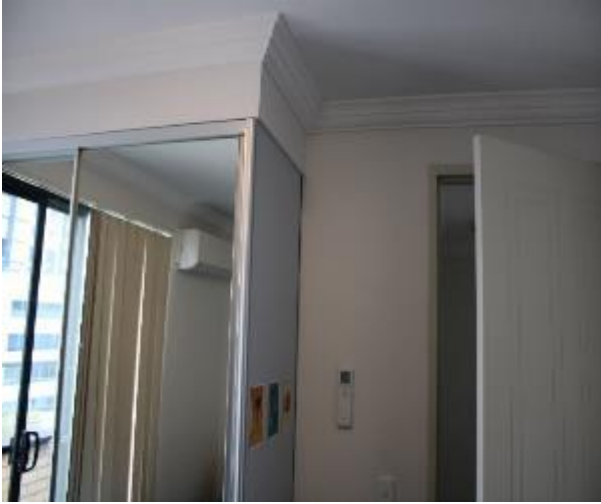
Figure 1613 - General condition of bedroom 3 internal wall

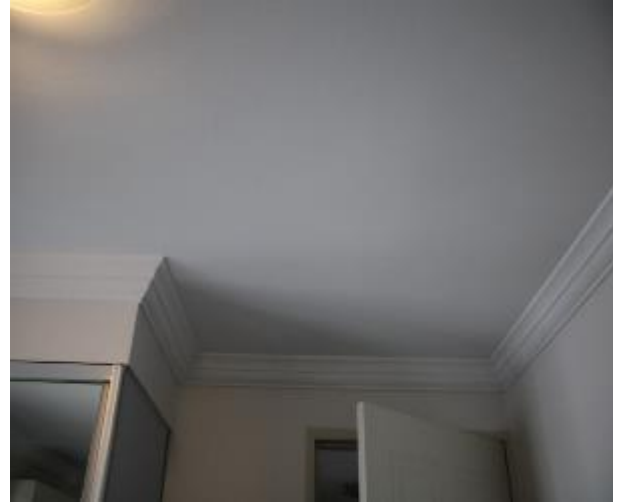
Figure 1614 - General condition of bedroom 3 ceiling

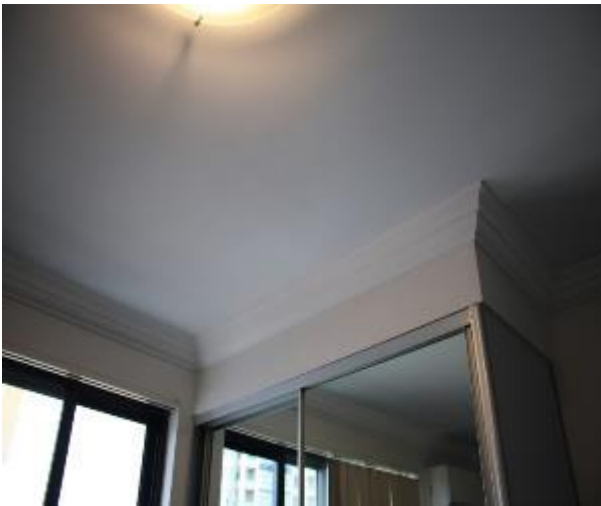
Figure 1615 - General condition of bedroom 3 ceiling

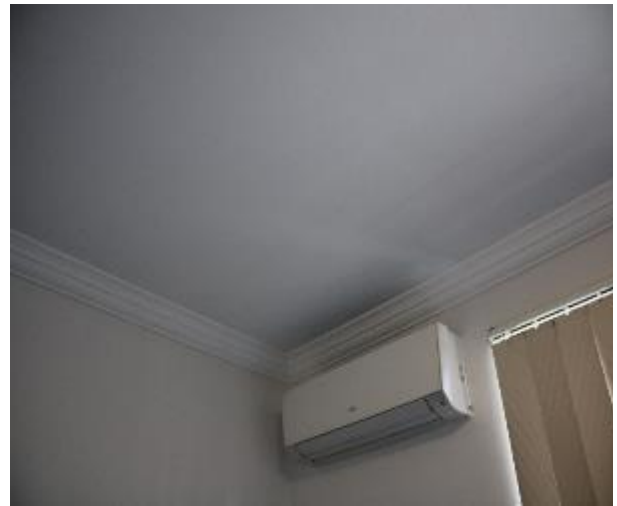
Figure 1616 - General condition of bedroom 3 ceiling

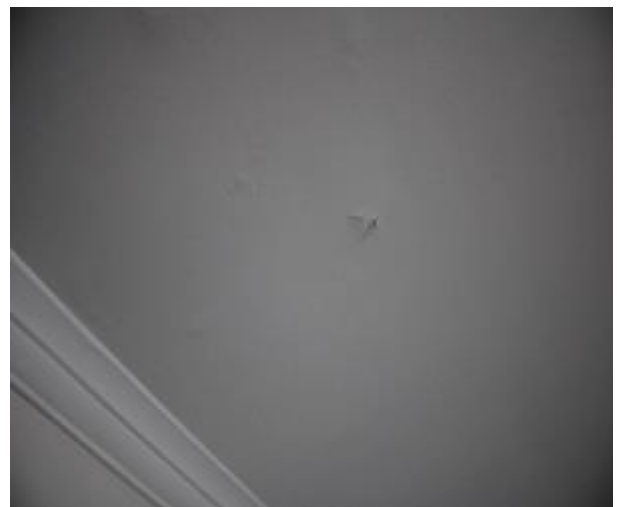
Figure 1618 - Paint flaking through bedroom 3 ceiling

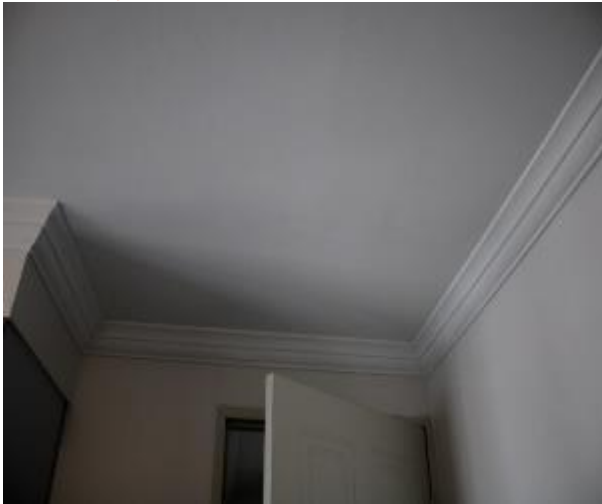
Figure 1619 - General condition of bedroom 3 ceiling

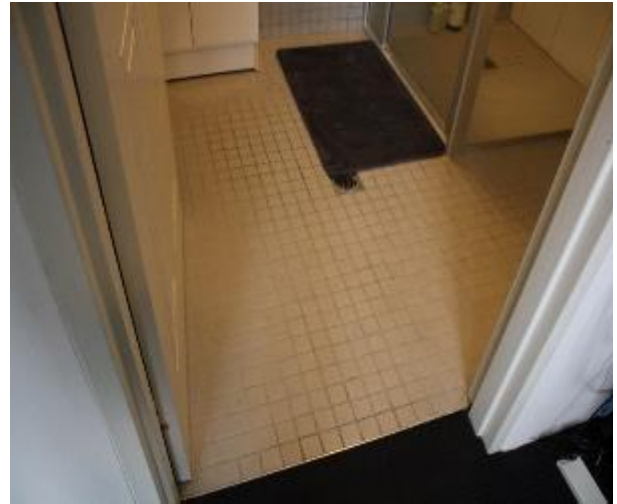
Figure 1620 - General condition of ensuite bathroom floor tiles

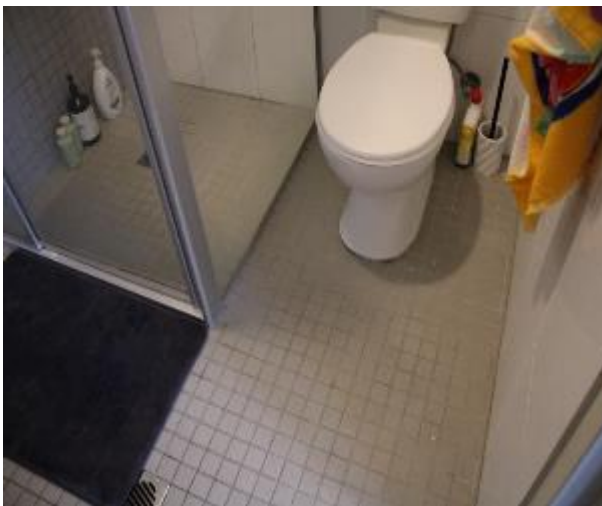
Figure 1621 - General condition of ensuite bathroom floor tiles

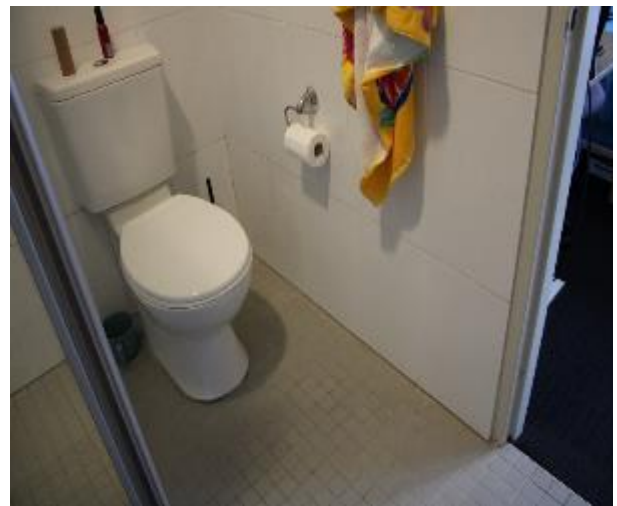
Figure 1622 - General condition of ensuite bathroom internal wall

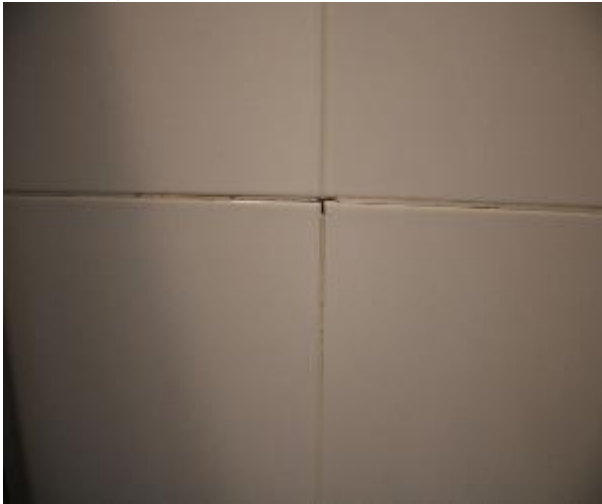
Figure 1625 - Crack propagation through ensuite bathroom internal wall

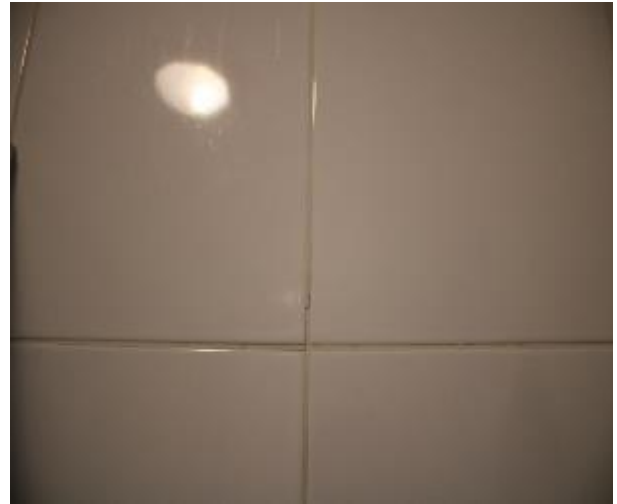
Figure 1626 - Crack propagation through ensuite bathroom internal wall

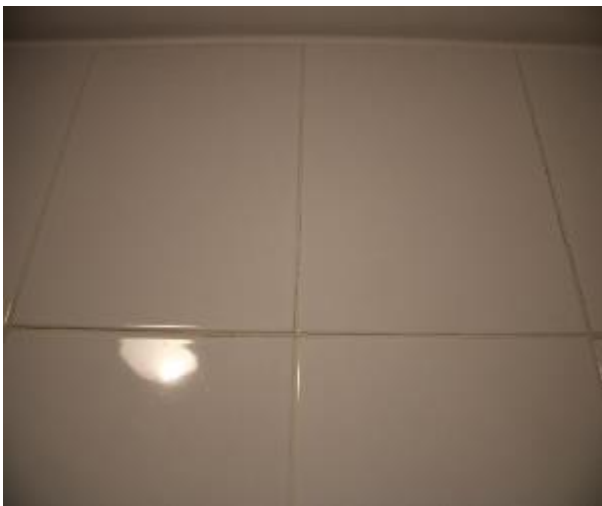
Figure 1627 - Crack propagation through ensuite bathroom internal wall

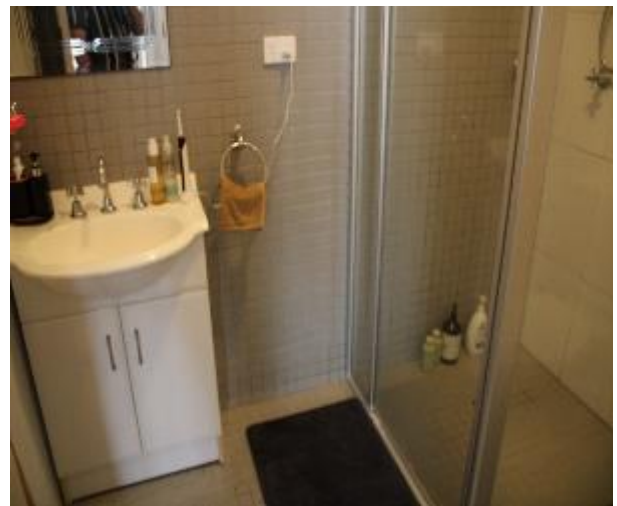
Figure 1628 - General condition of ensuite bathroom internal wall

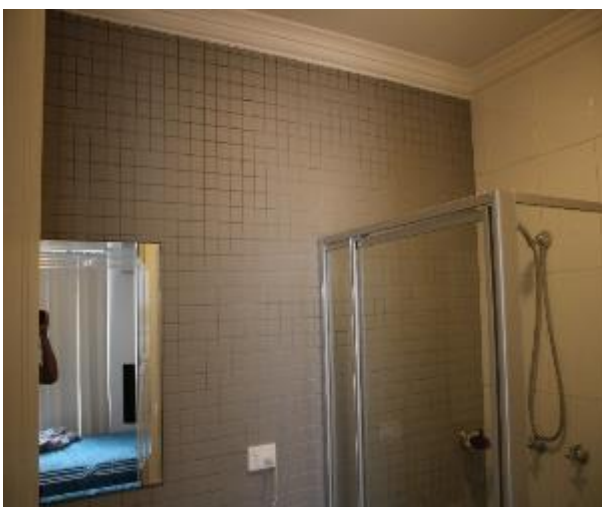
Figure 1629 - General condition of ensuite bathroom internal wall

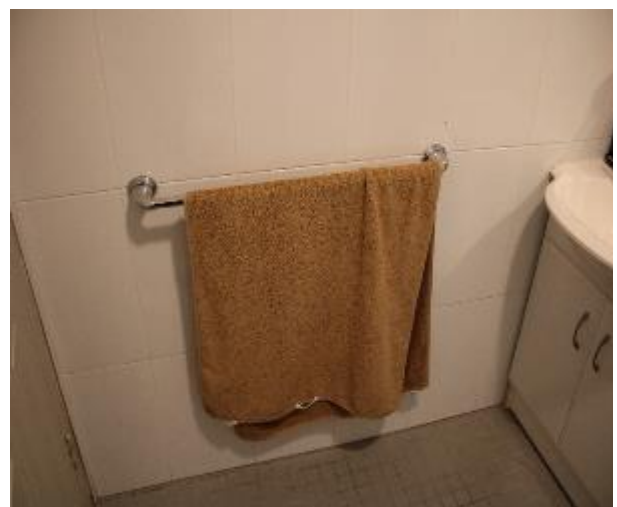
Figure 1630 - General condition of ensuite bathroom internal wall

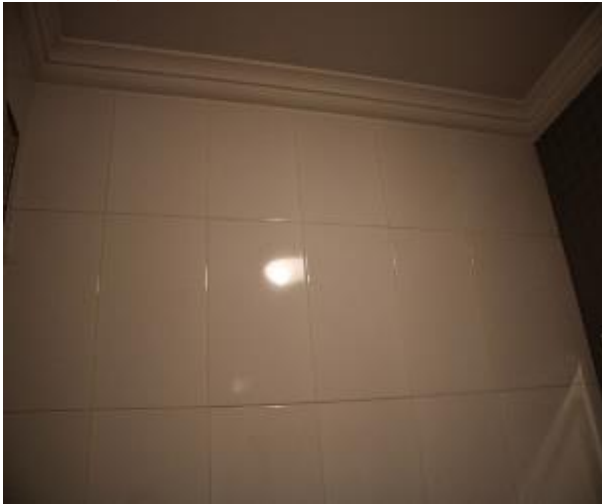
Figure 1631 - General condition of ensuite bathroom internal wall

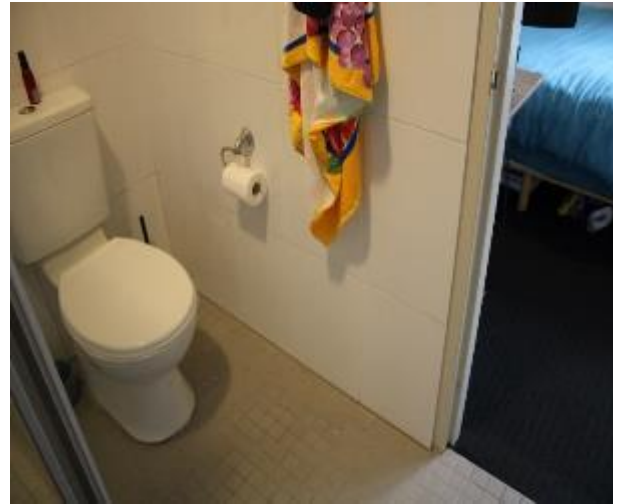
Figure 1632 - General condition of ensuite bathroom internal wall

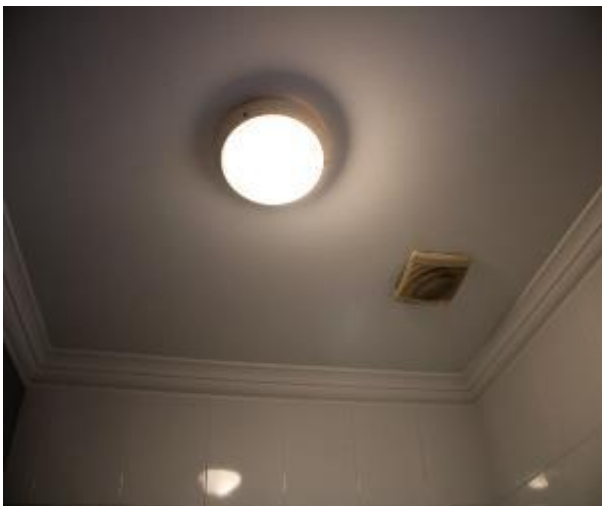
Figure 1633 - General condition of ensuite bathroom ceiling

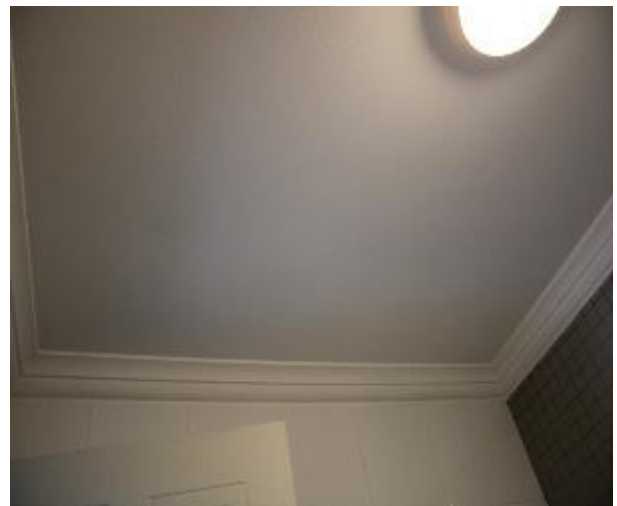
Figure 1634 - General condition of ensuite bathroom ceiling
