# **PRE-DILAPIDATION REPORT**

**COUNCIL ASSETS**

**21 GEORGE STREET,  
BURWOOD, NSW 2134**

PROJECT REFERENCE: 20250047.CA.1  
17/04/2026

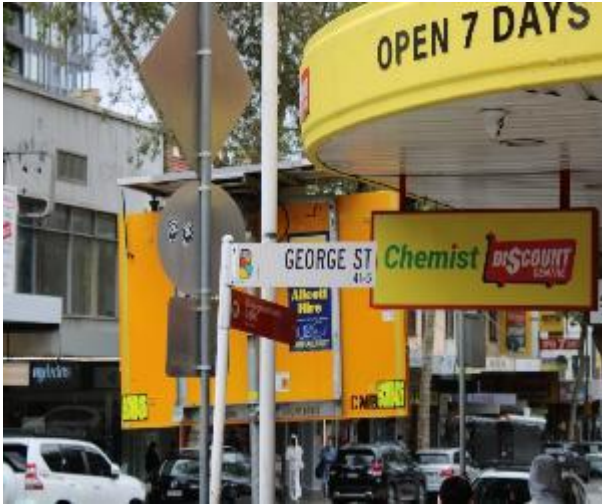
Figure 1 - The following images display the condition of George Street

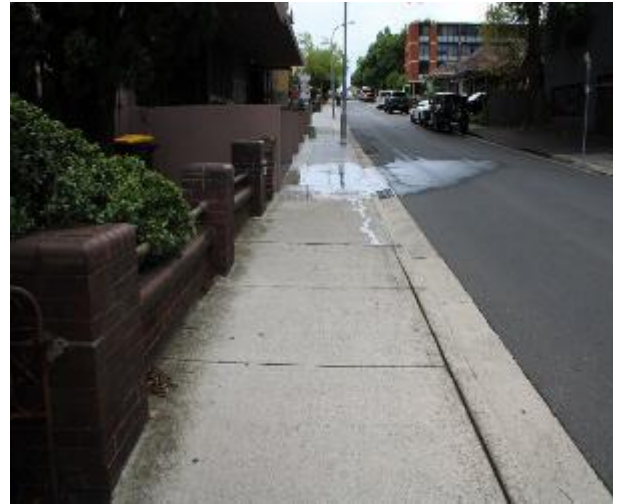
Figure 2 - General condition of footpath pavement heading East

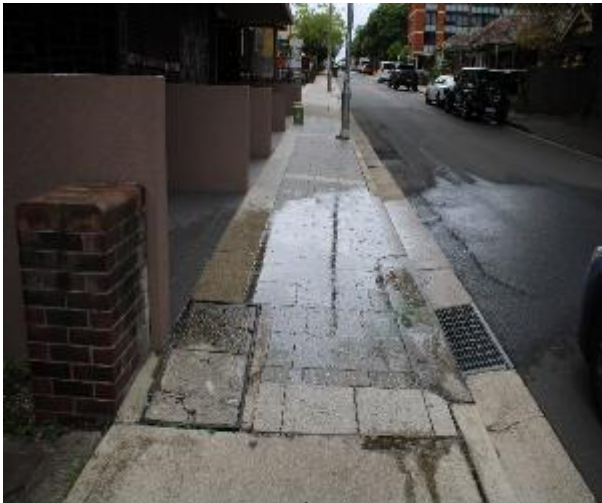
Figure 3 - General condition of footpath pavers heading East

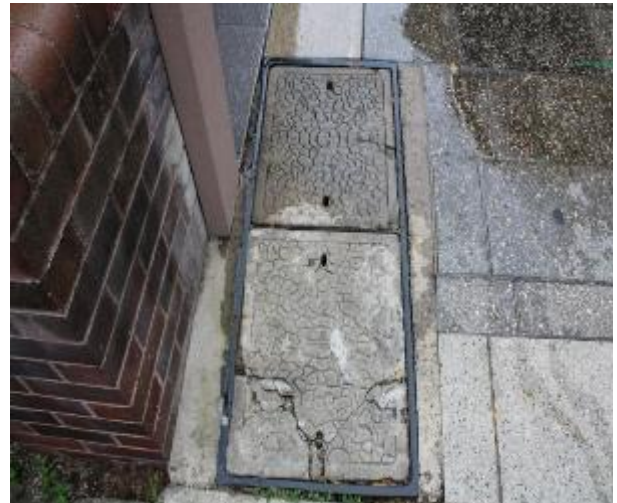
Figure 4 - General condition of service pit

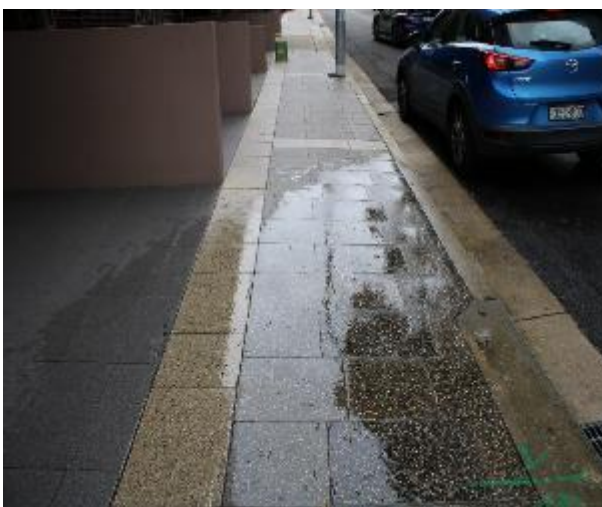
Figure 5 - General condition of footpath pavers heading East

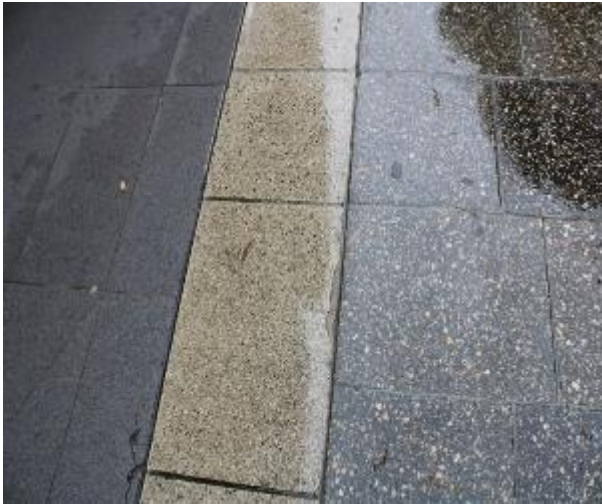
Figure 7 - General condition of footpath pavers heading East

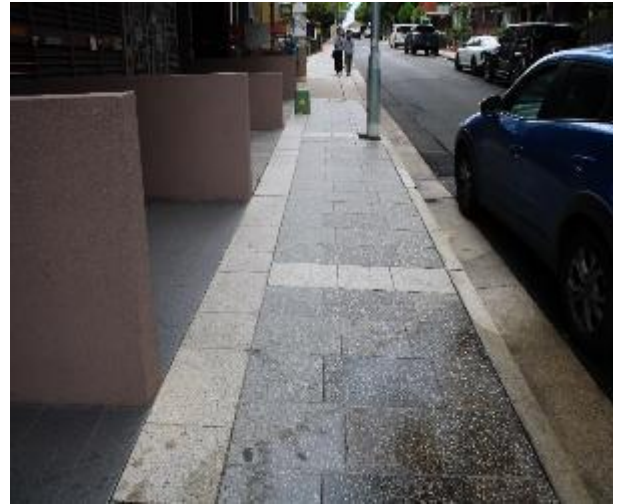
Figure 8 - General condition of footpath pavers heading East

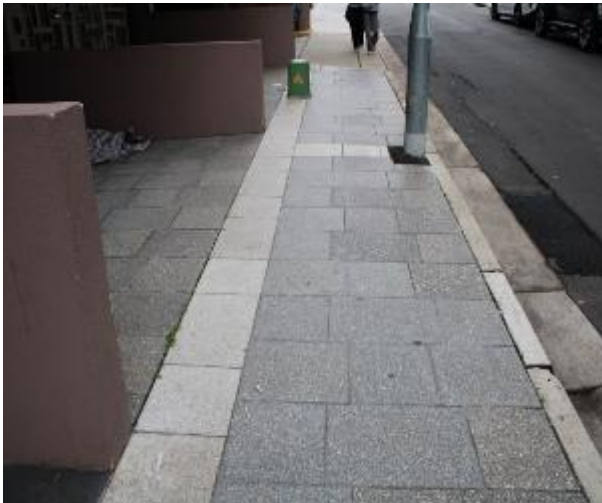
Figure 9 - General condition of footpath pavers heading East

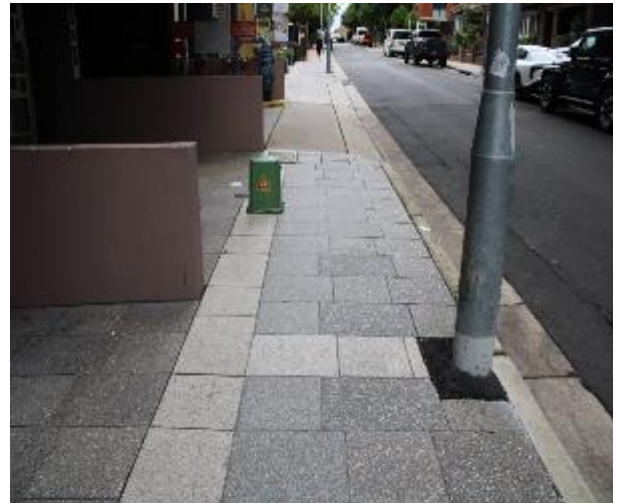
Figure 10 - General condition of footpath pavers heading East

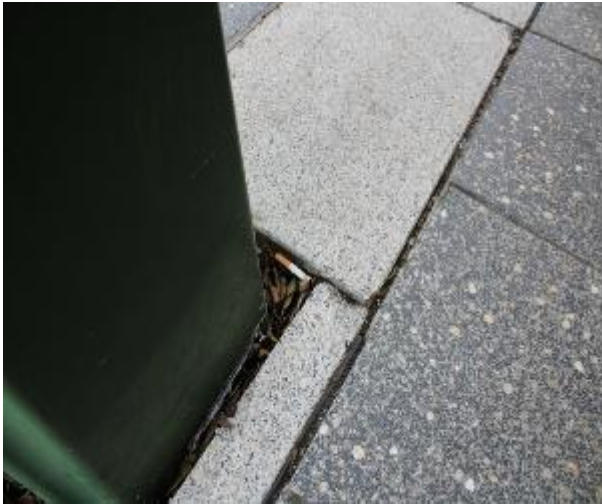
Figure 13 - General condition of footpath pavers heading East

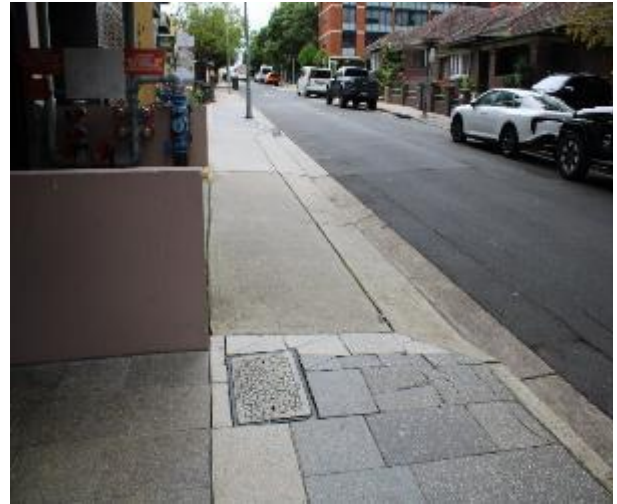
Figure 14 - General condition of footpath pavers heading East

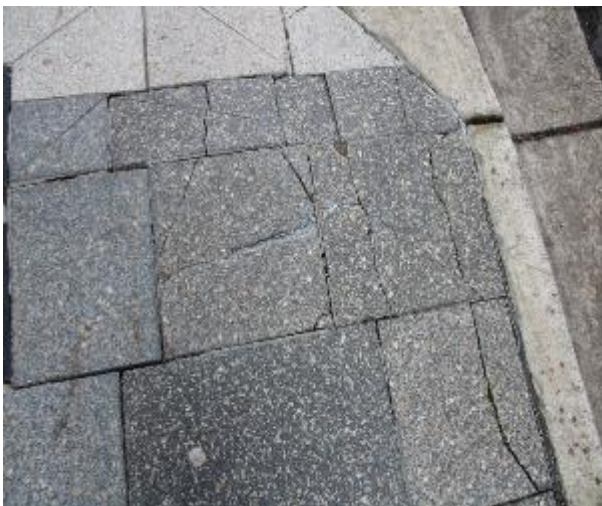
Figure 15 - Crack propagation through footpath pavers heading East

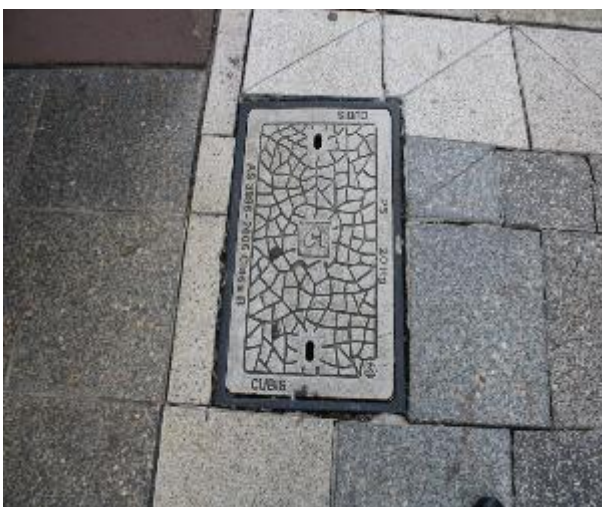
Figure 17 - General condition of service pit

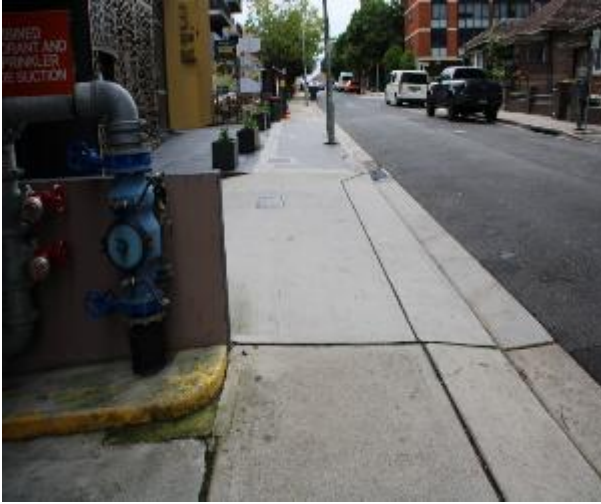
Figure 19 - General condition of driveway pavement heading East

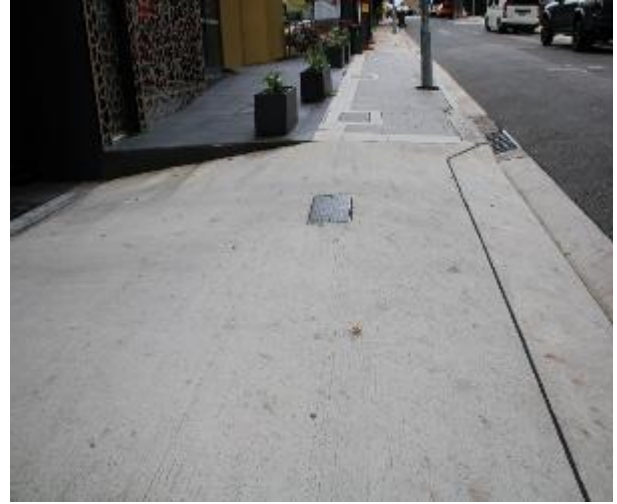
Figure 20 - General condition of driveway pavement heading East

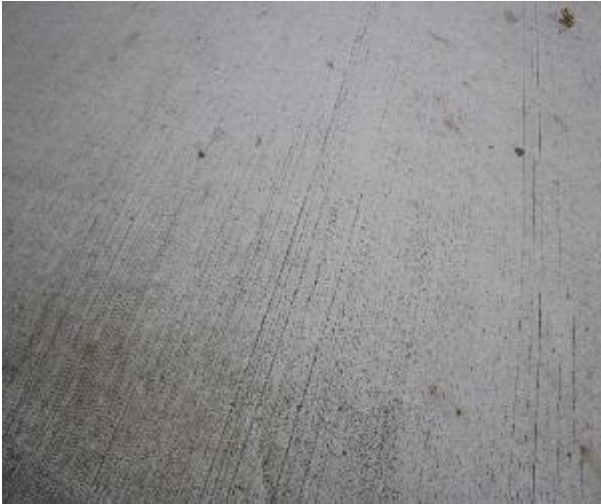
Figure 21 - Crack propagation through driveway pavement heading East

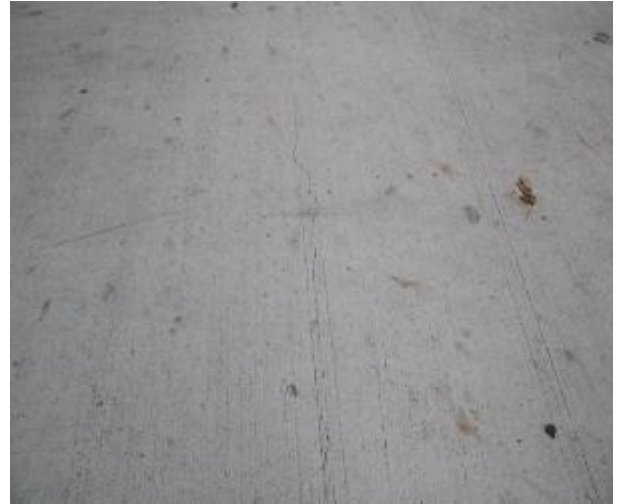
Figure 22 - Crack propagation through driveway pavement heading East

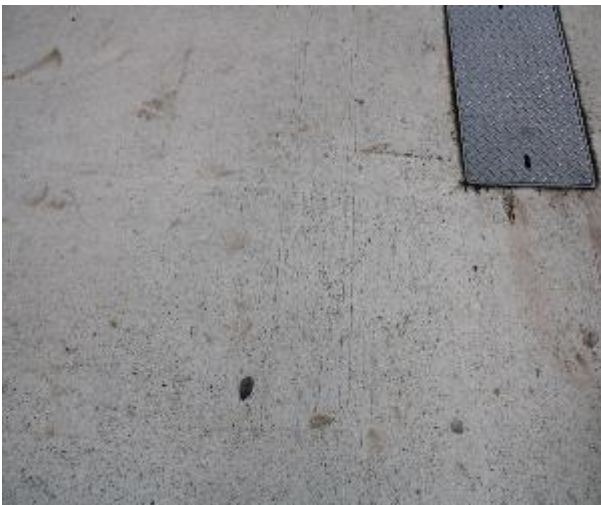
Figure 23 - Crack propagation through driveway pavement heading East

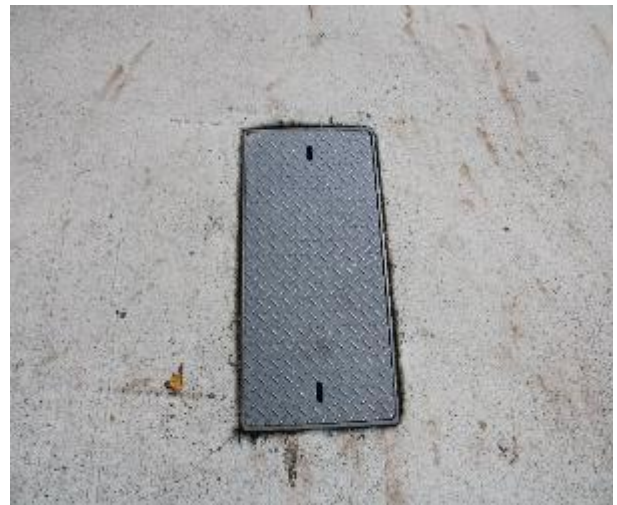
Figure 24 - General condition of service pit

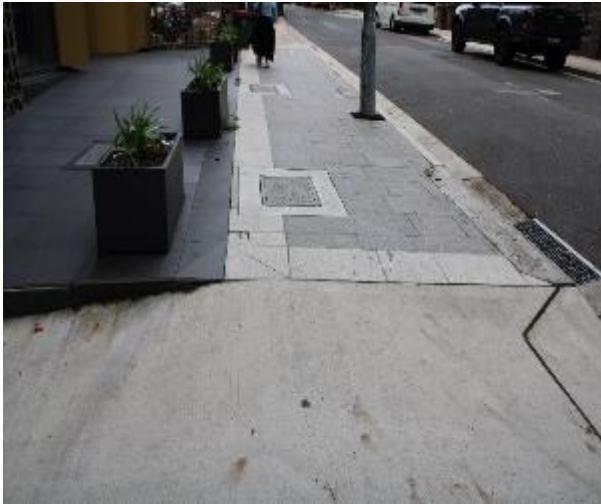
Figure 25 - General condition of footpath pavers heading East

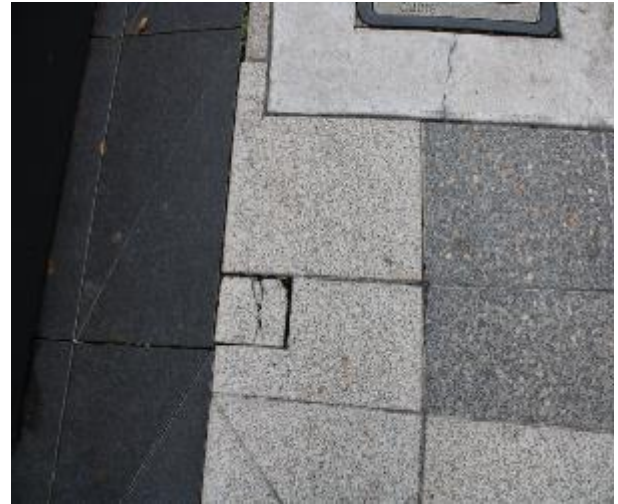
Figure 26 - Crack propagation through footpath pavers heading East

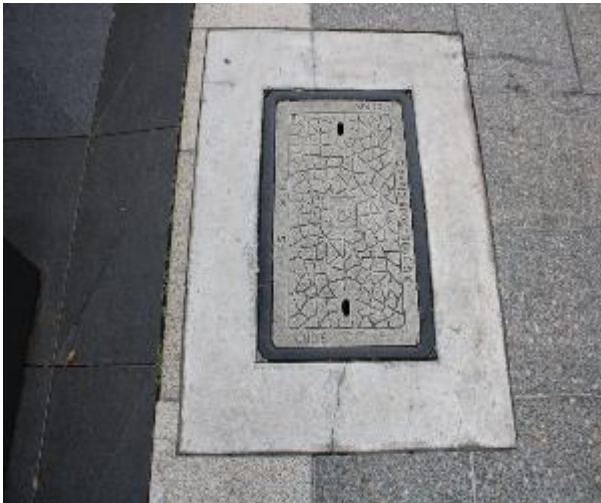
Figure 27 - General condition of service pit

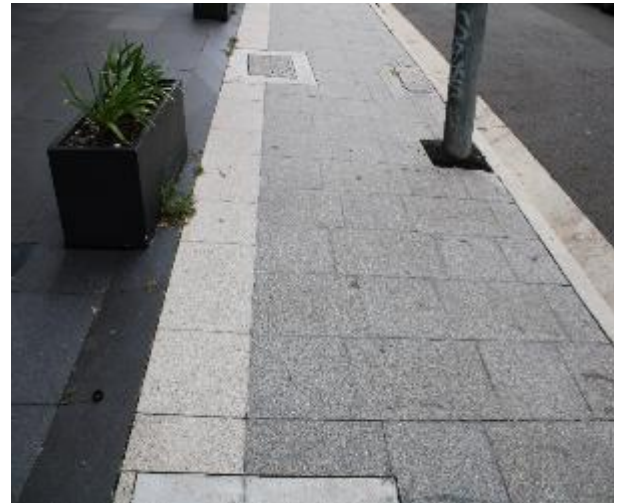
Figure 28 - General condition of footpath pavers heading East

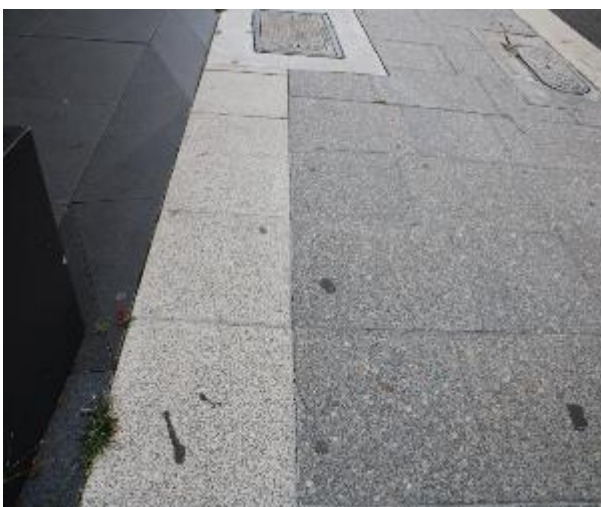
Figure 29 - General condition of footpath pavers heading East

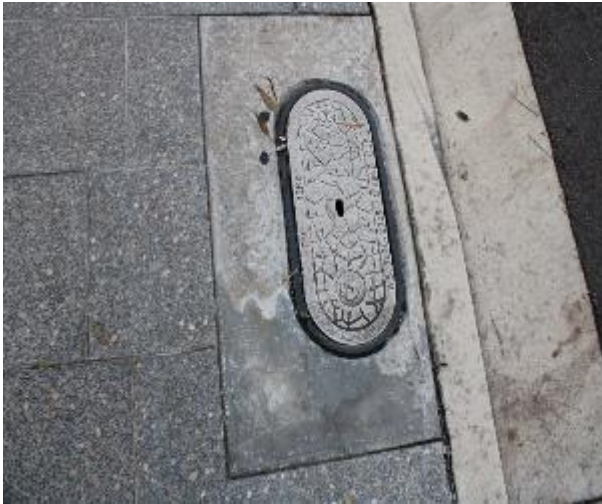
Figure 31 - General condition of service pit

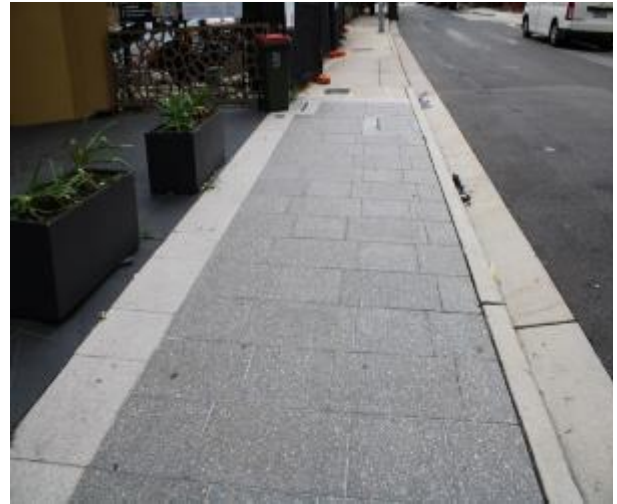
Figure 32 - General condition of footpath pavers heading East

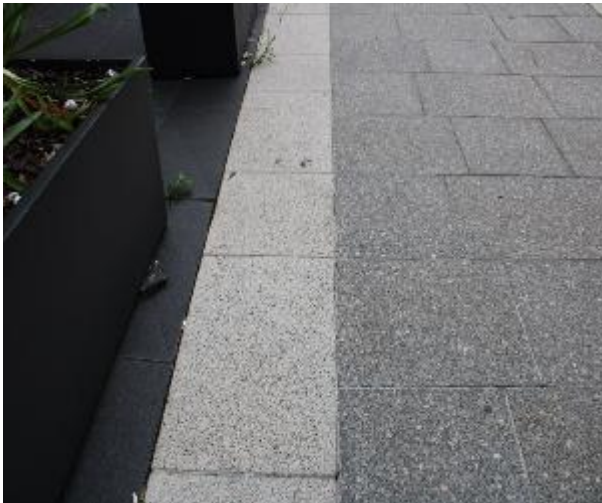
Figure 33 - General condition of footpath pavers heading East

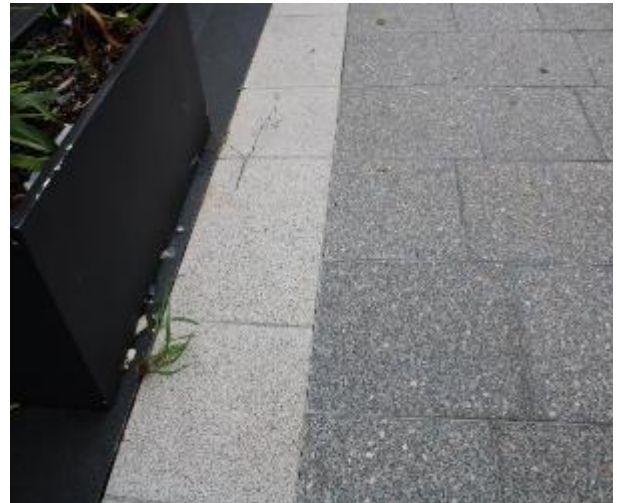
Figure 34 - General condition of footpath pavers heading East

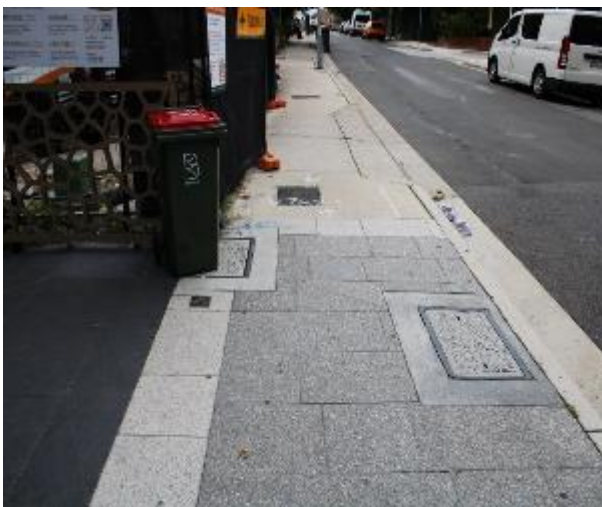
Figure 35 - General condition of footpath pavers heading East

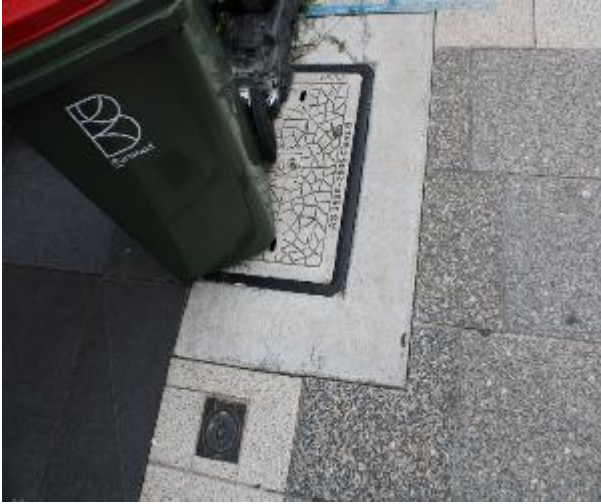
Figure 37 - General condition of service pit

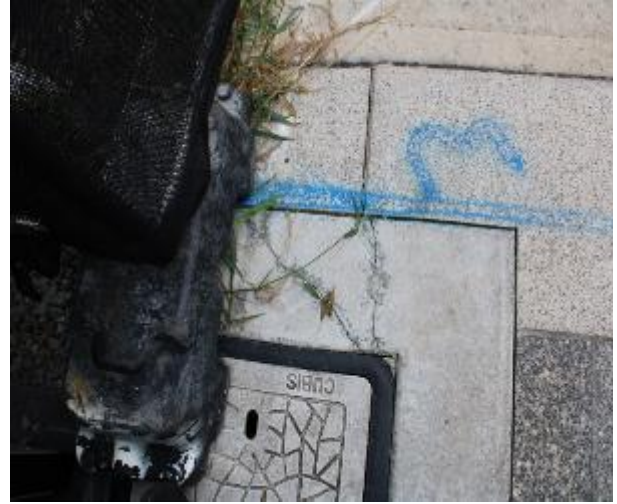
Figure 38 - Crack propagation through footpath pavers heading East

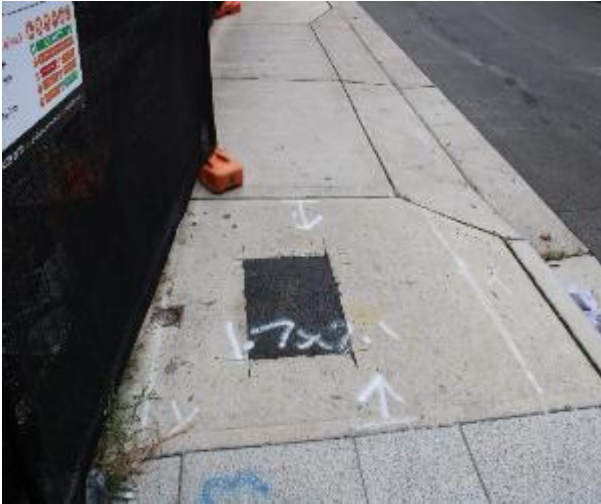
Figure 39 - General condition of footpath pavers heading East

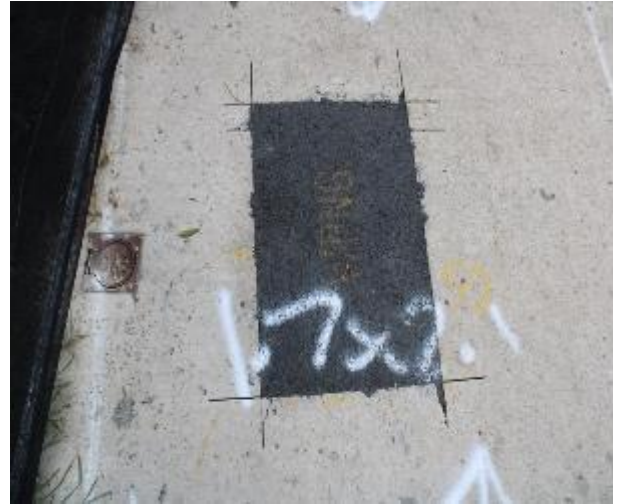
Figure 40 - Patchwork evident through footpath pavement heading East

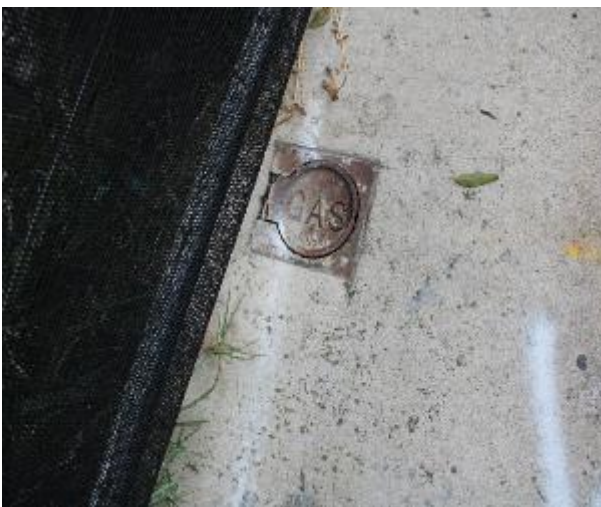
Figure 41 - General condition of service pit

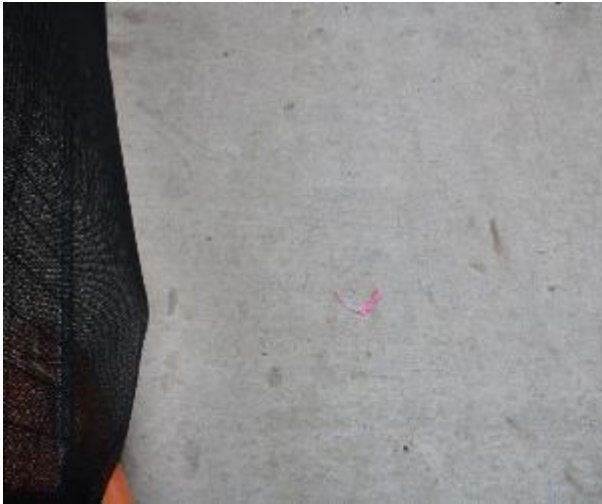
Figure 43 - Crack propagation through driveway pavement heading East

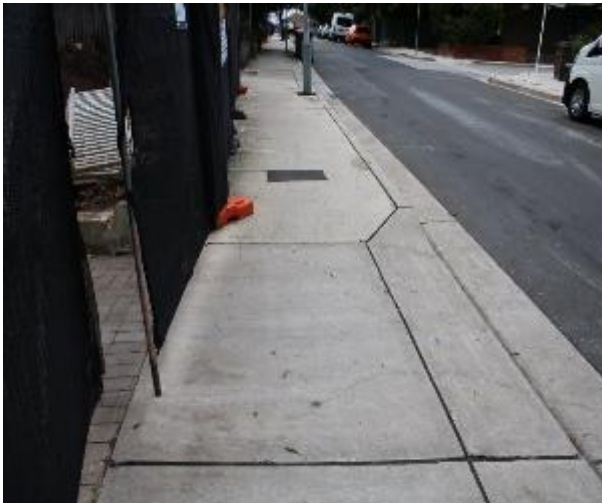
Figure 44 - Crack propagation through driveway pavement heading East

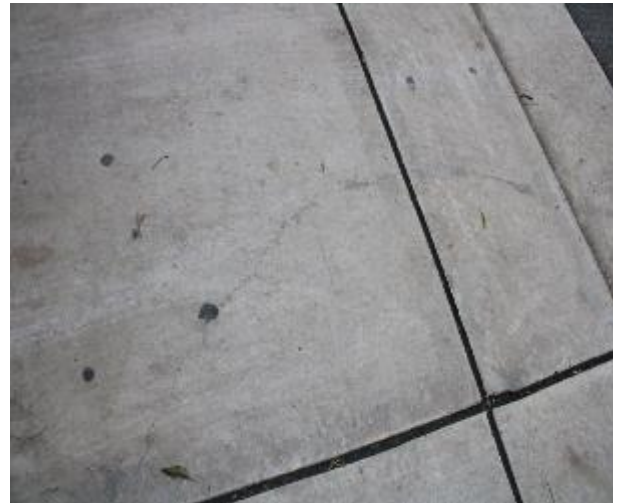
Figure 45 - General condition of driveway pavement heading East

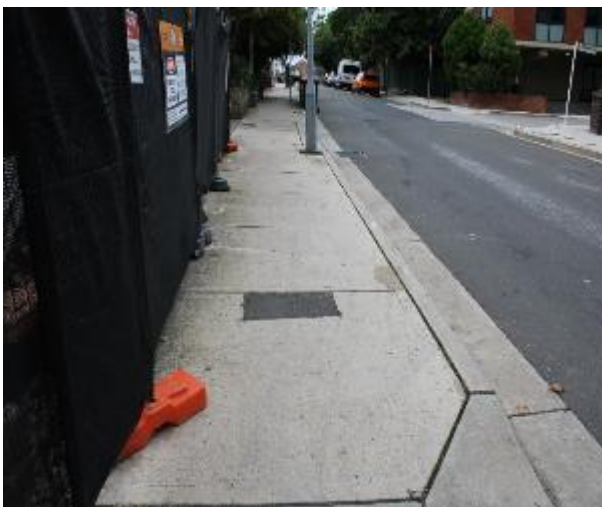
Figure 46 - Crack propagation through driveway pavement heading East

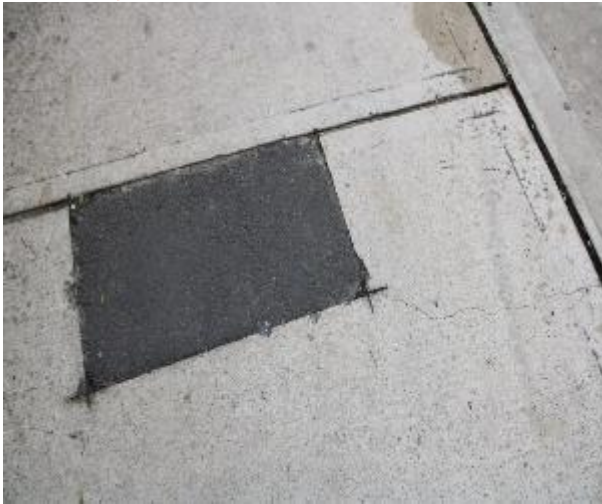
Figure 48 - Crack propagation through footpath pavement heading East

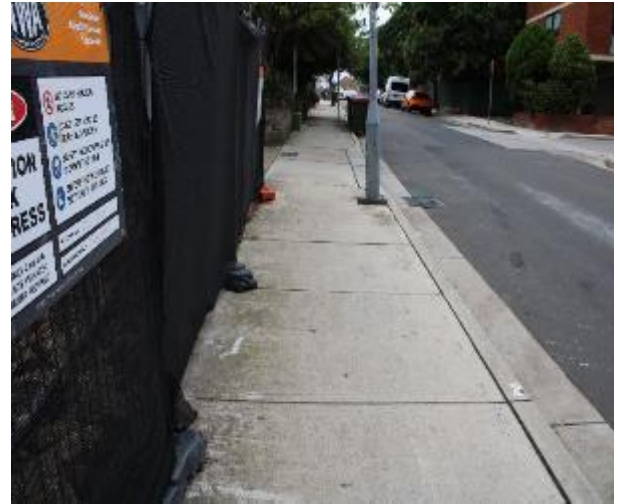
Figure 49 - Crack propagation and patchwork evident through footpath pavement heading East

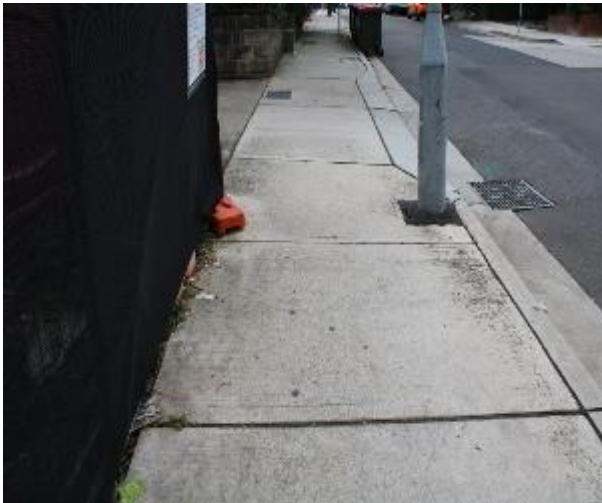
Figure 50 - General condition of footpath pavement heading East

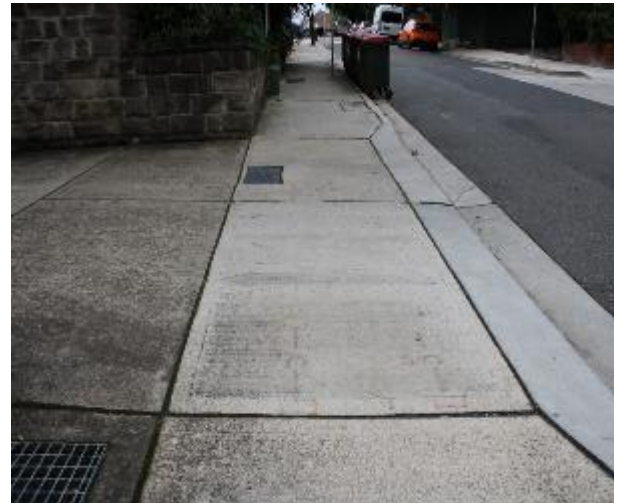
Figure 51 - General condition of footpath pavement heading East

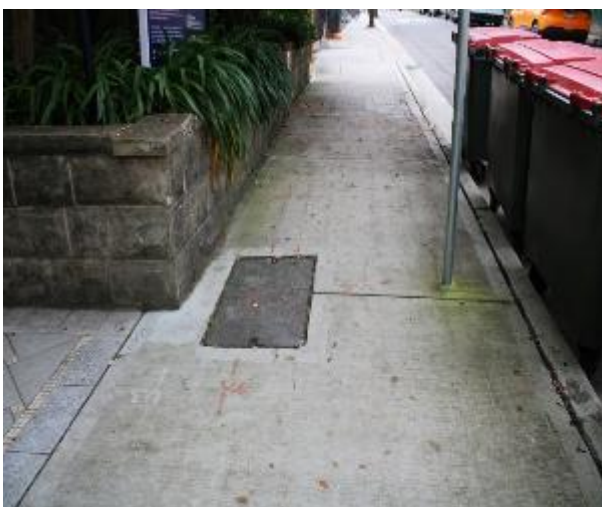
Figure 58 - General condition of footpath pavement heading East

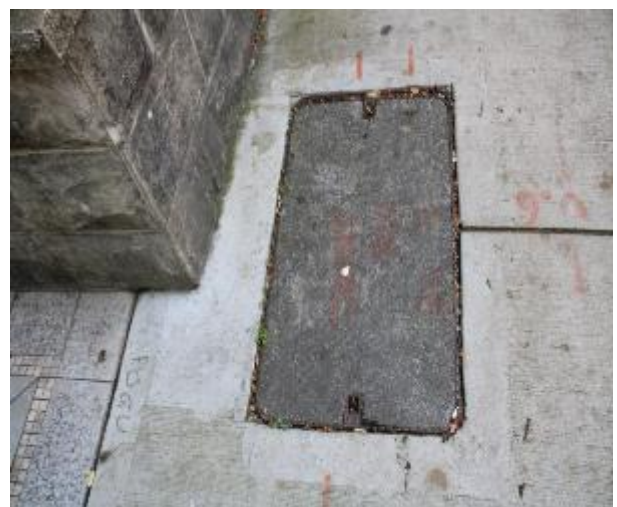
Figure 59 - General condition of footpath pavement heading East

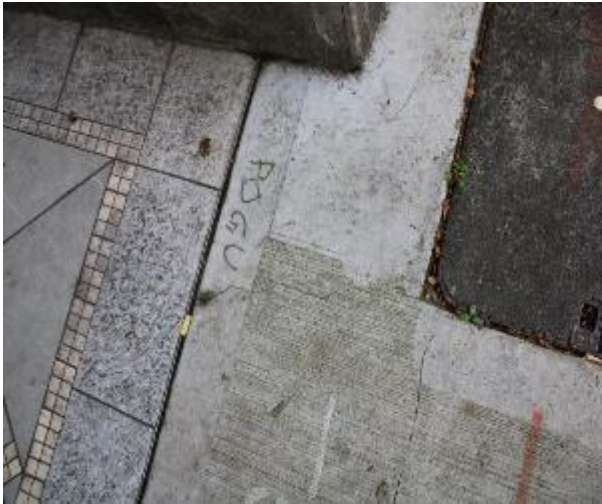
Figure 60 - General condition of service pit

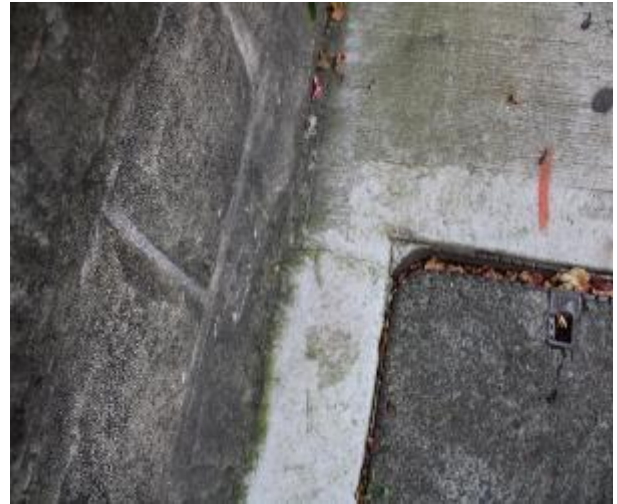
Figure 61 - Crack propagation through footpath pavement heading East

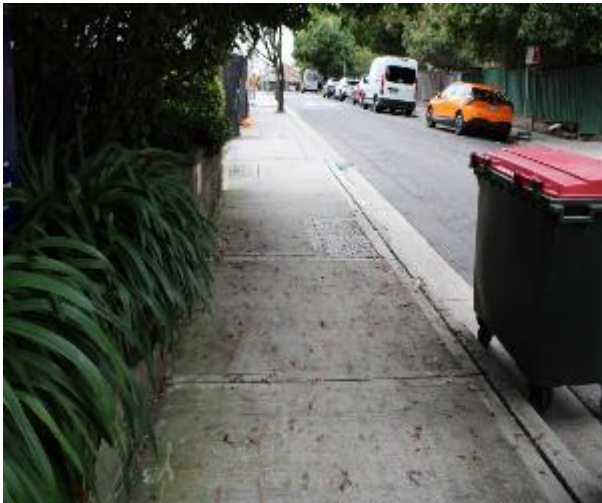
Figure 62 - Crack propagation through footpath pavement heading East

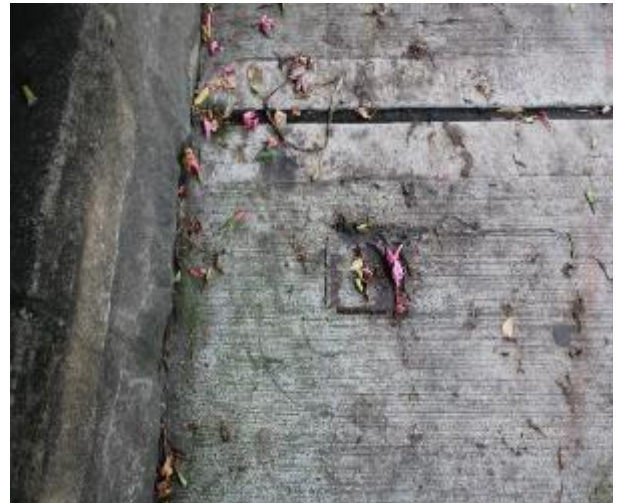
Figure 63 - General condition of footpath pavement heading East

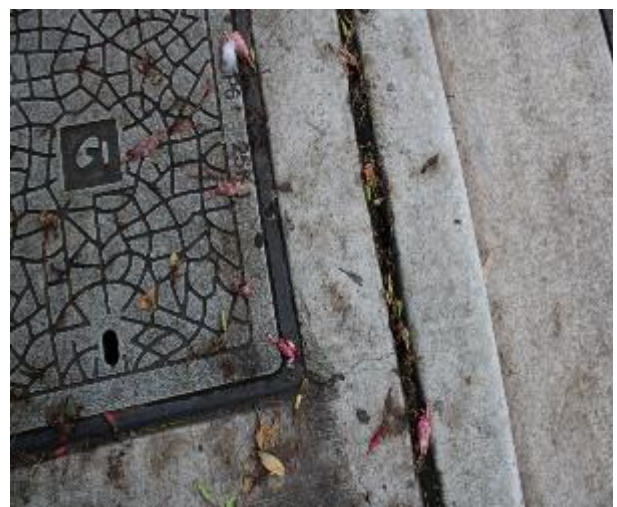
Figure 65 - General condition of service pit

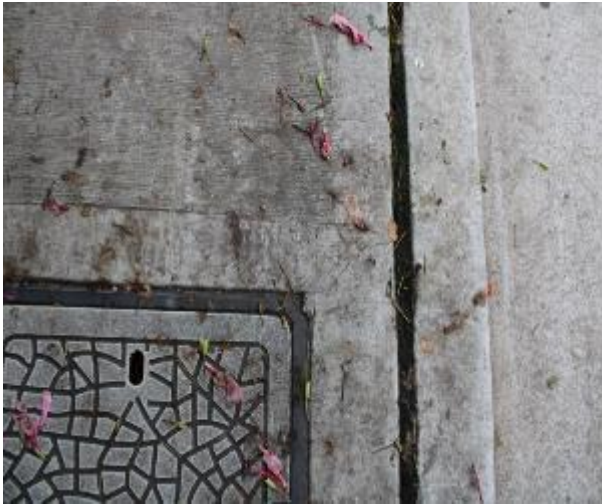
Figure 66 - Crack propagation through footpath pavement heading East

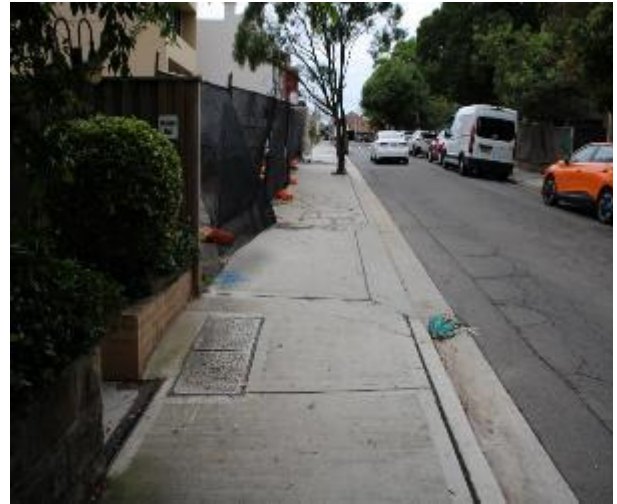
Figure 67 - Crack propagation through footpath pavement heading East

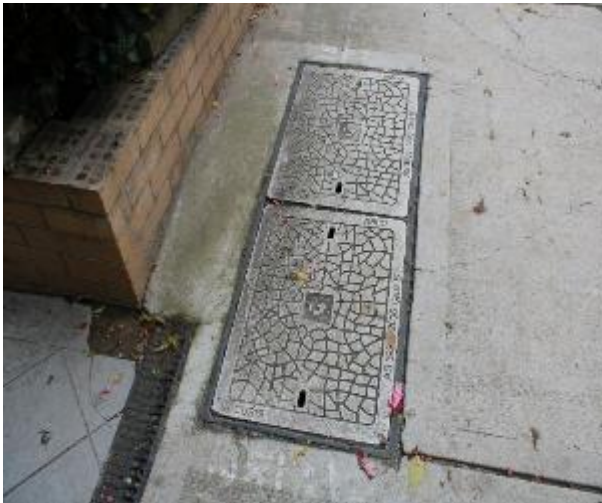
Figure 68 - General condition of footpath pavement heading East

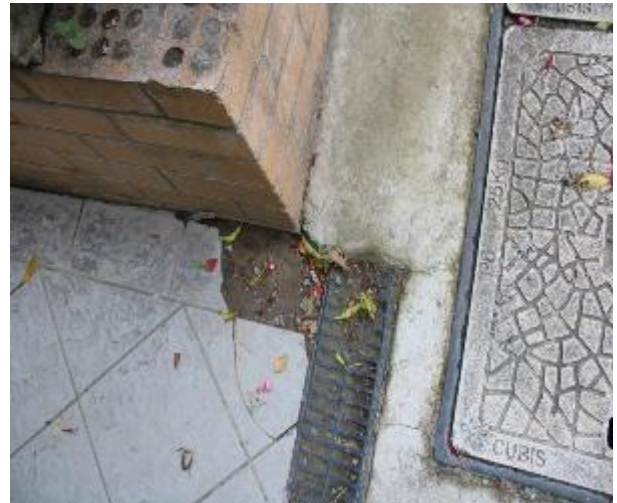
Figure 69 - General condition of service pit

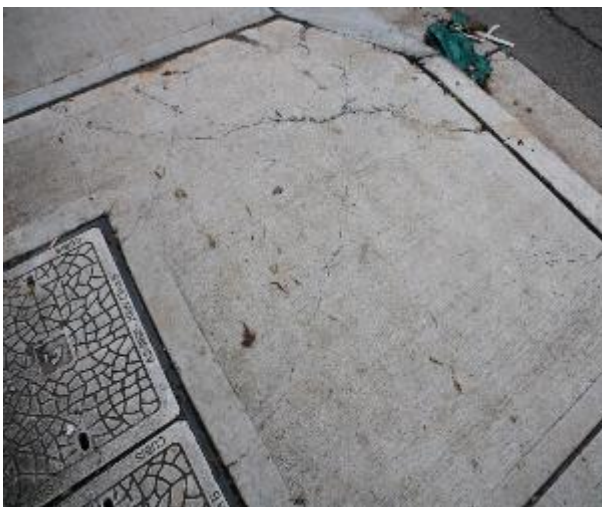
Figure 70 - Crack propagation through footpath pavement heading East

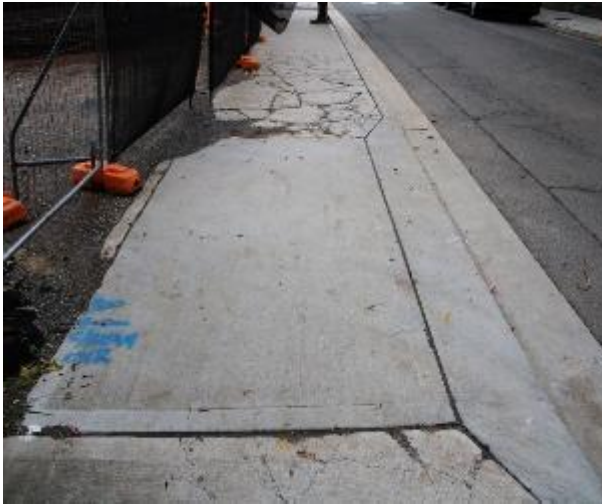
Figure 72 - Crack propagation through footpath pavement heading East

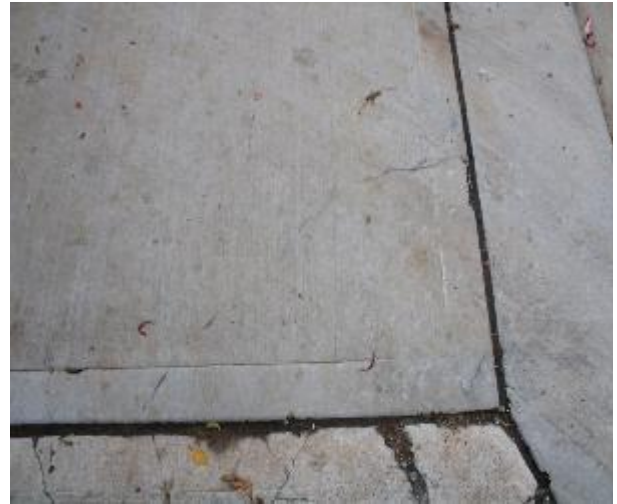
Figure 73 - General condition of footpath pavement heading East

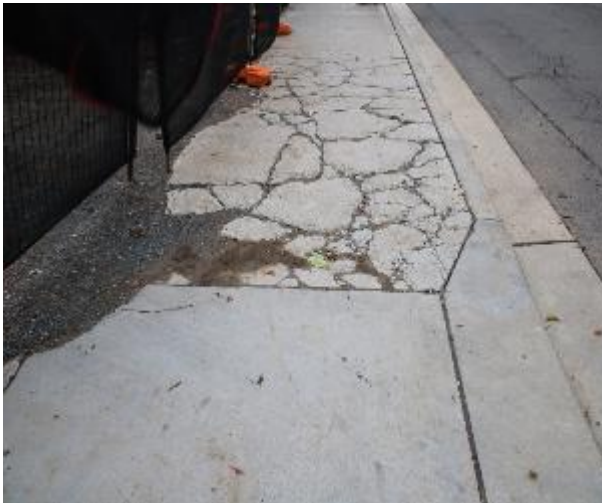
Figure 74 - Crack propagation through footpath pavement heading East

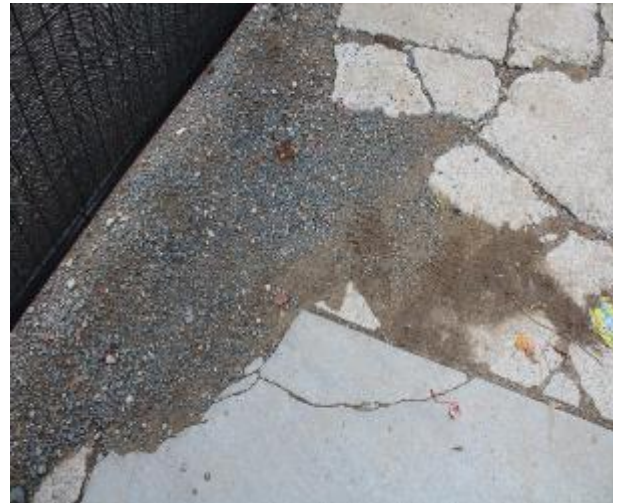
Figure 75 - General condition of footpath pavement heading East

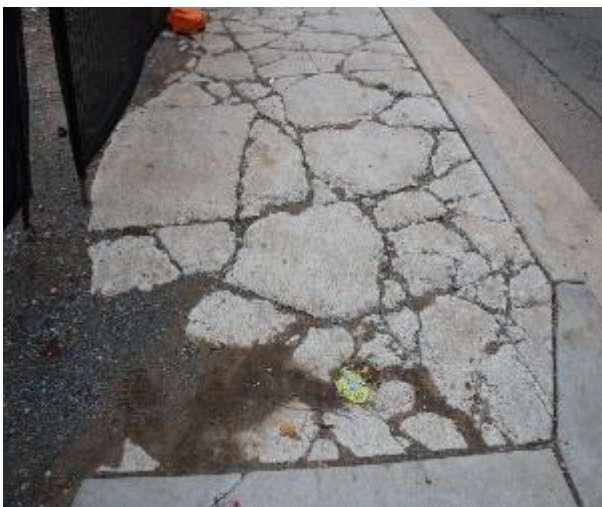
Figure 76 - Crack propagation and loss of materials through footpath pavement heading East

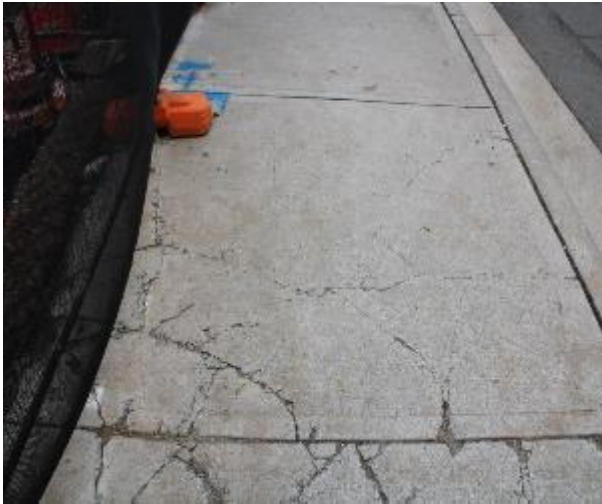
Figure 78 - Crack propagation through footpath pavement heading East

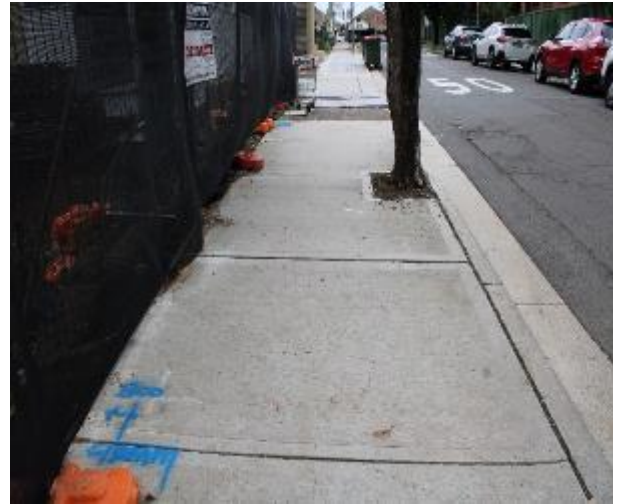
Figure 79 - Crack propagation through footpath pavement heading East

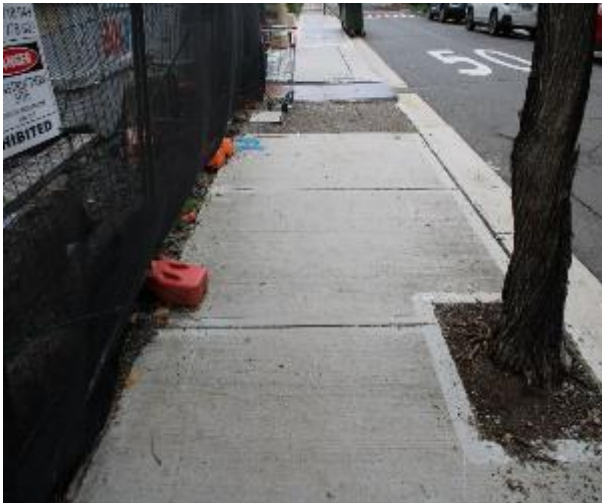
Figure 80 - General condition of footpath pavement heading East

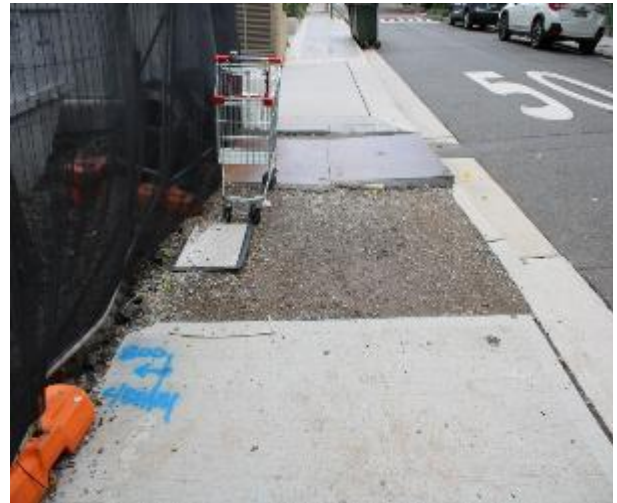
Figure 81 - General condition of footpath pavement heading East

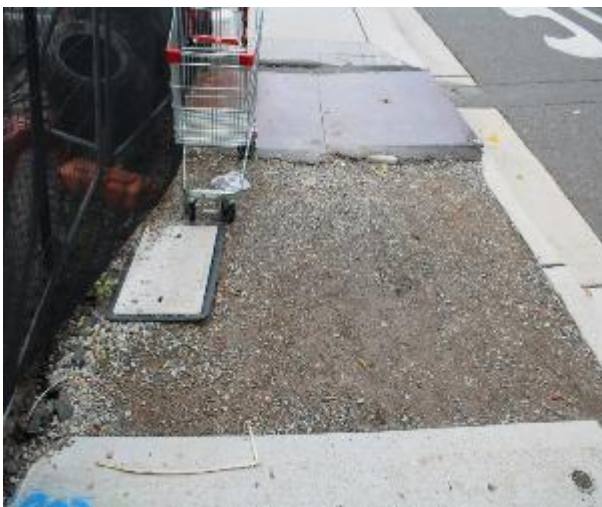
Figure 82 - General condition of footpath pavement heading East

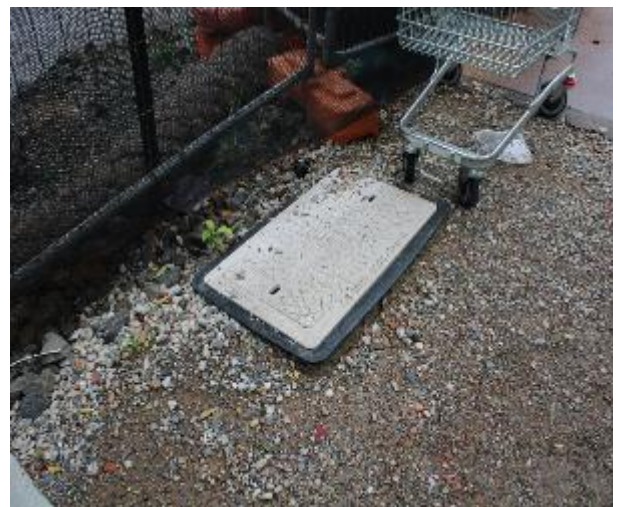
Figure 83 - General condition of footpath pavement heading East

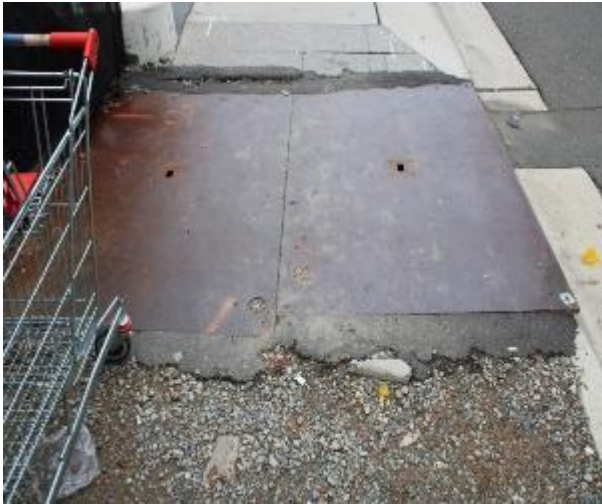
Figure 84 - General condition of service pit

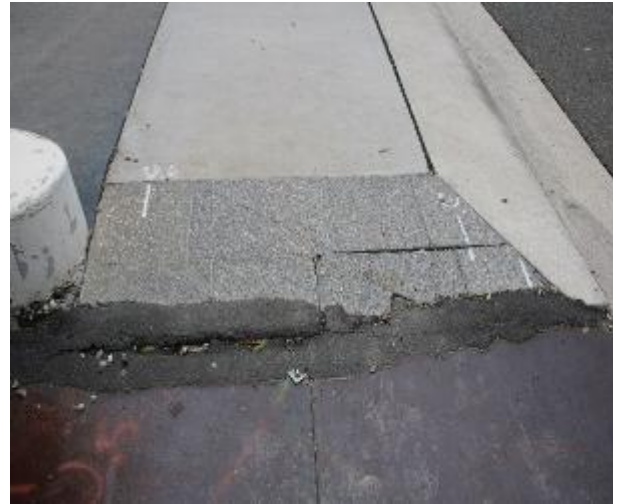
Figure 85 - General condition of service pit

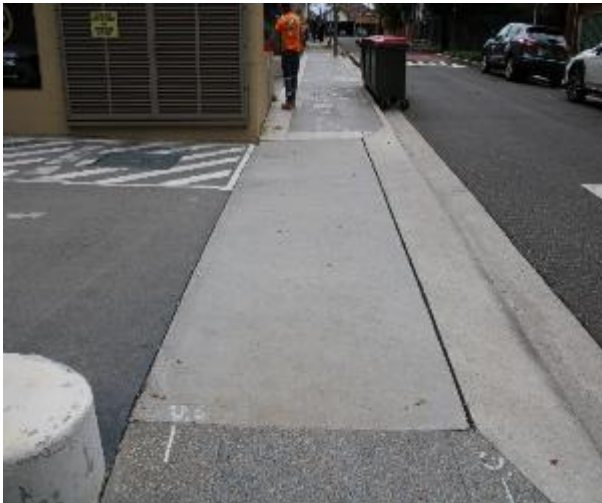
Figure 86 - Crack propagation through footpath pavement heading East

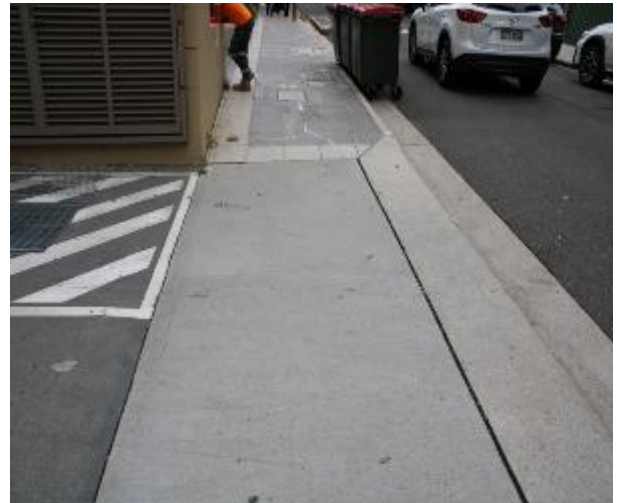
Figure 87 - General condition of footpath pavement heading East

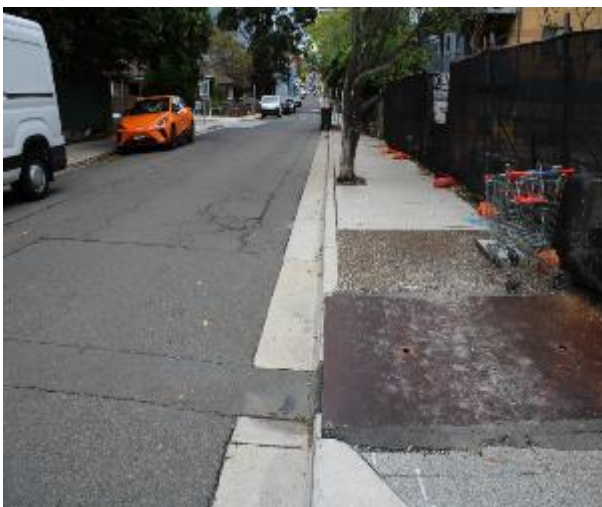
Figure 88 - General condition of footpath pavement heading East

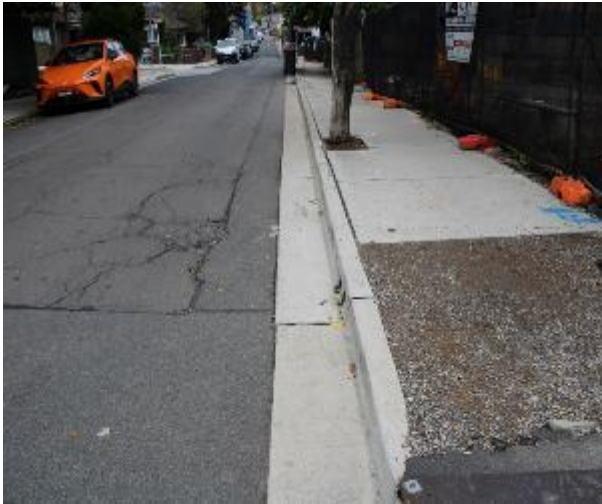
Figure 90 - Crack propagation through kerb and gutter heading West
