# **PRE-DILAPIDATION REPORT**

**COUNCIL ASSETS**

**21 GEORGE STREET,  
BURWOOD, NSW 2134**

PROJECT REFERENCE: 20250047.CA.1  
17/04/2026

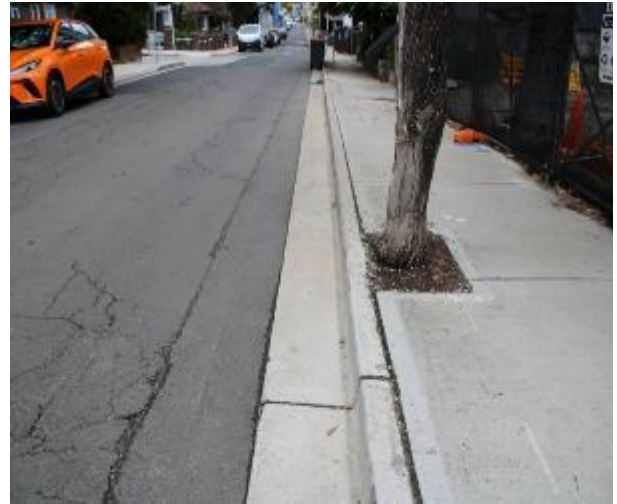
Figure 91 - General condition of kerb and gutter heading West

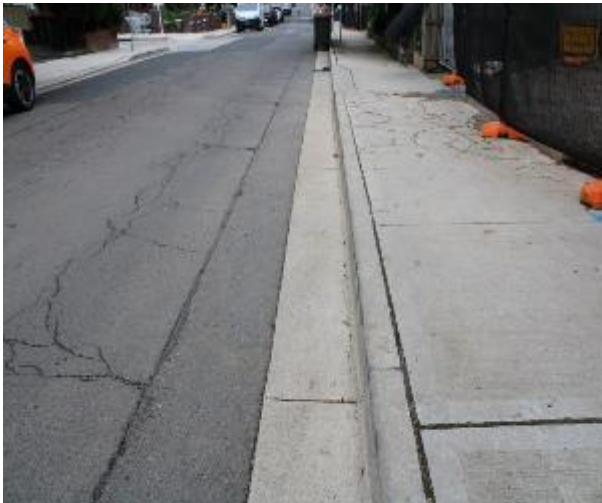
Figure 92 - General condition of kerb and gutter heading West

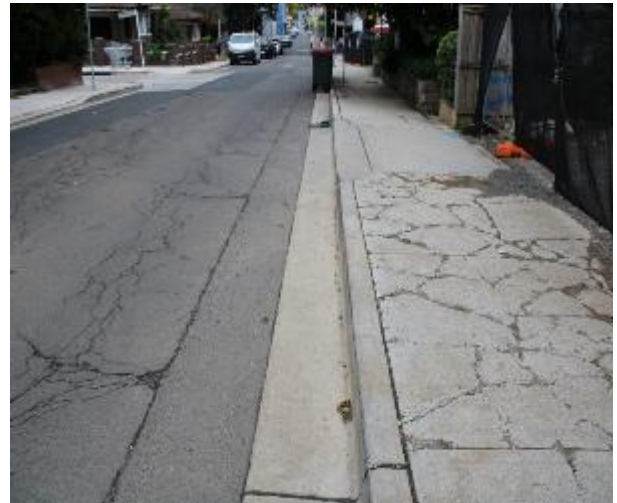
Figure 93 - General condition of kerb and gutter heading West

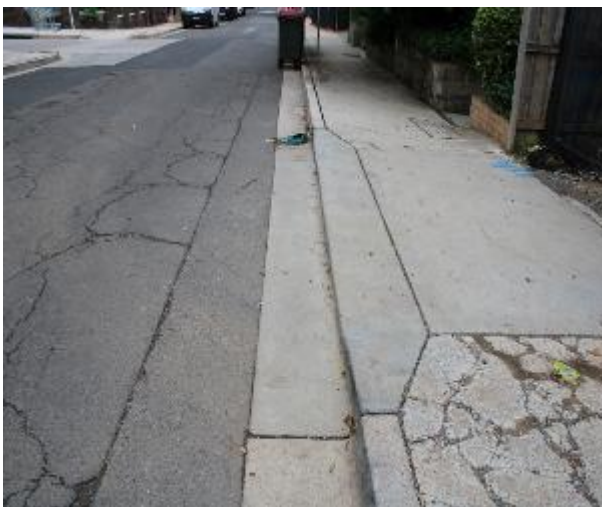
Figure 94 - General condition of kerb and gutter heading West

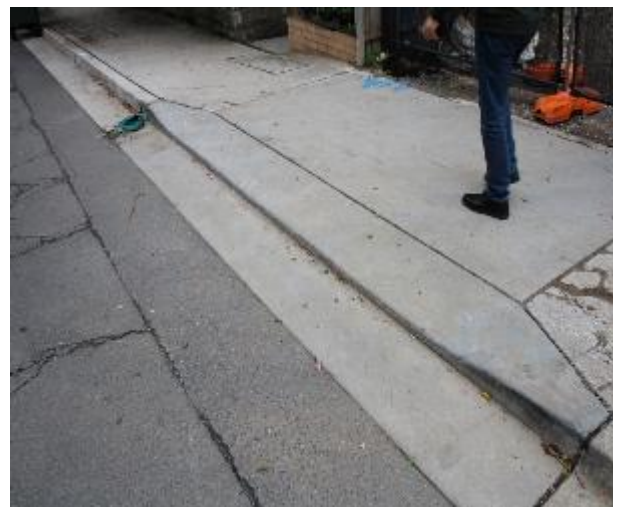
Figure 95 - General condition of driveway layback and gutter heading West

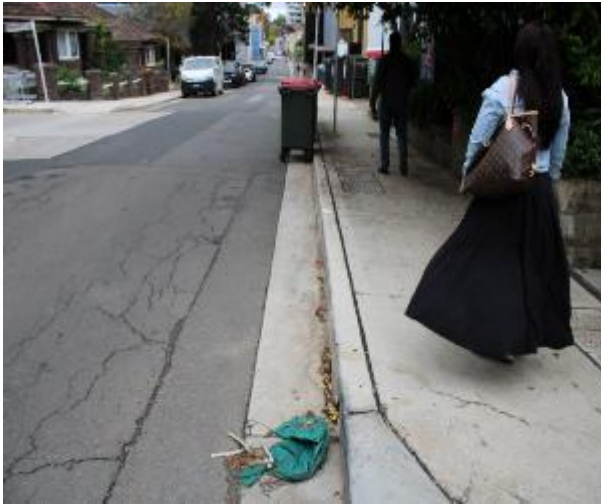
Figure 96 - General condition of driveway layback and gutter heading West

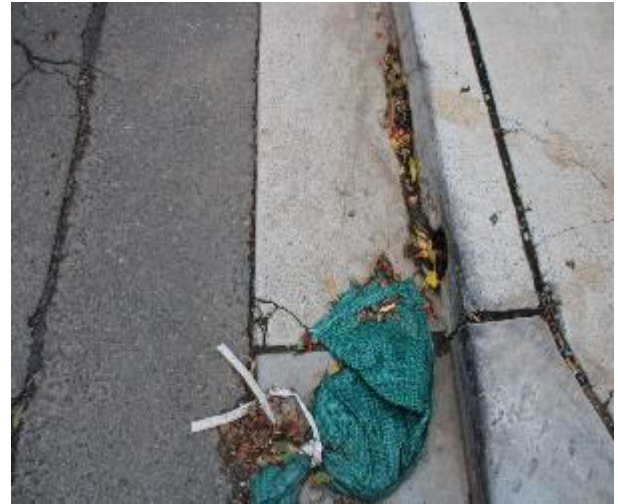
Figure 97 - General condition of kerb and gutter heading West

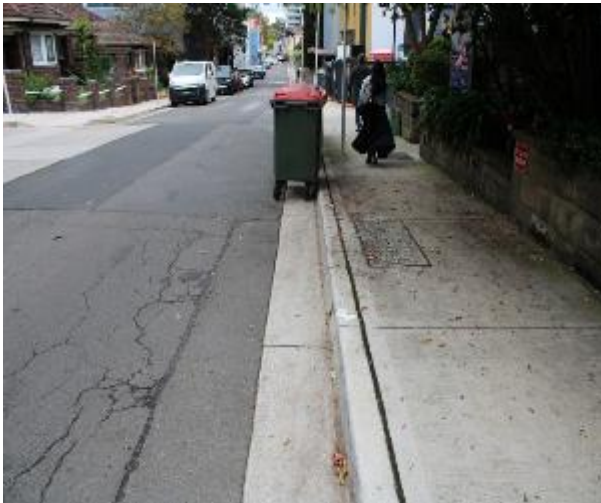
Figure 98 - Crack propagation through kerb and gutter heading West

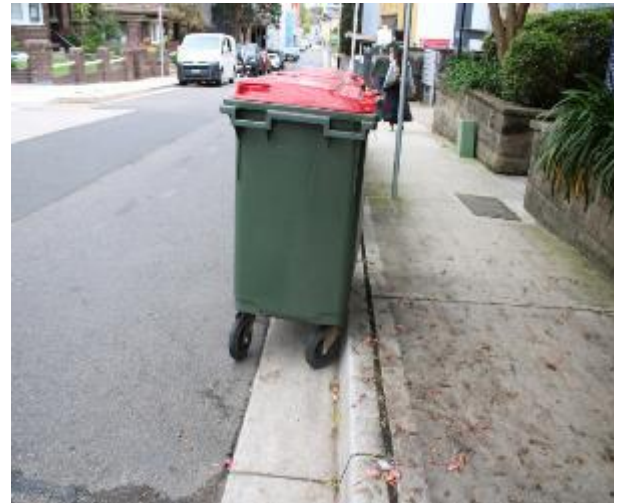
Figure 99 - General condition of kerb and gutter heading West

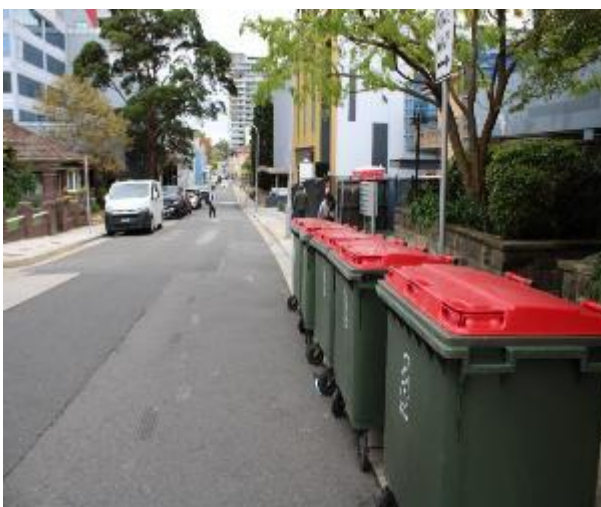
Figure 100 - General condition of kerb and gutter heading West

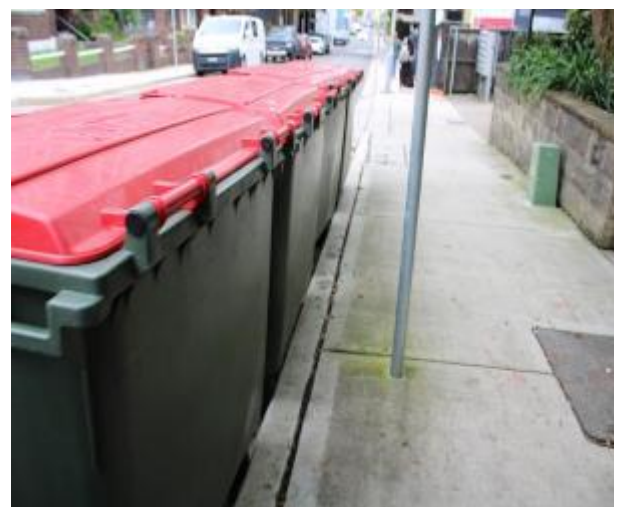
Figure 101 - General condition of kerb and gutter heading West

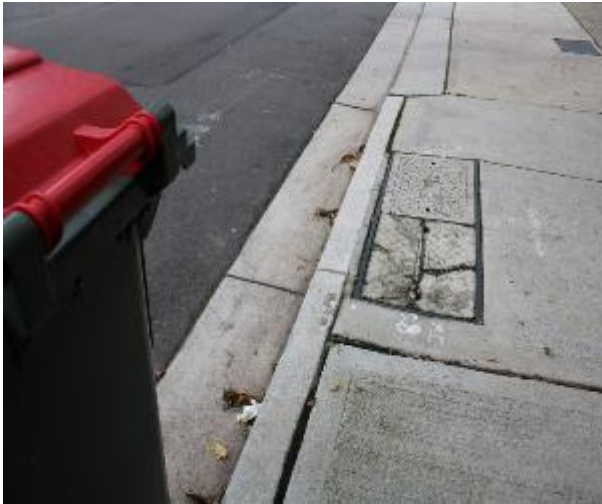
Figure 102 - General condition of kerb and gutter heading West

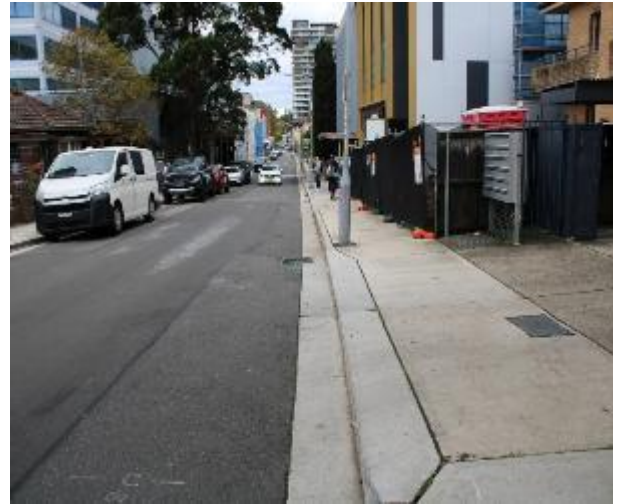
Figure 103 - General condition of kerb and gutter heading West

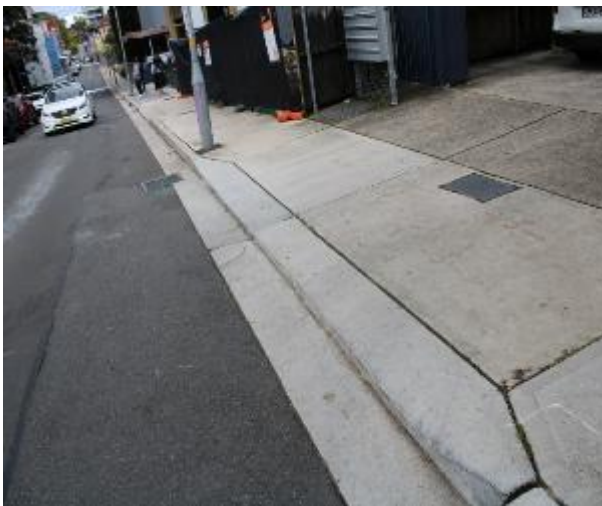
Figure 104 - General condition of kerb and gutter heading West

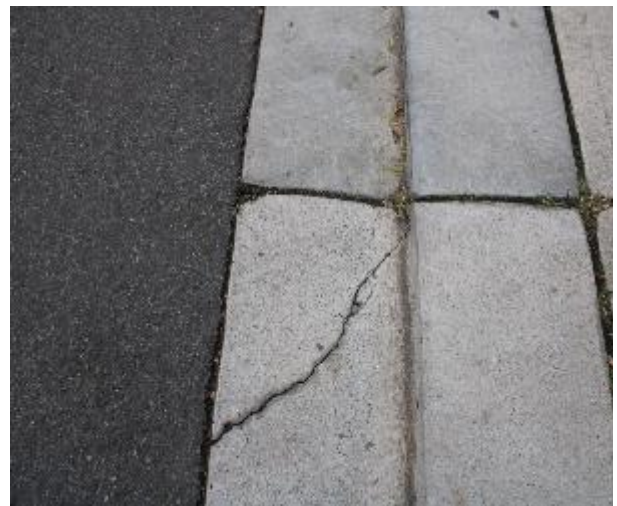
Figure 105 - General condition of driveway layback and gutter heading West

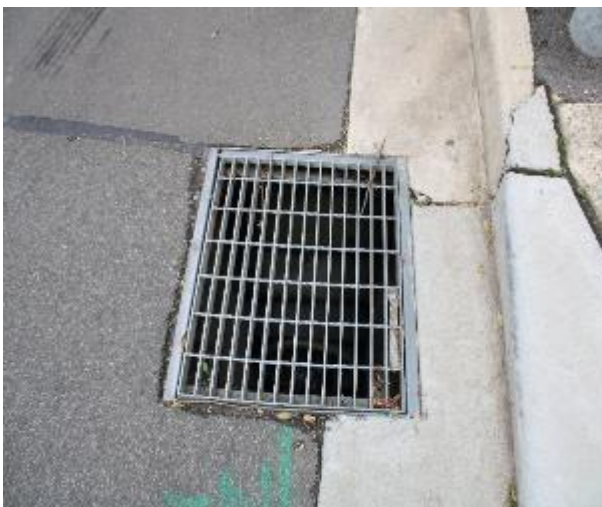
Figure 106 - Crack propagation through kerb and gutter heading West

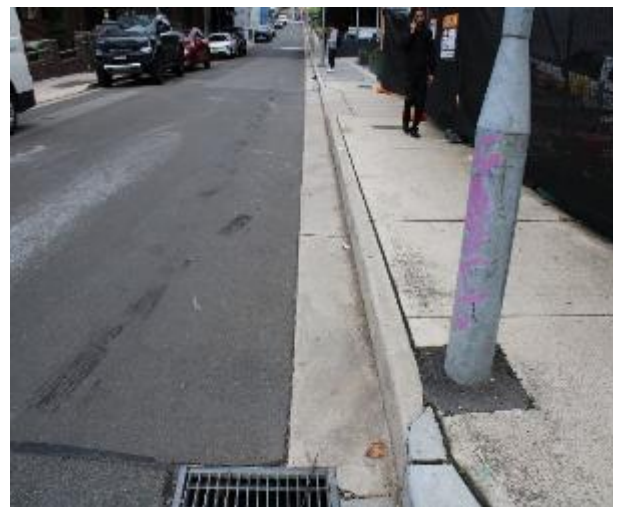
Figure 107 - General condition of stormwater inlet pit

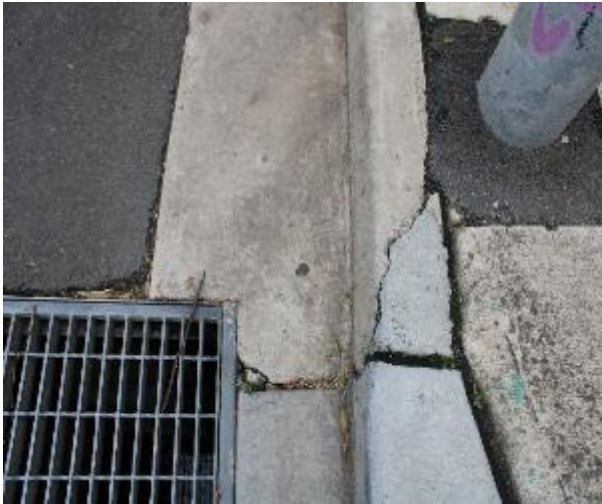
Figure 108 - General condition of kerb and gutter heading West

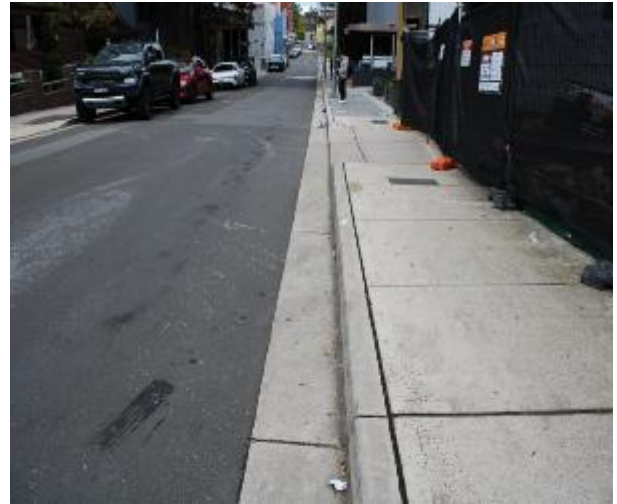
Figure 109 - Crack propagation through kerb and gutter heading West

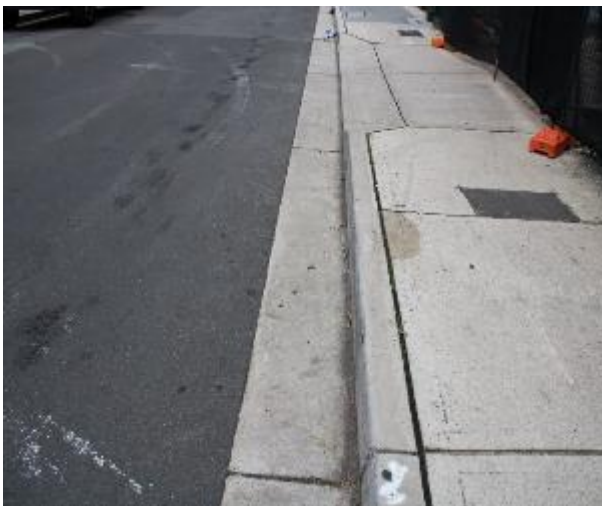
Figure 110 - General condition of kerb and gutter heading West

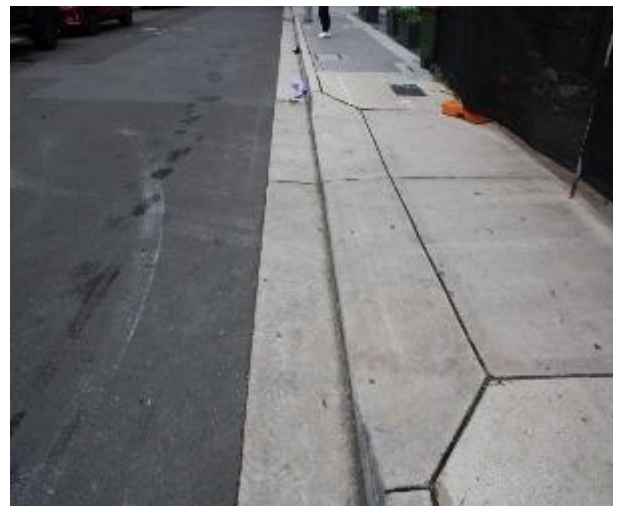
Figure 111 - General condition of kerb and gutter heading West

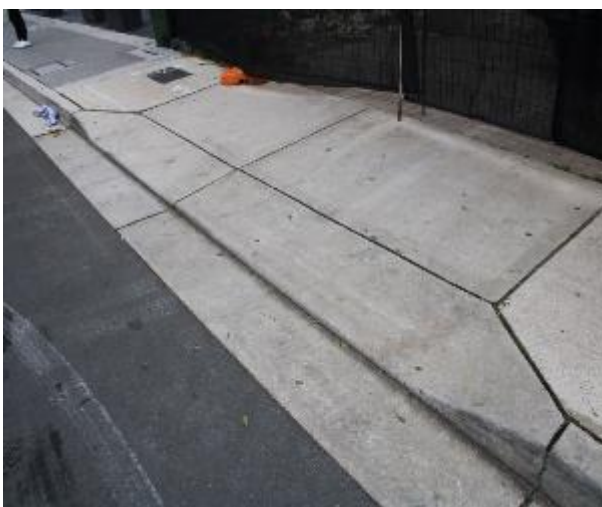
Figure 112 - General condition of driveway layback and gutter heading West

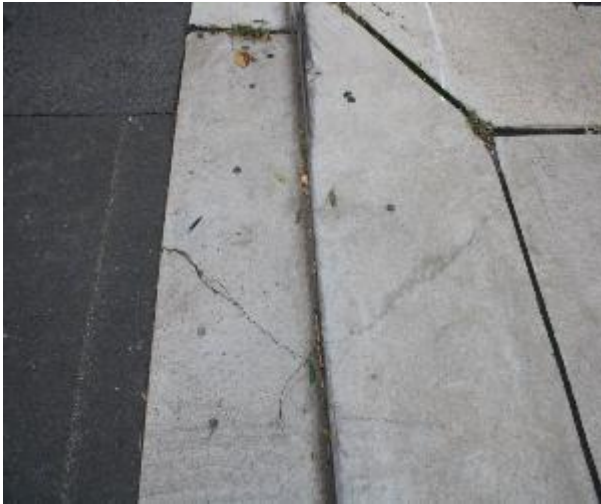
Figure 114 - Crack propagation through driveway layback driveway layback and gutter heading West

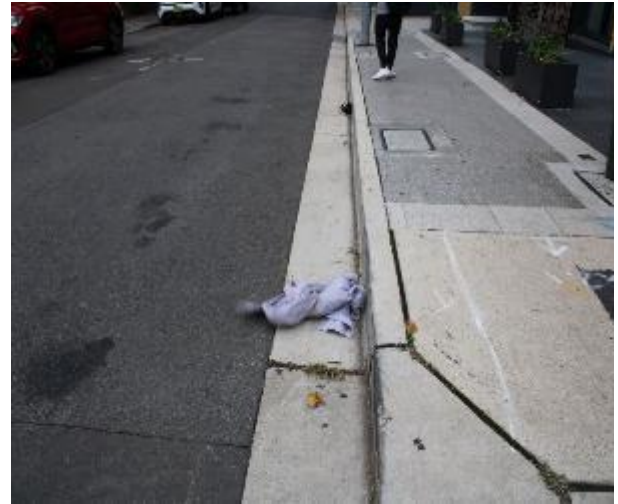
Figure 115 - Crack propagation through driveway layback and gutter heading West

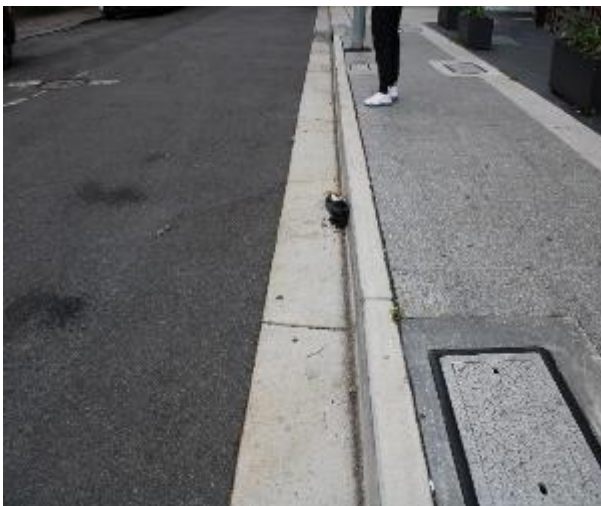
Figure 116 - General condition of kerb and gutter heading West

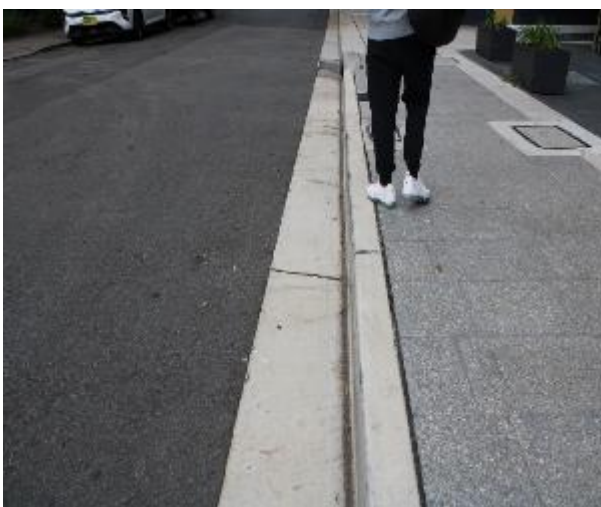
Figure 118 - General condition of kerb and gutter heading West

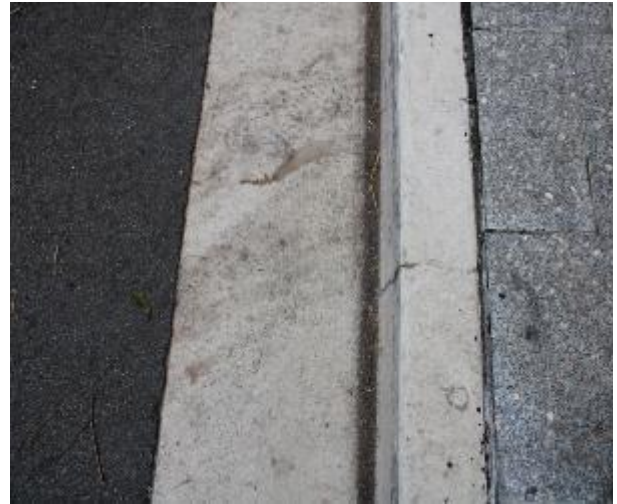
Figure 121 - General condition of kerb and gutter heading West

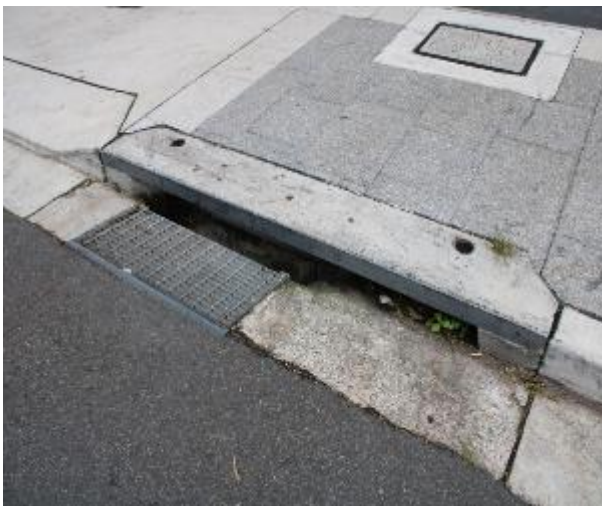
Figure 122 - Crack propagation through kerb and gutter heading West

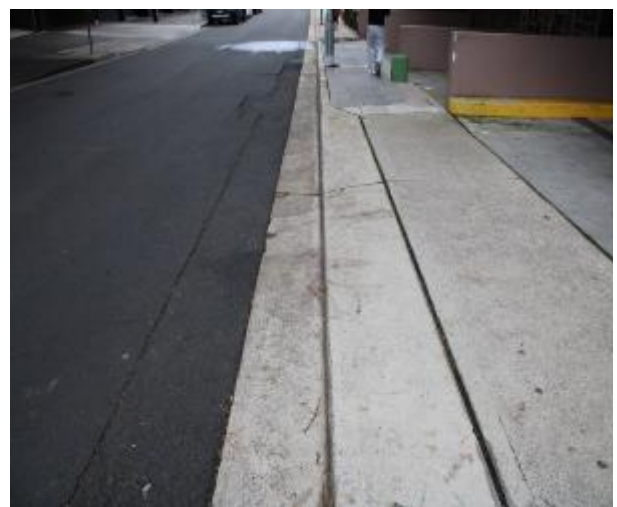
Figure 125 - General condition of driveway layback and gutter heading West

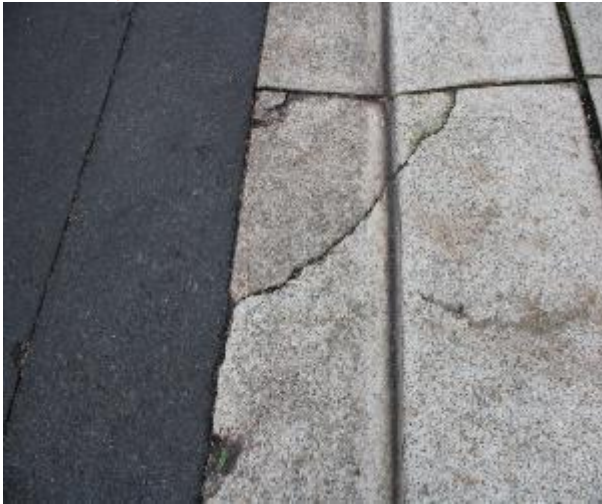
Figure 126 - General condition of driveway layback and gutter heading West

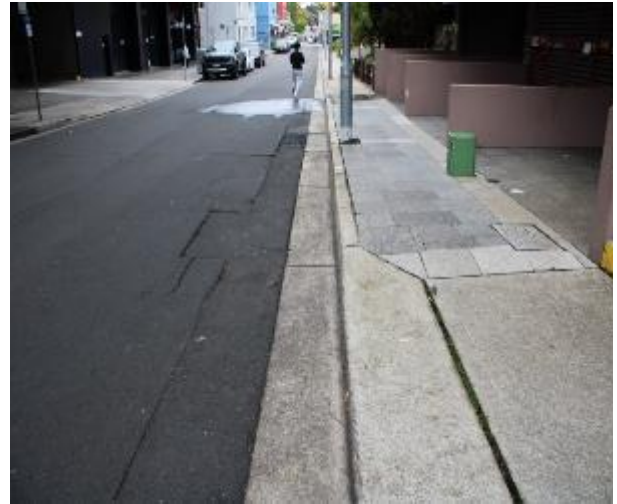
Figure 127 - Crack propagation through driveway layback and gutter heading West

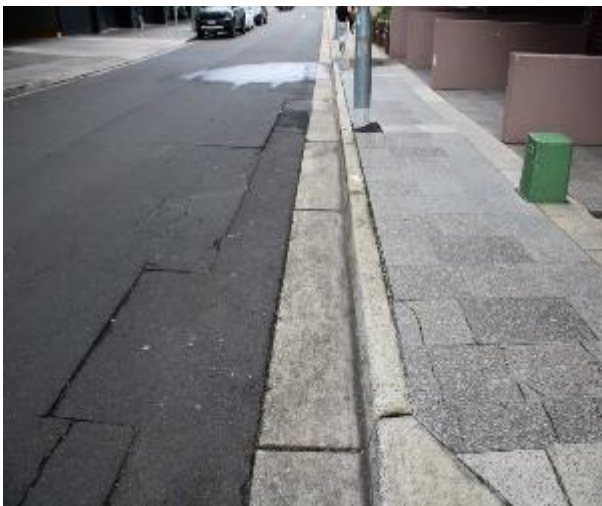
Figure 129 - General condition of kerb and gutter heading West

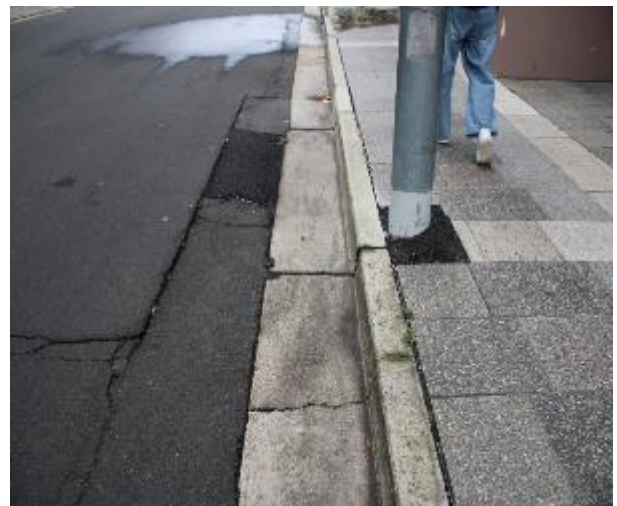
Figure 130 - General condition of kerb and gutter heading West

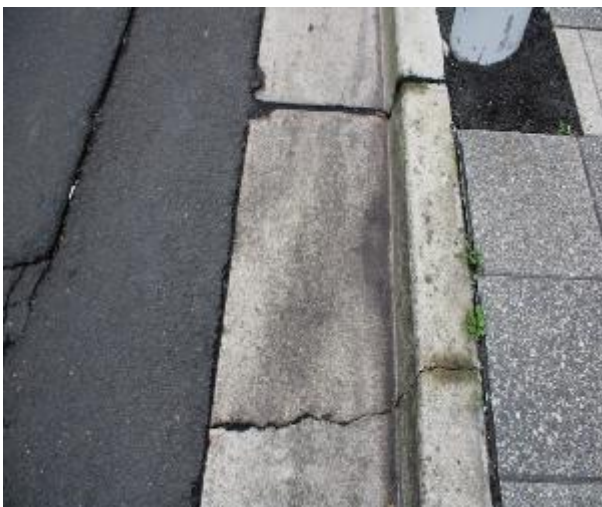
Figure 131 - Crack propagation through kerb and gutter heading West

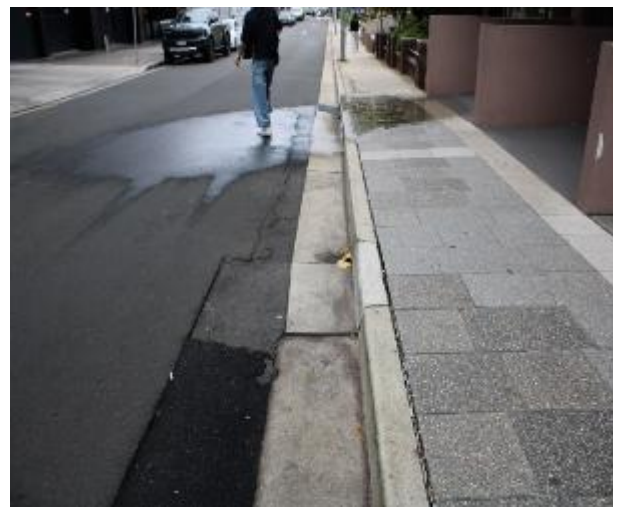
Figure 132 - General condition of kerb and gutter heading West

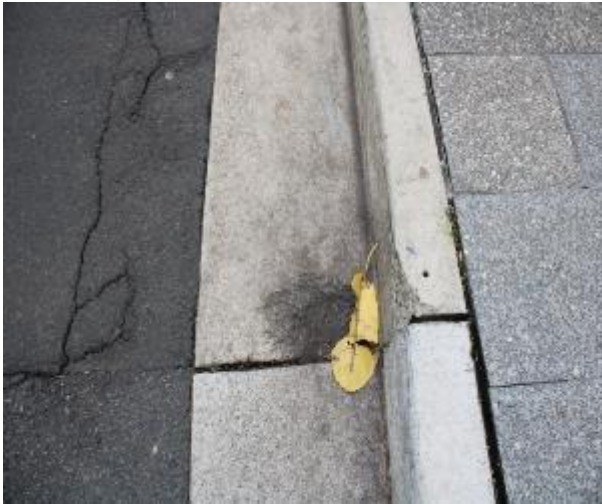
Figure 133 - Loss of material through kerb and gutter heading West

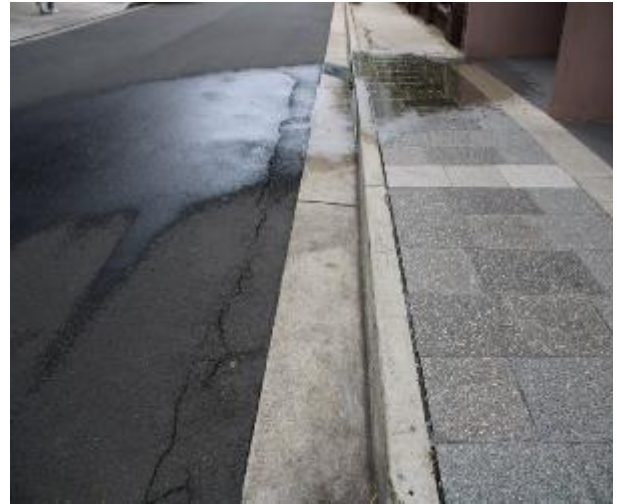
Figure 134 - General condition of kerb and gutter heading West

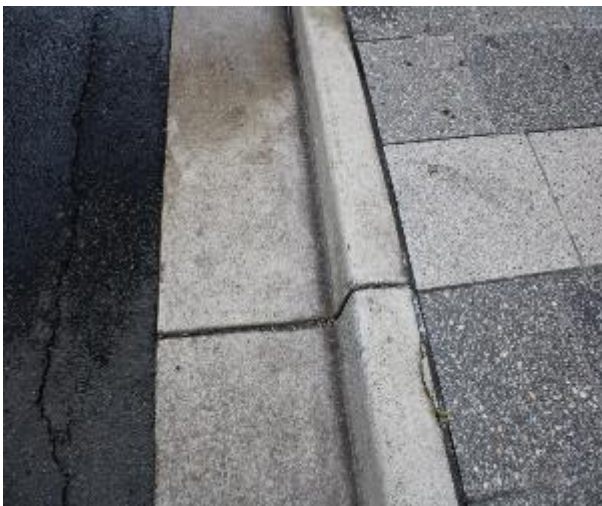
Figure 135 - Crack propagation through kerb and gutter heading West

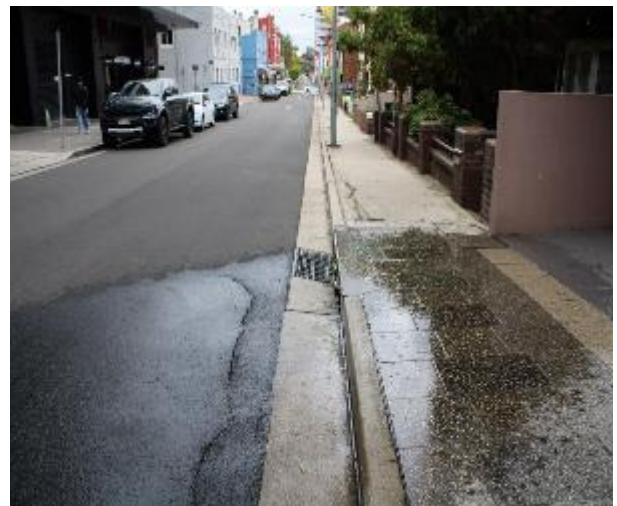
Figure 136 - General condition of kerb and gutter heading West

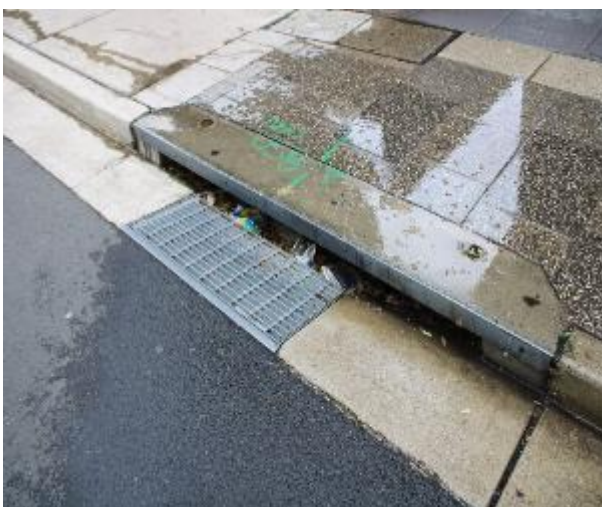
Figure 137 - General condition of stormwater inlet pit

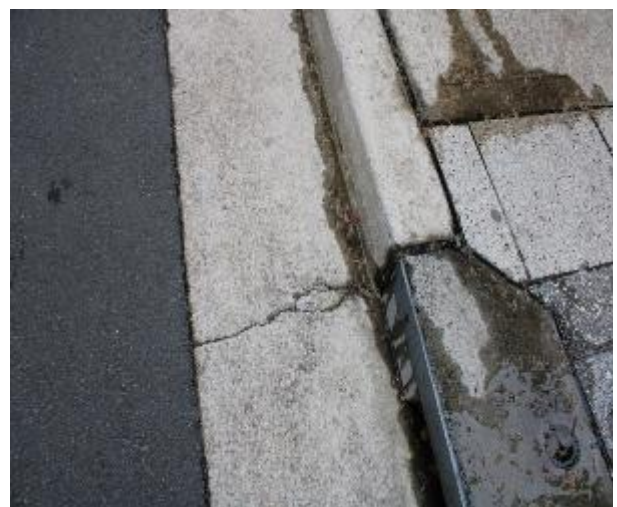
Figure 138 - Crack propagation through kerb and gutter heading West

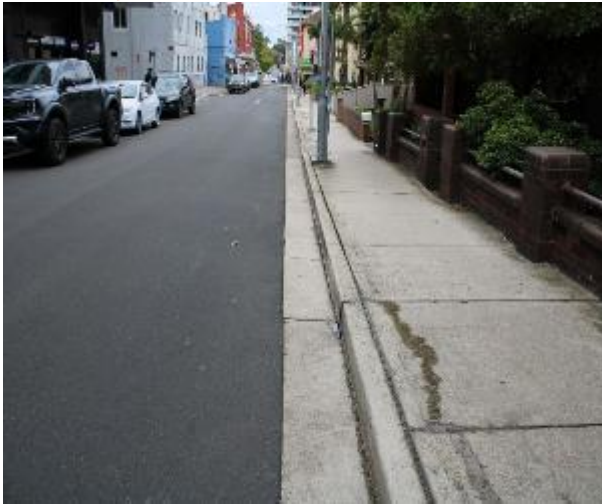
Figure 139 - General condition of kerb and gutter heading West

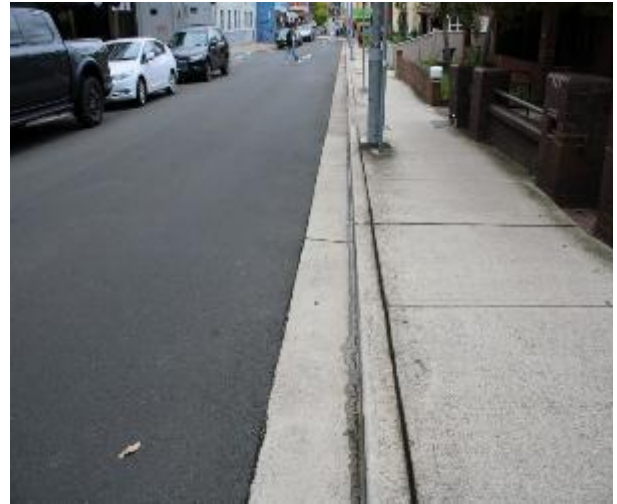
Figure 140 - General condition of kerb and gutter heading West

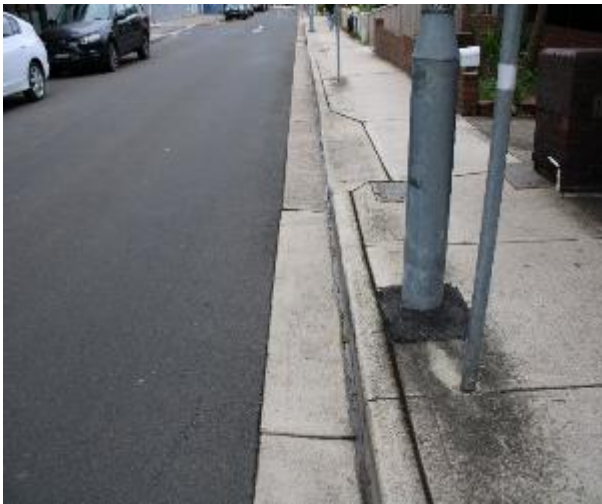
Figure 141 - General condition of kerb and gutter heading West

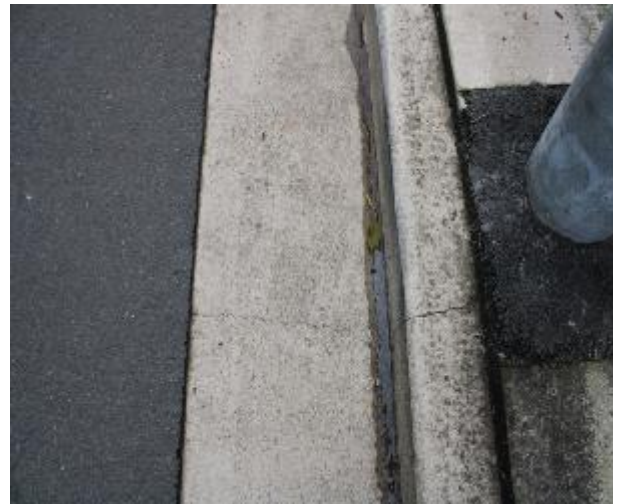
Figure 142 - Crack propagation through kerb and gutter heading West

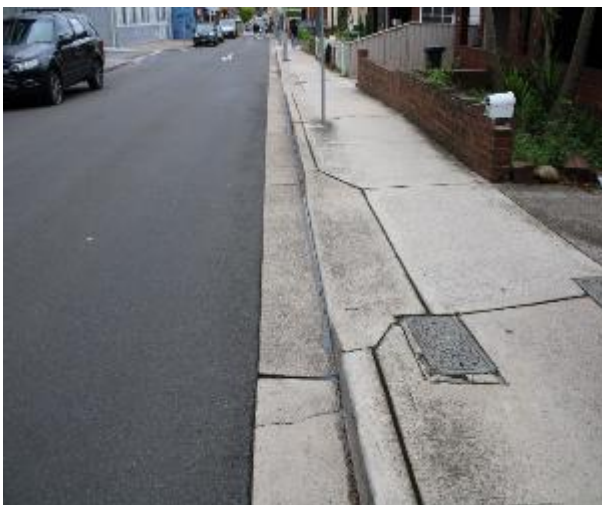
Figure 143 - General condition of kerb and gutter heading West

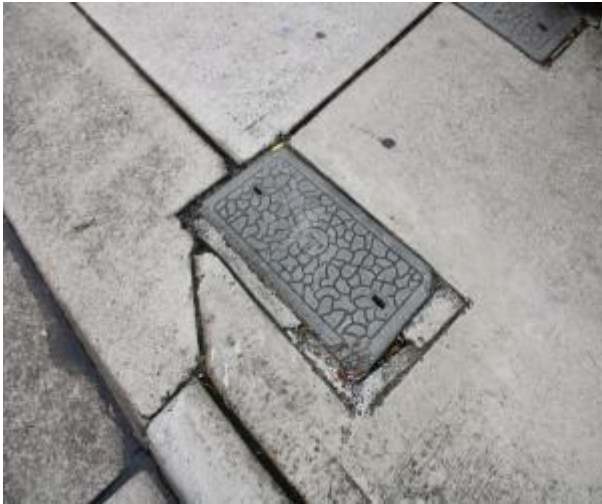
Figure 145 - General condition of service pit

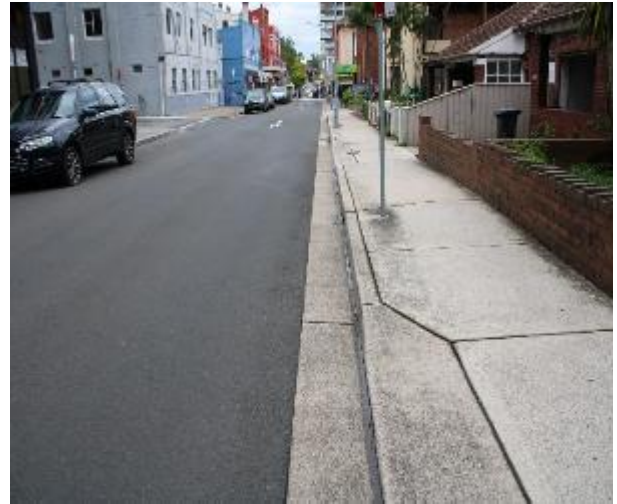
Figure 146 - General condition of kerb and gutter heading West

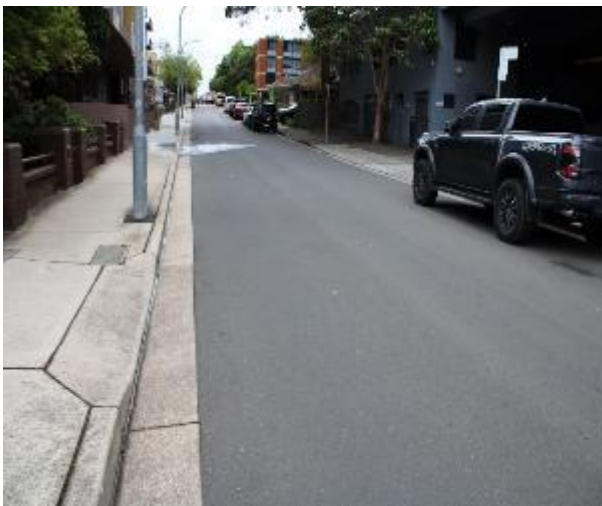
Figure 147 - General condition of road surface heading East

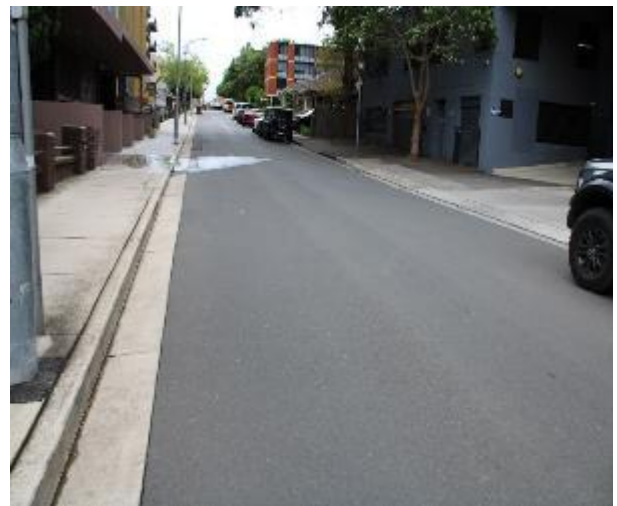
Figure 148 - General condition of road surface heading East

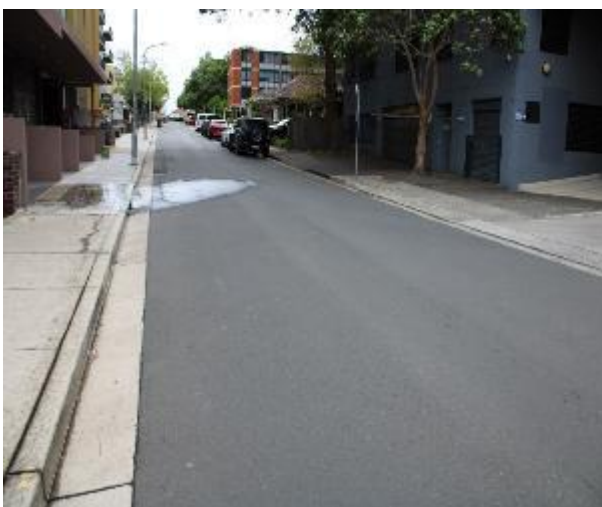
Figure 149 - General condition of road surface heading East

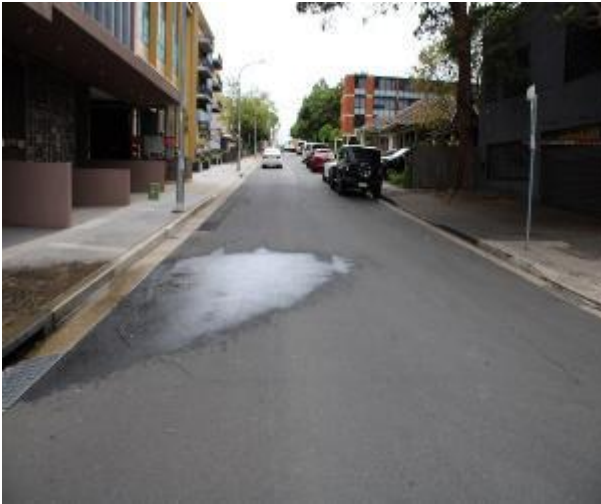
Figure 151 - General condition of road surface heading East

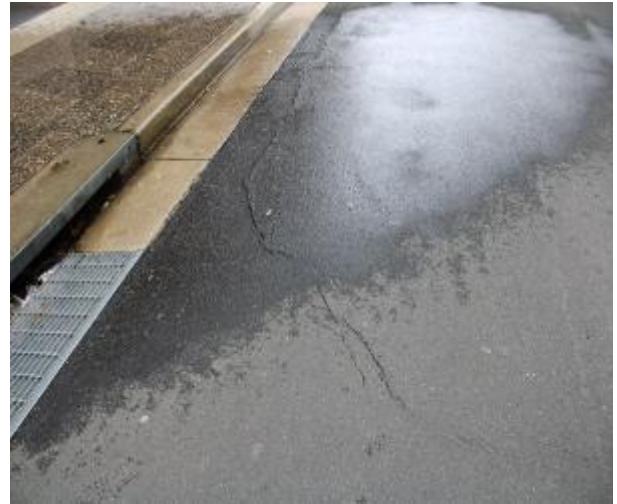
Figure 152 - Crack propagation through road surface heading East

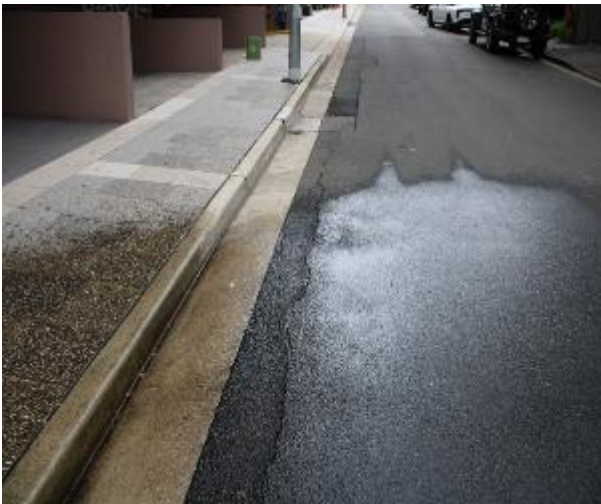
Figure 153 - General condition of road surface heading East

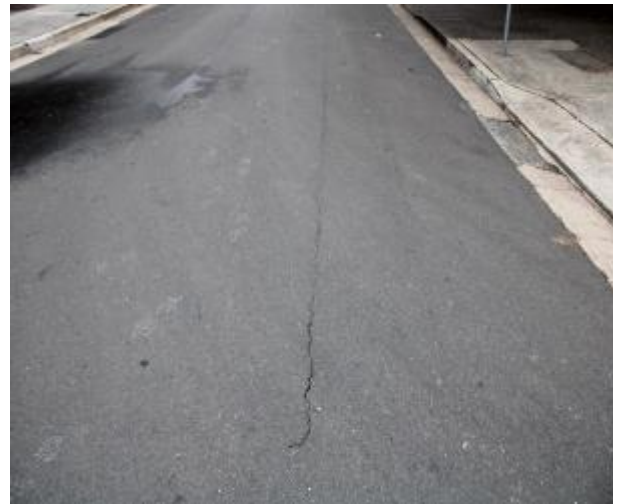
Figure 154 - Crack propagation through road surface heading East

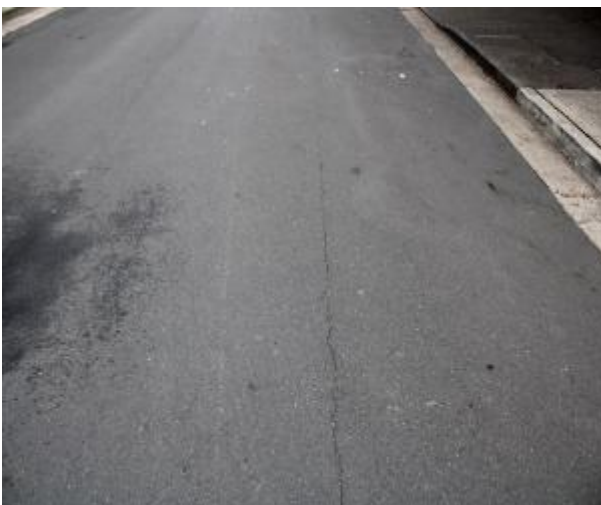
Figure 155 - Crack propagation through road surface heading East

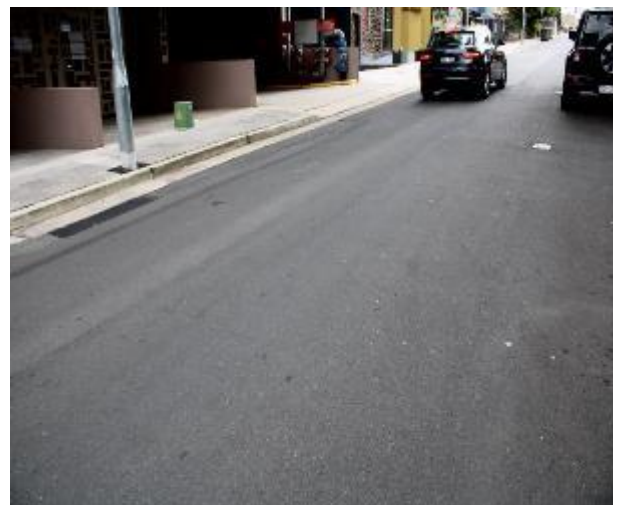
Figure 156 - General condition of road surface heading East

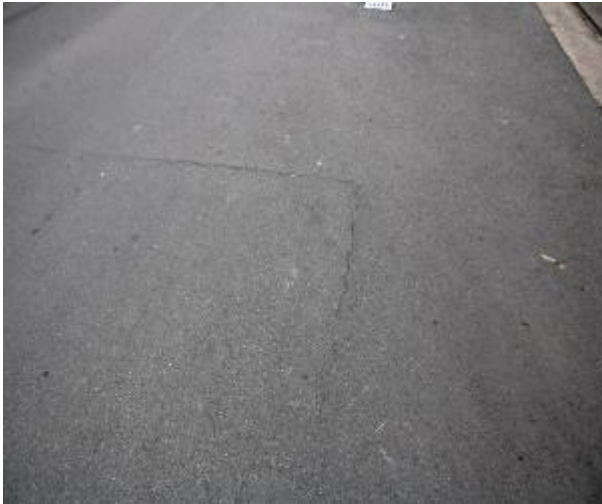
Figure 157 - Crack propagation through road surface heading East

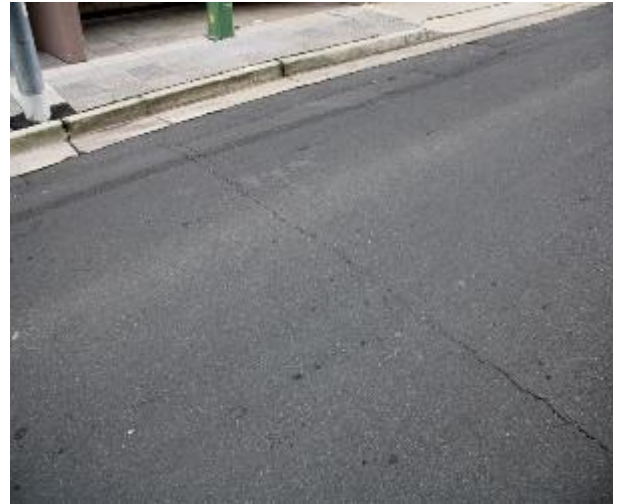
Figure 158 - Crack propagation through road surface heading East

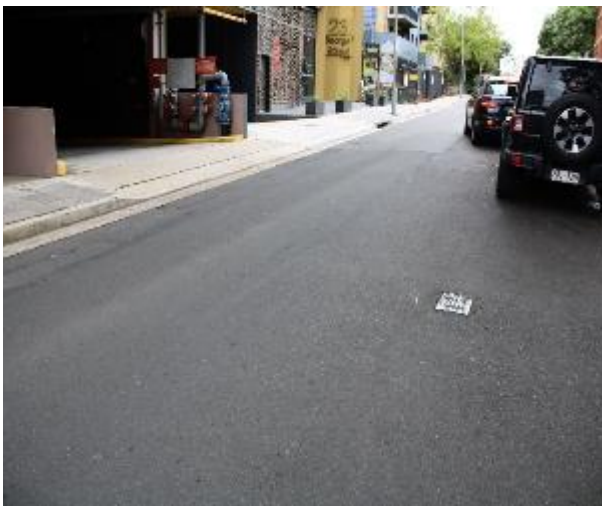
Figure 159 - General condition of road surface heading East

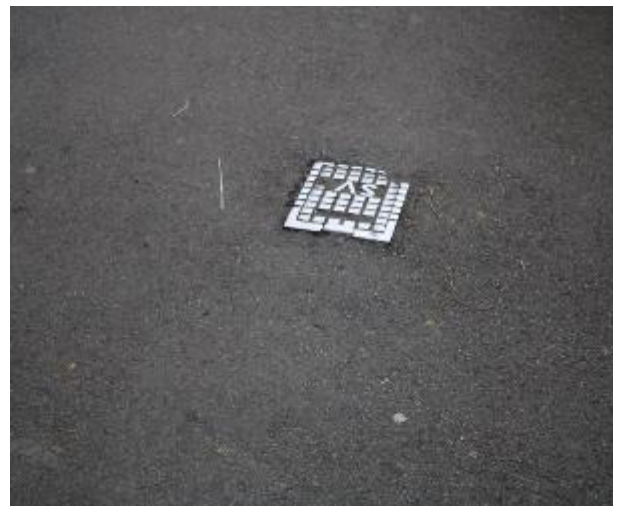
Figure 160 - General condition of service pit

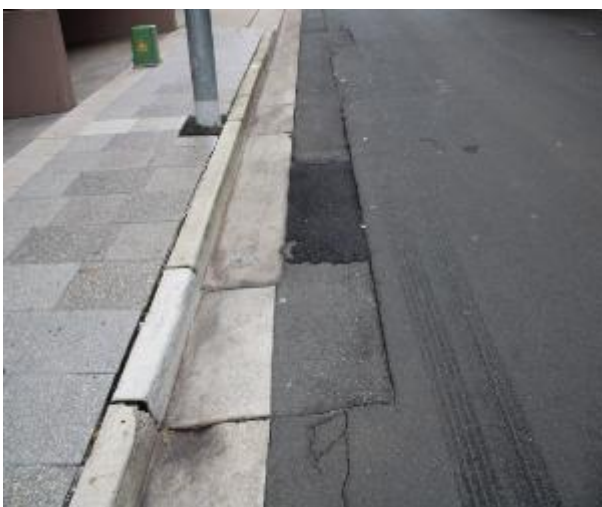
Figure 161 - Patchwork evident through road surface heading East

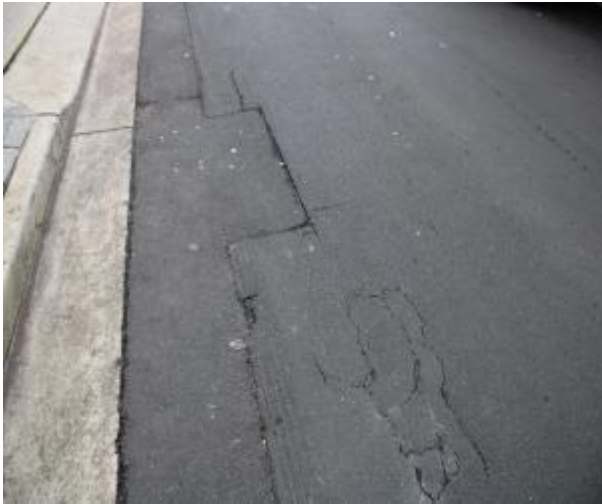
Figure 163 - Crack propagation through road surface heading East

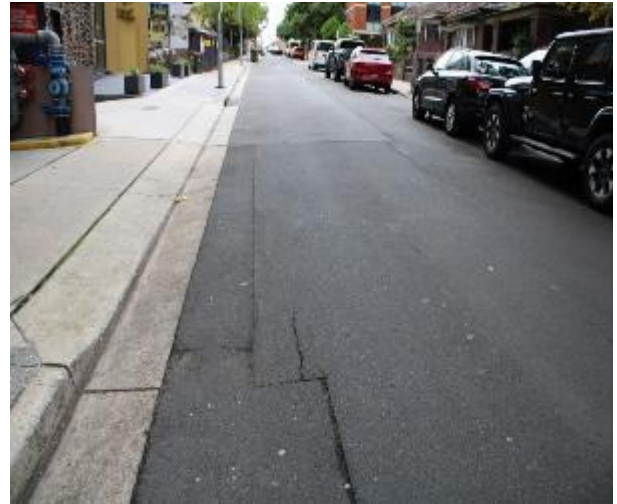
Figure 164 - General condition of road surface heading East

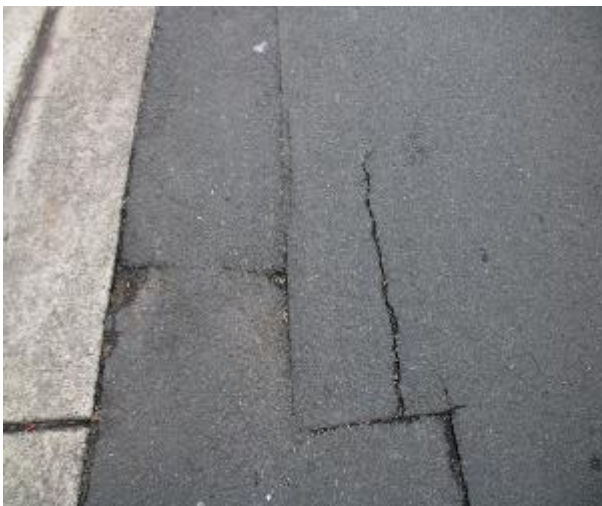
Figure 165 - Loss of material through road surface heading East

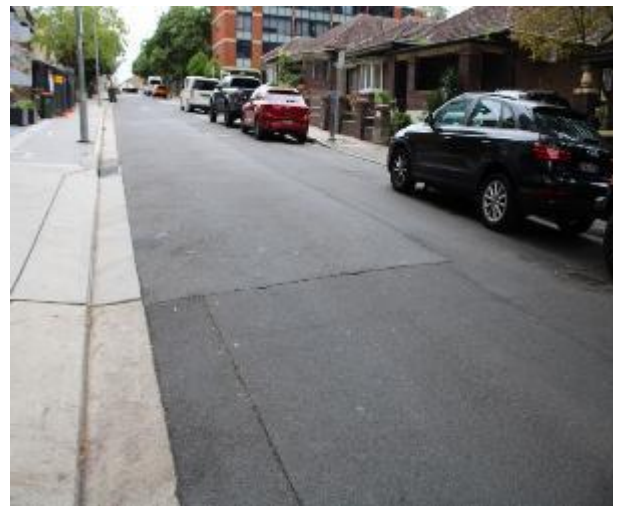
Figure 166 - General condition of road surface heading East

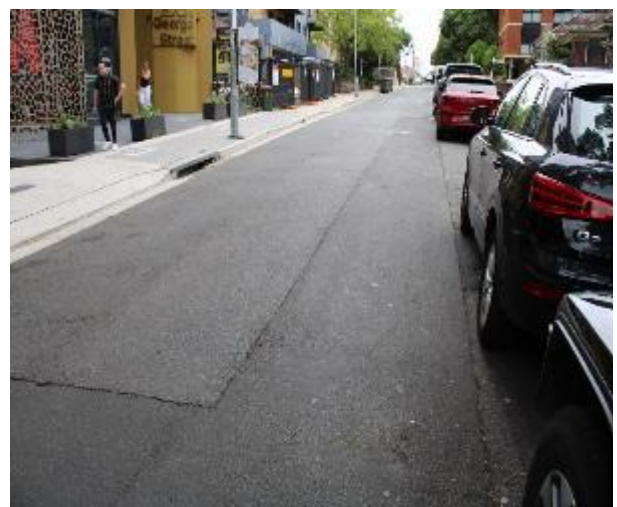
Figure 168 - General condition of road surface heading East

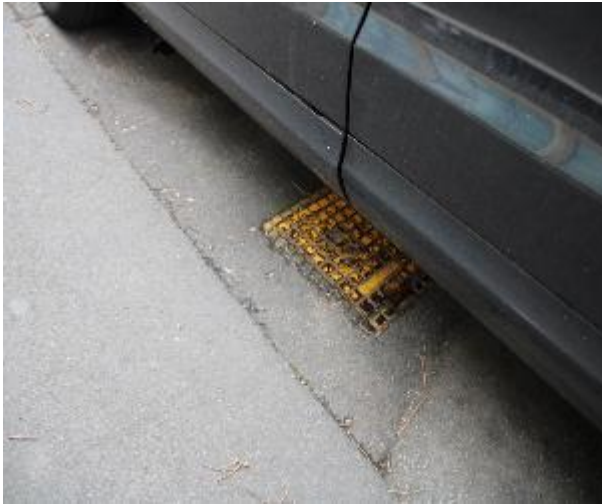
Figure 169 - General condition of service pit

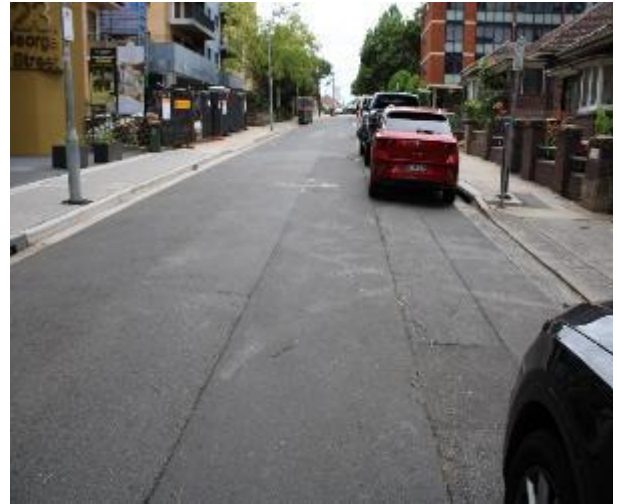
Figure 170 - General condition of road surface heading East

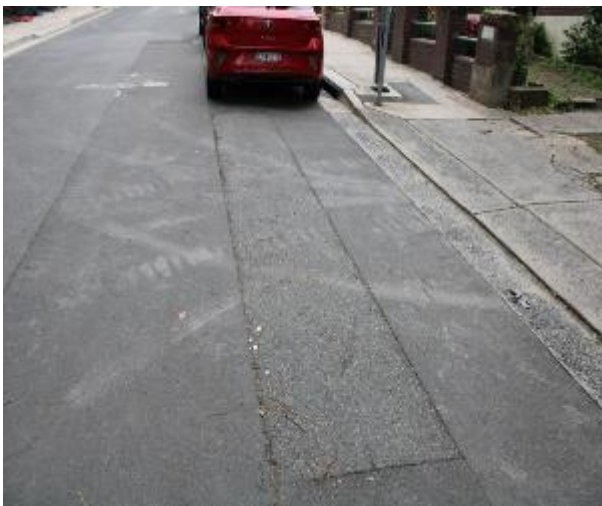
Figure 171 - Patchwork evident through road surface heading East

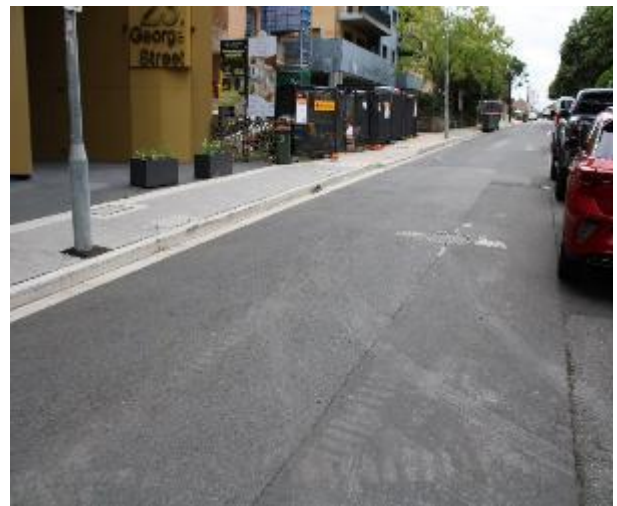
Figure 172 - General condition of road surface heading East
