# **PRE-DILAPIDATION REPORT**

**COUNCIL ASSETS**

**21 GEORGE STREET,  
BURWOOD, NSW 2134**

PROJECT REFERENCE: 20250047.CA.1  
17/04/2026

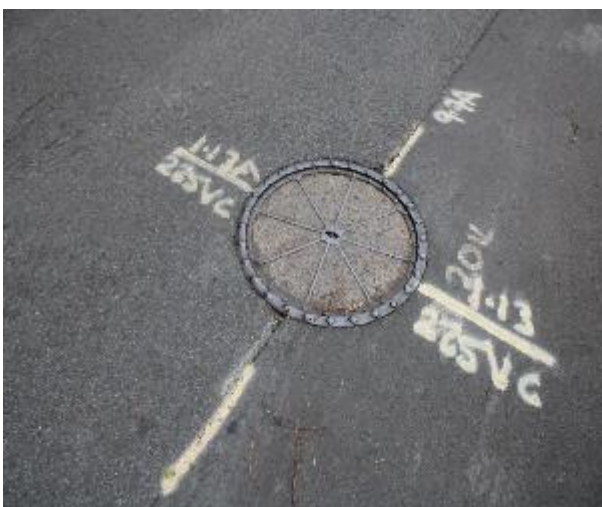
Figure 173 - General condition of sewer manhole cover

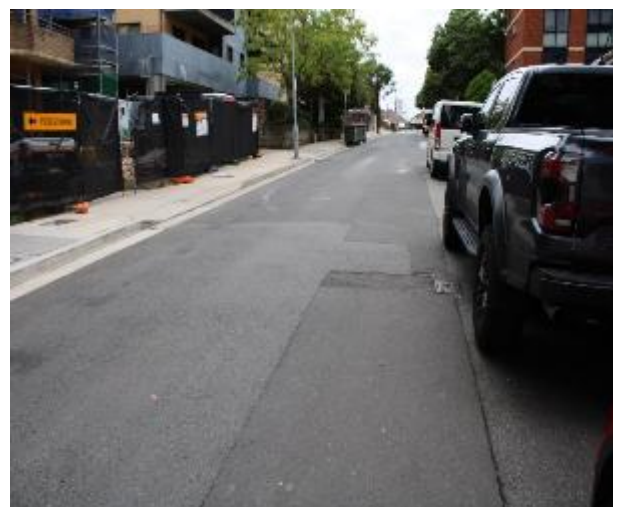
Figure 174 - General condition of road surface heading East

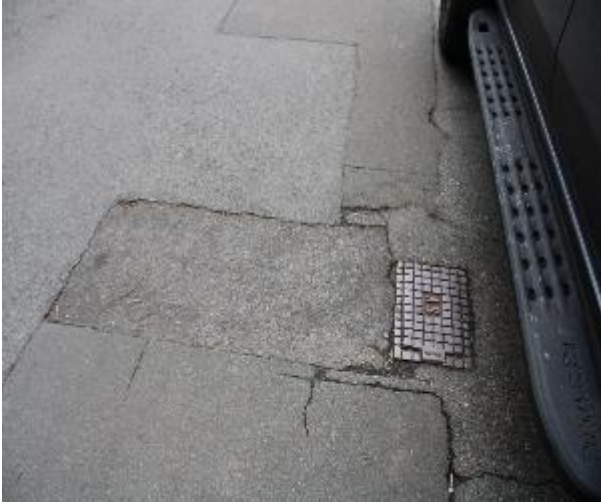
Figure 175 - Crack propagation and patchwork evident through road surface heading East

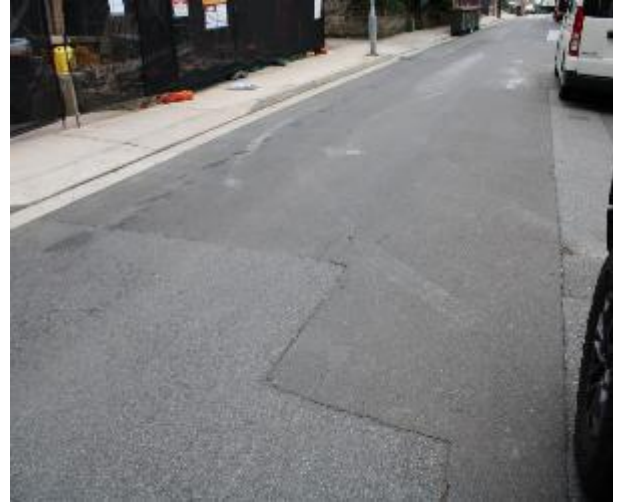
Figure 176 - General condition of road surface heading East

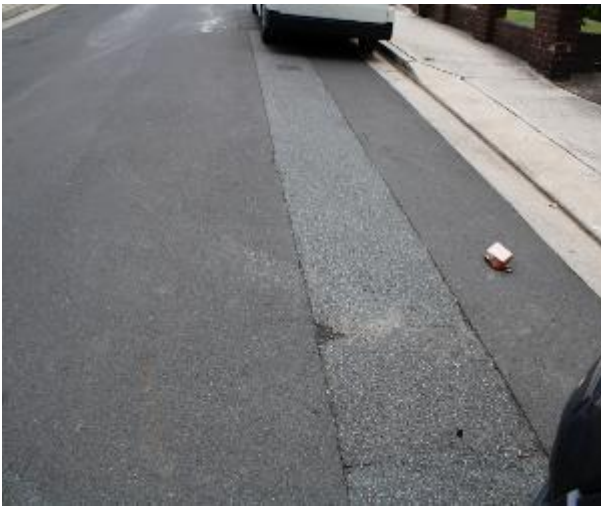
Figure 177 - Patchwork evident through road surface heading East

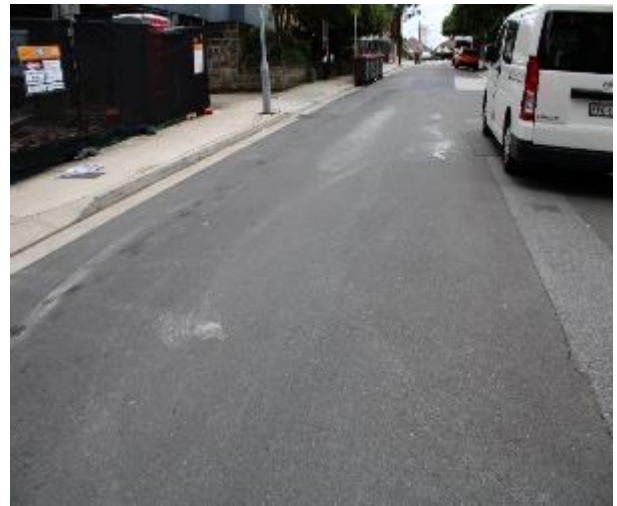
Figure 178 - General condition of road surface heading East

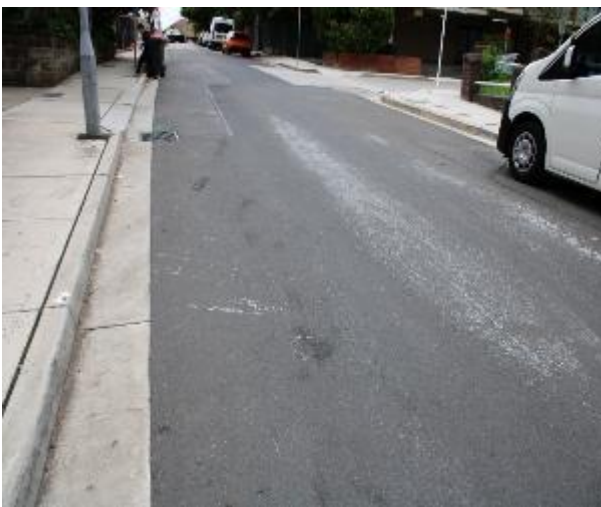
Figure 179 - General condition of road surface heading East

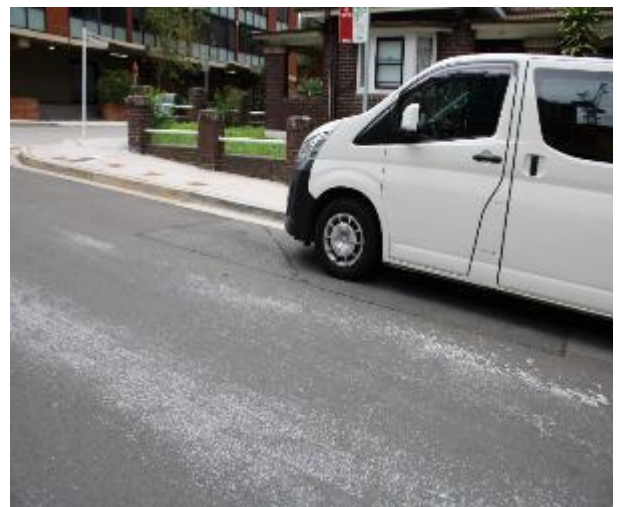
Figure 180 - General condition of road surface heading East

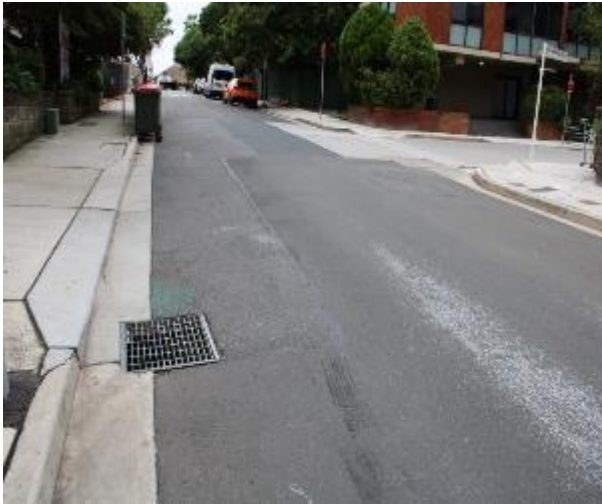
Figure 181 - General condition of road surface heading East

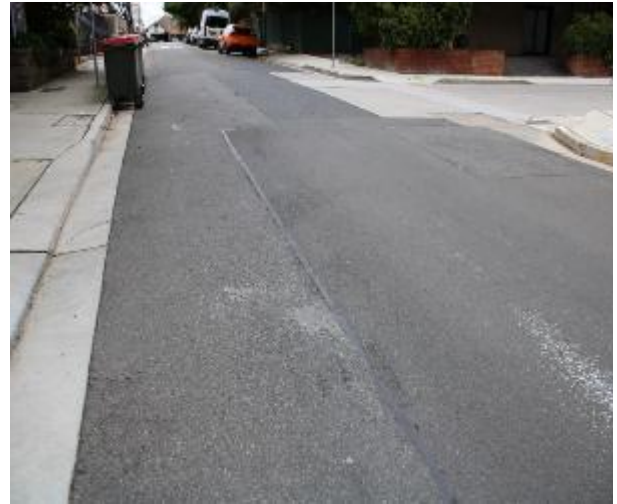
Figure 182 - General condition of road surface heading East

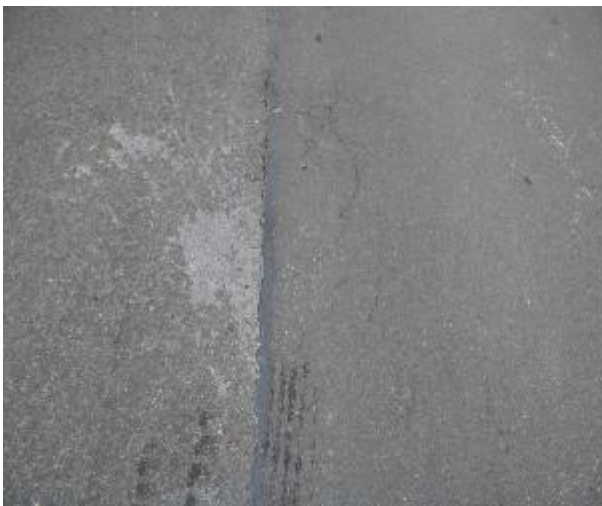
Figure 183 - Crack propagation through road surface heading East

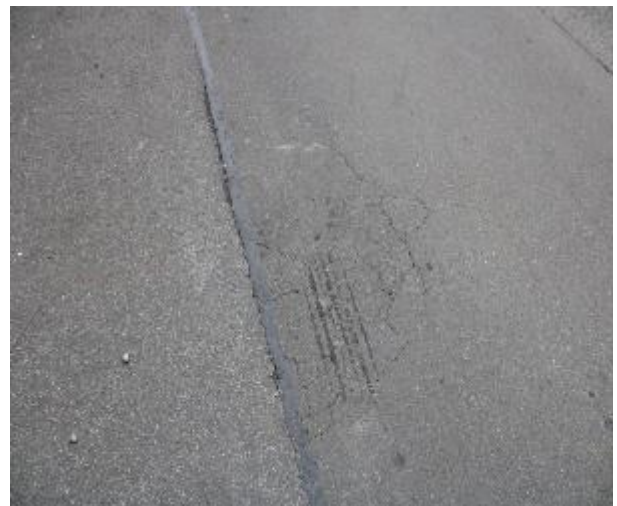
Figure 184 - Crack propagation through road surface heading East

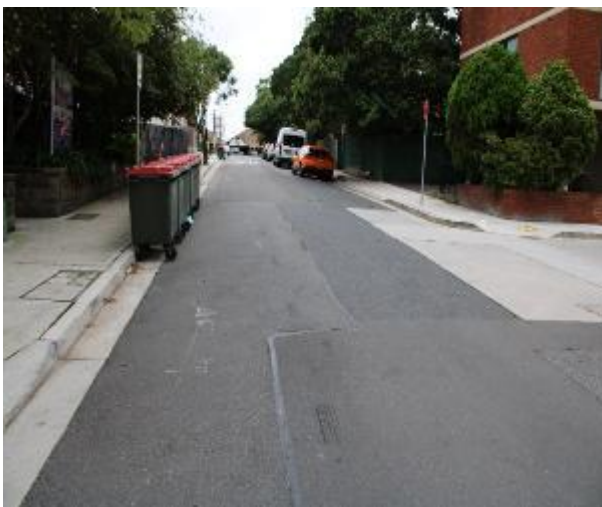
Figure 185 - General condition of road surface heading East

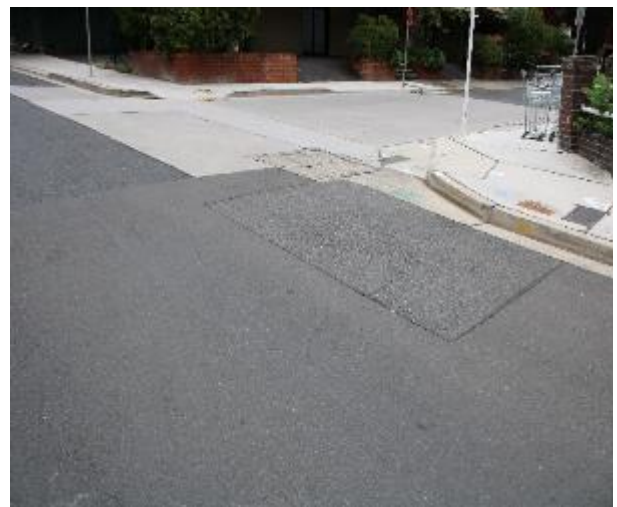
Figure 186 - General condition of road surface heading East

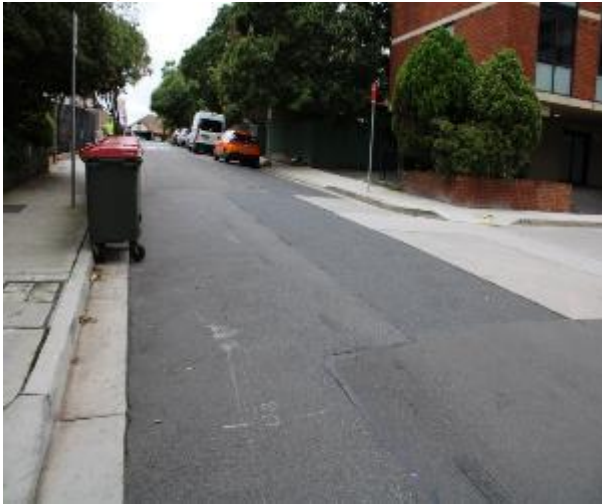
Figure 187 - General condition of road surface heading East

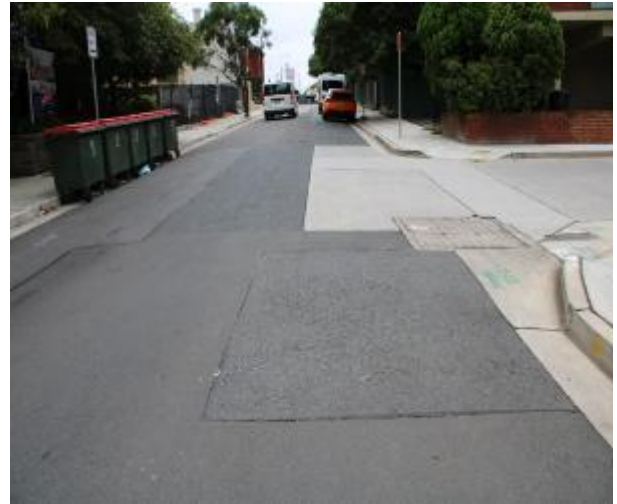
Figure 188 - General condition of road surface heading East

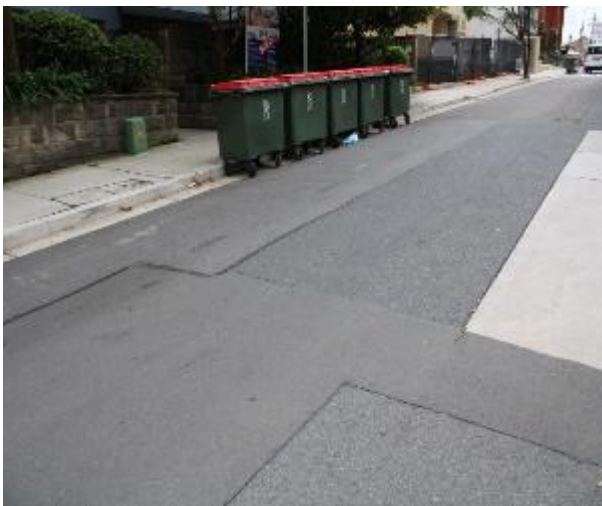
Figure 189 - General condition of road surface heading East

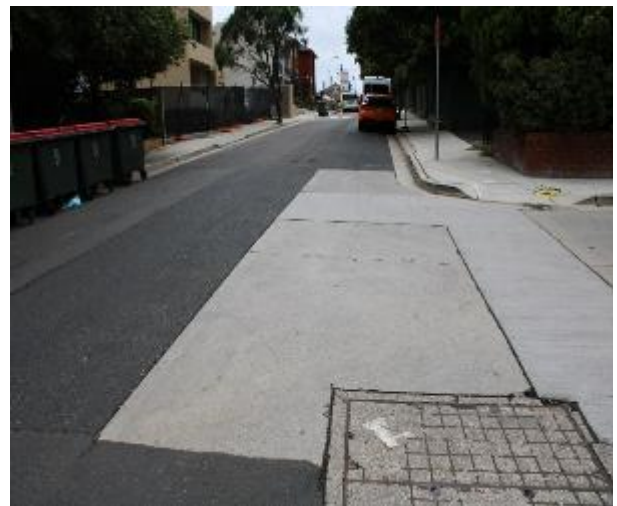
Figure 190 - General condition of road surface heading East

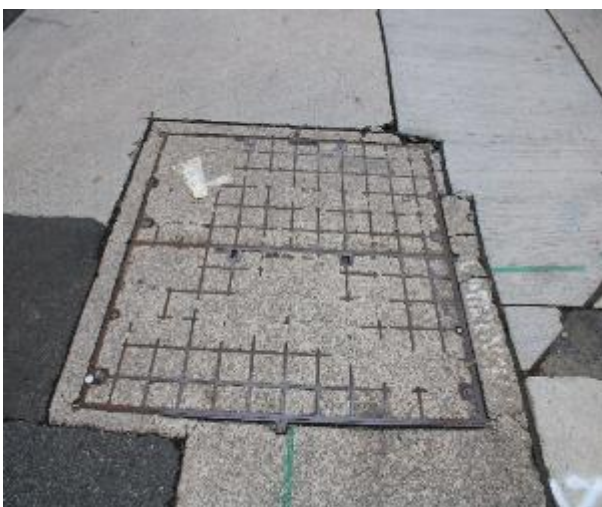
Figure 191 - General condition of service pit

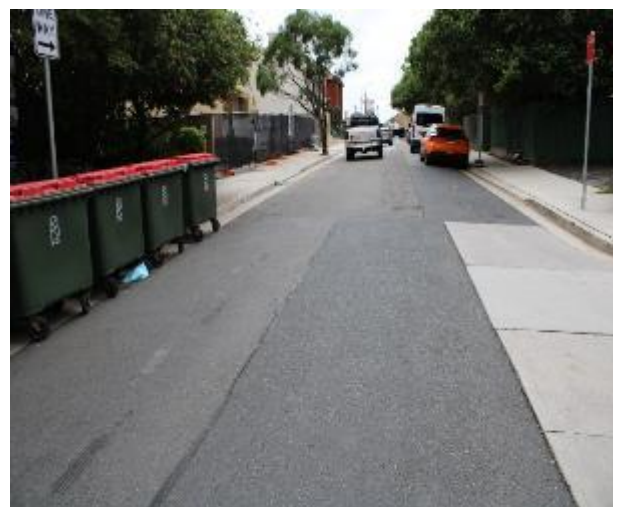
Figure 192 - General condition of road surface heading East

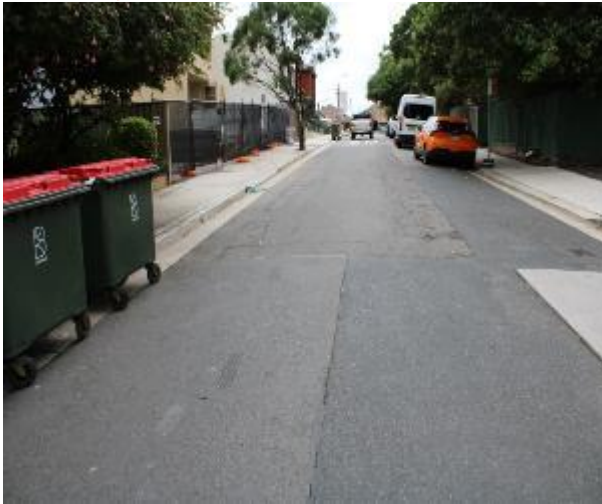
Figure 193 - General condition of road surface heading East

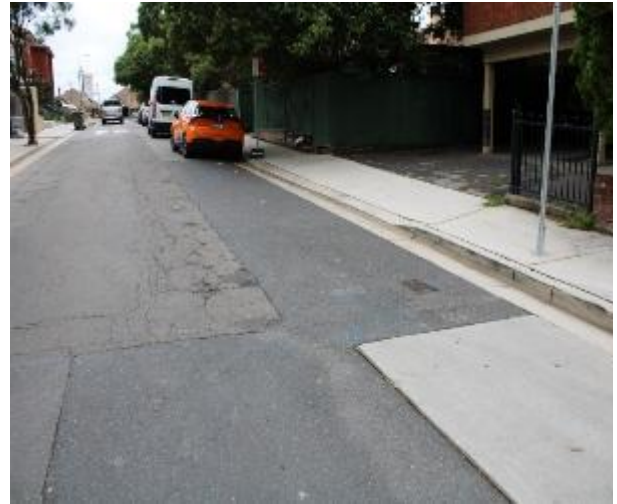
Figure 194 - General condition of road surface heading East

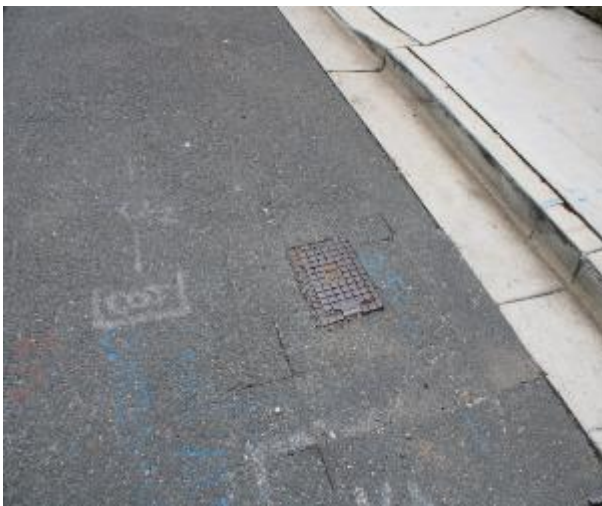
Figure 195 - General condition of service pit

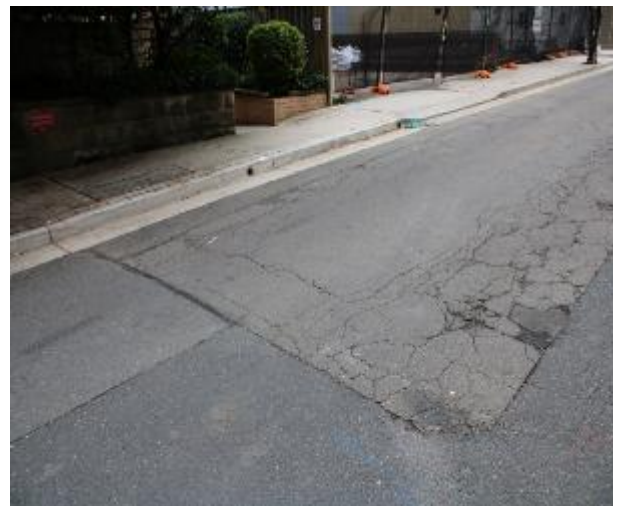
Figure 196 - General condition of road surface heading East

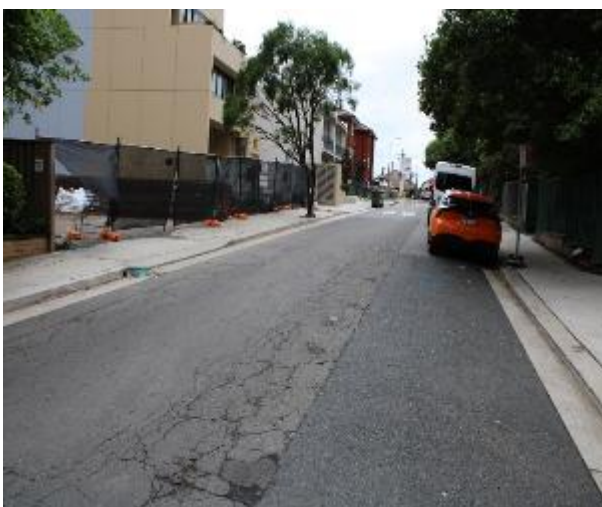
Figure 197 - General condition of road surface heading East

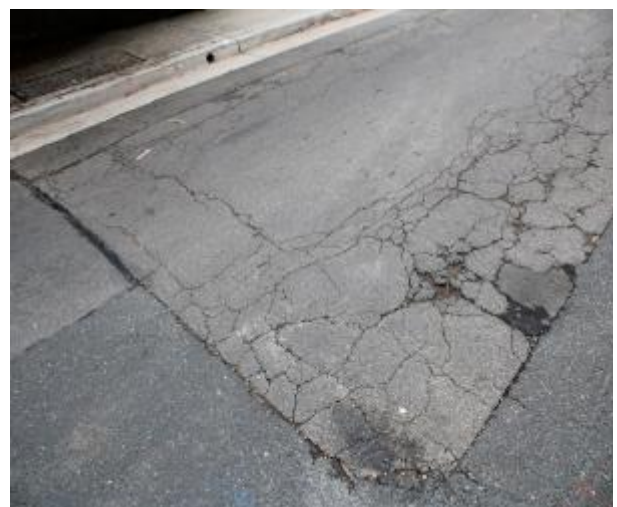
Figure 198 - Crack propagation and loss of materials through road surface heading East

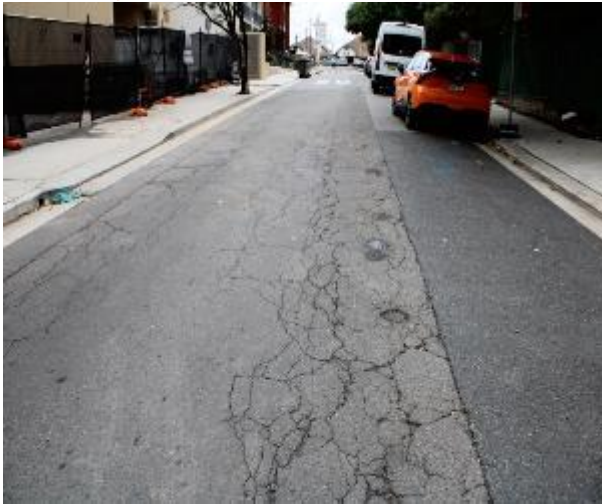
Figure 199 - General condition of road surface heading East

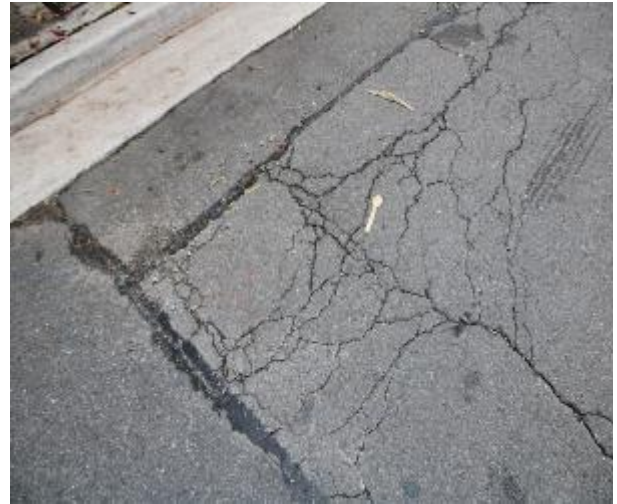
Figure 200 - Crack propagation through road surface heading East

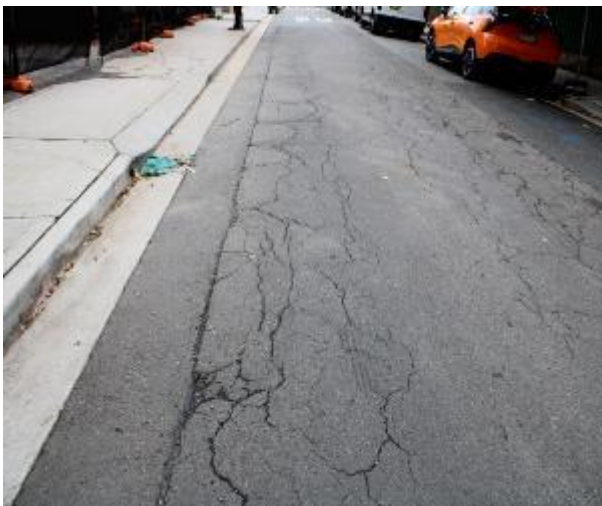
Figure 201 - Crack propagation through road surface heading East

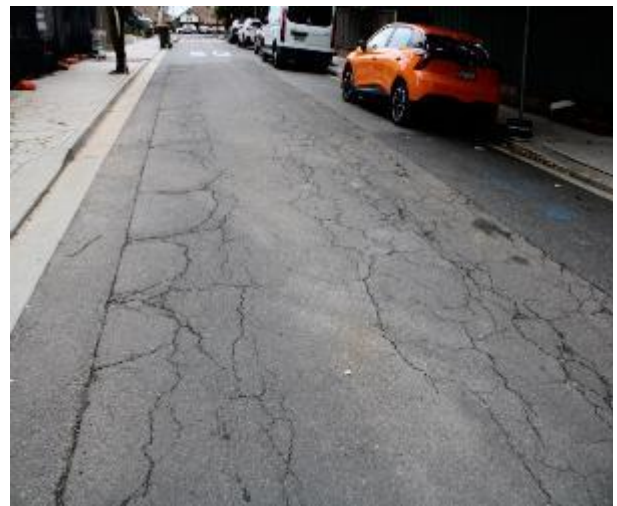
Figure 202 - Crack propagation through road surface heading East

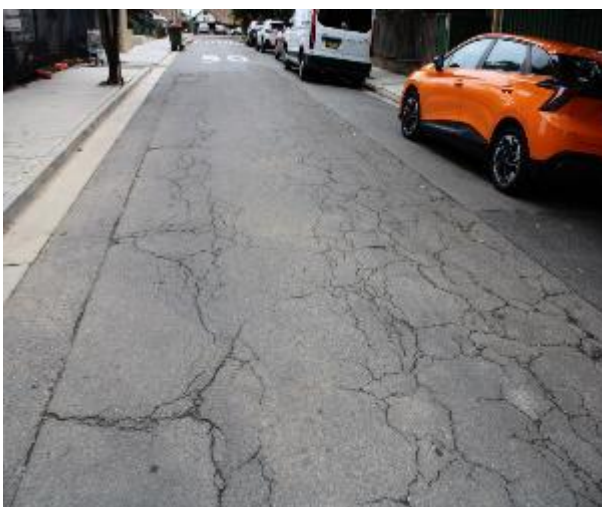
Figure 203 - General condition of road surface heading East

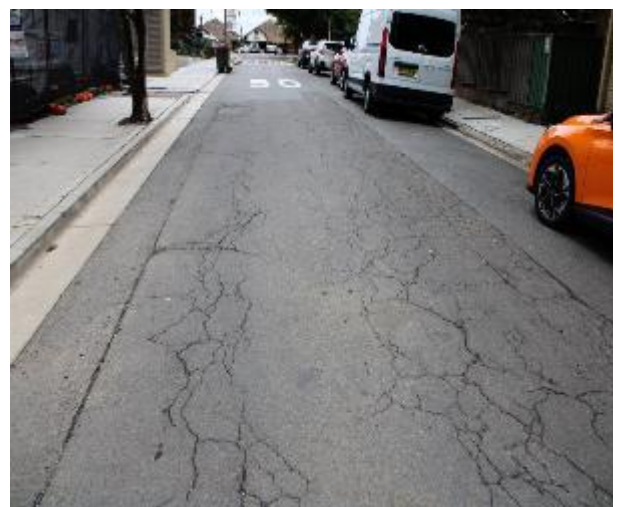
Figure 204 - General condition of road surface heading East

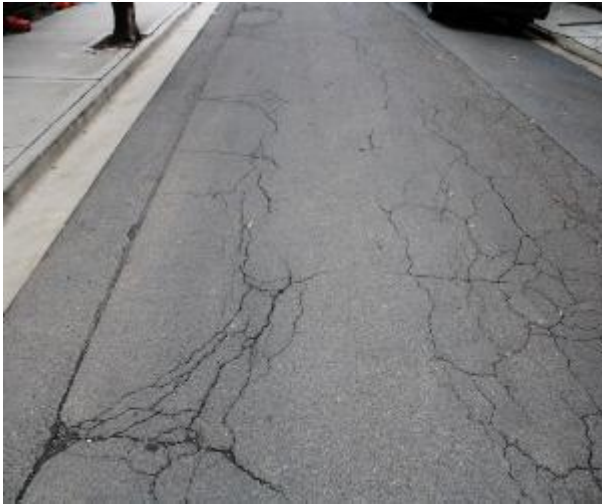
Figure 205 - Crack propagation through road surface heading East

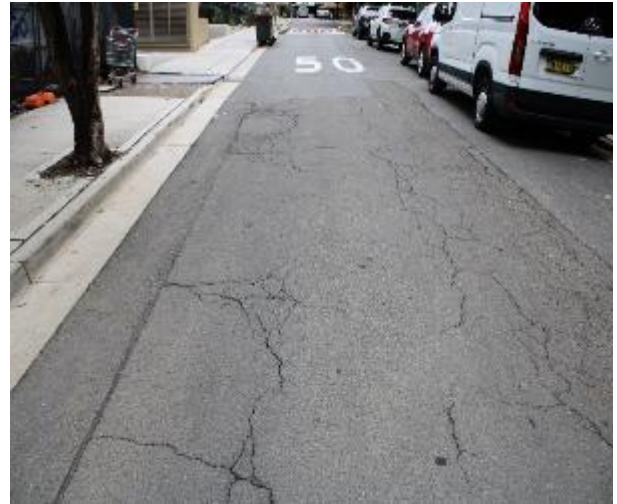
Figure 206 - Crack propagation through road surface heading East

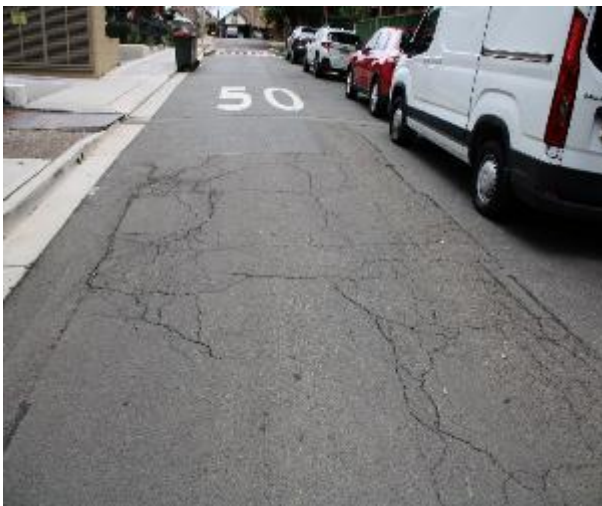
Figure 207 - General condition of road surface heading East

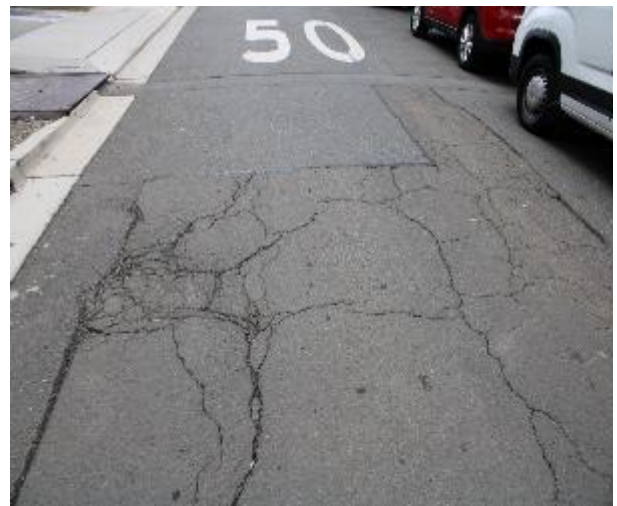
Figure 208 - Crack propagation through road surface heading East

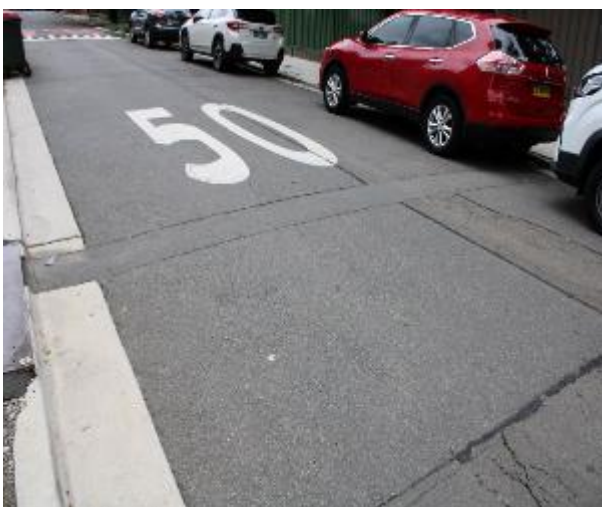
Figure 209 - General condition of road surface heading East

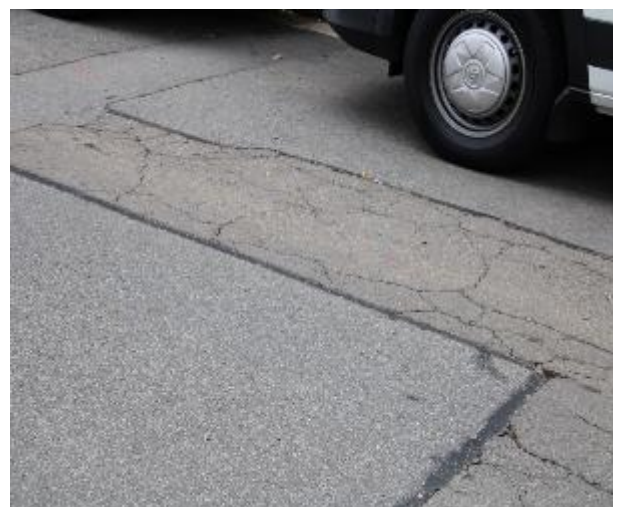
Figure 210 - Crack propagation through road surface heading East

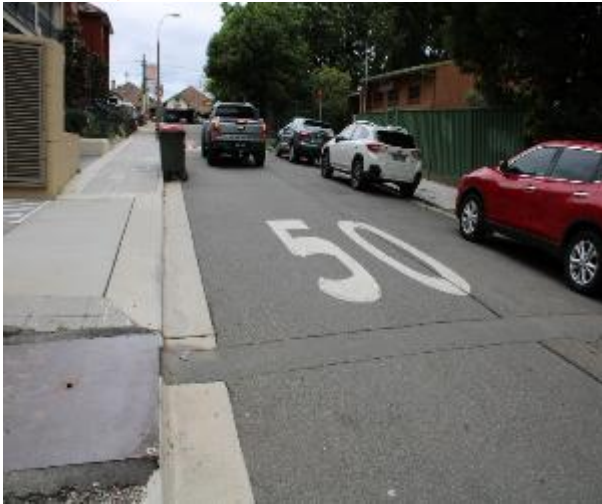
Figure 211 - General condition of road surface heading East

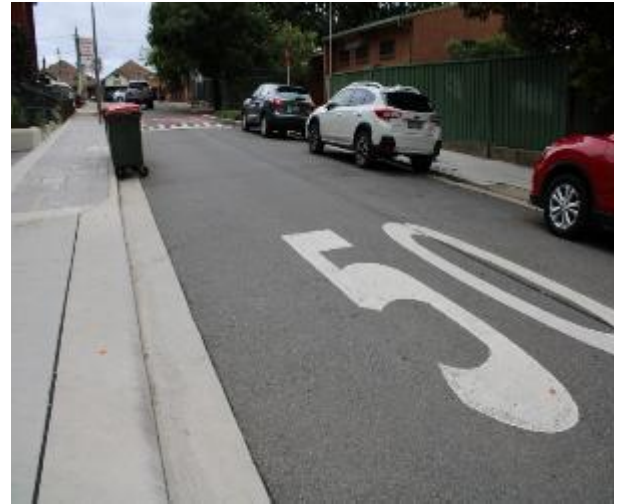
Figure 212 - General condition of

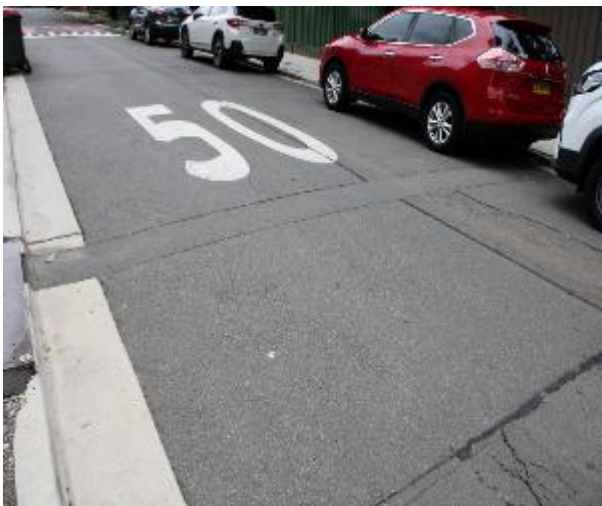
Figure 213 - General condition of road surface heading East

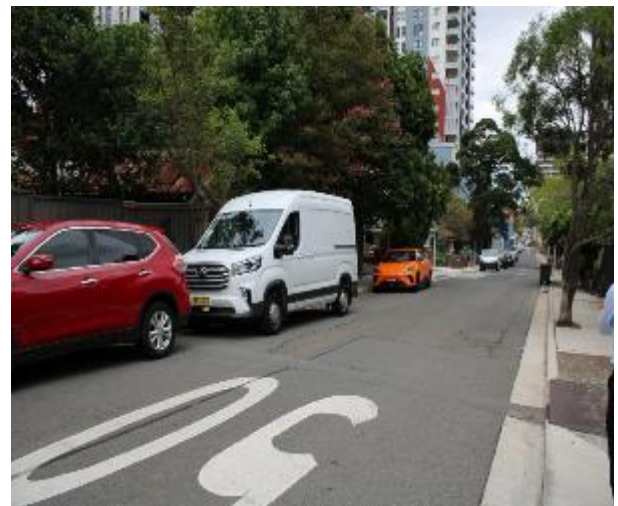
Figure 214 - General condition of road surface heading East

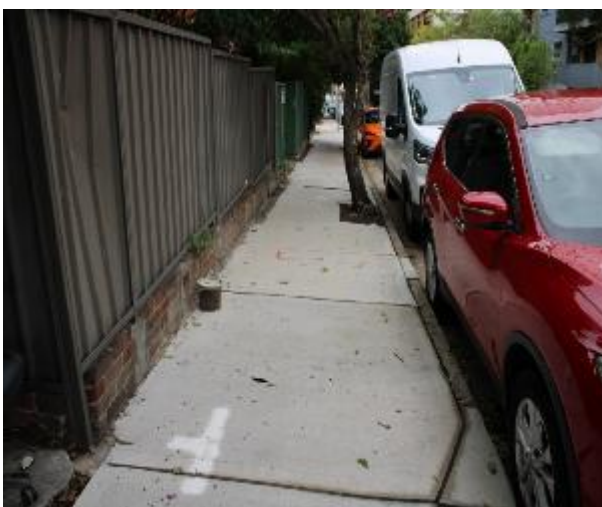
Figure 215 - General condition of footpath pavement heading West

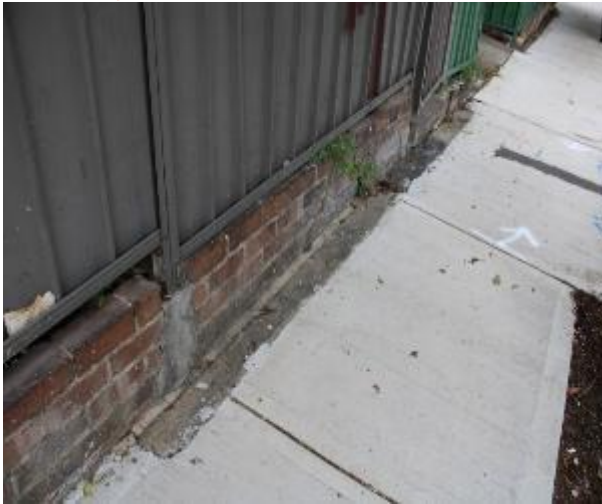
Figure 217 - General condition of footpath pavement heading West

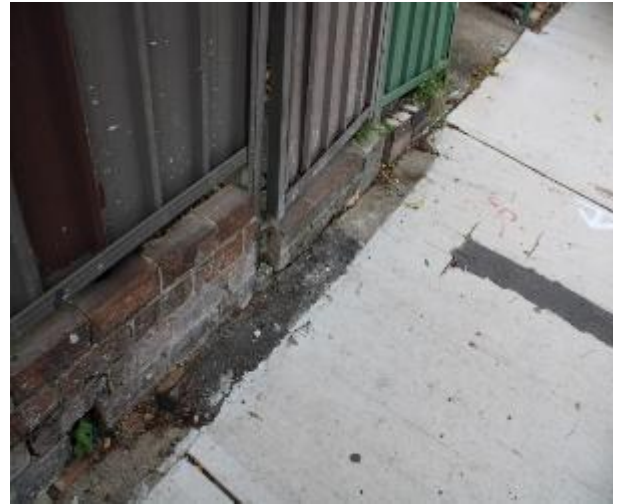
Figure 218 - General condition of footpath pavement heading West

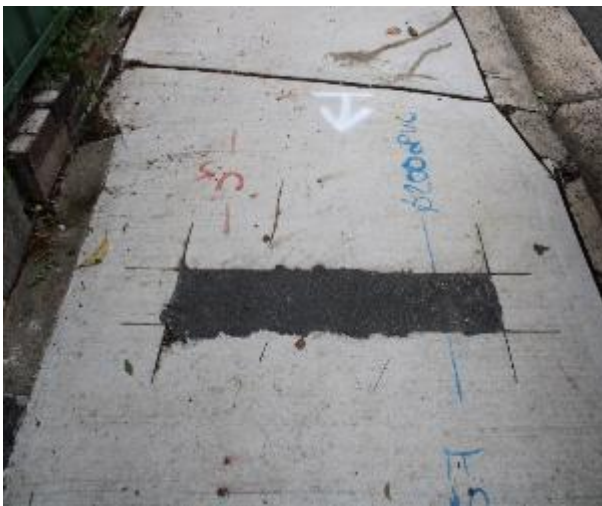
Figure 219 - Patchwork evident through footpath pavement heading West

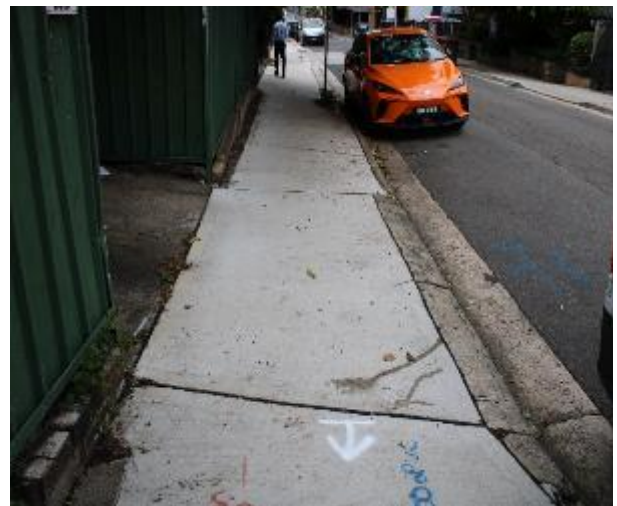
Figure 220 - General condition of footpath pavement heading West

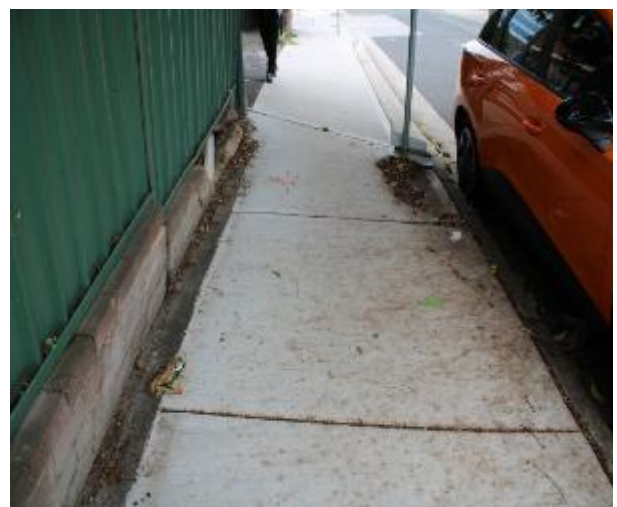
Figure 222 - General condition of footpath pavement heading West

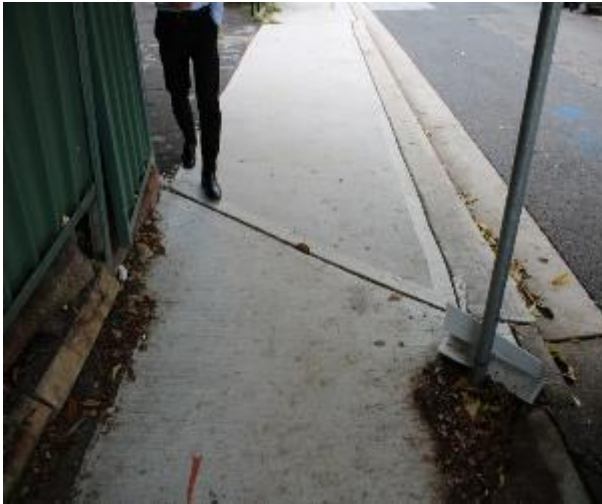
Figure 223 - General condition of footpath pavement heading West

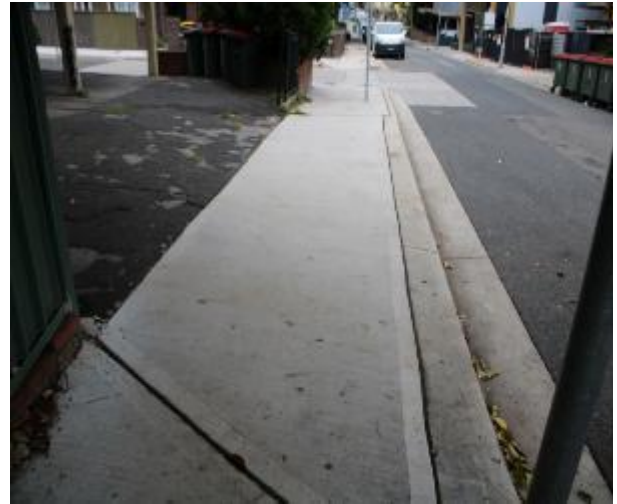
Figure 224 - General condition of footpath pavement heading West

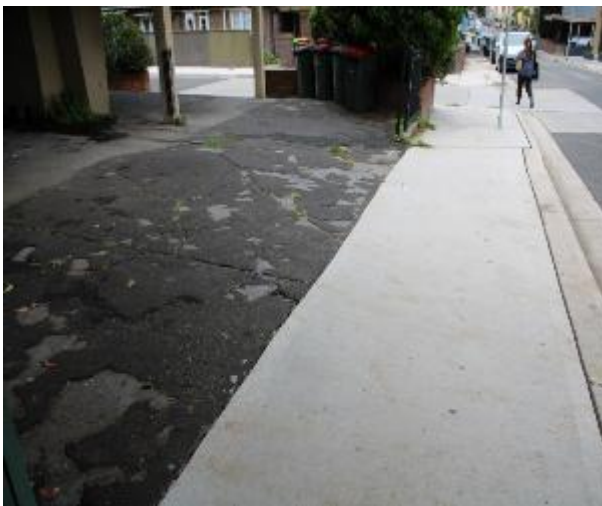
Figure 225 - General condition of footpath pavement heading West

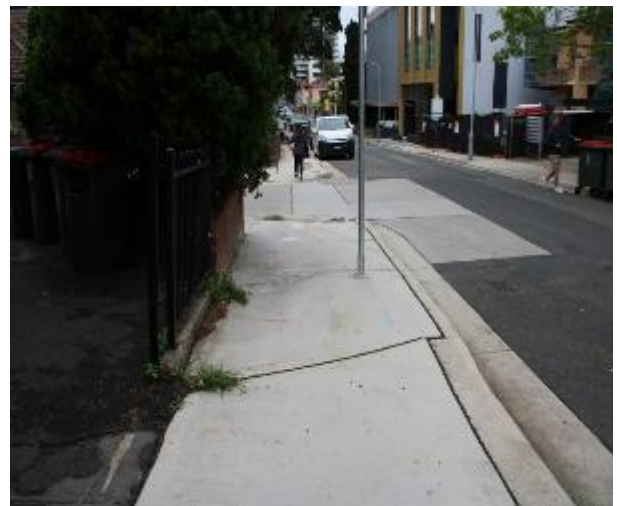
Figure 226 - General condition of footpath pavement heading West

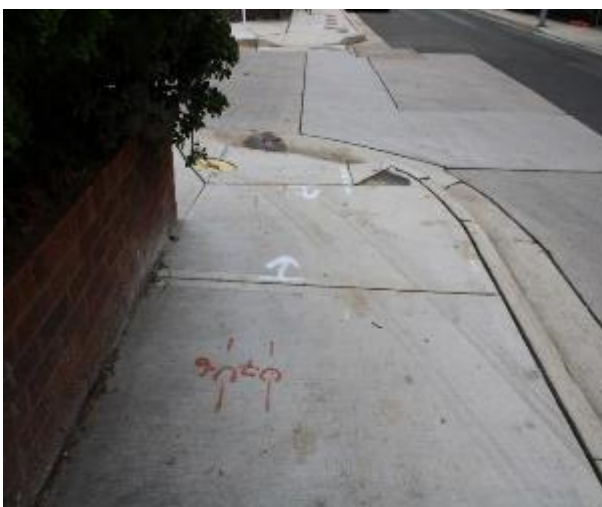
Figure 227 - General condition of footpath pavement heading West

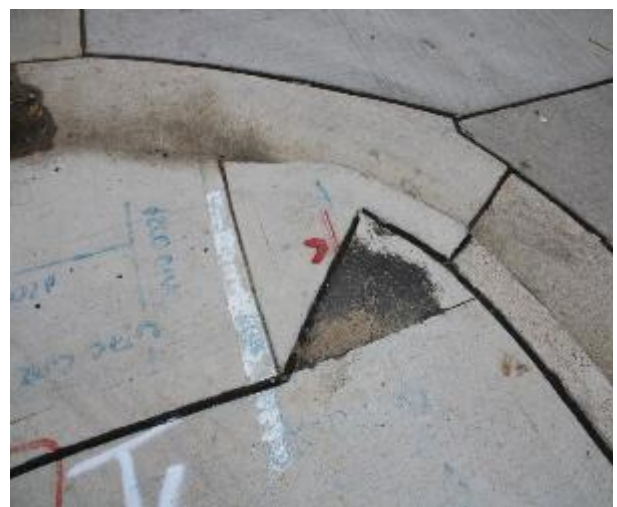
Figure 228 - Patchwork evident through footpath pavement heading West

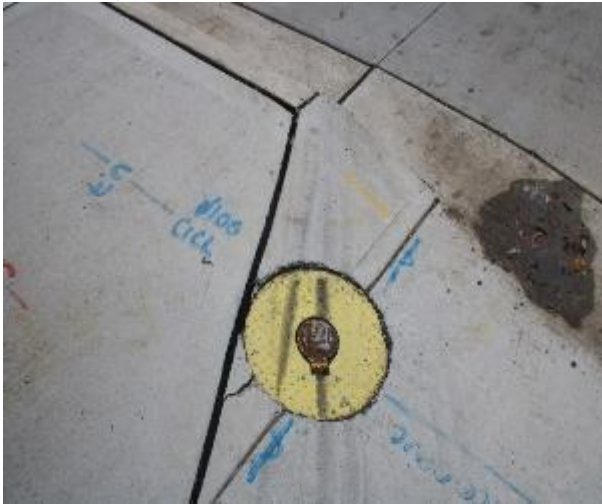
Figure 229 - General condition of service pit

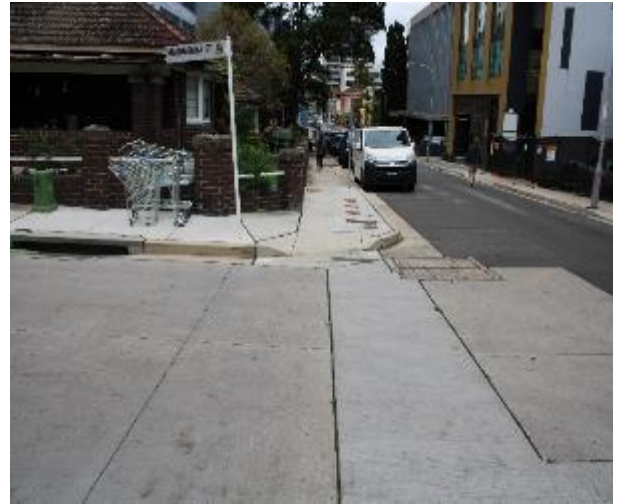
Figure 230 - General condition of footpath pavement heading West

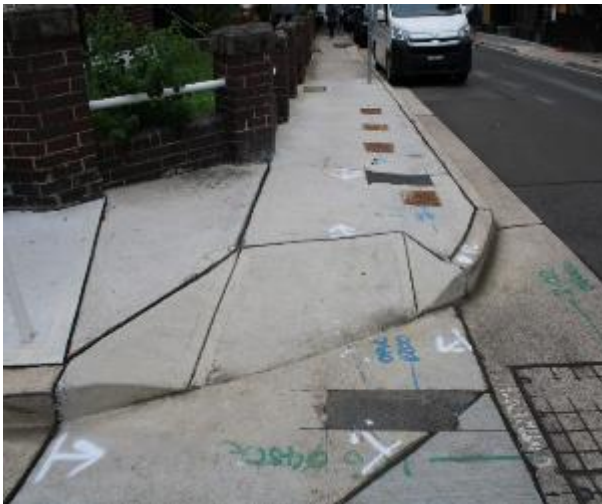
Figure 231 - General condition of footpath pavement heading West

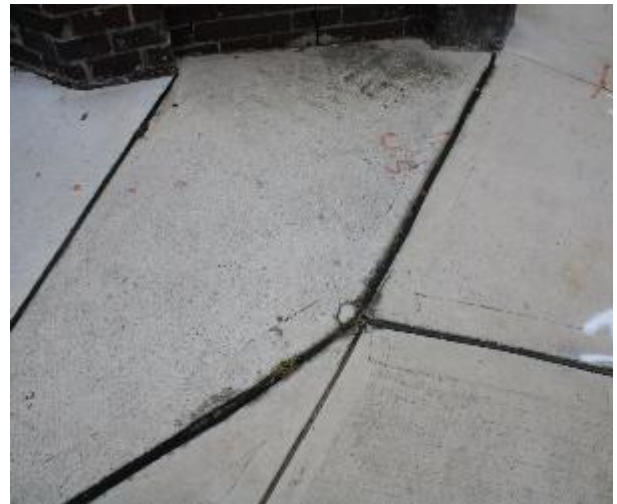
Figure 232 - Crack propagation through footpath pavement heading West

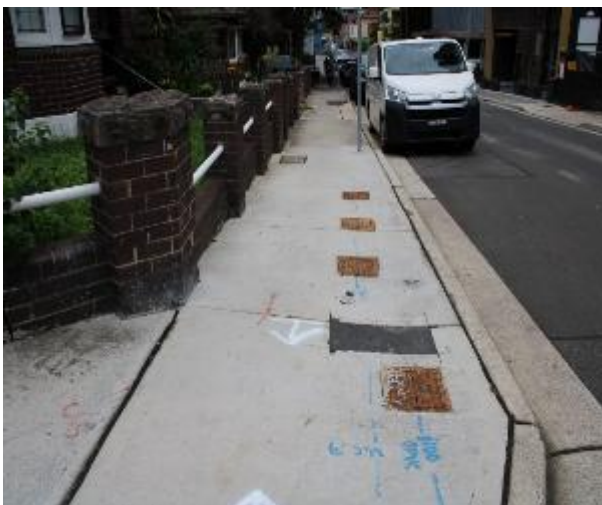
Figure 233 - General condition of footpath pavement heading West

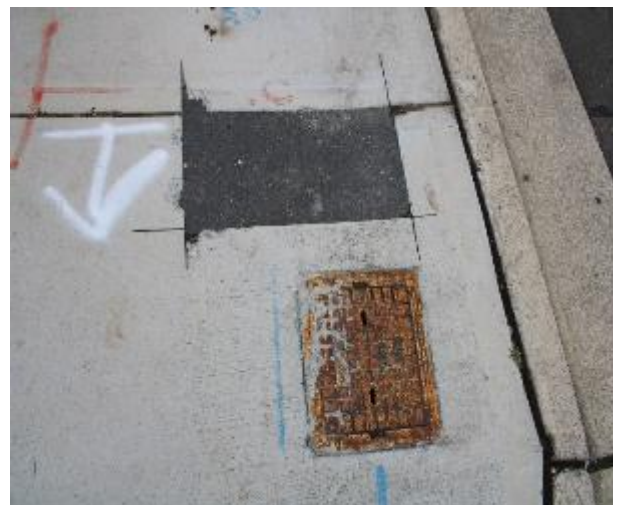
Figure 234 - General condition of service pit

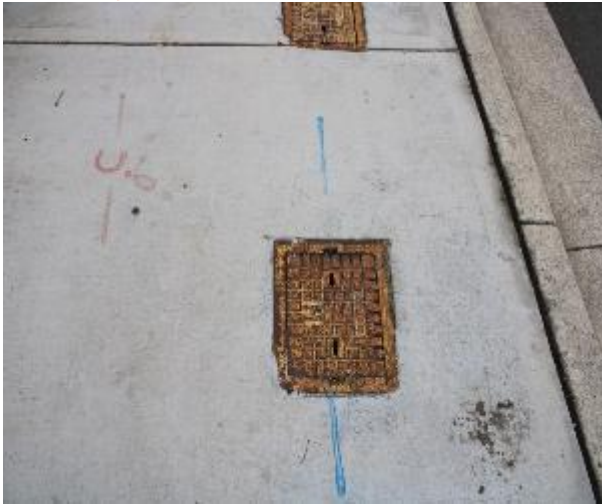
Figure 235 - General condition of service pit

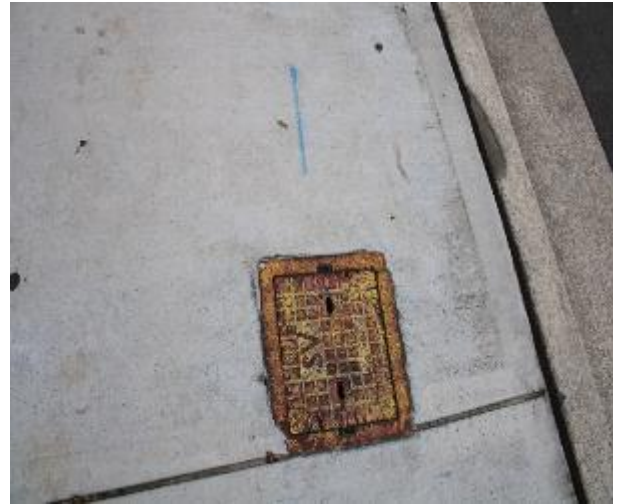
Figure 236 - General condition of service pit

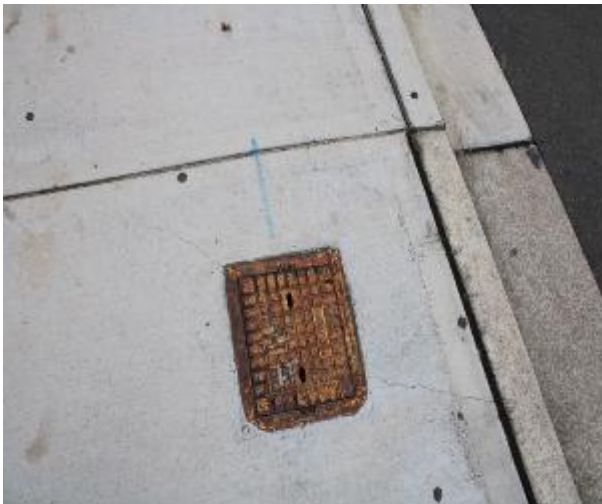
Figure 237 - General condition of service pit

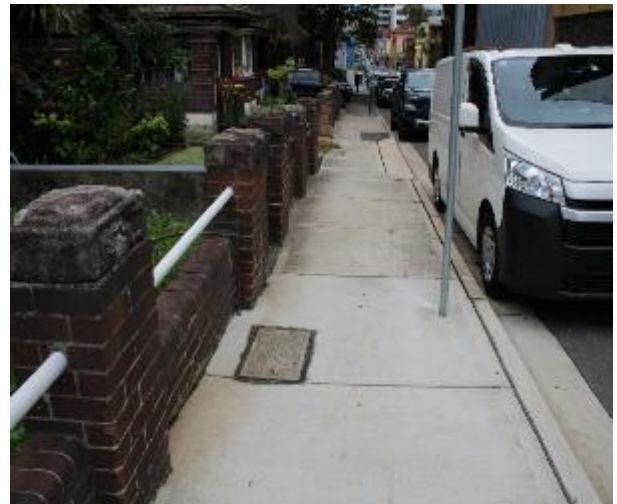
Figure 238 - General condition of footpath pavement heading West

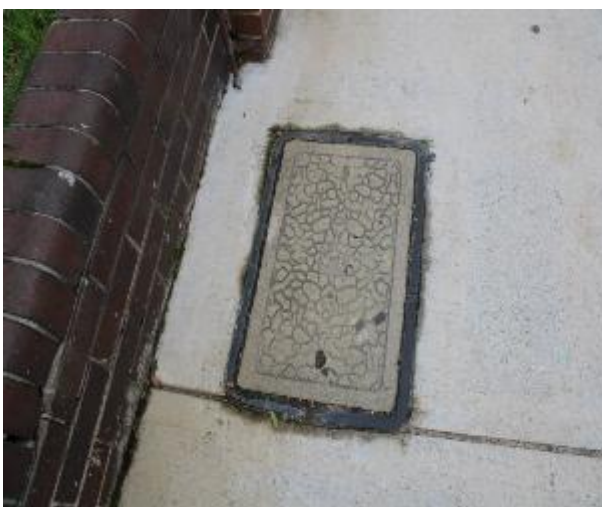
Figure 239 - General condition of service pit

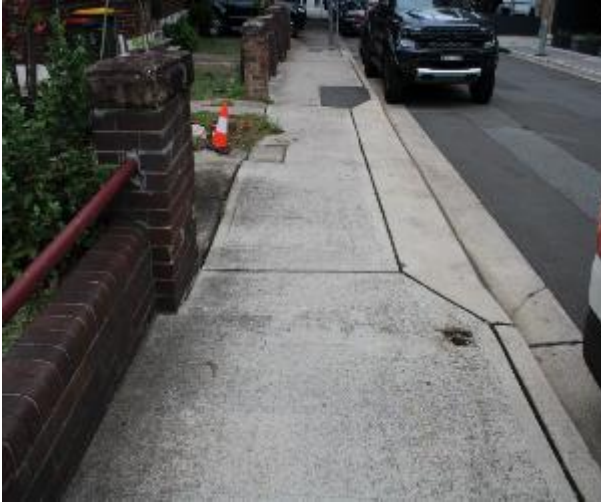
Figure 241 - General condition of footpath pavement heading West

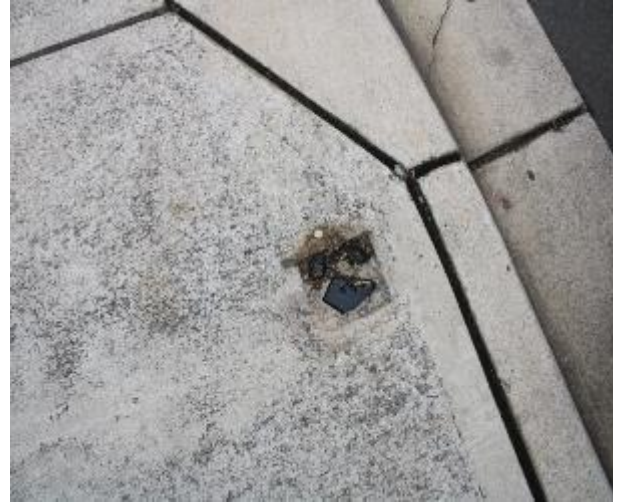
Figure 242 - General condition of service pit

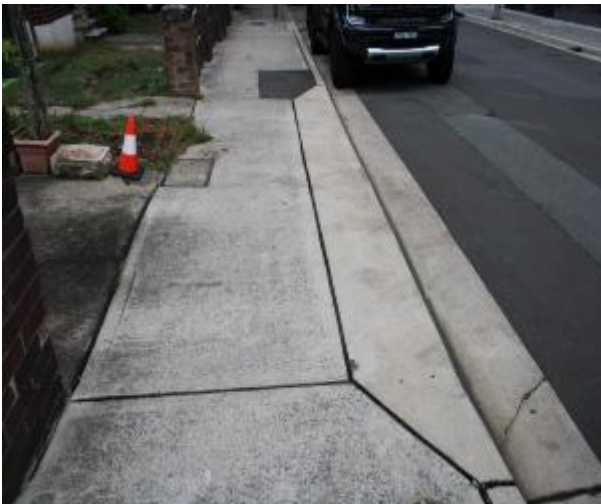
Figure 243 - General condition of footpath pavement heading West

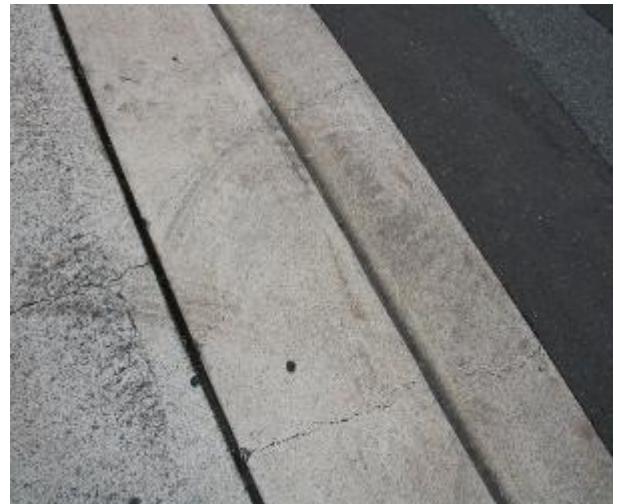
Figure 244 - Crack propagation through footpath pavement heading West

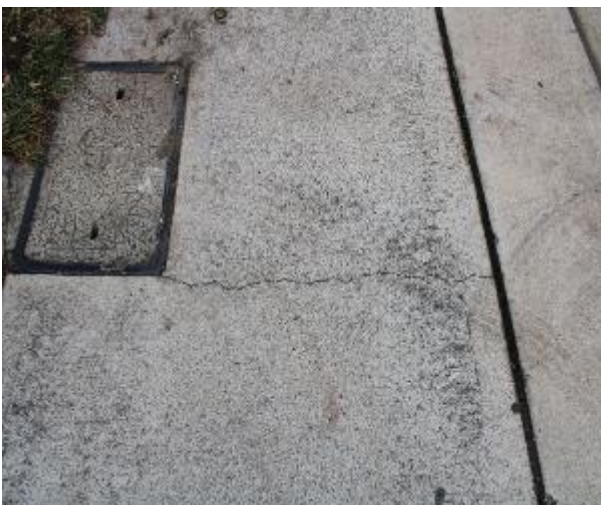
Figure 245 - Crack propagation through footpath pavement heading West

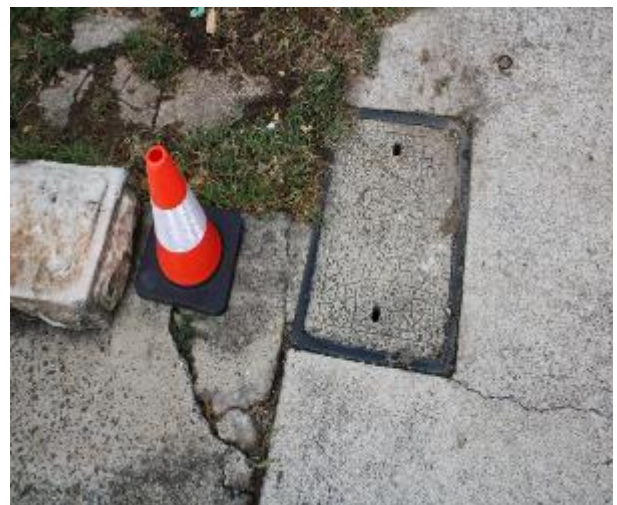
Figure 246 - General condition of service pit
