# **PRE-DILAPIDATION REPORT**

**COUNCIL ASSETS**

**21 GEORGE STREET,  
BURWOOD, NSW 2134**

PROJECT REFERENCE: 20250047.CA.1  
17/04/2026

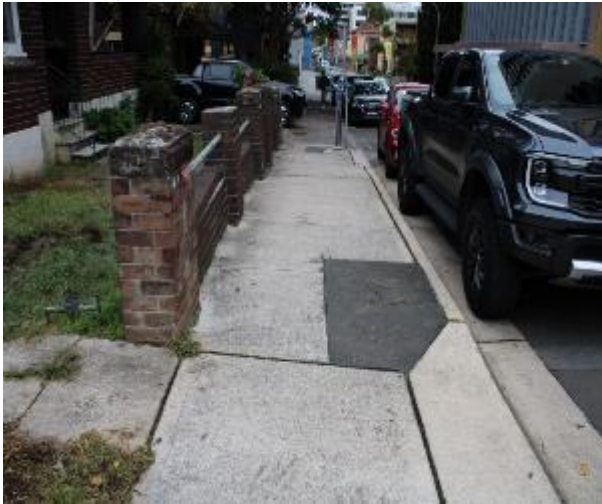
Figure 247 - General condition of footpath pavement heading West

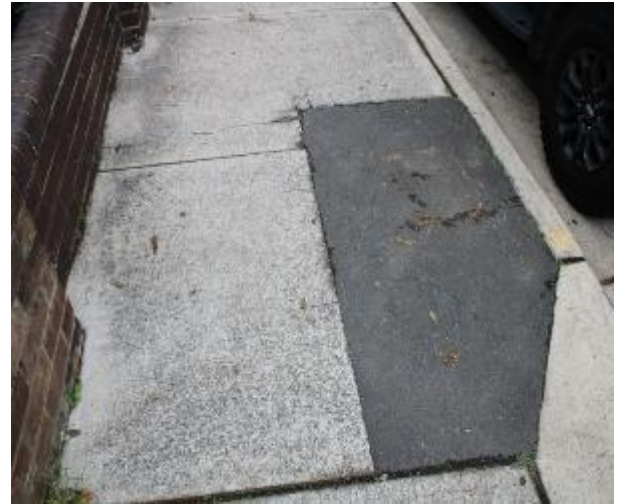
Figure 248 - Patchwork evident through footpath pavement heading West

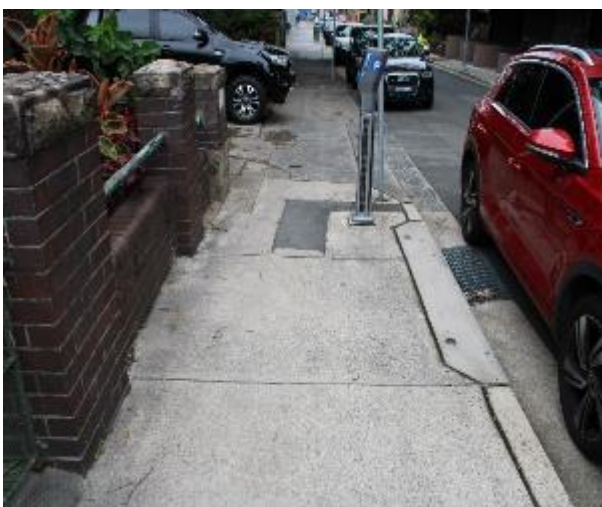
Figure 251 - General condition of footpath pavement heading West

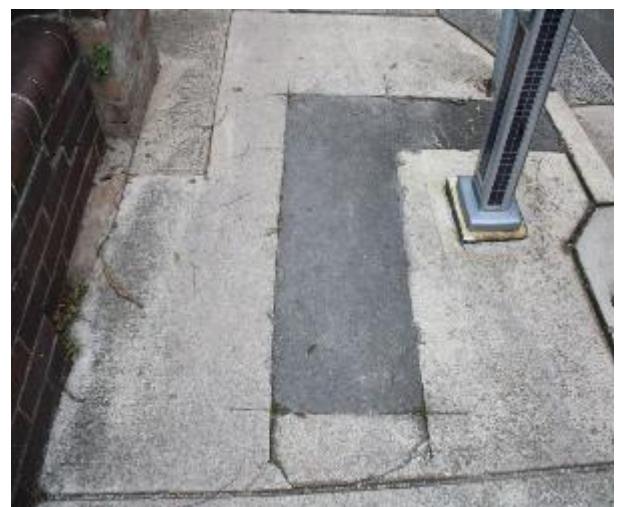
Figure 252 - General condition of patchwork evident through footpath pavement heading West

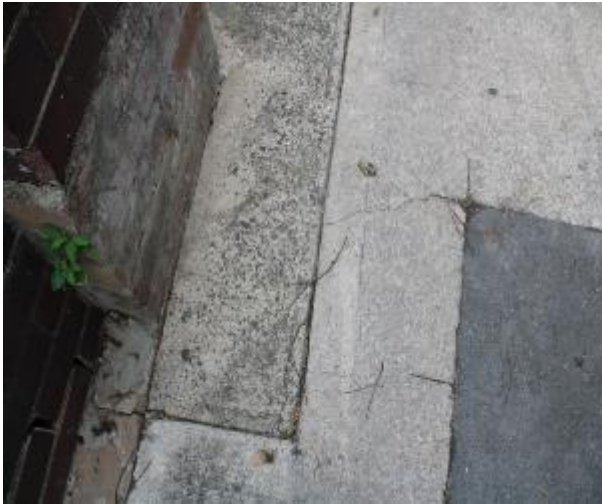
Figure 253 - Crack propagation through footpath pavement heading West

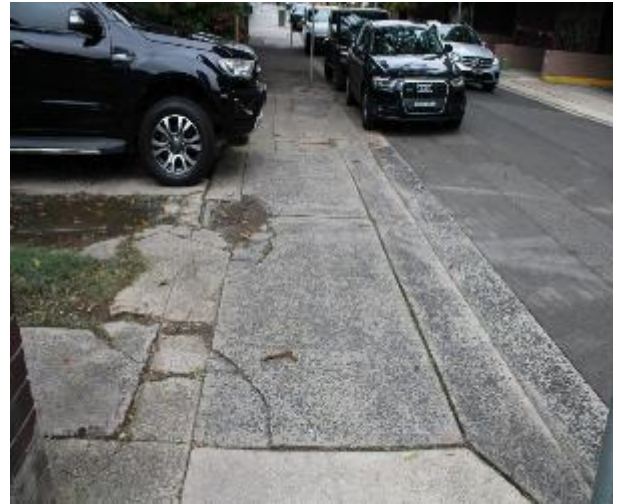
Figure 254 - General condition of footpath pavement heading West

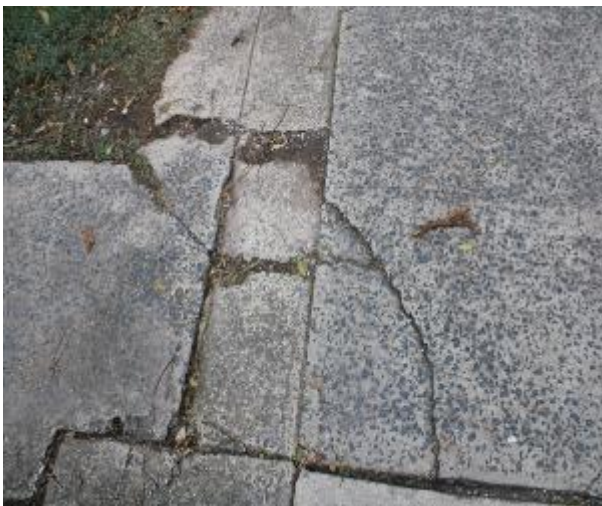
Figure 255 - Crack propagation through footpath pavement heading West

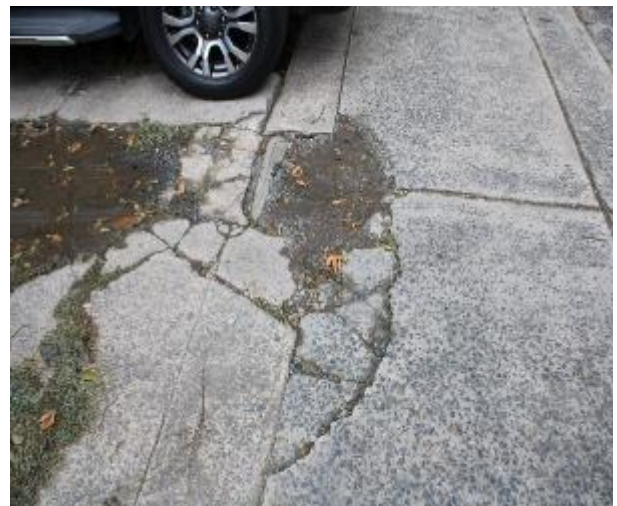
Figure 256 - Crack propagation and loss of materials through footpath pavement heading West

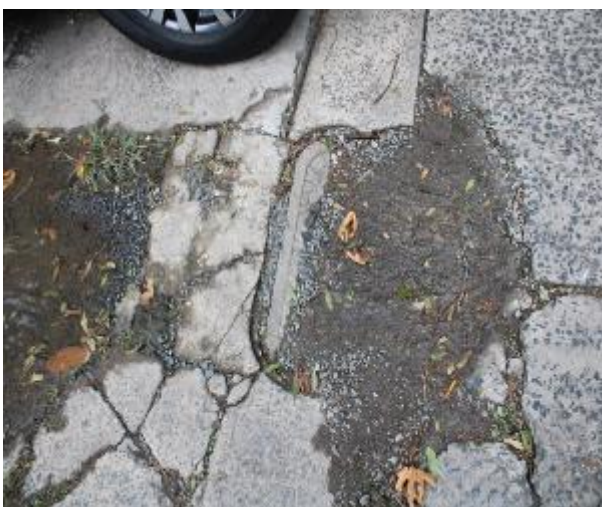
Figure 257 - Crack propagation and loss of materials through footpath pavement heading West

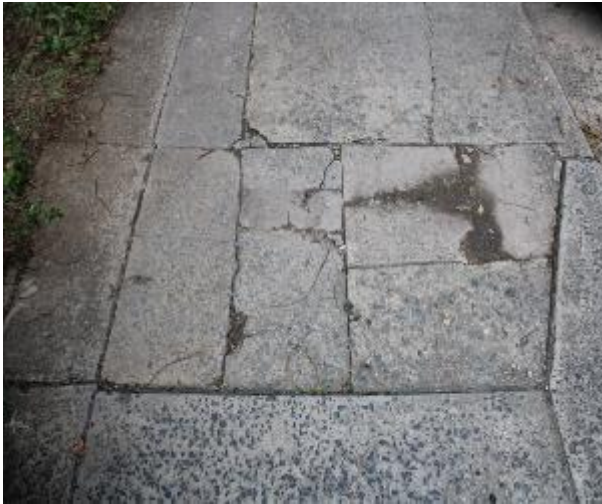
Figure 259 - Crack propagation through footpath pavement heading West

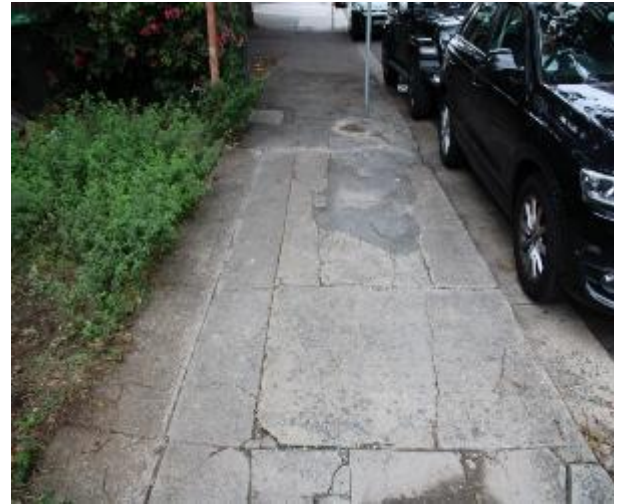
Figure 260 - General condition of footpath pavement heading West

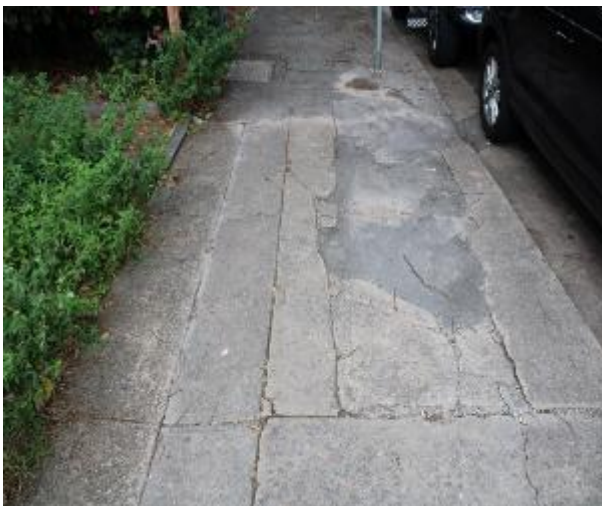
Figure 261 - Crack propagation through footpath pavement heading West

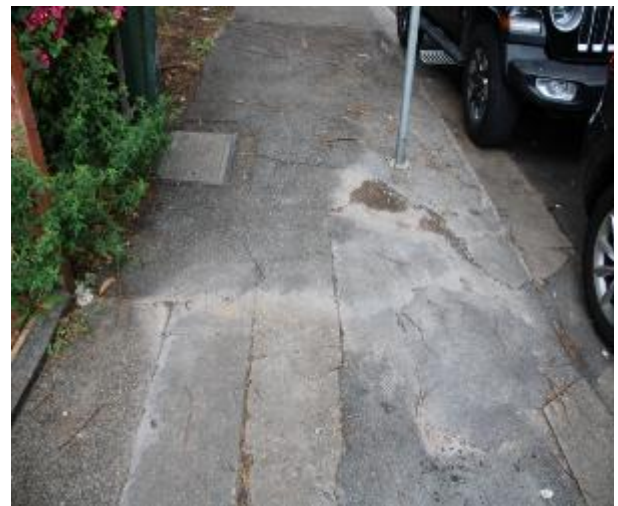
Figure 262 - General condition of footpath pavement heading West

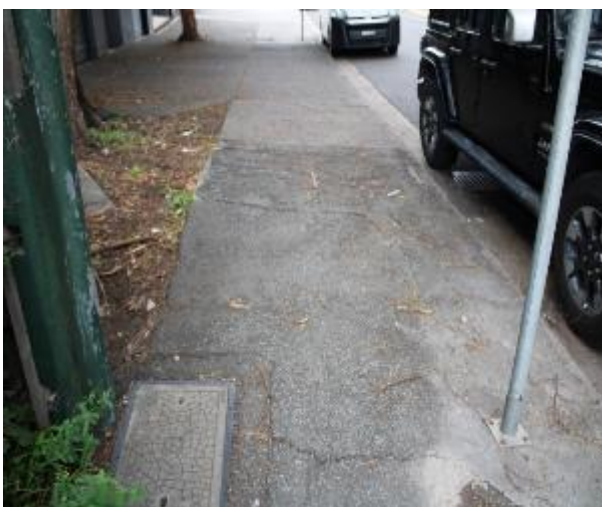
Figure 263 - General condition of footpath pavement heading West

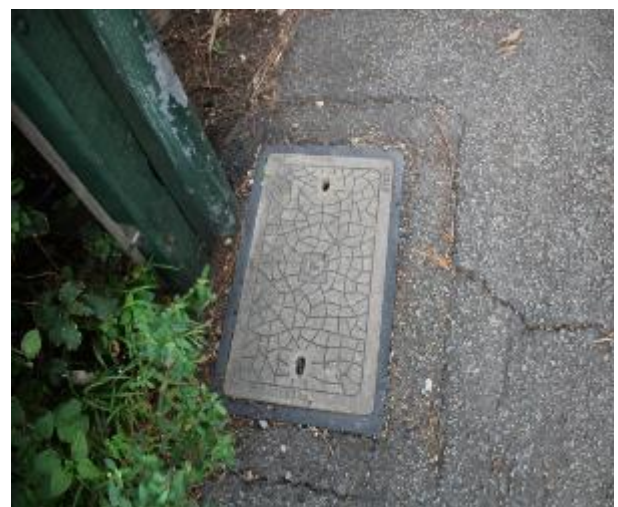
Figure 264 - General condition of service pit

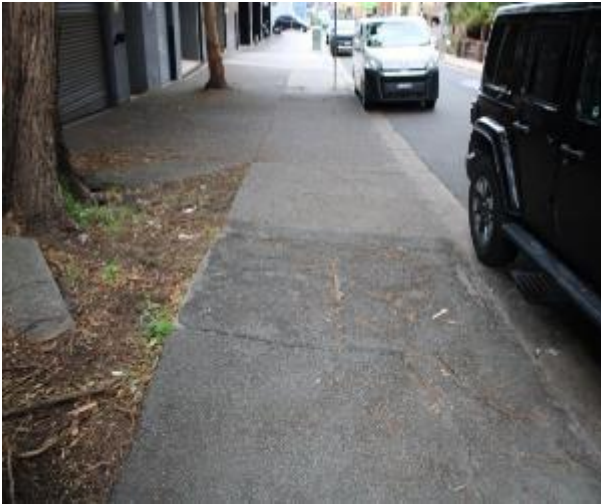
Figure 265 - General condition of footpath pavement heading West

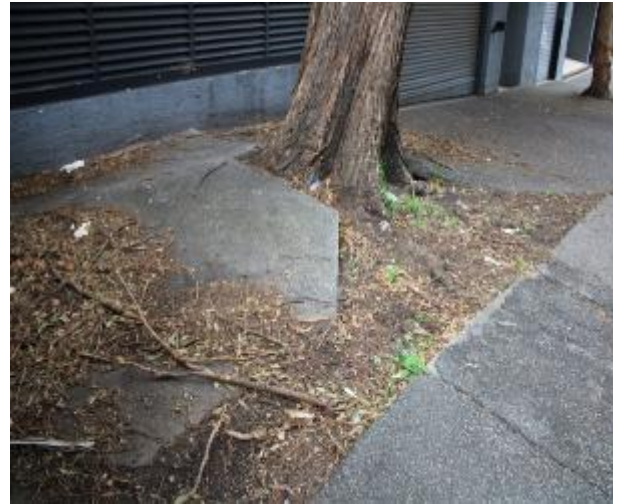
Figure 266 - General condition of footpath pavement heading West

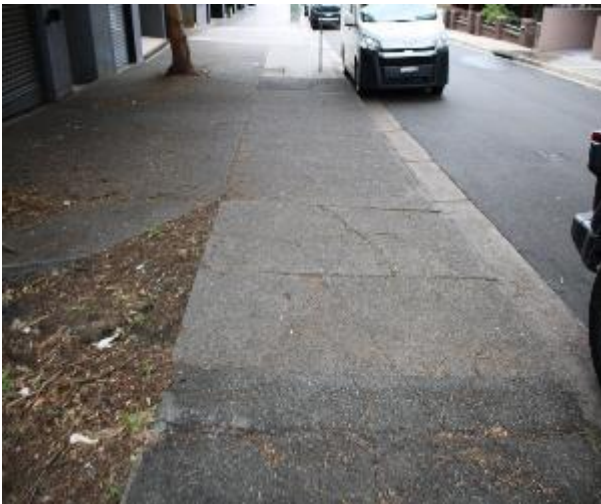
Figure 267 - General condition of footpath pavement heading West

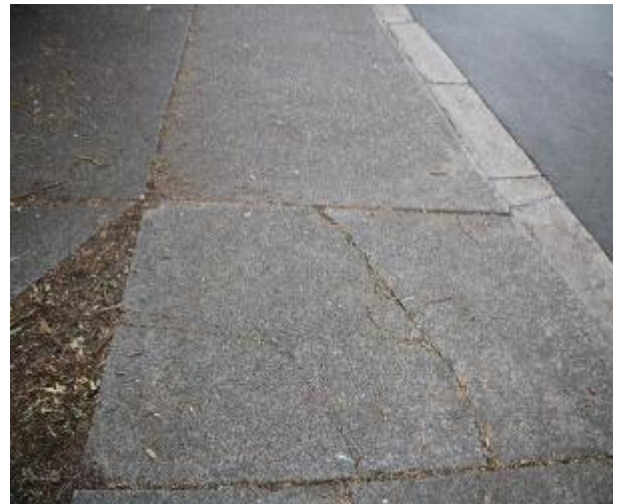
Figure 268 - Crack propagation through footpath pavement heading West

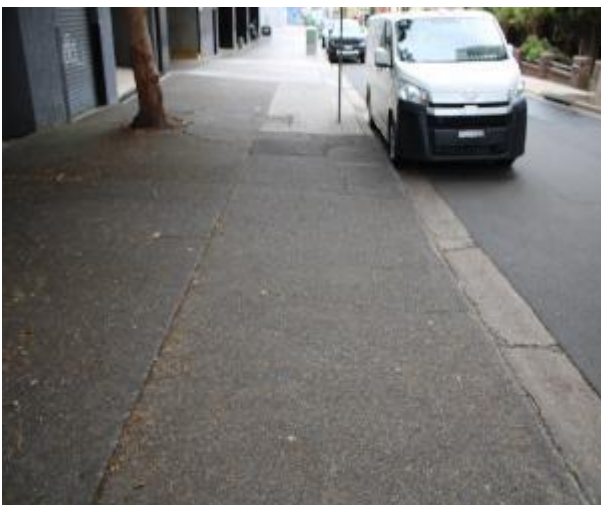
Figure 269 - General condition of footpath pavement heading West

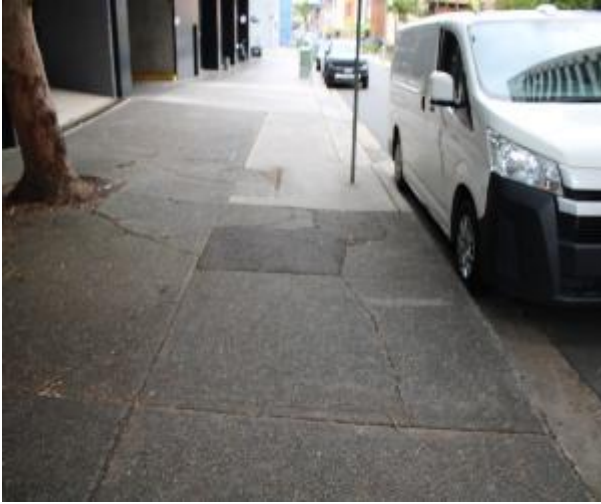
Figure 271 - General condition of footpath pavement heading West

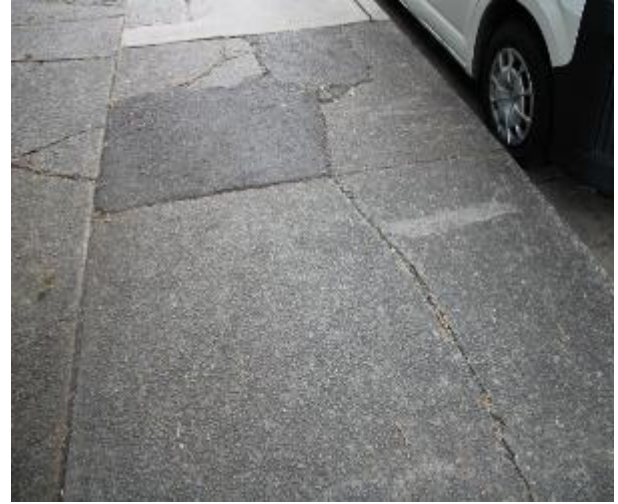
Figure 272 - Crack propagation through footpath pavement heading West

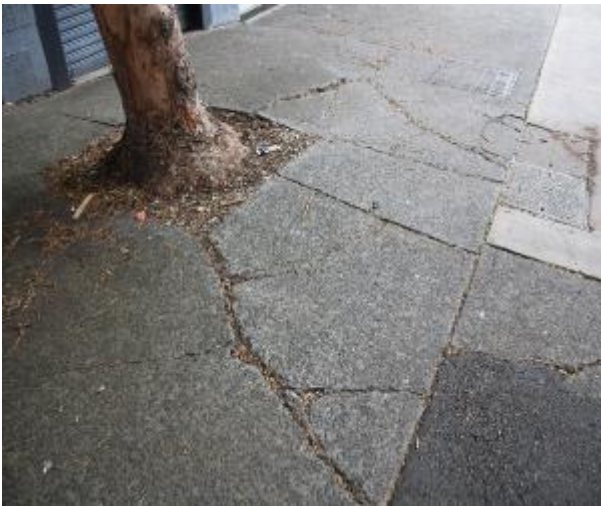
Figure 273 - Crack propagation through footpath pavement heading West

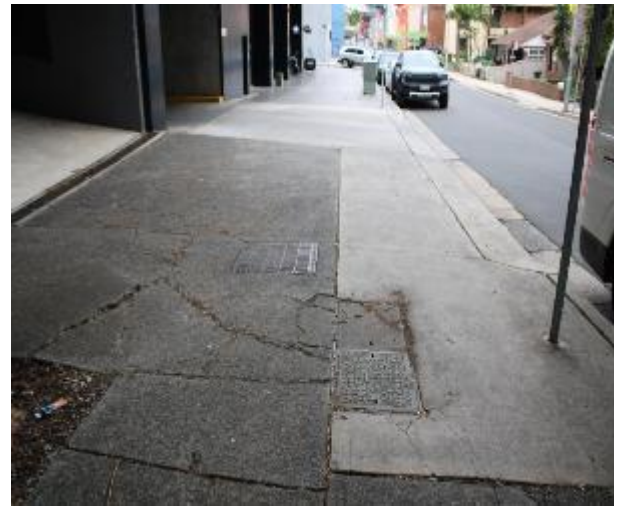
Figure 274 - General condition of footpath pavement heading West

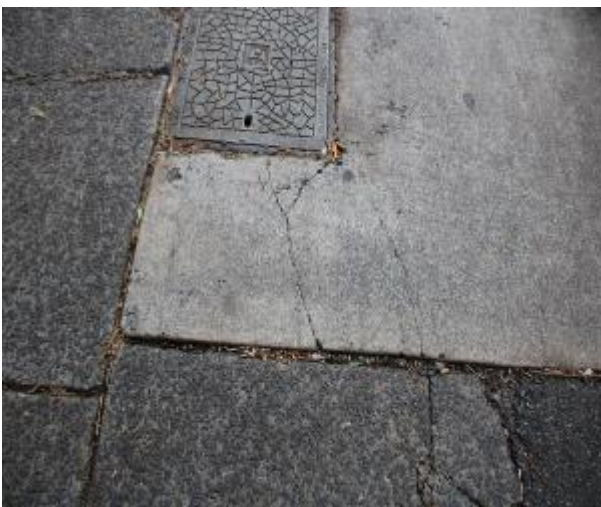
Figure 275 - Crack propagation through footpath pavement heading West

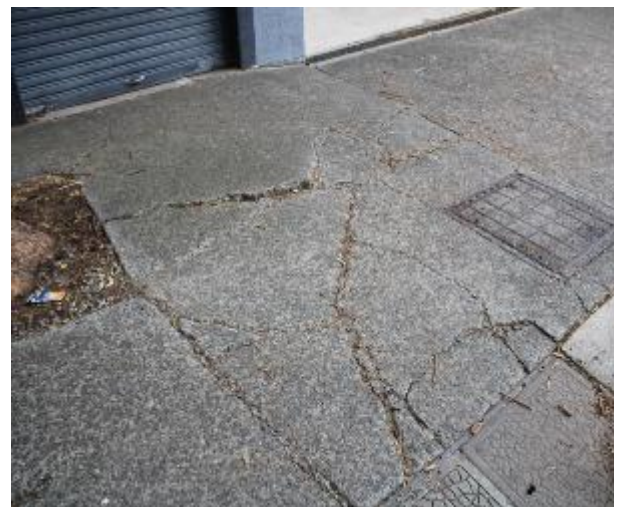
Figure 276 - Crack propagation through footpath pavement heading West

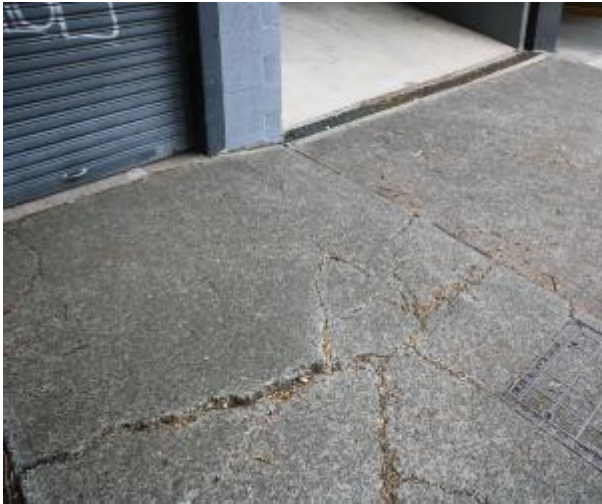
Figure 277 - Crack propagation through footpath pavement heading West

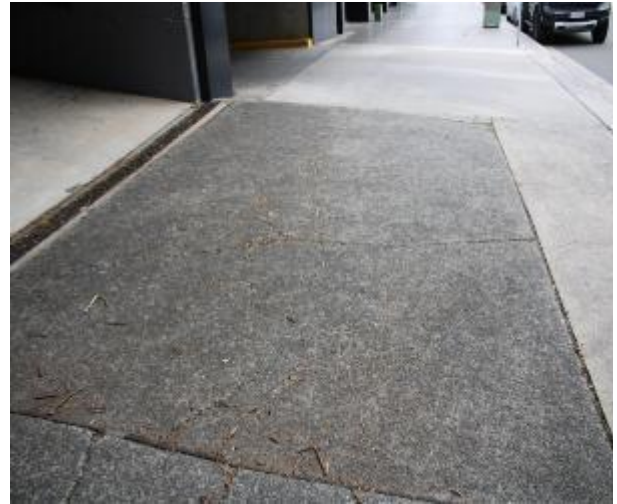
Figure 278 - General condition of footpath pavement heading West

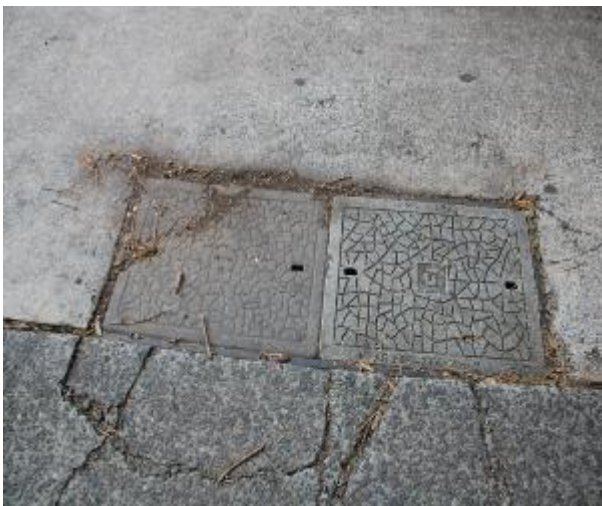
Figure 279 - General condition of service pit

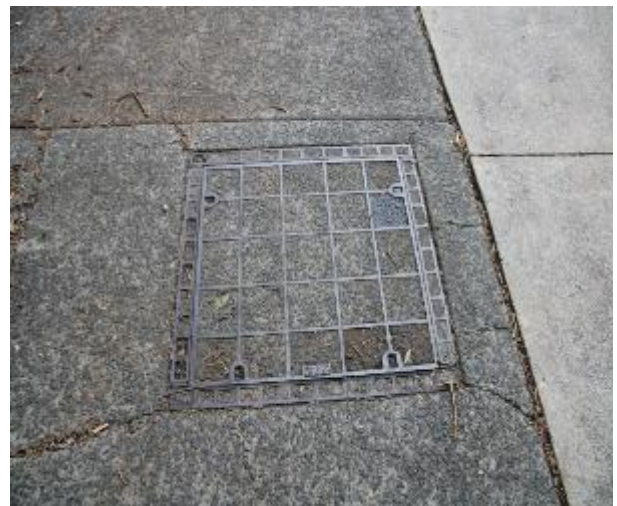
Figure 280 - General condition of service pit

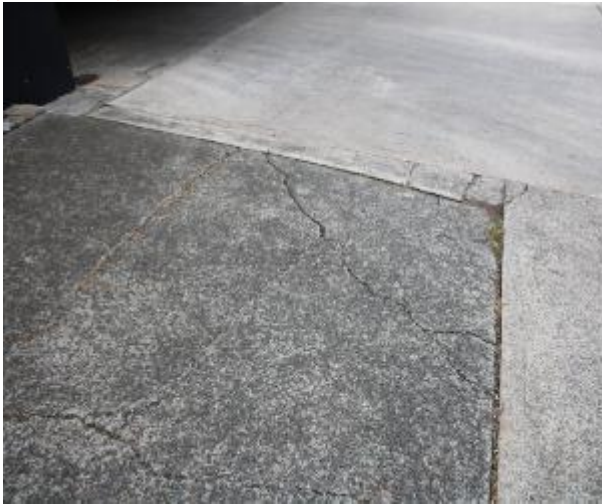
Figure 283 - Crack propagation through footpath pavement heading West

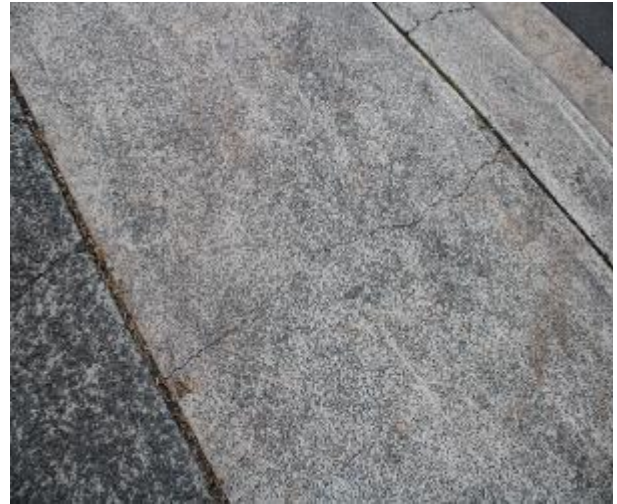
Figure 284 - Crack propagation through footpath pavement heading West

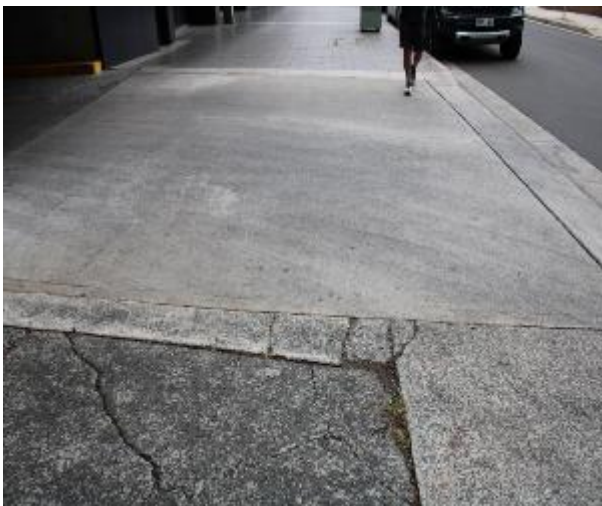
Figure 285 - General condition of footpath pavement heading West

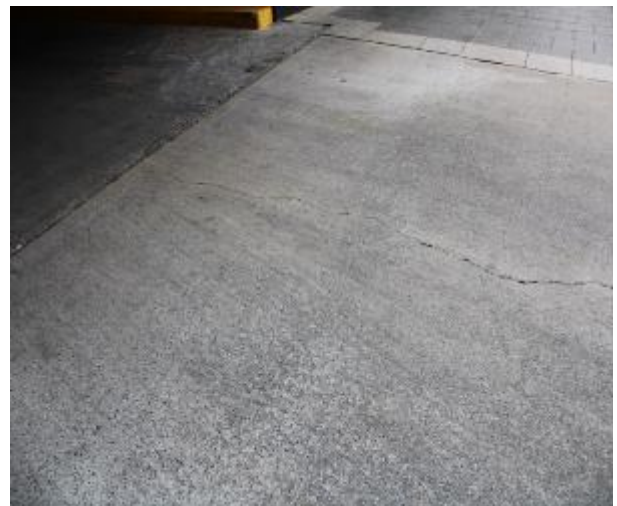
Figure 286 - Crack propagation through footpath pavement heading West

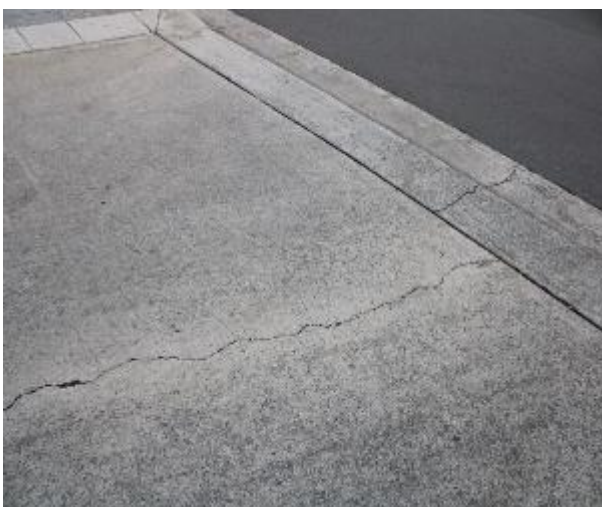
Figure 287 - Crack propagation through footpath pavement heading West

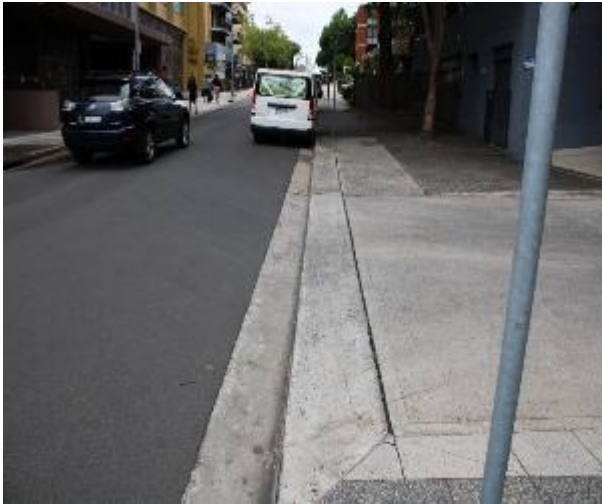
Figure 289 - General condition of kerb and gutter heading East

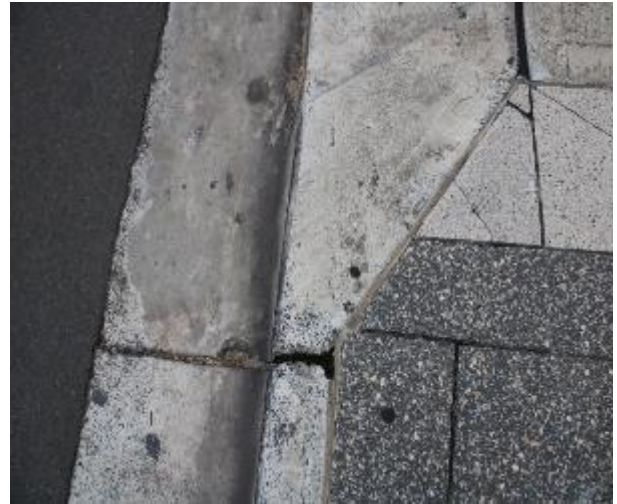
Figure 290 - General condition of kerb and gutter heading East

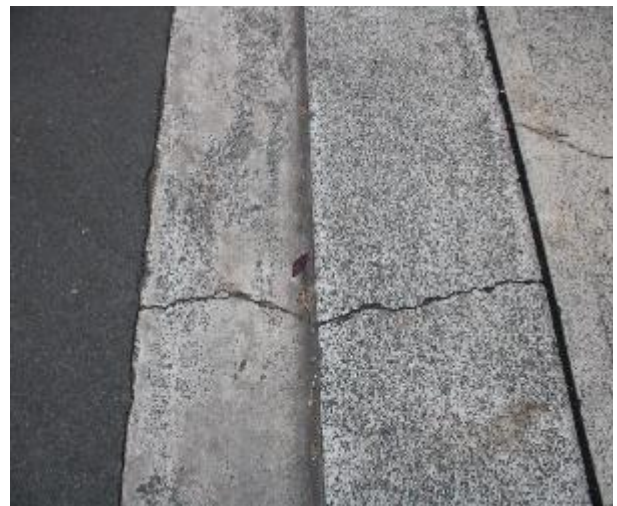
Figure 292 - Crack propagation through driveway layback and gutter heading East

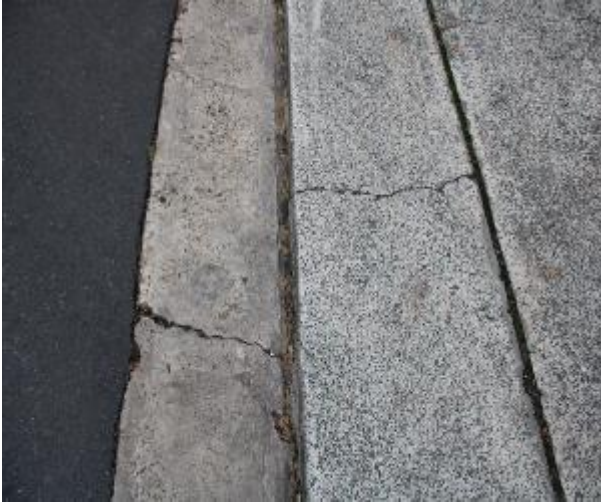
Figure 295 - Crack propagation through driveway layback and gutter heading East

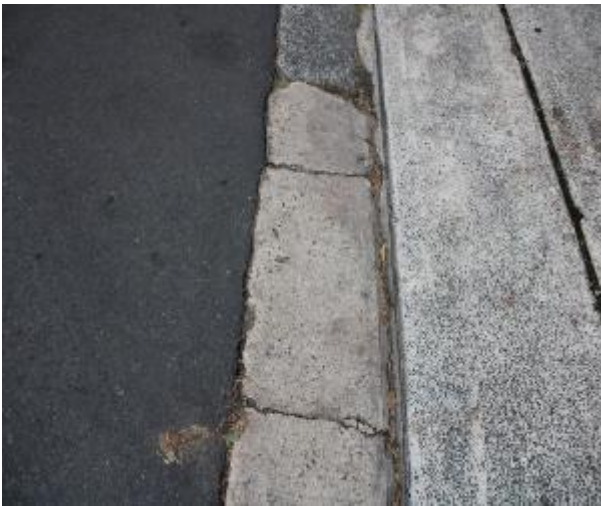
Figure 297 - Crack propagation through driveway layback and gutter heading East

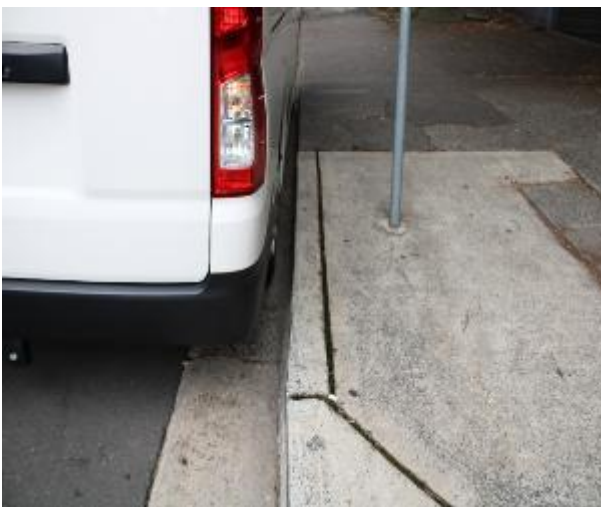
Figure 299 - General condition of kerb and gutter heading East

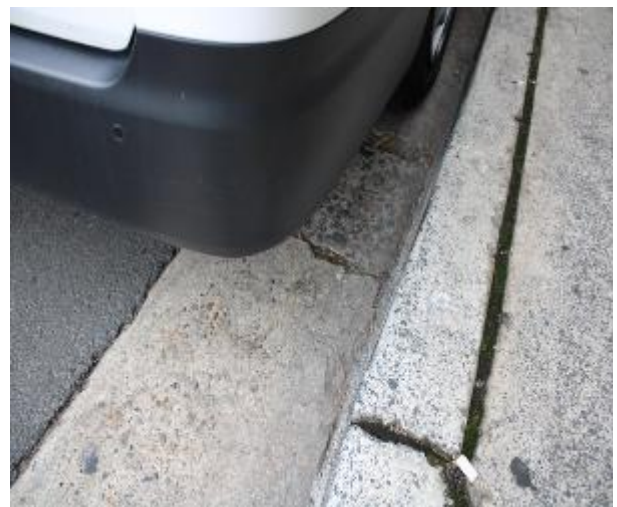
Figure 300 - Crack propagation through kerb and gutter heading East

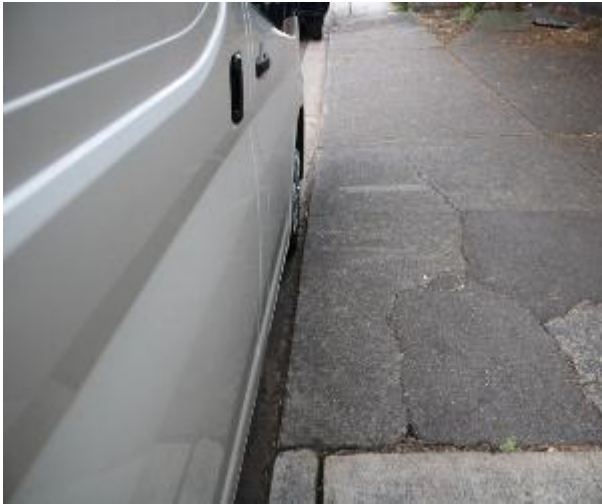
Figure 301 - General condition of kerb and gutter heading East

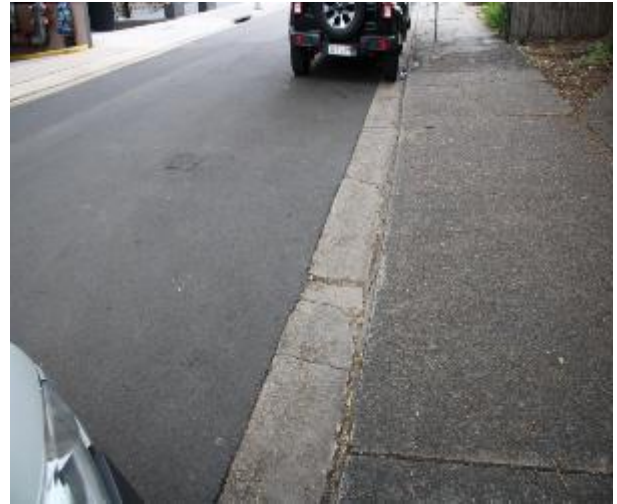
Figure 302 - General condition of kerb and gutter heading East

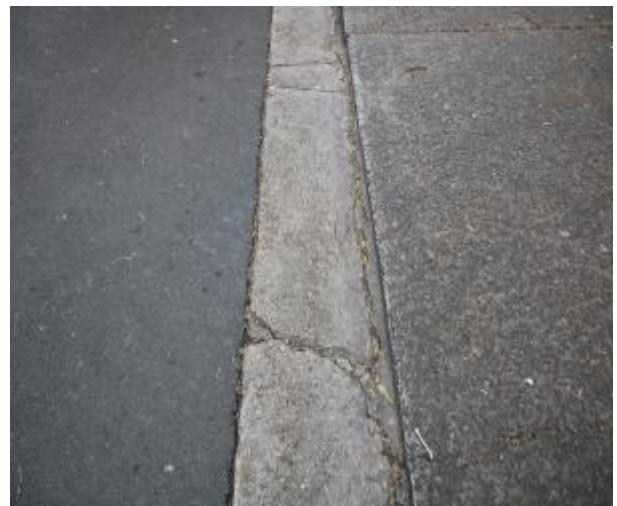
Figure 304 - Crack propagation through kerb and gutter heading East

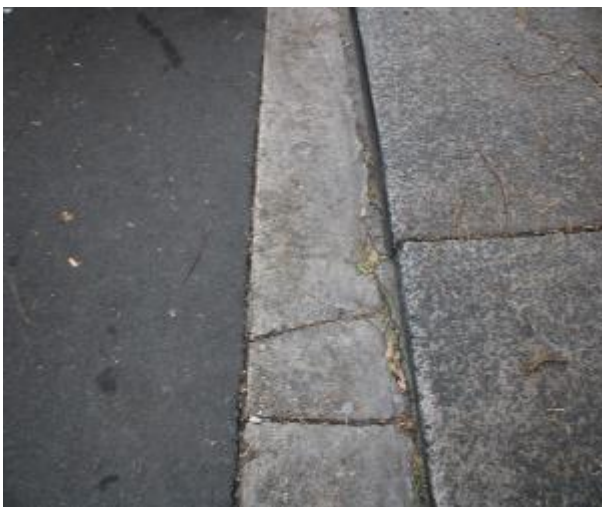
Figure 305 - Crack propagation through kerb and gutter heading East

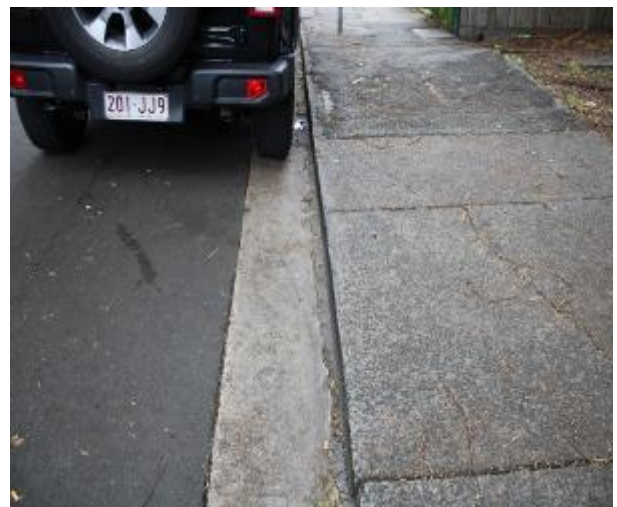
Figure 306 - General condition of kerb and gutter heading East

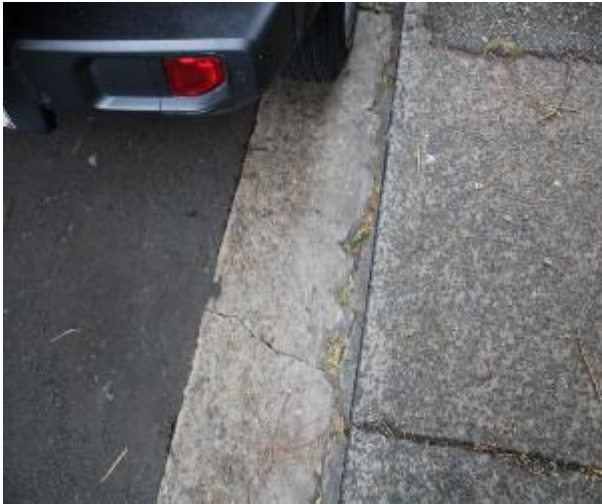
Figure 307 - Crack propagation through kerb and gutter heading East

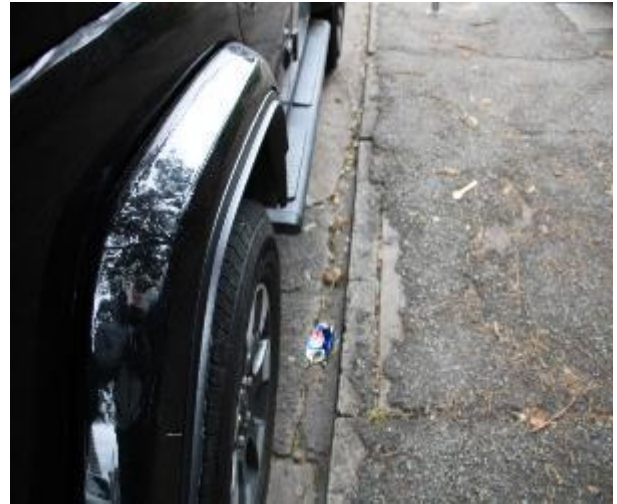
Figure 308 - General condition of kerb and gutter heading East

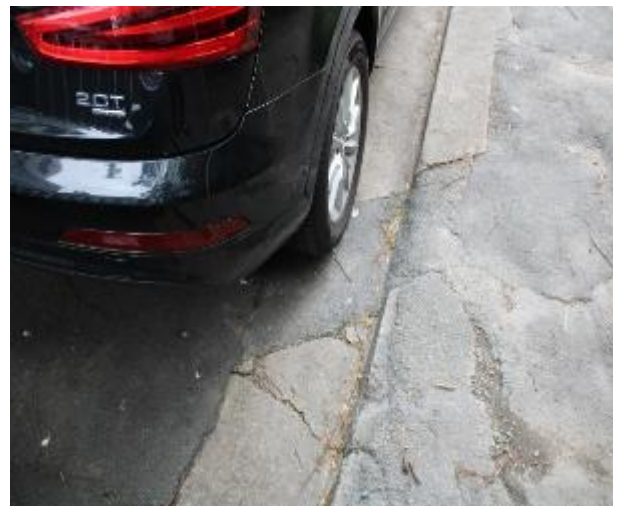
Figure 310 - Crack propagation through kerb and gutter heading East

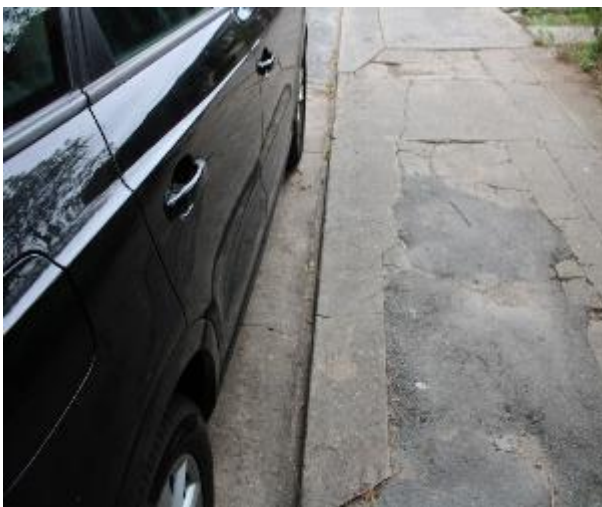
Figure 311 - General condition of kerb and gutter heading East

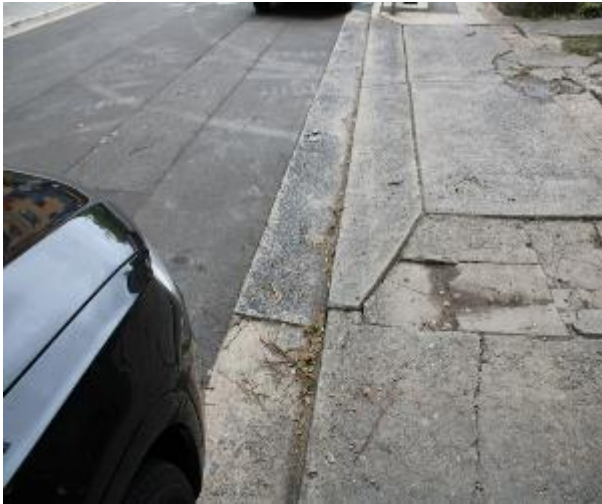
Figure 313 - General condition of kerb and gutter heading East

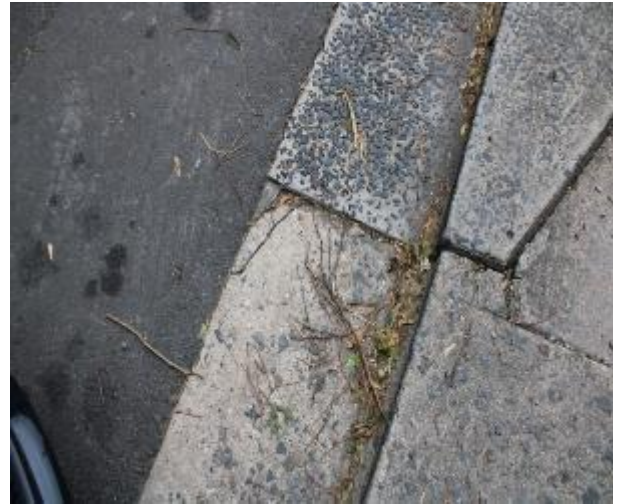
Figure 314 - Crack propagation through kerb and gutter heading East

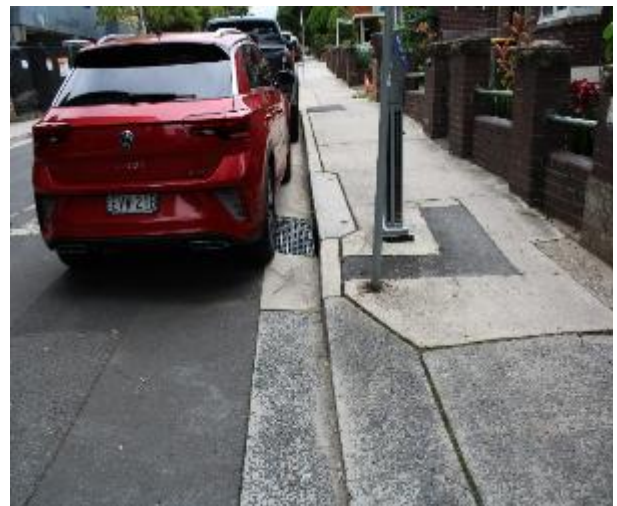
Figure 316 - General condition of kerb and gutter heading East

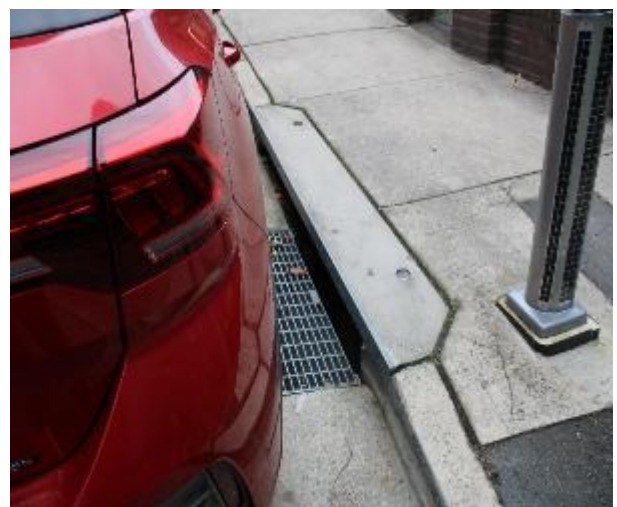
Figure 318 - General condition of stormwater inlet pit

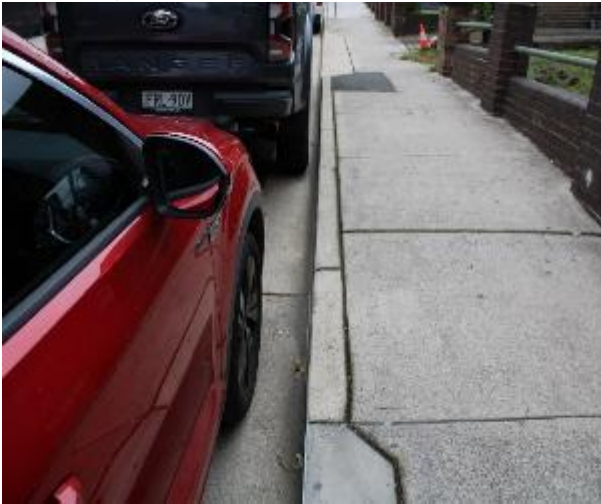
Figure 319 - General condition of kerb and gutter heading East

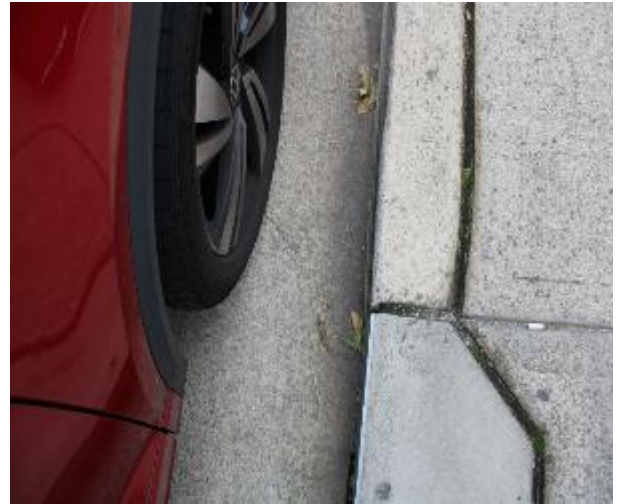
Figure 320 - Crack propagation through kerb and gutter heading East

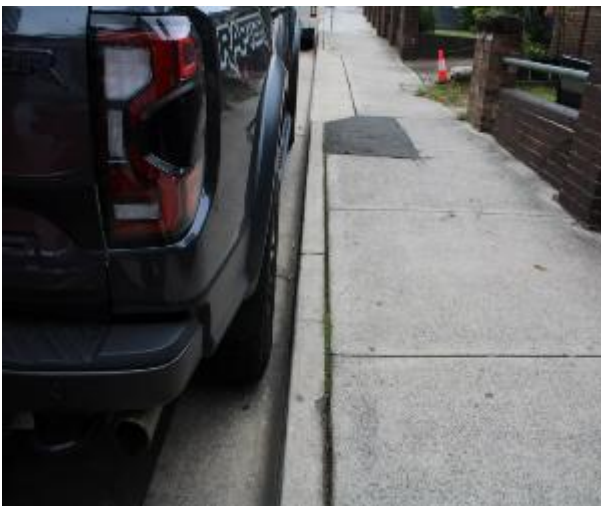
Figure 321 - General condition of kerb and gutter heading East

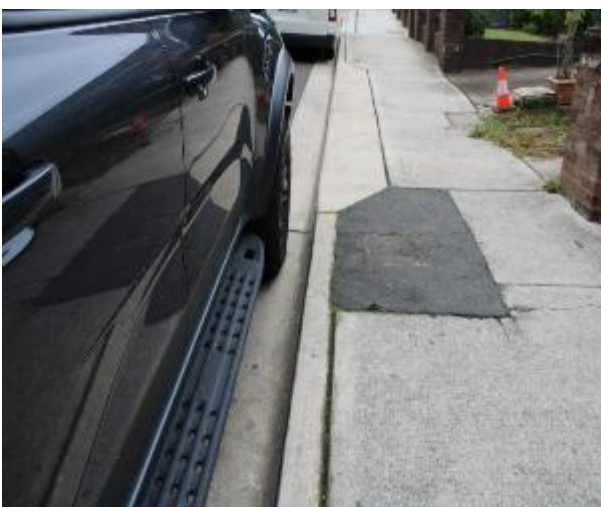
Figure 323 - General condition of kerb and gutter heading East

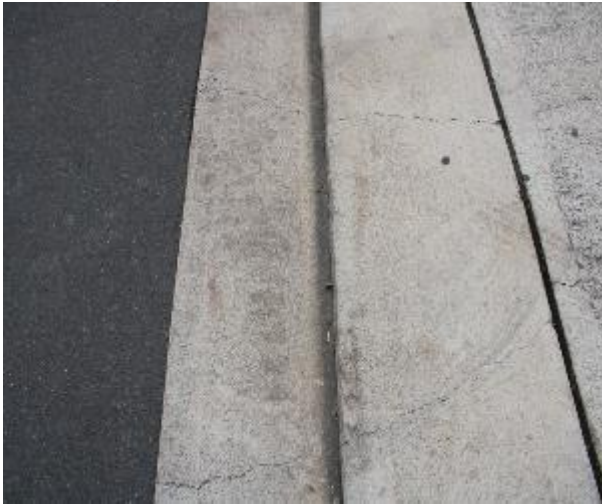
Figure 325 - Crack propagation through driveway layback and gutter heading East

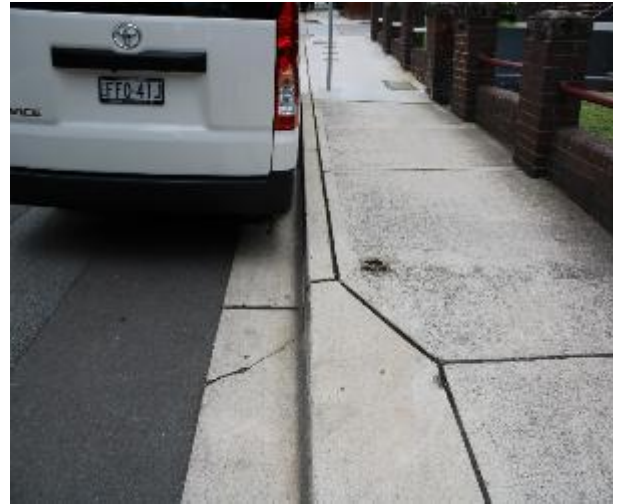
Figure 326 - General condition of kerb and gutter heading East

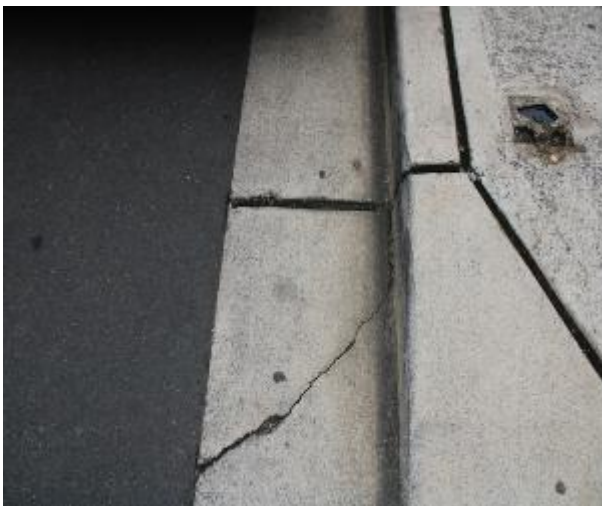
Figure 327 - Crack propagation through kerb and gutter heading East

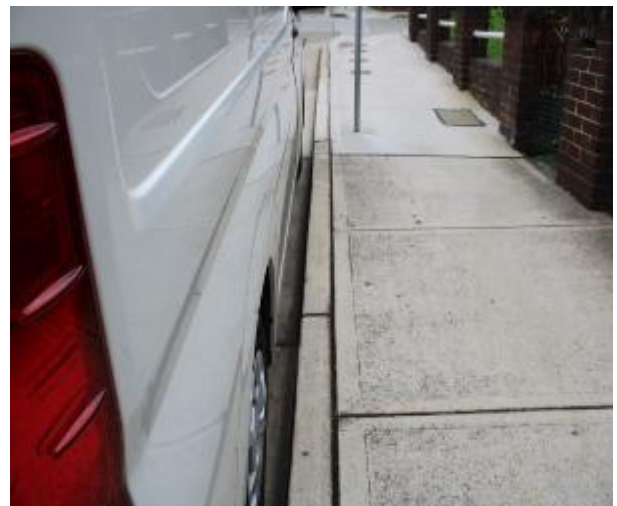
Figure 328 - General condition of kerb and gutter heading East

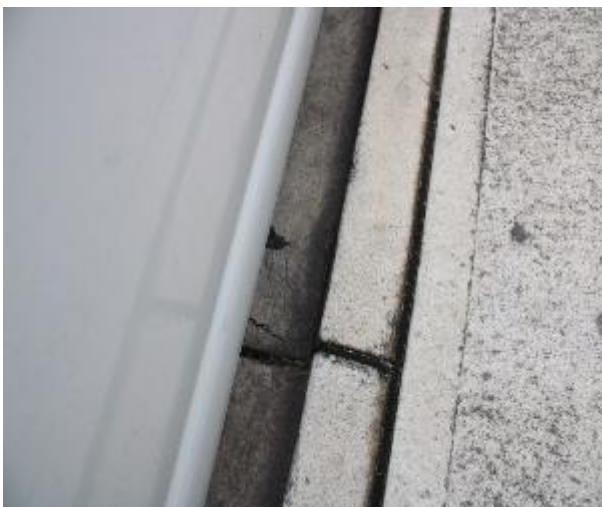
Figure 329 - Crack propagation through kerb and gutter heading East

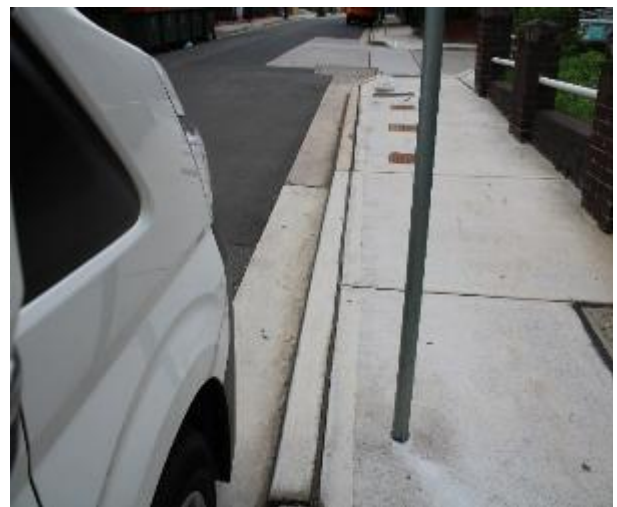
Figure 330 - General condition of kerb and gutter heading East

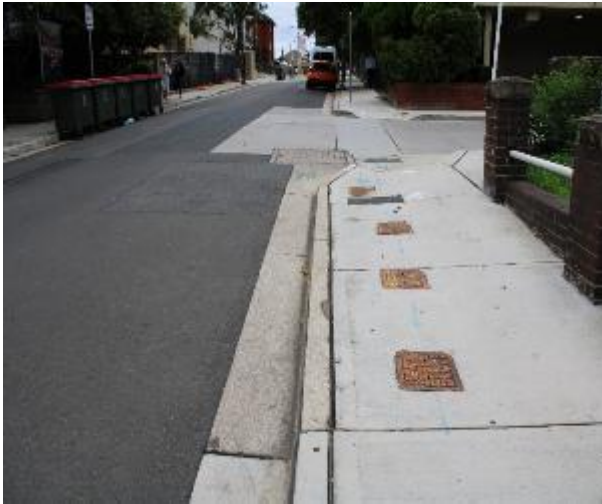
Figure 331 - General condition of kerb and gutter heading East

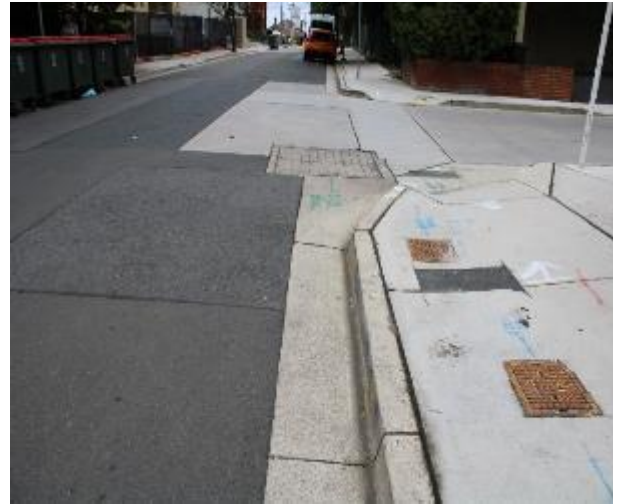
Figure 332 - General condition of kerb and gutter heading East

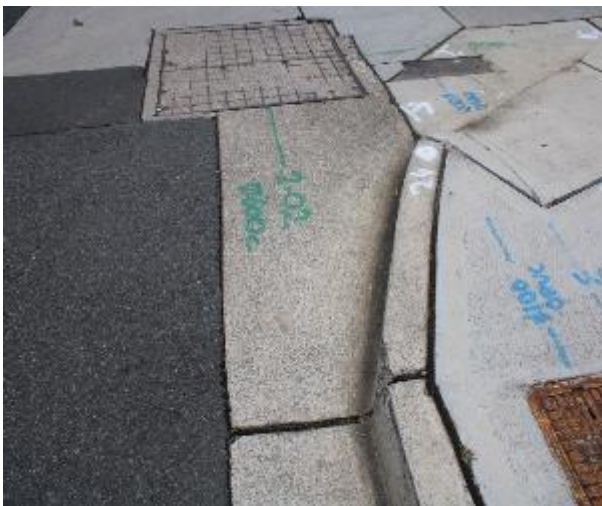
Figure 333 - General condition of kerb and gutter heading East

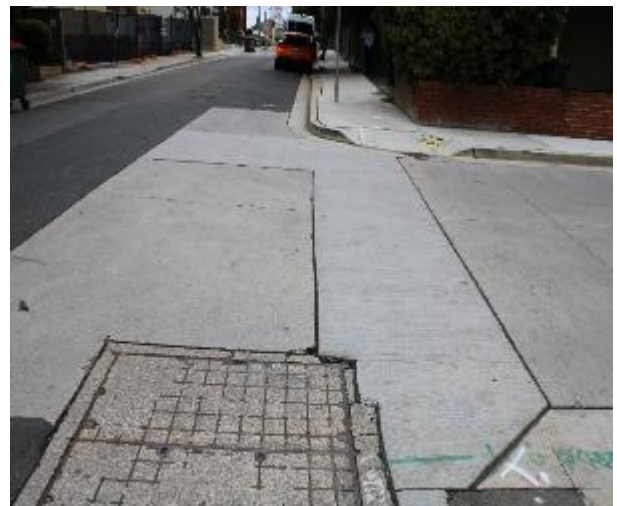
Figure 334 - General condition of road surface heading East

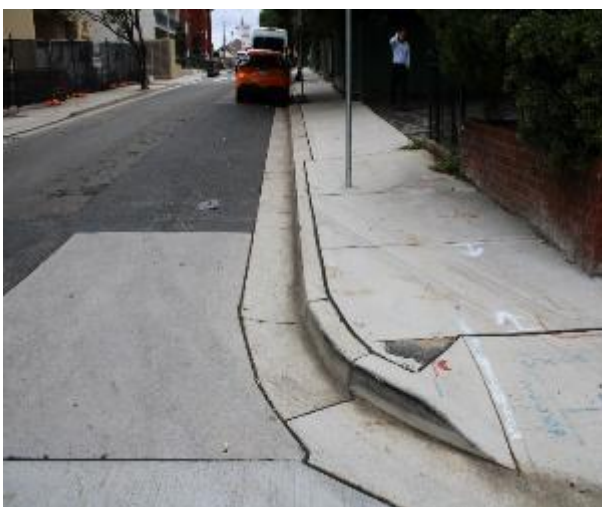
Figure 335 - General condition of kerb and gutter heading East

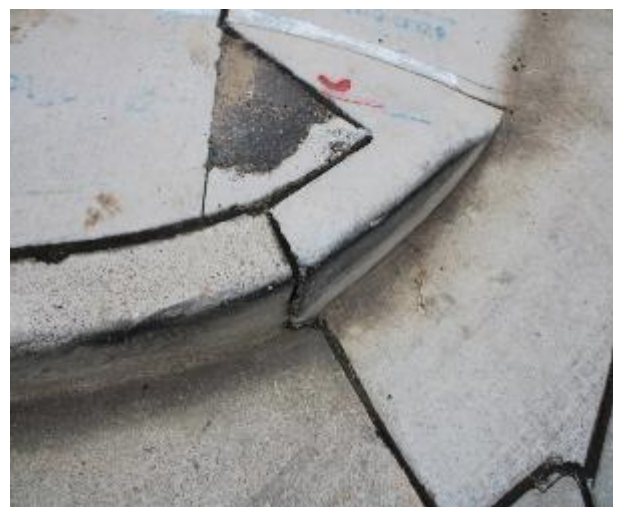
Figure 336 - General condition of kerb and gutter heading East
