# **PRE-DILAPIDATION REPORT**

**COUNCIL ASSETS**

**21 GEORGE STREET,  
BURWOOD, NSW 2134**

PROJECT REFERENCE: 20250047.CA.1  
17/04/2026

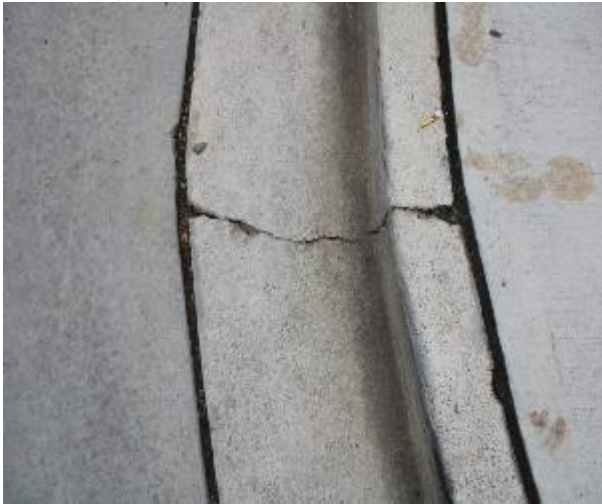
Figure 337 - Crack propagation through kerb and gutter heading East

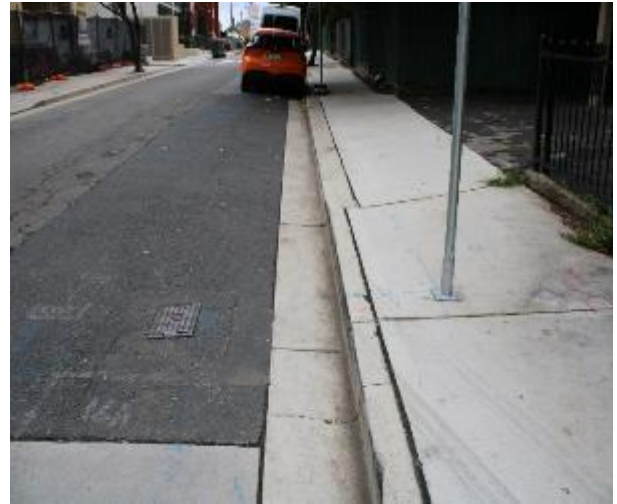
Figure 338 - General condition of kerb and gutter heading East

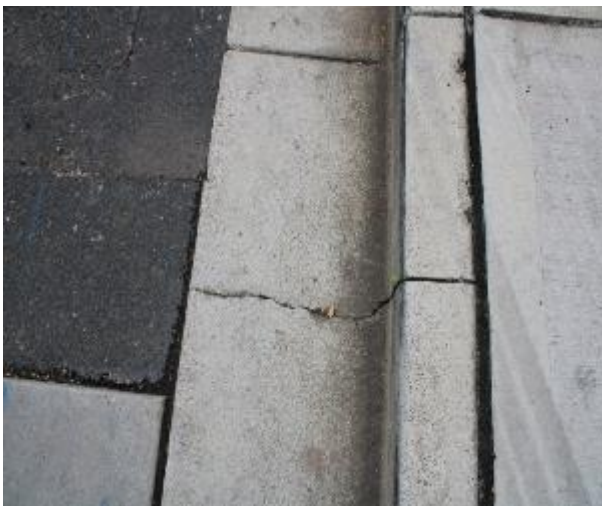
Figure 339 - Crack propagation through kerb and gutter heading East

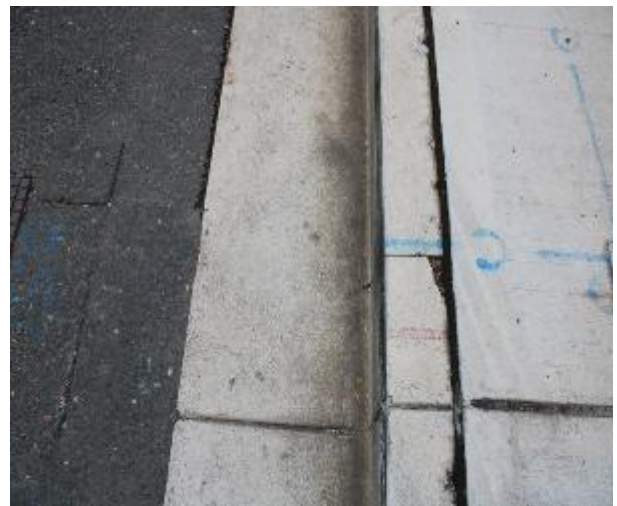
Figure 340 - General condition of kerb and gutter heading East

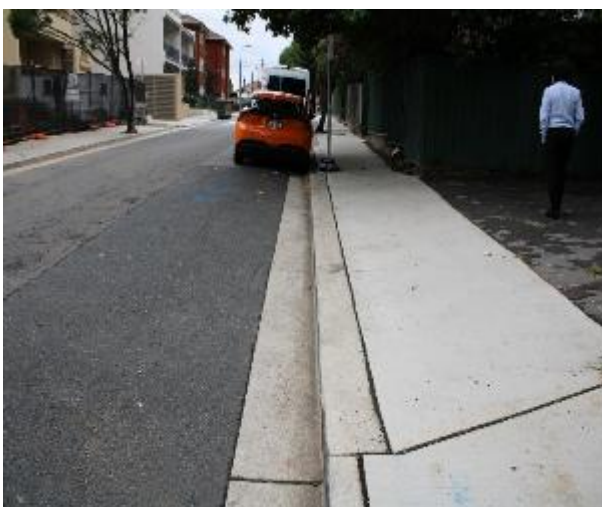
Figure 341 - General condition of kerb and gutter heading East

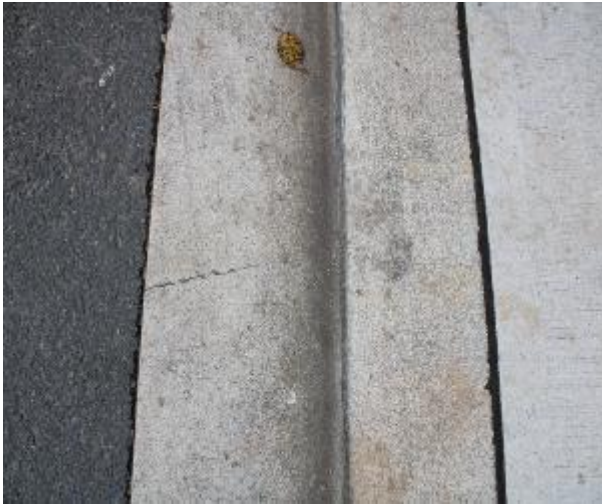
Figure 343 - Crack propagation through kerb and gutter heading East

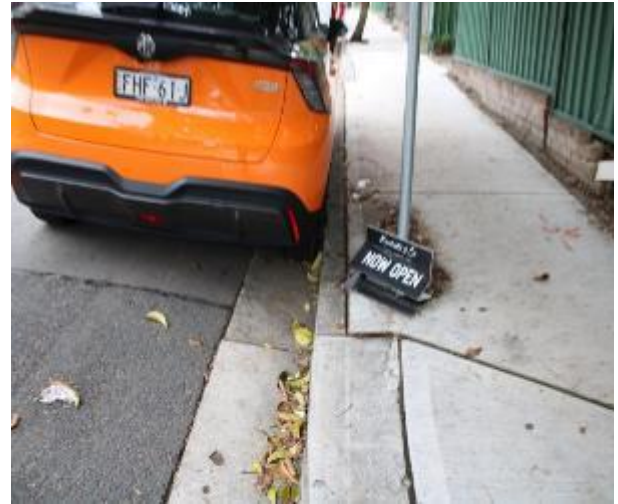
Figure 344 - General condition of kerb and gutter heading East

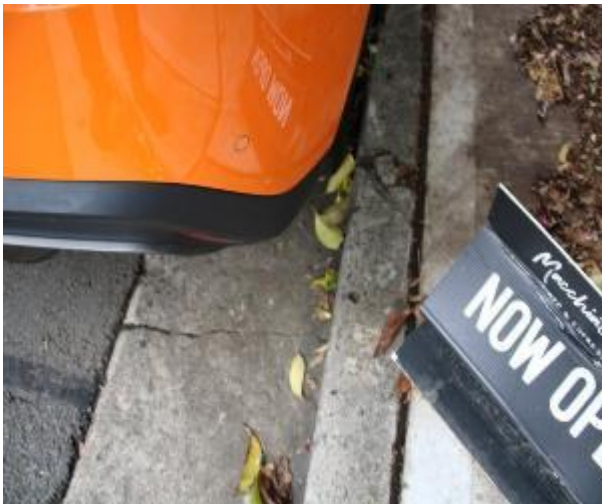
Figure 345 - Crack propagation through kerb and gutter heading East

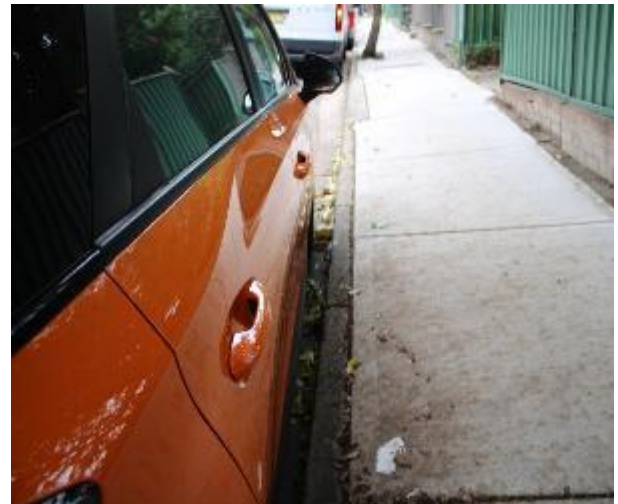
Figure 346 - General condition of kerb and gutter heading East

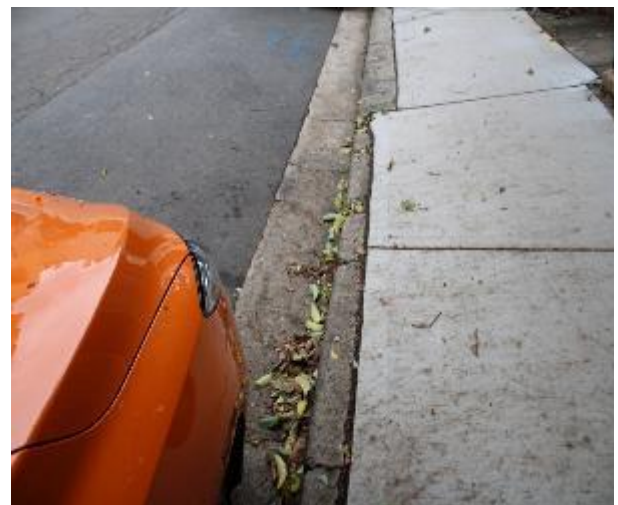
Figure 348 - General condition of kerb and gutter heading East

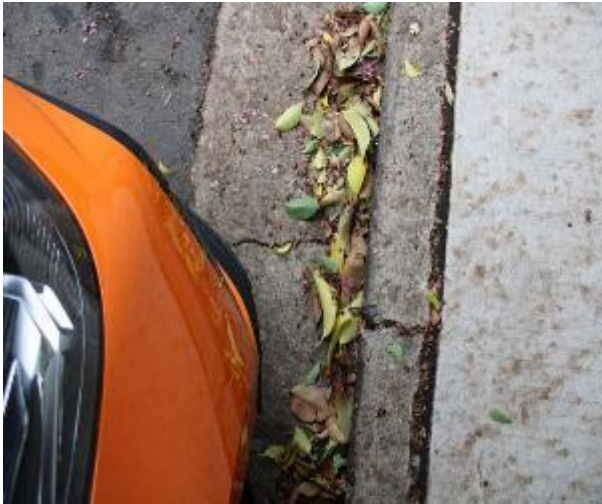
Figure 349 - Crack propagation through kerb and gutter heading East

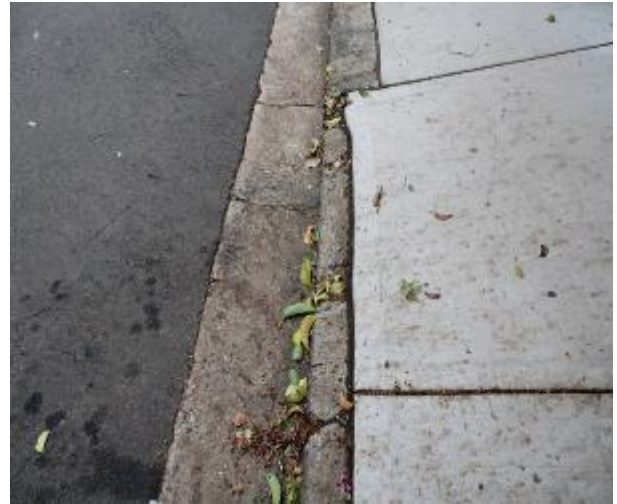
Figure 350 - General condition of kerb and gutter heading East

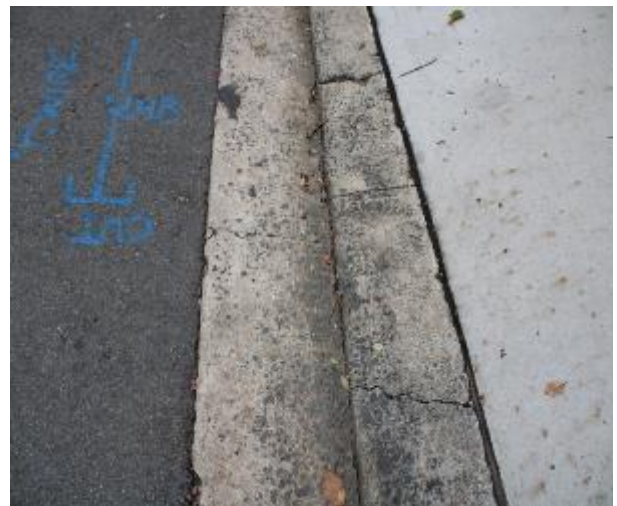
Figure 352 - Crack propagation through driveway layback and gutter heading East

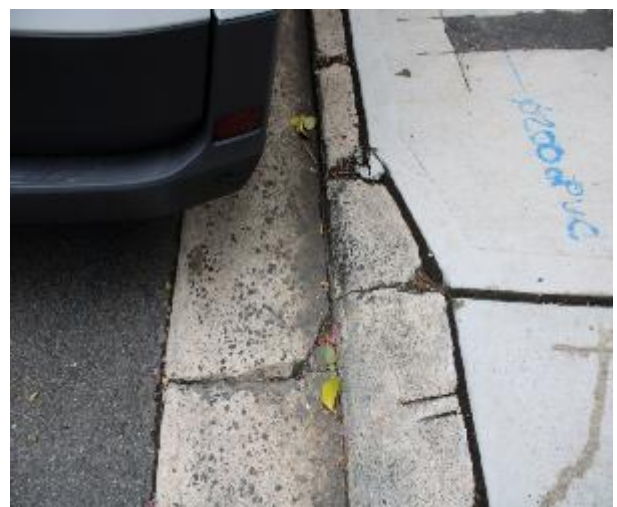
Figure 354 - Crack propagation through driveway layback and gutter heading East

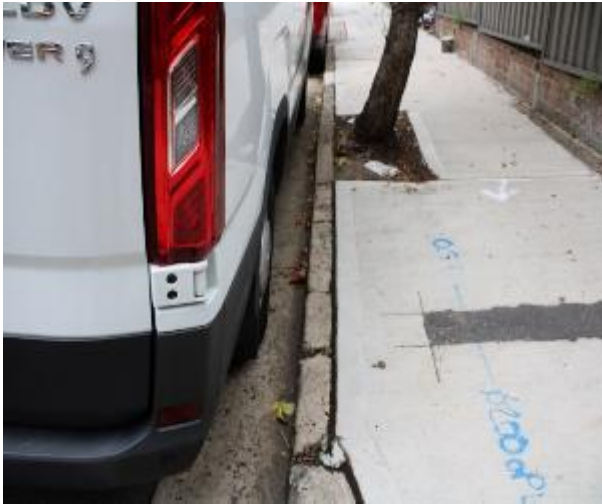
Figure 355 - General condition of kerb and gutter heading East

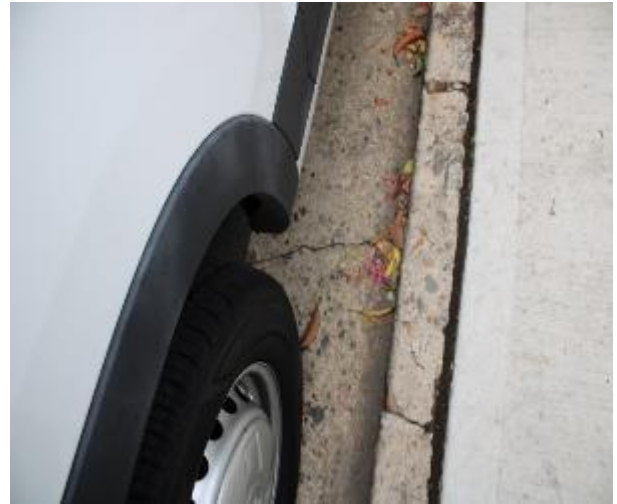
Figure 356 - Crack propagation through kerb and gutter heading East

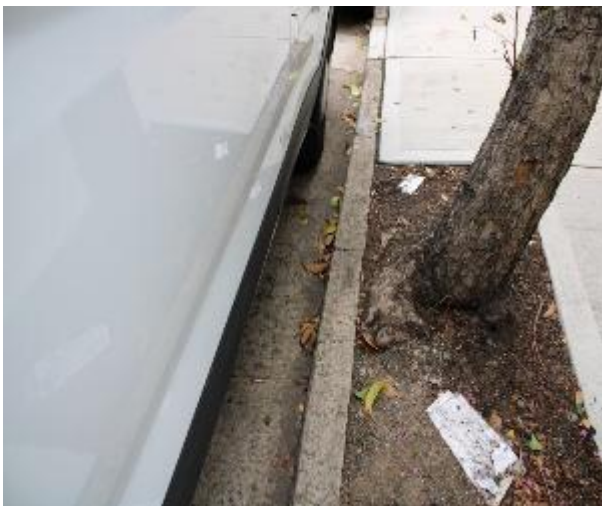
Figure 357 - General condition of kerb and gutter heading East

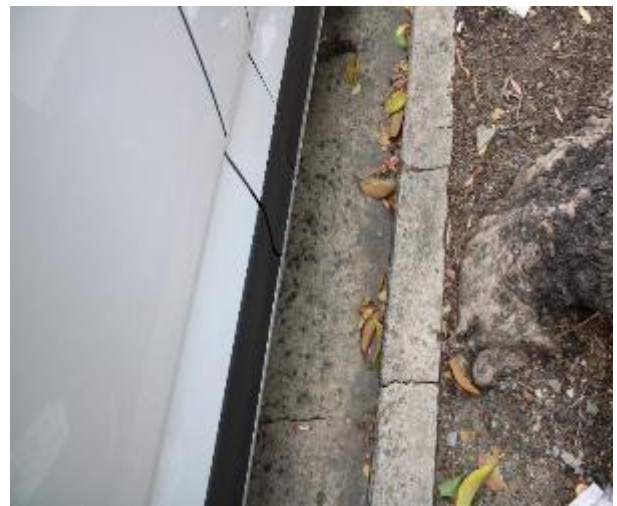
Figure 358 - Crack propagation through kerb and gutter heading East

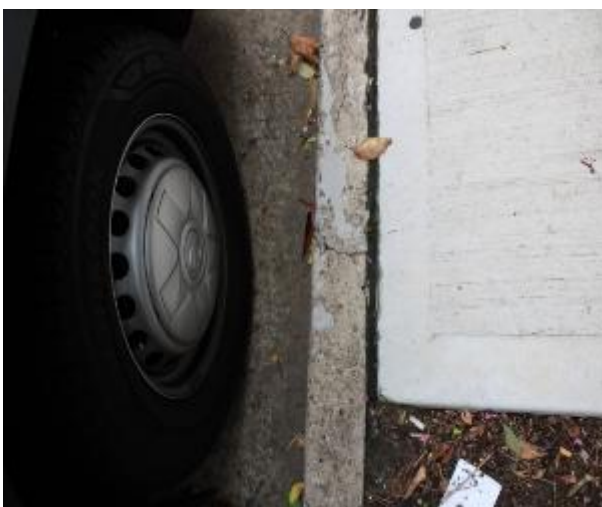
Figure 359 - Crack propagation through kerb and gutter heading East

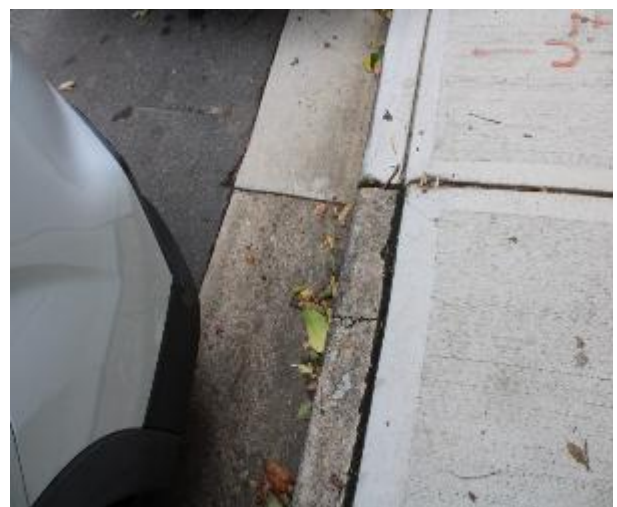
Figure 360 - Crack propagation through kerb and gutter heading East

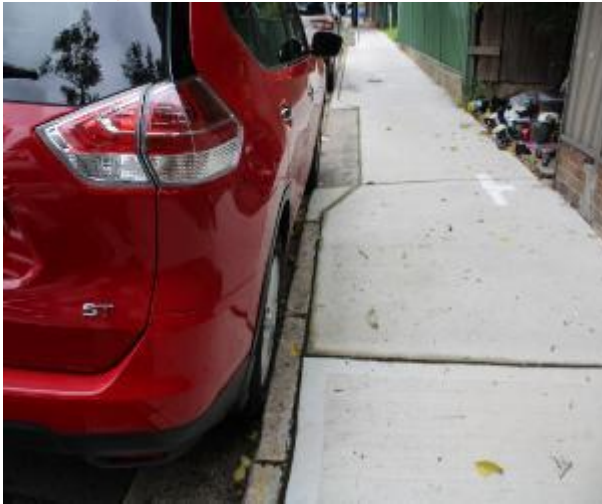
Figure 361 - General condition of kerb and gutter heading East

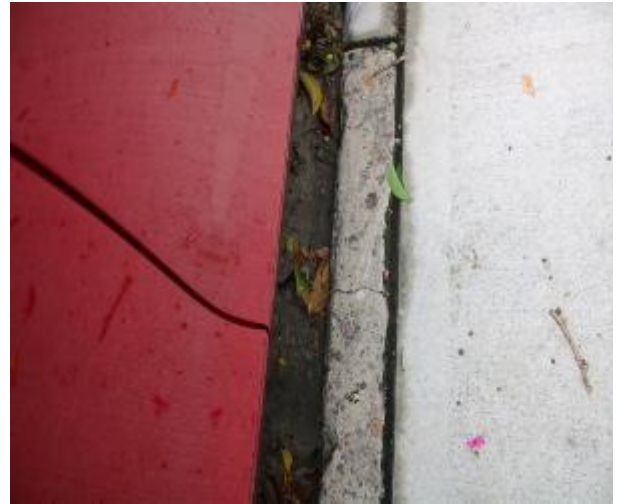
Figure 362 - Crack propagation through kerb and gutter heading East

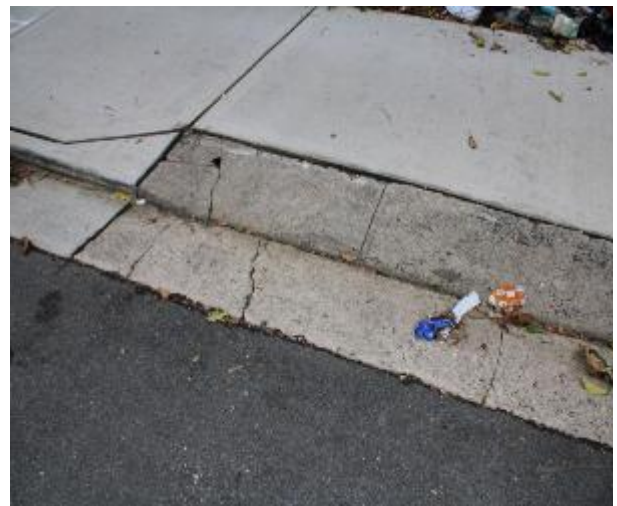
Figure 364 - Crack propagation through driveway layback and gutter heading East

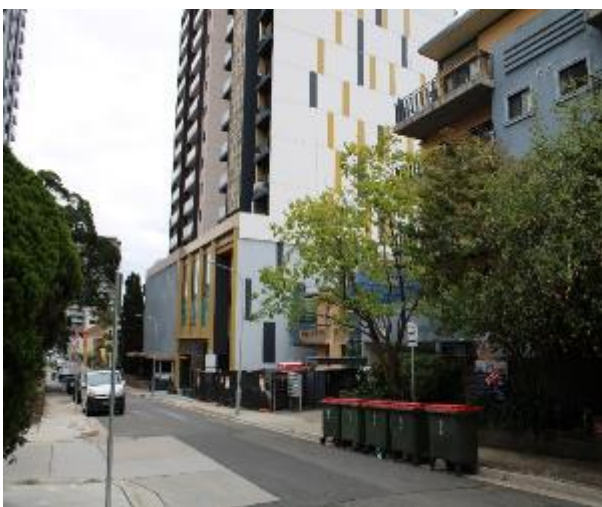
Figure 365 - General condition of street tree

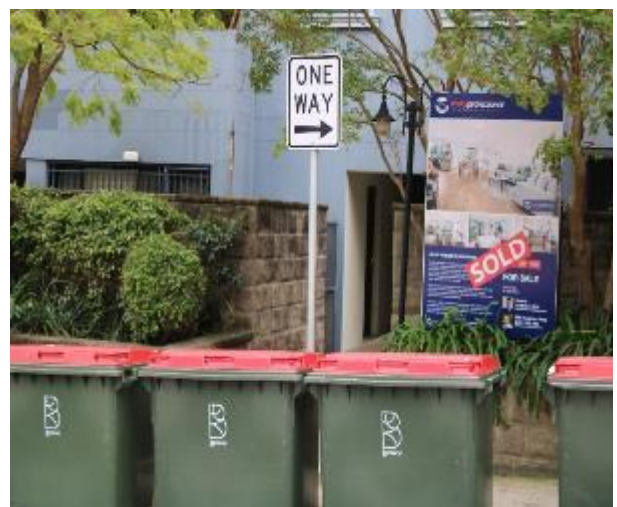
Figure 366 - General condition of street signage

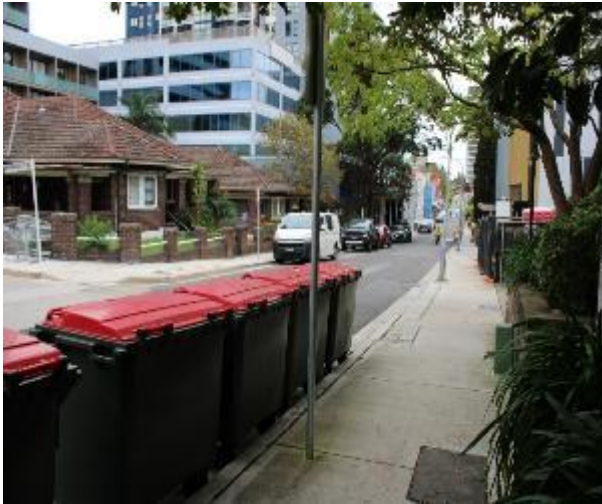
Figure 367 - General condition of street signage

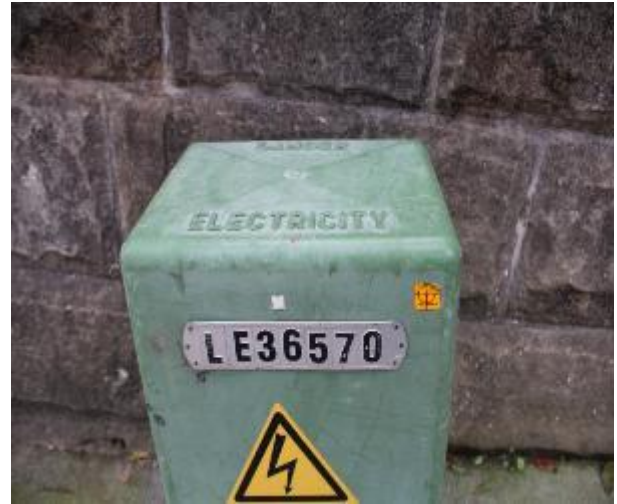
Figure 368 - The following images display the condition of electricity box identification No. LE36570

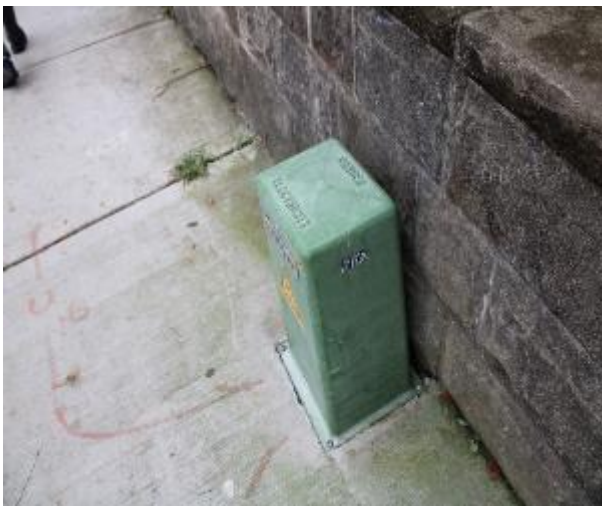
Figure 369 - General condition of electricity box identification No. LE36570

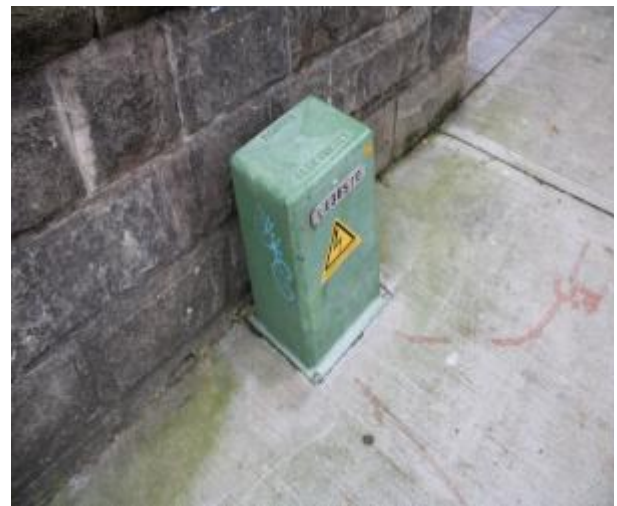
Figure 370 - General condition of electricity box identification No. LE36570

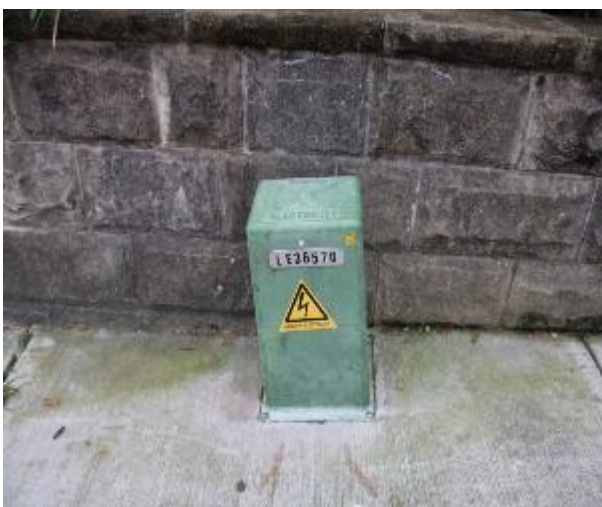
Figure 371 - General condition of electricity box identification No. LE36570

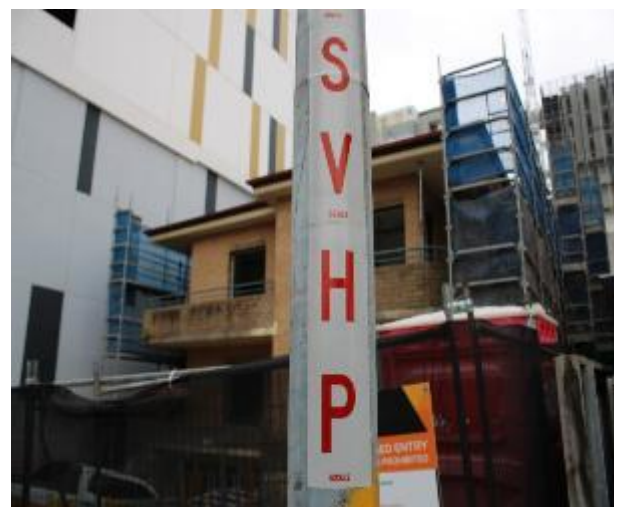
Figure 372 - General condition of street light post Identification No. SVHP62252

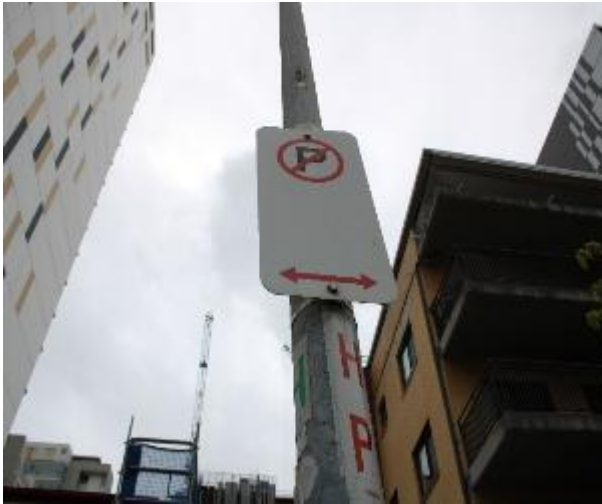
Figure 373 - General condition of street light post  
Identification No. SVHP62252

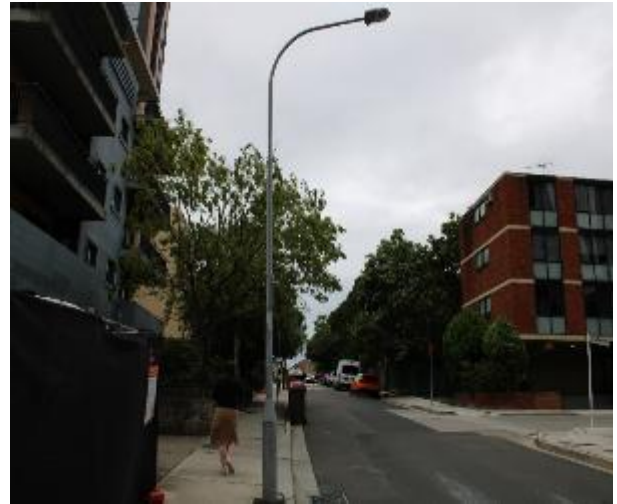
Figure 374 - General condition of street light post  
Identification No. SVHP62252

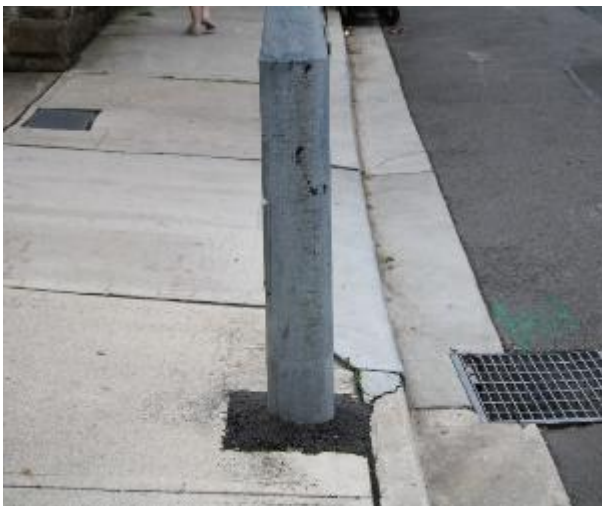
Figure 375 - General condition of street light post  
Identification No. SVHP62252

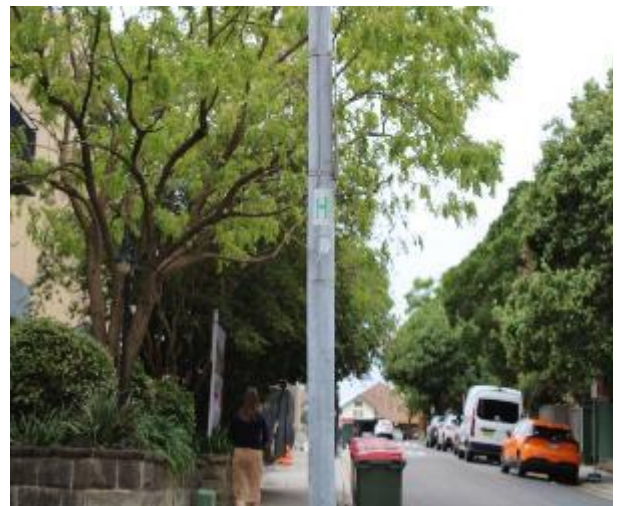
Figure 376 - General condition of street light post  
Identification No. SVHP62252

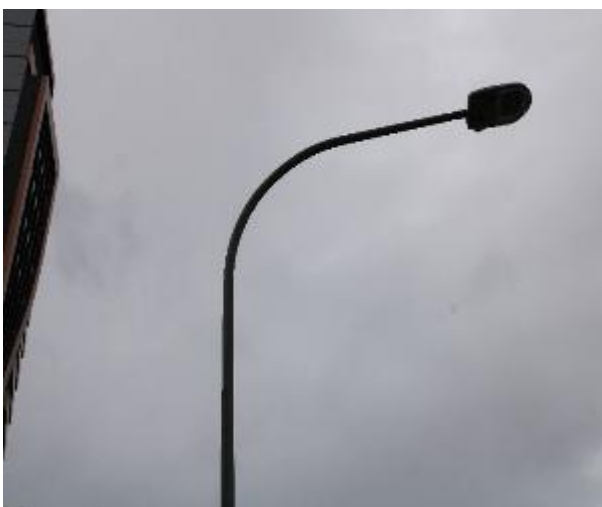
Figure 377 - General condition of street light post  
Identification No. SVHP62252

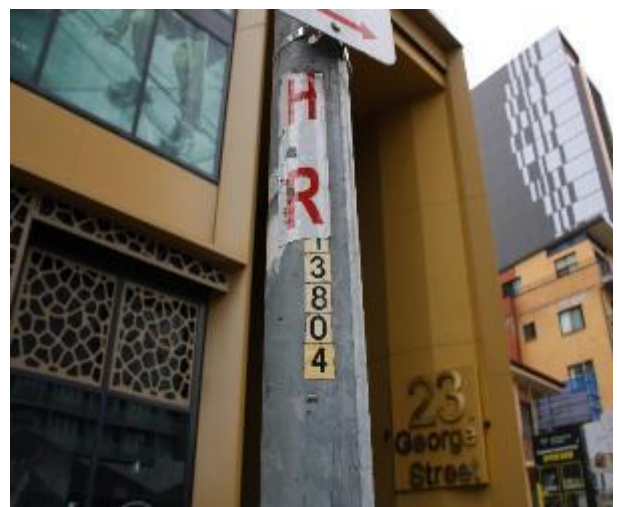
Figure 378 - General condition of street light post  
Identification No. HR13804

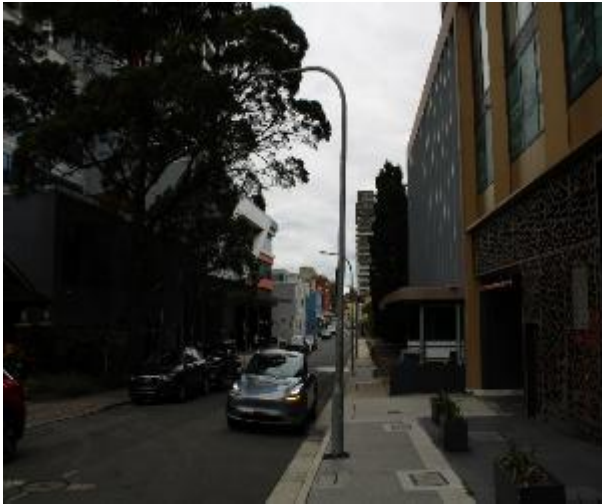
Figure 379 - General condition of street light post  
Identification No. HR13804

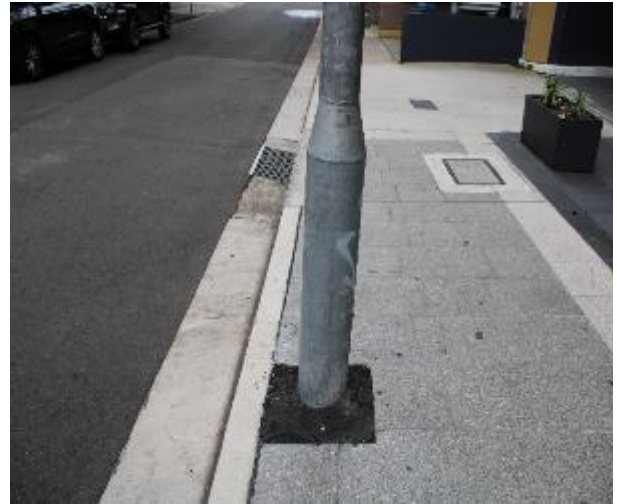
Figure 380 - General condition of street light post  
Identification No. HR13804

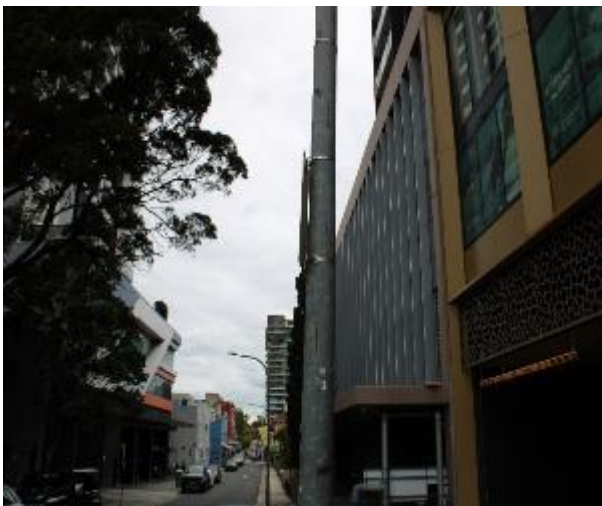
Figure 381 - General condition of street light post  
Identification No. HR13804

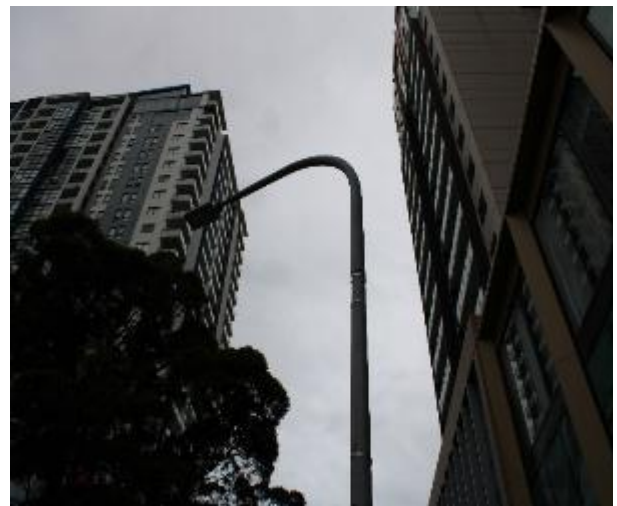
Figure 382 - General condition of street light post  
Identification No. HR13804

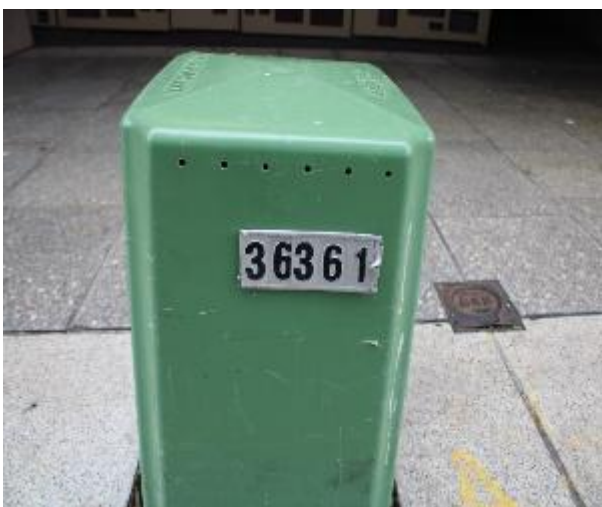
Figure 383 - General condition of electricity box  
identification No. 36361

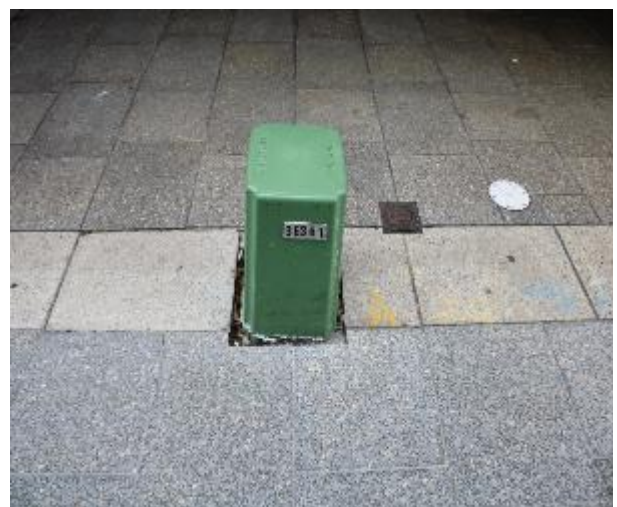
Figure 384 - General condition of electricity box  
identification No. 36361

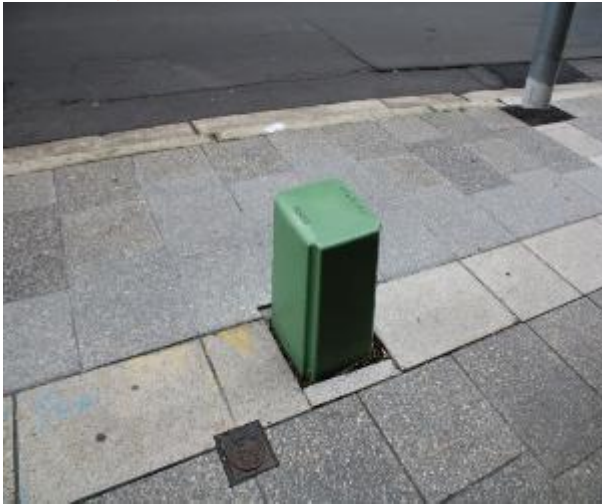
Figure 385 - General condition of electricity box  
identification No. 36361

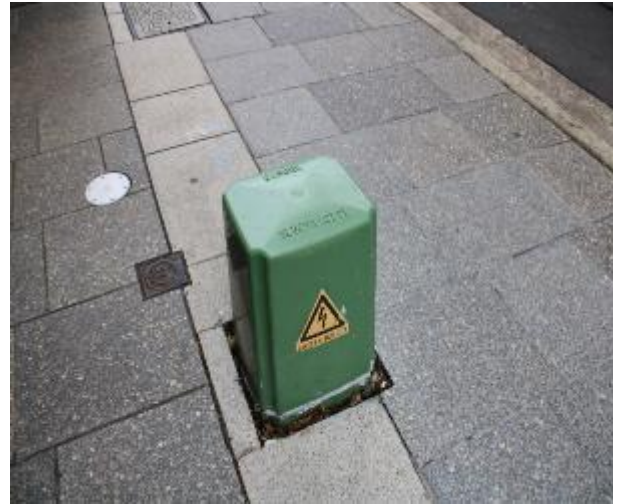
Figure 386 - General condition of electricity box  
identification No. 36361

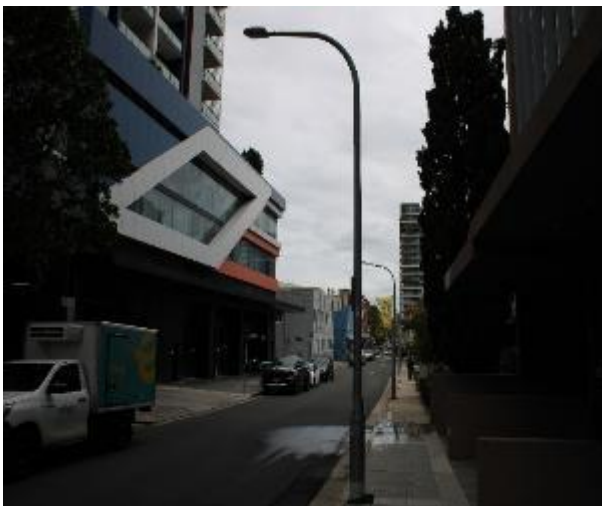
Figure 387 - General condition of streetlight post

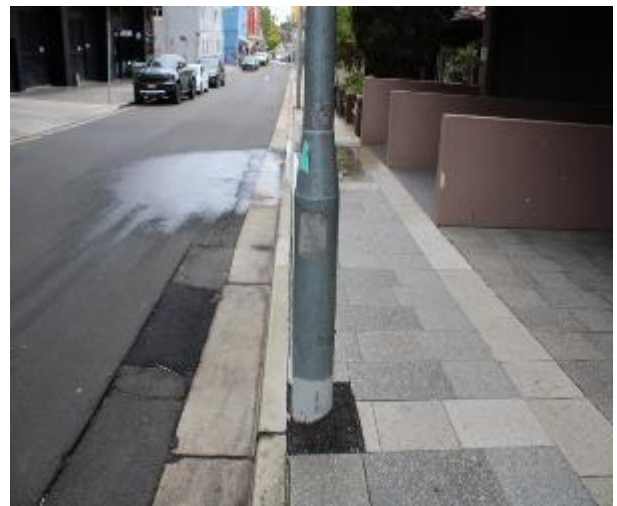
Figure 388 - General condition of streetlight post

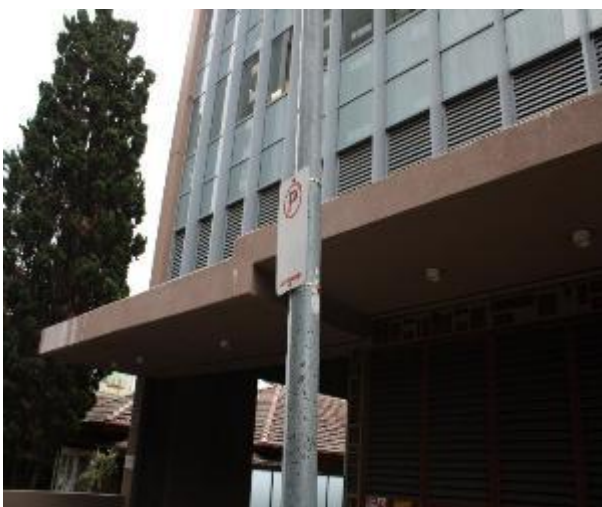
Figure 389 - General condition of streetlight post

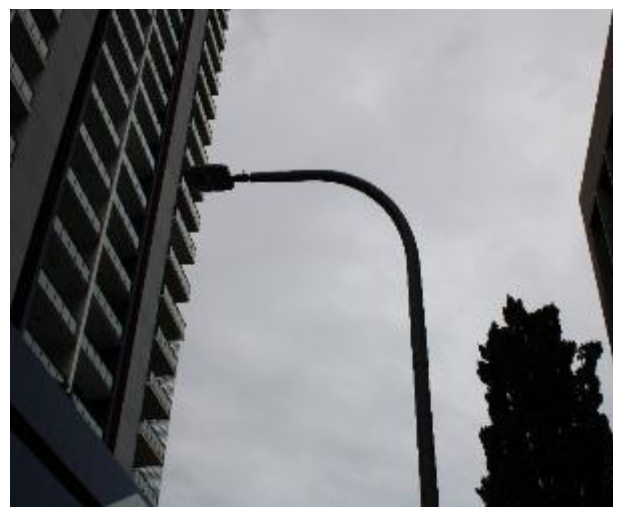
Figure 390 - General condition of streetlight post

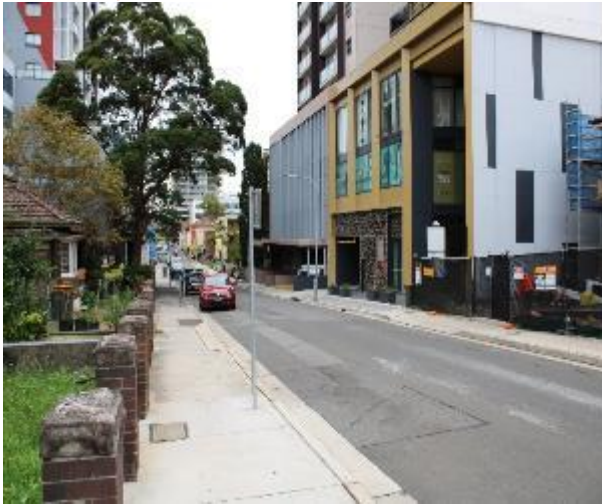
Figure 391 - General condition of street signage

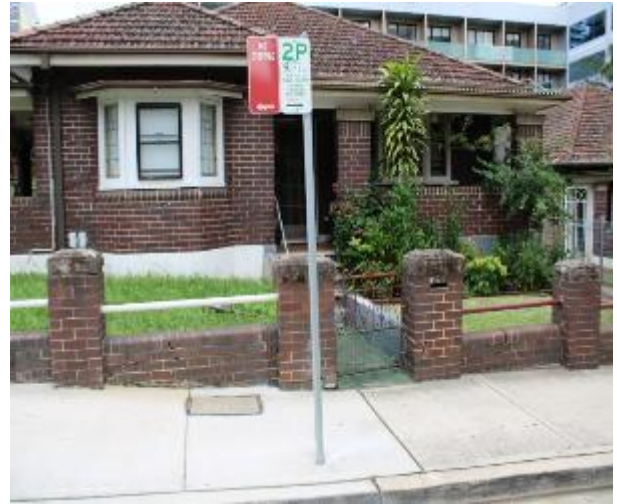
Figure 392 - General condition of street signage

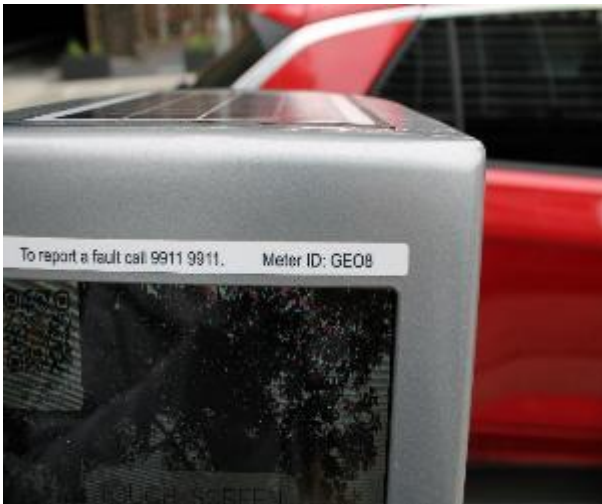
Figure 393 - General condition of parking meter identification No. GEO8

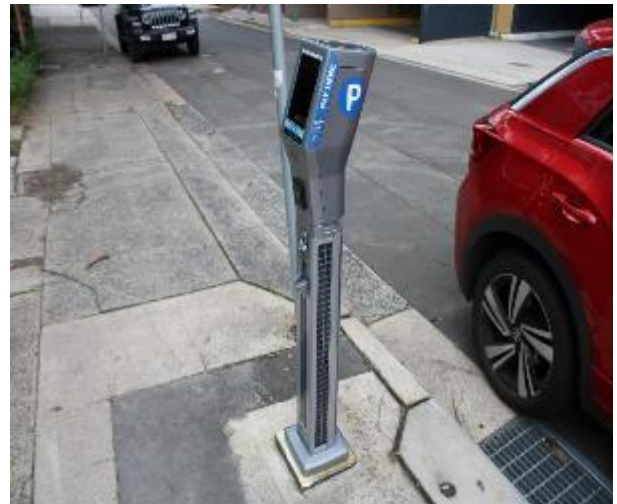
Figure 394 - General condition of parking meter identification No. GEO8

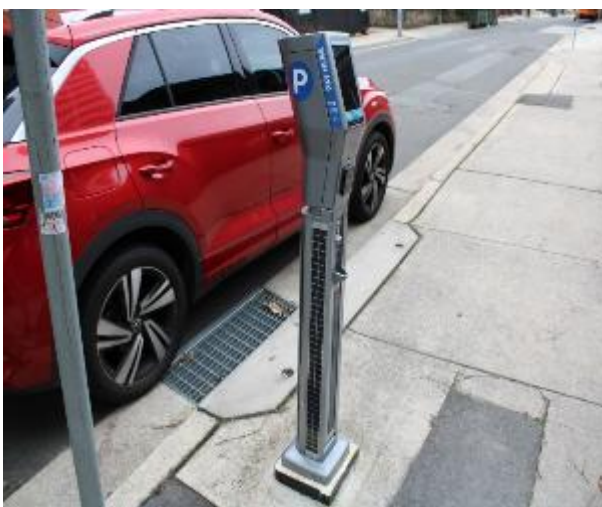
Figure 395 - General condition of parking meter identification No. GEO8

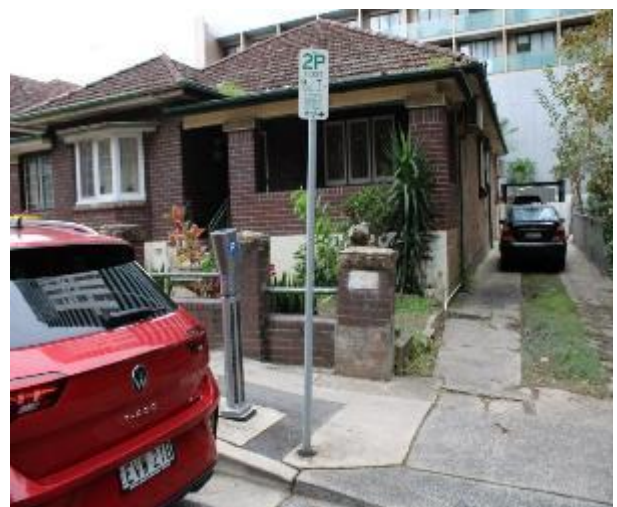
Figure 396 - General condition of street signage

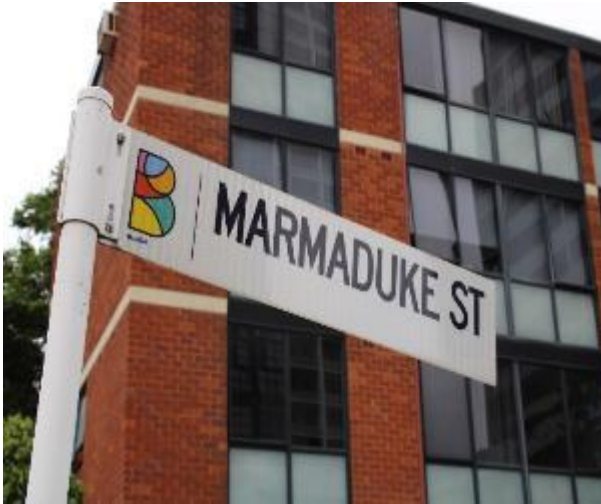
Figure 397 - The following images display the condition of Marmaduke Street

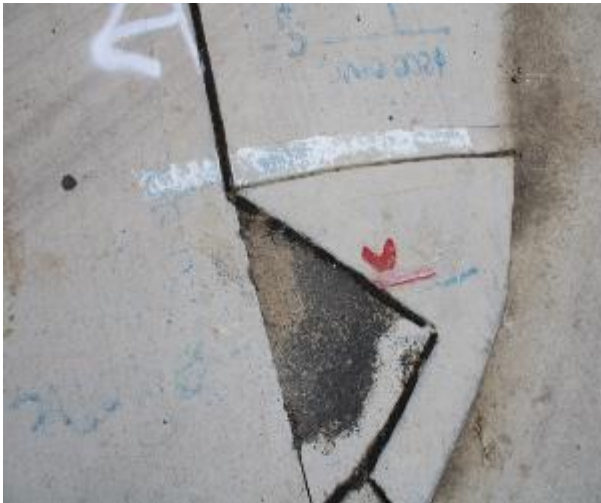
Figure 399 - Patchwork evident through footpath pavement heading South

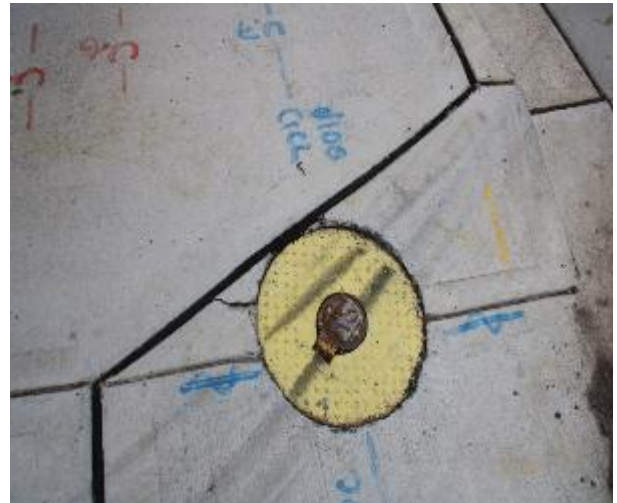
Figure 400 - General condition of service pit

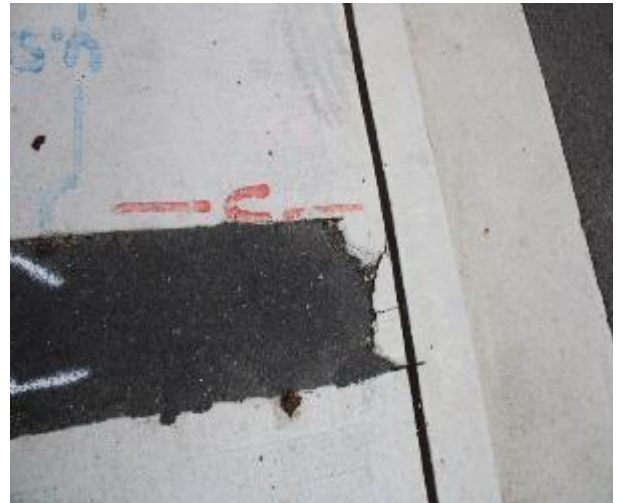
Figure 406 - Crack propagation through footpath pavement heading South

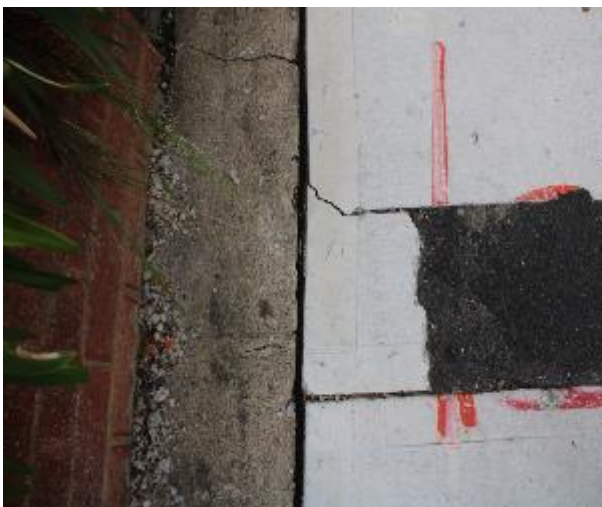
Figure 407 - Crack propagation through footpath pavement heading South

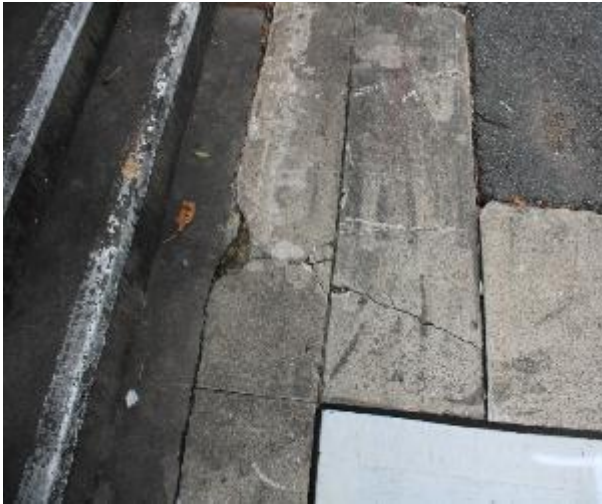
Figure 409 - Crack propagation and loss of materials through footpath pavement heading South

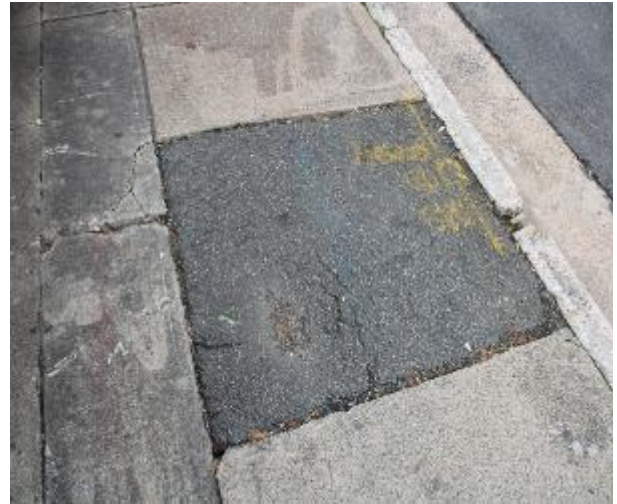
Figure 410 - Crack propagation and patchwork evident through footpath pavement heading South

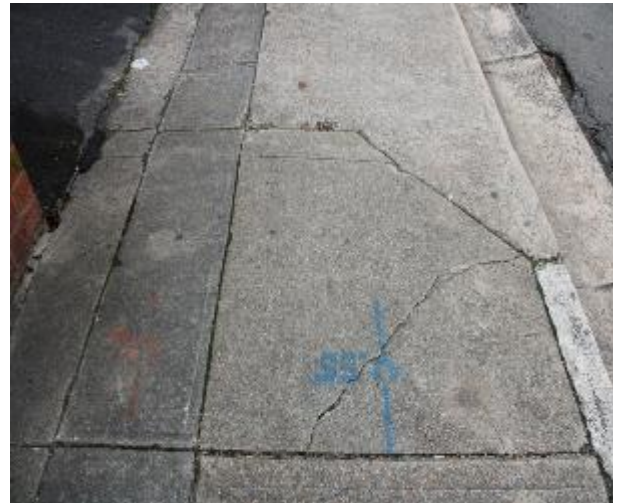
Figure 412 - Crack propagation through footpath pavement heading South

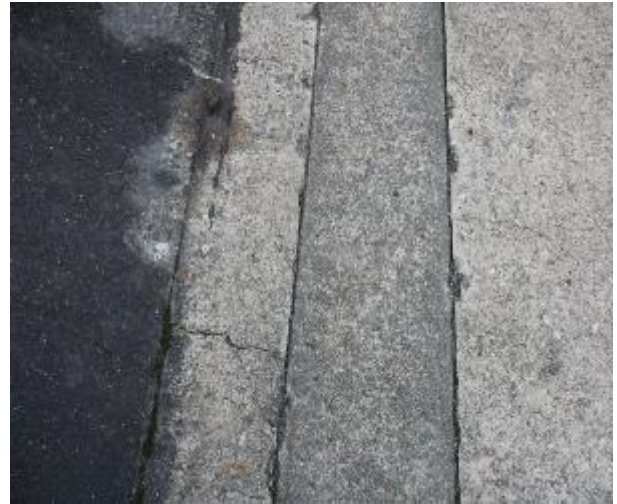
Figure 416 - Crack propagation through footpath pavement heading South

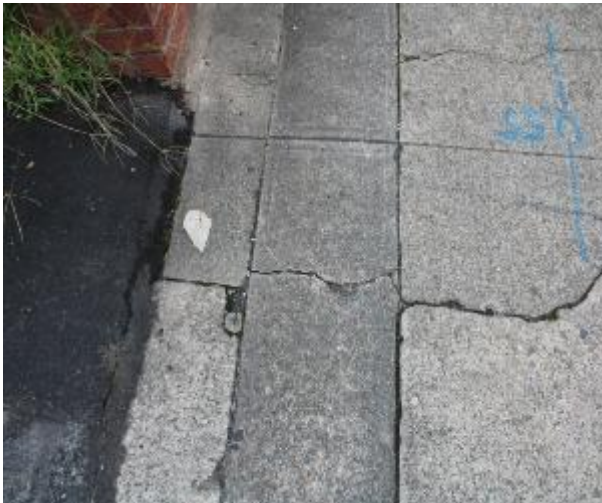
Figure 417 - Crack propagation through footpath pavement heading South

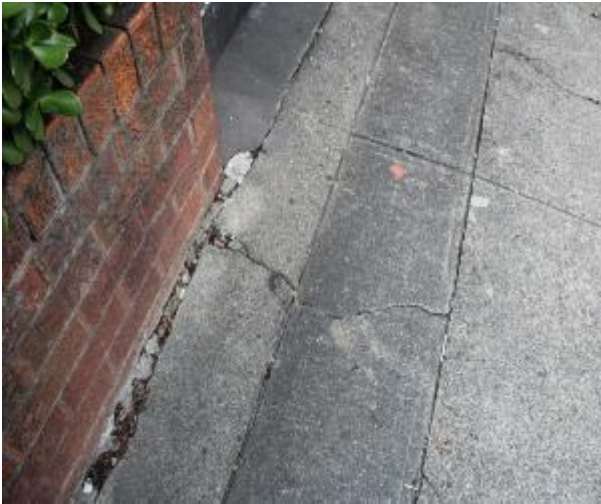
Figure 421 - Crack propagation through footpath pavement heading South

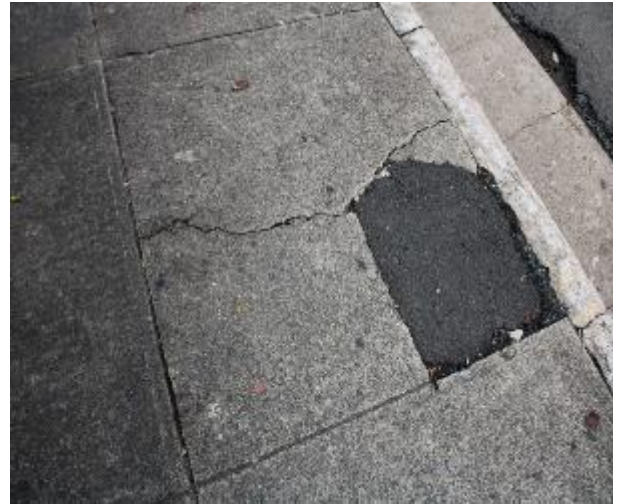
Figure 422 - Crack propagation and patchwork through footpath pavement heading South

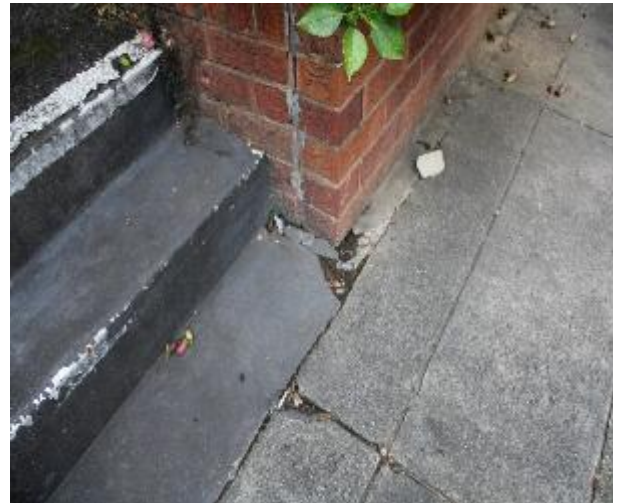
Figure 424 - Loss of material through footpath pavement heading South

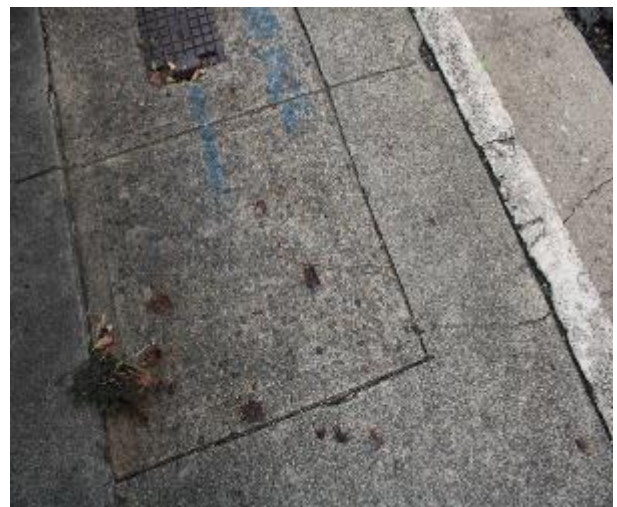
Figure 426 - Crack propagation through footpath pavement heading South

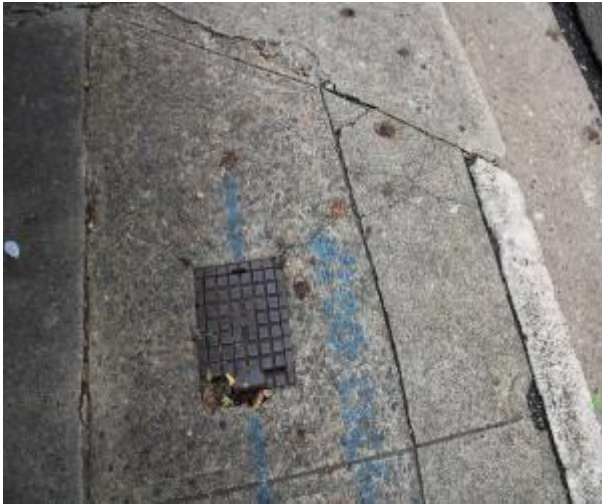
Figure 427 - General condition of service pit

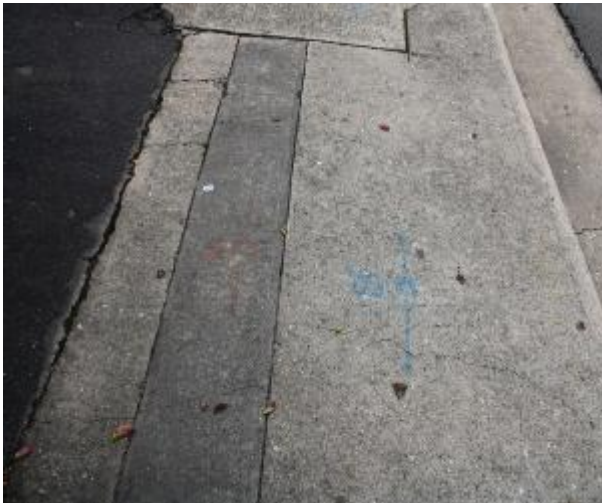
Figure 429 - Crack propagation through footpath pavement heading South
