# **PRE-DILAPIDATION REPORT**

**COUNCIL ASSETS**

**21 GEORGE STREET,  
BURWOOD, NSW 2134**

PROJECT REFERENCE: 20250047.CA.1  
17/04/2026

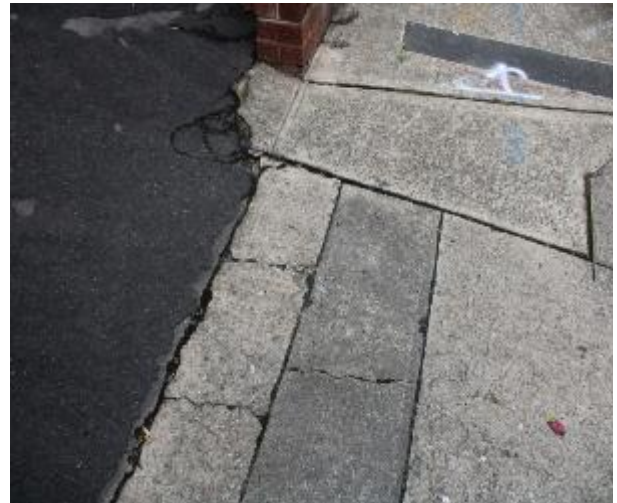
Figure 430 - Crack propagation through footpath pavement heading South

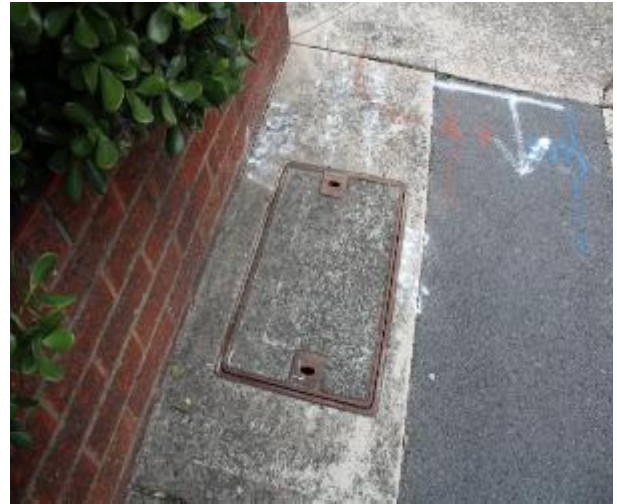
Figure 434 - General condition of service pit

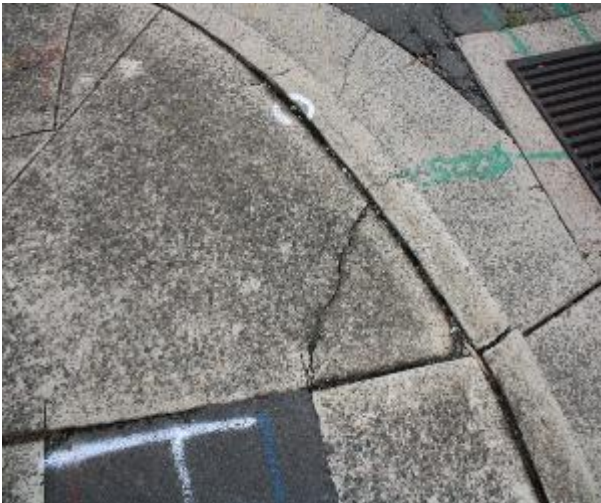
Figure 435 - Crack propagation through footpath pavement heading South

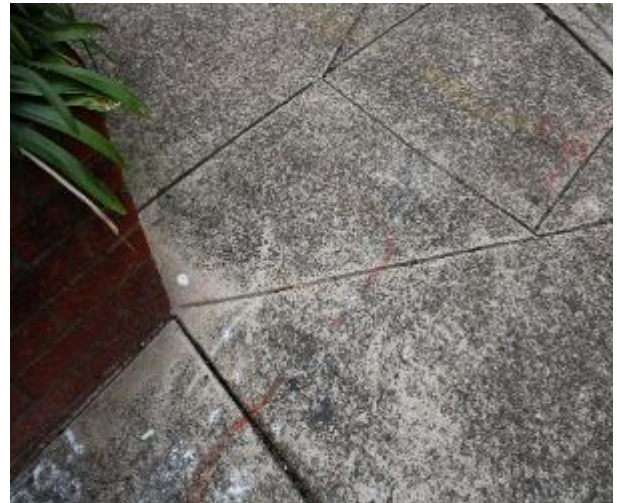
Figure 436 - Crack propagation through footpath pavement heading South

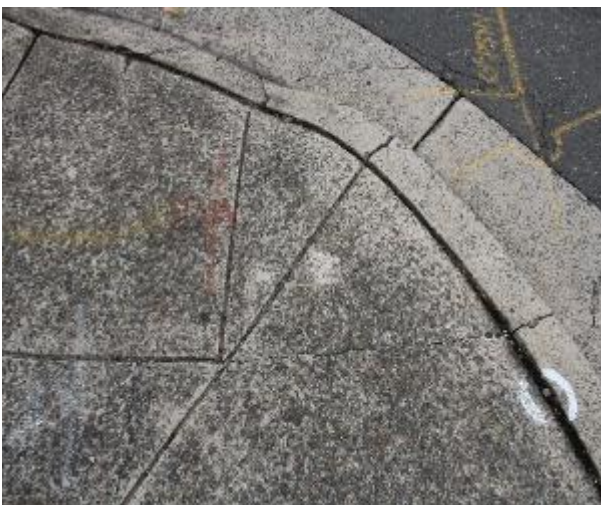
Figure 437 - Crack propagation through footpath pavement heading South

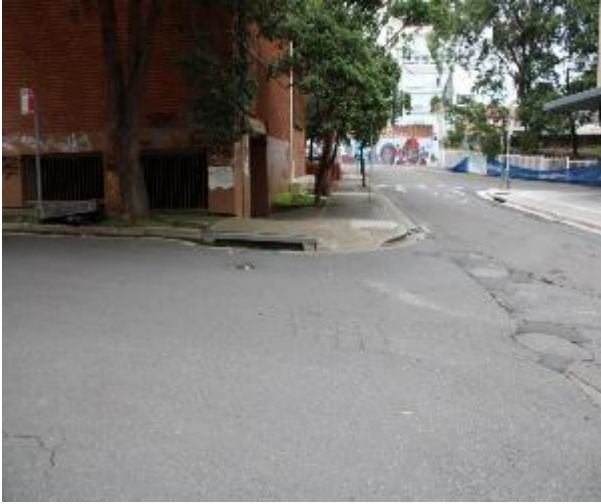
Figure 439 - General condition of road surface heading South

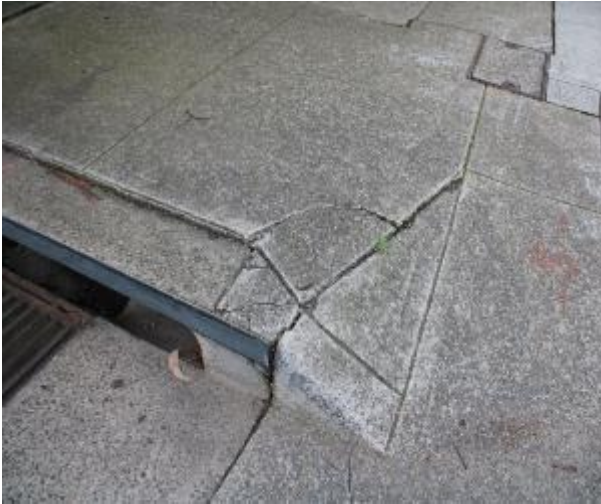
Figure 441 - Crack propagation through footpath pavement heading South

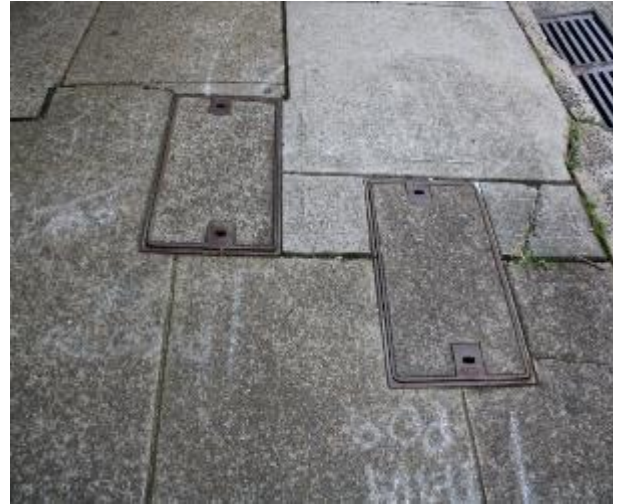
Figure 442 - General condition of service pits

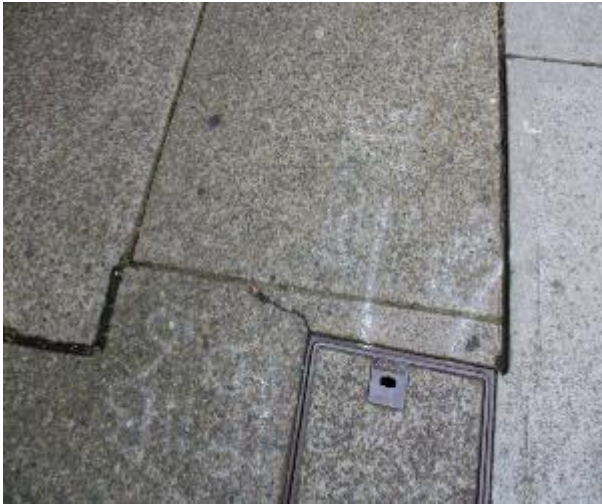
Figure 445 - Crack propagation through footpath pavement heading South

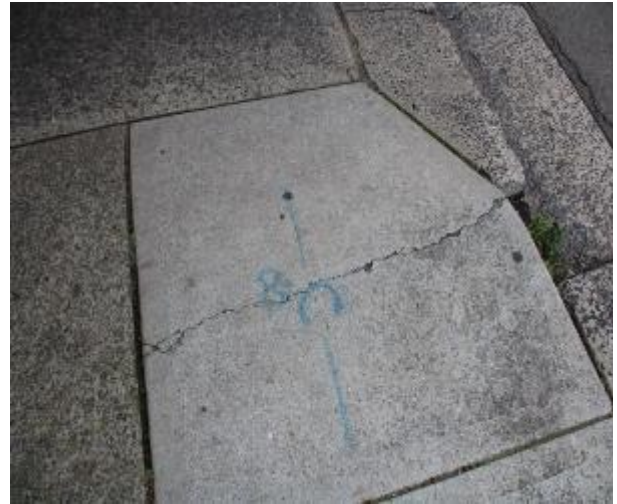
Figure 446 - Crack propagation through footpath pavement heading South

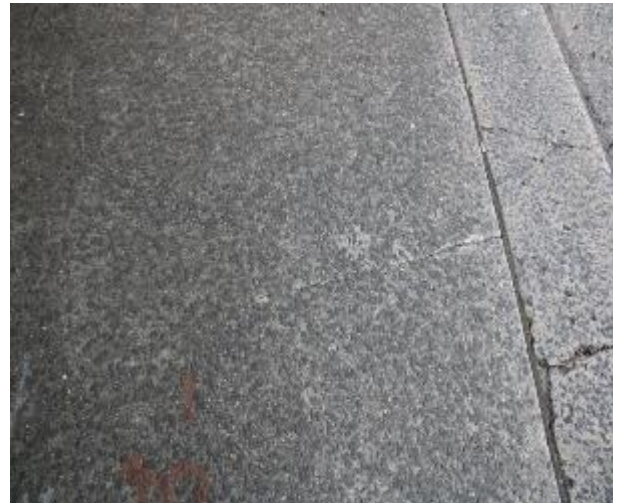
Figure 448 - Crack propagation through footpath pavement heading South

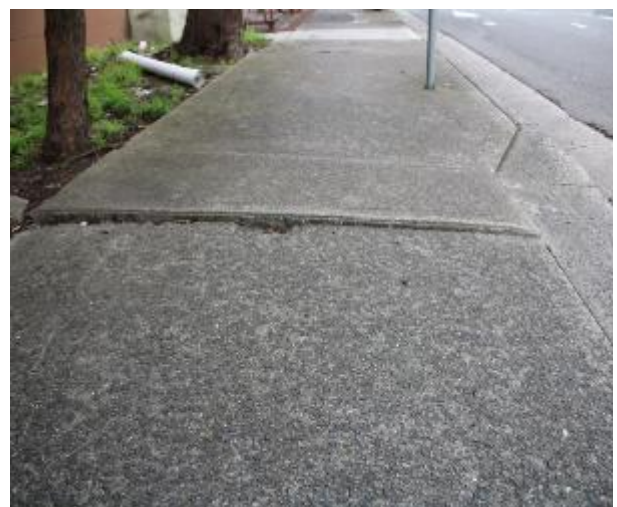
Figure 450 - Differential settlement evident through footpath pavement heading South

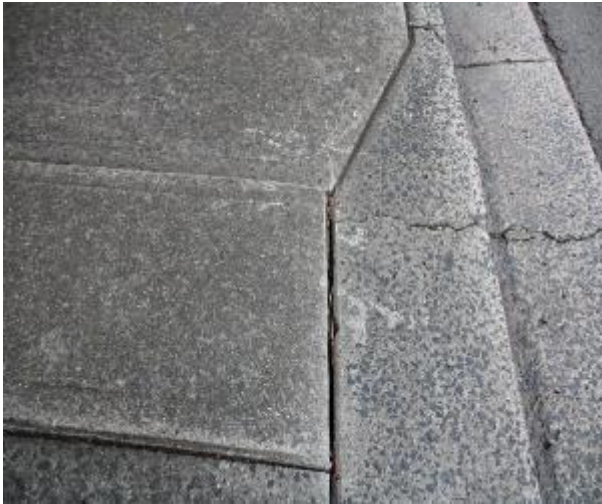
Figure 451 - Crack propagation through footpath pavement heading South

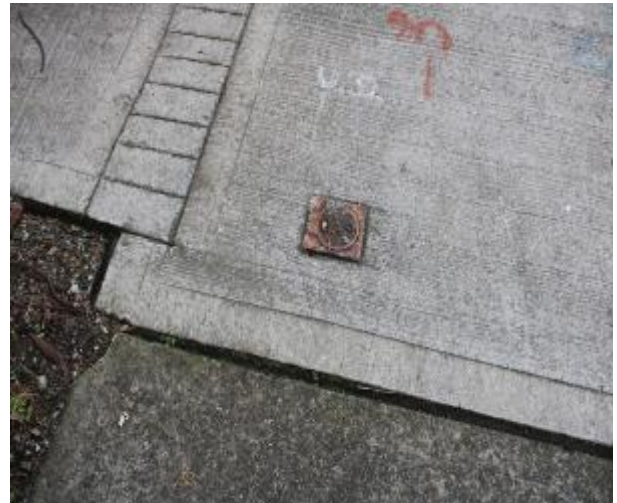
Figure 453 - General condition of footpath pavement heading South

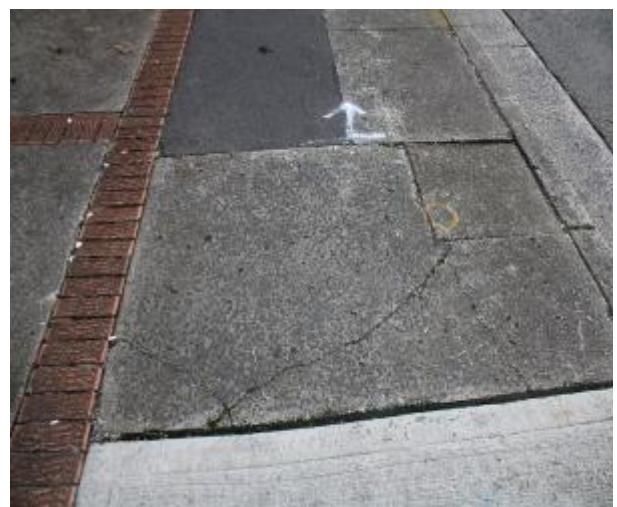
Figure 455 - General condition of footpath pavement heading South

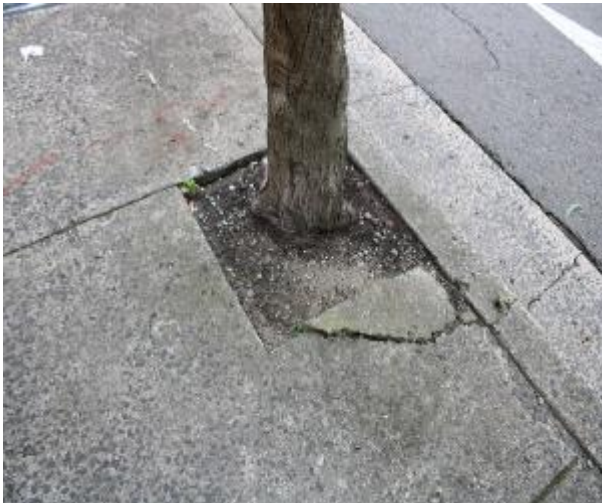
Figure 458 - General condition of footpath pavement heading South

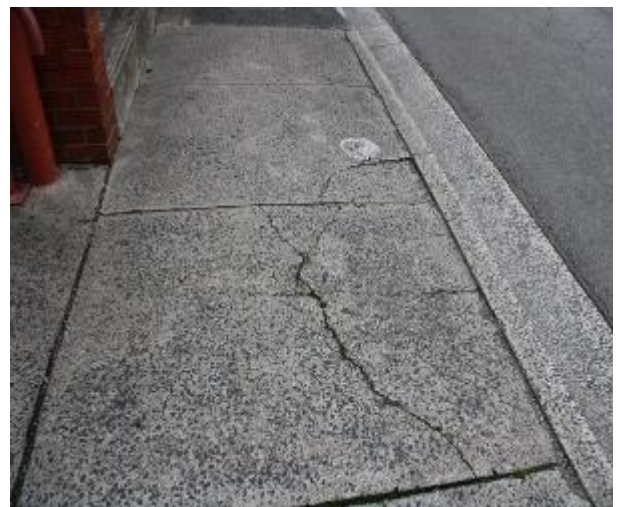
Figure 461 - General condition of footpath pavement heading South

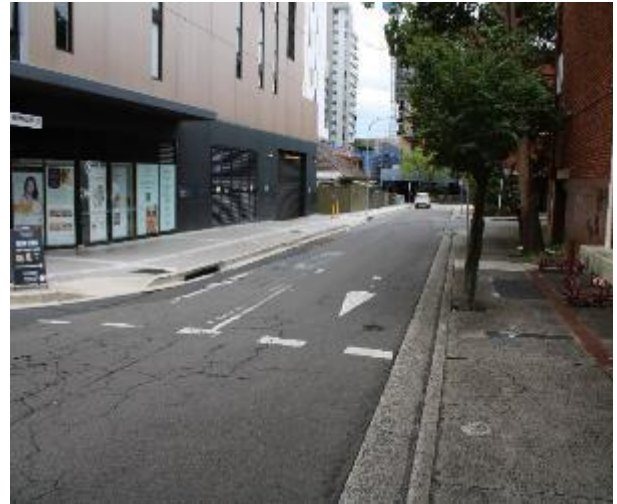
Figure 463 - General condition of footpath pavement heading South

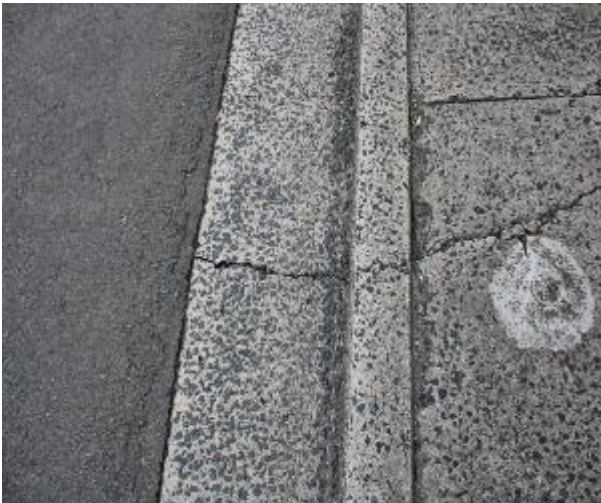
Figure 464 - General condition of kerb and gutter heading North

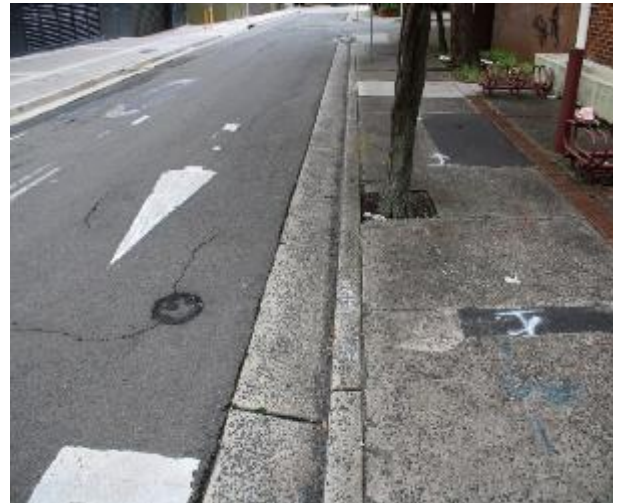
Figure 465 - Crack propagation through kerb and gutter heading North

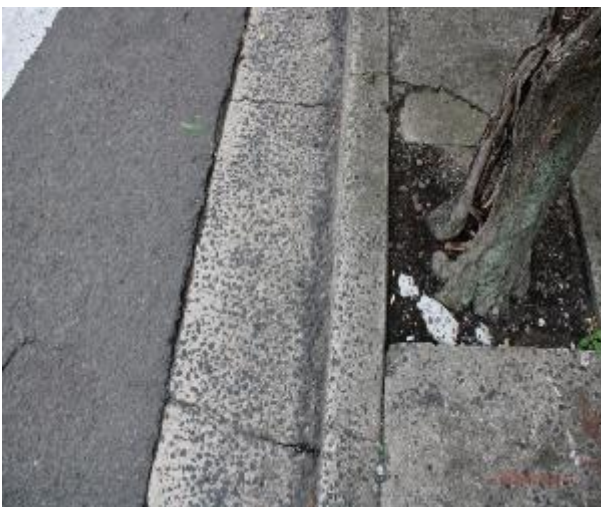
Figure 466 - General condition of kerb and gutter heading North

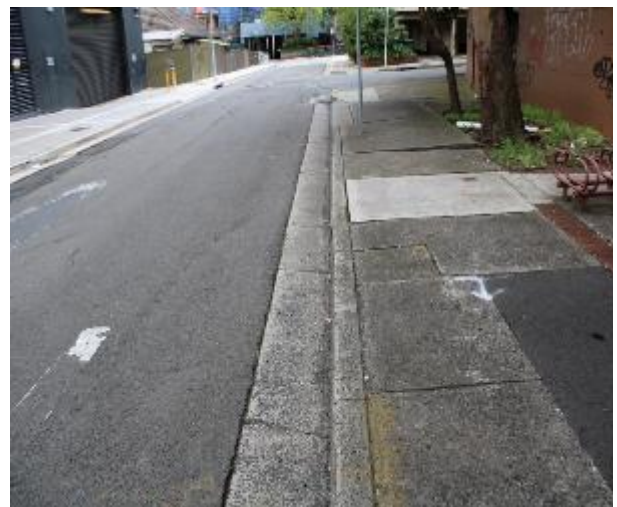
Figure 467 - Crack propagation through kerb and gutter heading North

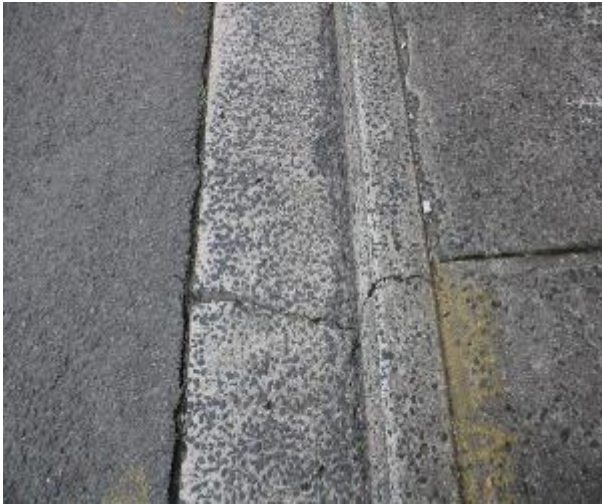
Figure 468 - General condition of kerb and gutter heading North

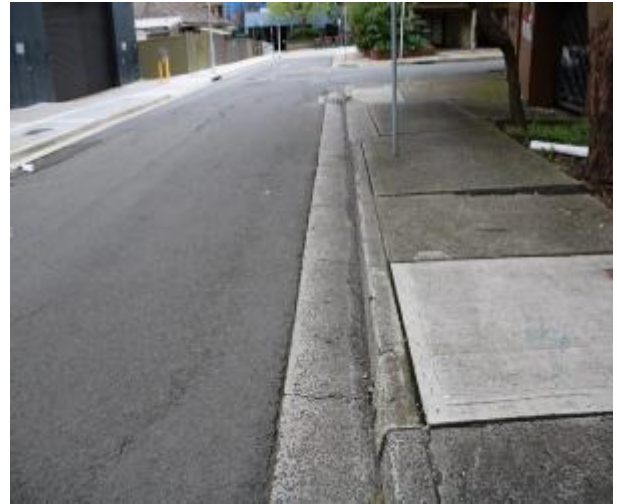
Figure 469 - Crack propagation through kerb and gutter heading North

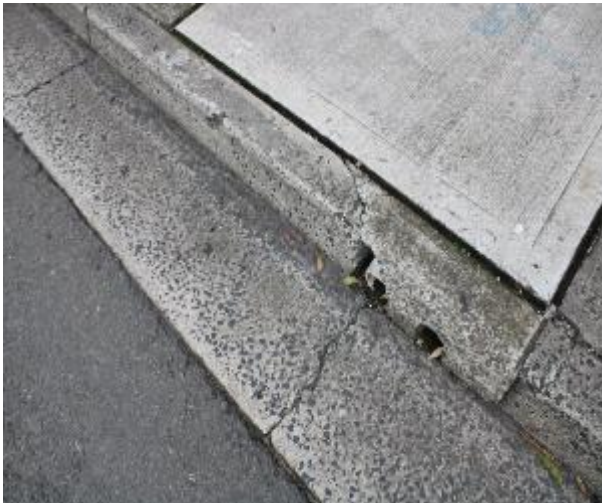
Figure 470 - General condition of kerb and gutter heading North

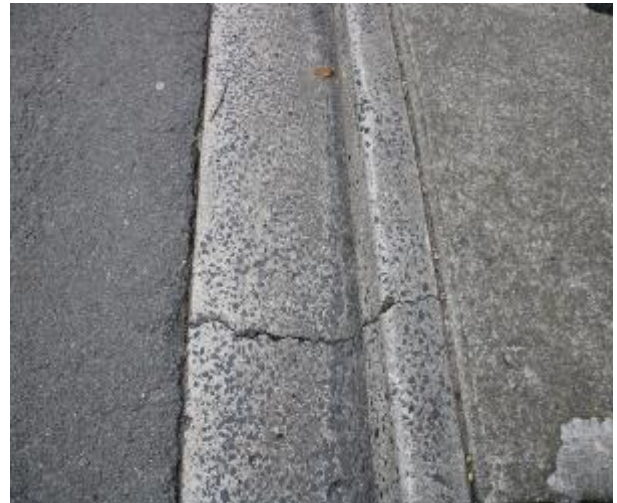
Figure 471 - Crack propagation through kerb and gutter heading North

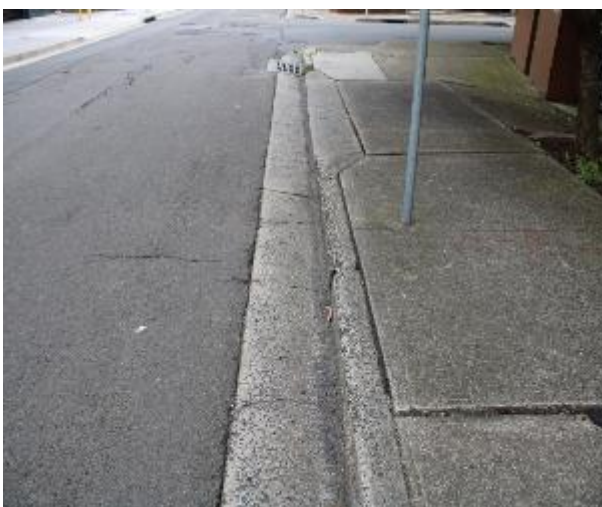
Figure 472 - Crack propagation through kerb and gutter heading North

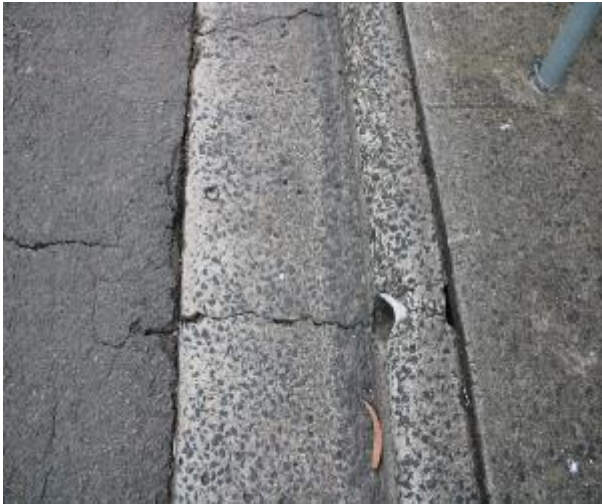
Figure 474 - Crack propagation through kerb and gutter heading North

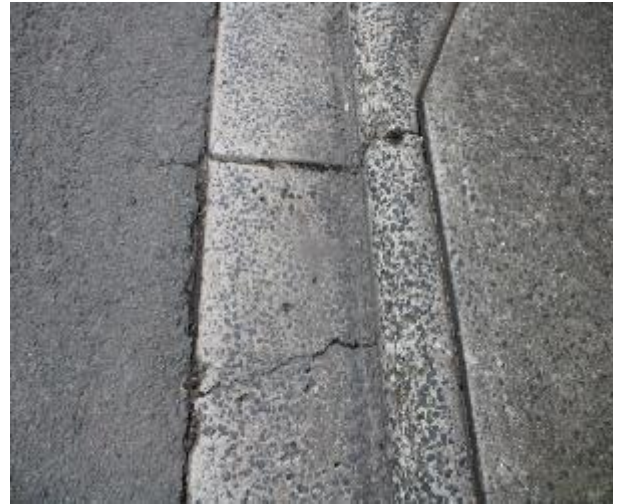
Figure 475 - Crack propagation through kerb and gutter heading North

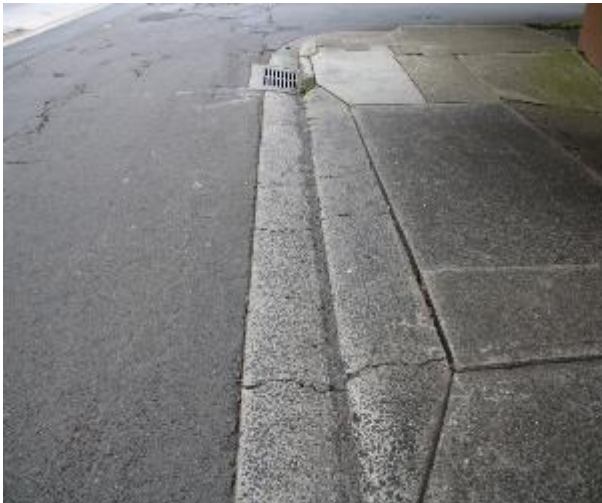
Figure 476 - Crack propagation through kerb and gutter heading North

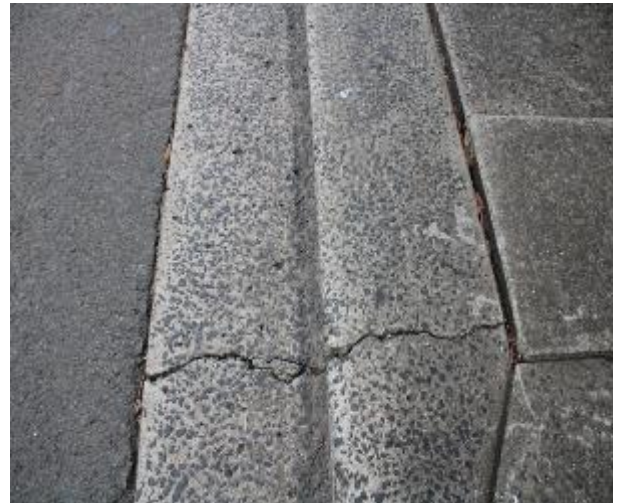
Figure 477 - General condition of driveway layback and gutter heading North

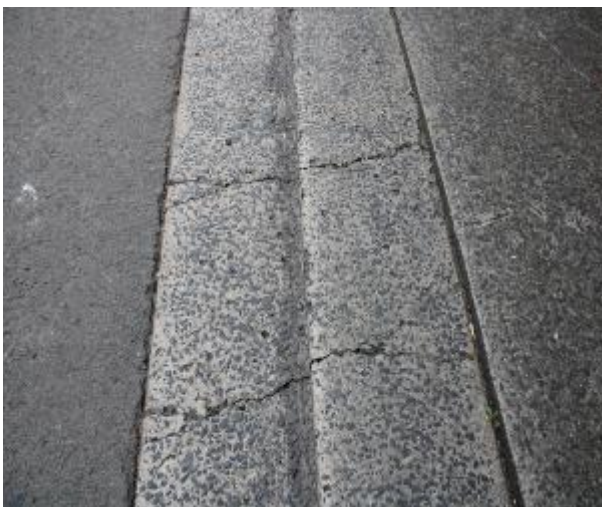
Figure 478 - Crack propagation through driveway layback and gutter heading North

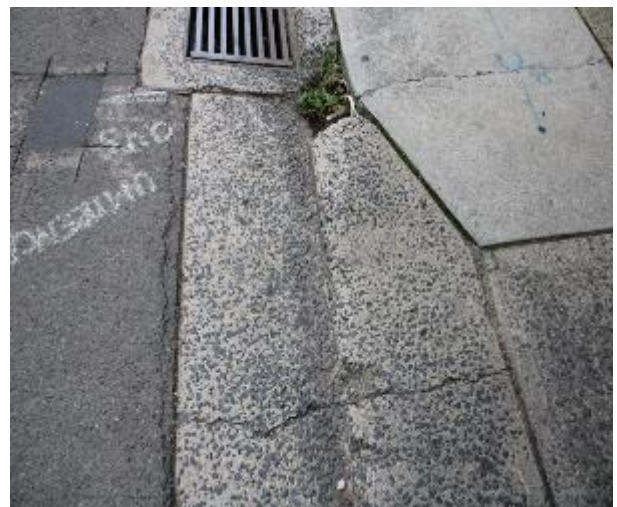
Figure 479 - Crack propagation through driveway layback and gutter heading North

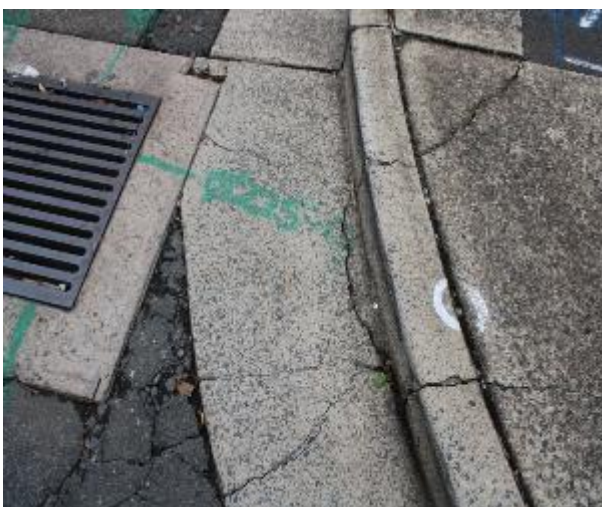
Figure 484 - General condition of kerb and gutter heading North

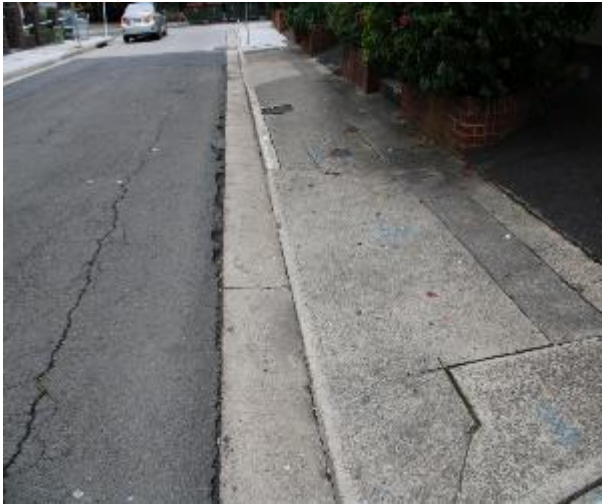
Figure 486 - General condition of kerb and gutter heading North

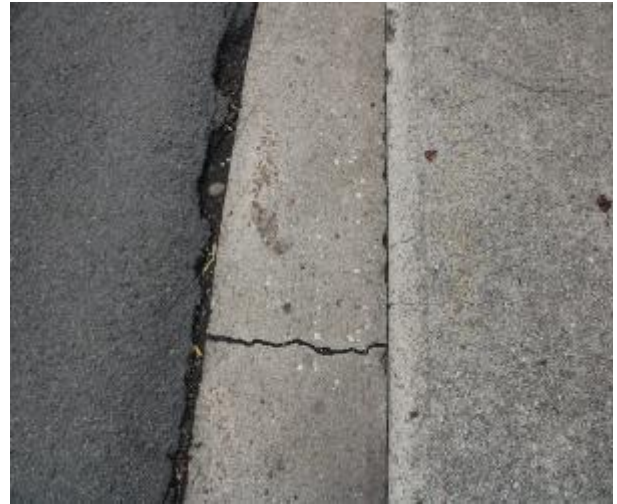
Figure 487 - General condition of kerb and gutter heading North

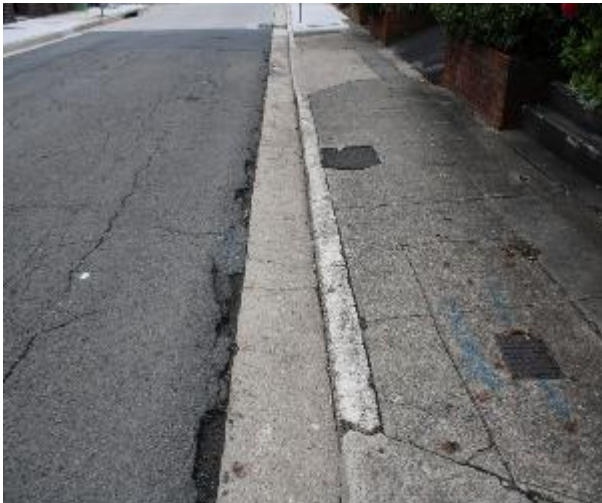
Figure 488 - Crack propagation through kerb and gutter heading North

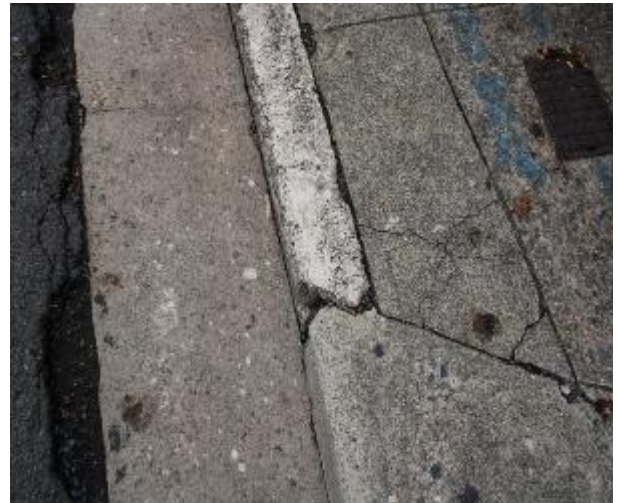
Figure 489 - General condition of kerb and gutter heading North

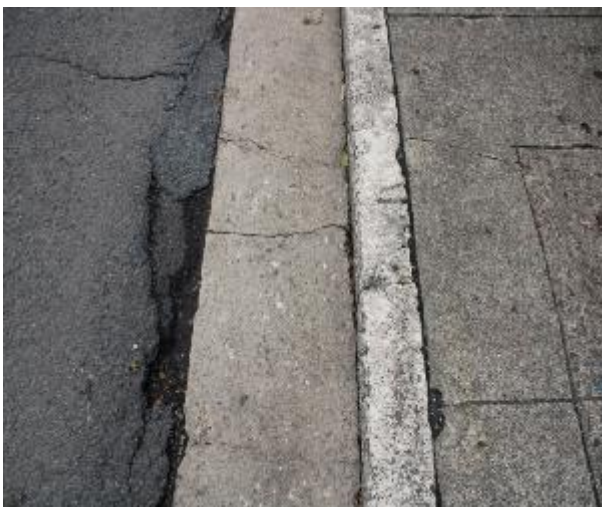
Figure 490 - Loss of material through kerb and gutter heading North

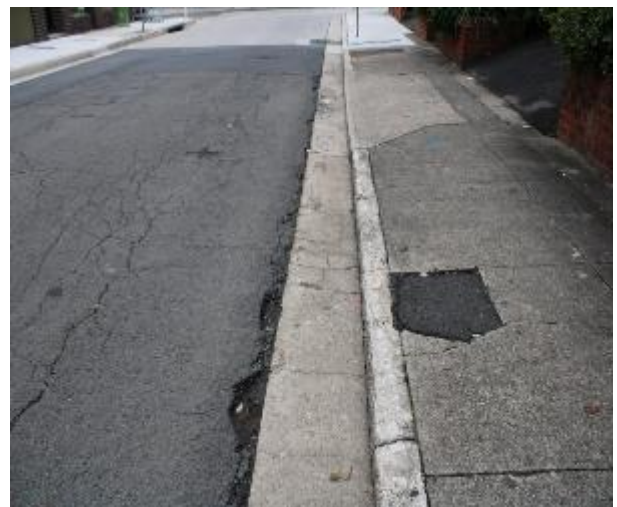
Figure 491 - Crack propagation through kerb and gutter heading North

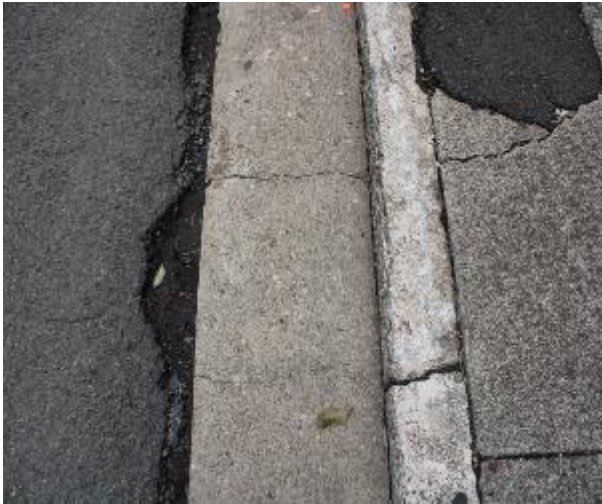
Figure 492 - General condition of kerb and gutter heading North

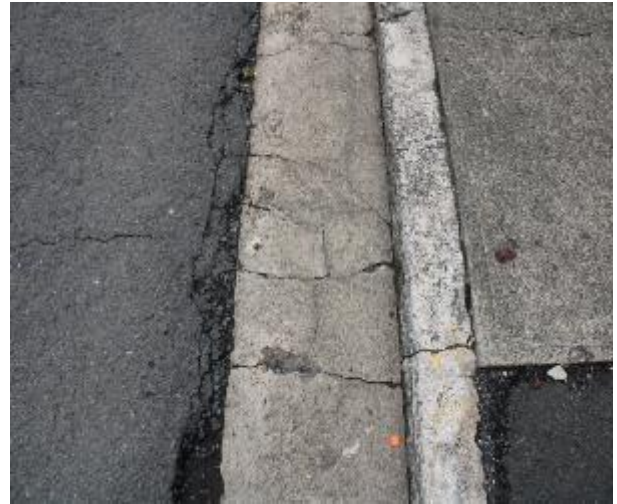
Figure 493 - Crack propagation through kerb and gutter heading North

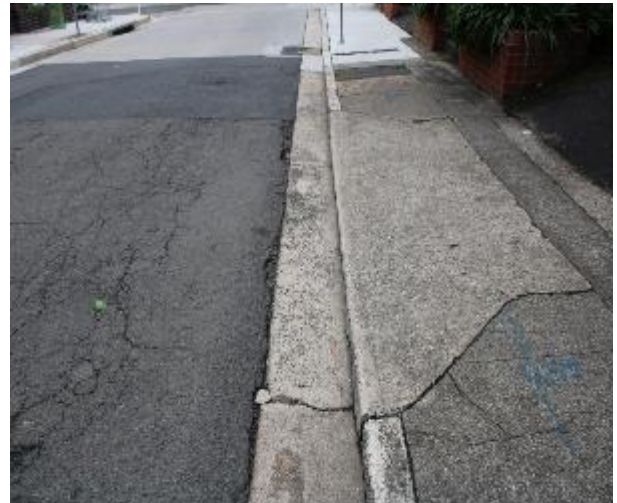
Figure 495 - Crack propagation and loss of materials through kerb and gutter heading North

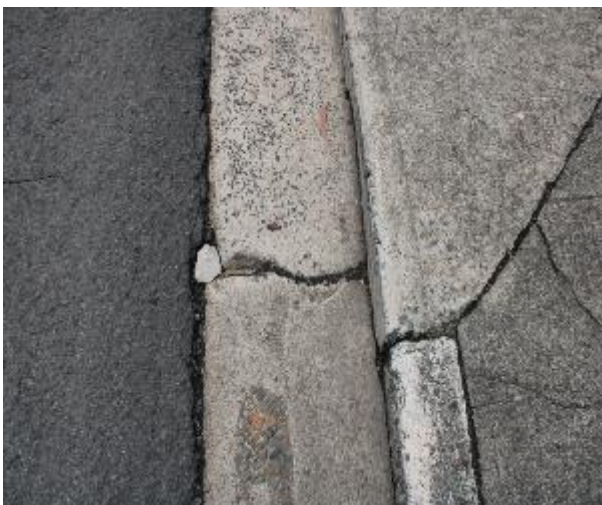
Figure 496 - General condition of driveway layback and gutter heading North

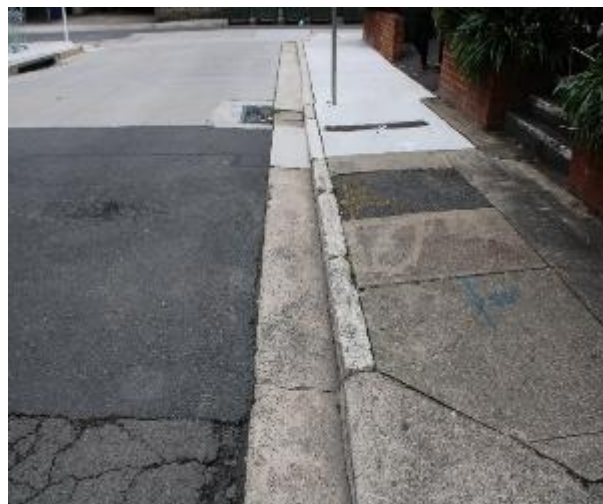
Figure 499 - General condition of driveway layback and gutter heading North

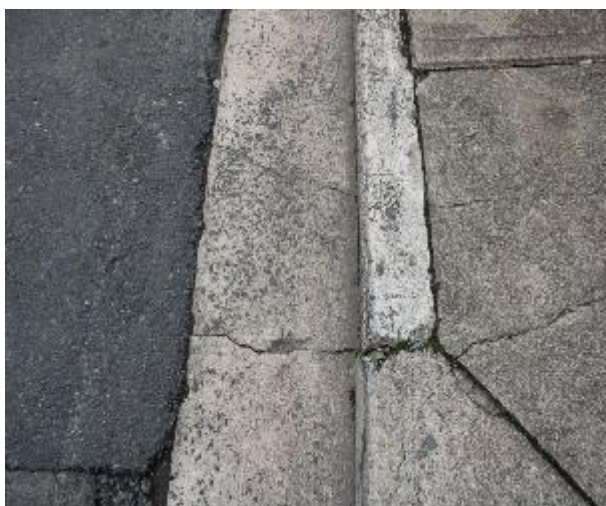
Figure 500 - General condition of kerb and gutter heading North

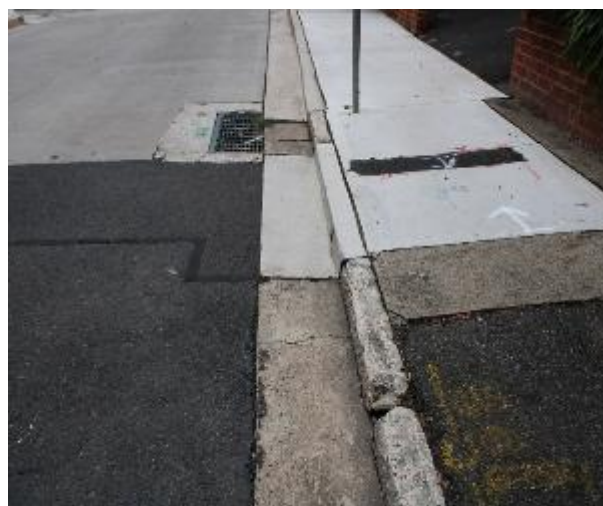
Figure 501 - Crack propagation and loss of materials through kerb and gutter heading North

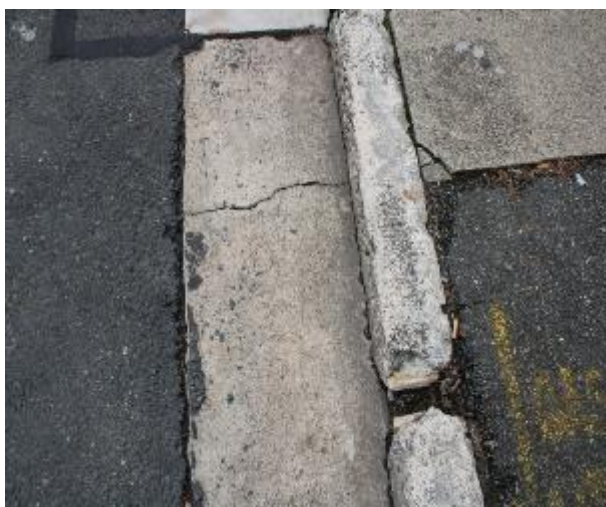
Figure 502 - General condition of kerb and gutter heading North

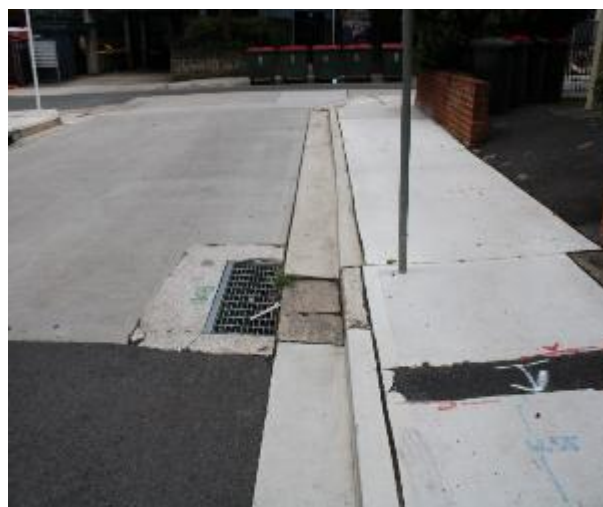
Figure 503 - Crack propagation and loss of material loss through kerb and gutter heading North

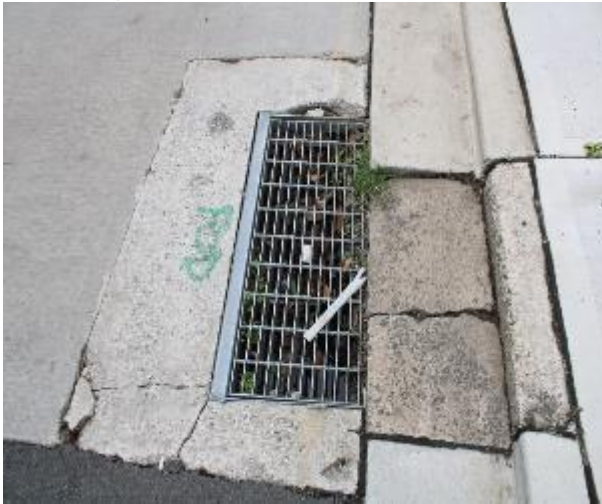
Figure 504 - General condition of kerb and gutter heading North

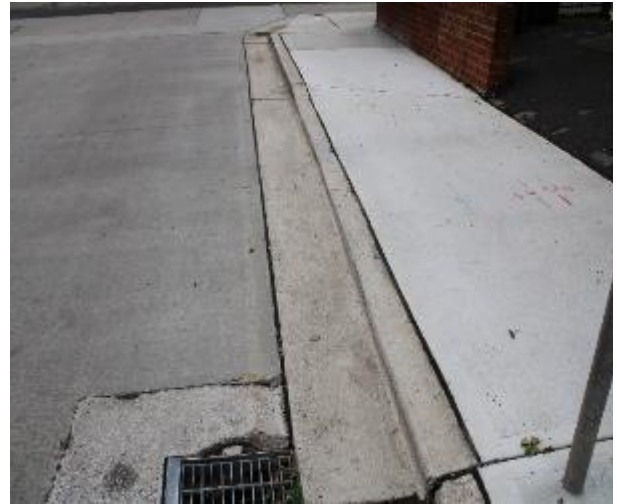
Figure 505 - General condition of stormwater inlet pit

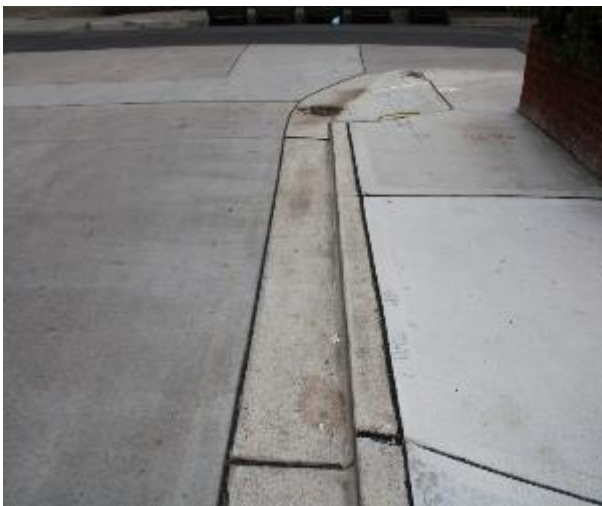
Figure 506 - General condition of kerb and gutter heading North

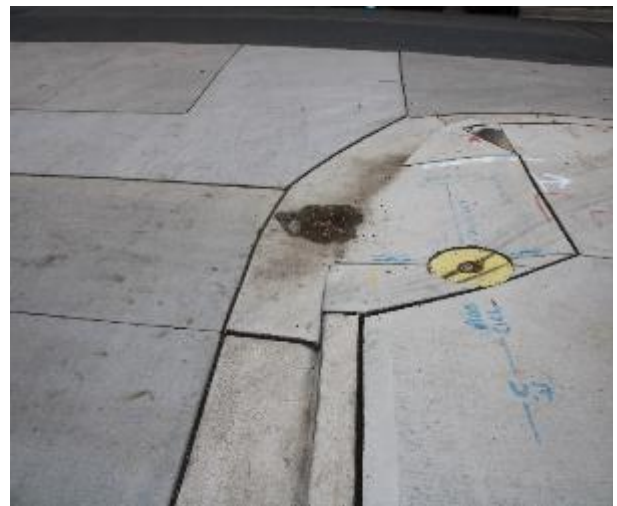
Figure 507 - General condition of kerb and gutter heading North

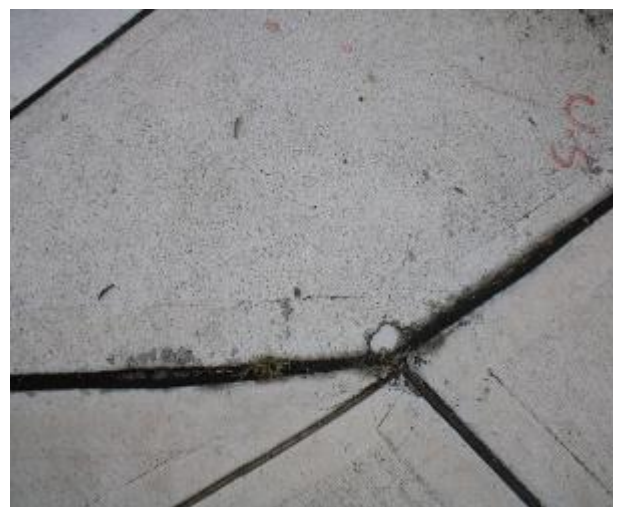
Figure 509 - General condition of footpath pavement heading South

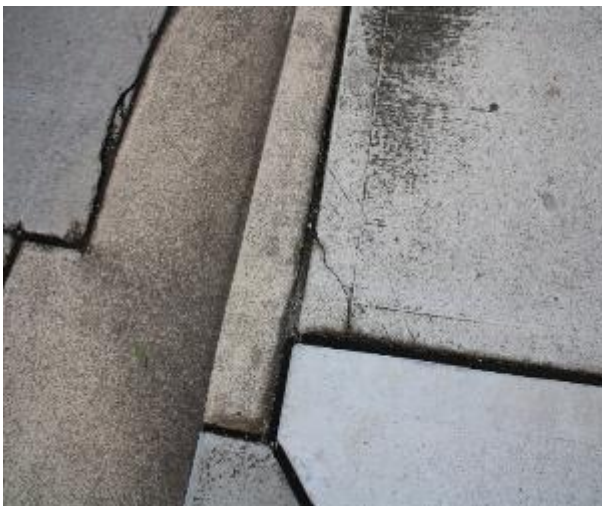
Figure 512 - General condition of footpath pavement heading South

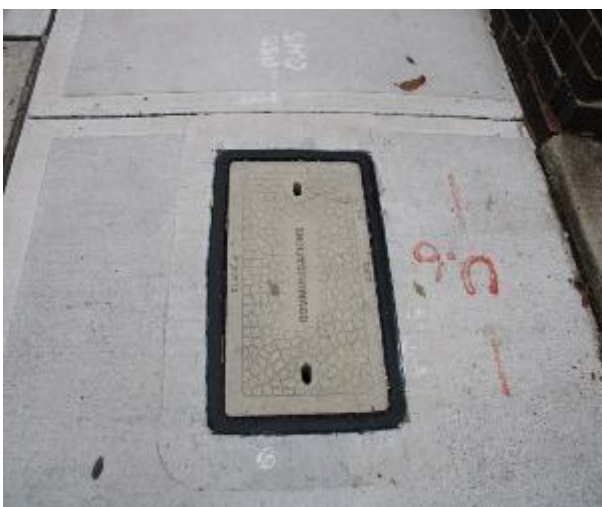
Figure 514 - General condition of footpath pavement heading South

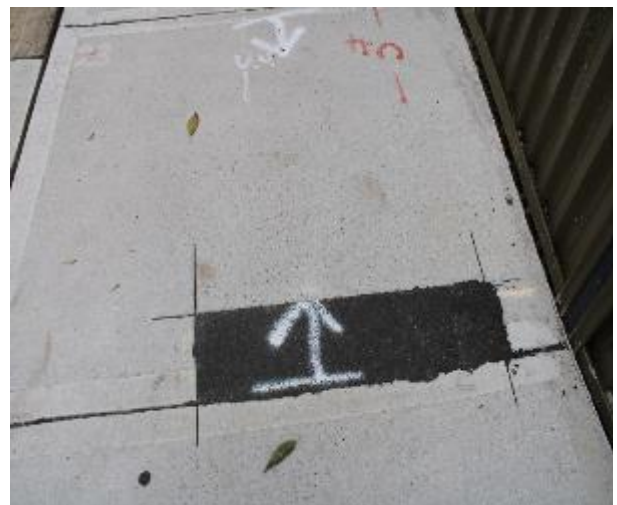
Figure 521 - General condition of footpath pavement heading South

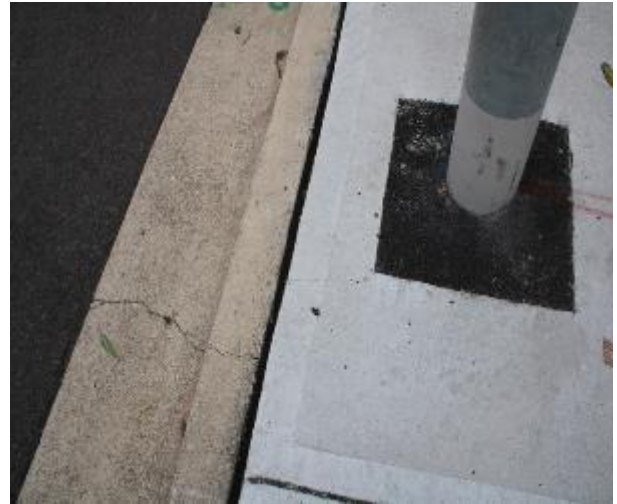
Figure 523 - General condition of footpath pavement heading South

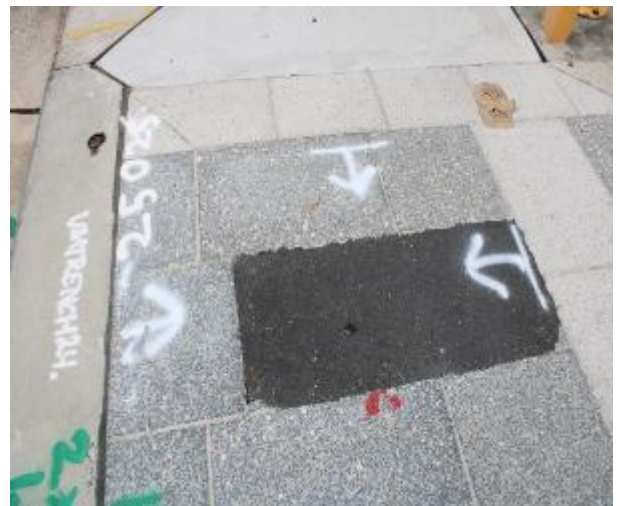
Figure 525 - General condition of footpath pavement heading South

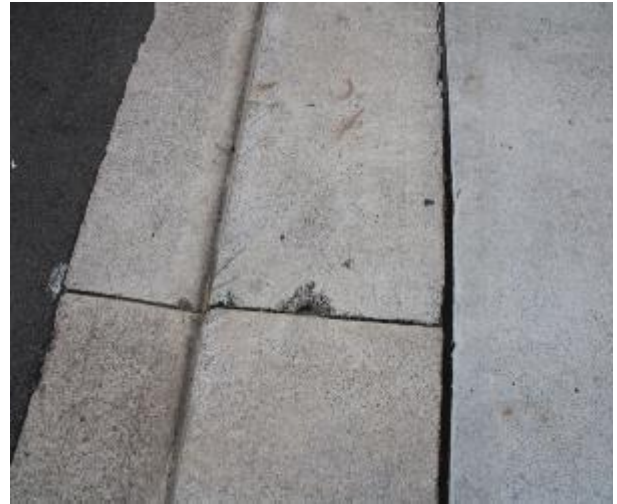
Figure 529 - General condition of footpath pavement heading South

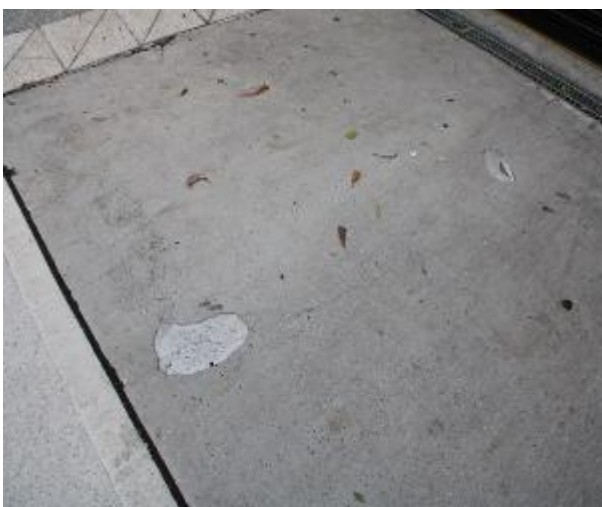
Figure 532 - Crack propagation through footpath pavement heading South

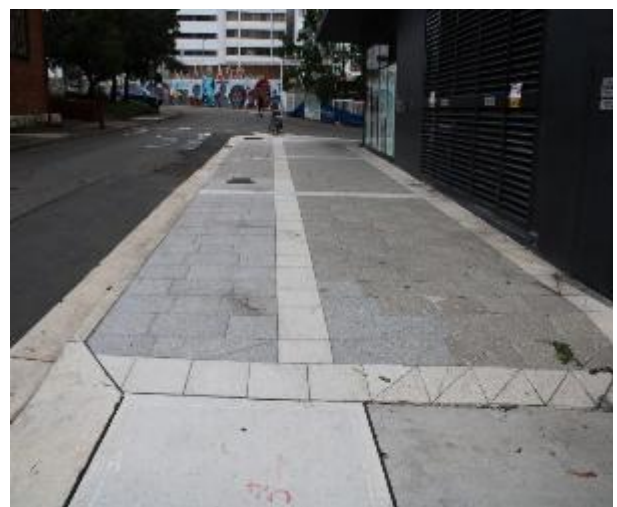
Figure 533 - Crack propagation through footpath pavement heading South

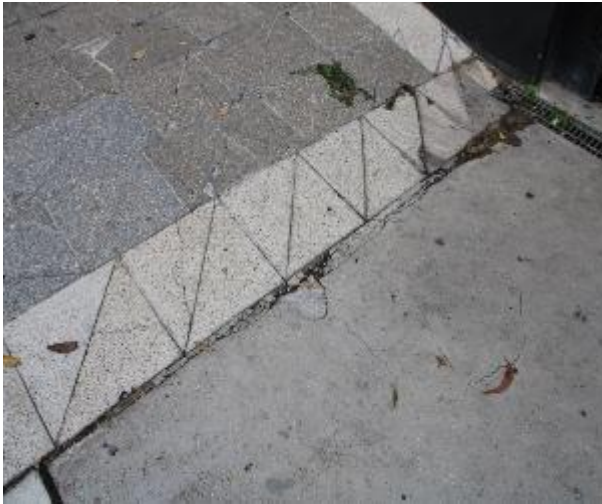
Figure 534 - General condition of footpath pavers heading South

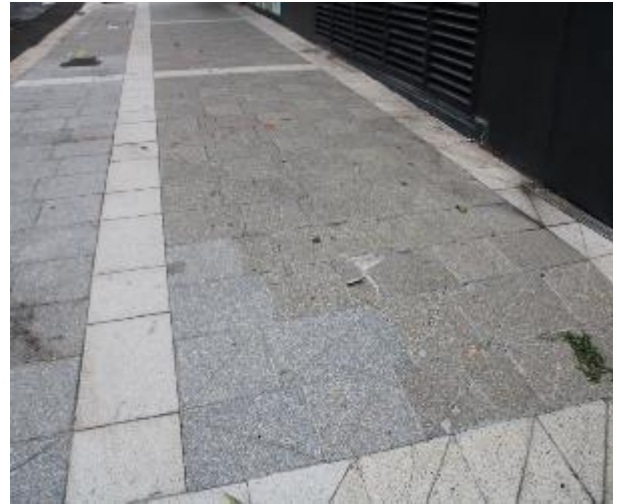
Figure 535 - General condition of footpath pavers heading South

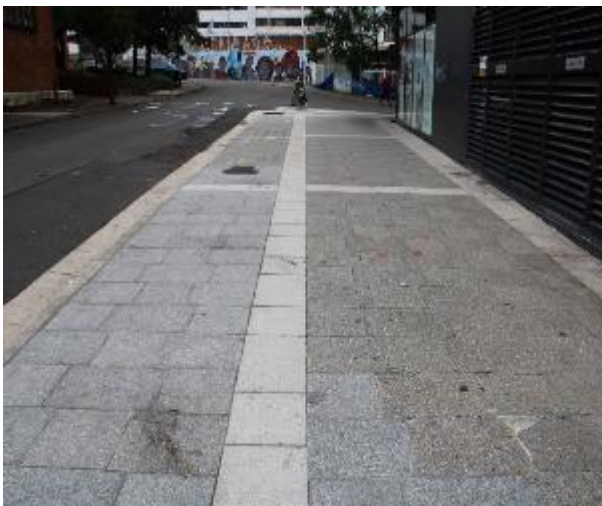
Figure 536 - General condition of footpath pavers heading South

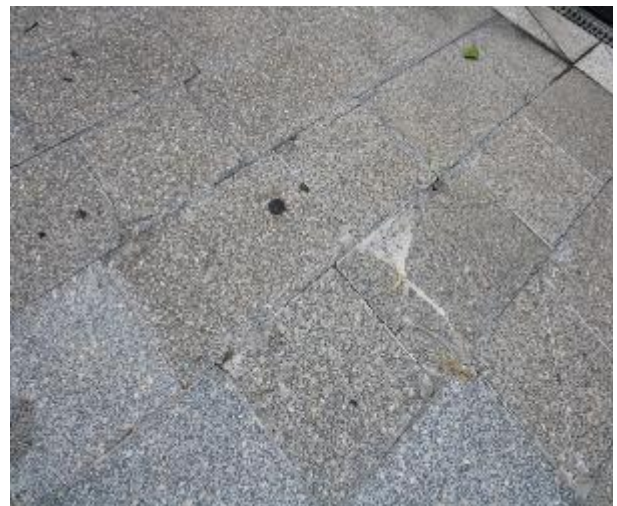
Figure 537 - General condition of footpath pavers heading South

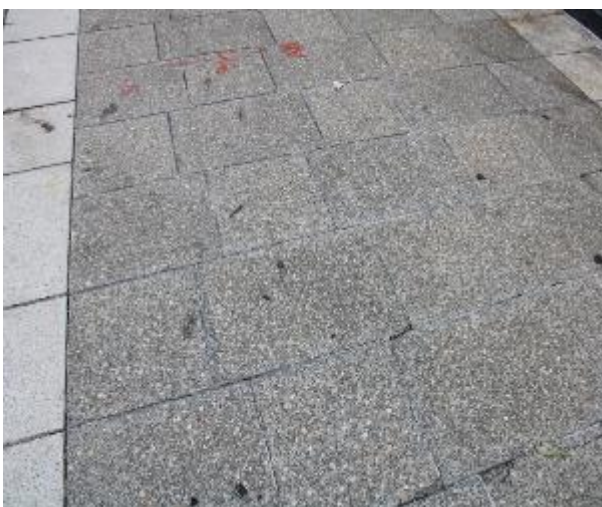
Figure 538 - Crack propagation through footpath pavers heading South

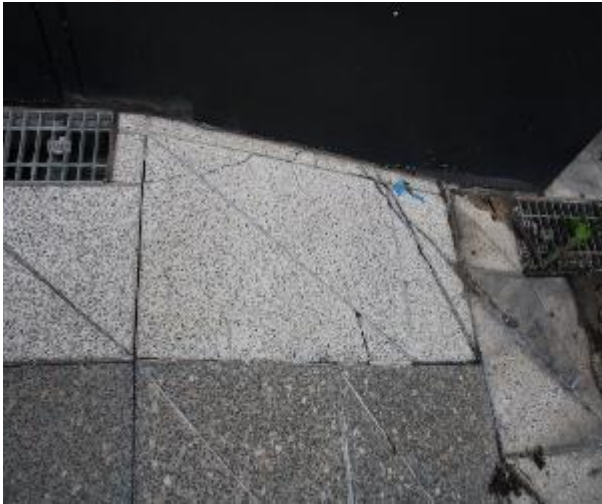
Figure 540 - General condition of footpath pavers heading South

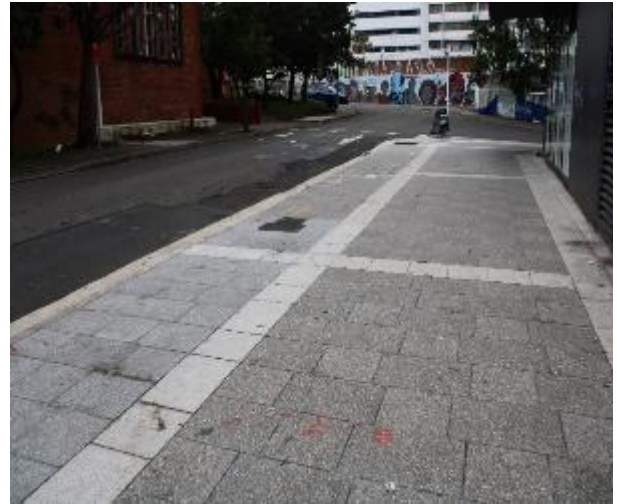
Figure 541 - Crack propagation through footpath pavers heading South

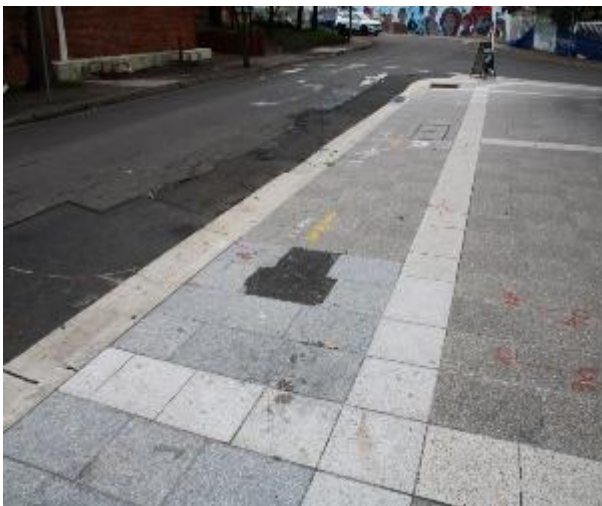
Figure 542 - General condition of footpath pavers heading South

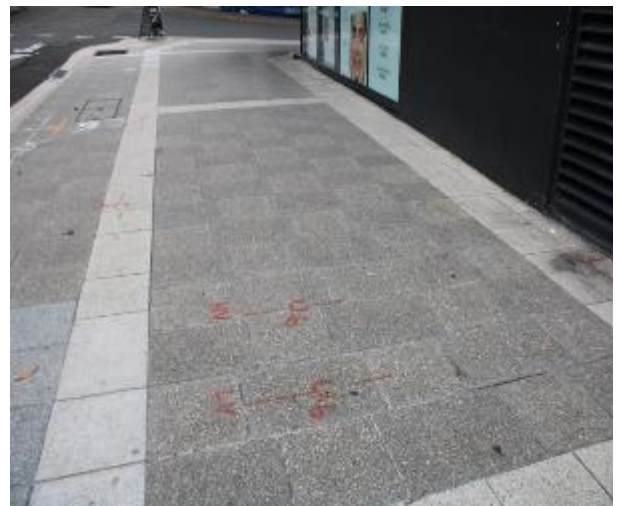
Figure 543 - General condition of footpath pavers heading South
