# **PRE-DILAPIDATION REPORT**

**COUNCIL ASSETS**

**21 GEORGE STREET,  
BURWOOD, NSW 2134**

PROJECT REFERENCE: 20250047.CA.1  
17/04/2026

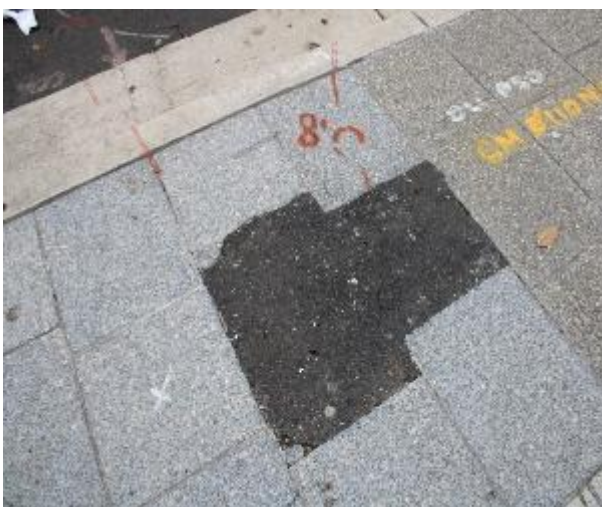
Figure 544 - General condition of footpath pavers heading South

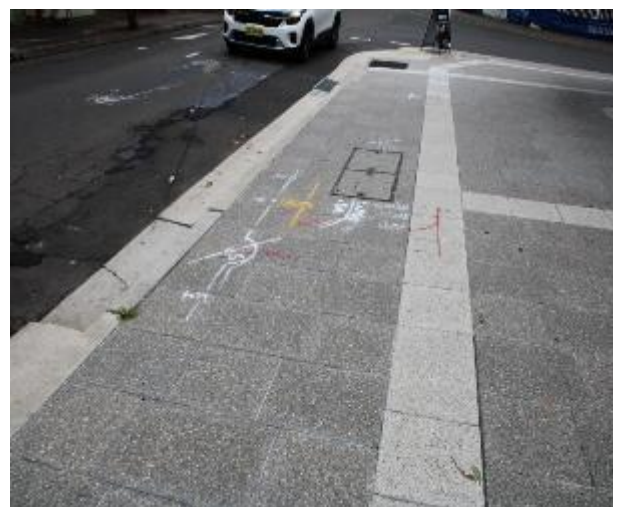
Figure 545 - Patchwork evident through footpath pavers heading South

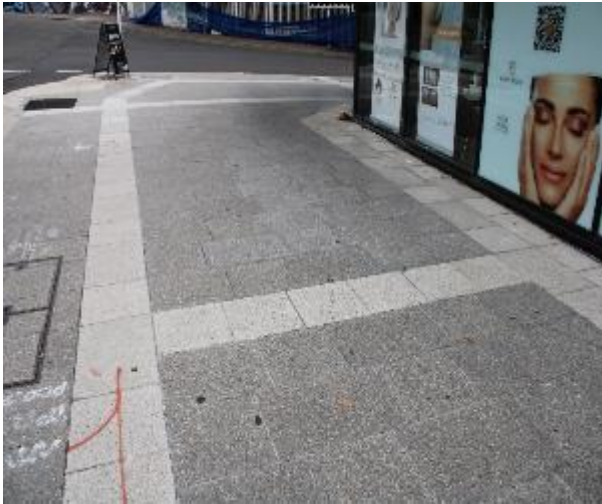
Figure 546 - General condition of footpath pavers heading South

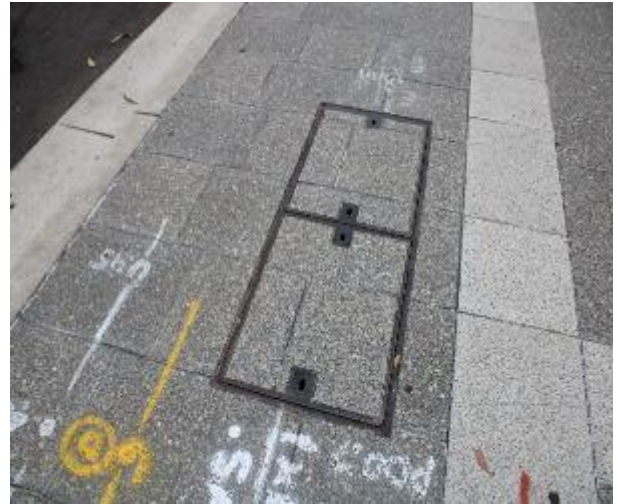
Figure 547 - General condition of footpath pavers heading South

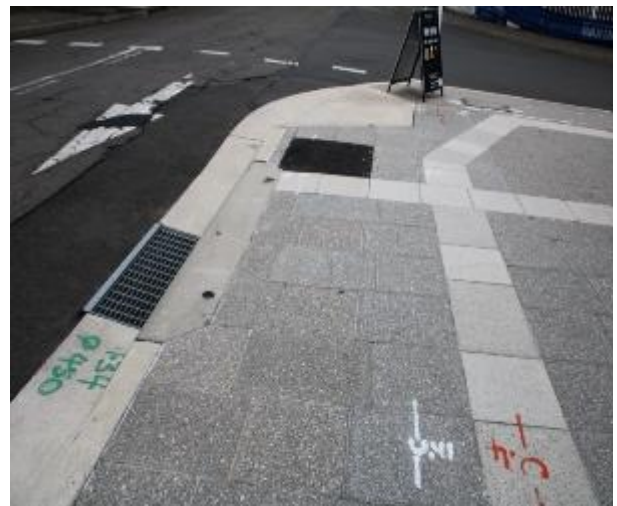
Figure 549 - General condition of footpath pavers heading South

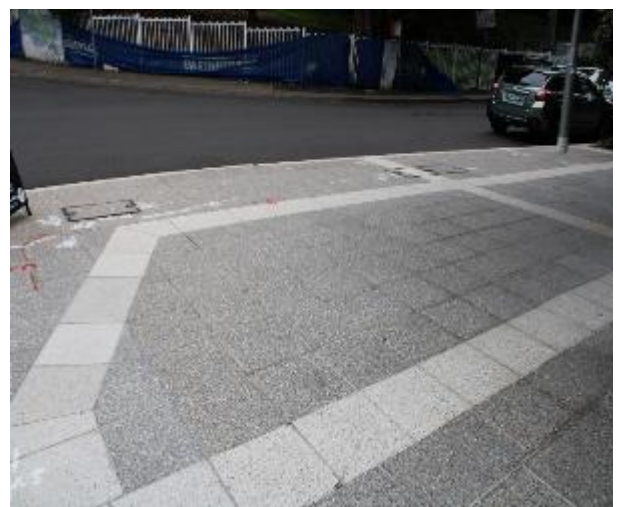
Figure 551 - Crack propagation through footpath pavers heading South

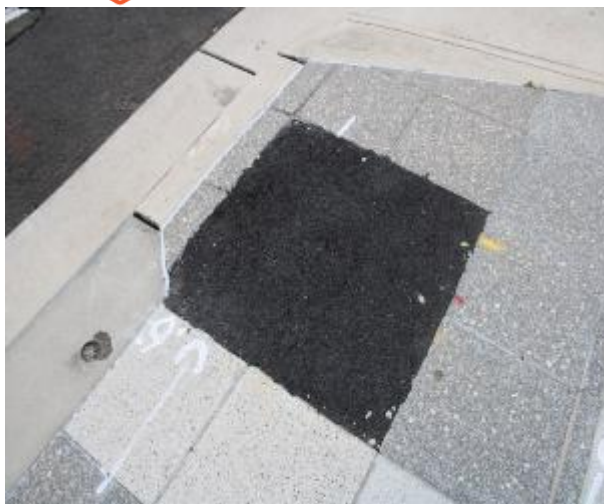
Figure 552 - General condition of footpath pavers heading South

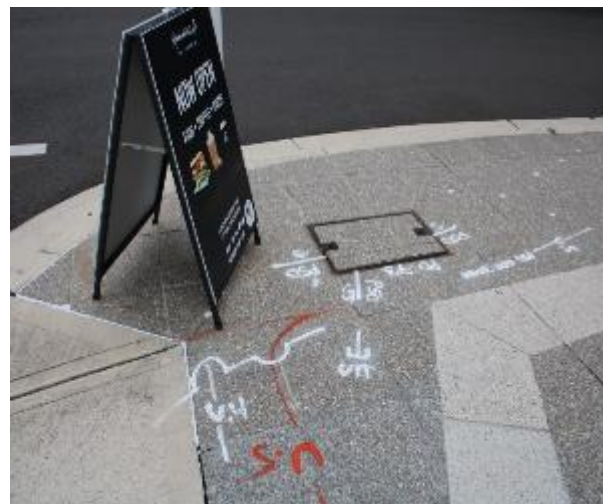
Figure 553 - Patchwork evident through footpath pavers heading South

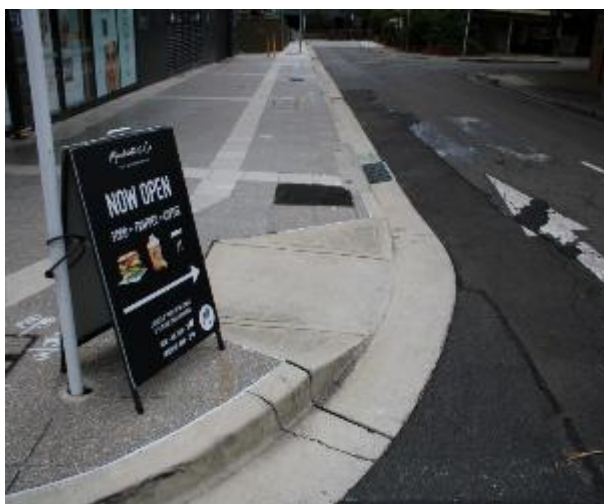
Figure 554 - General condition of footpath pavers heading South

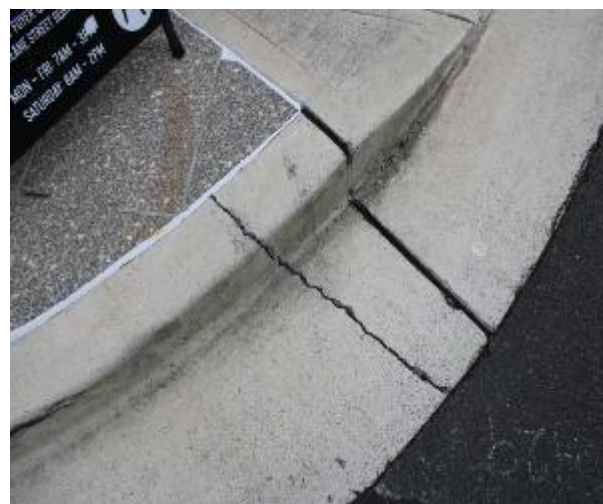
Figure 555 - General condition of kerb and gutter heading North

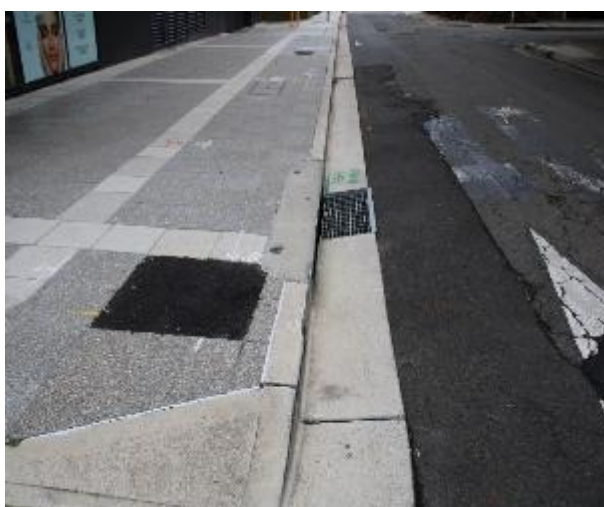
Figure 556 - Crack propagation through kerb and gutter heading North

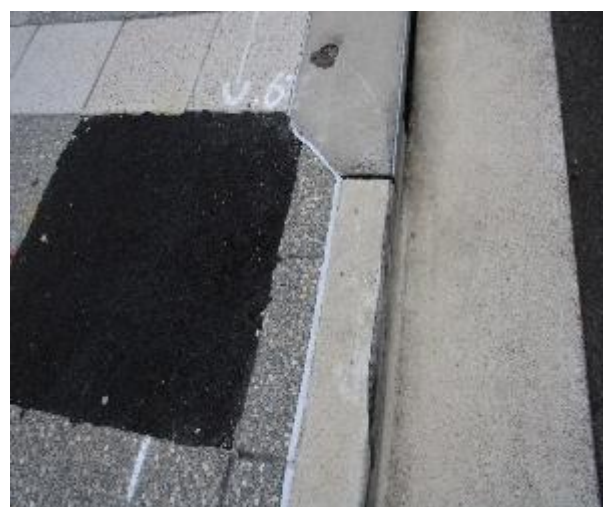
Figure 557 - General condition of kerb and gutter heading North

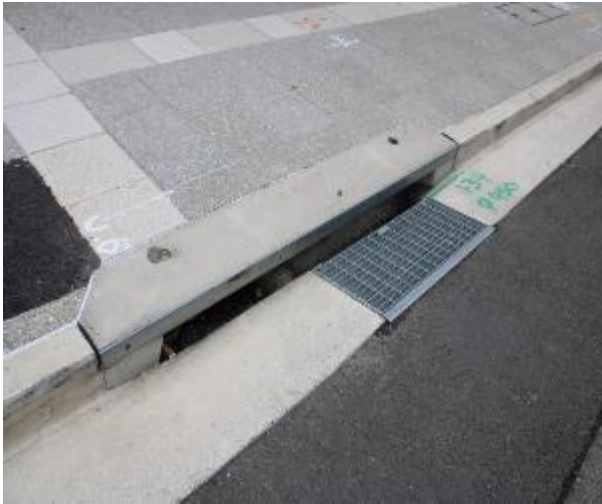
Figure 558 - General condition of kerb and gutter heading North

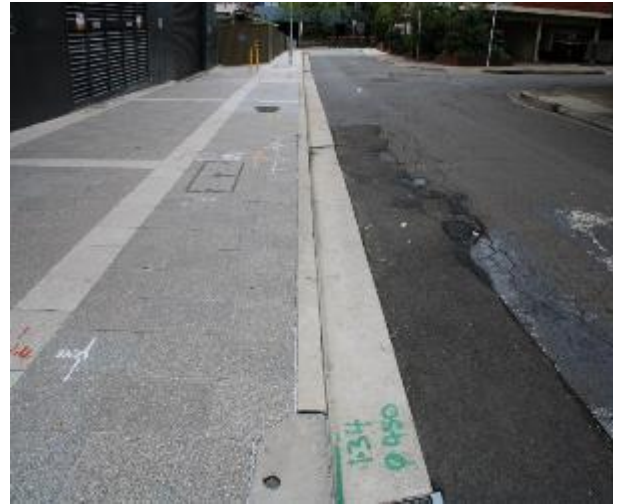
Figure 559 - General condition of stormwater inlet pit

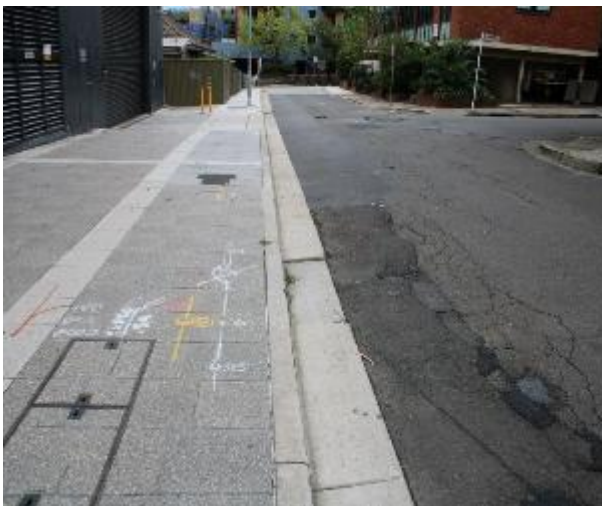
Figure 560 - General condition of kerb and gutter heading North

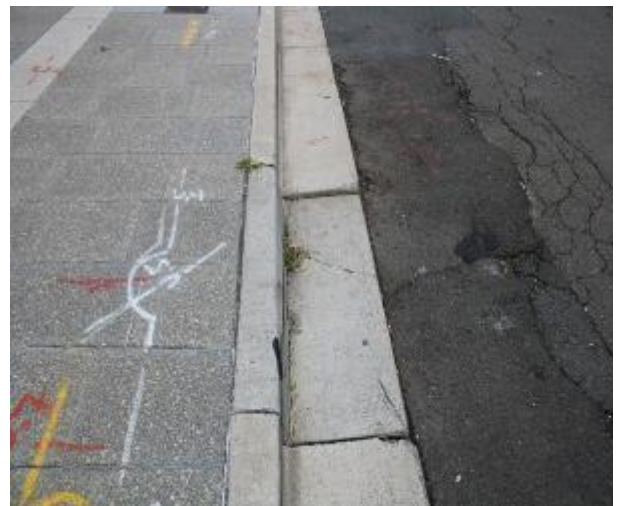
Figure 561 - General condition of kerb and gutter heading North

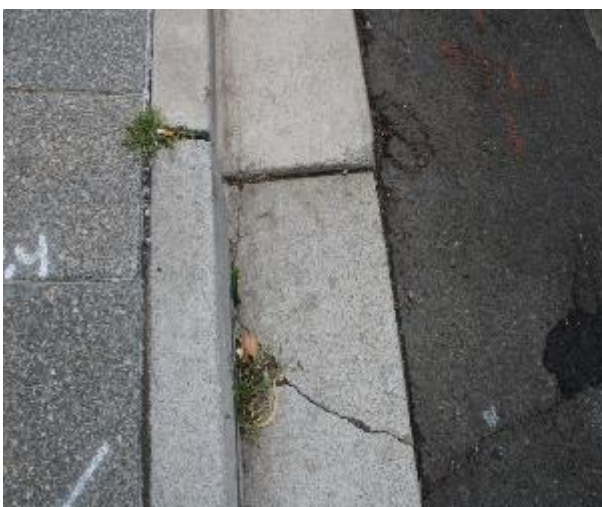
Figure 562 - General condition of kerb and gutter heading North

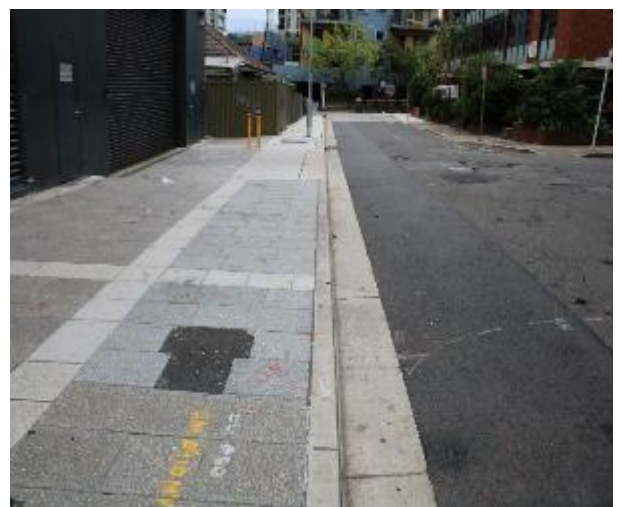
Figure 563 - Crack propagation through kerb and gutter heading North

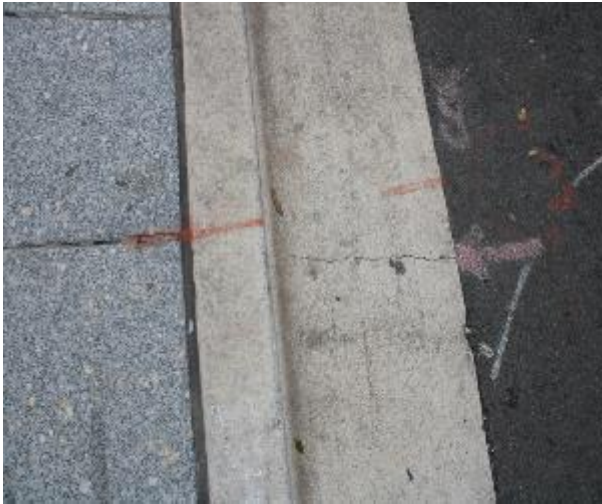
Figure 564 - General condition of kerb and gutter heading North

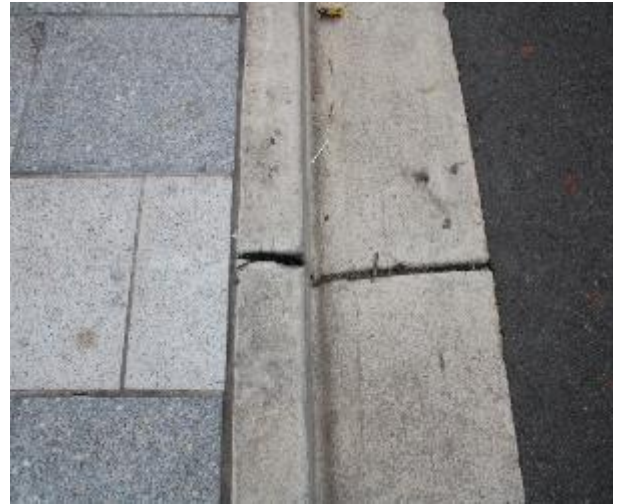
Figure 565 - Crack propagation through kerb and gutter heading North

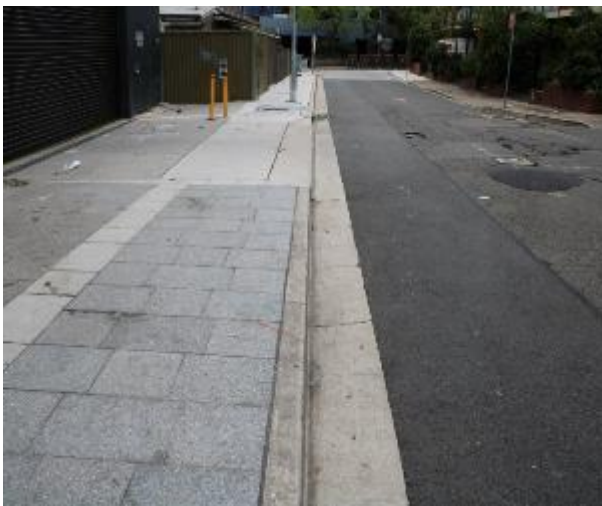
Figure 566 - General condition of kerb and gutter heading North

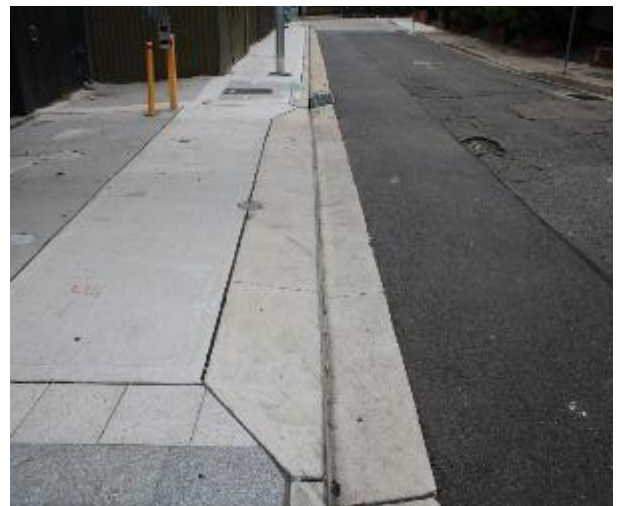
Figure 567 - General condition of kerb and gutter heading North

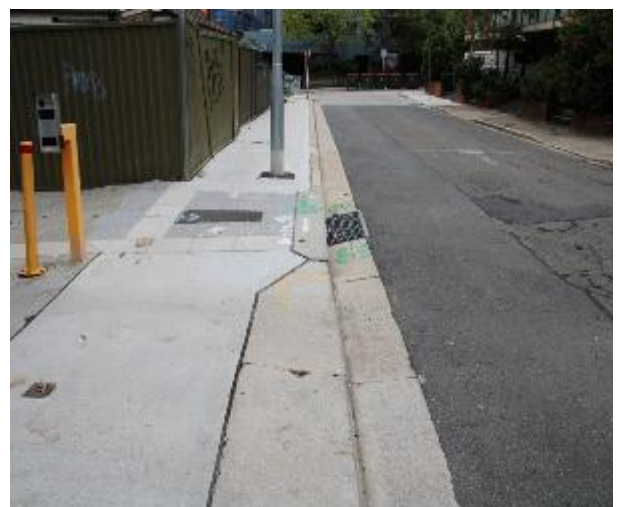
Figure 569 - Crack propagation through driveway layback and gutter heading North

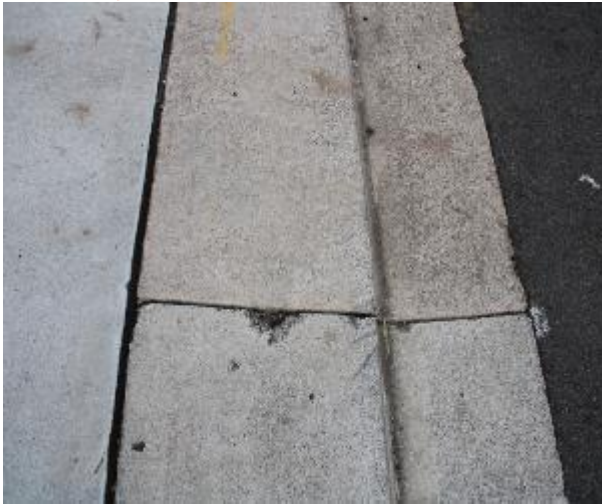
Figure 570 - General condition of driveway layback and gutter heading North

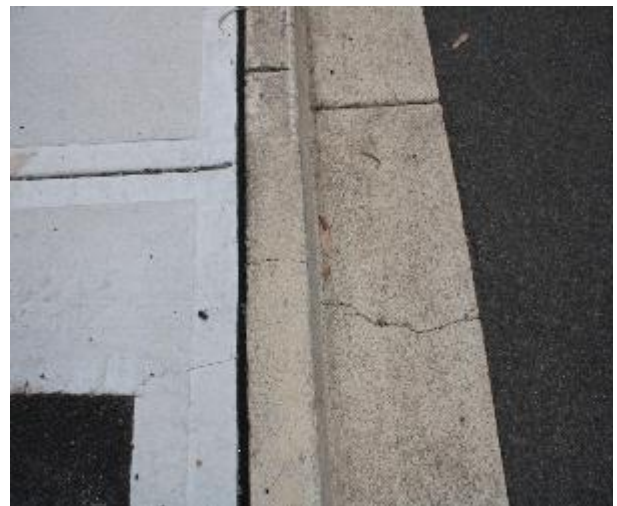
Figure 573 - General condition of kerb and gutter heading North

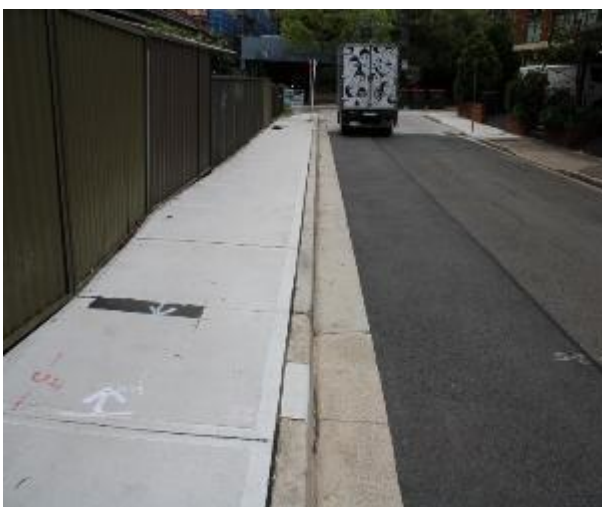
Figure 574 - Crack propagation through kerb and gutter heading North

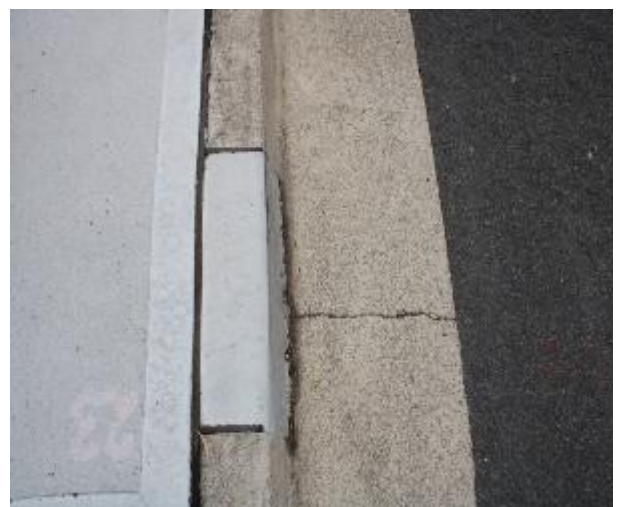
Figure 575 - General condition of kerb and gutter heading North

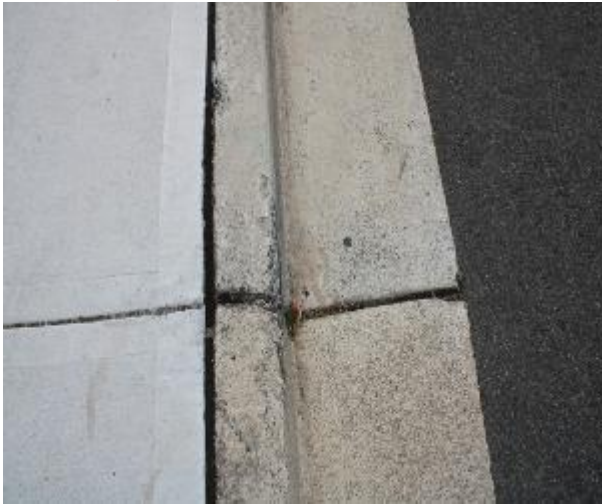
Figure 576 - Crack propagation through kerb and gutter heading North

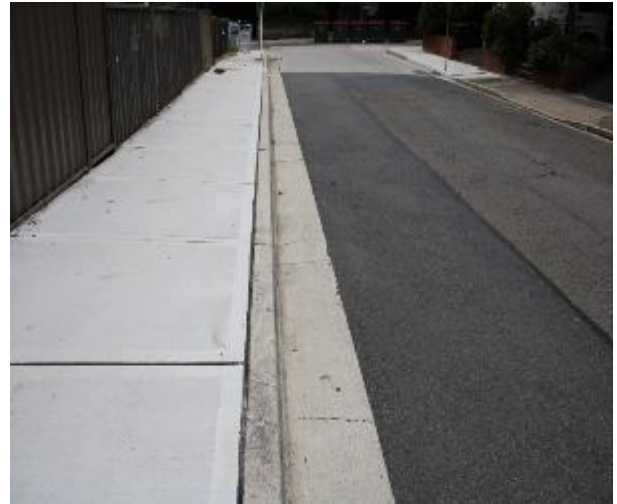
Figure 577 - Crack propagation through kerb and gutter heading North

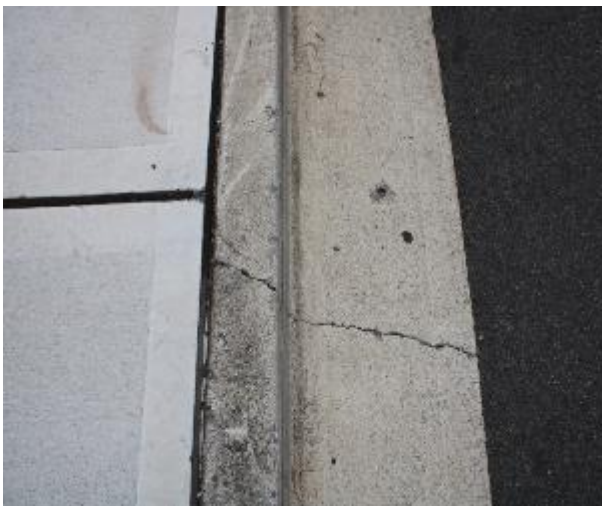
Figure 578 - General condition of kerb and gutter heading North

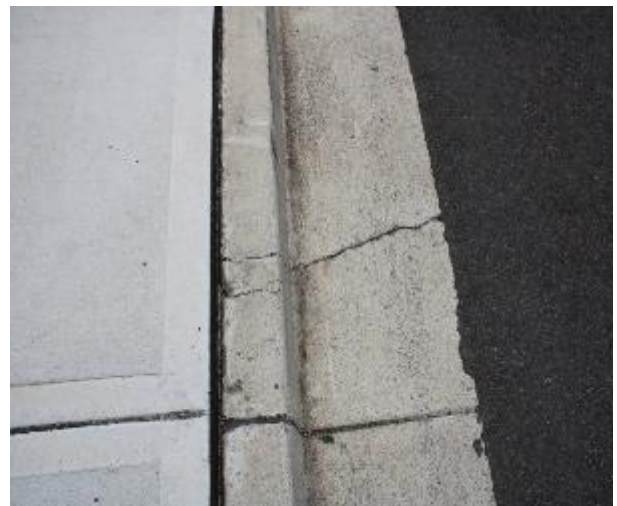
Figure 579 - Crack propagation through kerb and gutter heading North

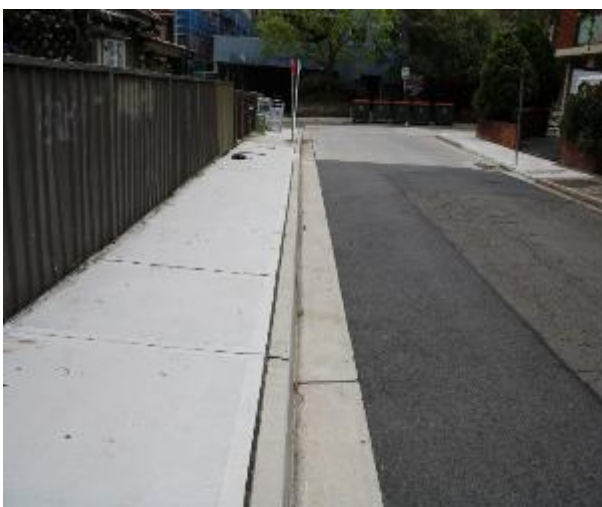
Figure 580 - Crack propagation through kerb and gutter heading North

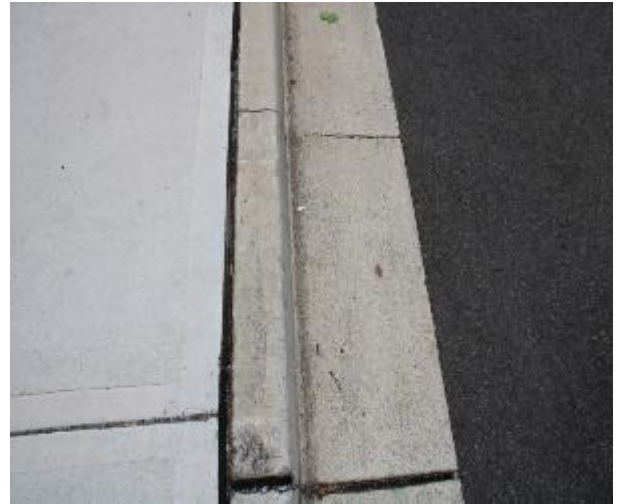
Figure 583 - General condition of kerb and gutter heading North

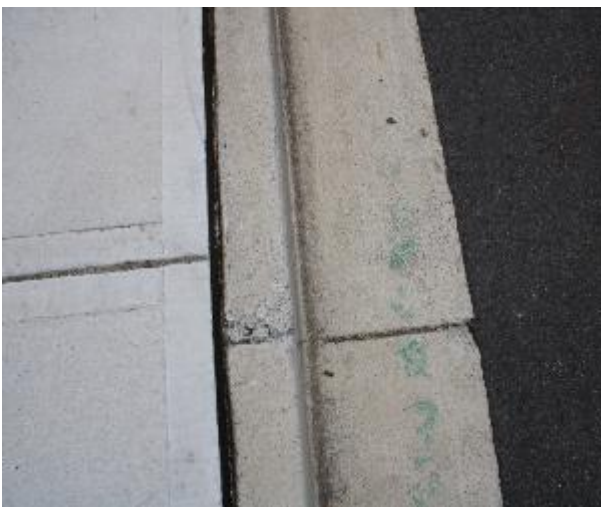
Figure 586 - General condition of kerb and gutter heading North

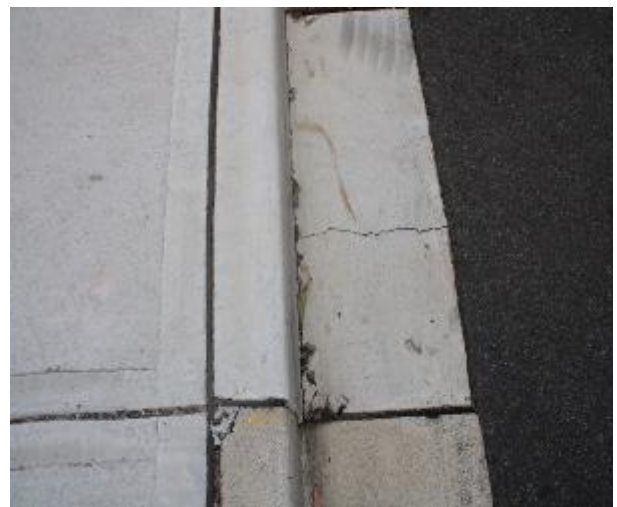
Figure 587 - Crack propagation through kerb and gutter heading North

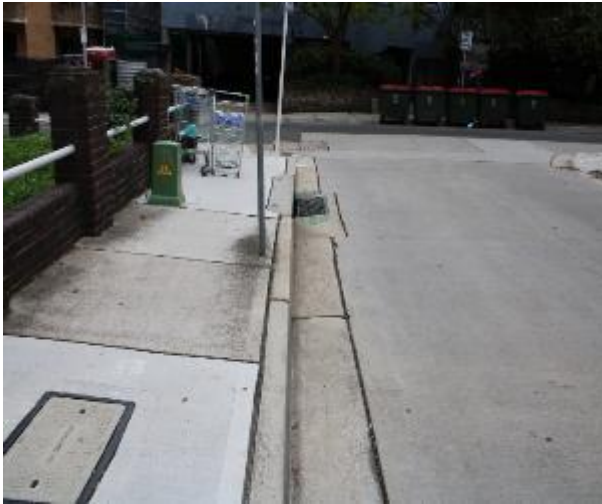
Figure 588 - Crack propagation through kerb and gutter heading North

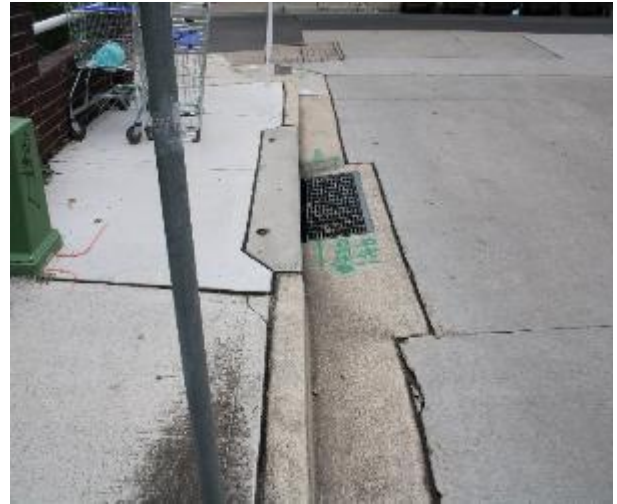
Figure 589 - General condition of kerb and gutter heading North

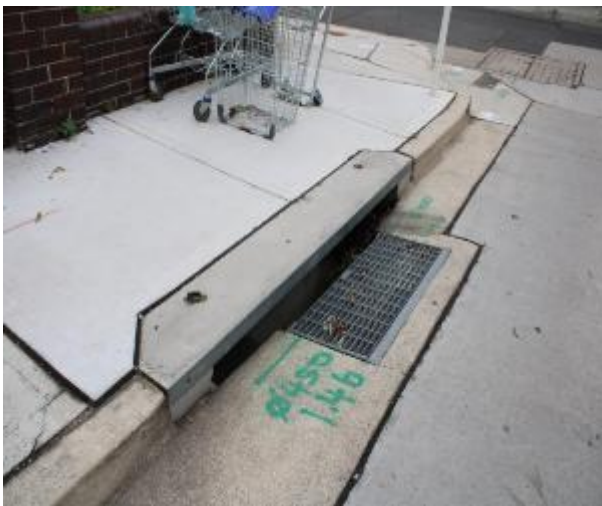
Figure 590 - General condition of kerb and gutter heading North

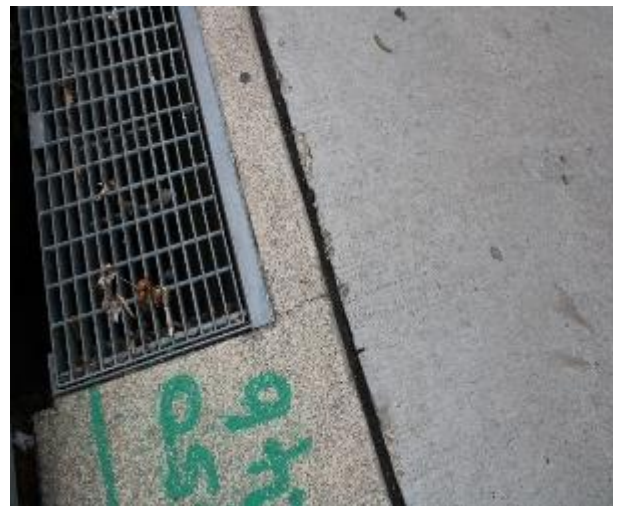
Figure 591 - General condition of stormwater inlet pit

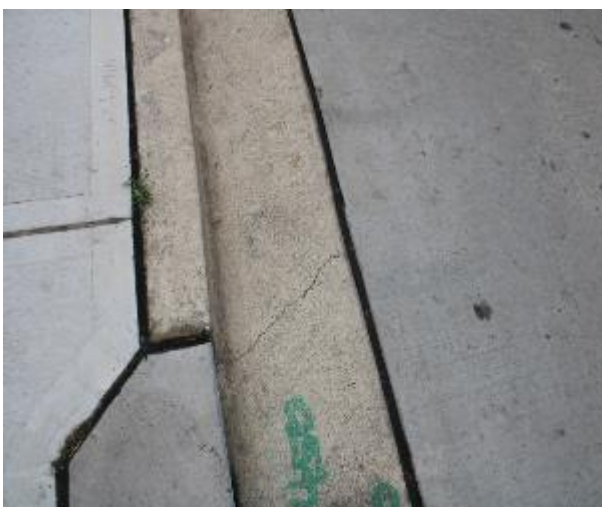
Figure 592 - Crack propagation through kerb and gutter heading North

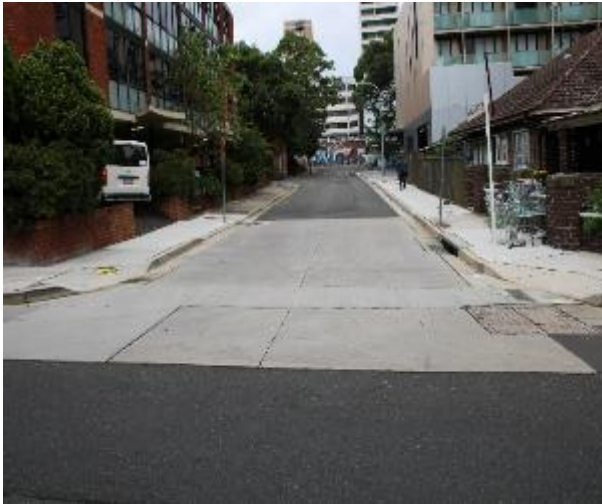
Figure 594 - General condition of kerb and gutter heading North

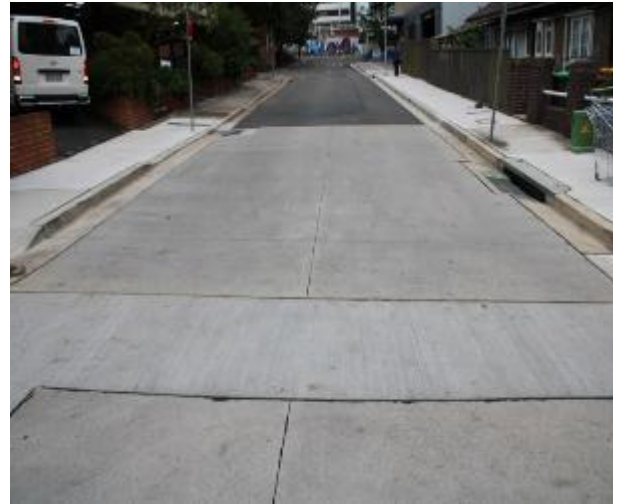
Figure 595 - General condition of road surface heading South

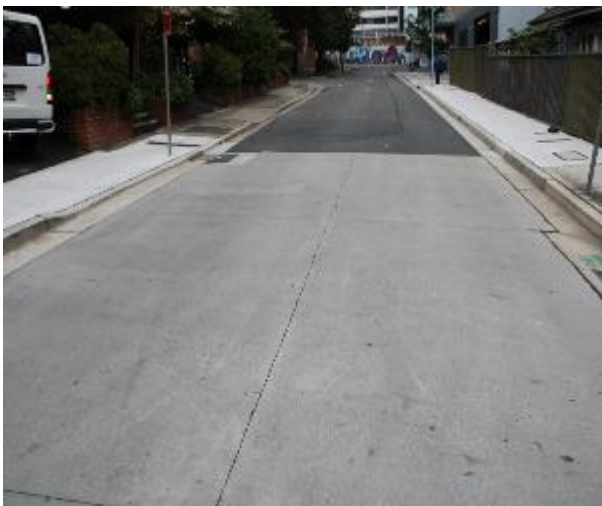
Figure 596 - General condition of road surface heading South

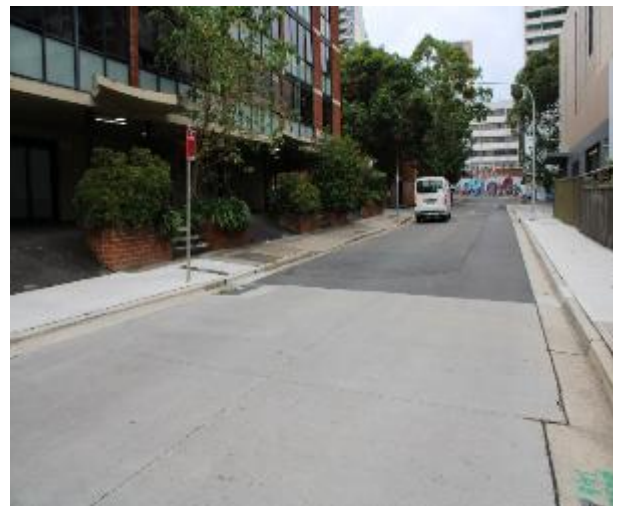
Figure 597 - General condition of road surface heading South

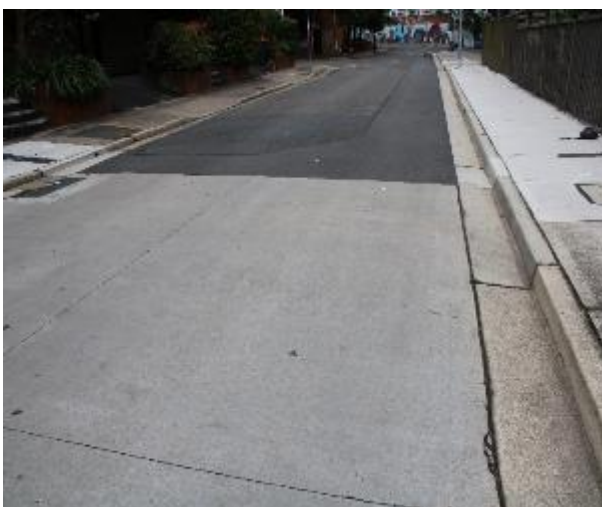
Figure 598 - General condition of road surface heading South

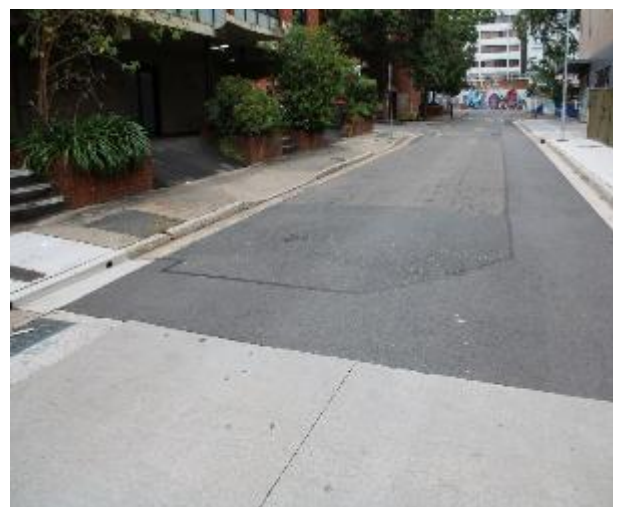
Figure 599 - General condition of road surface heading South

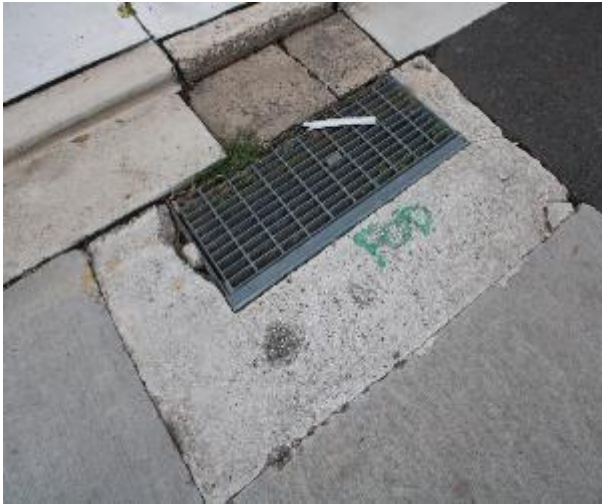
Figure 600 - General condition of road surface heading South

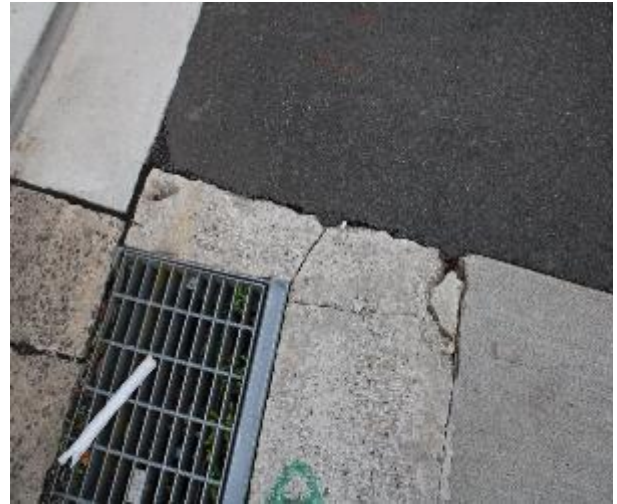
Figure 601 - General condition of stormwater inlet pit

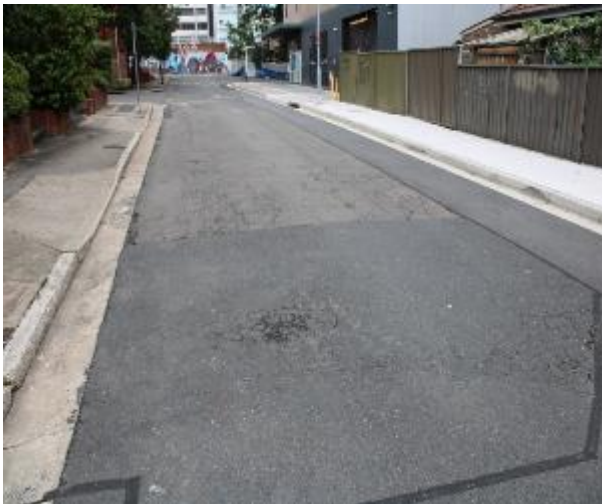
Figure 602 - Crack propagation and loss of materials through road surface heading South

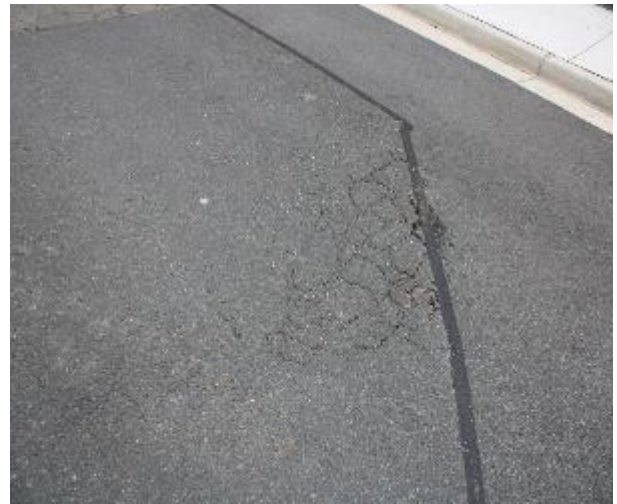
Figure 603 - General condition of road surface heading South

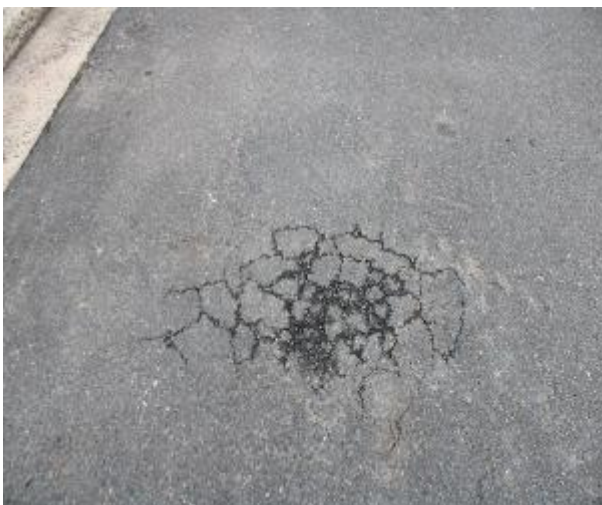
Figure 604 - Crack propagation through road surface heading South

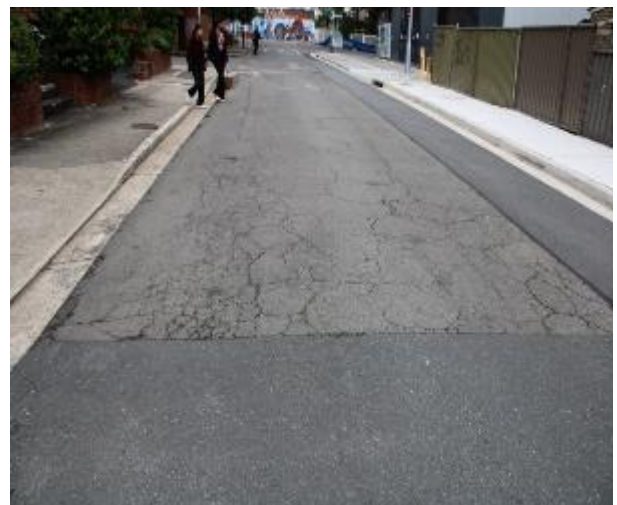
Figure 605 - Crack propagation through road surface heading South

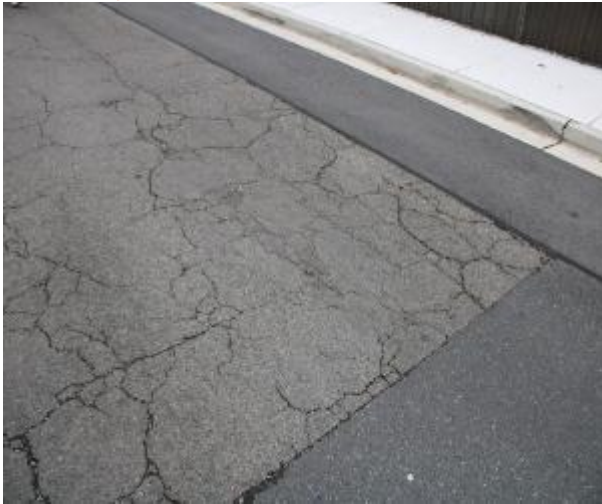
Figure 606 - General condition of road surface heading South

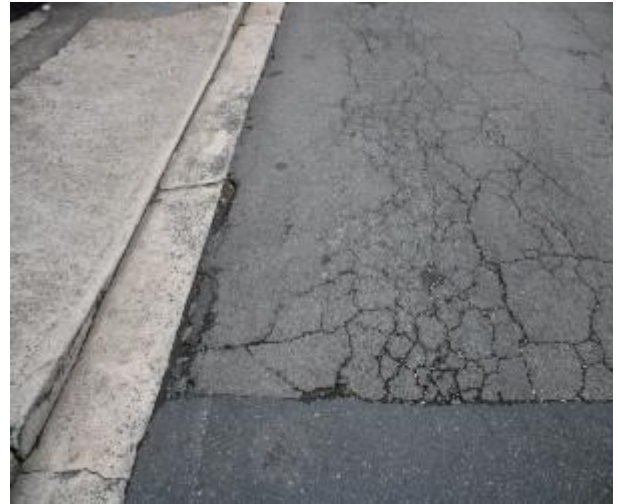
Figure 607 - Crack propagation through road surface heading South

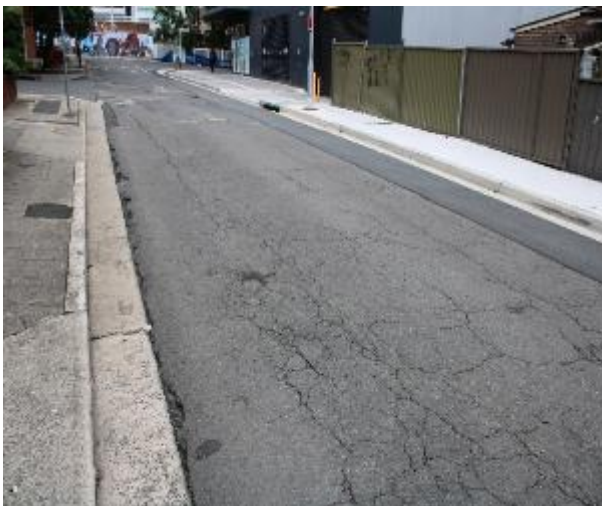
Figure 608 - Crack propagation through road surface heading South

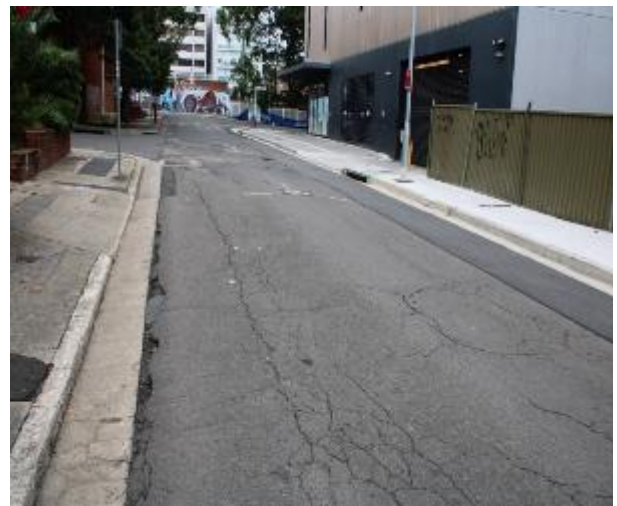
Figure 609 - General condition of road surface heading South

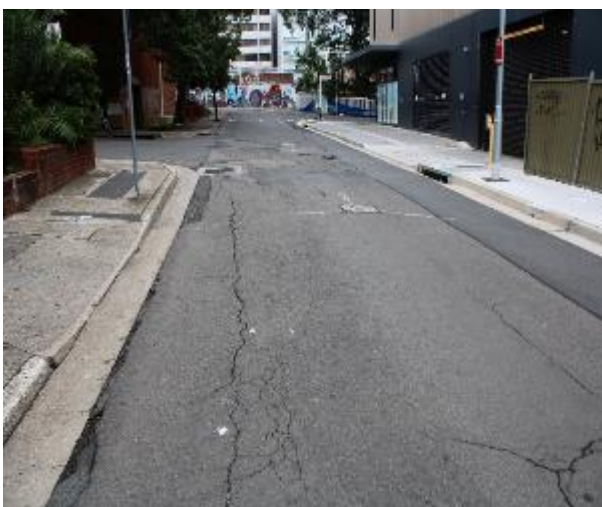
Figure 610 - General condition of road surface heading South

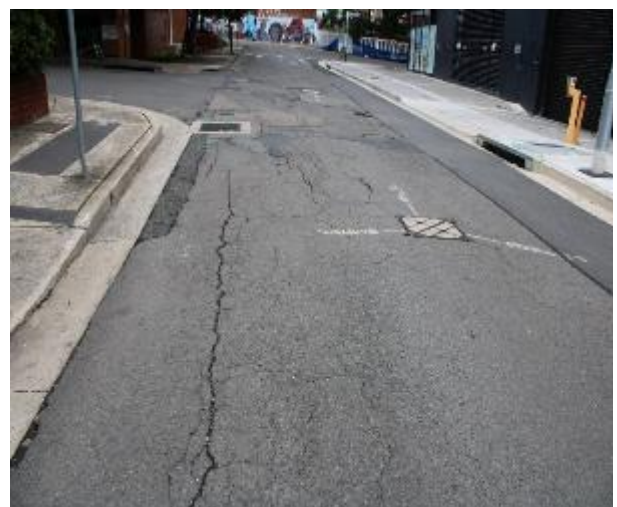
Figure 611 - General condition of road surface heading South

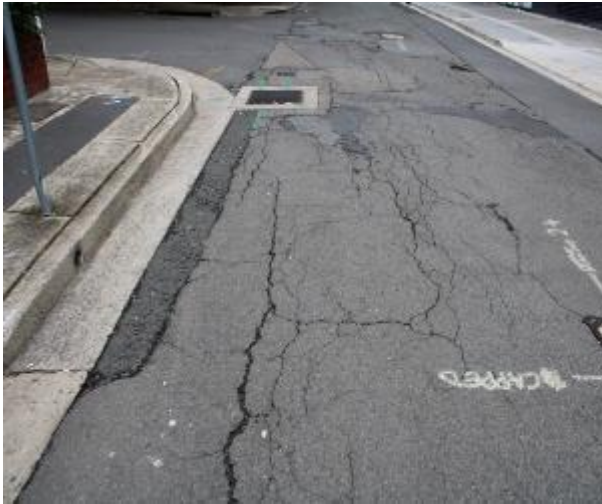
Figure 612 - General condition of road surface heading South

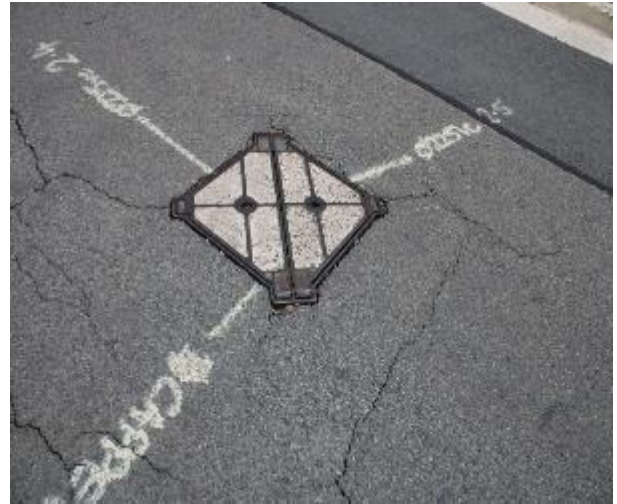
Figure 613 - Crack propagation through road surface heading South

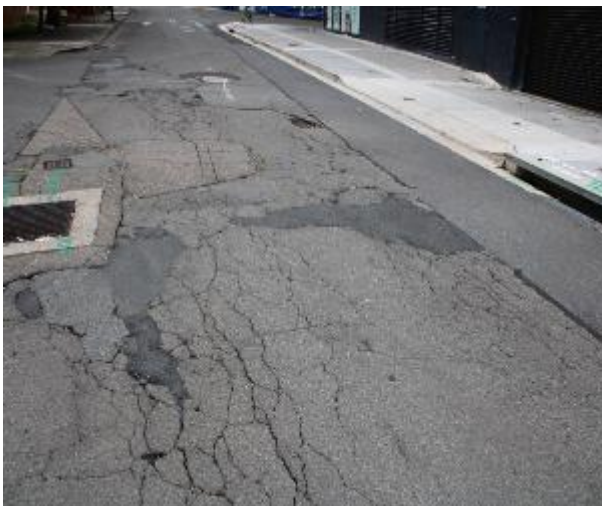
Figure 615 - General condition of road surface heading South

The road surface of Marmaduke Street at the time of the inspection was in a reasonable condition with evidence of cracking, patchwork, and material loss.

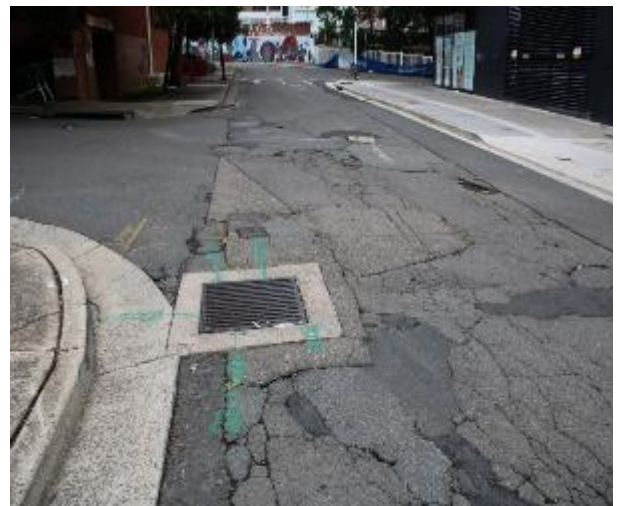
Figure 616 - General condition of road surface heading South

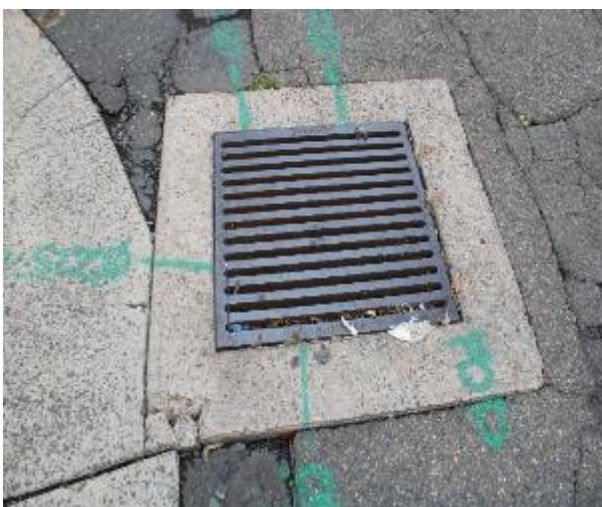
Figure 617 - General condition of stormwater inlet pit

The condition of the street light posts, street signs, stormwater inlet pits, and service pits were also inspected and were determined to be in a reasonable condition.

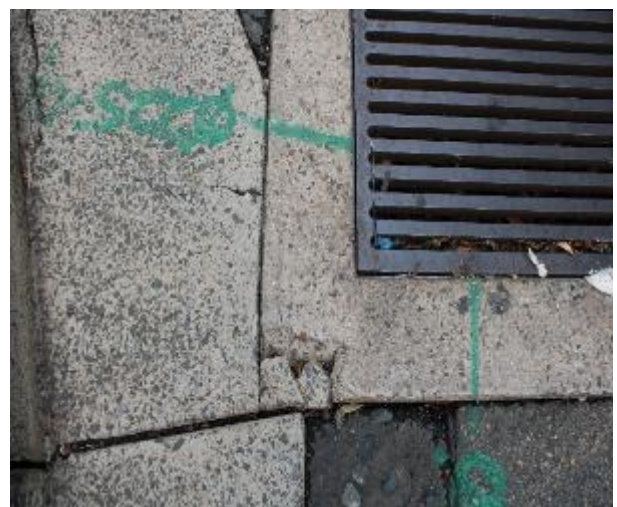
Figure 618 - Crack propagation and loss of materials through road surface heading South

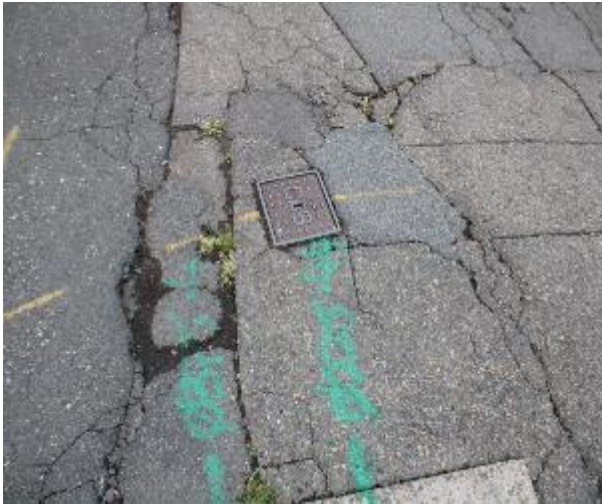
Figure 619 - General condition of service pit

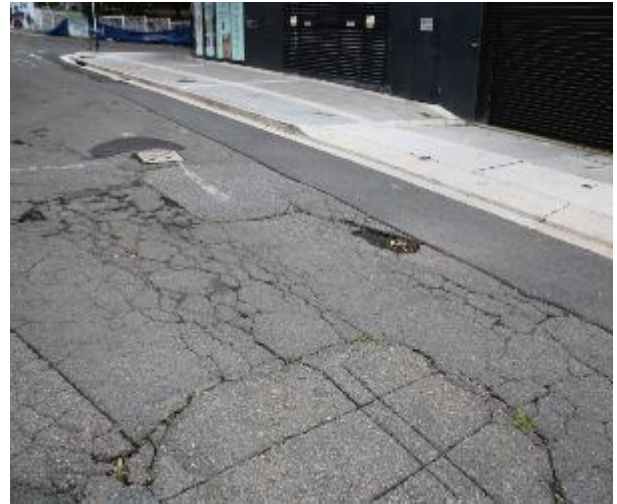
Figure 620 - General condition of road surface heading South

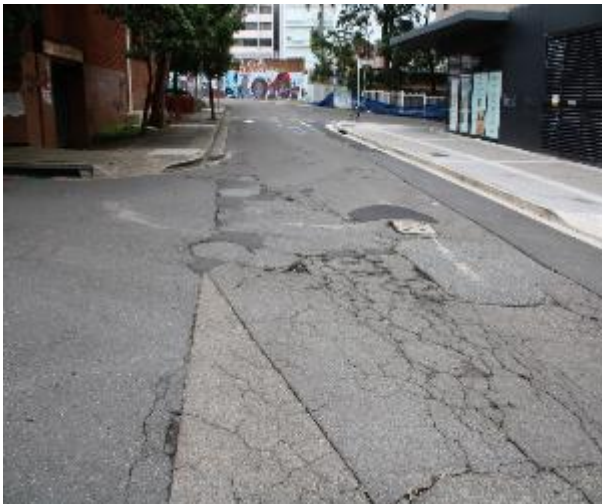
Figure 621 - General condition of road surface heading South

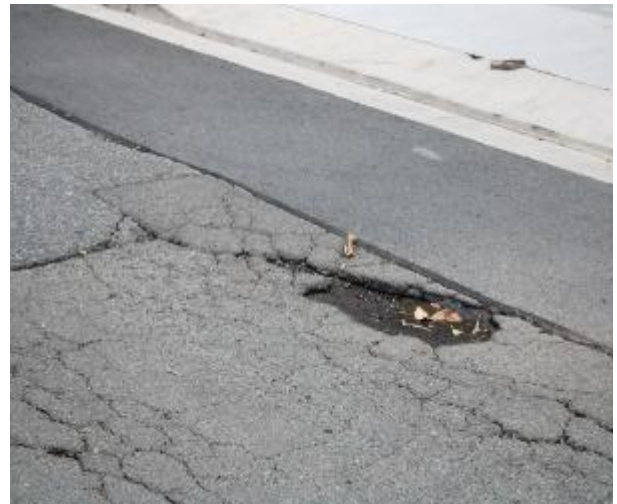
Figure 622 - Crack propagation and loss of materials through road surface heading South

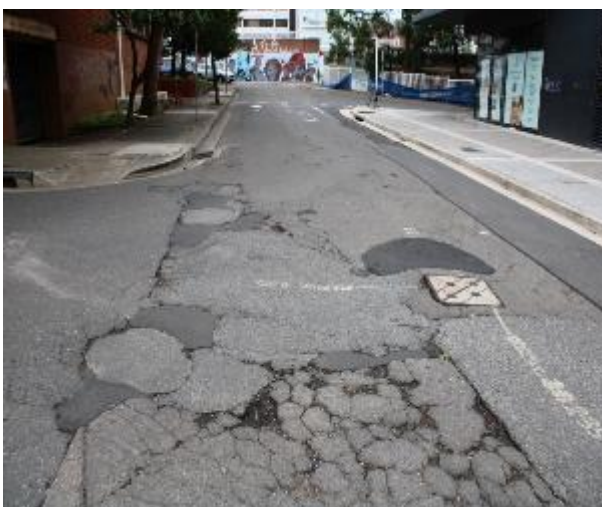
Figure 623 - General condition of road surface heading South

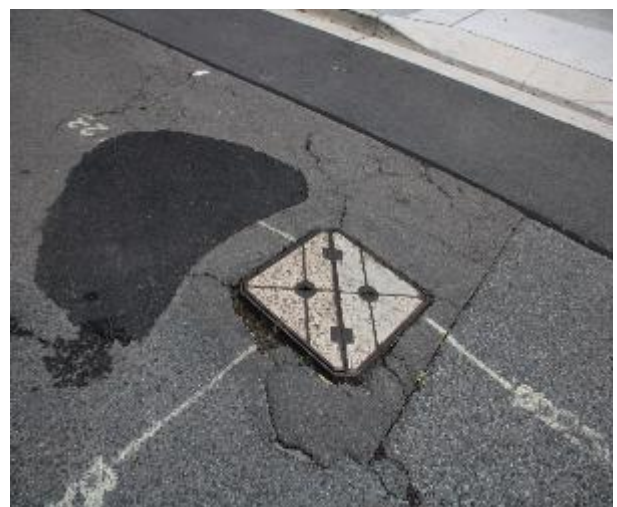
Figure 624 - General condition of service pit
