# **PRE-DILAPIDATION REPORT**

**COUNCIL ASSETS**

**21 GEORGE STREET,  
BURWOOD, NSW 2134**

PROJECT REFERENCE: 20250047.CA.1  
17/04/2026

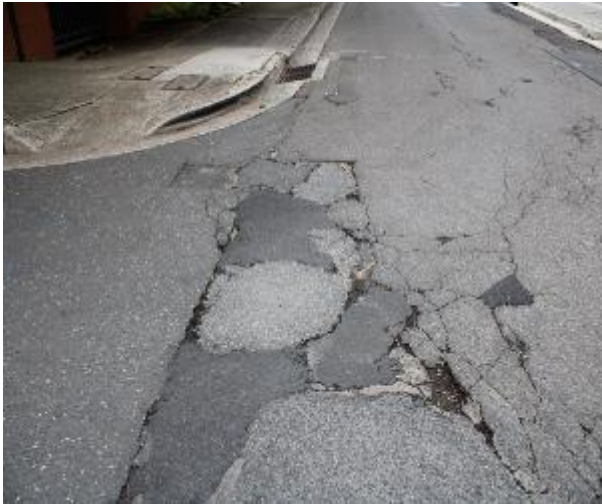
Figure 625 - Crack propagation, patchwork, and loss of materials through road surface heading South

The road surface of Marmaduke Street at the time of the inspection was in a reasonable condition with evidence of cracking, patchwork, and material loss.

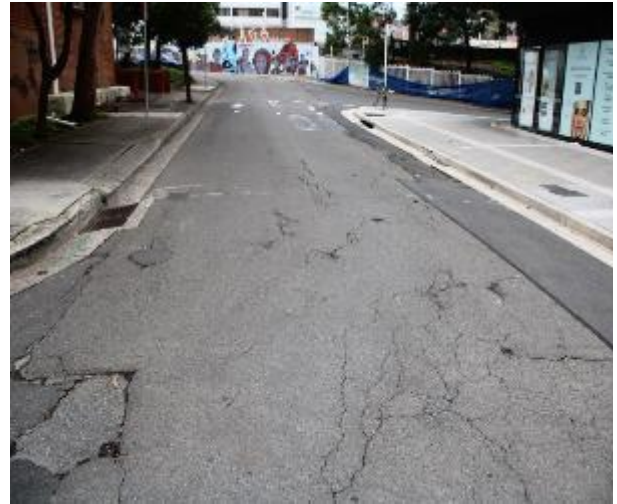
Figure 626 - General condition of road surface heading South

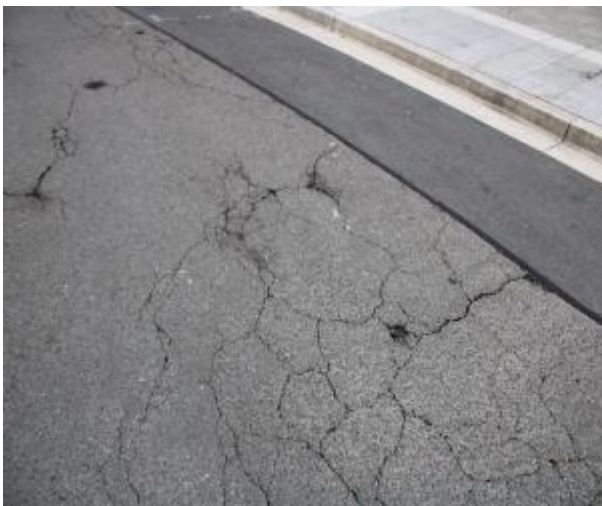
Figure 627 - Crack propagation through road surface heading South

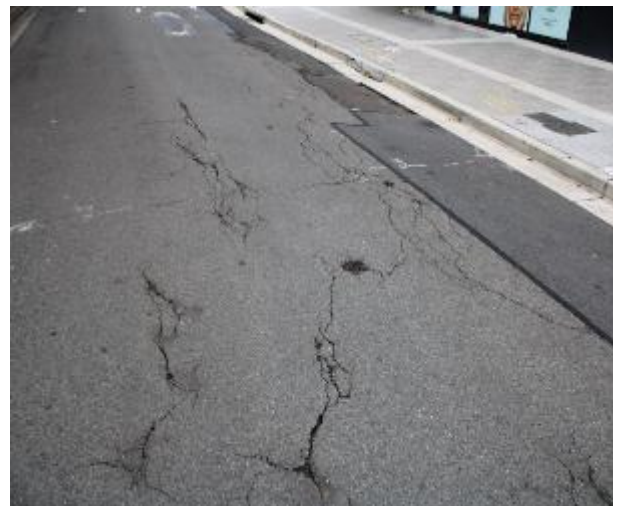
Figure 628 - Crack propagation through road surface heading South

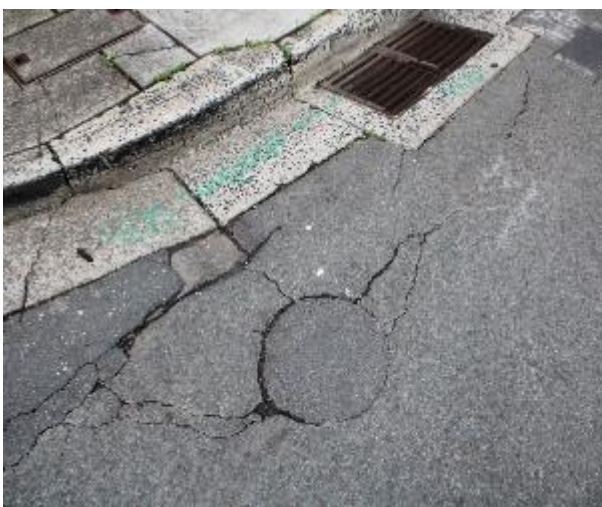
Figure 629 - Crack propagation through road surface heading South

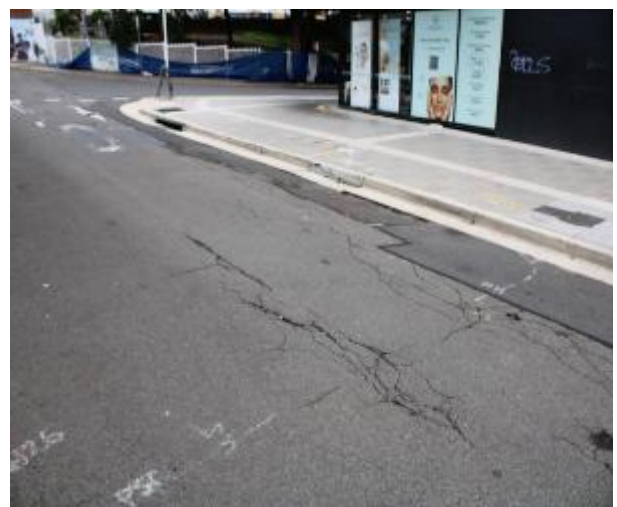
Figure 630 - General condition of road surface heading South

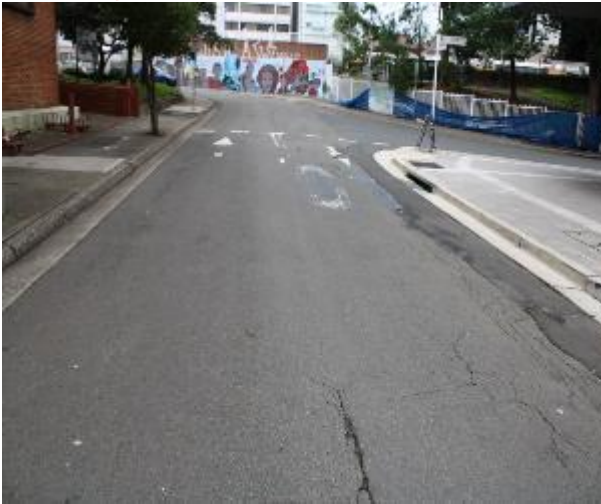
Figure 631 - General condition of road surface heading South

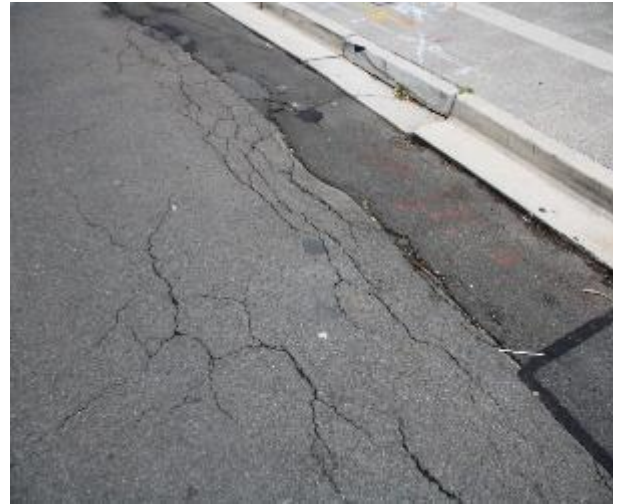
Figure 632 - Crack propagation and patchwork through road surface heading South

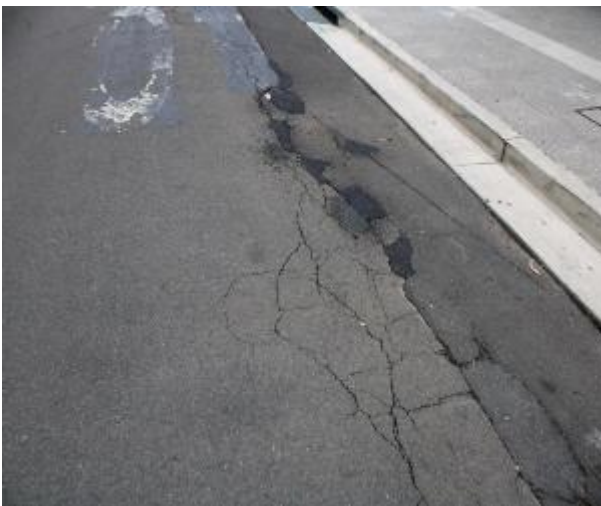
Figure 633 - Crack propagation through road surface heading South

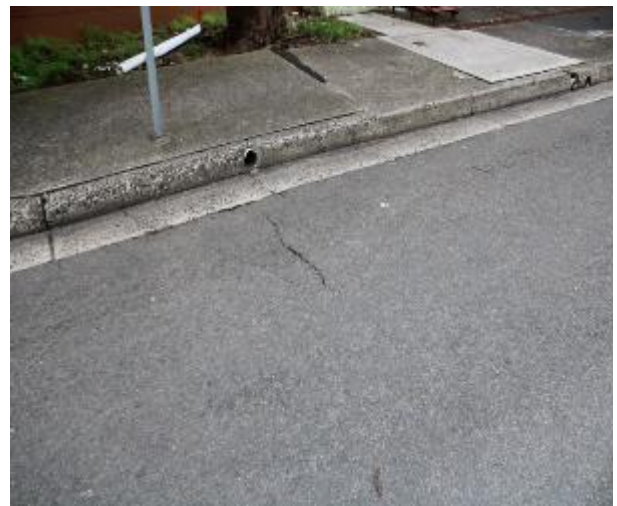
Figure 634 - Crack propagation through road surface heading South

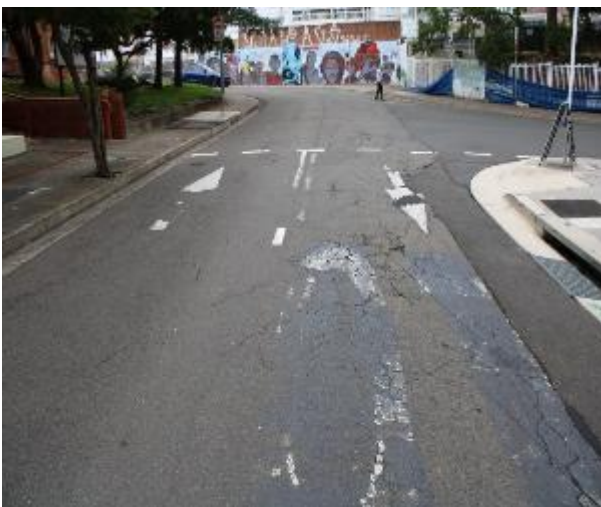
Figure 635 - General condition of road surface heading South

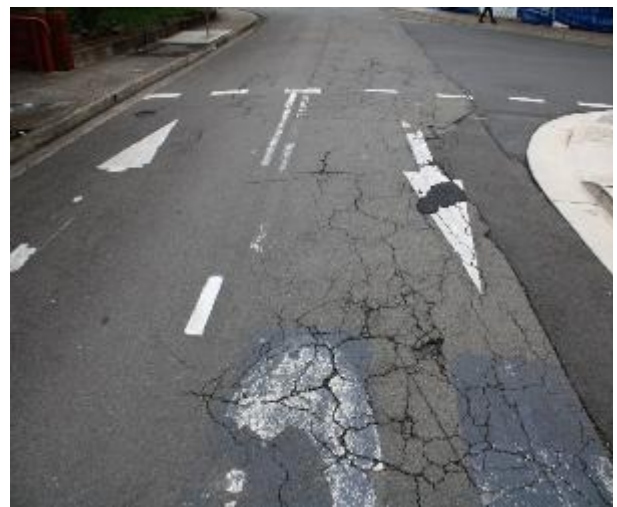
Figure 636 - Crack propagation through road surface heading South

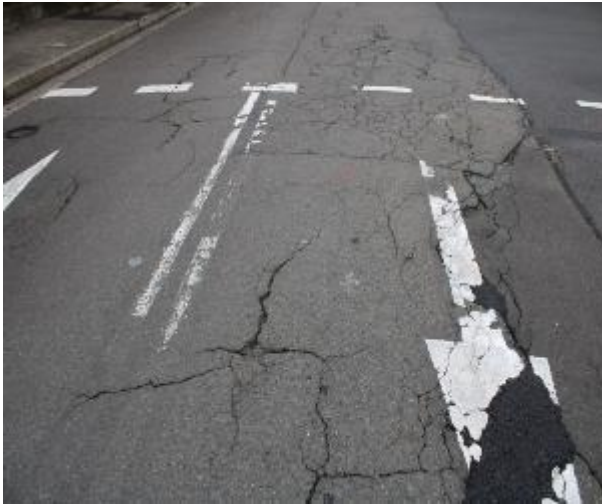
Figure 637 - Crack propagation through road surface heading South

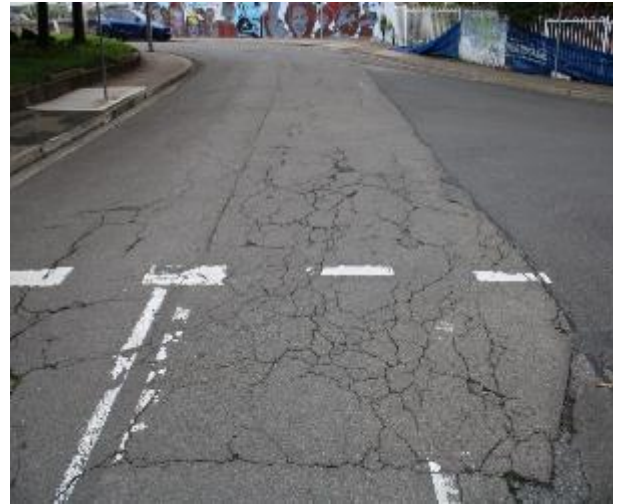
Figure 638 - Crack propagation through road surface heading South

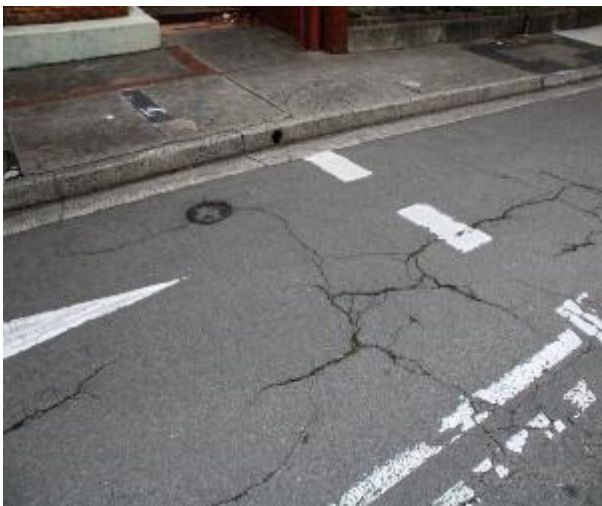
Figure 639 - Crack propagation through road surface heading South

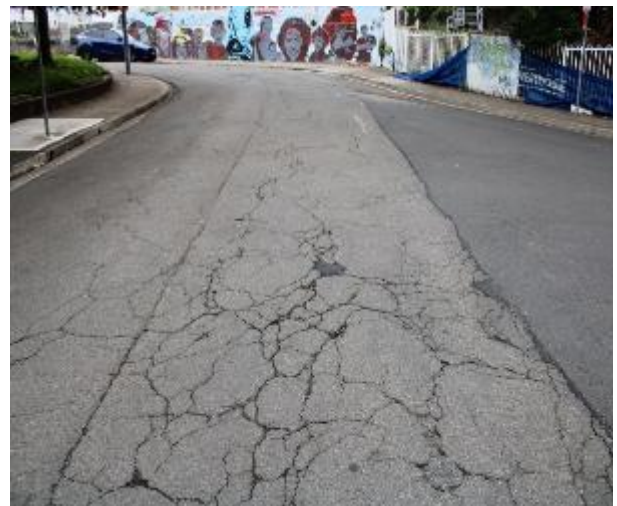
Figure 640 - Crack propagation through road surface heading South

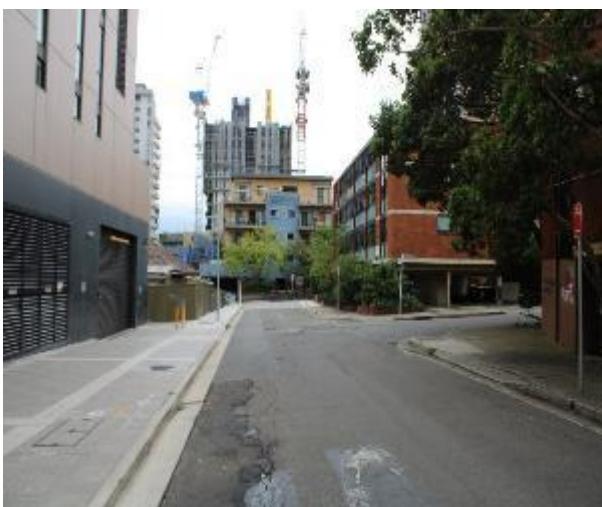
Figure 641 - General condition of road surface

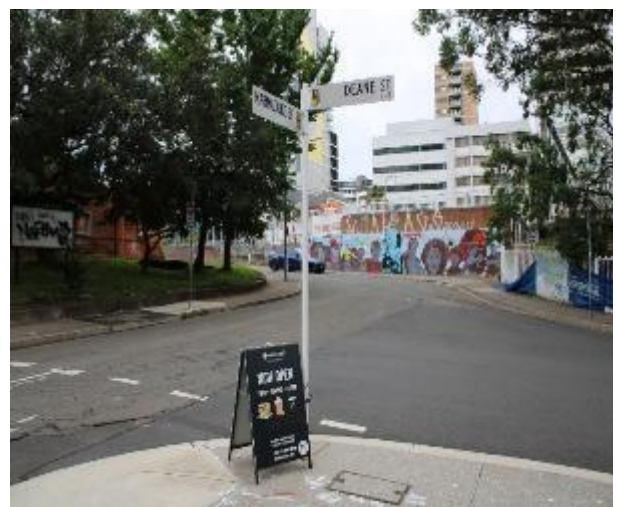
Figure 642 - General condition of street signage

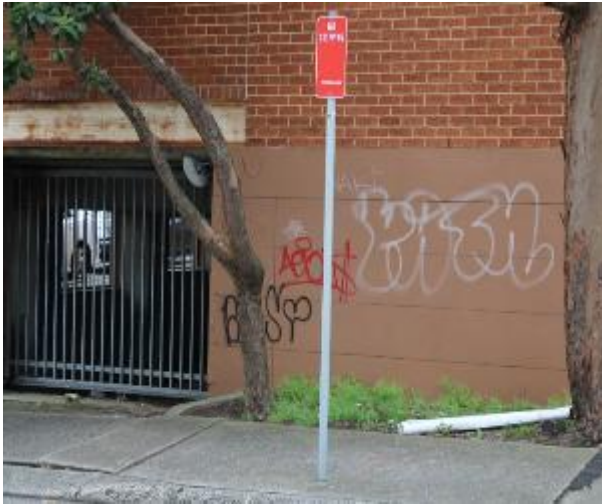
Figure 643 - General condition of street signage

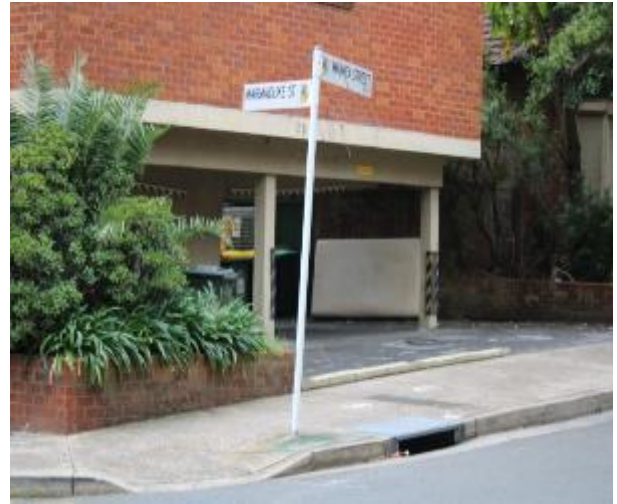
Figure 644 - General condition of street signage

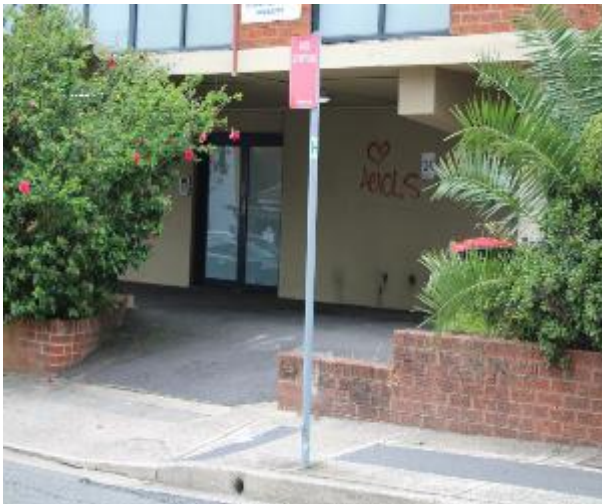
Figure 645 - General condition of street signage

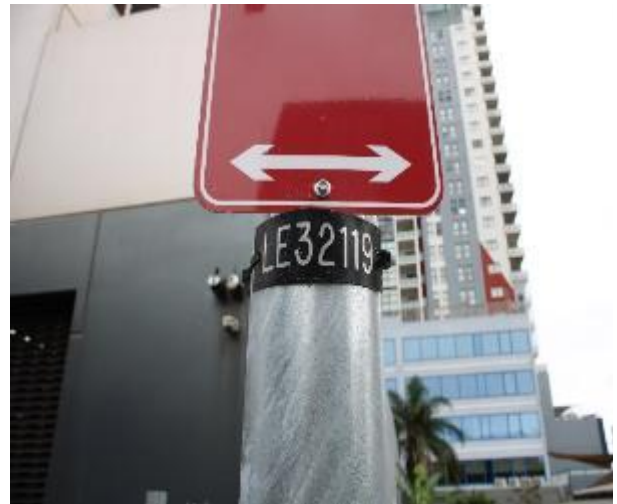
Figure 646 - General condition of street light post identification No. LE32119

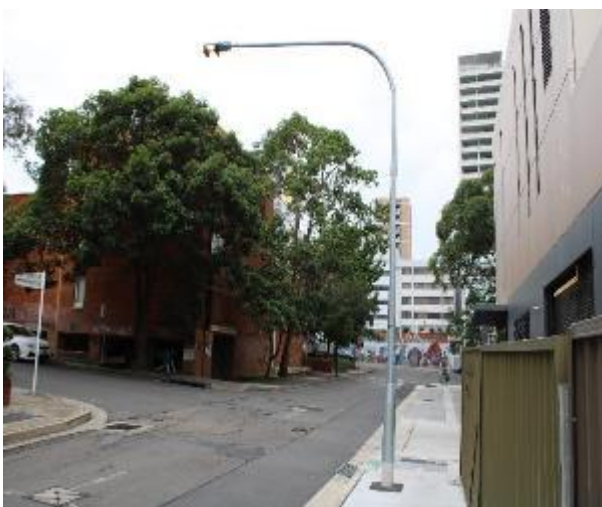
Figure 647 - General condition of street light post identification No. LE32119

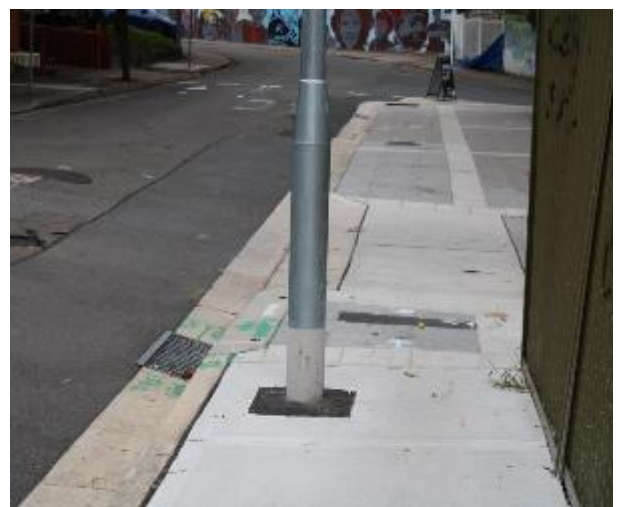
Figure 648 - General condition of street light post identification No. LE32119

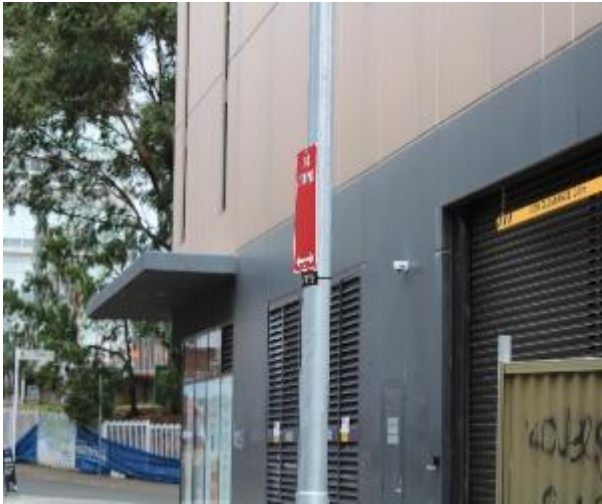
Figure 649 - General condition of street light post identification No. LE32119

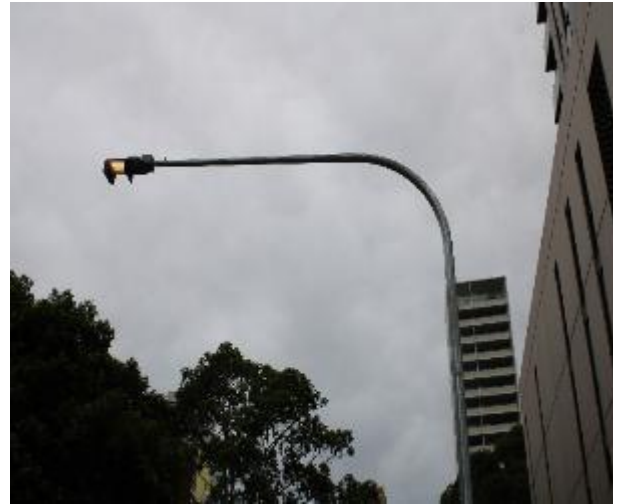
Figure 650 - General condition of street light post identification No. LE32119

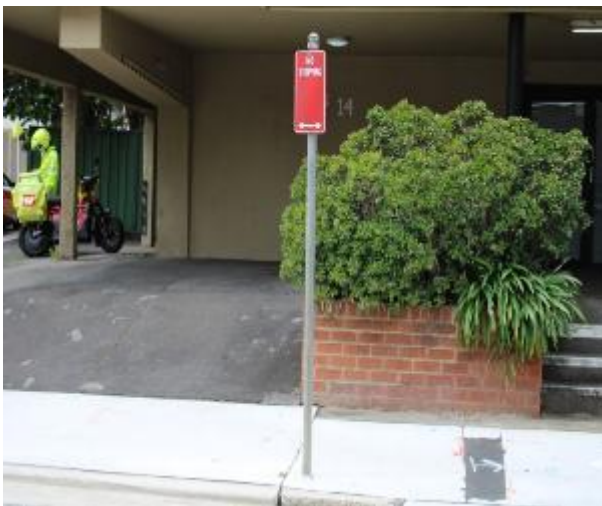
Figure 651 - General condition of street signage

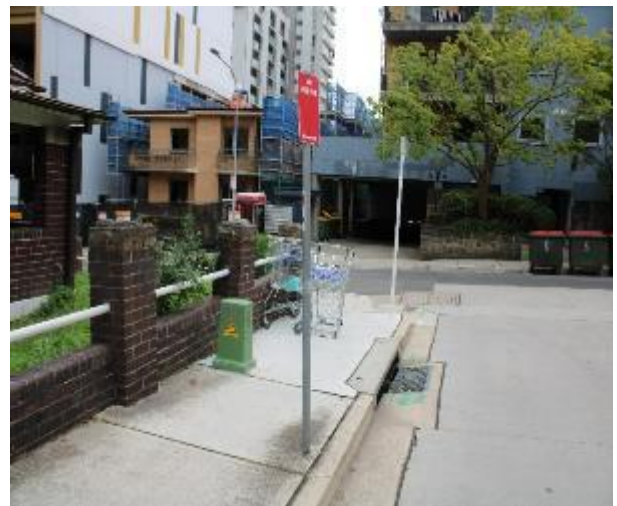
Figure 652 - General condition of street signage

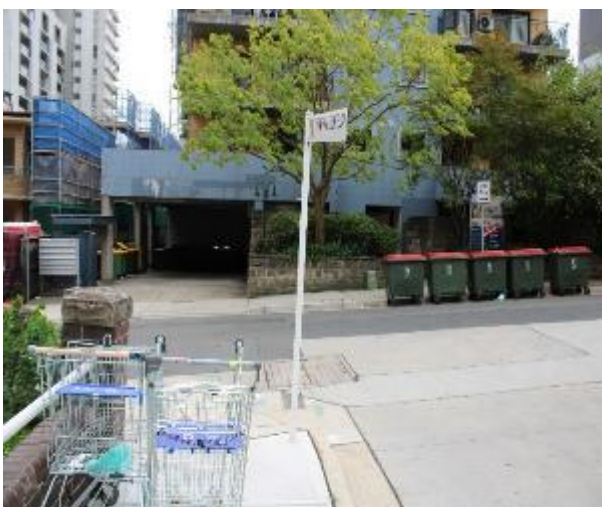
Figure 653 - General condition of street signage
