# Hazardous Material Report

**Burrah Park, 1953-2109 Elizabeth Drive,  
Badgerys Creek**

26 September 2024

**Our Ref:** 30206389-R02-Burrah Park-HazMat

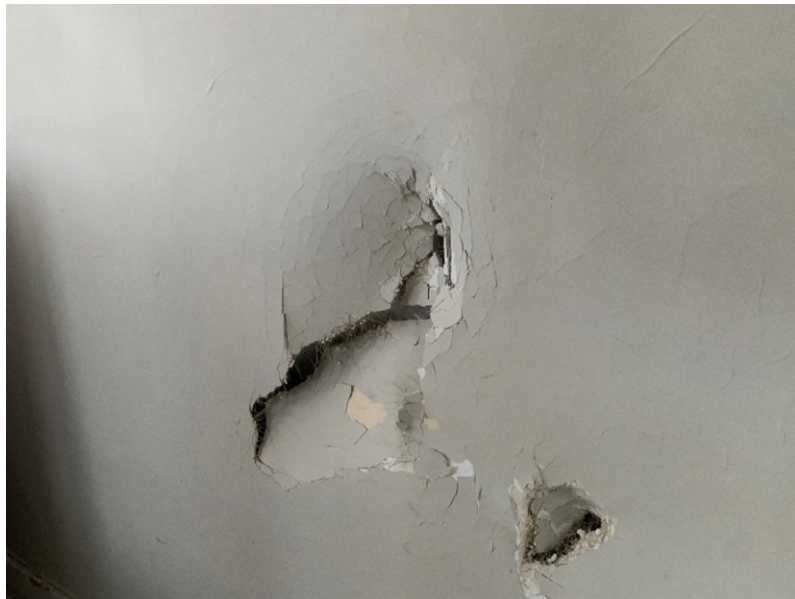
**Print 13**  
*Unoccupied house*  
Damaged internal wall in bedroom showing plasterboard composition.

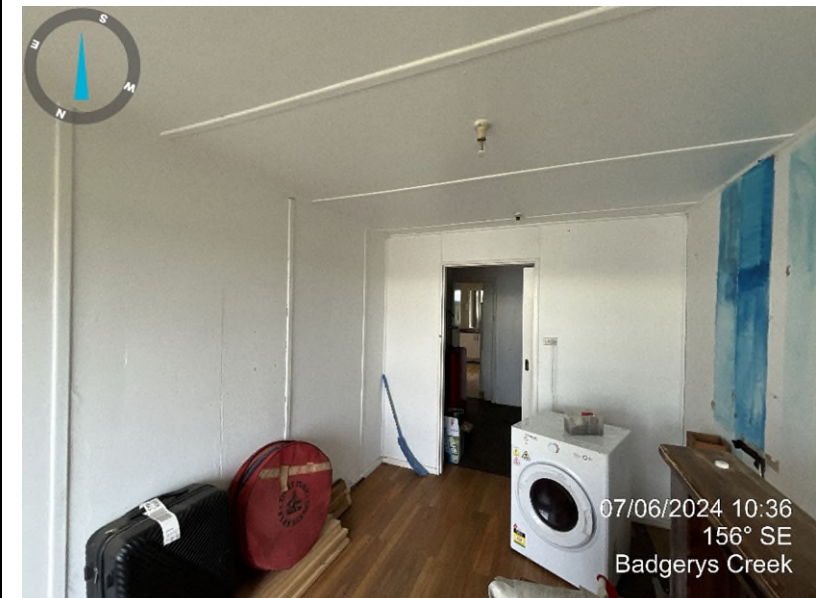
**Print 61**  
*Tenanted house*  
Sunroom

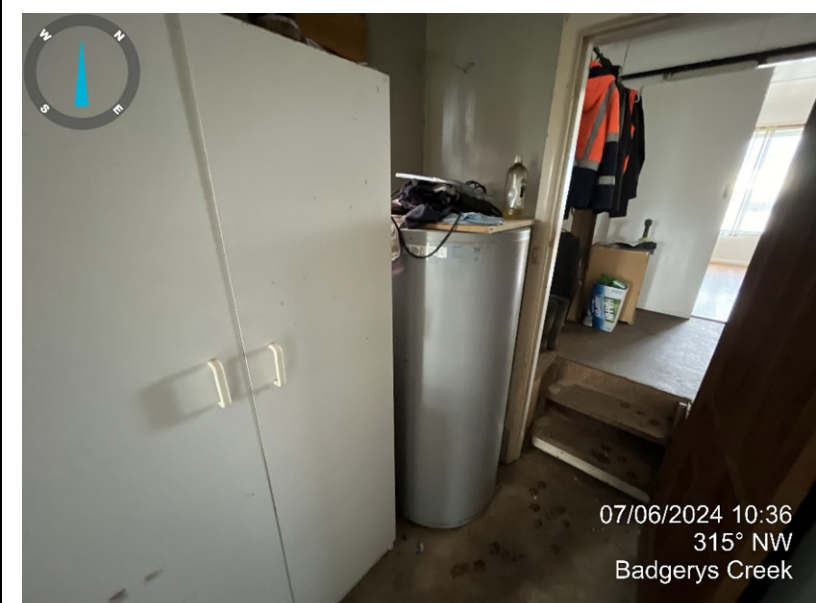
**Print 62**  
*Tenanted house*  
Laundry area looking back to store room

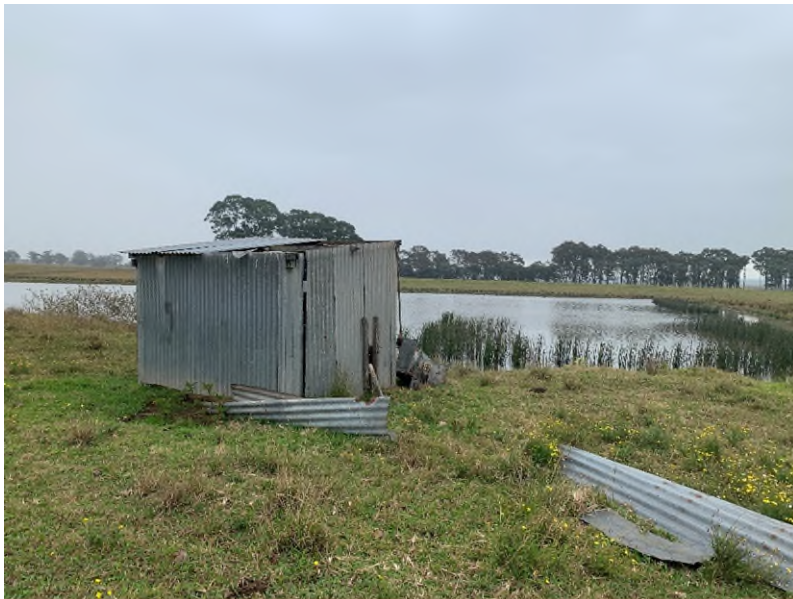
**Print 72**  
*Pump house 1*  
View of pump house 1 from the northeast.

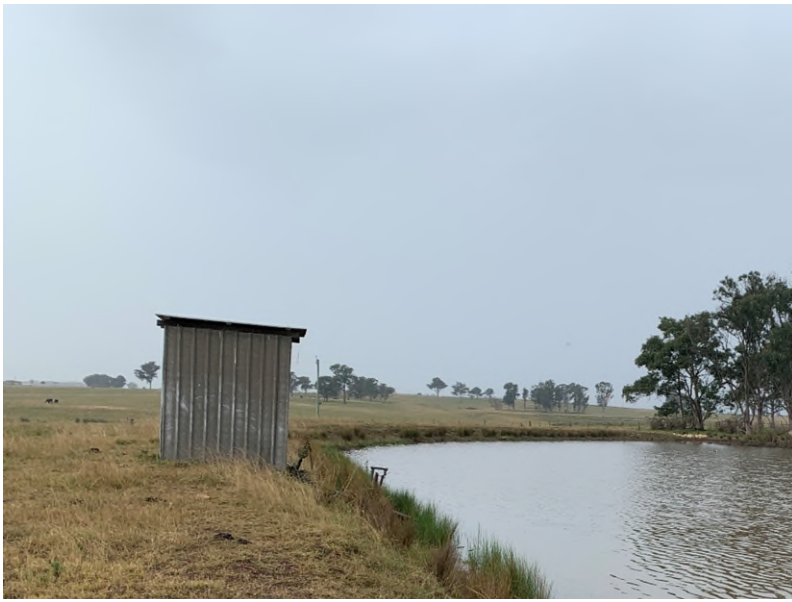
**Print 75**  
*Pump house 2*  
View of pump house 2 from the west.

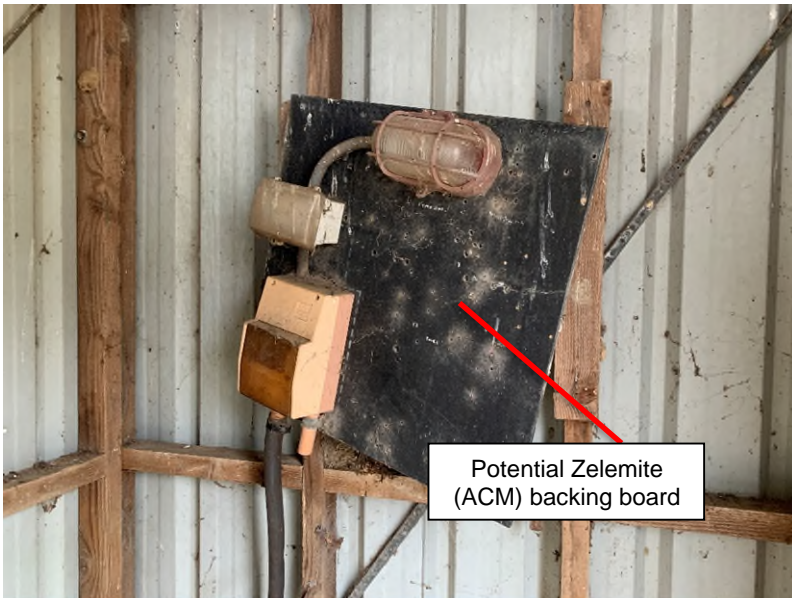
Feature	Area	Description	Print No.	Sample Collected	Hazardous Material Present
ACM pipe stockpile	NA	Stockpile of ACM pipes infilled with concrete.	71	No	Likely ACM
Pump house 1	Wall and floors	Timber structure with unlined metal walls and concrete slab floor construction.	72-73	No	Not identified
Pump house 1	Switchboards	Two switchboards with potential Zelemite backing boards (known ACM).	73-74	No	Likely ACM
Pump house 2	Wall, roof and floors	Timber structure with unlined metal roof, metal walls and concrete slab floor construction.	75-76	No	Not identified
Pump house 2	Switchboard	Switchboard with potential Zelemite backing board (known ACM).	76	No	Likely ACM

**Print 76**  
*Pump house 2*  
Switchboard on the inside wall.
