DEVELOPMENT IMPACT ASSESSMENT REPORT.

Campbells Stores

7-27 Circular Quay West-The Rocks-Sydney.

Prepared by: Tom Hare AQF Level 5.

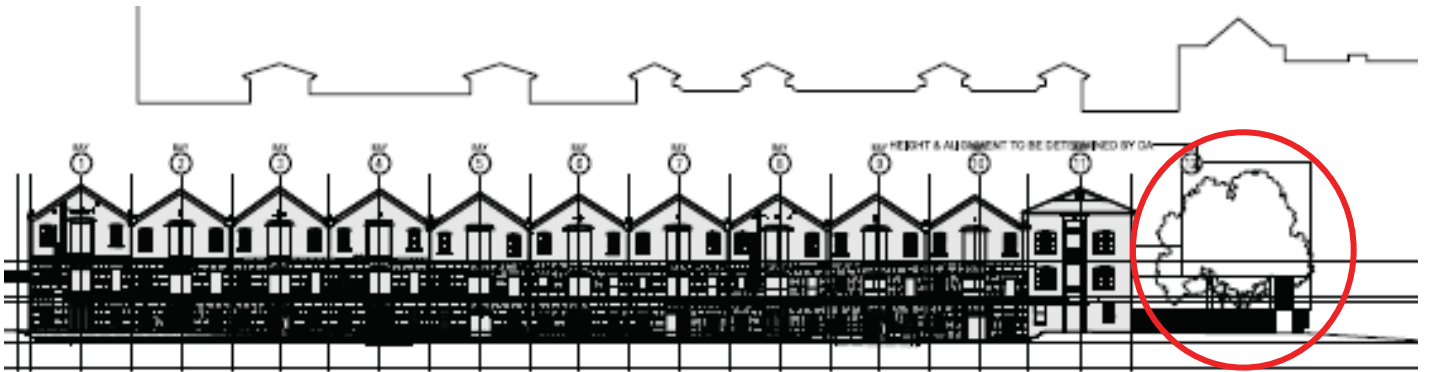
Figure 1: Preliminary DA drawing showing the existing buildings and the subject tree adjacent to bay eleven.

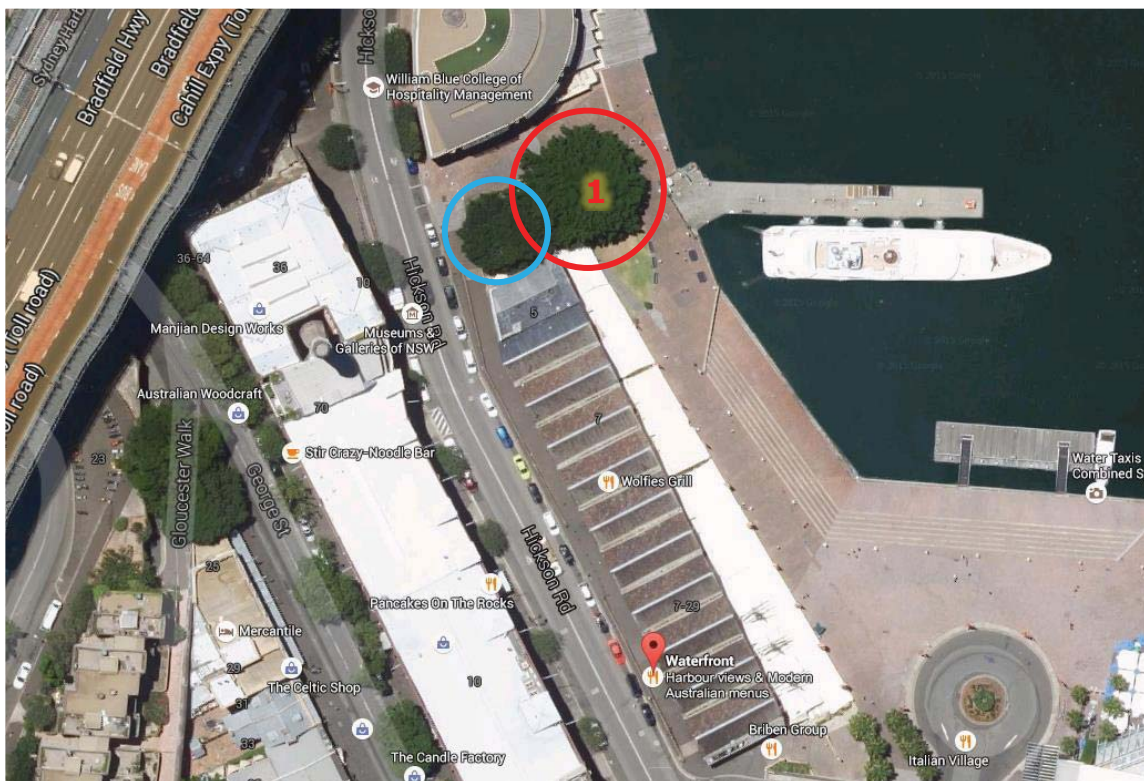
Figure 4: The subject site and the tree locations circled. The tree circled in Blue is a *Celtis sinensis* which is not included in the scope of this report as it is to be removed prior to construction.

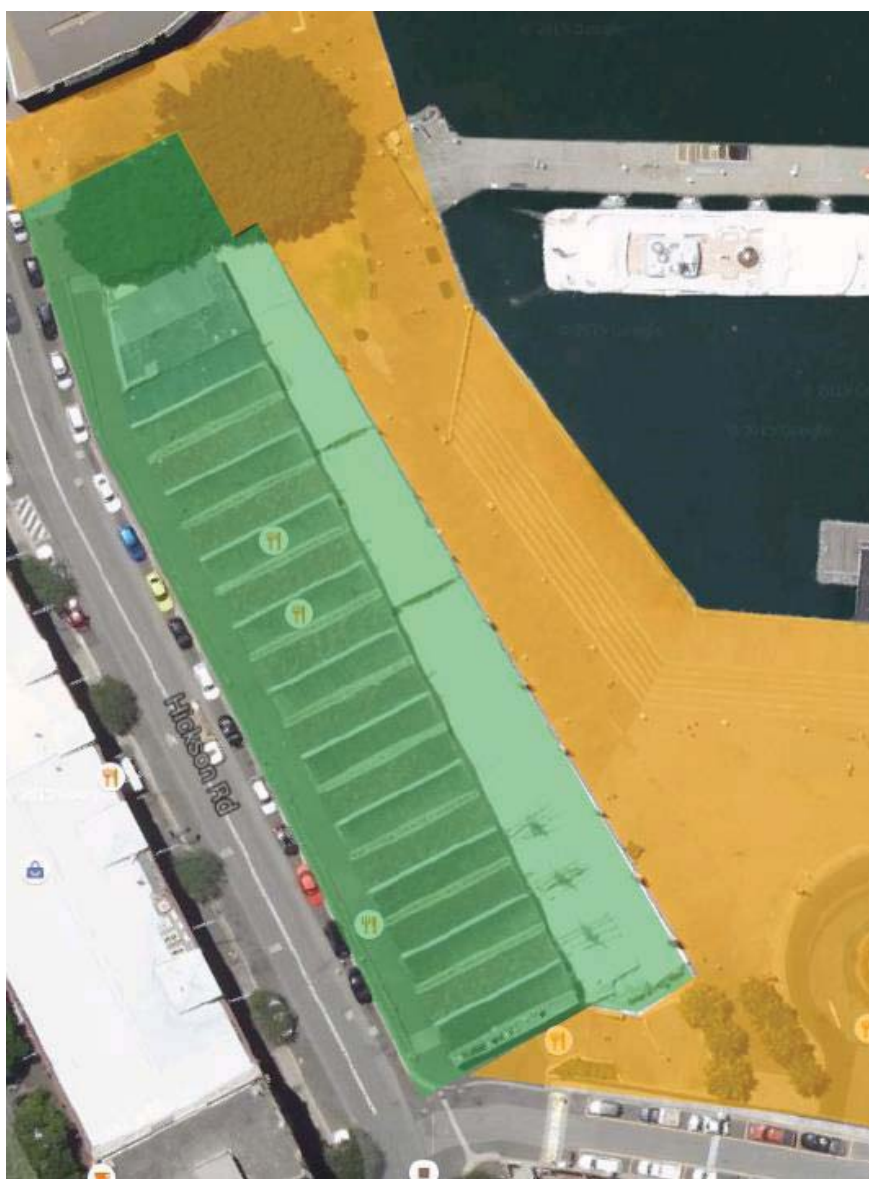
Figure 5: The extent of works covered by this report, highlighted in Green.

Minor pruning will be required on the Western side of the canopy to provide suitable construction access. The exact pruning dose will need to be quantified and approved by City of Sydney Council (the consent authority).
