Report on  
Hazardous Building Materials (HBM) Survey

DHL Stage 1  
Part of 1953 - 2109 Elizabeth Drive  
Badgerys Creek

Prepared for  
DHL Supply Chain (Australia) Pty Limited

Project 86548.20  
September 2024

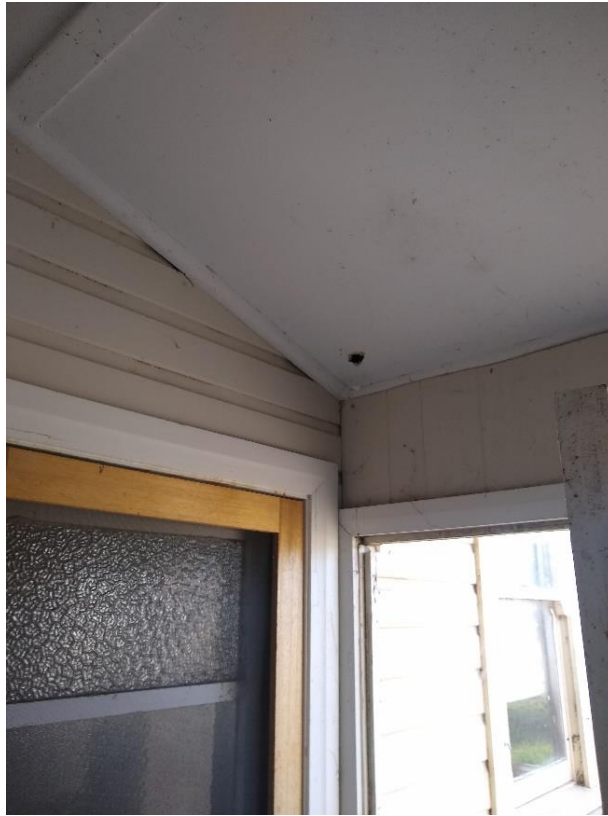
Photo 23: Building HS, interior, sheeting from ceiling near central northern entrance to house, fibre cement sheeting, sample HSA2, asbestos detected by analysis.

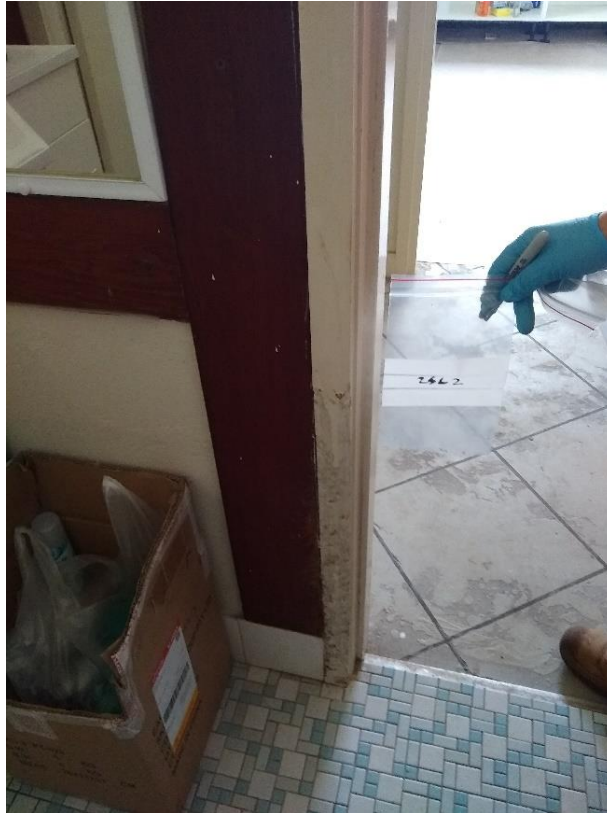
Photo 37: Building 25, interior, paint off timber door frame in southern portion of house, white paint, sample 25L2, lead paint(s) identified

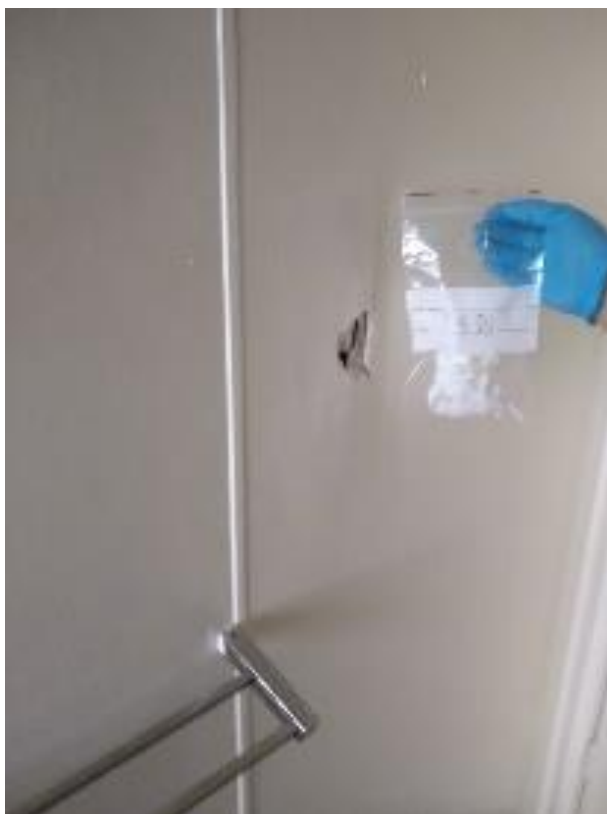
Photo 51: Building 24, wall cavity in central portion of house, throughout, settled dust, sample A4D1, lead concentration <0.5 mg/m2

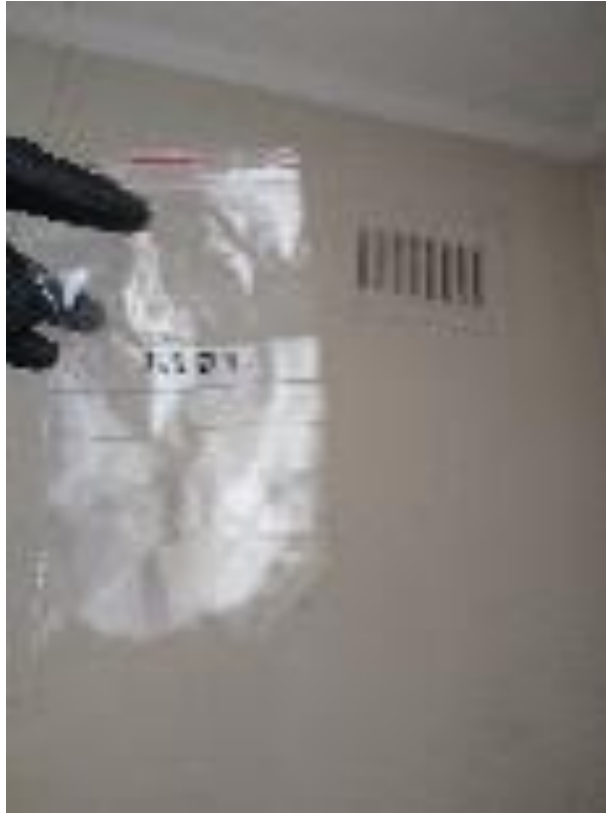
Photo 55: Building HS, ventilation grate in kitchen, throughout, settled dust, sample HSD1, elevated lead concentration ( $\geq 0.5$  mg/m<sup>2</sup>)
