**Re: ECOLOGICAL SURVEY FOR ADDITIONAL VEGETATION REMOVAL FOR THE  
EUROBODALLA WATER SUPPLY PROJECT**

Please find below an ecological assessment of areas requested for additional clearing for the Eurobodalla Water Supply Project. This report relates to an area identified as **Zone 3**.

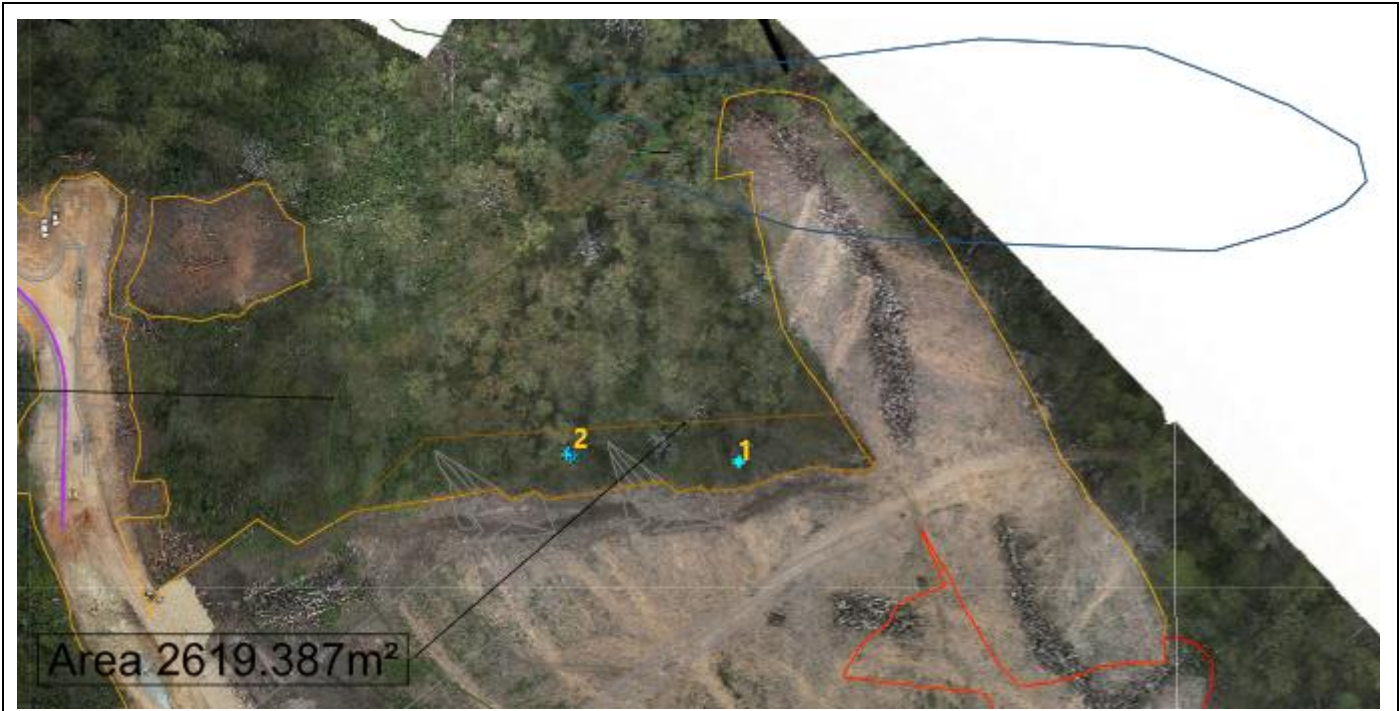
Table 1. Hollow-bearing trees located within zone 3 requested for clearing

Two HBTs have been identified as potentially requiring clearing within zone 2, though both may be avoided during works. Table 1 identifies species, hollows and the location of HBTs.

| | | | | | |
|---|---|---|---|---|---|
| HBT | Species | DBH | Comments | | |

The clearing request is for the clearing of HBT1 in a timeframe outside of that stipulated in the conditionals of consent for the Southern Water Storage project. To minimize the threat to fauna species the following recommended management actions are suggested:
