arboricultural impact assessment report

AIA-01

Revision A, Issued for SSDA
18 October 2024

FITZGERALD AVENUE, MAROUBRA

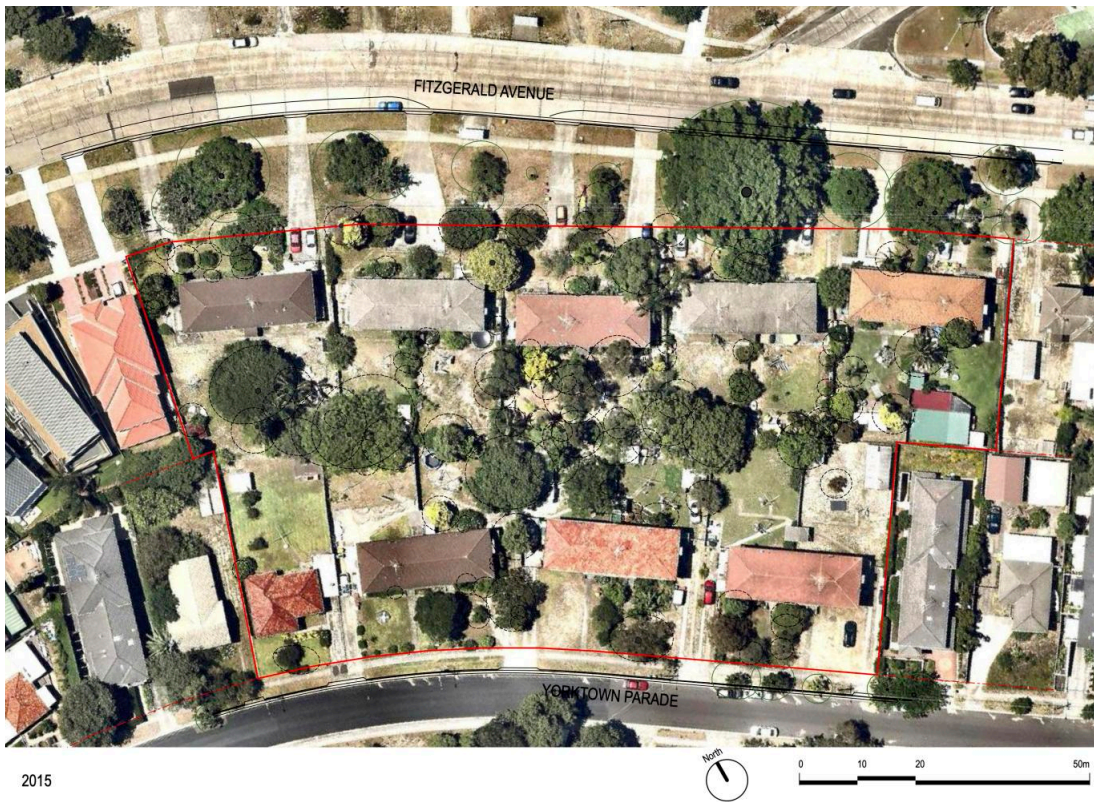
Figure 5 – Aerial image of the site in 2015 illustrating that the site appears relatively unchanged, however, several mature trees are now established and are clearly visible within and immediately adjoining the site, including **T140** (*Ficus microcarpa* var *hillii* – Hills Weeping Fig) fronting 207-209 Fitzgerald Avenue (Source: NearMap).

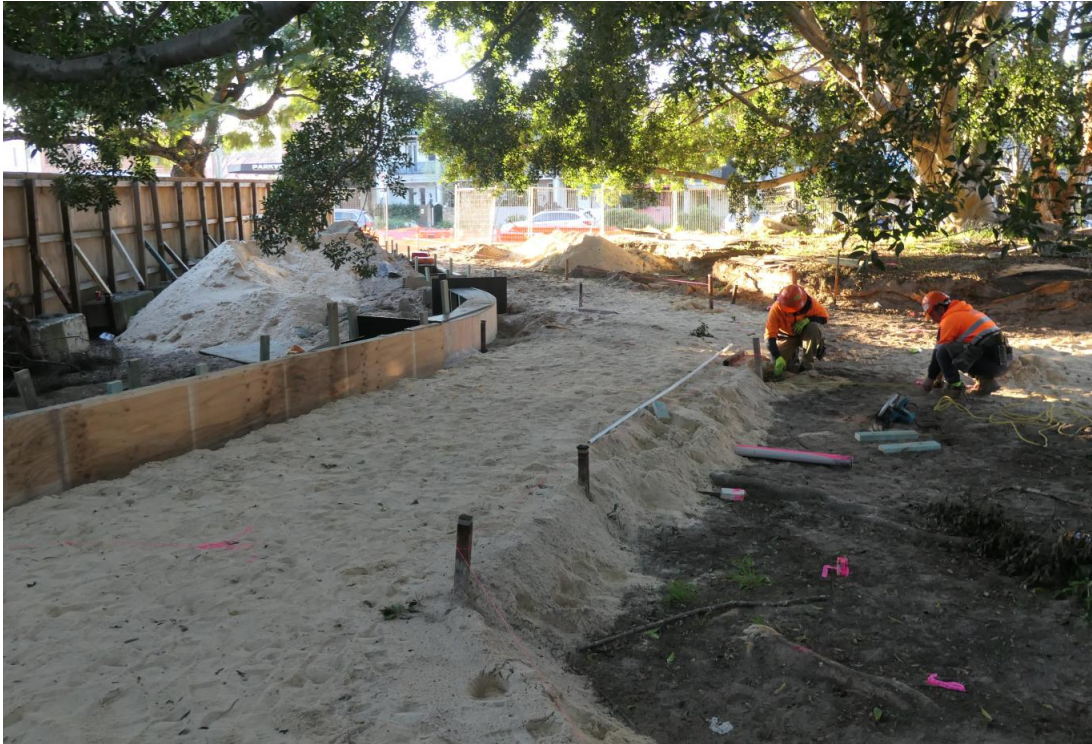
Figure 12 – Example in Ashmore of footpath proposed under Fig tree - Traditional installation of a concrete footpath on the existing ground surface was not an achievable option that protected the trees ongoing health. To protect the existing Fig tree and the above ground roots, the area under the trees was back filled with nominally 300-400mm of sandy soil. This covered over and protected the existing roots and created a level pad to install the concrete pathway without impacting on or compromising the existing roots (Photo: Arterra 20/07/20).

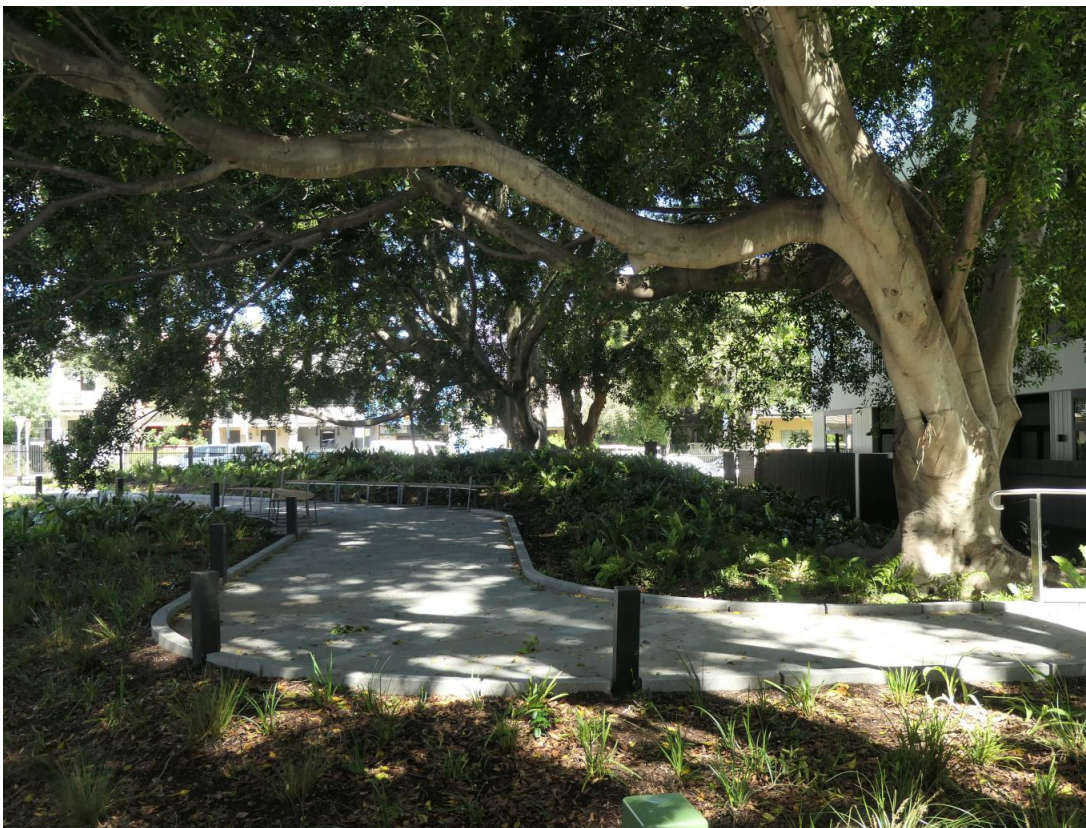
Figure 13 – Example in Ashmore of footpath proposed under Fig tree – This is the footpath installed and finished under the Fig tree. The footpath was installed above the existing surface levels and above the existing tree roots (Photo: Arterra 06/11/21).

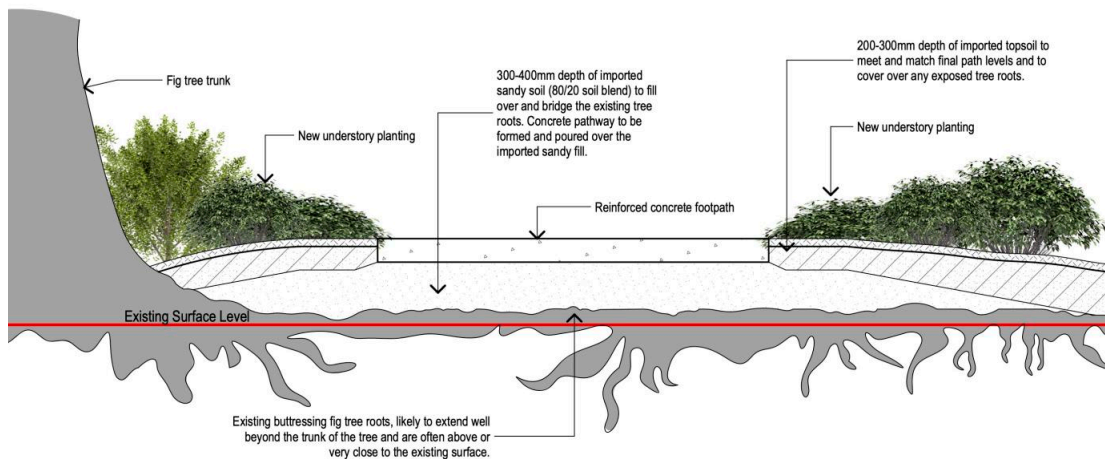
Figure 14 – Detail example of proposed concrete footpath over existing Fig tree roots, ensuring 300-400mm of sandy soil over the existing roots to protect them from disturbance (Photo: Arterra).

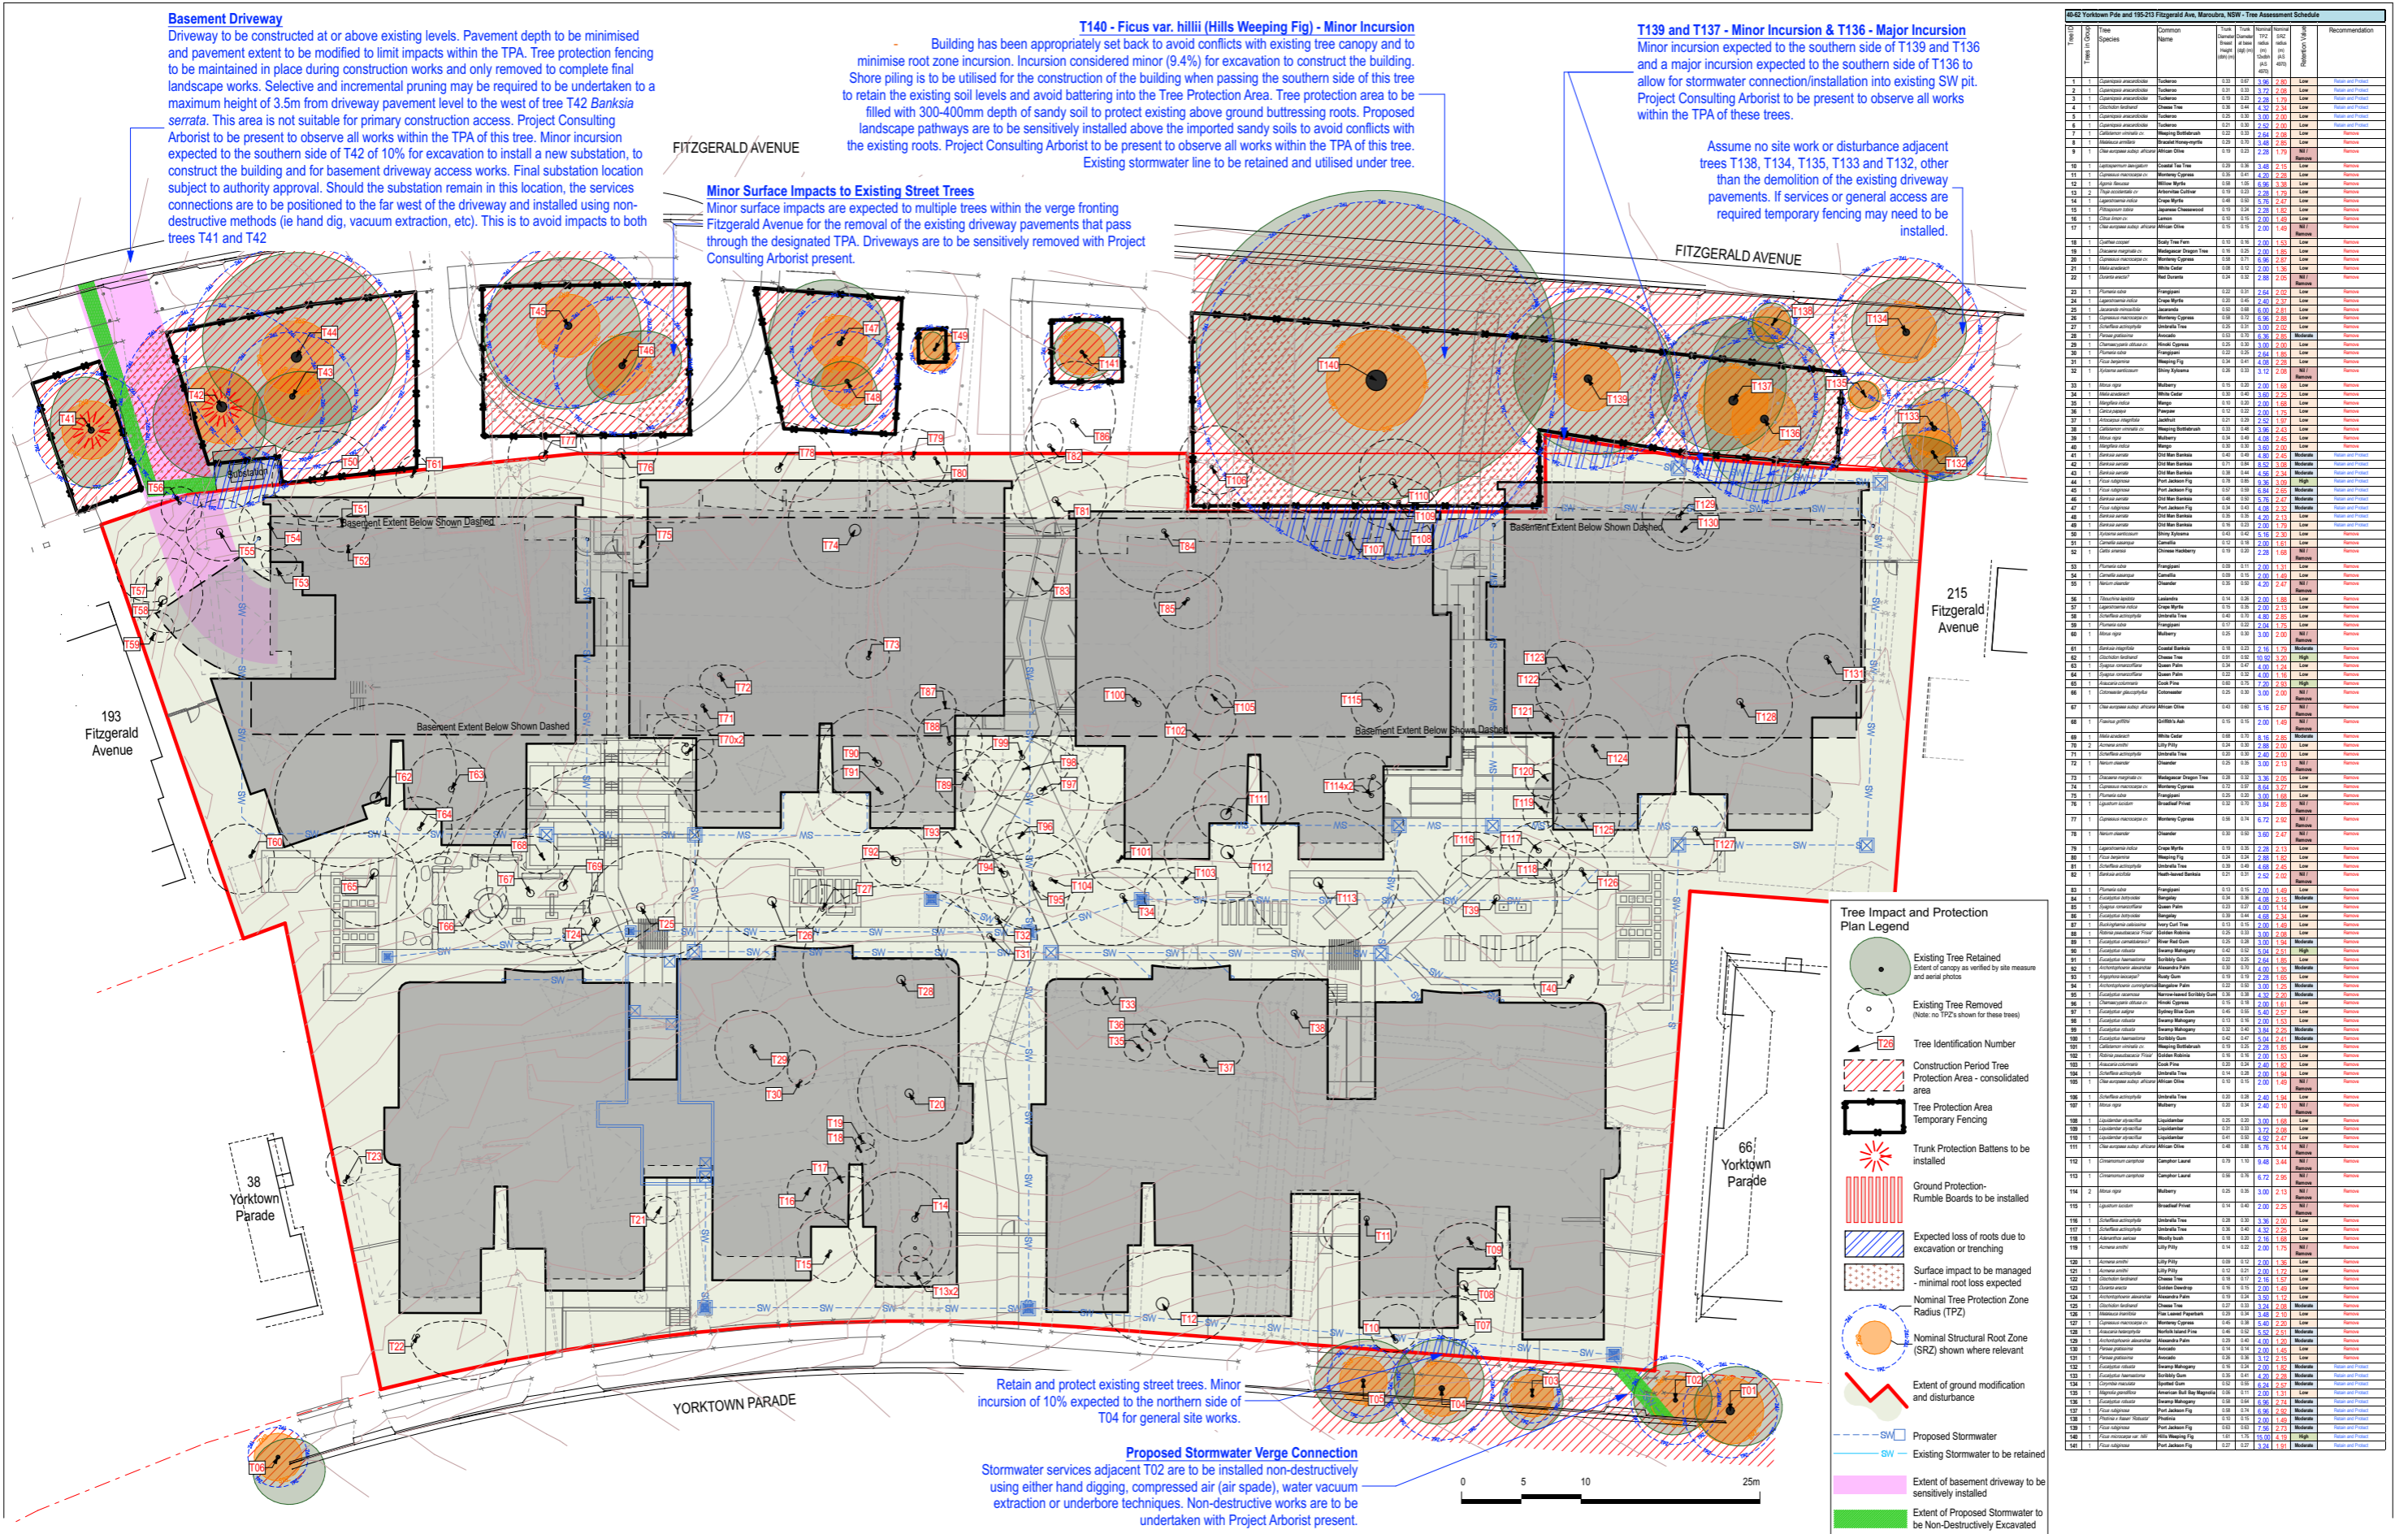
Retain and protect existing street trees. Minor incursion of 10% expected to the northern side of T04 for general site works.

Proposed Stormwater Verge Connection
Stormwater services adjacent T02 are to be installed non-destructively using either hand digging, compressed air (air spade), water vacuum extraction or underbore techniques. Non-destructive works are to be undertaken with Project Arborist present.
