GTE549-Stage 1 Contamination  
7 May 2015

**RE: STAGE 1 CONTAMINATION ASSESSMENT at 34 Yarrunga Street, Prestons.**

This letter presents a Stage 1 Contamination report on the inspection and testing services associated with the contamination assessment undertaken at the above project.

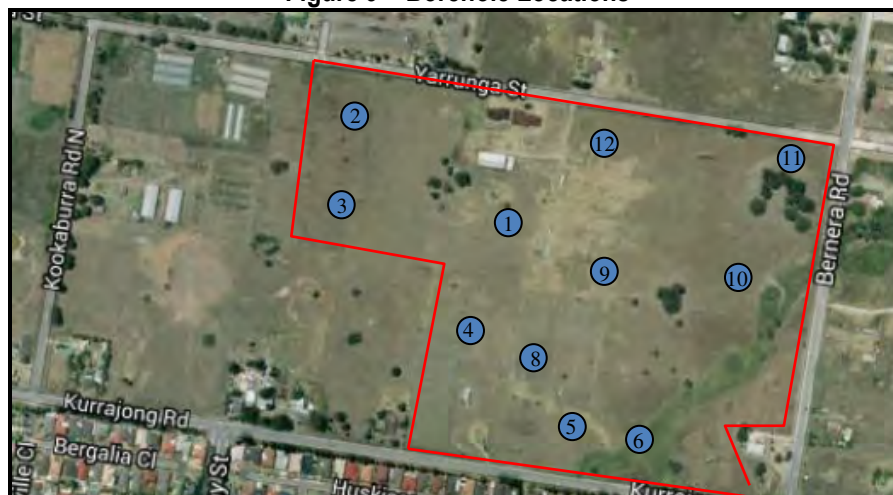
**Figure 9 – Borehole Locations**

Initial fieldwork was undertaken on the 11<sup>th</sup> of November 2014 and included one deep borehole (TS1) and eleven shallow boreholes (TS2-12) using a truck mount solid flight auger drill rig at locations shown on Figure 9.

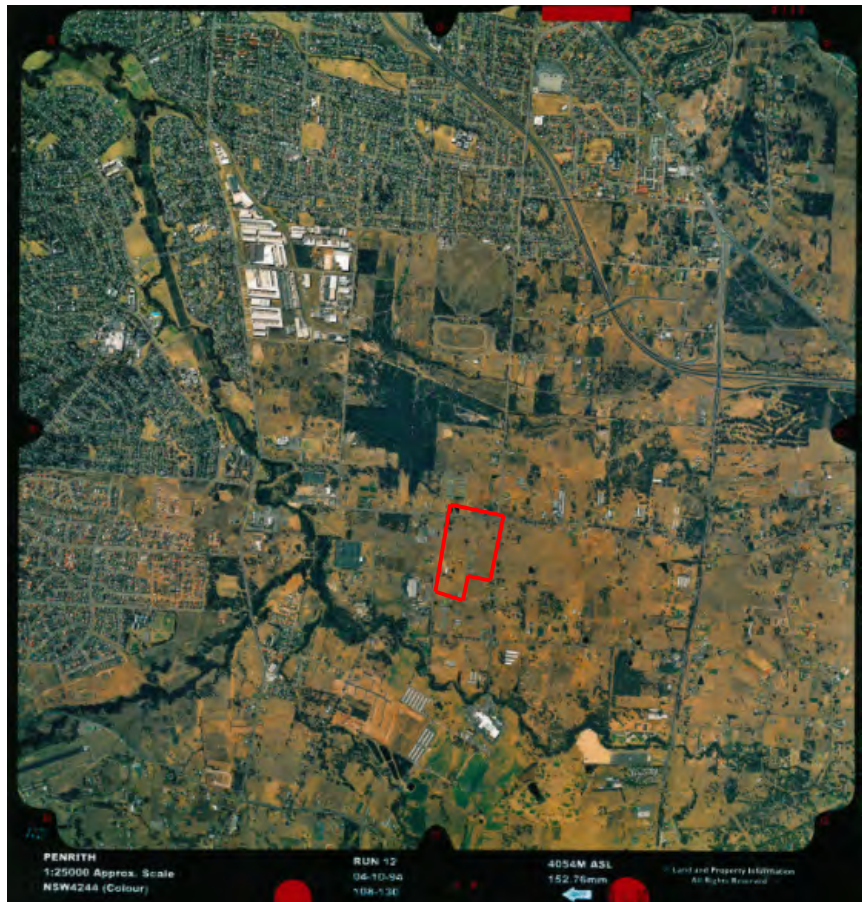
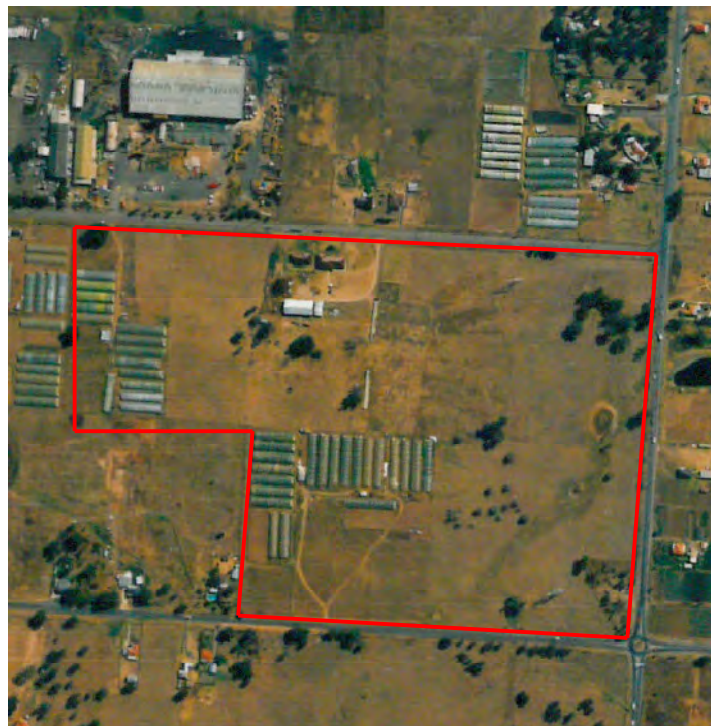
## Aerial Photograph - 1994

1994 – In 1994 the the original homestead, which was destroyed by fire, has been replaced by a new residential house and shed which have been constructed along the Yarunga Street frontage. The market gardening appears to have ceased and has been replaced by the green houses. No industrial or manufacturing plants could be identified within the aerial photograph. The subject site is highlighted in figure 5.

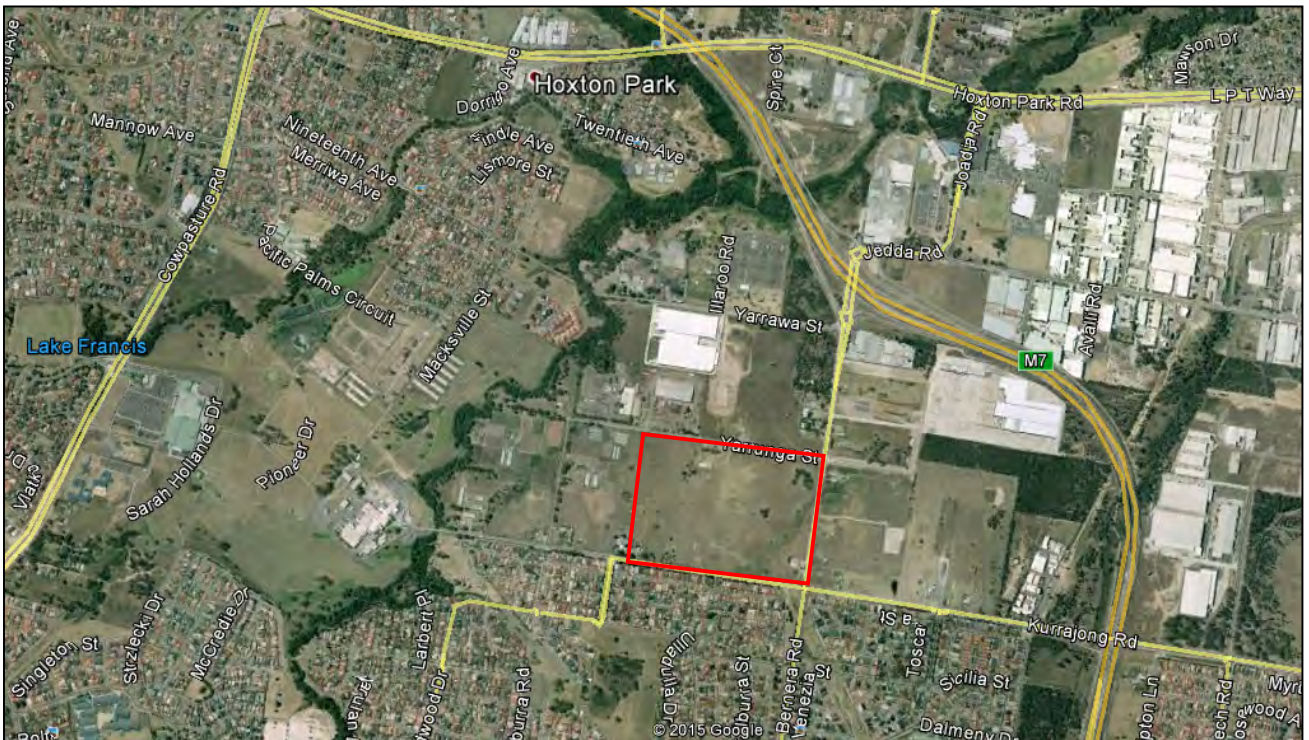
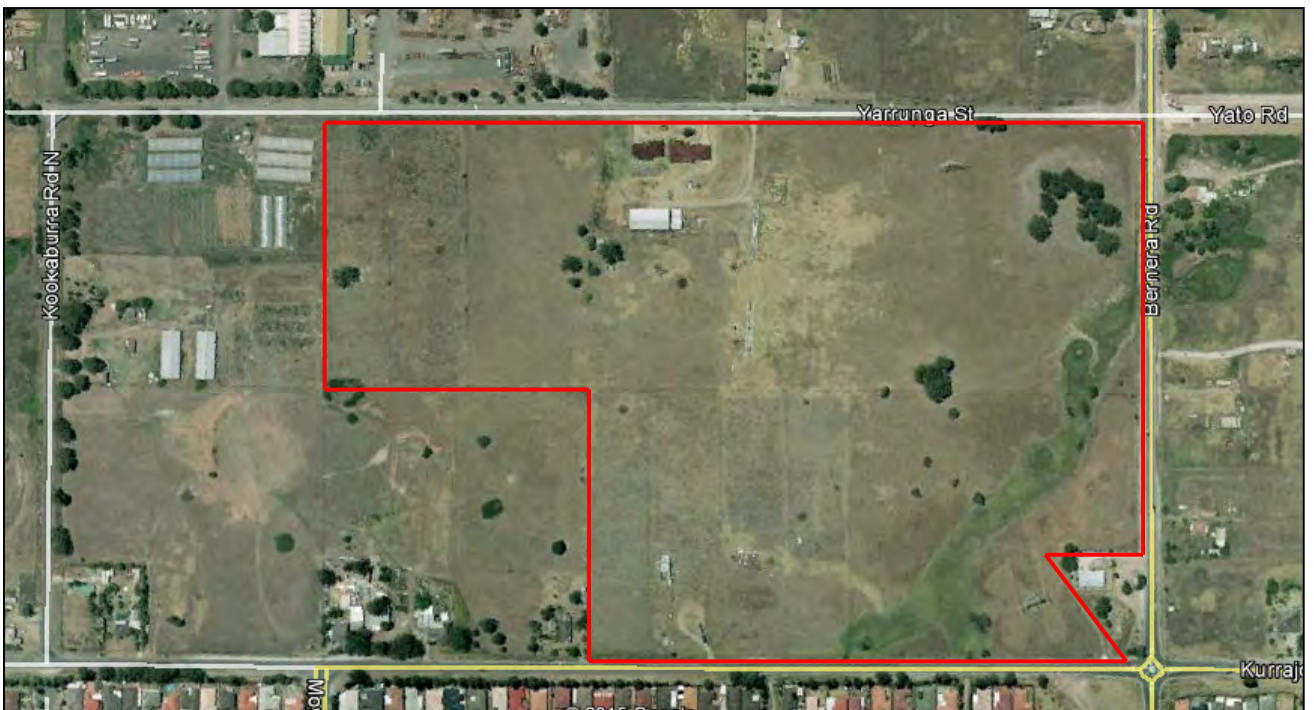
## Aerial Photograph - 2006

2006 – In 2006 the residential house and shed along the Yarunga Street frontage is still standing. The green houses have been removed. The remnants of market gardening can be observed within the western and south-western corners of the site. Industrial or manufacturing plants have started to be constructed within the region and new residential subdivisions have been constructed to the south of the site. The subject site is highlighted in figure 6.
