# Hazardous Materials Survey

34 Albert Avenue & 57-61 Archer St, Chatswood NSW

**Report No:** E26224.E10\_Rev0

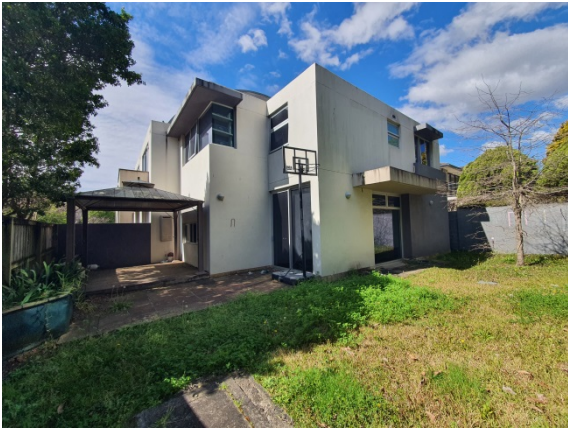
| Description | |
|---|---|
| <p><b>57 – 61 Archer Street</b></p> <p>This property contained a recently built townhouse complex of 12 dwellings (vacant), organised between two buildings of similar material. Each townhouse was 3-4 storeys, and connected to a shared single basement level.</p> <p>The principal materials of building construction were sheet metal roofing, brick external walls (rendered / painted), brick and plasterboard internal walls, plasterboard ceilings, and concrete and timber floors.</p> | |

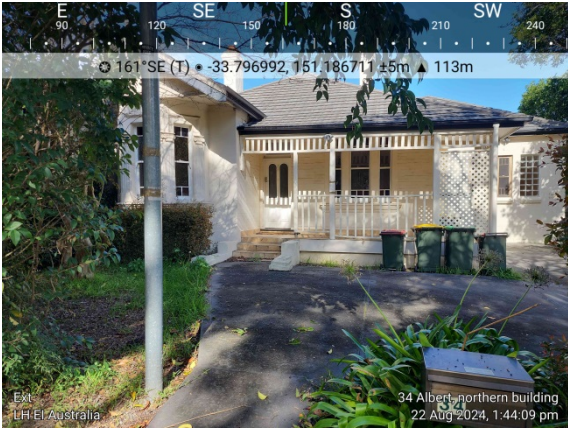
| Description | |
|---|---|
| <p><b>1/34 Albert Avenue</b></p> <p>This property contained a single storey, residential building (vacant).</p> <p>The principal materials of building construction were terracotta roof tiles, brick external walls (painted), brick and plasterboard internal walls, plasterboard ceilings, and concrete and timber flooring.</p> | |

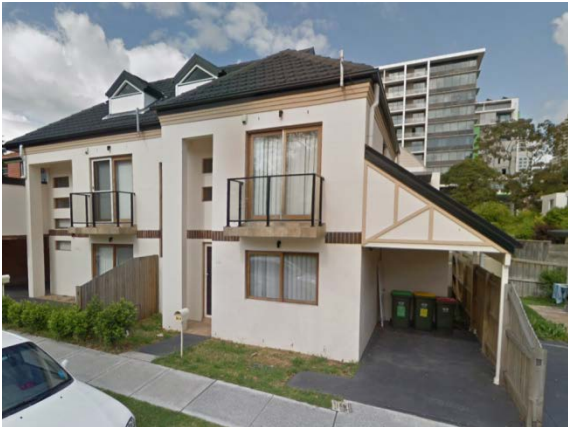
| Description | |
|---|---|
| <p><b>34A &amp; 34B Albert Avenue</b></p> <p>This property contained a 3 storey, residential duplex (vacant).</p> <p>The principal materials of building construction were terracotta roof tiles, brick external walls (rendered / painted), brick and plasterboard internal walls, and concrete and timber ceilings and floors.</p> | |
