Prepared for: Taronga Conservation Society Australia

# Arboricultural Impact Assessment

Address: Bradleys Head Road, Mosman

Prepared by: Michael Sullings – Consulting Arborist (AQF Level 5)  
November 17<sup>th</sup>, 2015

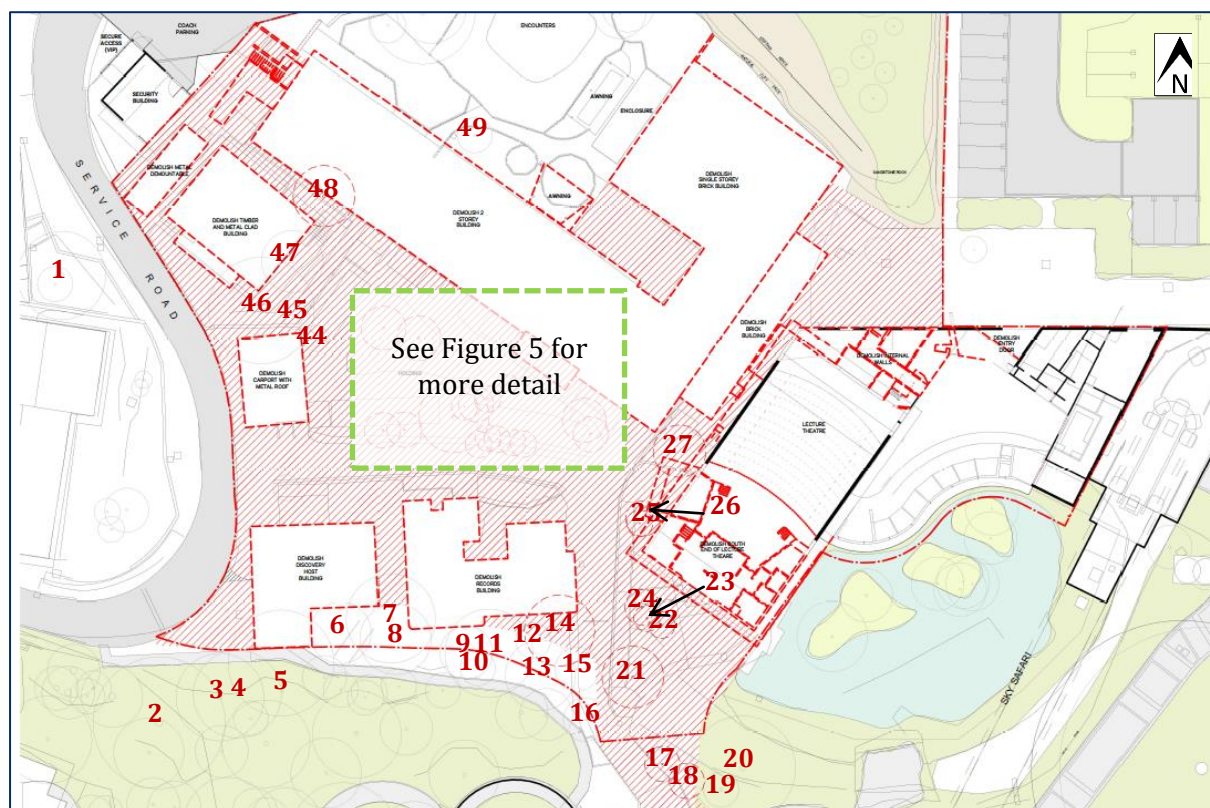
Figure 4 – An excerpt of Drawing 14490 – DD100 *Existing & Demolition Plan* shows the construction footprint for the proposed development, with structures to-be-demolished bounded by dotted red lines, and hard surfaces to-be-demolished shown by red cross-hatching. Approximate tree locations have been numbered. Plans supplied by Taronga Conservation Society Australia.

As shown in Figures 4 & 5, for purposes of structural soundness and public safety, Trees 5, 9, and 14 will require removal. Additionally, the extent of necessary demolition will likely require the removal of 21-48, and possibly of Trees 6-8, 14-18, 21-48.

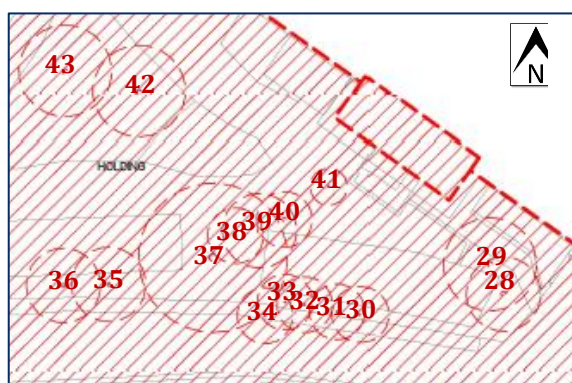
Figure 5 – An excerpt of Drawing 14490 – DD100 *Existing & Demolition Plan* shows Trees 28-43 in more detail. Plans supplied by Taronga Conservation Society Australia.
