Hazardous Materials Survey

37 Archer Street, Chatswood NSW

Report No: E26577.E10_Rev0

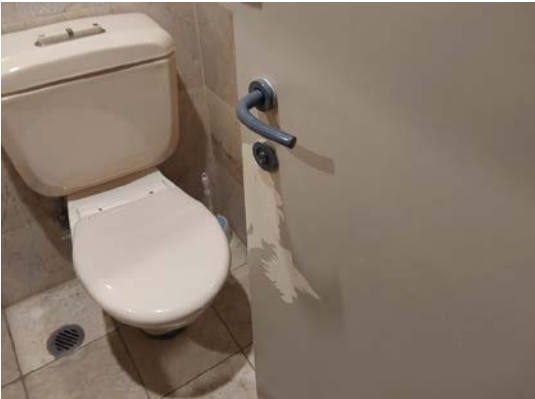
Unit 4, Internal, first floor, doors throughout	Grey Paint	Non-friable	4-Pb-1	0.014% w/w	N/A	N/A	N/A	N/A	N/A
---	------------	-------------	--------	------------	-----	-----	-----	-----	-----

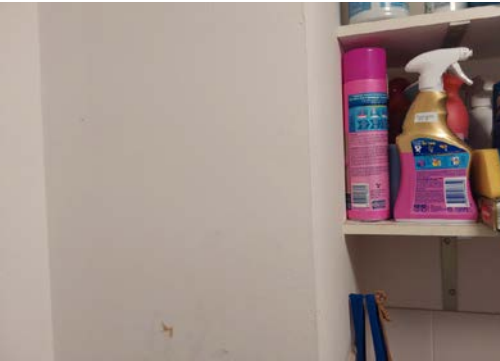
Unit 4, Internal, first floor, walls throughout	Pale Grey Paint	Non-friable	4-Pb-2	0.002% w/w	N/A	N/A	N/A	N/A	N/A
---	-----------------	-------------	--------	------------	-----	-----	-----	-----	-----

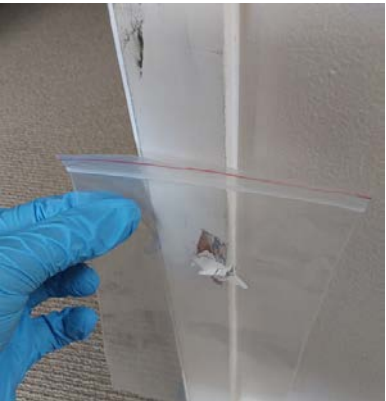
Unit 4, Internal, second floor, walls throughout	White Paint	Non-friable	4-Pb-3	0.052% w/w	N/A	N/A	N/A	N/A	N/A
--	-------------	-------------	--------	------------	-----	-----	-----	-----	-----

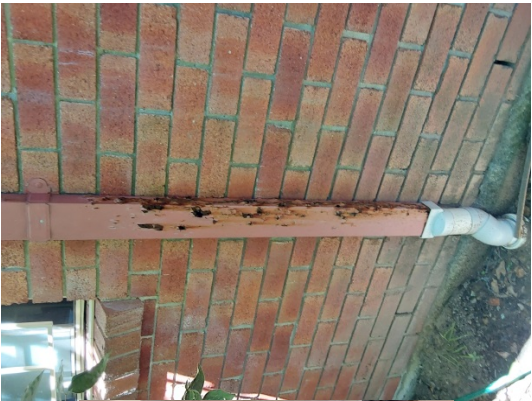
Unit 5, external, adjacent east fence, down pipe	Brown Paint	Non-friable	5-Pb-1	0.036% w/w	N/A	N/A	N/A	N/A	N/A
--	-------------	-------------	--------	------------	-----	-----	-----	-----	-----

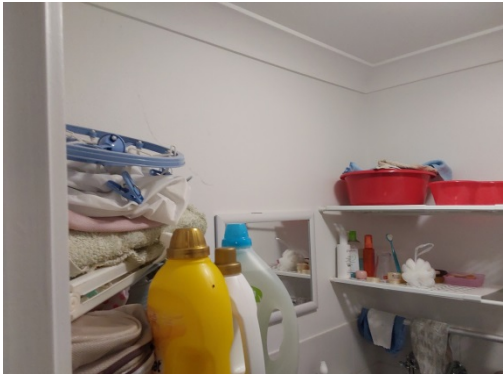
Unit 5, Internal, walls and doors throughout	White Paint	Non-friable	5-Pb-2	0.080% w/w	N/A	N/A	N/A	N/A	N/A

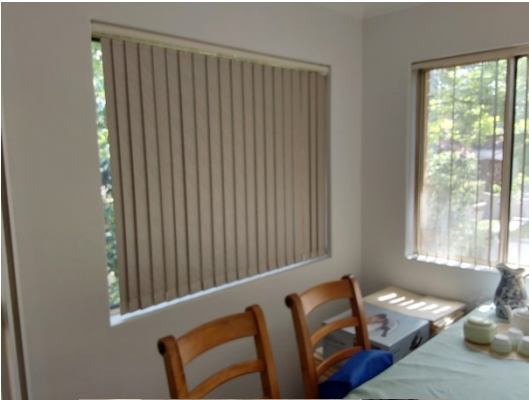
Unit 6, Internal, first floor, kitchen and living room, walls and ceilings	Very Pale Blue Paint	Non-friable	6-Pb-1	0.003% w/w	N/A	N/A	N/A	N/A	N/A

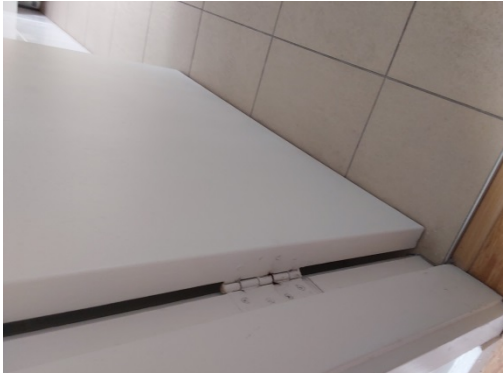
Unit 7, Internal, doors, door frames and window trimmings throughout	White Paint	Non-friable	6-Pb-2	0.007% w/w	N/A	N/A	N/A	N/A	N/A

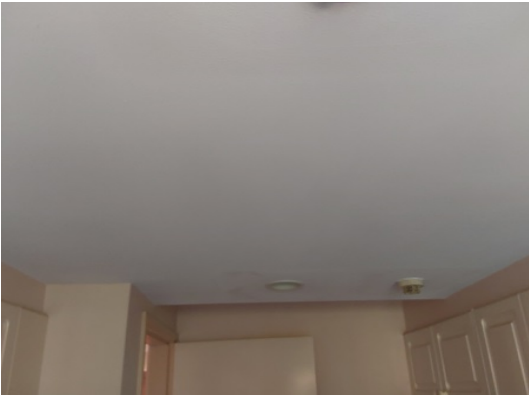
Unit 9, Internal, kitchen, bedroom, bathroom ceiling	White Paint	Non-friable	9-Pb-2	0.001% w/w	N/A	N/A	N/A	N/A	N/A

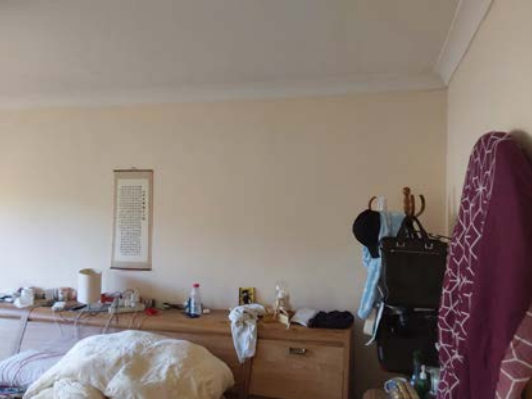
Unit 12, Internal, first and second floors living room, kitchen and bedroom, walls throughout	Off White Paint	Non-friable	12-Pb-1	0.002% w/w	N/A	N/A	N/A	N/A	N/A

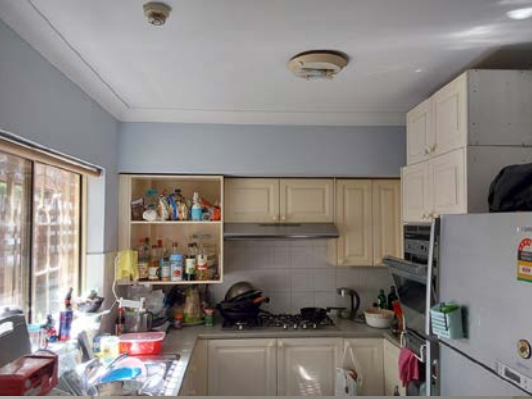
Unit 13, Internal, kitchen and laundry, walls throughout	Light Blue Paint	Non-friable	13-Pb-1	0.002% w/w	N/A	N/A	N/A	N/A	N/A

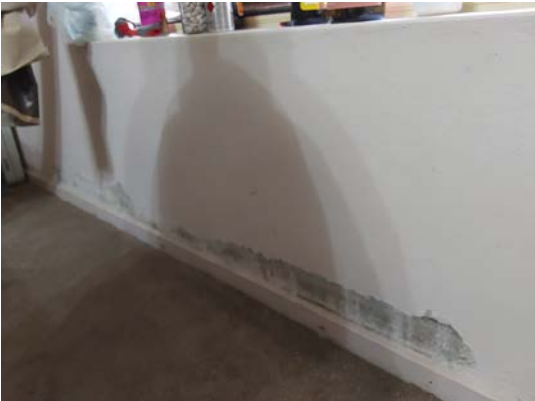
Unit 13, Internal, living room and bedroom, walls throughout	Pale Grey Paint	Non-friable	13-Pb-2	0.002% w/w	N/A	N/A	N/A	N/A	N/A
--	-----------------	-------------	---------	------------	-----	-----	-----	-----	-----

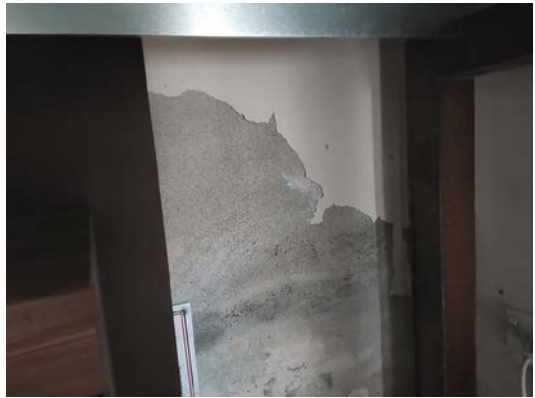
Unit 13, Internal, living room and bedroom, walls throughout	Pale Grey Paint	Non-friable	13-Pb-3	0.002% w/w	N/A	N/A	N/A	N/A	N/A
--	-----------------	-------------	---------	------------	-----	-----	-----	-----	-----

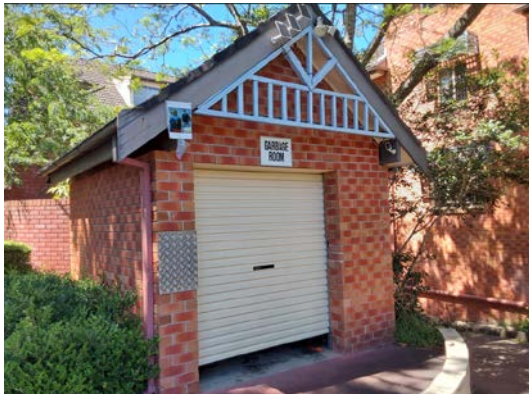
Hazardous Materials Register 37 Archer Street, Chatswood NSW										Shared Basement, Common Areas and Garbage Room	
Location	Material	Friability	Sample	Analysis Result	Quantity	Condition / Accessibility	Priority	Date of Identification	Recommendations / Comments	Photograph	
Inaccessible / Limited Access											
Garbage Room, Internal, eastern boundary adjacent to Bertram Street	Possible hazardous materials	N/A	-	-	N/A	N/A	N/A	16/12/2024	Inspect when access is made available, prior to demolition
