Arboricultural Impact Assessment

Shore Physical Education Centre

3rd of June 2016

RE: Arboricultural Impact Assessment of fifty trees for the Shore Physical Education Centre.

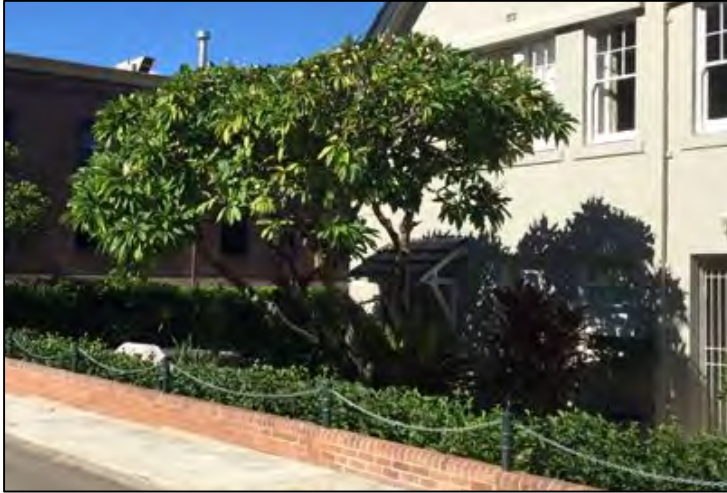
- 7.6.6 Tree 25 – Saucer Magnolia (*Magnolia x soulangeana*) has a Moderate Retention Value. This mature Magnolia tree was growing in the south west portion of the Shore North Sydney Residential site The TPZ required for the successful retention of this tree is currently 3.7m.
- 7.6.7 Tree 50 – Frangipani (*Plumeria acuminata*) has a Moderate Retention Value. This mature Frangipani tree was growing in the middle of the Shore North Sydney Campus. The TPZ required for the successful retention of this tree is currently 3.4m.

Fig. 12: Depicts Tree 50 in its growing environment. Source: Austin 11/05/2016

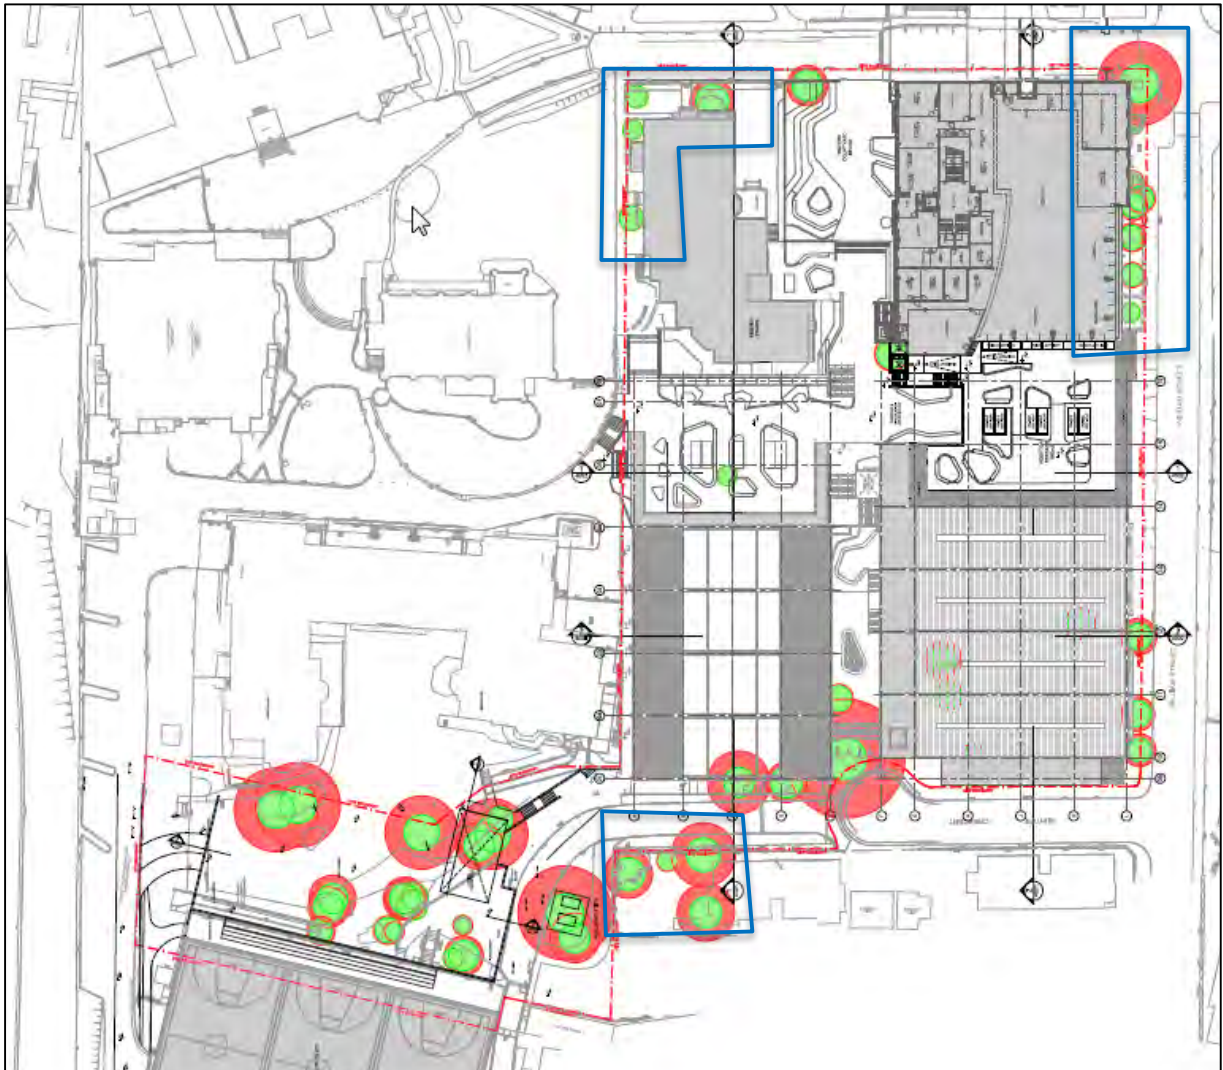
Fig. 23: Depicts the trees able to be retainable surrounded by blue boxes. All other trees will require removal if the proposal is to commence.

Source: Diagram Tree Protection Zone Proposed. Note. Outer red circle is the TPZ and inner green circle is the SRZ of each tree. (Drawing Number A-SK-002), by Cox Architecture, Project 21304. 03.06.2016

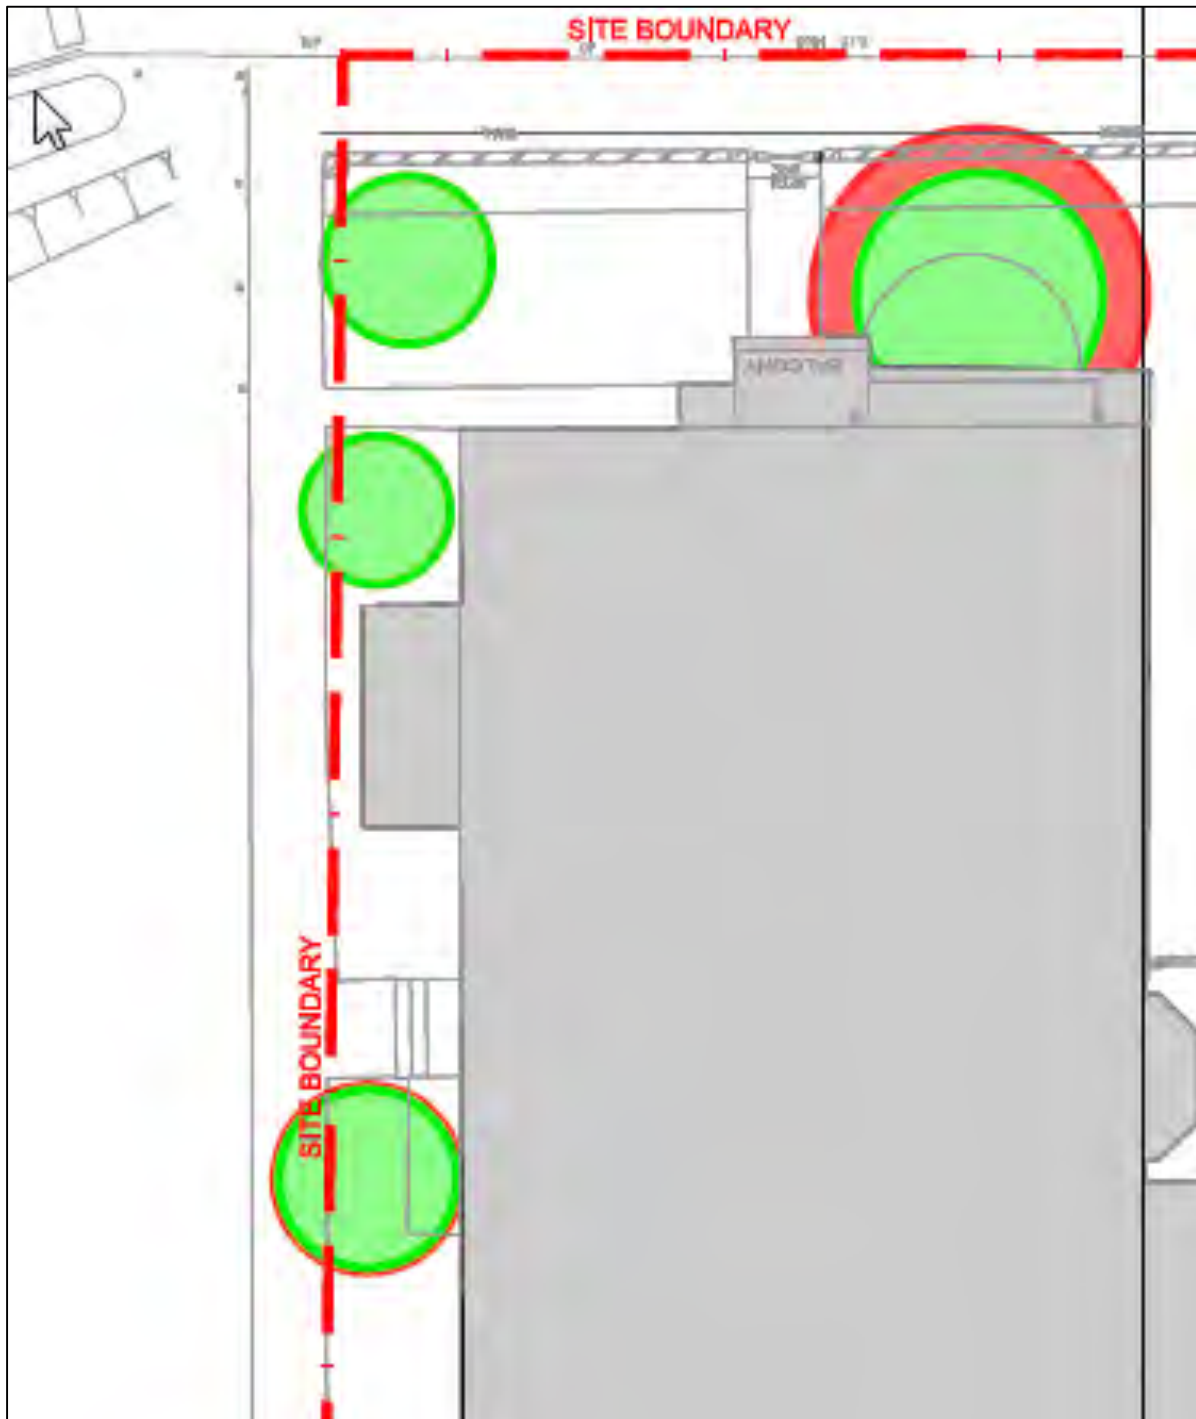
9.4.1 Tree numbers 50 – 54 appear to be away from the proposed works as no works are evident on the western side of Robson House. No Protection fence should be required. .

Fig. 24: Depicts tree numbers 50, 51, 52 & 54 which are able to be retained. Source: Diagram Tree Protection Zone Proposed. (Drawing Number A-SK-002), by Cox Architecture, Project 21304. 03.06.2016

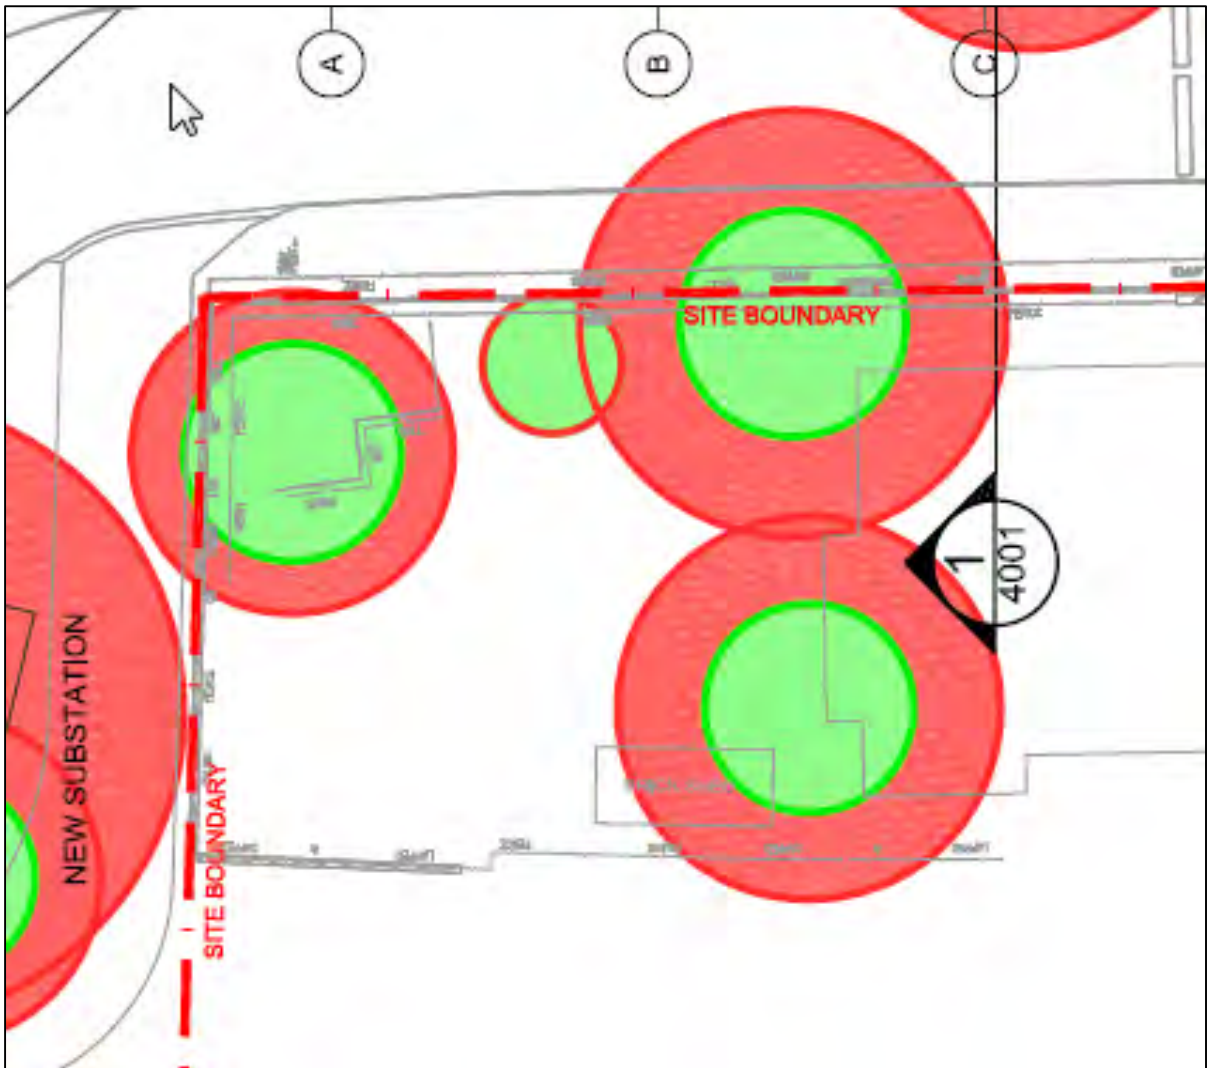
9.4.2 The existing rear fence of 1-4/1 Hunter Crescent serves as an adequate tree protection fence for trees 20, 23, 25 & 29. If no changes to the adjacent Shore driveway or garden bed occur, protection of the root zone will not be required.

Fig. 25: Depicts tree numbers 20, 23, 25 & 29 which able to be retained. Source: Diagram Tree Protection Zone Proposed. (Drawing Number A-SK-002), by Cox Architecture, Project 21304. 03.06.2016

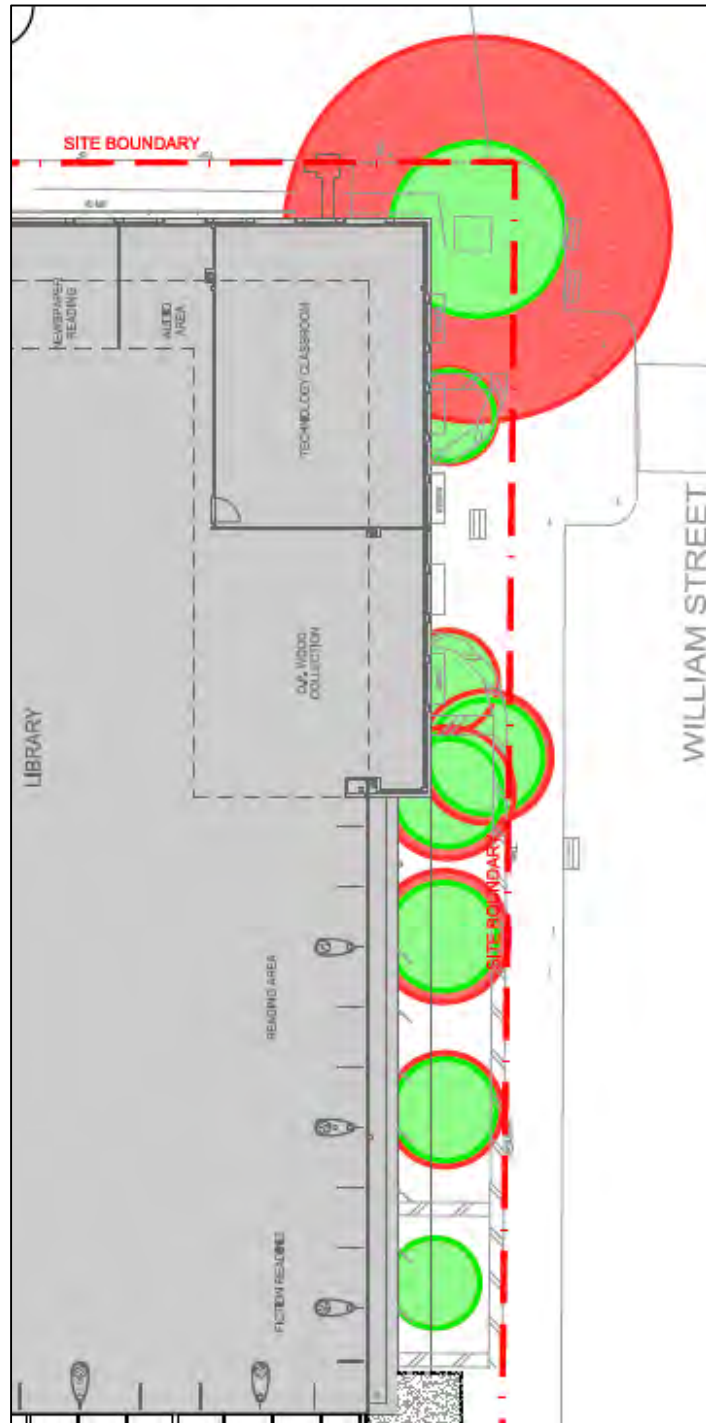
- 9.4.3 The William street frontage (Outside the Library) does not appear to have any works occurring.
- 9.4.4 The existing garden bed and retaining walls adequately protect trees 34 – 40 from works outside the bed and walls.
- 9.4.5 Tree 33 is located in the foot path and will require trunk protection. Ground protection and Arborist supervision will be required if works to existing pavement or services occurs.

Fig. 26: Depicts tree numbers 33, 34, 35, 36, 37, 38, 39 & 40 which are able to be retained. Source: Diagram Tree Protection Zone Proposed. (Drawing Number A-SK-002), by Cox Architecture, Project 21304. 03.06.2016

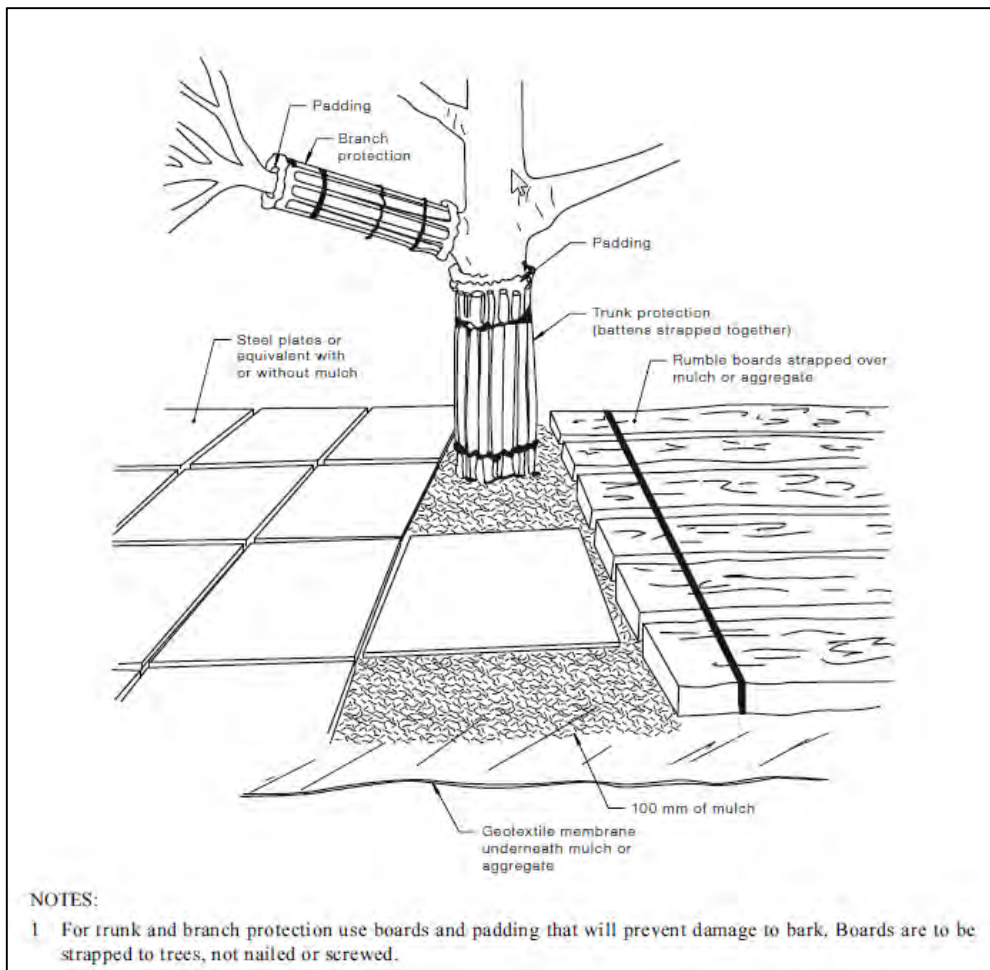
Fig. 27: Trunk Protection Requirements for tree 33. Source: Australian Standard 4970:2009.

- 10.2.1 Tree 33 will require trunk protection as outlined in Figure 27 below.
