**Report on Hazardous Building Materials
(HAZMAT) Survey**

3-5 Help Street, Chatswood NSW

Prepared for Loftex Chatswood Pty Limited

Project 232749.00

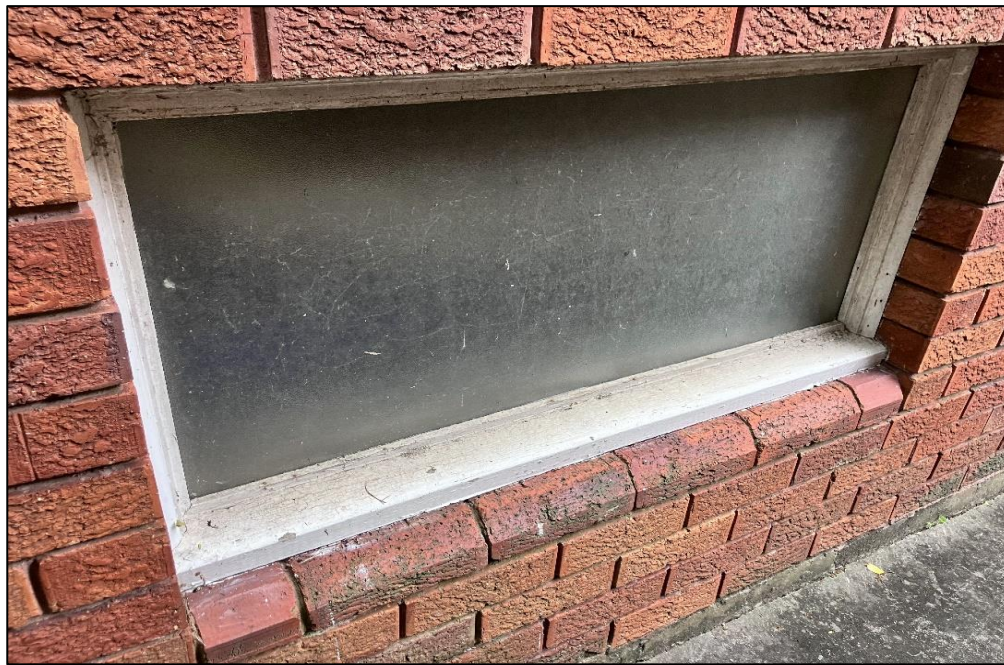
3 Help Street	exterior	western façade, southern end, window frame	white paint	lead paint detected	positive	3-E-LP2	0.28	similar 16, 17	<p>Lead paint identified. Analysis results are above the threshold criteria for lead paint outlined in AS4361.2 (i.e. >0.1 % lead w/w).</p> <p>Any areas of damaged/flaking paint and any associated dust/debris should be removed.</p> <p>Minimise disturbance and implement controls to prevent exposure and dispersal during any lead paint abatement activity and any building work (e.g. maintenance, refurbishment and demolition).</p> <p>Classify material for disposal in accordance with the NSW EPA Waste Classification Guidelines and segregate material, if required, for disposal.</p>
3 Help Street	exterior	western facade, northern end, concrete awning	white paint	lead paint not detected	N/A	3-E-LP3	<0.005	18	<p>Analysis results non-detect and/or below the threshold concentration criteria for lead containing paint projects as outlined in AS4361.2 (i.e. ≤0.1 % lead w/w).</p> <p>Classify material for disposal in accordance with the NSW EPA Waste Classification Guidelines and segregate material, if required, for disposal.</p> <p>Minimise disturbance and implement controls to prevent exposure and dispersal during any paint disturbance or building work (e.g. maintenance, refurbishment and demolition)</p>

Photograph 16: 3 Help Street, exterior, typical window frame.

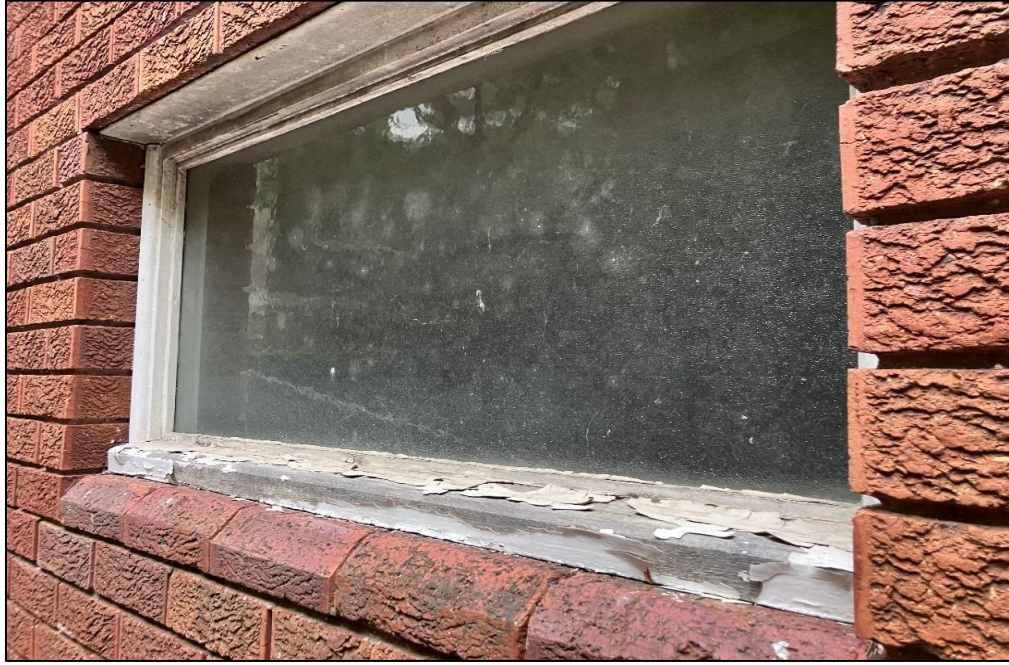
Photograph 17: 3 Help Street, exterior, typical window frame.
