# Hazardous Materials Survey

**RTL Co**

177-191 Victoria Rd, Marrickville NSW

**Report Title** Hazardous Materials Survey  
**Project Reference Number:** WEC201.HMS.002  
**Document Date:** 16 December 2024

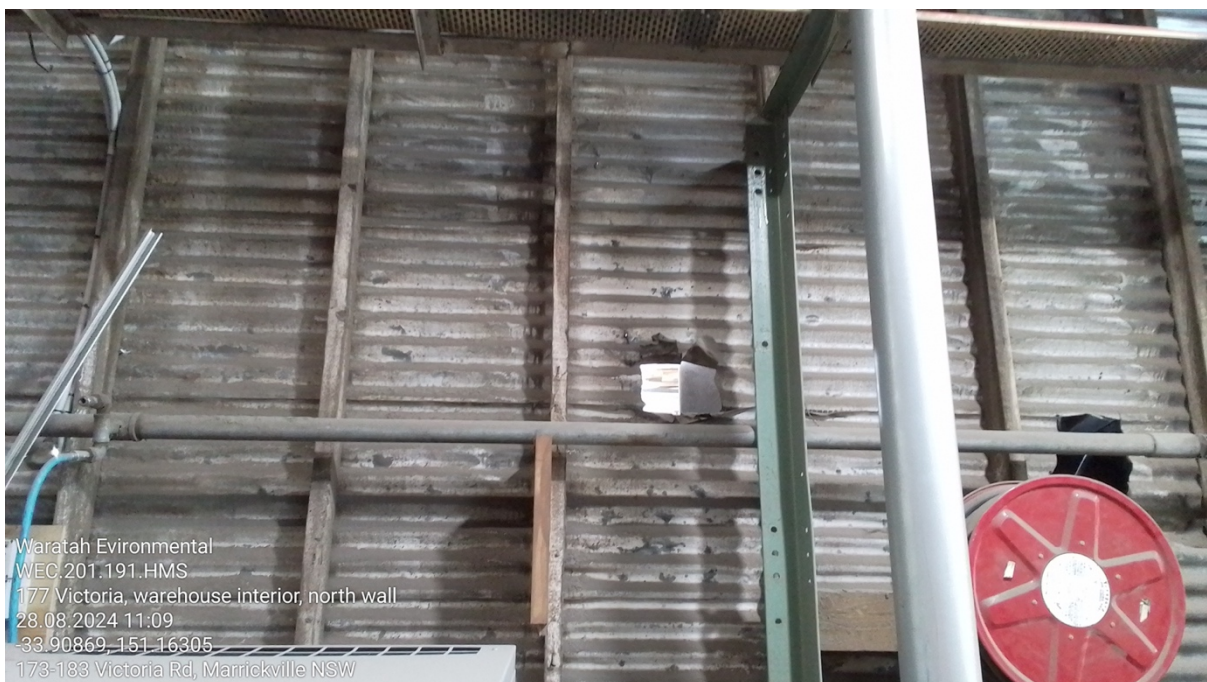
**Photograph 12:**

| Location Description | Material | Condition | Sample ID | Analytical Result | Estimated Quantity | Accessibility | Priority Rating | Recommendations | Photograph Register |
|---|---|---|---|---|---|---|---|---|---|
| Warehouse interior, north wall and north ceiling | Corrugated metal | Fair | Visual assessment | Comprises steel | 250m <sup>2</sup> | Regular | NA | NA | Photograph 12 |

177 Victoria, warehouse interior, north wall, corrugated metal (28/08/24)
