# Hazardous Materials Survey

**RTL Co**

2-12 Mitchell Street, Marrickville NSW

**Report Title** Hazardous Materials Survey  
**Project Reference Number:** WEC201.HMS.001\_v1.1  
**Document Date:** 16 December 2024

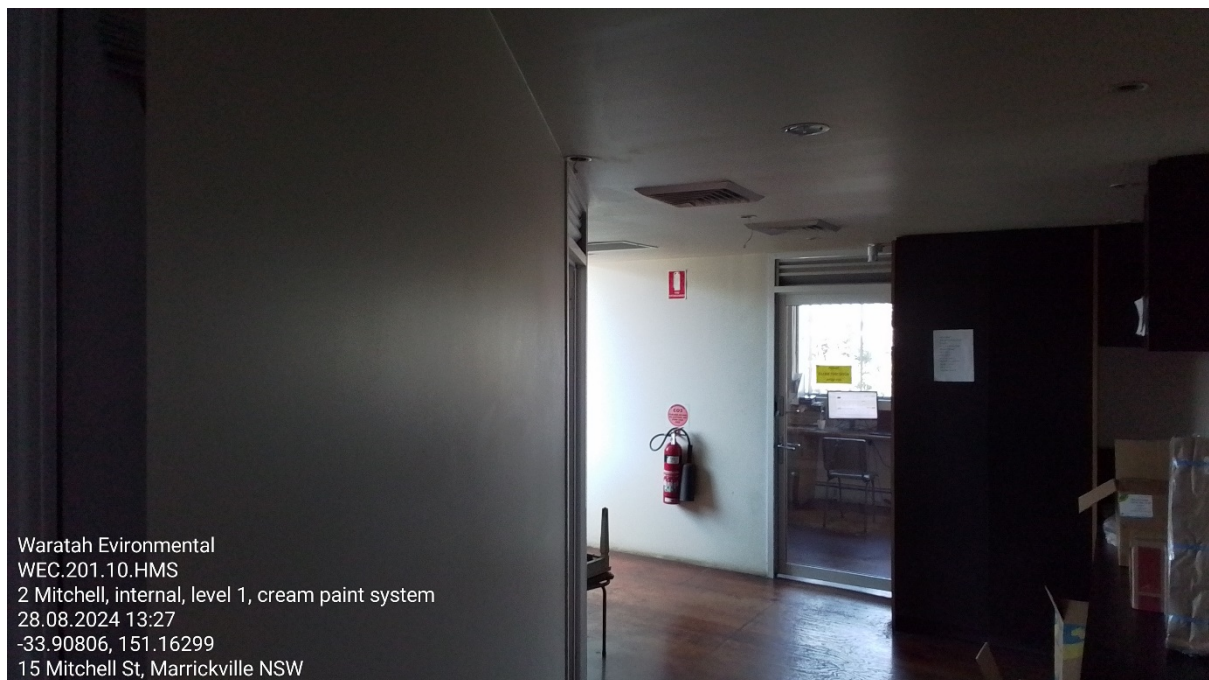
**Photograph 2:**

| Location Description | Material | Condition | Sample ID | Analytical Result | Estimated Quantity | Accessibility | Priority Rating | Recommendations | Photograph Register |
|---|---|---|---|---|---|---|---|---|---|
| Interior, level 1, walls throughout stairwell and office | White paint system | Good | Visual assessment | Presumed not to contain lead | 100m <sup>2</sup> | Maintenance only | NA | NA | Photograph 2 |

2 Mitchell, interior, level 1, walls throughout stairwell and office, white paint system (28/08/24)

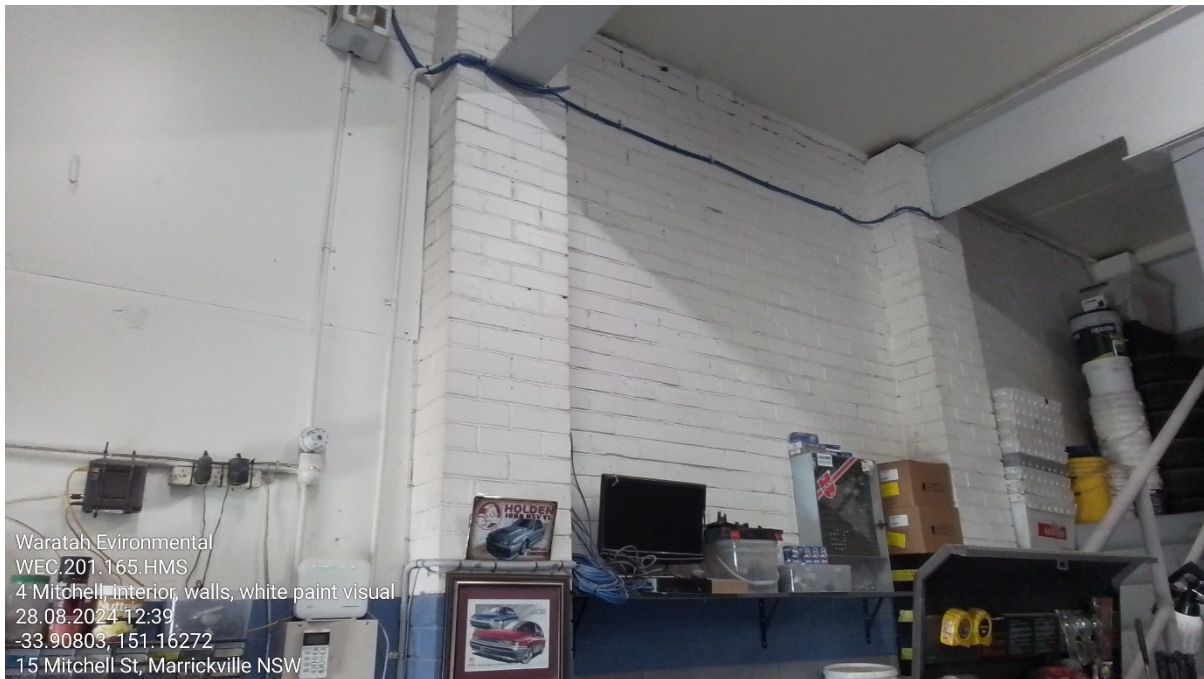
**Photograph 5:**

| Location Description | Material | Condition | Sample ID | Analytical Result | Estimated Quantity | Accessibility | Priority Rating | Recommendations | Photograph Register |
|---|---|---|---|---|---|---|---|---|---|
| Interior, walls throughout | White paint system | Good | Visual assessment | Presumed not to contain lead | 150m <sup>2</sup> | Maintenance only | NA | NA | Photograph 5 |

4 Mitchell, interior, walls throughout, white paint system (28/08/24)

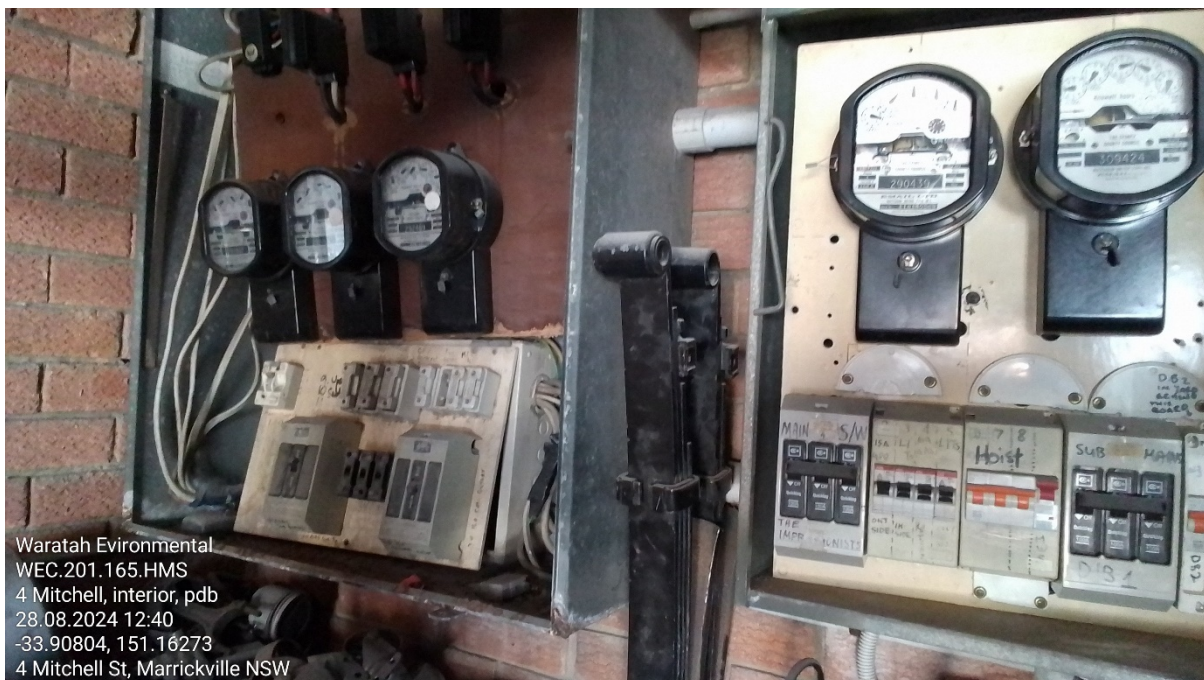
**Photograph 6:**

| Location Description | Material | Condition | Sample ID | Analytical Result | Estimated Quantity | Accessibility | Priority Rating | Recommendations | Photograph Register |
|---|---|---|---|---|---|---|---|---|---|
| Interior, ground level, west wall | Power distribution board | Good | Visual assessment | Presumed not to contain ACM | 2 units | Maintenance only | NA | NA | Photograph 6<br>Photograph 7 |

4 Mitchell, interior, ground level, west wall, power distribution boards (28/08/24)

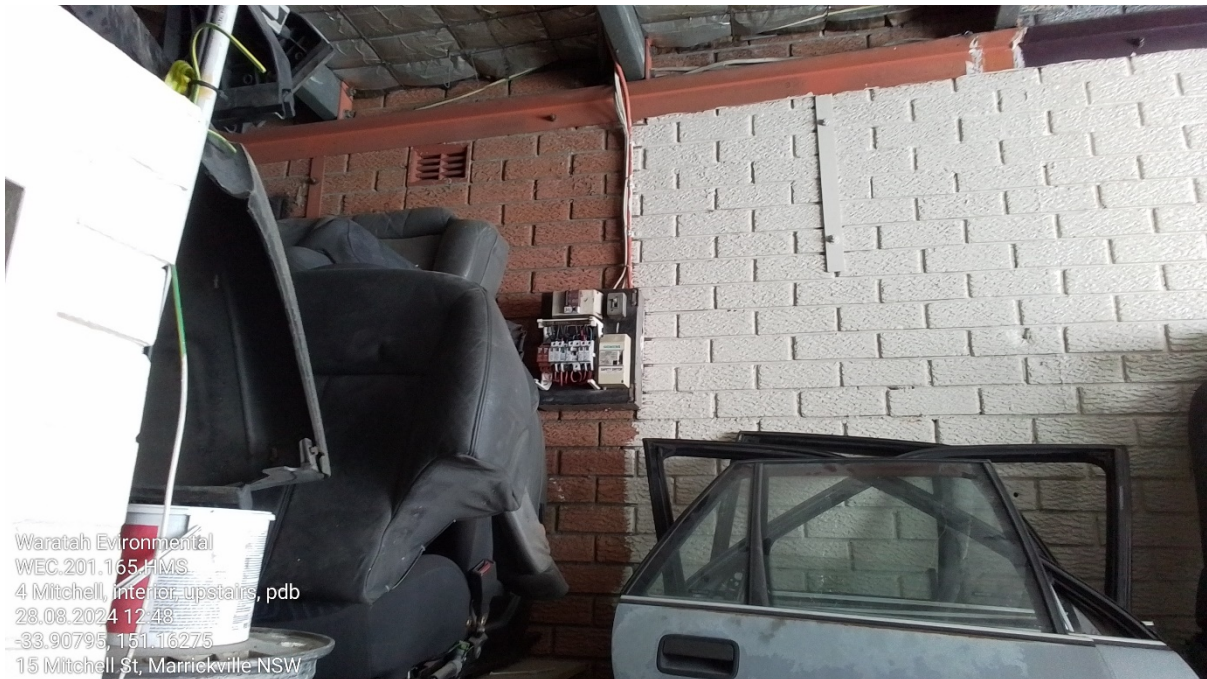
**Photograph 7:**

4 Mitchell, interior, ground level, west wall, power distribution boards (28/08/24)

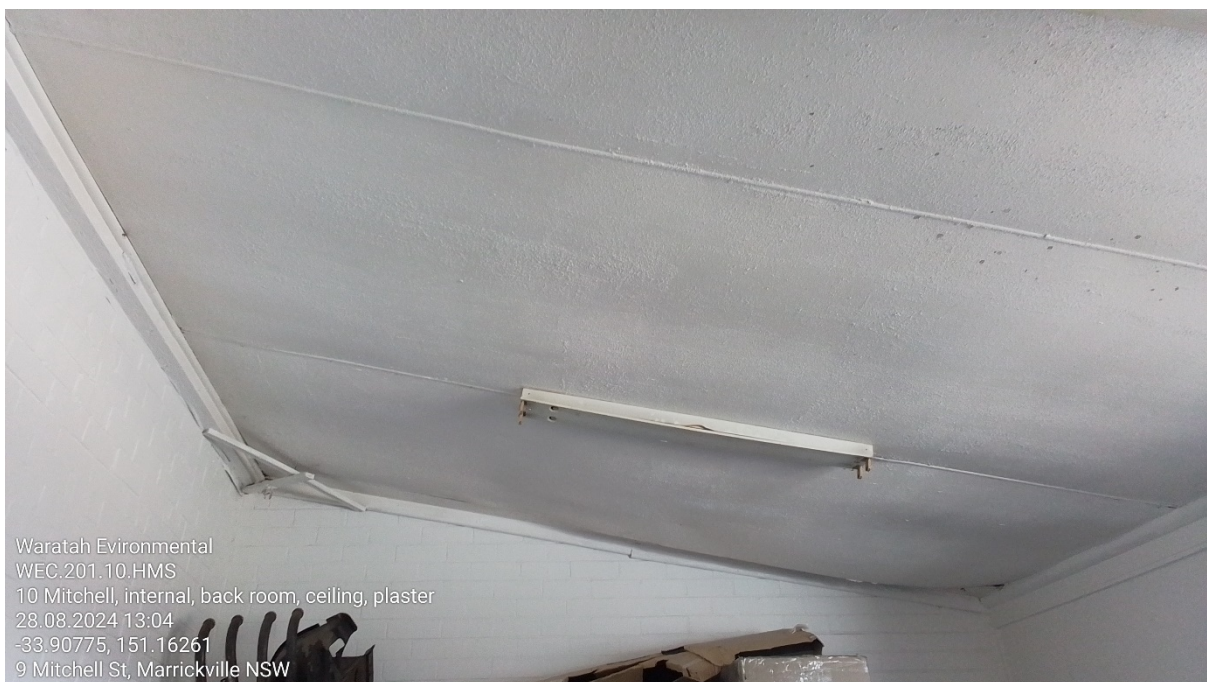
**Photograph 12:**

| Location Description | Material | Condition | Sample ID | Analytical Result | Estimated Quantity | Accessibility | Priority Rating | Recommendations | Photograph Register |
|---|---|---|---|---|---|---|---|---|---|
| Interior, backroom, ceiling | Cement sheet | Good | Visual assessment | Presumed not to contain ACM | 20m <sup>2</sup> | Maintenance only | NA | NA | Photograph 12 |

Waratah Evironmental  
WEC.201.10.HMS  
10 Mitchell, internal, back room, ceiling, plaster  
28.08.2024 13:04  
-33.90775, 151.16261  
9 Mitchell St, Marrickville NSW

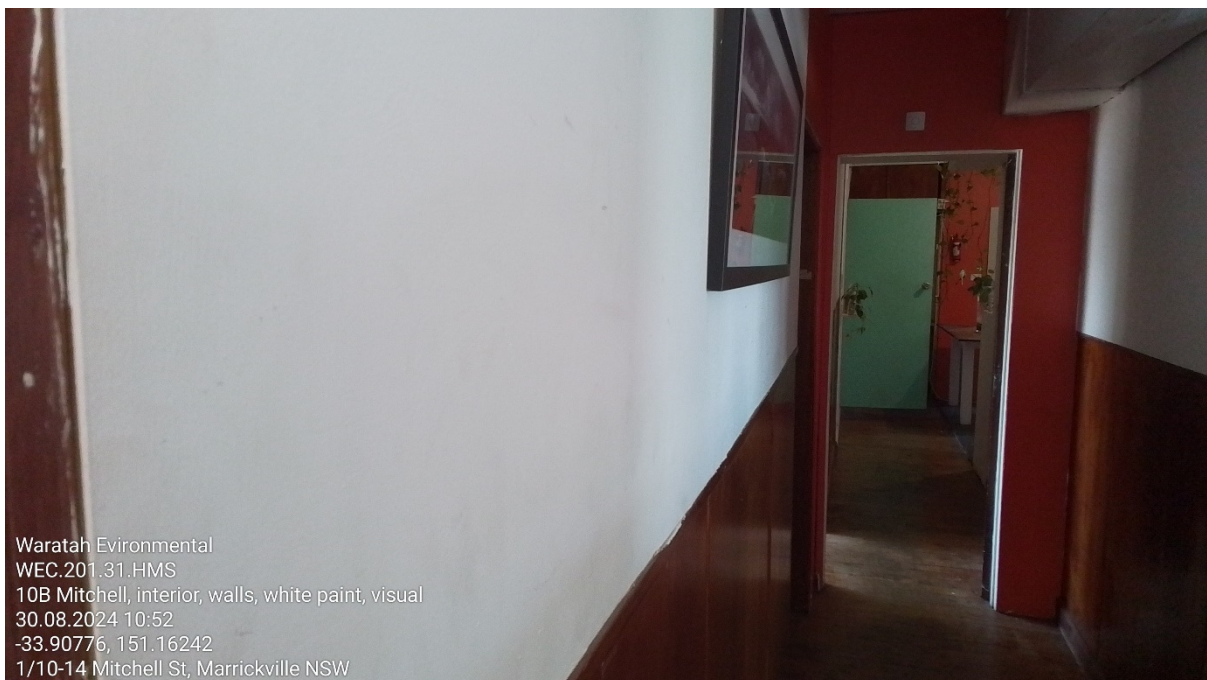
**Photograph 18:**

| Location Description | Material | Condition | Sample ID | Analytical Result | Estimated Quantity | Accessibility | Priority Rating | Recommendations | Photograph Register |
|---|---|---|---|---|---|---|---|---|---|
| Interior, walls throughout | White paint system | Good | Visual assessment | Presumed not to contain Pb | 50m <sup>2</sup> | Occasional | NA | NA | Photograph 18 |

10B Mitchell, interior, walls, white paint system (28/08/24)

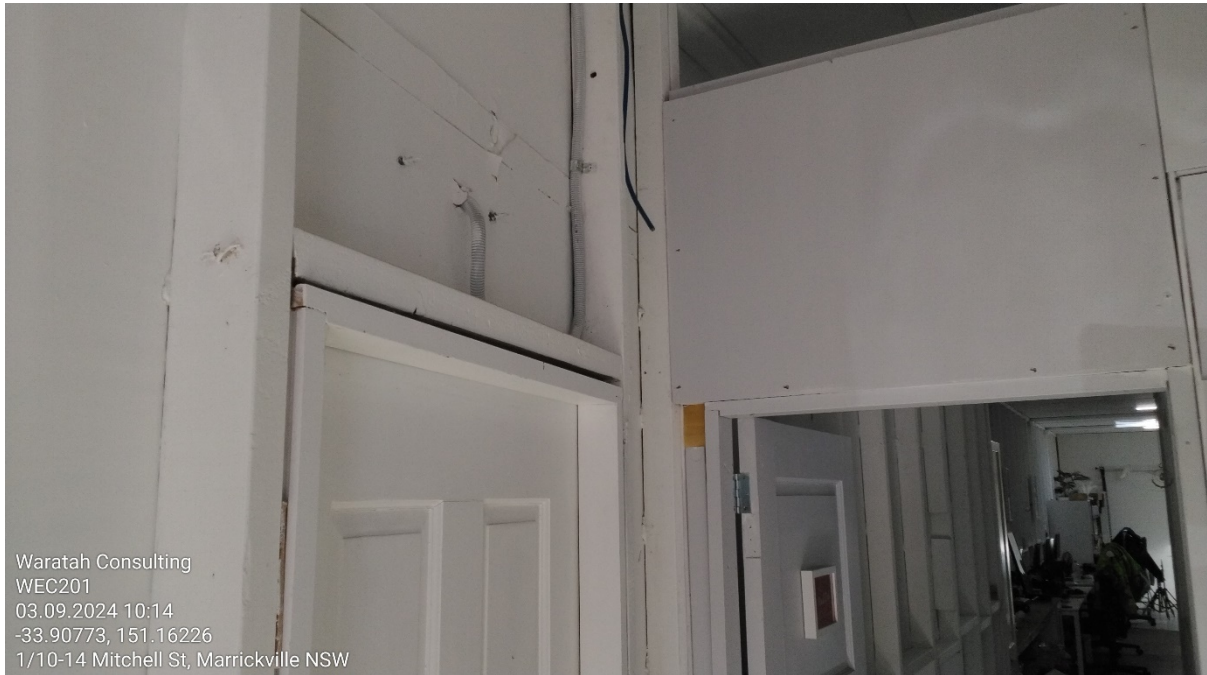
**Photograph 21:**

| Location Description | Material | Condition | Sample ID | Analytical Result | Estimated Quantity | Accessibility | Priority Rating | Recommendations | Photograph Register |
|---|---|---|---|---|---|---|---|---|---|
| Interior, ceilings, walls | White paint system | Good | Visual assessment | Presumed to not contain lead | 250m <sup>2</sup> | Regular | NA | NA | Photograph 21 |

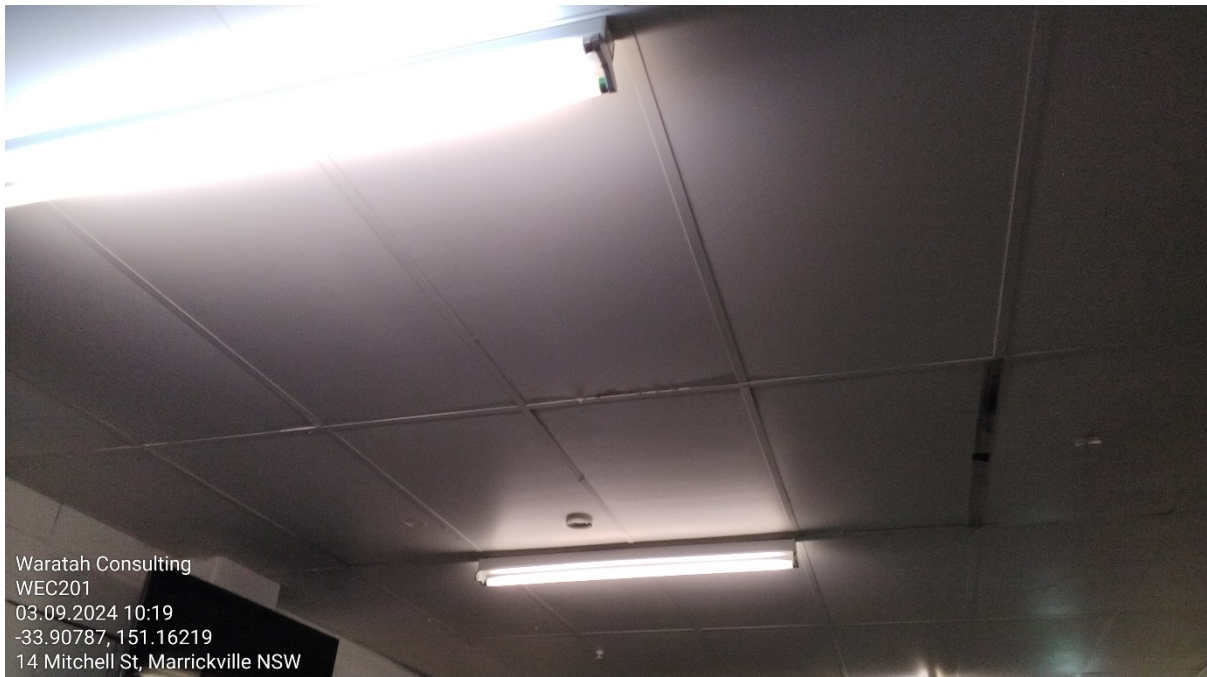
**Photograph 23:**

| Location Description | Material | Condition | Sample ID | Analytical Result | Estimated Quantity | Accessibility | Priority Rating | Recommendations | Photograph Register |
|---|---|---|---|---|---|---|---|---|---|
| Interior, ceiling | Ceiling panels | Good | Visual assessment | Presumed not to contain ACM | 100m <sup>2</sup> | Maintenance only | NA | NA | Photograph 23 |
