# Hazardous Materials Survey

**RTL Co**

7-35 Farr Street, Marrickville NSW

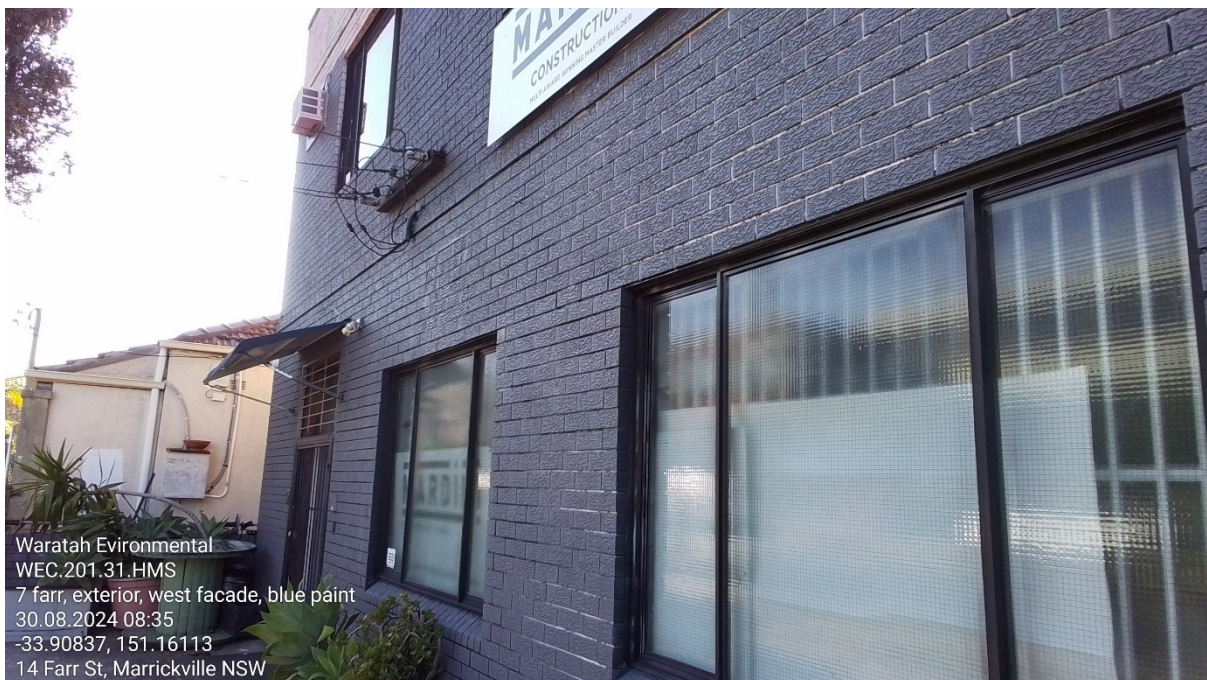
**Photograph 2:**

| Location Description | Material | Condition | Sample ID | Analytical Result | Estimated Quantity | Accessibility | Priority Rating | Recommendations | Photograph Register |
|---|---|---|---|---|---|---|---|---|---|
| Exterior, west façade, walls | Blue paint system | Good | Visual assessment | Presumed not to contain lead | 50m <sup>2</sup> | Occasional | NA | NA | Photograph 2 |

7 Farr Street, exterior, west façade, walls (30/08/24)

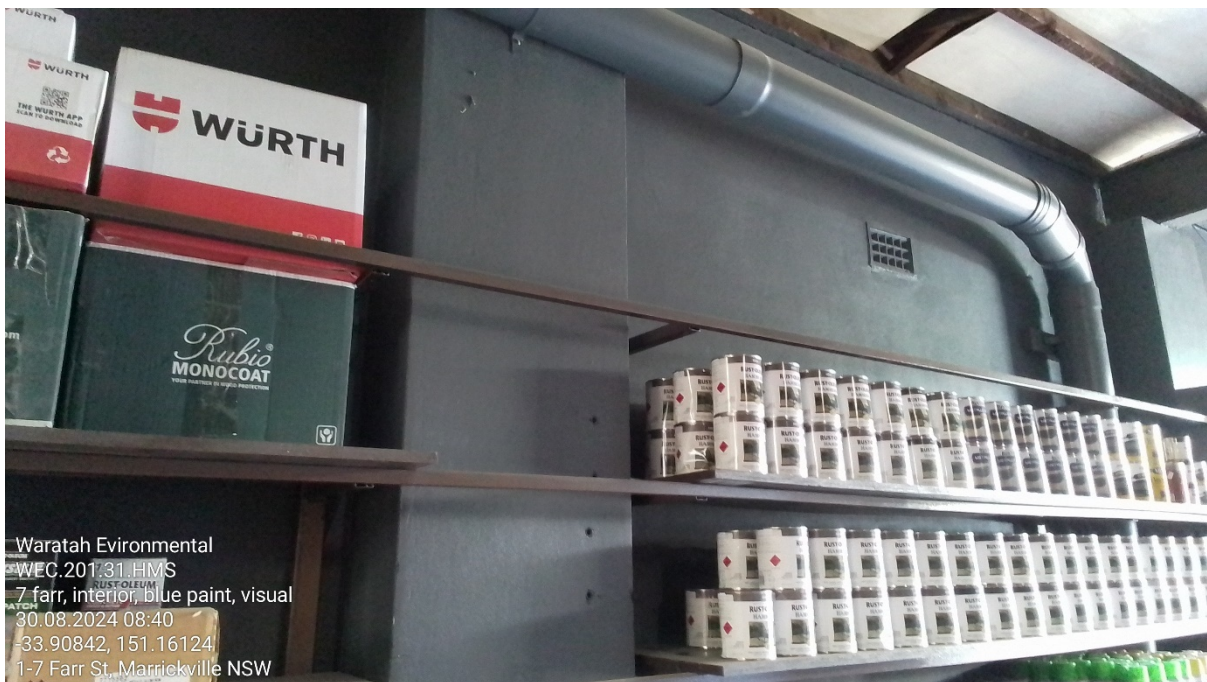
**Photograph 4:**

| Location Description | Material | Condition | Sample ID | Analytical Result | Estimated Quantity | Accessibility | Priority Rating | Recommendations | Photograph Register |
|---|---|---|---|---|---|---|---|---|---|
| Interior, walls throughout | Green paint system | Good | Visual assessment | Presumed not to contain lead | 50m <sup>2</sup> | Occasional | NA | NA | Photograph 4 |

7 Farr Street, interior, walls throughout (30/08/24)

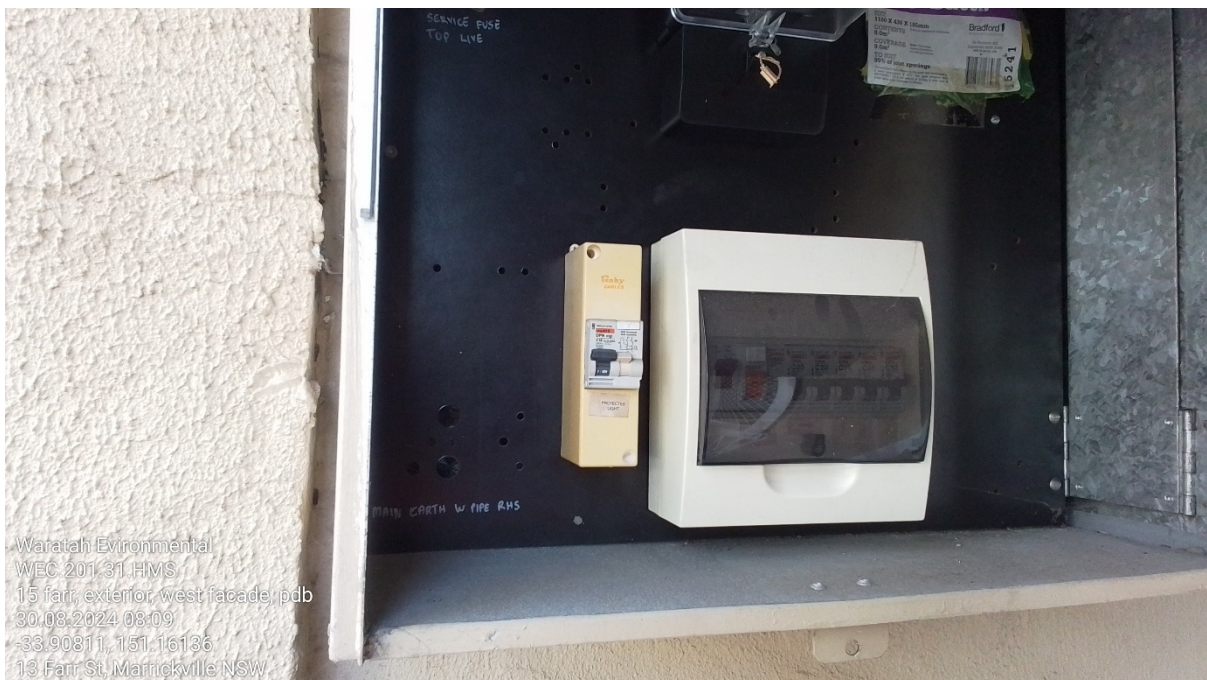
**Photograph 8:**

| Location Description | Material | Condition | Sample ID | Analytical Result | Estimated Quantity | Accessibility | Priority Rating | Recommendations | Photograph Register |
|---|---|---|---|---|---|---|---|---|---|
| Exterior, west façade, wall | Power distribution board | Good | Visual assessment | Presumed not to contain asbestos | 1 unit | Maintenance only | NA | NA | Photograph 8 |

15 Farr Street, exterior, west façade, wall, power distribution board (30/08/24)

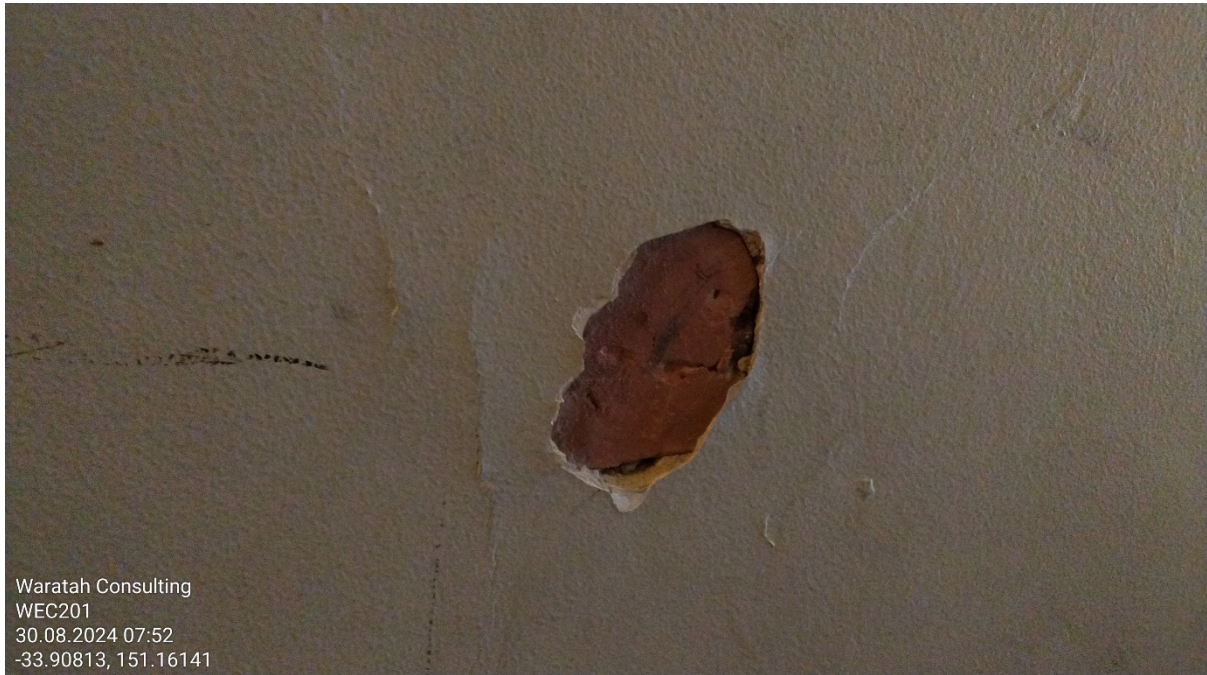
**Photograph 11:**

| Location Description | Material | Condition | Sample ID | Analytical Result | Estimated Quantity | Accessibility | Priority Rating | Recommendations | Photograph Register |
|---|---|---|---|---|---|---|---|---|---|
| Interior, walls throughout | Grey paint system | Good | Visual assessment | Presumed not to contain lead | 100m <sup>2</sup> | Regular | NA | NA | Photograph 11 |

17 Farr Street, interior, walls throughout, grey paint system (30/08/24)

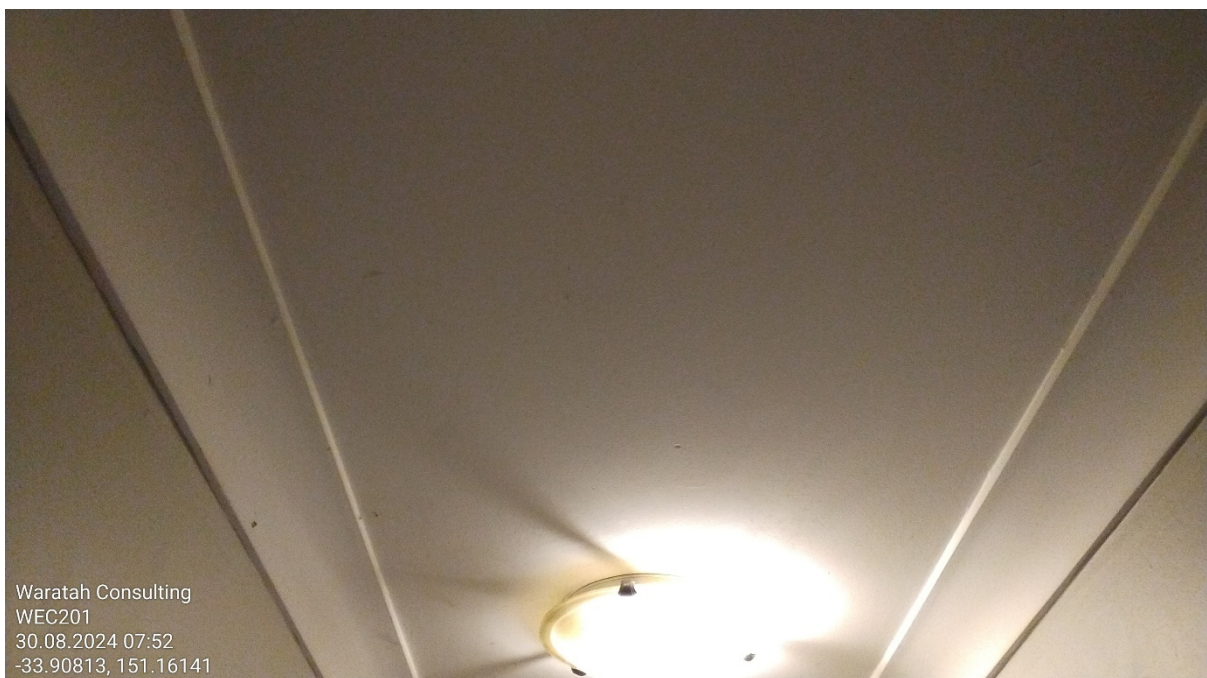
**Photograph 12:**

| Location Description | Material | Condition | Sample ID | Analytical Result | Estimated Quantity | Accessibility | Priority Rating | Recommendations | Photograph Register |
|---|---|---|---|---|---|---|---|---|---|
| Interior, ceiling surface throughout | White paint system | Good | Visual assessment | Presumed not to contain lead | 75m <sup>2</sup> | Regular | NA | NA | Photograph 12 |

17 Farr Street, interior, ceiling surface throughout, white paint system (30/08/24)

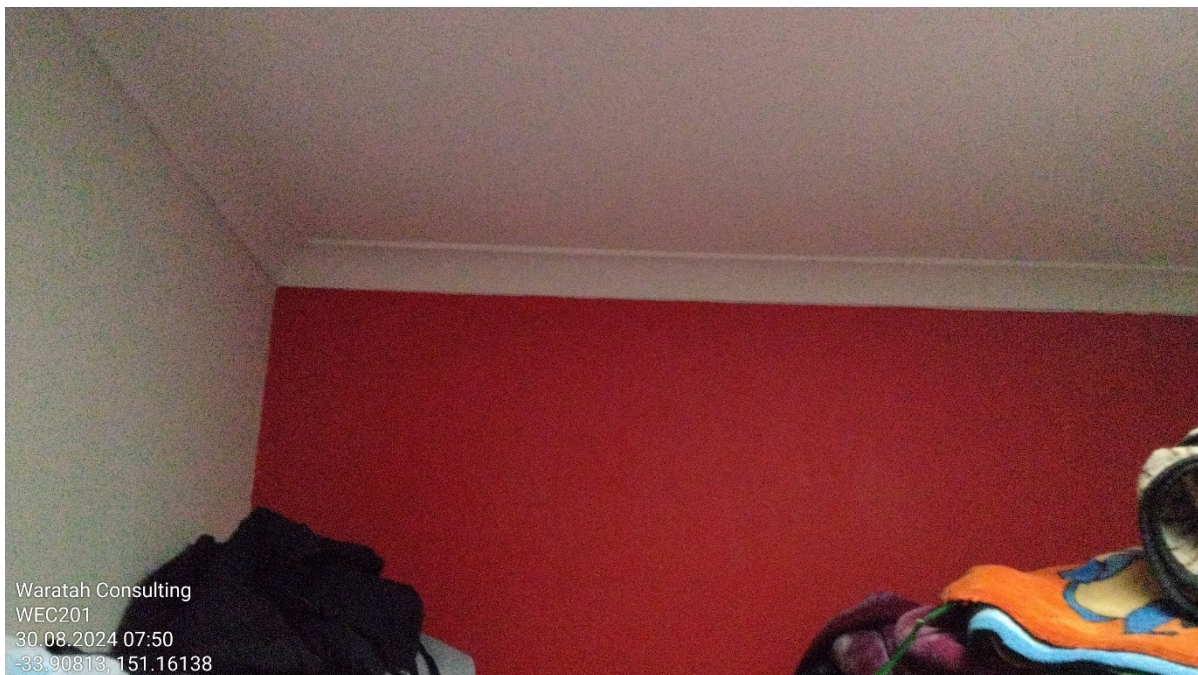
**Photograph 13:**

| Location Description | Material | Condition | Sample ID | Analytical Result | Estimated Quantity | Accessibility | Priority Rating | Recommendations | Photograph Register |
|---|---|---|---|---|---|---|---|---|---|
| Interior, rooms, northern wall surfaces | Red paint system | Good | Visual assessment | Presumed not to contain lead | 15m <sup>2</sup> | Regular | NA | NA | Photograph 13 |

17 Farr Street, interior, rooms, northern wall surfaces, red paint system (30/08/24)

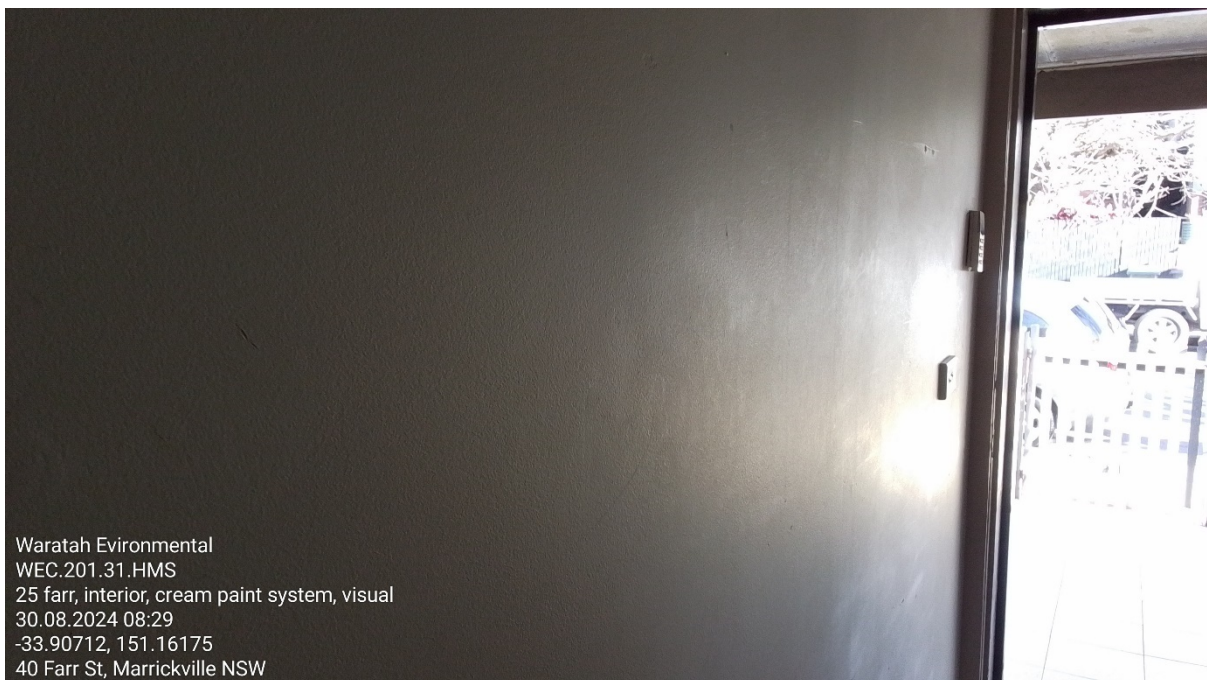
**Photograph 16:**

| Location Description | Material | Condition | Sample ID | Analytical Result | Estimated Quantity | Accessibility | Priority Rating | Recommendations | Photograph Register |
|---|---|---|---|---|---|---|---|---|---|
| Interior, walls throughout | Cream paint system | Good | Visual assessment | Presumed not to contain lead | 100m <sup>2</sup> | Occasional | NA | NA | Photograph 16 |

25 Farr Street, interior, walls throughout, cream paint system (30/08/24)

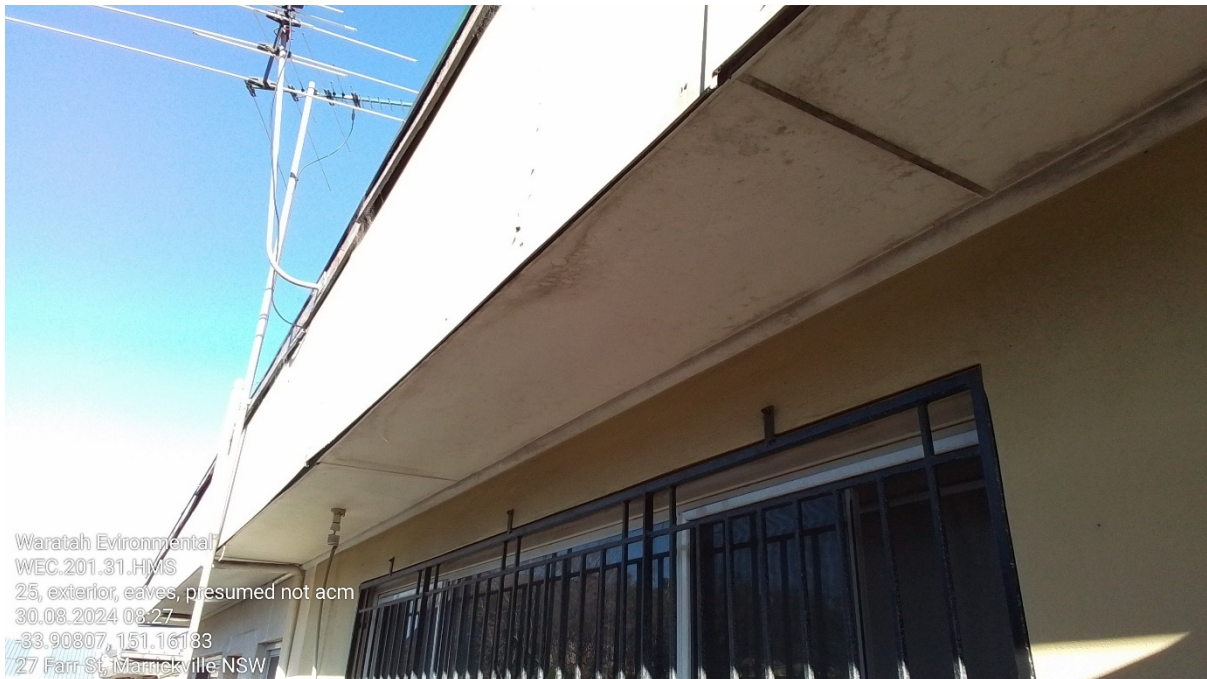
**Photograph 17:**

| Location Description | Material | Condition | Sample ID | Analytical Result | Estimated Quantity | Accessibility | Priority Rating | Recommendations | Photograph Register |
|---|---|---|---|---|---|---|---|---|---|
| Exterior, east façade, eaves | Wood board | Good | Visual assessment | Comprises timber | 20m <sup>2</sup> | Maintenance only | NA | NA | Photograph 17 |

25 Farr Street, exterior, east façade, eaves, wooden eaves (30/08/24)

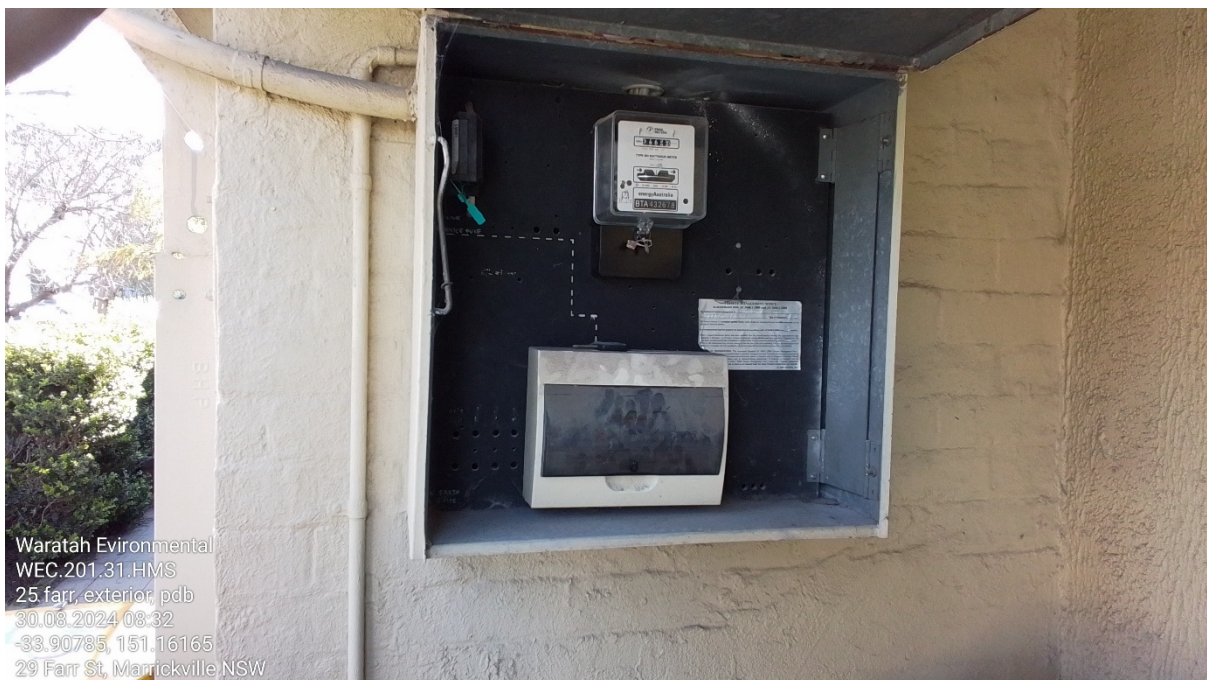
**Photograph 18:**

| Location Description | Material | Condition | Sample ID | Analytical Result | Estimated Quantity | Accessibility | Priority Rating | Recommendations | Photograph Register |
|---|---|---|---|---|---|---|---|---|---|
| Exterior, west façade, wall | Power distribution board | Good | Visual assessment | Presumed not to contain asbestos | 1 unit | Maintenance only | NA | NA | Photograph 18 |

25 Farr Street, exterior, west facade, wall, power distribution board (30/08/24)

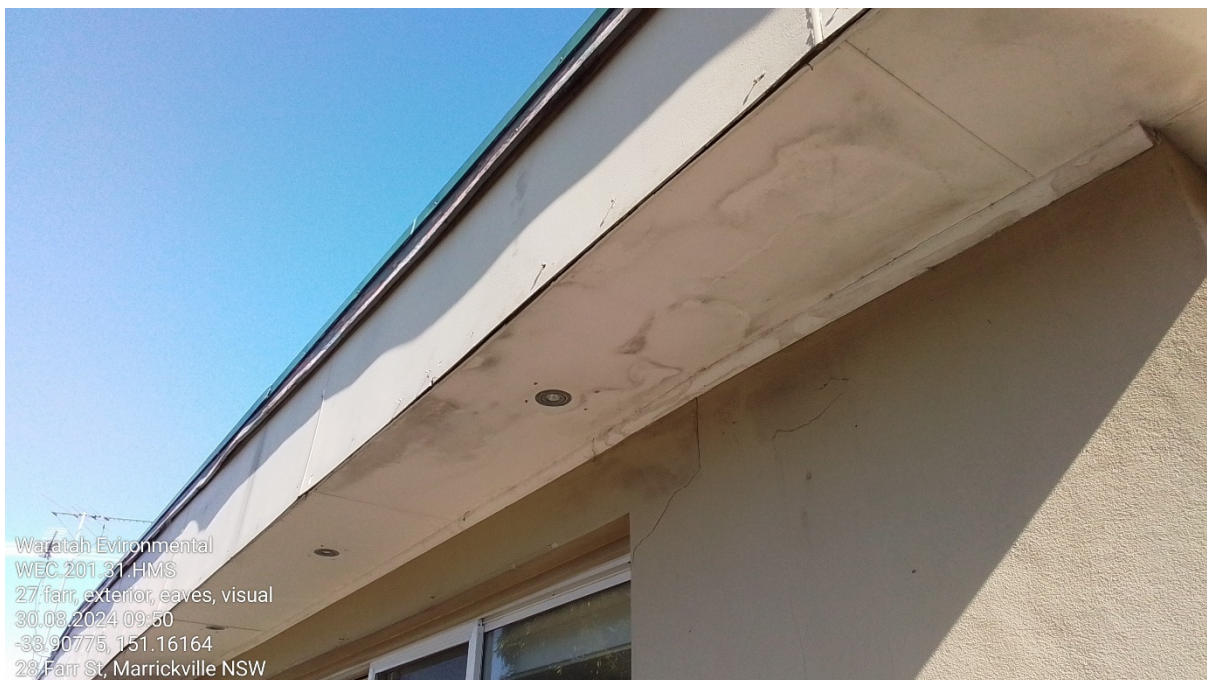
**Photograph 22:**

| Location Description | Material | Condition | Sample ID | Analytical Result | Estimated Quantity | Accessibility | Priority Rating | Recommendations | Photograph Register |
|---|---|---|---|---|---|---|---|---|---|
| Exterior, east façade, eaves | Wood board | Good | Visual assessment | Comprises timber | 20m <sup>2</sup> | Maintenance only | NA | NA | Photograph 22 |

27 Farr Street, west façade, exterior, eaves, wood board (30/08/24)

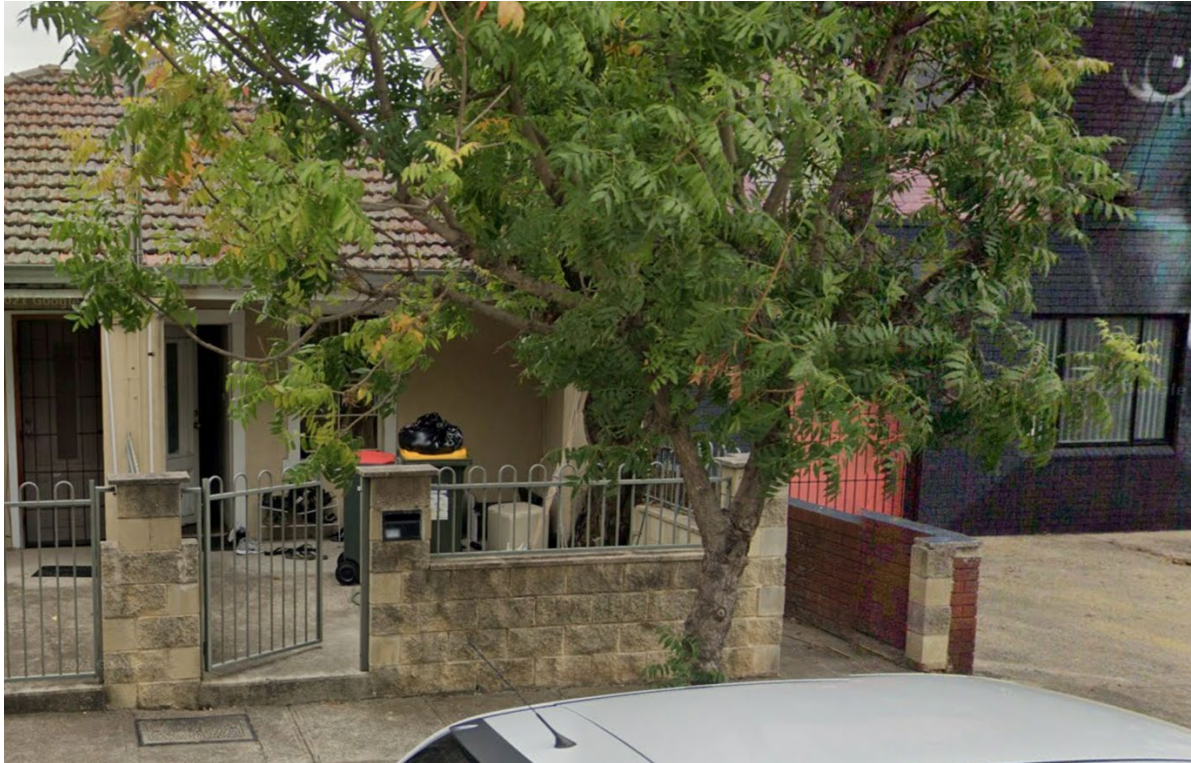
**Photograph 29:**

| Location Description | Material | Condition | Sample ID | Analytical Result | Estimated Quantity | Accessibility | Priority Rating | Recommendations | Photograph Register |
|---|---|---|---|---|---|---|---|---|---|
| Exterior, walls, render, throughout | Yellow paint system | Good | Visual assessment | Presumed same as Pb201 | 200m <sup>2</sup> | Regular | NA | NA | Photograph 29 |

9 Farr Street, exterior, walls, render, yellow paint system (22.10.24)

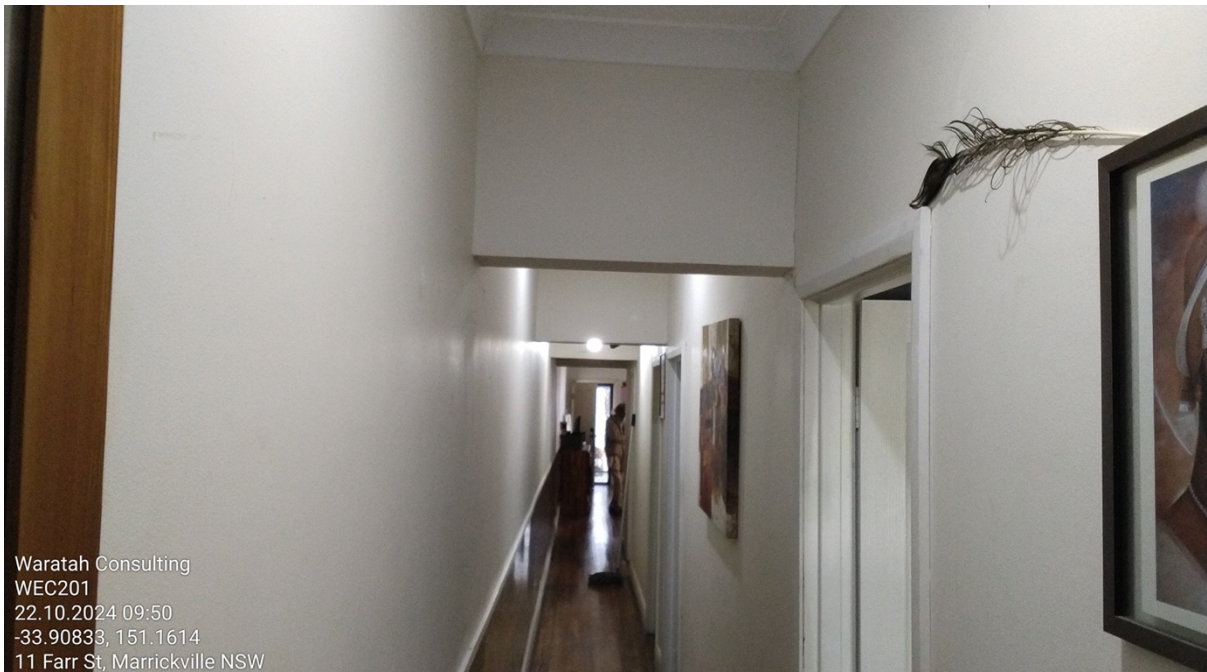
**Photograph 30:**

| Location Description | Material | Condition | Sample ID | Analytical Result | Estimated Quantity | Accessibility | Priority Rating | Recommendations | Photograph Register |
|---|---|---|---|---|---|---|---|---|---|
| Interior, walls throughout | Cream paint system | Good | Visual assessment | Presumed not to contain lead | 100m <sup>2</sup> | Regular | NA | NA | Photograph 30 |

9 Farr Street, interior, surface of walls, cream paint system (22.10.24)

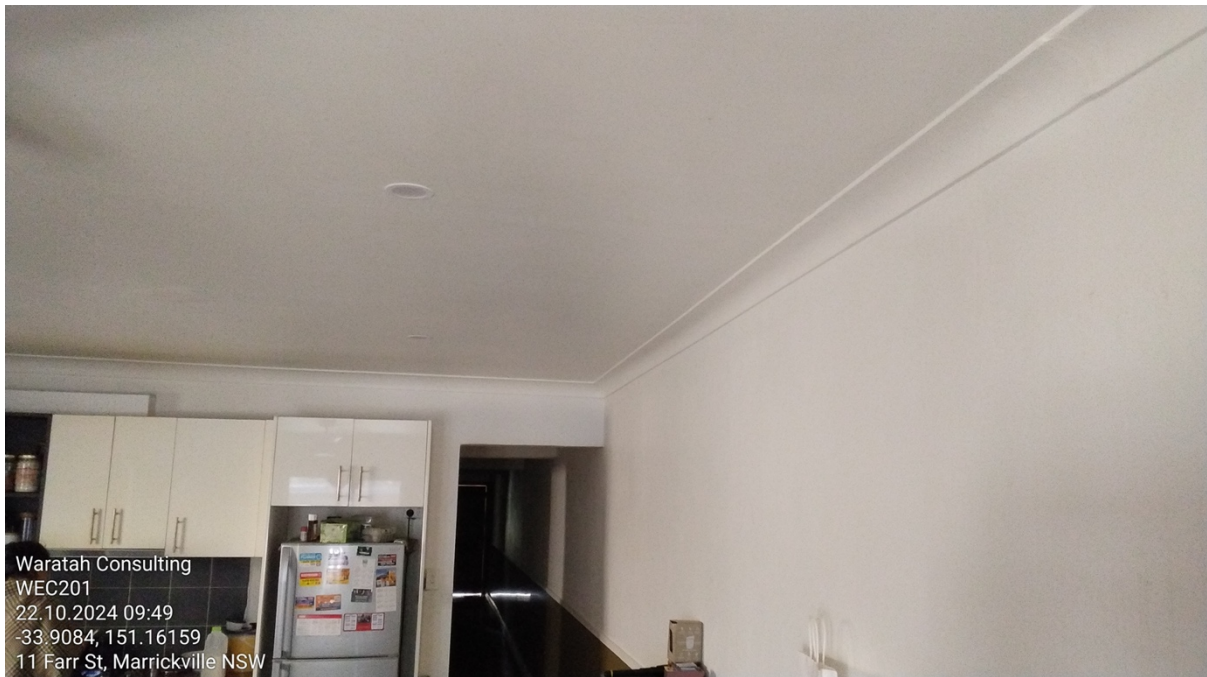
**Photograph 31:**

| Location Description | Material | Condition | Sample ID | Analytical Result | Estimated Quantity | Accessibility | Priority Rating | Recommendations | Photograph Register |
|---|---|---|---|---|---|---|---|---|---|
| Interior, ceiling surface throughout | White paint system | Good | Visual assessment | Presumed not to contain lead | 75m <sup>2</sup> | Regular | NA | NA | Photograph 31 |

9 Farr Street, interior, ceiling, white paint system (22.10.24)

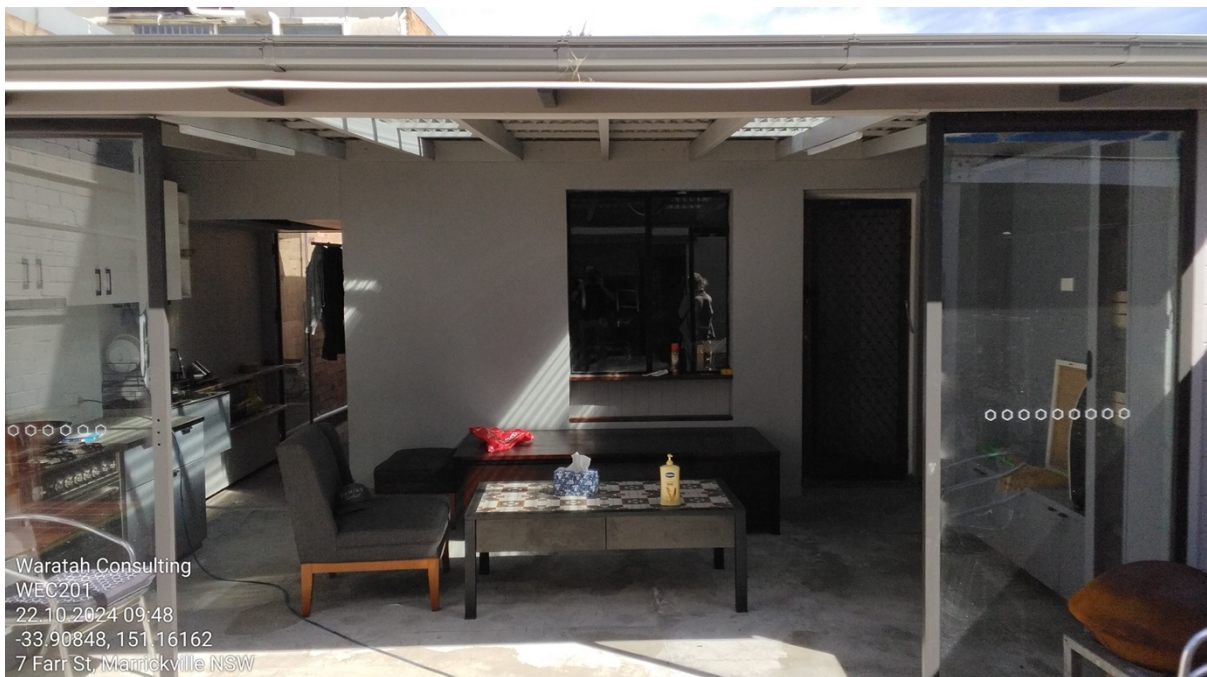
**Photograph 32:**

| Location Description | Material | Condition | Sample ID | Analytical Result | Estimated Quantity | Accessibility | Priority Rating | Recommendations | Photograph Register |
|---|---|---|---|---|---|---|---|---|---|
| Exterior, rear courtyard, surface of walls | Grey paint system | Good | Visual assessment | Presumed not to contain lead | 15m <sup>2</sup> | Regular | NA | NA | Photograph 32 |

9 Farr Street, exterior, rear courtyard, walls, grey paint system (22.10.24)

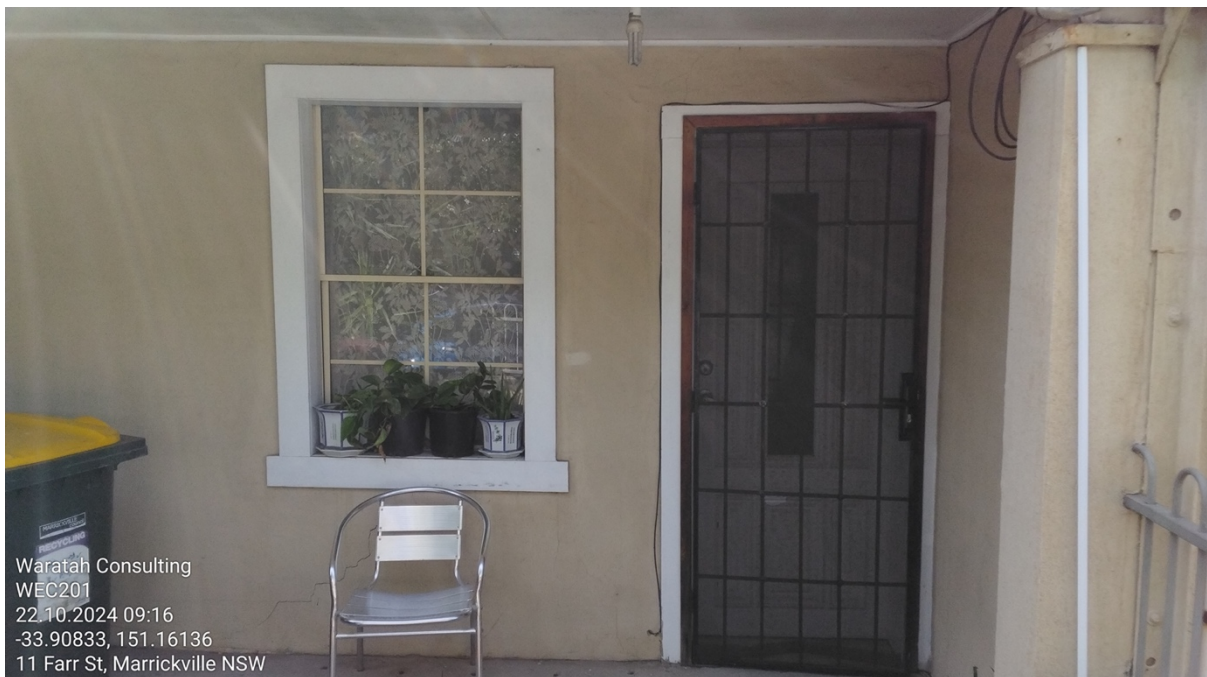
**Photograph 34:**

| Location Description | Material | Condition | Sample ID | Analytical Result | Estimated Quantity | Accessibility | Priority Rating | Recommendations | Photograph Register |
|---|---|---|---|---|---|---|---|---|---|
| Exterior, walls, render, throughout | Yellow paint system | Good | Visual assessment | Presumed same as Pb201 | 200m <sup>2</sup> | Regular | NA | NA | Photograph 34 |

11 Farr Street, exterior, walls, render, yellow paint system

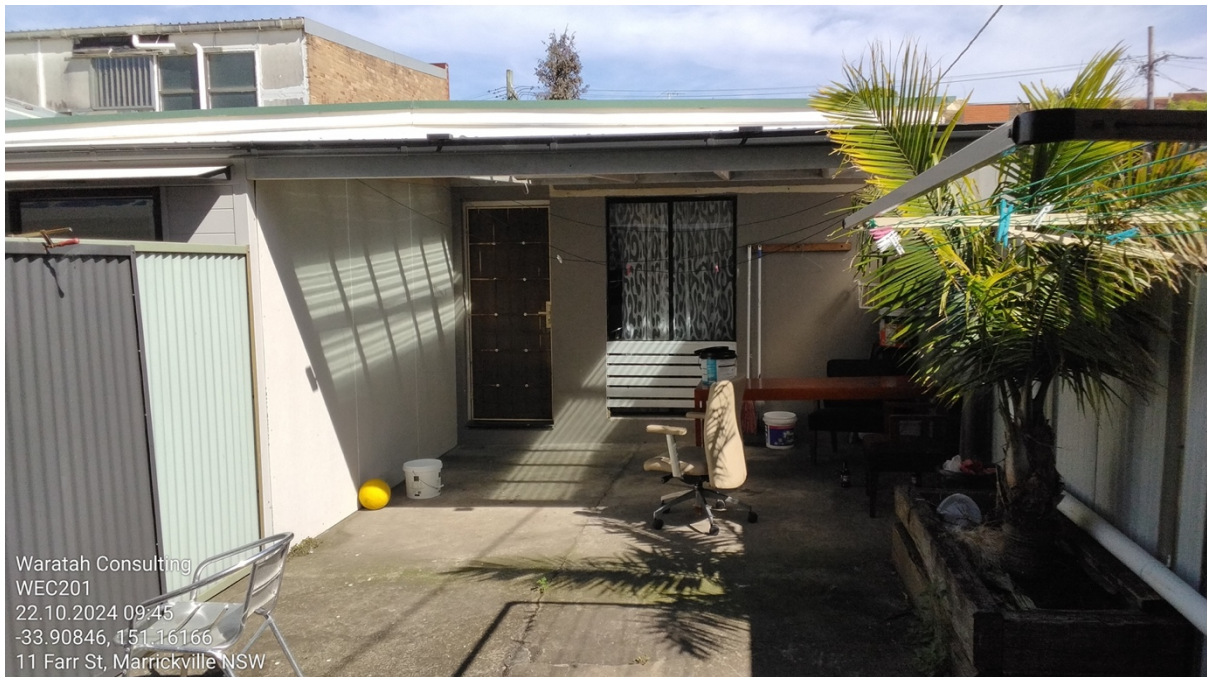
**Photograph 37:**

| Location Description | Material | Condition | Sample ID | Analytical Result | Estimated Quantity | Accessibility | Priority Rating | Recommendations | Photograph Register |
|---|---|---|---|---|---|---|---|---|---|
| Exterior, rear courtyard, surface of walls | Grey paint system | Good | Visual assessment | Presumed not to contain lead | 10m <sup>2</sup> | Regular | NA | NA | Photograph 37 |

11 Farr Street, exterior, rear courtyard, walls, grey paint system (22.10.24)

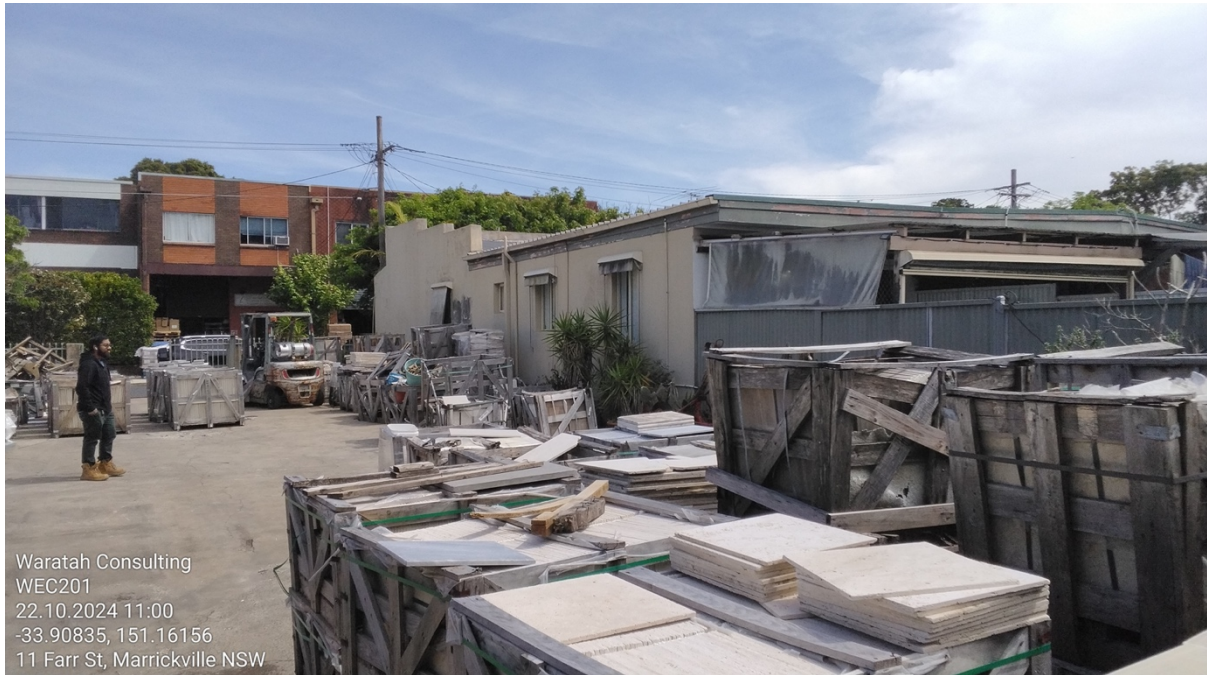
**Photograph 38:**

13 Farr Street, commercial yard (22.10.24)

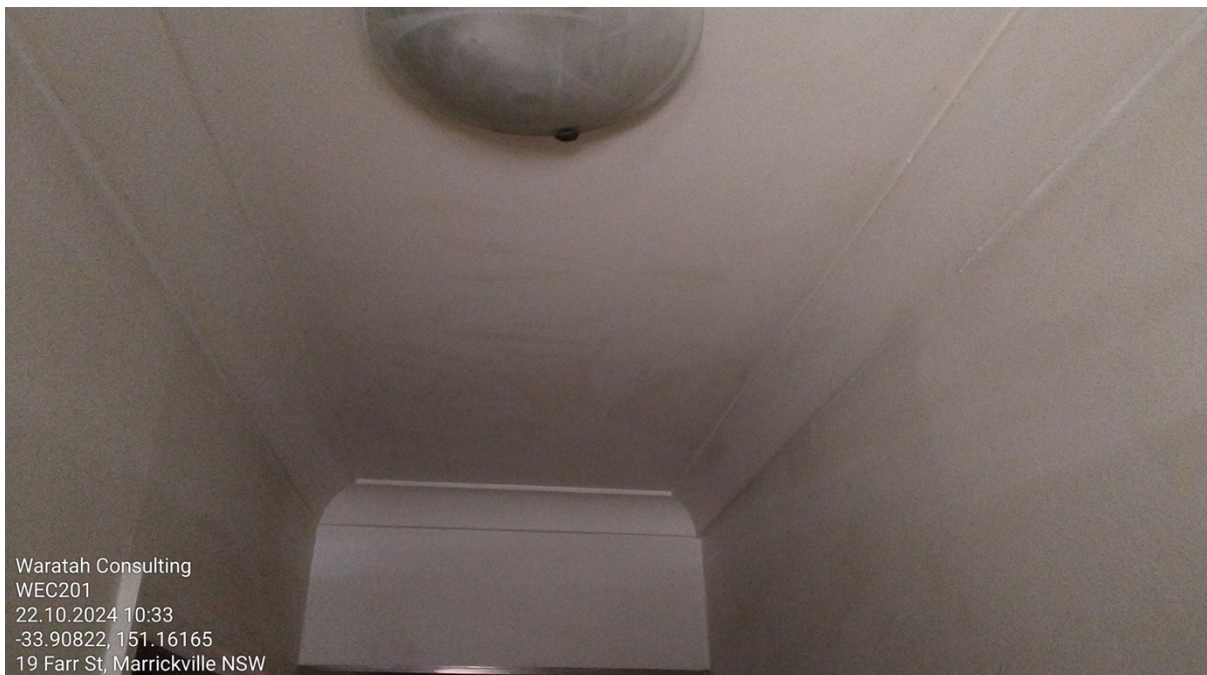
**Photograph 41:**

| Location Description | Material | Condition | Sample ID | Analytical Result | Estimated Quantity | Accessibility | Priority Rating | Recommendations | Photograph Register |
|---|---|---|---|---|---|---|---|---|---|
| Interior, walls throughout | Cream paint system | Good | Visual assessment | Presumed not to contain lead | 100m <sup>2</sup> | Regular | NA | NA | Photograph 41 |

21 Farr Street, interior, walls, cream paint system (22.10.24)

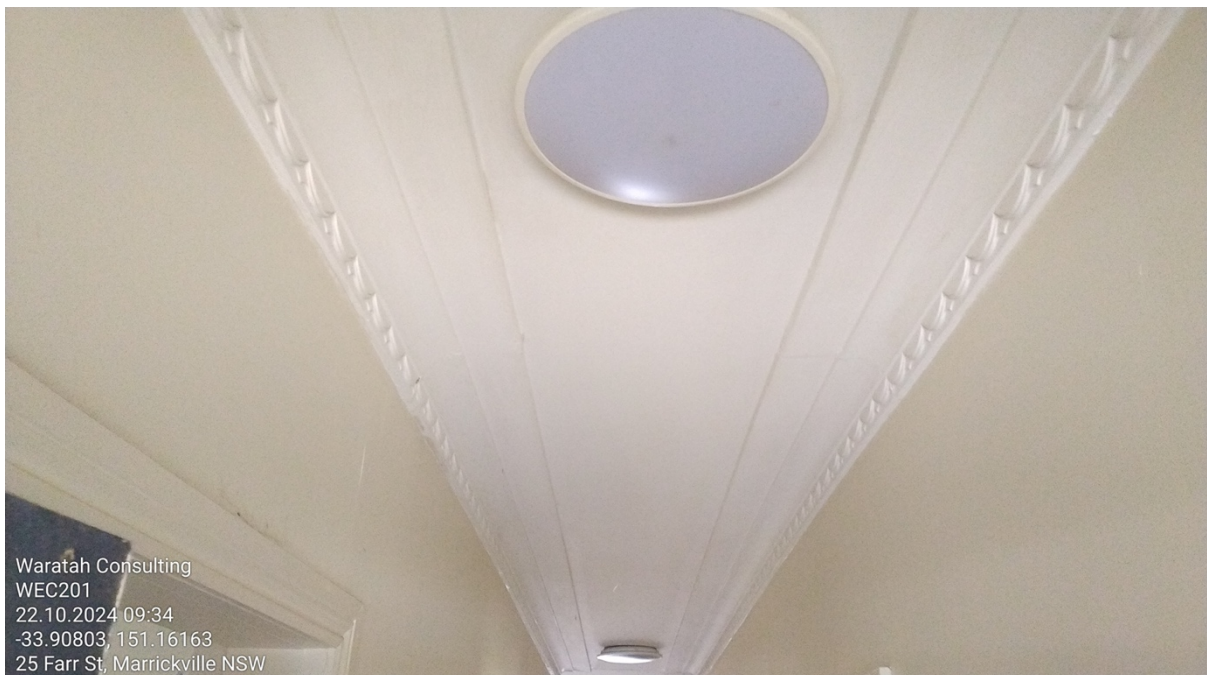
**Photograph 45:**

| Location Description | Material | Condition | Sample ID | Analytical Result | Estimated Quantity | Accessibility | Priority Rating | Recommendations | Photograph Register |
|---|---|---|---|---|---|---|---|---|---|
| Interior, walls throughout | Cream paint system | Good | Visual assessment | Presumed not to contain lead | 100m <sup>2</sup> | Regular | NA | NA | Photograph 45 |

23 Farr Street, interior, walls, cream paint system (22.10.24)
