# HAZARDOUS MATERIALS SURVEY REPORT

136 NEW SOUTH HEAD ROAD  
EDGECLIFF NSW, 2027

Hazardous Materials Survey Report  
136 New South Head Road Edgecliff NSW, 2027  
LENDLEASE DEVELOPMENT

## Hazardous Materials Survey Report 142-146 & 148 New South Head Road Edgecliff, NSW, 2027 LENDLEASE DEVELOPMENT

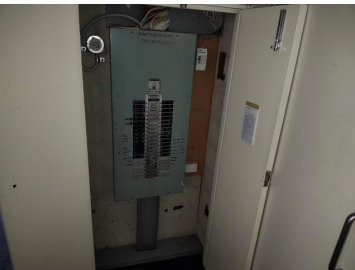
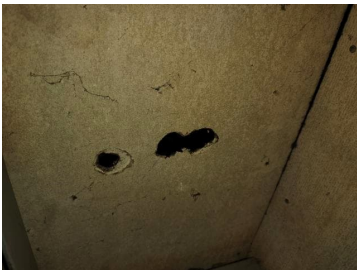
| ASBESTOS - Confirmed | | | |
|---|---|---|---|
| Photo Ref | <a href="#">170277</a> | Sample No | WSP-326737 |

| ASBESTOS - Confirmed | | | |
|---|---|---|---|
| Material | Fibre cement sheeting | | |
| Risk Rating | Low | | |

| ASBESTOS - Confirmed | | | |

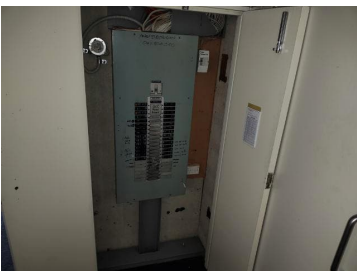
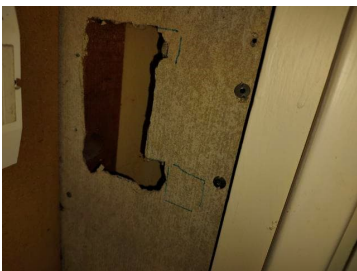
| ASBESTOS - Confirmed | | | |
|---|---|---|---|
| Photo Ref | <a href="#">170278</a> | Sample No | WSP-326742 |

| ASBESTOS - Confirmed | | | |
|---|---|---|---|
| Material | Fibre cement sheeting | | |
| Risk Rating | Low | | |

| ASBESTOS - Confirmed | | | |

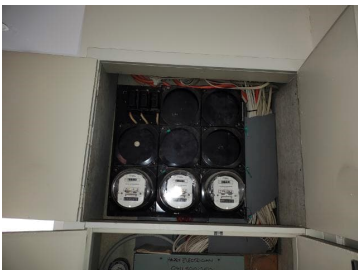
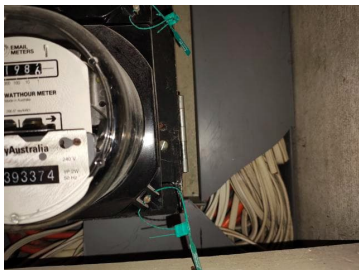
| NO ACCESS | | | |
|---|---|---|---|
| Photo Ref | <a href="#">170415</a> | Sample No | - |

| ASBESTOS - Confirmed | | | |
|---|---|---|---|
| Material | Electrical mounting board | | |
| Risk Rating | Low | | |

| NO ACCESS | | | |

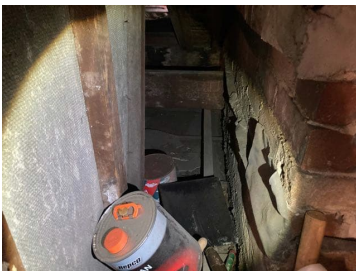
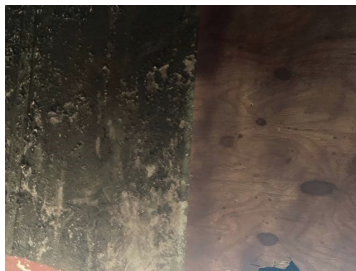
| ASBESTOS - Confirmed | | | |
|---|---|---|---|
| Photo Ref | <a href="#">170423</a> | Sample No | WSP-231457 |

| ASBESTOS - Confirmed | | | |
|---|---|---|---|
| Material | Fibre cement sheeting | | |
| Risk Rating | Medium | | |

| ASBESTOS - Confirmed | | | |

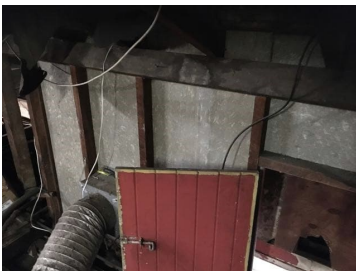
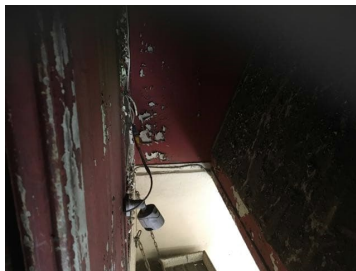
| ASBESTOS - Confirmed | | | |
|---|---|---|---|
| Photo Ref | <a href="#">170500</a> | Sample No | Ref: WSP-231457 |

| ASBESTOS - Confirmed | | | |
|---|---|---|---|
| Material | Fibre cement sheeting | | |
| Risk Rating | Medium | | |

| ASBESTOS - Confirmed | | | |

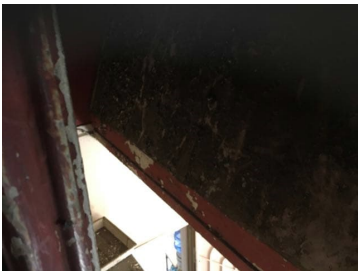
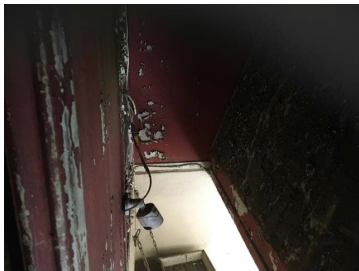
| ASBESTOS - Confirmed | | | |
|---|---|---|---|
| Photo Ref | <a href="#">170418</a> | Sample No | WSP-231467 |

| ASBESTOS - Confirmed | | | |
|---|---|---|---|
| Material | Fibre cement sheeting | | |
| Risk Rating | Low | | |

| ASBESTOS - Confirmed | | | |

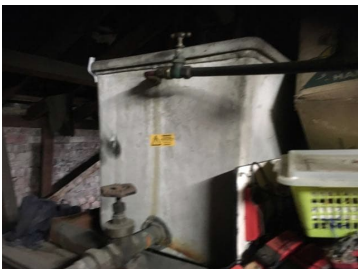
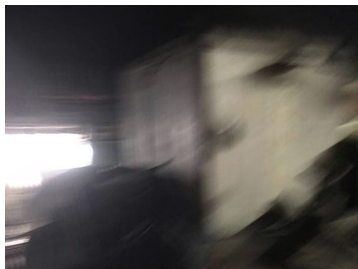
| ASBESTOS - Confirmed | | | |
|---|---|---|---|
| Material | Compressed sheeting | | |
| Risk Rating | Low | | |

| ASBESTOS - Assumed | | | |

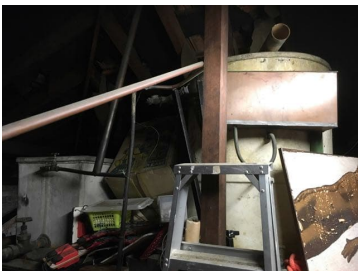
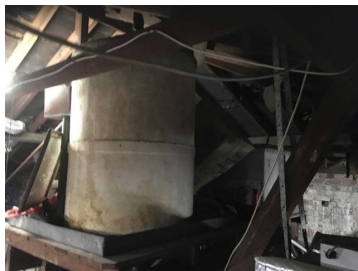
| NO ACCESS | | | |
|---|---|---|---|
| Photo Ref | <a href="#">170404</a> | Sample No | - |

| ASBESTOS - Assumed | | | |
|---|---|---|---|
| Material | Insulation material | | |
| Risk Rating | Low | | |

| NO ACCESS | | | |

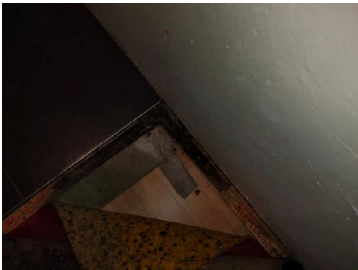
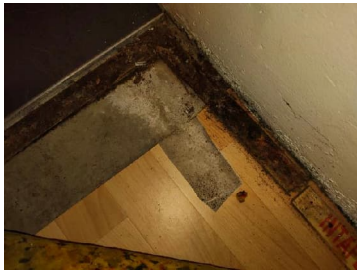
| NON-ASBESTOS CONTAINING MATERIAL | | | |
|---|---|---|---|
| Photo Ref | <a href="#">170327</a> | Sample No | WSP-326749 |

| NON-ASBESTOS CONTAINING MATERIAL | | | |
|---|---|---|---|
| Material | Vinyl sheeting | | |
| Risk Rating | No Asbestos | | |

| NON-ASBESTOS CONTAINING MATERIAL | | | |

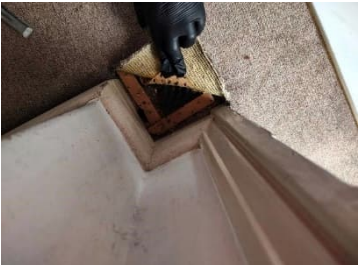
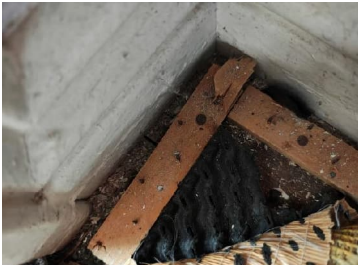
| NON-ASBESTOS CONTAINING MATERIAL | | | |
|---|---|---|---|
| Photo Ref | <a href="#">170328</a> | Sample No | WSP-326694 |

| NON-ASBESTOS CONTAINING MATERIAL | | | |
|---|---|---|---|
| Material | Insulation Board | | |
| Risk Rating | No Asbestos | | |

| NON-ASBESTOS CONTAINING MATERIAL | | | |

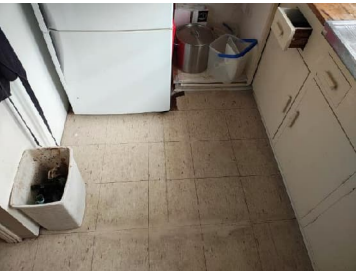
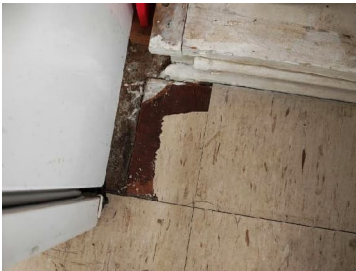
| NON-ASBESTOS CONTAINING MATERIAL | | | |
|---|---|---|---|
| Photo Ref | <a href="#">170403</a> | Sample No | WSP-231468 |

| NON-ASBESTOS CONTAINING MATERIAL | | | |
|---|---|---|---|
| Material | Vinyl tile | | |
| Risk Rating | No Asbestos | | |

| NON-ASBESTOS CONTAINING MATERIAL | | | |

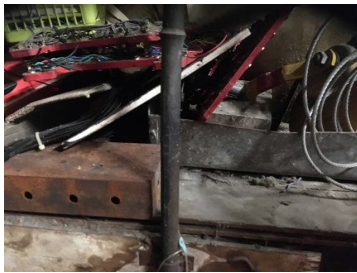
| NON-ASBESTOS CONTAINING MATERIAL | | | |
|---|---|---|---|
| Photo Ref | <a href="#">170405</a> | Sample No | WSP-231469 |

| NON-ASBESTOS CONTAINING MATERIAL | | | |
|---|---|---|---|
| Risk Rating | No Asbestos | | |

| NON-ASBESTOS CONTAINING MATERIAL | | | |

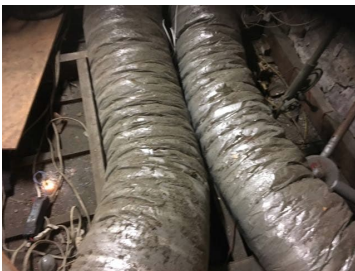
| SYNTHETIC MINERAL FIBRE | | | |
|---|---|---|---|
| Application | Air conditioning ductwork, insulation material | | |
| Risk Rating | Low Risk | | |

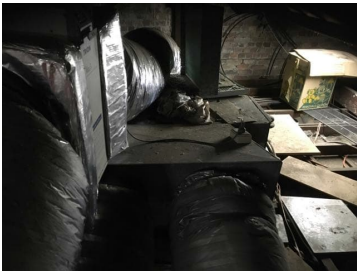
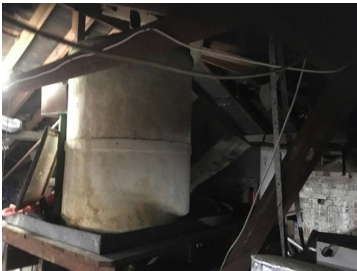
| SYNTHETIC MINERAL FIBRE | | | |
|---|---|---|---|
| Photo Ref | <a href="#">SMF-30382</a> | Sample No | Visual Observation |

| SYNTHETIC MINERAL FIBRE | | | |
|---|---|---|---|
| Application | Plant and equipment | | |
| Risk Rating | Low Risk | | |

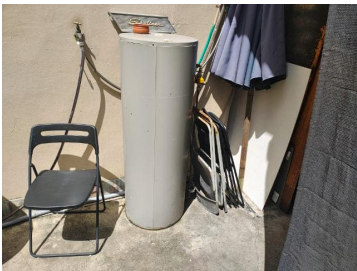
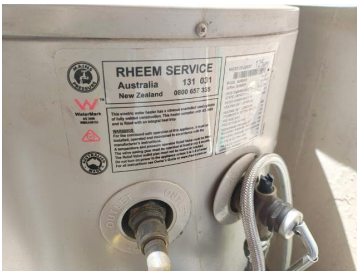
| SYNTHETIC MINERAL FIBRE | | | |
|---|---|---|---|
| Application | Water heater | | |
| Risk Rating | Low Risk | | |

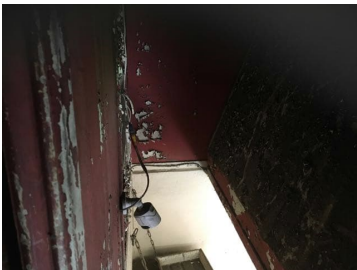
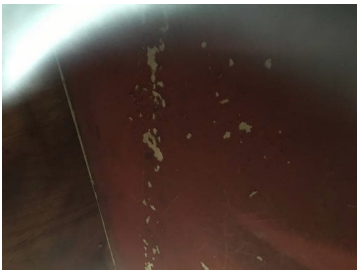
| LBP DETECTED | | | |
|---|---|---|---|
| Application | Upstands and door/trim | | |
| Risk Rating | High Risk | | |

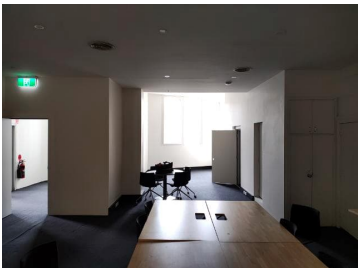
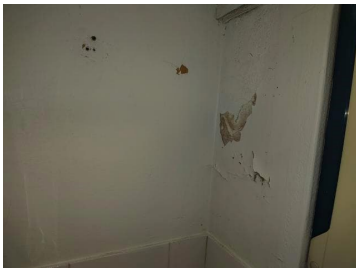
| LBP DETECTED | | | |
|---|---|---|---|
| Photo Ref | <a href="#">LBP-30350</a> | Sample No | Lead Paint Sample WSP-326738 |

| 136 New South Head Rd | | | | | | | | | | | |
|---|---|---|---|---|---|---|---|---|---|---|---|
| Ground Floor | Throughout | Walls and ceiling white based paint system | White | Lead Paint Sample WSP-326738 | <b>LBP Detected 0.27 %w/w</b> | 500 m² | Fair | Medium | Medium Risk | Hazardous Waste. Remove by experienced lead abatement contractor. | <a href="#">LBP-30350</a> |

| LBP DETECTED | | | |
|---|---|---|---|
| Application | Walls and ceiling white based paint system | | |
| Risk Rating | Medium Risk | | |

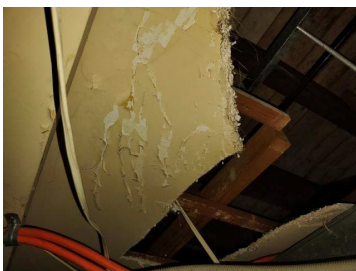
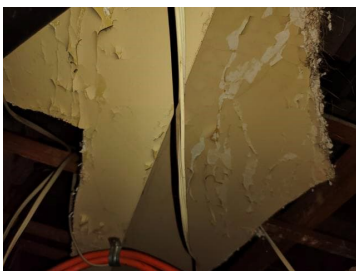
| LBP DETECTED | | | |
|---|---|---|---|
| Photo Ref | <a href="#">LBP-30345</a> | Sample No | Lead Paint Sample WSP-326740 |

| 136 New South Head Rd | | | | | | | | | | | |
|---|---|---|---|---|---|---|---|---|---|---|---|
| Level 1 | Residential unit, Ceiling cavity main room | Cream based paint to walls | Cream | Lead Paint Sample WSP-326740 | <b>LBP Detected 1.4 %w/w</b> | 50 m² | Fair | Medium | Medium Risk | Hazardous Waste. Remove by experienced lead abatement contractor. | <a href="#">LBP-30345</a> |

| LBP DETECTED | | | |
|---|---|---|---|
| Application | Cream based paint to walls | | |
| Risk Rating | Medium Risk | | |

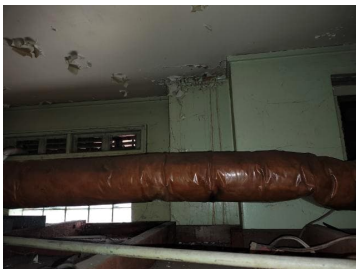
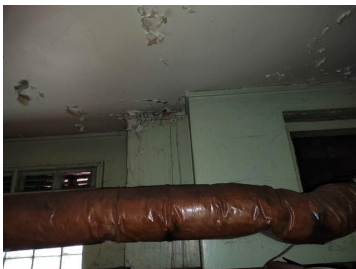
| LBP DETECTED | | | |
|---|---|---|---|
| Photo Ref | <a href="#">LBP-30351</a> | Sample No | Lead Paint Sample WSP-326741 |

| 136 New South Head Rd | | | | | | | | | | | |
|---|---|---|---|---|---|---|---|---|---|---|---|
| Level 1 | Residential unit, Female toilet | Walls green paint based system | Green | Lead Paint Sample WSP-326741 | <b>LBP Detected 18 %w/w</b> | 30 m² | Fair | Medium | Medium Risk | Hazardous Waste. Remove by experienced lead abatement contractor. | <a href="#">LBP-30351</a> |

| LBP DETECTED | | | |
|---|---|---|---|
| Application | Walls green paint based system | | |
| Risk Rating | Medium Risk | | |

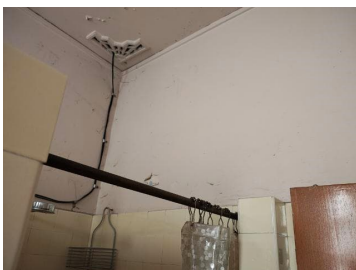
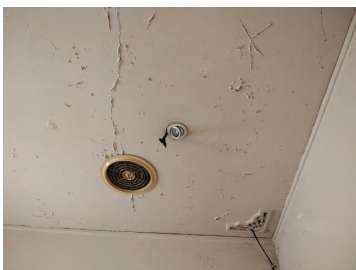
| LBP DETECTED | | | |
|---|---|---|---|
| Photo Ref | <a href="#">LBP-30373</a> | Sample No | Lead Paint Sample WSP-326747 |

| 136 New South Head Rd | | | | | | | | | | | |
|---|---|---|---|---|---|---|---|---|---|---|---|
| Level 1 | Residential unit | Bathroom and toilet pink based paint system walls and ceiling | Pink | Lead Paint Sample WSP-326747 | <b>LBP Detected 0.34 %w/w</b> | 20 m² | Fair | Medium | Medium Risk | Hazardous Waste. Remove by experienced lead abatement contractor. | <a href="#">LBP-30373</a> |

| LBP DETECTED | | | |
|---|---|---|---|
| Application | Bathroom and toilet pink based paint system walls and ceiling | | |
| Risk Rating | Medium Risk | | |

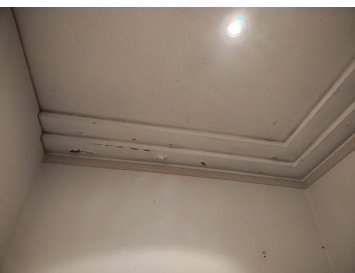
| LBP DETECTED | | | |
|---|---|---|---|
| Photo Ref | <a href="#">LBP-30374</a> | Sample No | Lead Paint Sample WSP-326748 |

| 136 New South Head Rd | | | | | | | | | | | |
|---|---|---|---|---|---|---|---|---|---|---|---|
| Level 1 | Residential unit | Wall cornice throughout interior | White | Lead Paint Sample WSP-326748 | <b>LBP Detected 5.5 %w/w</b> | 50 m² | Fair | Medium | Medium Risk | Hazardous Waste. Remove by experienced lead abatement contractor. | <a href="#">LBP-30374</a> |

| LBP DETECTED | | | |
|---|---|---|---|
| Application | Wall cornice throughout interior | | |
| Risk Rating | Medium Risk | | |

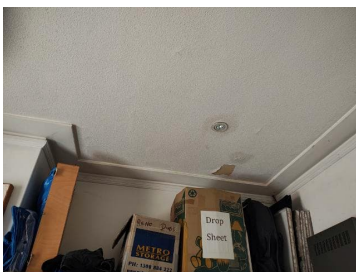
| 136 New South Head Rd | | | | | | | | | | | |
|---|---|---|---|---|---|---|---|---|---|---|---|
| Level 1 | Residential unit | Ceiling texture white based paint system internal throughout ceiling | White | Lead Paint Sample WSP-326752 | <b>LBP Detected 0.22 %w/w</b> | 100 m² | Fair | Medium | Medium Risk | Hazardous Waste. Remove by experienced lead abatement contractor. | <a href="#">LBP-30370</a> |

| LBP DETECTED | | | |
|---|---|---|---|
| Application | Ceiling texture white based paint system internal throughout ceiling | | |
| Risk Rating | Medium Risk | | |

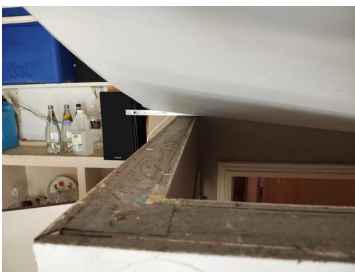
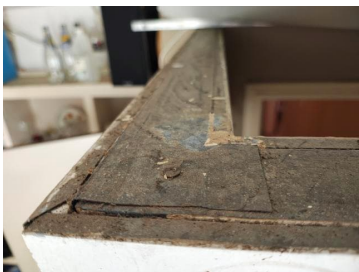
| Lead Metal | | | |
|---|---|---|---|
| Application | Lead flashing on top of wall | | |

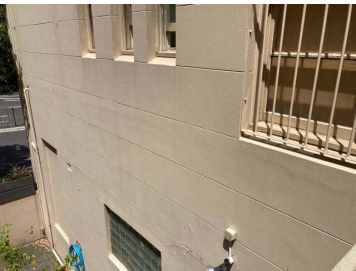
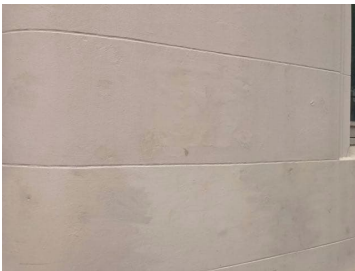
| 136 New South Head Rd | | | | | | | | | | | |
|---|---|---|---|---|---|---|---|---|---|---|---|
| External | Exterior | Walls and window frames | Yellow | Not Sampled | <b>Presumed LBP</b> | 100 m² | Good/Fair | Low | Low | Hazardous Waste. Remove by experienced lead abatement contractor. | <a href="#">LBP-30387</a> |

| LBP PRESUMED | | | |
|---|---|---|---|
| Application | Walls and window frames | | |
| Risk Rating | Low | | |

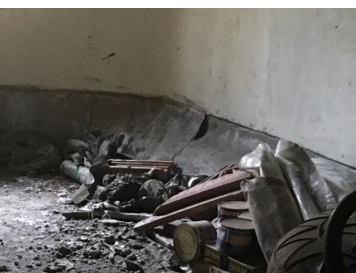
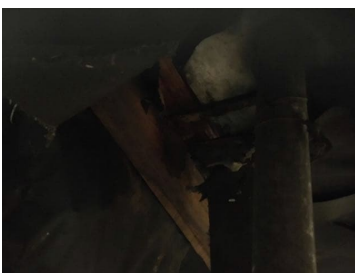
| LEAD METAL | | | |
|---|---|---|---|
| Photo Ref | <a href="#">LBP-30383</a> | Sample No | Lead Paint Presumed |

| LEAD METAL | | | |
|---|---|---|---|
| Application | Lead flashing | | |

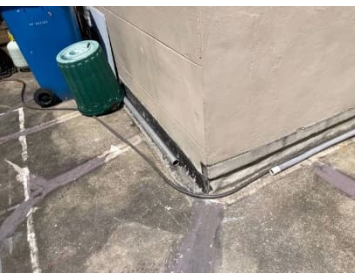
| LEAD METAL | | | |
|---|---|---|---|
| Photo Ref | LBP-30386 | Sample No | Lead Paint Presumed |

| LEAD METAL | | | |
|---|---|---|---|
| Application | Lead flashing | | |

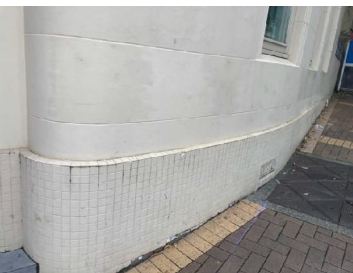
| LEAD METAL | | | |
| Application | Lead flashing | | |
| Risk Rating | - | | |

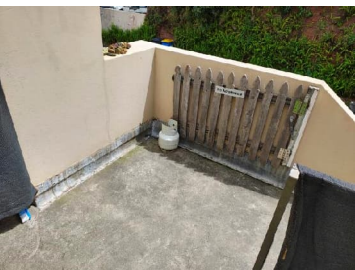
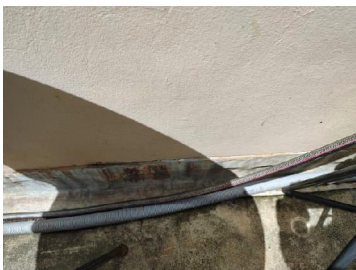
| LEAD DUST DETECTED | | | |
|---|---|---|---|
| Photo Ref | <a href="#">LBP-30381</a> | Sample No | Lead Dust Sample WSP-231459 |

| LEAD DUST DETECTED | | | |
| Application | Accumulated Dust | | |
| Risk Rating | High Risk | | |

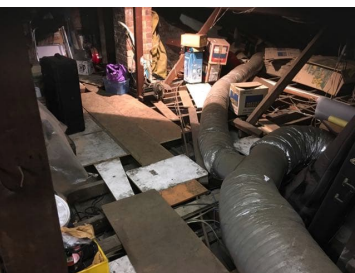
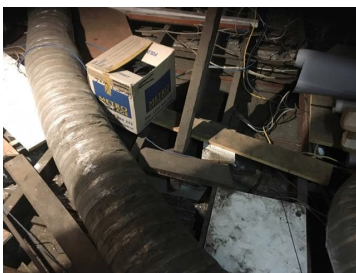
| LEAD DUST DETECTED | | | |
|---|---|---|---|
| Photo Ref | <a href="#">LBP-30382</a> | Sample No | Lead Dust Sample WSP-231460 |

| LEAD DUST DETECTED | | | |
| Application | Accumulated Dust | | |
| Risk Rating | High Risk | | |

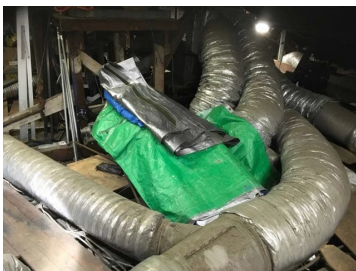
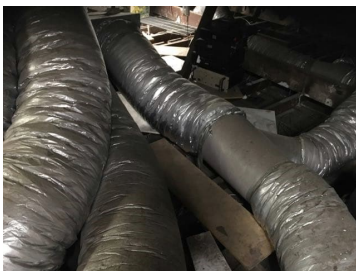
| LEAD DUST DETECTED | | | |
|---|---|---|---|
| Photo Ref | <a href="#">LBP-30379</a> | Sample No | Lead Dust Sample WSP-231461 |

| LEAD DUST DETECTED | | | |
| Application | Accumulated Dust | | |
| Risk Rating | High Risk | | |

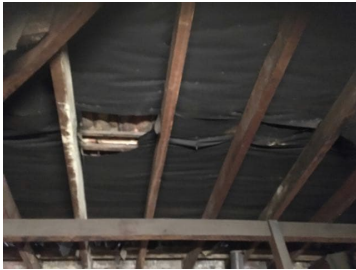
| LEAD DUST DETECTED | | | |
| Application | Accumulated Dust | | |
| Risk Rating | High Risk | | |

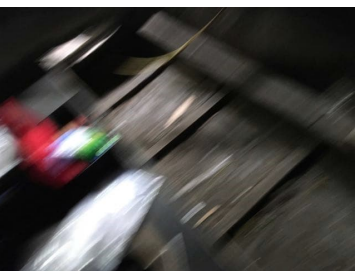
| LEAD DUST DETECTED | | | | | No Photo Available |
|---|---|---|---|---|---|
| Photo Ref | LBP-30384 | Sample No | Lead Dust Sample WSP-231464 | | |

| LEAD DUST DETECTED | | | | | No Photo Available |

| LEAD DUST DETECTED | | | |
|---|---|---|---|
| Application | Accumulated Dust | | |
| Risk Rating | High Risk | | |

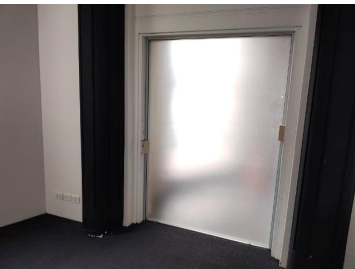
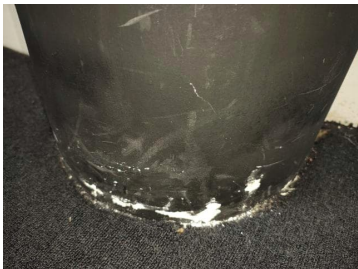
| LBP NOT DETECTED | | | |
|---|---|---|---|
| Photo Ref | <a href="#">LBP-30348</a> | Sample No | Lead Paint Sample WSP-326744 |

| LBP NOT DETECTED | | | |
| Application | Brown based paint sample | | |
| Risk Rating | - | | |

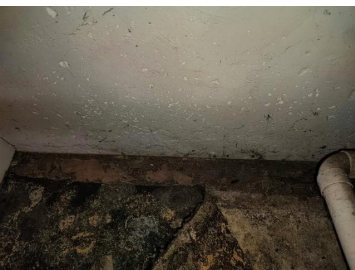
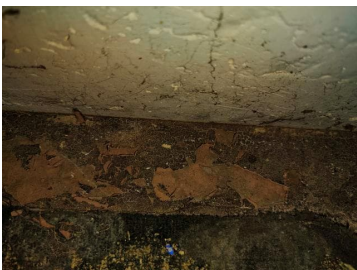
| LEAD DUST DETECTED | | | |
|---|---|---|---|
| Photo Ref | <a href="#">LBP-30346</a> | Sample No | Lead Dust Sample WSP-326745 |

| LEAD DUST DETECTED | | | |
| Application | Accumulated Dust | | |
| Risk Rating | High Risk | | |

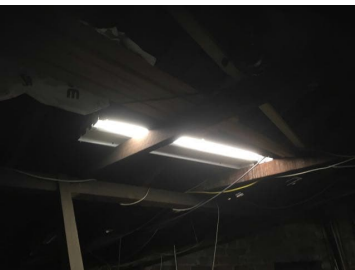
| PCB CAPACITOR | | | | | No Photo Available |
|---|---|---|---|---|---|
| Photo Ref | <a href="#">PCB-27624</a> | Sample No | Visual Observation | | |

| PCB CAPACITOR | | | | | No Photo Available |

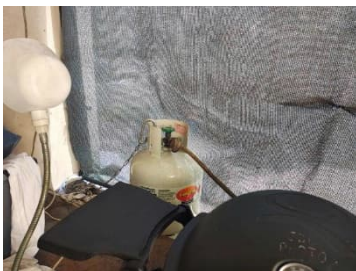
| COMBUSTIBLE MATERIALS | | | |
|---|---|---|---|
| Photo Ref | <a href="#">ODS-27401</a> | Sample No | Visual Observation |

| COMBUSTIBLE MATERIALS | | | |
| Material | Flammable and Combustible Materials | | |
| Risk Rating | - | | |

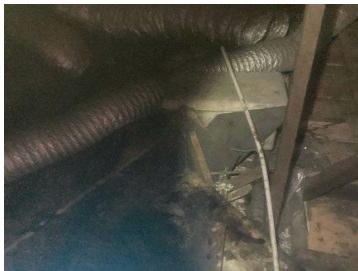
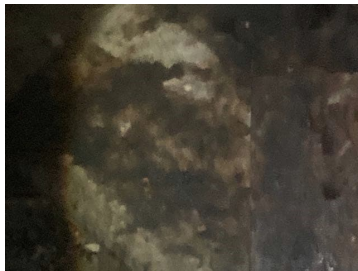
| ASBESTOS - Confirmed | | | | | |
|---|---|---|---|---|---|
| Photo Ref | <a href="#">170067</a> | Sample No | WSP-231450 | | |

| ASBESTOS - Confirmed | | | | | |

| NO ACCESS | | | |
|---|---|---|---|
| Material | - | | |
| Risk Rating | Inaccessible | | |

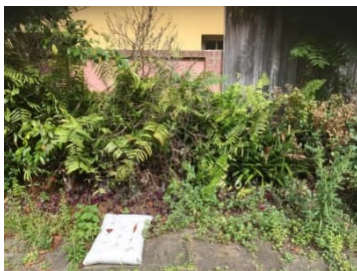
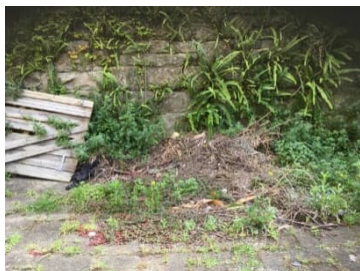
| NO ACCESS | | | |
|---|---|---|---|
| Photo Ref | <a href="#">170420</a> | Sample No | - |

| NO ACCESS | | | |
| Material | - | | |
| Risk Rating | Inaccessible | | |

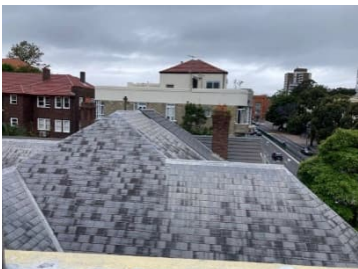
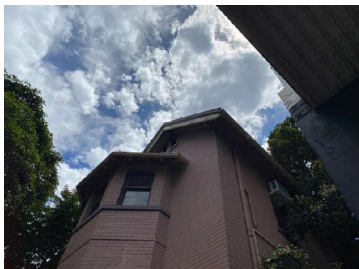
| ASBESTOS - Confirmed | | | |
|---|---|---|---|
| Photo Ref | <a href="#">170066</a> | Sample No | WSP-231453 |

| ASBESTOS - Confirmed | | | |
| Material | Fibre cement sheeting | | |
| Risk Rating | Low | | |

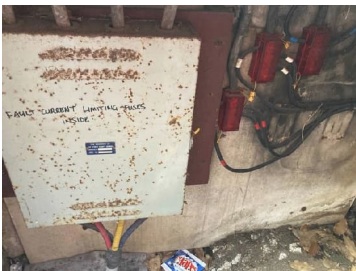
| ASBESTOS - Confirmed | | | |
| Material | Fibre cement sheeting | | |
| Risk Rating | Medium | | |

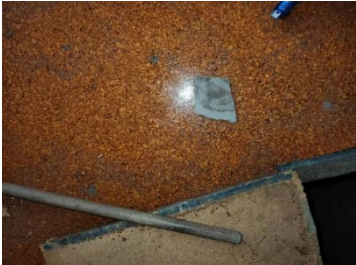
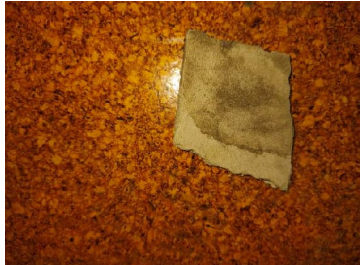
| ASBESTOS - Confirmed | | | |
|---|---|---|---|
| Photo Ref | <a href="#">169647</a> | Sample No | WSP-326681 |

| ASBESTOS - Confirmed | | | |

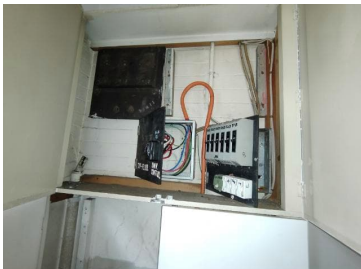
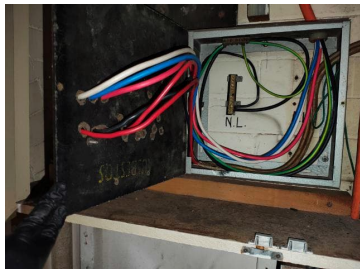
| ASBESTOS - Confirmed | | | |
|---|---|---|---|
| Material | Electrical mounting board | | |
| Risk Rating | Low | | |

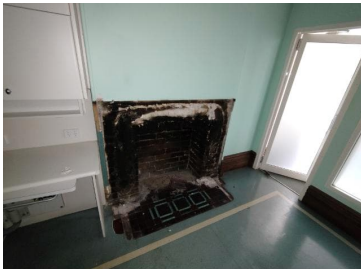
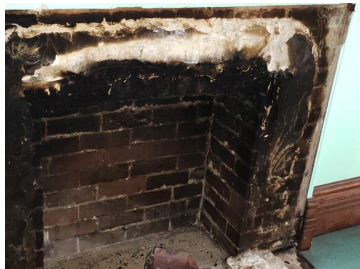
| NO ACCESS | | | |
|---|---|---|---|
| Material | - | | |
| Risk Rating | Inaccessible | | |

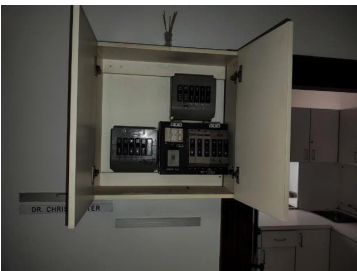
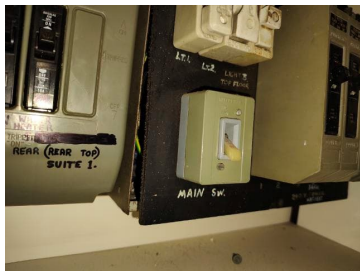
| ASBESTOS - Confirmed | | | |
|---|---|---|---|
| Material | Electrical mounting board | | |
| Risk Rating | Low | | |

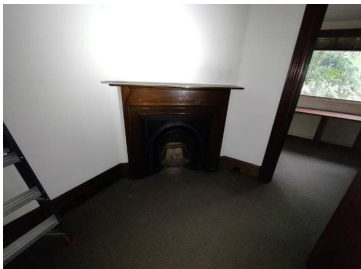
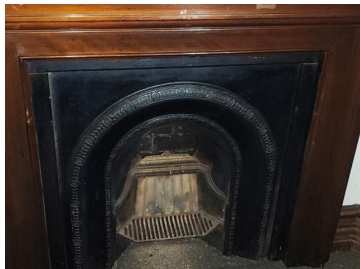
| NO ACCESS | | | |
|---|---|---|---|
| Material | - | | |
| Risk Rating | Inaccessible | | |

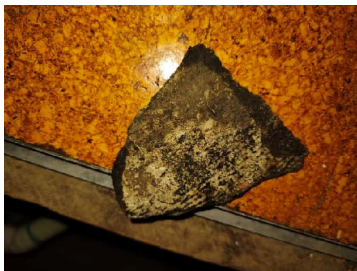
| NON-ASBESTOS CONTAINING MATERIAL | | | |
|---|---|---|---|
| Photo Ref | <a href="#">169646</a> | Sample No | WSP-326680 |

| NON-ASBESTOS CONTAINING MATERIAL | | | |
| Material | Vinyl tile | | |
| Risk Rating | No Asbestos | | |

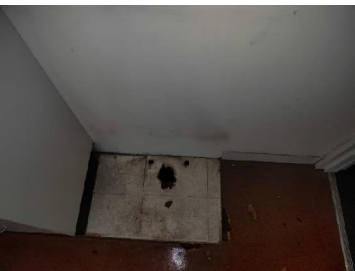
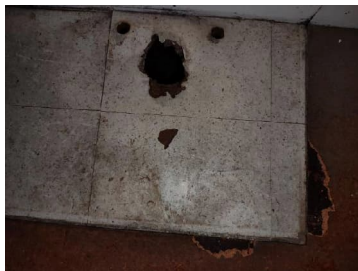
| NON-ASBESTOS CONTAINING MATERIAL | | | |
|---|---|---|---|
| Photo Ref | <a href="#">169648</a> | Sample No | WSP-326677 |

| NON-ASBESTOS CONTAINING MATERIAL | | | |
| Material | Fibre cement casting | | |
| Risk Rating | No Asbestos | | |

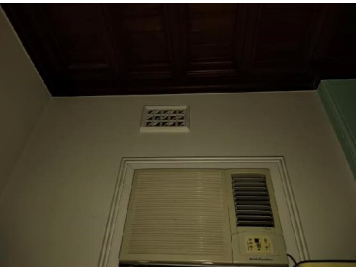
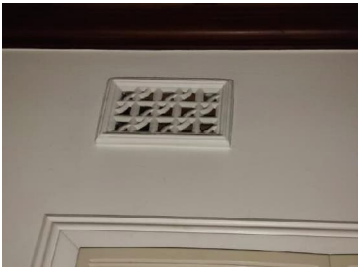
| NON-ASBESTOS CONTAINING MATERIAL | | | |
|---|---|---|---|
| Photo Ref | <a href="#">169651</a> | Sample No | WSP-326674 |

| NON-ASBESTOS CONTAINING MATERIAL | | | |
| Material | Dust/insulation | | |
| Risk Rating | No Asbestos | | |

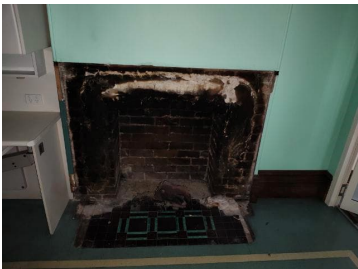
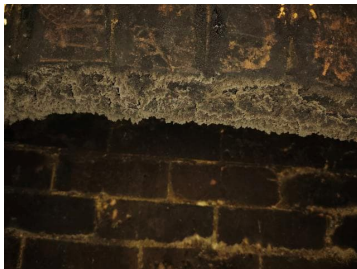
| NON-ASBESTOS CONTAINING MATERIAL | | | |
|---|---|---|---|
| Photo Ref | <a href="#">169652</a> | Sample No | WSP-326673 |

| NON-ASBESTOS CONTAINING MATERIAL | | | |

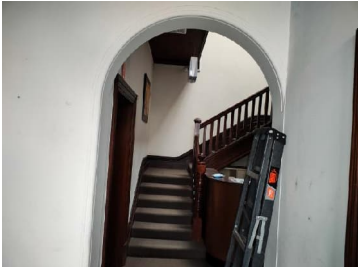
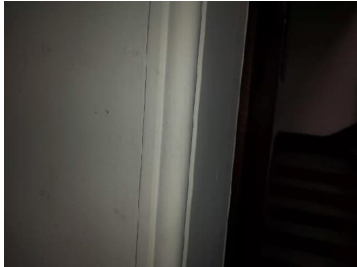
| NON-ASBESTOS CONTAINING MATERIAL | | | |
|---|---|---|---|
| Photo Ref | <a href="#">169669</a> | Sample No | WSP-326679 |

| NON-ASBESTOS CONTAINING MATERIAL | | | |

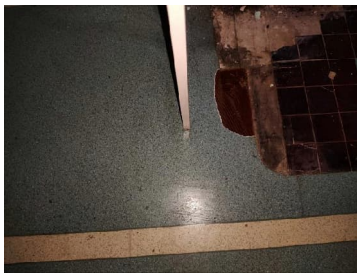
| NON-ASBESTOS CONTAINING MATERIAL | | | |
|---|---|---|---|
| Photo Ref | <a href="#">169673</a> | Sample No | WSP-326678 |

| NON-ASBESTOS CONTAINING MATERIAL | | | |
| Material | Bituminous material | | |
| Risk Rating | No Asbestos | | |

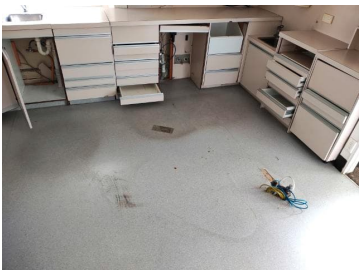
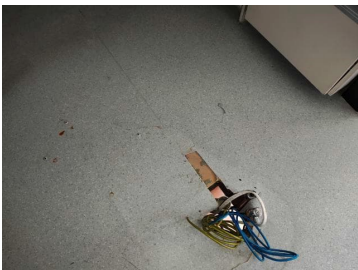
| NON-ASBESTOS CONTAINING MATERIAL | | | |
|---|---|---|---|
| Photo Ref | <a href="#">169663</a> | Sample No | WSP-326690 |

| NON-ASBESTOS CONTAINING MATERIAL | | | |
| Material | Vinyl sheeting | | |
| Risk Rating | No Asbestos | | |

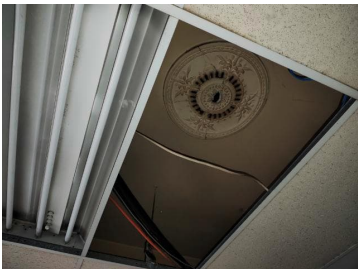
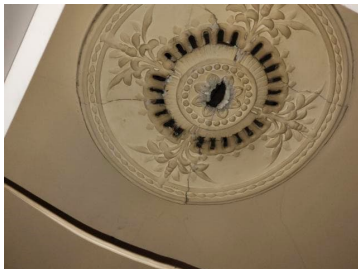
| NON-ASBESTOS CONTAINING MATERIAL | | | |
|---|---|---|---|
| Photo Ref | <a href="#">169667</a> | Sample No | WSP-326687 |

| NON-ASBESTOS CONTAINING MATERIAL | | | |
| Material | Putty | | |
| Risk Rating | No Asbestos | | |

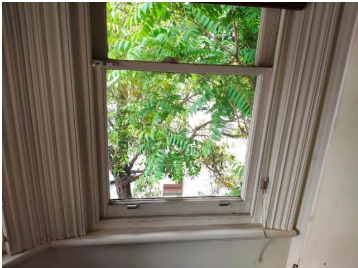
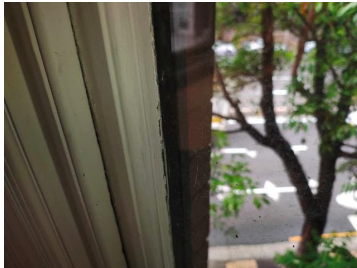
| NON-ASBESTOS CONTAINING MATERIAL | | | |
|---|---|---|---|
| Photo Ref | <a href="#">169660</a> | Sample No | WSP-326692 |

| NON-ASBESTOS CONTAINING MATERIAL | | | |
| Material | Dust | | |
| Risk Rating | No Asbestos | | |

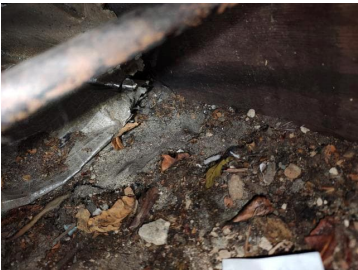
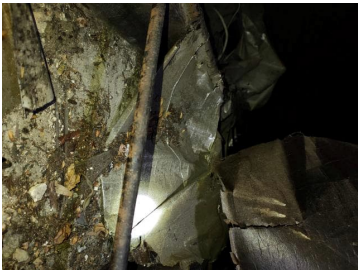
| NON-ASBESTOS CONTAINING MATERIAL | | | |
|---|---|---|---|
| Photo Ref | <a href="#">169656</a> | Sample No | WSP-326693 |

| NON-ASBESTOS CONTAINING MATERIAL | | | |
| Material | Other | | |
| Risk Rating | No Asbestos | | |

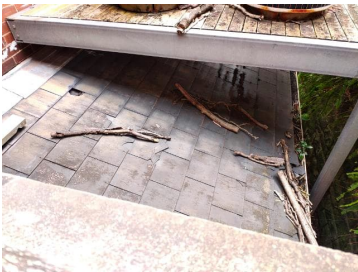
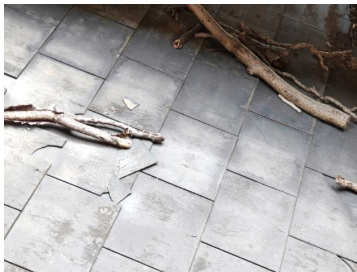
| NON-ASBESTOS CONTAINING MATERIAL | | | |
|---|---|---|---|
| Photo Ref | <a href="#">169671</a> | Sample No | WSP-326701 |

| NON-ASBESTOS CONTAINING MATERIAL | | | |
| Material | Sealant | | |
| Risk Rating | No Asbestos | | |

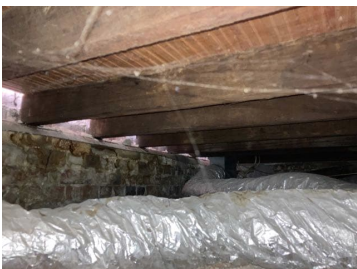
| SYNTHETIC MINERAL FIBRE | | | | | No Photo Available |
|---|---|---|---|---|---|
| Photo Ref | <a href="#">SMF-30222</a> | Sample No | Visual Observation | | |

| SYNTHETIC MINERAL FIBRE | | | | | No Photo Available |
| Application | Air conditioning ductwork - insulation material | | | | |

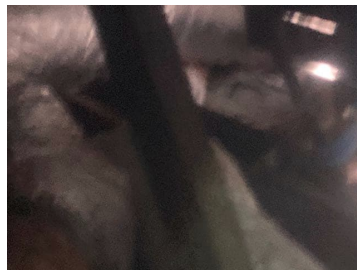
| SYNTHETIC MINERAL FIBRE | | | |
|---|---|---|---|
| Photo Ref | <a href="#">SMF-30220</a> | Sample No | Visual Observation |

| SYNTHETIC MINERAL FIBRE | | | |
| Application | Air conditioning ductwork - insulation material | | |

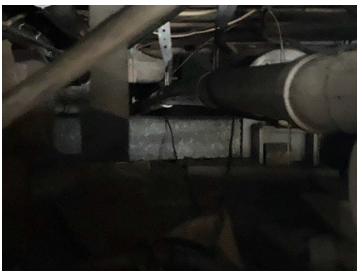
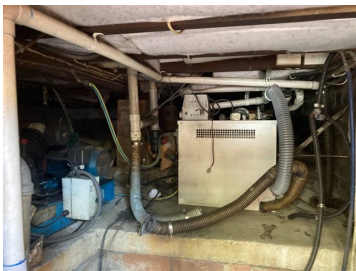
| SYNTHETIC MINERAL FIBRE | | | |
|---|---|---|---|
| Photo Ref | <a href="#">SMF-30230</a> | Sample No | Visual Observation |

| SYNTHETIC MINERAL FIBRE | | | |

| SYNTHETIC MINERAL FIBRE | | | |
|---|---|---|---|
| Application | Window air conditioner | | |

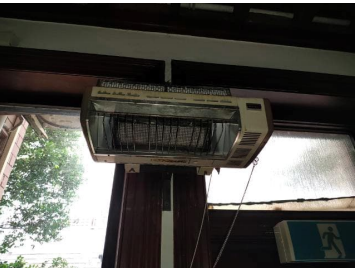
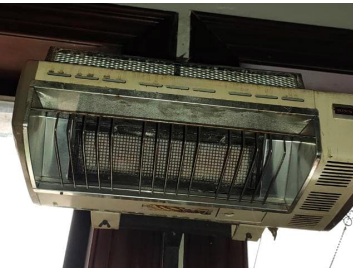
| SYNTHETIC MINERAL FIBRE | | | |
|---|---|---|---|
| Application | Heater | | |
| Risk Rating | Low Risk | | |

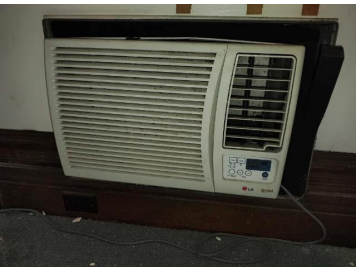
| SYNTHETIC MINERAL FIBRE | | | |
|---|---|---|---|
| Photo Ref | SMF-30228 | Sample No | Visual Observation |

| SYNTHETIC MINERAL FIBRE | | | |
|---|---|---|---|
| Risk Rating | Low Risk | | |

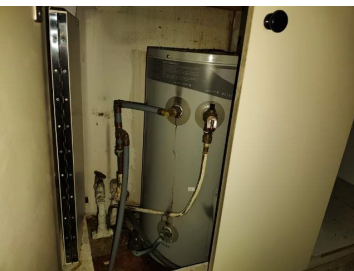
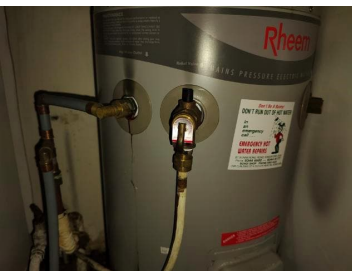
| SYNTHETIC MINERAL FIBRE | | | |
|---|---|---|---|
| Photo Ref | SMF-30225 | Sample No | Visual Observation |

| SYNTHETIC MINERAL FIBRE | | | |
|---|---|---|---|
| Application | Hater | | |
| Risk Rating | Low Risk | | |

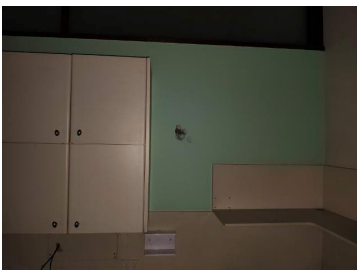
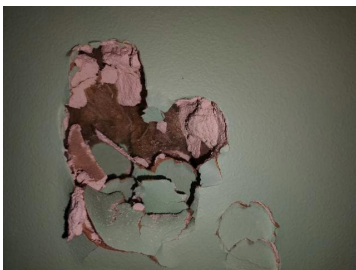
| SYNTHETIC MINERAL FIBRE | | | |
|---|---|---|---|
| Photo Ref | <a href="#">SMF-30224</a> | Sample No | Visual Observation |

| SYNTHETIC MINERAL FIBRE | | | |
|---|---|---|---|
| Application | Insulation batts in walls | | |
| Risk Rating | Low Risk | | |

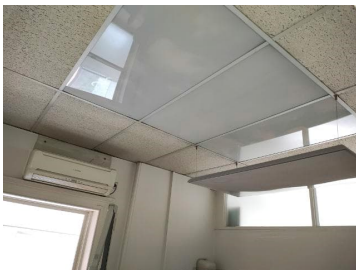
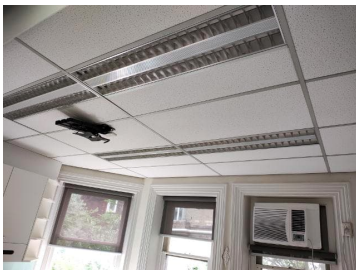
| SYNTHETIC MINERAL FIBRE | | | |
|---|---|---|---|
| Photo Ref | SMF-30231 | Sample No | Visual Observation |

| SYNTHETIC MINERAL FIBRE | | | |
|---|---|---|---|
| Application | Ceiling tiles | | |
| Risk Rating | Low Risk | | |

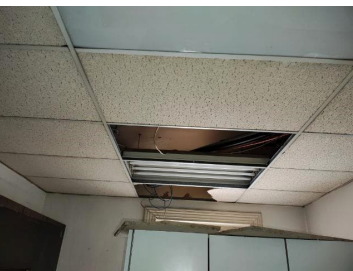
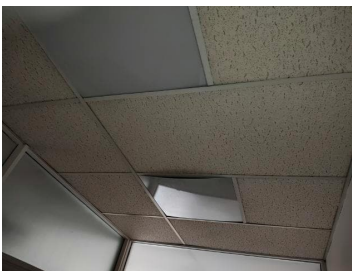
| SYNTHETIC MINERAL FIBRE | | | |
|---|---|---|---|
| Photo Ref | SME-30227 | Sample No | Visual Observation |

| SYNTHETIC MINERAL FIBRE | | | |
|---|---|---|---|
| Application | Ceiling tiles | | |
| Risk Rating | Low Risk | | |

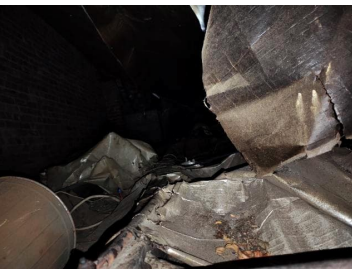
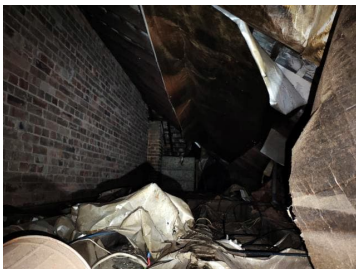
| SYNTHETIC MINERAL FIBRE | | | |
|---|---|---|---|
| Photo Ref | SMF-30226 | Sample No | Visual Observation |

| SYNTHETIC MINERAL FIBRE | | | |
|---|---|---|---|
| Application | Sarking to the roof and ducting | | |
| Risk Rating | Low Risk | | |

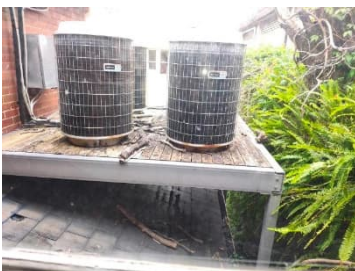
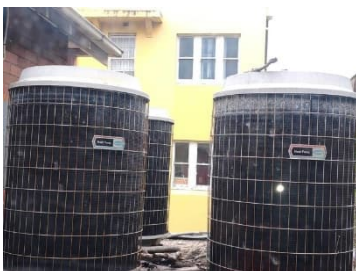
| SYNTHETIC MINERAL FIBRE | | | |
|---|---|---|---|
| Photo Ref | SMF-30229 | Sample No | Visual Observation |

| SYNTHETIC MINERAL FIBRE | | | |
|---|---|---|---|
| Application | Heat pumps external | | |
| Risk Rating | Low Risk | | |

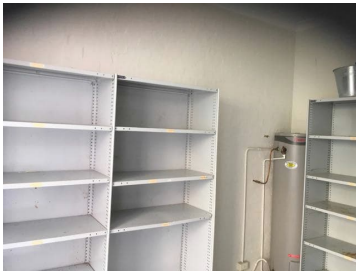
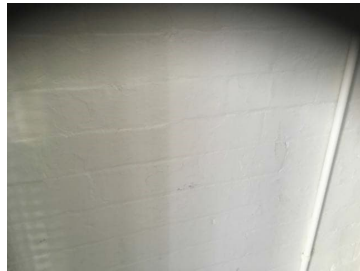
| LBP DETECTED | | | |
| Application | Brickwork walls | | |
| Risk Rating | Low Risk | | |

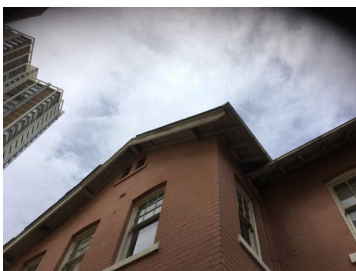
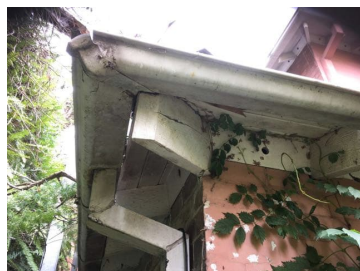
| LBP DETECTED | | | |
|---|---|---|---|
| Photo Ref | <a href="#">LBP-30249</a> | Sample No | Ref: WSP-231427 |

| LBP DETECTED | | | |
| Application | Timber frame work | | |
| Risk Rating | Medium Risk | | |

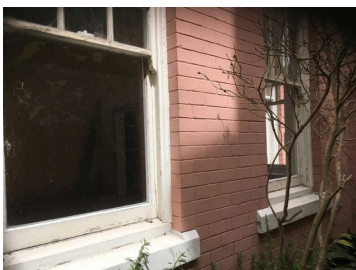
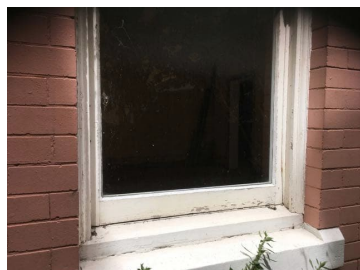
| LBP DETECTED | | | |
|---|---|---|---|
| Photo Ref | <a href="#">LBP-30252</a> | Sample No | Lead Paint Sample WSP-231427 |

| LBP DETECTED | | | |
| Application | Timber windows | | |
| Risk Rating | Medium Risk | | |

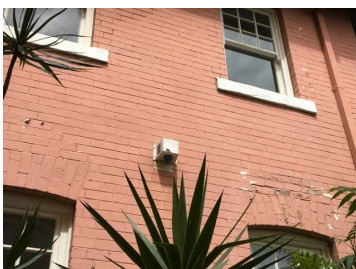
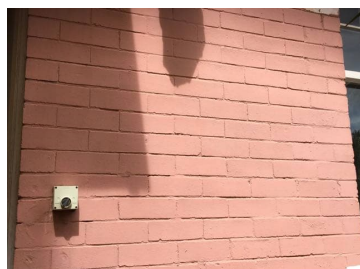
| LBP DETECTED | | | |
|---|---|---|---|
| Photo Ref | <a href="#">LBP-30245</a> | Sample No | Lead Paint Sample WSP-231428 |

| LBP DETECTED | | | |
| Application | Perimeter walls | | |
| Risk Rating | Medium Risk | | |

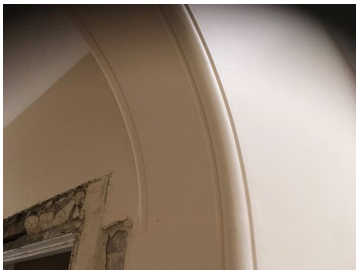
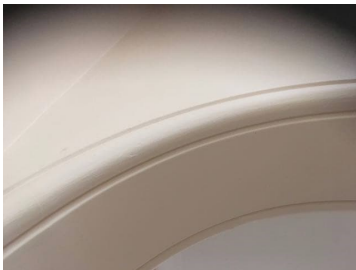
| LBP DETECTED | | | |
|---|---|---|---|
| Photo Ref | <a href="#">LBP-30246</a> | Sample No | Lead Paint Sample WSP-231406 |

| LBP DETECTED | | | |
| Application | Walls, decorative trim | | |
| Risk Rating | Low Risk | | |

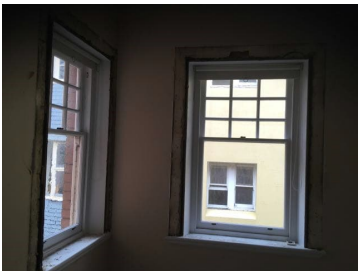
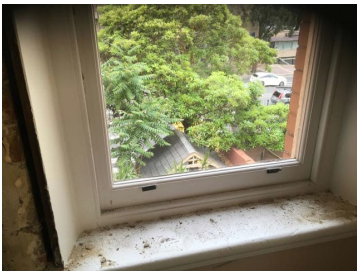
| LBP DETECTED | | | |
|---|---|---|---|
| Photo Ref | <a href="#">LBP-30244</a> | Sample No | Lead Paint Sample WSP-231409 |

| LBP DETECTED | | | |
| Application | Window frames | | |
| Risk Rating | Low Risk | | |

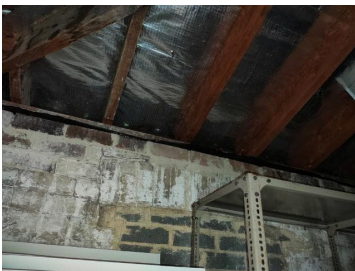
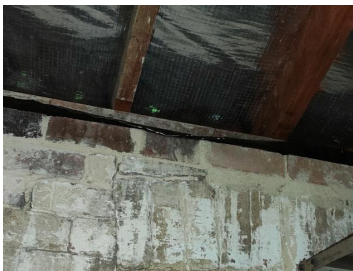
| LEAD METAL | | | |
|---|---|---|---|
| Photo Ref | <a href="#">LBP-30349</a> | Sample No | Lead Paint Presumed |

| LEAD METAL | | | |
| Application | Lead flashing | | |

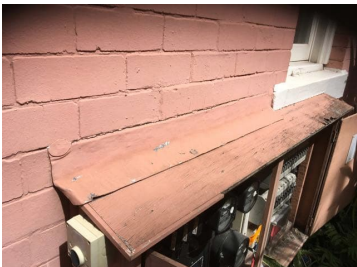
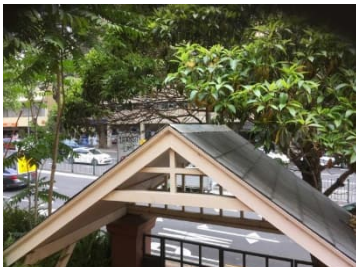
| LEAD METAL | | | |
|---|---|---|---|
| Photo Ref | LBP-30248 | Sample No | Lead Paint Presumed |

| LEAD METAL | | | |
| Application | Lead flashing | | |

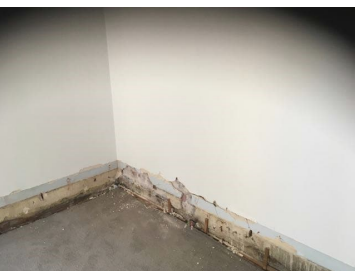
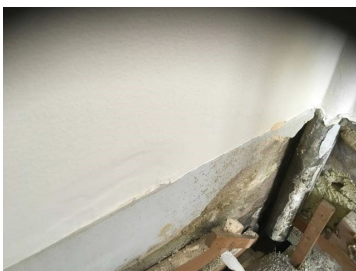
| LBP NOT DETECTED | | | |
|---|---|---|---|
| Photo Ref | <a href="#">LBP-30250</a> | Sample No | Lead Paint Sample WSP-231412 |

| LBP NOT DETECTED | | | |
| Application | Walls | | |

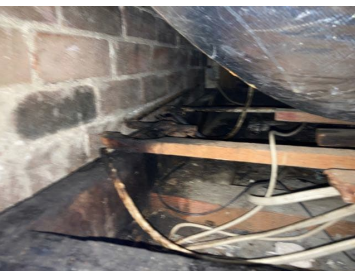
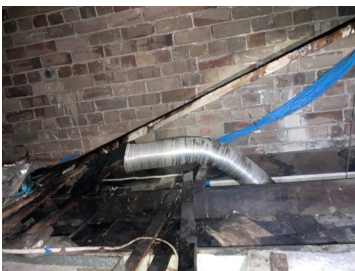
| LEAD DUST DETECTED | | | |
|---|---|---|---|
| Photo Ref | <a href="#">LBP-30251</a> | Sample No | Lead Dust Sample WSP-231414 |

| LEAD DUST DETECTED | | | |
| Application | Settled dust (swab) | | |
| Risk Rating | High Risk | | |

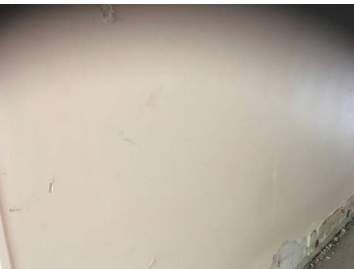
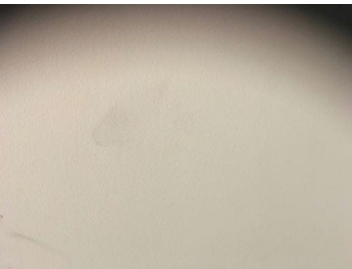
| LBP NOT DETECTED | | | |
|---|---|---|---|
| Photo Ref | <a href="#">LBP-30253</a> | Sample No | Lead Paint Sample WSP-231419 |

| LBP NOT DETECTED | | | |
| Application | Interior walls | | |

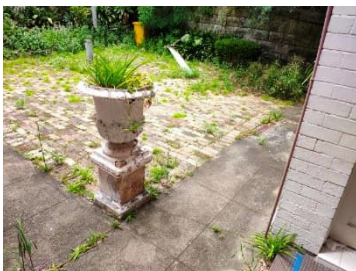
| LBP DETECTED | | | |
|---|---|---|---|
| Application | White based paint system | | |
| Risk Rating | Medium Risk | | |

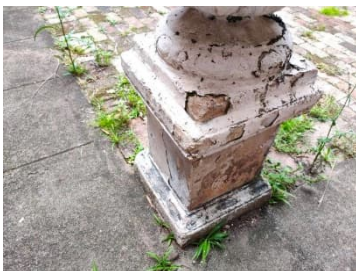
| LBP DETECTED | | | |
| Application | Grey based paint system | | |
| Risk Rating | Medium Risk | | |

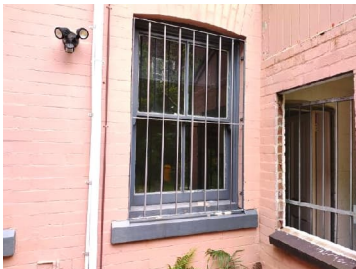
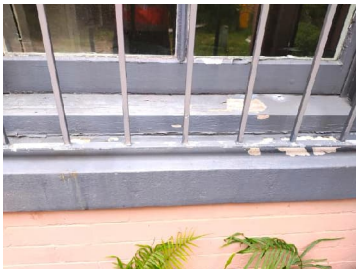
| LBP DETECTED | | | |
|---|---|---|---|
| Photo Ref | <a href="#">LBP-30257</a> | Sample No | Lead Paint Sample WSP-326703 |

| LBP NOT DETECTED | | | |
| Application | White based paint | | |
| Risk Rating | - | | |

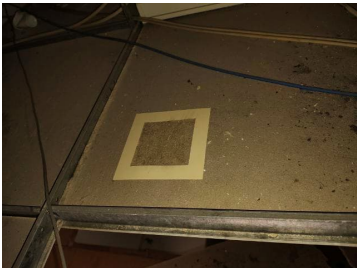
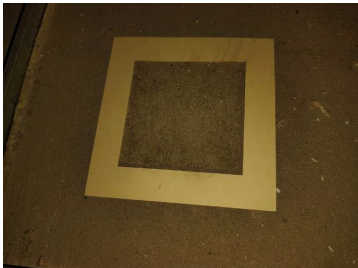
| LBP NOT DETECTED | | | |
|---|---|---|---|
| Application | Lead dust above ceiling tiles | | |
| Risk Rating | - | | |

| LEAD DUST DETECTED | | | |

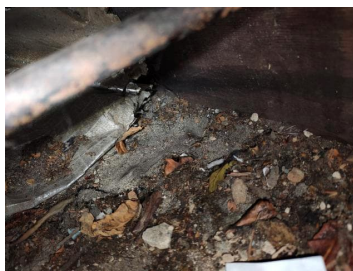
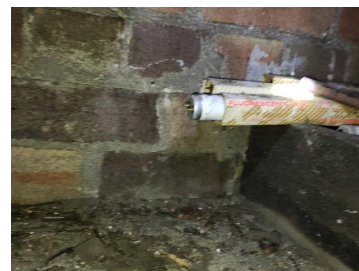
| LEAD DUST DETECTED | | | |
|---|---|---|---|
| Photo Ref | <a href="#">LBP-30262</a> | Sample No | Lead Dust Sample WSP-326691 |

| LEAD DUST DETECTED | | | |
|---|---|---|---|
| Application | Dust in roof void | | |
| Risk Rating | High Risk | | |

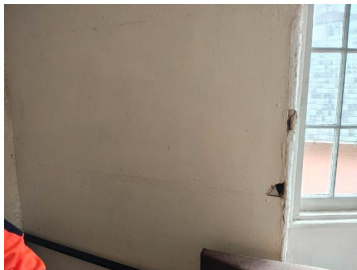
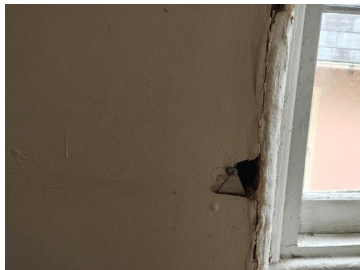
| ASBESTOS - Confirmed | | | |
|---|---|---|---|
| Material | Fibre cement sheeting | | |
| Risk Rating | Medium | | |

| ASBESTOS - Confirmed | | | |

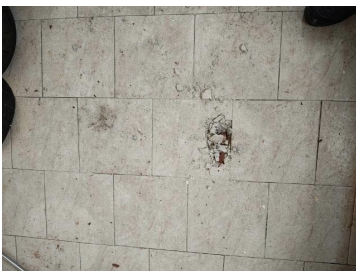
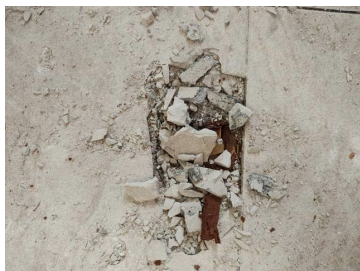
| ASBESTOS - Confirmed | | | |
|---|---|---|---|
| Photo Ref | <a href="#">170005</a> | Sample No | WSP-326709 |

| ASBESTOS - Confirmed | | | |
|---|---|---|---|
| Material | Vinyl sheeting | | |
| Risk Rating | Low | | |

| ASBESTOS - Confirmed | | | |

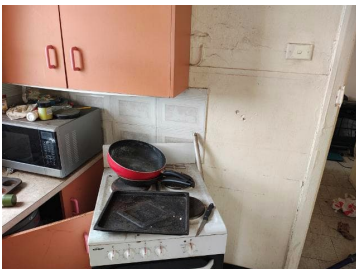
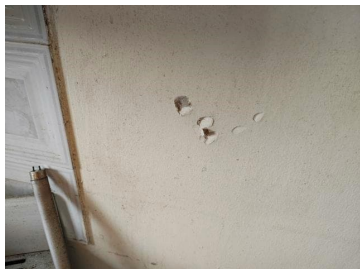
| ASBESTOS - Confirmed | | | |
|---|---|---|---|
| Photo Ref | <a href="#">170001</a> | Sample No | WSP-326728 |

| ASBESTOS - Confirmed | | | |
|---|---|---|---|
| Material | Fibre cement sheeting | | |
| Risk Rating | Medium | | |

| ASBESTOS - Confirmed | | | |

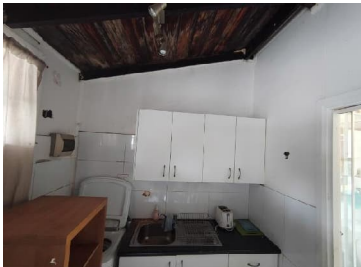
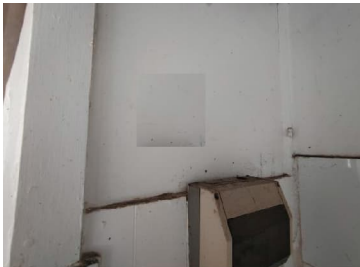
| ASBESTOS - Confirmed | | | |
|---|---|---|---|
| Material | Fibre cement sheeting | | |
| Risk Rating | Low | | |

| ASBESTOS - Confirmed | | | |

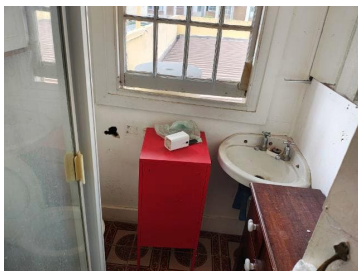
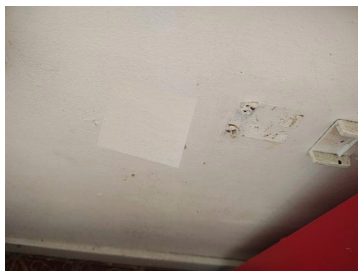
| ASBESTOS - Confirmed | | | |
|---|---|---|---|
| Photo Ref | <a href="#">169803</a> | Sample No | WSP-326717 |

| ASBESTOS - Confirmed | | | |
|---|---|---|---|
| Material | Fibre cement sheeting | | |
| Risk Rating | Low | | |

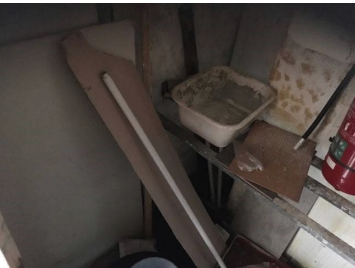
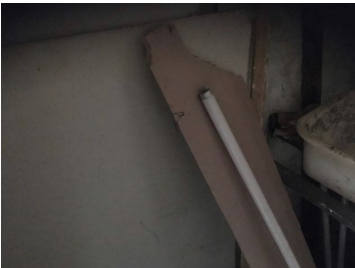
| NON-ASBESTOS CONTAINING MATERIAL | | | |
|---|---|---|---|
| Photo Ref | <a href="#">169795</a> | Sample No | NSM |

| NON-ASBESTOS CONTAINING MATERIAL | | | |
|---|---|---|---|
| Material | Fibre cement sheeting | | |
| Risk Rating | No Asbestos | | |

| NON-ASBESTOS CONTAINING MATERIAL | | | |

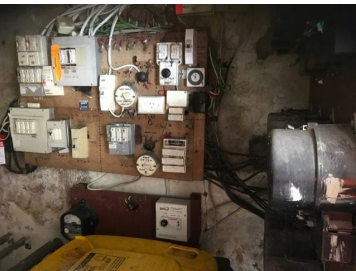
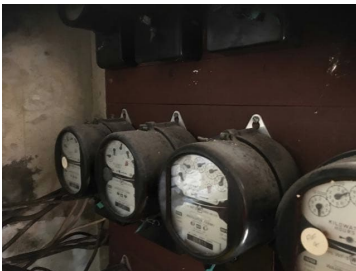
| NON-ASBESTOS CONTAINING MATERIAL | | | |
|---|---|---|---|
| Photo Ref | <a href="#">169796</a> | Sample No | WSP-231440 |

| NON-ASBESTOS CONTAINING MATERIAL | | | |
|---|---|---|---|
| Material | Timber | | |

| NON-ASBESTOS CONTAINING MATERIAL | | | |

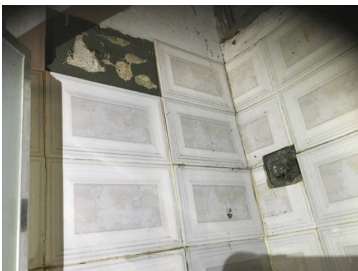
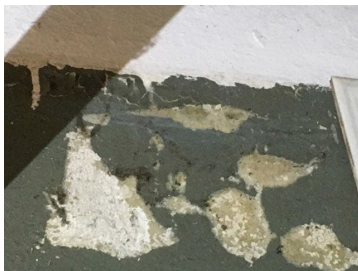
| NON-ASBESTOS CONTAINING MATERIAL | | | |
|---|---|---|---|
| Photo Ref | <a href="#">169998</a> | Sample No | WSP-326735 |

| NON-ASBESTOS CONTAINING MATERIAL | | | |
|---|---|---|---|
| Material | Screed | | |
| Risk Rating | No Asbestos | | |

| NON-ASBESTOS CONTAINING MATERIAL | | | |

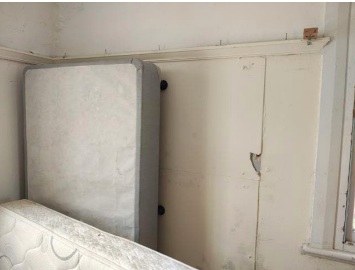
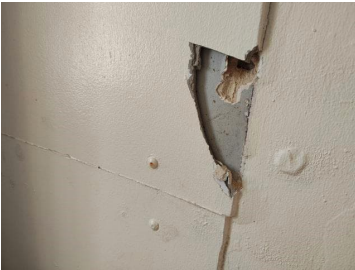
| NON-ASBESTOS CONTAINING MATERIAL | | | |
|---|---|---|---|
| Photo Ref | <a href="#">170000</a> | Sample No | WSP-326734 |

| NON-ASBESTOS CONTAINING MATERIAL | | | |
|---|---|---|---|
| Material | Fibre cement sheeting | | |
| Risk Rating | No Asbestos | | |

| NON-ASBESTOS CONTAINING MATERIAL | | | |

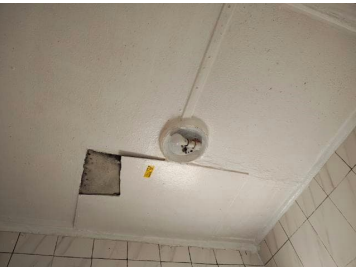
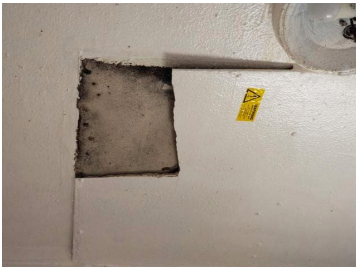
| NON-ASBESTOS CONTAINING MATERIAL | | | |
|---|---|---|---|
| Photo Ref | <a href="#">169997</a> | Sample No | WSP-326711 |

| NON-ASBESTOS CONTAINING MATERIAL | | | |
|---|---|---|---|
| Material | Fibre cement sheeting | | |
| Risk Rating | No Asbestos | | |

| NON-ASBESTOS CONTAINING MATERIAL | | | |
