# HAZARDOUS MATERIALS SURVEY REPORT

136 NEW SOUTH HEAD ROAD  
EDGECLIFF NSW, 2027

Hazardous Materials Survey Report  
136 New South Head Road Edgecliff NSW, 2027  
LENDLEASE DEVELOPMENT

## Hazardous Materials Survey Report 142-146 & 148 New South Head Road Edgecliff, NSW, 2027 LENDLEASE DEVELOPMENT

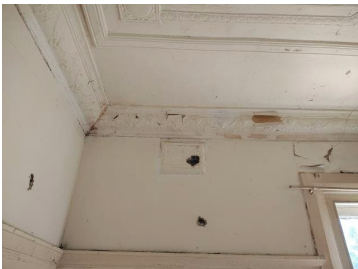
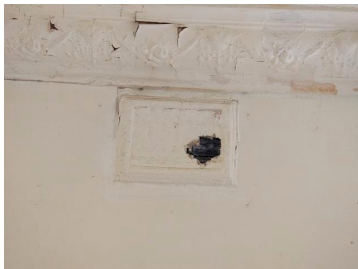
| NON-ASBESTOS CONTAINING MATERIAL | | | |
|---|---|---|---|
| Photo Ref | <a href="#">169999</a> | Sample No | WSP-326705 |

| NON-ASBESTOS CONTAINING MATERIAL | | | |
|---|---|---|---|
| Material | Cement casting | | |
| Risk Rating | No Asbestos | | |

| NON-ASBESTOS CONTAINING MATERIAL | | | |

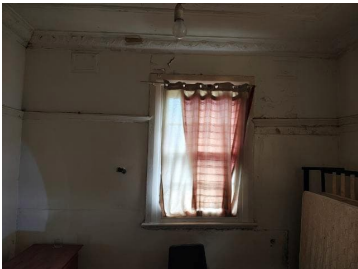
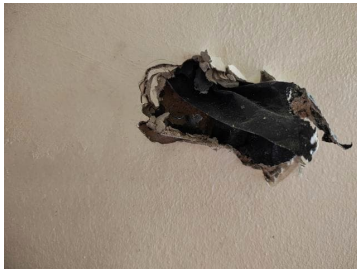
| NON-ASBESTOS CONTAINING MATERIAL | | | |
|---|---|---|---|
| Photo Ref | <a href="#">170004</a> | Sample No | WSP-326725 |

| NON-ASBESTOS CONTAINING MATERIAL | | | |
|---|---|---|---|
| Material | Fibre cement sheeting | | |
| Risk Rating | No Asbestos | | |

| NON-ASBESTOS CONTAINING MATERIAL | | | |

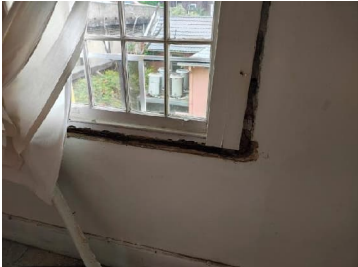
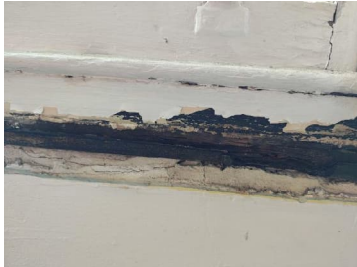
| NON-ASBESTOS CONTAINING MATERIAL | | | |
|---|---|---|---|
| Photo Ref | <a href="#">169996</a> | Sample No | WSP-326727 |

| NON-ASBESTOS CONTAINING MATERIAL | | | |
|---|---|---|---|
| Material | Bituminous material | | |
| Risk Rating | No Asbestos | | |

| NON-ASBESTOS CONTAINING MATERIAL | | | |

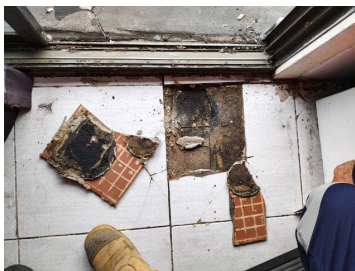
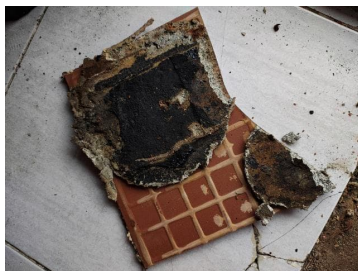
| NON-ASBESTOS CONTAINING MATERIAL | | | |
|---|---|---|---|
| Photo Ref | <a href="#">169788</a> | Sample No | WSP-231439 |

| NON-ASBESTOS CONTAINING MATERIAL | | | |
|---|---|---|---|
| Material | Bituminous material | | |
| Risk Rating | No Asbestos | | |

| NON-ASBESTOS CONTAINING MATERIAL | | | |

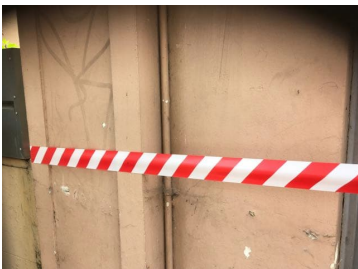
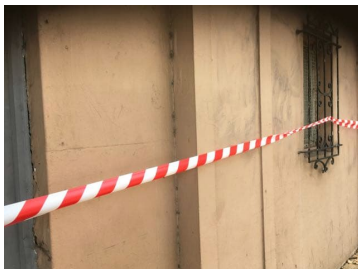
| NON-ASBESTOS CONTAINING MATERIAL | | | |
|---|---|---|---|
| Photo Ref | <a href="#">169789</a> | Sample No | NSM |

| NON-ASBESTOS CONTAINING MATERIAL | | | |
|---|---|---|---|
| Material | Screed | | |
| Risk Rating | No Asbestos | | |

| NON-ASBESTOS CONTAINING MATERIAL | | | |

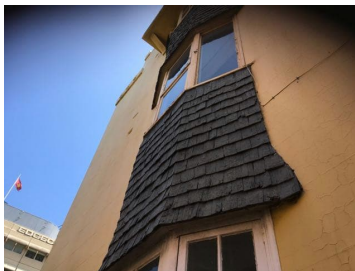
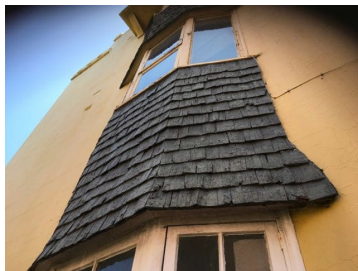
| NON-ASBESTOS CONTAINING MATERIAL | | | |
|---|---|---|---|
| Photo Ref | <a href="#">169790</a> | Sample No | WSP-231445 |

| NON-ASBESTOS CONTAINING MATERIAL | | | |
|---|---|---|---|
| Material | Timber | | |

| NON-ASBESTOS CONTAINING MATERIAL | | | |

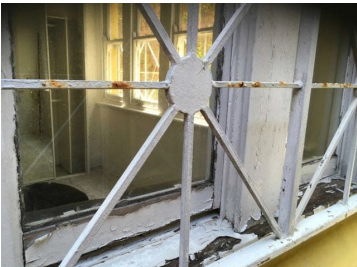
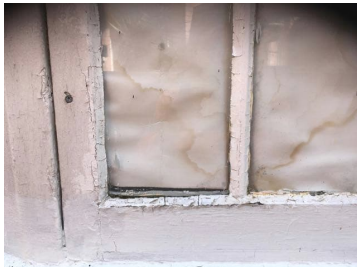
| NON-ASBESTOS CONTAINING MATERIAL | | | |
|---|---|---|---|
| Photo Ref | <a href="#">169797</a> | Sample No | WSP-326707 |

| NON-ASBESTOS CONTAINING MATERIAL | | | |
|---|---|---|---|
| Material | Mastic | | |
| Risk Rating | No Asbestos | | |

| NON-ASBESTOS CONTAINING MATERIAL | | | |

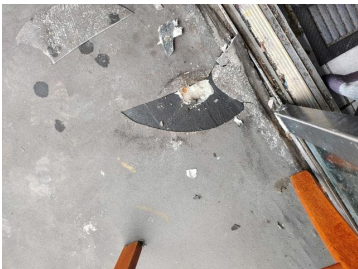
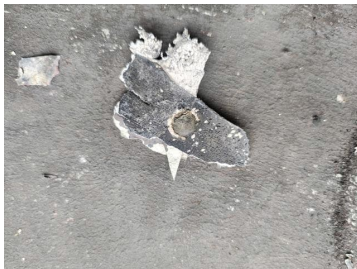
| NON-ASBESTOS CONTAINING MATERIAL | | | |
|---|---|---|---|
| Photo Ref | <a href="#">169798</a> | Sample No | WSP-326706 |

| NON-ASBESTOS CONTAINING MATERIAL | | | |
|---|---|---|---|
| Material | Roof felt | | |
| Risk Rating | No Asbestos | | |

| NON-ASBESTOS CONTAINING MATERIAL | | | |

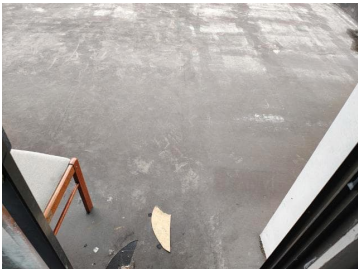
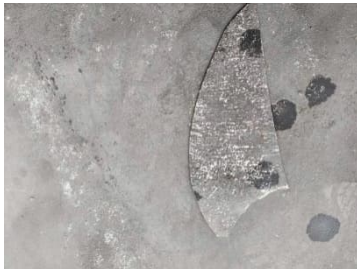
| NON-ASBESTOS CONTAINING MATERIAL | | | |
|---|---|---|---|
| Photo Ref | <a href="#">170501</a> | Sample No | WSP-231483 |

| NON-ASBESTOS CONTAINING MATERIAL | | | |
|---|---|---|---|
| Material | Other | | |
| Risk Rating | No Asbestos | | |

| NON-ASBESTOS CONTAINING MATERIAL | | | |

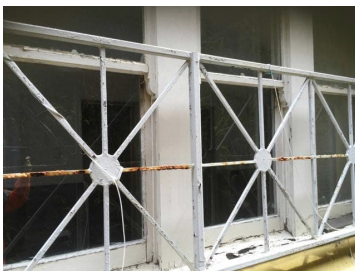
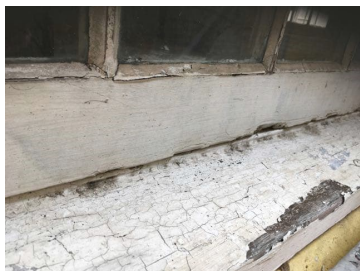
| LBP NOT DETECTED | | | |
|---|---|---|---|
| Photo Ref | <a href="#">LBP-30274</a> | Sample No | Lead Paint Sample WSP-231434 |

| LBP DETECTED | | | |
|---|---|---|---|
| Application | Timber frame work | | |

| LBP NOT DETECTED | | | |

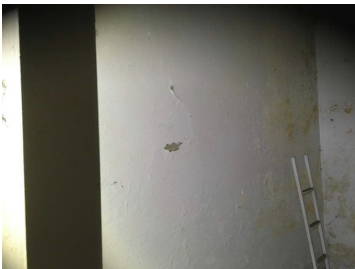
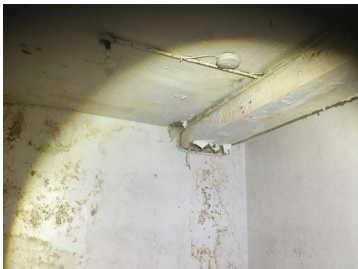
| LBP DETECTED | | | |
|---|---|---|---|
| Photo Ref | <a href="#">LBP-30276</a> | Sample No | Lead Paint Sample WSP-231437 |

| 138-140 New South Head Rd | | | | | | | | | | | |
|---|---|---|---|---|---|---|---|---|---|---|---|
| External | Basement | Walls | Pink | Lead Paint Sample WSP-231437 | <b>LBP Detected 3.9%w/w</b> | 100 m² | Poor | Medium | Medium Risk | Hazardous Waste. Remove by experienced lead abatement contractor. | <a href="#">LBP-30276</a> |

| LBP NOT DETECTED | | | |
|---|---|---|---|
| Application | Walls and ceiling | | |

| LBP DETECTED | | | |

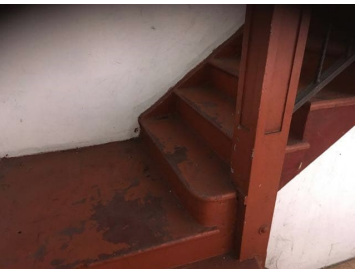
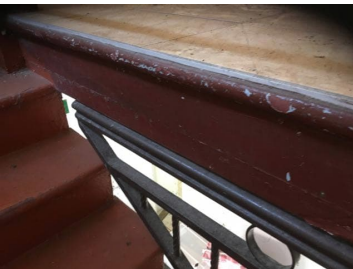
| LEAD IN DUST DETECTED | | | |
|---|---|---|---|
| Photo Ref | <a href="#">LBP-30306</a> | Sample No | Lead Dust Sample WSP-326731 |

| LEAD IN DUST DETECTED | | | |
| Application | Dust | | |
| Risk Rating | High | | |

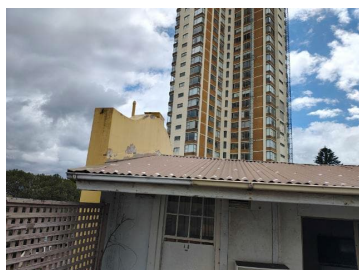
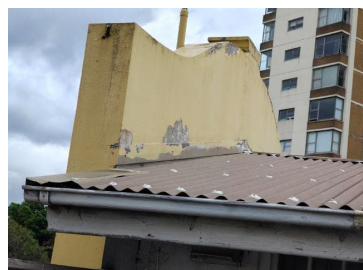
| LEAD METAL | | | |
|---|---|---|---|
| Photo Ref | <a href="#">LBP-30285</a> | Sample No | Lead Paint Presumed |

| LEAD METAL | | | |
| Application | Lead flashing | | |
