## AQUALAND PRESTIGE 2 PTY LTD

## Hazardous Materials Survey

2-16 Pockley Avenue, Roseville NSW

**Report No:** E26491.E10\_Rev1

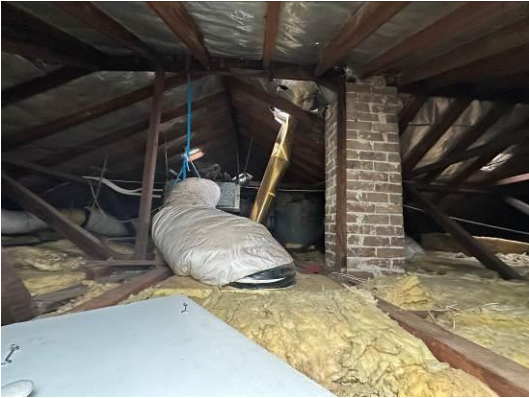
| Location | Material | Friability | Sample | Analysis Result | Quantity | Condition / Accessibility | Priority | Date of Identification | Recommendations / Comments | Photograph |
|---|---|---|---|---|---|---|---|---|---|---|
| Main dwelling, ceiling cavity, partially accessible | Possible hazardous materials | Unknown | - | - | Unknown | Unknown | Unknown | - | Inspect when access is made available, prior to demolition | |

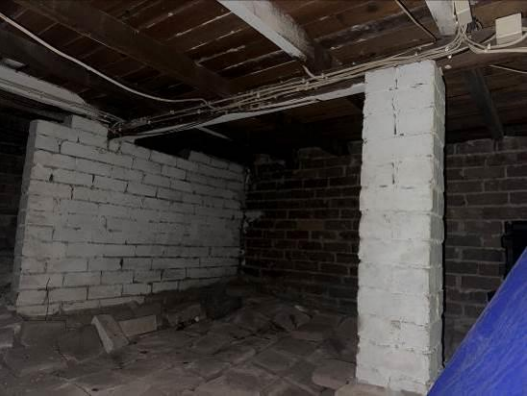
| Location | Material | Friability | Sample | Analysis Result | Quantity | Condition / Accessibility | Priority | Date of Identification | Recommendations / Comments | Photograph |
|---|---|---|---|---|---|---|---|---|---|---|
| Main dwelling, subfloor space, partially accessible | Possible hazardous materials | Unknown | - | - | Unknown | Unknown | Unknown | - | Inspect when access is made available, prior to demolition | |

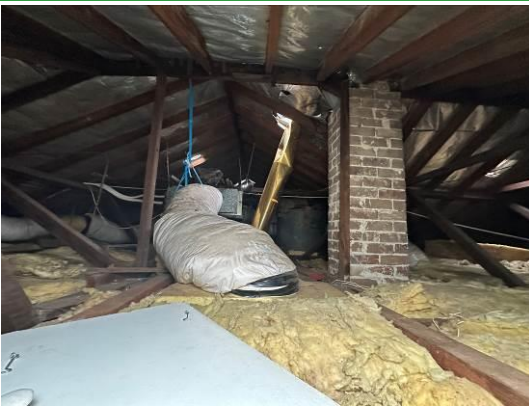
| Internal, main dwelling, ceiling cavity, insulation | SMF-lined insulation (assumed) | Sealed | Visual inspection | - | ND | Good / Maintenance only | Priority 4 - Negligible Risk Level | 20/02/2025 | Remove during initial stage of demolition works | |

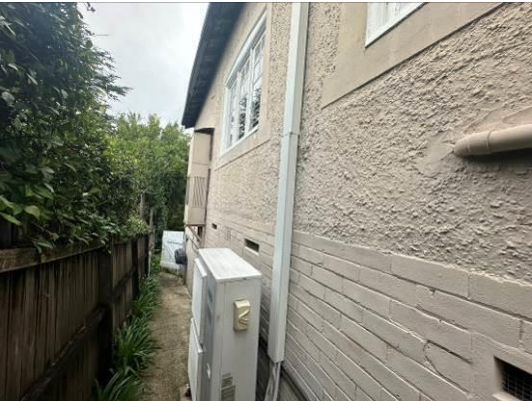
| External, main dwelling, western wall | Cream Paint | Non-friable | LP-2 | 0.019% w/w | N/A | N/A | N/A | N/A | N/A |

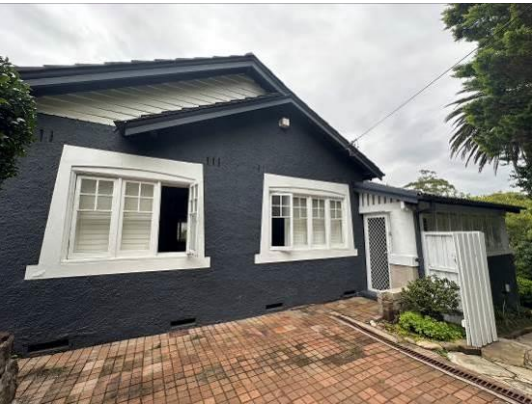
| External, main dwelling, eastern wall | Blue Paint | Non-friable | LP-3 | 0.073% w/w | N/A | N/A | N/A | N/A | N/A |

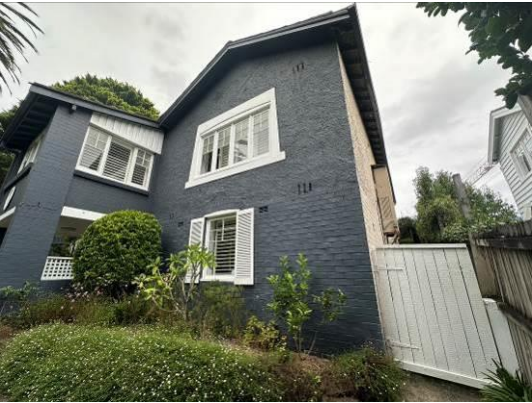
| External, main dwelling, walls throughout | Blue Paint | Non-friable | Visual inspection – similar to LP-3 | - | N/A | N/A | N/A | N/A | N/A |

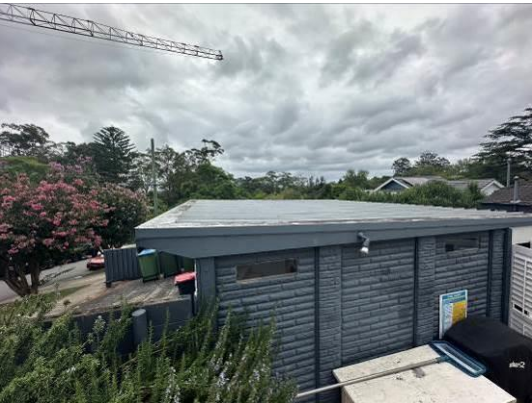
| External, detached garage, walls throughout | Blue Paint | Non-friable | Visual inspection – similar to LP-3 | - | N/A | N/A | N/A | N/A | N/A |

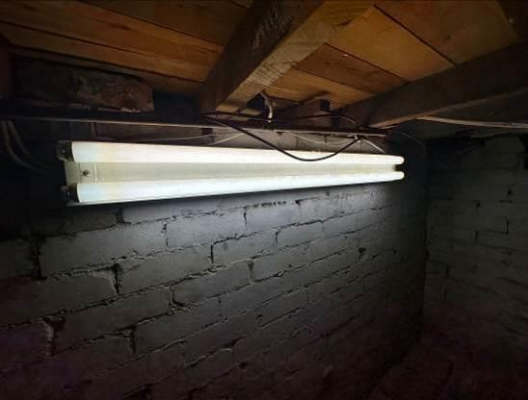
| Main dwelling, subfloor space, fluorescent light fittings | PCB-containing single-tube fluorescent light fitting capacitors (assumed) | N/A | Visual inspection - electrical hazard | - | 1 x unit | Good / Maintenance only | Priority 4 - Negligible Risk Level | 20/02/2025 | Remove prior to demolition works. Avoid damage to capacitors. | |

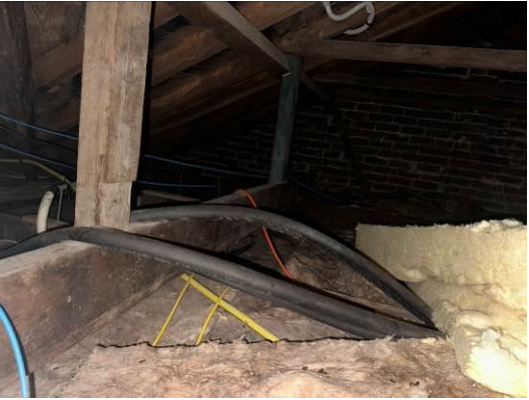
| Location | Material | Friability | Sample | Analysis Result | Quantity | Condition / Accessibility | Priority | Date of Identification | Recommendations / Comments | Photograph |
|---|---|---|---|---|---|---|---|---|---|---|
| Main dwelling, ceiling cavity, partially accessible | Possible hazardous materials | Unknown | - | - | Unknown | Unknown | Unknown | - | Inspect when access is made available, prior to demolition | |

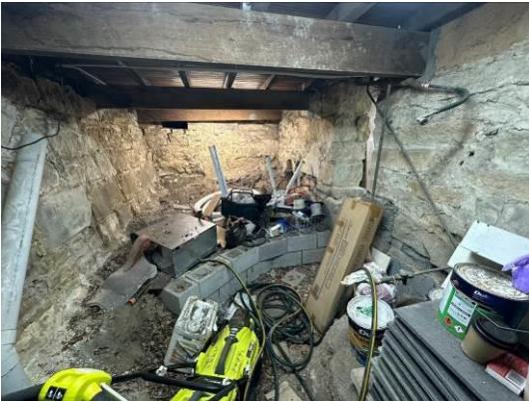
| Location | Material | Friability | Sample | Analysis Result | Quantity | Condition / Accessibility | Priority | Date of Identification | Recommendations / Comments | Photograph |
|---|---|---|---|---|---|---|---|---|---|---|
| Subfloor space, partially accessible | Possible hazardous materials | Unknown | - | - | Unknown | Unknown | Unknown | - | Inspect when access is made available, prior to demolition | |

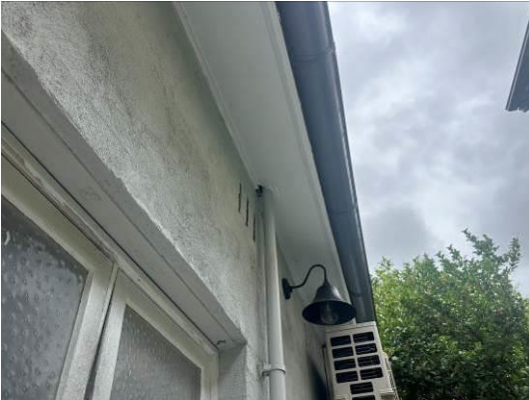
| Location | Material | Friability | Sample | Analysis Result | Quantity | Condition / Accessibility | Priority | Date of Identification | Recommendations / Comments | Photograph |
|---|---|---|---|---|---|---|---|---|---|---|
| External, main dwelling , eaves throughout | ACM (assumed) | Non-friable | Visual inspection - height restriction | - | >100m <sup>2</sup> | Good / Maintenance only | Priority 4 - Negligible Risk Level | 20/02/2025 | Remove during initial stage of demolition works | |

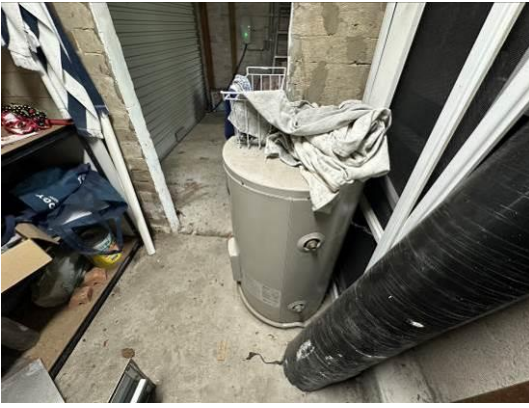
| Internal, detached garage, hot water unit | SMF-lined insulation (assumed) | Sealed | Visual inspection | - | 1 x unit | Good / Maintenance only | | 20/02/2025 | Remove during initial stage of demolition works | |

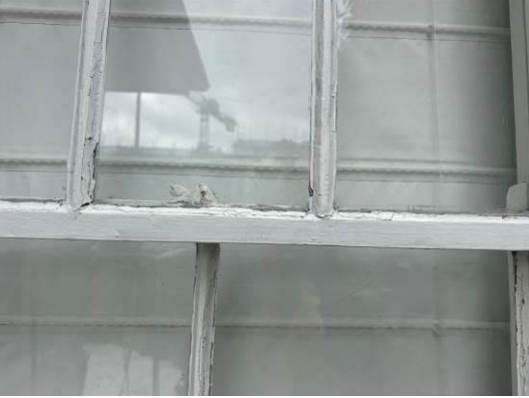
| External, main dwelling, ground level, south eastern side, window frame | White LBP | Non-friable | LP-6 | 4.9% w/w | Approximately 2m <sup>2</sup> | Fair / Occasional | Priority 3 - Low Risk Level | 20/02/2025 | Remove grossly peeling paint. Stabilise remaining membrane. Minimise abrasive works that will disturb paint during demolition. | |

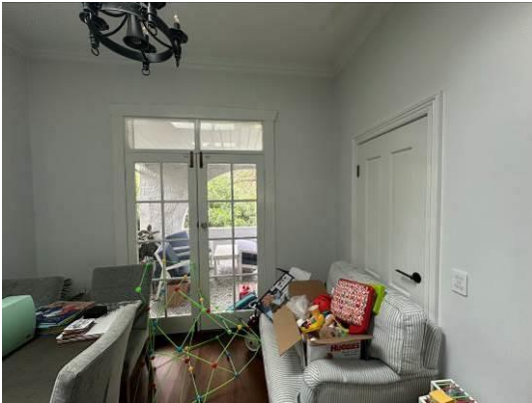
| Internal, main dwelling, ground level, window frames, doors, and staircase throughout | White LBP (assumed) | Non-friable | Visual inspection – similar to LP-4 | - | ND | Good Occasional | | 20/02/2025 | Remove grossly peeling paint. Stabilise remaining membrane. Minimise abrasive works that will disturb paint during demolition. | |

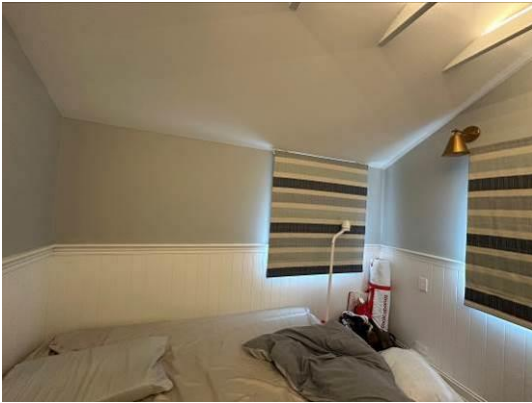
| Internal, main dwelling, level 1, eastern bedroom, walls | Light blue Paint | Non-friable | LP-5 | <0.001% w/w | N/A | N/A | N/A | N/A | N/A | |

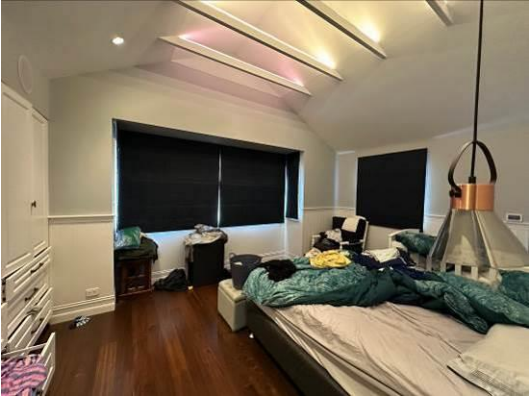
| Internal, main dwelling, level 1, walls throughout | Light blue Paint | Non-friable | Visual inspection – similar to LP-5 | - | N/A | N/A | N/A | N/A | N/A | |

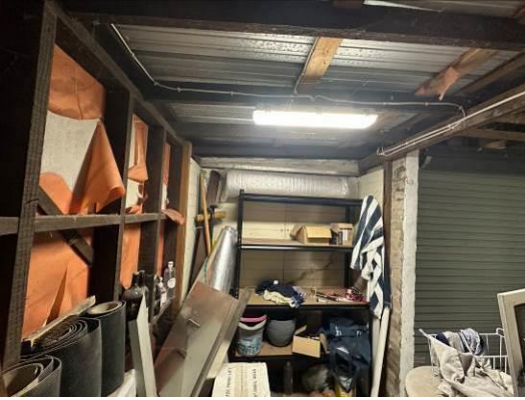
| Internal, detached garage, ceilings, fluorescent light fittings | PCB-containing single-tube fluorescent light fitting capacitors (assumed) | N/A | Visual inspection - electrical hazard | - | 3 x units | Good / Maintenance only | Priority 4 - Negligible Risk Level | 20/02/2025 | Remove prior to demolition works.<br>Avoid damage to capacitors. | |

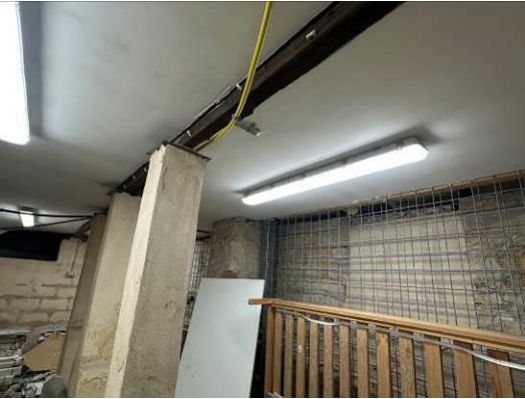
| Main dwelling, subfloor space, ceilings, fluorescent light fittings | PCB-containing single-tube fluorescent light fitting capacitors (assumed) | N/A | Visual inspection - electrical hazard | - | 6 x units | Good / Maintenance only | Priority 4 - Negligible Risk Level | 20/02/2025 | Remove prior to demolition works.<br>Avoid damage to capacitors. | |

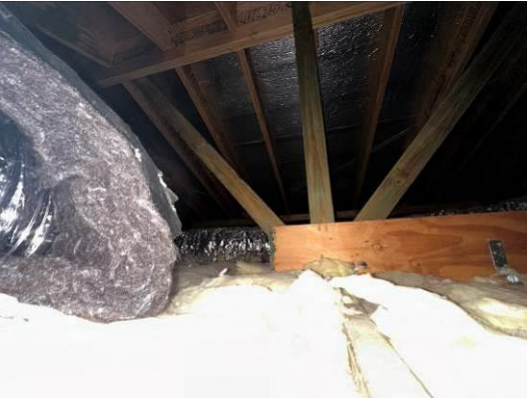
| Hazardous Materials Register<br>6 Pockley Avenue, Roseville NSW | | | | | | | | | | Two storey dwelling |
|---|---|---|---|---|---|---|---|---|---|---|
| Ceiling cavity, partially accessible | Possible hazardous materials | Unknown | - | - | Unknown | Unknown | Unknown | - | Inspect when access is made available, prior to demolition | |

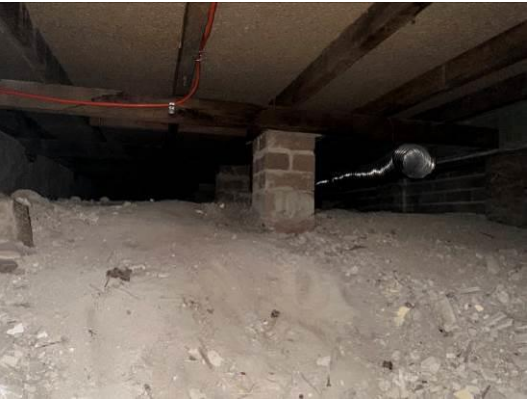
| Hazardous Materials Register<br>6 Pockley Avenue, Roseville NSW | | | | | | | | | | Two storey dwelling |
|---|---|---|---|---|---|---|---|---|---|---|
| Subfloor space, partially accessible | Possible hazardous materials | Unknown | - | - | Unknown | Unknown | Unknown | - | Inspect when access is made available, prior to demolition | |

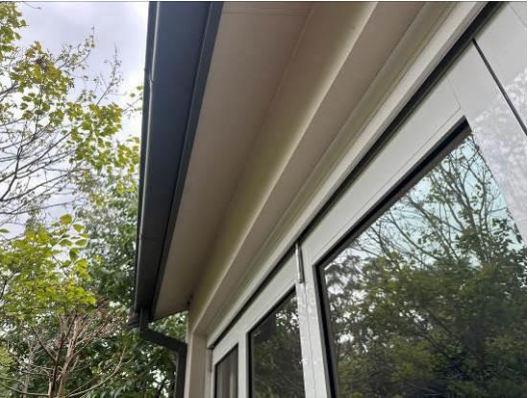
| Hazardous Materials Register<br>6 Pockley Avenue, Roseville NSW | | | | | | | | | | Two storey dwelling |
|---|---|---|---|---|---|---|---|---|---|---|
| External, eaves throughout | ACM (assumed) | Non-friable | Visual inspection - height restriction | - | >100m <sup>2</sup> | Good / Maintenance only | Priority 4 - Negligible Risk Level | 20/02/2024 | Remove during initial stage of demolition works | |

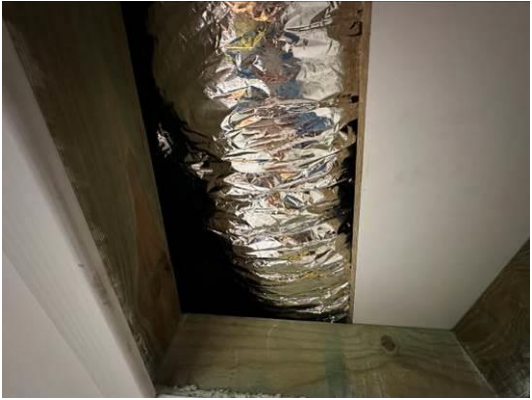
| Internal, ceiling cavity, ducting | SMF-lined insulation (assumed) | Sealed | Visual inspection | - | ND | Good / Maintenance only | Priority 4 - Negligible Risk Level | 20/02/2025 | Remove during initial stage of demolition works | |

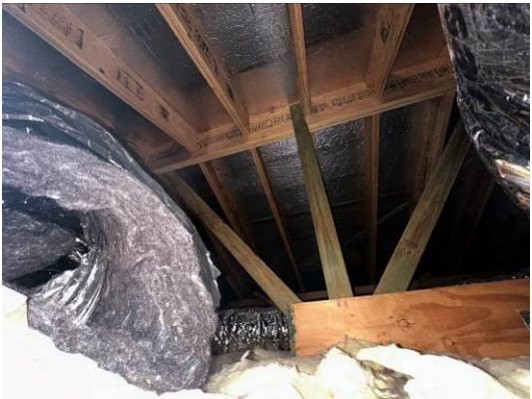
| Internal, ceiling cavity, roof sarking, insulation | SMF-lined insulation (assumed) | Sealed | Visual inspection | - | Approximately 150m <sup>2</sup> | Good / Maintenance only | Priority 4 - Negligible Risk Level | 20/02/2025 | Remove during initial stage of demolition works | |

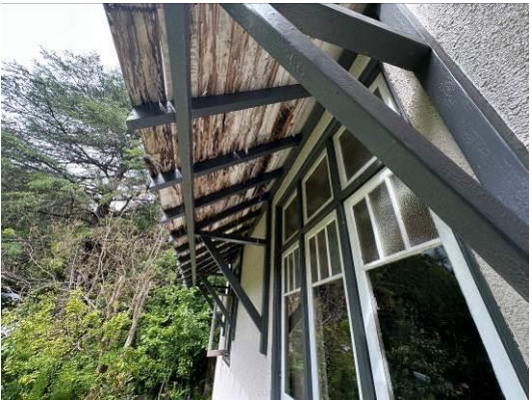
| External, northern awnings | White Paint | Non-friable | LP-8 | <0.001% w/w | N/A | N/A | N/A | N/A | N/A | |

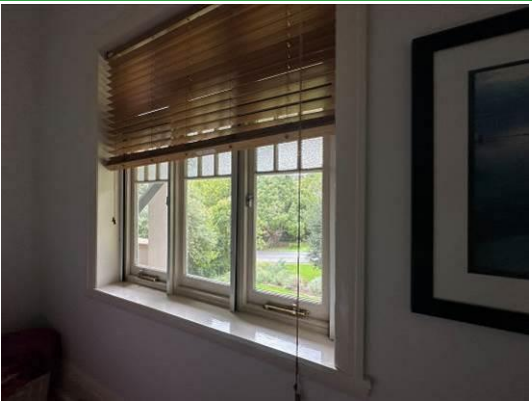
| Internal, ground level, north eastern bedroom, window frame | Cream Paint | Non-friable | LP-7 | 0.037% w/w | N/A | N/A | N/A | N/A | N/A | |

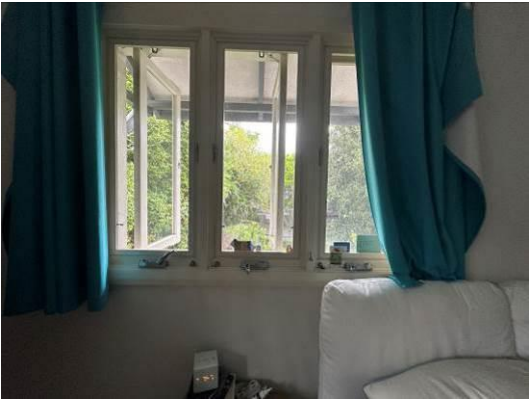
| Internal, window frames throughout | Cream Paint | Non-friable | Visual inspection – similar to LP-7 | - | N/A | N/A | N/A | N/A | N/A | |

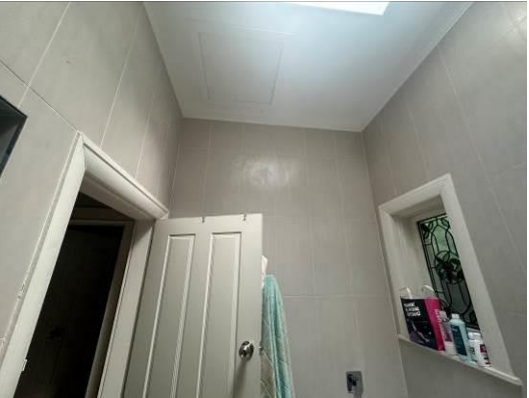
| Location | Material | Friability | Sample | Analysis Result | Quantity | Condition / Accessibility | Priority | Date of Identification | Recommendations / Comments | Photograph |
|---|---|---|---|---|---|---|---|---|---|---|
| Ceiling cavity | Possible hazardous materials | Unknown | - | - | Unknown | Unknown | Unknown | - | Inspect when access is made available, prior to demolition | |

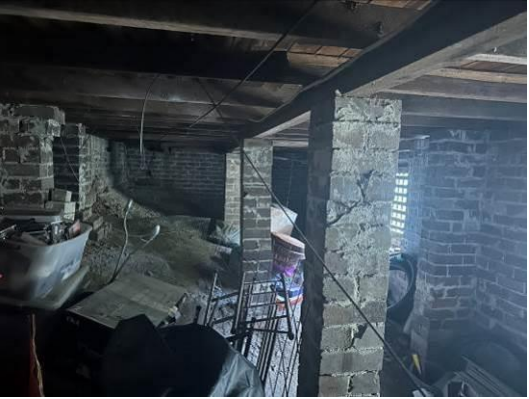
| Location | Material | Friability | Sample | Analysis Result | Quantity | Condition / Accessibility | Priority | Date of Identification | Recommendations / Comments | Photograph |
|---|---|---|---|---|---|---|---|---|---|---|
| Subfloor space, partially accessible | Possible hazardous materials | Unknown | - | - | Unknown | Unknown | Unknown | - | Inspect when access is made available, prior to demolition | |

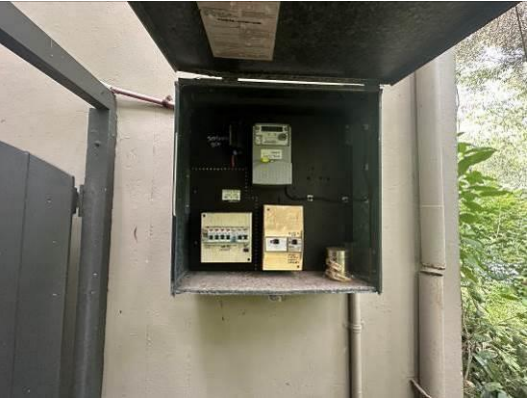
| Location | Material | Friability | Sample | Analysis Result | Quantity | Condition / Accessibility | Priority | Date of Identification | Recommendations / Comments | Photograph |
|---|---|---|---|---|---|---|---|---|---|---|
| External, eastern side, black meter backing board | ACM (assumed) | Non-friable | Visual inspection - electrical hazard | - | 1 x board | Good / Maintenance only | Priority 4 - Negligible Risk Level | 21/02/2024 | Remove during initial stage of demolition works | |

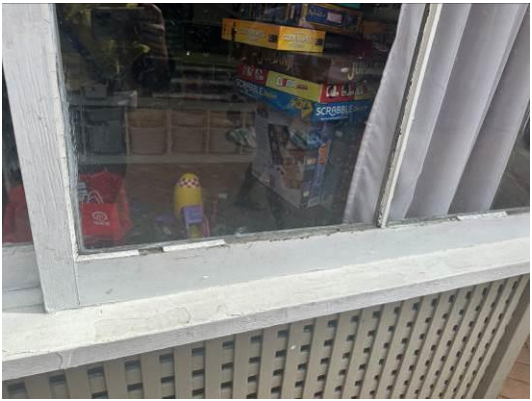
| External, southern side, window frame | Putty | Non-friable | Asb-5A | No Asbestos Detected | N/A | N/A | N/A | N/A | N/A | |

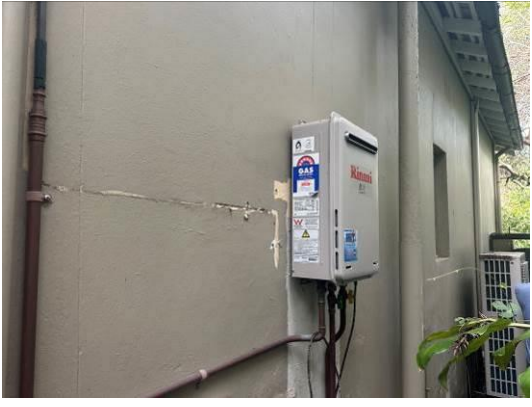
| External, eastern side, hot water unit | SMF-lined insulation (assumed) | Sealed | Visual inspection | - | 1 x unit | Good / Maintenance only | Priority 4 - Negligible Risk Level | 21/02/2025 | Remove during initial stage of demolition works | |

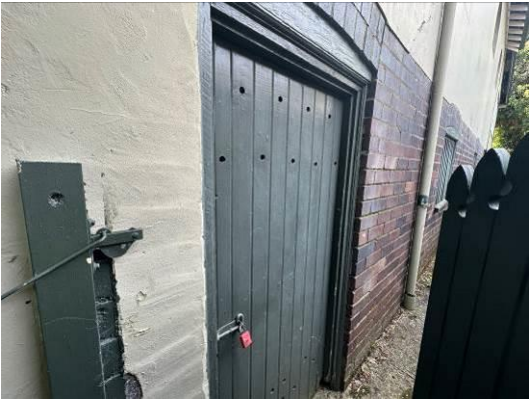
| External, western, door to subfloor space | Green LBP | Non-friable | LP-11 | 1.5% w/w | Approximately 2m <sup>2</sup> | Good / Occasional | Priority 4 - Negligible Risk Level | 21/02/2025 | Remove grossly peeling paint. Stabilise remaining membrane. Minimise abrasive works that will disturb paint during demolition. | |

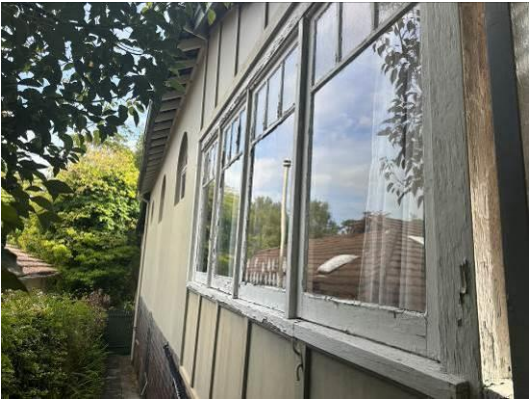
| External, eastern wall | Brown LBP | Non-friable | LP-12 | 0.35% w/w | Approximately 25m <sup>2</sup> | Good / Fair Occasional | Priority 3 - Low Risk Level | 21/02/2025 | Remove grossly peeling paint. Stabilise remaining membrane. Minimise abrasive works that will disturb paint during demolition. | |

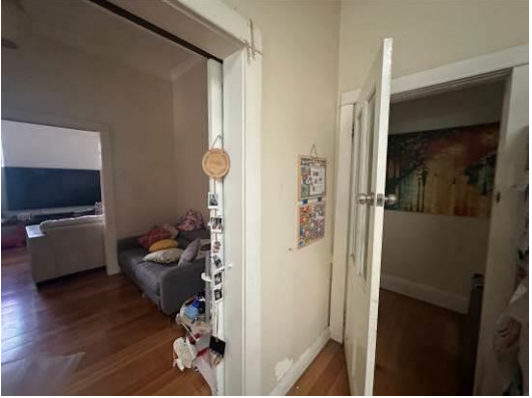
| Internal, southern side, kitchen, eastern wall | Cream Paint | Non-friable | LP-10 | 0.011% w/w | N/A | N/A | N/A | N/A | N/A | |

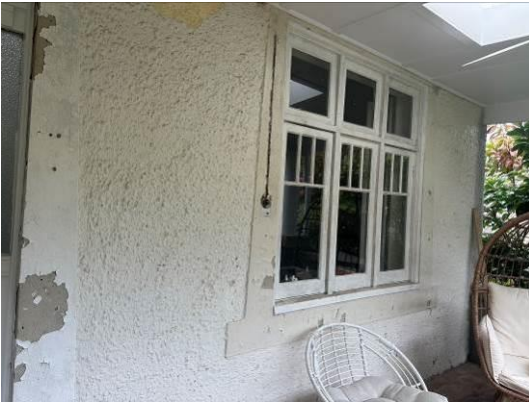
| External, main dwelling, northern side, window frame | Putty | Non-friable | Asb-5B | No Asbestos Detected | N/A | N/A | N/A | N/A | N/A | |

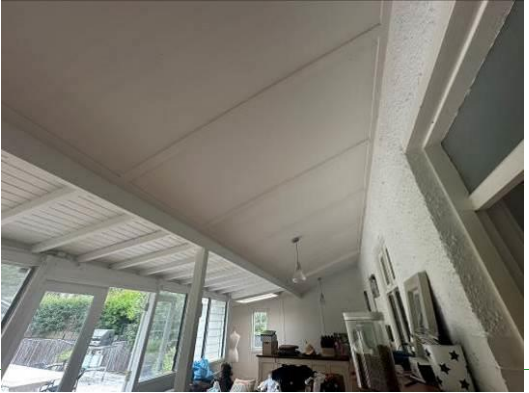
| Internal, main dwelling, southern side, sunroom, awnings, western and eastern walls | ACM (assumed) | Non-friable | Visual inspection – similar to Asb-6 | - | Approximately 40m <sup>2</sup> | Good / Occasional | Priority 4 - Negligible Risk Level | 21/02/2025 | Remove during initial stage of demolition works | |

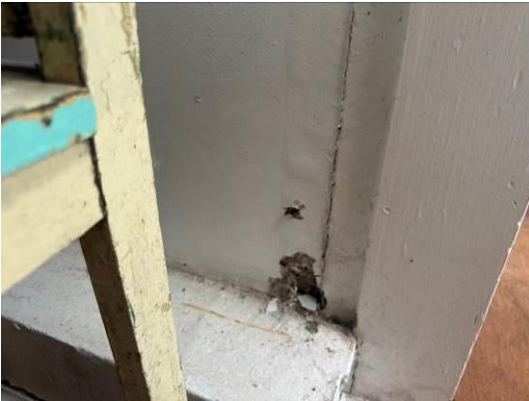
| Internal, main dwelling, southern side, sunroom, southern lower panels | Plasterboard | Non-friable | Asb-7 | No Asbestos Detected<br>Organic Fibres Detected | N/A | N/A | N/A | N/A | N/A | |

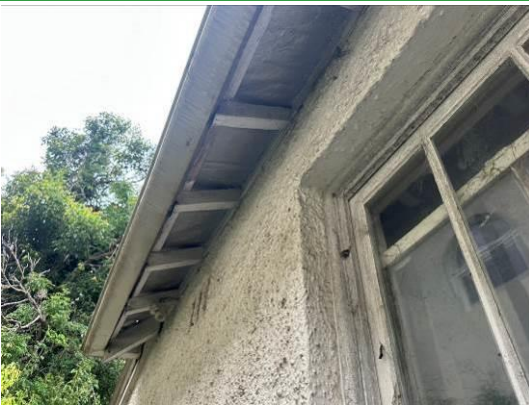
| External, main dwelling, eastern and western sides, eaves, roof sarking | SMF-lined insulation (assumed) | Sealed | Visual inspection | - | ND | Good / Maintenance only | Priority 4 - Negligible Risk Level | 21/02/2025 | Remove during initial stage of demolition works | |

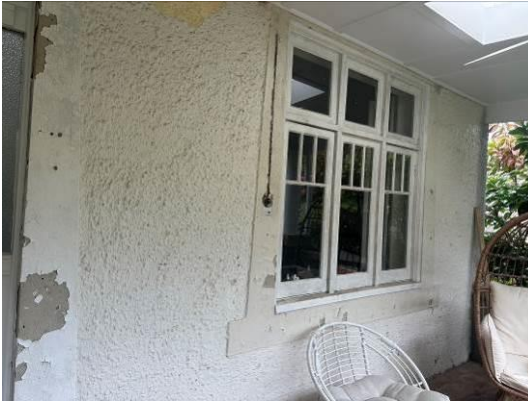
| External, main dwelling , northern side, outer window frame | Cream LBP | Non-friable | LP-14 | 6.6% w/w | Approximately 2m <sup>2</sup> | Good Occasional | Priority 4 - Negligible Risk Level | 21/02/2025 | Remove grossly peeling paint. Stabilise remaining membrane. Minimise abrasive works that will disturb paint during demolition. | |

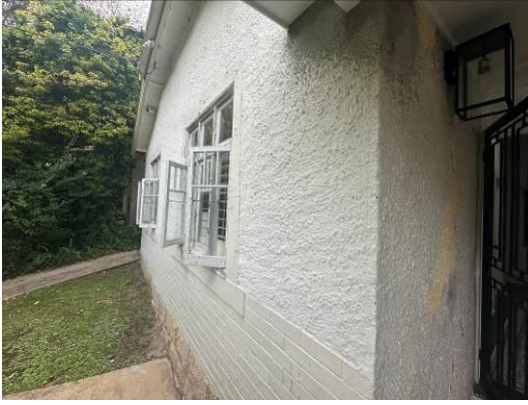
| External, main dwelling, outer window frames throughout | Cream LBP (assumed) | Non-friable | Visual inspection – similar to LP-14 | - | >100m <sup>2</sup> | Good Occasional | Priority 4 - Negligible Risk Level | 21/02/2025 | Remove grossly peeling paint. Stabilise remaining membrane. Minimise abrasive works that will disturb paint during demolition. | |

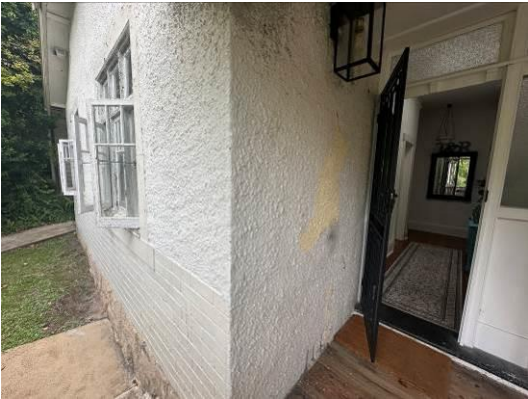
| External, main dwelling , northern side, wall | Cream Paint | Non-friable | LP-15 | 0.018% w/w | N/A | N/A | N/A | N/A | N/A | |

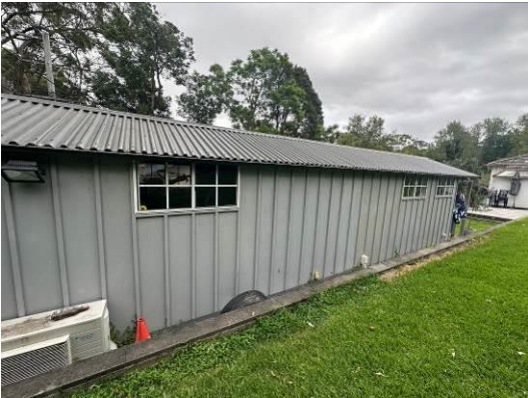
| External, detached shed throughout | Grey Paint | Non-friable | LP-18 | <0.001% w/w | N/A | N/A | N/A | N/A | N/A | |

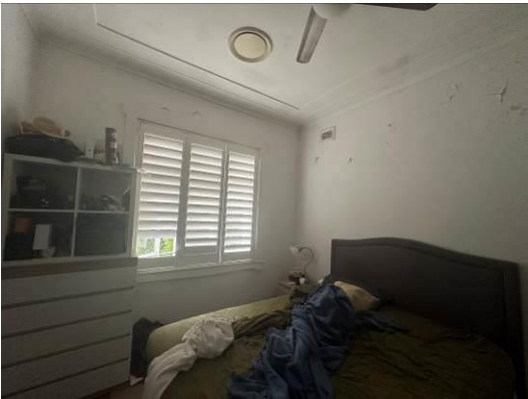
| Internal, main dwelling, north western bedroom, western wall | White Paint | Non-friable | LP-17 | <0.001 % w/w | N/A | N/A | N/A | N/A | N/A | |

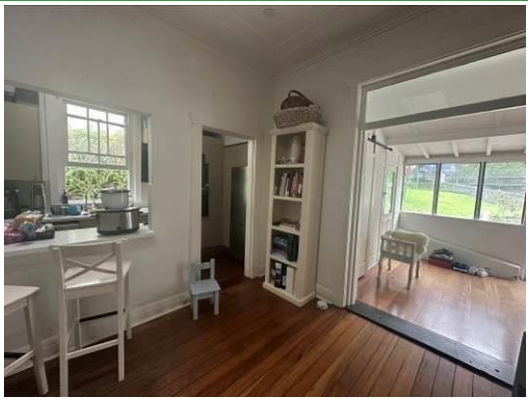
| Internal, main dwelling, walls throughout | White Paint | Non-friable | Visual inspection – similar to LP-17 | - | N/A | N/A | N/A | N/A | N/A | |

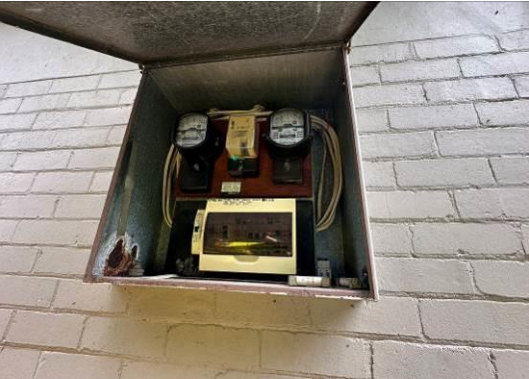
| External, main dwelling, eastern side, black meter backing board | ACM<br>(assumed) | Non-friable | Visual inspection - electrical hazard | - | 1 x board | Good / Maintenance only | Priority 4 - Negligible Risk Level | 21/02/2025 | Remove during initial stage of demolition works | |

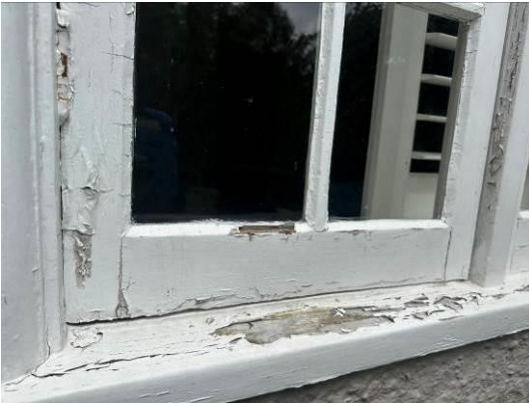
| External, main dwelling, northern side, window frame | Putty | Non-friable | Asb-8 | No Asbestos Detected | N/A | N/A | N/A | N/A | N/A | |

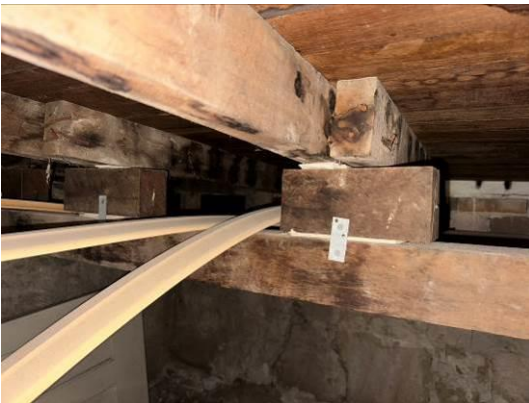
| Subfloor space, main dwelling, western access, packers | FCS | Non-friable | Asb-9 | No Asbestos Detected<br>Organic Fibres Detected | N/A | N/A | N/A | N/A | N/A | |

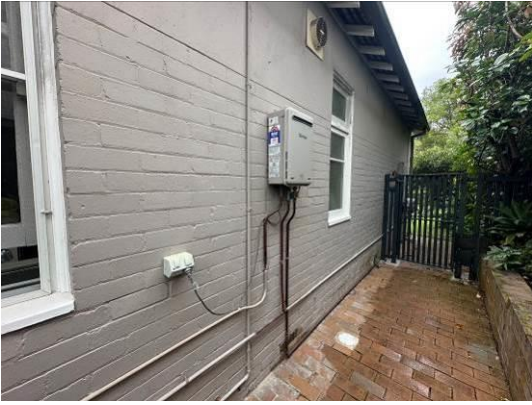
| External, main dwelling, eastern side, hot water unit | SMF-lined insulation (assumed) | Sealed | Visual inspection | - | 1 x unit | Good / Maintenance only | Priority 4 - Negligible Risk Level | 21/02/2025 | Remove during initial stage of demolition works | |

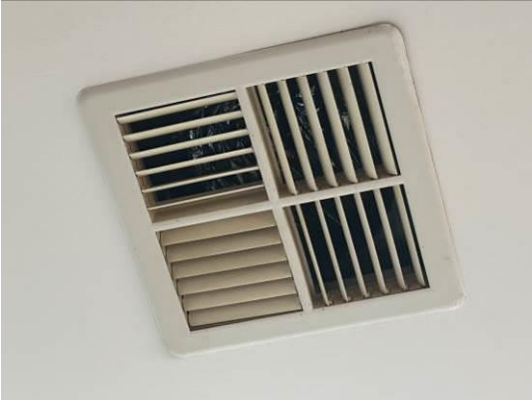
| Internal, main dwelling, ceiling cavity, ducting | SMF-lined insulation (assumed) | Sealed | Visual inspection | - | ND | Good / Maintenance only | Priority 4 - Negligible Risk Level | 21/02/2025 | Remove during initial stage of demolition works | |

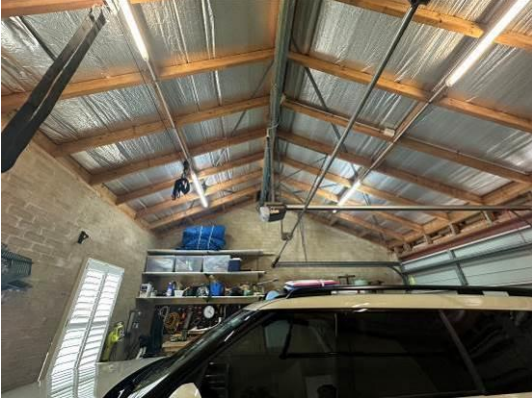
| Internal, detached granny flat / garage, rooking sarking | SMF-lined insulation (assumed) | Sealed | Visual inspection | - | Approximately 30m <sup>2</sup> | Good / Maintenance only | Priority 4 - Negligible Risk Level | 21/02/2025 | Remove during initial stage of demolition works | |

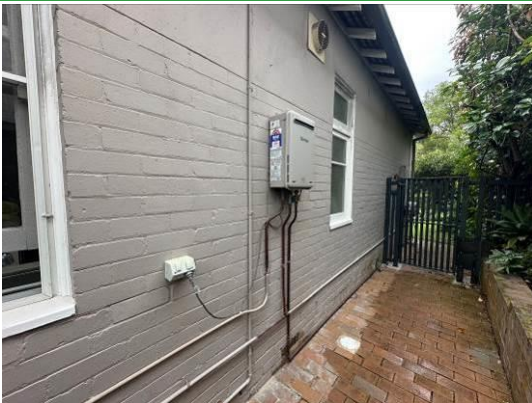
| External, main dwelling , eastern wall | Brown Paint | Non-friable | LP-20 | 0.001% w/w | N/A | N/A | N/A | N/A | N/A | |

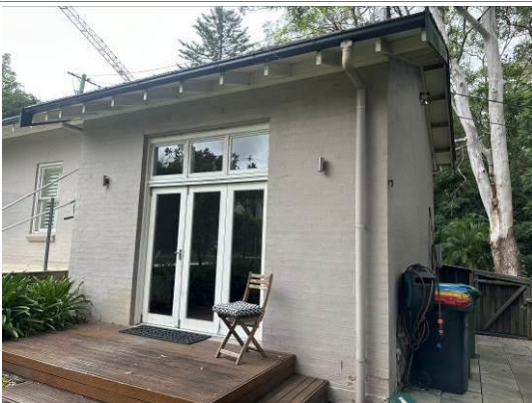
| External, main dwelling and detached granny flat / garage | Brown Paint | Non-friable | Visual inspection – similar to LP-20 | - | N/A | N/A | N/A | N/A | N/A | |

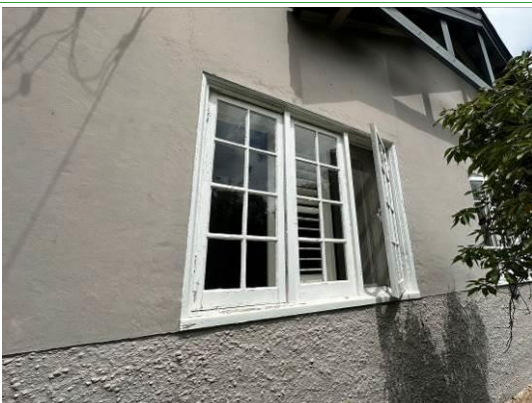
| External, main dwelling, northern side, window frame | White Paint | Non-friable | LP-19 | 0.019% w/w | N/A | N/A | N/A | N/A | N/A | |

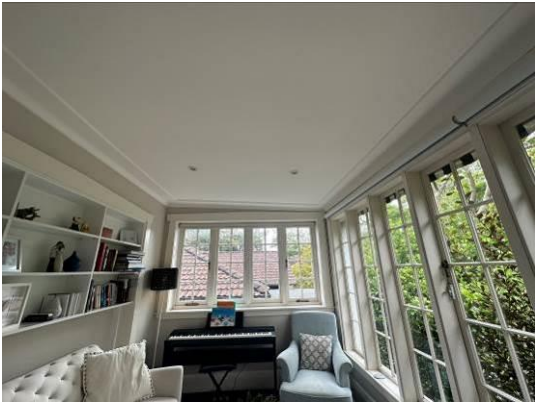
| External, main dwelling, window frames throughout | White Paint | Non-friable | Visual inspection – similar to LP-19 | - | N/A | N/A | N/A | N/A | N/A |

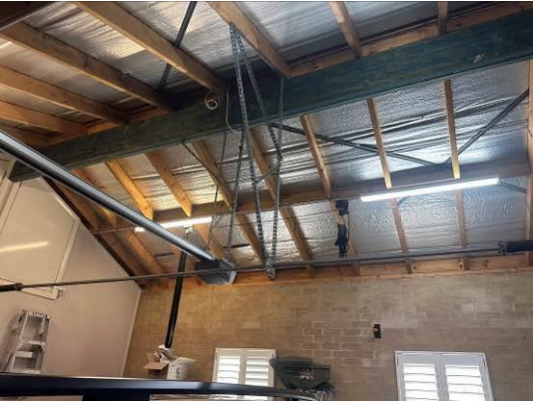
| Internal, detached granny flat / garage, ceilings, fluorescent light fittings | PCB-containing single-tube fluorescent light fitting capacitors (assumed) | N/A | Visual inspection - electrical hazard | - | 2 x units | Good / Maintenance only | Priority 4 - Negligible Risk Level | 21/02/2025 | Remove prior to demolition works. Avoid damage to capacitors. |

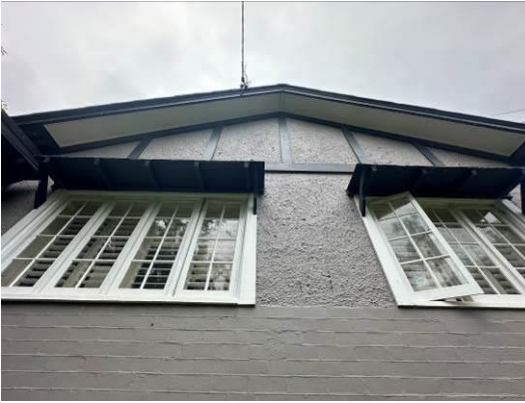
| External, main dwelling , eaves throughout | ACM (assumed) | Non-friable | Visual inspection - height restriction | - | >100m <sup>2</sup> | Good / Maintenance only | Priority 4 - Negligible Risk Level | 20/02/2024 | Remove during initial stage of demolition works | |

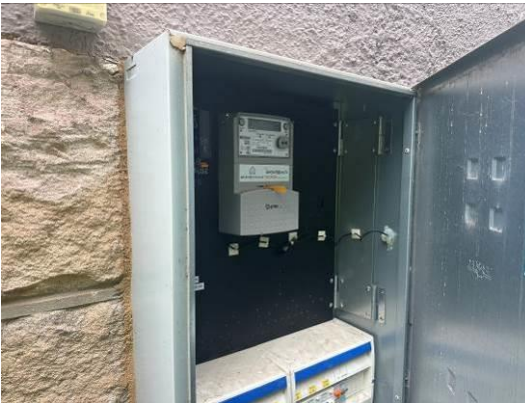
| External, main dwelling, western side, black meter backing board | ACM (assumed) | Non-friable | Visual inspection - electrical hazard | - | 1 x board | Good / Maintenance only | Priority 4 - Negligible Risk Level | 20/02/2025 | Remove during initial stage of demolition works | |

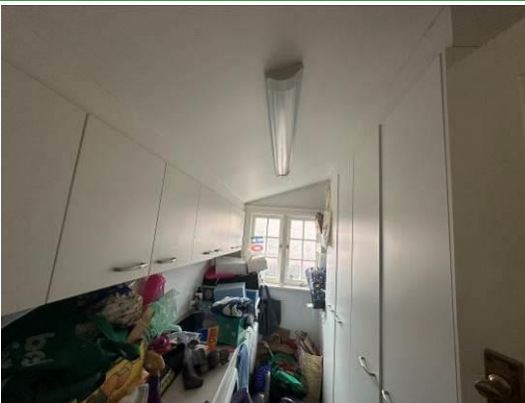
| Internal, main dwelling, south western side, laundry, ceiling and walls | ACM (assumed) | Non-friable | Visual inspection | - | Approximately 30m <sup>2</sup> | Good / Maintenance only | Priority 4 - Negligible Risk Level | 24/02/2025 | Remove during initial stage of demolition works | |

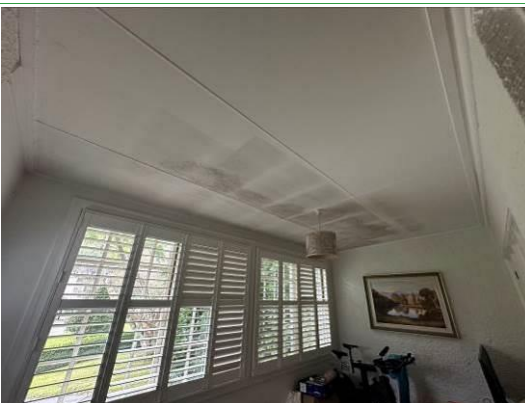
| Internal, main dwelling, northern side, sunroom, ceiling | ACM (assumed) | Non-friable | Visual inspection | - | Approximately 20m <sup>2</sup> | Good / Maintenance only | Priority 4 - Negligible Risk Level | 24/02/2025 | Remove during initial stage of demolition works | |

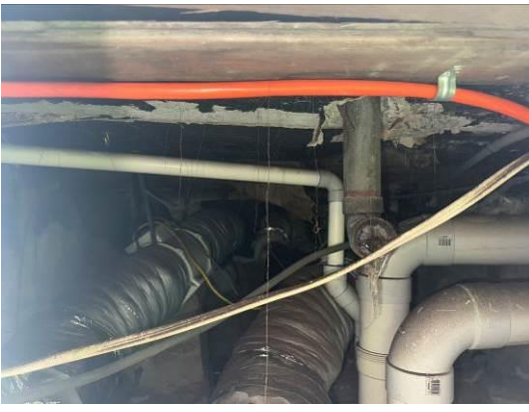
| Main dwelling, subfloor space, western, ducting | SMF-lined insulation (assumed) | Sealed | Visual inspection | - | ND | Good / Maintenance only | Priority 4 - Negligible Risk Level | 24/02/2025 | Remove during initial stage of demolition works | |

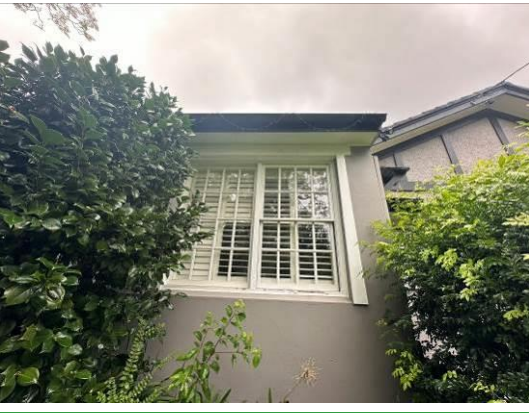
| External, main dwelling, northern side, window frame | White Paint | Non-friable | LP-21 | 0.009% w/w | N/A | N/A | N/A | N/A | N/A | |

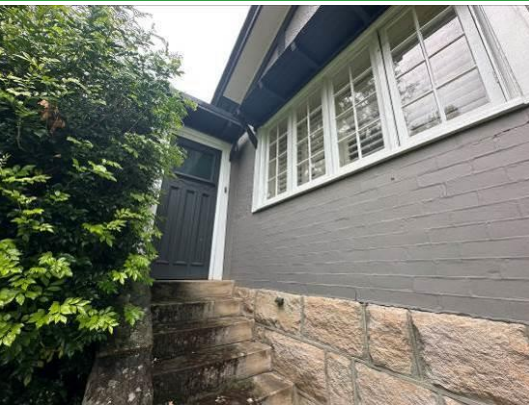
| External, main dwelling, window frames throughout | White Paint | Non-friable | Visual inspection – similar to LP-21 | - | N/A | N/A | N/A | N/A | N/A | |

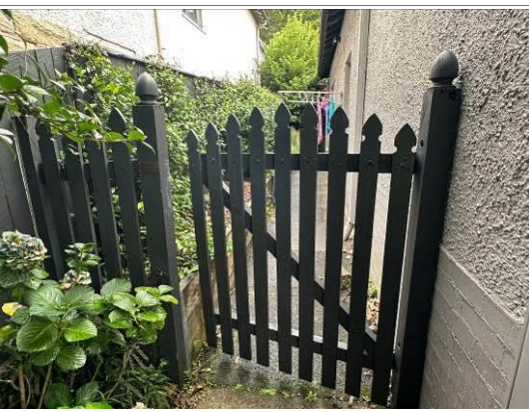
| External, main dwelling, eastern side, backyard gate and fences | Grey Paint | Non-friable | LP-23A | 0.007% w/w | N/A | N/A | N/A | N/A | N/A | |

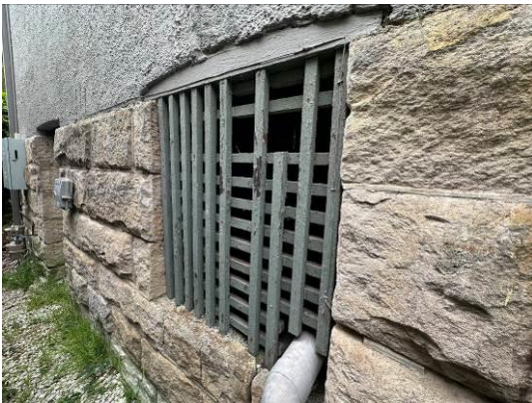
| Subfloor space, western side, timber window frame | Green Paint | Non-friable | LP-22 | 0.004% w/w | N/A | N/A | N/A | N/A | N/A |

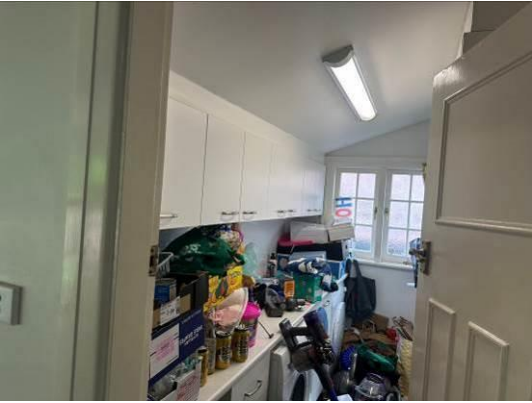
| Internal, main dwelling, south western side, laundry, ceiling, fluorescent light fittings | PCB-containing single-tube fluorescent light fitting capacitors (assumed) | N/A | Visual inspection - electrical hazard | - | 1 x unit | Good / Maintenance only | Priority 4 - Negligible Risk Level | 21/02/2025 | Remove prior to demolition works.<br>Avoid damage to capacitors. |

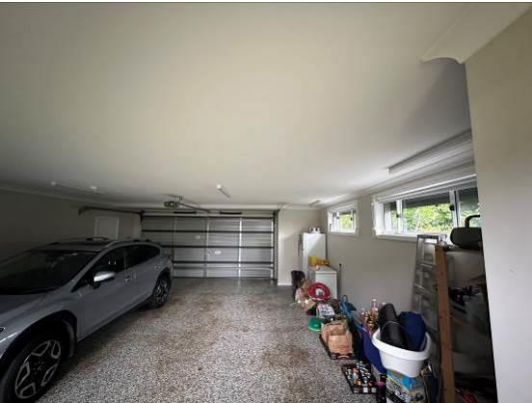
| Internal, detached granny flat / garage, ceilings, fluorescent light fittings | PCB-containing single-tube fluorescent light fitting capacitors (assumed) | N/A | Visual inspection - electrical hazard | - | 7 x units | Good / Maintenance only | Priority 4 - Negligible Risk Level | 21/02/2025 | Remove prior to demolition works.<br>Avoid damage to capacitors. |

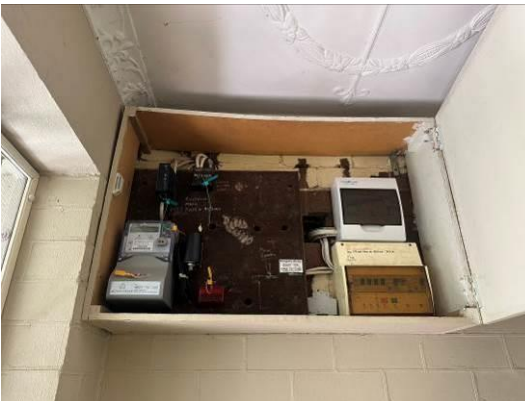
| External, main dwelling, northern side, black meter backing board | ACM (assumed) | Non-friable | Visual inspection - electrical hazard | - | 1 x board | Good / Maintenance only | Priority 4 - Negligible Risk Level | 24/02/2024 | Remove during initial stage of demolition works | |

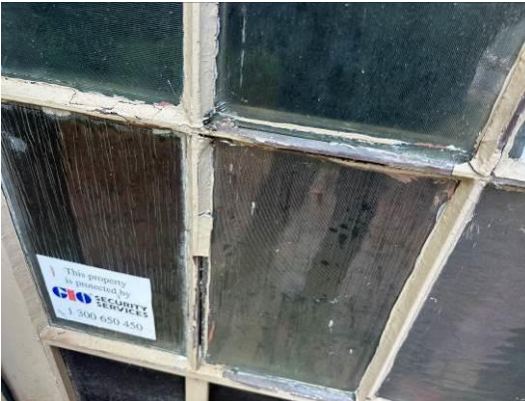
| External, main dwelling, western side, door to subfloor space, window frame | Putty | Non-friable | Asb-10 | No Asbestos Detected | N/A | N/A | N/A | N/A | N/A | |

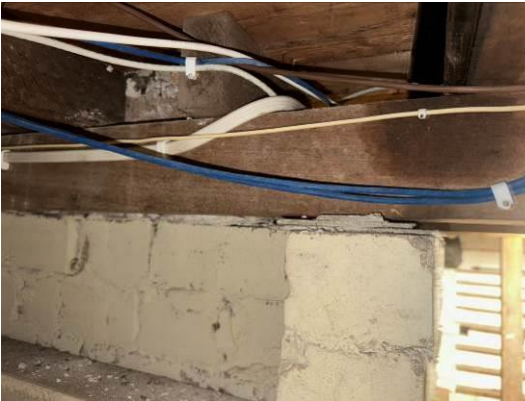
| Main dwelling, subfloor space, western, packers | ACM | Non-friable | Asb-11 | Chrysotile Asbestos Detected | Approximately 2m <sup>2</sup> | Poor / Maintenance only | Priority 3 - Low Risk Level | 24/02/2025 | ACM packers are likely present throughout the entire subfloor area<br>Remove under controlled demolition conditions | |

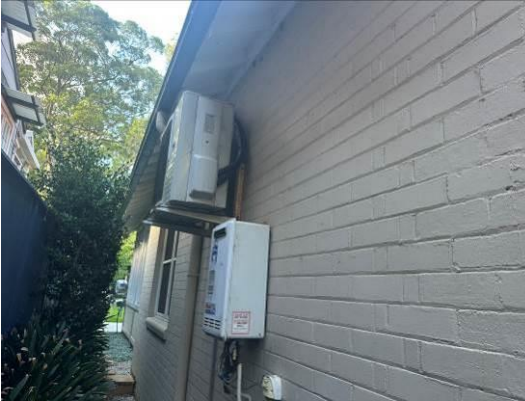
| External, eastern side, hot water unit | SMF-lined insulation (assumed) | Sealed | Visual inspection | - | 1 x unit | Good / Maintenance only | Priority 4 - Negligible Risk Level | 24/02/2025 | Remove during initial stage of demolition works | |

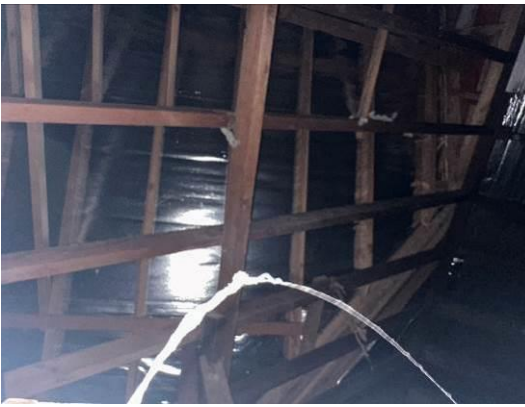
| Main dwelling, ceiling cavity, roof sarking | SMF-lined insulation (assumed) | Sealed | Visual inspection | - | ND | Good / Maintenance only | Priority 4 - Negligible Risk Level | 24/02/2025 | Remove during initial stage of demolition works | |

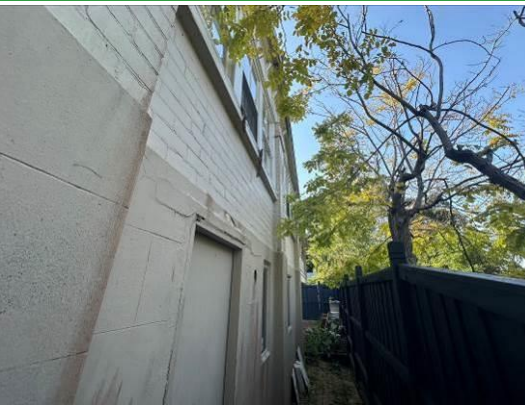
| External, main dwelling, western wall | Cream LBP | Non-friable | LP-24 | 0.10% w/w | >50m <sup>2</sup> | Good Occasional | Priority 4 - Negligible Risk Level | 24/02/2025 | Remove grossly peeling paint. Stabilise remaining membrane. Minimise abrasive works that will disturb paint during demolition. | |

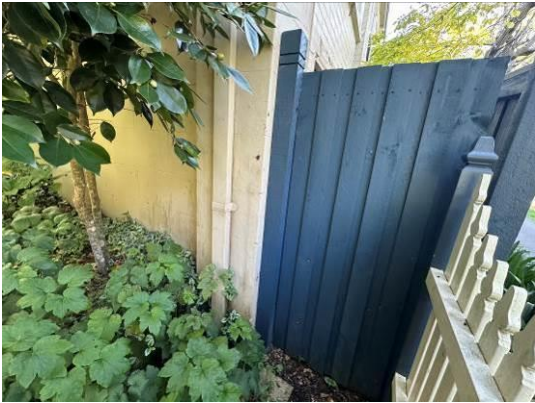
| External, main dwelling, western, gate to backyard | Blue Paint | Non-friable | LP-25 | 0.003% w/w | N/A | N/A | N/A | N/A | N/A | |

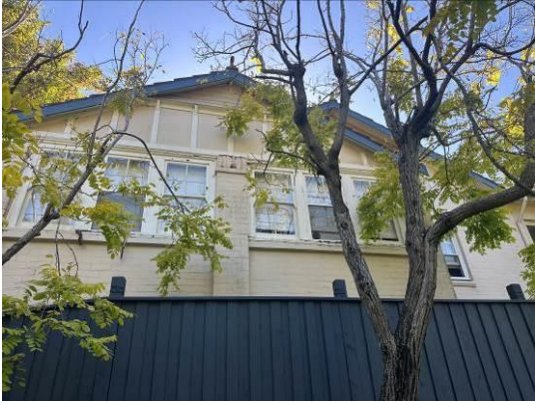
| External, main dwelling, fences, gates and awnings | Blue Paint | Non-friable | Visual inspection – similar to LP-25 | - | N/A | N/A | N/A | N/A | N/A | |

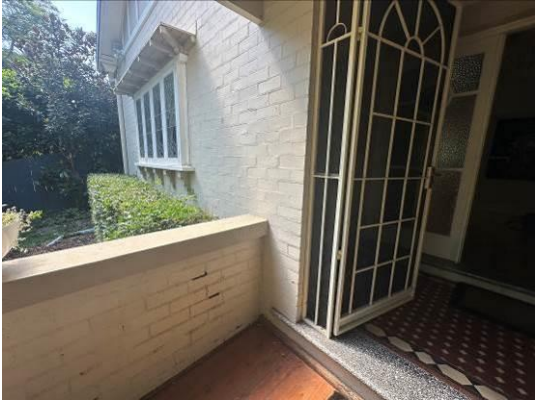
| External, main dwelling, western side, window frames | Cream Paint | Non-friable | LP-27 | 0.007% w/w | N/A | N/A | N/A | N/A | N/A | |

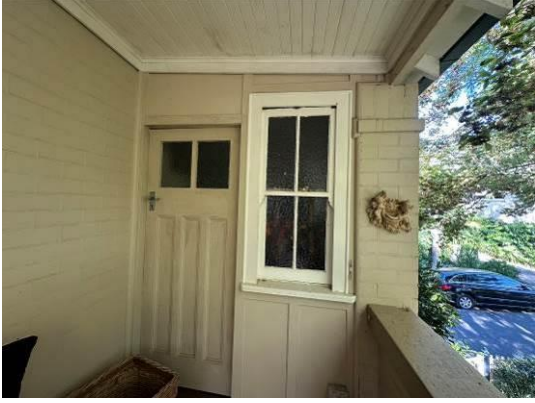
| External, main dwelling, window frames and door frames throughout | Cream Paint | Non-friable | Visual inspection – similar to LP-27 | - | N/A | N/A | N/A | N/A | N/A | |

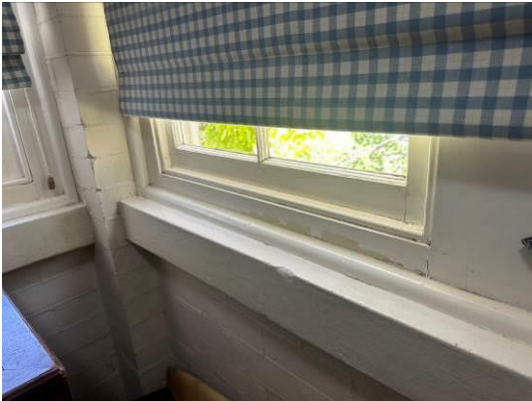
| Internal, ground level, north western side, sunroom, window frames | Cream Paint | Non-friable | LP-28 | 0.036 % w/w | N/A | N/A | N/A | N/A | N/A | |

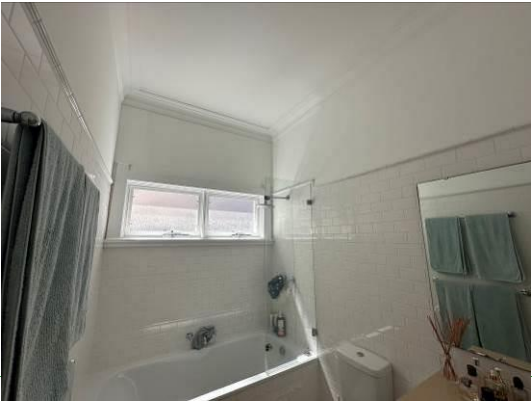
| Internal, window frames throughout | Cream Paint | Non-friable | Visual inspection – similar to LP-28 | - | N/A | N/A | N/A | N/A | N/A | |

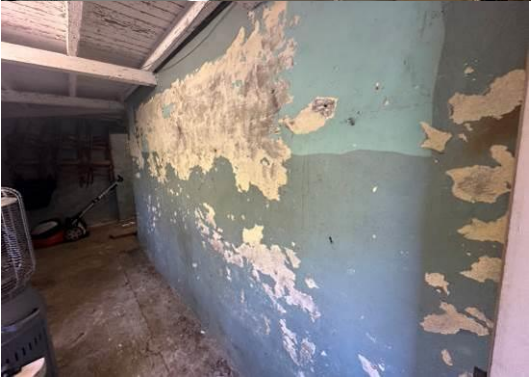
| Main dwelling, subfloor space, western access, upper wall | Light blue LBP | Non-friable | LP-30 | 0.14% w/w | Approximately 10m <sup>2</sup> | Poor Occasional | Priority 3 - Low Risk Level | 24/02/2025 | Remove grossly peeling paint. Stabilise remaining membrane. Minimise abrasive works that will disturb paint during demolition. | |

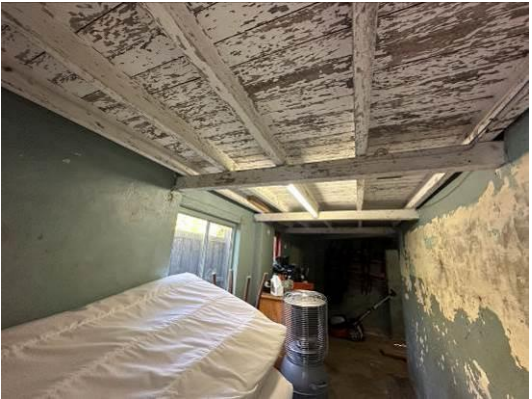
| Subfloor space, western access, walls | Blue Paint | Non-friable | LP-29 | 0.013% w/w | N/A | N/A | N/A | N/A | N/A |
