## AQUALAND PRESTIGE 2 PTY LTD

## Hazardous Materials Survey

2-16 Pockley Avenue, Roseville NSW

**Report No:** E26491.E10\_Rev1

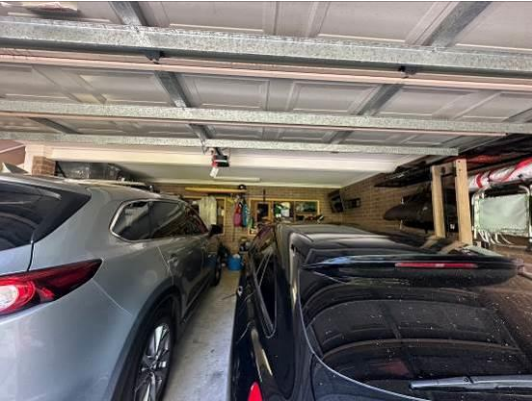
| Internal, main dwelling, lower ground level, garage, ceiling, fluorescent light fittings | PCB-containing single-tube fluorescent light fitting capacitors (assumed) | N/A | Visual inspection - electrical hazard | - | 3 x units | Good / Maintenance only | Priority 4 - Negligible Risk Level | 24/02/2025 | Remove prior to demolition works. Avoid damage to capacitors. |
