Hazardous Materials Survey

93-107 Cecil Avenue and 9-10 Roger Avenue, Castle Hill,
NSW

E26536.E10_Rev1
6 December 2024

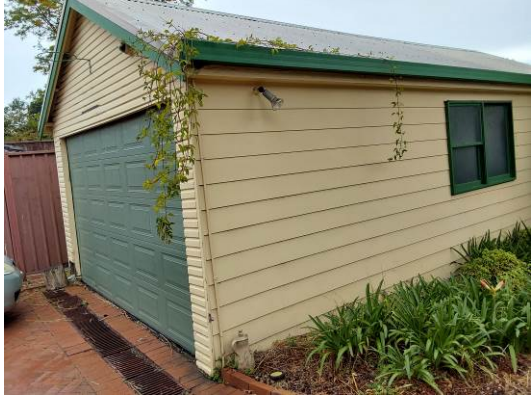
Detached Garage, internals	Possible hazardous materials	Unknown	-	-	Unknown	Unknown	Unknown	Inspect when access is made available, prior to demolition

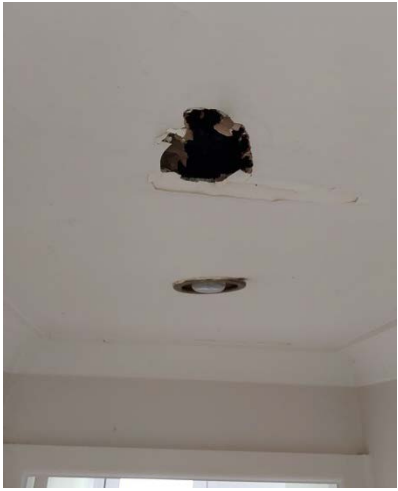
Main dwelling, internal, , ceiling	FCS	Non-friable	Asb-3	No Asbestos Detected	N/A	N/A	N/A	N/A

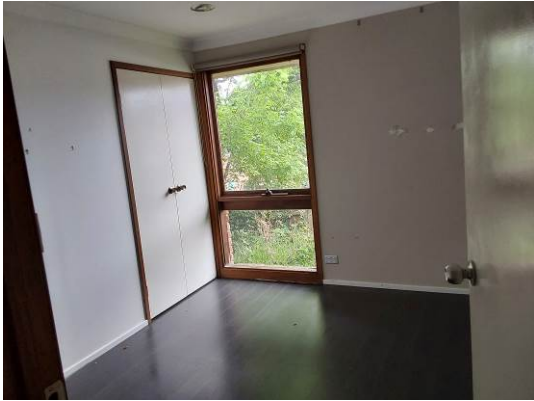
Location	Material	Friability	Sample	Analysis Result	Quantity	Condition / Accessibility	Priority	Recommendations / Comments	Photograph
ACM									
Internal and External, throughout	ACM	-	Visual inspection	-	N/A	N/A	N/A	No suspected ACM containing materials identified within visible and safely accessible areas during the inspection	
SMF									
Internal and External, throughout	SMF	-	Visual inspection	-	N/A	N/A	N/A	No suspected SMF containing materials identified within visible and safely accessible areas during the inspection	-
LBP									
Internal, central room, western wall	Pink paint	Non-friable	Pb-32	<0.001% w/w	N/A	N/A	N/A	N/A

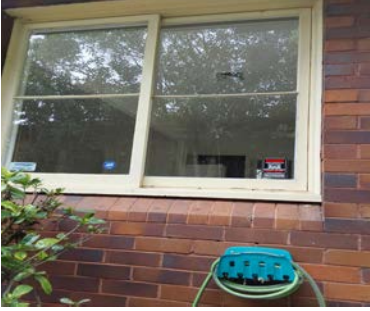
Main dwelling, external, window sill	White LBP	Non-friable	Pb-20	0.80% w/w	7 x windows	Good / Maintenance only	Priority 4 - Negligible Risk Level	Remove grossly peeling paint. Stabilise remaining membrane. Minimise abrasive works that will disturb paint during demolition.

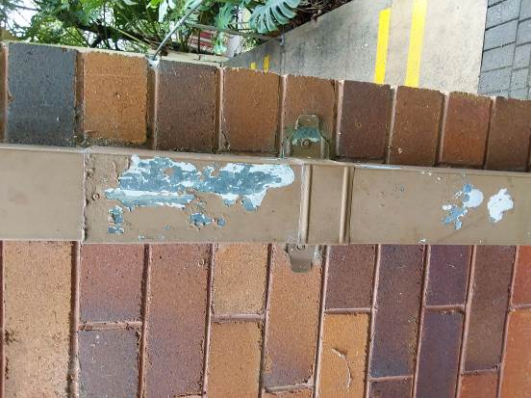
Main dwelling, external, trimming	Brown LBP	Friable	Pb-21	0.21% w/w	Approximately 10m ²	Good / Maintenance only	Priority 4 - Negligible Risk Level	Remove grossly peeling paint. Stabilise remaining membrane. Minimise abrasive works that will disturb paint during demolition

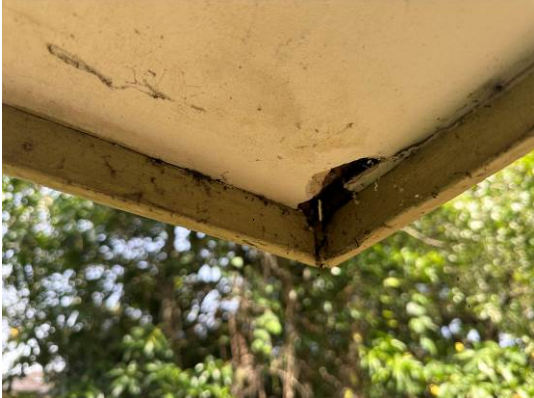
Location	Material	Friability	Sample	Analysis Result	Quantity	Condition / Accessibility	Priority	Recommendations / Comments	Photograph
ACM									
External, eaves throughout	FCS	Non-friable	Asb2-3	No Asbestos Detected	N/A	N/A	N/A	N/A

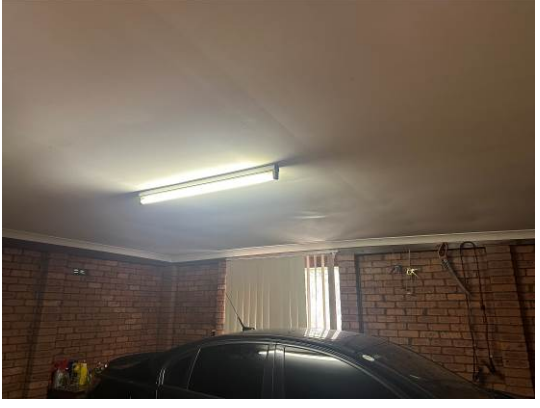
Internal, garage, ceiling, fluorescent lights	PCB-containing single-tube fluorescent light fitting capacitors (assumed)	N/A	Visual inspection - electrical hazard	-	1 x fixture	Good / Maintenance only	Priority 4 - Negligible Risk Level	Remove prior to demolition works. Avoid damage to capacitors.

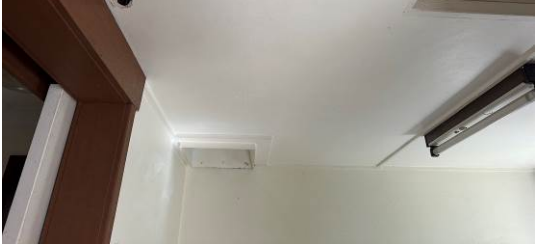
Internal, ground floor, northern bathroom, ceiling	FCS	Non-friable	Asb2-4	No Asbestos Detected Organic Fibres Detected	N/A	N/A	N/A	N/A

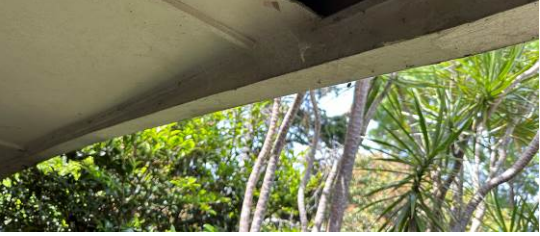
External, veranda, awning	FCS	Non-friable	Asb2-5	No Asbestos Detected Organic Fibres Detected	N/A	N/A	N/A	N/A

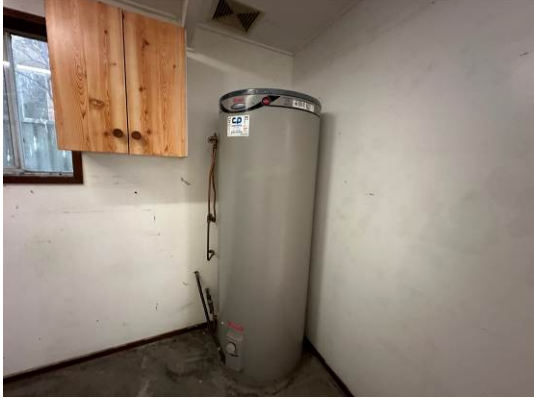
Internal, garage, hot water heater	SMF-lined insulation (assumed)	Sealed	Visual inspection	-	1 x unit	Good / Maintenance only	Priority 4 - Negligible Risk Level	Remove during initial stage of demolition works

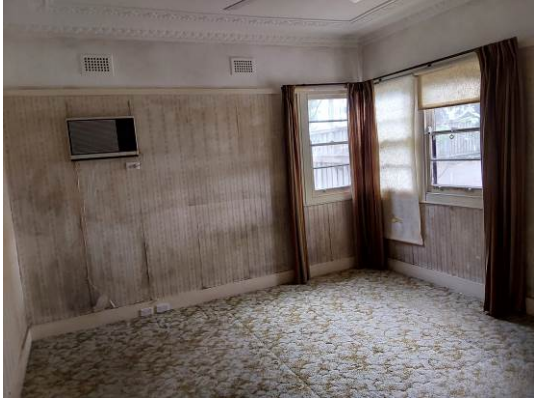
Location	Material	Friability	Sample	Analysis Result	Quantity	Condition / Accessibility	Priority	Recommendations / Comments	Photograph
ACM									
Internal, northern wall, wallpaper	Vinyl wallpaper	Non-friable	Asb-5	No Asbestos Detected	N/A	N/A	N/A	N/A

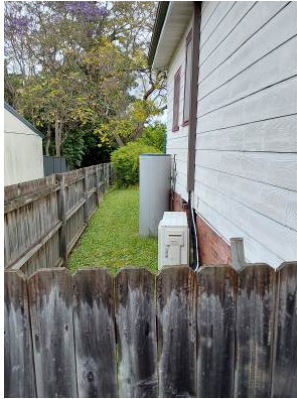
SMF									
External, eastern wall, hot water heater	SMF-lined insulation (assumed)	Sealed	Visual inspection	-	1 x unit	Good / Maintenance only	Priority 4 - Negligible Risk Level	Remove during initial stage of demolition works

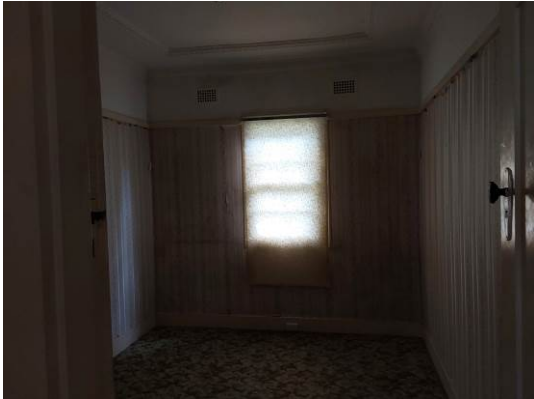
LBP									
Internal, northern room, door frame	White LBP	Non-friable	Pb-16	0.39% w/w	ND	Good / Maintenance only	Priority 4 - Negligible Risk Level	Remove grossly peeling paint. Stabilise remaining membrane. Minimise abrasive works that will disturb paint during demolition.

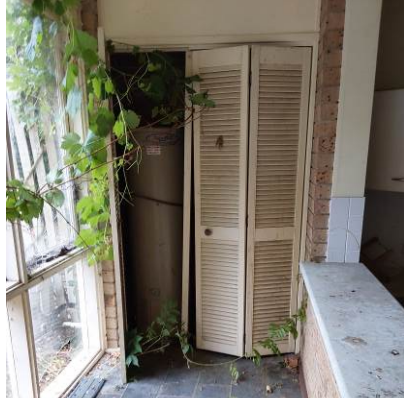
Internal, northern room, hot water heater	SMF-lined insulation (assumed)	Sealed	Visual inspection	-	1 x unit	Good / Maintenance only	Priority 4 - Negligible Risk Level	Remove during initial stage of demolition works

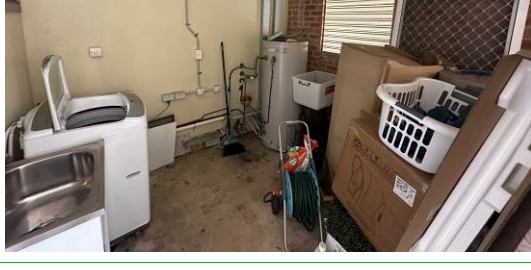
Main dwelling, internal, western room, laundry, hot water heater	SMF-lined insulation (assumed)	Sealed	Visual inspection	-	1 x unit	Good / Maintenance only	Priority 4 - Negligible Risk Level	Remove during initial stage of demolition works

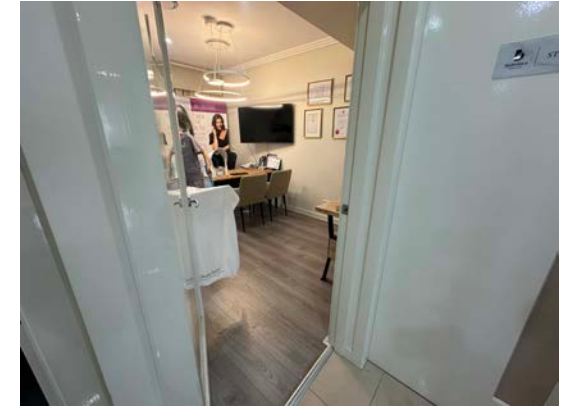
Main dwelling, internal, western room, door frame, paint	White paint	Non-friable	Pb2-9	<0.001% w/w	N/A	N/A	N/A	N/A
--	-------------	-------------	-------	-------------	-----	-----	-----	-----

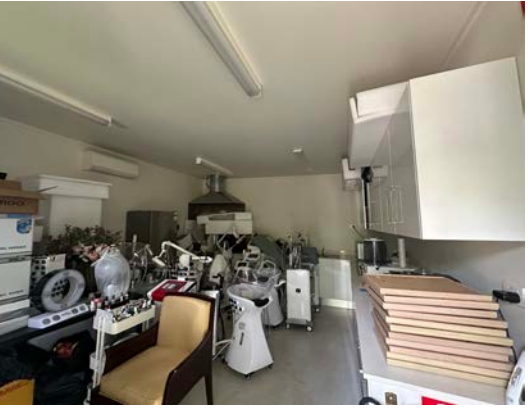
PCB									
North western detached office, ceiling, fluorescent lights	PCB-containing single-tube fluorescent light fitting capacitors (assumed)	N/A	Visual inspection - electrical hazard	-	4x fixtures	Good / Maintenance only	Priority 4 - Negligible Risk Level	Remove prior to demolition works. Avoid damage to capacitors.

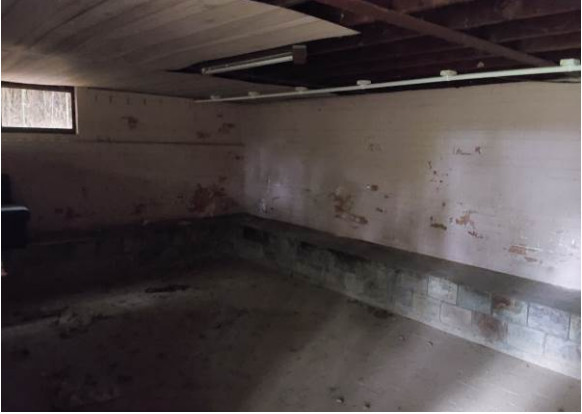
Internal, basement, walls,	Pink paint	Non-friable	Pb-35	0.002% w/w	N/A	N/A	N/A	N/A

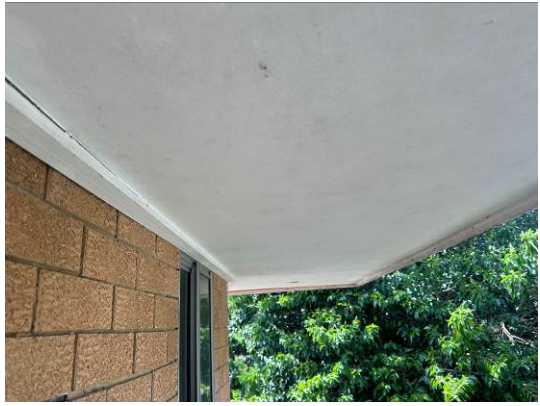
Main building external, eaves throughout	ACM	Non-friable	Asb2-1	Amosite & Chrysotile Asbestos Detected	Approximately 30m ²	Good / Maintenance only	Priority 3 - Low Risk Level	Remove during initial stage of demolition works

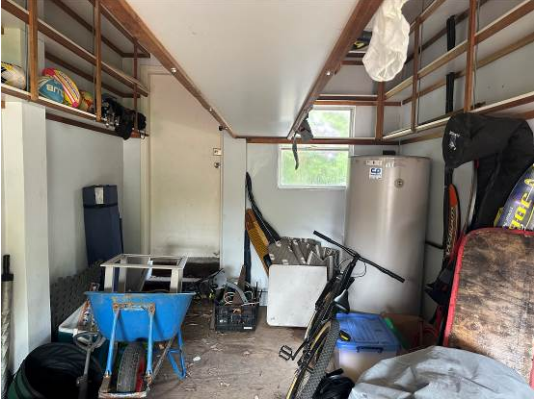
Attached Garage, internal, hot water heater	SMF-lined insulation (assumed)	Sealed	Visual inspection	-	1 x unit	Good / Maintenance only	Priority 4 - Negligible Risk Level	Remove during initial stage of demolition works

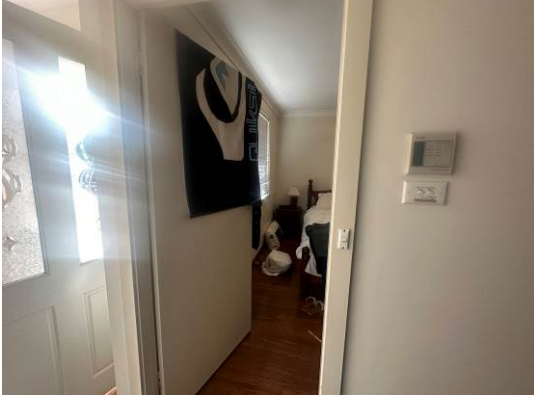
Main building, internal, western room, door frame,	Cream paint	Non-friable	Pb2-2	0.004% w/w	N/A	N/A	N/A	N/A

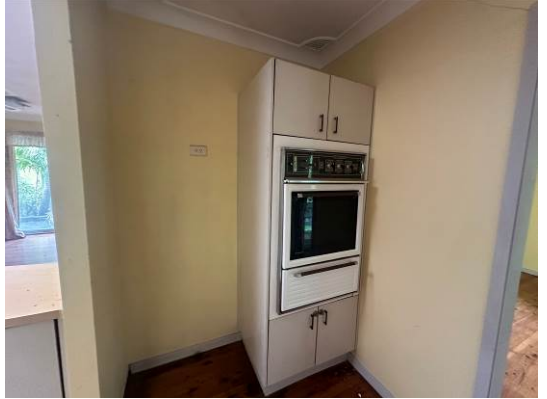
Location	Material	Friability	Sample	Analysis Result	Quantity	Condition / Accessibility	Priority	Recommendations / Comments	Photograph
ACM									
Internal, kitchen, walls	ACM	Non-friable	Asb2-9	Chrysotile Asbestos Detected Organic Fibres Detected	Approximately 40m ²	Good / Maintenance only	Priority 3 - Low Risk Level	Remove during initial stage of demolition works

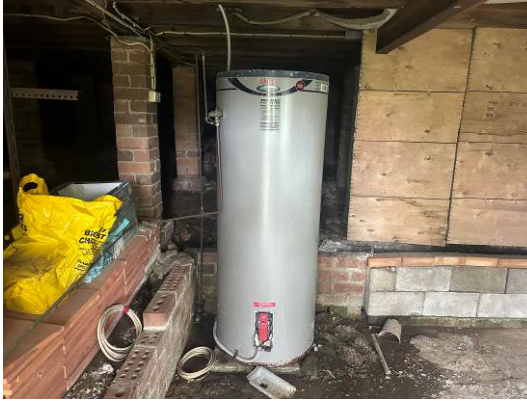
External, floor cavity, hot water heater	SMF-lined insulation (assumed)	Sealed	Visual inspection	-	1 x unit	Good / Maintenance only	Priority 4 - Negligible Risk Level	Remove during initial stage of demolition works

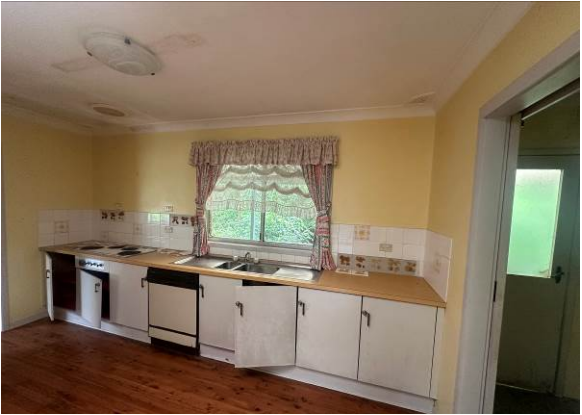
Internal, kitchen, walls	Cream paint	Non-friable	Pb2-13	0.002% w/w	N/A	N/A	N/A	N/A

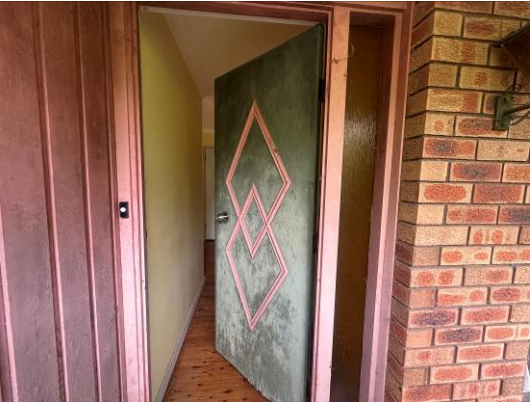
Internal, eastern rooms, walls,	Blue paint	Non-friable	Pb2-14	0.001% w/w	N/A	N/A	N/A	N/A	 
Internal, eastern rooms, door frames and window frames	Green paint	Non-friable	Pb2-15	0.064% w/w	N/A	N/A	N/A	N/A	 
External, southern main entrance	Pink paint	Non-friable	Pb2-16	0.065% w/w	N/A	N/A	N/A	N/A

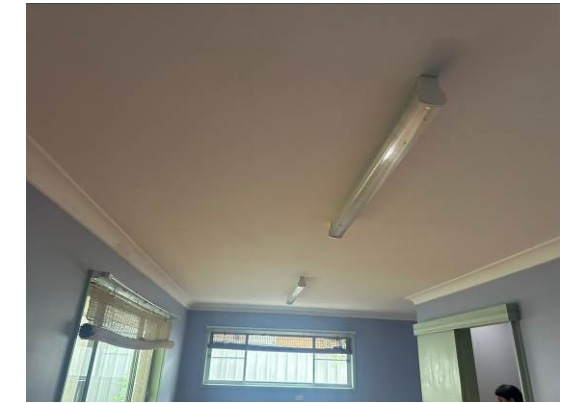
Internal, north western room, ceiling, fluorescent lights	PCB-containing single-tube fluorescent light fitting capacitors (assumed)	N/A	Visual inspection - electrical hazard	-	2x fittings	Good / Maintenance only	Priority 4 - Negligible Risk Level	Remove prior to demolition works. Avoid damage to capacitors.
---	--	-----	---------------------------------------	---	-------------	-------------------------	------------------------------------	--

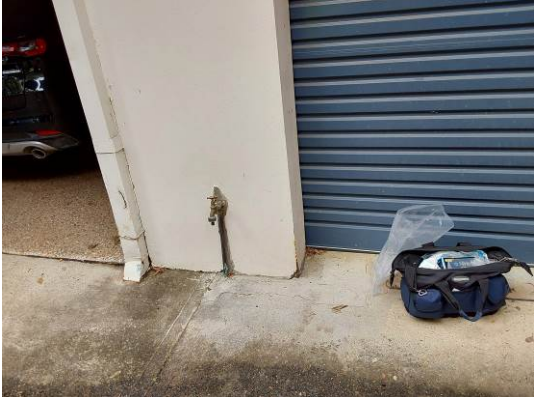
Location	Material	Friability	Sample	Analysis Result	Quantity	Condition / Accessibility	Priority	Recommendations / Comments	Photograph
ACM									
Detached garage, external, walls	FCS	Non-friable	Asb-1	No Asbestos Detected	N/A	N/A	N/A	N/A

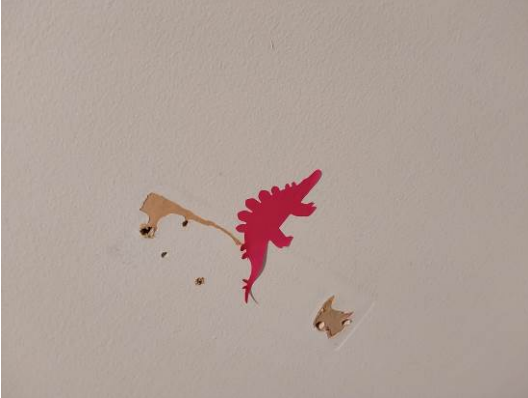
Main building internal,, second floor, eastern bedroom, walls, lilac paint	Lilac paint	Non-friable	Pb-6	0.004% w/w	N/A	N/A	N/A	N/A

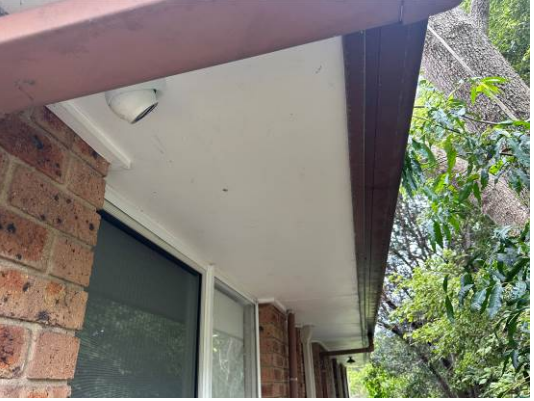
Location	Material	Friability	Sample	Analysis Result	Quantity	Condition / Accessibility	Priority	Recommendations / Comments	Photograph
ACM									
Main dwelling, external, eaves	FCS	Non-friable	Asb2-8	No Asbestos Detected Organic Fibres Detected	N/A	N/A	N/A	N/A

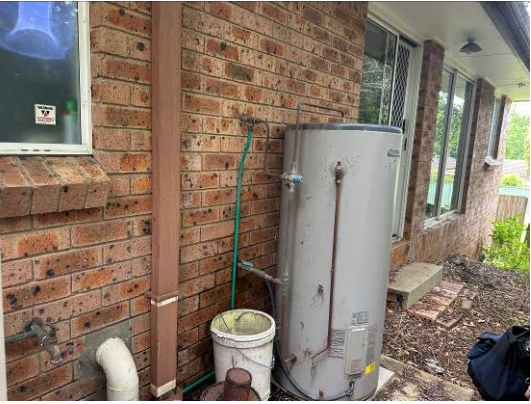
Main dwelling, external, western wall, hot water heater	SMF-lined insulation (assumed)	Sealed	Visual inspection	-	1x unit	Good / Maintenance only	Priority 4 - Negligible Risk Level	Remove during initial stage of demolition works

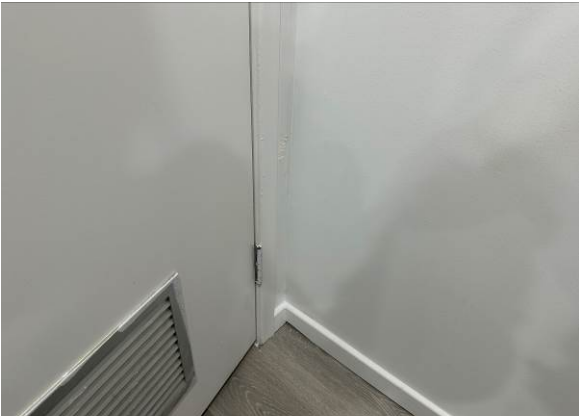
Main dwelling, internal, central east room, walls	White paint	Non-friable	Pb2-11	<0.001% w/w	N/A	N/A	N/A	N/A

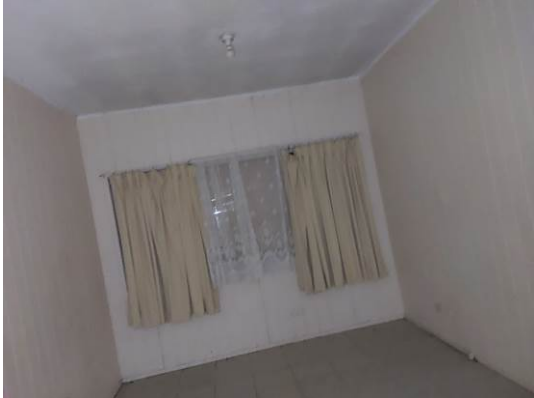
Location	Material	Friability	Sample	Analysis Result	Quantity	Condition / Accessibility	Priority	Recommendations / Comments	Photograph
ACM									
Internal, central room, walls	FCS	Non-friable	Asb-7	No Asbestos Detected Organic Fibres Detected	N/A	N/A	N/A	N/A

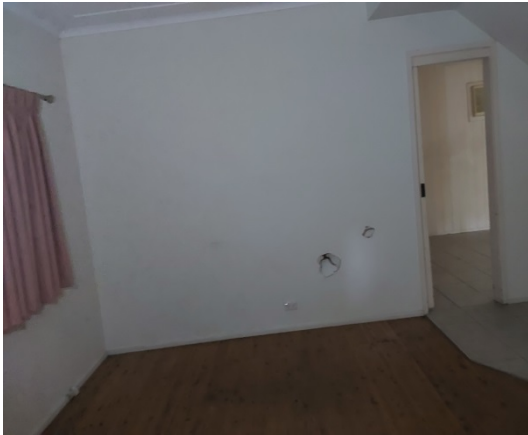
Internal, central room, walls	White paint	Non-friable	Pb2-9	0.006% w/w	N/A	N/A	N/A	N/A

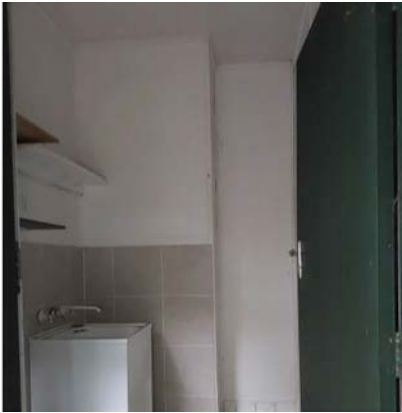
External, laundry, door	Green paint	Non-friable	Pb-30	0.012% w/w	N/A	N/A	N/A	N/A

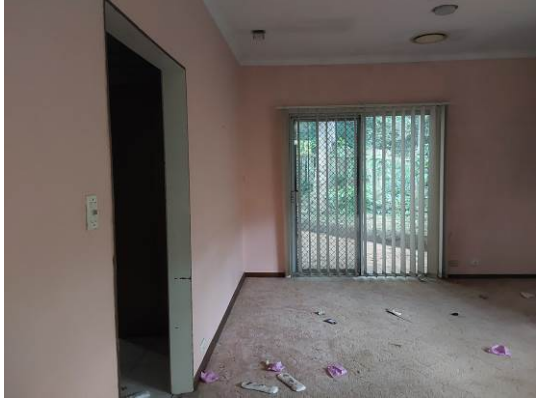
Internal, south eastern room, walls	FCS	Non-friable	Asb-6	No Asbestos Detected Organic Fibres Detected	N/A	N/A	N/A	N/A

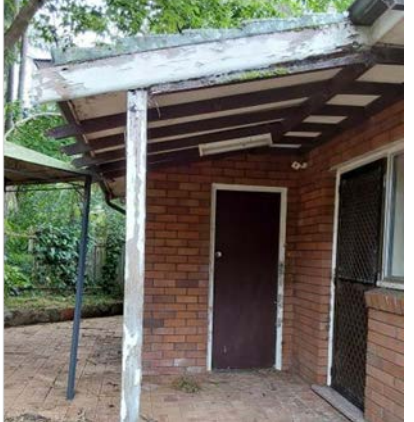
External, northern support beam, white paint	White LBP	Non-friable	Pb-27	3.2% w/w	1x unit	Fair / Maintenance only	Priority 3 - Low Risk Level	Remove grossly peeling paint. Stabilise remaining membrane. Minimise abrasive works that will disturb paint during demolition.

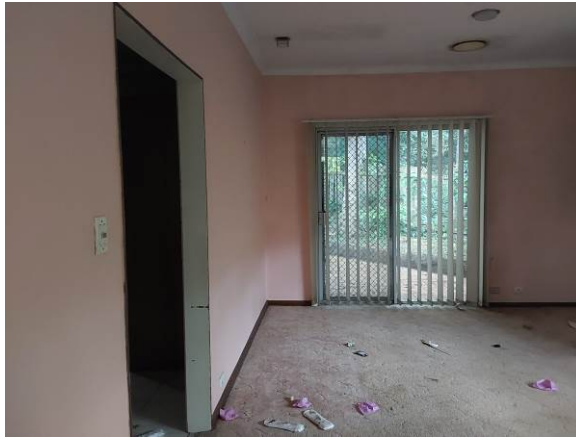
Internal, south eastern room, walls	Pink paint	Non-friable	Pb-24	0.002% w/w	N/A	N/A	N/A	N/A

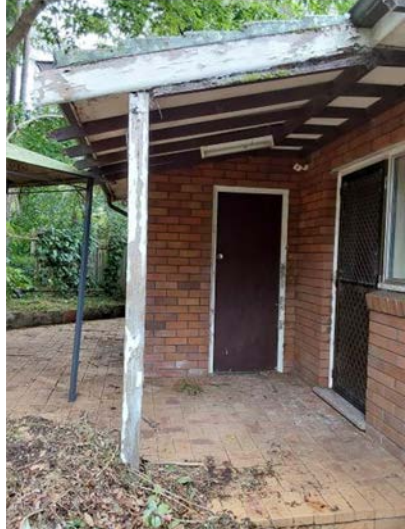
<p>External, veranda, fluorescent light</p>	<p>PCB-containing single-tube fluorescent light fitting capacitors (assumed)</p>	<p>N/A</p>	<p>Visual inspection - electrical hazard</p>	<p>-</p>	<p>1x unit</p>	<p>Good / Maintenance only</p>	<p>Priority 4 - Negligible Risk Level</p>	<p>Remove prior to demolition works. Avoid damage to capacitors.</p>
