## Hazardous Construction Materials Survey

12 – 16 Bent Street, Lindfield NSW

10 February 2025

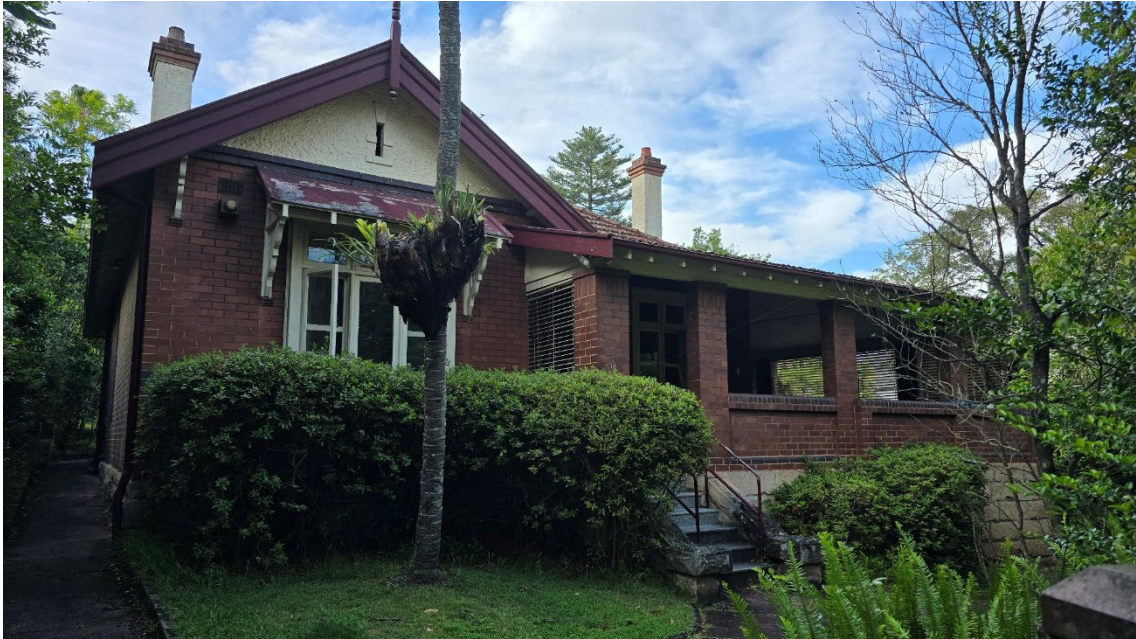
#### 14 Bent Street, Lindfield NSW

The house located on the residential property at 14 Bent Street is a full masonry and timber framed building that has terracotta tiles over the main roof area with corrugated metal or corrugated asbestos cement sheet over the rear skillion roofs, face brick external wall cladding with stone walls below floor level and painted rough cement render to the front gable wall, fibrous plaster soffit lining over the front verandah, timber lining boards to the eaves, timber framed windows and entry doors, timber fascias and metal eaves gutters and down pipes. See photograph Nos. 1, 2, 3 and 4.

- The verge tiles along the roof gable ends are presumed to be supported on strips of flat asbestos cement sheet.
- Within the house the ceiling lining in the kitchen is flat asbestos cement sheet.
- The blue coloured tiles in the lower layer of vinyl floor tiles in the kitchen contain chrysotile asbestos.
- SMF insulation batts may be present within the roof space on top of the ceiling linings.
- Paint finishes on and in the house are all in good condition and are presumed to be lead based paints.
- Settled dust in the roof space will contain lead contamination.

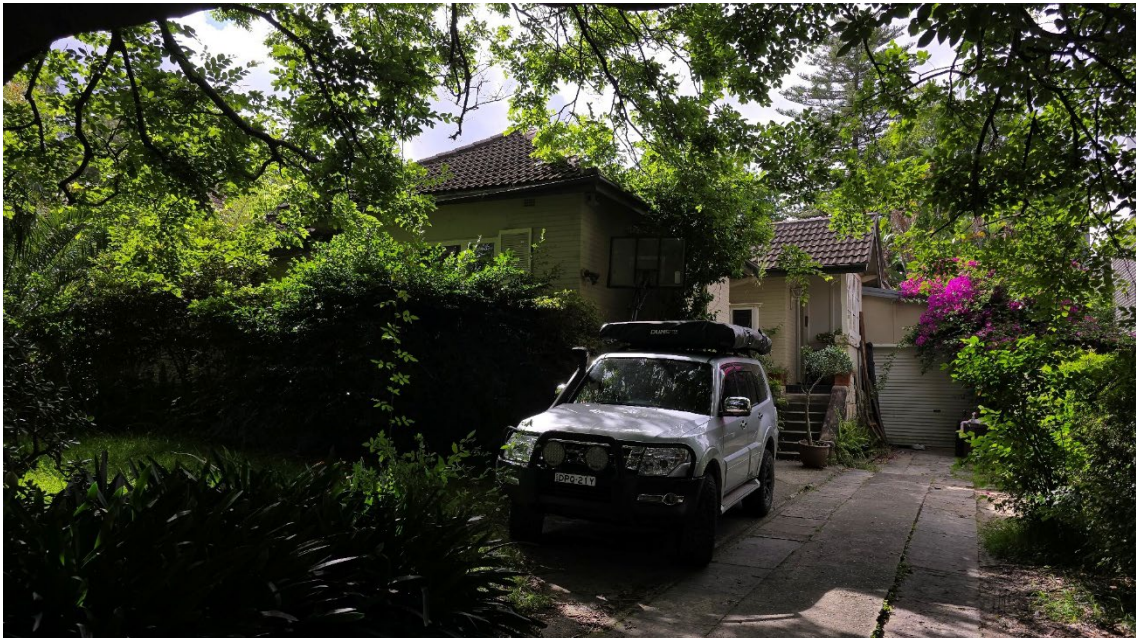
### House at 16 Bent Street, Lindfield NSW

The house located on the residential property at 16 Bent Street is a single storey full masonry and timber framed building that has concrete tiles over the main original roof area, metal tray profile roof cladding over the rear covered verandah, painted face brick external wall cladding with stone walls below floor level and flat asbestos cement sheet cladding to the various framed walls, flat asbestos cement sheet and timber lining boards to the eaves and entry porch ceiling, timber lining boards to the soffit over the rear covered verandah, timber framed windows and entry doors, timber fascias and metal eaves gutters and downpipes.
