# **DILAPIDATION REPORT**

**For Property At  
3A Valley Rd,  
Lindfield, NSW 2070**

**For Development At  
59-63 Trafalgar Ave & 1A-1B Valley Rd,  
Lindfield, NSW 2070**

**Ref: 26009-DR-001-R1-3A Valley Rd  
Date: 25.05.2026**

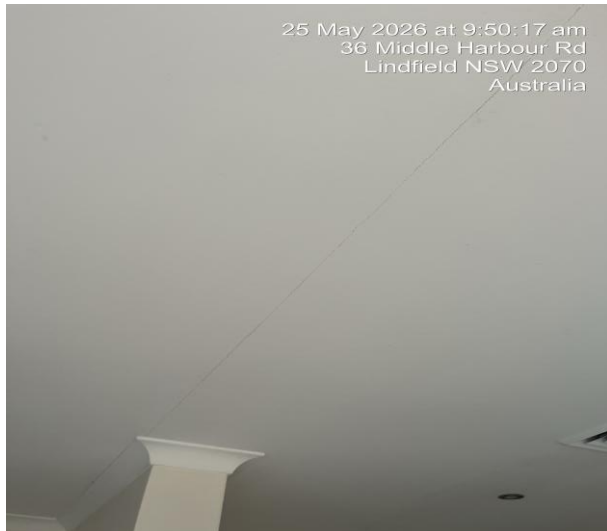
Photo 13 – Cracking observed to ceiling

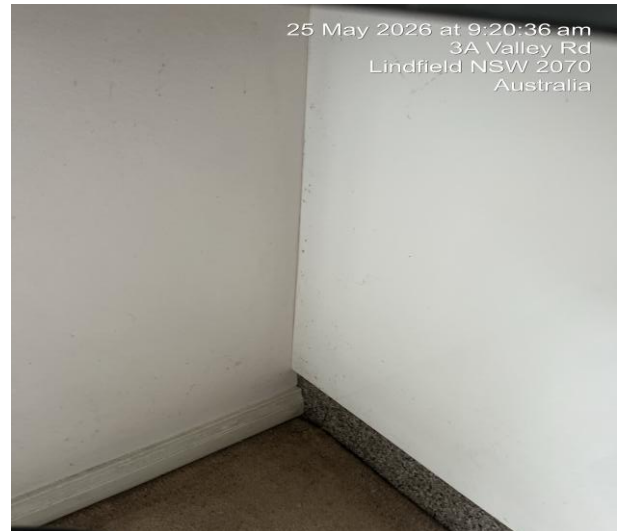
Photo 20 – Cracking observed to skirting

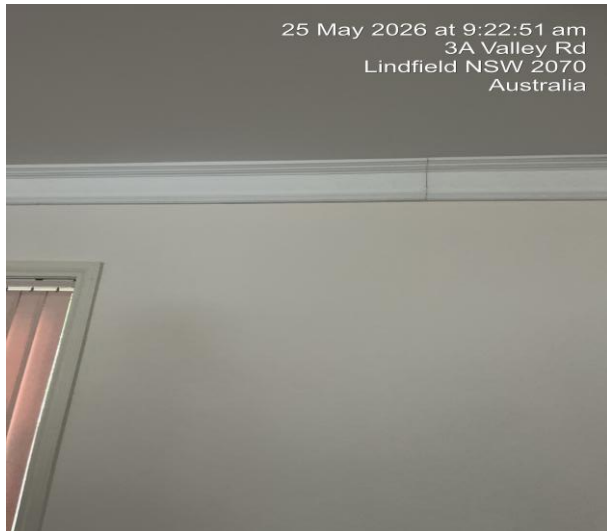
Photo 31 – Cracking observed to coving

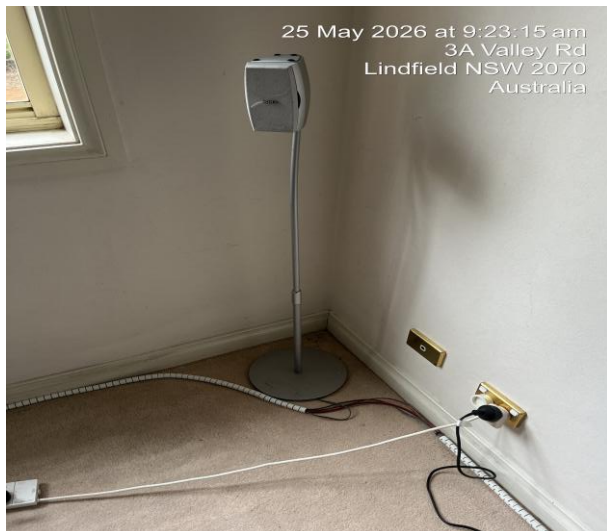
Photo 33 – Cracking observed to skirting

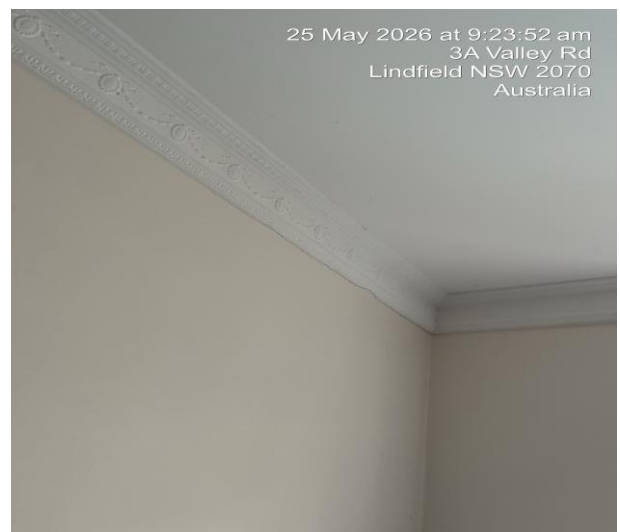
Photo 36 – Cracking observed to coving

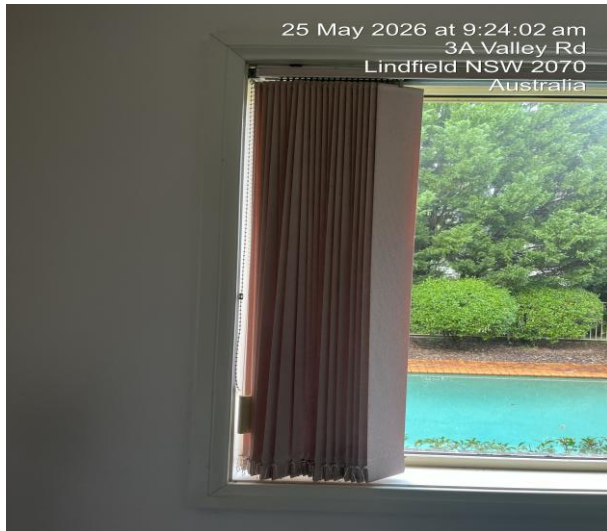
Photo 37 – Cracking observed to framing

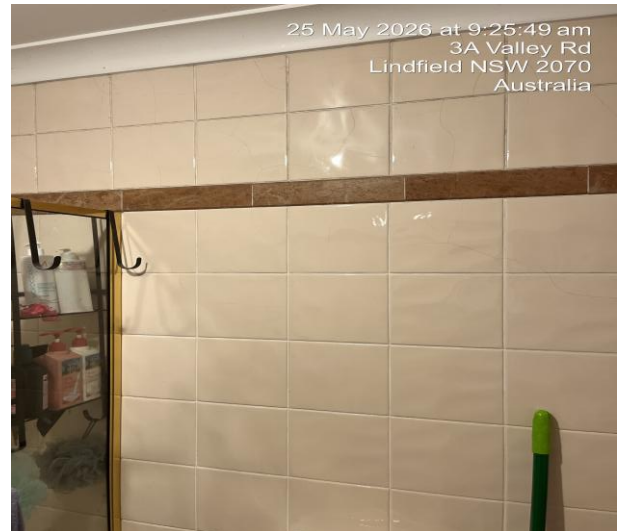
Photo 44 – Cracking observed to tiles

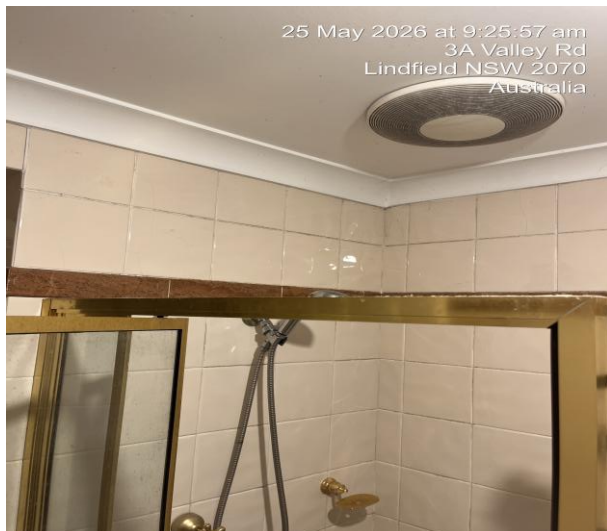
Photo 45 – Cracking observed to tiles

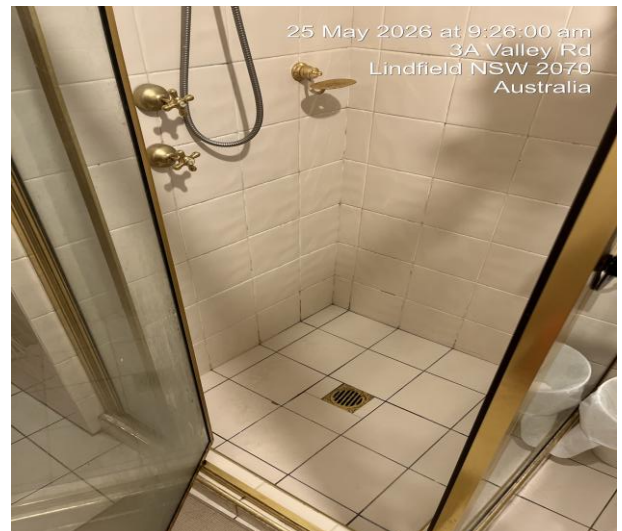
Photo 46 – Cracking observed to tiles

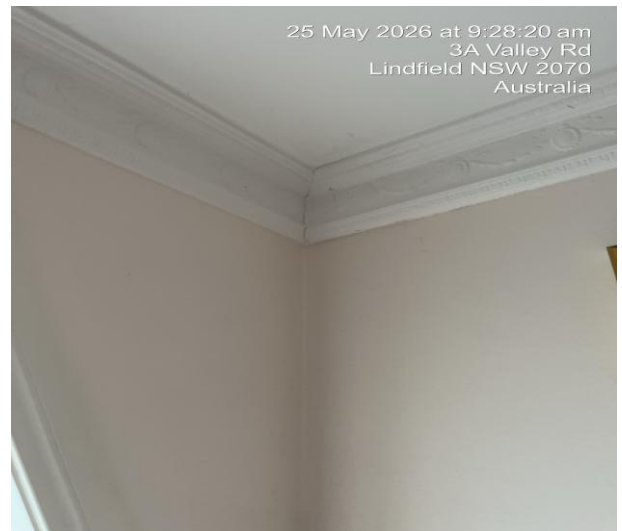
Photo 58 – Cracking observed to coving

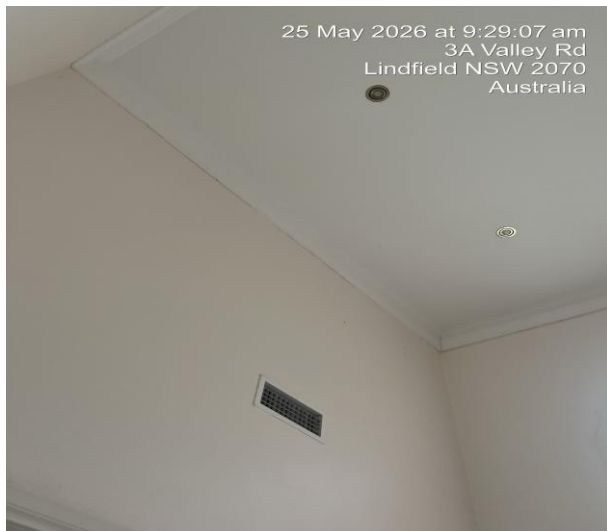
Photo 63 – Cracking observed to coving

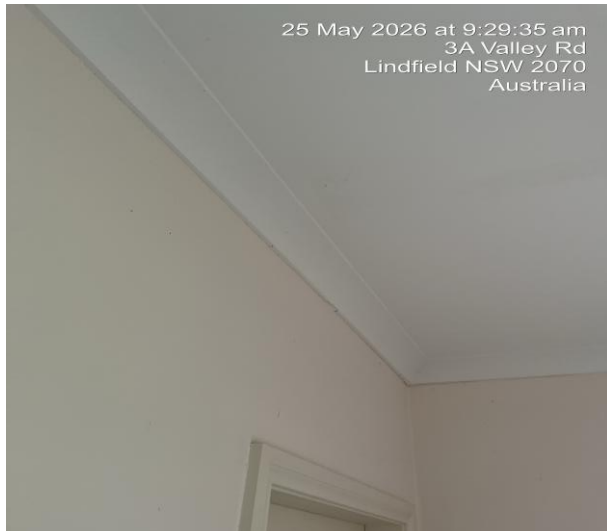
Photo 67 - Cracking observed to coving

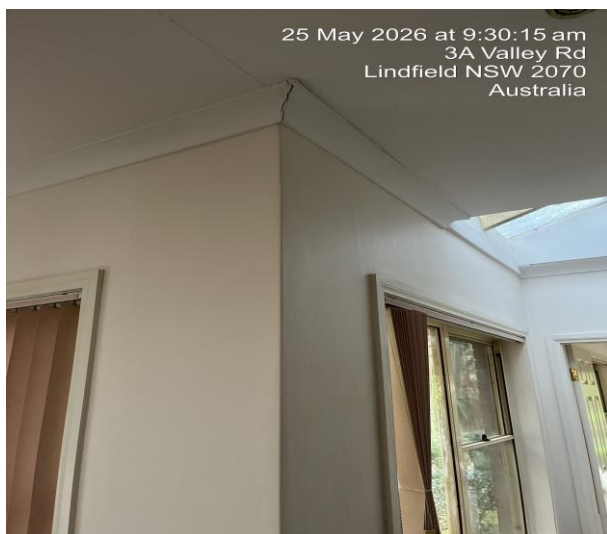
Photo 71 – Cracking observed to coving

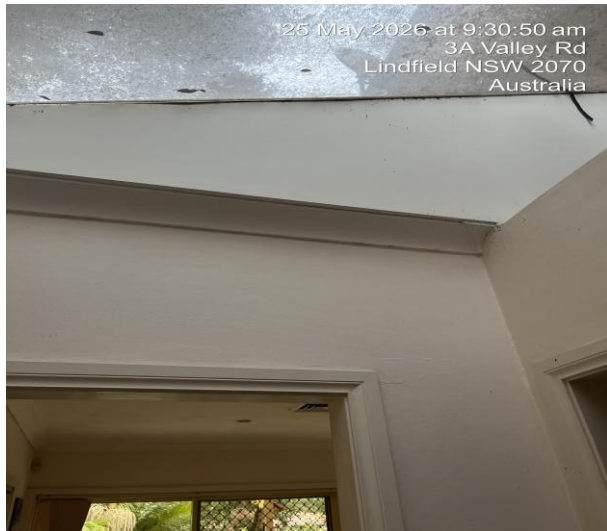
Photo 73 – Cracking observed to coving

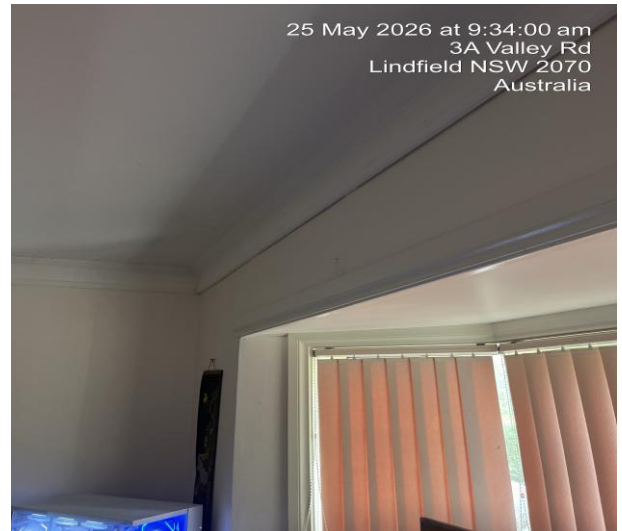
Photo 86 - Movement observed to coving

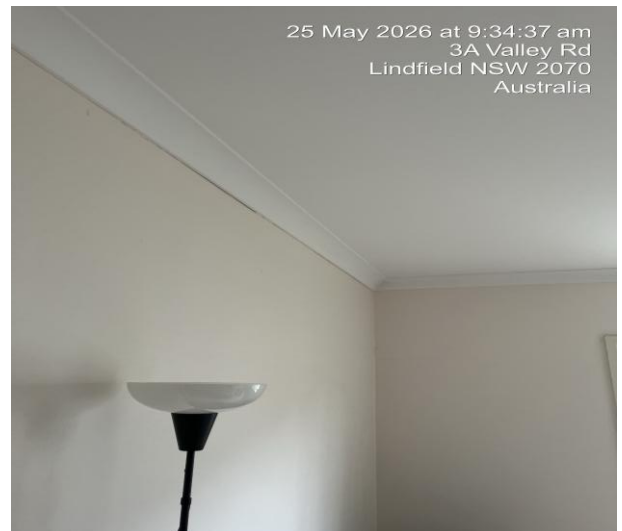
Photo 88 - Cracking observed to coving

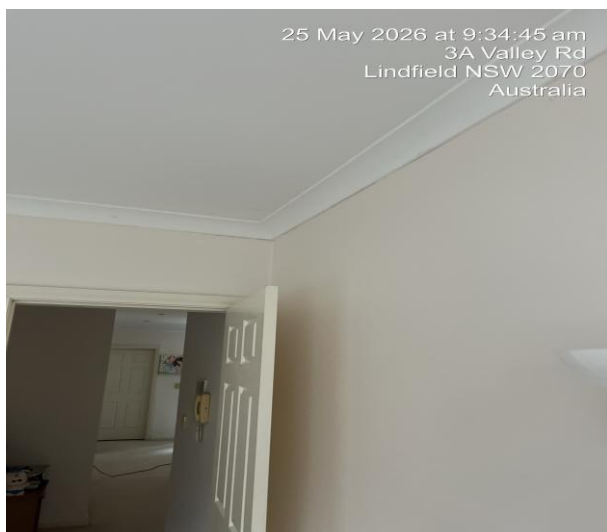
Photo 89 - Cracking observed to coving

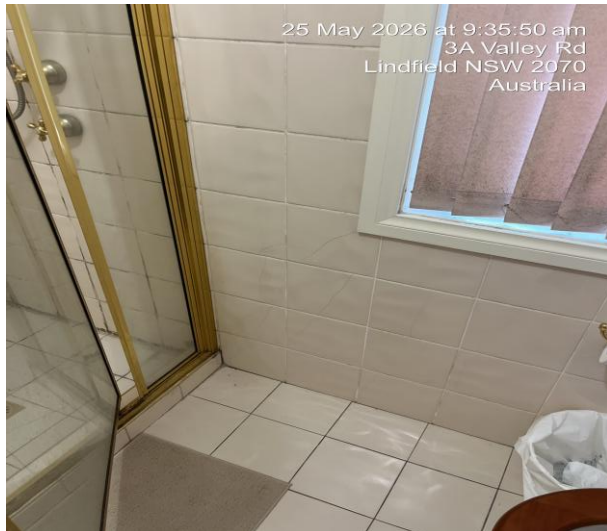
Photo 97 – Cracking observed to tiles

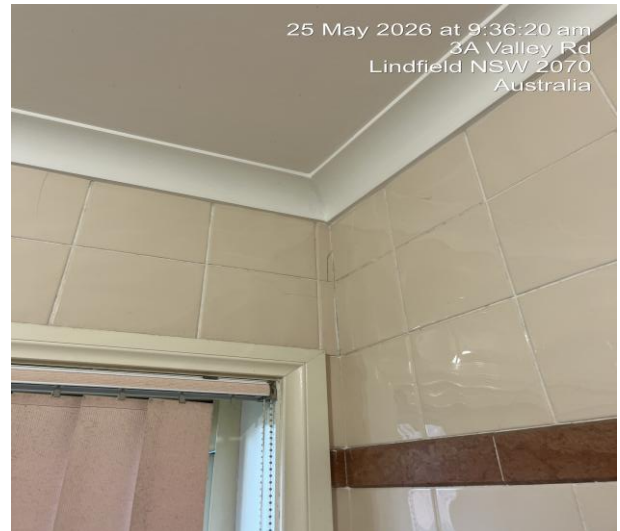
Photo 98 – Cracking observed to tiles

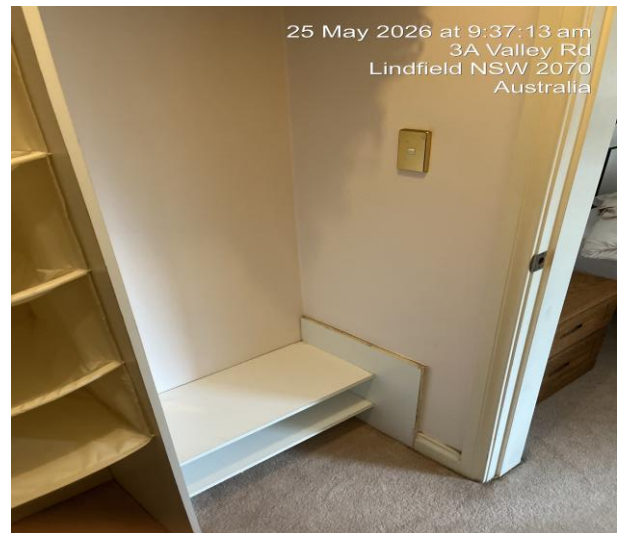
Photo 100 – Cracking observed to paint

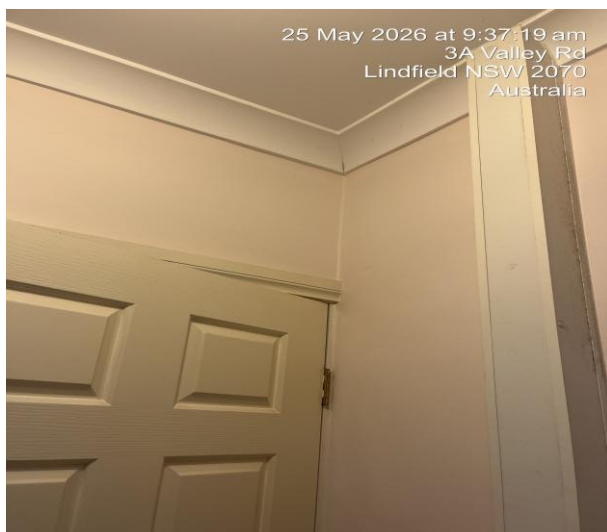
Photo 101 – Cracking observed to coving

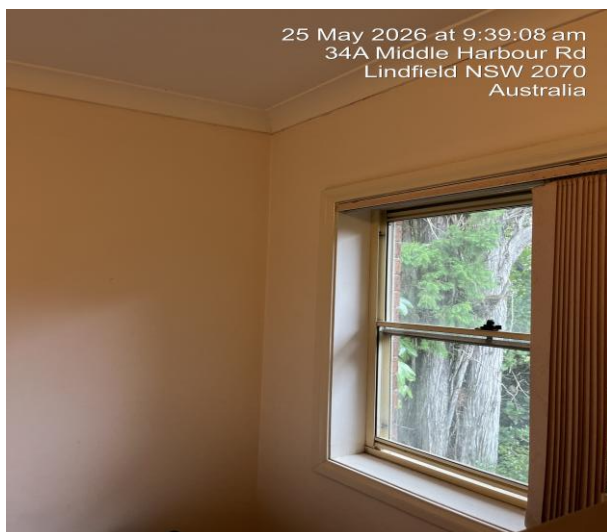
Photo 107 – Cracking observed to coving

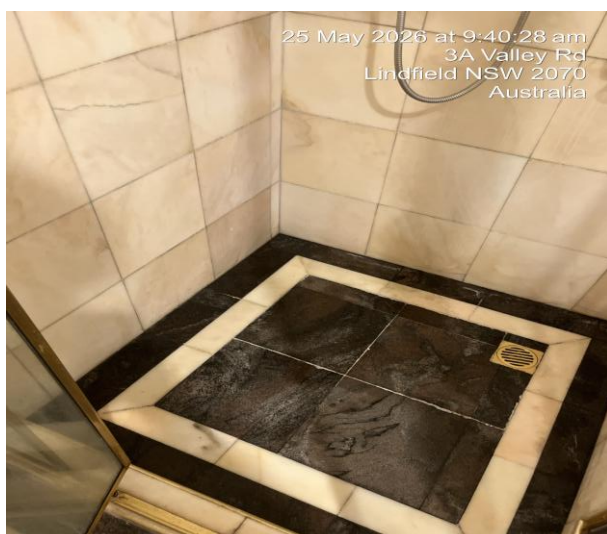
Photo 113 – Cracking observed to tiles

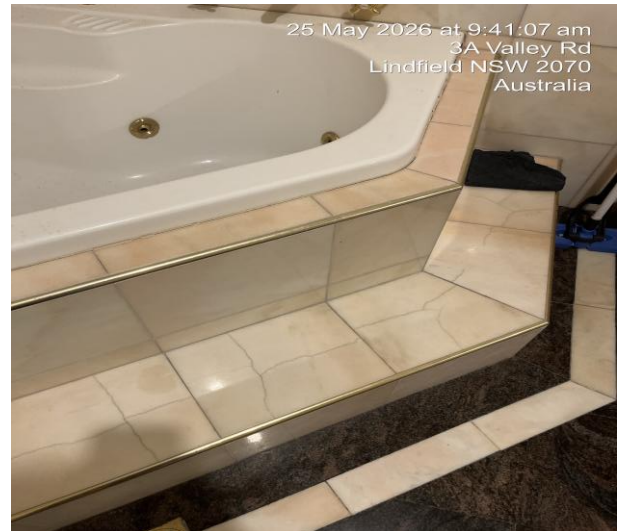
Photo 116 – Cracking observed to tiles

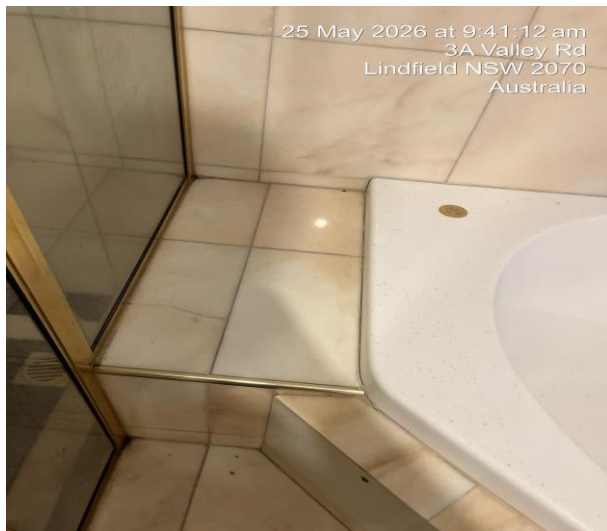
Photo 117 – Cracking observed to tiles

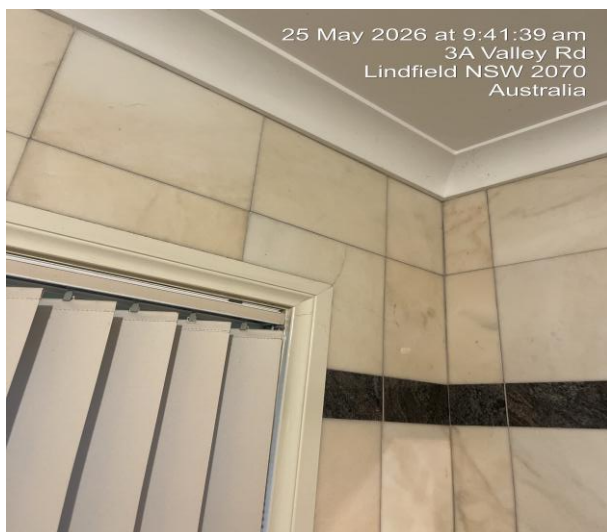
Photo 119 – Cracking observed to tiles and frame

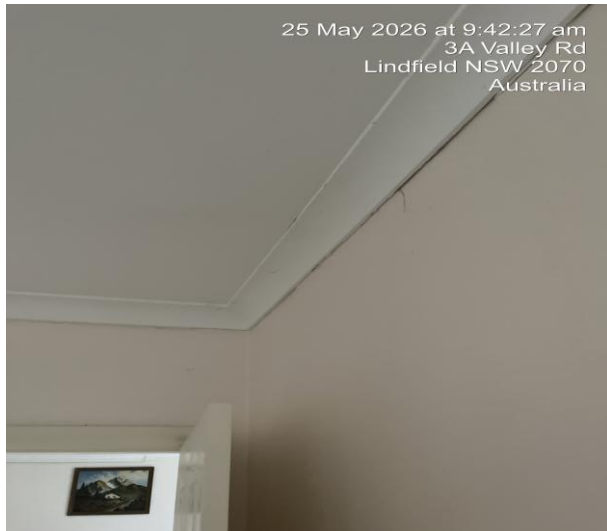
Photo 121 – Cracking observed to coving

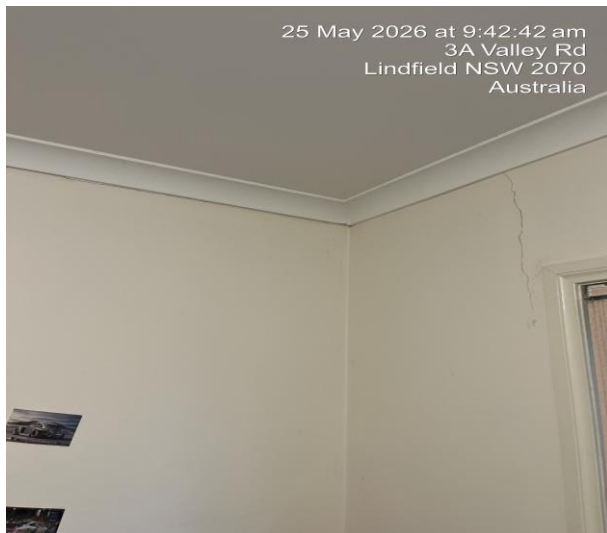
Photo 123 – Cracking observed to wall

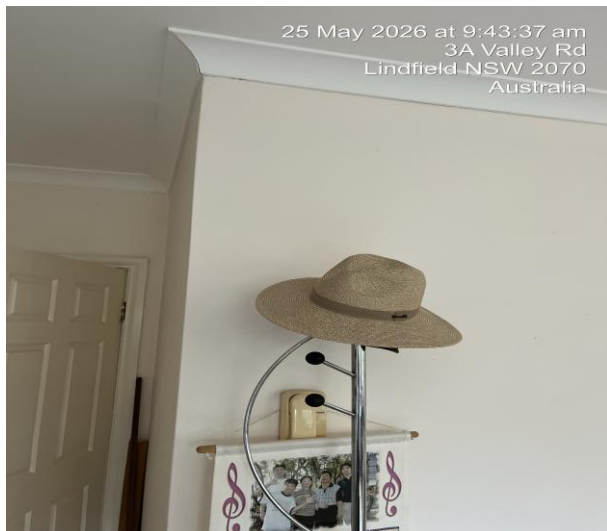
Photo 129 – Cracking observed to coving

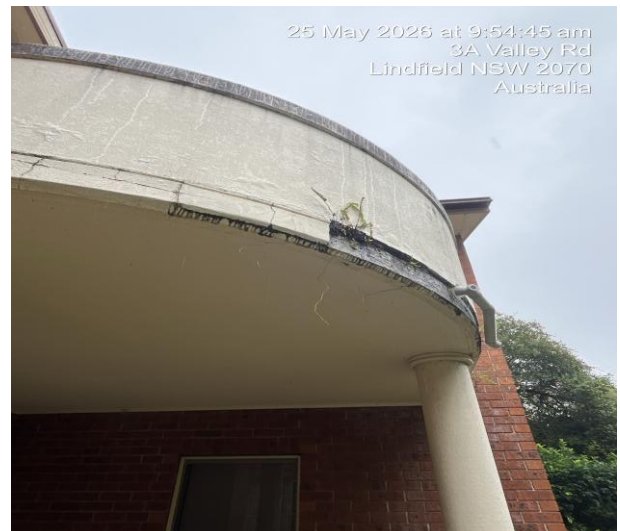
Photo 165 – Water ingress observed to upturn

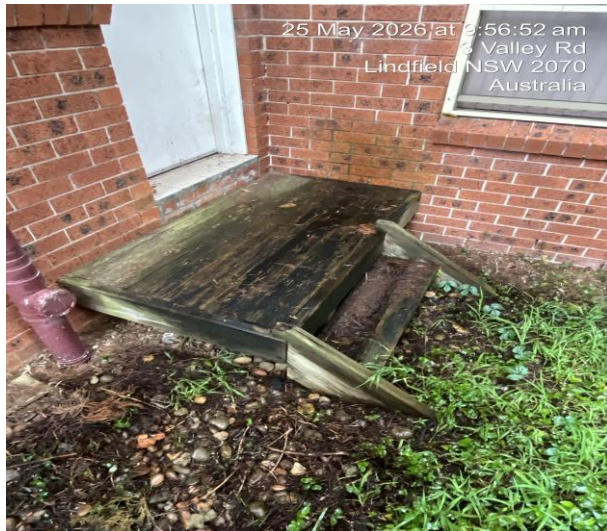
Photo 181 – Weathering observed to stairs

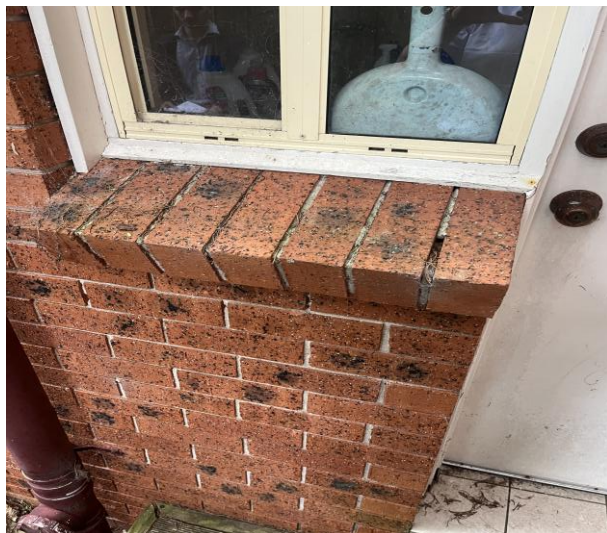
Photo 183 – Damage observed to mortar

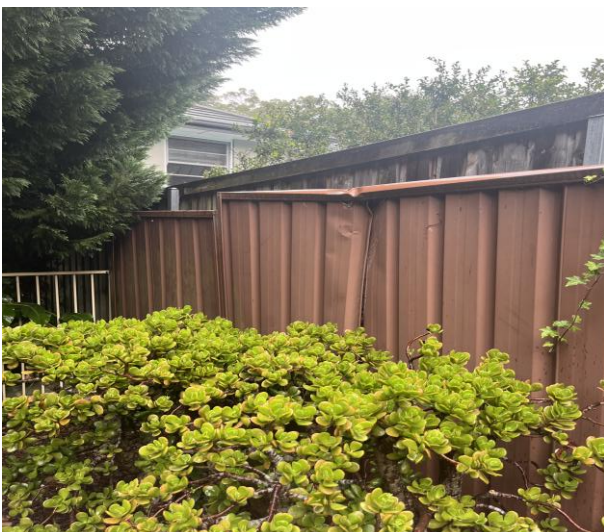
Photo 191 – Damage observed to fence

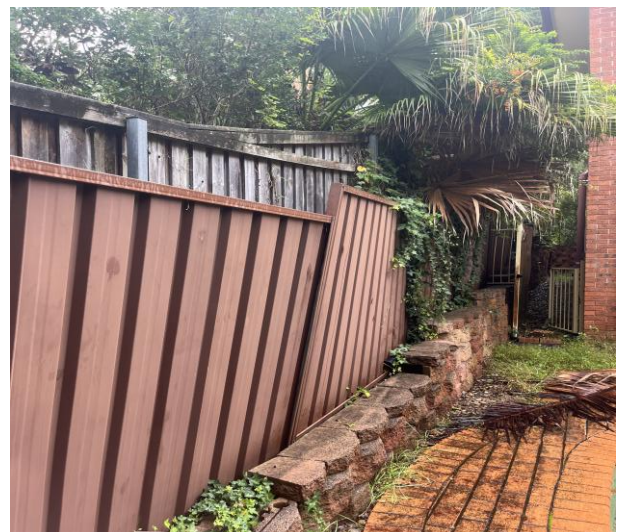
Photo 192 – Overturning of fence observed

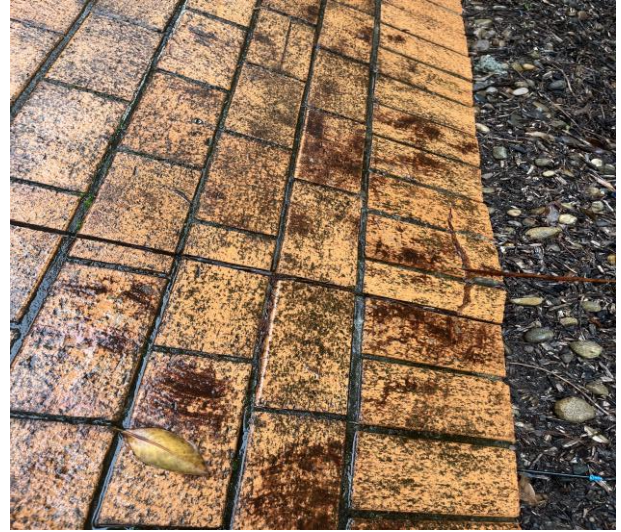
Photo 194 – Cracking observed to paver

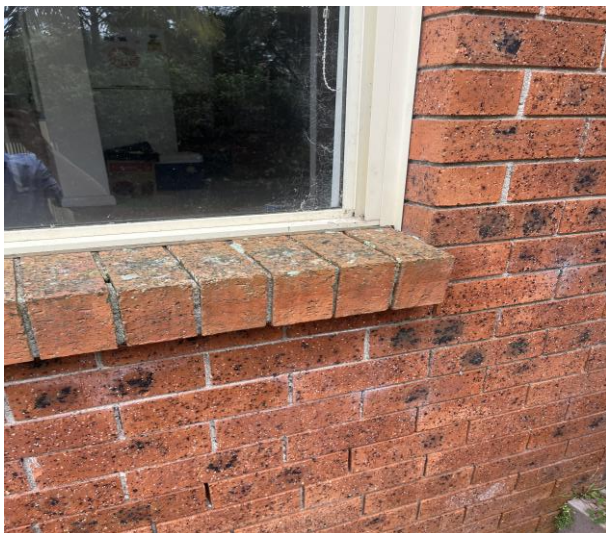
Photo 201 – Damage observed to mortar

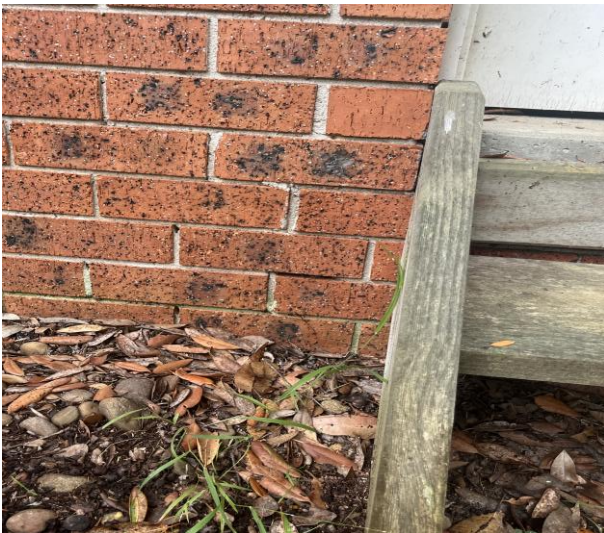
Photo 207 – Gaps observed to mortar

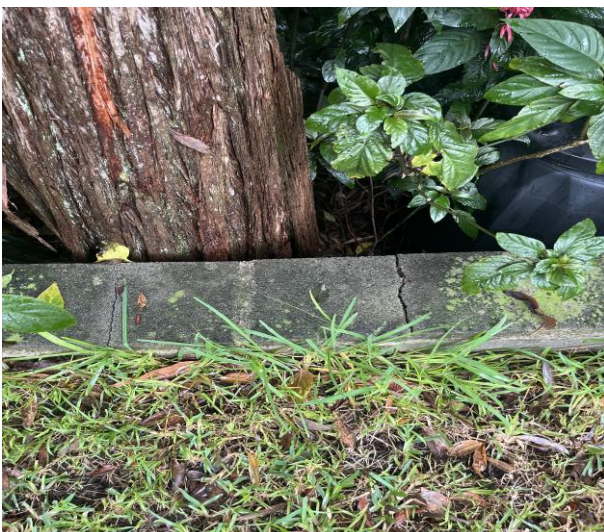
Photo 209 – Cracking observed to capping block

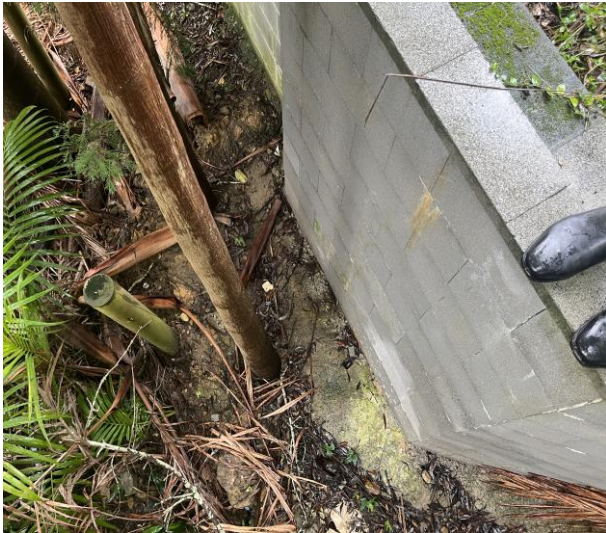
Photo 211 – Efflorescence observed to block retaining wall

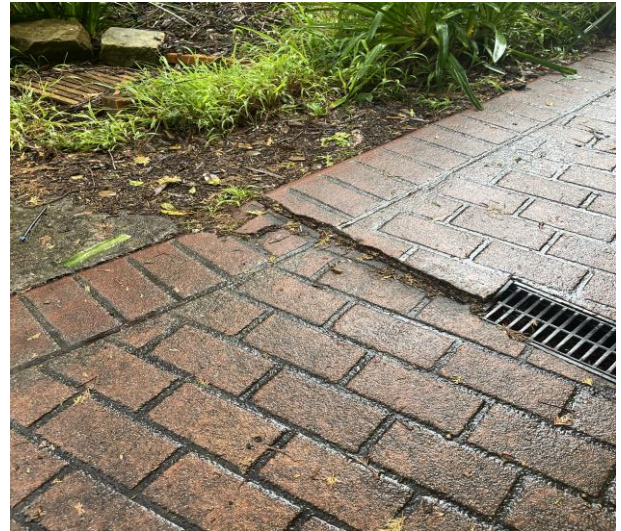
Photo 218 – Settlement observed to driveway pavers

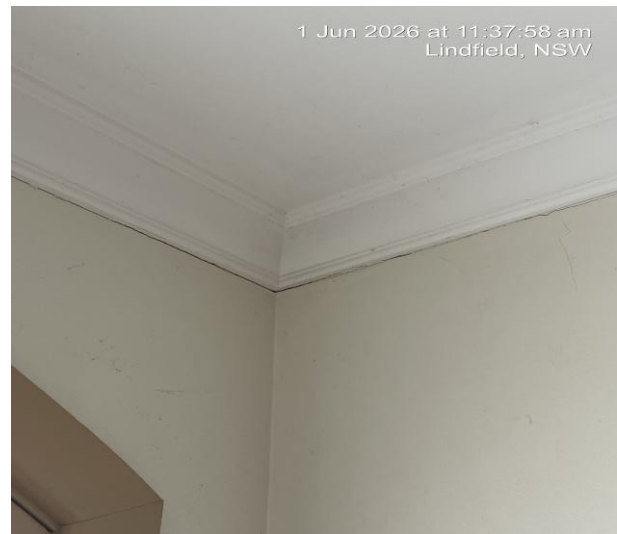
Photo 2 – Movement observed to coving

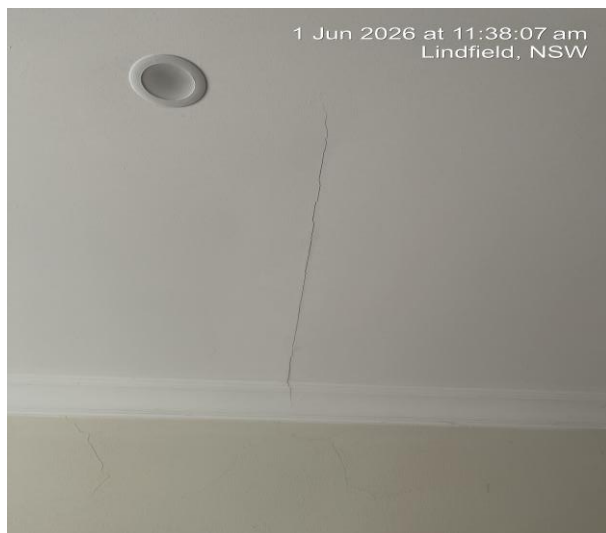
Photo 3 – Cracking observed to render and ceiling

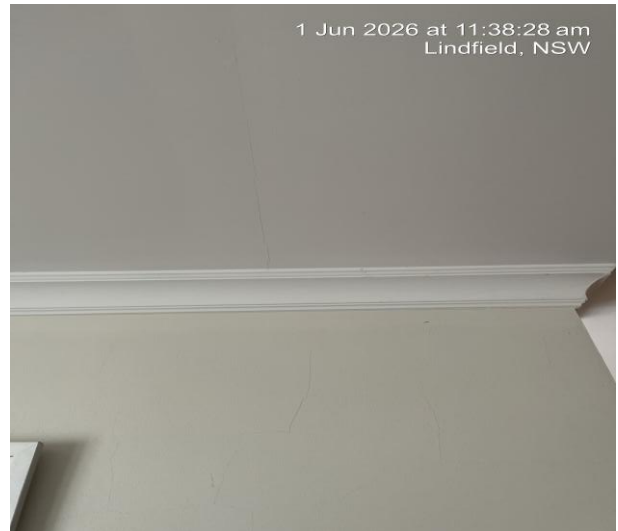
Photo 8 – Cracking observed to render and ceiling

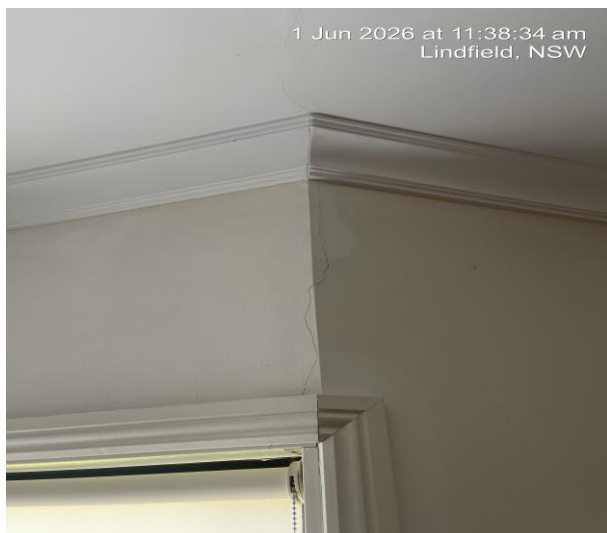
Photo 9 – Cracking observed to render

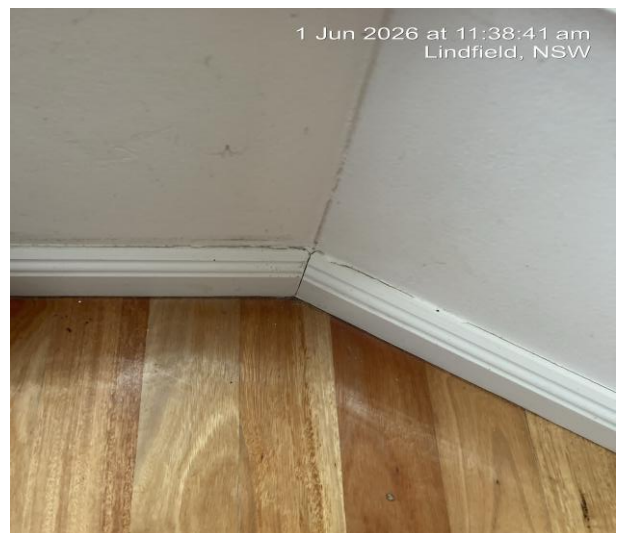
Photo 10 – Cracking observed to skirting

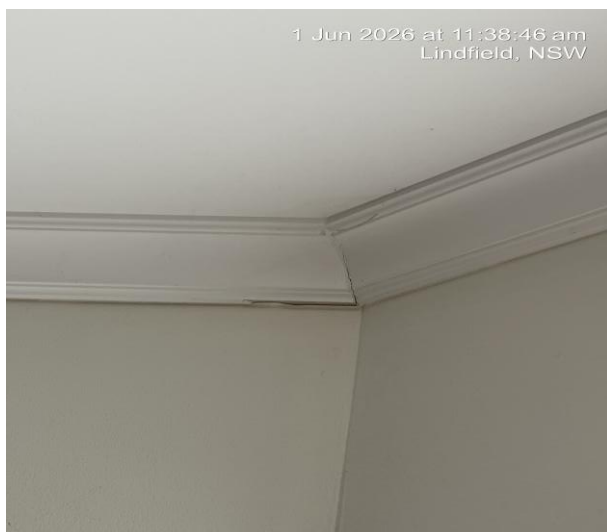
Photo 11 – Cracking and delamination of paint observed to coving

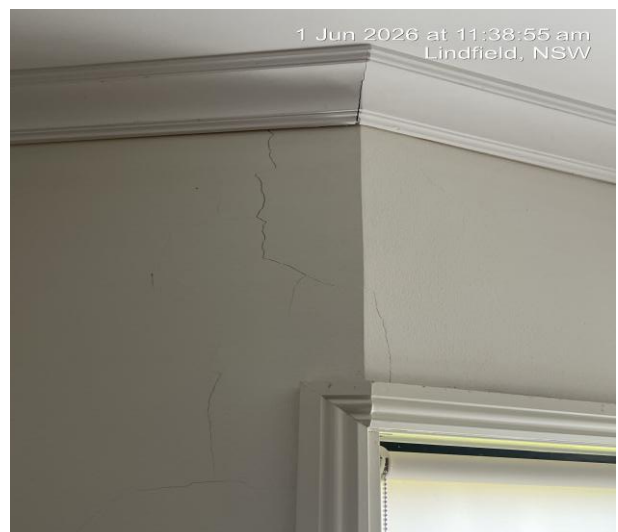
Photo 12 – Cracking observed to render

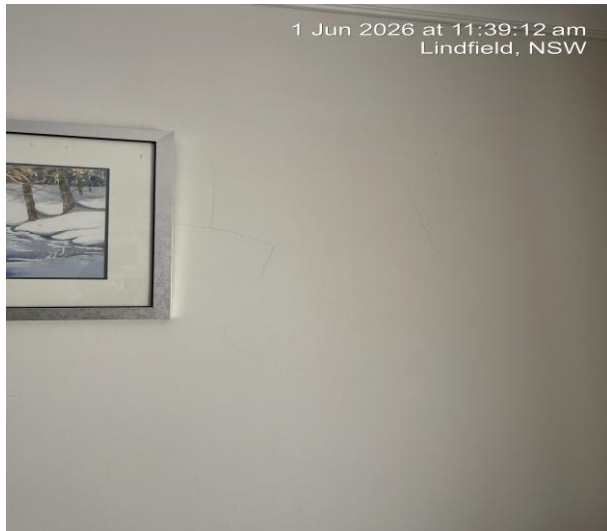
Photo 13 – Cracking observed to render

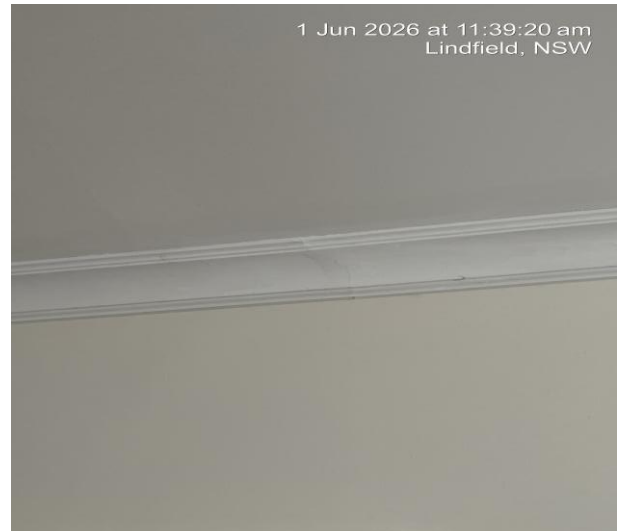
Photo 14 – Damaged observed to coving

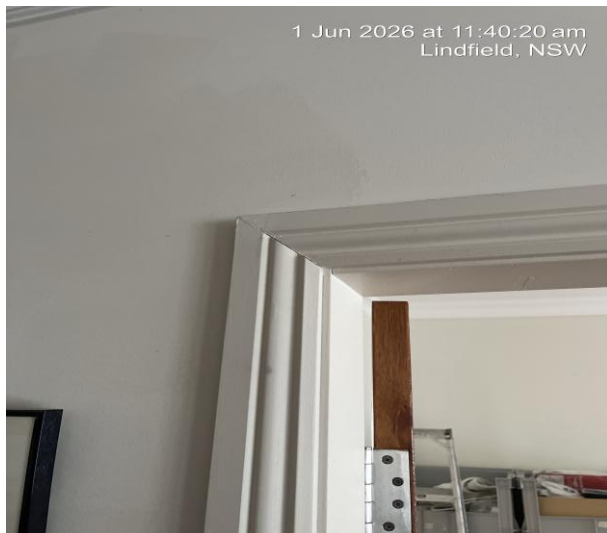
Photo 15 – Cracking observed to door frame

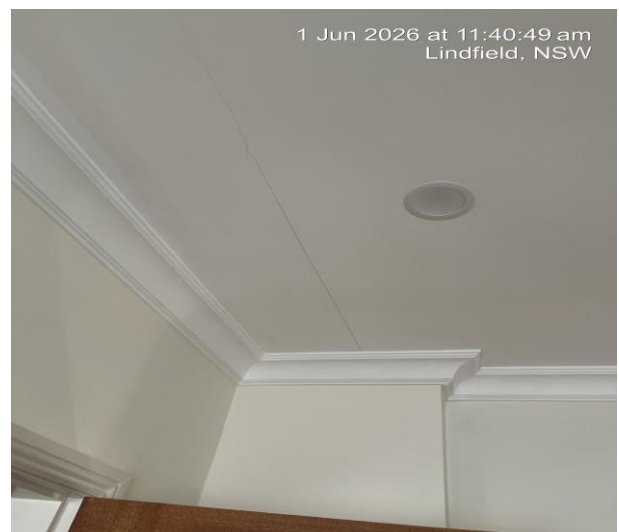
Photo 18 – Cracking observed to ceiling

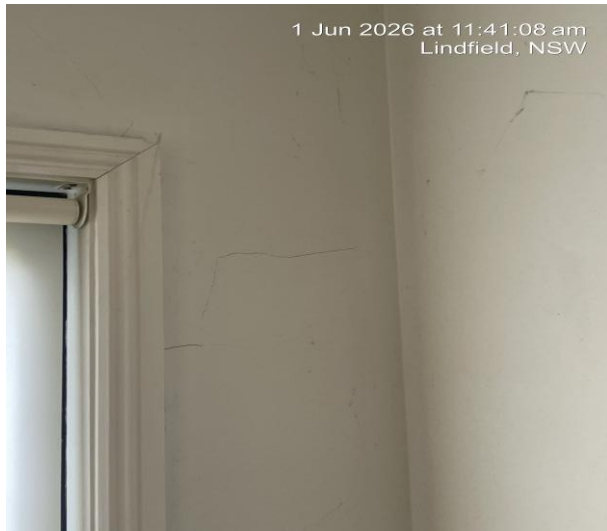
Photo 19 – Cracking observed to render

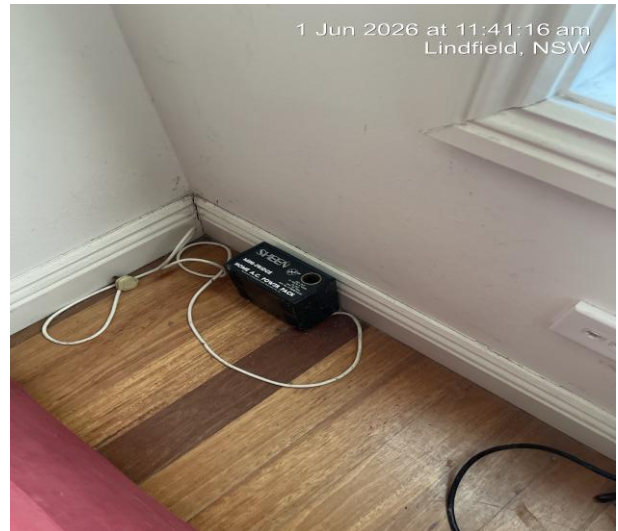
Photo 20 – Movement observed to skirting

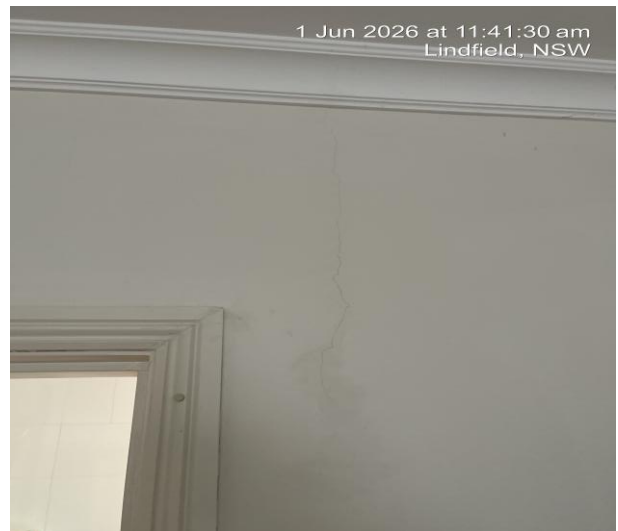
Photo 22 - Cracking observed to render

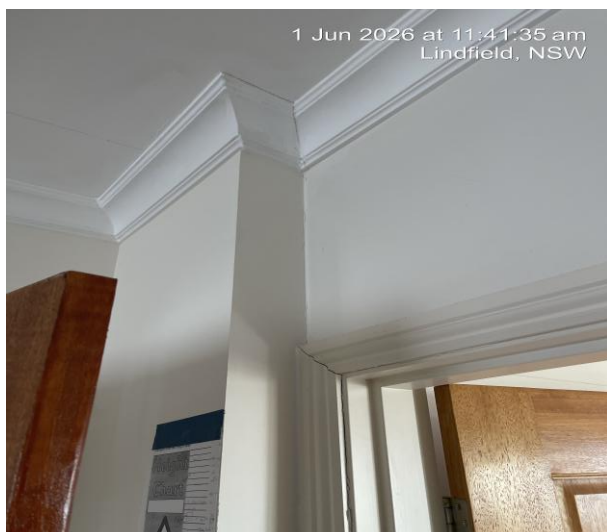
Photo 23 – Cracking observed to door frame and coving

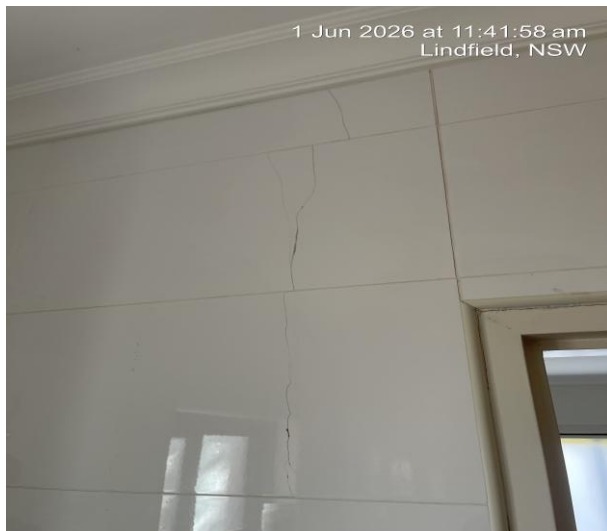
Photo 27 – Cracking observed to tiles

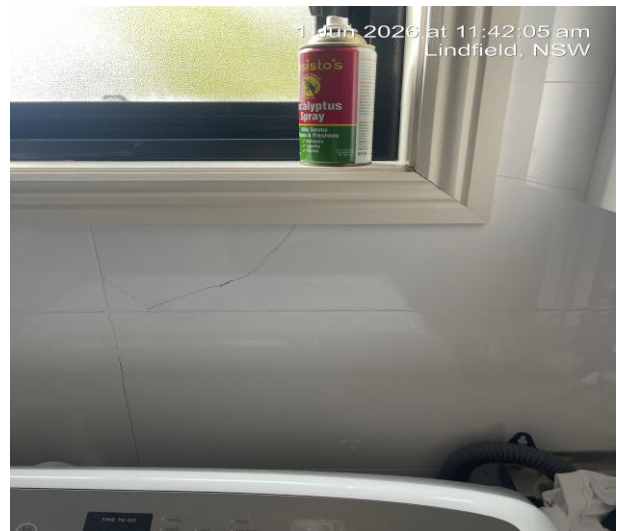
Photo 28 - Cracking observed to tiles

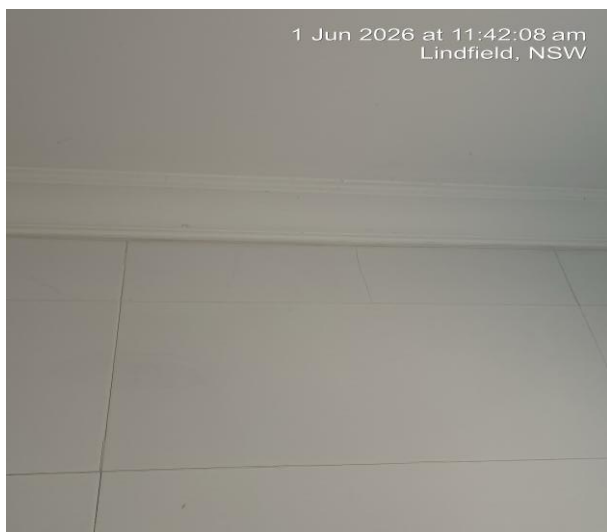
Photo 29 - Cracking observed to tiles

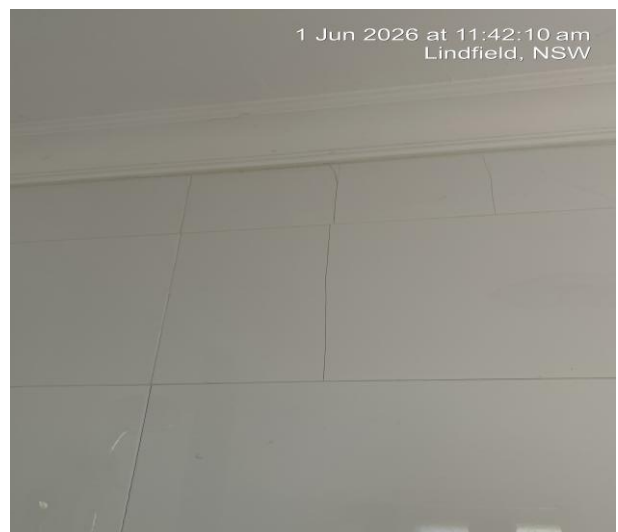
Photo 30 – Cracking observed to tiles

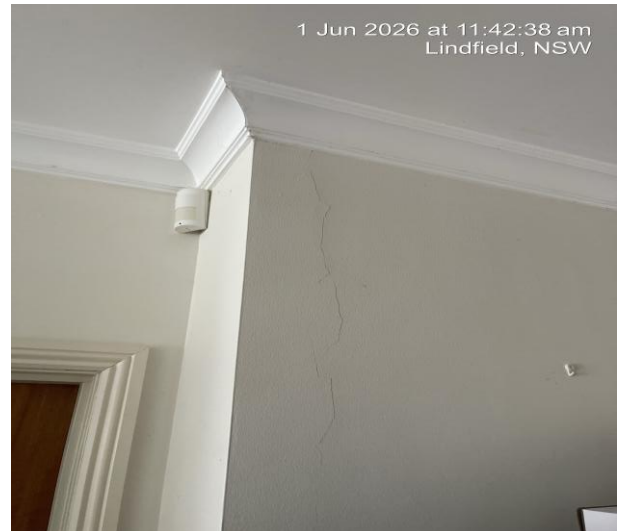
Photo 32 – Cracking observed to render

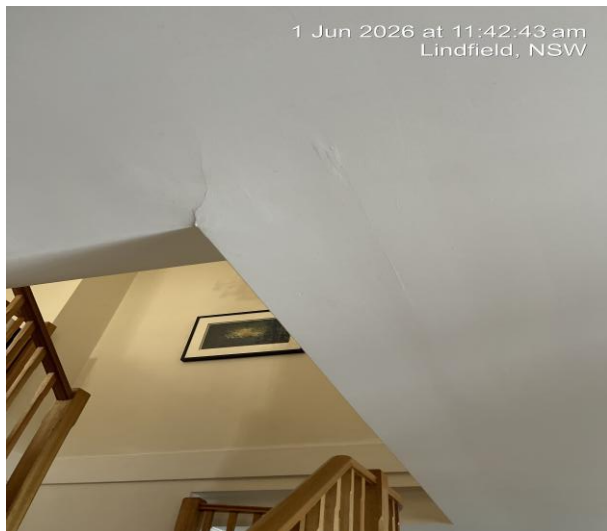
Photo 33 – Damage observed to ceiling

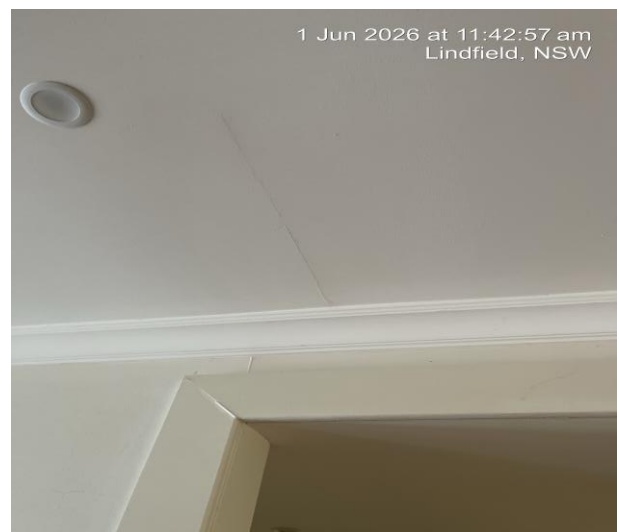
Photo 36 - Cracking observed to ceiling

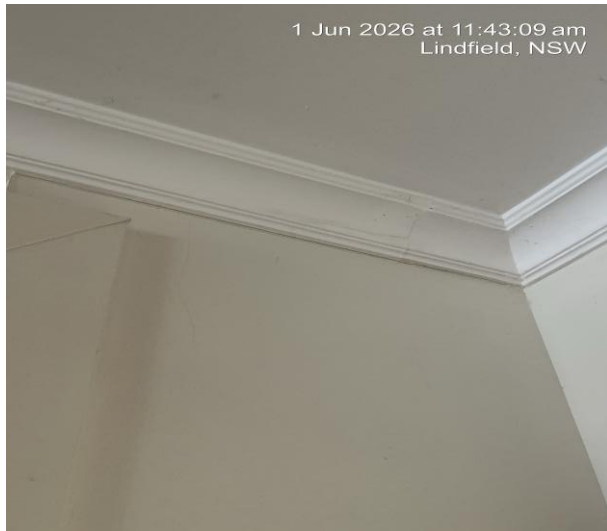
Photo 37 – Cracking observed to coving

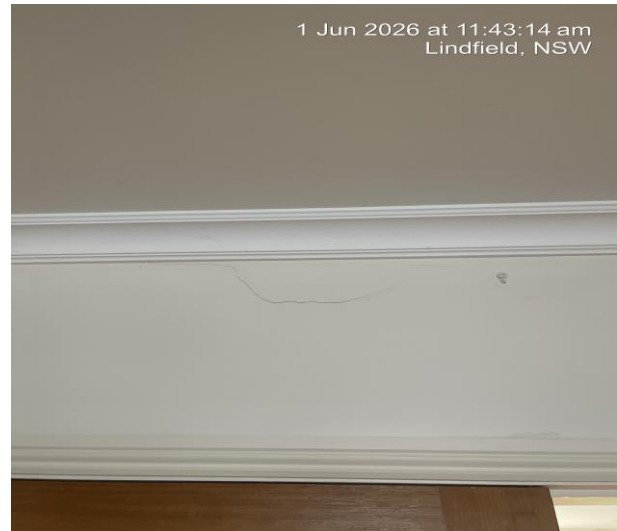
Photo 38 – Cracking observed to render

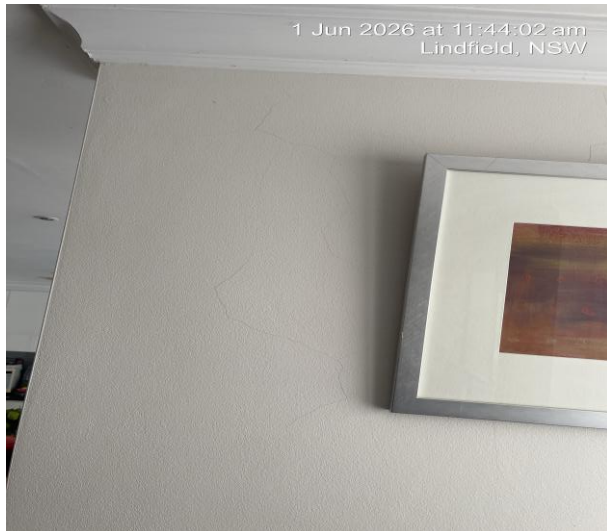
Photo 43 – Cracking observed to render

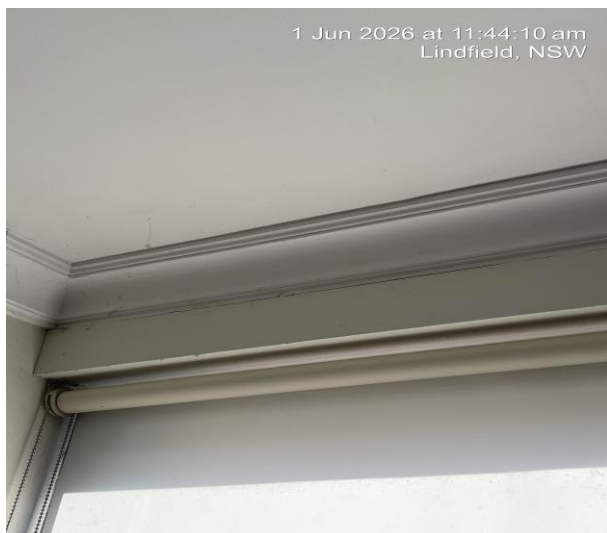
Photo 45 – Movement observed to coving

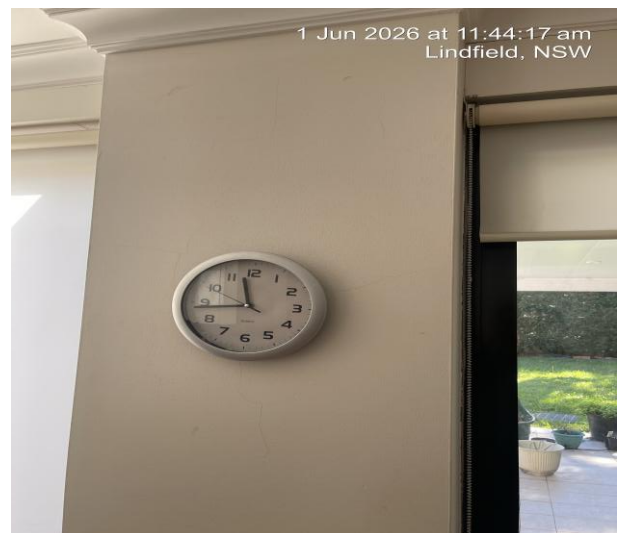
Photo 46 - Cracking observed to render

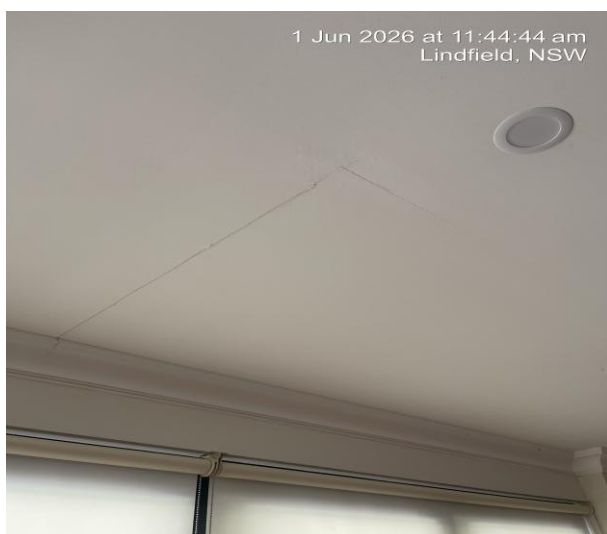
Photo 47 - Cracking observed to ceiling

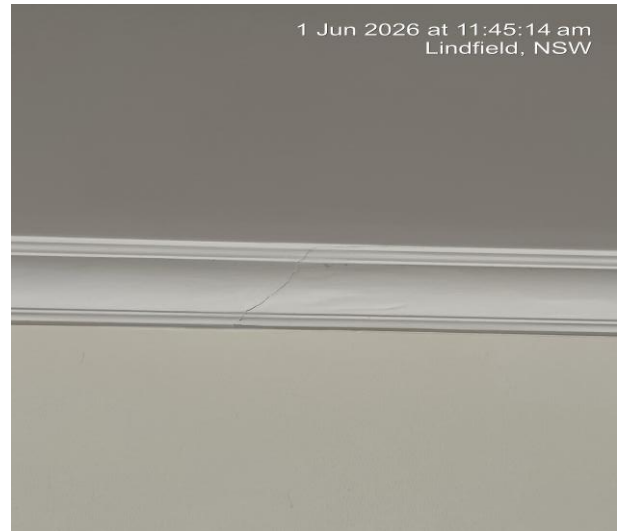
Photo 50 – Damage observed to coving
