# **DILAPIDATION REPORT**

**For Property At  
3A Valley Rd,  
Lindfield, NSW 2070**

**For Development At  
59-63 Trafalgar Ave & 1A-1B Valley Rd,  
Lindfield, NSW 2070**

**Ref: 26009-DR-001-R1-3A Valley Rd  
Date: 25.05.2026**

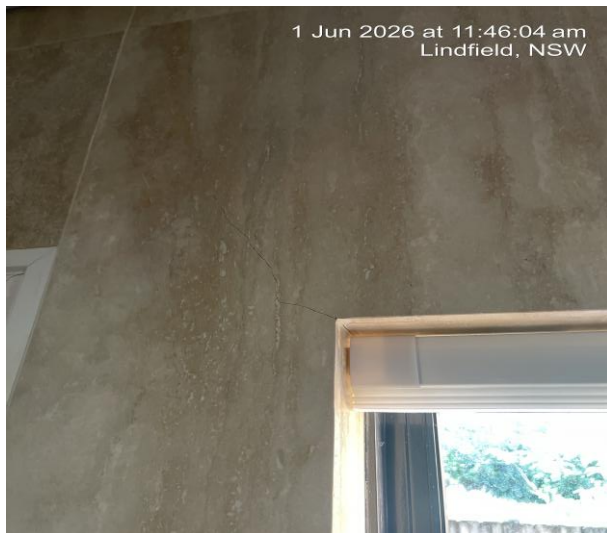
Photo 57 – Cracking observed to tiles

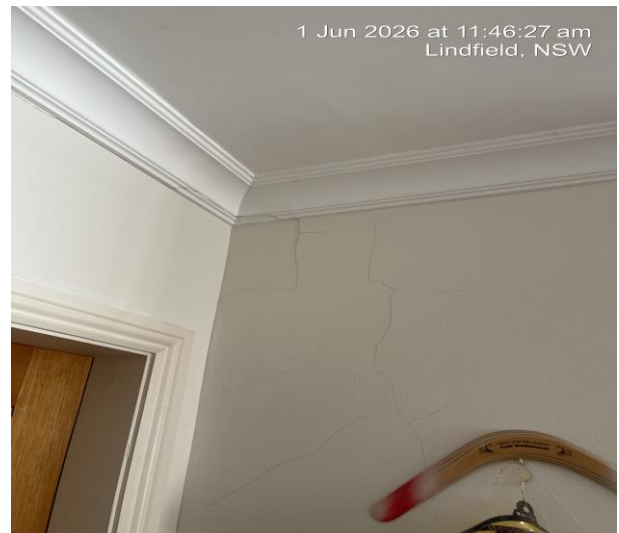
Photo 58 – Cracking observed to render

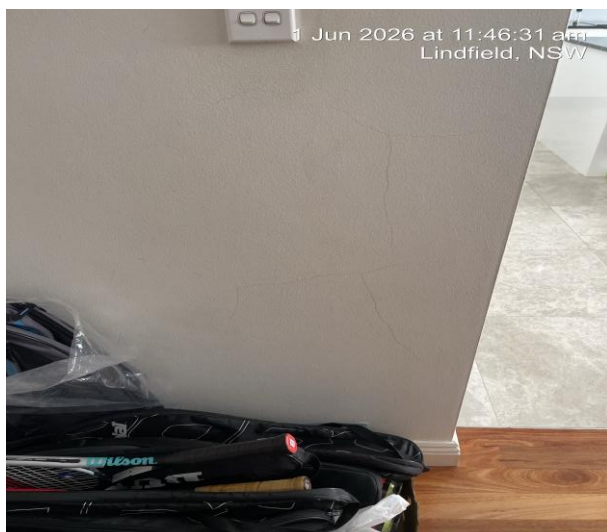
Photo 59 – Cracking observed to render

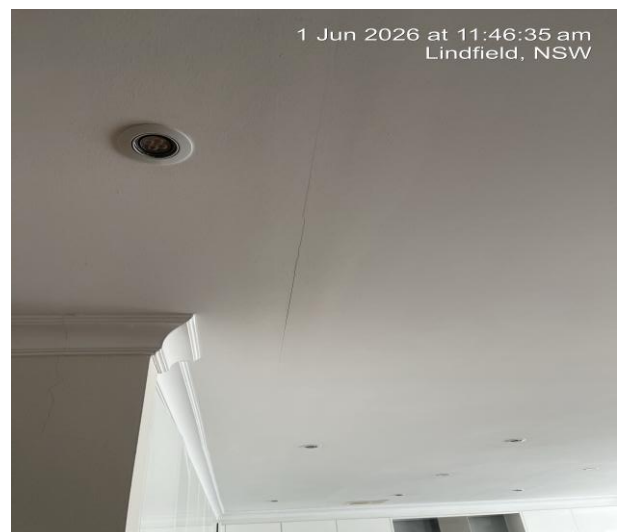
Photo 60 – Cracking observed to ceiling

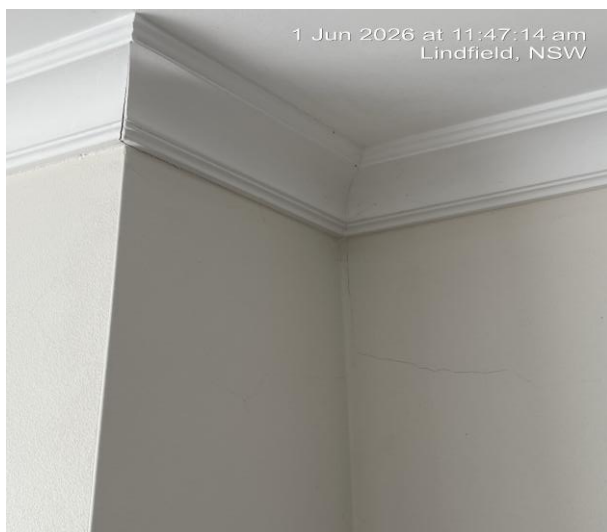
Photo 65 – Cracking observed to coving

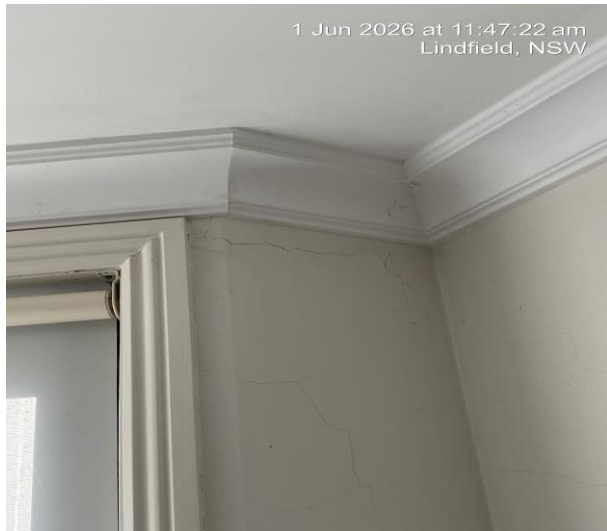
Photo 67 – Cracking observed to render

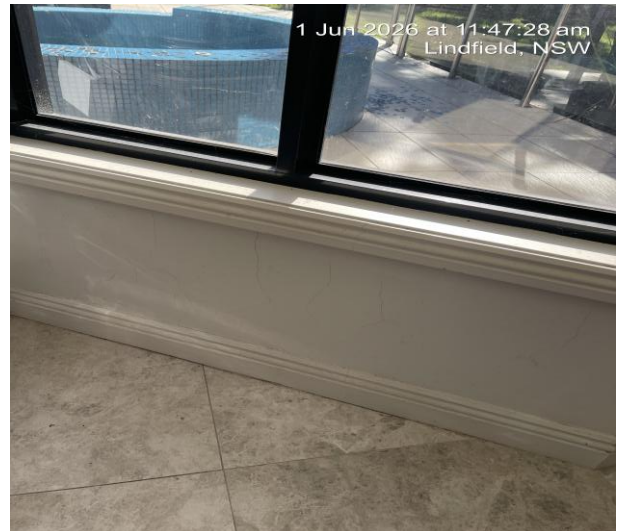
Photo 68 – Cracking observed to render

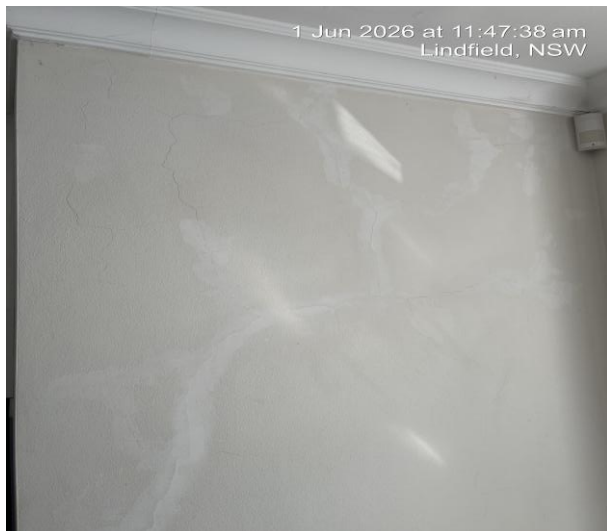
Photo 69 – Cracking observed to render with signs of attempts to repair

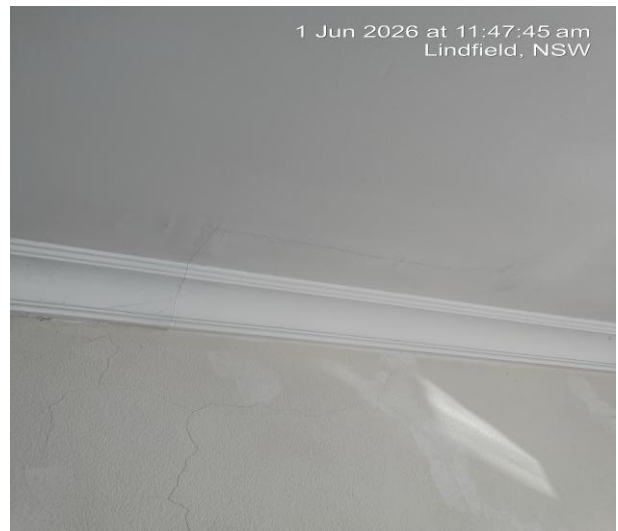
Photo 70 – Cracking observed to ceiling and render

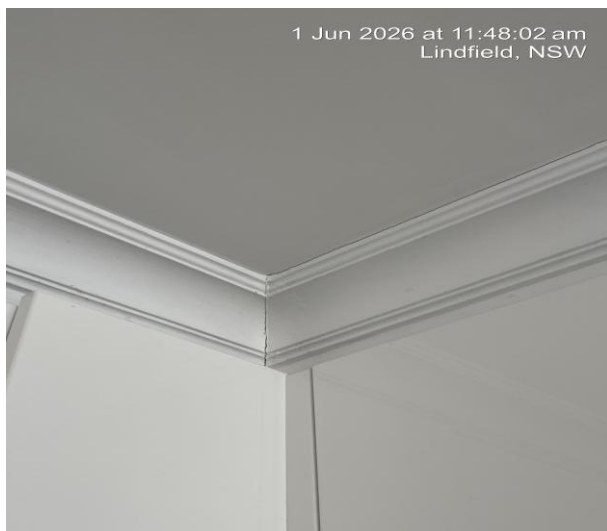
Photo 71 – Movement observed to coving

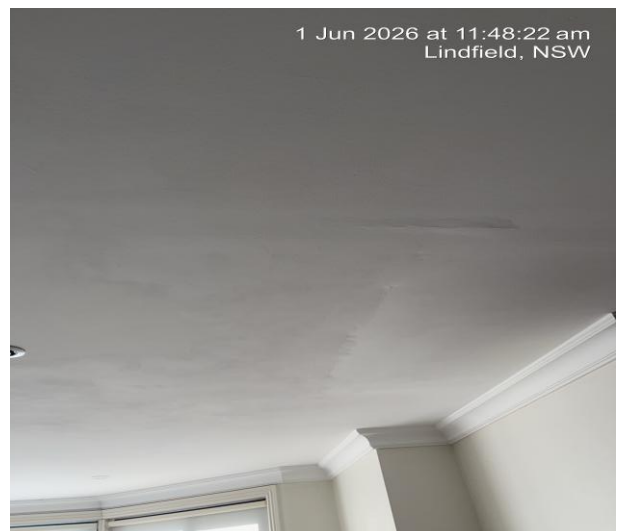
Photo 72 – Damage observed to ceiling consistent with water ingress

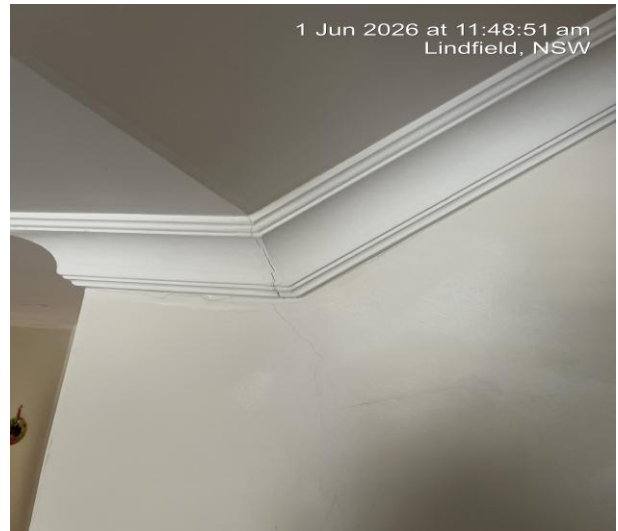
Photo 74 – Cracking observed to render and coving

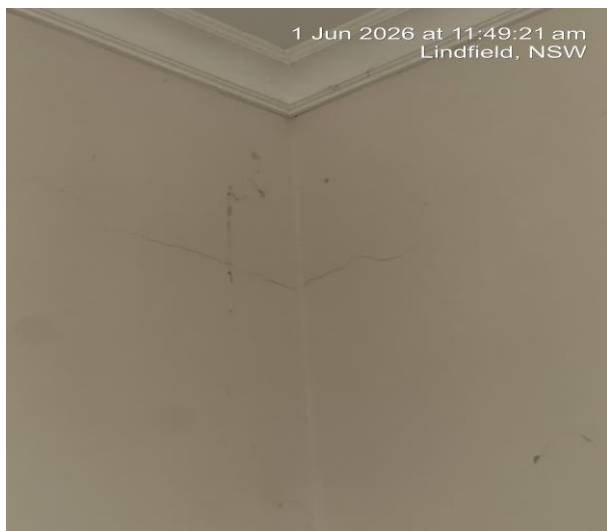
Photo 77 – Cracking observed to render

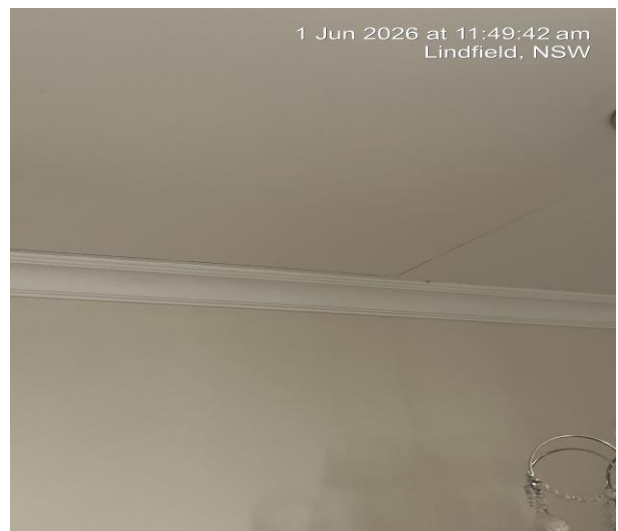
Photo 78 – Cracking observed to ceiling

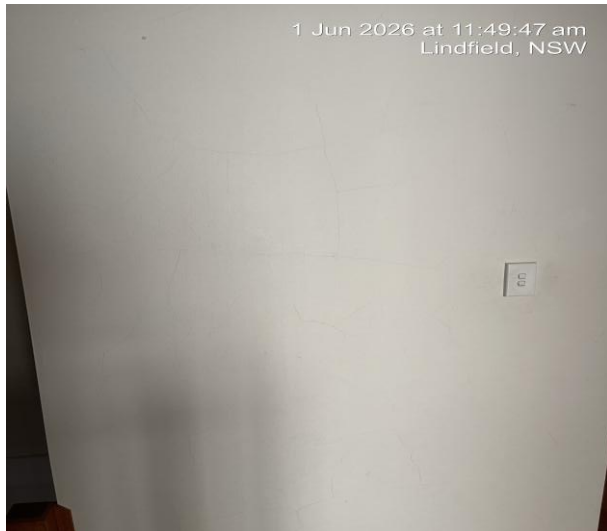
Photo 79 – Cracking observed to render

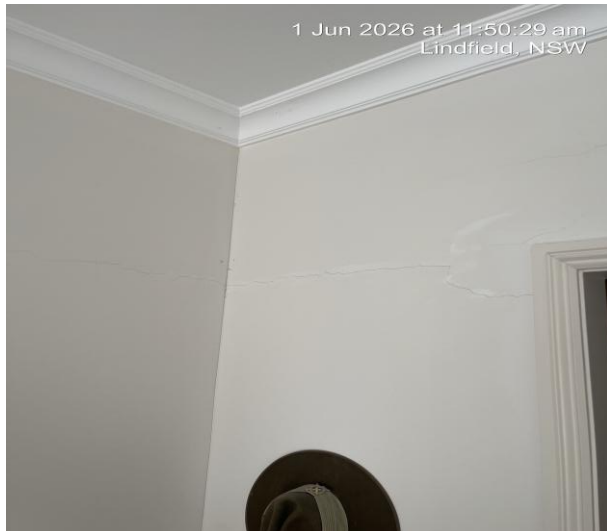
Photo 85 - Cracking observed to render with signs of attempts to repair

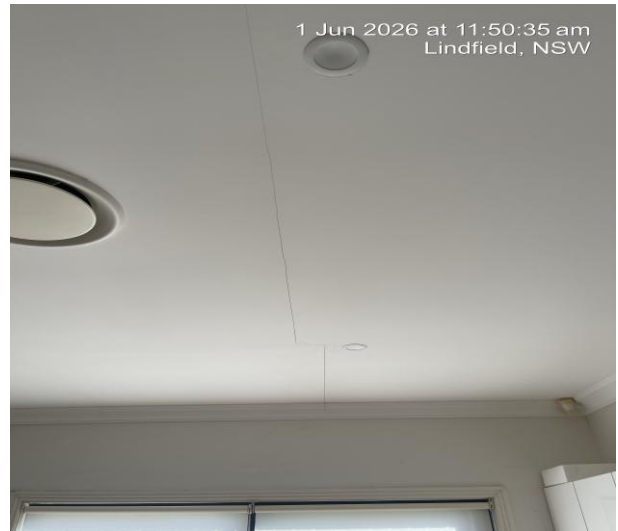
Photo 86 - Cracking observed to ceiling

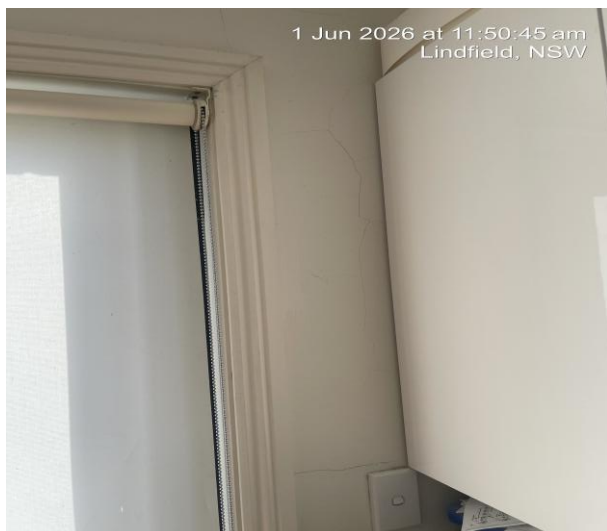
Photo 87 - Cracking observed to render

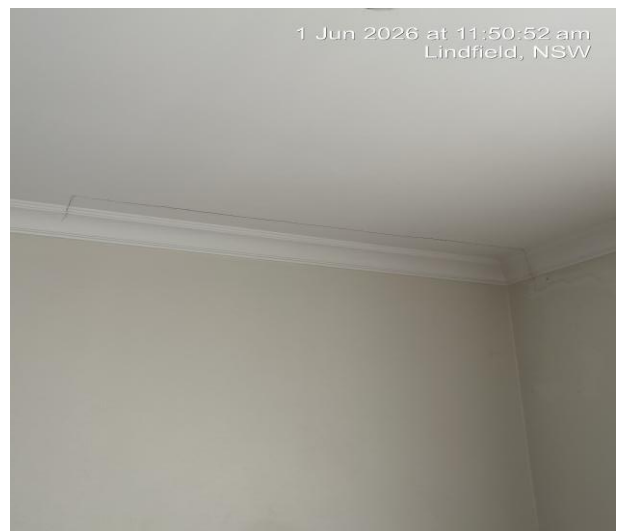
Photo 88 - Cracking observed to ceiling and render with signs of attempts to repair

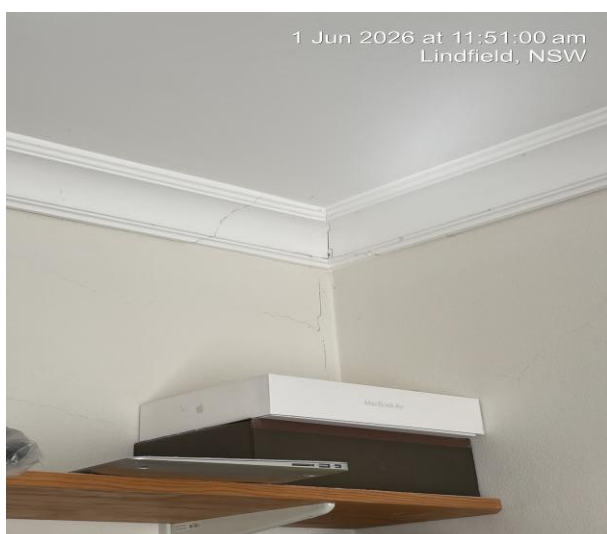
Photo 89 - Cracking observed to coving and render

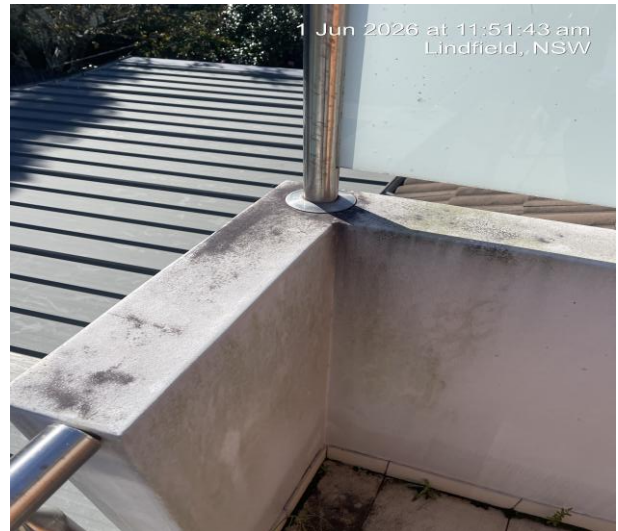
Photo 92 – Mould growth observed

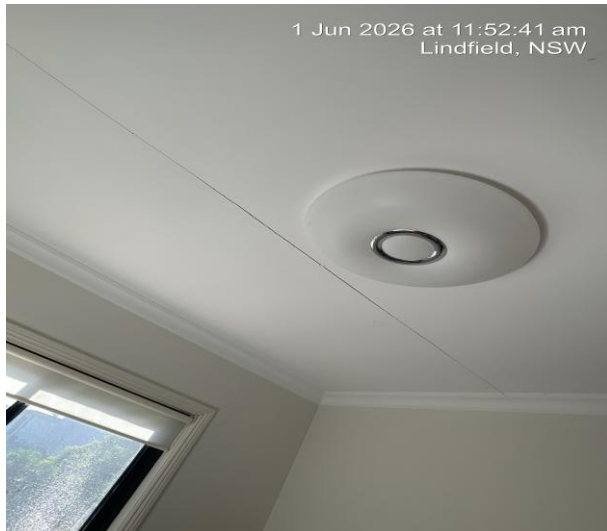
Photo 97 – Cracking observed to ceiling

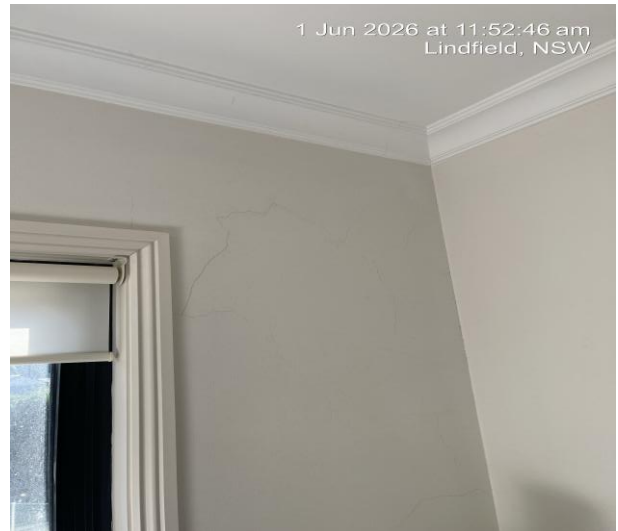
Photo 98 – Cracking observed to render

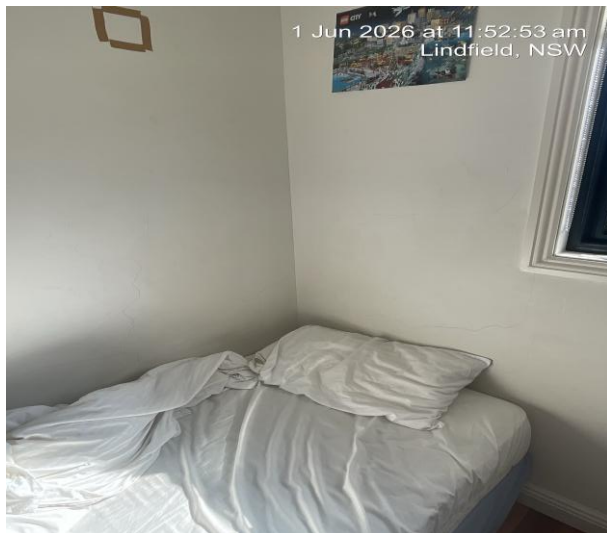
Photo 99 - Cracking observed to render

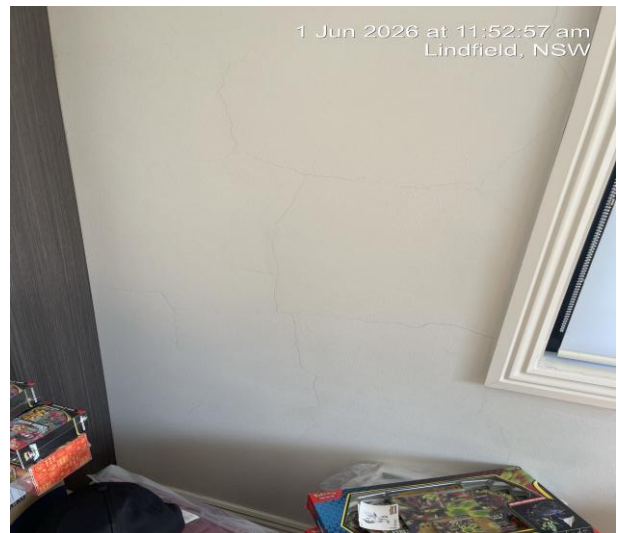
Photo 100 - Cracking observed to render

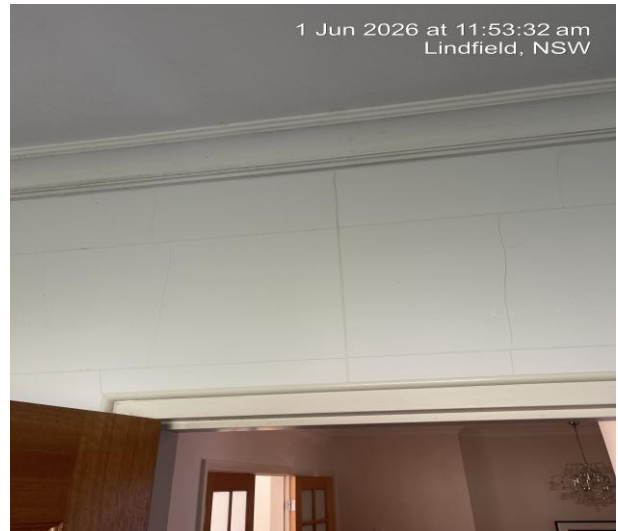
Photo 104 – Cracking observed to tiles

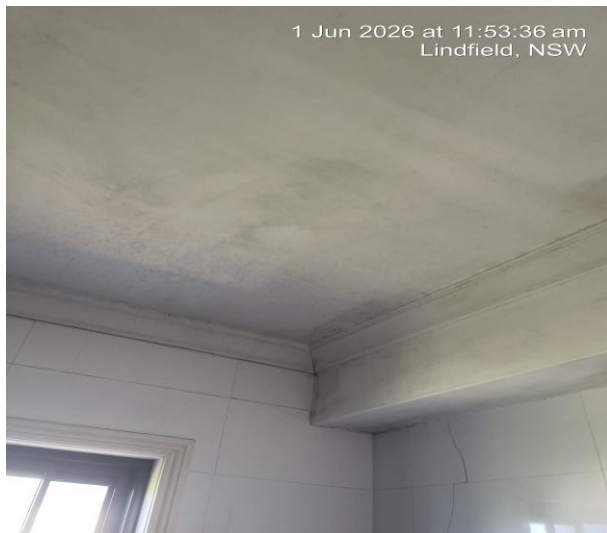
Photo 105 – Mould growth observed to ceiling

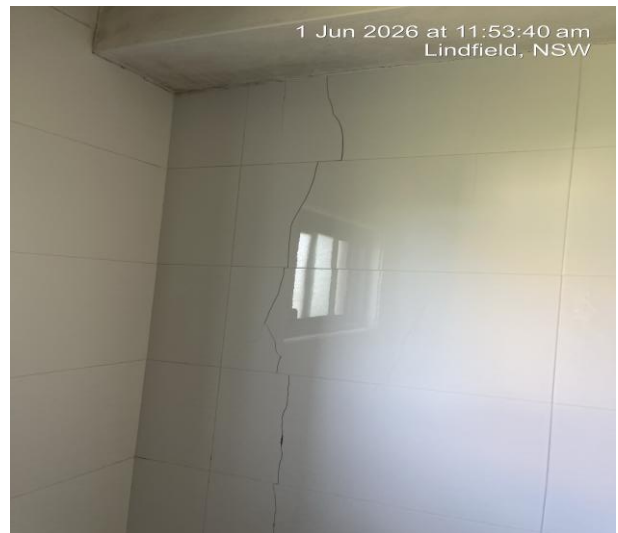
Photo 106 - Cracking observed to render

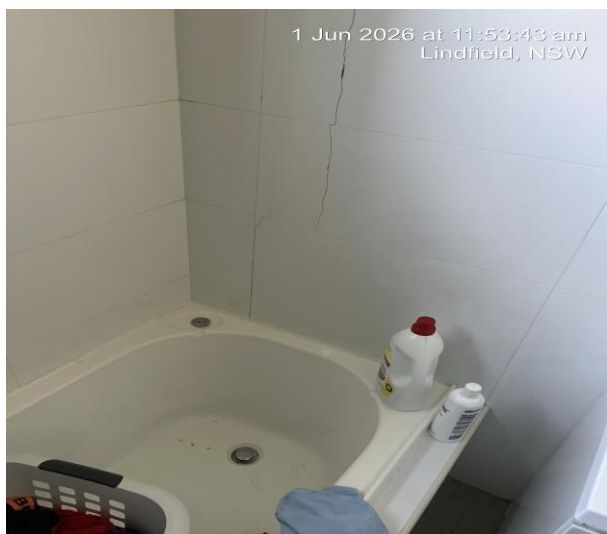
Photo 107 – Cracking observed to render

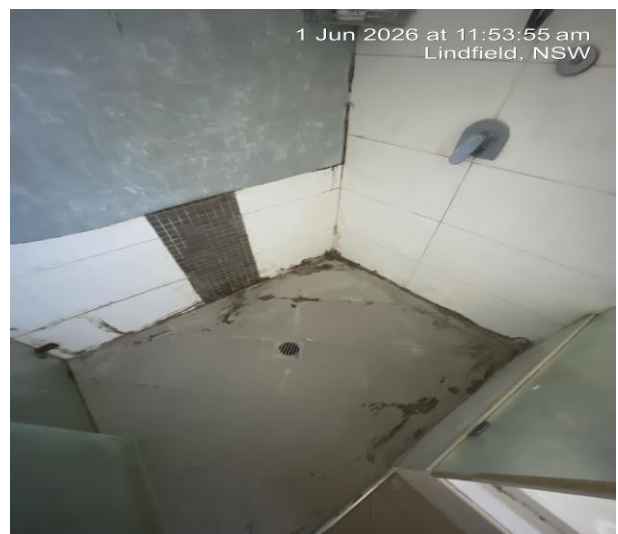
Photo 108 – Mould growth observed to shower area

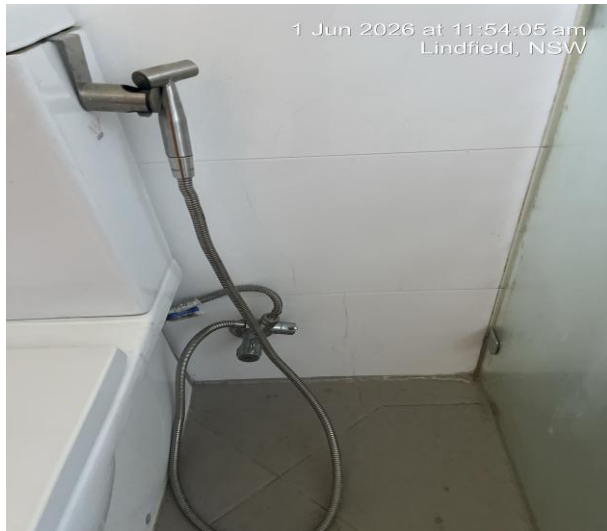
Photo 109 – Cracking observed to tiles

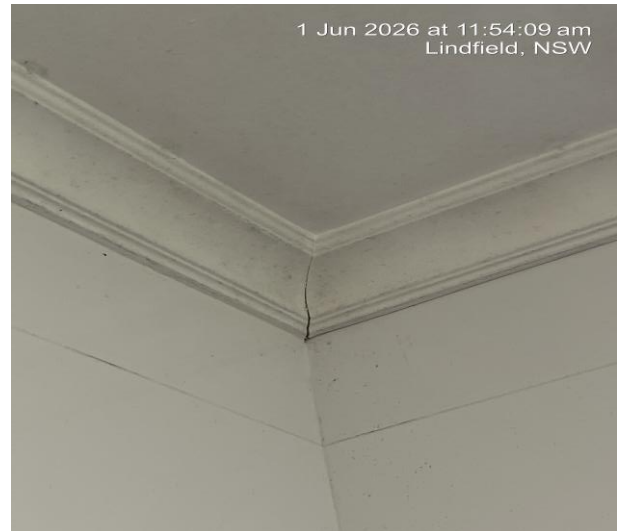
Photo 110 – Movement observed to coving

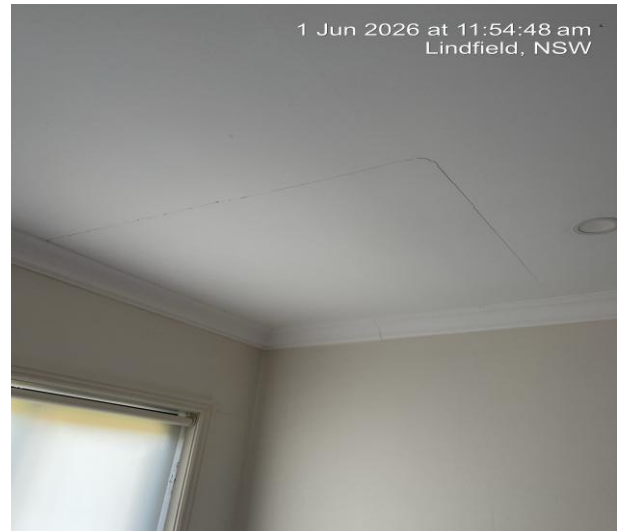
Photo 116 – Cracking observed to ceiling

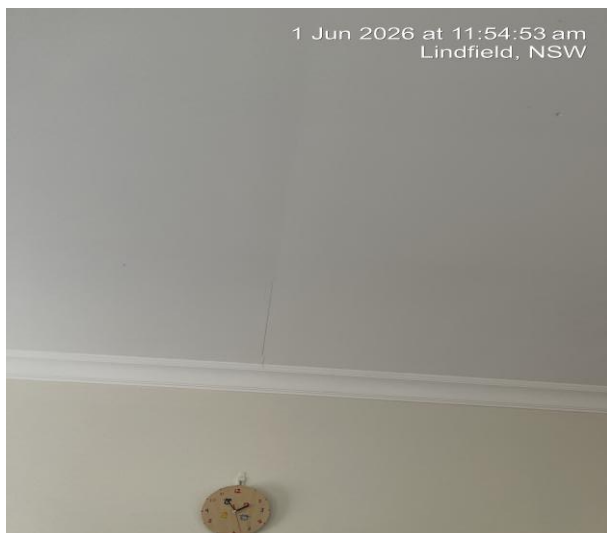
Photo 117 - Cracking observed to ceiling

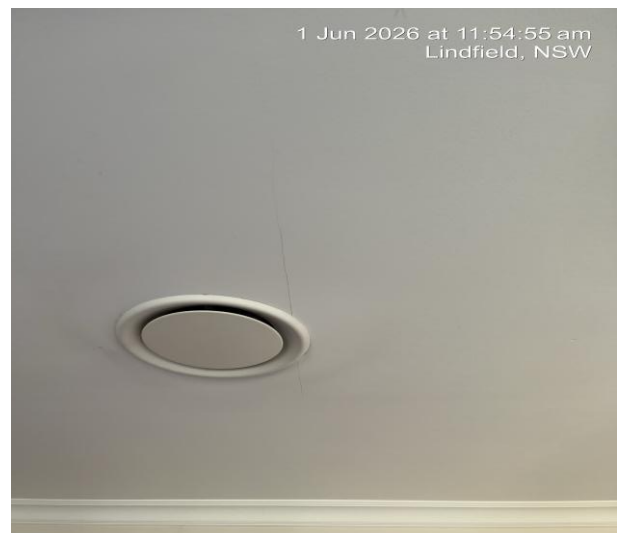
Photo 118 - Cracking observed to ceiling

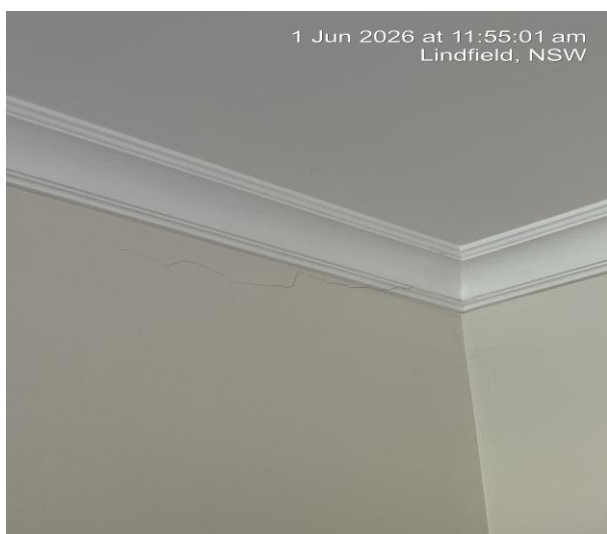
Photo 119 – Cracking observed to render

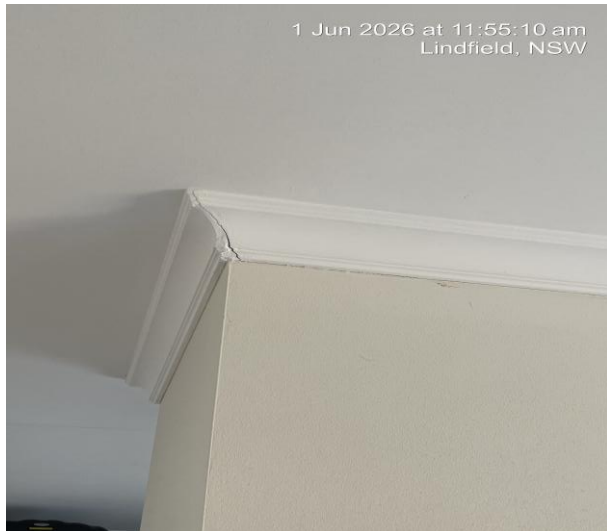
Photo 121 – Cracking observed to coving

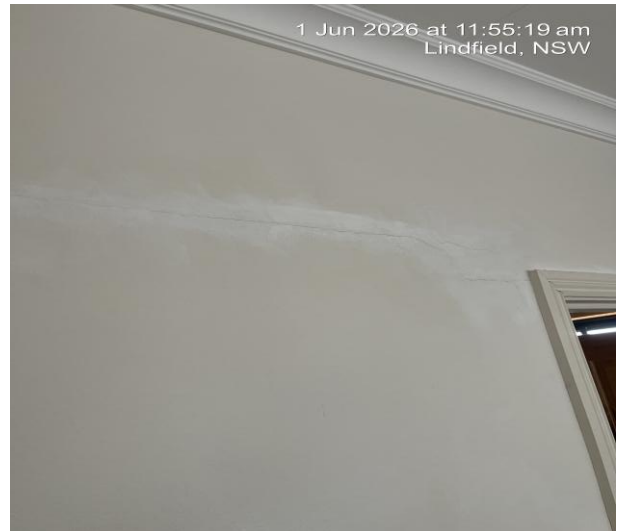
Photo 122 - Cracking observed to render with signs of attempts to repair

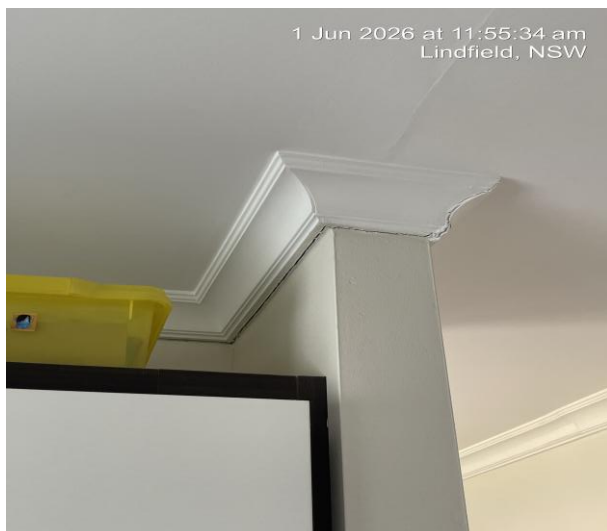
Photo 125 – Movement observed to coving

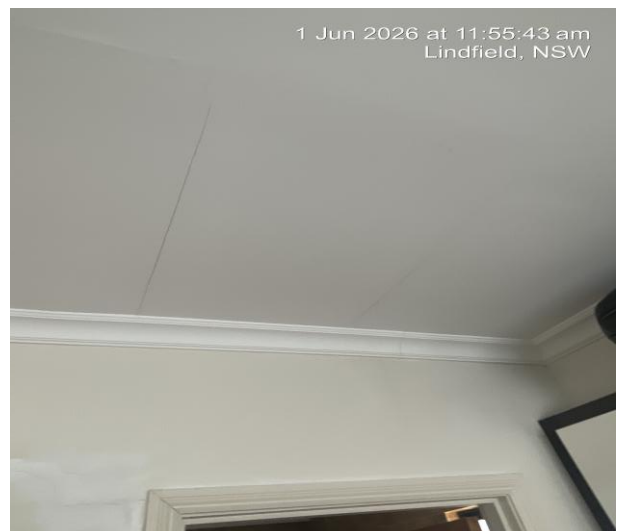
Photo 126 - Cracking observed to ceiling

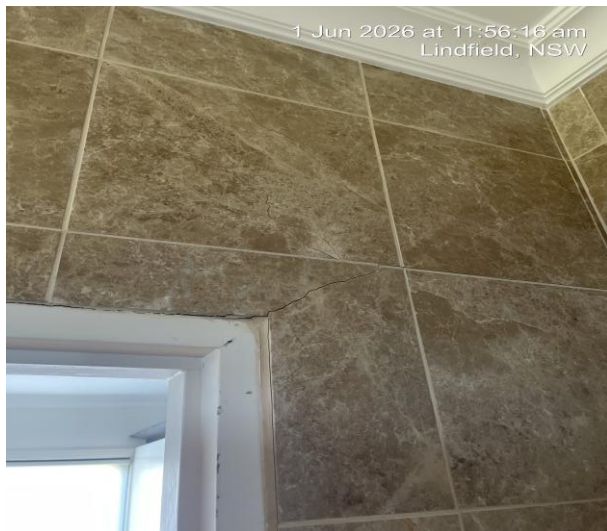
Photo 129 - Cracking observed to tiles

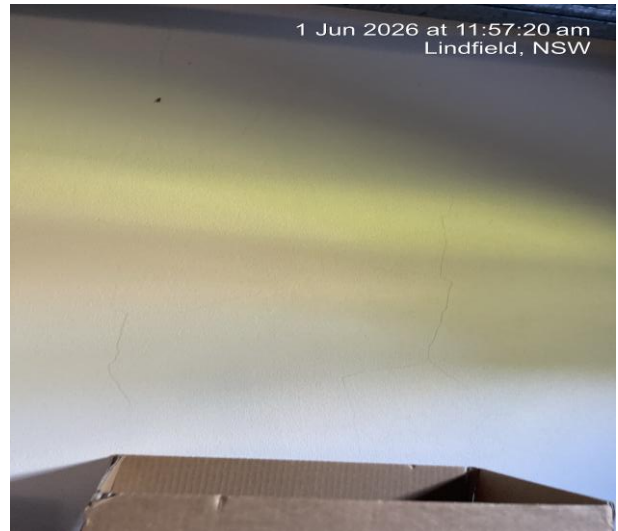
Photo 134 – Cracking observed to render

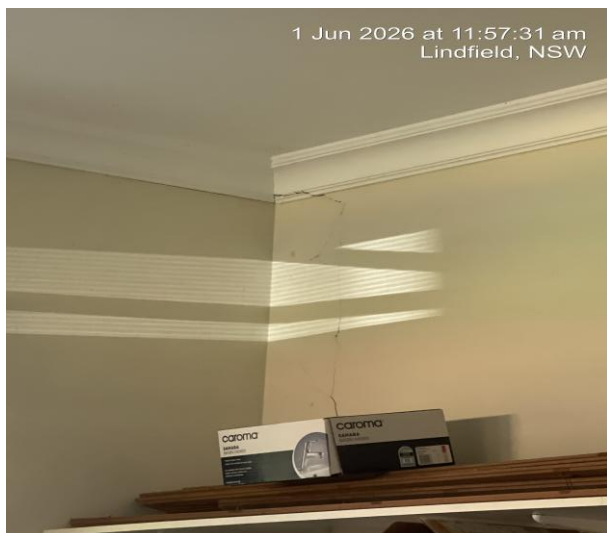
Photo 135 - Cracking observed to render

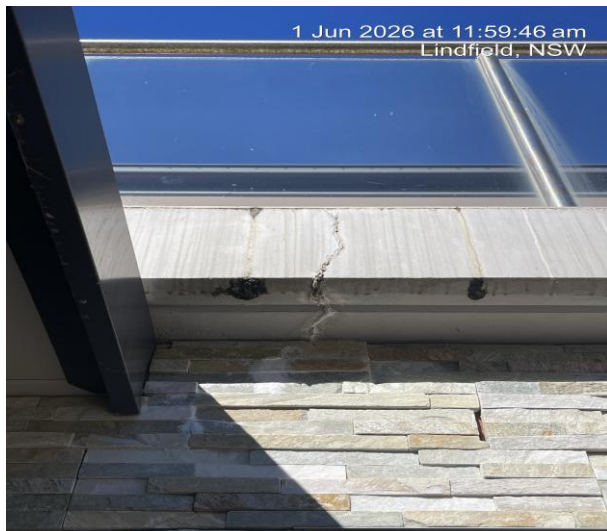
Photo 141 – Cracking and efflorescence observed to edge of balcony

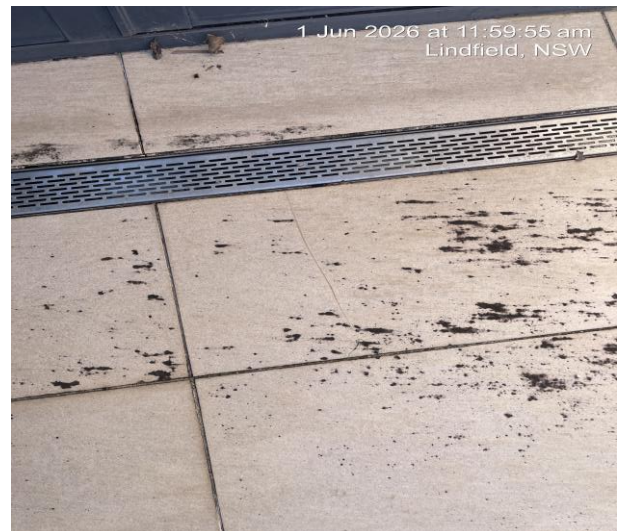
Photo 142 – Cracking observed to tiles

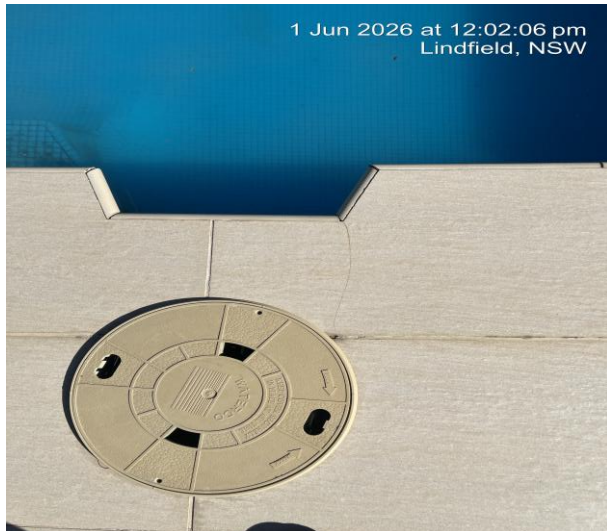
Photo 151 - Cracking observed to tiles

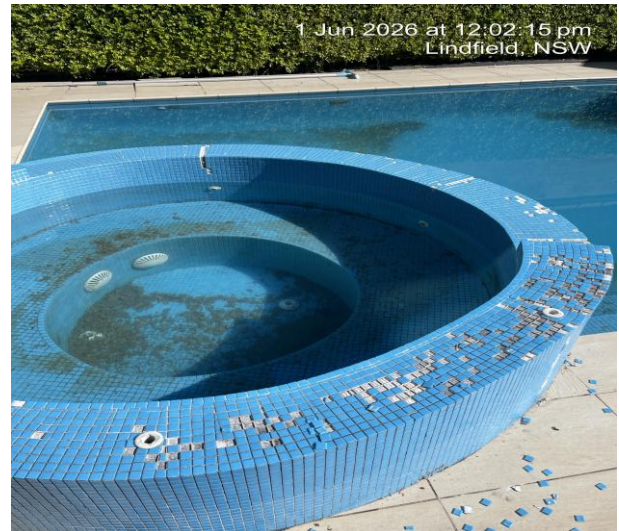
Photo 152 – Dislodgement of tiles observed

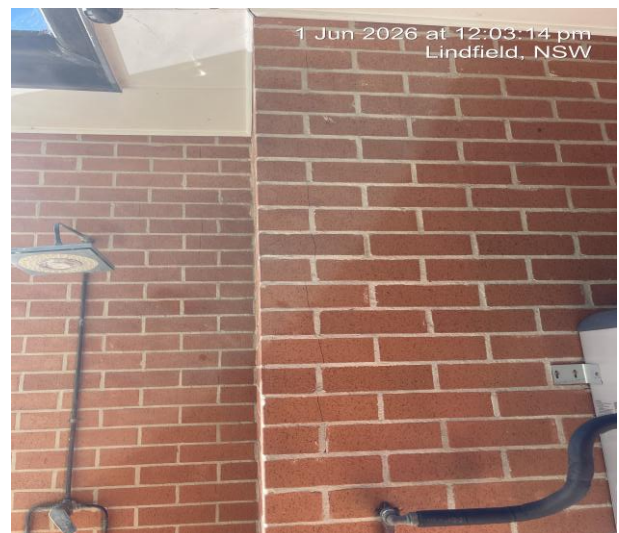
Photo 156 – Cracking observed to brick facade

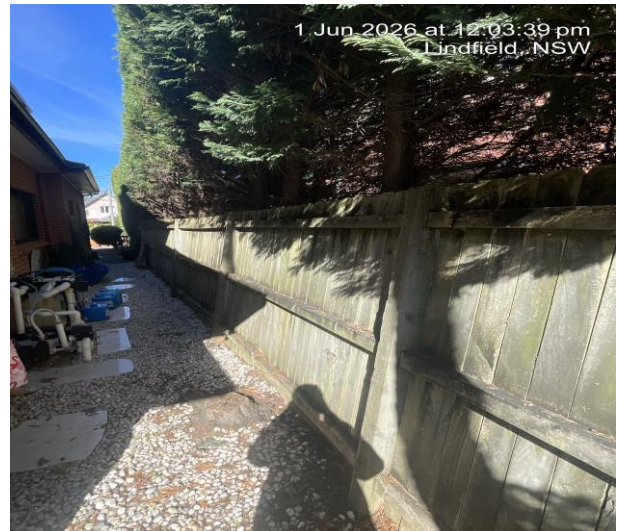
Photo 158 – Overturning of fence observed

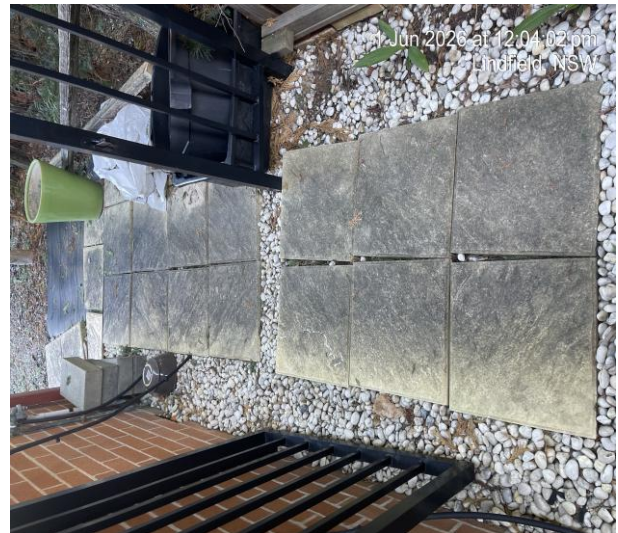
Photo 160 – Settlement observed to pavers

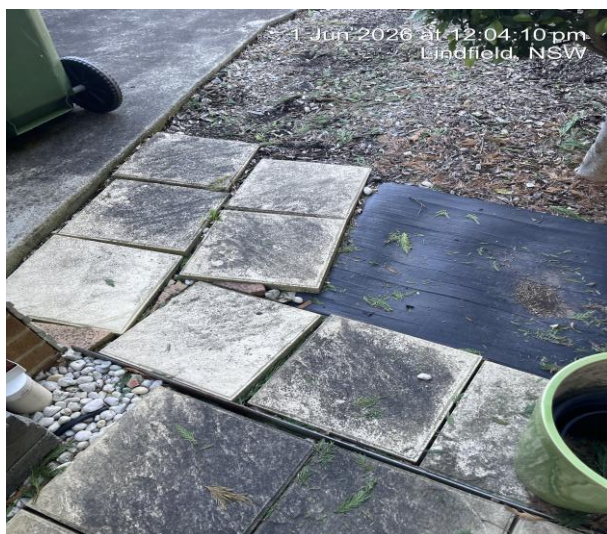
Photo 161 - Settlement observed to pavers

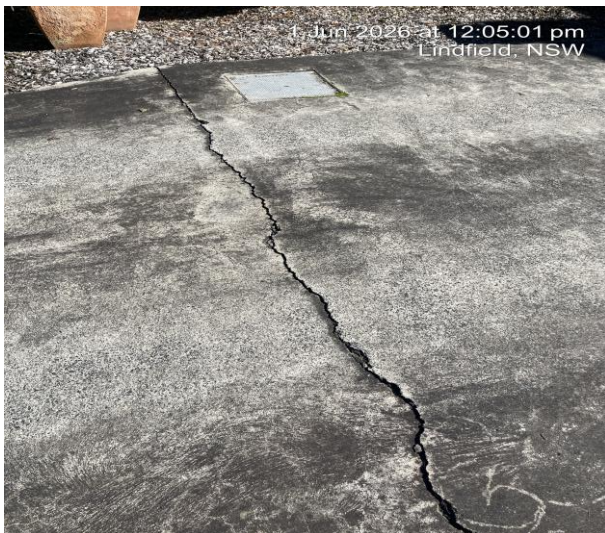
Photo 165 – Cracking observed to concrete

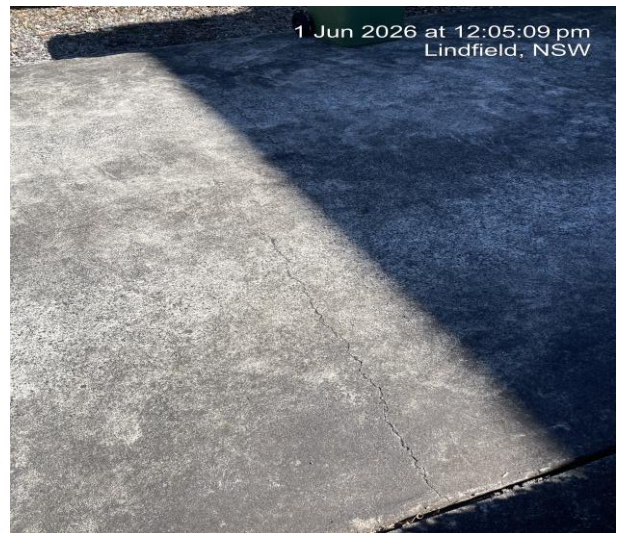
Photo 166 - Cracking observed to concrete

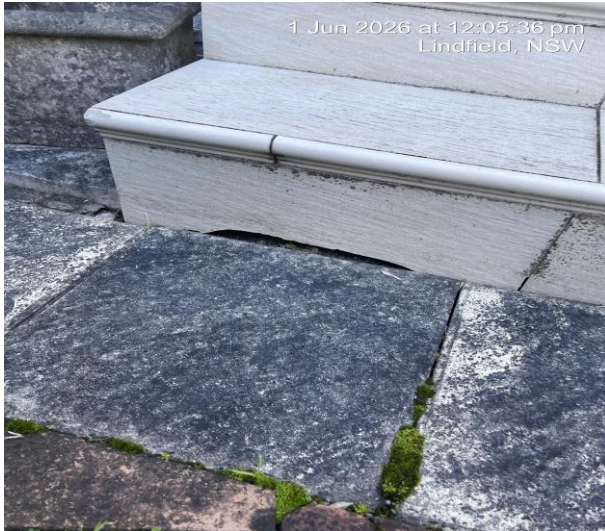
Photo 169 – Damage observed to tile

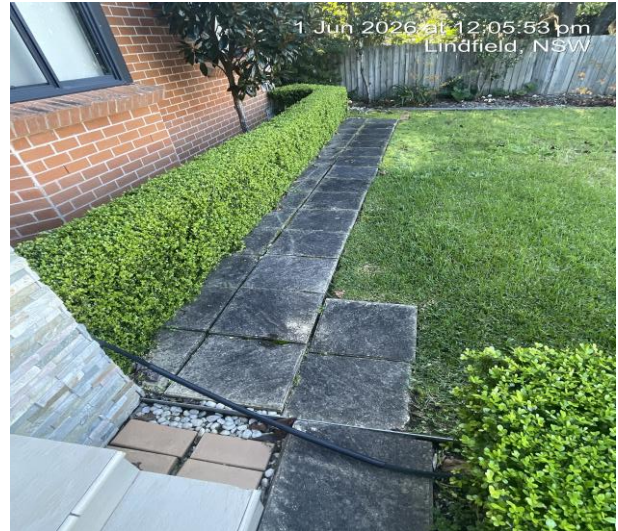
Photo 170 – Settlement observed to pavers

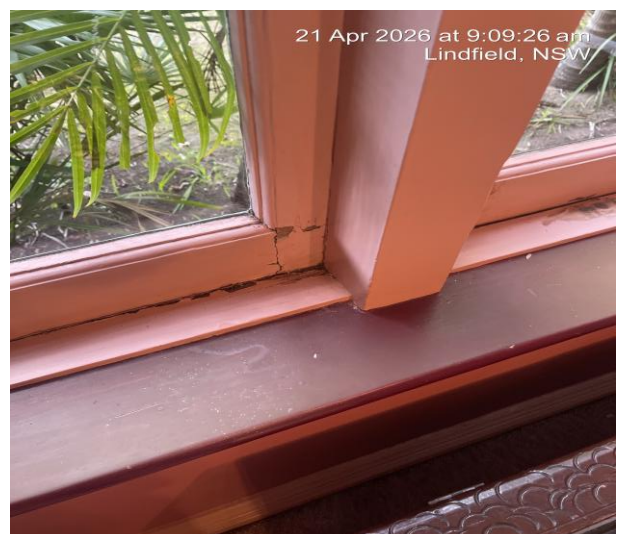
Photo 6 – Cracking observed to window frame

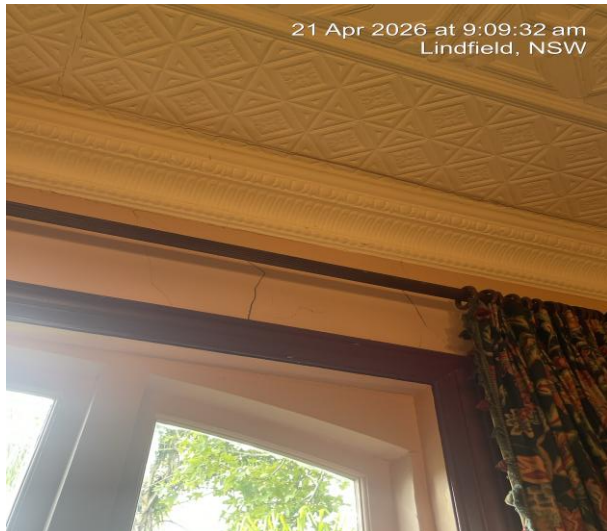
Photo 7 – Vertical cracking observed to wall

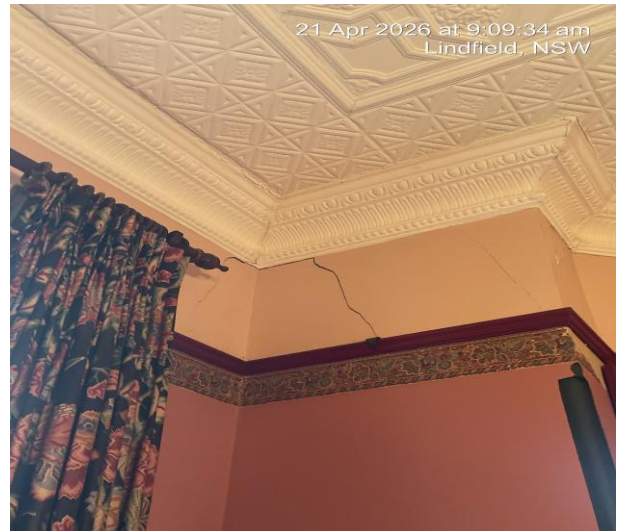
Photo 8 – Cracking observed to wall and coving

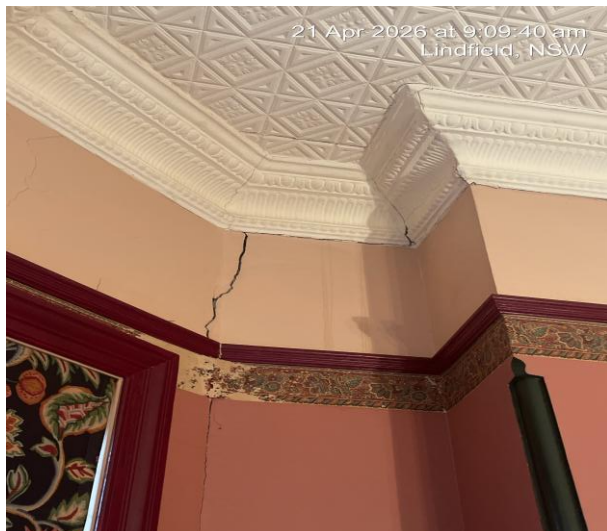
Photo 9 – Vertical cracking observed to wall and coving

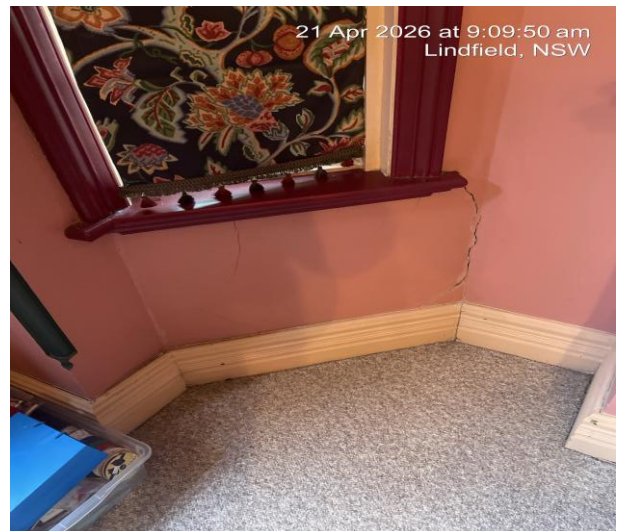
Photo 10 – Vertical cracking observed to wall

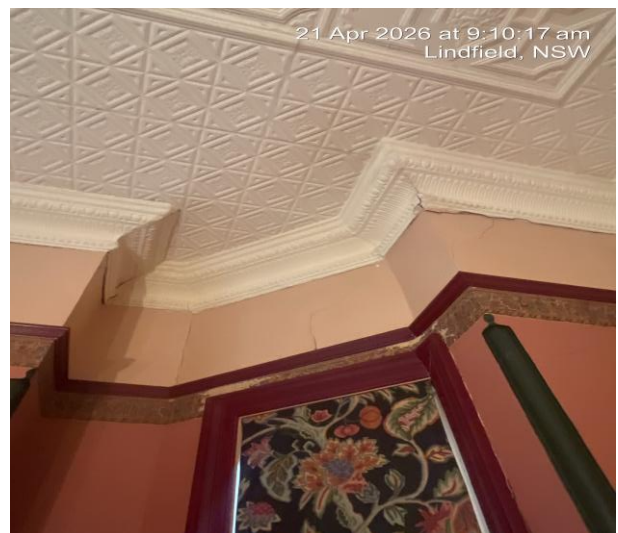
Photo 12 – Cracking observed to wall and coving

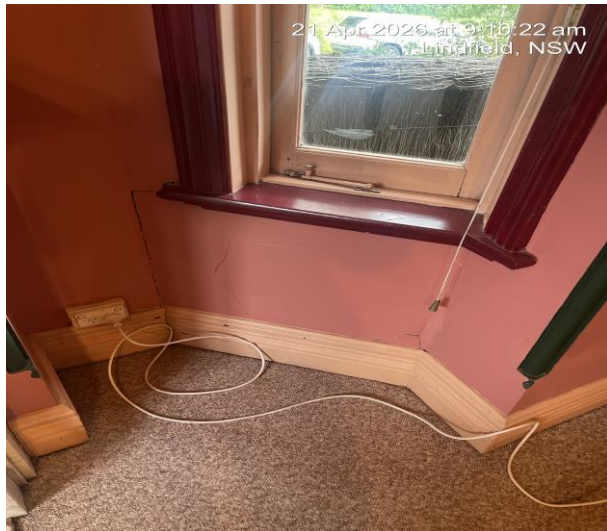
Photo 13 – Vertical cracking observed to wall

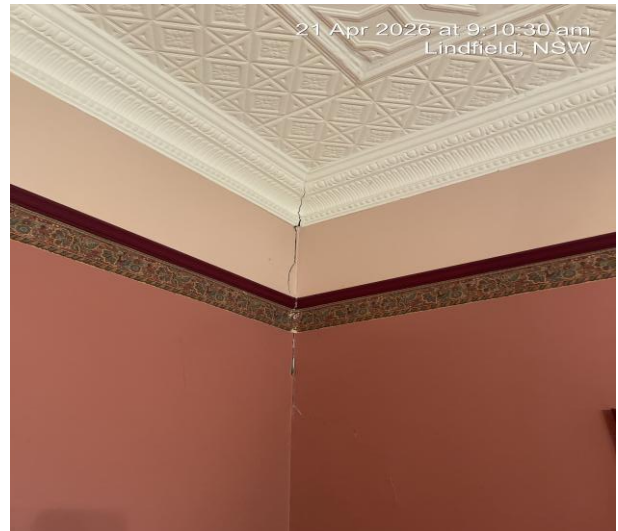
Photo 14 – Vertical cracking observed to wall and coving

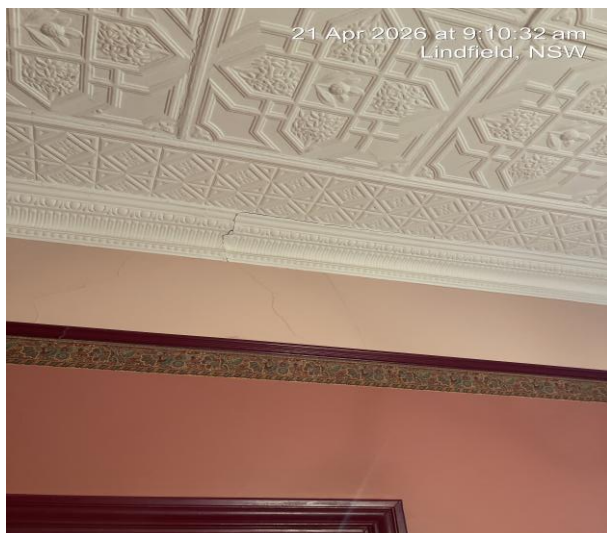
Photo 15 - Cracking observed to wall and coving

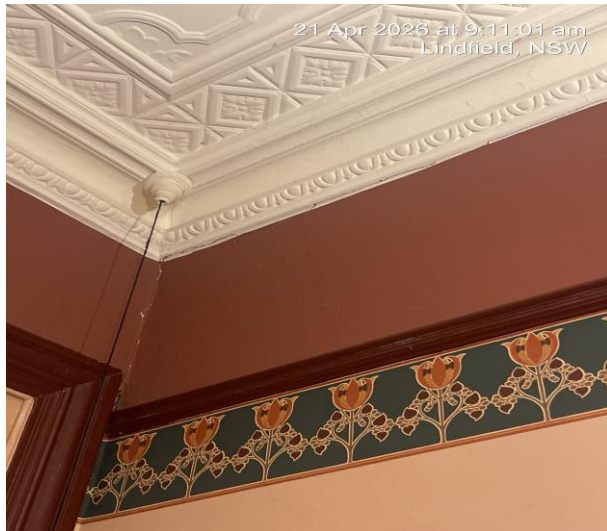
Photo 18 – Cracking observed to wall

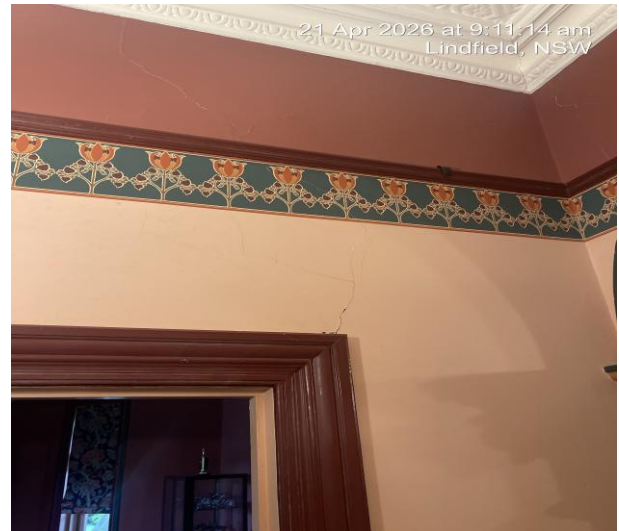
Photo 19 – Cracking observed to wall

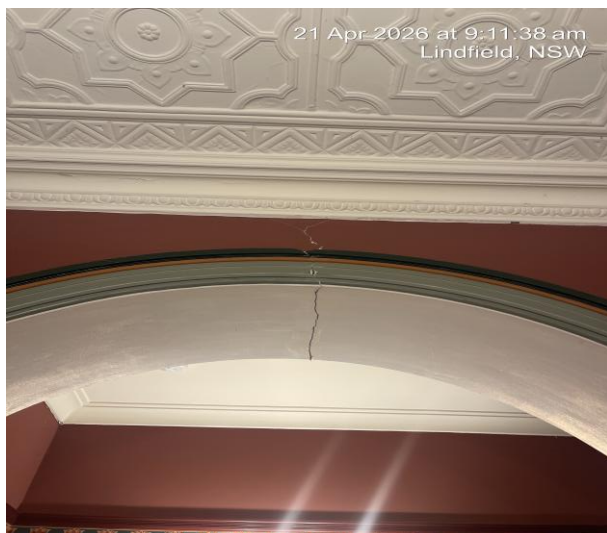
Photo 20 - Cracking observed to wall

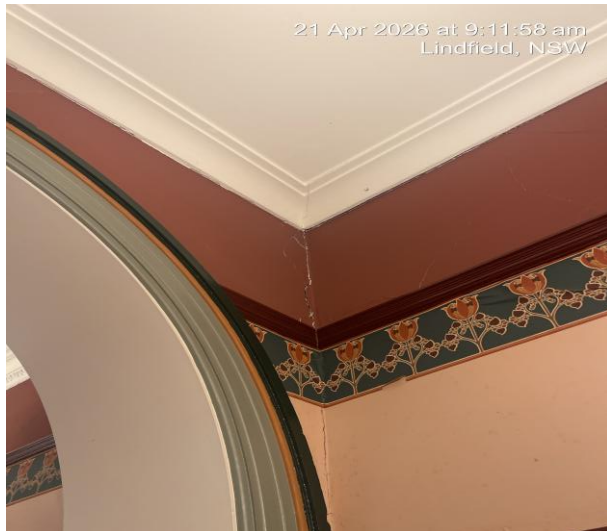
Photo 24 – 45° crack observed to wall
