# **DILAPIDATION REPORT**

**For Property At  
3A Valley Rd,  
Lindfield, NSW 2070**

**For Development At  
59-63 Trafalgar Ave & 1A-1B Valley Rd,  
Lindfield, NSW 2070**

**Ref: 26009-DR-001-R1-3A Valley Rd  
Date: 25.05.2026**

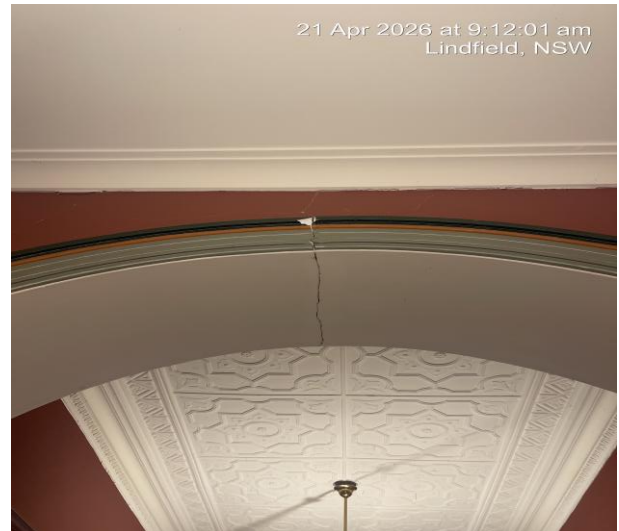
Photo 25 – Vertical cracking observed to wall

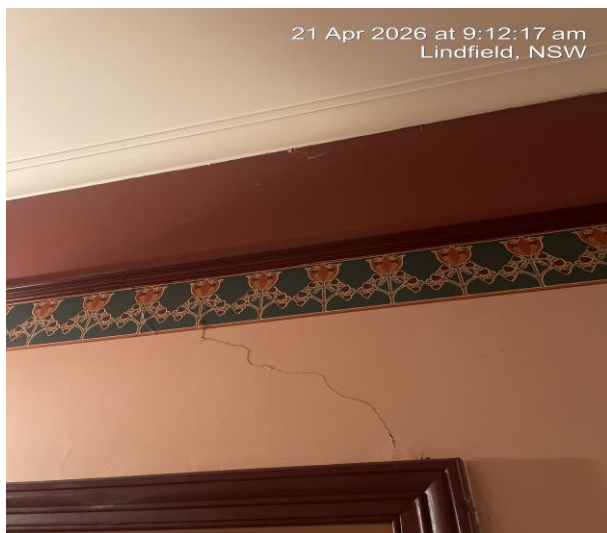
Photo 26 - Cracking observed to archway

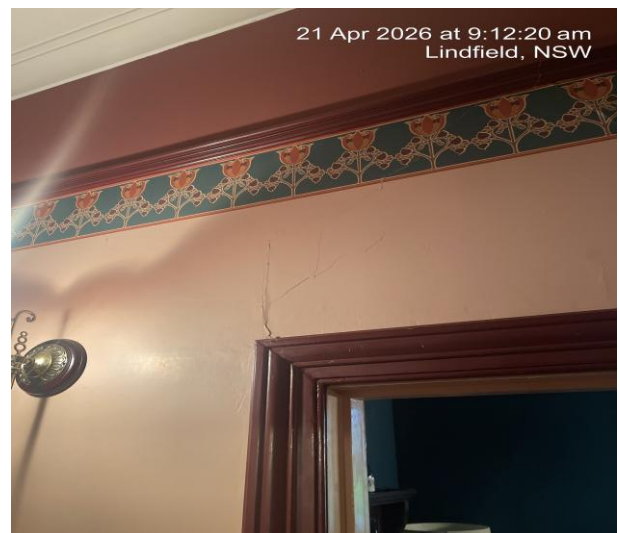
Photo 27 – 45° crack observed to wall

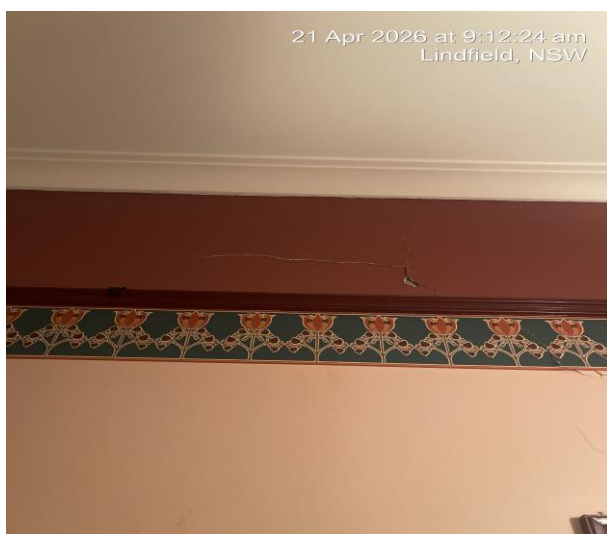
Photo 28 - Cracking observed to wall

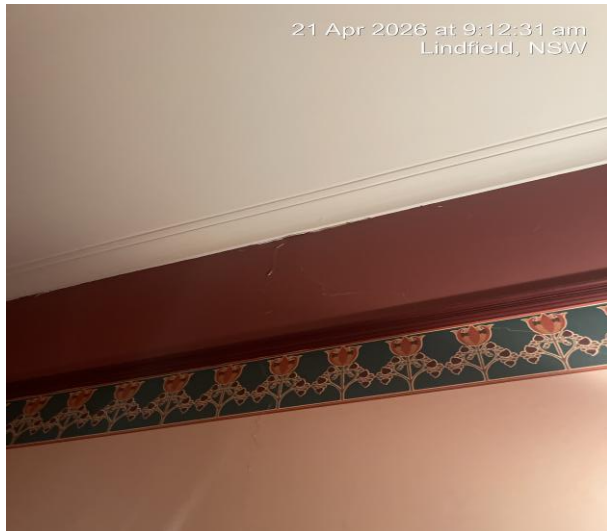
Photo 30 – 45° crack observed to wall

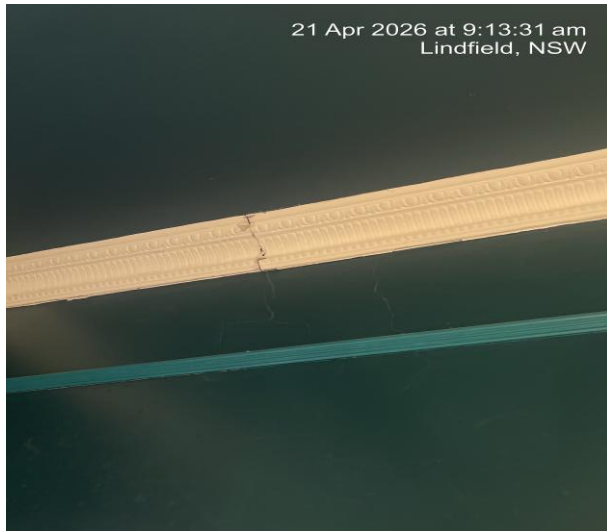
Photo 36 - Cracking observed to wall

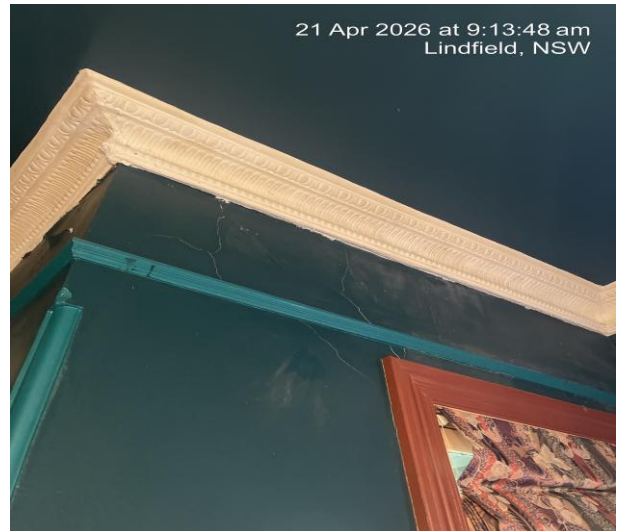
Photo 37 – Cracking observed to wall and coving

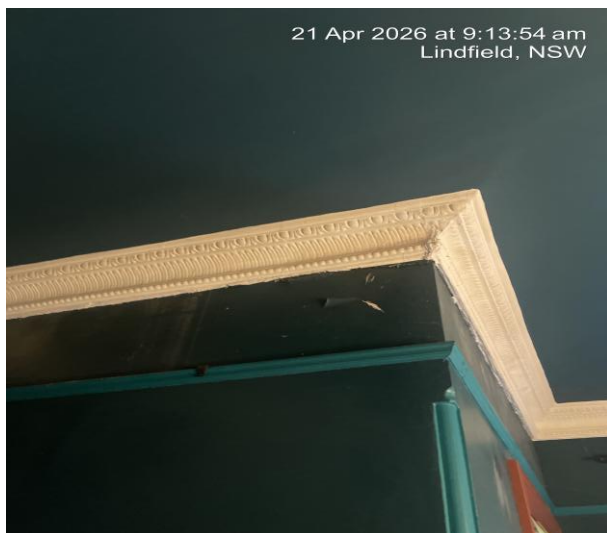
Photo 38 – Cracking observed to wall and coving

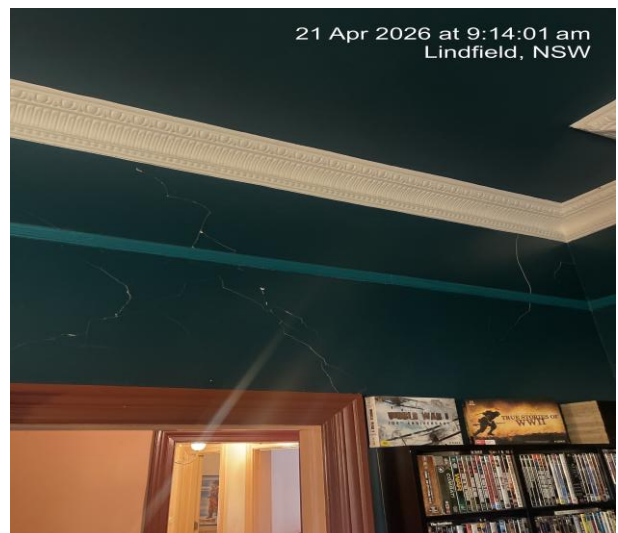
Photo 39 – Cracking observed to wall and coving

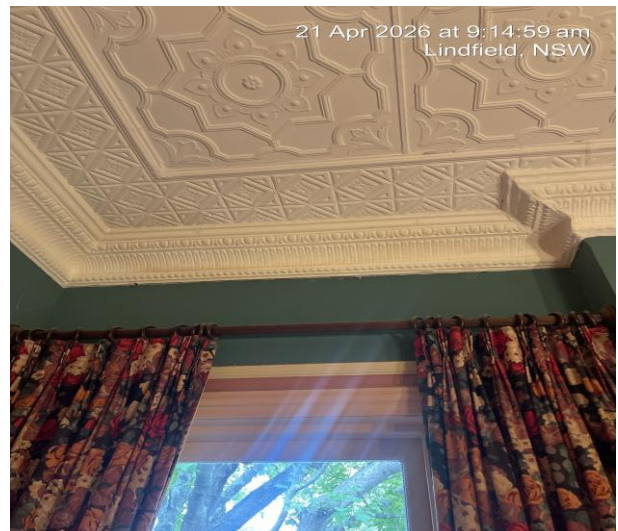
Photo 45 – Cracking observed to wall and coving

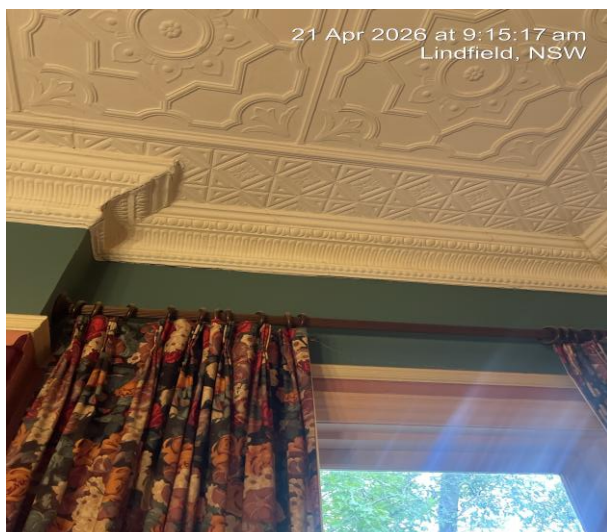
Photo 46 - Cracking observed to wall and coving

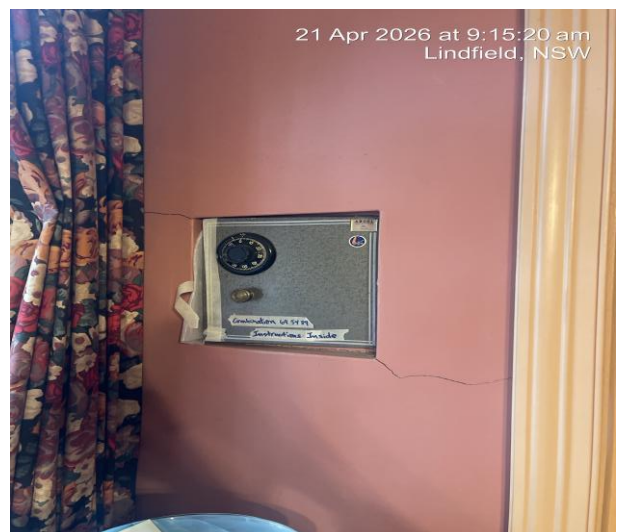
Photo 47 - Cracking observed to wall and coving

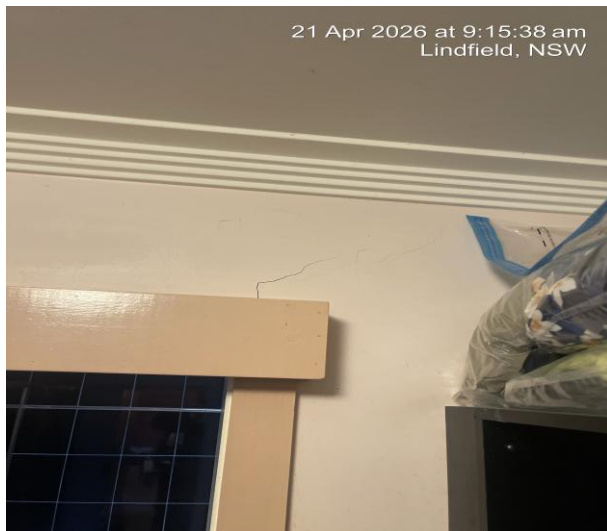
Photo 50 – Cracking observed to wall

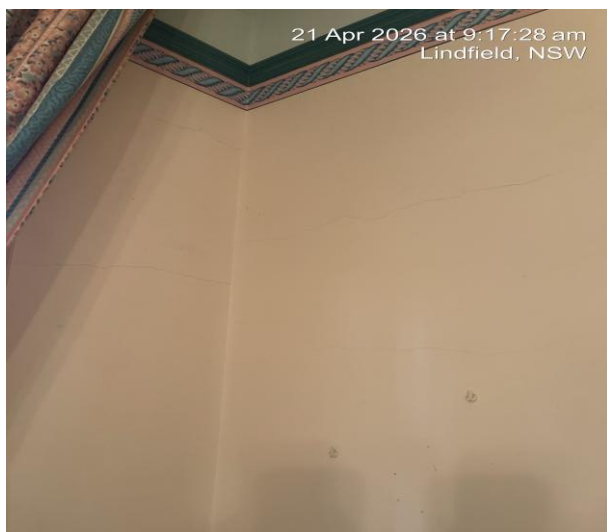
Photo 58 – Horizontal cracking observed to wall

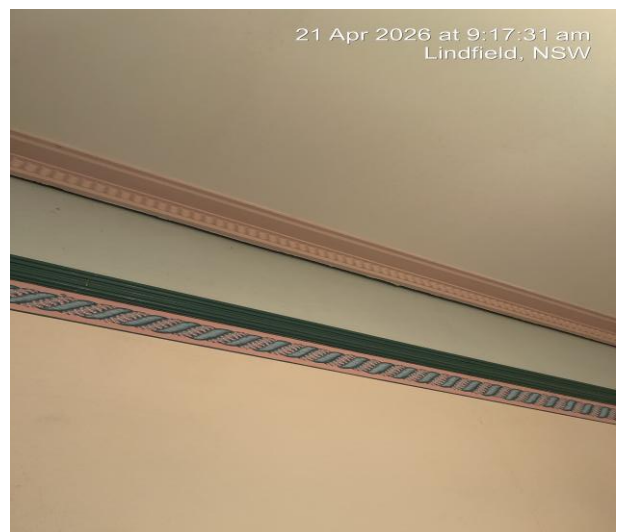
Photo 60 – Movement observed to coving

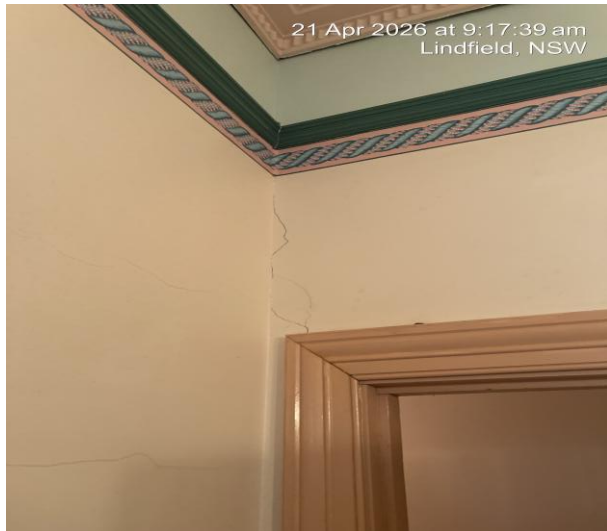
Photo 61 – Cracking observed to wall

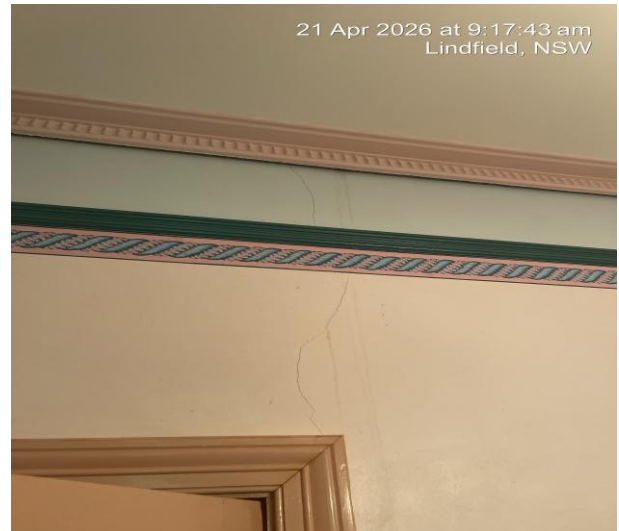
Photo 62 - Cracking observed to wall

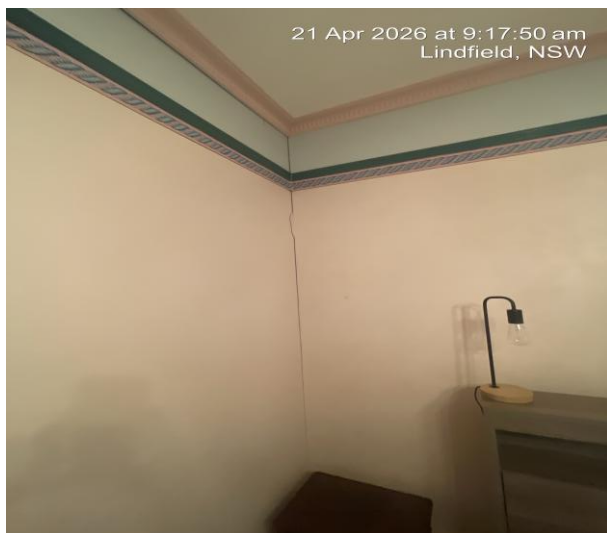
Photo 63 – Vertical crack observed at wall junction

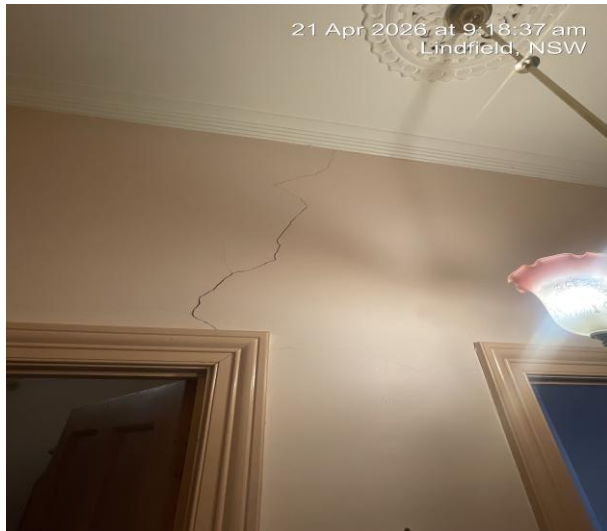
Photo 67 – Vertical crack observed to wall

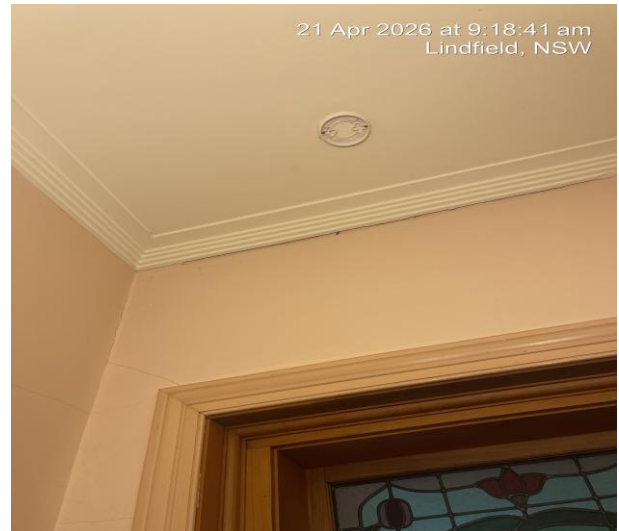
Photo 68 – Cracking observed to wall and movement observed to coving

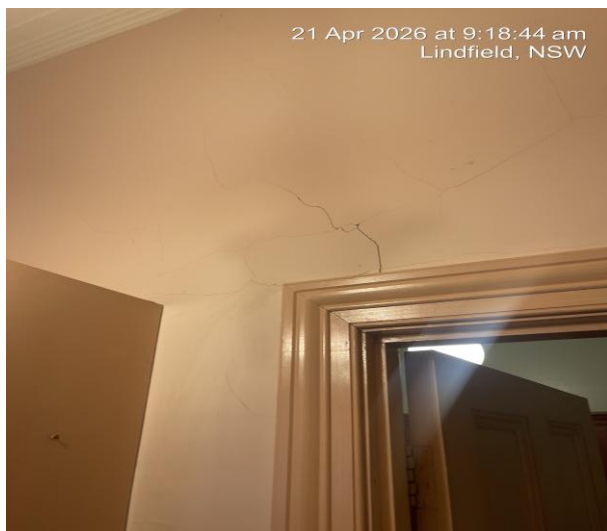
Photo 69 – Cracking observed to wall

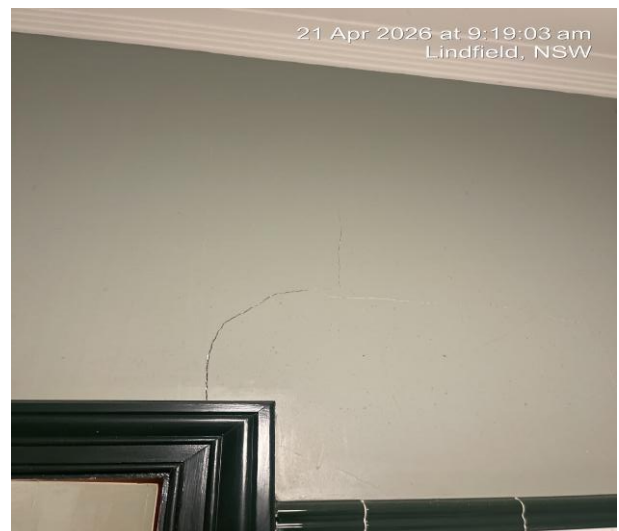
Photo 72 – Cracking observed to wall

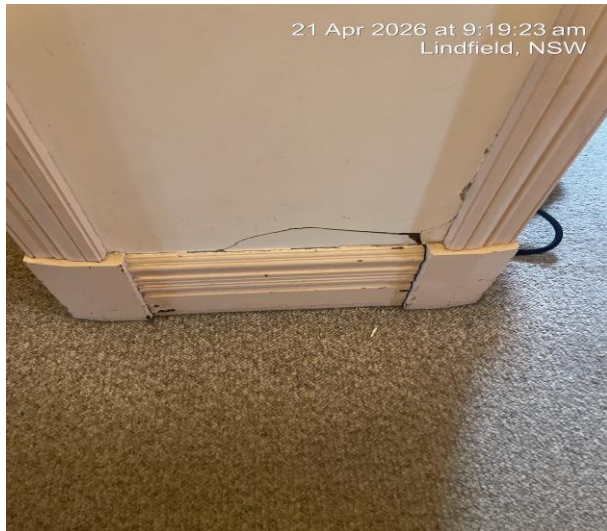
Photo 73 – Cracking observed to wall and skirting

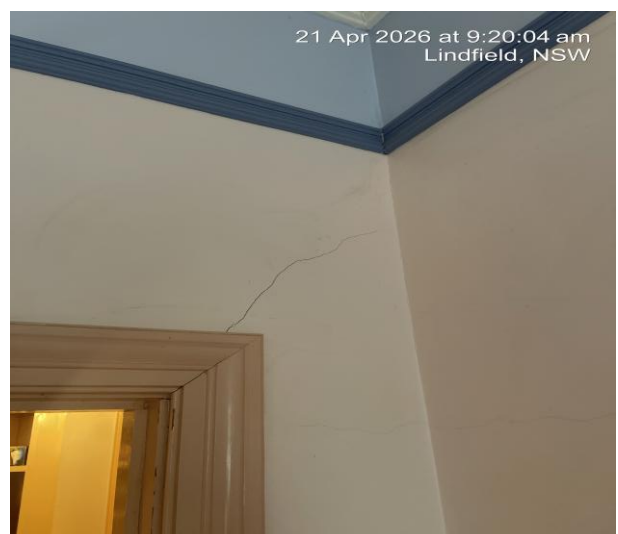
Photo 78 – 45° crack observed to wall

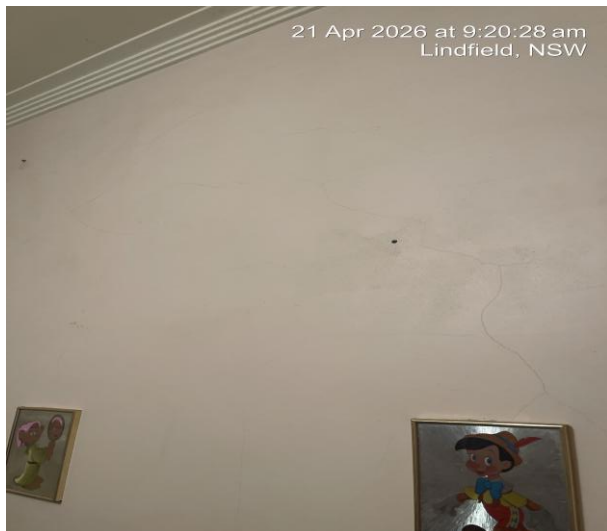
Photo 81 - Cracking observed to wall

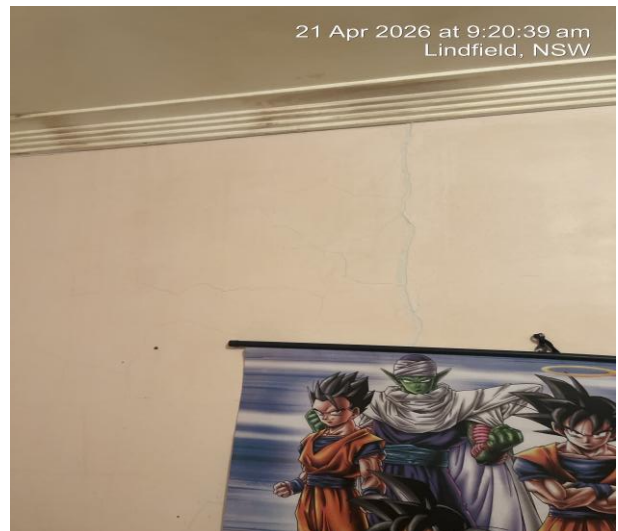
Photo 82 – Cracking observed to wall

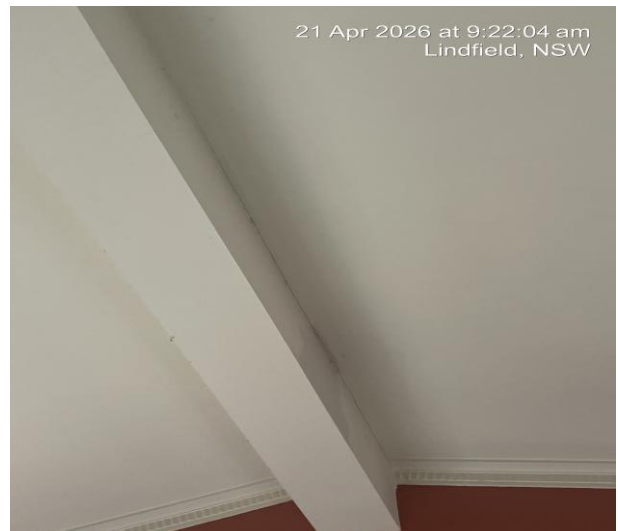
Photo 88 - Cracking observed to ceiling junction

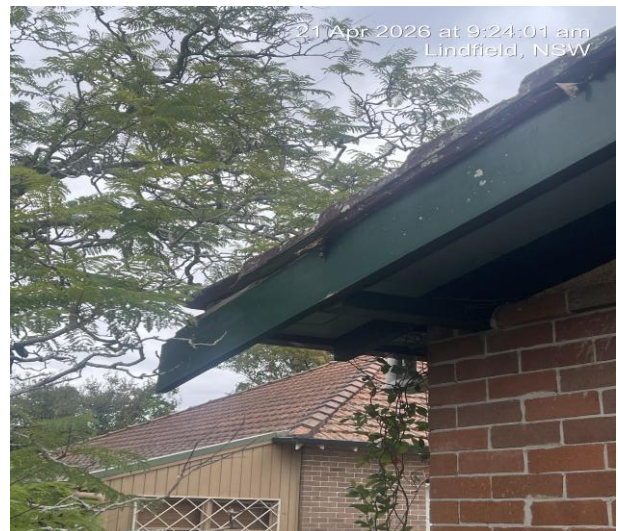
Photo 94 – Weathering observed to fascia

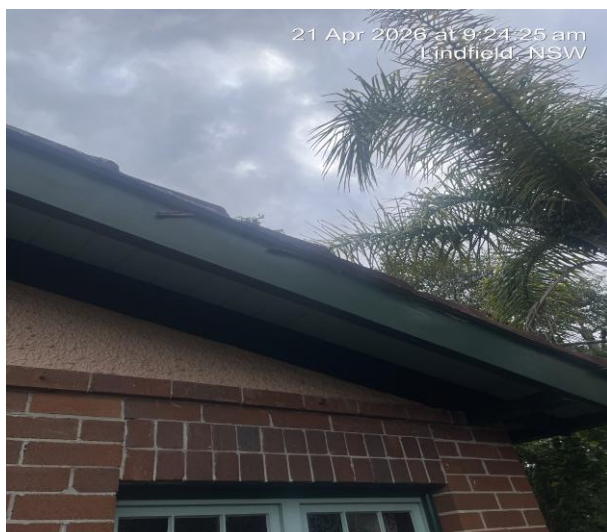
Photo 95 – Weathering observed to fascia

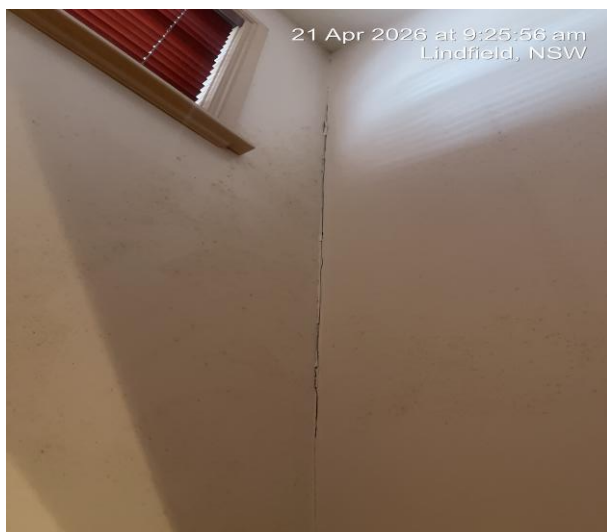
Photo 101 – Vertical crack observed to wall junction

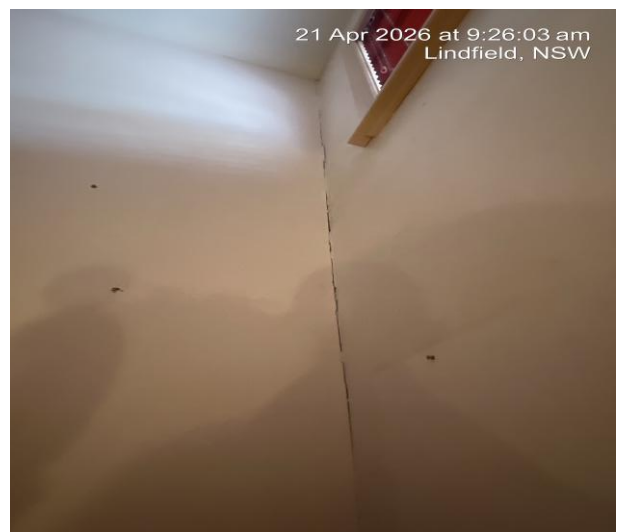
Photo 102 – Vertical crack observed to wall junction

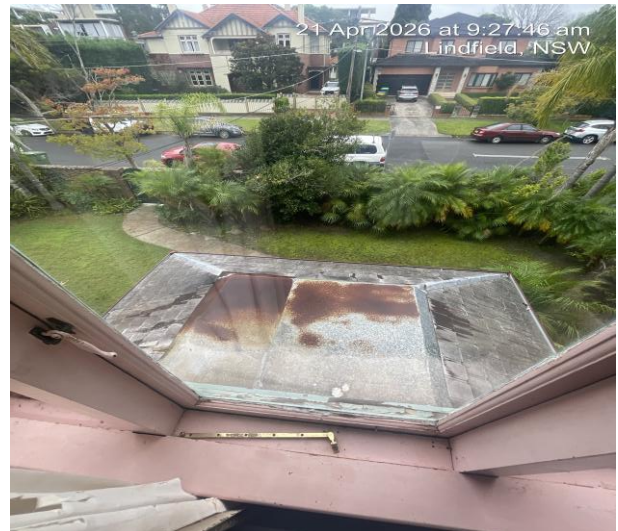
Photo 110 – Rust and age-related wear observed to front porch roof

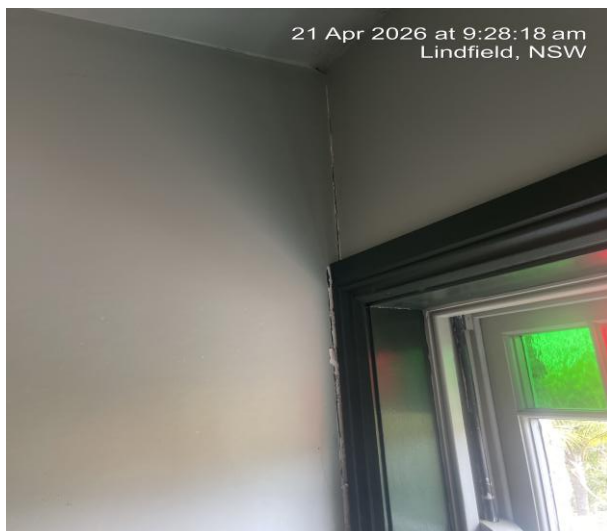
Photo 113 – Vertical crack observed to wall junction

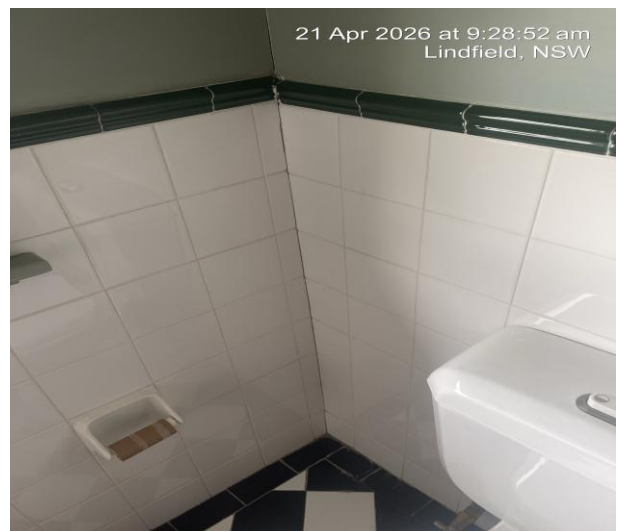
Photo 114 - Vertical crack observed to wall junction

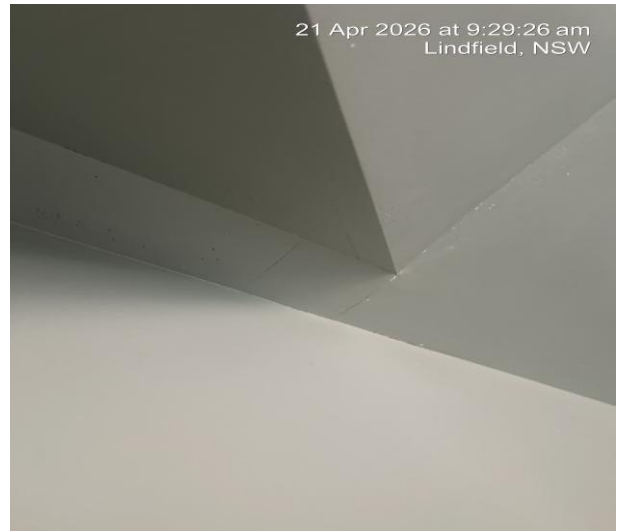
Photo 116 – Cracking observed to ceiling

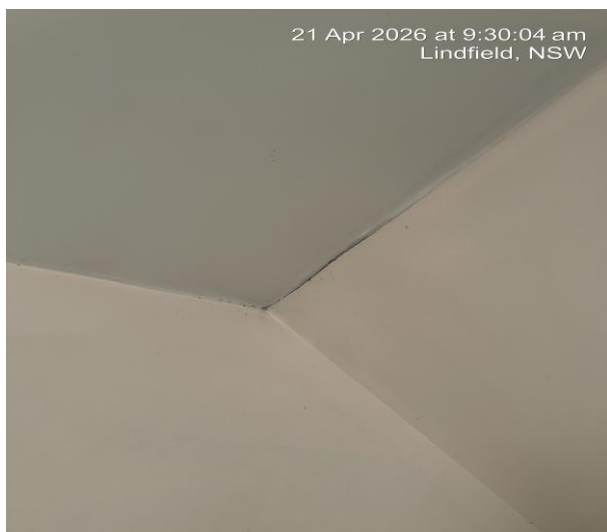
Photo 119 – Cracking observed to ceiling junction

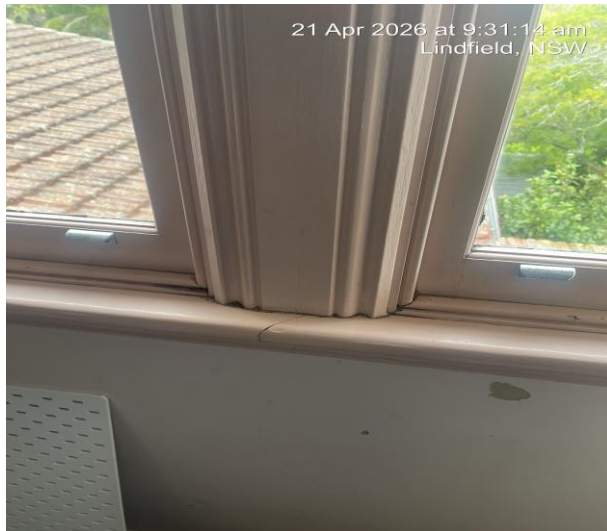
Photo 121 – Cracking observed to window frame

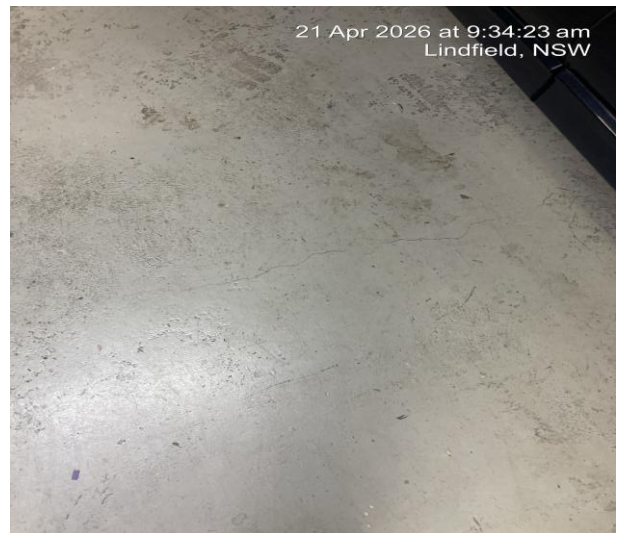
Photo 130 – Cracking observed to concrete

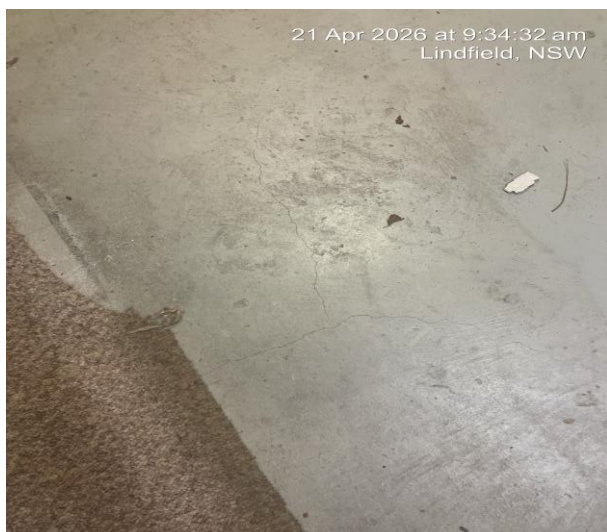
Photo 131 - Cracking observed to concrete

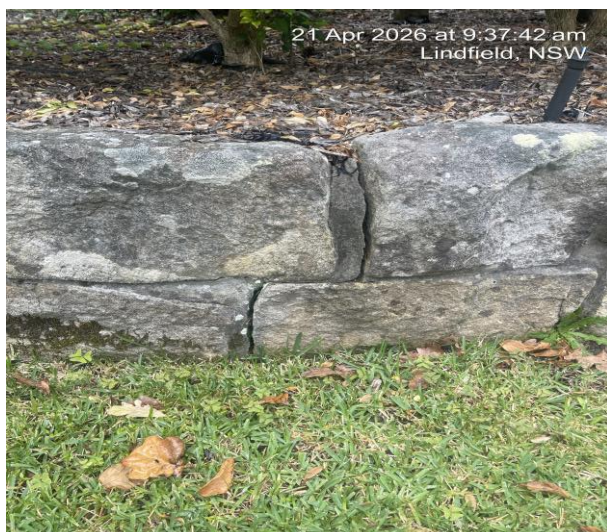
Photo 143 – Cracking observed to mortar

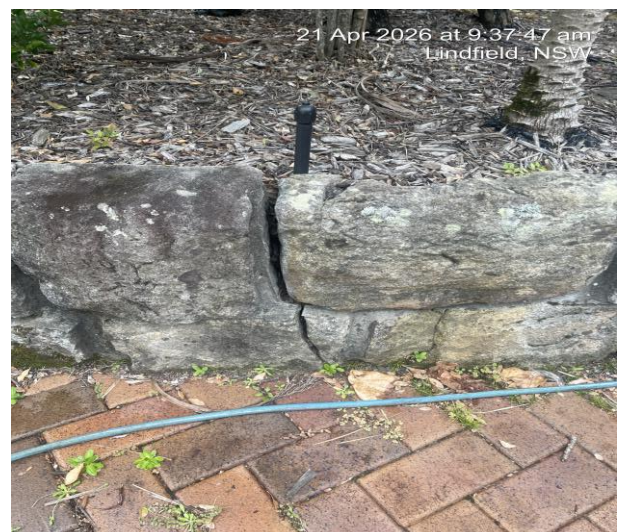
Photo 144 - Cracking observed to mortar

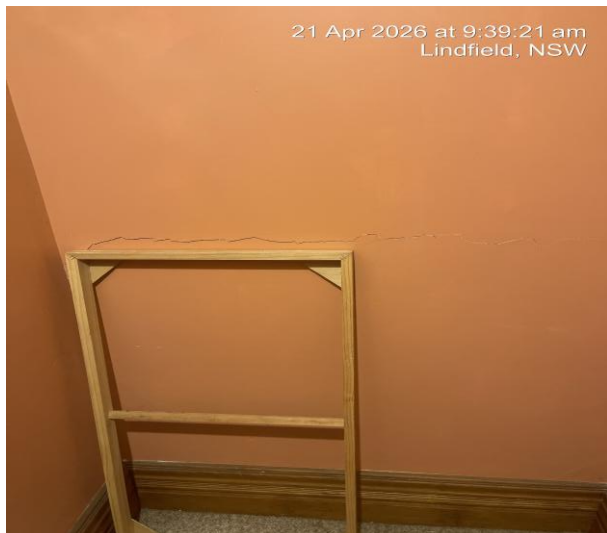
Photo 147 – Horizontal crack observed to wall

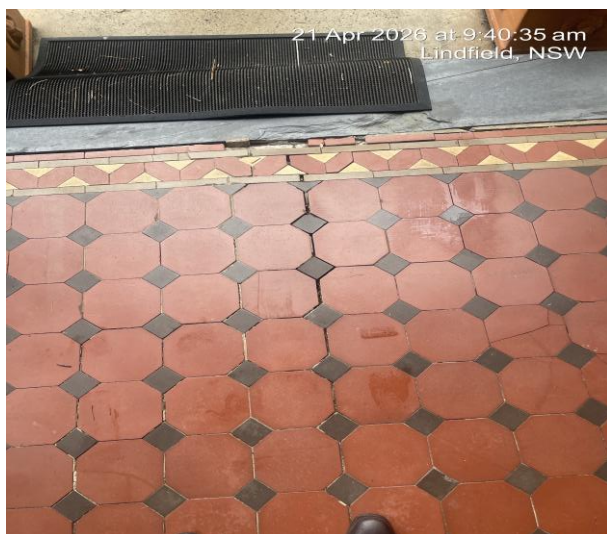
Photo 149 – Cracking observed to tiles

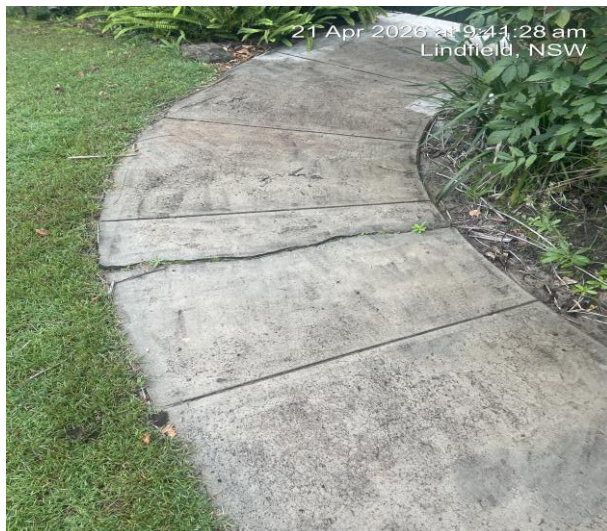
Photo 153 – Cracking observed to footpath

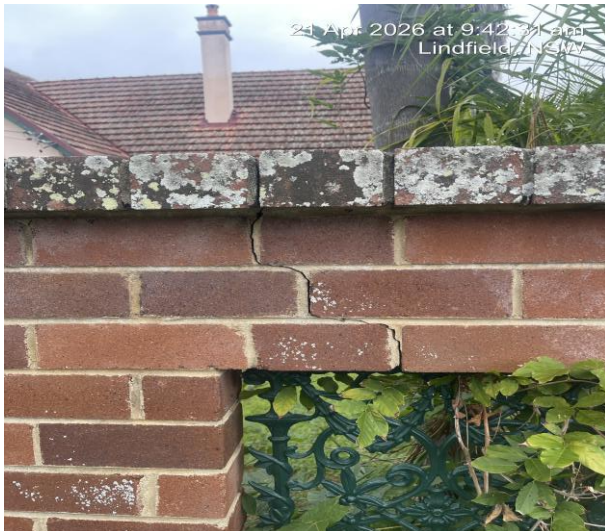
Photo 157 – Cracking observed to brick fence

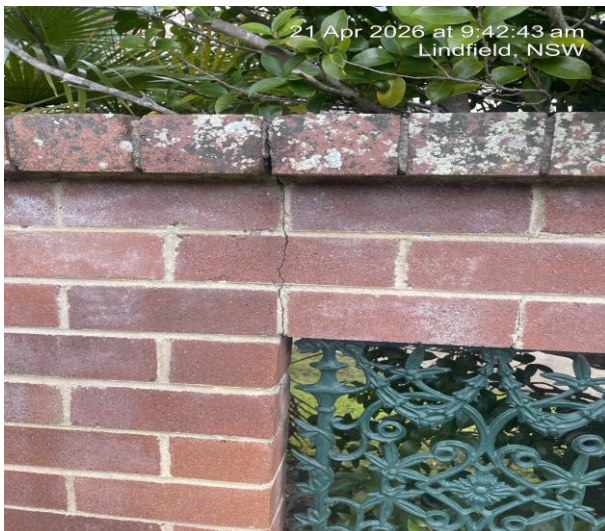
Photo 159 - Cracking observed to brick fence

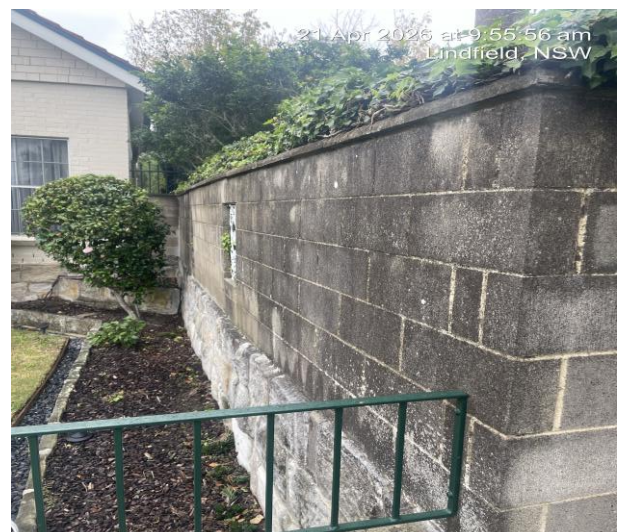
Photo 162 – Rear boundary block wall exhibiting outward bowing toward neighboring property

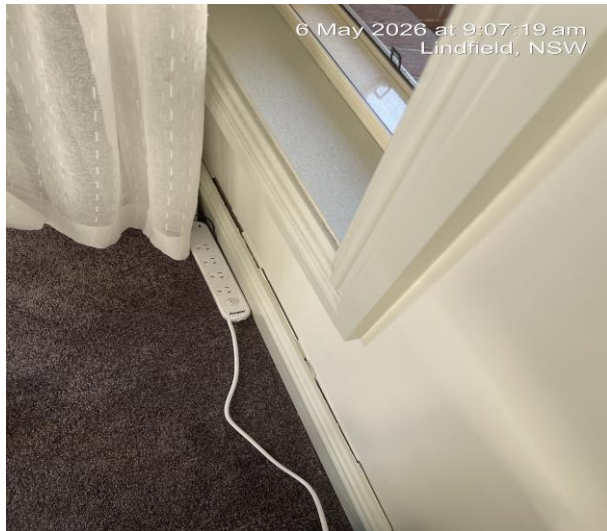
Photo 7 – Movement observed to skirting

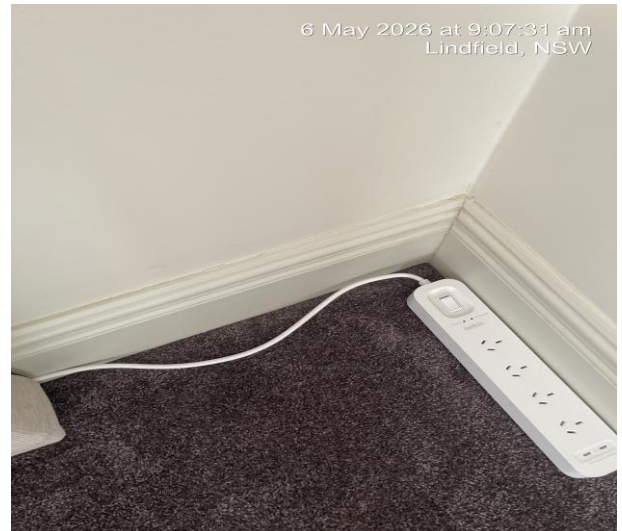
Photo 8 – Cracking observed to skirting

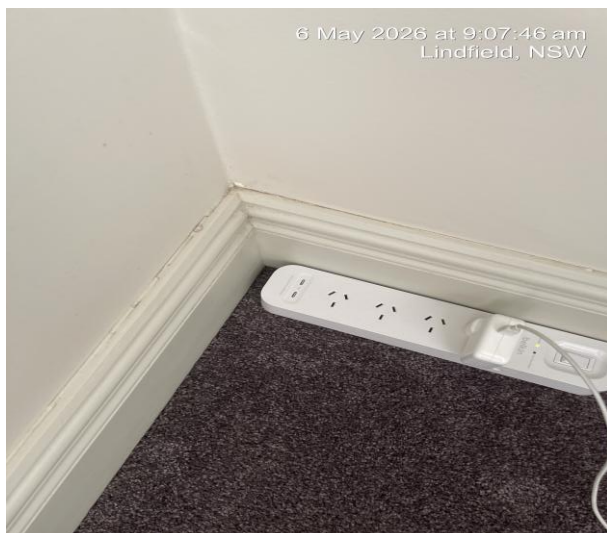
Photo 9 - Cracking observed to skirting

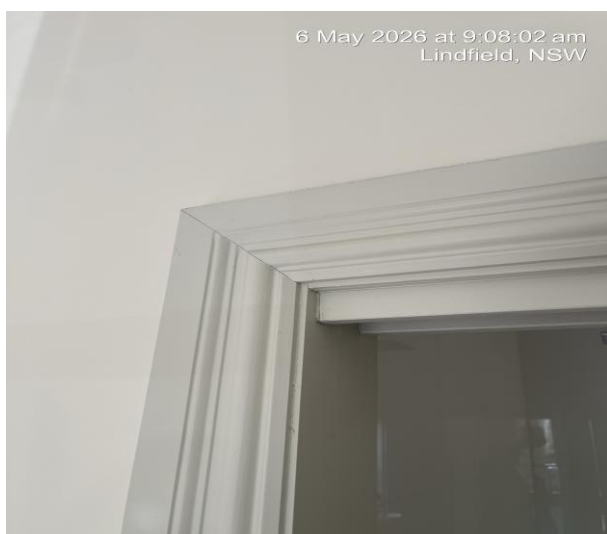
Photo 11 - Cracking observed to doorframe

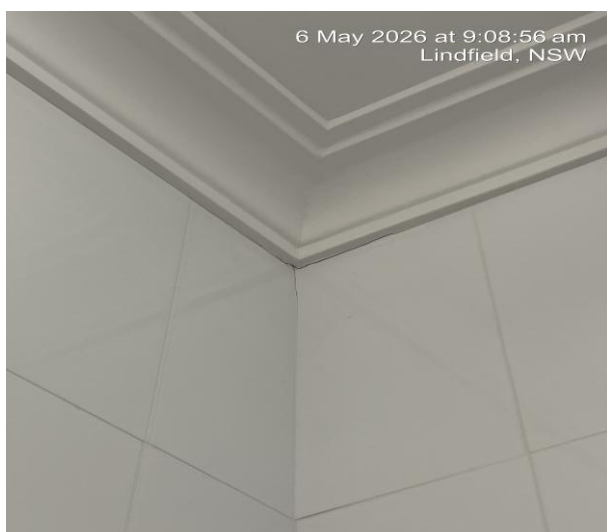
Photo 17 – Cracking observed to grout and coving

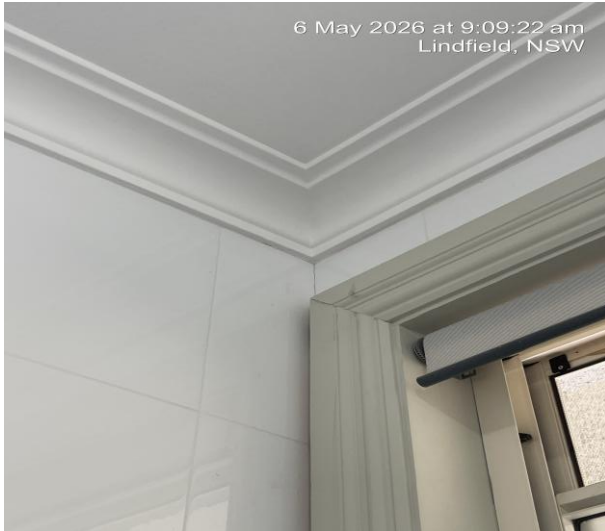
Photo 19 – Cracking observed to grout and coving

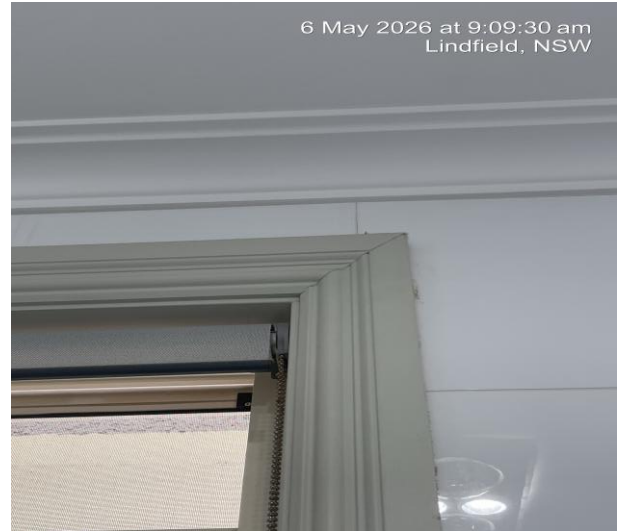
Photo 20 - Cracking observed to grout and window frame

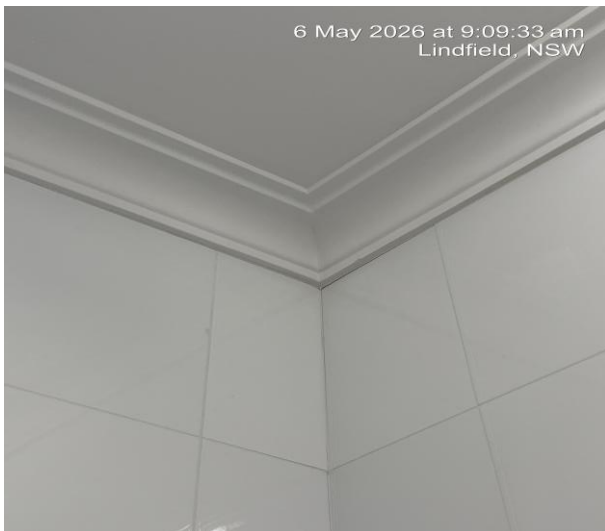
Photo 21 – Cracking observed to grout and coving

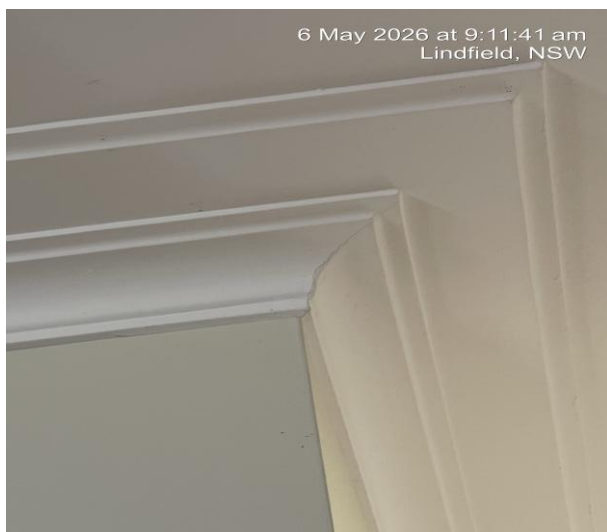
Photo 29 – Cracking observed to coving

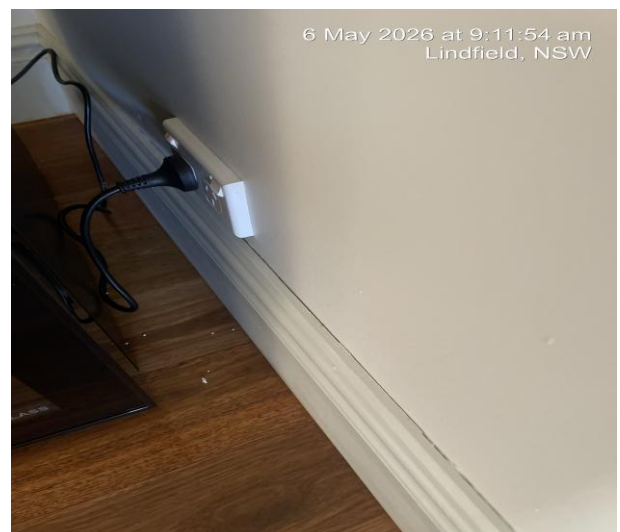
Photo 30 – Movement observed to skirting

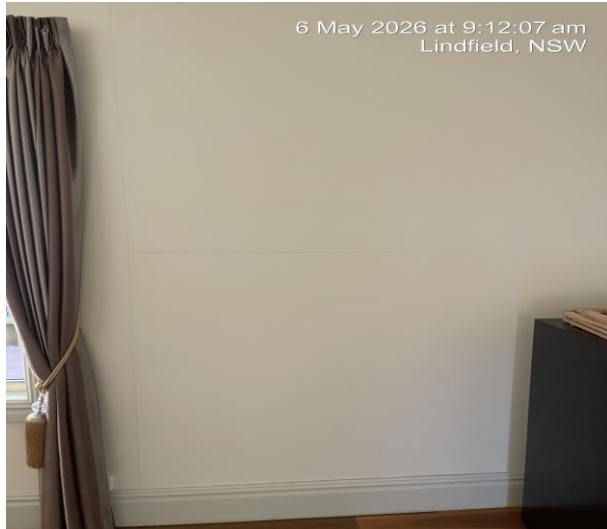
Photo 31 – Horizontal crack observed to gyprock

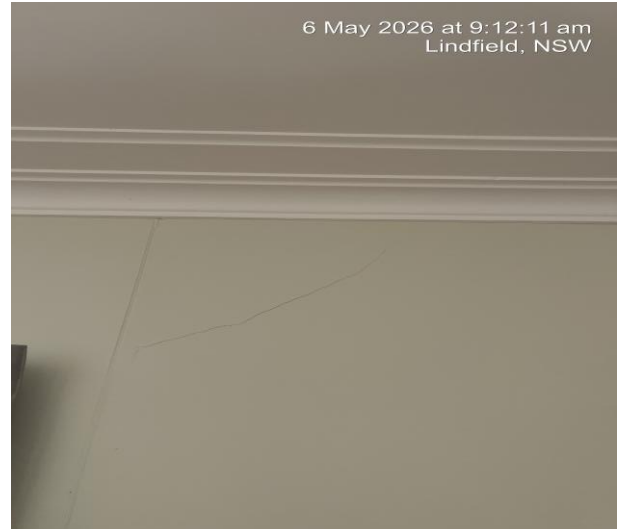
Photo 32 – 45° crack observed to gyprock

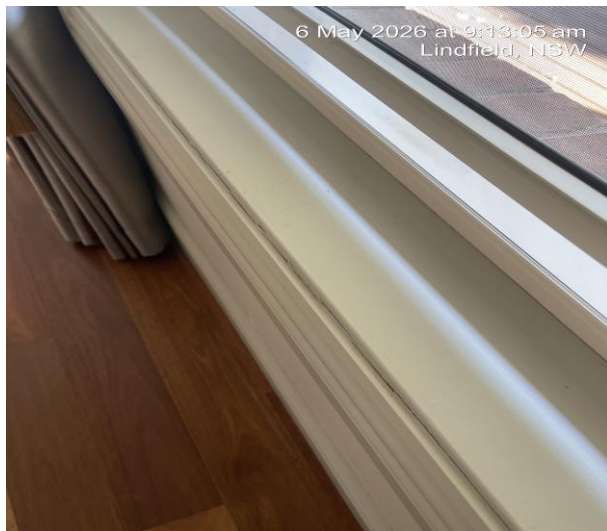
Photo 33 – Cracking observed to window frame

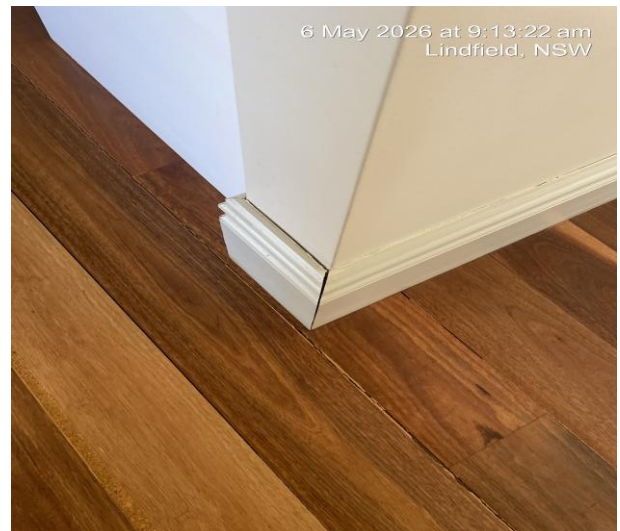
Photo 34 – Movement observed to skirting

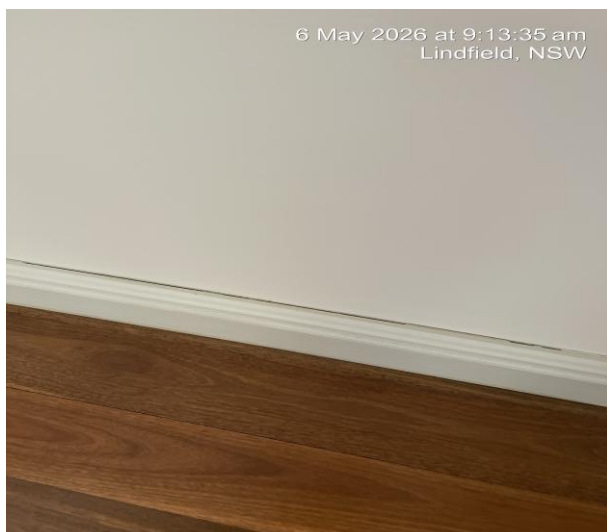
Photo 35 - Movement observed to skirting

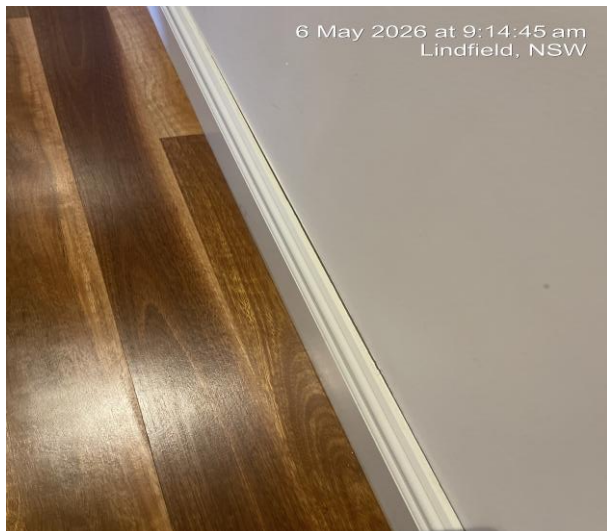
Photo 39 – Movement observed to skirting

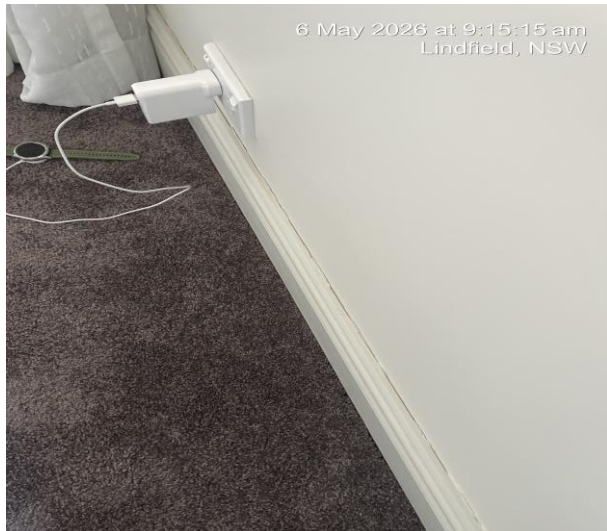
Photo 43 – Cracking observed to skirting

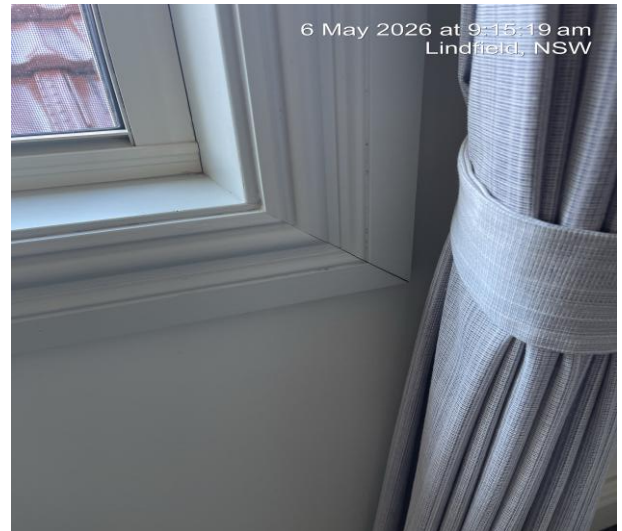
Photo 44 – Cracking observed to window frame

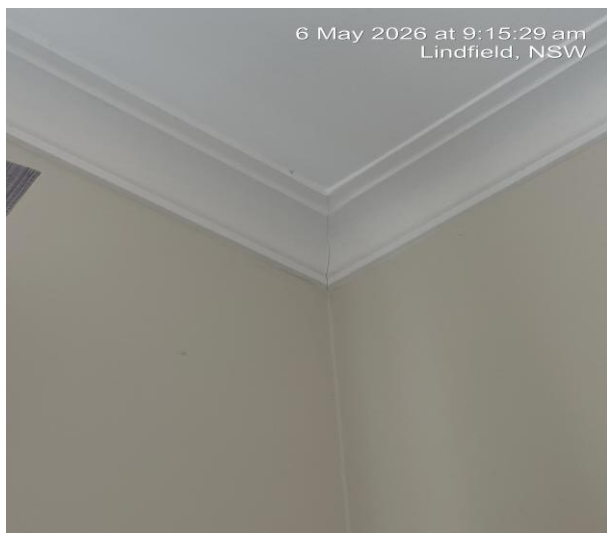
Photo 45 – Cracking observed to coving

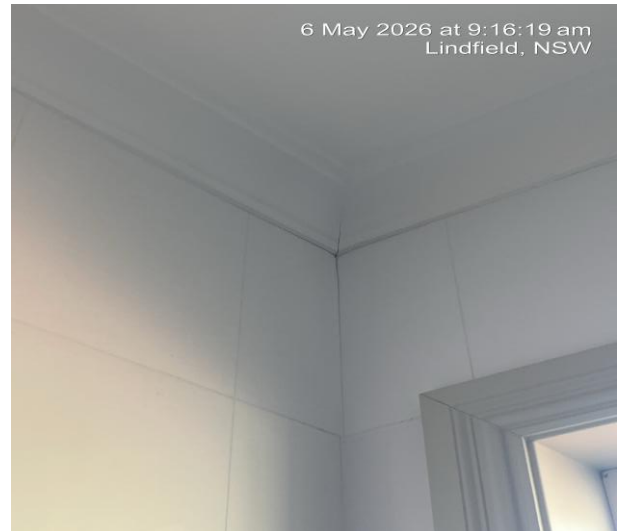
Photo 50 – Cracking observed to grout and coving

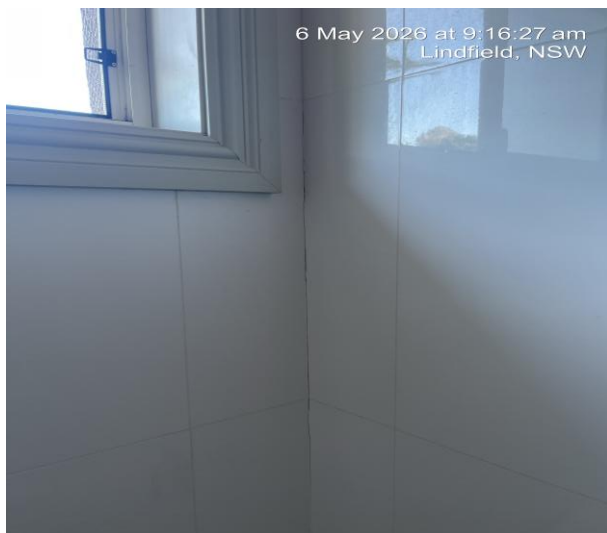
Photo 51 - Cracking observed to grout
