# **DILAPIDATION REPORT**

**For Property At  
3A Valley Rd,  
Lindfield, NSW 2070**

**For Development At  
59-63 Trafalgar Ave & 1A-1B Valley Rd,  
Lindfield, NSW 2070**

**Ref: 26009-DR-001-R1-3A Valley Rd  
Date: 25.05.2026**

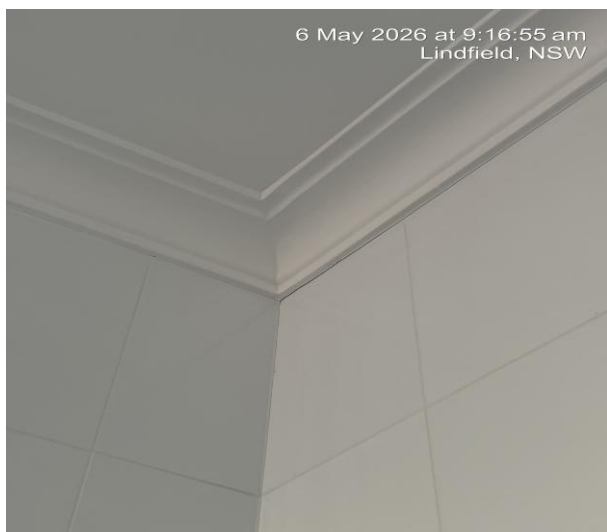
Photo 53 – Cracking observed to grout and coving

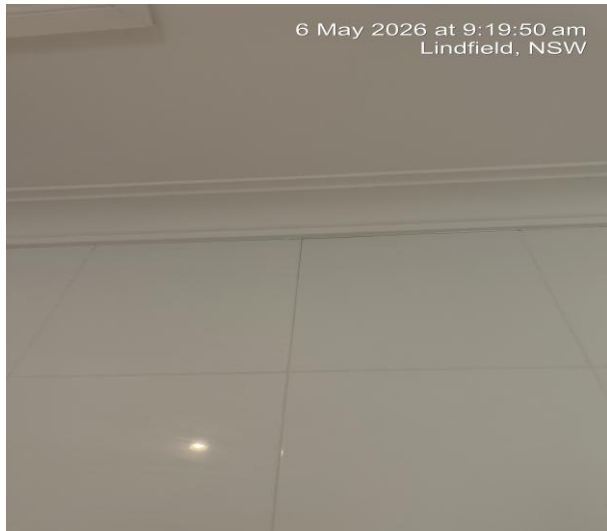
Photo 66 - Cracking observed to grout and coving

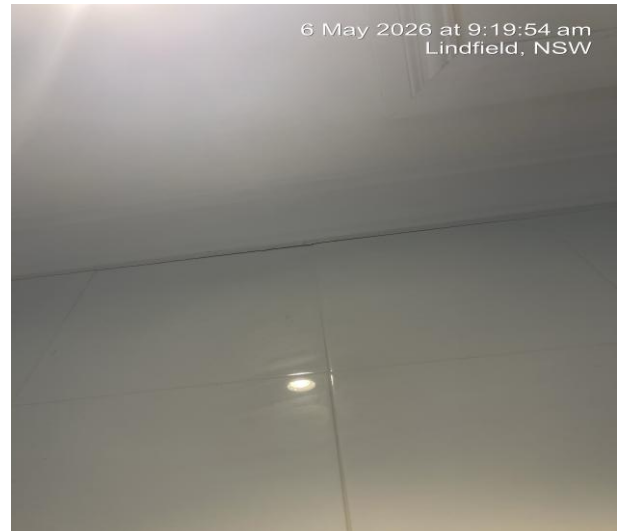
Photo 67 - Movement observed to coving

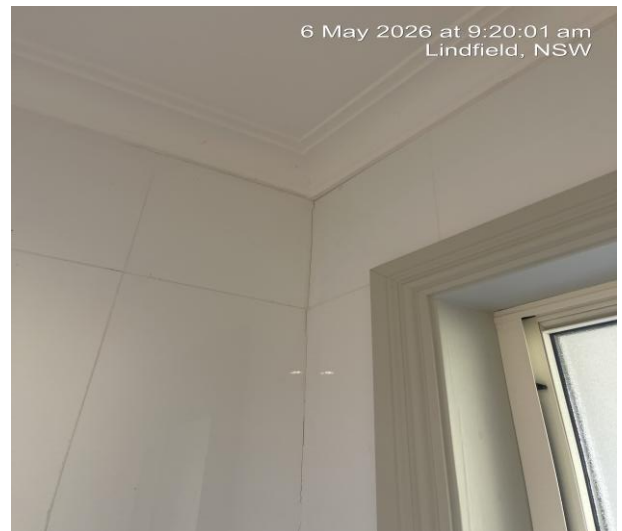
Photo 69 – Cracking observed to grout and coving

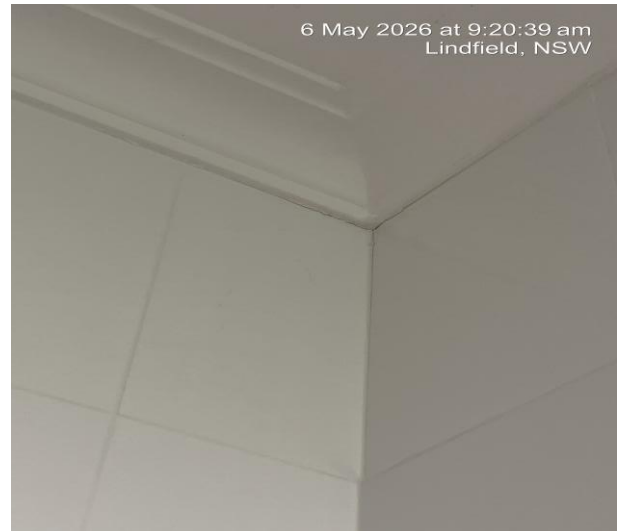
Photo 73 – Cracking observed to grout and coving

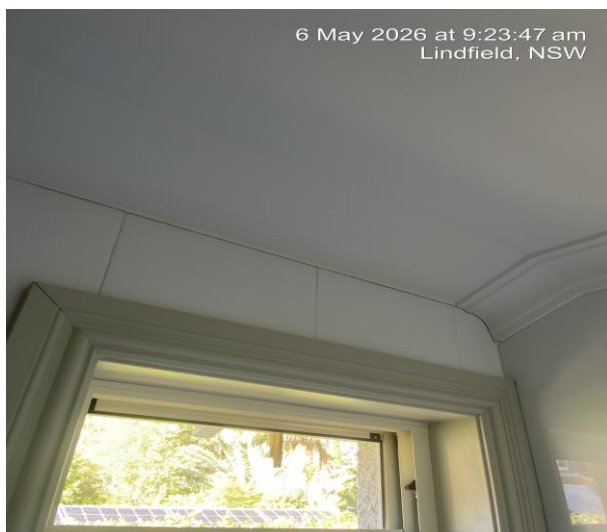
Photo 88 – Cracking observed to window frame

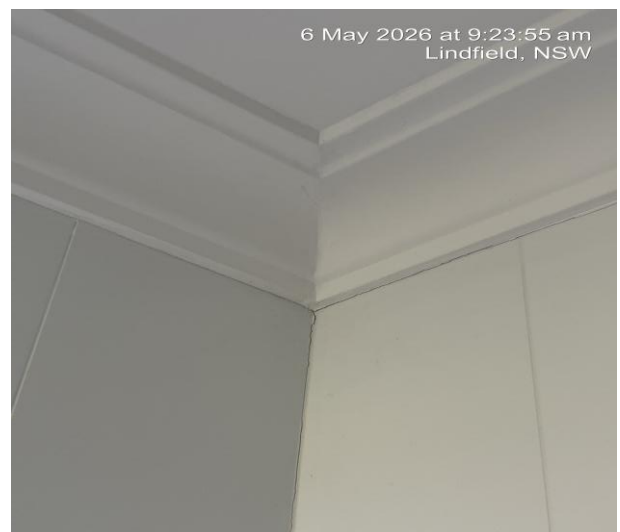
Photo 89 – Movement observed to wall/ceiling junction

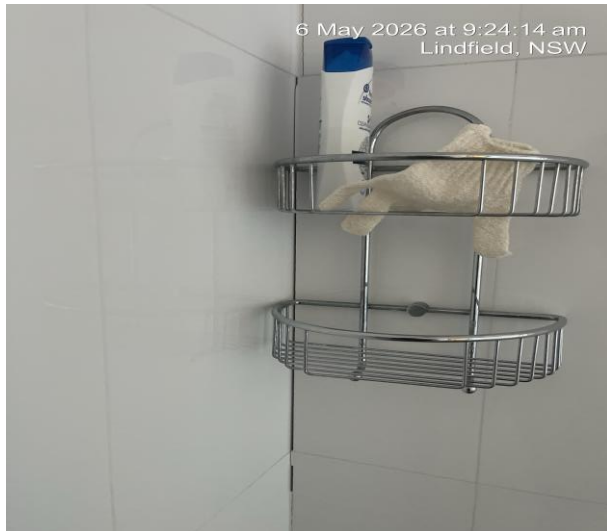
Photo 90 – Cracking observed to grout and coving

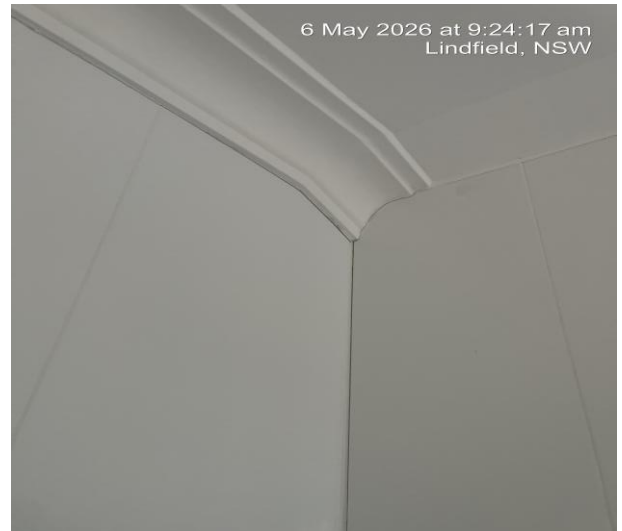
Photo 91 – Cracking observed to grout

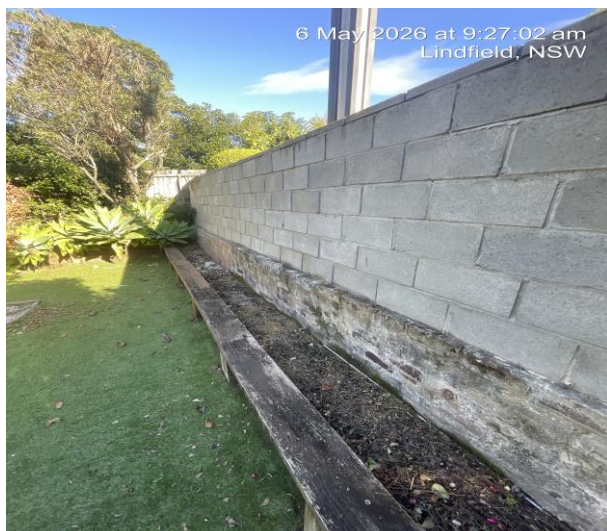
Photo 101 – Overturning observed to brick retaining wall

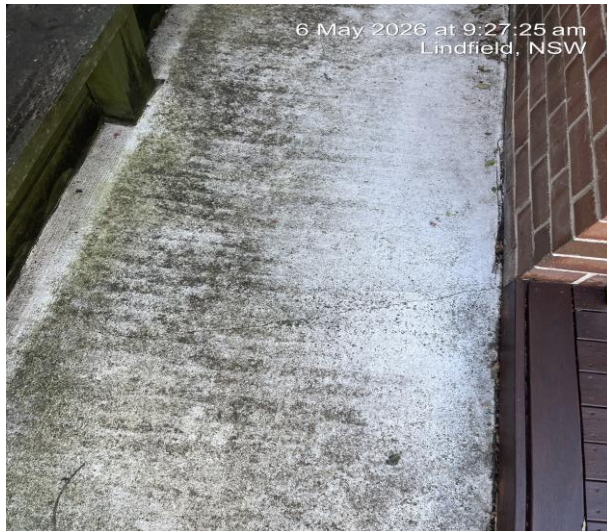
Photo 103 – Cracking observed to concrete

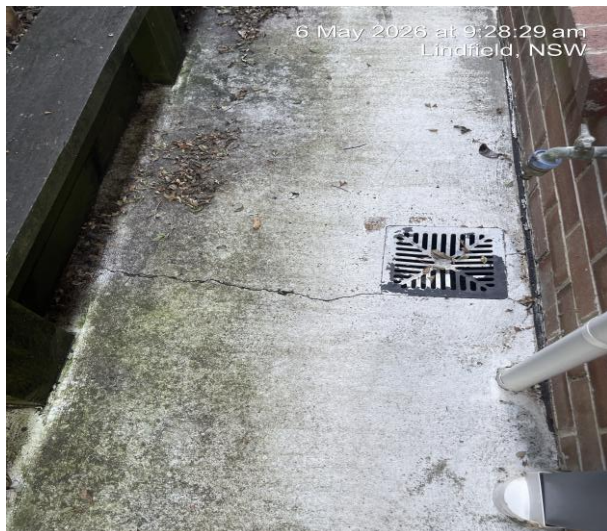
Photo 105 – Cracking observed to concrete

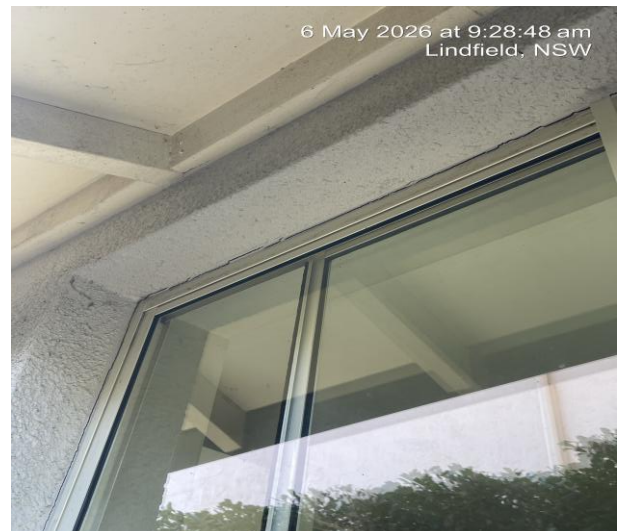
Photo 106 – Cracking observed to render

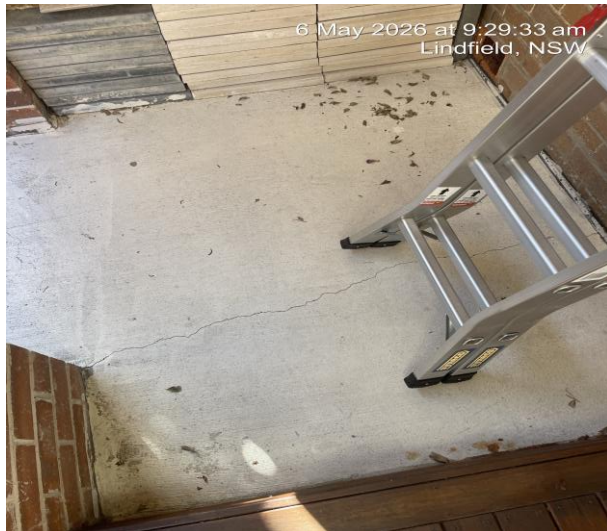
Photo 109 – Cracking observed to concrete

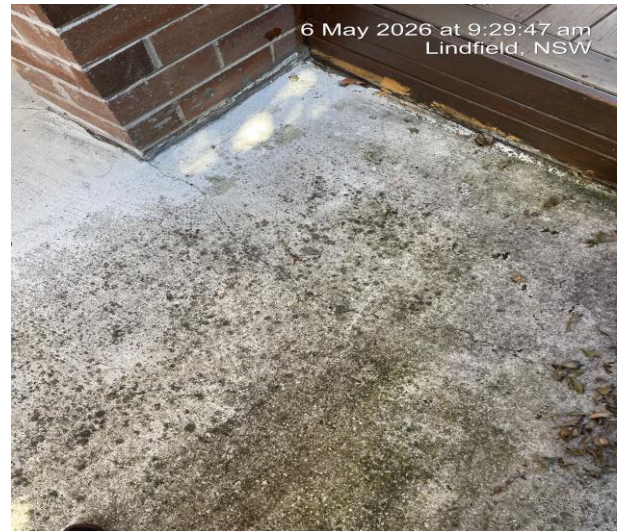
Photo 110 - Cracking observed to concrete

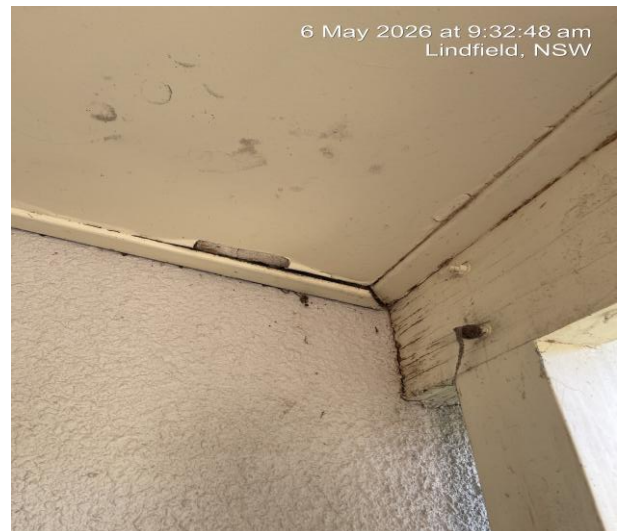
Photo 118 – Deterioration observed to ceiling and framing

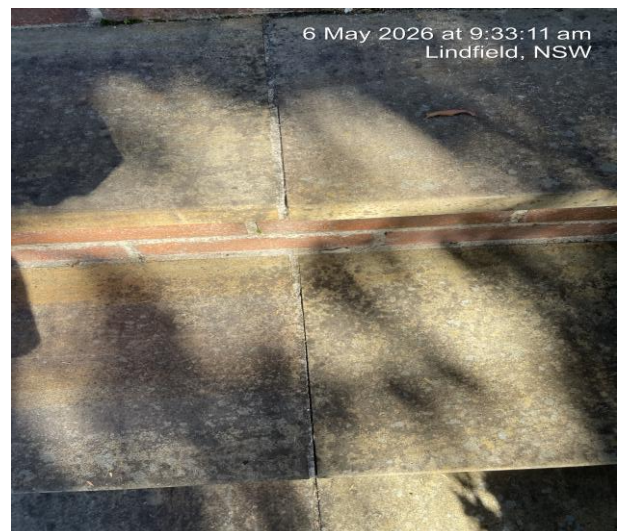
Photo 120 – Cracking observed to grout

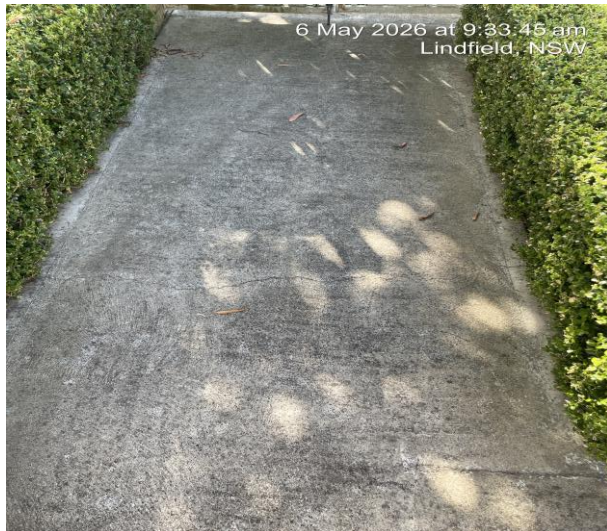
Photo 127 – Cracking observed to concrete

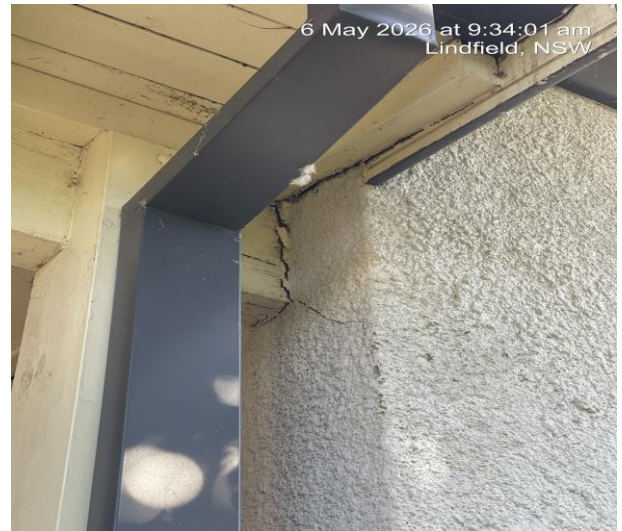
Photo 128 – Deterioration observed to ceiling and framing

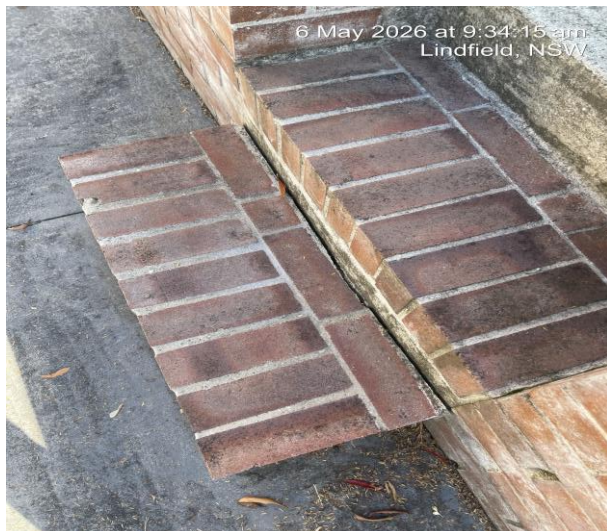
Photo 129 – Movement observed to stairs

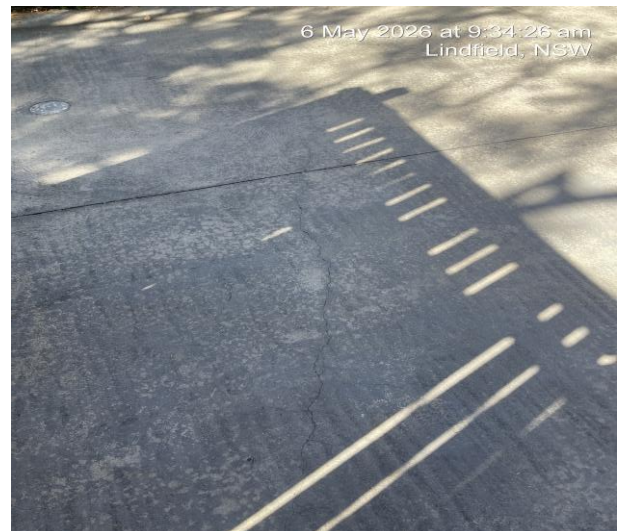
Photo 130 – Cracking observed to concrete

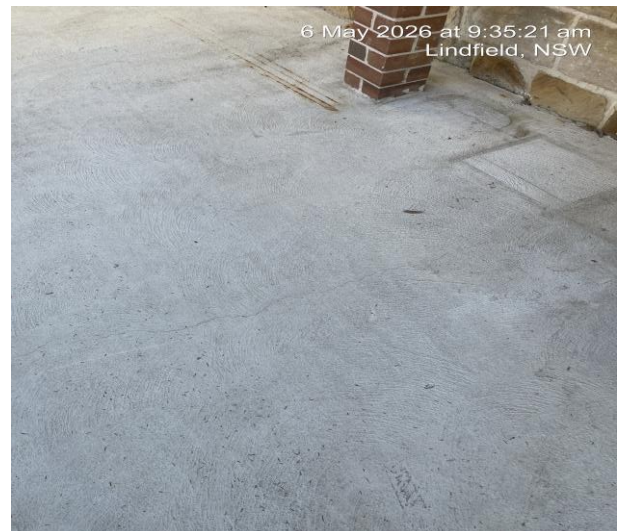
Photo 136 – Cracking observed to concrete

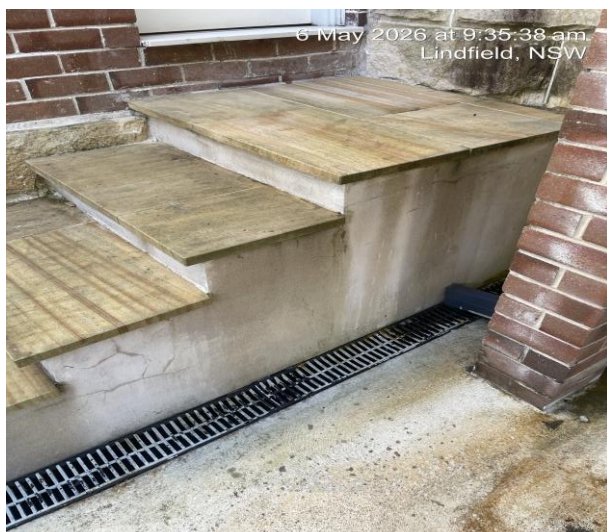
Photo 137 – Cracking observed to render

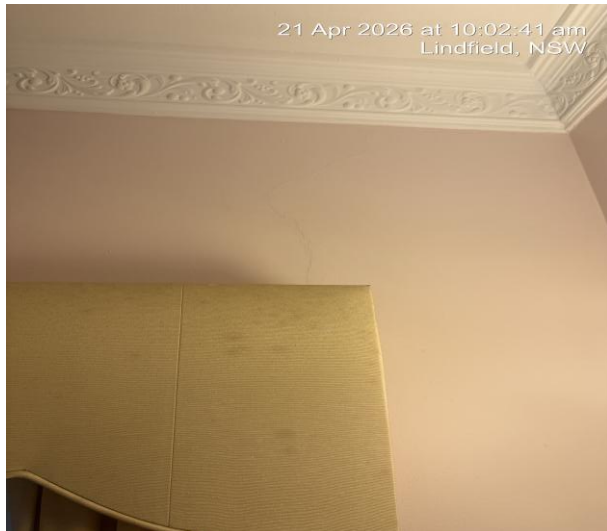
Photo 13 – Cracking observed to wall

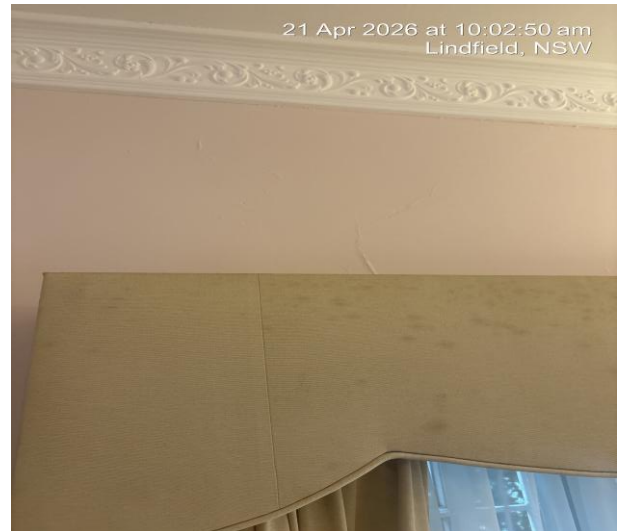
Photo 14 - Cracking observed to wall

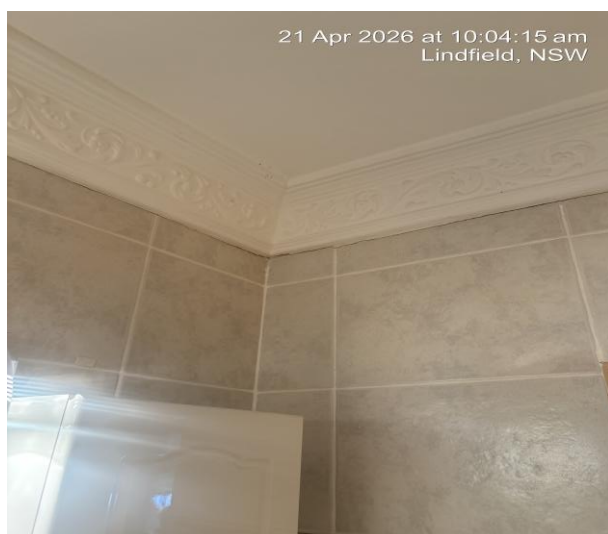
Photo 23 – Cracking observed to coving

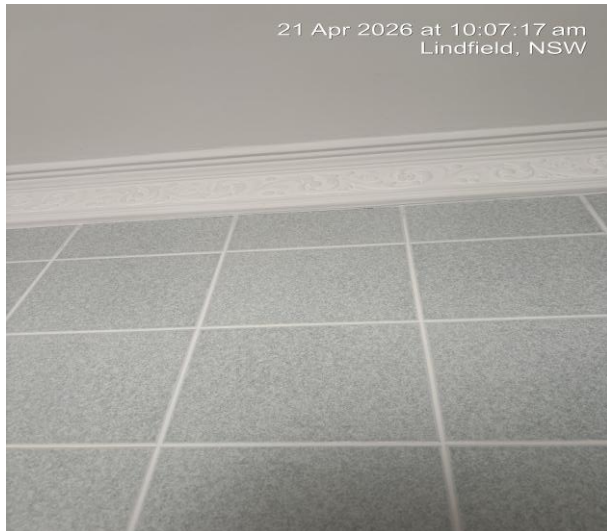
Photo 37 – Movement observed to tiles and coving

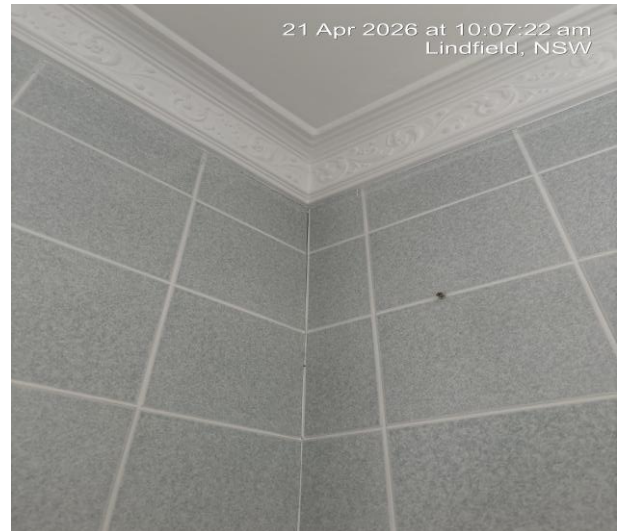
Photo 38 – Cracking observed to grout

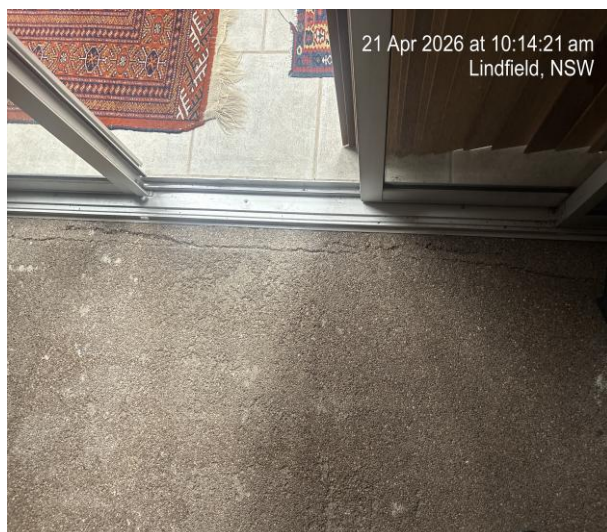
Photo 52 – Repair patching observed to epoxy pebble flooring

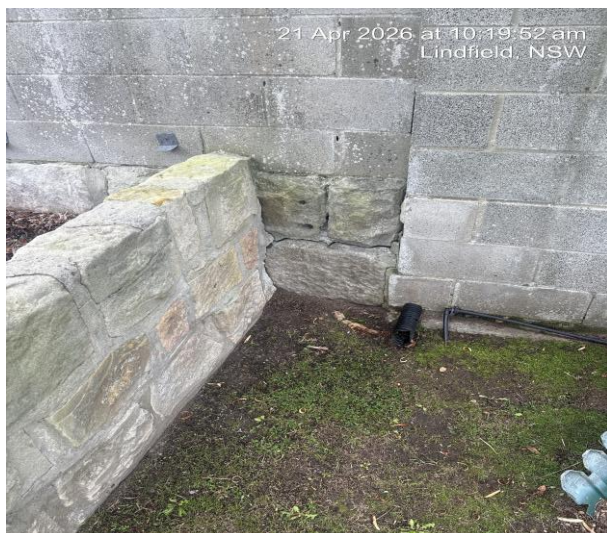
Photo 74 – Settlement observed to stone wall

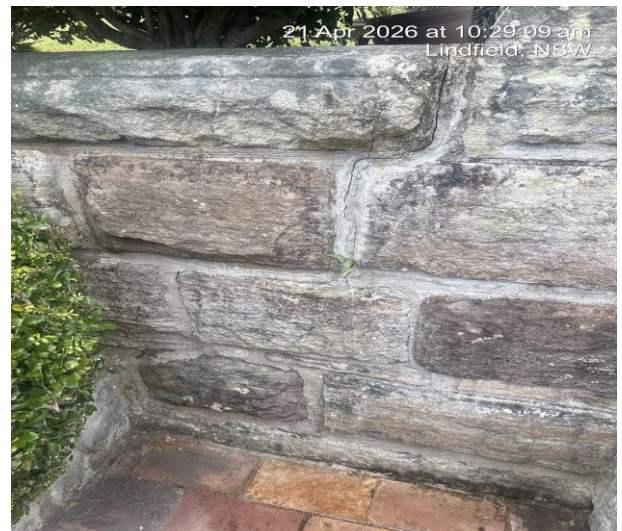
Photo 93 – Cracking observed to tiles

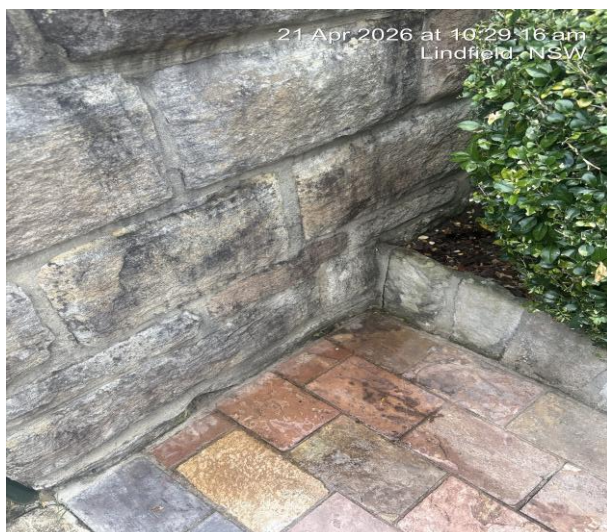
Photo 94 – Cracking observed to mortar

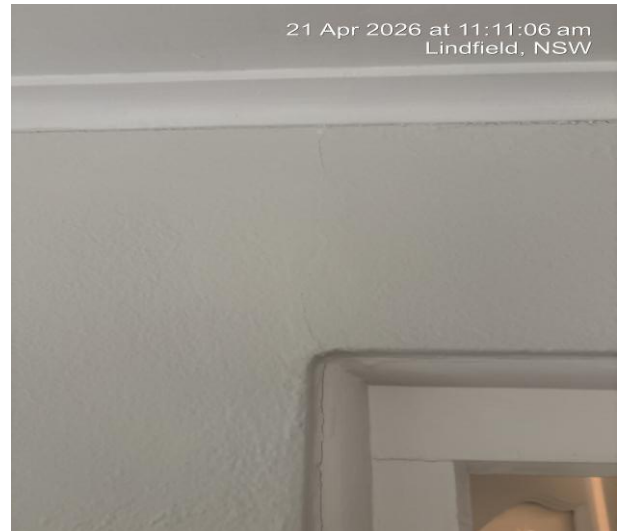
Photo 14 - Vertical cracking observed to wall

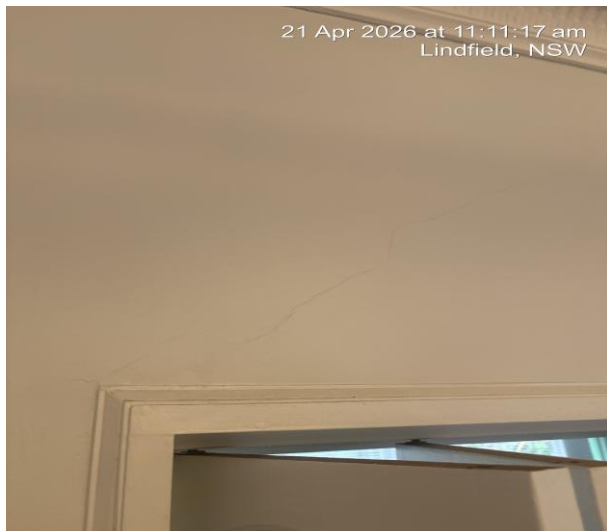
Photo 15 - 45° crack observed to wall

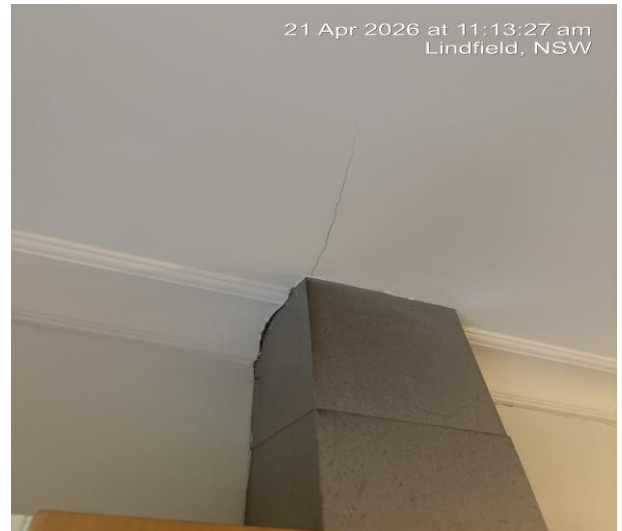
Photo 20 - Cracking observed to ceiling

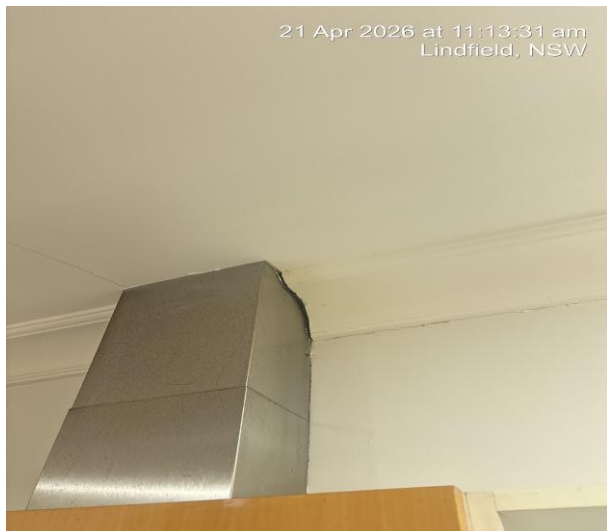
Photo 21 – Cracking observed to wall/coving junction

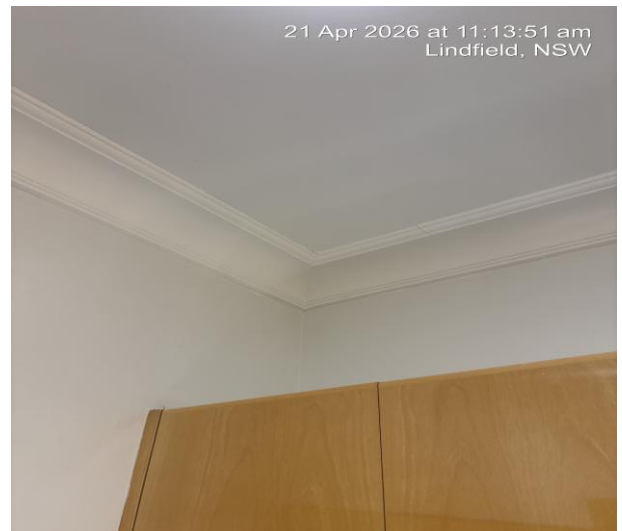
Photo 22 - Cracking observed to coving

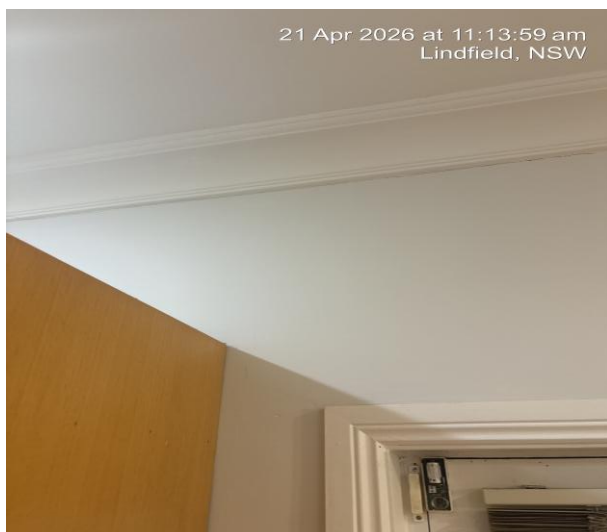
Photo 23 - Cracking observed to wall

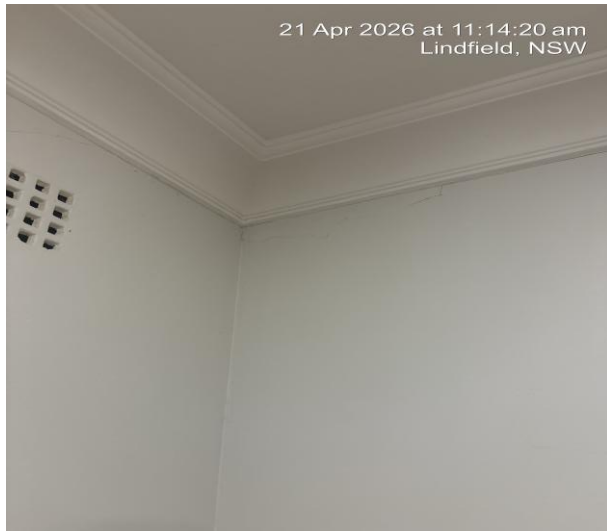
Photo 24 – 45° crack observed to wall

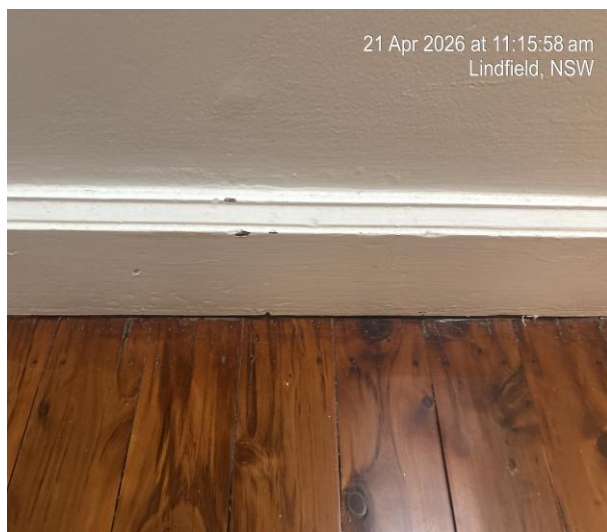
Photo 28 – Cracking observed to wall

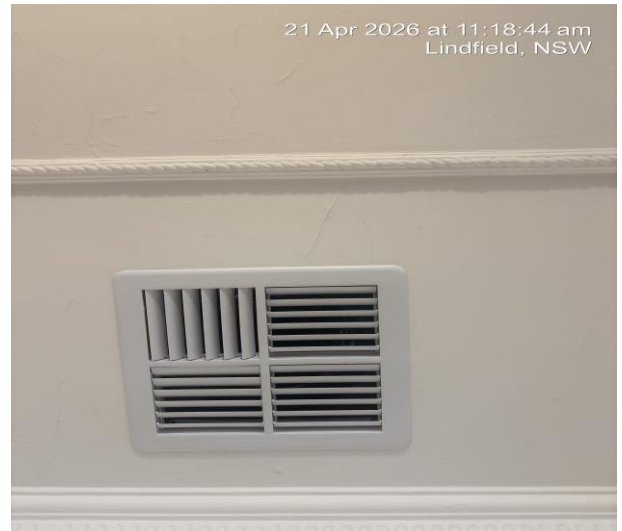
Photo 37 – Cracking observed to coving

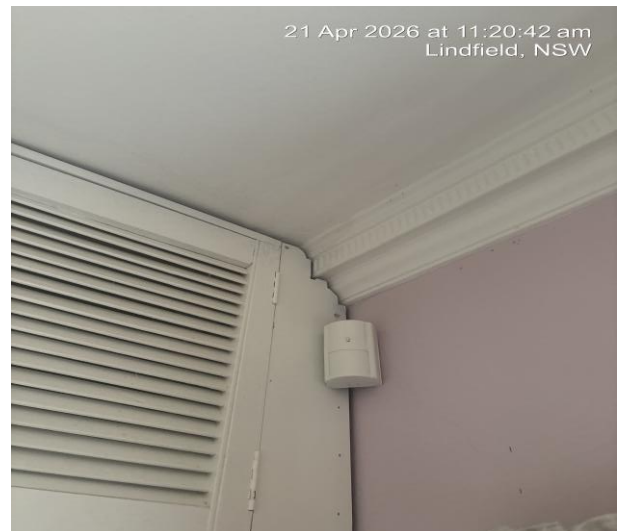
Photo 45 – Cracking observed to coving

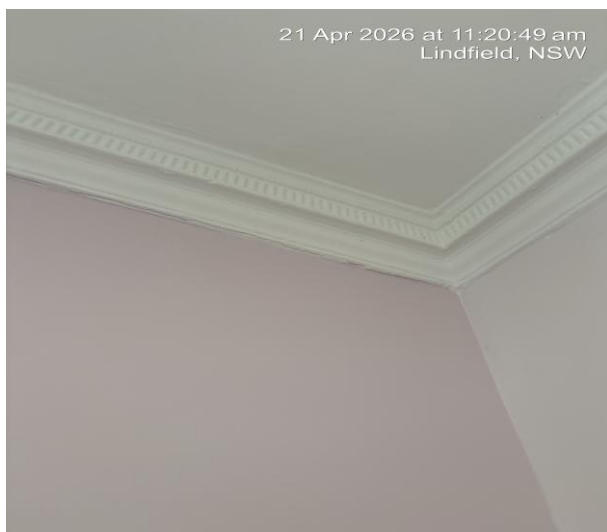
Photo 46 – Cracking observed to ceiling

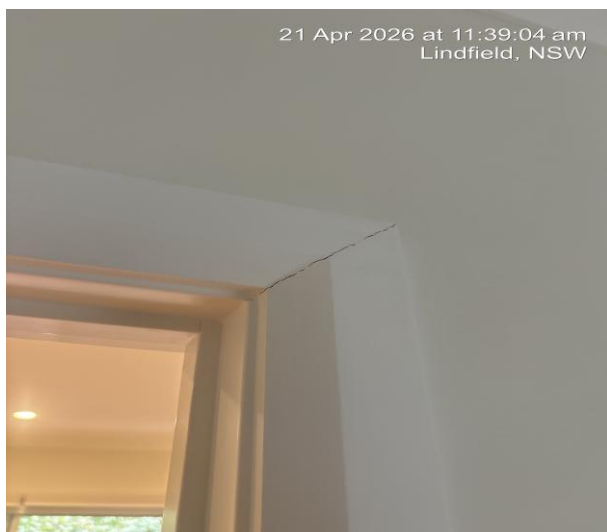
Photo 107 – Cracking observed to door frame

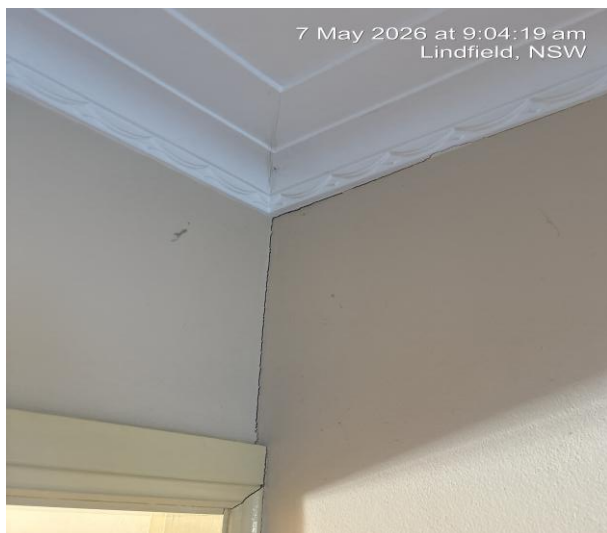
Photo 3 – Cracking observed to wall

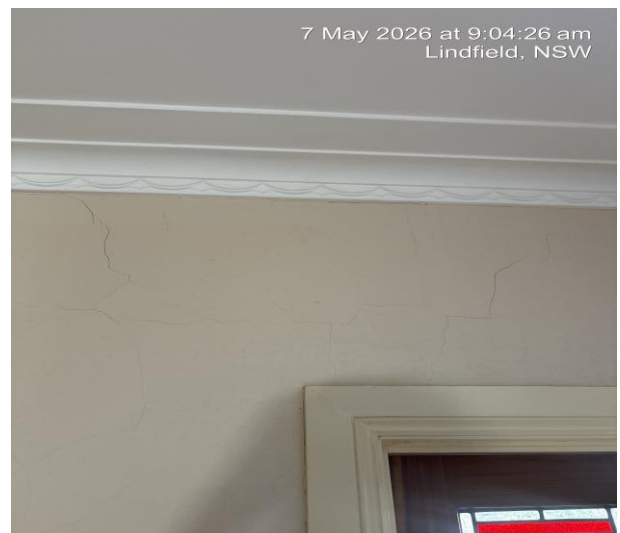
Photo 4 – Cracking observed to wall

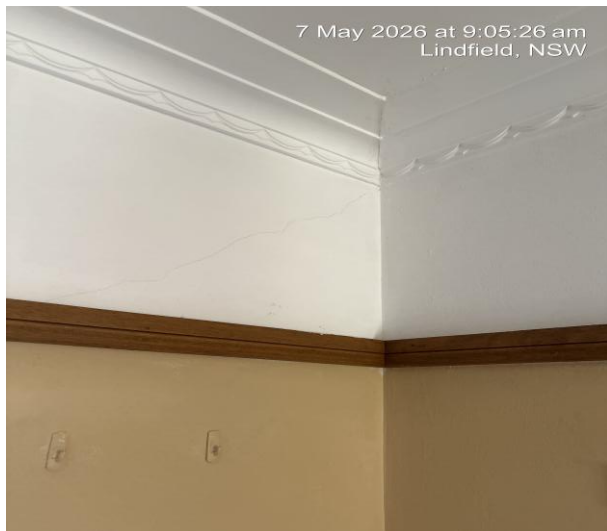
Photo 9 - Cracking observed to wall and coving

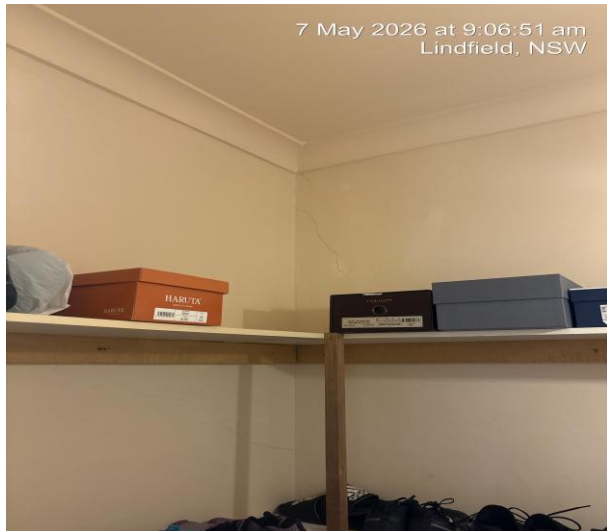
Photo 13 – Cracking observed to wall

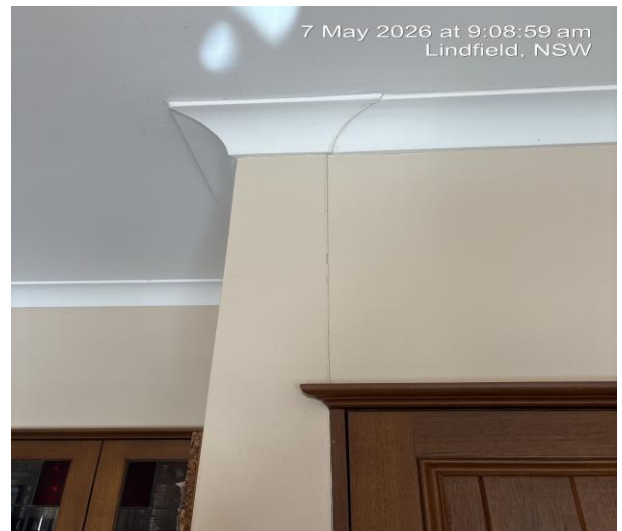
Photo 22 - Cracking observed to wall and coving

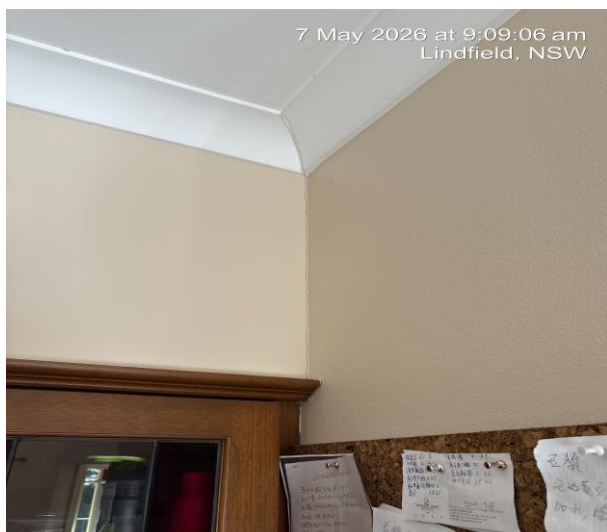
Photo 23 - Cracking observed to wall and coving

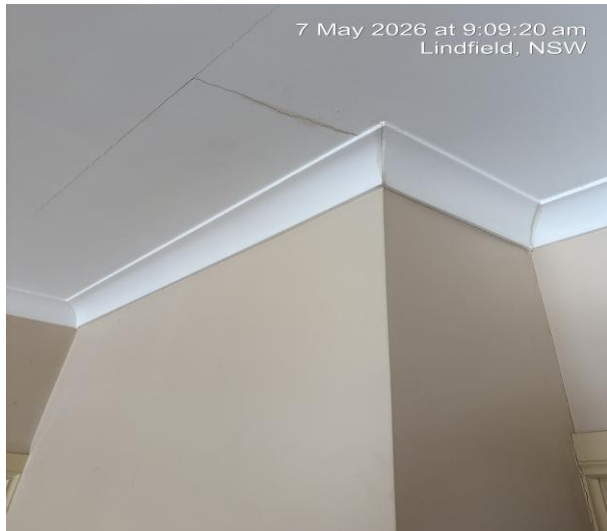
Photo 25 - Cracking observed to ceiling and coving

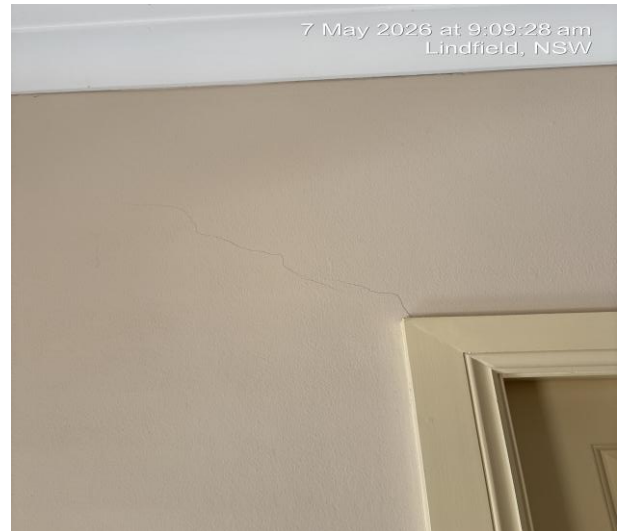
Photo 26 - Cracking observed to wall

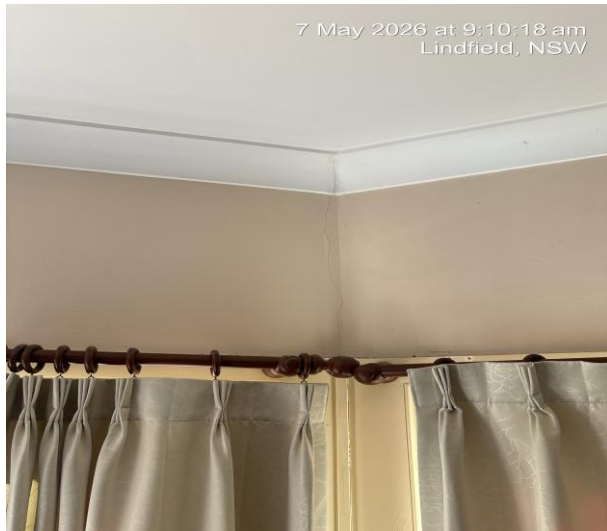
Photo 31 – Cracking observed to wall and coving

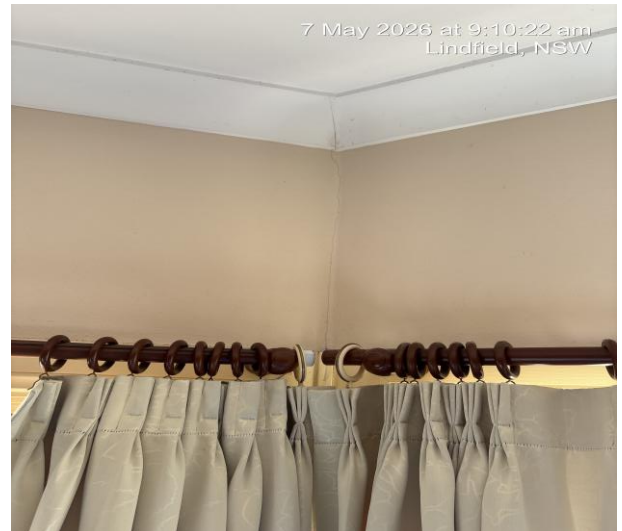
Photo 32 – Cracking observed to wall and coving

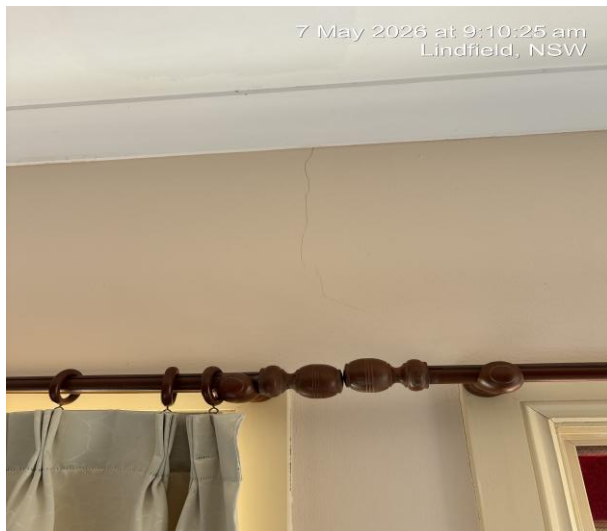
Photo 33 – Cracking observed to wall

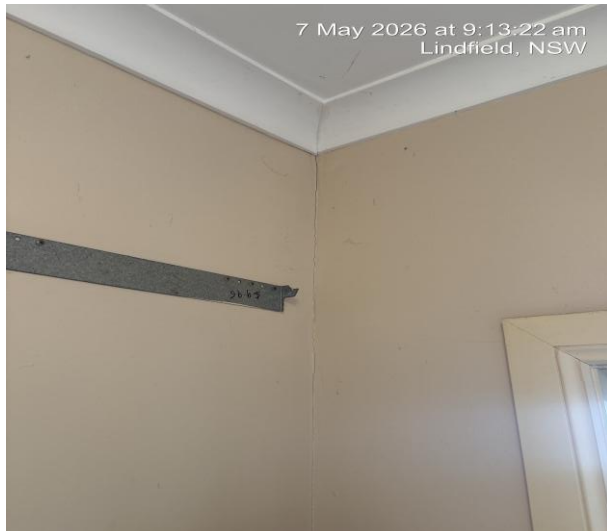
Photo 43 – Cracking observed to wall and coving

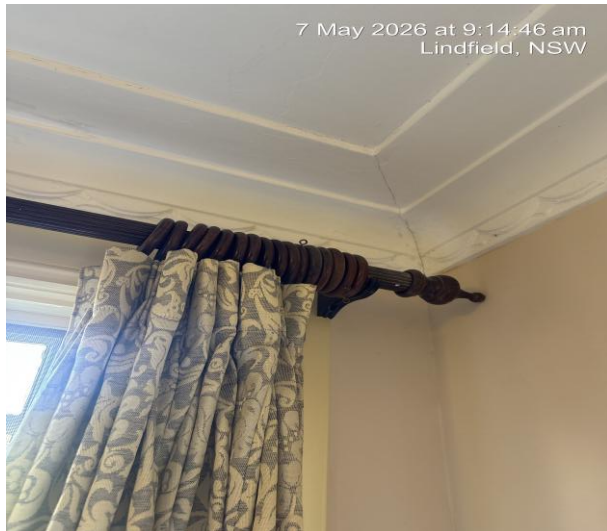
Photo 49 - Cracking observed to coving

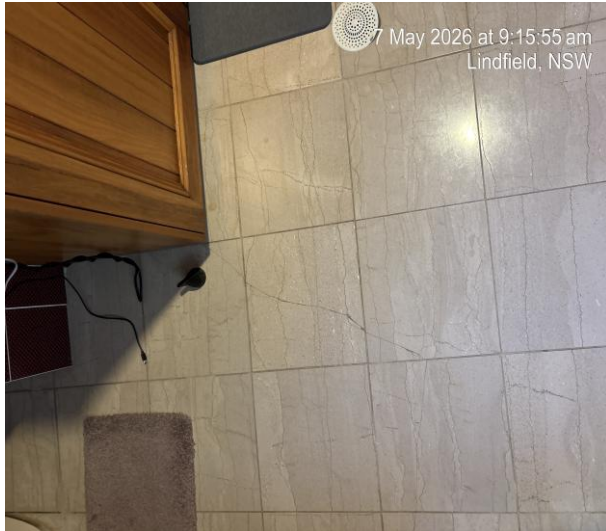
Photo 55 - Cracking observed to tiling

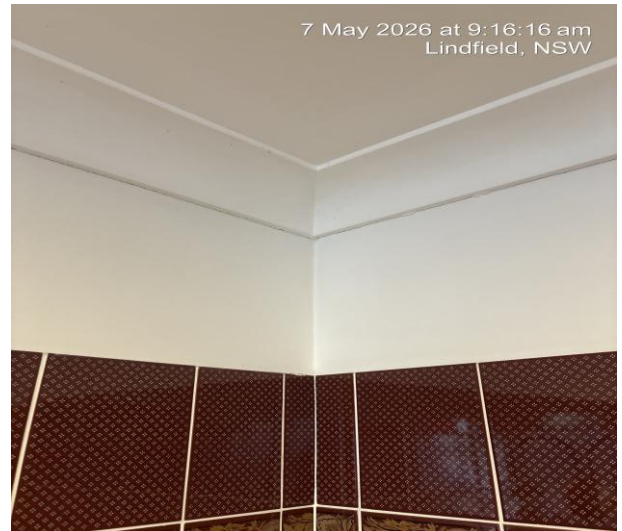
Photo 56 - Cracking observed to wall-coving join

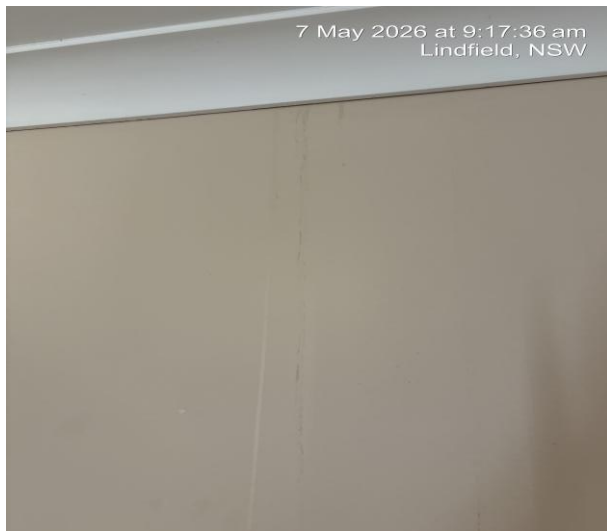
Photo 63 – Water damage observed to wall

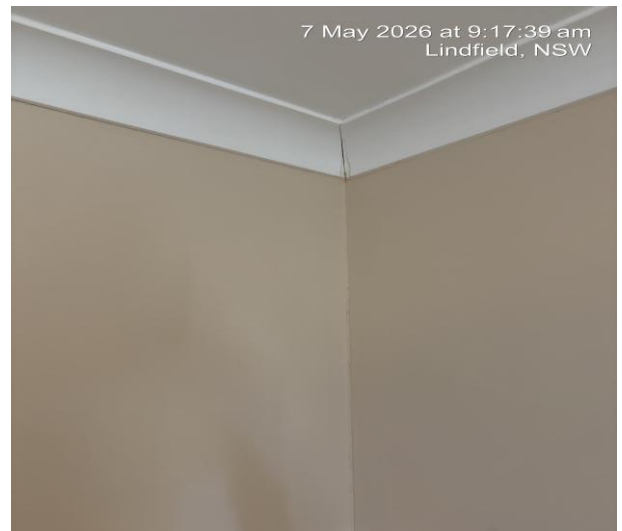
Photo 64 - Cracking observed to coving

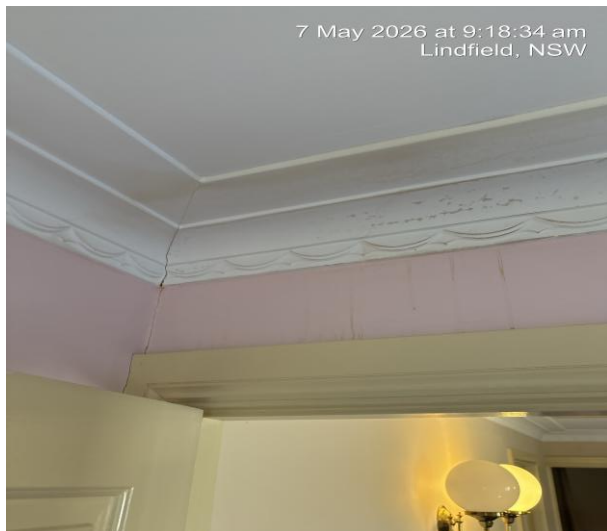
Photo 69 – Cracking and water damage observed to wall, coving and ceiling

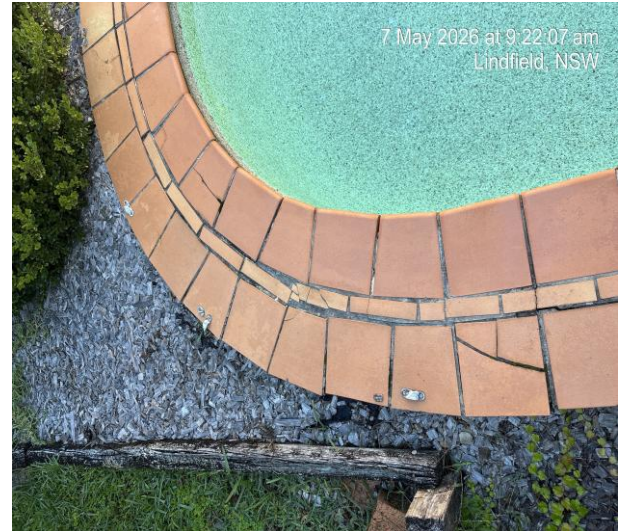
Photo 80 - Cracking observed to pavers

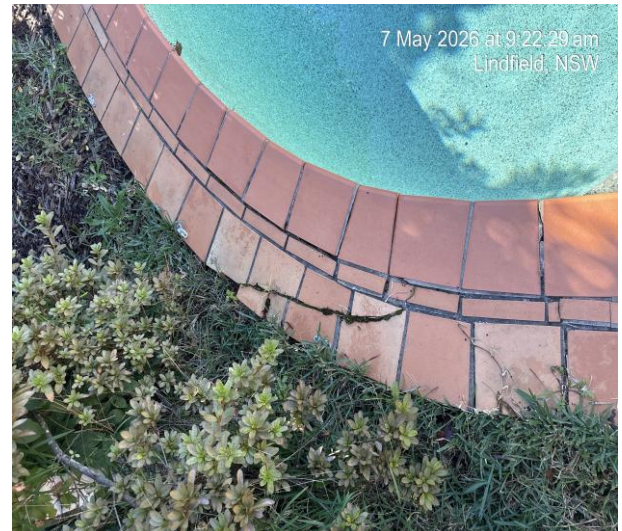
Photo 82 – Cracking observed to pavers

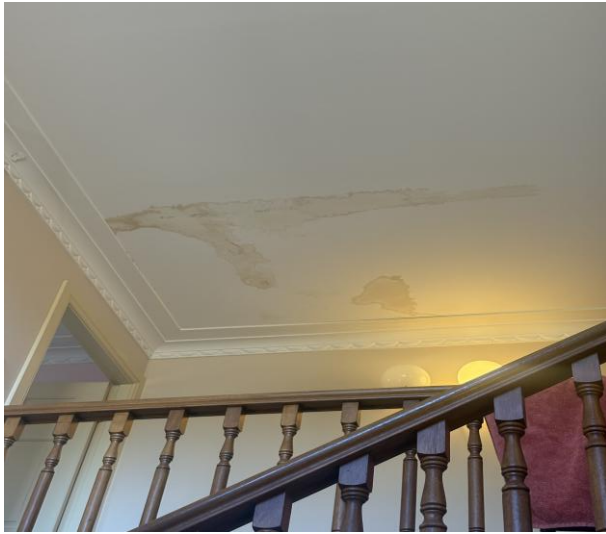
Photo 97 – Water damage observed to ceiling
