# **Arboricultural Impact Assessment**

**10 Missenden Rd, Camperdown**

**Prepared by Alex Austin  
For  
ISPT  
August 2025 V006**

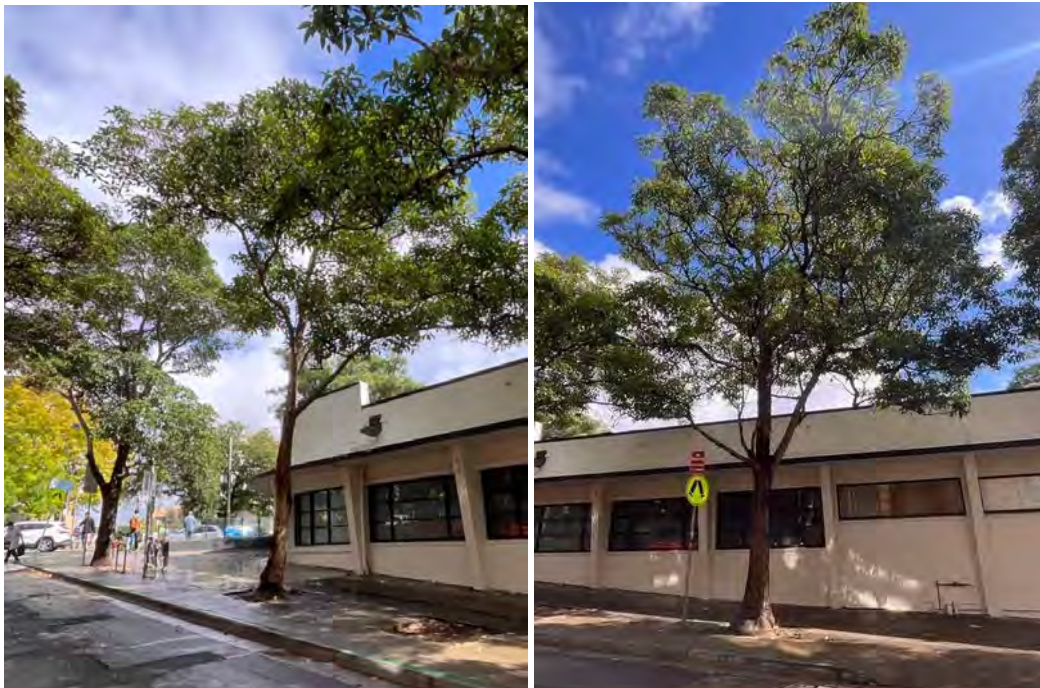
Growing conditions for Trees 7 - 9 are expected to improve following the demolition of the existing structure and viability for the trees is not expected to be impacted.

**Figures 42 & 43:** Trees 7 & 8 (Left) and Tree 9 (Right) can be observed next to the existing building. (Source: Austin 28<sup>th</sup> of April 2025).

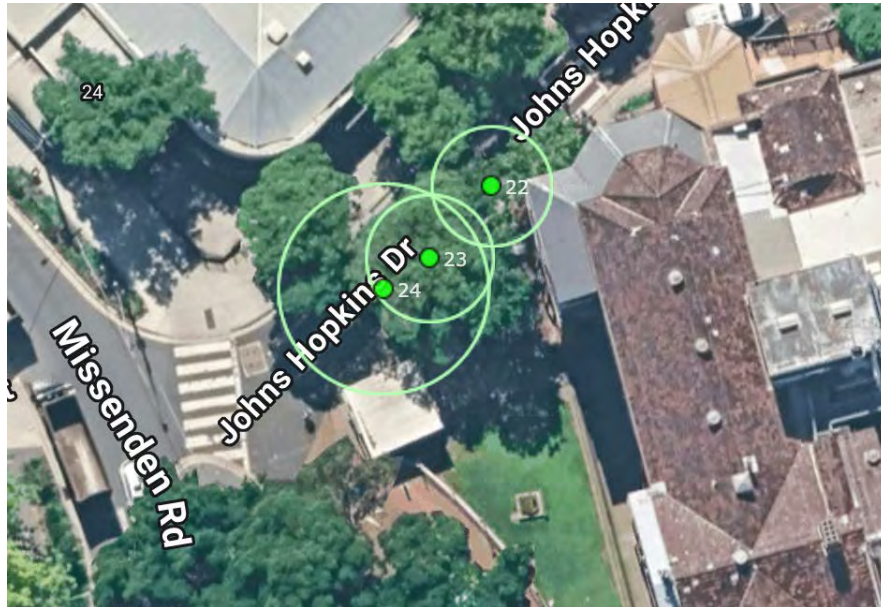
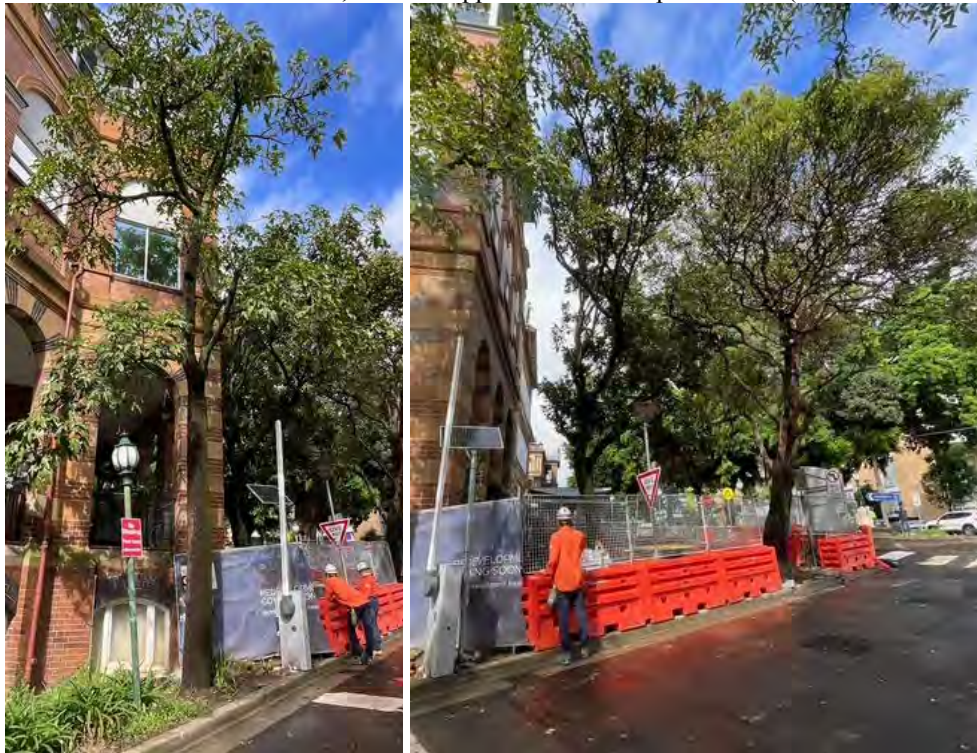
Tree numbers 22, 23 & 24 are located on the opposite of John Hopkins drive and are not directly impacted by the works. At the time of inspection, these trees had construction activities occurring within their TPZ's including the storage of materials against the trunk of trees 23 & 24. These trees must be protected from the slinging of loads by future site cranes. The canopies must be placed on lift plans.

**Figures 45 & 46:** Neighbours tree 22 (Left) and Neighbours Trees 23 & 24 can be observed next to John Hopkins Drive (Right) (Source: Austin 28<sup>th</sup> of April 2025).

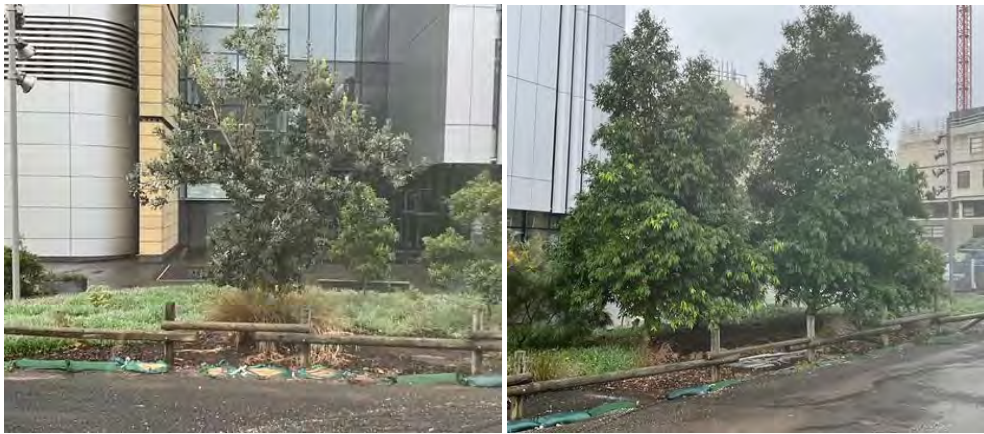
Tree numbers 91,92 & 93 are located on USYD land to the east of the site. Tree numbers 91,92 & 93 are not impacted by the works.

**Figures 48 & 49:** Neighbours tree 91(Left) and Neighbours Trees 92 & 93 can be observed next to the existing carpark (Right). (Source: Austin 28<sup>th</sup> of April 2025).

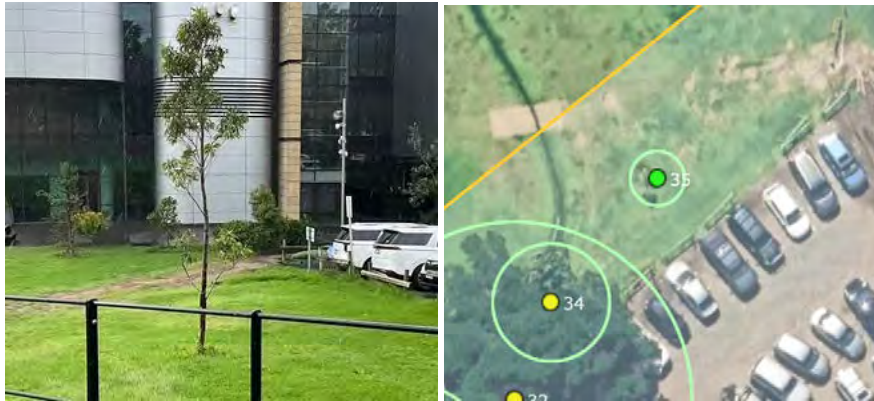
Tree 35 is a small tree in the St Johns Landscape area that is not impacted by the works.

**Figures 52 & 53:** Tree 35 in the landscape (Left) and the location of tree 35. (Right). (Source Left: Austin 28<sup>th</sup> of April 2025) & (Source Right: Tree Plotter 2025).

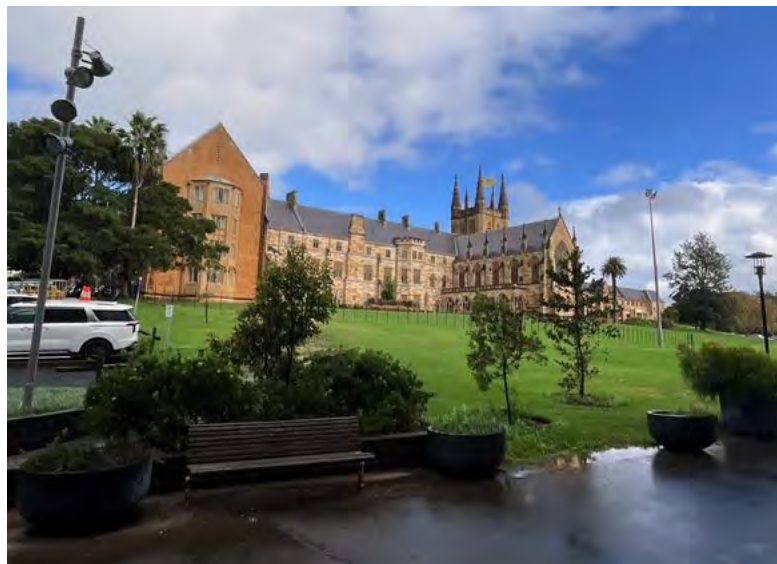
**Figure 56:** The lawn area in the St Johns College grounds where trees 31 & 32 are proposed to be relocated. . (Source: Austin 28<sup>th</sup> of April 2025).
