Geological Structure Review

Dendrobium Mine

Geological Structures Review

PSM3021-007R REV1 26 April 2019

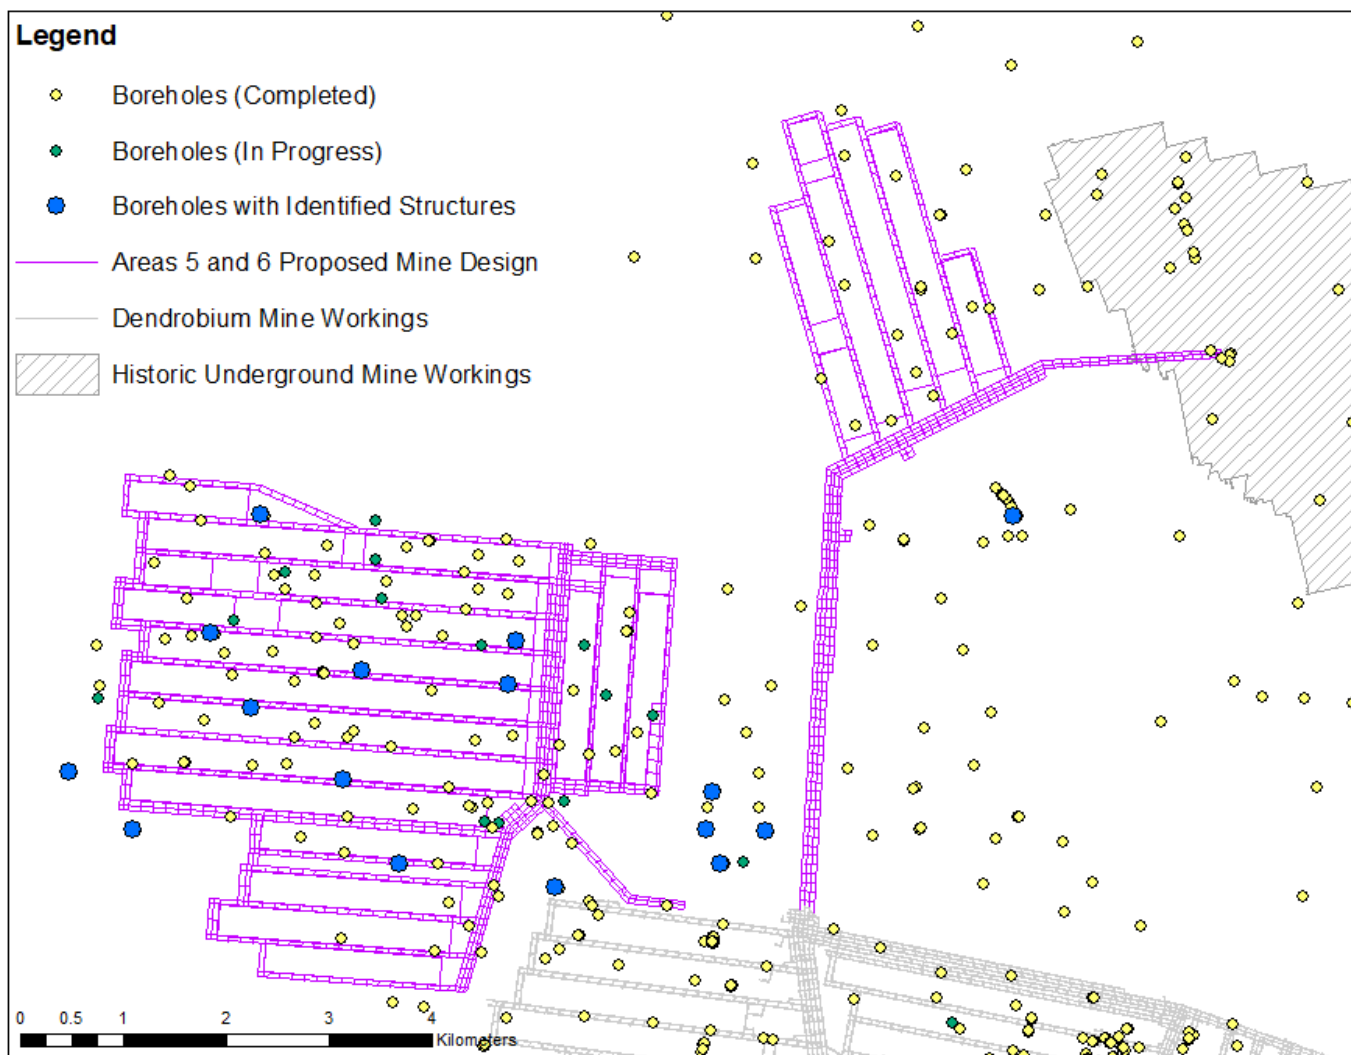
Figure 1: Plan showing boreholes (completed/in progress) within the study area.

Figure 1 shows boreholes with structures identified by South32 in Area 5. Identified boreholes with structure were verified where core photographs and/or televiewer data were available. This is discussed further in Section 5.
