TANNER KIBBLE DENTON ARCHITECTS PTY LTD HAZARDOUS BUILDING MATERIALS SURVEY

NORTH CURL CURL PRIMARY SCHOOL PLAYFAIR ROAD, NORTH CURL CURL NSW 2099

REFERENCE No. S9372

NOVEMBER 2016

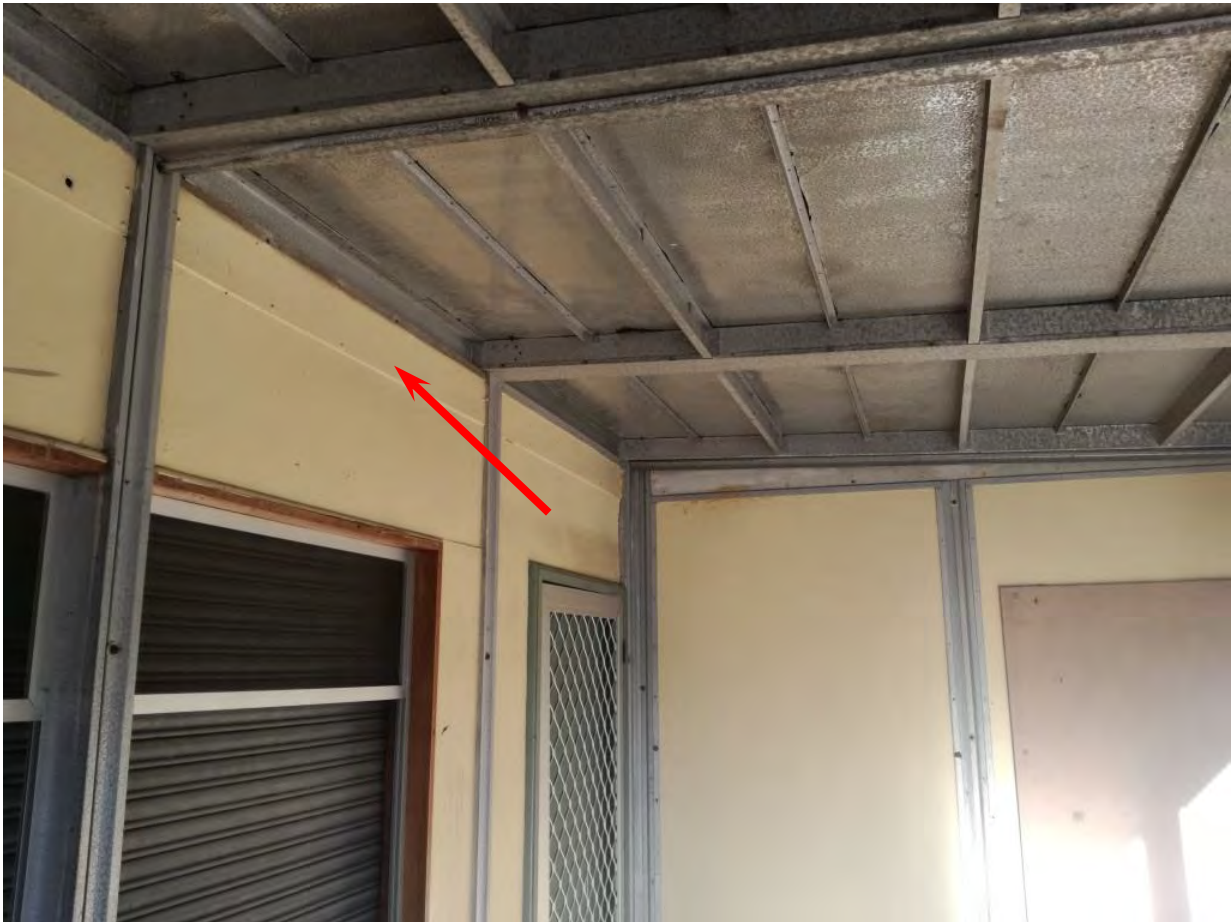
Photograph 07

Description: The red arrow points to cement sheeting (may contain asbestos).

Recommendation: Leave and maintain in good condition. Confirm asbestos status prior to refurbishment or demolition

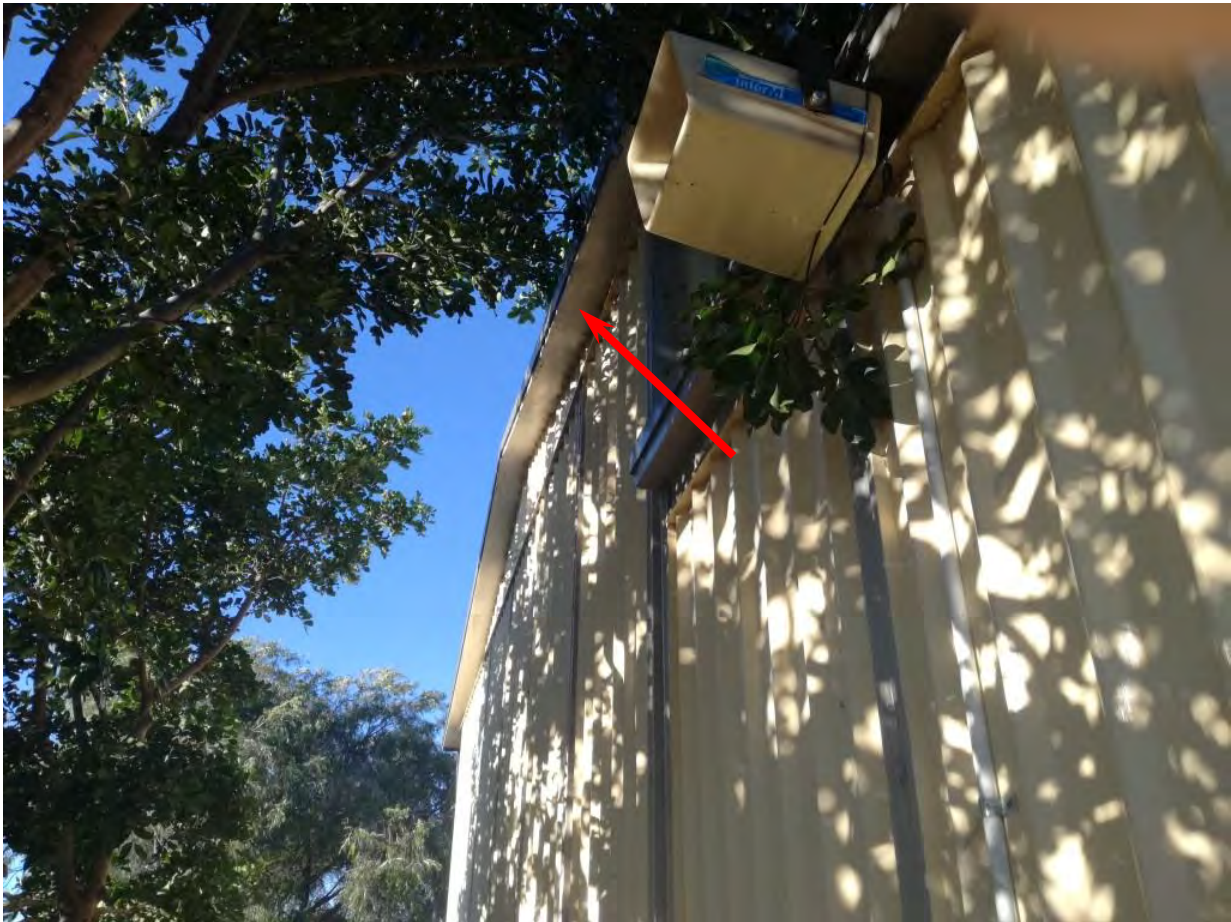
Photograph 08

Description: The red arrow points to cement sheeting which may contain asbestos.

Recommendation: Leave and maintain in good condition. Confirm asbestos status prior to refurbishment or demolition

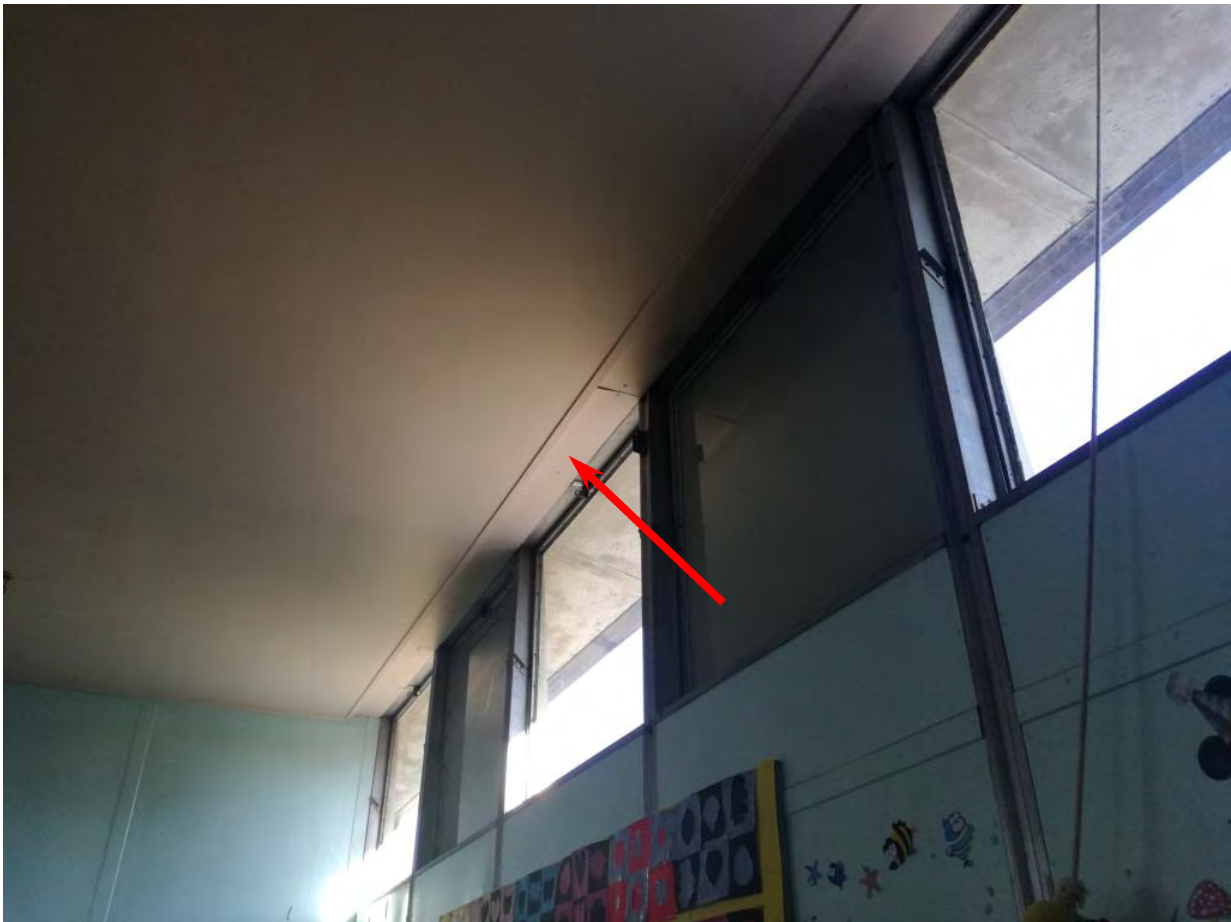
Building E. Storeroom, walls	Flat asbestos cement sheet	Similar to S9372/01 Photograph 09	15m ²	Good	Occasional	Priority 4: Negligible Risk under Present Conditions	Leave and maintain in good condition.	Oct 2021

Description: The red arrow points to flat asbestos cement sheet.

Recommendation: Leave and maintain in good condition.

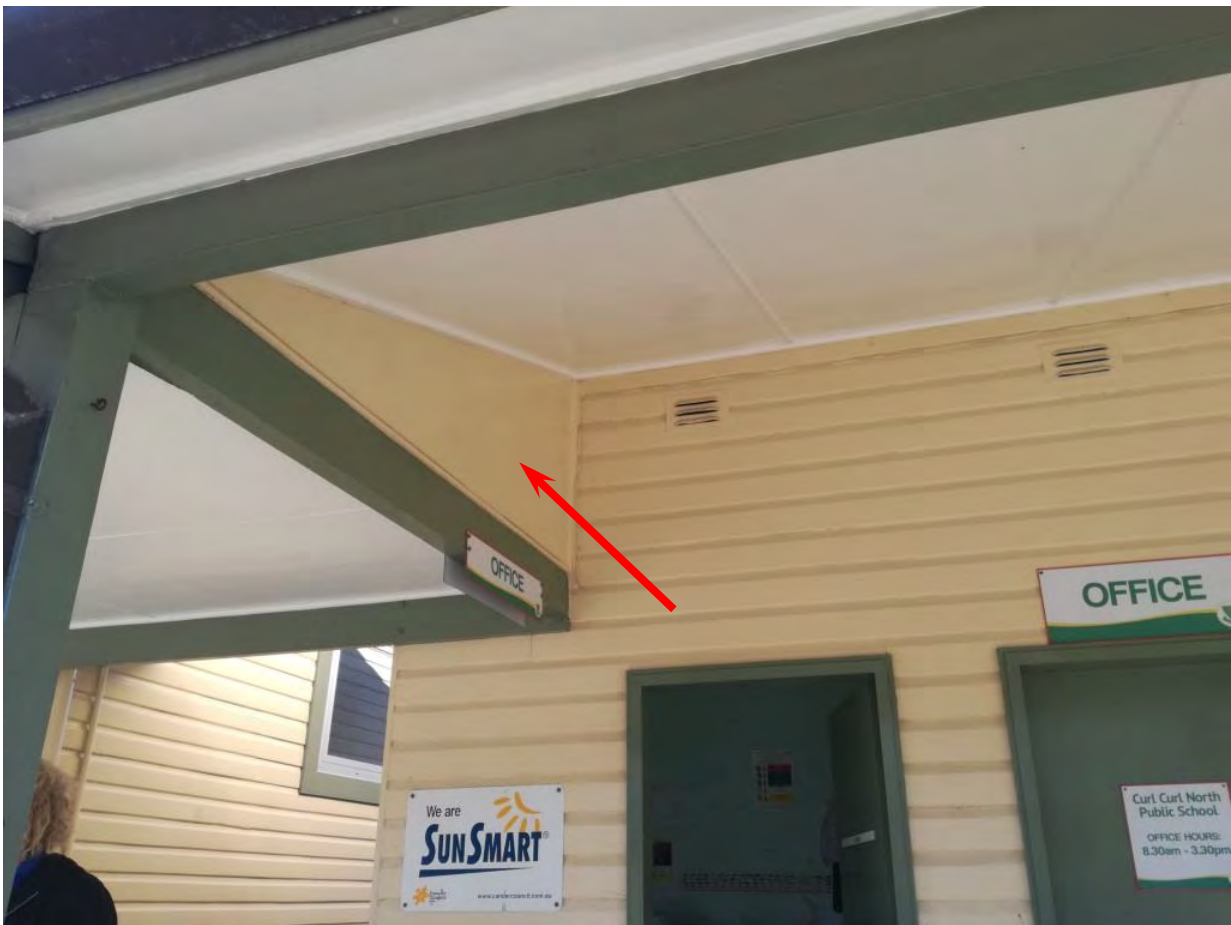
Photograph 16

Site: North Curl Curl Primary School.
Location: Building G. External, eaves on southern side.
Description: The red arrow points to flat asbestos cement sheet.
Recommendation: Leave and maintain in good condition.

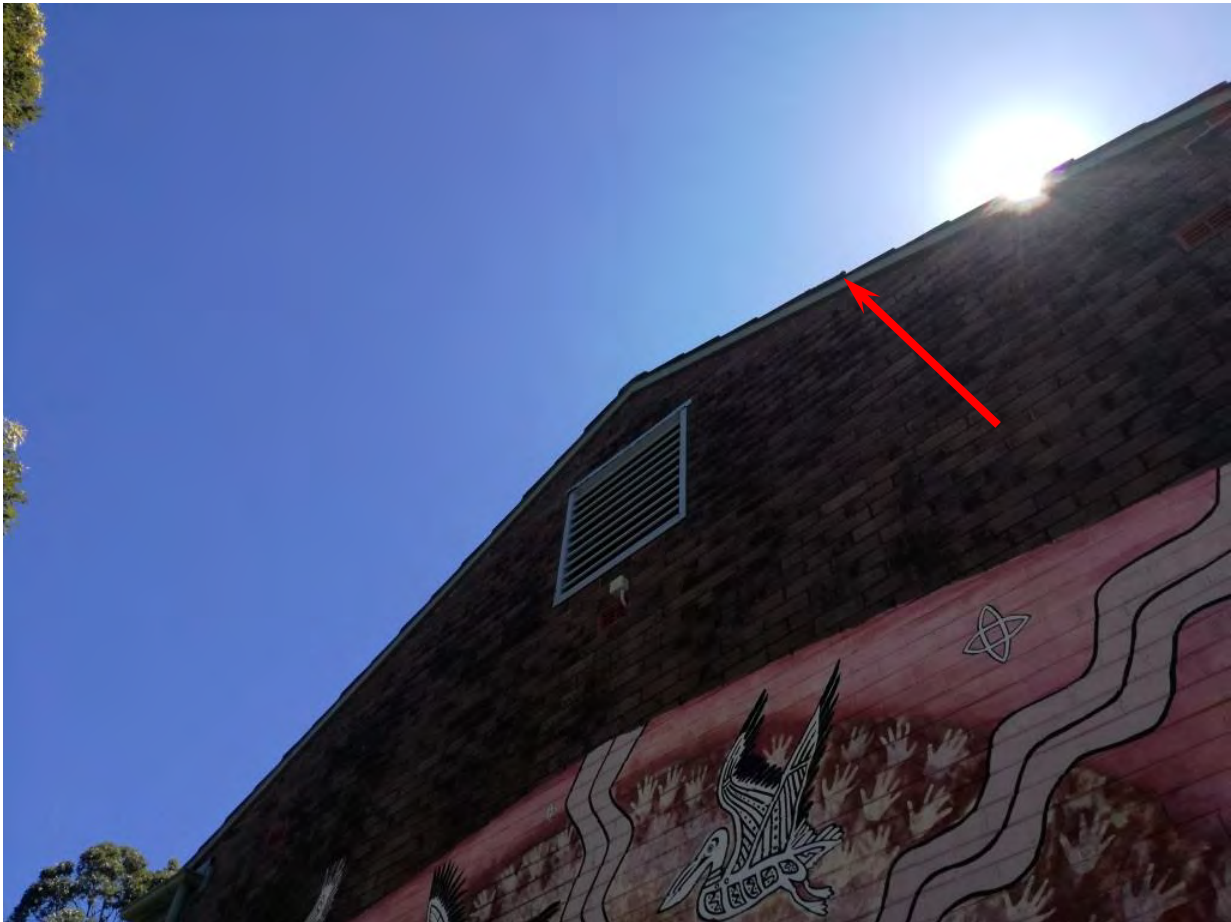
LOCATION	MATERIAL TYPE	SAMPLE / PHOTOGRAPH REFERENCE	QUAN-TITY	COND-ITION	ACCESS-IBILITY	RISK PRIORITY RATING	RECOMMENDATIONS	TIMING
Building J								
Asbestos								
Building J. External, eaves	Flat asbestos cement sheet	S9372/12 Photograph 22	40m ²	Good	Maintenance Only	Priority 4: Negligible Risk under Present Conditions	Leave and maintain in good condition.	Oct 2021
Building J. Storerooms ceiling, both toilets	Fibre cement sheeting	S9372/11	NA	NA	NA	No asbestos detected	NA	NA
Synthetic Mineral Fibre								
Building J. External and internal, throughout	No synthetic mineral fibre materials identified		NA	NA	NA	No SMF detected	NA	NA
Lead Based Paints								
Building J. Internal, ceiling	White coloured paint system	S9372/P26	NA	NA	NA	Does not contain lead	NA	NA
Building J. Internal, walls	Cream coloured paint system	S9372/P25	NA	NA	NA	Does not contain lead	NA	NA

Site: North Curl Curl Primary School.
Location: Building J. External, eaves.
Description: The red arrow points to flat asbestos cement sheet.
Recommendation: Leave and maintain in good condition.

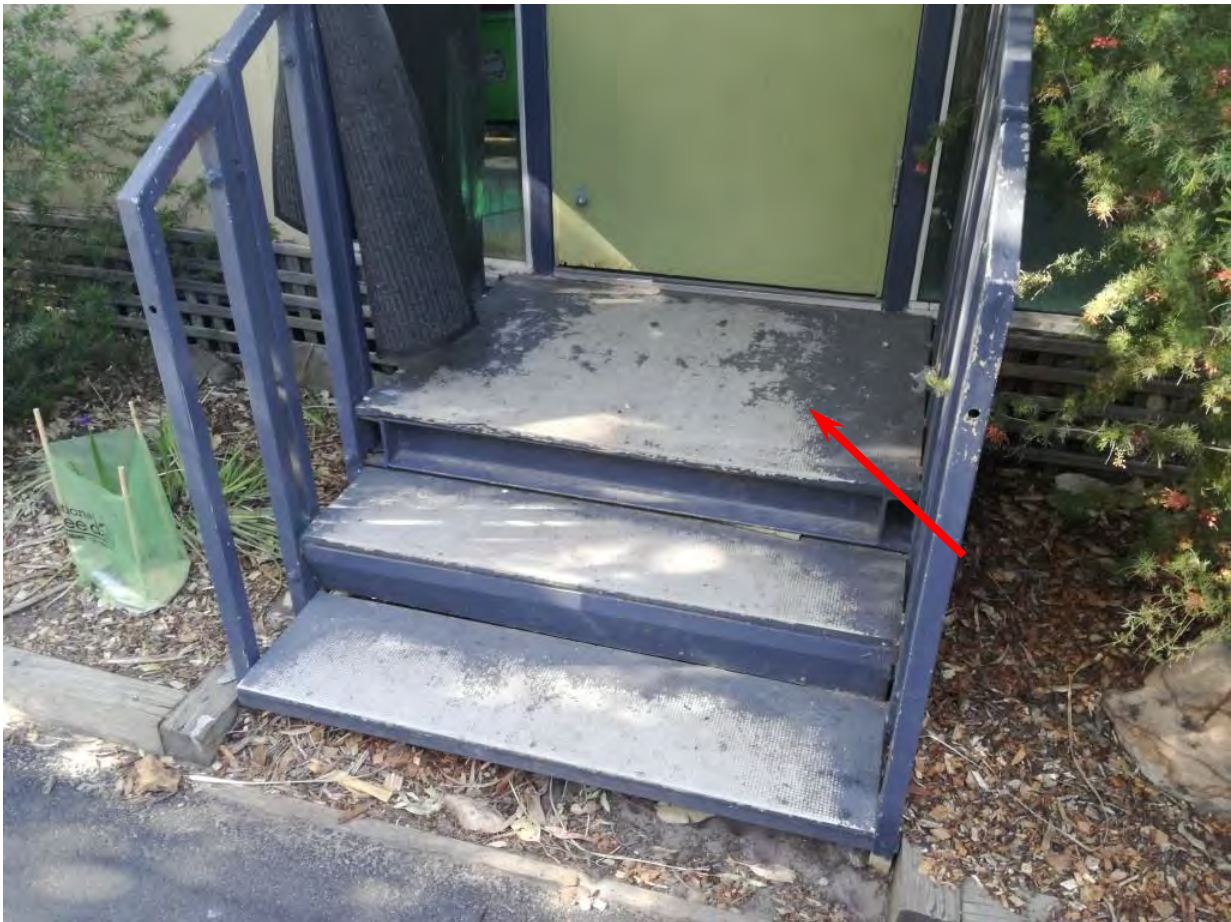
LOCATION	MATERIAL TYPE	SAMPLE / PHOTOGRAPH REFERENCE	QUAN-TITY	COND-ITION	ACCESS-IBILITY	RISK PRIORITY RATING	RECOMMENDATIONS	TIMING
D11335								
Asbestos								
D11335. External, steps	Thick compressed asbestos cement sheet	S9372/37 Photograph 26	2m ²	Fair	Regular	Priority 4: Negligible Risk under Present Conditions	Leave and maintain in good condition.	Oct 2021
D11335. Classroom, ceiling	Fibre cement sheeting	Similar to S9372/38	NA	NA	NA	No asbestos detected	NA	NA
D11335. External, eaves	Fibre cement sheeting	S9372/38	NA	NA	NA	No asbestos detected	NA	NA
Synthetic Mineral Fibre								
D11335. External and internal, throughout	No synthetic mineral fibre materials identified		NA	NA	NA	No SMF detected	NA	NA
Lead Based Paints								
D11335. External, cladding	Yellow coloured paint system	S9372/P31	NA	NA	NA	Does not contain Lead	NA	NA

Description: The red arrow points to thick compressed asbestos cement sheet.

Recommendation: Leave and maintain in good condition.

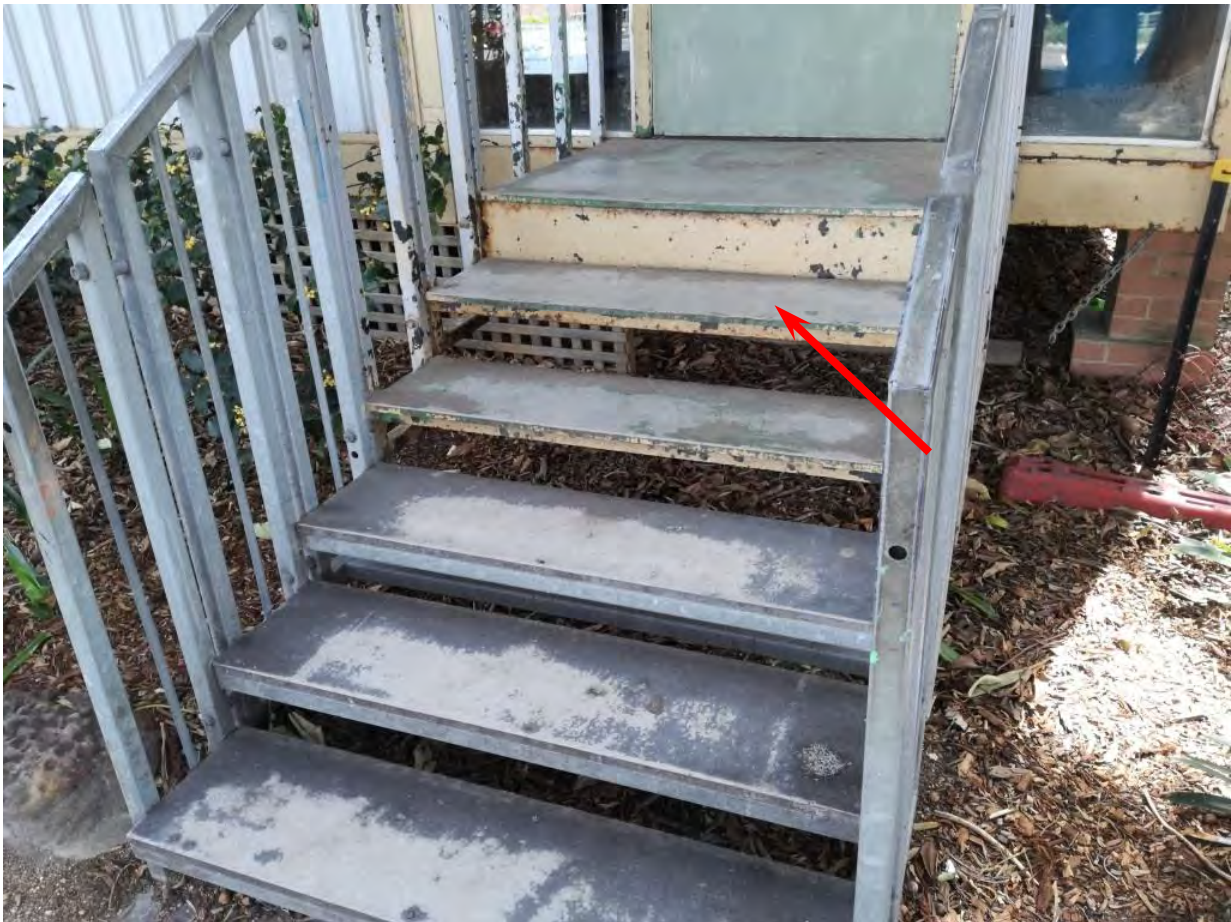
LOCATION	MATERIAL TYPE	SAMPLE / PHOTOGRAPH REFERENCE	QUAN-TITY	COND-ITION	ACCESS-IBILITY	RISK PRIORITY RATING	RECOMMENDATIONS	TIMING
D11620								
Asbestos								
D11620. Lobby and store, green tiles to floor	Asbestos vinyl floor tiles	S9372/42 Photograph 27	20m ²	Fair	Maintenance Only	Priority 4: Negligible Risk under Present Conditions	Leave and maintain in good condition.	Oct 2021
D11620. External, steps	Thick compressed asbestos cement sheet	Similar to S9372/39 Photograph 28	2m ²	Fair	Regular	Priority 4: Negligible Risk under Present Conditions	Leave and maintain in good condition.	Oct 2021
D11620. External, eaves	Fibre cement sheeting	Similar to S9372/40	NA	NA	NA	No asbestos detected	NA	NA
Synthetic Mineral Fibre								
D11620. External and internal, throughout	No synthetic mineral fibre materials identified		NA	NA	NA	No SMF detected	NA	NA

Description: The red arrow points to asbestos containing vinyl floor tiles.

Recommendation: Leave and maintain in good condition.

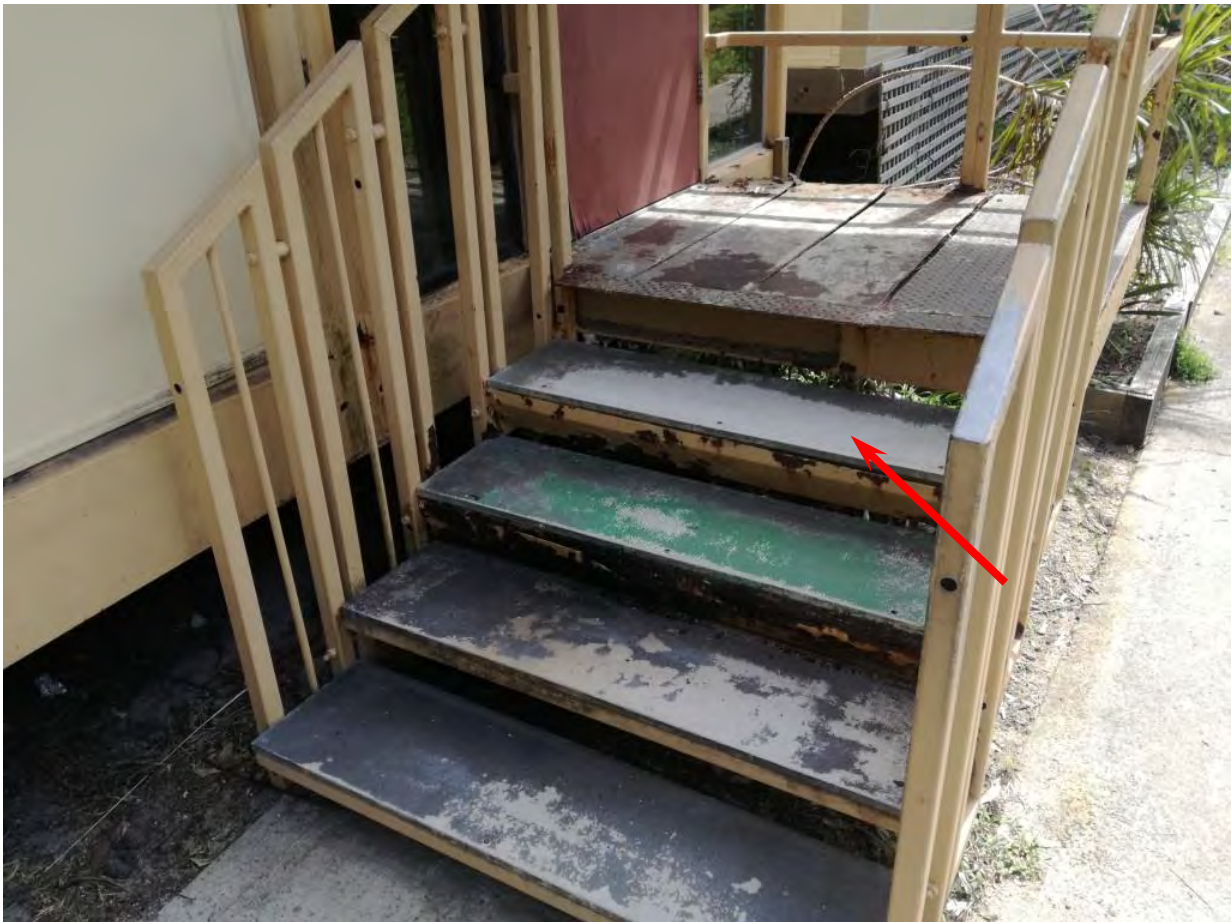
LOCATION	MATERIAL TYPE	SAMPLE / PHOTOGRAPH REFERENCE	QUAN-TITY	COND-ITION	ACCESS-IBILITY	RISK PRIORITY RATING	RECOMMENDATIONS	TIMING
D14308								
Asbestos								
D14308. External, steps	Thick compressed asbestos cement sheet	S9372/33 Photograph 29	2m ²	Fair	Regular	Priority 4: Negligible Risk under Present Conditions	Leave and maintain in good condition.	Oct 2021
D14308. External, eaves	Fibre cement sheeting	S9372/34	NA	NA	NA	No asbestos detected	NA	NA
Synthetic Mineral Fibre								
D14308. External and internal, throughout	No synthetic mineral fibre materials identified		NA	NA	NA	NA		NA
Lead Based Paints								
D14308. External, cladding	Yellow coloured paint system	S9372/P34	NA	NA	NA	Does not contain lead	NA	NA
PCB's								
D14308. External and internal, throughout	No PCB's identified		NA	NA	NA	Light fitting does not contain PCB	NA	NA

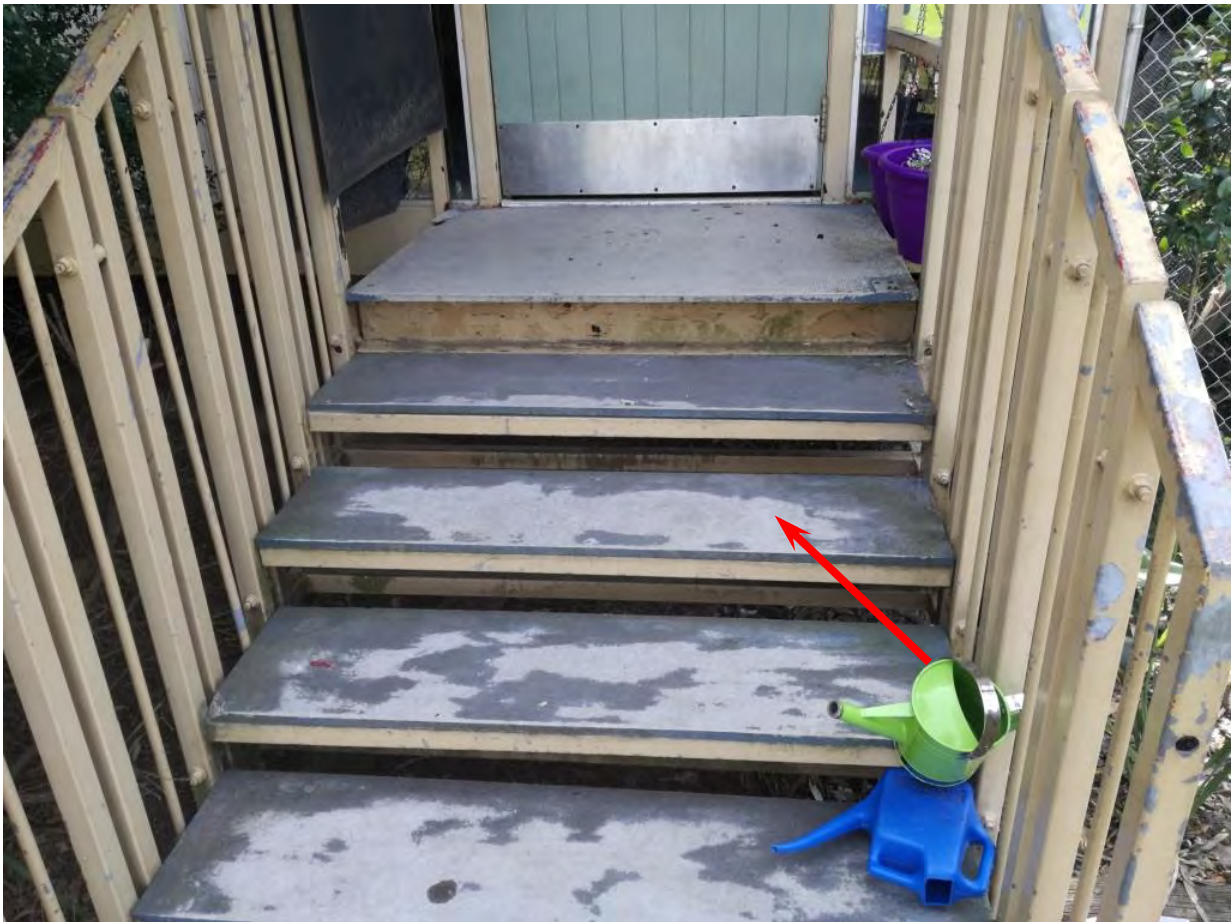
Description: The red arrow points to thick compressed asbestos cement sheet.

Recommendation: Leave and maintain in good condition.

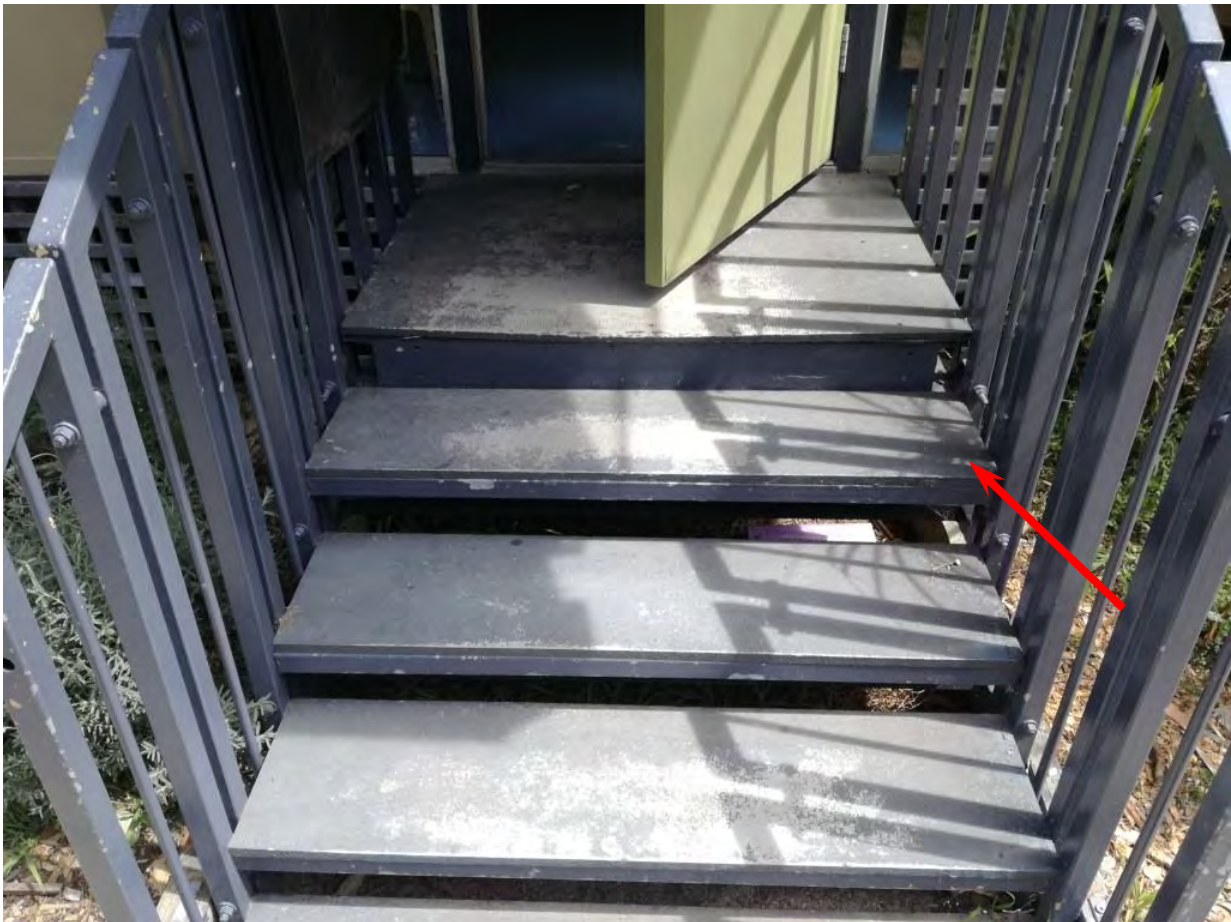
LOCATION	MATERIAL TYPE	SAMPLE / PHOTOGRAPH REFERENCE	QUAN-TITY	COND-ITION	ACCESS-IBILITY	RISK PRIORITY RATING	RECOMMENDATIONS	TIMING
D14870/D10516								
Asbestos								
D14870/D10516. External, steps	Thick compressed asbestos cement sheet	S9372/39 Photograph 30	4m ²	Fair	Regular	Priority 4: Negligible Risk under Present Conditions	Leave and maintain in good condition.	Oct 2021
D14870/D10516. External, Classroom	Fibre cement sheeting	S9372/41	NA	NA	NA	No asbestos detected	NA	NA
D14870/D10516. External, eaves	Fibre cement sheeting	S9372/40	NA	NA	NA	No asbestos detected	NA	NA
Synthetic Mineral Fibre								
D14870/D10516. External and internal, throughout	No synthetic mineral fibre materials identified		NA	NA	NA	No SMF detected	NA	NA
Lead Based Paints								
D14870/D10516. External, cladding	yellow coloured paint system	S9372/P29	NA	NA	NA	Does not contain lead	NA	NA

Description: The red arrow points to thick compressed asbestos cement sheet.

Recommendation: Leave and maintain in good condition.

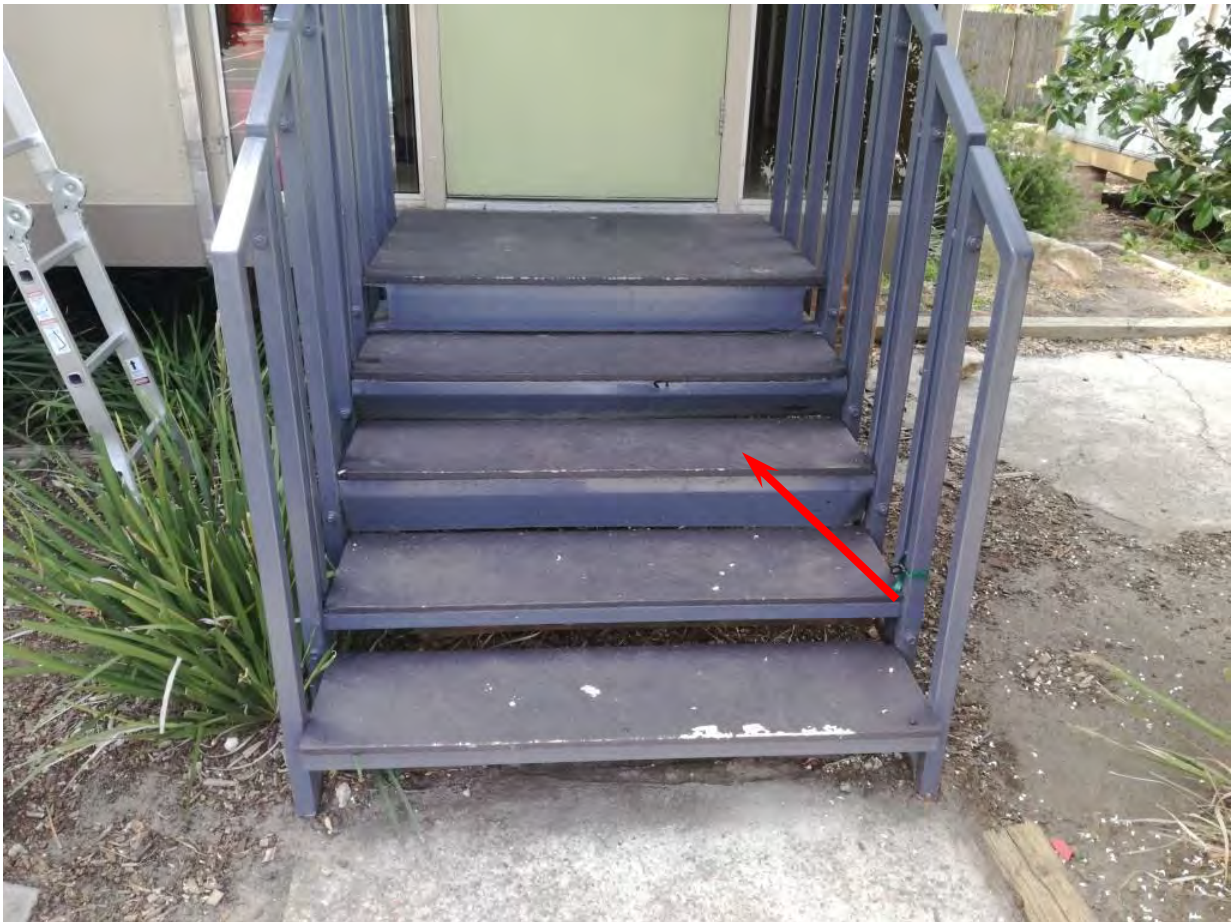
Photograph 31

Description: The red arrow points to thick compressed asbestos cement sheet.

Recommendation: Leave and maintain in good condition.

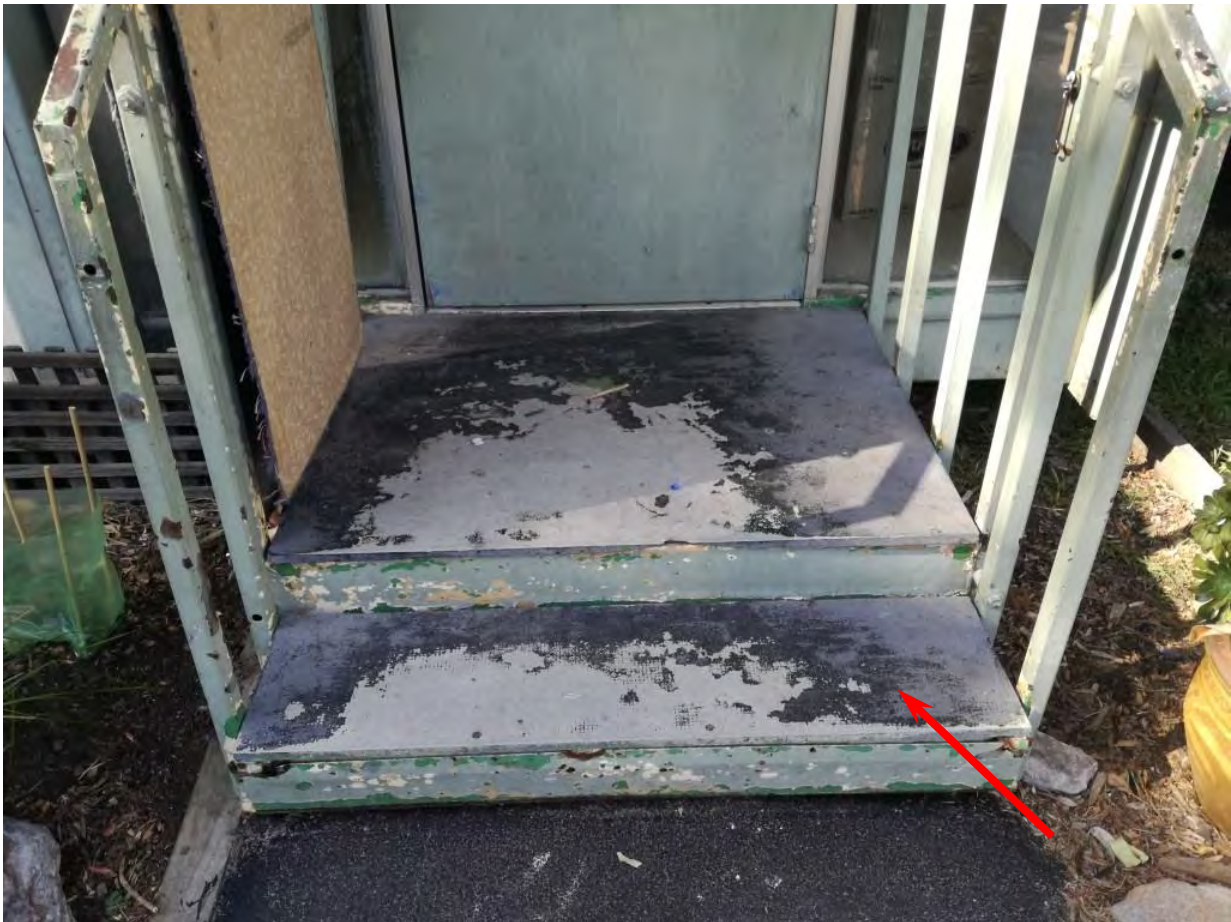
LOCATION	MATERIAL TYPE	SAMPLE / PHOTOGRAPH REFERENCE	QUAN-TITY	COND-ITION	ACCESS-IBILITY	RISK PRIORITY RATING	RECOMMENDATIONS	TIMING
D11018								
Asbestos								
D11018. External, steps	Thick compressed asbestos cement sheet	S9372/20 Photograph 32	2m ²	Fair	Regular	Priority 4: Negligible Risk under Present Conditions	Leave and maintain in good condition.	Oct 2021
D11018. Classroom, ceiling	Fibre cement sheeting	S9372/19	NA	NA	NA	No asbestos detected	NA	NA
D11018. External, eaves	Flat asbestos cement sheet	S9372/18	NA	NA	NA	No asbestos detected	NA	NA
Synthetic Mineral Fibre								
D11018. External and internal, throughout	No synthetic mineral fibre materials identified		NA	NA	NA	No SMF detected	NA	NA
Lead Based Paints								
D11018. External, cladding	Yellow coloured paint system	S9372/P42	NA	NA	NA	Does not contain lead	NA	NA

Description: The red arrow points to thick compressed asbestos cement sheet.

Recommendation: Leave and maintain in good condition.
