# arboricultural impact assessment report

Revision A, Issued for SSDA  
2 September 2025

## AFFORDABLE HOUSING

211A-215 Harbour Drive,  
Coffs Harbour, NSW, 2450

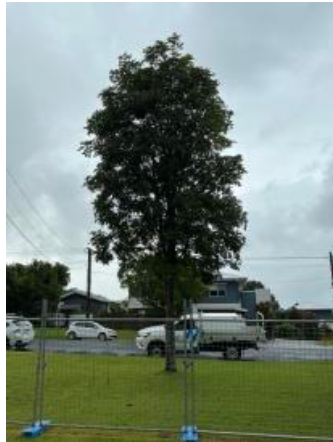
**ID # 001**  
 Species: *Flindersia australis*  
 Common: Crows Ash  
 Height: 9.0  
 No. in grp 1  
 DBH: 0.27 DGL: 0.34  
 TPZ: 3.24 SRZ: 2.1  
 Current Form: Excellent  
 Current Vigour: Good  
 Age Class: Mature  
 SULE: Long (>40 years)  
 Retention Value: **High**

Public street tree. Part of a consistent avenue row planting along street. Early mature specimen, good condition and should be retained.

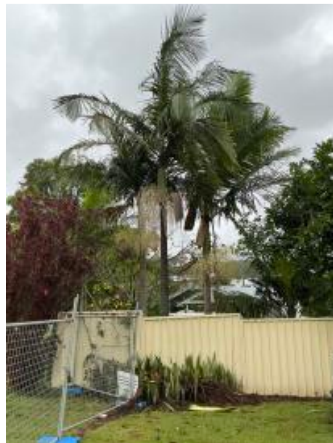
**ID # 002**  
 Species: *Archontophoenix cunninghamiana*  
 Common: Bangalow Palm  
 Height: 5.50  
 No. in grp 3  
 DBH: 0.19 DGL: 0.22  
 TPZ: 2.28 SRZ: 1.75  
 Current Form: Average  
 Current Vigour: Good  
 Age Class: Mature  
 SULE: Long (>40 years)  
 Retention Value: **Moderate**

Neighbouring property tree, very close to fenceline. Cluster of 3. Typical average dimension given.

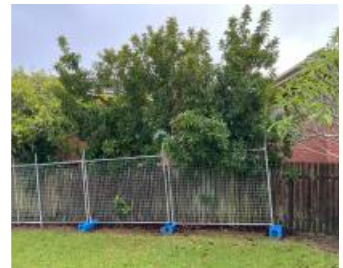
**ID # 005**  
 Species: *Xanthostemon chrysanthus*  
 Common: Golden Penda  
 Height: 6.0  
 No. in grp 3  
 DBH: 0.08 DGL: 0.09  
 TPZ: 2 SRZ: 1.5  
 Current Form: Average  
 Current Vigour: Good  
 Age Class: Semi-mature  
 SULE: Long (>40 years)  
 Retention Value: **Moderate**

Row planting of neighbouring property tree, very close to fenceline.

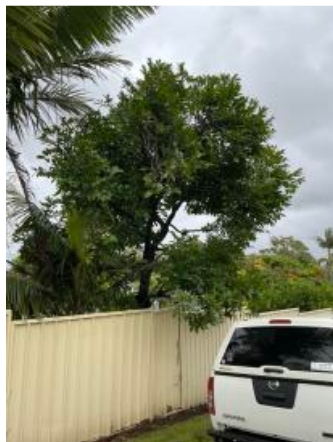
**ID # 003**  
 Species: *Diospyros nigra*  
 Common: Chocolate Pudding Fruit Tree  
 Height: 7.0  
 No. in grp 1  
 DBH: 0.26 DGL: 0.31  
 TPZ: 3.12 SRZ: 2.02  
 Current Form: Average  
 Current Vigour: Good  
 Age Class: Mature  
 SULE: Medium (15-40 years)  
 Retention Value: **Moderate**

Neighbouring property fruit tree, very close to fenceline, overhanging boundary.

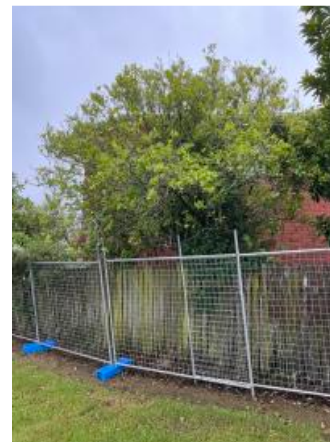
**ID # 006**  
 Species: *Michelia figo*  
 Common: Port-Wine Magnolia  
 Height: 9.0  
 No. in grp 1  
 DBH: 0.20 DGL: 0.20  
 TPZ: 2.4 SRZ: 1.68  
 Current Form: Average  
 Current Vigour: Poor  
 Age Class: Over-mature  
 SULE: Short (5-15 years)  
 Retention Value: **Low**

Neighbouring property tree, very close to fenceline. Overmature, generally poor condition. Multi-stemmed from base. Large shrub.

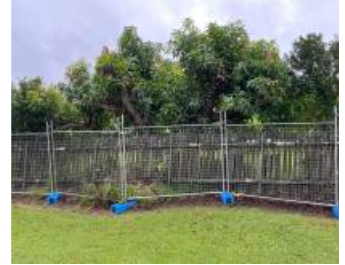
**ID # 010**  
 Species: *Mangifera indica*  
 Common: Mango  
 Height: 5.0  
 No. in grp 2  
 DBH: 0.38 DGL: 0.47  
 TPZ: 4.56 SRZ: 2.41  
 Current Form: Poor  
 Current Vigour: Good  
 Age Class: Mature  
 SULE: Medium (15-40 years)  
**Retention Value: Moderate**  
**Comments**

Neighbouring property trees, two specimens very closely spaced, very close to fenceline. Previously heavily pruned.

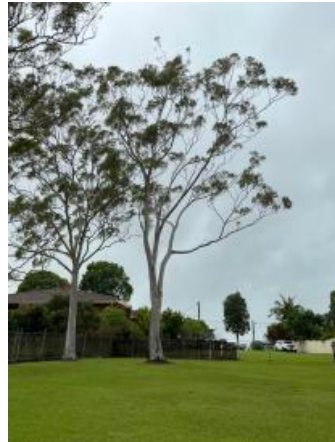
**ID # 013**  
 Species: *Corymbia citriodora*  
 Common: Lemon Scented Gum  
 Height: 18.0  
 No. in grp 1  
 DBH: 0.72 DGL: 0.99  
 TPZ: 8.64 SRZ: 3.3  
 Current Form: Average  
 Current Vigour: Poor  
 Age Class: Mature  
 SULE: Medium (15-40 years)  
 Retention Value: **Low**

Slightly asymmetric canopy form to south. Lower trunk bulges with numerous locations of sap exudate around lower trunk. Generally quite sparse canopy.

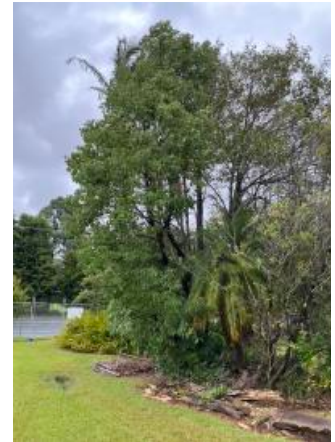
**ID # 016**  
 Species: *Cinnamomum camphora*  
 Common: Camphor Laurel  
 Height: 9.0  
 No. in grp 2  
 DBH: 0.08 DGL: 0.10  
 TPZ: 2 SRZ: 1.5  
 Current Form: Poor  
 Current Vigour: Fair  
 Age Class: Semi-mature  
 SULE: Remove (<5 years)  
 Retention Value: **Nil / Remove**

Self sown saplings. Invasive and undesirable species, should be removed.

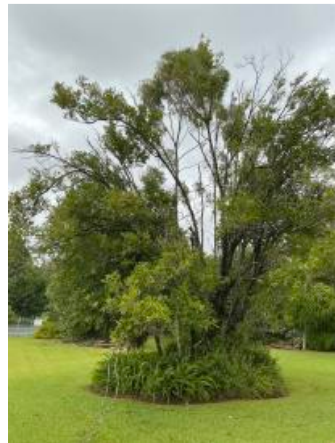
**ID # 014**  
 Species: *Corymbia citriodora*  
 Common: Lemon Scented Gum  
 Height: 8.50  
 No. in grp 1  
 DBH: 0.14 DGL: 0.17  
 TPZ: 2 SRZ: 1.57  
 Current Form: Poor  
 Current Vigour: Fair  
 Age Class: Semi-mature  
 SULE: Replaceable  
 Retention Value: **Low**

Self sown sapling growing in unmaintained area. Small and replaceable.

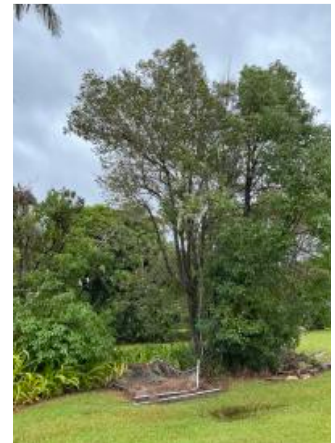
**ID # 017**  
 Species: *Glochidion ferdinandi*  
 Common: Cheese Tree  
 Height: 9.50  
 No. in grp 2  
 DBH: 0.18 DGL: 0.24  
 TPZ: 2.16 SRZ: 1.82  
 Current Form: Average  
 Current Vigour: Fair  
 Age Class: Mature  
 SULE: Replaceable  
 Retention Value: **Low**

Group of two specimens, one larger specimen and one smaller sapling to the north. Only fair condition. Considered small and replaceable. Large specimens dimensions given. Smaller tree DBH 0.08m, DGL 0.09m

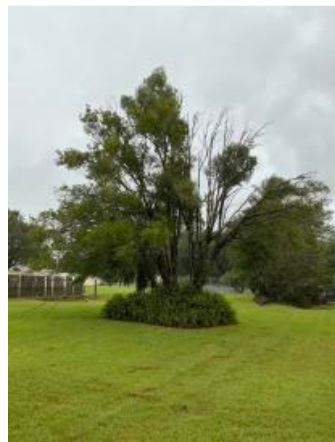
**ID # 015**  
 Species: *Glochidion ferdinandi*  
 Common: Cheese Tree  
 Height: 8.0  
 No. in grp 1  
 DBH: 0.59 DGL: 0.83  
 TPZ: 7.08 SRZ: 3.06  
 Current Form: Poor  
 Current Vigour: Poor  
 Age Class: Mature  
 SULE: Remove (<5 years)  
 Retention Value: **Nil / Remove**

Very multi-trunked tree with extensive dieback, deadwood and branch failures.

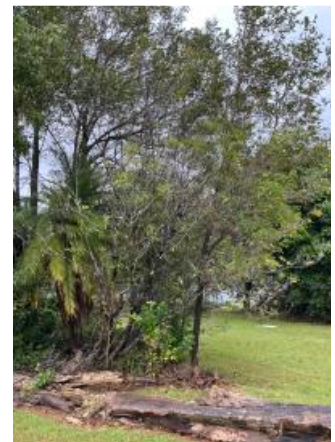
**ID # 018**  
 Species: *Pittosporum undulatum*  
 Common: Sweet Pittosporum  
 Height: 6.0  
 No. in grp 1  
 DBH: 0.15 DGL: 0.24  
 TPZ: 2 SRZ: 1.82  
 Current Form: Poor  
 Current Vigour: Poor  
 Age Class: Mature  
 SULE: Remove (<5 years)  
 Retention Value: **Nil / Remove**

Multi-trunked with major butt sweep at base and asymmetric form to north.

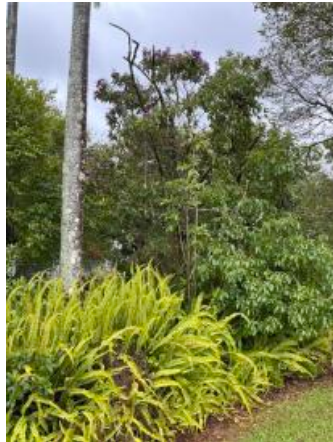
**ID # 019**  
 Species: *Tibouchina lepidota*  
 Common: Lasiandra  
 Height: 6.0  
 No. in grp 1  
 DBH: 0.20 DGL: 0.31  
 TPZ: 2.4 SRZ: 2.02  
 Current Form: Poor  
 Current Vigour: Fair  
 Age Class: Over-mature  
 SULE: Short (5-15 years)  
 Retention Value: **Low**

Over-mature, multi-trunked specimen.

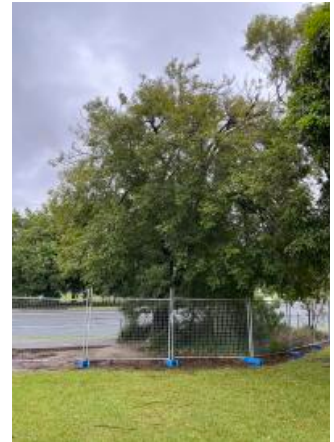
**ID # 022**  
 Species: *Glochidion ferdinandi*  
 Common: Cheese Tree  
 Height: 9.0  
 No. in grp 1  
 DBH: 0.65 DGL: 0.67  
 TPZ: 7.8 SRZ: 2.8  
 Current Form: Average  
 Current Vigour: Fair  
 Age Class: Mature  
 SULE: Long (>40 years)  
 Retention Value: **Moderate**

22	1	<i>Glochidion ferdinandii</i>	Cheese Tree	9.0	10.0	0.65	0.67	7.80	2.80	Mature	Fair	Average	Endemic		Long (>40 years)	Moderate	Prominent native tree on Harbour Drive street frontage. Some minor tip dieback but otherwise in good condition. Small Cupaniopsis sapling growing next to trunk and through canopy. Extensive exposed surface roots emanating around tree. Single street lighting power line passing through canopy.	Major incursion (>40%) to north side of tree for building, driveway and grade changes and within SRZ. Impact considered unacceptable.	Remove
23	1	<i>Ceratopetalum gummiferum</i>	New South Wales Christmas Bush	9.0	4.0	0.29	0.39	3.48	2.23	Over-mature	Poor	Average	Native	Tip Dieback, Epicormic Growth	Short (5-15 years)	Low	Overmature specimen with extensive dieback. Tall Celtis sinensis sapling also growing under and along side tree.	Within construction and disturbance footprint.	Remove

Prominent native tree on Harbour Drive street frontage. Some minor tip dieback but otherwise in good condition. Small *Cupaniopsis* sapling growing next to trunk and through canopy. Extensive exposed surface roots emanating around tree. Single street lighting power line passing through canopy.

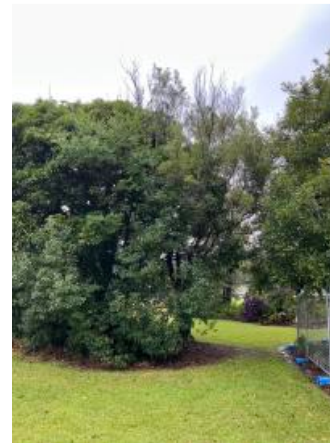
Overmature specimen with extensive dieback. Tall *Celtis sinensis* sapling also growing under and along side tree.

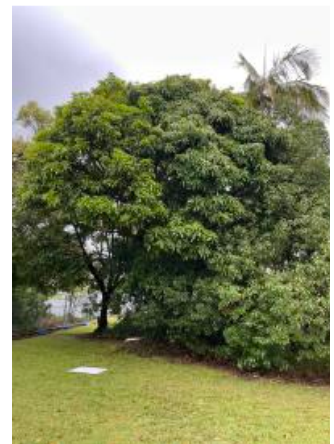
**ID # 024**  
 Species: *Mangifera indica*  
 Common: Mango  
 Height: 9.0  
 No. in grp 1  
 DBH: 0.62 DGL: 0.65  
 TPZ: 7.44 SRZ: 2.76  
 Current Form: Excellent  
 Current Vigour: Excellent  
 Age Class: Mature  
 SULE: Long (>40 years)  
 Retention Value: **Moderate**

24	1	<i>Mangifera indica</i>	Mango	9.0	10.0	0.62	0.65	7.44	2.76	Mature	Excellent	Excellent	Exotic	Co-dominant Stems	Long (>40 years)	Moderate	DBH taken at 0.6m due to branching habit. Good specimen with no observable defects. Exotic species but good tree worthy of retention.	Within construction and disturbance footprint.	Remove
25	1	<i>Archontophoenix cunninghamiana</i>	Bangalow Palm	8.5	4.0	0.21	0.26	3.00	1.13	Mature	Good	Average	Endemic		Long (>40 years)	Moderate		Within construction and disturbance footprint.	Remove
26	4	<i>Cinnamomum camphora</i>	Camphor Laurel	9.0	6.0	0.10	0.25	2.00	1.85	Semi-mature	Fair	Average	Invasive		Remove (<5 years)	Nil / Remove	Group of four self sown, saplings. Invasive and undesirable species, should be removed.	Within construction and disturbance footprint.	Remove

DBH taken at 0.6m due to branching habit. Good specimen with no observable defects. Exotic species but good tree worthy of retention.

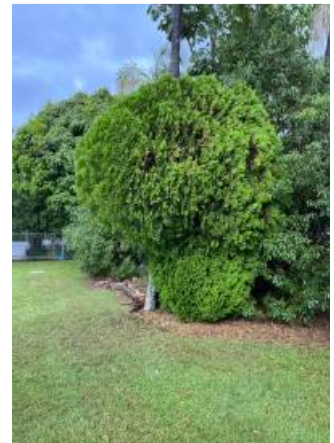
**ID # 029**  
Species: Thuja orientalis cv.  
Common: Chinese Arborvitae  
Height: 5.0  
No. in grp 1  
DBH: 0.20 DGL: 0.32  
TPZ: 2.4 SRZ: 2.05  
Current Form: Average  
Current Vigour: Good  
Age Class: Mature  
SULE: Replaceable  
Retention Value: **Low**  
**Comments**

Multi-trunked from base.

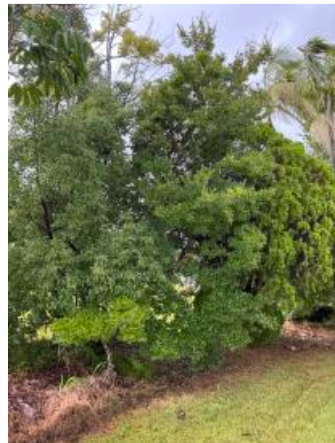
**ID # 032**  
 Species: *Celtis sinensis*  
 Common: Chinese Hackberry  
 Height: 9.0  
 No. in grp 3  
 DBH: 0.13 DGL: 0.23  
 TPZ: 2 SRZ: 1.79  
 Current Form: Average  
 Current Vigour: Fair  
 Age Class: Mature  
 SULE: Remove (<5 years)  
 Retention Value: **Nil / Remove**

Multiple saplings and stems. Invasive exotic species, should be removed.

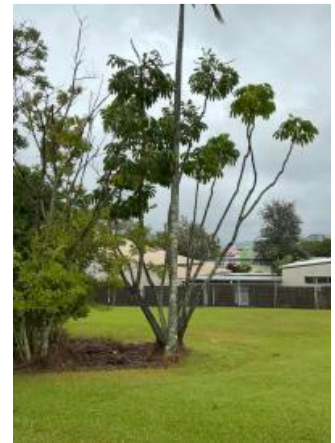
**ID # 035**  
 Species: *Schefflera actinophylla*  
 Common: Umbrella Tree  
 Height: 7.50  
 No. in grp 1  
 DBH: 0.29 DGL: 0.50  
 TPZ: 3.48 SRZ: 2.47  
 Current Form: Average  
 Current Vigour: Fair  
 Age Class: Mature  
 SULE: Remove (<5 years)  
 Retention Value: **Nil / Remove**

Generally invasive and undesirable exotic species.

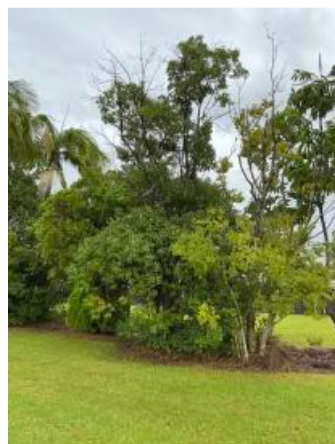
**ID # 033**  
 Species: *Cinnamomum camphora*  
 Common: Camphor Laurel  
 Height: 8.0  
 No. in grp 2  
 DBH: 0.23 DGL: 0.25  
 TPZ: 2.76 SRZ: 1.85  
 Current Form: Average  
 Current Vigour: Fair  
 Age Class: Semi-mature  
 SULE: Remove (<5 years)  
 Retention Value: **Nil / Remove**

Multiple saplings and stems. Invasive exotic species, should be removed.

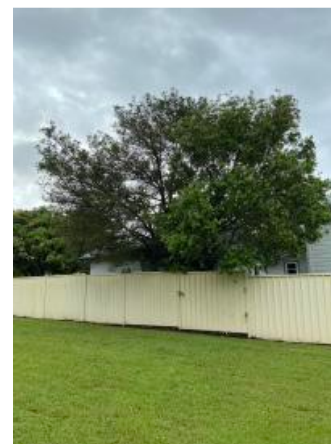
**ID # 036**  
 Species: *Glochidion ferdinandi*  
 Common: Cheese Tree  
 Height: 8.0  
 No. in grp 1  
 DBH: 0.38 DGL: 0.48  
 TPZ: 4.56 SRZ: 2.43  
 Current Form: Average  
 Current Vigour: Fair  
 Age Class: Mature  
 SULE: Medium (15-40 years)  
 Retention Value: **Moderate**

Large neighbouring property tree. Southern side of tree appears in better condition to northern side. Overhanging boundary fence.

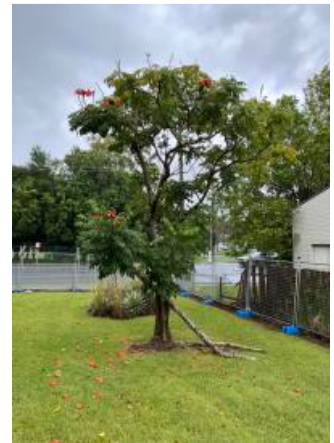
**ID # 041**  
 Species: *Spathodea campanulata*  
 Common: African Tulip Tree  
 Height: 9.0  
 No. in grp 1  
 DBH: 0.24 DGL: 0.37  
 TPZ: 2.88 SRZ: 2.18  
 Current Form: Average  
 Current Vigour: Fair  
 Age Class: Mature  
 SULE: Remove (<5 years)  
 Retention Value: **Low**

Undesirable invasive species.
