**Hazardous Materials Risk Assessment
Conrad Gargett Ancher Mortlock Woolley
Smalls Road Public School
Smalls Road, North Ryde NSW 2113**

Site Reference: 002

Our Reference : C120920 : J146932-02

Date: February 2017

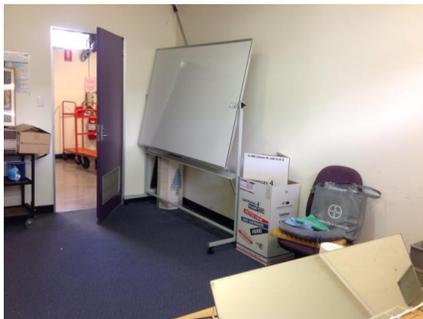
PHOTO NO.: J146932-02-002-PHOTO390
 RESULT:
 BUILDING/LEVEL: B00G - GROUND LEVEL
 ROOM/LOCATION: GR0002 OFFICE - VARIOUS THROUGHOUT
 FEATURE/MATERIAL: NON-HAZARDOUS FEATURE - NON-HAZARDOUS MATERIAL
 SAMPLE NO.: -

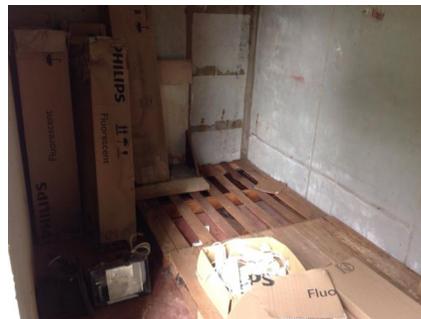
PHOTO NO.: J146932-02-002-PHOTO015
 RESULT:
 BUILDING/LEVEL: B00H - GROUND LEVEL
 ROOM/LOCATION: HR0006 STORAGE ROOM - THROUGHOUT
 FEATURE/MATERIAL: NON-HAZARDOUS FEATURE - NON-HAZARDOUS MATERIAL
 SAMPLE NO.: -

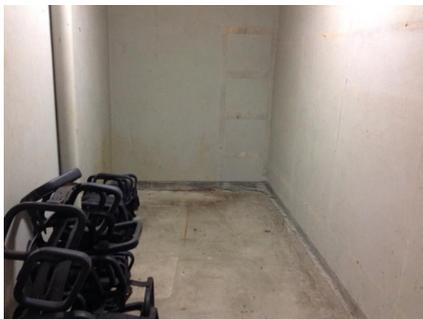
PHOTO NO.: J146932-02-002-PHOTO032
 RESULT:
 BUILDING/LEVEL: B00H - GROUND LEVEL
 ROOM/LOCATION: HR0010 STORAGE ROOM - THROUGHOUT
 FEATURE/MATERIAL: NON-HAZARDOUS FEATURE - NON-HAZARDOUS MATERIAL
 SAMPLE NO.: -

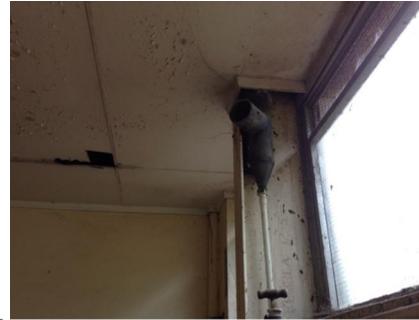
PHOTO NO.: J146932-02-002-PHOTO086
 RESULT: ASBESTOS - PRESUMED POSITIVE
 BUILDING/LEVEL: B00H - BASEMENT LEVEL
 ROOM/LOCATION: HR9009 TOILET/SHOWER - EAST
 FEATURE/MATERIAL: PIPEWORK - MOULDED FIBRE CEMENT
 SAMPLE NO.: SIMILAR TO: J146932-02-002-005

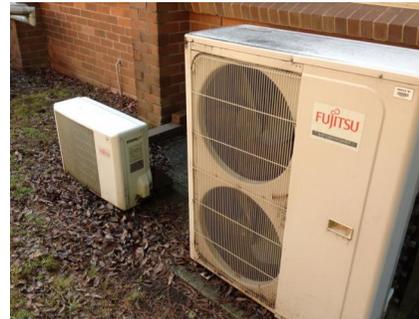
PHOTO NO.: J146932-02-002-PHOTO186
 RESULT: ODS - POSITIVE
 BUILDING/LEVEL: B00L - GROUND LEVEL
 ROOM/LOCATION: EXTERIOR - NORTH & SOUTH
 FEATURE/MATERIAL: A/C UNIT - R22 - CHLORODIFLUOROMETHANE
 SAMPLE NO.: -

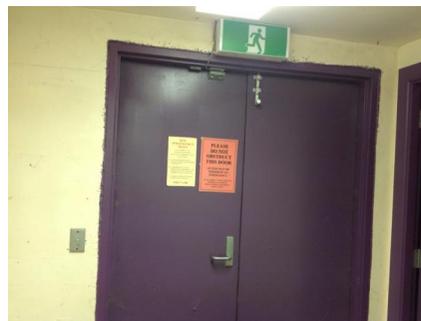
PHOTO NO.: J146932-02-002-PHOTO200
 RESULT: ASBESTOS - PRESUMED POSITIVE
 BUILDING/LEVEL: B00L - GROUND LEVEL
 ROOM/LOCATION: LR0004 MOVEMENT - EAST
 FEATURE/MATERIAL: FIRE DOOR - DOUBLE - FIRE DOOR CORE
 SAMPLE NO.: NOT SAMPLED RESTRICTED ACCESS

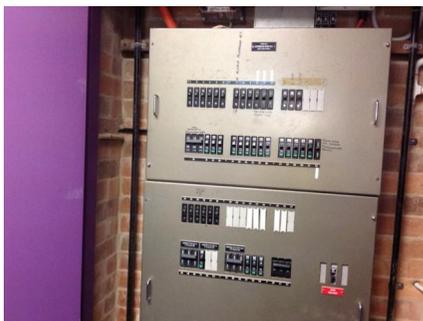
PHOTO NO.: J146932-02-002-PHOTO204
 RESULT: ASBESTOS - PRESUMED POSITIVE
 BUILDING/LEVEL: B00L - GROUND LEVEL
 ROOM/LOCATION: LR0006 SWITCHBOARD ROOM - EAST
 FEATURE/MATERIAL: ELECTRICAL - SWITCH BOARD - COMPRESSED BITUMINOUS ELECTRICAL PANEL
 SAMPLE NO.: NOT SAMPLED LIVE ELECTRICAL HAZARD

LR0004 Movement - Throughout Concrete floor and walls, Gyprock south wall and ceiling.	None													
LR0005 Storage Area - Throughout Concrete floor and ceiling, Brick wall.	None													
LR0006 Switchboard Room - East Electrical - Switch Board - Compressed Bituminous Electrical Panel	Asbestos	Not Sampled Live Electrical Hazard	Presumed Positive	J146932-02-002-Photo204	1 Unit/s	Good				Not Labelled	27/02/2018		Confirm status, label, maintain in current condition and incorporate into a HMMP. Remove by licensed asbestos contractor prior to demolition or refurbishment.	
LR0006 Switchboard Room - South Electrical - Switch Board - Compressed Bituminous Electrical Panel	Asbestos	Similar To: J146932-02-002-009	Presumed Positive	J146932-02-002-Photo205	1 Unit/s	Good	Non Friable	Low	Low	Not Labelled	27/02/2018	P4	Maintain in current condition, label and incorporate into a HMMP. Remove by licensed asbestos contractor prior to demolition or refurbishment.

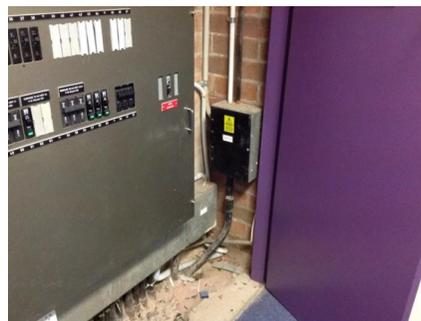
PHOTO NO.: J146932-02-002-PHOTO205
 RESULT: ASBESTOS - PRESUMED POSITIVE
 BUILDING/LEVEL: B00L - GROUND LEVEL
 ROOM/LOCATION: LR0006 SWITCHBOARD ROOM - SOUTH
 FEATURE/MATERIAL: ELECTRICAL - SWITCH BOARD - COMPRESSED BITUMINOUS ELECTRICAL PANEL
 SAMPLE NO.: SIMILAR TO: J146932-02-002-009

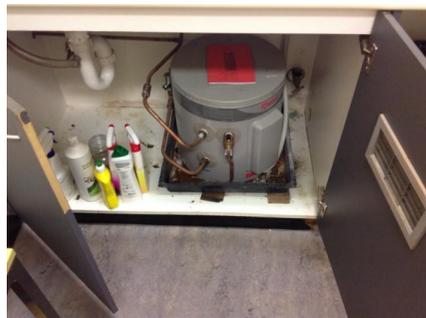
PHOTO NO.: J146932-02-002-PHOTO208
 RESULT: SMF - PRESUMED POSITIVE
 BUILDING/LEVEL: B00L - GROUND LEVEL
 ROOM/LOCATION: LR0013 KITCHEN - WEST
 FEATURE/MATERIAL: HOT WATER SERVICE INSULATION - INSULATION MATERIAL
 SAMPLE NO.: -

LR0013 Kitchen - Throughout Ceiling Lining - Sprayed Vermiculite	Asbestos	Similar To: J146932-02-002-012	Presumed Negative											
LR0013 Kitchen - Throughout Concrete walls, Modern brown spec vinyl floor sheeting.	None													
LR0013 Kitchen - West Hot Water Service Insulation - Insulation Material - Zip and Rheem units.	SMF		Presumed Positive	J146932-02-002-Photo208 J146932-02-002-Photo211	2 Unit/s	Good	Bonded (SMF)						Maintain in good condition and incorporate into a HMMP. Remove under controlled conditions prior to demolition or refurbishment.	
LR0015 Storage Space - Throughout Concrete floor and ceiling, Brick walls.	None													
LR0016 Switchboard Room - Throughout Brick walls, Concrete floor and ceiling.	None													
LR0016 Switchboard Room - West Electrical - Switch Board - Compressed Bituminous Electrical Panel	Asbestos	Not Sampled Live Electrical Hazard	Presumed Positive	J146932-02-002-Photo182	1 Unit/s	Good	Non Friable	Low	Low	Not Labelled	27/02/2022	P4	Confirm status, label, maintain in current condition and incorporate into a HMMP. Remove by licensed asbestos contractor prior to demolition or refurbishment.

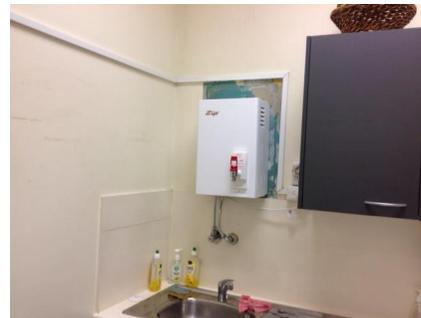
PHOTO NO.: J146932-02-002-PHOTO211
 RESULT: SMF - PRESUMED POSITIVE
 BUILDING/LEVEL: B00L - GROUND LEVEL
 ROOM/LOCATION: LR0013 KITCHEN - WEST
 FEATURE/MATERIAL: HOT WATER SERVICE INSULATION - INSULATION MATERIAL
 SAMPLE NO.: -

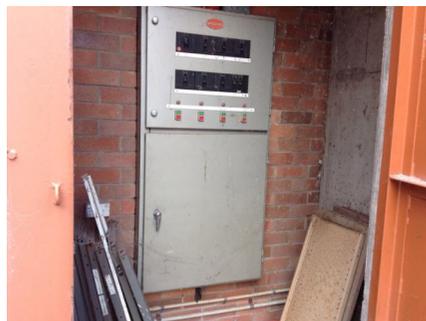
PHOTO NO.: J146932-02-002-PHOTO182
 RESULT: ASBESTOS - PRESUMED POSITIVE
 BUILDING/LEVEL: B00L - GROUND LEVEL
 ROOM/LOCATION: LR0016 SWITCHBOARD ROOM - WEST
 FEATURE/MATERIAL: ELECTRICAL - SWITCH BOARD - COMPRESSED BITUMINOUS ELECTRICAL PANEL
 SAMPLE NO.: NOT SAMPLED LIVE ELECTRICAL HAZARD

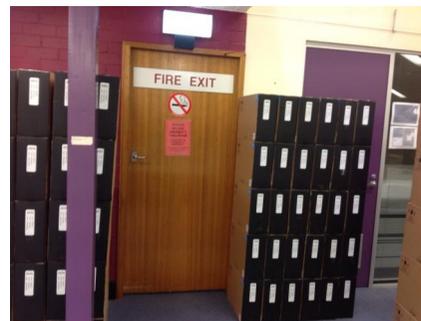
PHOTO NO.: J146932-02-002-PHOTO123
 RESULT: ASBESTOS - PRESUMED POSITIVE
 BUILDING/LEVEL: B00L - LEVEL ONE
 ROOM/LOCATION: LR1007 CLEANERS/ FIRE EXIT - EAST & WEST
 FEATURE/MATERIAL: FIRE DOOR - FIRE DOOR CORE
 SAMPLE NO.: NOT SAMPLED

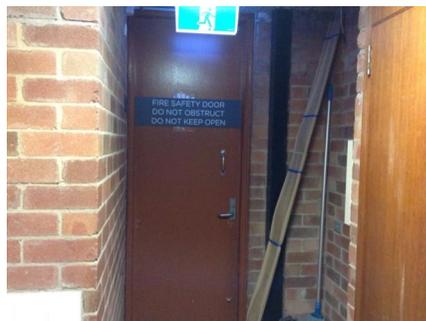
PHOTO NO.: J146932-02-002-PHOTO124
 RESULT: ASBESTOS - PRESUMED POSITIVE
 BUILDING/LEVEL: B00L - LEVEL ONE
 ROOM/LOCATION: LR1007 CLEANERS/ FIRE EXIT - EAST & WEST
 FEATURE/MATERIAL: FIRE DOOR - FIRE DOOR CORE
 SAMPLE NO.: NOT SAMPLED

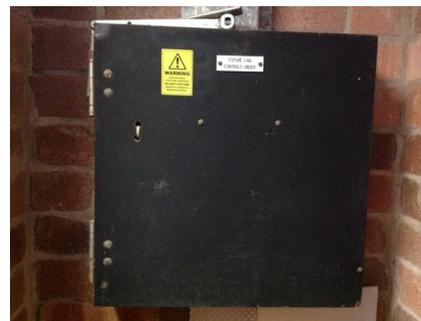
PHOTO NO.: J146932-02-002-PHOTO122
 RESULT: ASBESTOS - POSITIVE
 BUILDING/LEVEL: B00L - LEVEL ONE
 ROOM/LOCATION: LR1007 CLEANERS/ FIRE EXIT - SOUTH
 FEATURE/MATERIAL: ELECTRICAL - SWITCH BOARD - COMPRESSED BITUMINOUS ELECTRICAL PANEL
 SAMPLE NO.: J146932-02-002-009

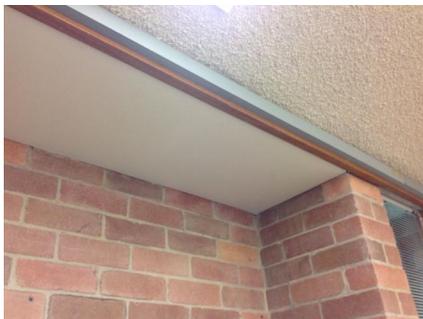
PHOTO NO.: J146932-02-002-PHOTO127
 RESULT: **ASBESTOS - POSITIVE**
 BUILDING/LEVEL: **B00L - LEVEL ONE**
 ROOM/LOCATION: **LR1010 OFFICE - VARIOUS THROUGHOUT**
 FEATURE/MATERIAL: **INFILL PANELS - FIBRE CEMENT SHEETING**
 SAMPLE NO.: **J146932-02-002-011**

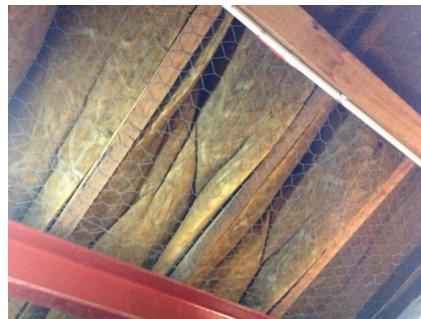
PHOTO NO.: J146932-02-002-PHOTO154
 RESULT: **SMF - POSITIVE**
 BUILDING/LEVEL: **B00L - MEZZANINE LEVEL ONE**
 ROOM/LOCATION: **LM1002 AIRCONDITIONING DUCT AREA - THROUGHOUT**
 FEATURE/MATERIAL: **ROOF LINING - INSULATION MATERIAL**
 SAMPLE NO.: -

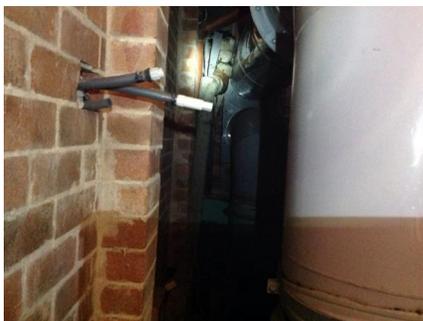
PHOTO NO.: J146932-02-002-PHOTO160
 RESULT: **ASBESTOS - POSITIVE**
 BUILDING/LEVEL: **B00L - MEZZANINE LEVEL ONE**
 ROOM/LOCATION: **LM1003 AIRCONDITIONING DUCT AREA - NORTH**
 FEATURE/MATERIAL: **PIPE WORK - MOULDED FIBRE CEMENT**
 SAMPLE NO.: **J146932-02-002-015**

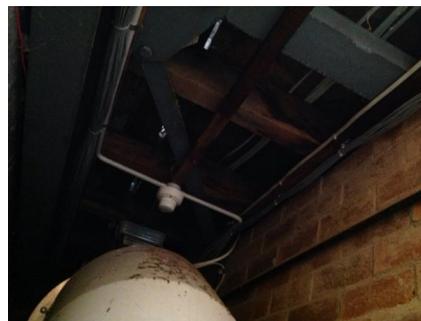
PHOTO NO.: J146932-02-002-PHOTO163
 RESULT: **SMF - POSITIVE**
 BUILDING/LEVEL: **B00L - MEZZANINE LEVEL ONE**
 ROOM/LOCATION: **LM1003 AIRCONDITIONING DUCT AREA - THROUGHOUT**
 FEATURE/MATERIAL: **ROOF LINING - INSULATION MATERIAL**
 SAMPLE NO.: -

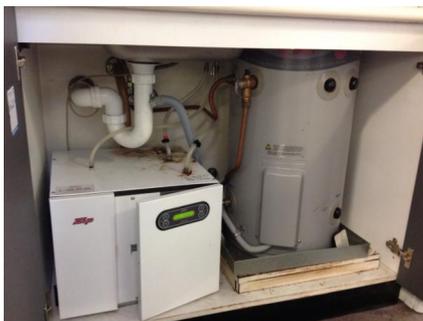
PHOTO NO.: J146932-02-002-PHOTO164
 RESULT: **SMF - PRESUMED POSITIVE**
 BUILDING/LEVEL: **B00L - MEZZANINE LEVEL ONE**
 ROOM/LOCATION: **LM1004 KITCHENETTE - WEST**
 FEATURE/MATERIAL: **HOT WATER SERVICE INSULATION - INSULATION MATERIAL**
 SAMPLE NO.: -

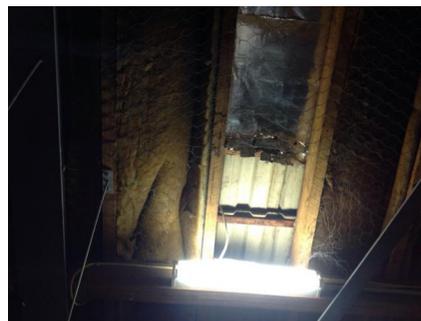
PHOTO NO.: J146932-02-002-PHOTO175
 RESULT: **SMF - POSITIVE**
 BUILDING/LEVEL: **B00L - MEZZANINE LEVEL ONE**
 ROOM/LOCATION: **LM1007 AIRCONDITIONING DUCT AREA - THROUGHOUT**
 FEATURE/MATERIAL: **ROOF LINING - INSULATION MATERIAL**
 SAMPLE NO.: -

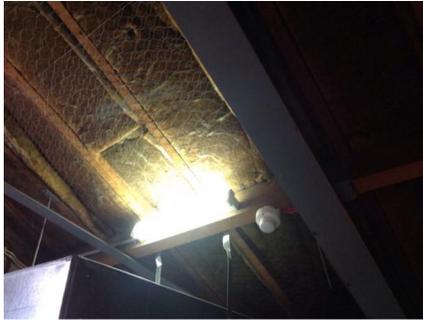
PHOTO NO.: J146932-02-002-PHOTO176

RESULT: **SMF - POSITIVE**
