**Re: Expert opinion on the potential impact on traffic safety at the Railway Crossing (LXM ID 349) located on Railway Street in Corrimal, NSW**

# **Railway Crossing (LXM ID 349) located on Railway Street in Corrimal, NSW**

## **Stage 5 (Existing road) Road Safety Audit**

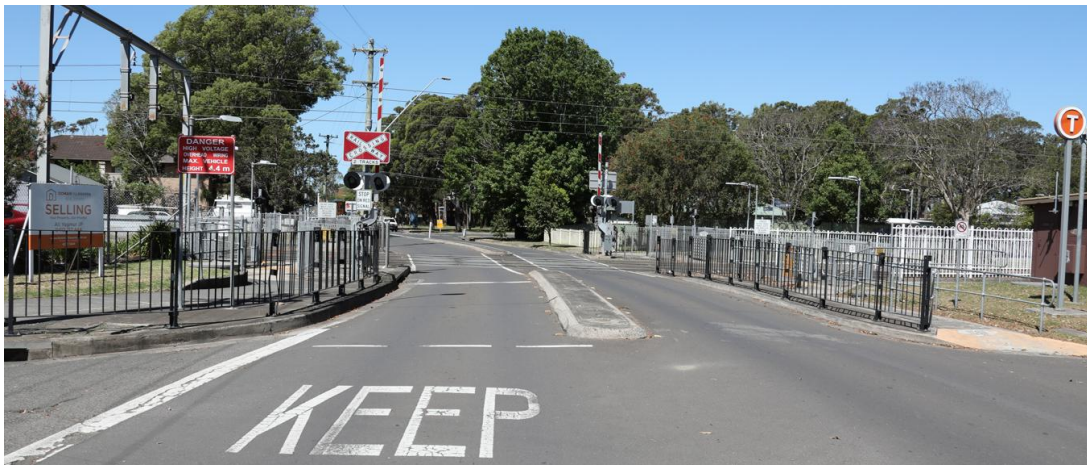
**Photo 3.1: Railway Street, on the western approach to the Railway Crossing – in daylight**  
(Photo: Traffic Engineering Centre)

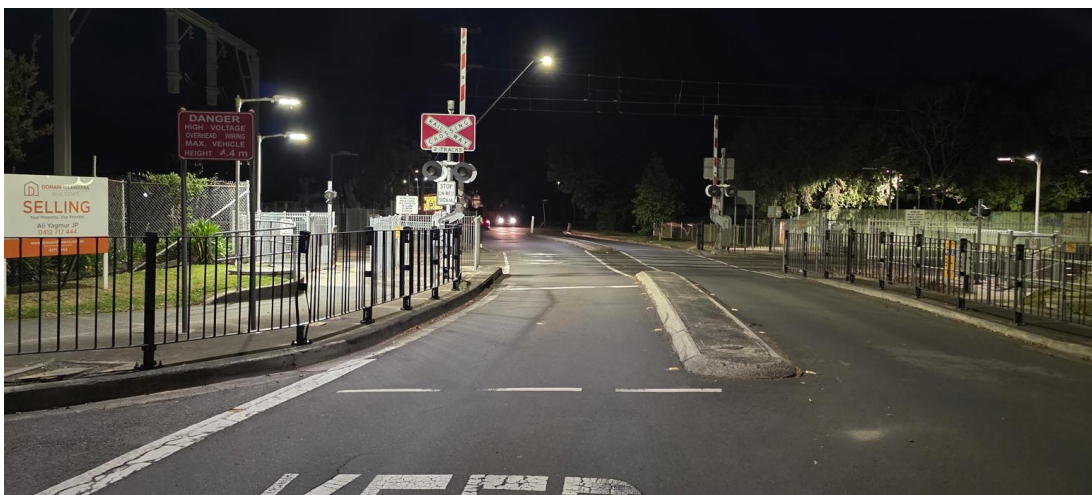
**Photo 3.2: Railway Street, on the western approach to the Railway Crossing – at night**  
(Photo: Traffic Engineering Centre)

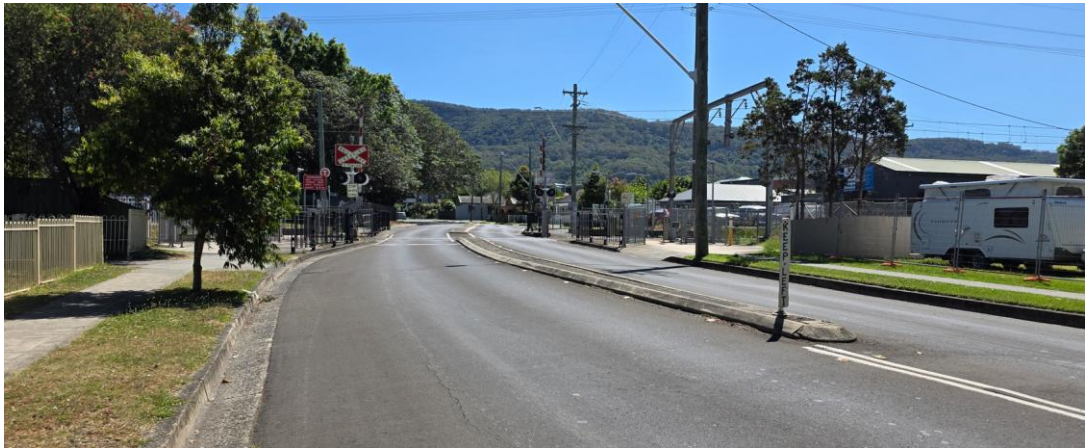
**Photo 3.3: Railway Street, on the eastern approach to the Railway Crossing – in daylight**  
(Photo: Traffic Engineering Centre)

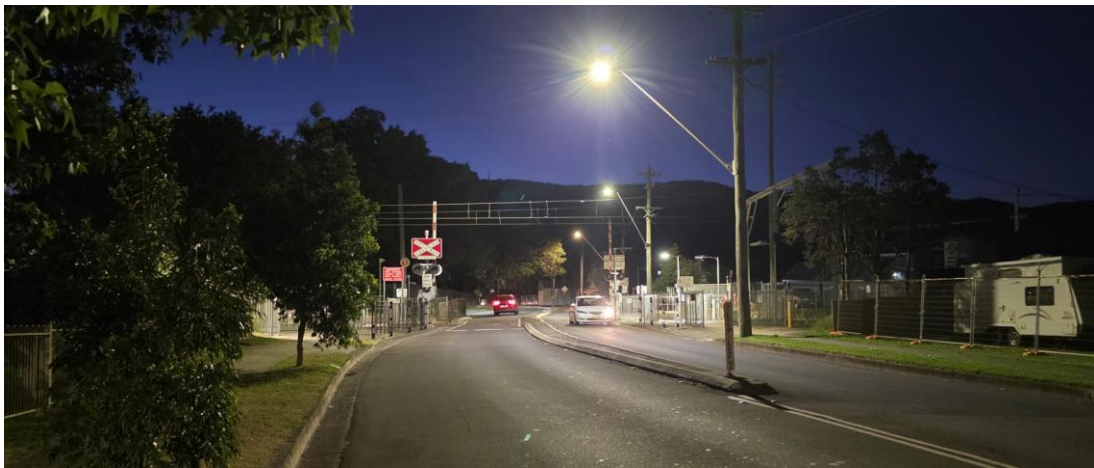
**Photo 3.4: Railway Street, on the eastern approach to the Railway Crossing – at night**  
(Photo: Traffic Engineering Centre)
