**SY214006**

# **Post–Construction Dilapidation Report**

**Council Assets**

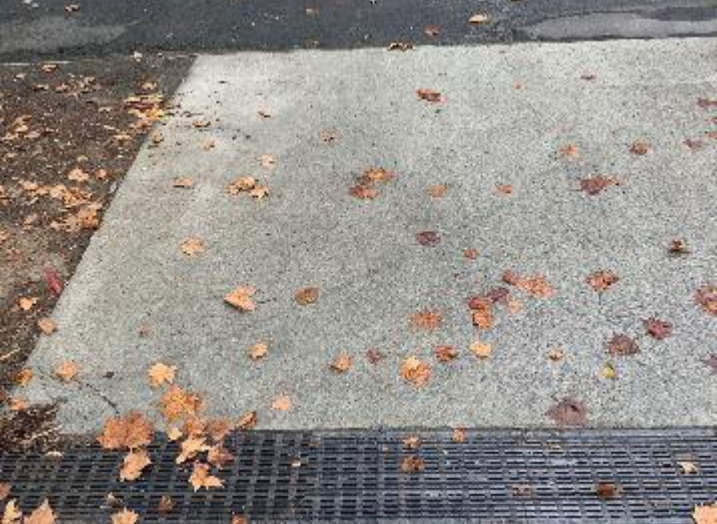
| | <p><b>Photograph 2.EW.6</b></p> <p><u>East Walkway</u><br/><u>Minor</u></p> <p>Various cracks approximately max. 3000mm long x max. 1.2mm wide located at the south end of the concrete in front of the loading bay door at the north end of workshop 1.</p> <p>Photographed looking west.</p> |

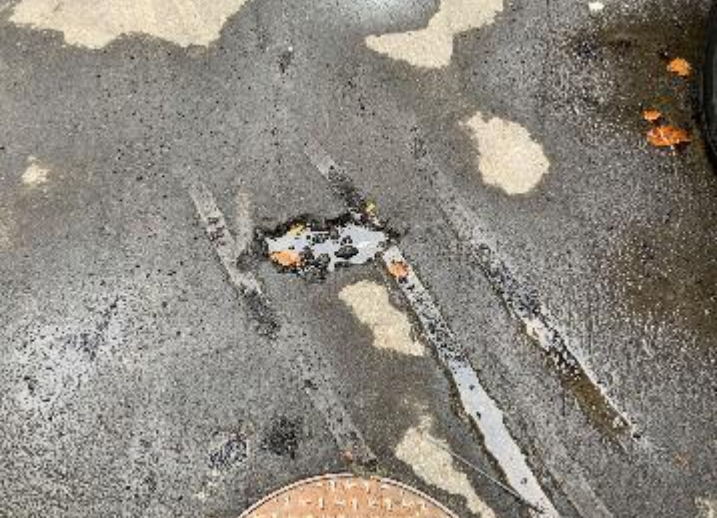
| | <p><b>Photograph 2.EW.7</b></p> <p><u>East Walkway</u><br/><u>Minor</u></p> <p>Pothole in the bitumen next to the second north window.</p> <p>Photographed looking south.</p> |

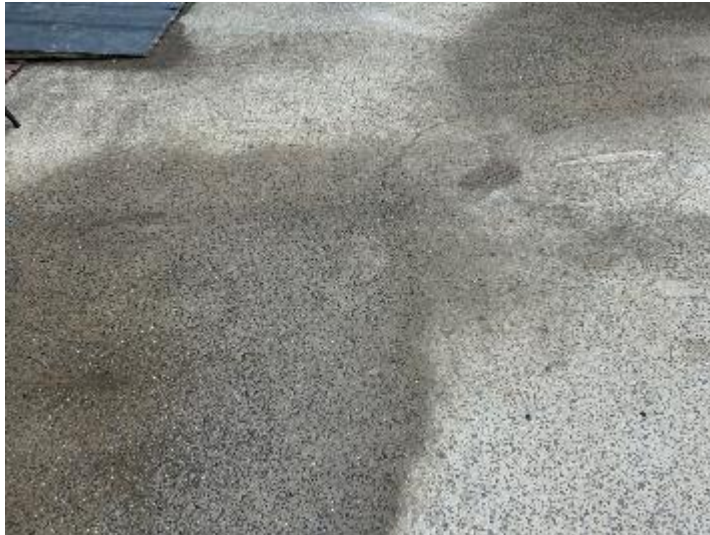
| | <p><b>Photograph 2.EW.15</b></p> <p><u>East Walkway</u><br/><u>Minor</u></p> <p>Various cracks approximately max. 4500mm long x max. 1.4mm wide located in the concrete between the central doors.</p> <p>Photographed looking north.</p> |

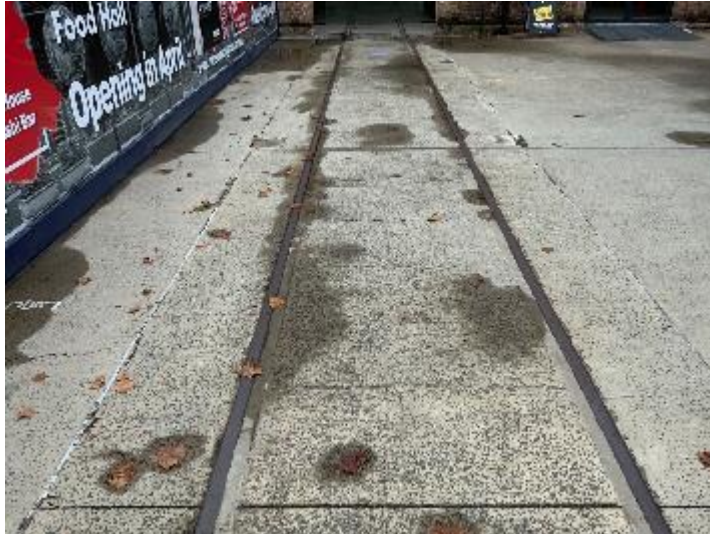
| | <p><b>Photograph 2.EW.16</b></p> <p><u>East Walkway</u><br/><u>Minor</u></p> <p>Various cracks approximately max. 1400mm long x max. 1.8mm wide located in the concrete around the tracks in front of the main entry door to workshop 1, chipping of the concrete at the slab joints.</p> <p>Photographed looking west.</p> |

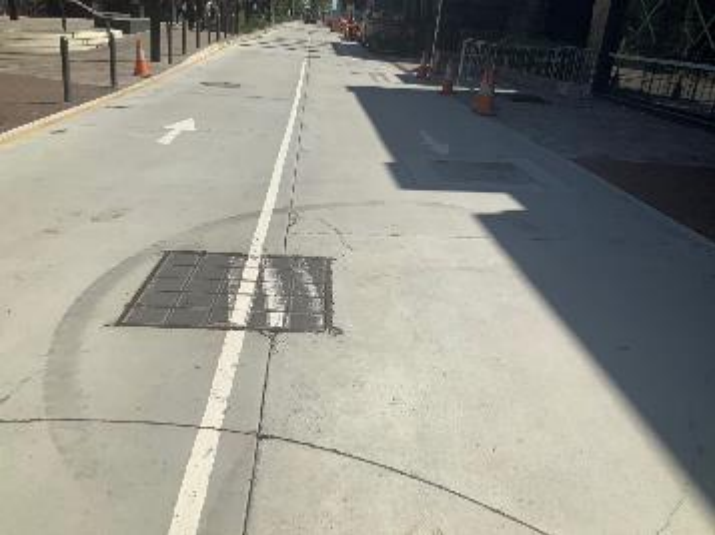
| | <p><b>Photograph 2.L.81</b></p> <p><u>Locomotive Street - Outside Workshop 1</u><br/><u>General Photograph</u></p> <p>General photograph of the three service pits located in the road in front of workshop 1.</p> <p>Photographed looking west.</p> |

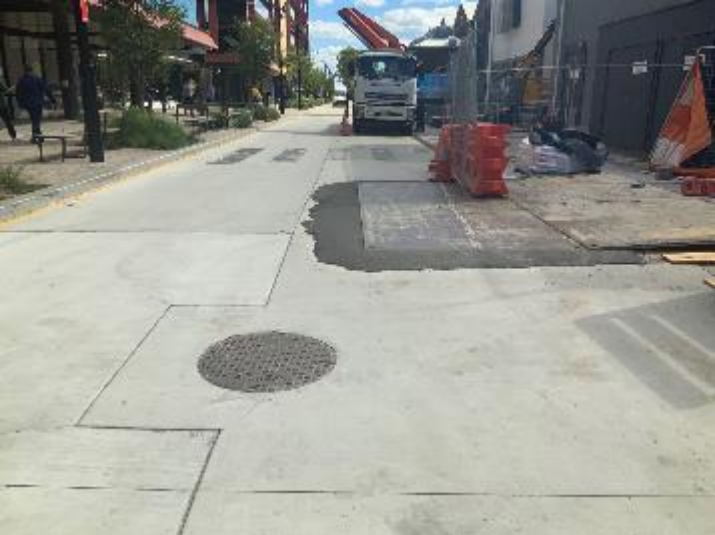
| | <p><b>Photograph 2.L.87</b></p> <p><u>Locomotive Street - Outside Workshop 4A<br/>(Formerly Workshop 5)</u><br/><u>General Photograph</u></p> <p>General photograph of the bitumen patch and sewer pit located in front of workshop 4A.</p> <p>Photographed looking west.</p> |

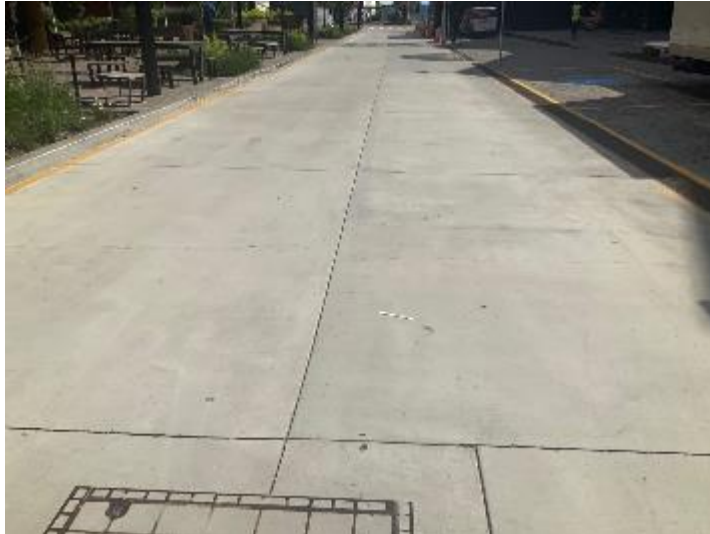
| | <p><b>Photograph 2.L.95</b></p> <p><u>Locomotive Street - Outside Workshop 10</u><br/><u>(Formerly Workshop 11)</u><br/><u>Minor</u></p> <p>Various cracks approximately max. 3000mm long x max. 1mm wide located in the road, typical.</p> <p>Photographed looking west.</p> |

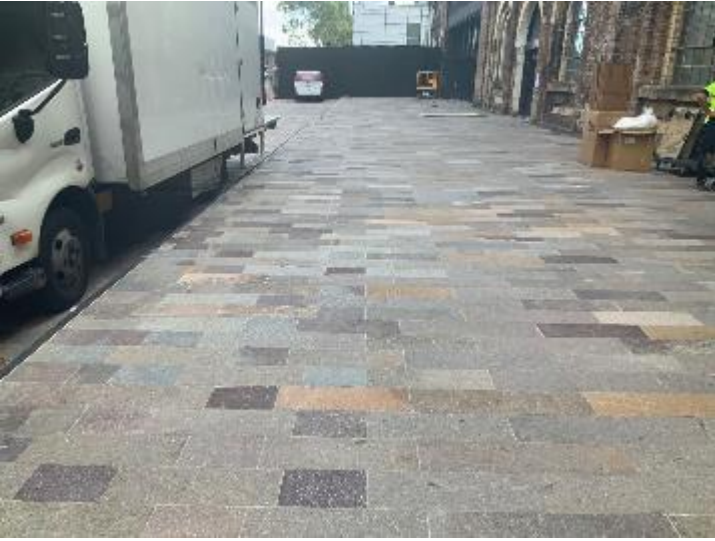
| | <p><b>Photograph 1.L.26 – Rev.B</b></p> <p><u>Locomotive Street - Outside Workshop 11</u><br/> <u>(Formerly Workshop 12)</u><br/> <u>General Photograph</u></p> <p>General photograph of the new pavement.</p> <p>Photographed looking west.</p> |

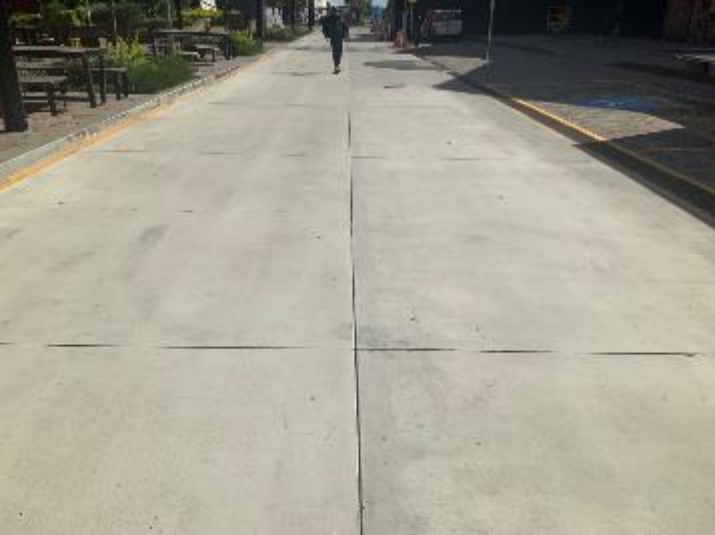
| | <p><b>Photograph 1.L.27 – Rev.B</b></p> <p><u>Locomotive Street - Outside Workshop 11</u><br/> <u>(Formerly Workshop 12)</u><br/> <u>General Photograph</u></p> <p>General photograph of the road.</p> <p>Photographed looking west.</p> |

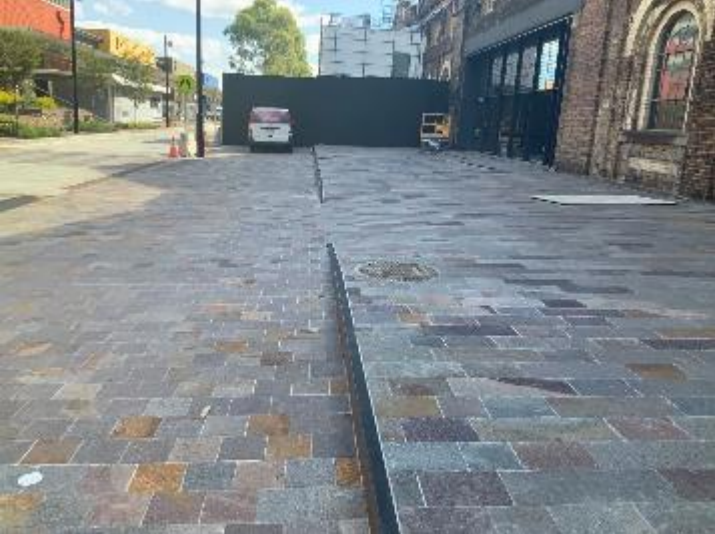
| | <p><b>Photograph 1.L.18 – Rev.B</b></p> <p><u>Locomotive Street - Outside Workshop 12</u><br/> <u>(Formerly Workshop 13)</u><br/> <u>General Photograph</u></p> <p>General photograph of the new pavement.</p> <p>Photographed looking west.</p> |

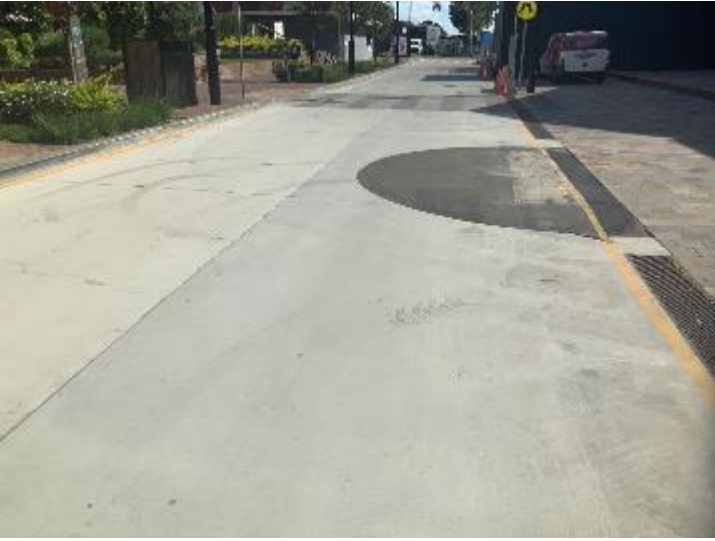
| | <p><b>Photograph 1.L.17 – Rev.B</b></p> <p><u>Locomotive Street - Outside Workshop 12</u><br/><u>(Formerly Workshop 13)</u><br/><u>General Photograph</u></p> <p>General photograph of the road and bitumen patch.</p> <p>Photographed looking west.</p> |

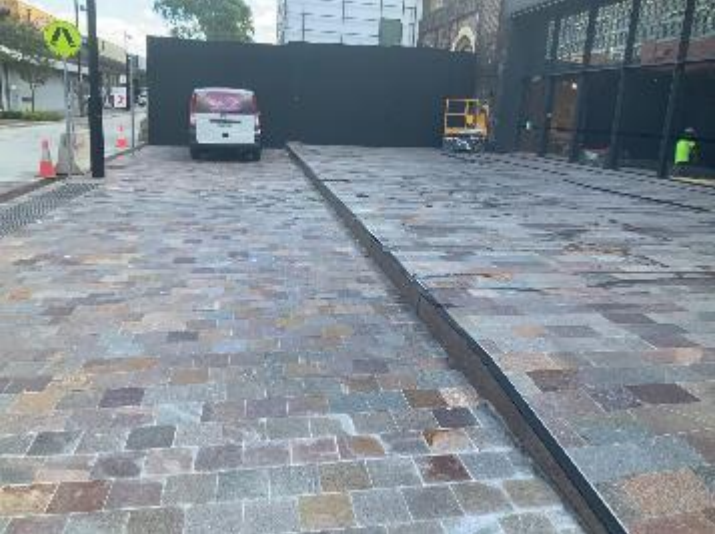
| | <p><b>Photograph 1.L.13 – Rev.B</b></p> <p><u>Locomotive Street - Outside Workshop 13</u><br/><u>(Formerly Workshop 14)</u><br/><u>General Photograph</u></p> <p>General photograph of the new pavement.</p> <p>Photographed looking west.</p> |

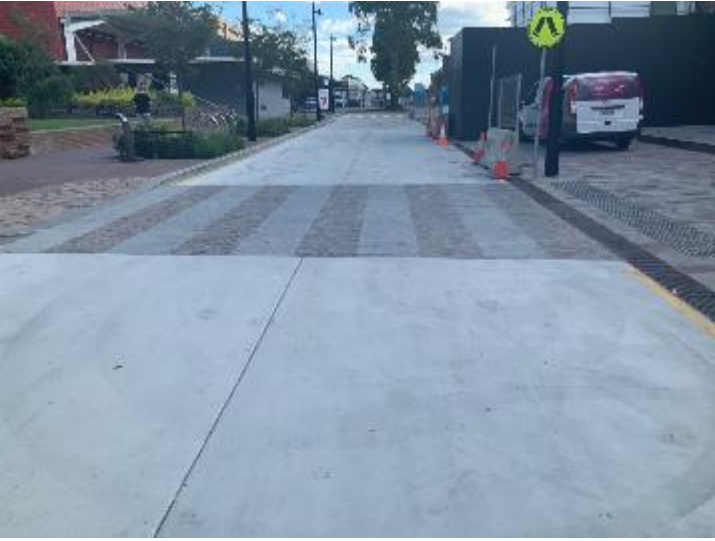
| | <p><b>Photograph 1.L.12 – Rev.B</b></p> <p><u>Locomotive Street - Outside Workshop 13 (Formerly Workshop 14)</u><br/><u>General Photograph</u></p> <p>General photograph of the new road.</p> <p>Photographed looking west.</p> |

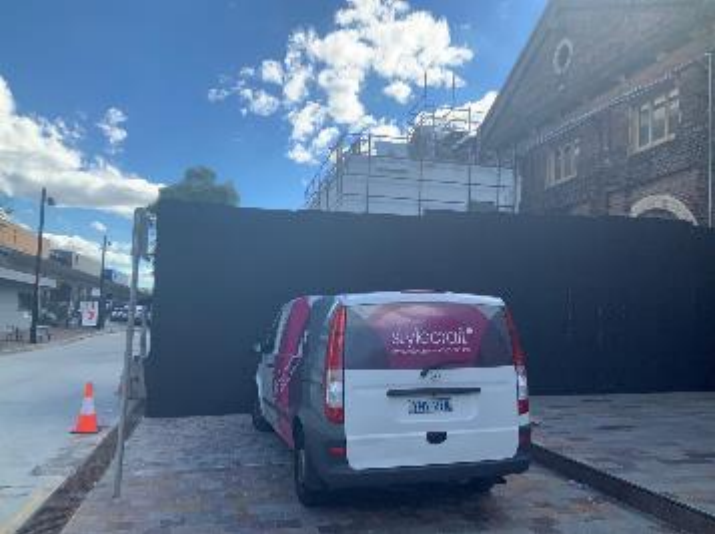
| | <p><b>Photograph 1.L.10 – Rev.B</b></p> <p><u>Locomotive Street - Outside Workshop 14 (Formerly Workshop 15)</u><br/><u>General Photograph</u></p> <p>General photograph of the construction hoarding on the footpath, no access beyond workshop 14.</p> <p>Photographed looking west.</p> |

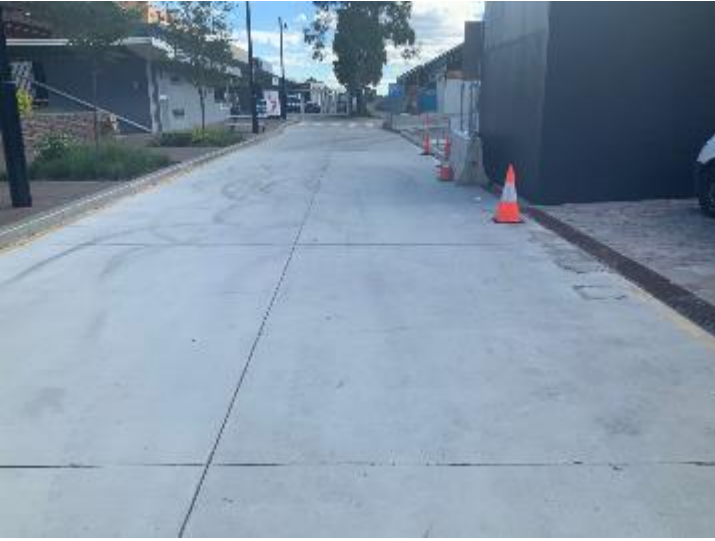
| | <p><b>Photograph 1.L.9 – Rev.B</b></p> <p><u>Locomotive Street - Outside Workshop 14 (Formerly Workshop 15)</u><br/><u>General Photograph</u></p> <p>General photograph of the road.</p> <p>Photographed looking west.</p> |

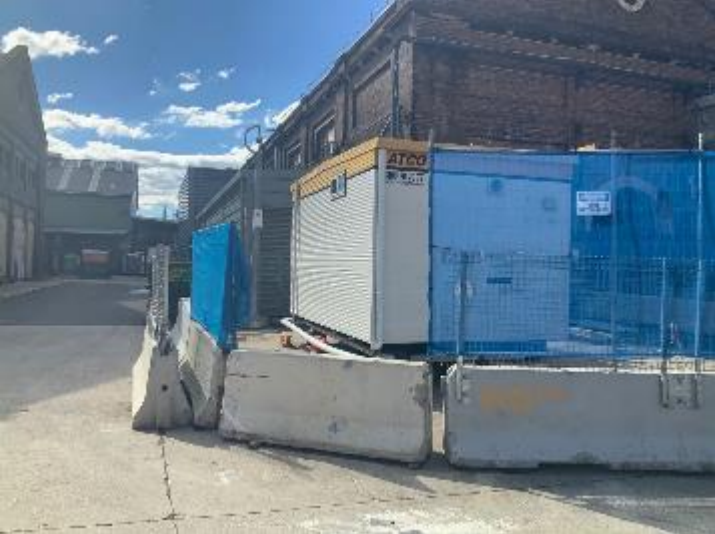
| | <p><b>Photograph 2.L.99</b></p> <p><u>Locomotive Street - Outside Workshop 15 (Formerly Workshop 16)</u><br/><u>General Photograph</u></p> <p>General photograph of the construction hoarding outside workshop 15, no access.</p> <p>Photographed looking north.</p> |

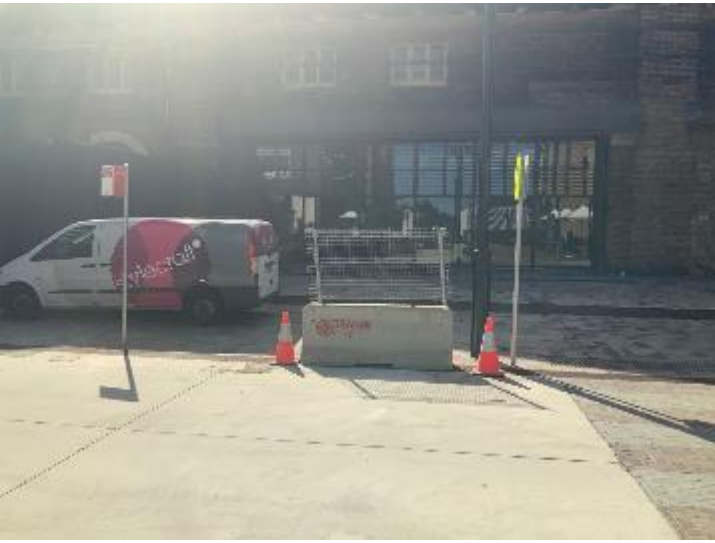
| | <p><b>Photograph 2.L.100</b></p> <p><u>Locomotive Street - Outside Workshop 13</u><br/> <u>(Formerly Workshop 14)</u><br/> <u>General Photograph</u></p> <p>General photograph of the two traffic signs.</p> <p>Photographed looking north.</p> |

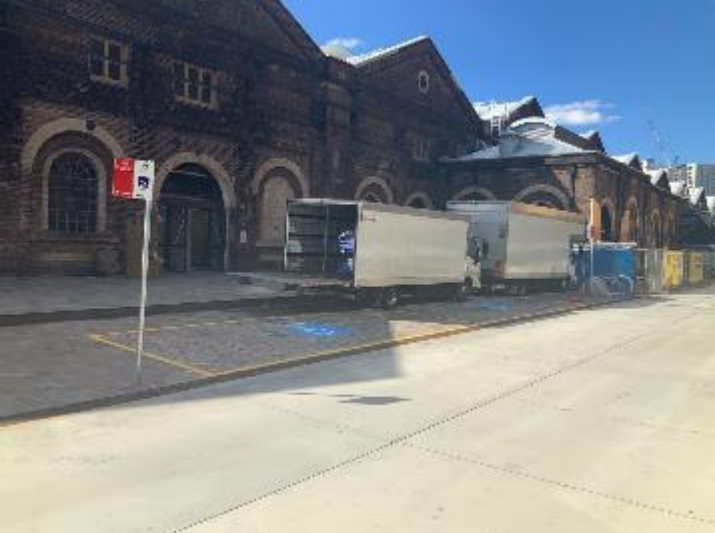
| | <p><b>Photograph 2.L.101</b></p> <p><u>Locomotive Street - Outside Workshop 11</u><br/> <u>(Formerly Workshop 12)</u><br/> <u>General Photograph</u></p> <p>General photograph of the two traffic signs.</p> <p>Photographed looking north-east.</p> |

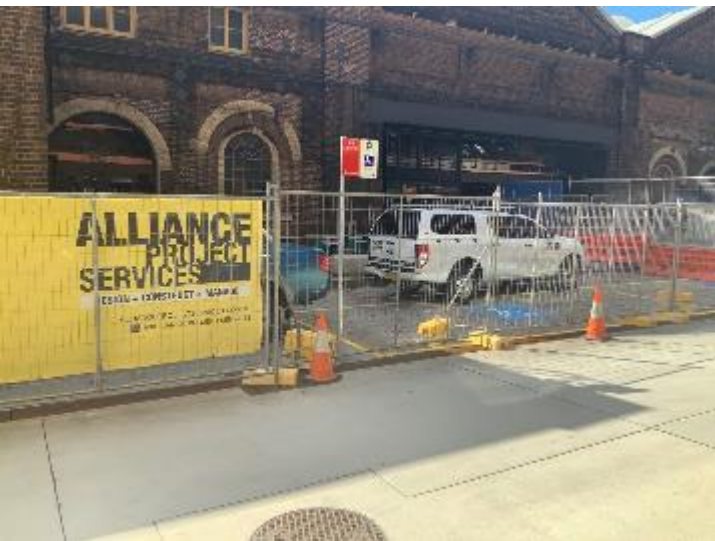
| | <p><b>Photograph 2.L.102</b></p> <p><u>Locomotive Street - Outside Workshop 8</u><br/> <u>(Formerly Workshop 9)</u><br/> <u>General Photograph</u></p> <p>General photograph of the traffic sign.</p> <p>Photographed looking north.</p> |

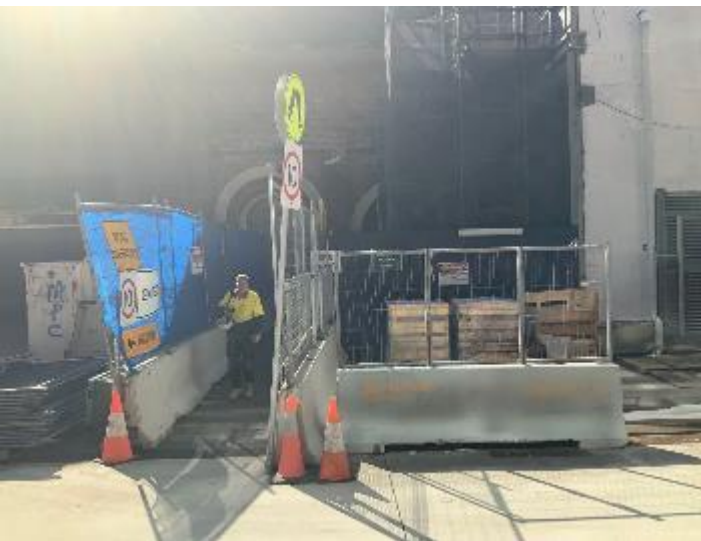
| | <p><b>Photograph 2.L.103</b></p> <p><u>Locomotive Street - Outside Workshop 6 (Formerly Workshop 7)</u><br/><u>General Photograph</u></p> <p>General photograph of the traffic signage, leaning to the east.</p> <p>Photographed looking north.</p> |

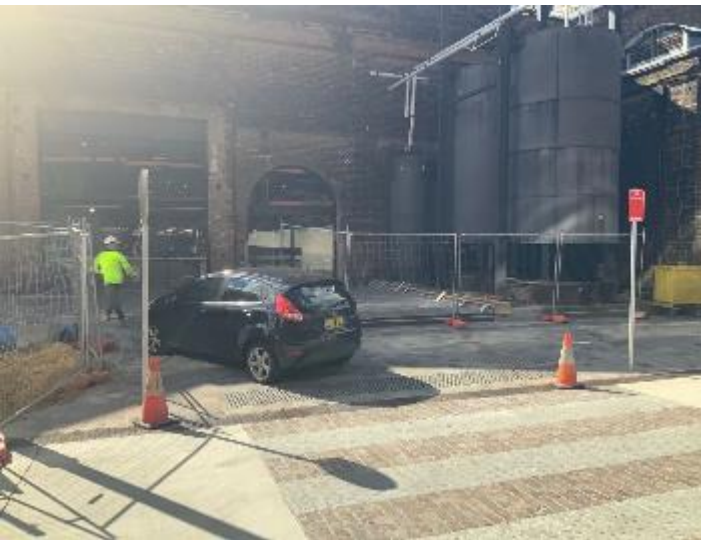
| | <p><b>Photograph 2.L.104</b></p> <p><u>Locomotive Street - Outside Workshop 4</u><br/><u>General Photograph</u></p> <p>General photograph of the two traffic signs.</p> <p>Photographed looking north.</p> |

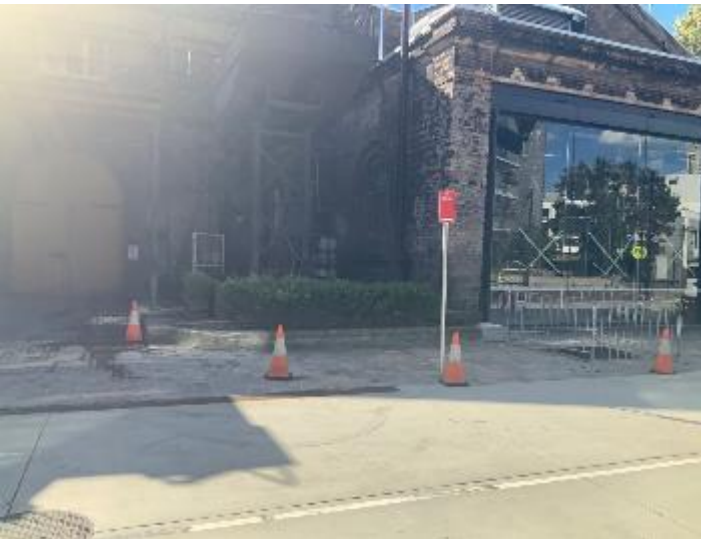
| | <p><b>Photograph 2.L.105</b></p> <p><u>Locomotive Street - Outside Workshop 2</u><br/><u>General Photograph</u></p> <p>General photograph of the traffic sign.</p> <p>Photographed looking north.</p> |

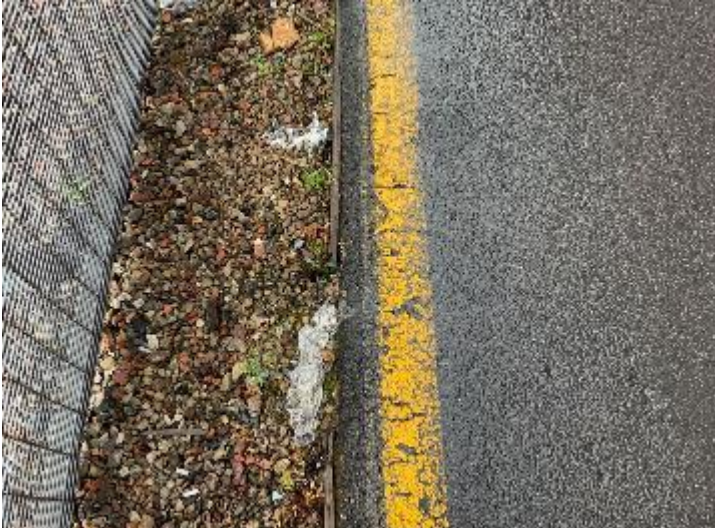
| | <p><b>Photograph 2.NW.35</b></p> <p><u>North Walkway - Workshop 13</u><br/><u>(Formerly Workshop 14)</u></p> <p><u>Minor</u></p> <p>Timber split on the north side of the pathway.</p> <p>Photographed looking east.</p> |

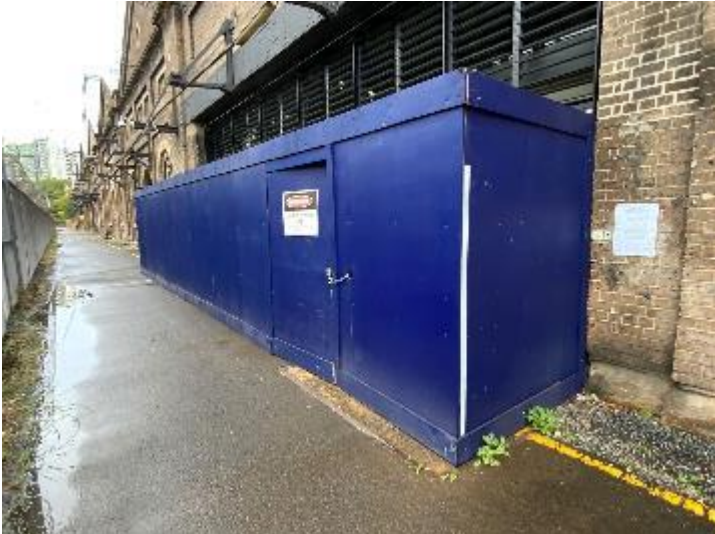
| | <p><b>Photograph 2.NW.39</b></p> <p><u>North Walkway - Workshop 7</u><br/> <u>(Formerly Workshop 8)</u><br/> <u>General Photograph</u></p> <p>General photograph of the construction hoarding outside workshop 7.</p> <p>Photographed looking south-east.</p> |

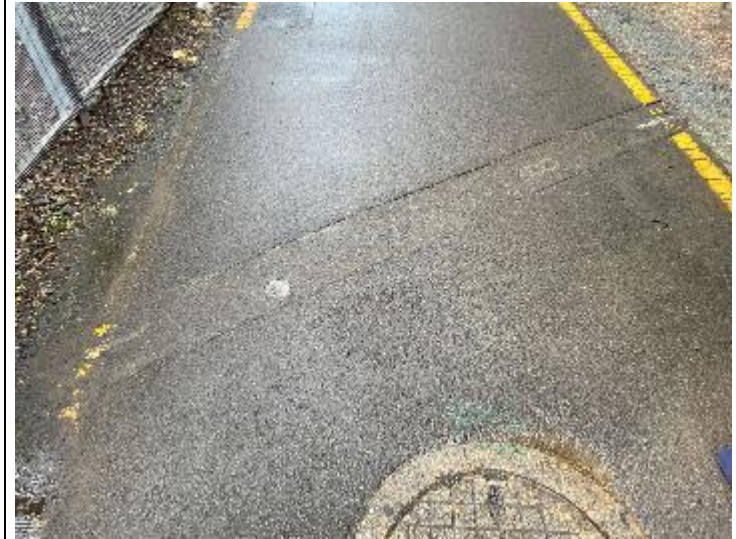
| | <p><b>Photograph 2.NW.41</b></p> <p><u>North Walkway - Workshop 7</u><br/><u>(Formerly Workshop 8)</u><br/><u>General Photograph</u></p> <p>General photograph of the bitumen trench located east of the service pit.</p> <p>Photographed looking east.</p> |

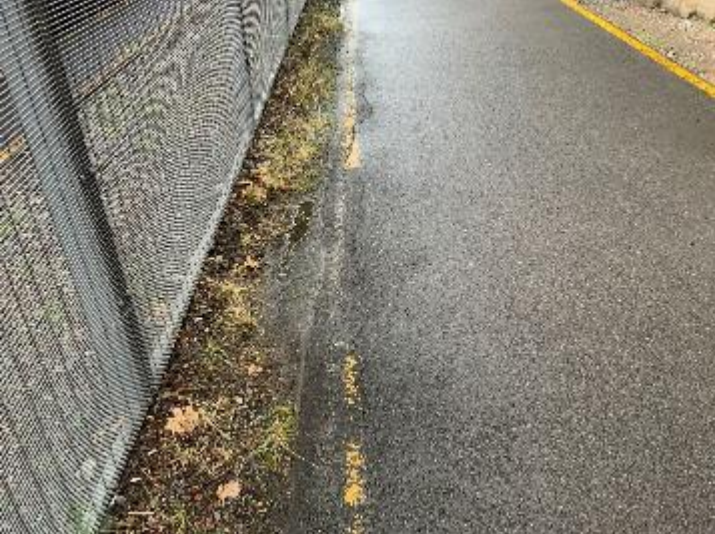
| | <p><b>Photograph 2.NW.45</b></p> <p><u>North Walkway - Workshop 6</u><br/><u>(Formerly Workshop 7)</u><br/><u>Minor</u></p> <p>Various cracks approximately max. 3000mm long x max. 8mm wide located in the north side of the walkway opposite the door to workshop 6.</p> <p>Photographed looking east.</p> |

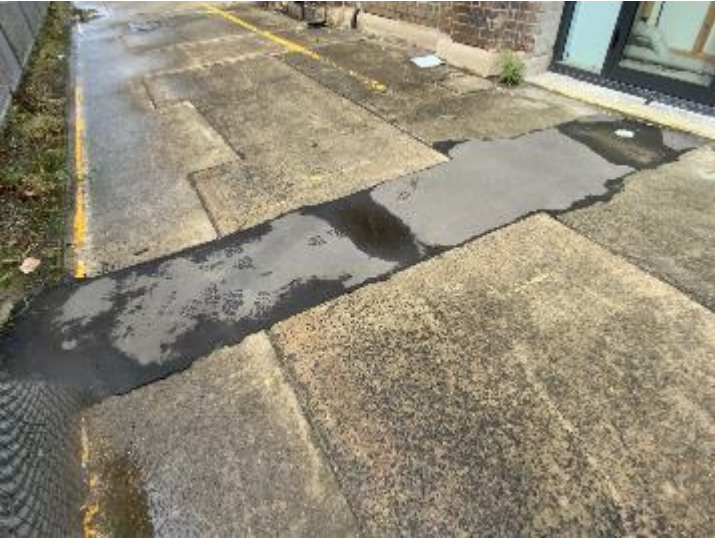
| | <p><b>Photograph 2.NW.46</b></p> <p><u>North Walkway - Workshop 5</u><br/> <u>(Formerly Workshop 6)</u><br/> <u>General Photograph</u></p> <p>General photograph of the bitumen trench outside the doorway to workshop 5.</p> <p>Photographed looking south-east.</p> |

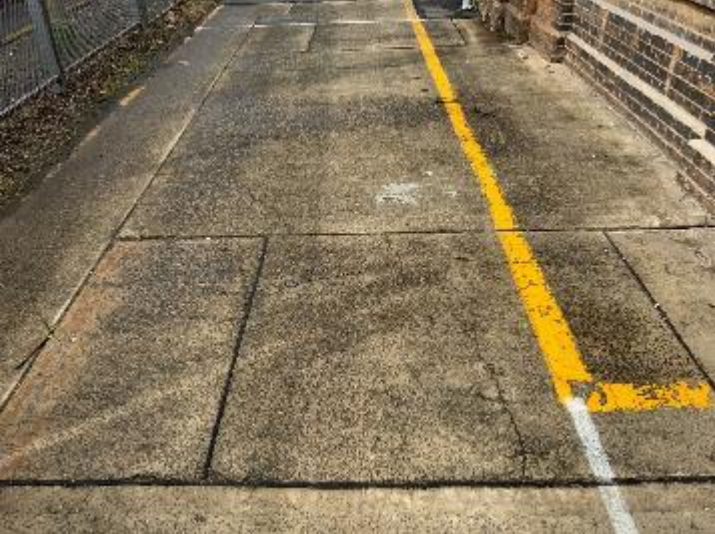
| | <p><b>Photograph 2.NW.48</b></p> <p><u>North Walkway - Workshop 4A</u><br/> <u>(Formerly Workshop 5)</u><br/> <u>Minor</u></p> <p>Various cracks in the walkway at the east section of workshop 4A.</p> <p>Photographed looking south-west.</p> |

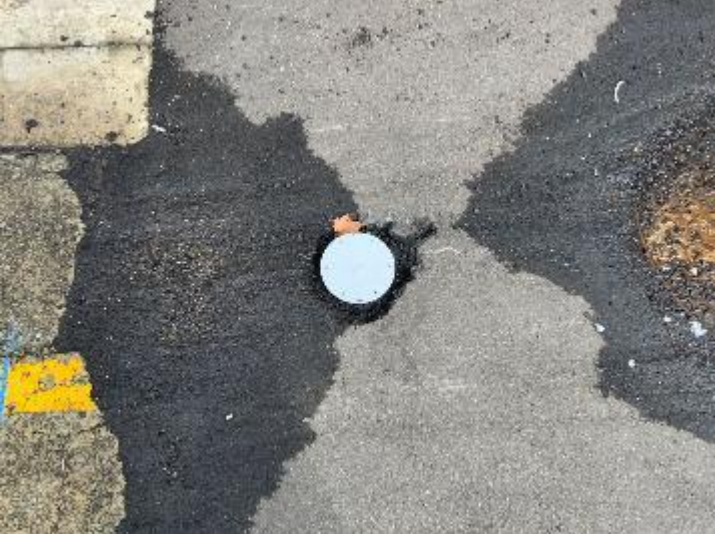
| | <p><b>Photograph 2.NW.51</b></p> <p><u>North Walkway - Workshop 4</u><br/><u>Minor</u></p> <p>Chipping of the bitumen patch at the service pit located east of the metal service covers.</p> <p>Photographed looking south.</p> |

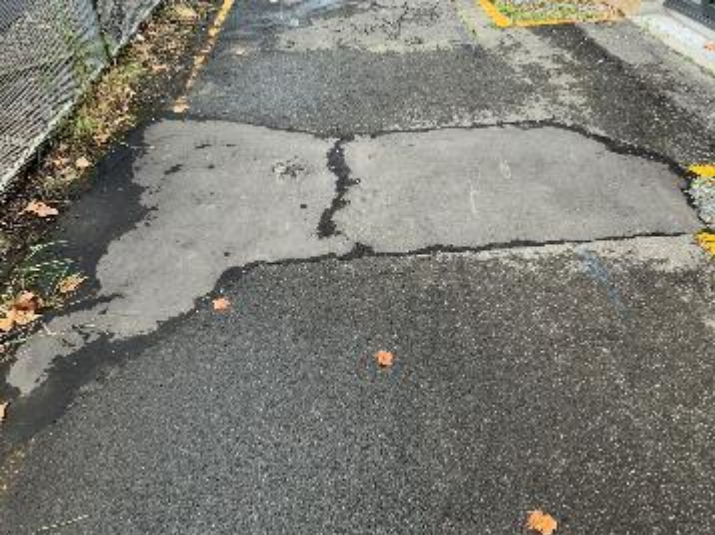
| | <p><b>Photograph 2.NW.53</b></p> <p><u>North Walkway - Workshop 3</u><br/><u>General Photograph</u></p> <p>General photograph of the bitumen trench outside the door to workshop 3.</p> <p>Photographed looking east.</p> |

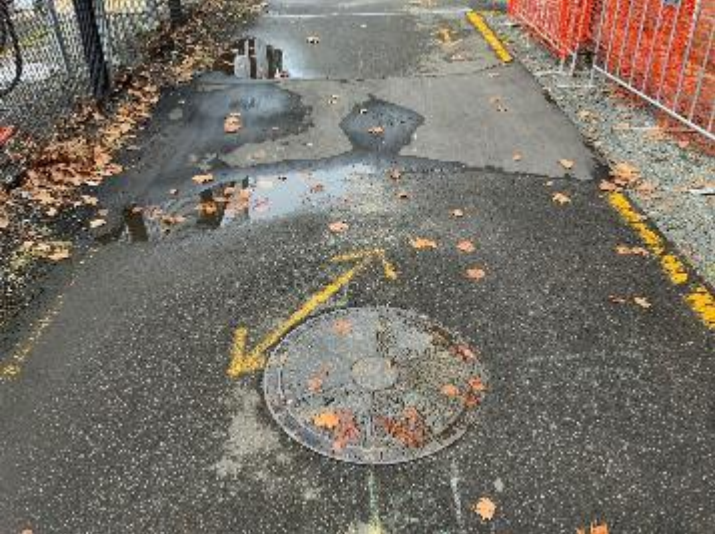
| | <p><b>Photograph 2.NW.54</b></p> <p><u>North Walkway - Workshop 1</u><br/><u>General Photograph</u></p> <p>General photograph of the bitumen patch and service pit at the west end of workshop 1.</p> <p>Photographed looking east.</p> |

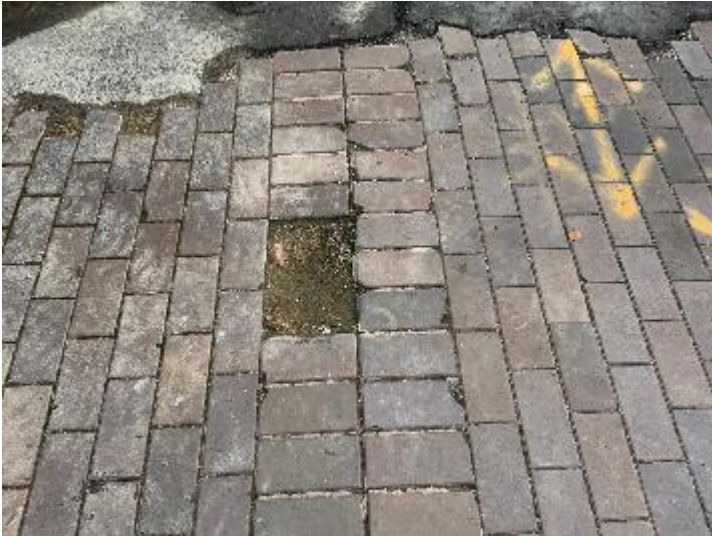
| | <p><b>Photograph 2.NW.57</b></p> <p><u>North Walkway - Workshop 1</u><br/><u>Minor</u></p> <p>Missing pavers with chipping of the pavers evident near the north-east corner of workshop 1.</p> <p>Photographed looking west.</p> |

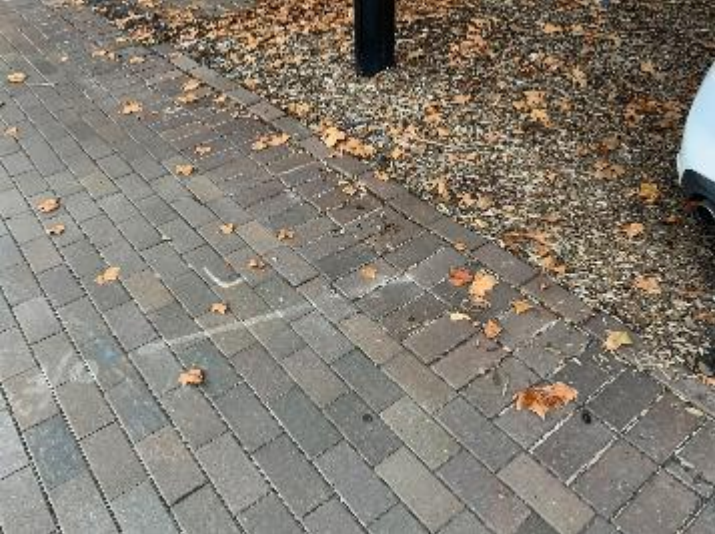
| | <p><b>Photograph 2.NW.60</b></p> <p><u>North Walkway - Workshop 1</u><br/><u>Minor</u></p> <p>Upheaval of the pavers in front of the light pole.</p> <p>Photographed looking south-east.</p> |

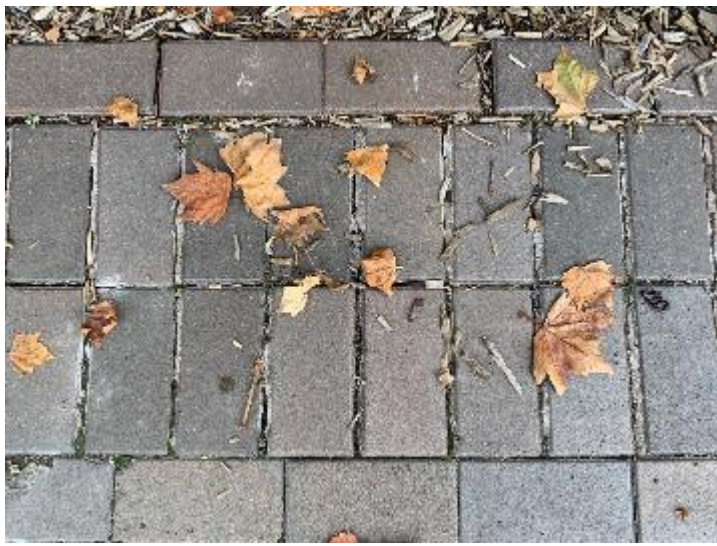
**Photograph 2.NW.61**

North Walkway - Workshop 1  
Minor
