**SY214006**

# **Post–Construction Dilapidation Report**

**Council Assets**

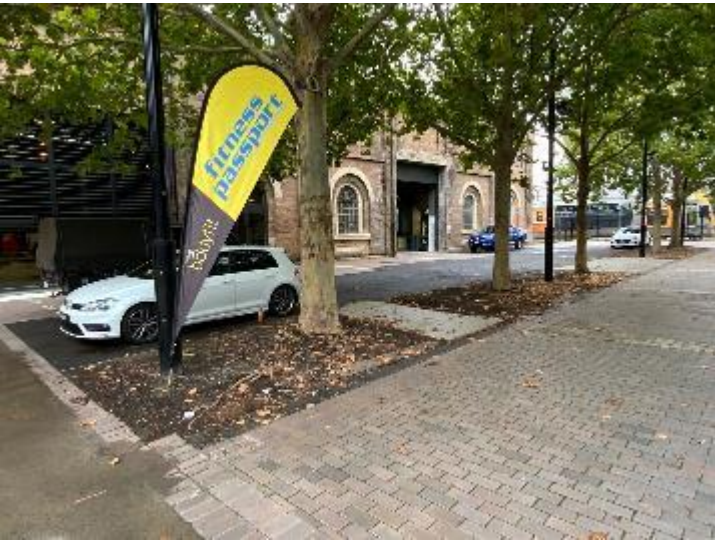
<p><b>Photograph 1.EW.5 - Rev.B</b></p> <p><u>East Walkway</u> <u>General Photograph</u></p> <p>General photograph of the new bitumen patching at the north half of the east walkway.</p> <p>Photographed looking north-west.</p>

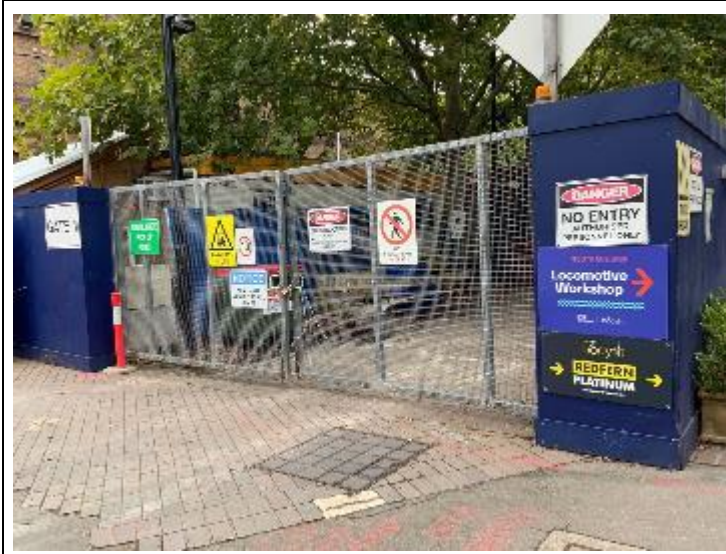
**Photograph 2.EW.17**

General photograph of the construction hoarding, no access.

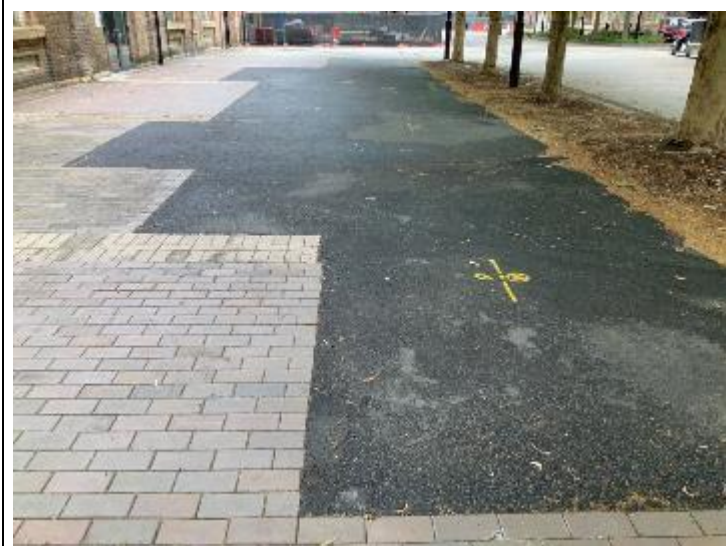
**Photograph 2.EW.18**

General photograph of the bitumen patching on the south end of the east walkway.

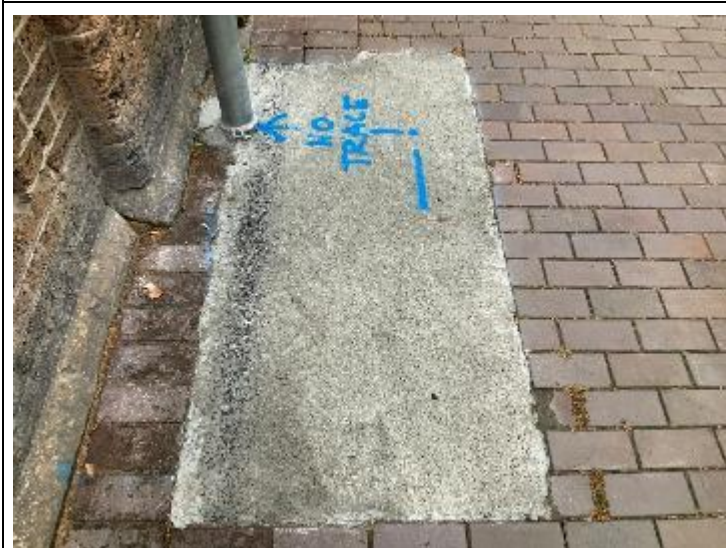
**Photograph 2.EW.19**

East Walkway  
Minor

Chipping and spalling of the concrete patching at the hydrant location.

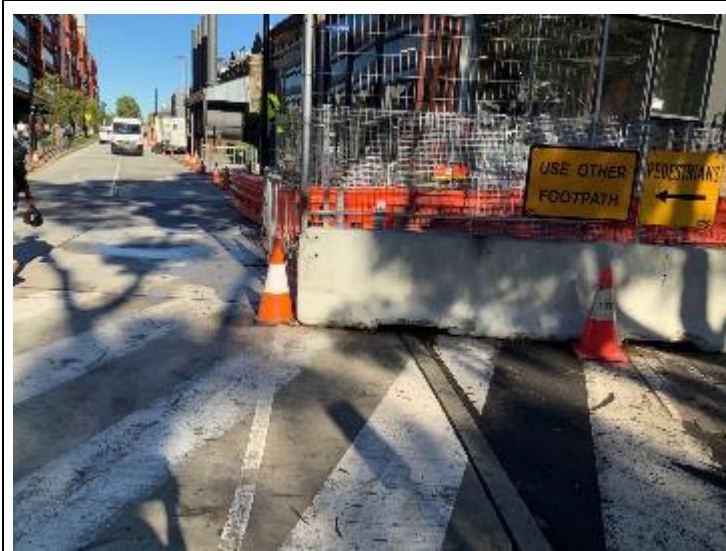
**Photograph 2.L.78**

General photograph of the brick paved pathway outside workshop 1, construction works in progress, typical along the south pathway.

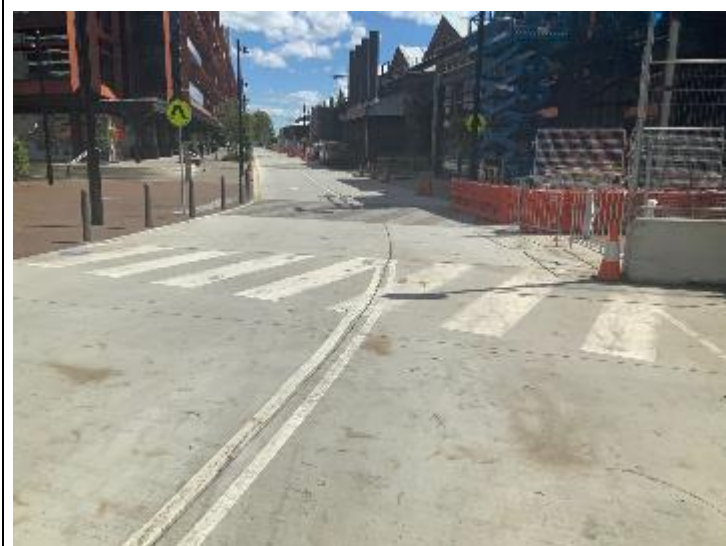
**Photograph 1.L.77 – Rev.B**

General photograph of the pathway and road located outside workshop 1.

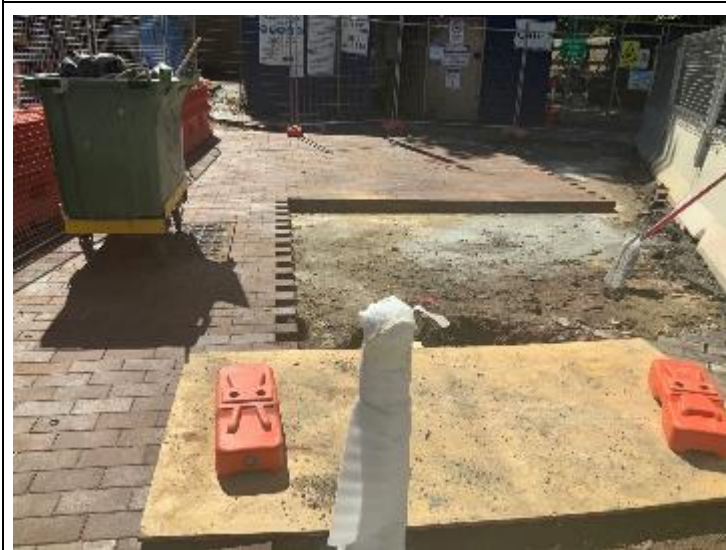
**Photograph 2.L.79**

General photograph of the footpath under construction/replacement at the time of inspection.

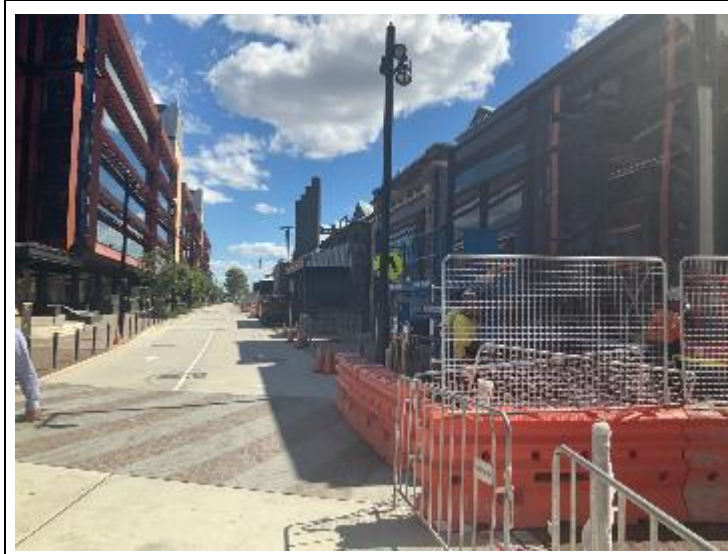
**Photograph 2.L.80**

General photograph of Construction works in progress outside bay 1.

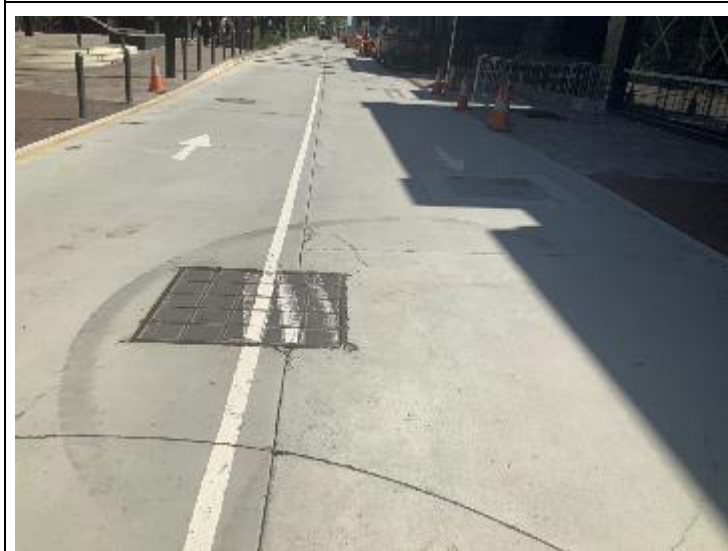
**Photograph 2.L.81**

General photograph of the three service pits located in the road in front of workshop 1.

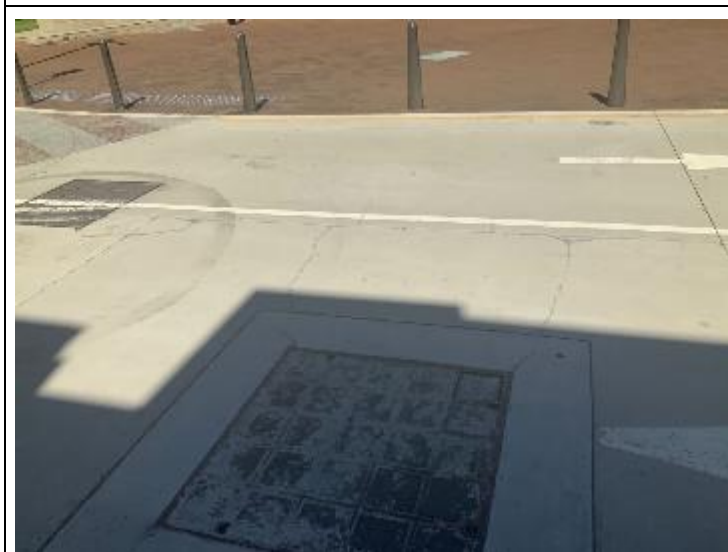
**Photograph 2.L.82**

Locomotive Street - Outside Workshop 1  
Minor

Various cracks approximately max. 2000mm long x max. 2mm wide located in the road in front of bay 1 near the central service pit, typical.

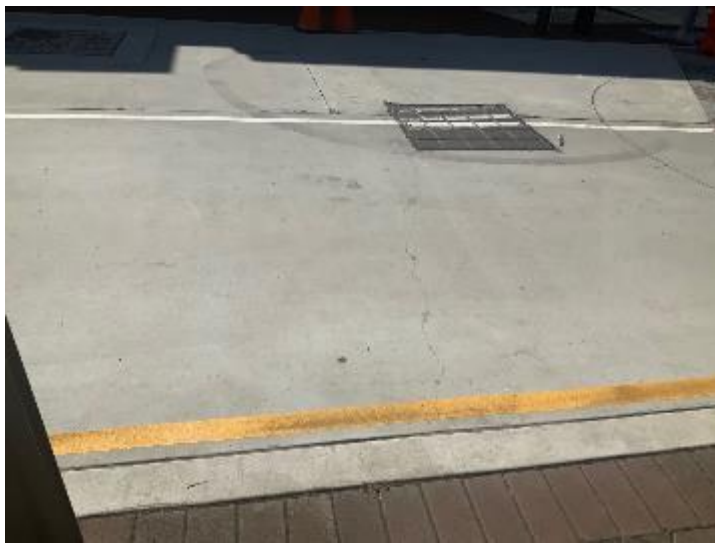
**Photograph 2.L.83**

Locomotive Street - Outside Workshop 1  
Minor

Various cracks approximately max. 2000mm long x max. 2mm wide located in the road near the east service pit.

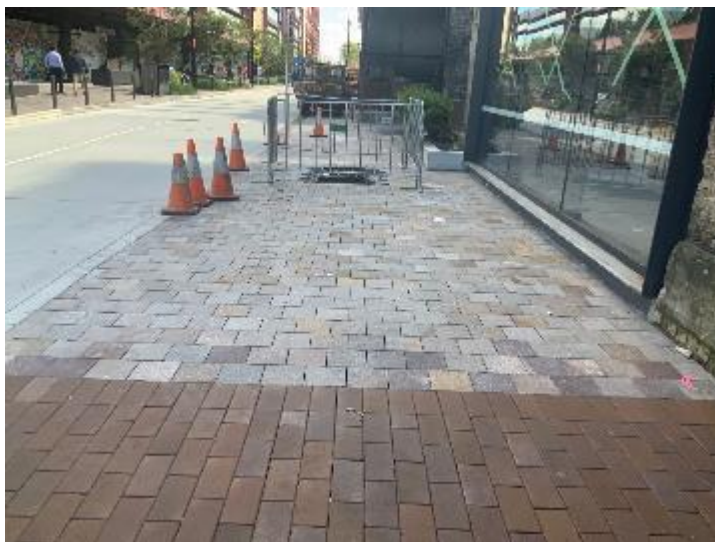
**Photograph 2.L.84**

General photograph of the new pavement installed in front of workshop 1, typical.

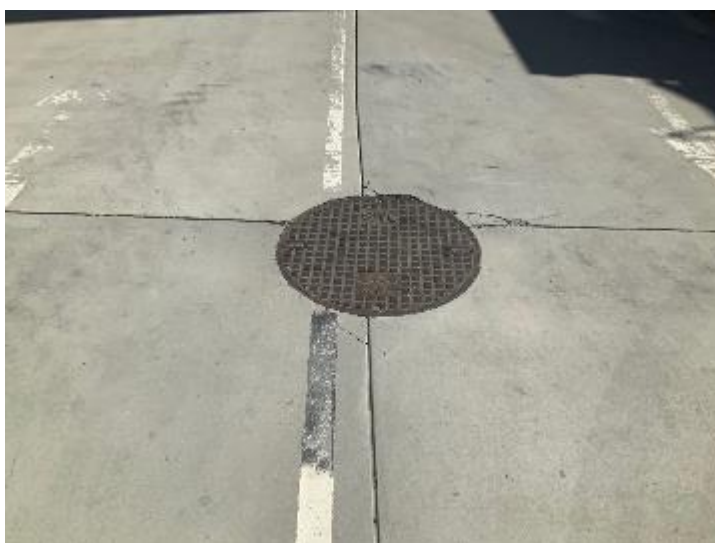
**Photograph 1.L.75 - Rev.B**

Locomotive Street - Outside Workshop 2  
Minor

General photograph of the service pit located in front of workshop 2, various chips and cracks located around the perimeter of the pit.

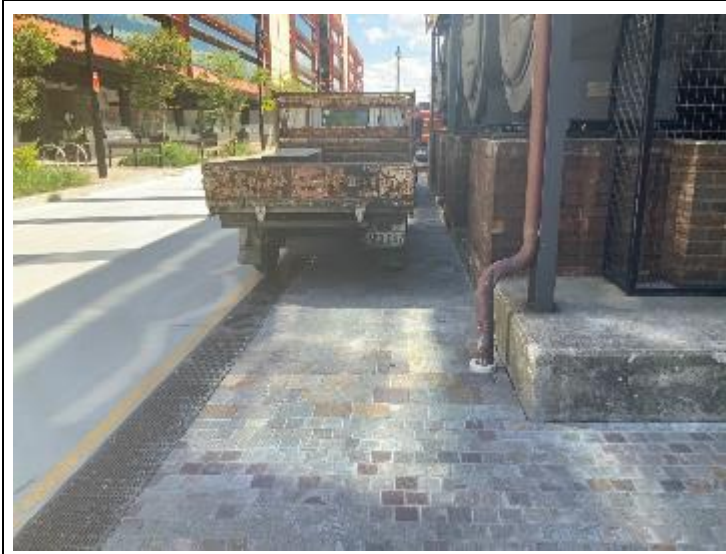
**Photograph 1.L.74 – Rev.B**

General photograph of the new pavement in front of workshop 2, obstructions present at the time of inspection.

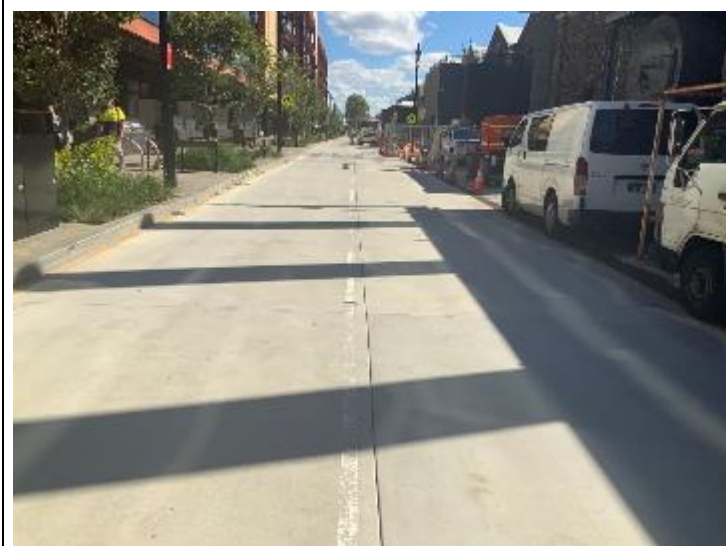
**Photograph 1.L.73 – Rev.B**

General photograph of the new road in front of workshop 2, currently being used for construction access.

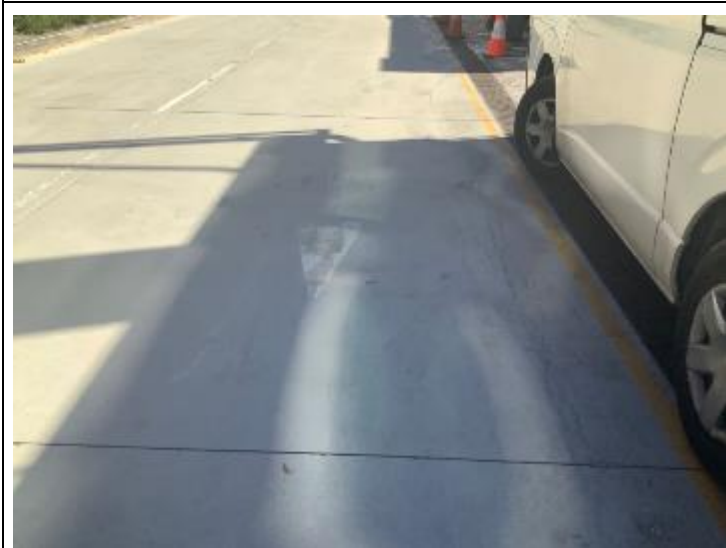
**Photograph 2.L.85**

Locomotive Street - Outside Workshop 2  
Minor

Various cracks approximately max. 2000mm long x max. 1mm wide located in the north lane in front of workshop 2.

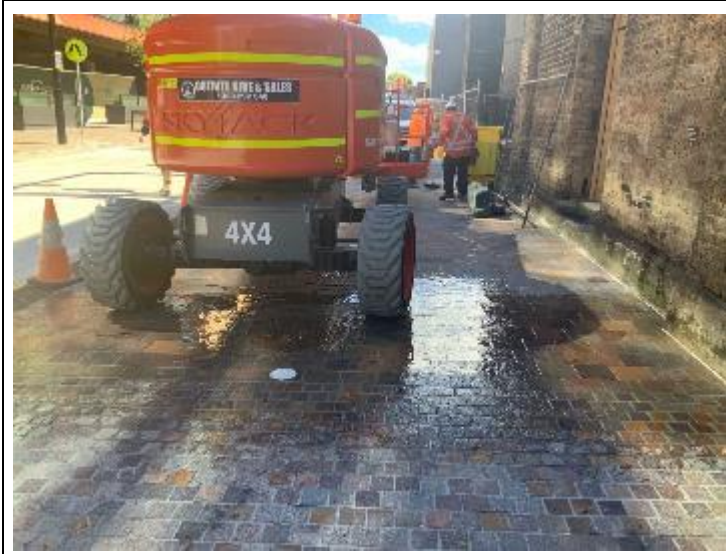
**Photograph 1.L.69 - Rev.B**

General photograph of the new pavement outside workshop 3, construction works in progress.

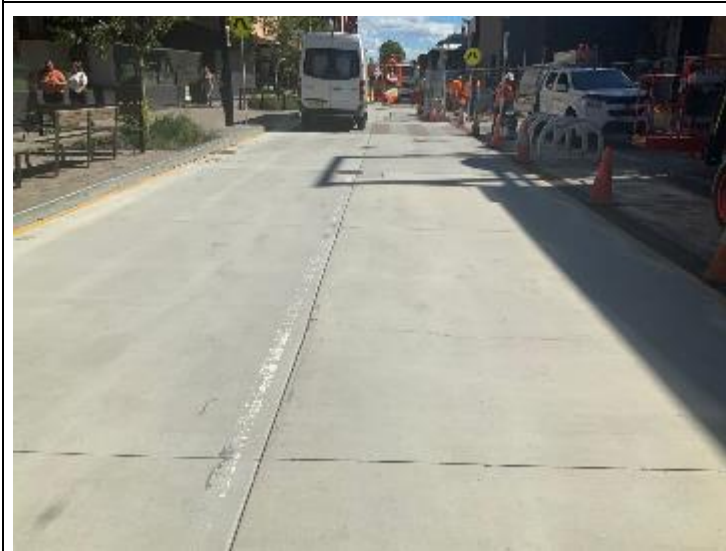
**Photograph 1.L.68 - Rev.B**

General photograph of the road in front of workshop 3.

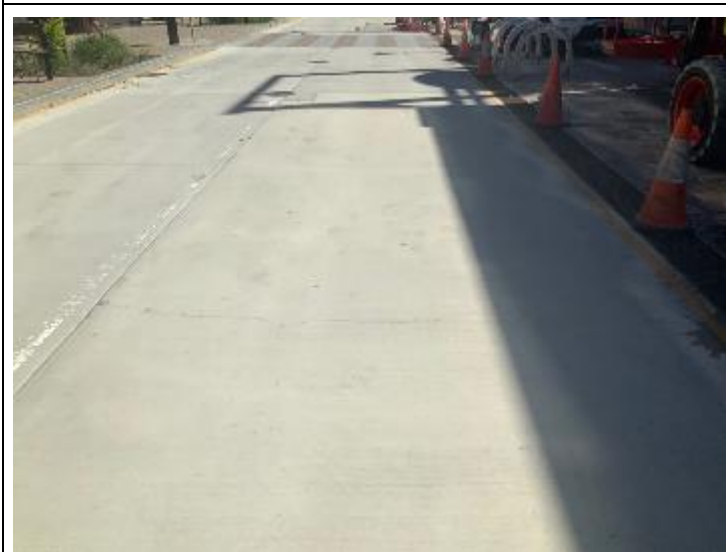
**Photograph 2.L.86**

Locomotive Street - Outside Workshop 3  
Minor

Horizontal crack approximately 2500mm long x 1mm wide located in the north lane of the road.

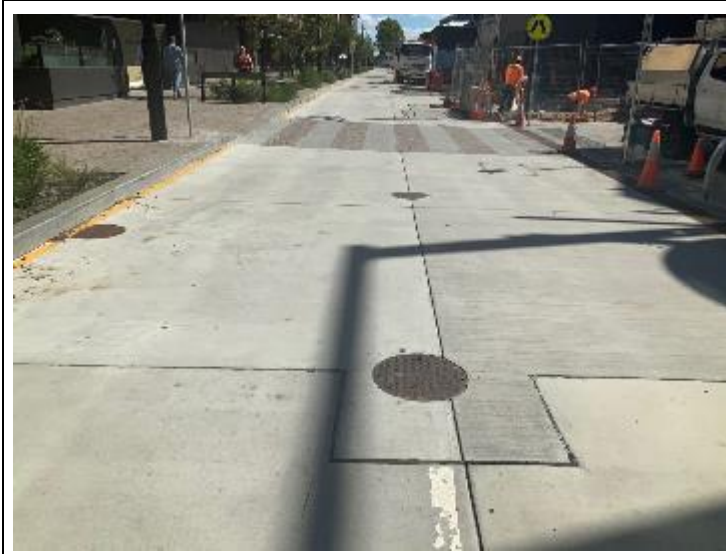
**Photograph 1.L.63 – Rev.B**

General photograph of the road and four service pits located in the road.

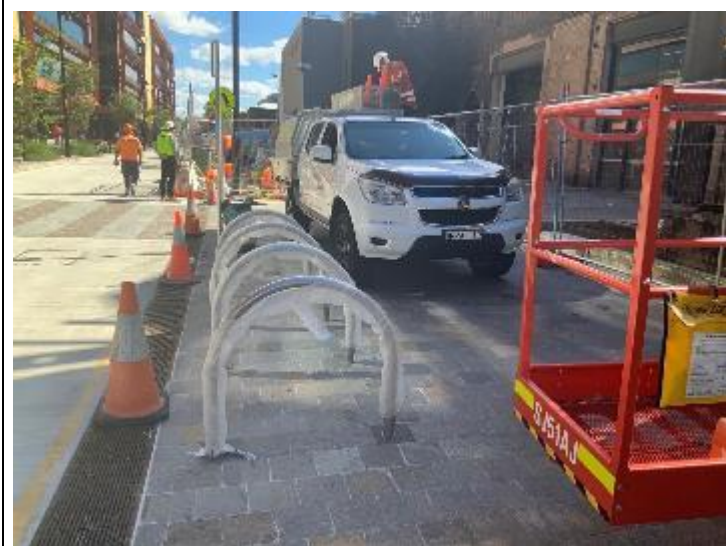
**Photograph 1.L.62 – Rev.B**

General photograph of the new pavement and construction works in progress.

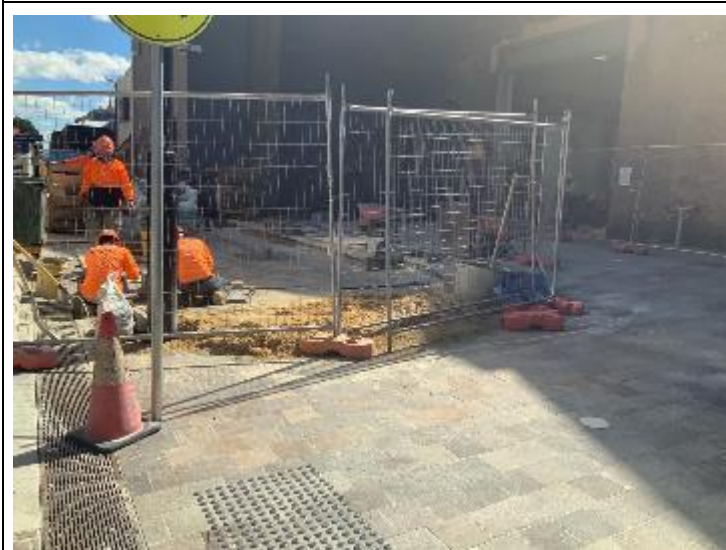
**Photograph 1.L.57 – Rev.B**

General photograph of the new pavement and replacement of pavement in progress.

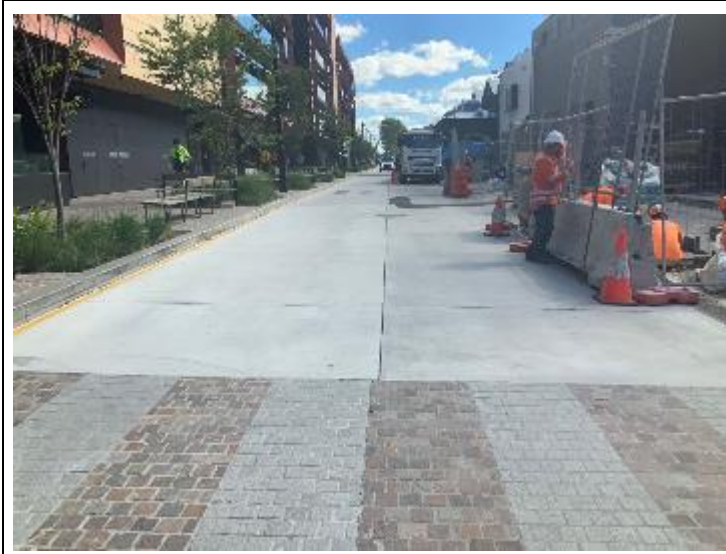
**Photograph 1.L.56 – Rev.B**

General photograph of the new road outside workshop 4A.

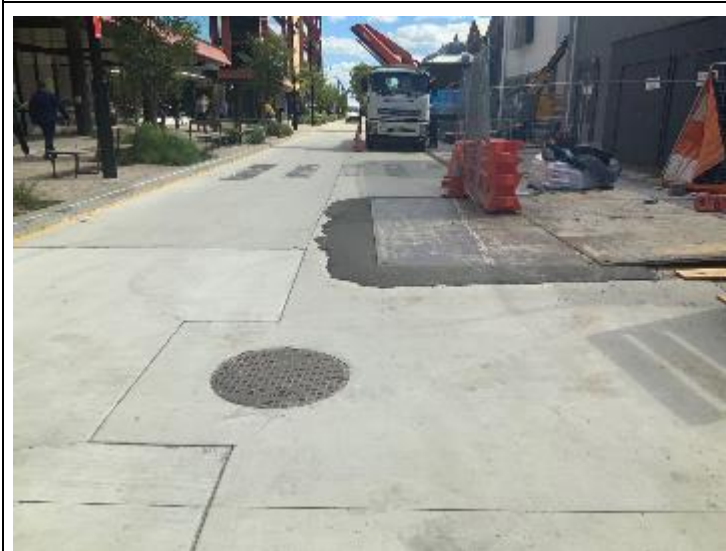
**Photograph 2.L.87**

General photograph of the bitumen patch and sewer pit located in front of workshop 4A.

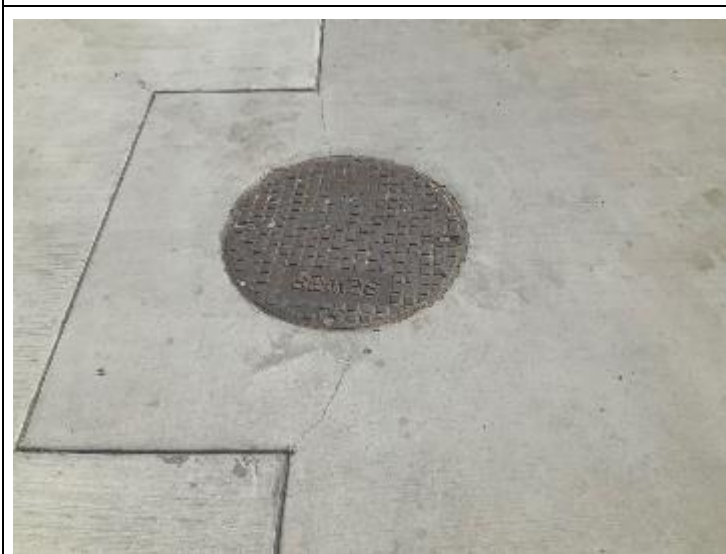
**Photograph 2.L.88**

Locomotive Street - Outside Workshop 4A  
(Formerly Workshop 5)  
Minor

Various horizontal cracks approximately max. 500mm long x max. 1mm wide located near the sewer pit in the road.

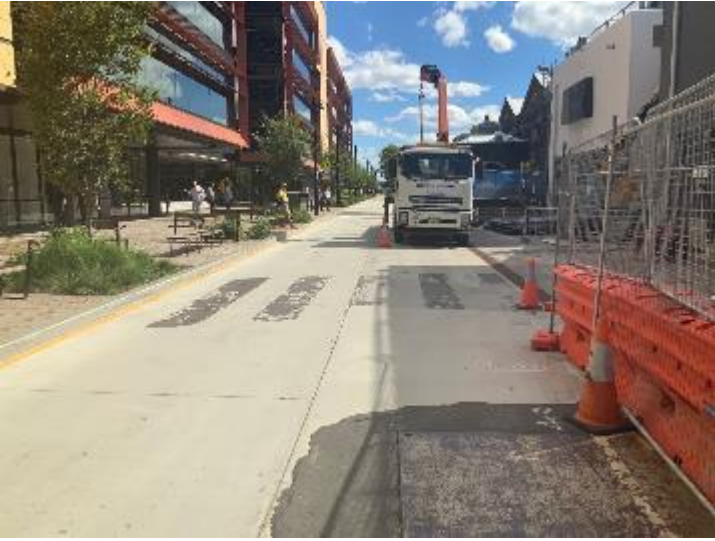
<p><b>Photograph 1.L.48 - Rev.B</b></p> <p><u>Locomotive Street - Outside Workshop 5 (Formerly Workshop 6)</u> <u>General Photograph</u></p> <p>General photograph of the road in front of bay 5.</p> <p>Photographed looking west.</p>

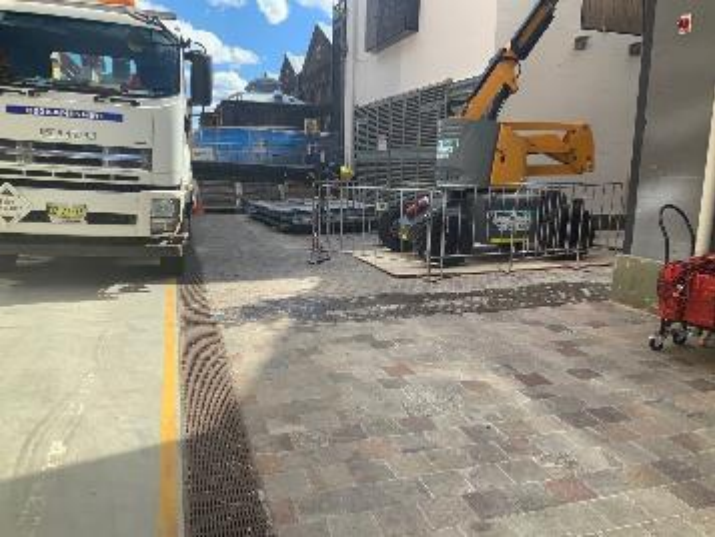
<p><b>Photograph 1.L.54 - Rev.B</b></p> <p><u>Locomotive Street - Outside Workshop 5 (Formerly Workshop 6)</u> <u>General Photograph</u></p> <p>General photograph of the new pavers in front of bay 6, construction works in progress no access available.</p> <p>Photographed looking west.</p>

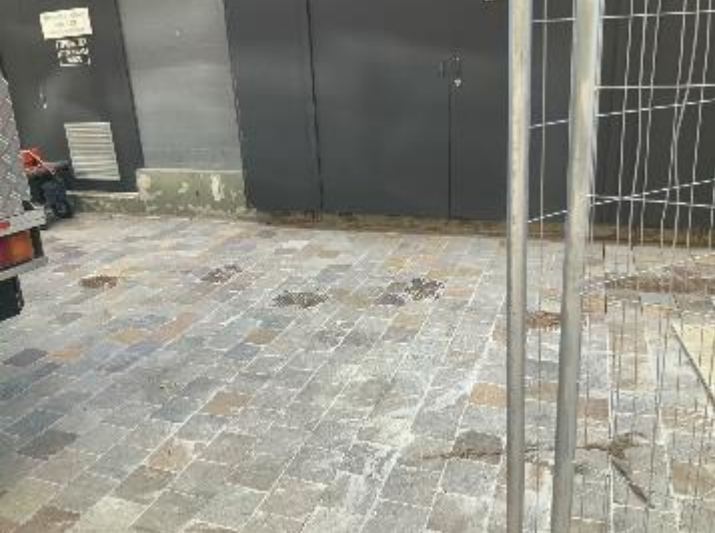
<p><b>Photograph 2.L.89</b></p> <p><u>Locomotive Street - Outside Workshop 5 (Formerly Workshop 6)</u> <u>General Photograph</u></p> <p>General photograph of the 5 SV pits located in front of workshop 5.</p> <p>Photographed looking north.</p>

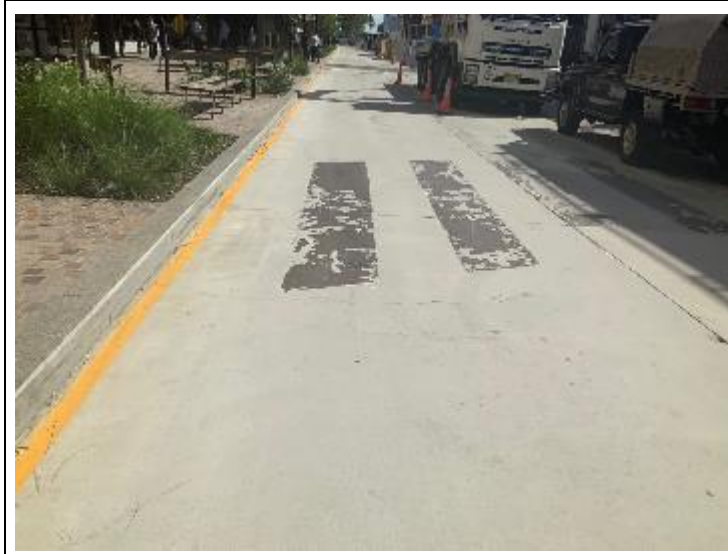
**Photograph 2.L.90**

Various cracks approximately max. 2500mm long x max. 1mm wide located in the road near the south lane outside workshop 5.

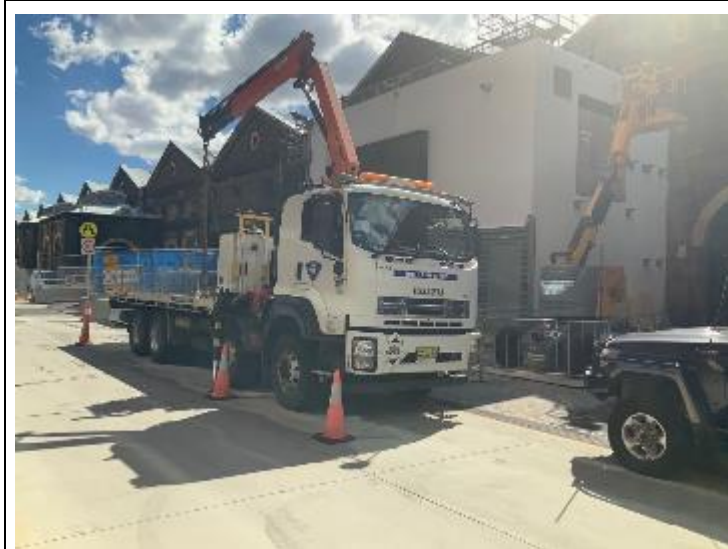
**Photograph 1.L.44 – Rev. B**

General photograph of the construction works in front of workshop 6, no access to pavement.

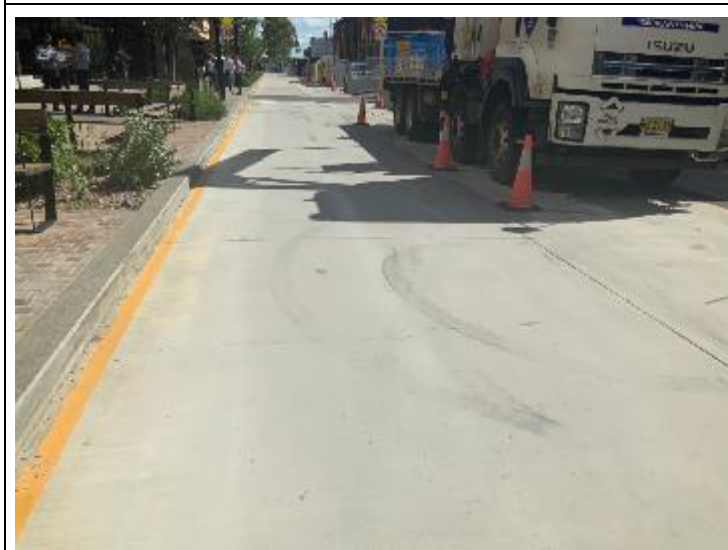
**Photograph 2.L.91**

Various cracks approximately max. 2200mm long x max. 2mm wide located in the road in front of workshop 6.

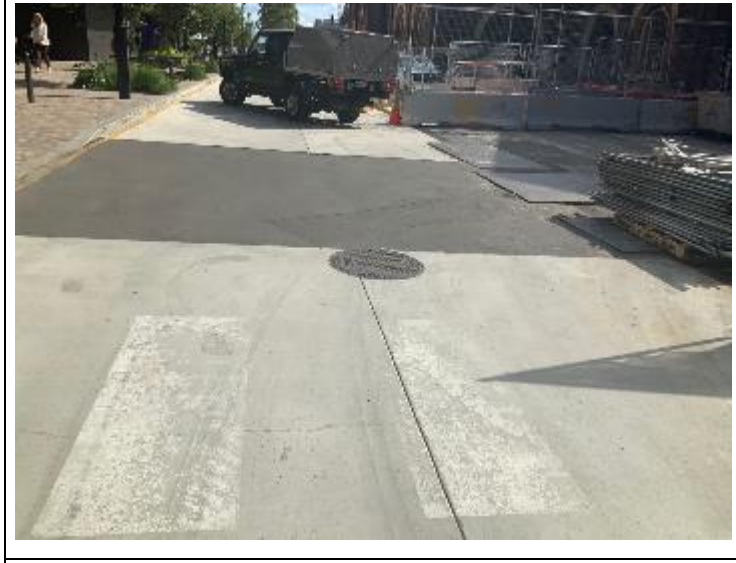
<p><b>Photograph 1.L.41 – Rev.B</b></p> <p><u>Locomotive Street - Outside Workshop 7 (Formerly Workshop 8)</u> <u>General Photograph</u></p> <p>General photograph of the road and bitumen patch located in front of workshop 7, currently used as access for the site.</p> <p>Photographed looking west.</p>

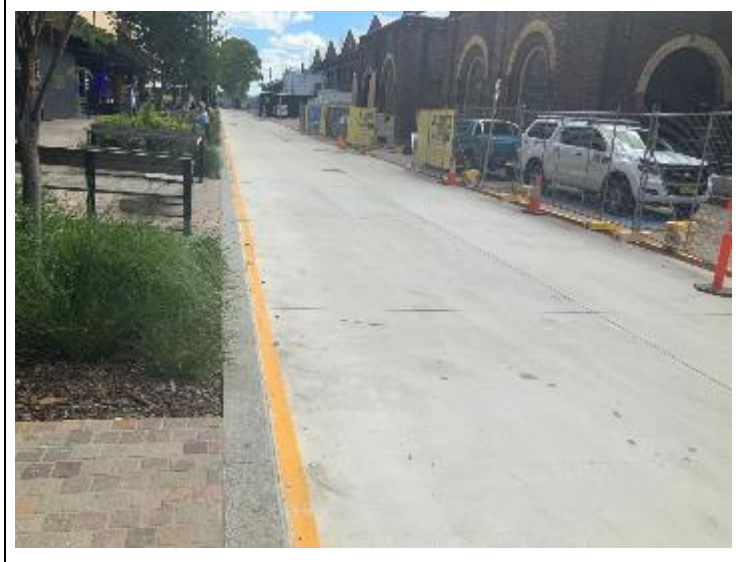
<p><b>Photograph 1.L.36 – Rev.B</b></p> <p><u>Locomotive Street - Outside Workshop 8 (Formerly Workshop 9)</u> <u>General Photograph</u></p> <p>General photograph of the road.</p> <p>Photographed looking west.</p>

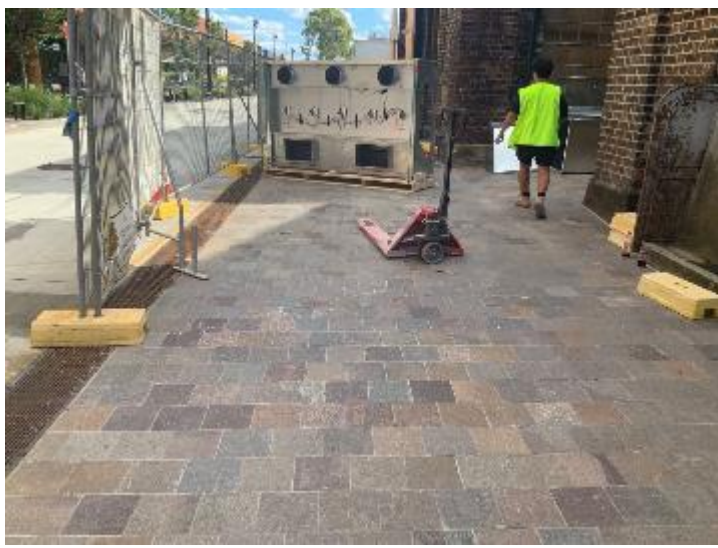
**Photograph 1.L.37 – Rev.B**

General photograph of the pavement in front of workshop 9, various obstructions present and construction in progress.

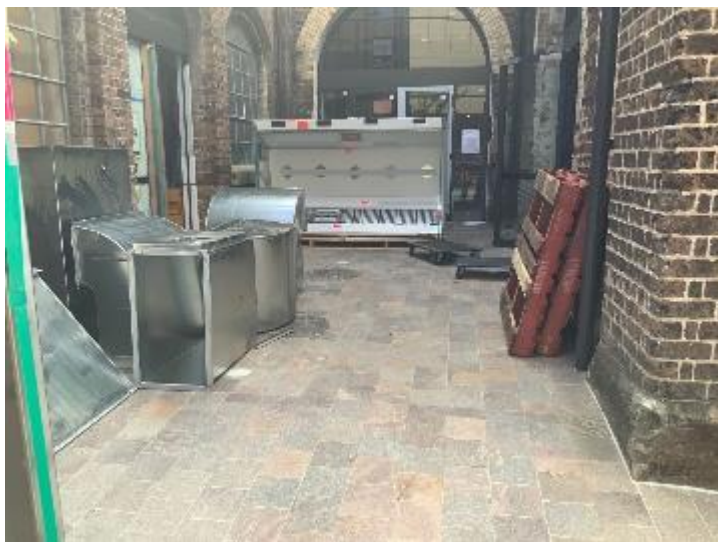
**Photograph 1.L.34 – Rev.B**

General photograph of the new pavement in front of workshop 10, obstructions present.

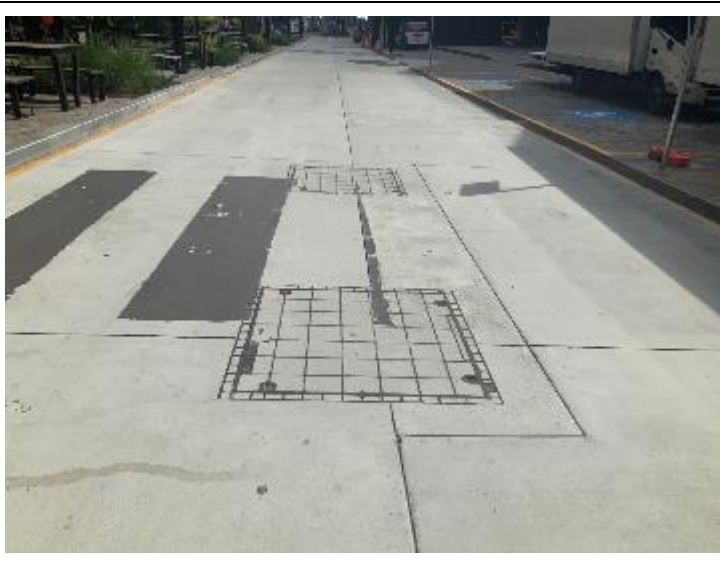
<p><b>Photograph 2.L.94</b></p> <p><u>Locomotive Street - Outside Workshop 9 (Formerly Workshop 10)</u> <u>General Photograph</u></p> <p>General photograph of the two service pits located in the road.</p> <p>Photographed looking west.</p>

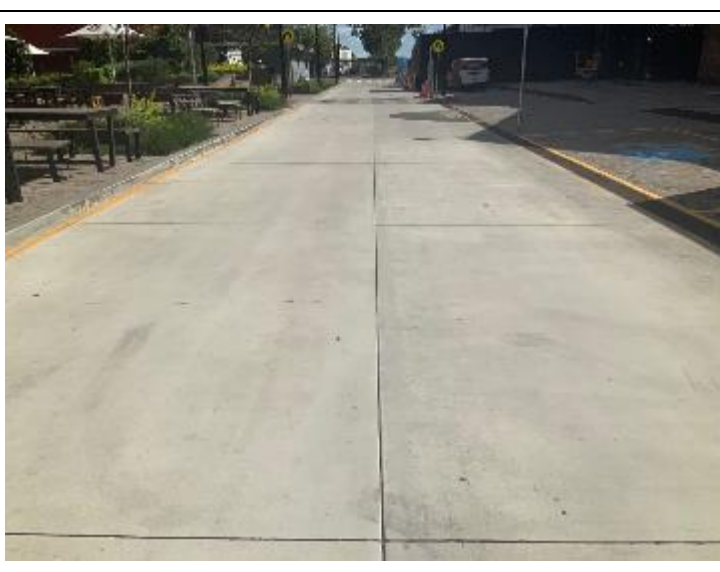
<p><b>Photograph 1.L.32 – Rev.B</b></p> <p><u>Locomotive Street - Outside Workshop 10 (Formerly Workshop 11)</u> <u>General Photograph</u></p> <p>General photograph of the road outside bay 10.</p> <p>Photographed looking west.</p>

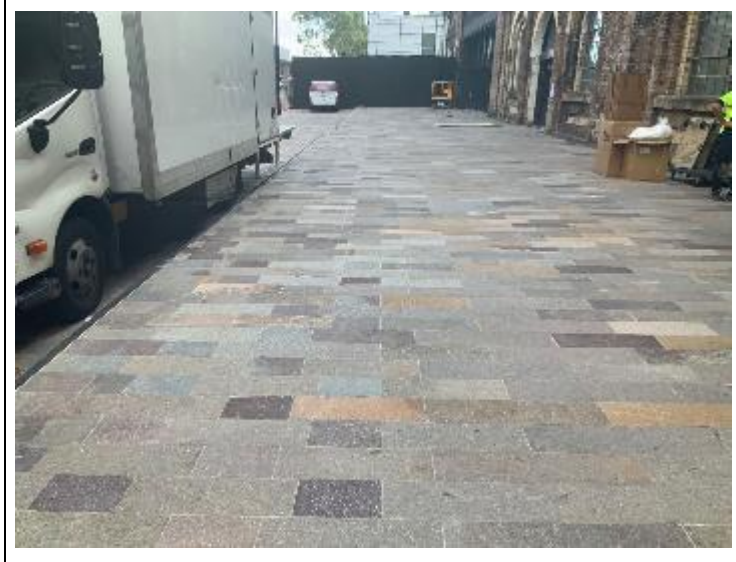
<p><b>Photograph 1.L.26 – Rev.B</b></p> <p><u>Locomotive Street - Outside Workshop 11</u> <u>(Formerly Workshop 12)</u></p> <p><u>General Photograph</u></p> <p>General photograph of the new pavement.</p> <p>Photographed looking west.</p>

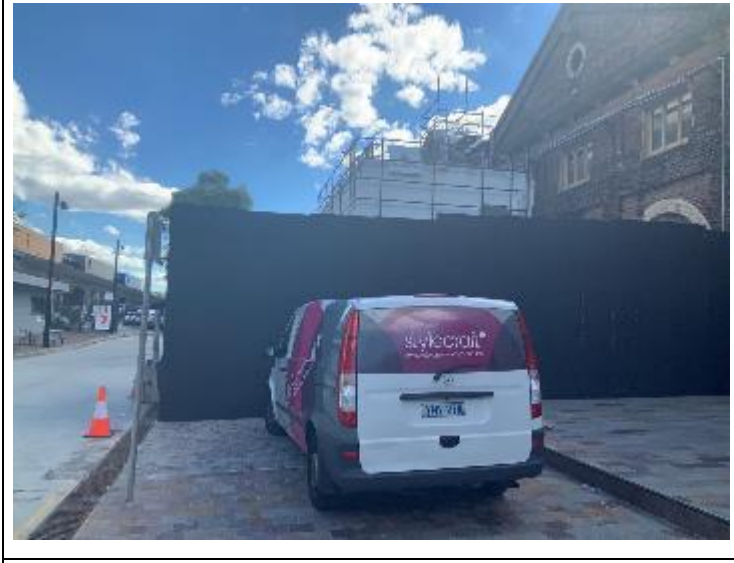
**Photograph 2.L.97**

Locomotive Street - Outside Workshop 13  
(Formerly Workshop 14)  
Minor

Various cracks approximately max. 1500mm long x max. 1mm wide located in the slab near the pedestrian crossing.

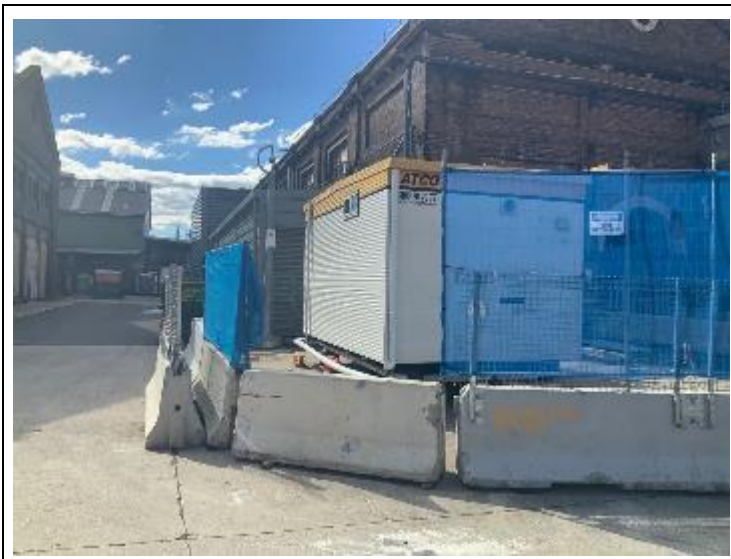
<p><b>Photograph 2.L.98</b></p> <p><u>Locomotive Street - Outside Workshop 14</u>  <u>(Formerly Workshop 15)</u>  <u>Minor</u></p> <p>Various cracks approximately max. 3000mm long x max. 1mm wide located in the road, typical.</p> <p>Photographed looking west.</p>

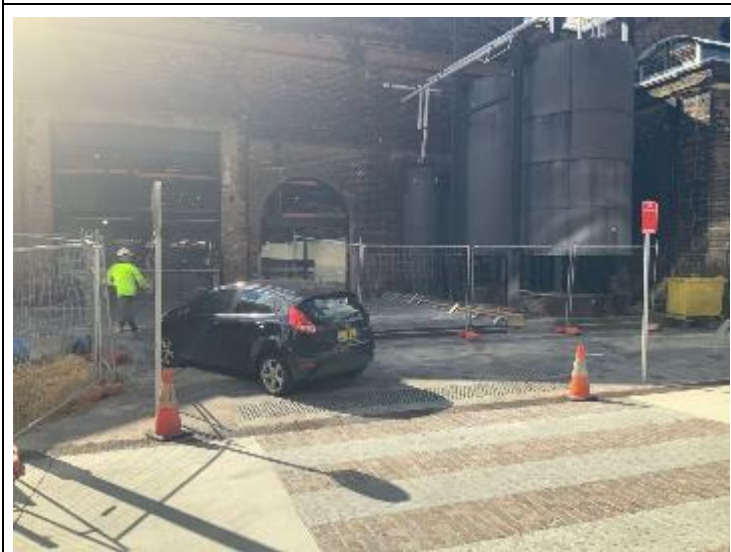
**Photograph 2.L.103**

Locomotive Street - Outside Workshop 6  
(Formerly Workshop 7)  
General Photograph

General photograph of the traffic signage, leaning to the east.

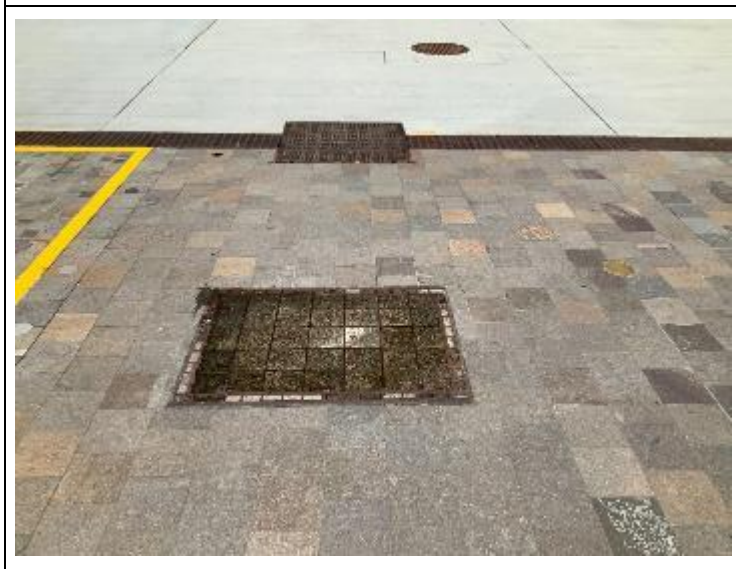
<p><b>Photograph 2.L.109</b></p> <p><u>Outside Workshop 8</u> <u>(Formerly Workshop 9)</u> <u>Minor</u></p> <p>Crack approximately 1500mm long x 0.5mm wide located in the north lane outside workshop 8.</p> <p>Photographed looking west.</p>

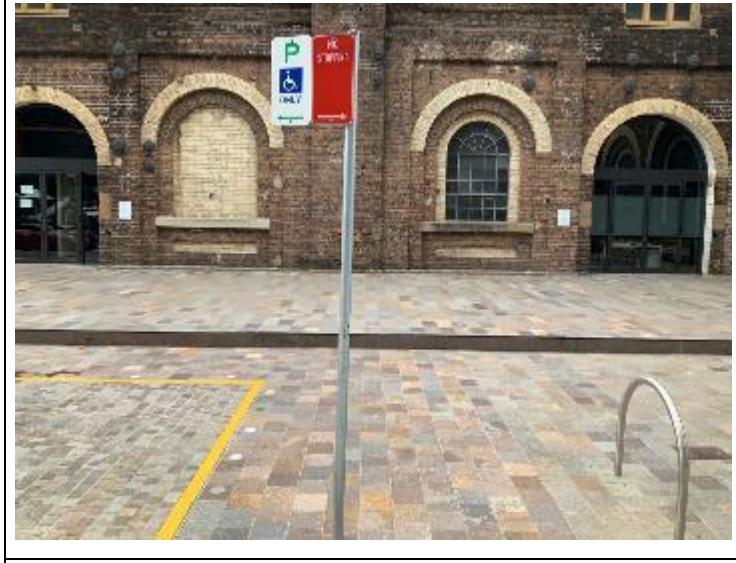
<p><b>Photograph 2.L.113</b></p> <p><u>Outside Workshop 10</u>  <u>(Formerly Workshop 11)</u>  <u>Minor</u></p> <p>Bollard leaning towards the east direction.</p> <p>Photographed looking south.</p>

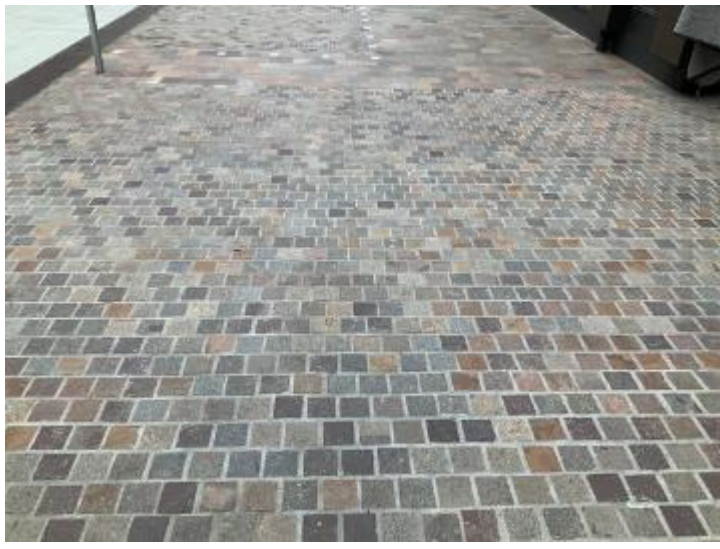
<p><b>Photograph 2.L.120</b></p> <p><u>Outside Workshop 5</u> <u>(Formerly Workshop 6)</u> <u>Minor</u></p> <p>Various cracks approximately max. 1500mm long x max. 0.5mm wide located in the road lanes.</p> <p>Photographed looking west.</p>

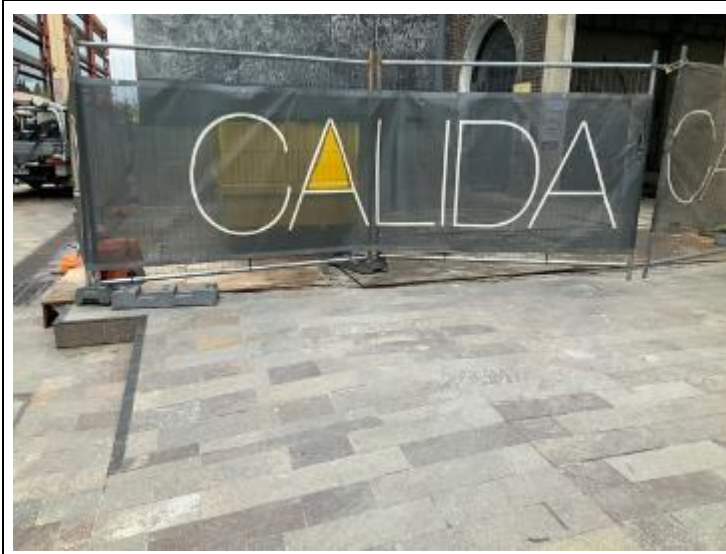
<p><b>Photograph 2.L.122</b></p> <p><u>Outside Workshop 4a</u> <u>(Formerly Workshop 5)</u> <u>Minor</u></p> <p>Various cracks approximately max. 1500mm long x max. 0.2mm wide located in the road lanes. Bitumen patching, temporary steel cover and concrete barriers evident. Service pit evident.</p> <p>Photographed looking west.</p>

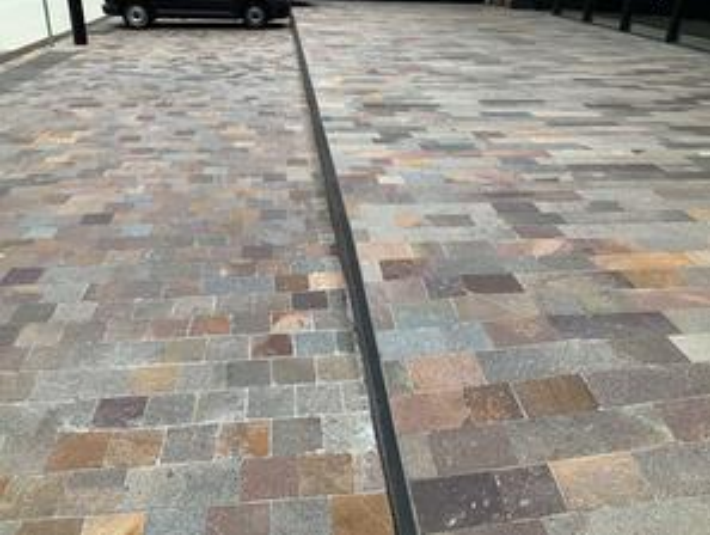
<p><b>Photograph 2.L.126</b></p> <p><u>Outside Workshop 4</u> <u>Minor</u></p> <p>Various cracks approximately max. 500mm long x max. 0.2mm wide located in the north road lane.</p> <p>Photographed looking west.</p>

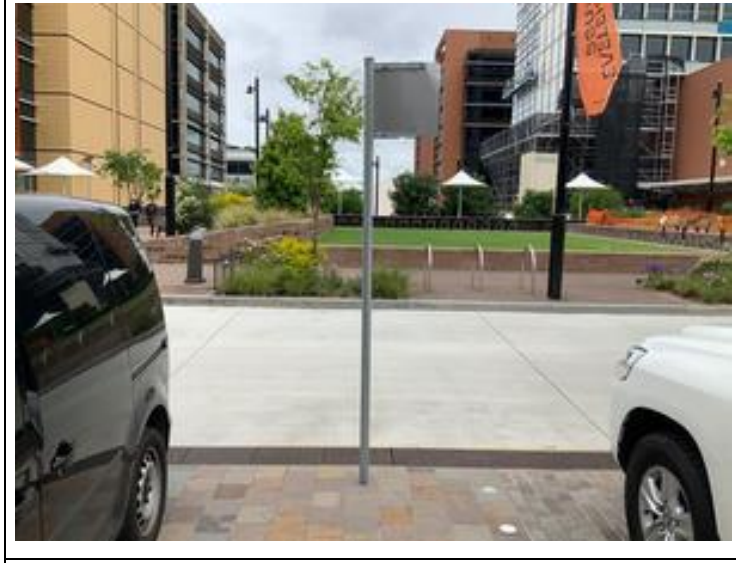
<p><b>Photograph 2.L.131</b></p> <p><u>Outside Workshop 13</u>  <u>(Formerly Workshop 14)</u>  <u>Minor</u></p> <p>Various cracks approximately max. 1500mm long x max. 0.5mm wide located in the north and south road lanes.</p> <p>Photographed looking west.</p>

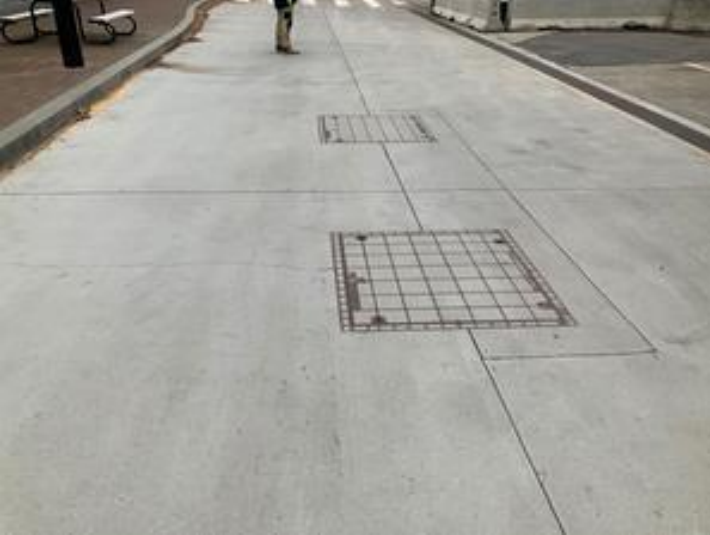
<p><b>Photograph 2.L.135</b></p> <p><u>Outside Workshop 14</u> <u>(Formerly Workshop 15)</u> <u>Minor</u></p> <p>Chipping and spalling of concrete at the joint between the slabs of the road.</p> <p>Photographed looking west.</p>

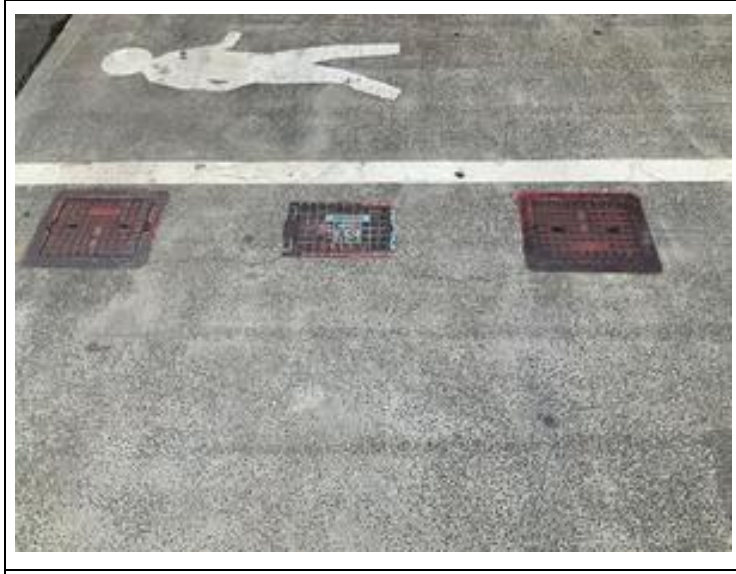
<p><b>Photograph 2.L.137</b></p> <p><u>Outside Workshop 15</u> <u>(Formerly Workshop 16)</u> <u>Minor</u></p> <p>Various cracks approximately max. 1500mm long x max. 0.5mm wide located in the north and south road lanes.</p> <p>Photographed looking west.</p>

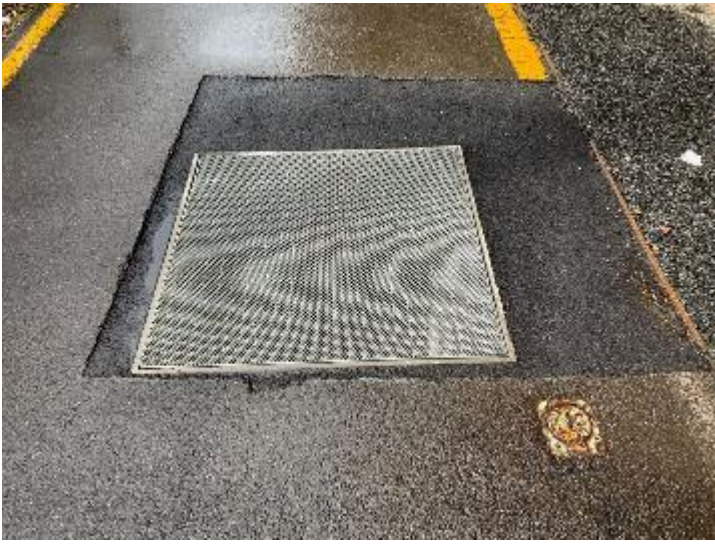
<p><b>Photograph 2.NW.31</b></p> <p><u>North Walkway - Workshop 15</u> <u>(Formerly Workshop 16)</u></p> <p><u>Minor</u></p> <p>General photograph of the new drain and bitumen patching, settlement of the new bitumen patching.</p> <p>Photographed looking east.</p>

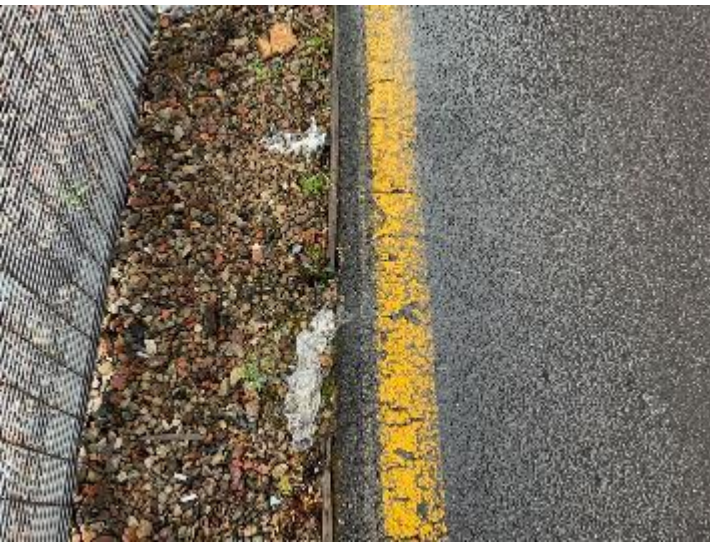
<p><b>Photograph 2.NW.35</b></p> <p><u>North Walkway - Workshop 13</u> <u>(Formerly Workshop 14)</u></p> <p><u>Minor</u></p> <p>Timber split on the north side of the pathway.</p> <p>Photographed looking east.</p>
