**SY214006**

# **Post–Construction Dilapidation Report**

**Council Assets**

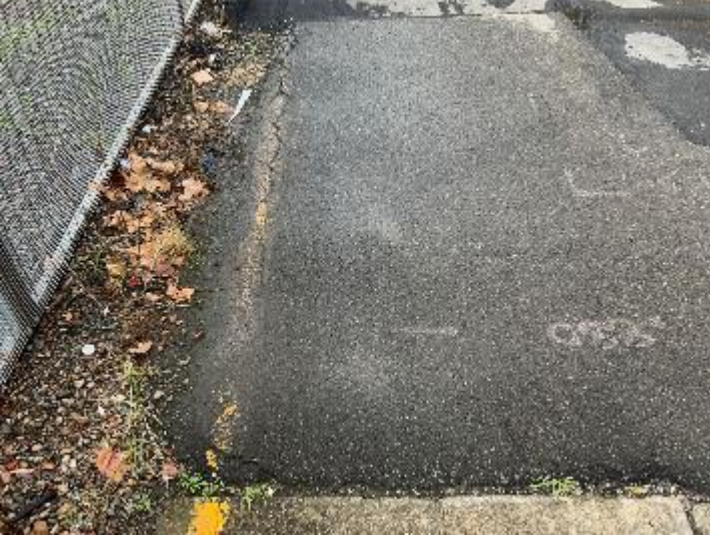
<p><b>Photograph 2.NW.49</b></p> <p><u>North Walkway - Workshop 4</u> <u>Minor</u></p> <p>General photograph of the bitumen patch outside the west door of workshop 4, uneven surface evident.</p> <p>Photographed looking east.</p>

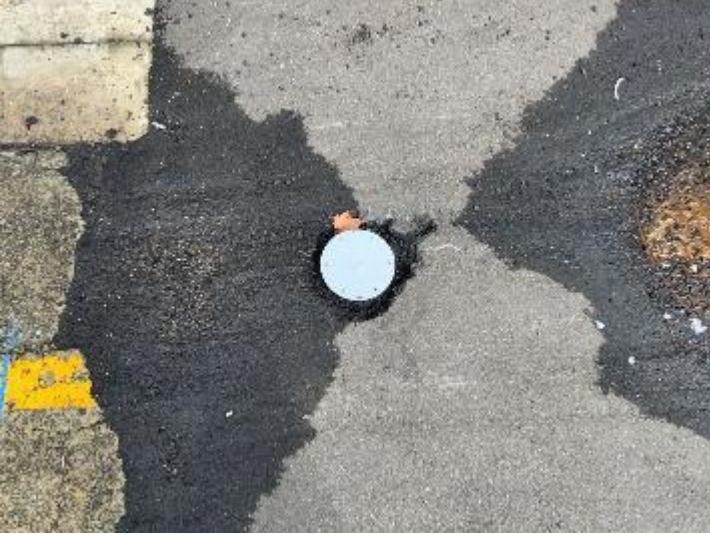
<p><b>Photograph 2.NW.50</b></p> <p><u>North Walkway - Workshop 4</u> <u>Minor</u></p> <p>Various cracks approximately max. 2500mm long x max. 10mm wide located at the north end of the walkway opposite the west door of workshop 4.</p> <p>Photographed looking east.</p>

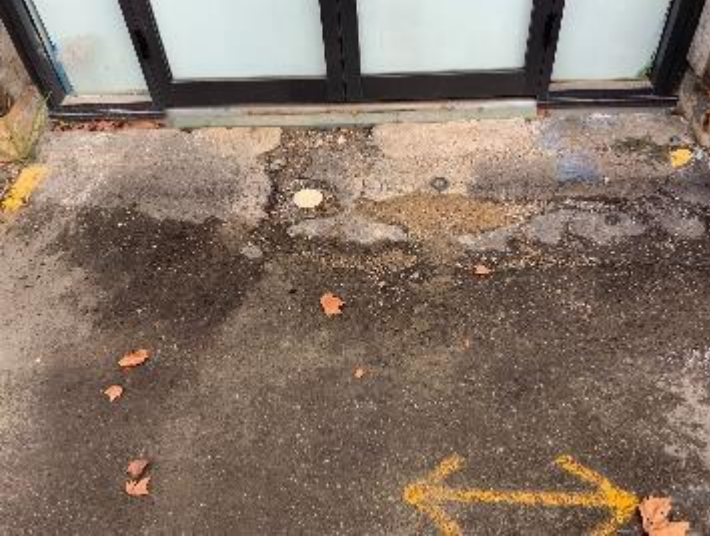
<p><b>Photograph 2.NW.52</b></p> <p><u>North Walkway - Workshop 4</u> <u>Minor</u></p> <p>Various cracks approximately max. 1400mm long x max. 7mm wide located at the north side of the walkway opposite the east door for workshop 4.</p> <p>Photographed looking east.</p>
 	<p><b>Photograph 2.NW.53</b></p> <p><u>North Walkway - Workshop 3</u> <u>General Photograph</u></p> <p>General photograph of the bitumen trench outside the door to workshop 3.</p> <p>Photographed looking east.</p>
 	<p><b>Photograph 2.NW.54</b></p> <p><u>North Walkway - Workshop 1</u> <u>General Photograph</u></p> <p>General photograph of the bitumen patch and service pit at the west end of workshop 1.</p> <p>Photographed looking east.</p>

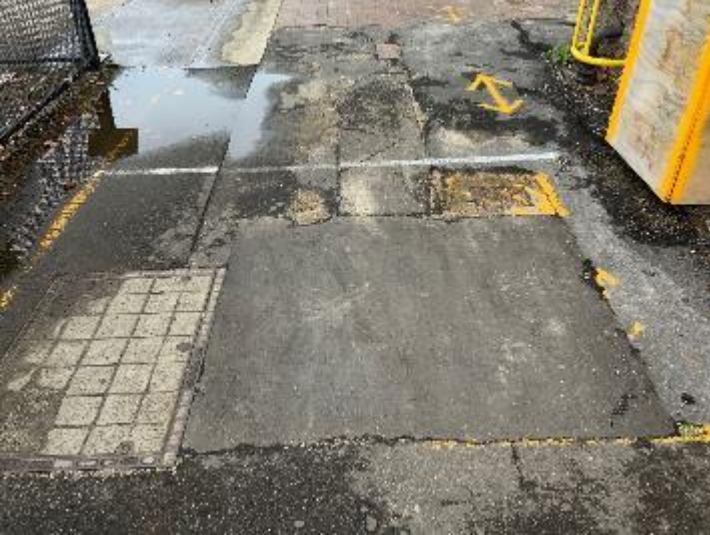
<p><b>Photograph 2.NW.55</b></p> <p><u>North Walkway - Workshop 1</u> <u>Minor</u></p> <p>Chipping and spalling of the walkway in front of the doorway to workshop 1.</p> <p>Photographed looking south.</p>

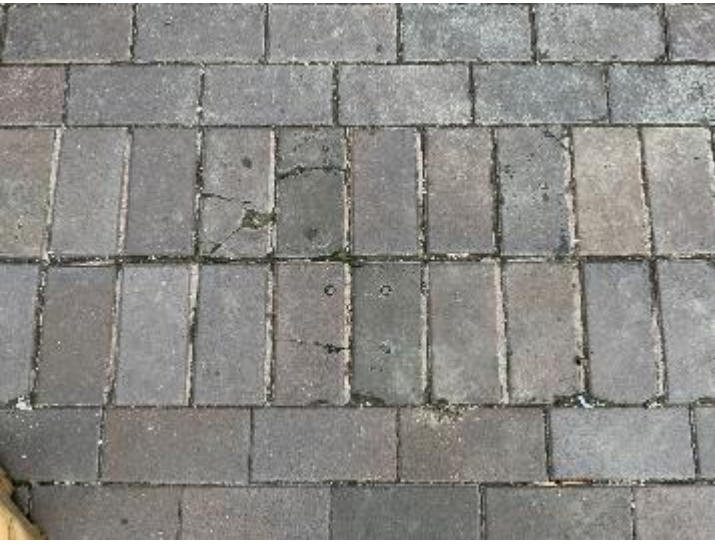
<p><b>Photograph 2.NW.57</b></p> <p><u>North Walkway - Workshop 1</u> <u>Minor</u></p> <p>Missing pavers with chipping of the pavers evident near the north-east corner of workshop 1.</p> <p>Photographed looking west.</p>

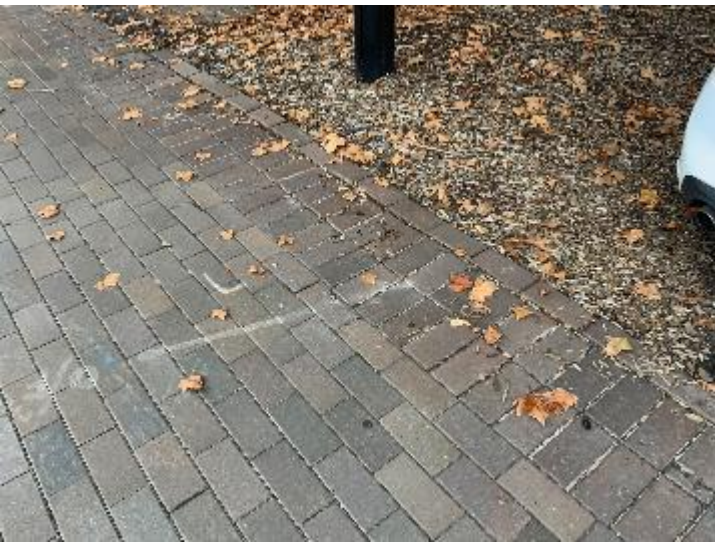
<p><b>Photograph 2.NW.59</b></p> <p><u>North Walkway - Workshop 1</u> <u>Minor</u></p> <p>Settlement of the pavers between the light pole and workshop 1.</p> <p>Photographed looking south.</p>

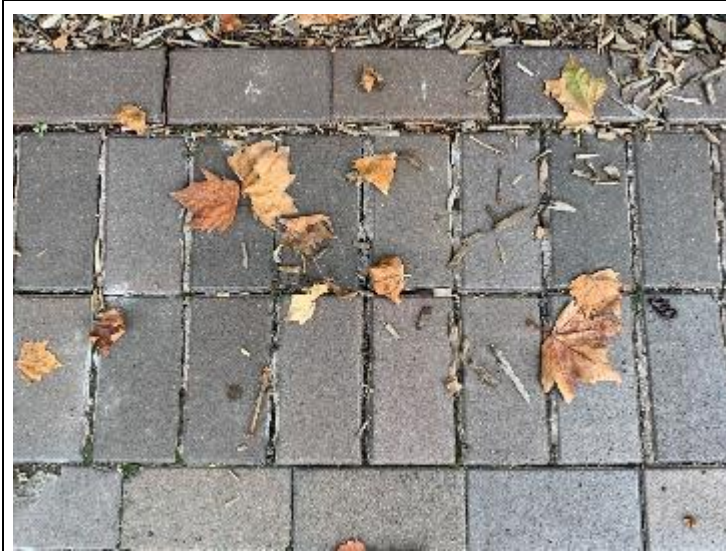
<p><b>Photograph 2.NW.60</b></p> <p><u>North Walkway - Workshop 1</u> <u>Minor</u></p> <p>Upheaval of the pavers in front of the light pole.</p> <p>Photographed looking south-east.</p>

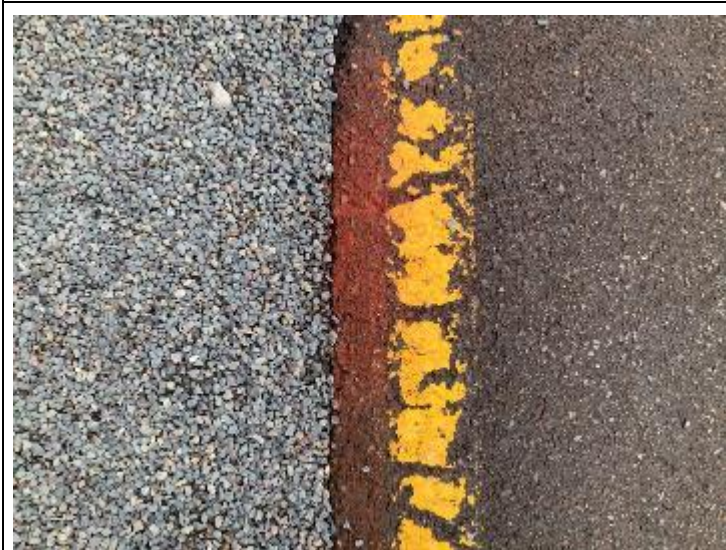
**Photograph 2.NW.62**

Outside Workshop 7  
(Formerly Workshop 8)  
General Photograph

General photograph of the road base and newly laid concrete slab.
