Mirvac Projects Pty Ltd  
Hazardous Materials Survey  
Locomotive Workshop Building  
Australian Technology Park

2 Locomotive Street  
Eveleigh, NSW

9 August 2017

51142-110236 (Rev A)  
JBS&G Australia Pty Ltd

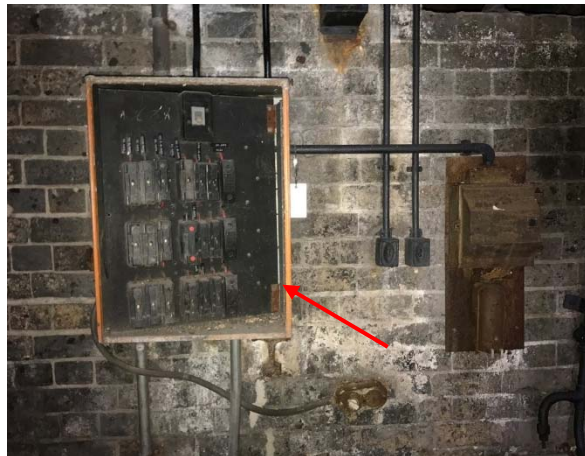
Photo 5: Exterior – Boiler House, suspected asbestos containing electrical backing board and lead based orange paint to fuse box, north wall

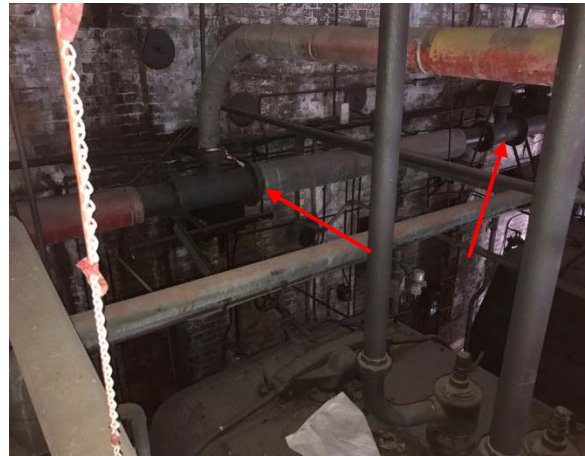
Photo 8: Exterior – Boiler House, old, unrestored boiler pipework assumed to contain asbestos gaskets

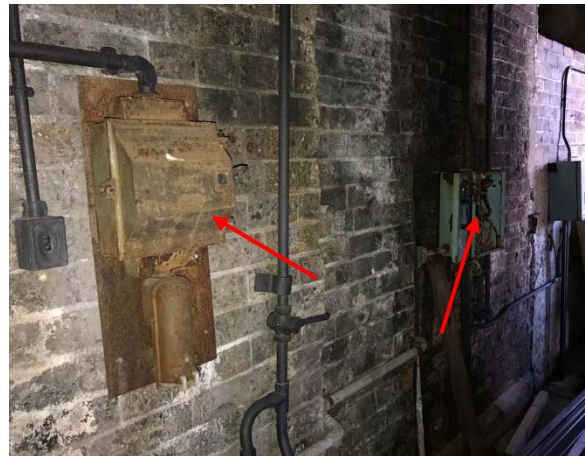
Photo 11: Exterior – SE Annex & Boiler House, XRF screening of old electrical boxes identified lead based paint. Potential ACM may be present in boxes that could not be opened at the time of inspection.

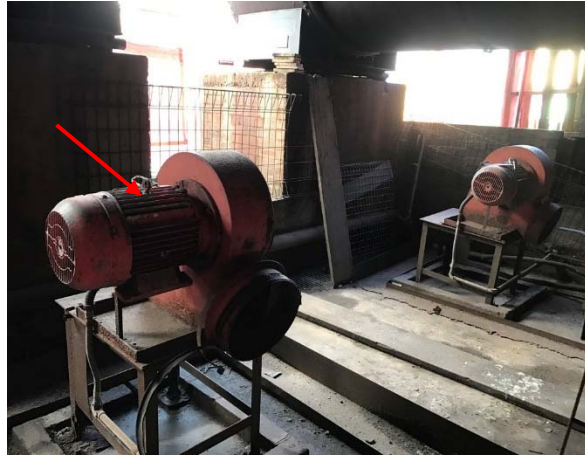
Photo 14: Exterior – Boiler House, XRF screening of the orange boiler gaskets identified lead based paint

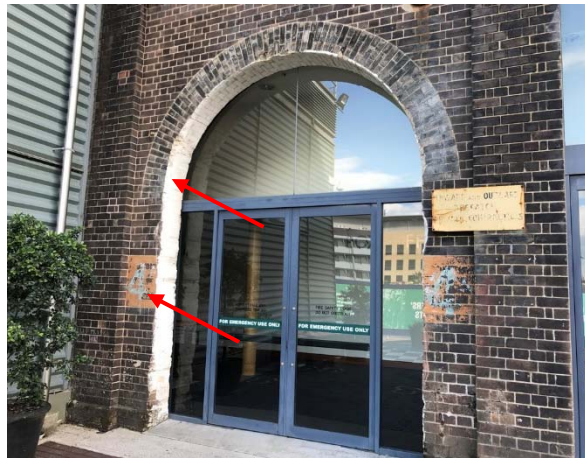
Photo 17: Exterior – North & south walls, XRF screening of residual white paint around brick archways and old orange and white bay number signs identified lead based paint

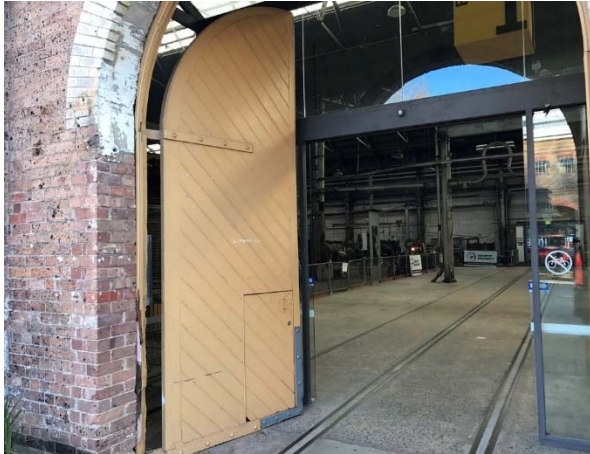
Photo 19: Exterior – East wall, XRF screening of the mustard coloured central door identified lead based paint

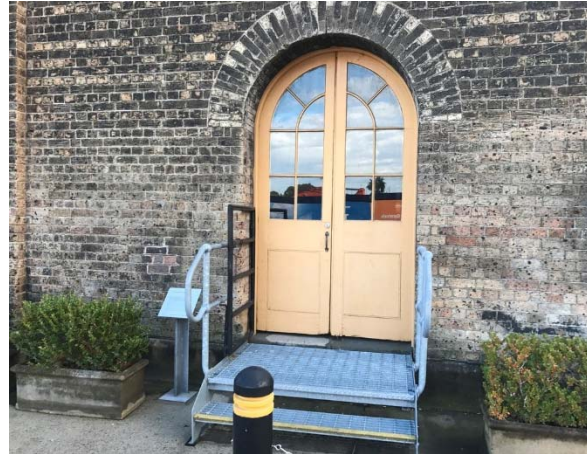
Photo 20: Exterior – Bay 3 south wall, XRF screening of the mustard coloured timber arched doors identified lead based paint

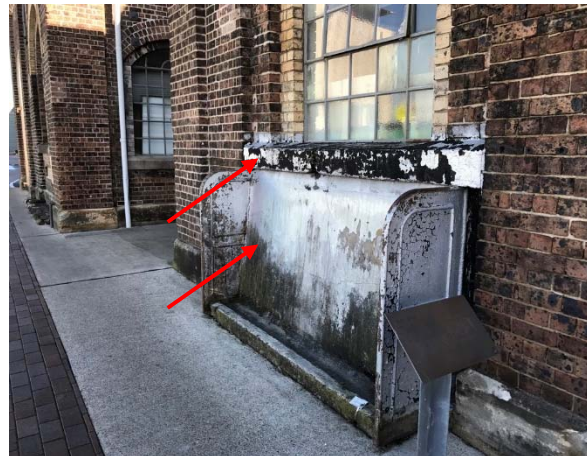
Photo 23: Exterior – Bay 9 south, XRF screening of the silver external urinal and overlying window sill identified lead based paint

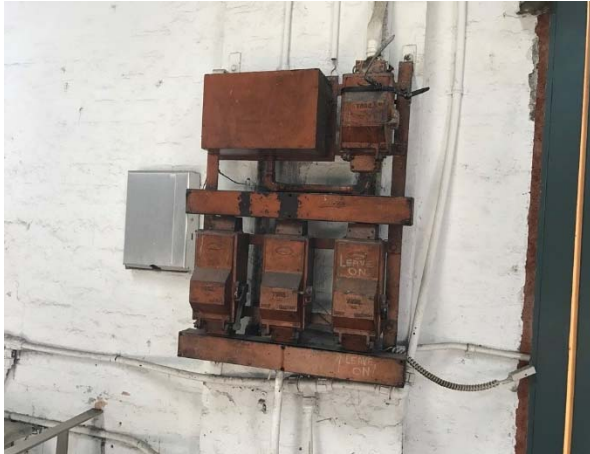
Photo 25: Bay 1 north - Fuse box compartments on north wall contain asbestos paper linings (friable)

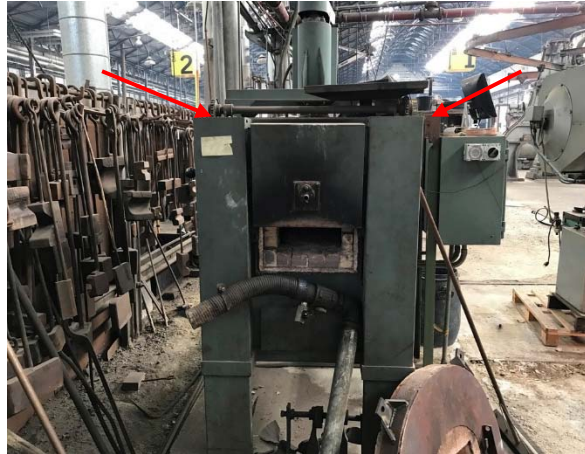
Photo 26: Bay 1 south - The top seal on the HC Thornthwaite Furnace is woven asbestos (friable)

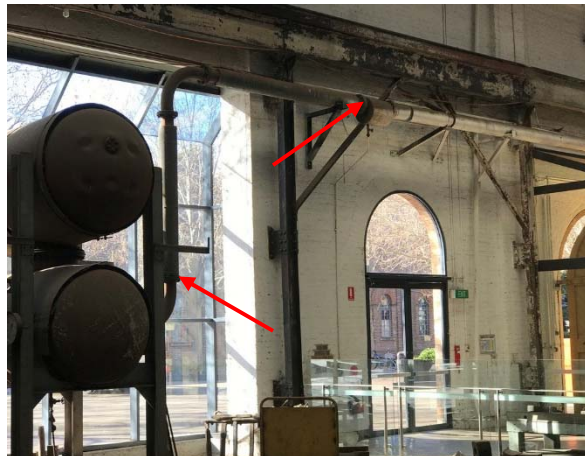
Photo 29: Bay 1 - Non-rubberised gaskets associated with the Davy water feed pipe contain asbestos based gaskets

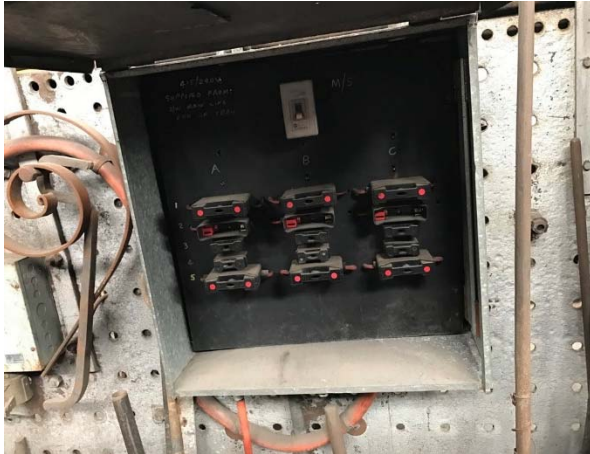
Photo 31: Bay 1 south - Two old black electrical board in the central west of Bay 1 south are presumed to contain asbestos

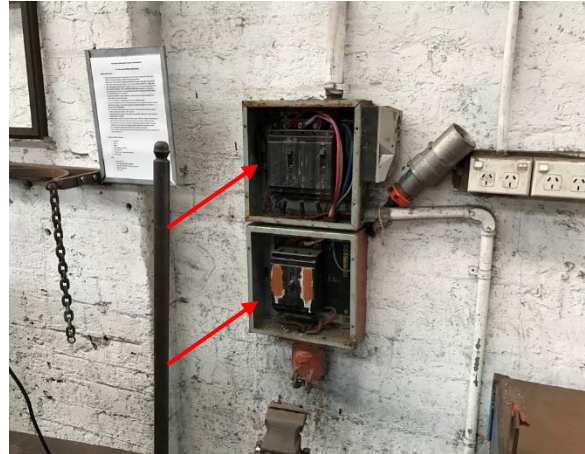
Photo 32: Bay 1 south - Two old black electrical board in the central east of Bay 1 south are presumed to contain asbestos

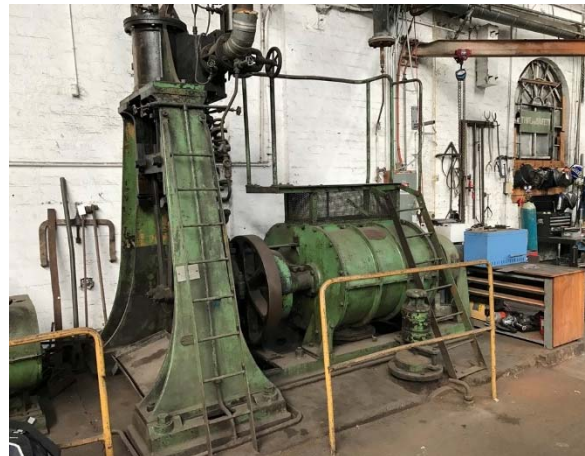
Photo 35: Bay 1 south - The green Blower No.6 contains lead based paint

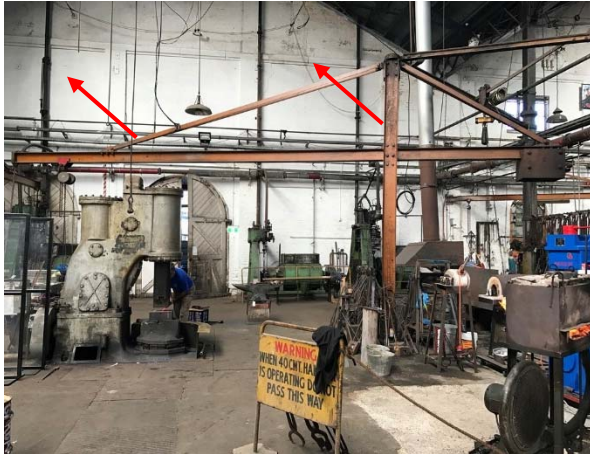
Photo 37: Bays 1 & 2 – All walls, older patchy undercoats concealed beneath the white surface coat may contain lead based paint

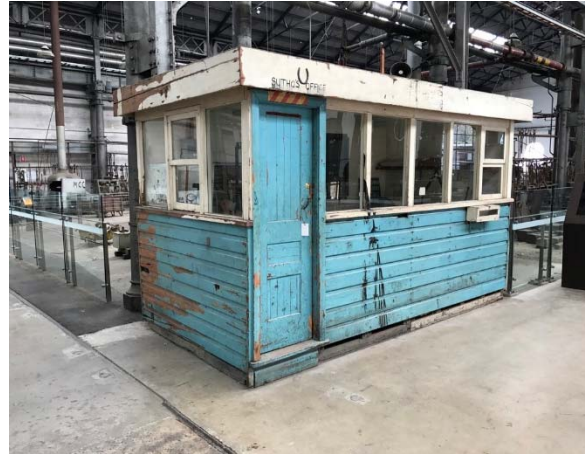
Photo 38: Bay 1 north - XRF screening of the blue Sub Foreman's Office identified lead based paint.

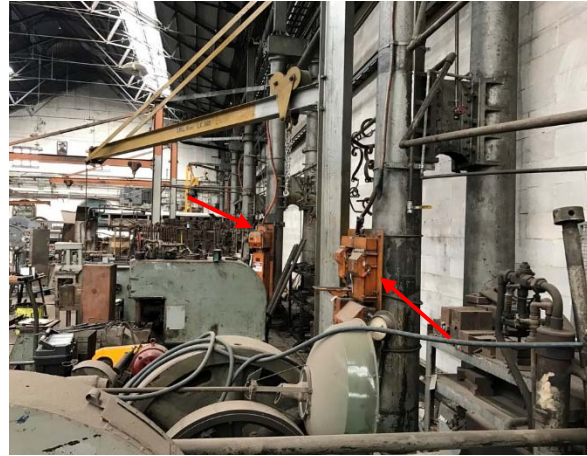
Photo 44: Bay 2 - Several electrical boxes in Bay 2 contain backing boards assumed to contain asbestos. Some of the boxes could not be opened at the time of inspection

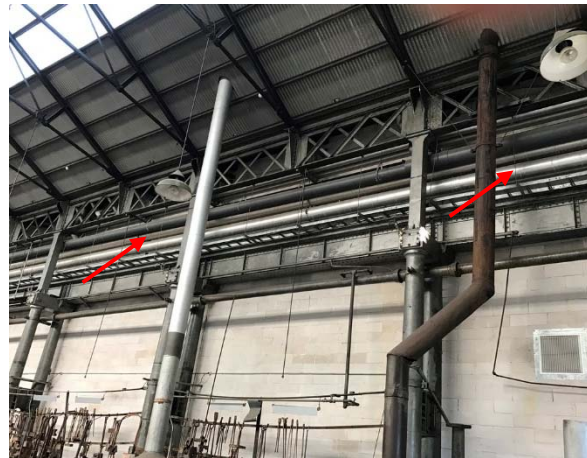
Photo 47: Bay 2 - Old pipework associated with the former steam plant may contain asbestos gaskets. Old and new pipework traversing the upper walls of the bay is insulated with SMF

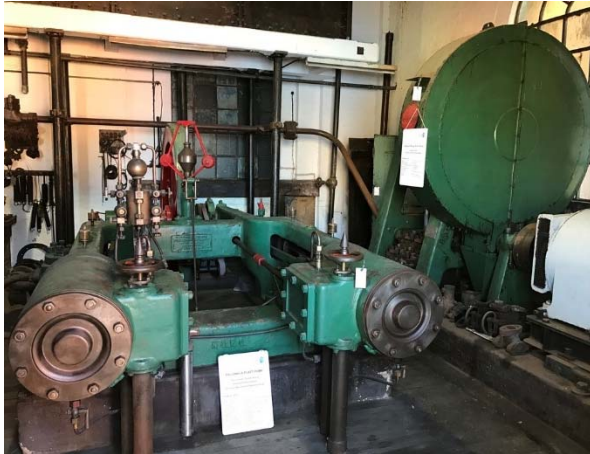
Photo 49: Bay 3 south, Pump House – The green Fielding & Platt steam and electric pumps in the southern Pump House annex, contain lead based paint

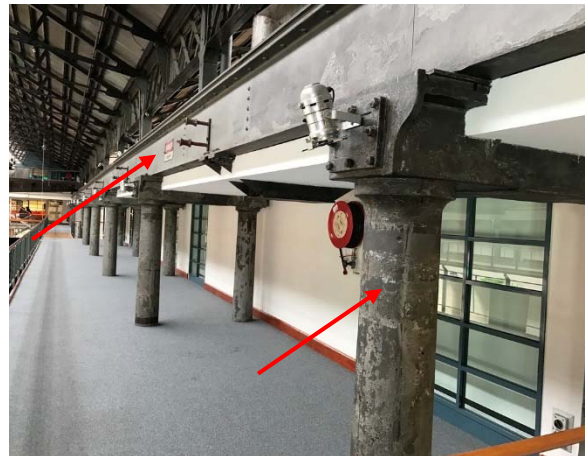
Photo 53: Bay 4 – Structural steel columns, beams and trusses throughout the bay contain lead based paint

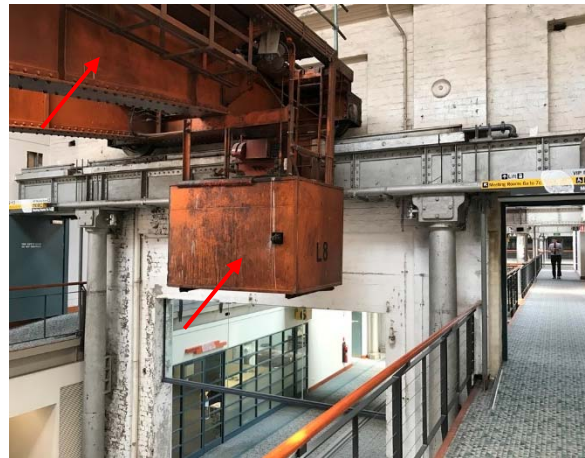
Photo 59: Bay 5 - XRF screening of the orange overhead travelling crane identified lead based paint

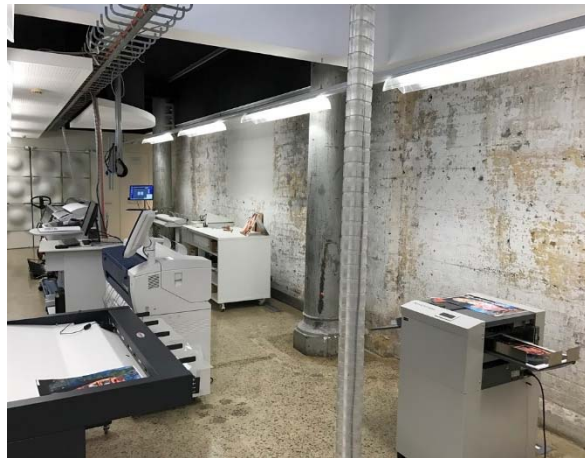
Photo 65: Bay 6 – All walls, older patchy undercoats concealed beneath the white surface coat may contain lead based paint.

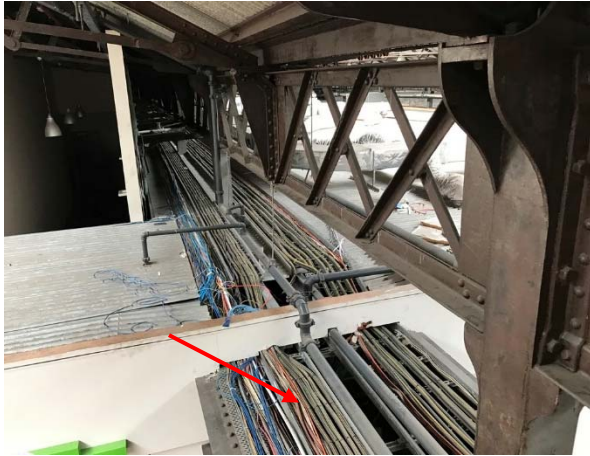
Photo 67: Bay 6 – A lead dust swab sample collected from the top of the cable tray above Central Road identified lead contaminated dusts.

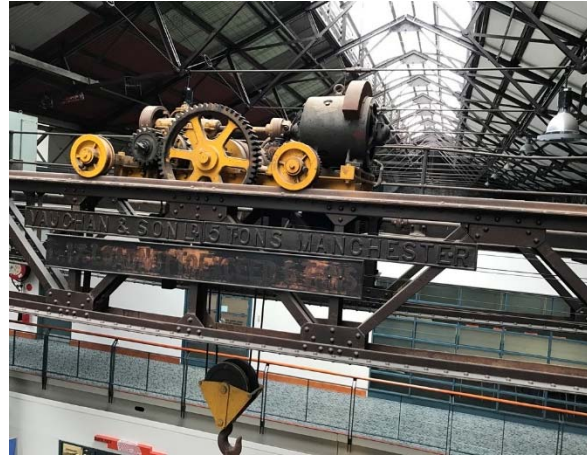
Photo 68: Bay 7 - XRF screening of the overhead travelling crane identified lead based paints. Electrical boards in the operators cabin and brake pads associated with the crane winch gear are presumed to contain asbestos.

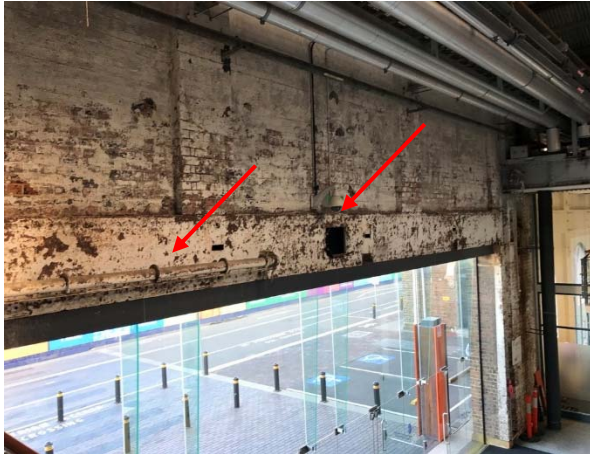
Photo 73: Bay 8 – Lead dust samples collected from the top of the lintel beam above the southern entry doors identified lead contaminated dusts. The off-white paint on the lintel beam is lead based paint.

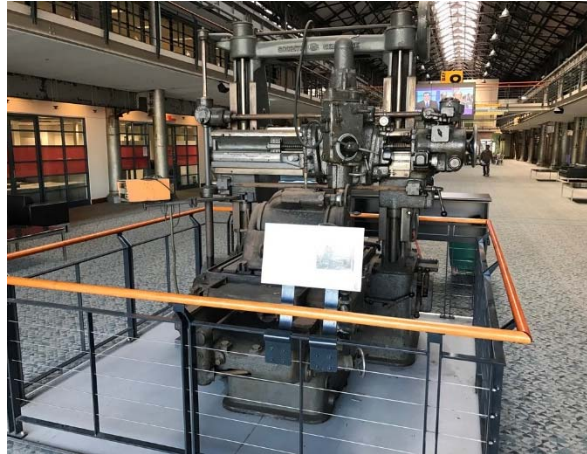
Photo 74: Bay 8 - XRF screening of the green Genevoise Drilling and Boring machines (1925 & 1938) identified lead based paints

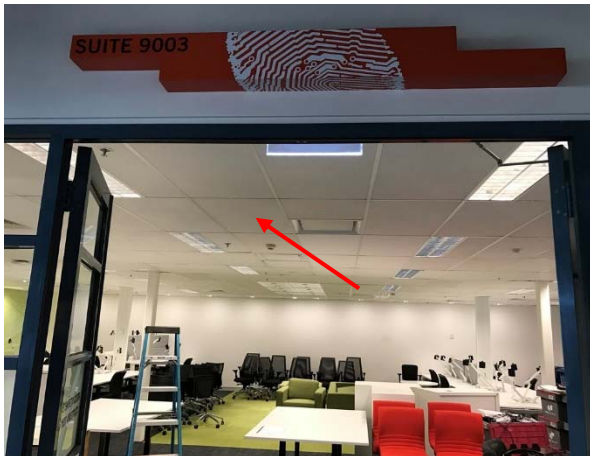
Photo 76: Bay 9 – Ceiling tiles in offices and amenities throughout the bay contain SMF

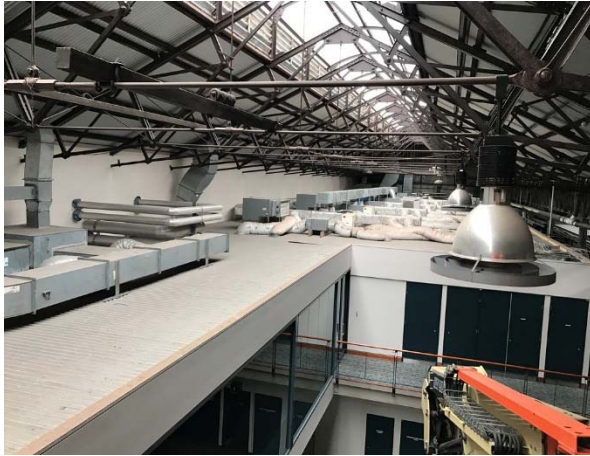
Photo 79: Bay 9 – Lead dust samples collected from the top of the roof of the northern office block identified lead contaminated dusts. XRF screening of heritage structural steel columns, capitals, beams, downpipes, purlins, crane rails and roof trusses throughout the bay identified lead based paints.

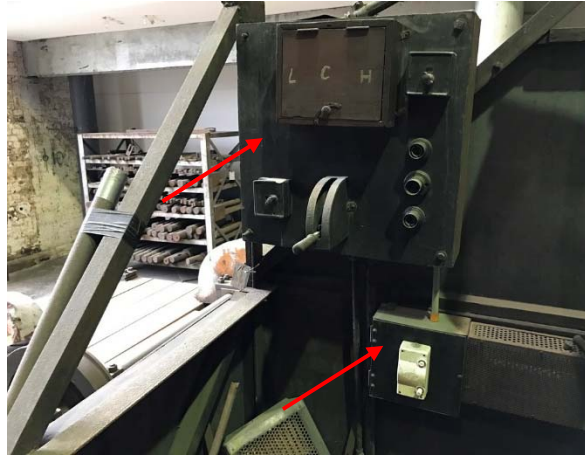
Photo 80: Bay 10 north - Two black electrical boards crane operators cabin in the northern display area are presumed to contain asbestos

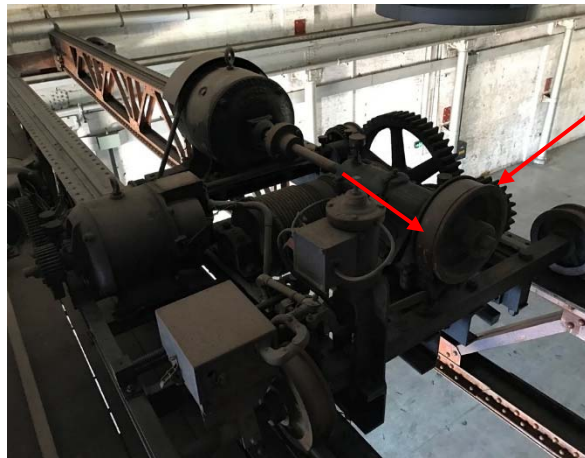
Photo 83: Bays 10 - 14 – Brake pads associated with winch gear for the overhead travelling cranes are presumed to contain asbestos

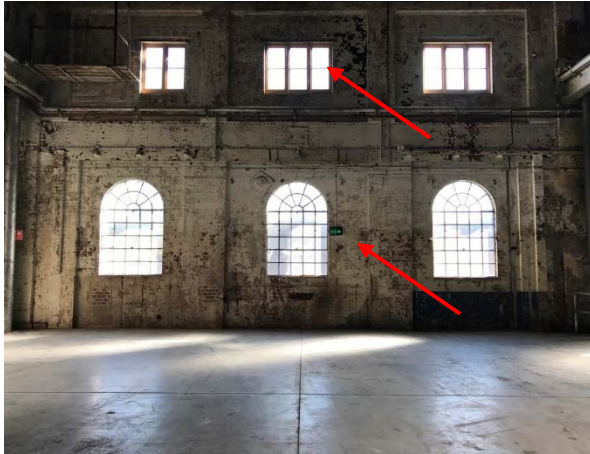
Photo 85: Bays 10 - 14 – All walls, older patchy undercoats concealed beneath the white surface coat may contain lead based paint. XRF screening of the mustard rectangular timber windows located on the upper north and south walls of the bays identified lead based paints.

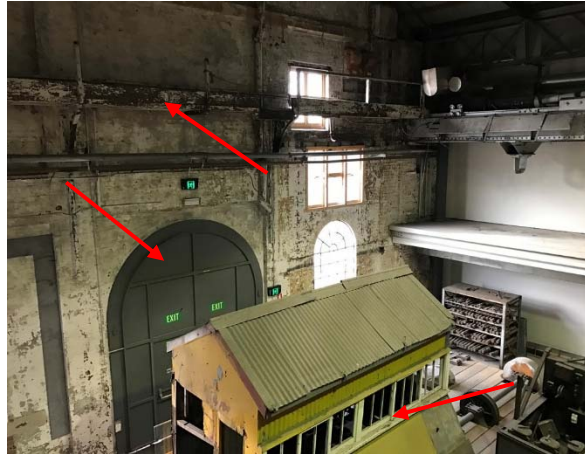
Photo 86: Bays 10 - 14 – XRF screening of the grey metal arched double door located in the bays identified lead based paints. XRF screening of the yellow crane operators cabin in the display area of Bay 10 identified lead based paints.

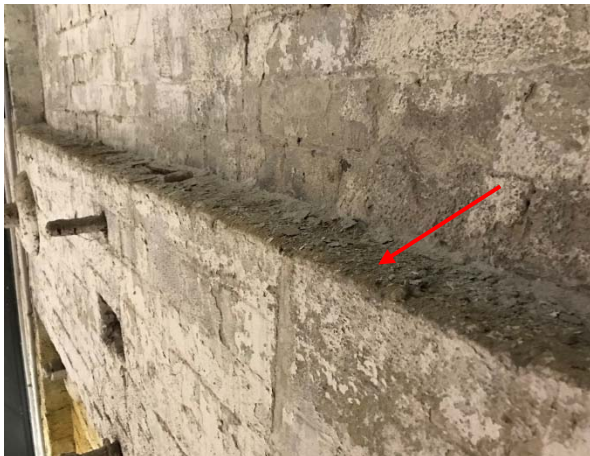
Photo 88: Bay 11 – A lead dust sample collected from the upper northern wall ledge of Bay 11 identified lead contaminated dusts. Accumulated dust and debris is typical on upper wall ledged throughout Bays 10 - 14.

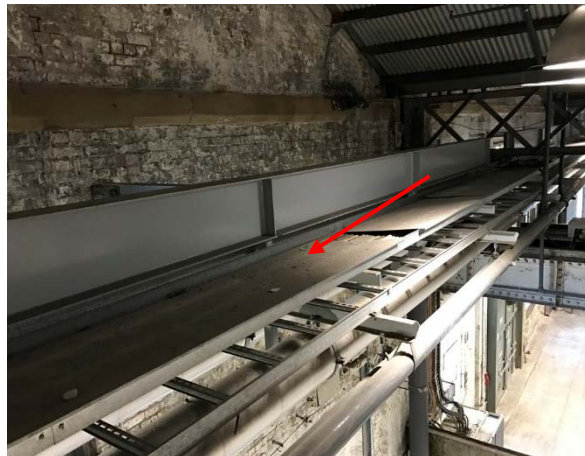
Photo 89: Bay 13 – A lead dust sample collected from the main cable tray above the upper southern wall of Bay 13 identified lead contaminated dusts. This cable tray traverses Bays 10 - 14.

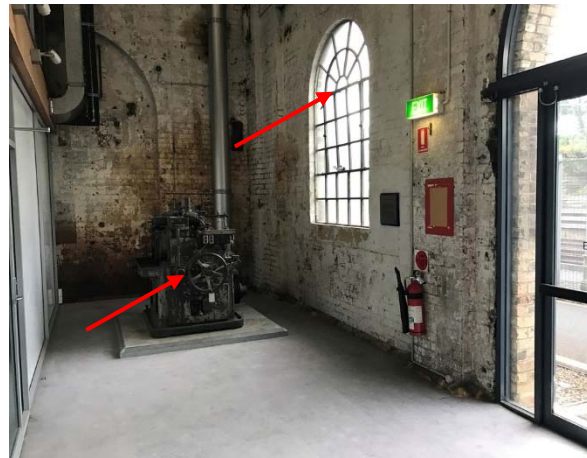
Photo 95: Bay 15 – Analysis and XRF screening of off-white arched heritage window frame on the northern wall and the majority of heritage machinery on display throughout the bay identified lead based paints

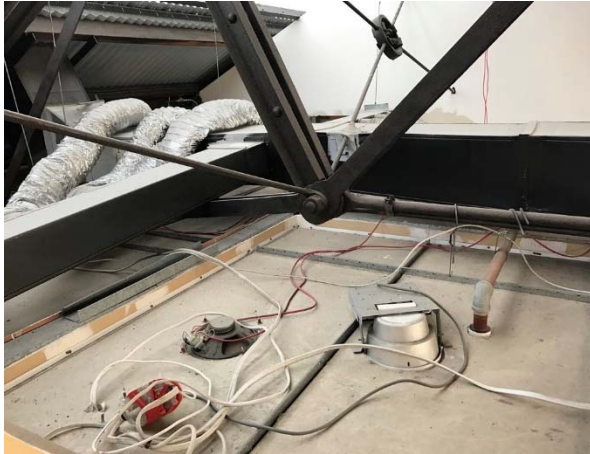
Photo 97: Bay 15 – A lead dust sample collected from the flat roof of the northern office amenities area identified lead contaminated dusts.

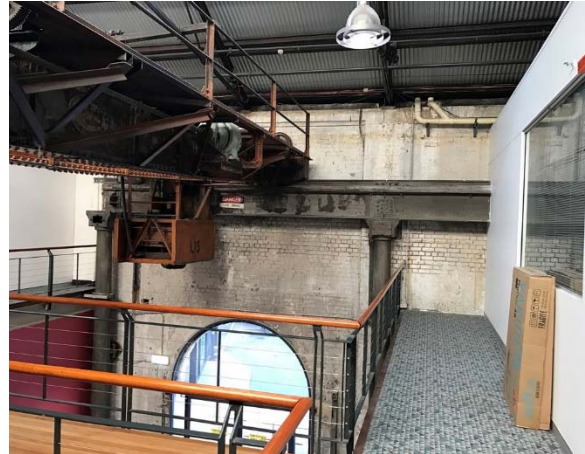
Photo 98: Bay 16 – XRF screening of the overhead travelling crane identified lead based paints. Electrical boards and brake pads associated with the crane are presumed to contain asbestos.

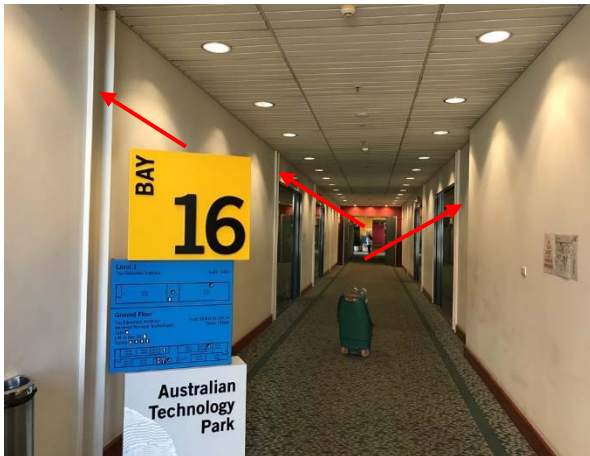
Photo 100: Bay 16 – XRF screening of the white RSJ stanchions in the ground level central hallway of Bay 16 south identified lead based paint

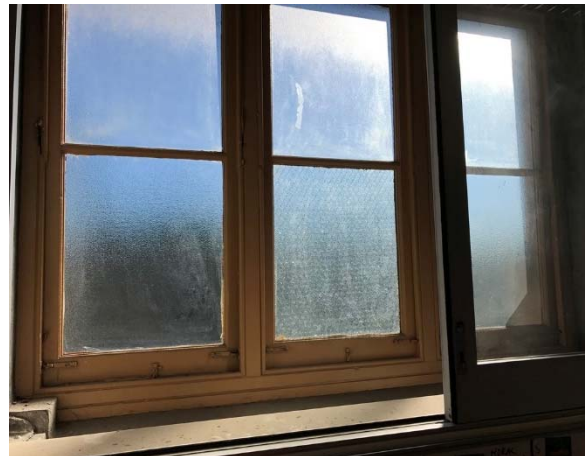
Photo 101: Bay 16 – XRF screening of the mustard coloured rectangular timber windows on Level 1 identified lead based paint
