# AMENDED TREE REMOVAL & PRUNING APPLICATION REPORT

Innovation Plaza - Australian Technology Park,  
Redfern 27.7.2018.

Prepared by Lee Hancock Consulting Arborist AQF Level 5  
[lee@leehancockarborist.com.au](mailto:lee@leehancockarborist.com.au)

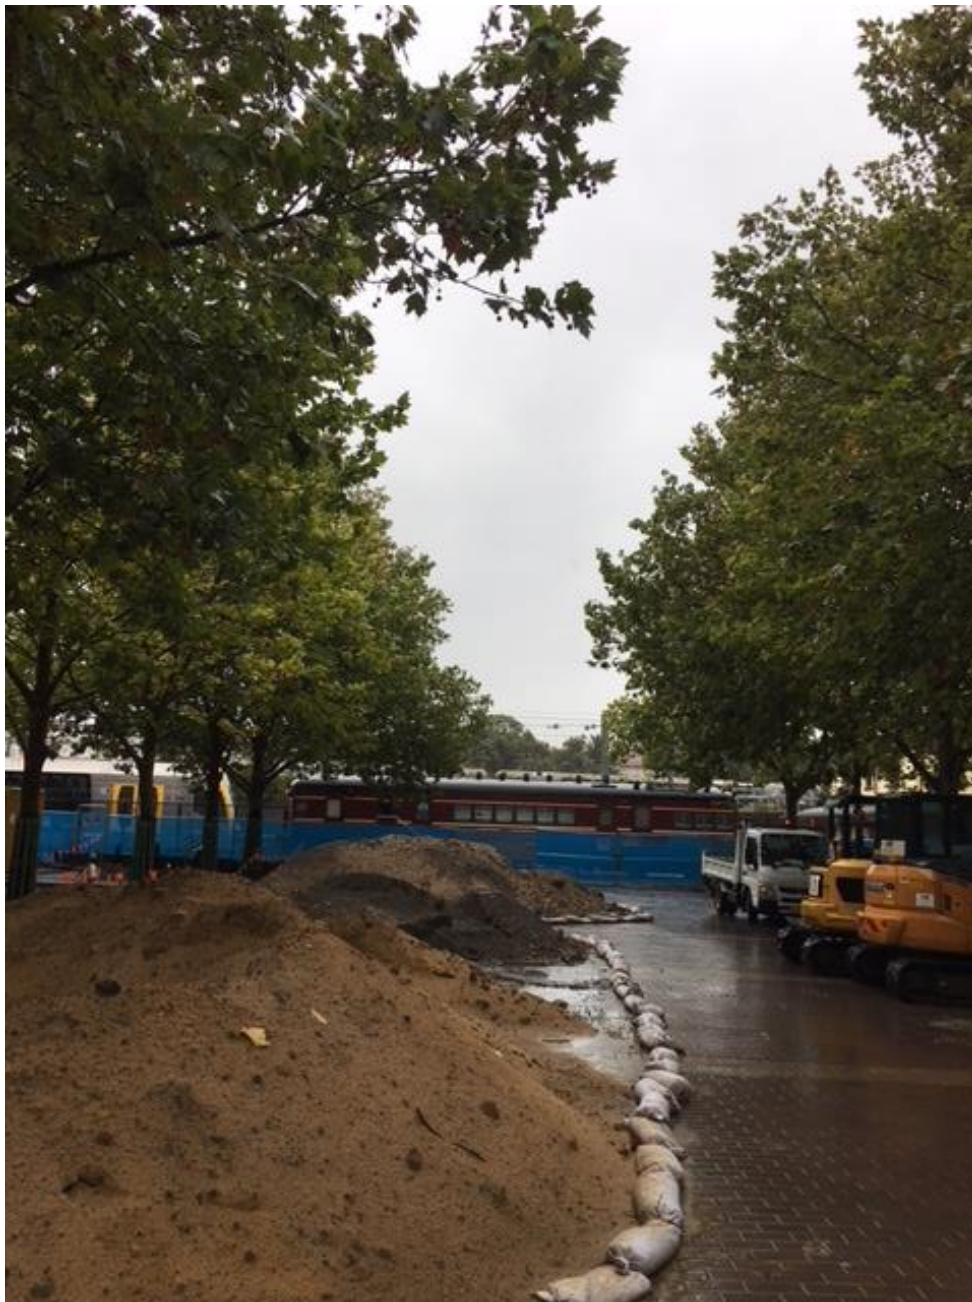
The subject trees 66 and 68 *Platanus x Hybrida*. (London Plane Tree) were assessed to be semi-mature specimens which are in good health and vigour, with sound structural branch attachments. The proposed delivery truck route to access the loading dock will impact upon the lower structural branches of trees 66 and 68. Selectively pruning the lower branches of trees 66 and 68 will minimise any mitigating issues relating to trunk and branch damage. Damage to trunk and branches leaving open wounds can predispose the tree to fungal infections or wood decay fungi.

Tree 66 . Red line indicates selective pruning of one branch.

The remaining London Plane trees 66 and 68 shall be selectively pruned by the project arborist. To attain clearance for vehicles. It is recommended that pruning lower branches to a height of 4.5m clearance. The maximum diameter of branches removed should not exceed 100mm in diameter.

Installation of ornamental tree guards around trees 66 and 68 is also recommended. Tree guards provide protection from acts of vandalism but in this scenario provide added protection from the trucks entering and leaving the dock.
